TECHNICAL REPORT CERC-85-8

# BREAKWATER REHABILITATION STUDY, CRESCENT CITY HARBOR, CALIFORNIA

## Coastal Model Investigation

November 1985

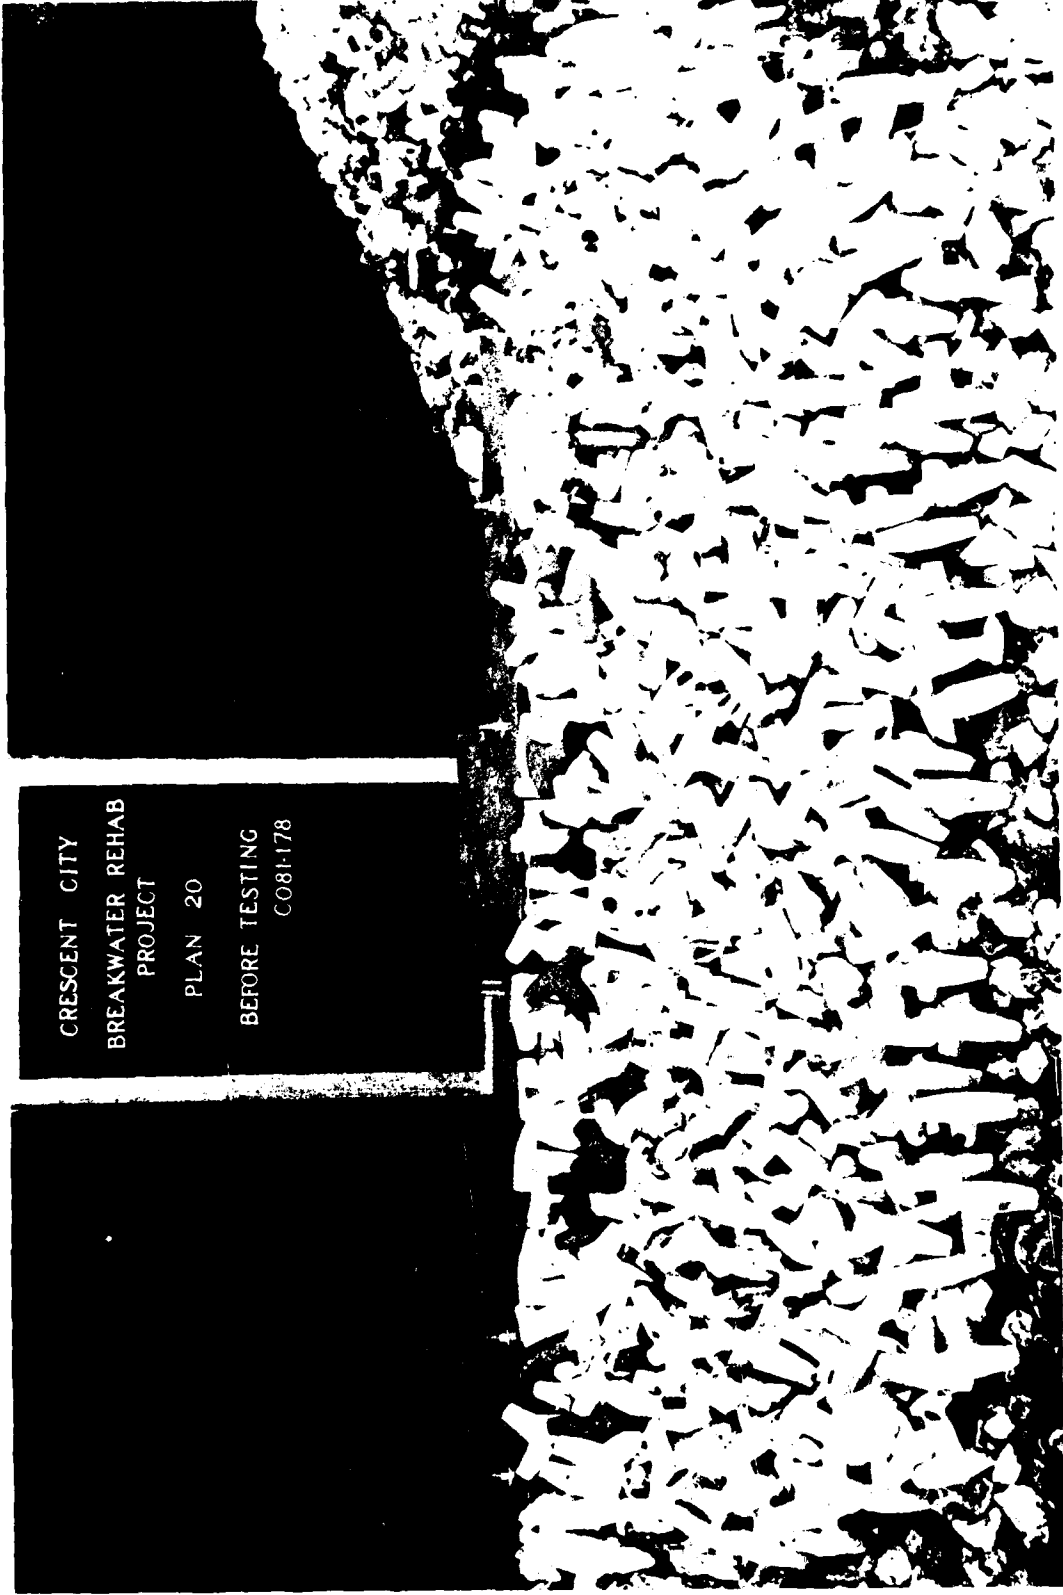
CRESCENT CITY  
BREAKWATER REHAB  
PROJECT  
PLAN 20  
BEFORE TESTING  
C081178

Photo 154. Sea-side view of Plan 20 before wave attack

50. Plan 20 (Plate 22 and Photos 154-156) had about the same area of coverage as Plan 18; however, 74 rehabilitation dolosse were removed and replaced with 82 37-ton tetrapods (37-ton tetrapods were used since this was the model size tetrapod available nearest to the 42-ton dolos size). The tetrapods were placed in one layer. It was thought that the tetrapods might be a more appropriate shape for interfacing the existing stone. A total of 334 42-ton dolosse were used. The tetrapods suffered extensive damage. There was minimum movement of the dolosse during the abbreviated hydrograph, but since they had lost the protection afforded by the tetrapods it is likely damage would have progressed to this area for a longer duration storm. Photos 157-159 show the structure after testing.

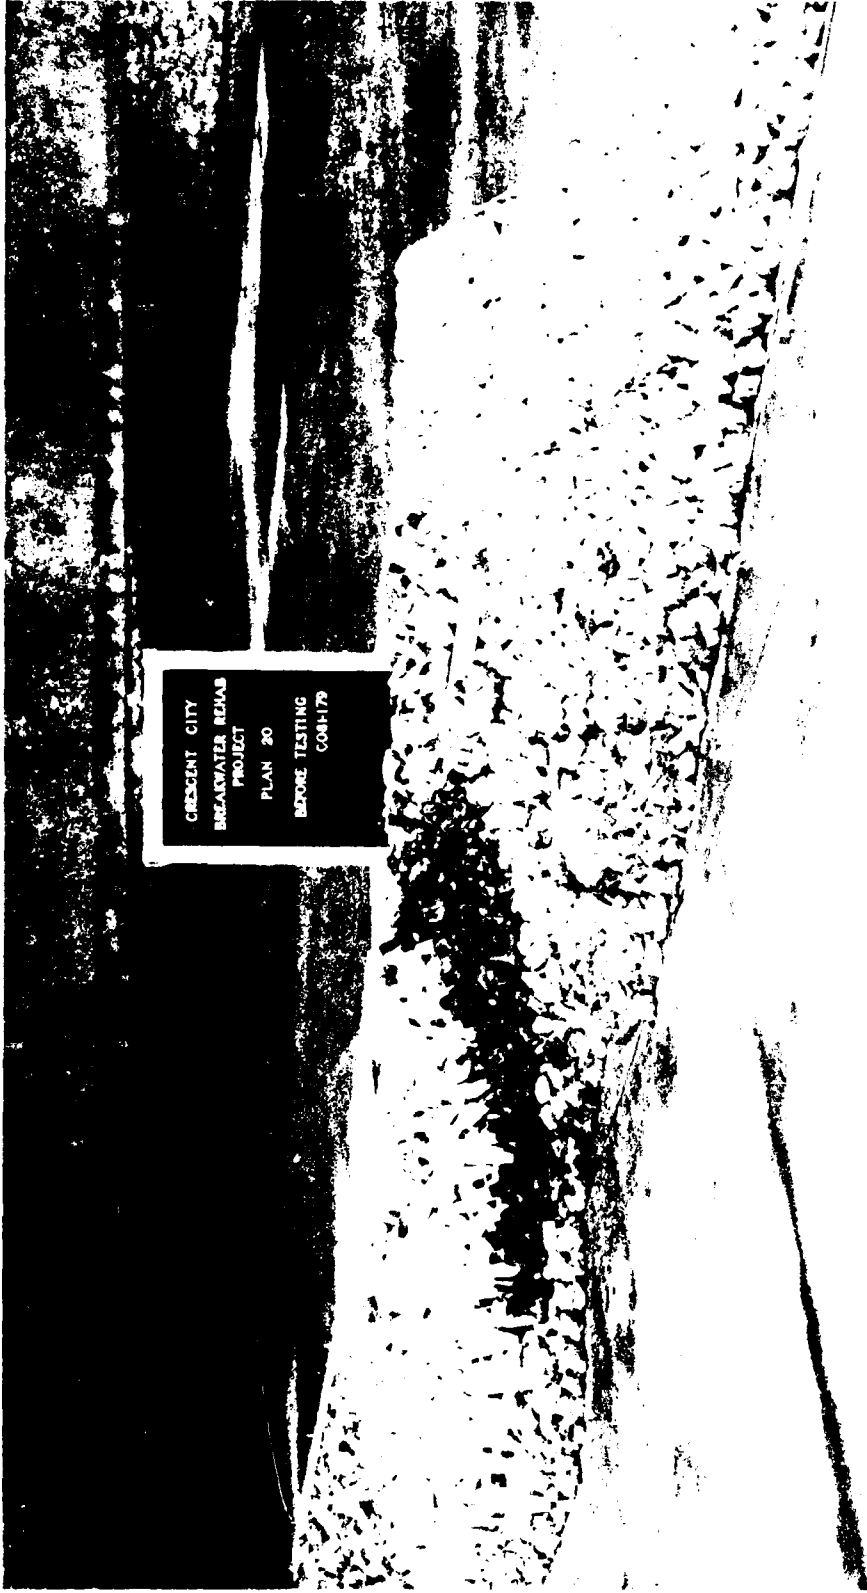
Photo 155. Seaward oblique view of Plan 20 before wave attack

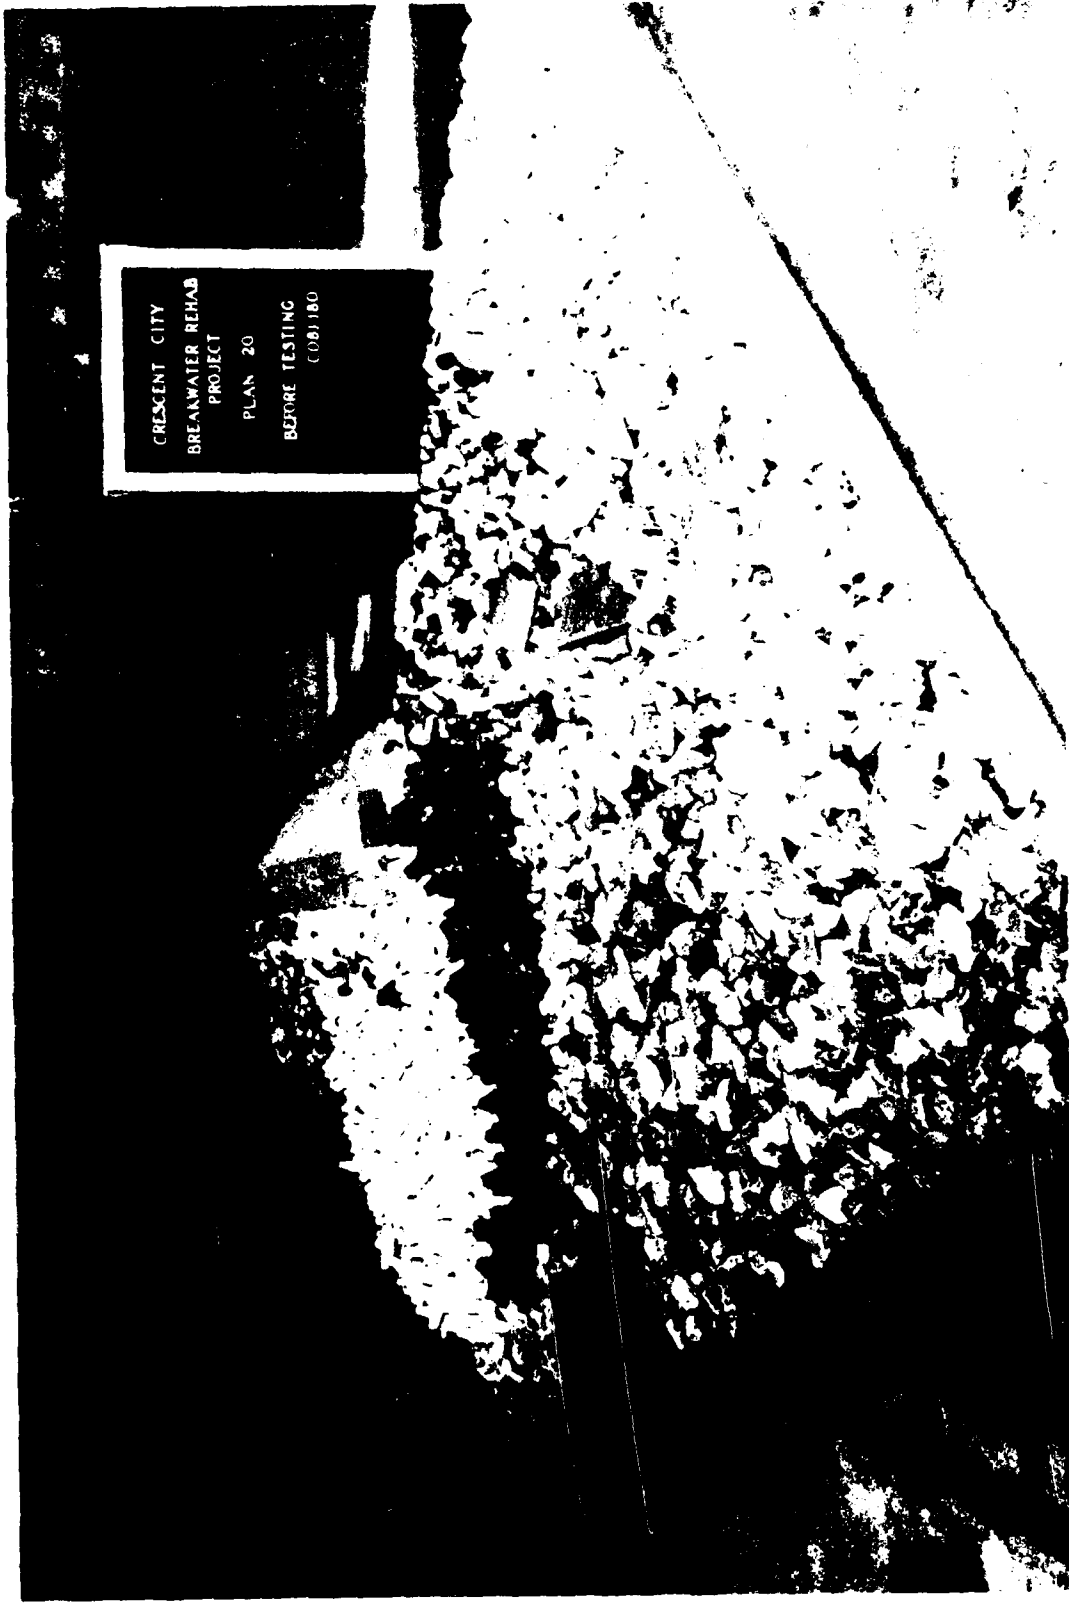
Photo 156. Seaward end view of Plan 20 before wave attack

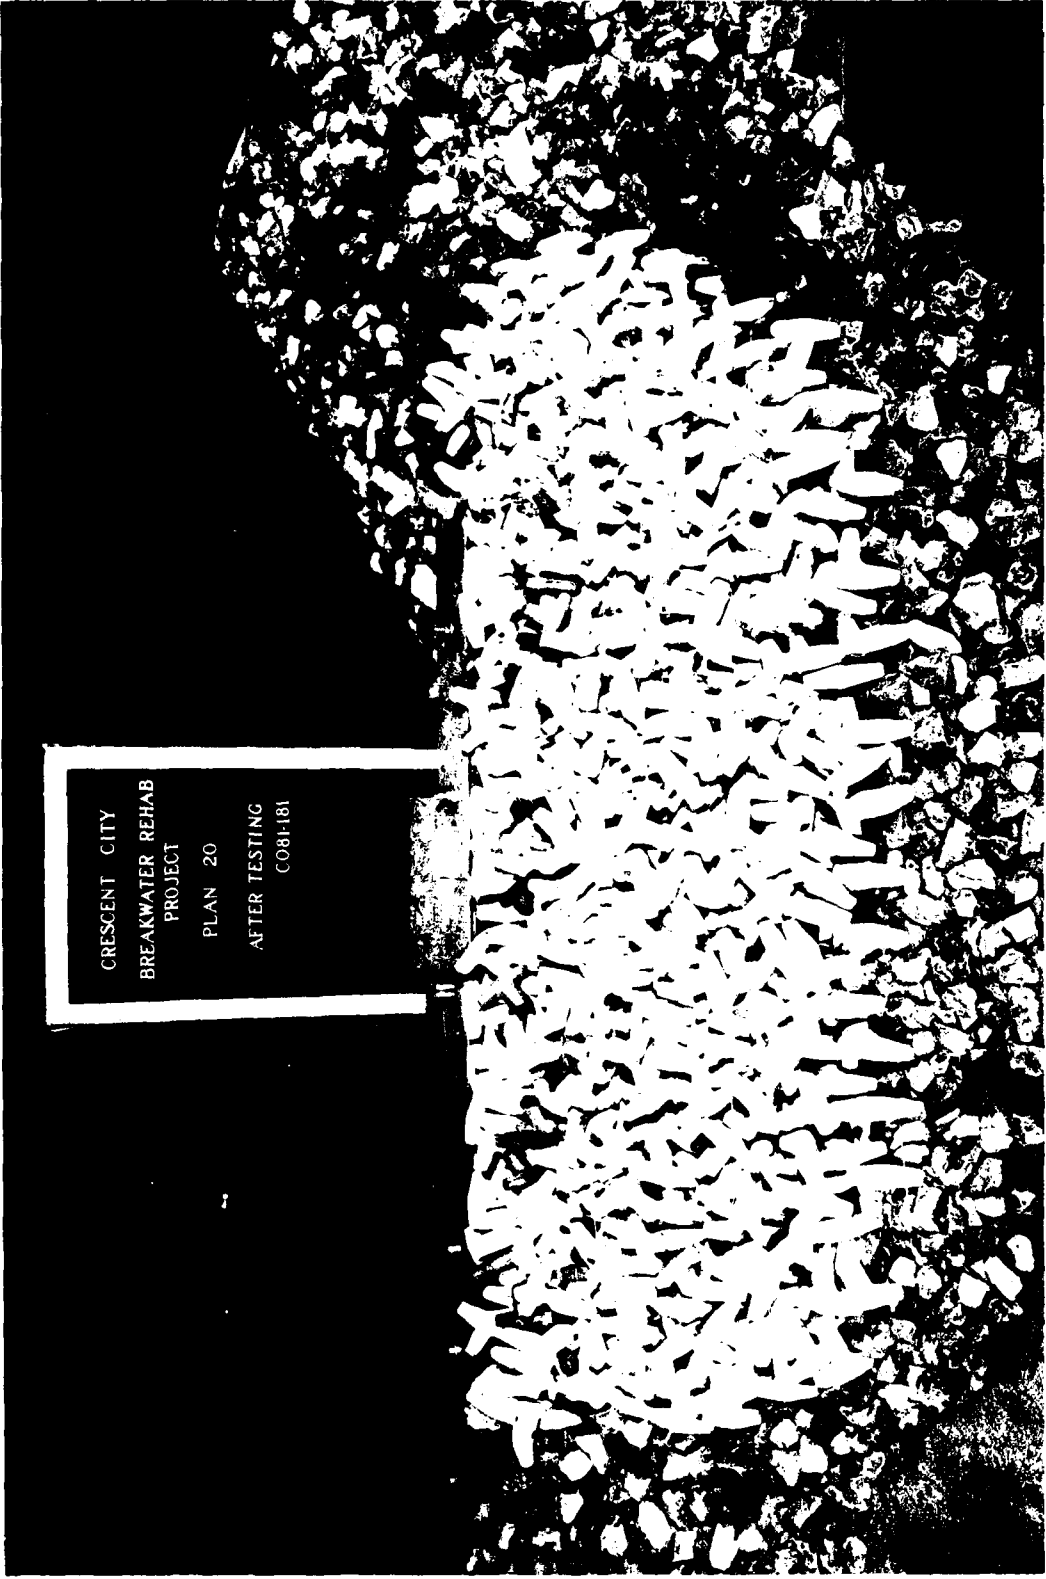
CRESCENT CITY  
BREAKWATER REHAB  
PROJECT  
PLAN 20  
AFTER TESTING  
C08H181

Photo 157. Sea-side view of Plan 20 after completion of abbreviated hydrograph

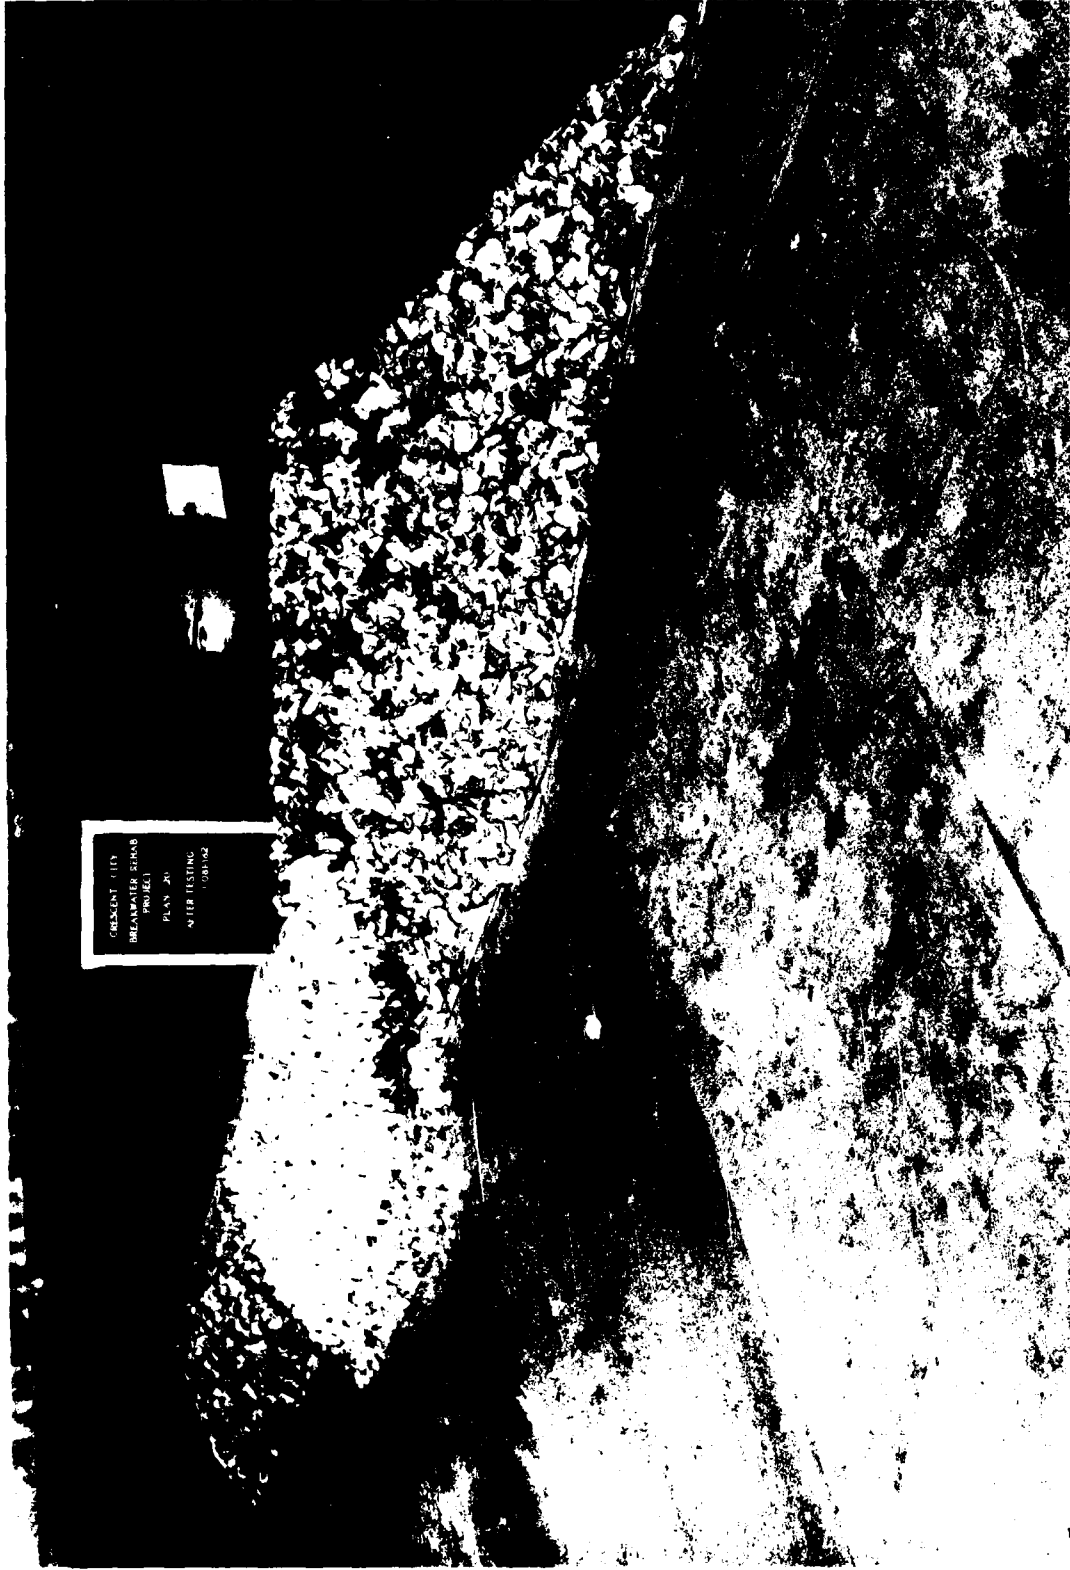
CRESCENT CITY  
BREAKWATER STAIRS  
PROJECT  
PLAN 20  
AFTER TESTING  
11/08/52

Photo 158. Seaward oblique view of Plan 20 after completion of abbreviated hydrograph

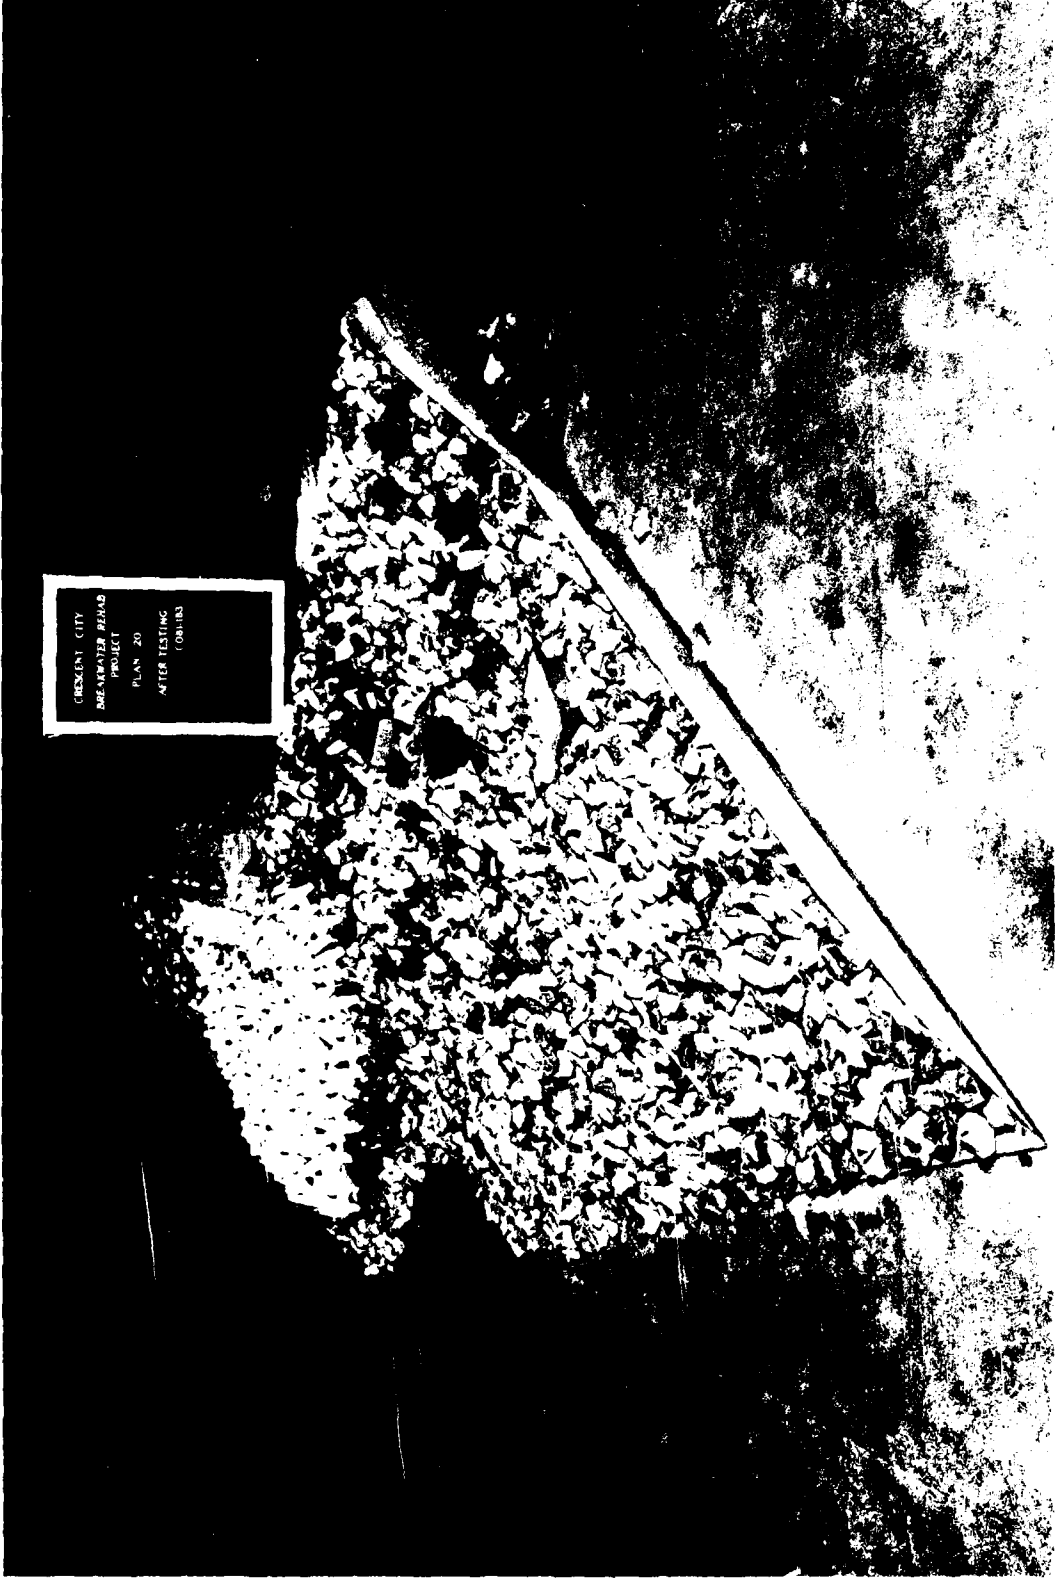
CHICKEN CITY  
SEAWATER HEAD  
PROJECT  
PLAN 20  
AFTER TESTING  
(08/18)

Photo 159. Seaward end view of Plan 20 after completion of abbreviated hydrograph

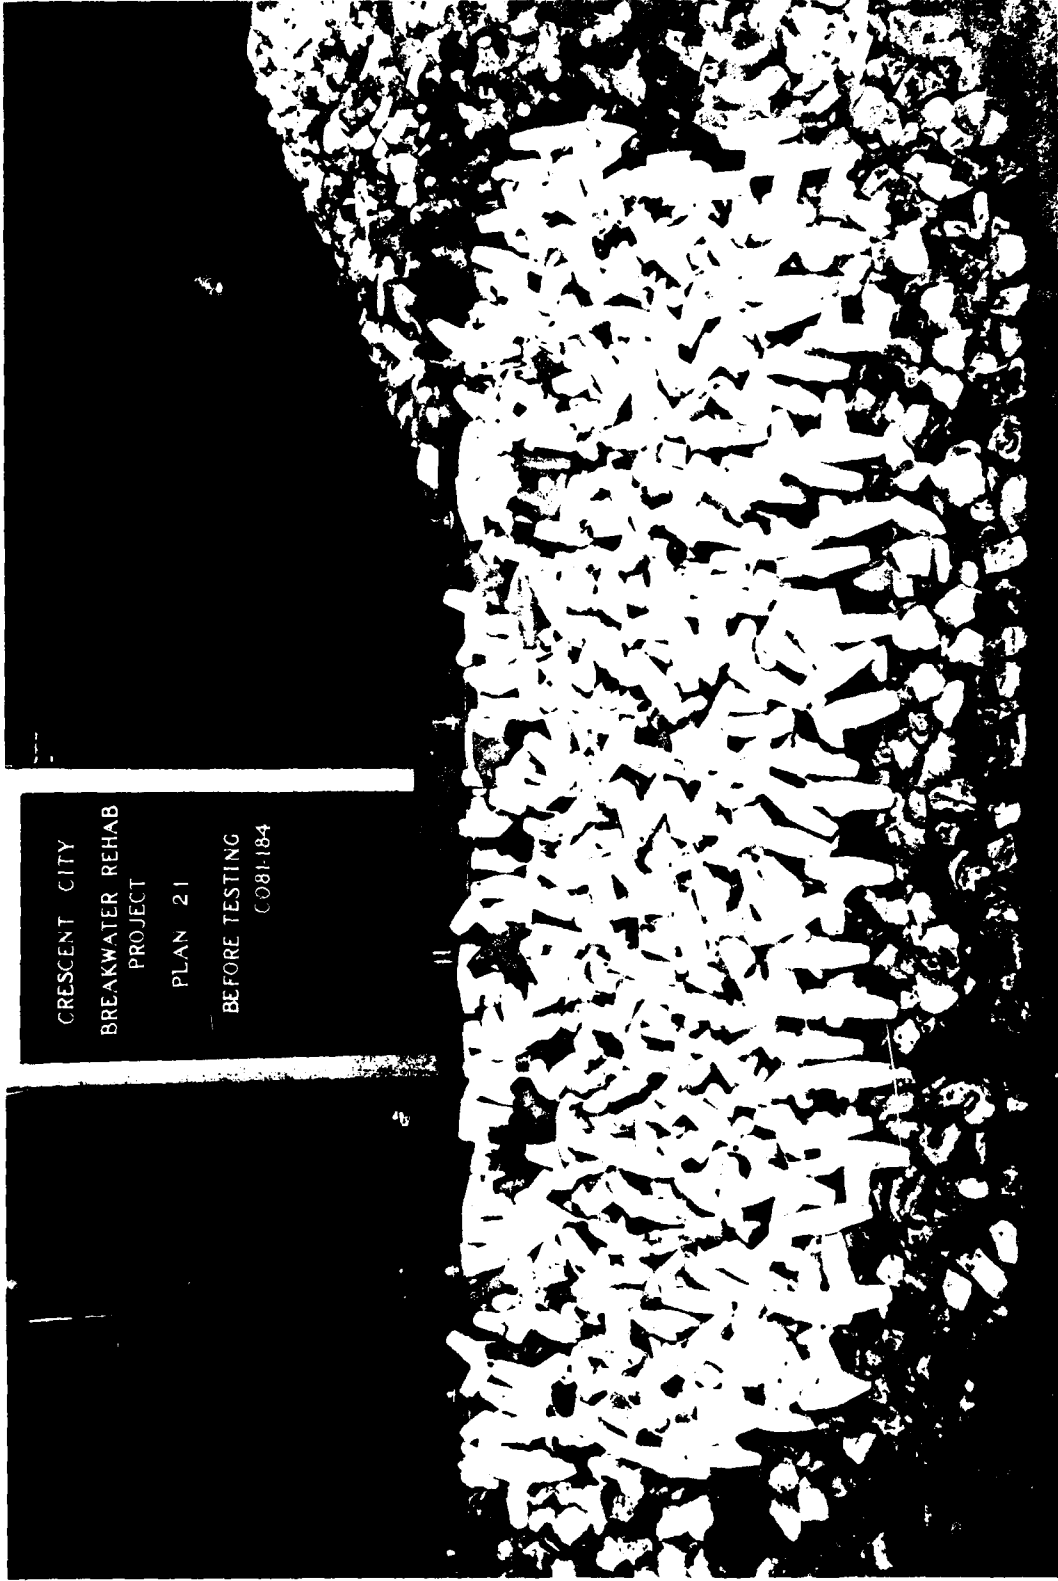
CRESCENT CITY  
BREAKWATER REHAB  
PROJECT  
PLAN 21  
BEFORE TESTING  
COB1184

Photo 160. Sea-side view of Plan 21 before wave attack

51. Plan 21 (Plate 23 and Photos 160-162) was similar to Plan 20, except more dolosse were replaced with tetrapods and the tetrapods were placed in two layers. A total of 304 42-ton rehabilitation dolosse and 116 37-ton tetrapods were used. The tetrapods sustained severe damage; damage progressed to the dolosse. Photos 163-165 show the structure after testing. Using tetrapods to stabilize the seaward transition was found to be unfeasible.

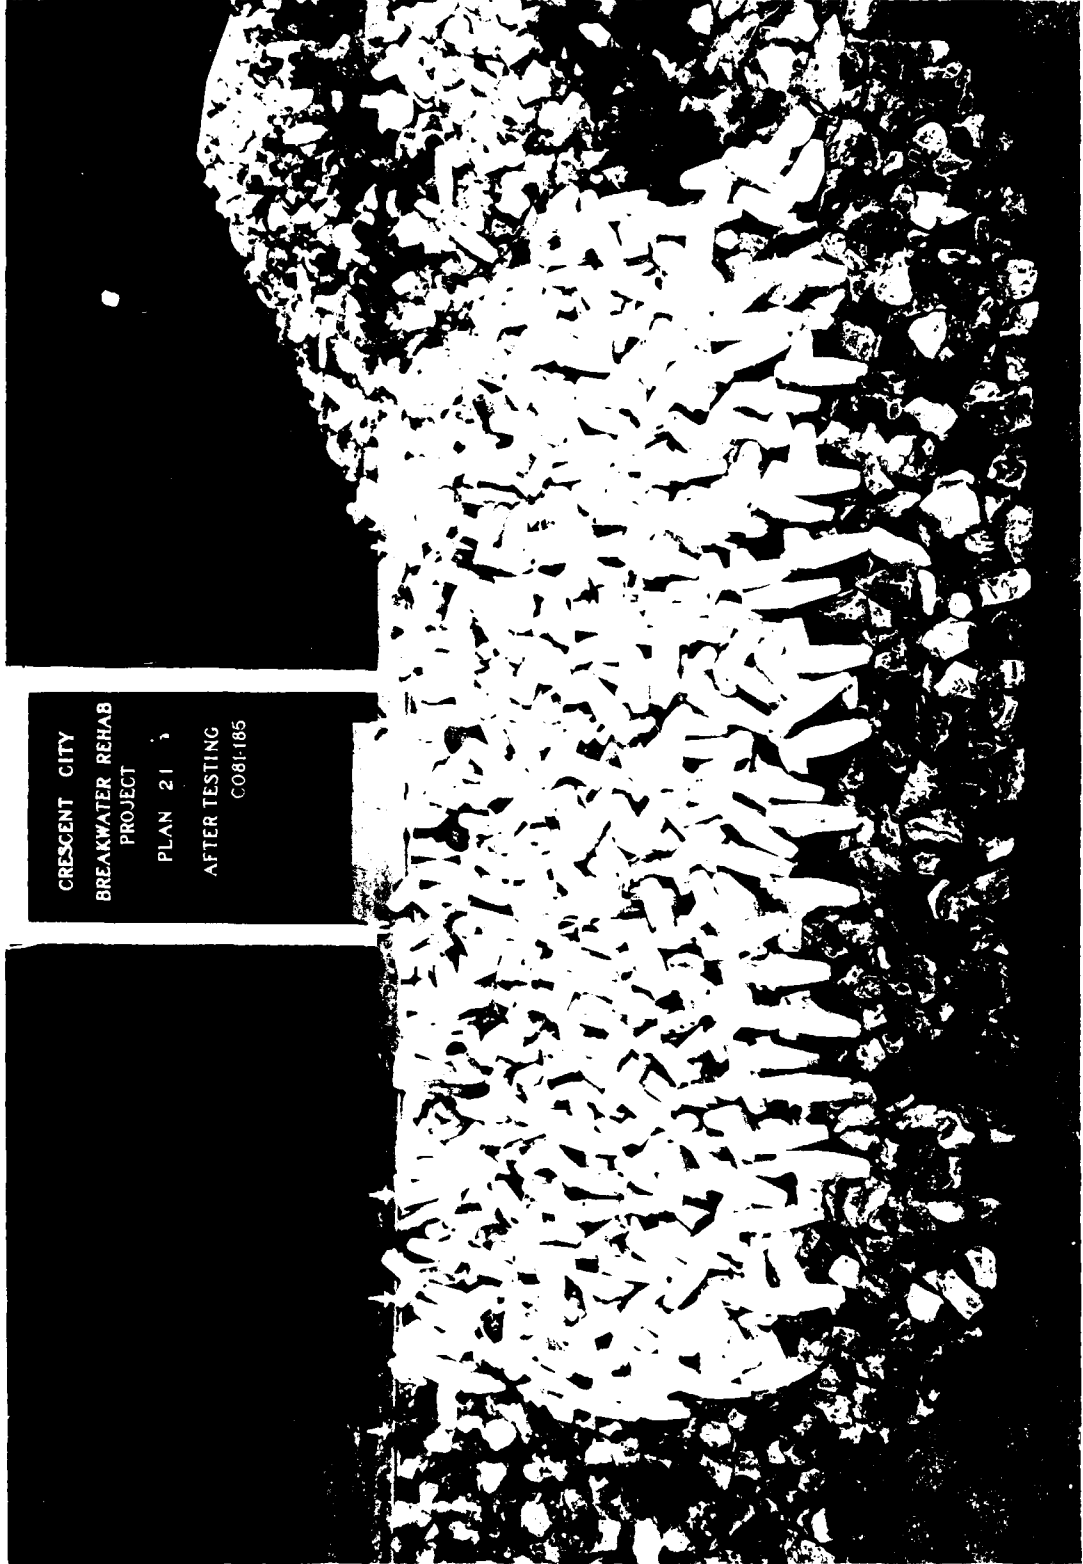
CRESCENT CITY  
BREAKWATER REHAB  
PROJECT  
PLAN 21  
AFTER TESTING  
C081185

Photo 161. Seaward oblique view of Plan 21 before wave attack

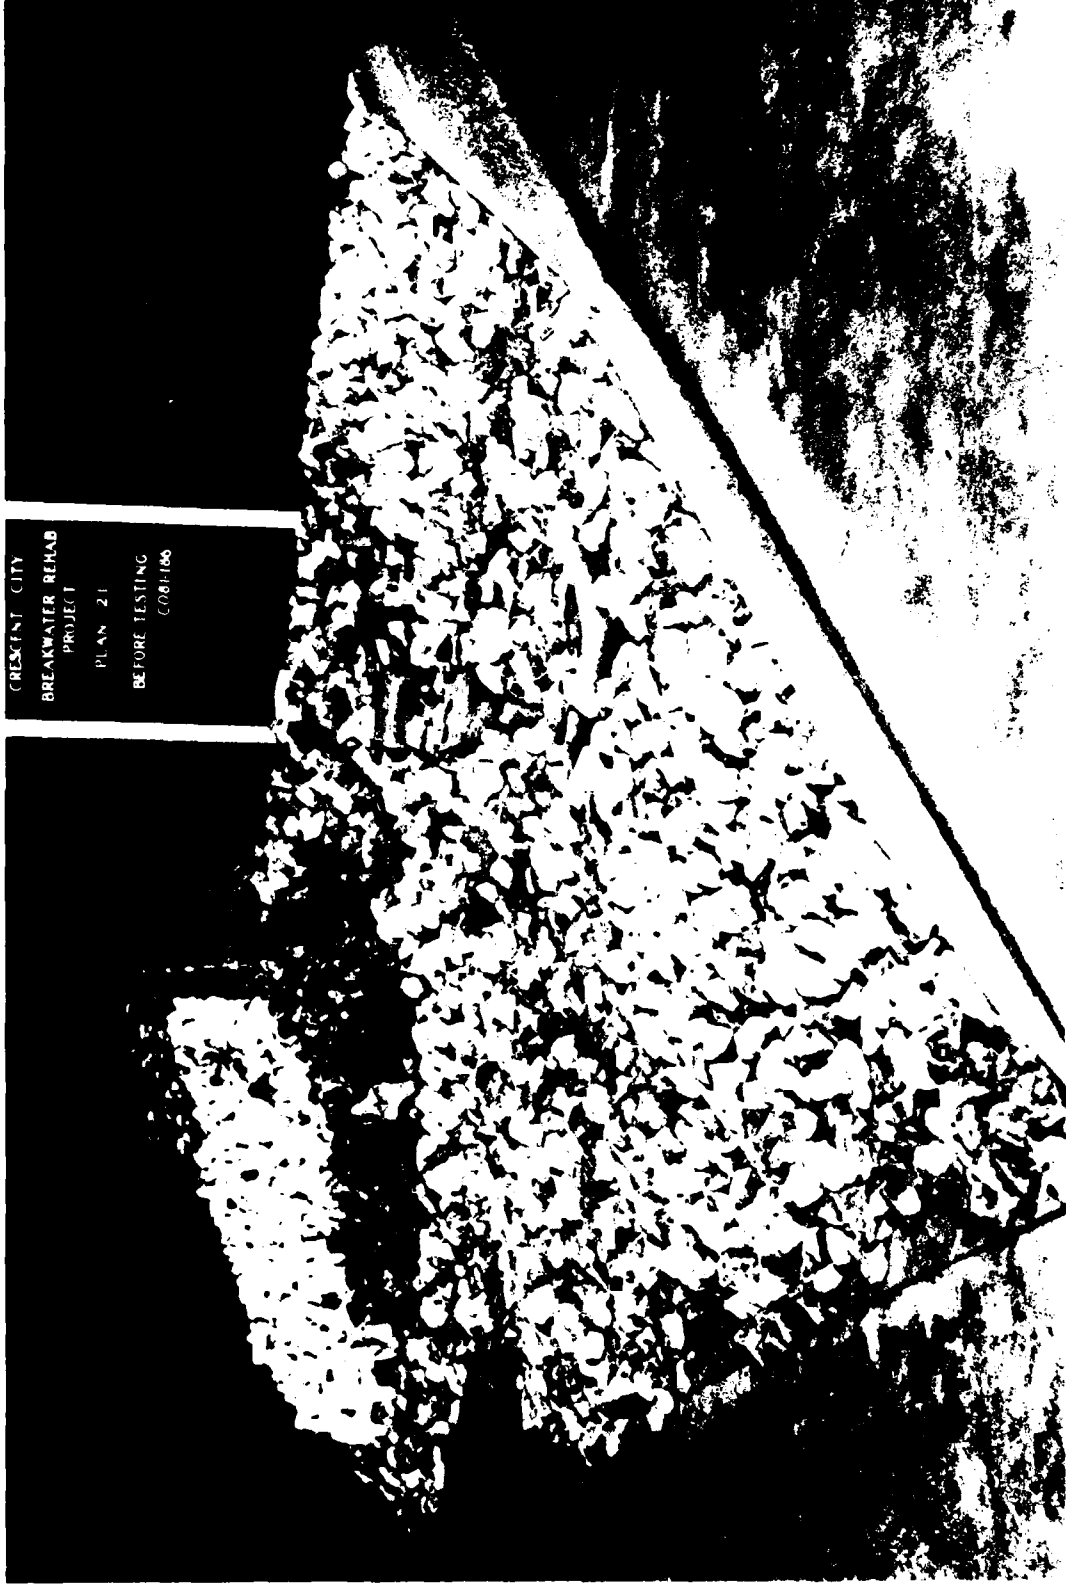
CRESCENT CITY  
BREAKWATER REHAB  
PROJECT  
PLAN 21  
BEFORE TESTING  
C08H166

Photo 164. Seaward oblique view of Plan 21 after completion of abbreviated hydrograph

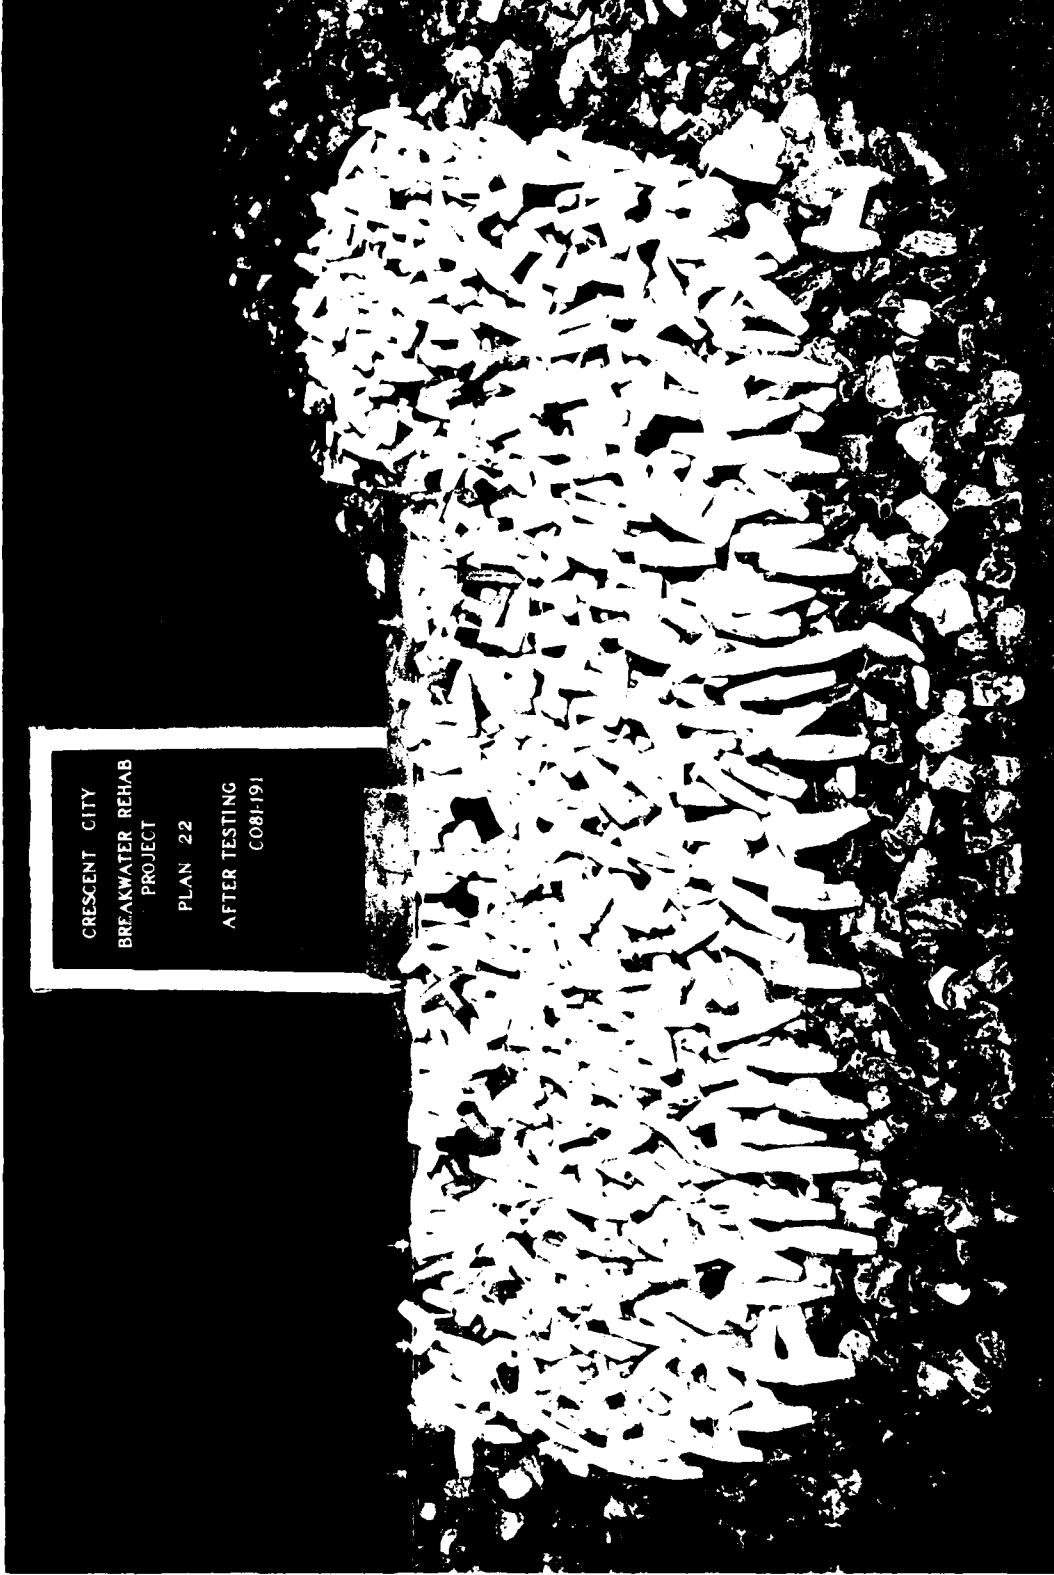
CRESCENT CITY  
BREAKWATER REHAB  
PROJECT  
PLAN 22  
AFTER TESTING  
COBI-191

Photo 169. Sea-side view of Plan 22 after completion of abbreviated hydrograph

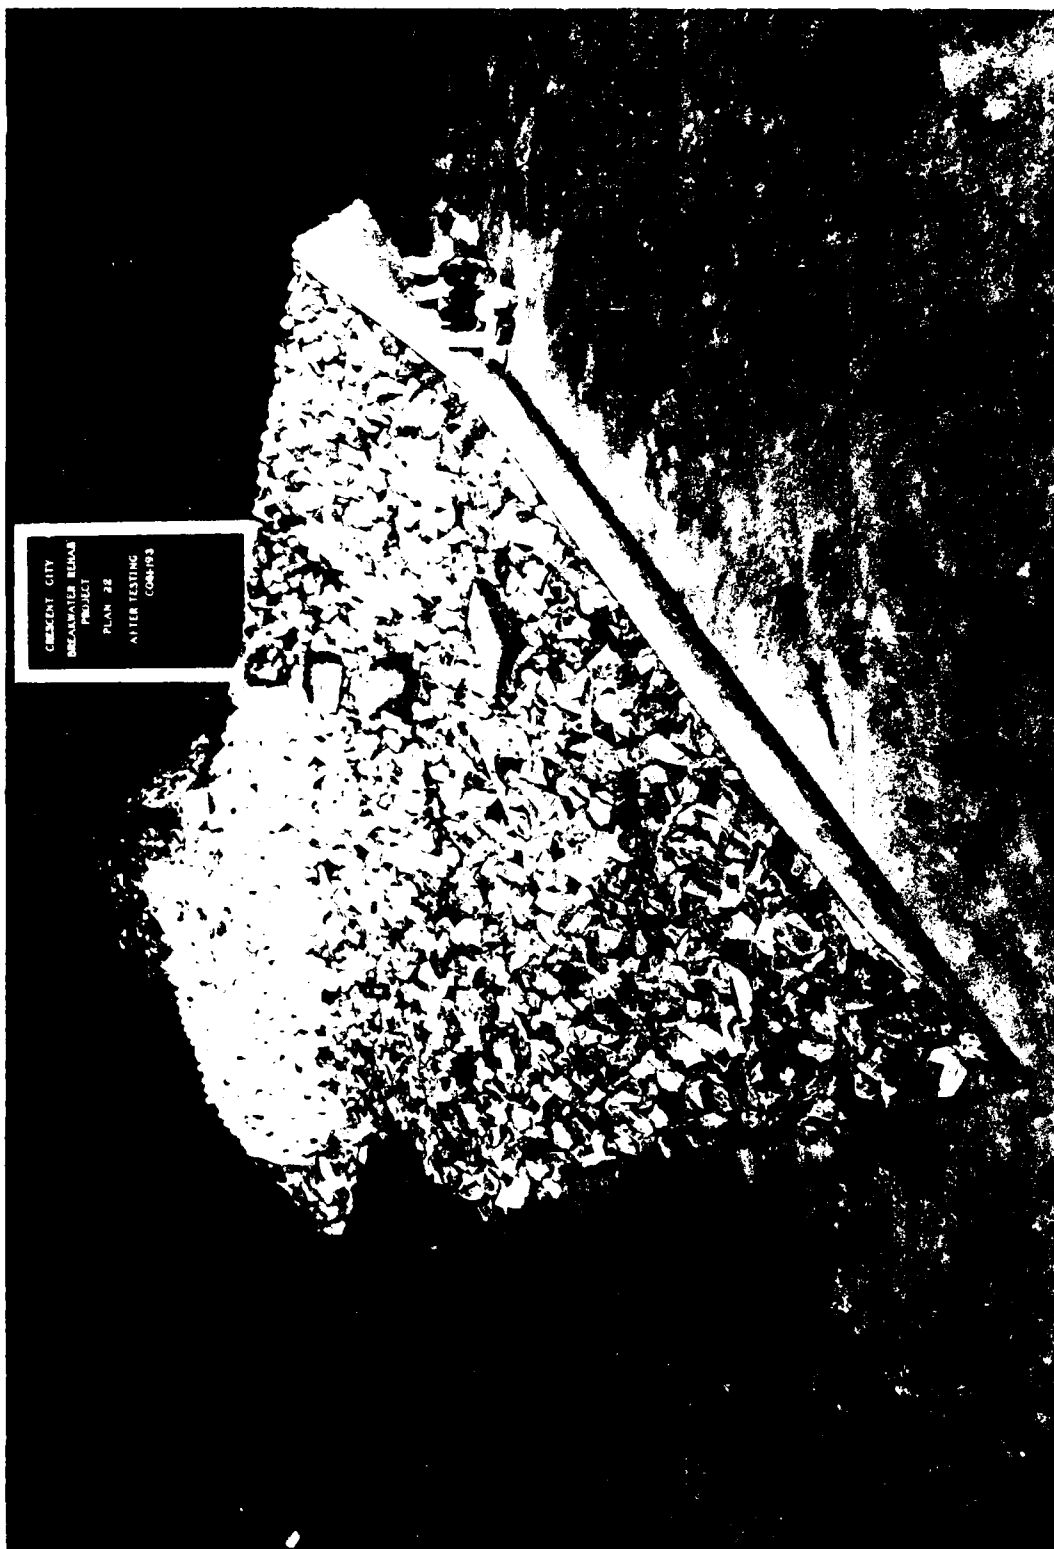
Photo 171. Seaward end view of Plan 22 after completion of abbreviated hydrograph

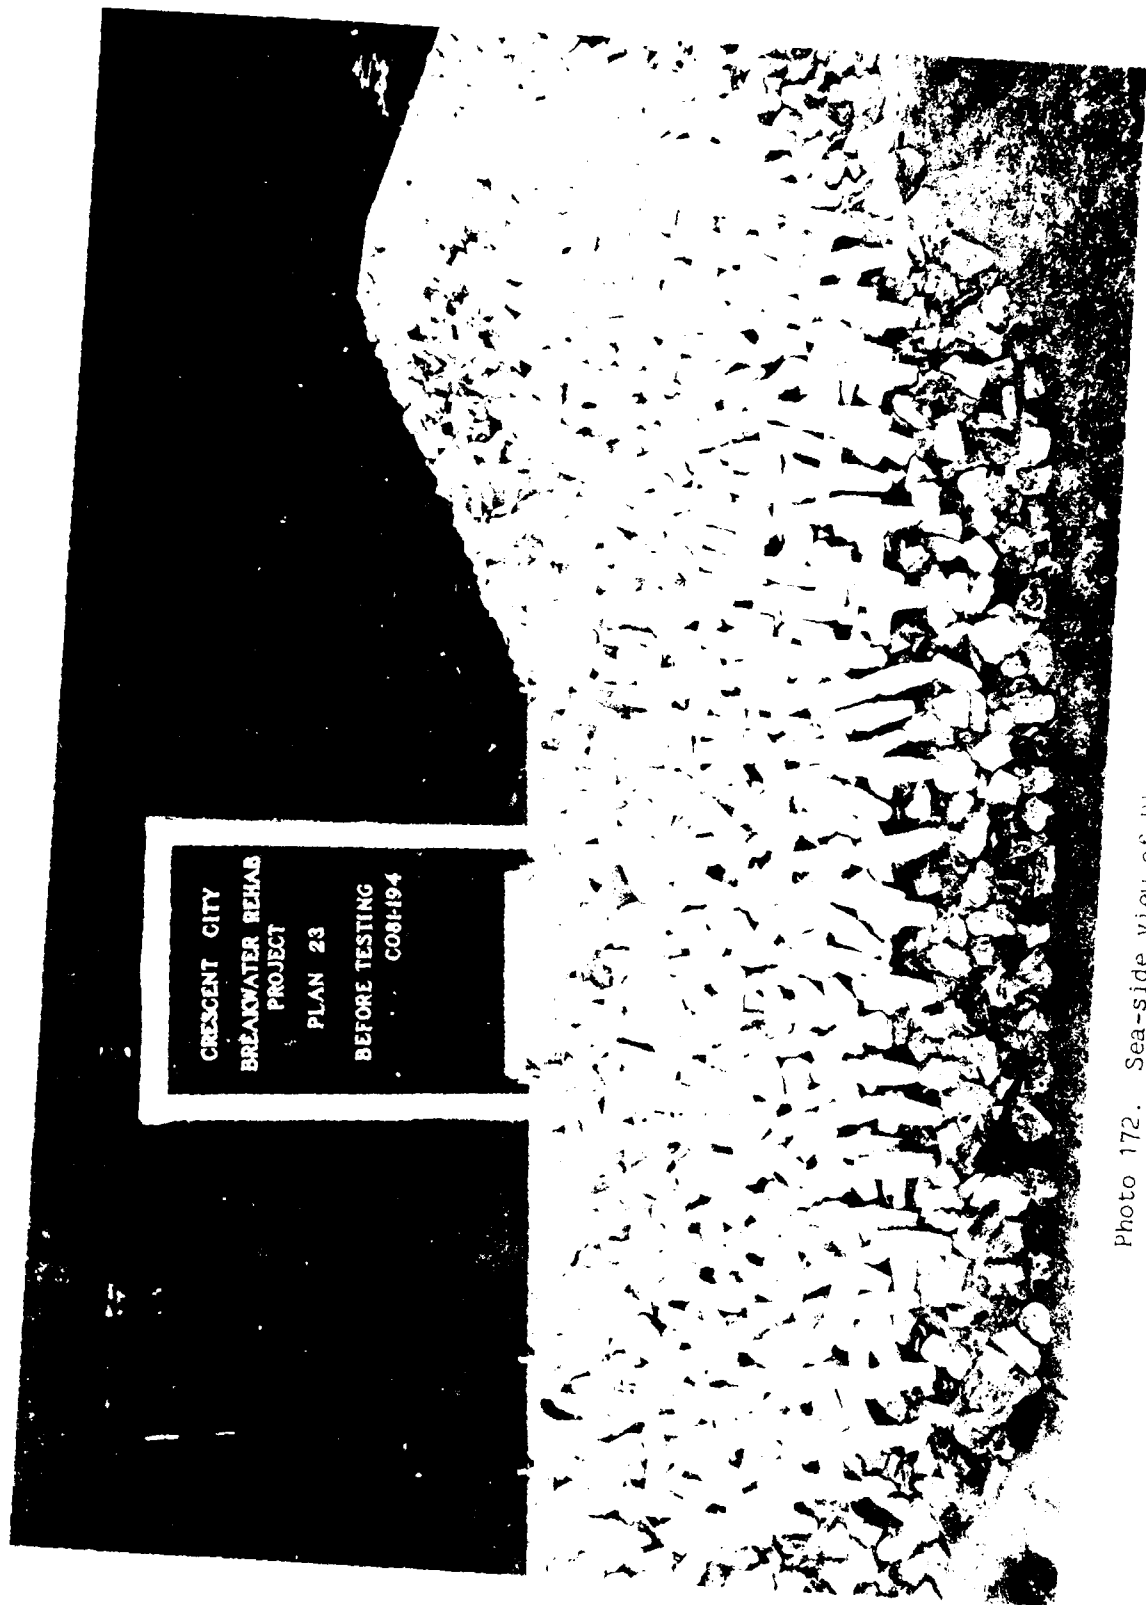
CRESCENT CITY  
BREAKWATER REHAB  
PROJECT  
PLAN 23  
BEFORE TESTING  
C081194

Photo 172. Sea-side view of Plan 23 before testing.

53. Plan 23 (Plate 25 and Photos 172-174) was similar to Plan 22, except coverage was reduced near the crown of the dogleg where dolosse were not needed and coverage was increased along the lower part of the seaward transition toe to provide additional protection in this area. A total of 484 42-ton rehabilitation dolosse were placed. Damage was severe in the seaward transition area for the abbreviated hydrograph. Photos 175-177 show the structure after testing.

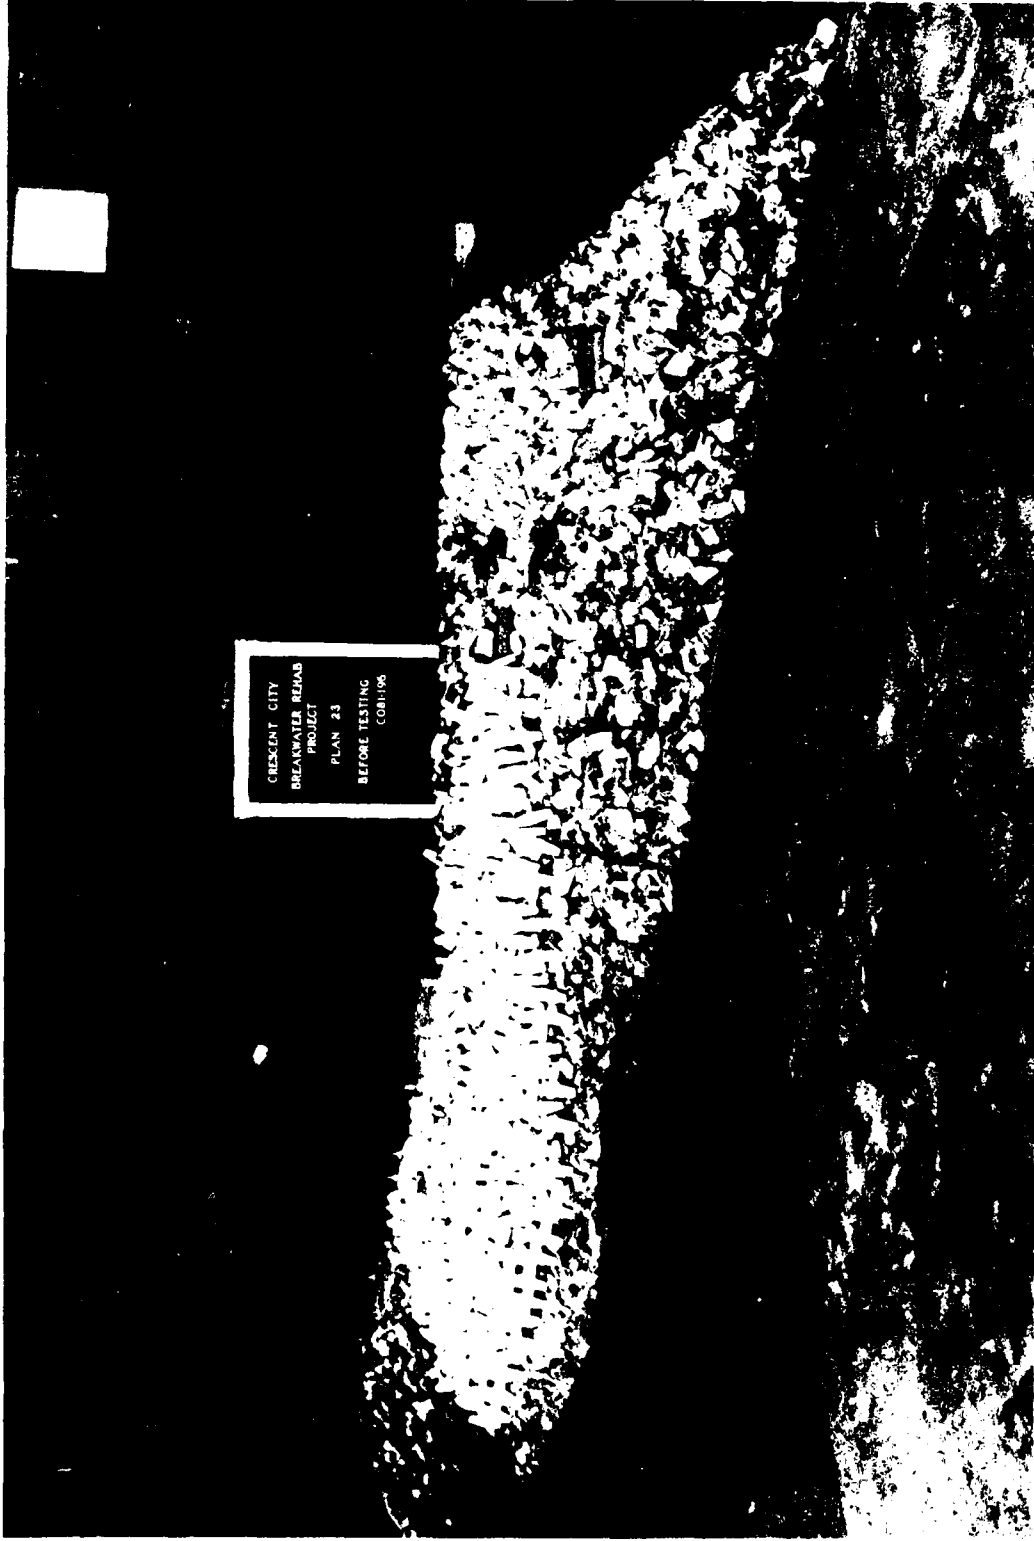
Photo 173. Seaward oblique view of Plan 23 before wave attack
