TECHNICAL REPORT CERC-85-8

# BREAKWATER REHABILITATION STUDY, CRESCENT CITY HARBOR, CALIFORNIA

## Coastal Model Investigation

November 1985

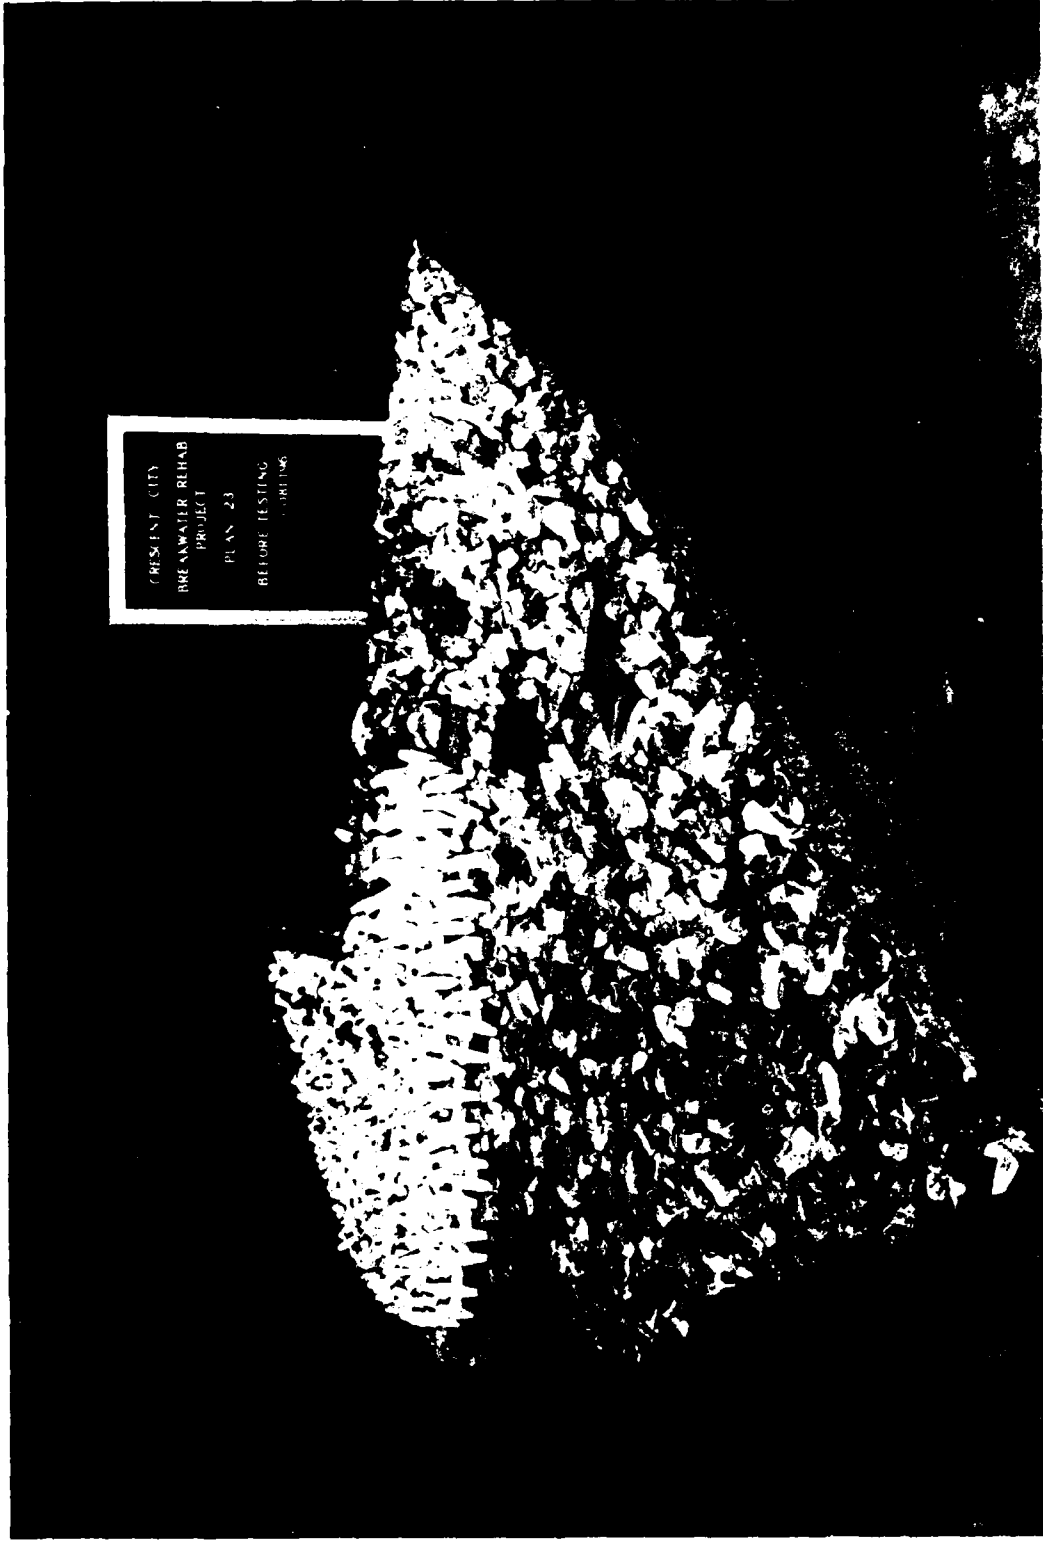
Phcto 174. Seaward end view of Plan 23 before wave attack

53. Plan 23 (Plate 25 and Photos 172-174) was similar to Plan 22, except coverage was reduced near the crown of the dogleg where dolosse were not needed and coverage was increased along the lower part of the seaward transition toe to provide additional protection in this area. A total of 484 42-ton rehabilitation dolosse were placed. Damage was severe in the seaward transition area for the abbreviated hydrograph. Photos 175-177 show the structure after testing.

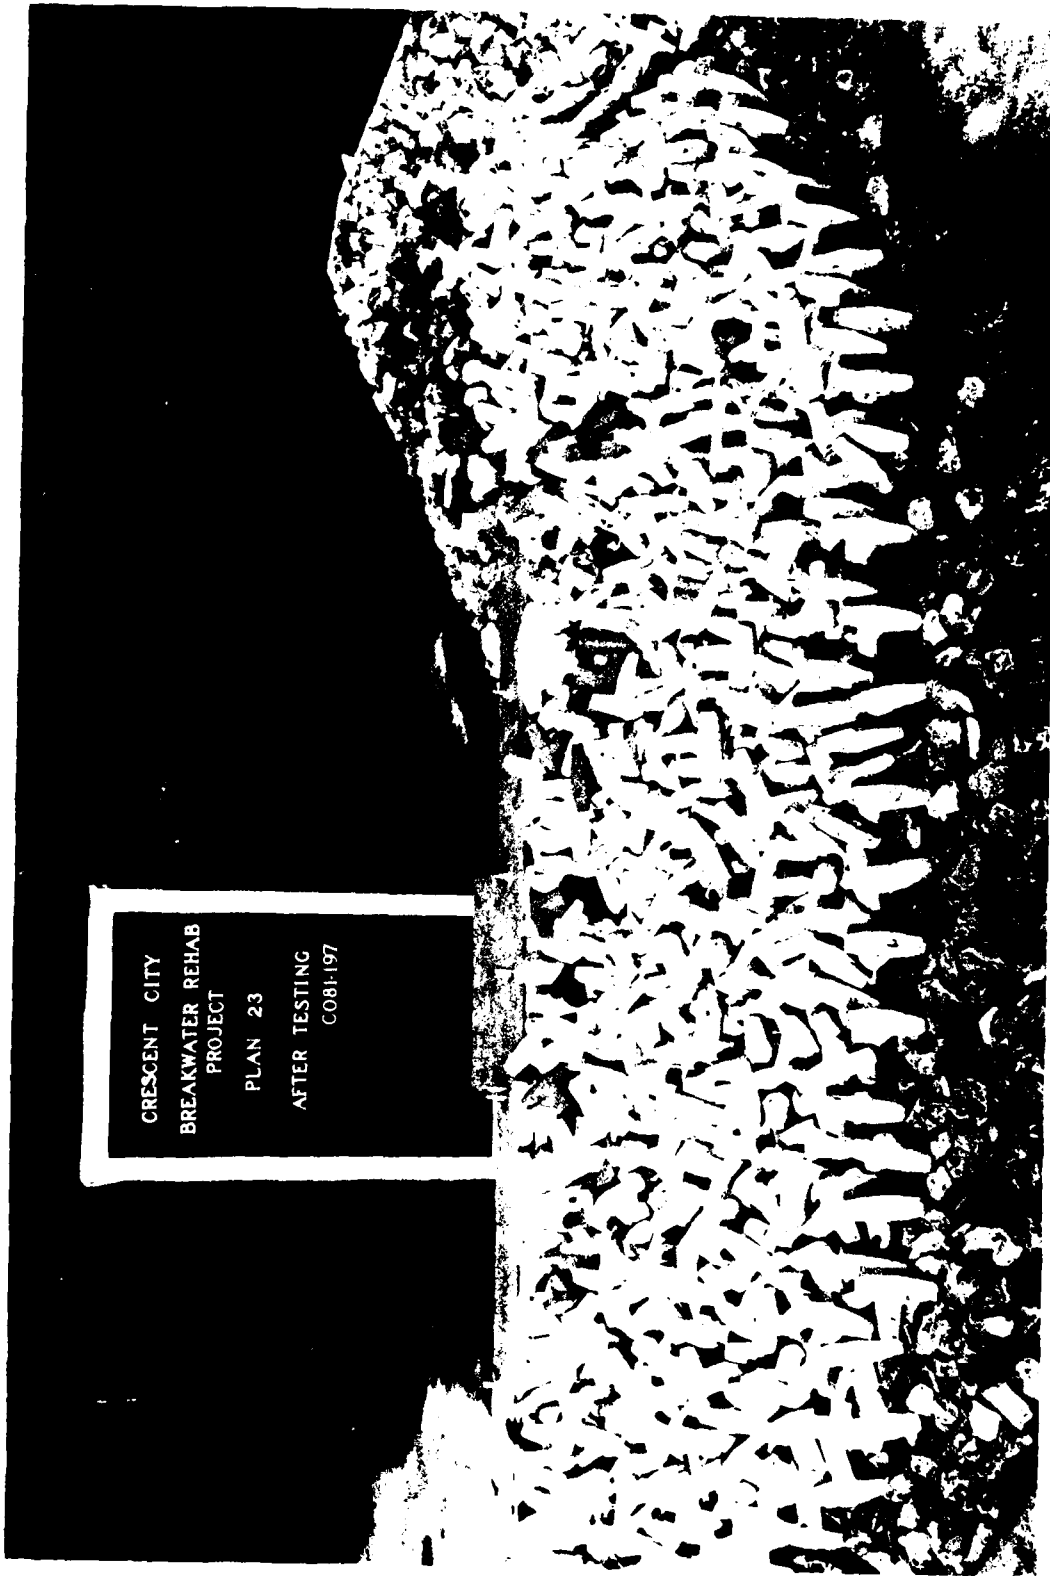
Photo 175. Sea-side view of Plan 23 after completion of abbreviated hydrograph

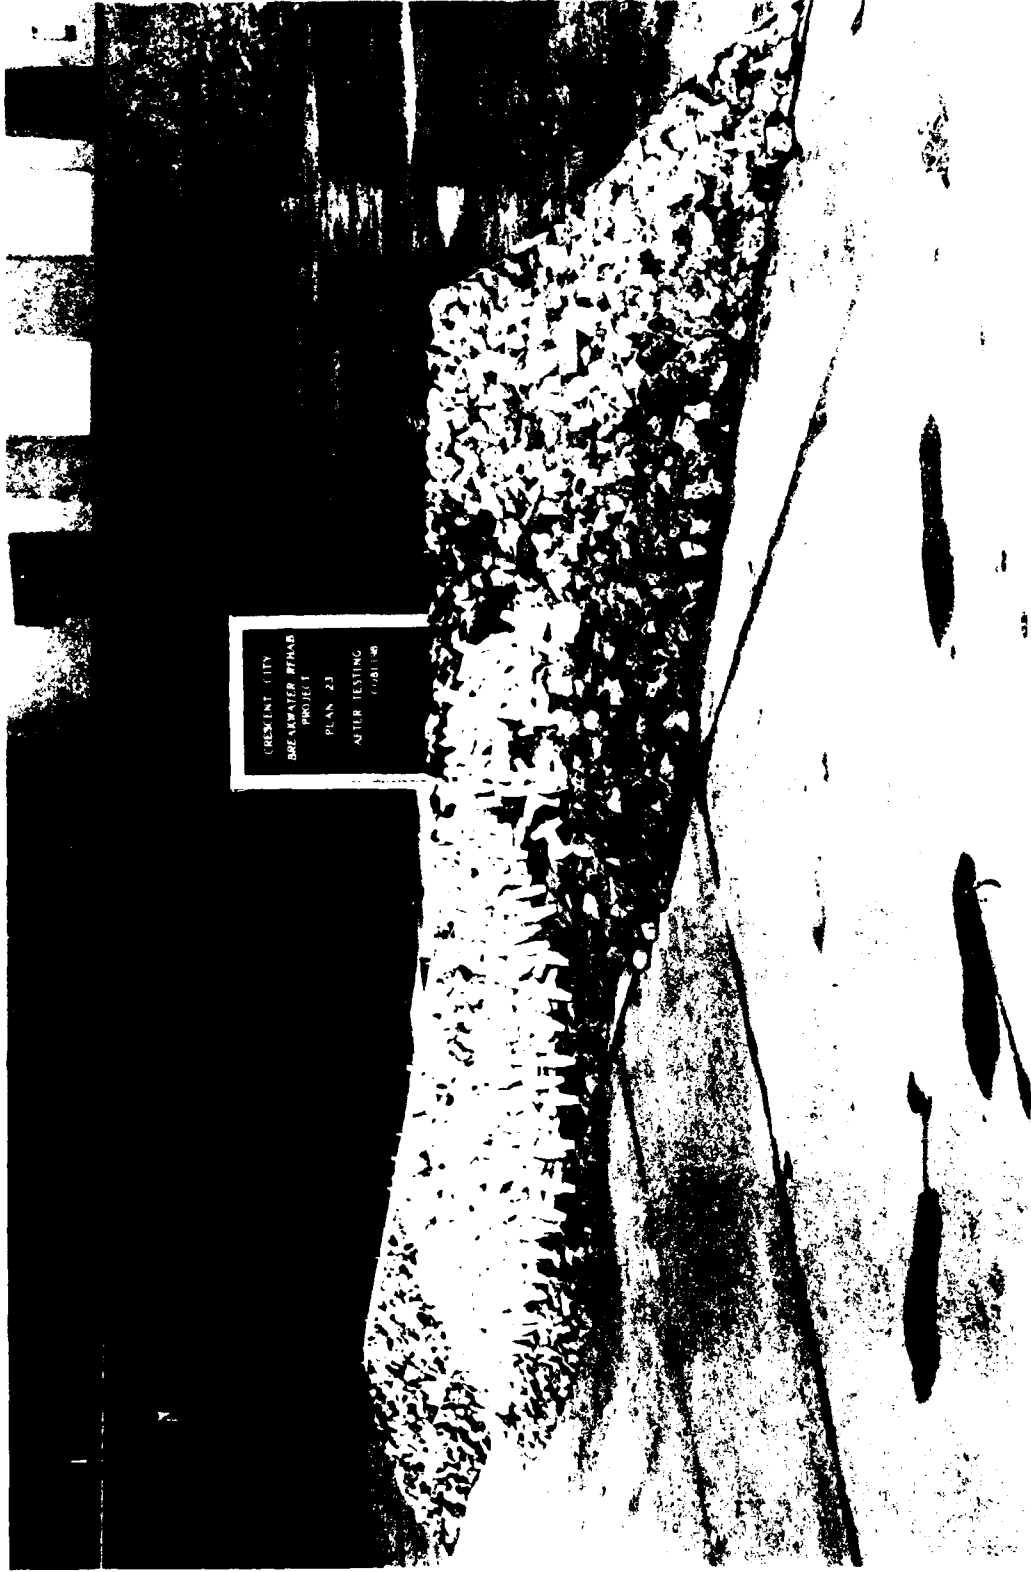
CRESCENT CITY  
BREAKWATER #784B  
PROJECT  
PLAN 23  
AFTER TESTING  
1/10/1966

Photo 176. Seaward oblique view of Plan 23 after completion of abbreviated hydrograph

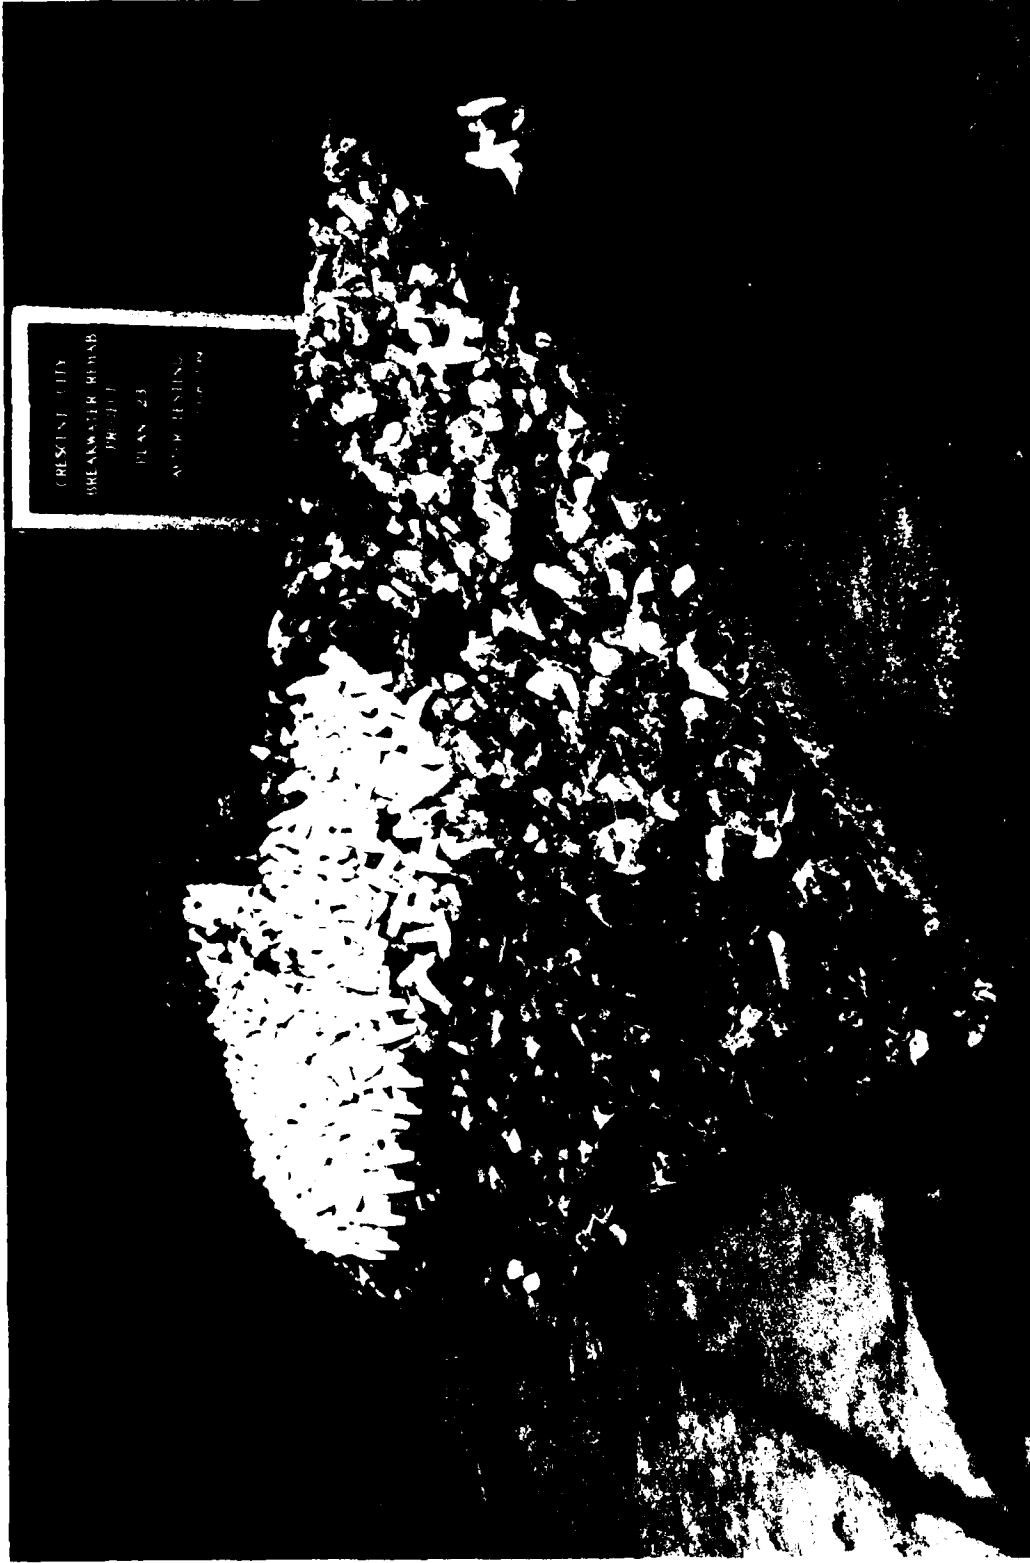
Photo 177. Seaward end view of Plan 23 after completion of abbreviated hydrograph

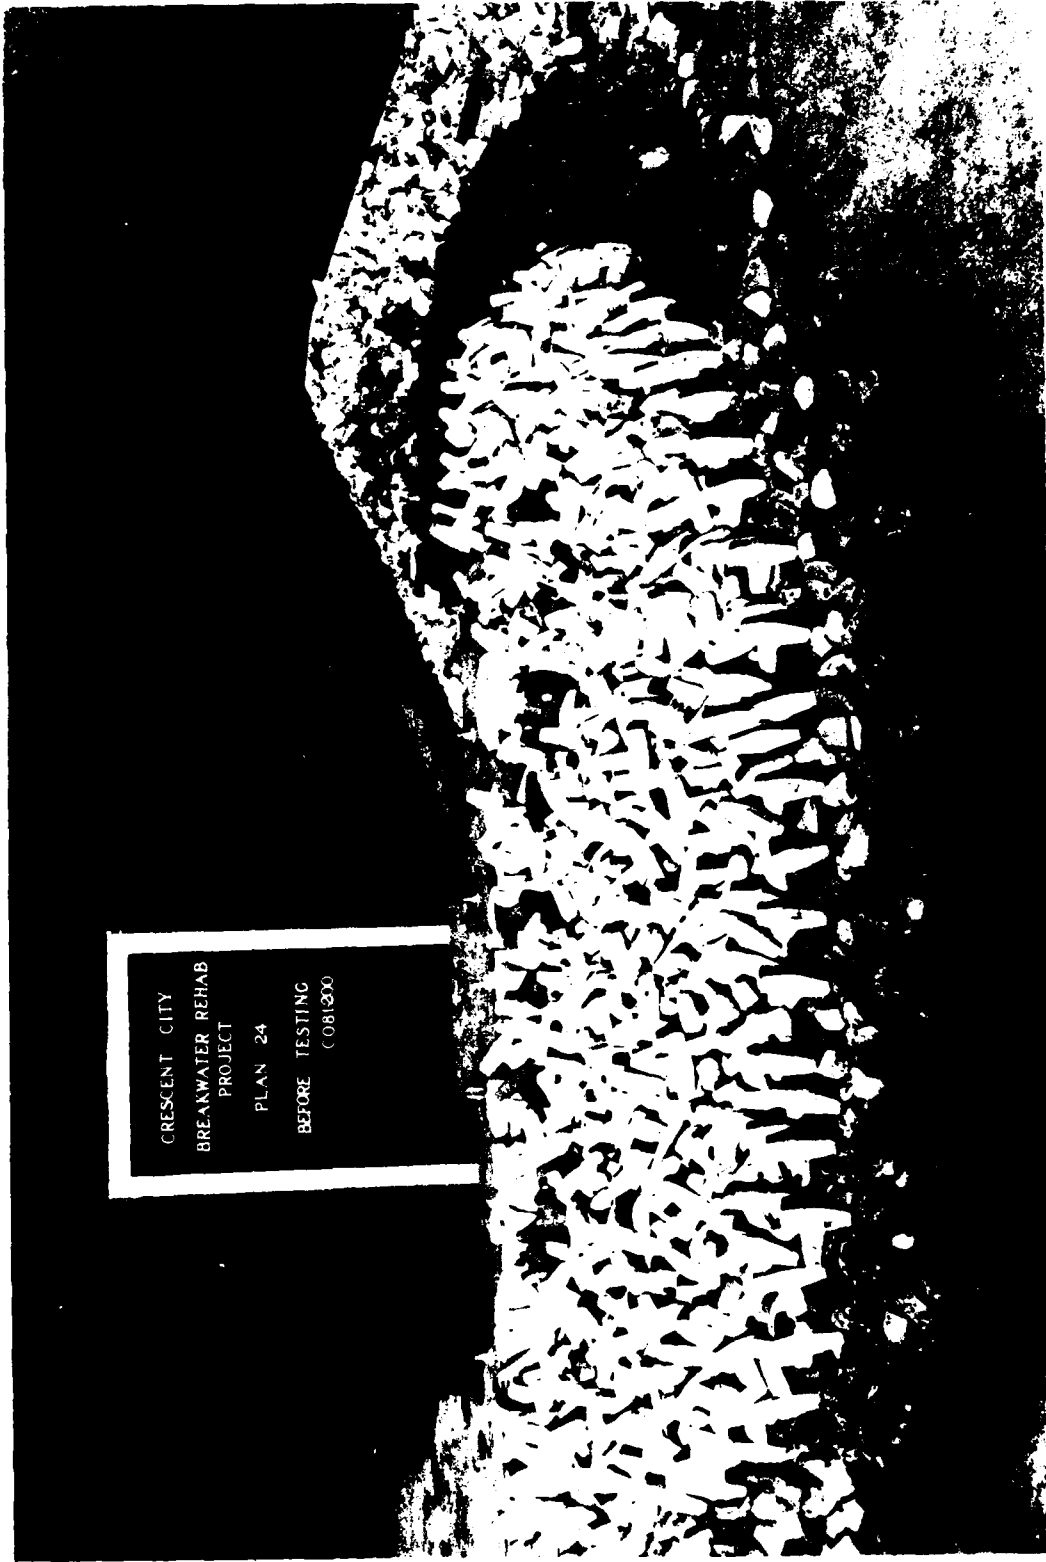
CRESCENT CITY  
BREAKWATER REHAB  
PROJECT  
PLAN 24  
BEFORE TESTING  
(081300)

Photo 178. Sea-side view of Plan 24 before wave attack

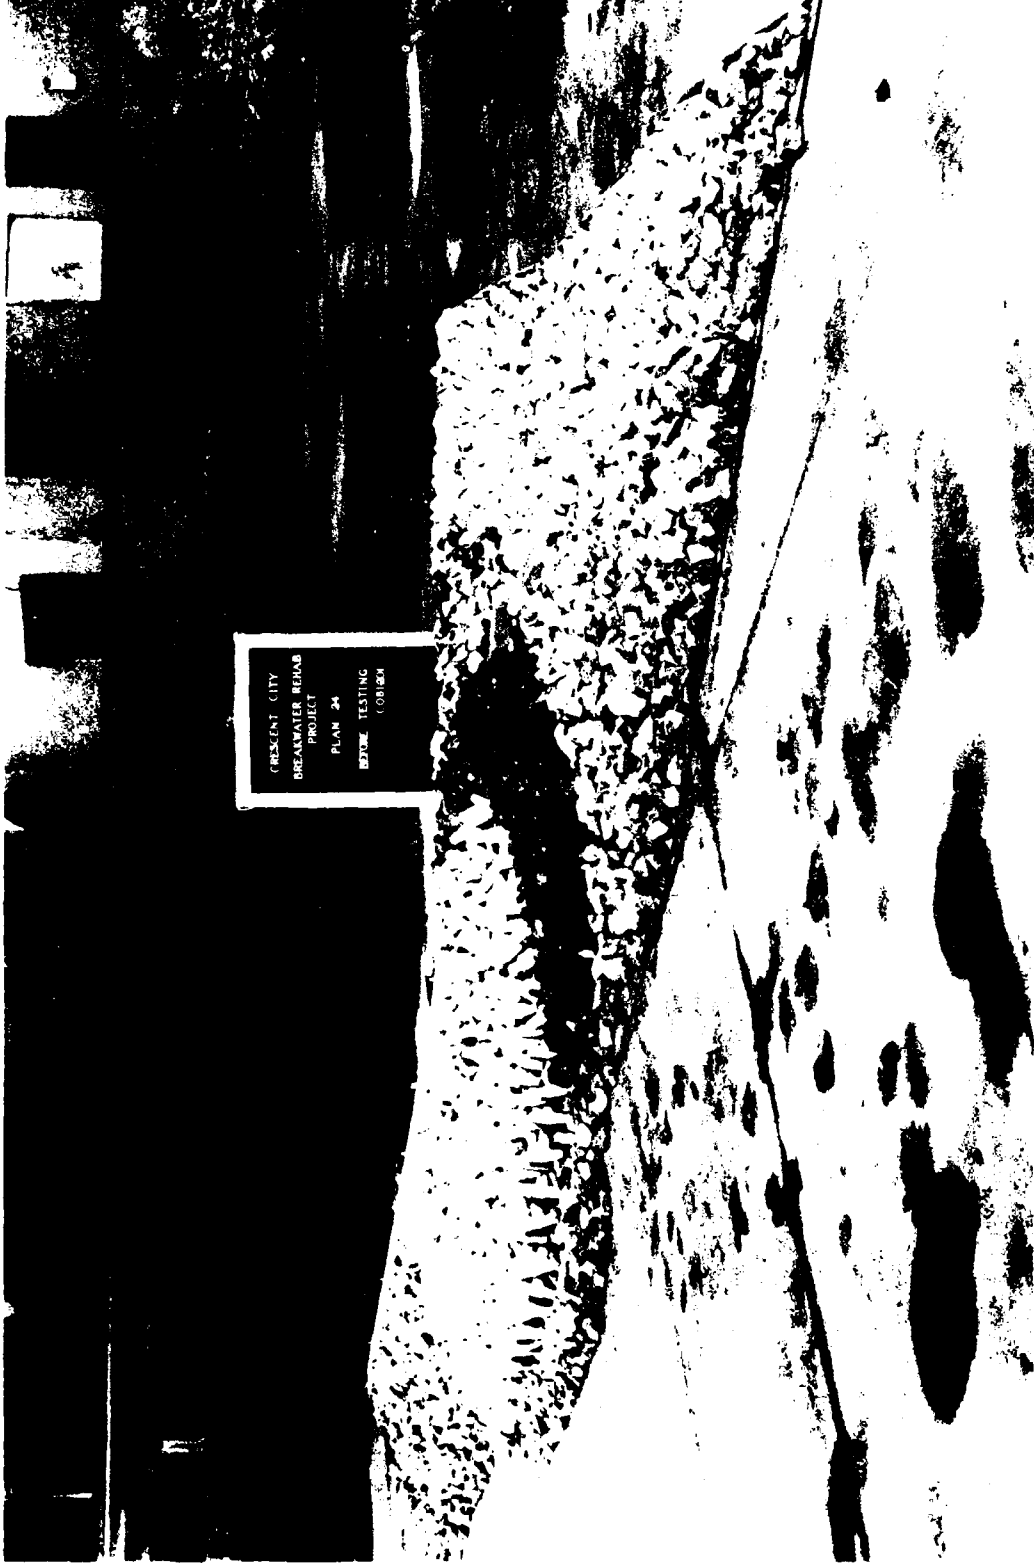
CRESCENT CITY  
BREAKWATER REHAB  
PROJECT  
PLAN 24  
BEFORE TESTING  
TORBER

Photo 179. Seaward oblique view of Plan 24 before wave attack

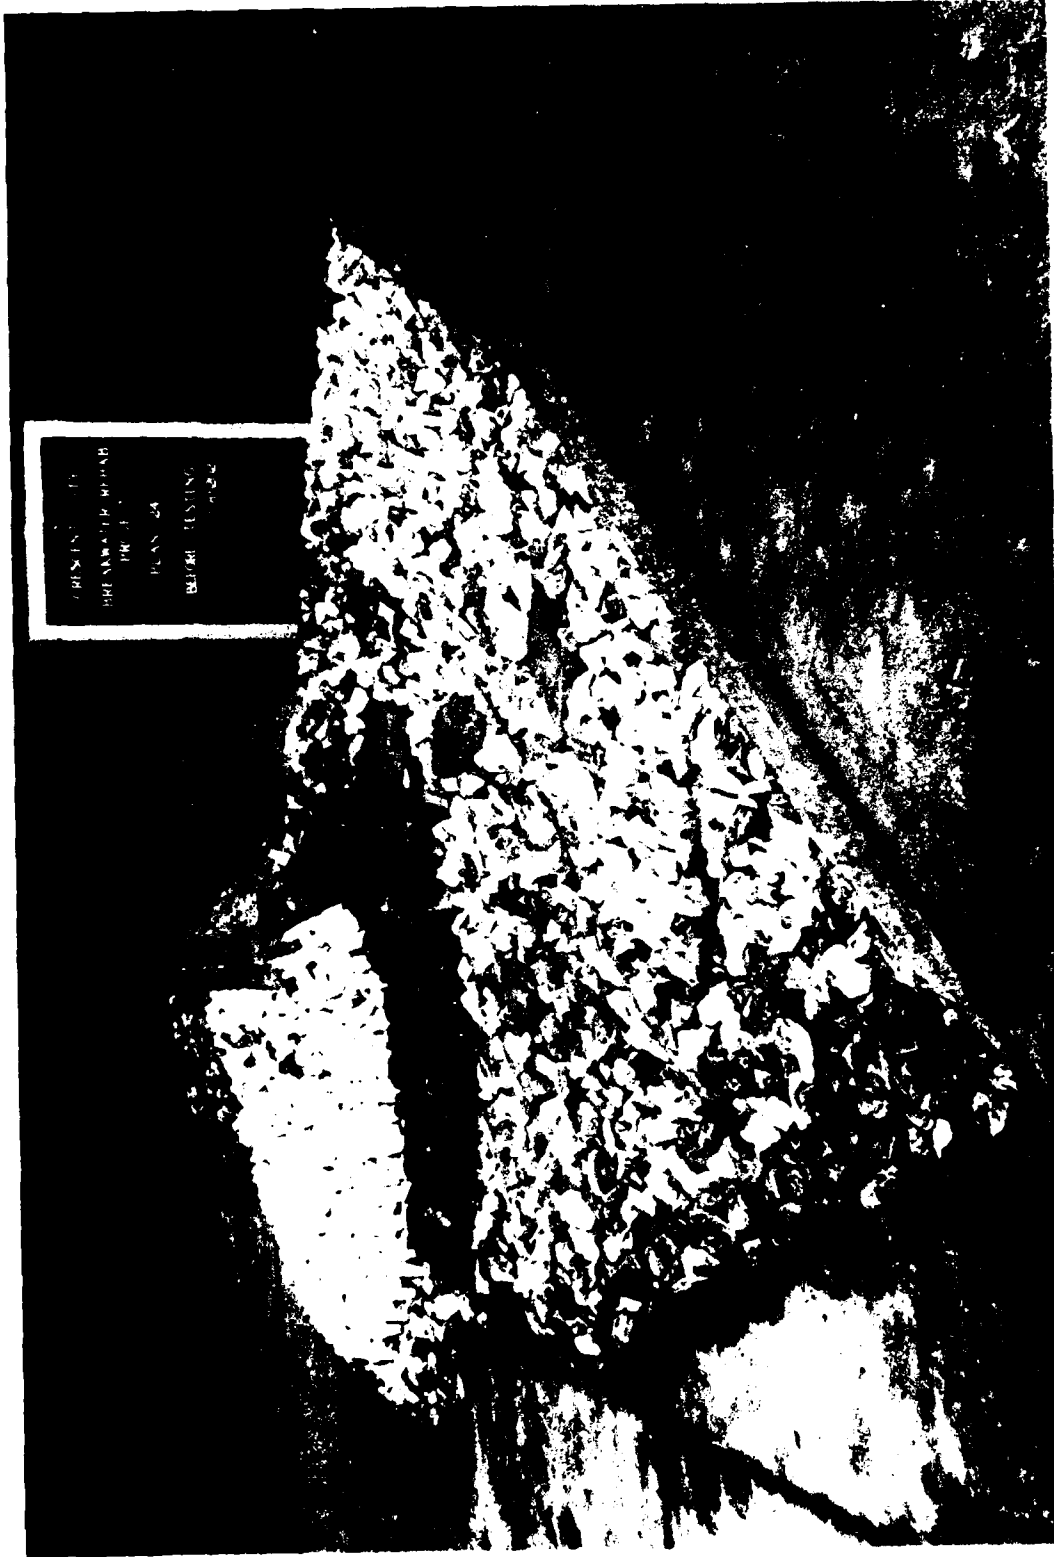
Photo 180. Seaward end view of Plan 24 before wave attack

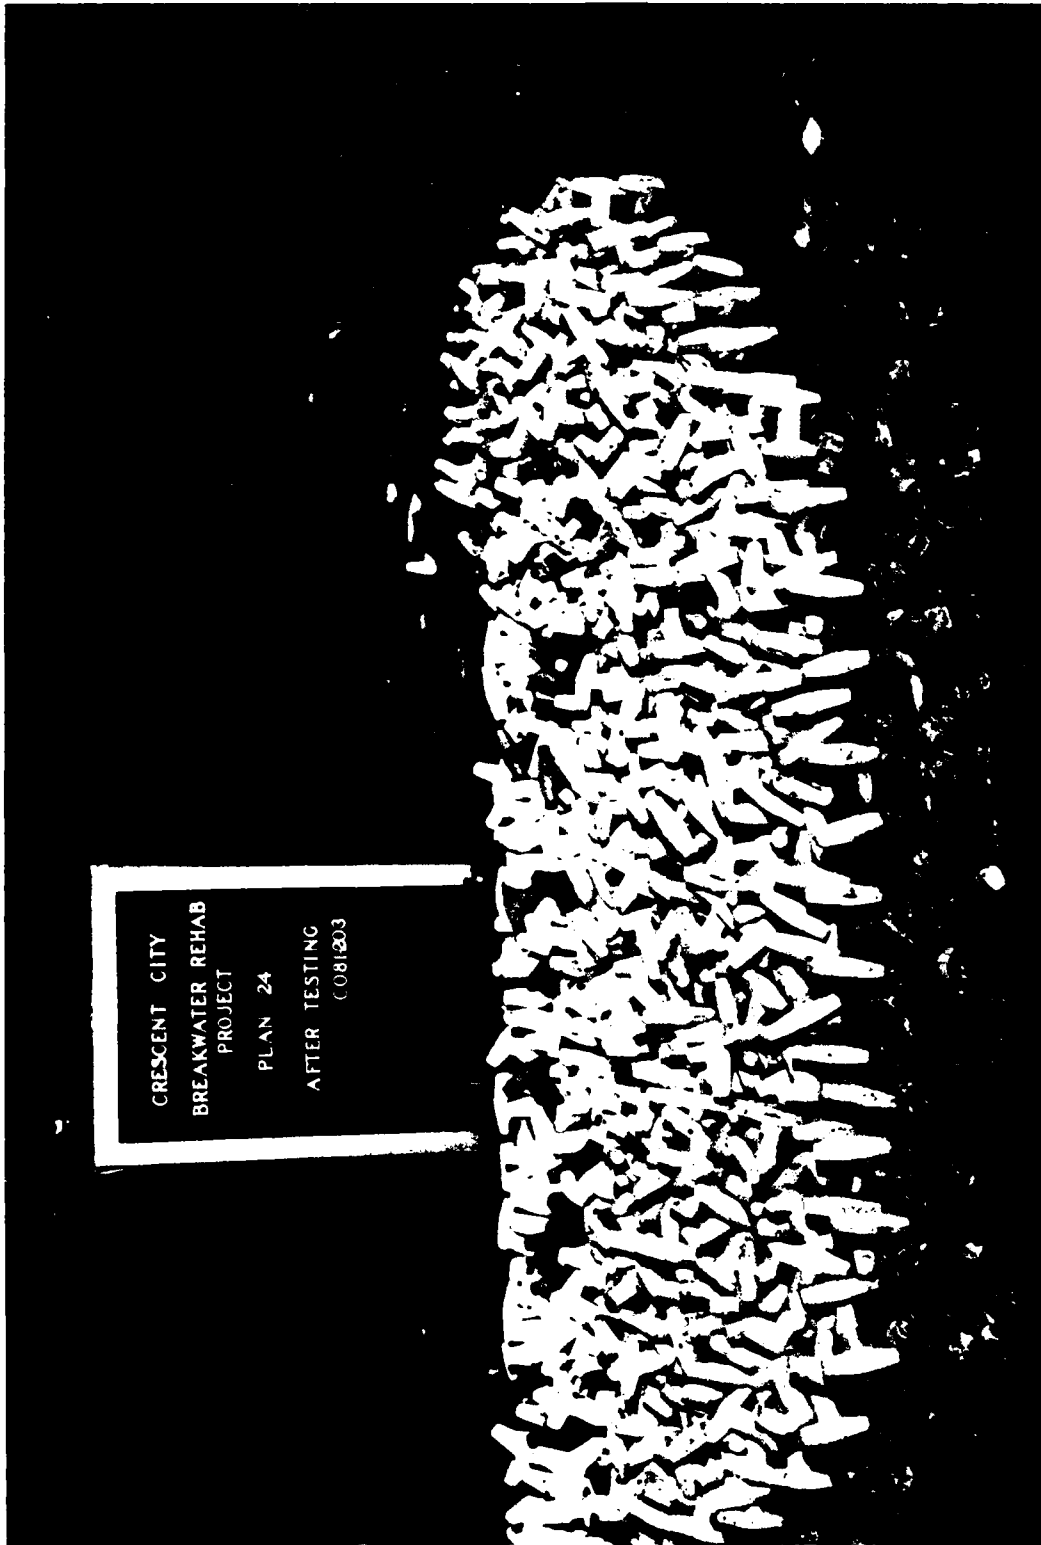
Photo 181. Sea-side view of Plan 24 after completion of abbreviated hydrograph

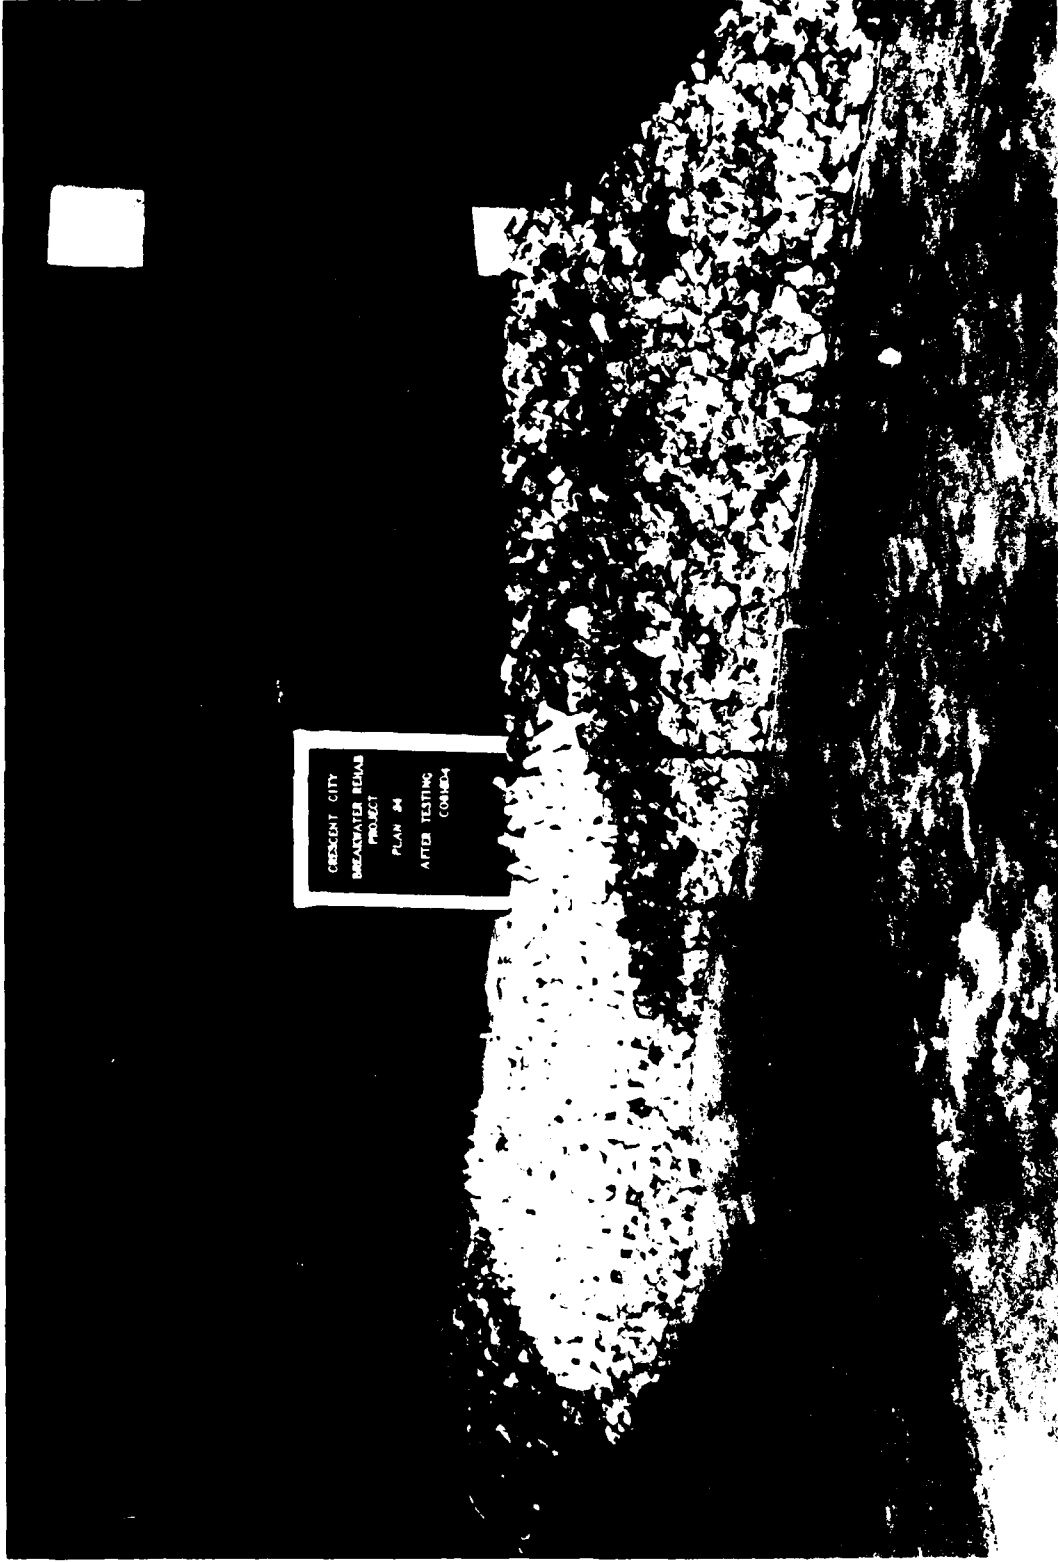
Photo 182. Seaward oblique view of Plan 24 after completion of abbreviated hydrograph

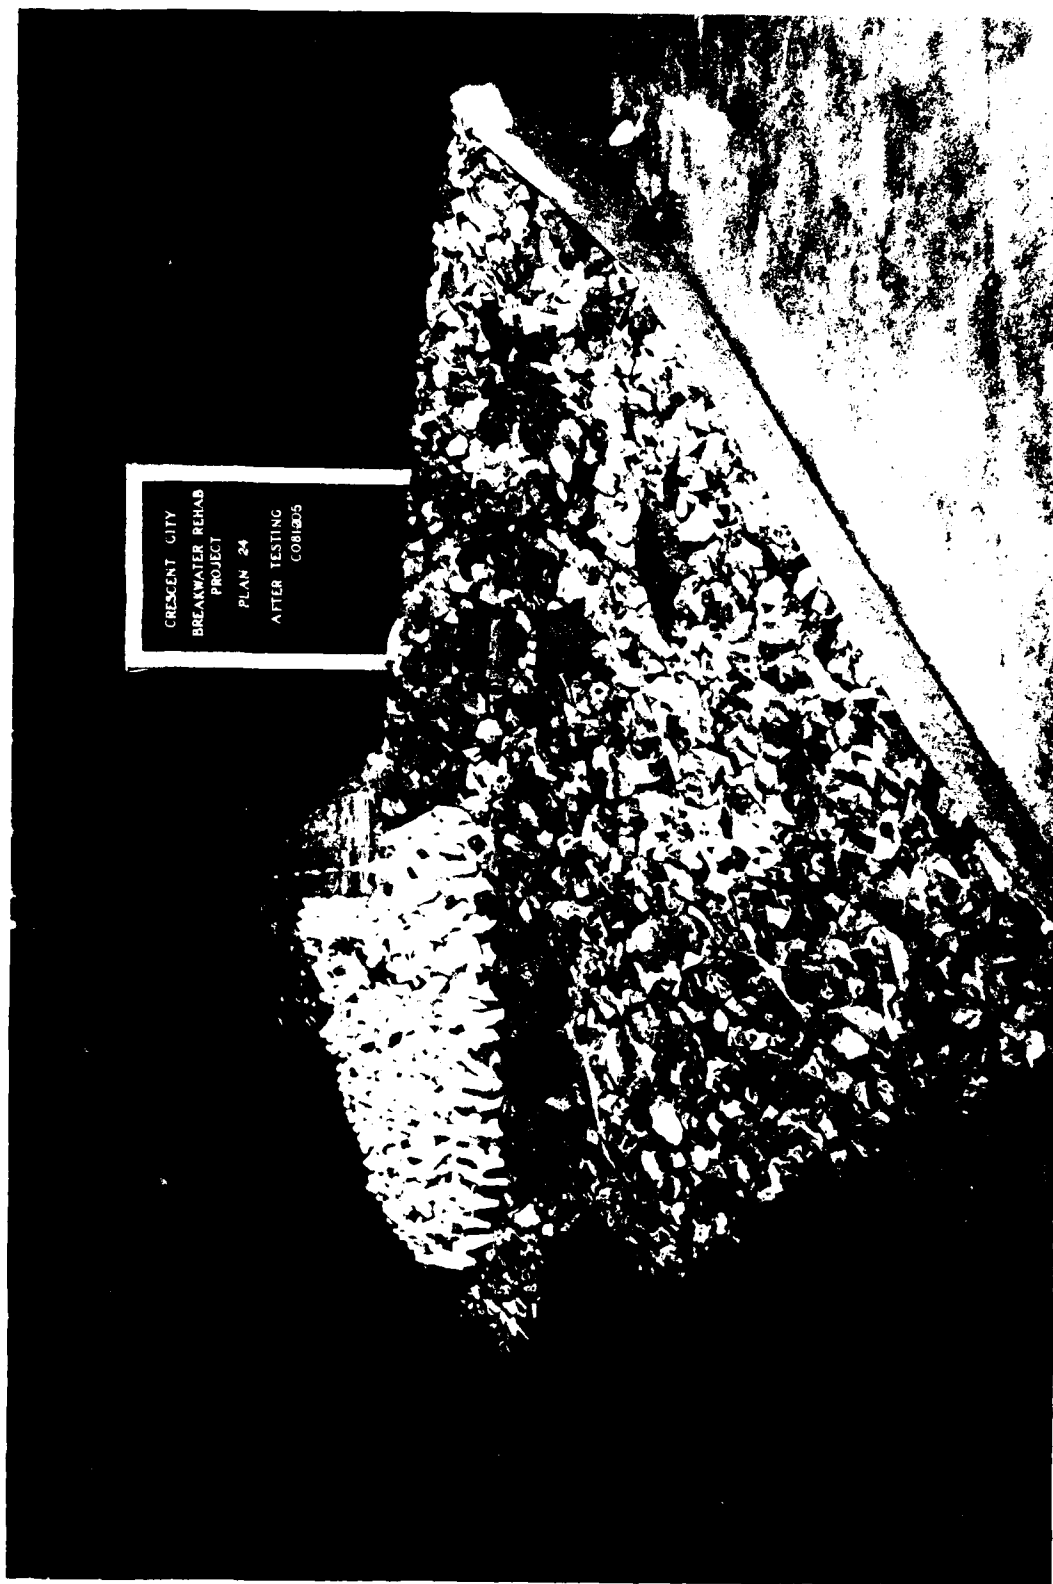
CRESCENT CITY  
BREAKWATER REHAB  
PROJECT  
PLAN 24  
AFTER TESTING  
CORRIDORS

Photo 183. Seaward end view of Plan 24 after completion of abbreviated hydrograph

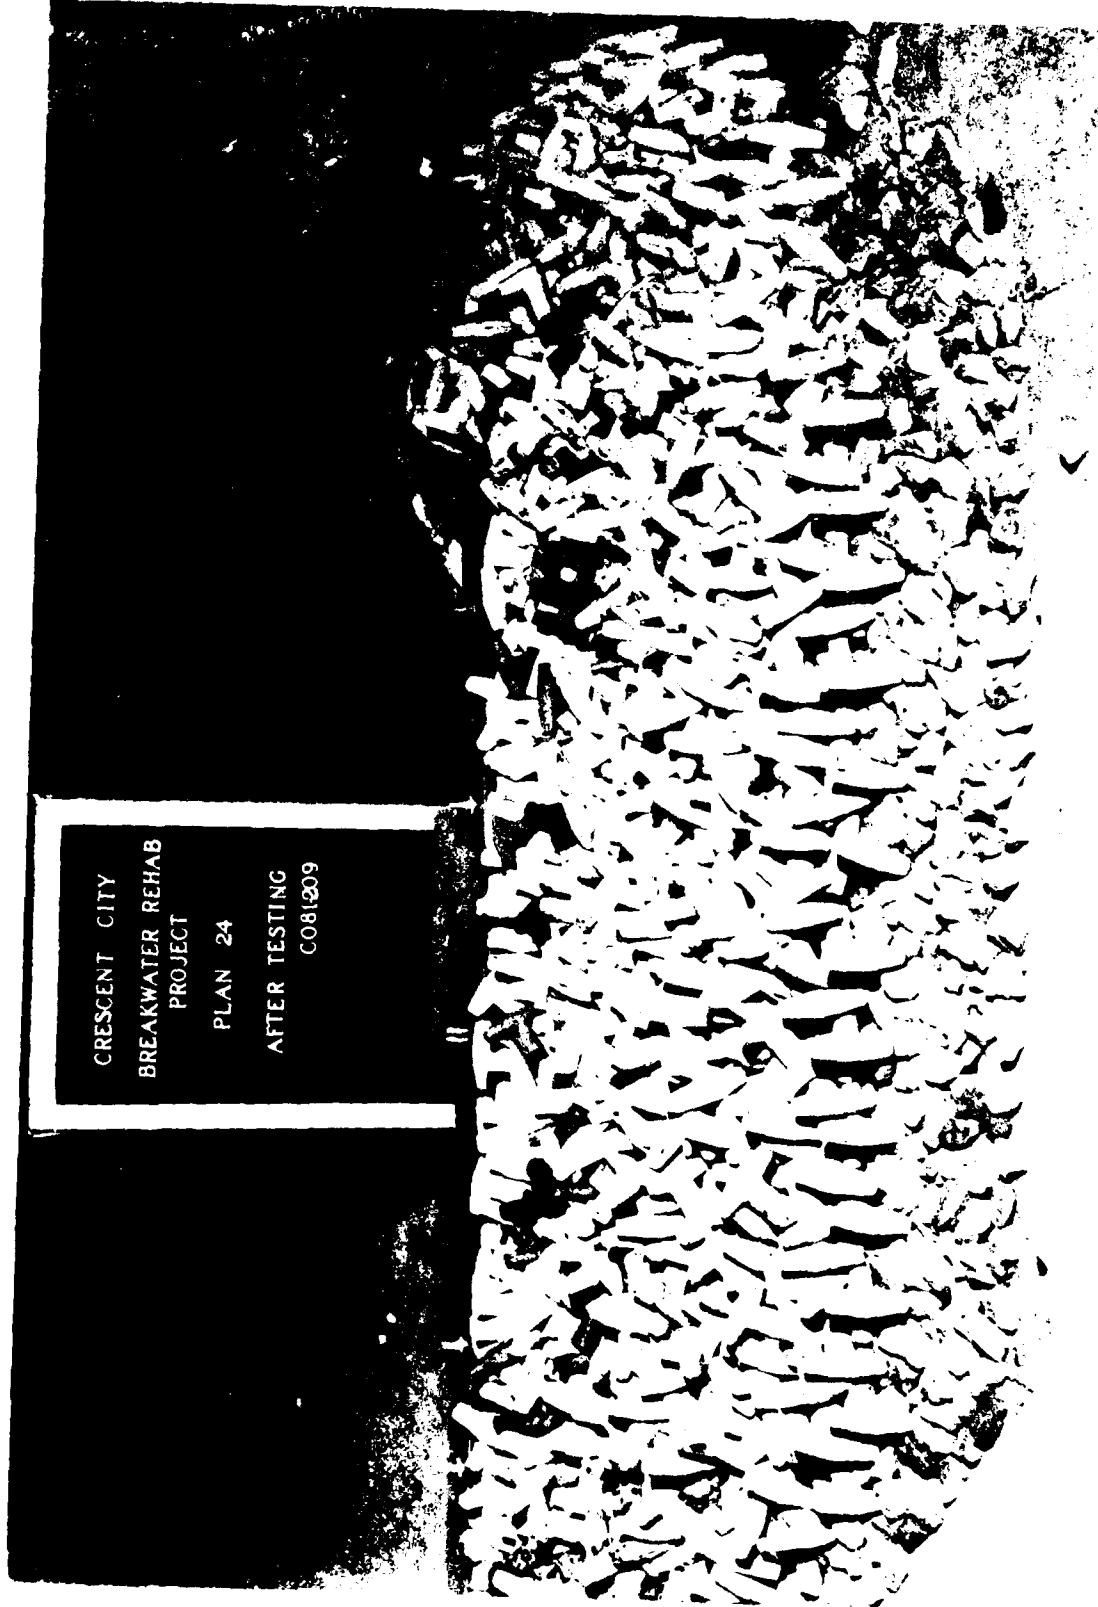
CRESCENT CITY  
BREAKWATER REHAB  
PROJECT  
PLAN 24  
AFTER TESTING  
C081209

Photo 184. Sea-side view of Plan 24 after completion of Hydrograph A

left without buttressing for subsequent storm events. Based on these results and discussion with the Los Angeles District, it was decided that the test should be continued using Hydrograph B (Table 3). During testing of Hydrograph B, deterioration of the 25-ton buttressing stone continued and additional separation and displacement of dolos occurred in the lower seaward quadrant. Photos 187-189 show the structure after cumulative testing of Hydrograph A and B. Based on the overall test results, it appears that the stability of Plan 24 is questionable.

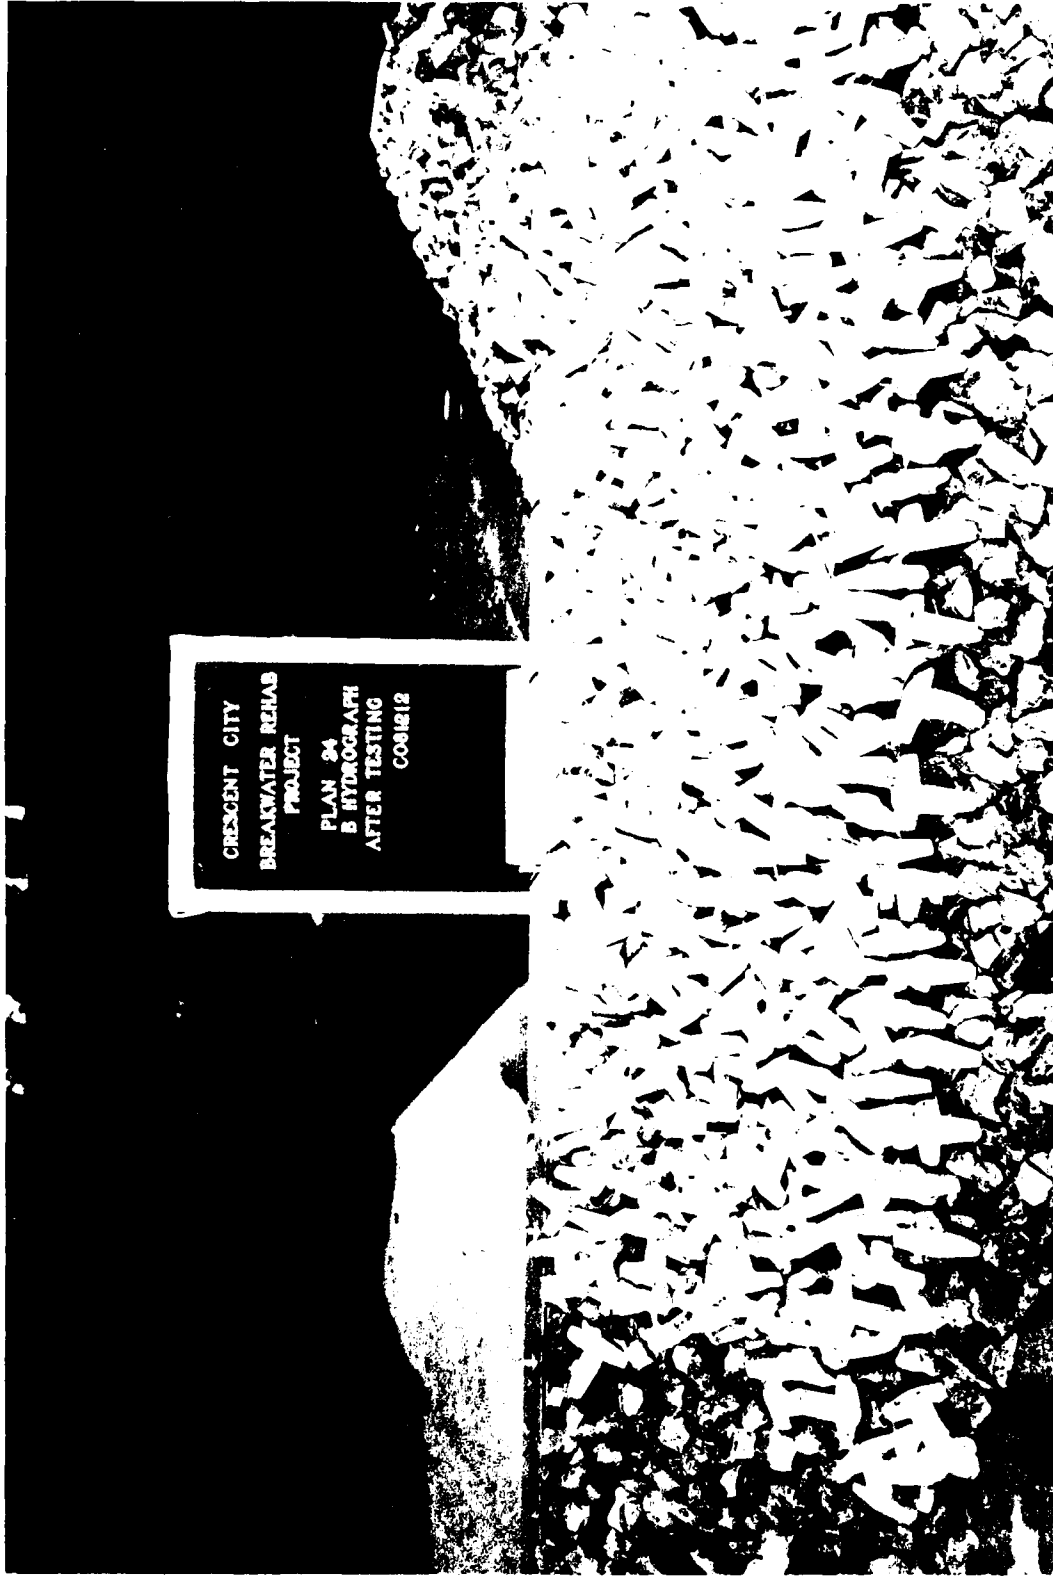
Photo 187. Sea-side view of Plan 24 after cumulative testing of Hydrographs A and B

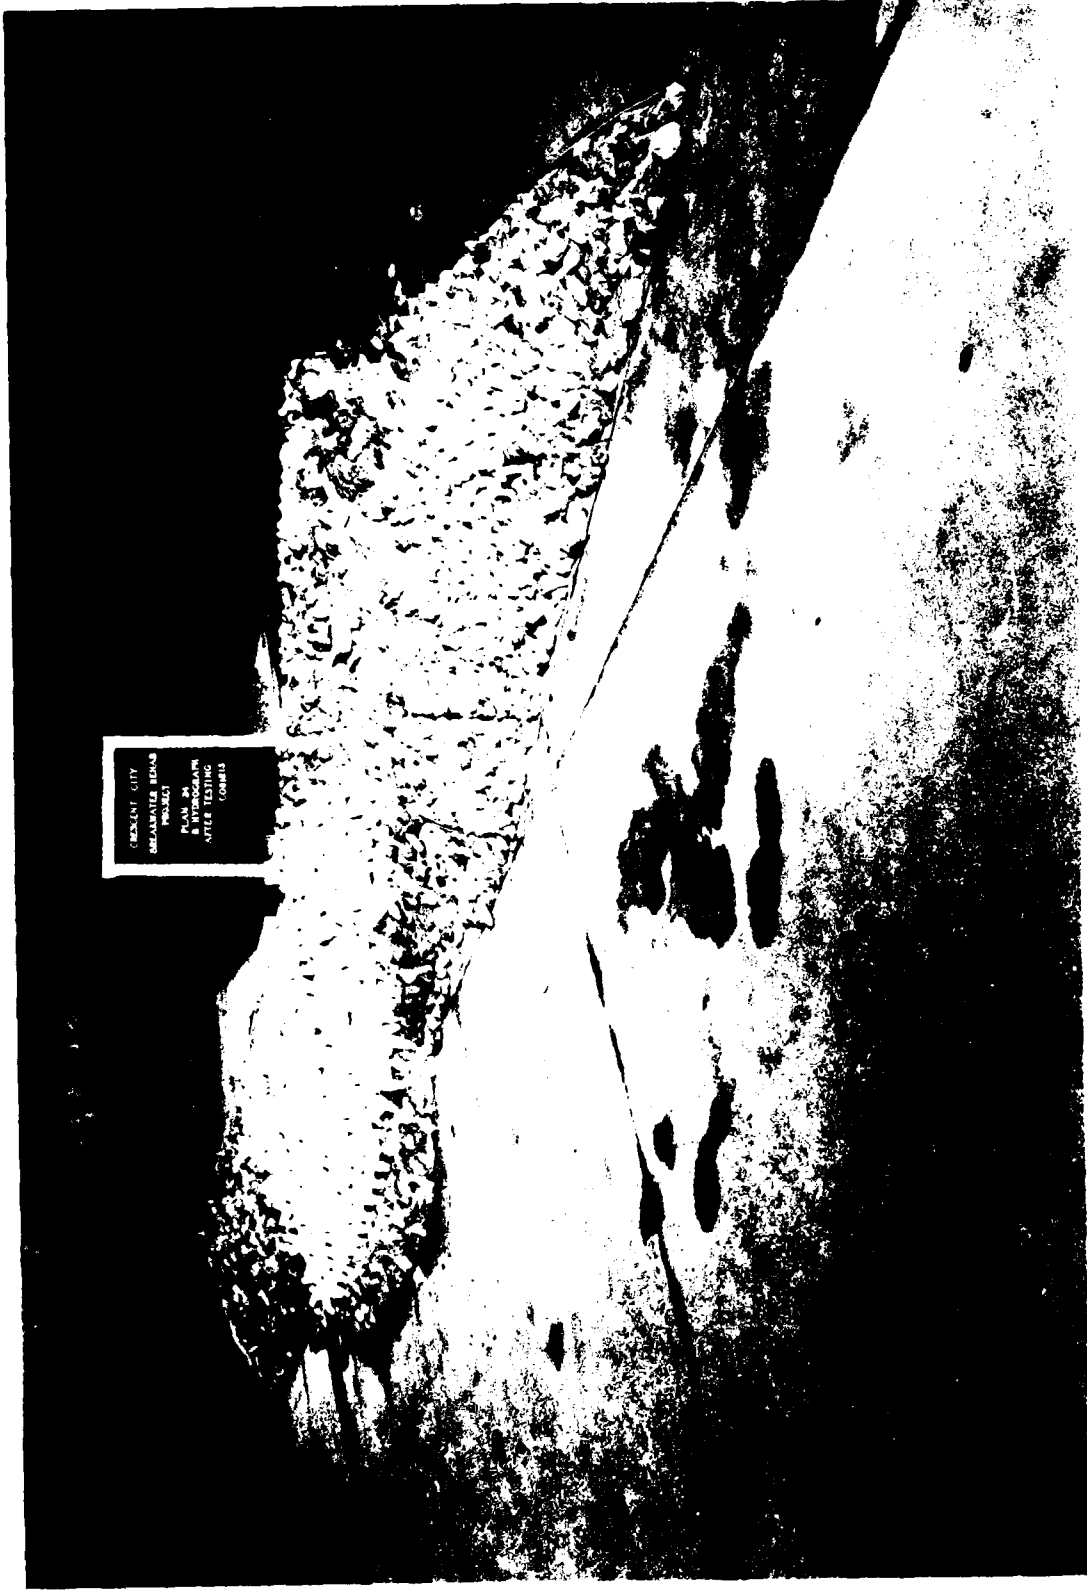
Photo 188. Seaward oblique view of Plan 24 after cumulative testing of Hydrographs A and B
