TECHNICAL REPORT CERC-85-8

# BREAKWATER REHABILITATION STUDY, CRESCENT CITY HARBOR, CALIFORNIA

## Coastal Model Investigation

November 1985

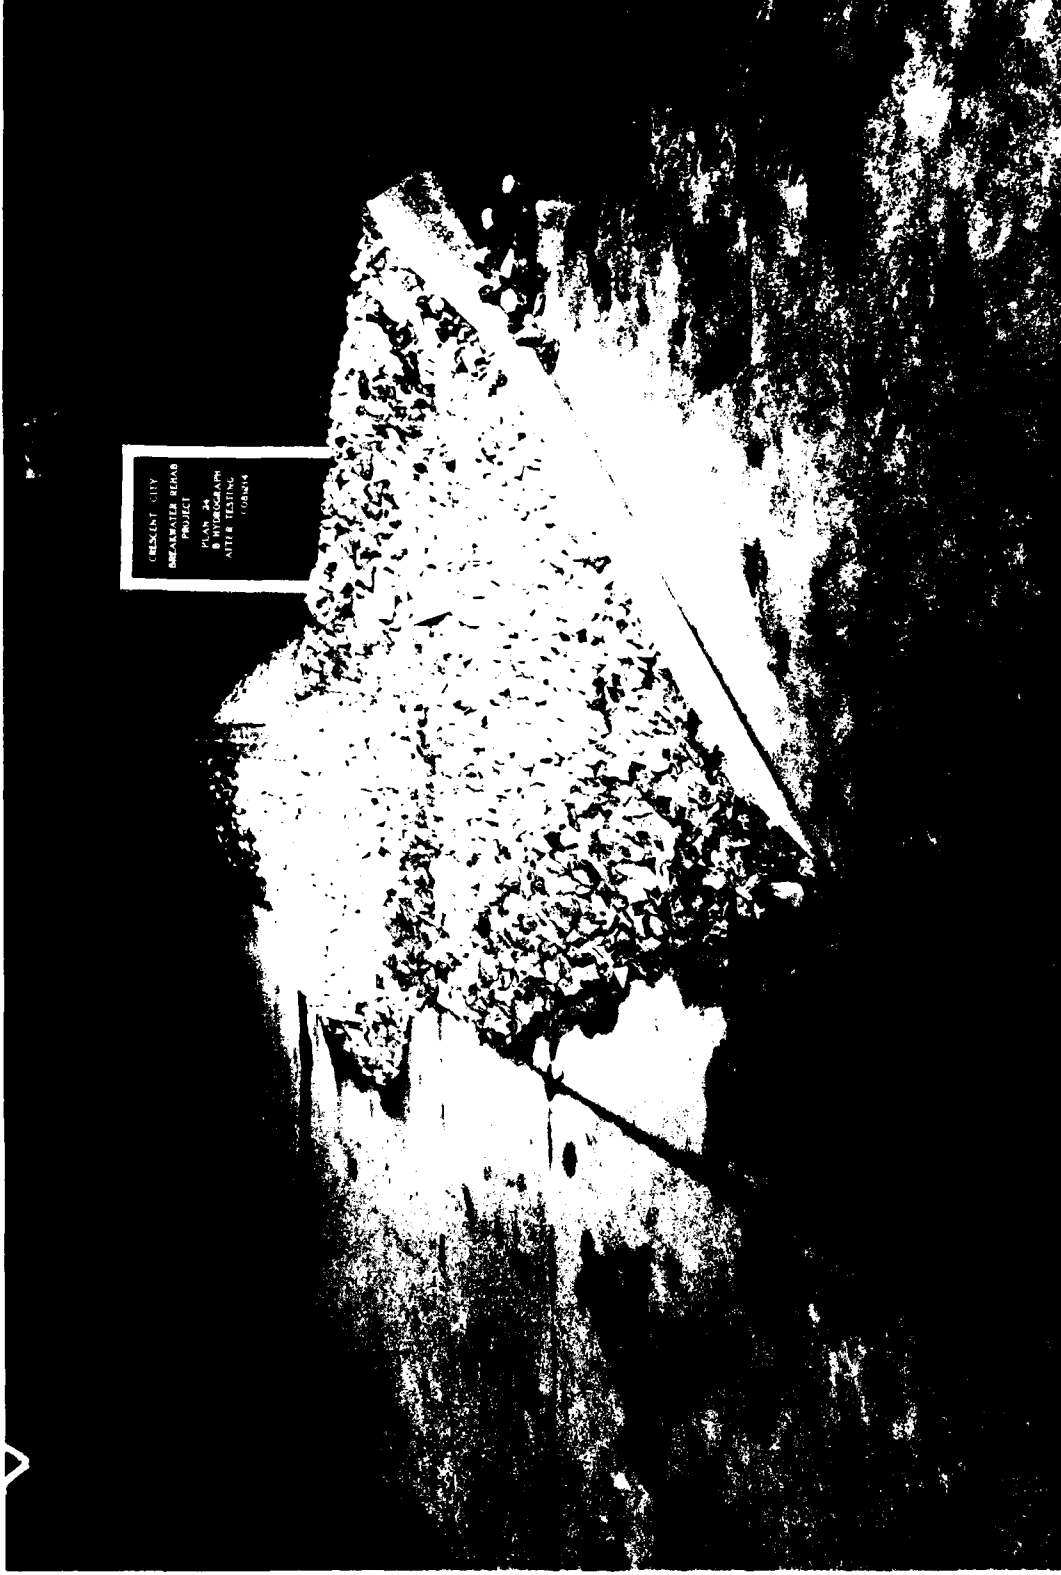
Photo 189. Seaward end view of Plan 24 after cumulative testing of Hydrographs A and B

left without buttressing for subsequent storm events. Based on these results and discussion with the Los Angeles District, it was decided that the test should be continued using Hydrograph B (Table 3). During testing of Hydrograph B, deterioration of the 25-ton buttressing stone continued and additional separation and displacement of dolos occurred in the lower seaward quadrant. Photos 187-189 show the structure after cumulative testing of Hydrograph A and B. Based on the overall test results, it appears that the stability of Plan 24 is questionable.

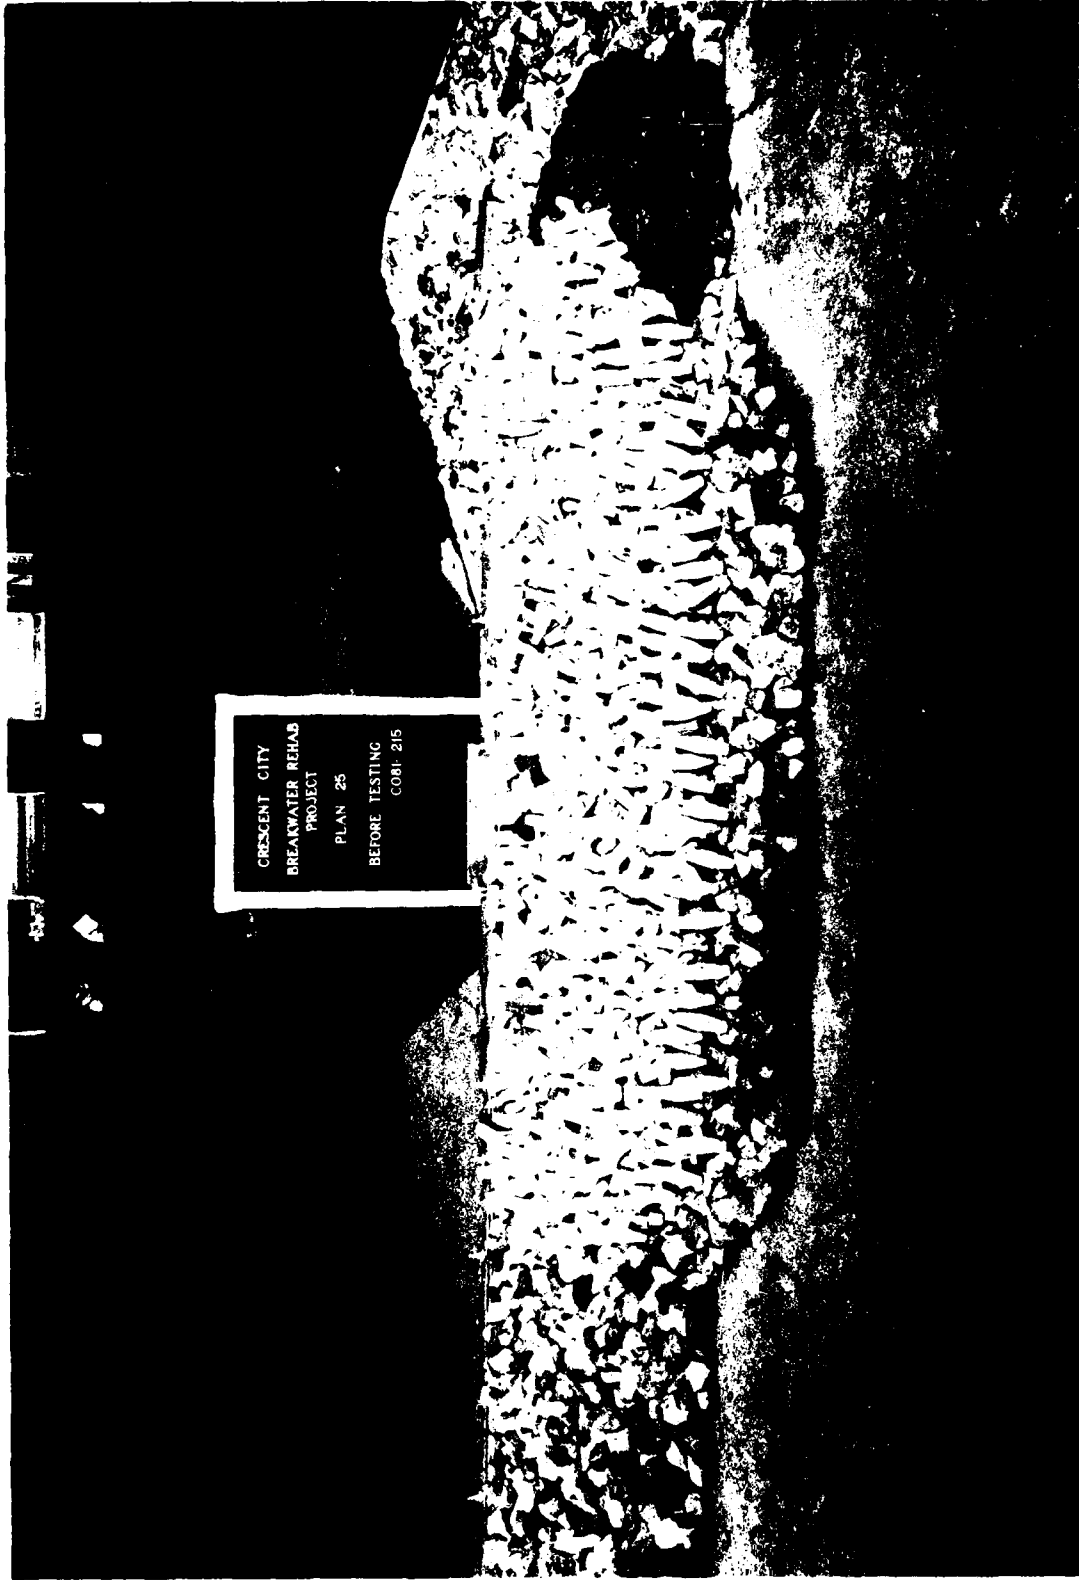
CRESCENT CITY  
BREAKWATER REHAD  
PROJECT  
PLAN 25  
BEFORE TESTING  
COB-215

Photo 190. Sea-side view of Plan 25 before wave attack

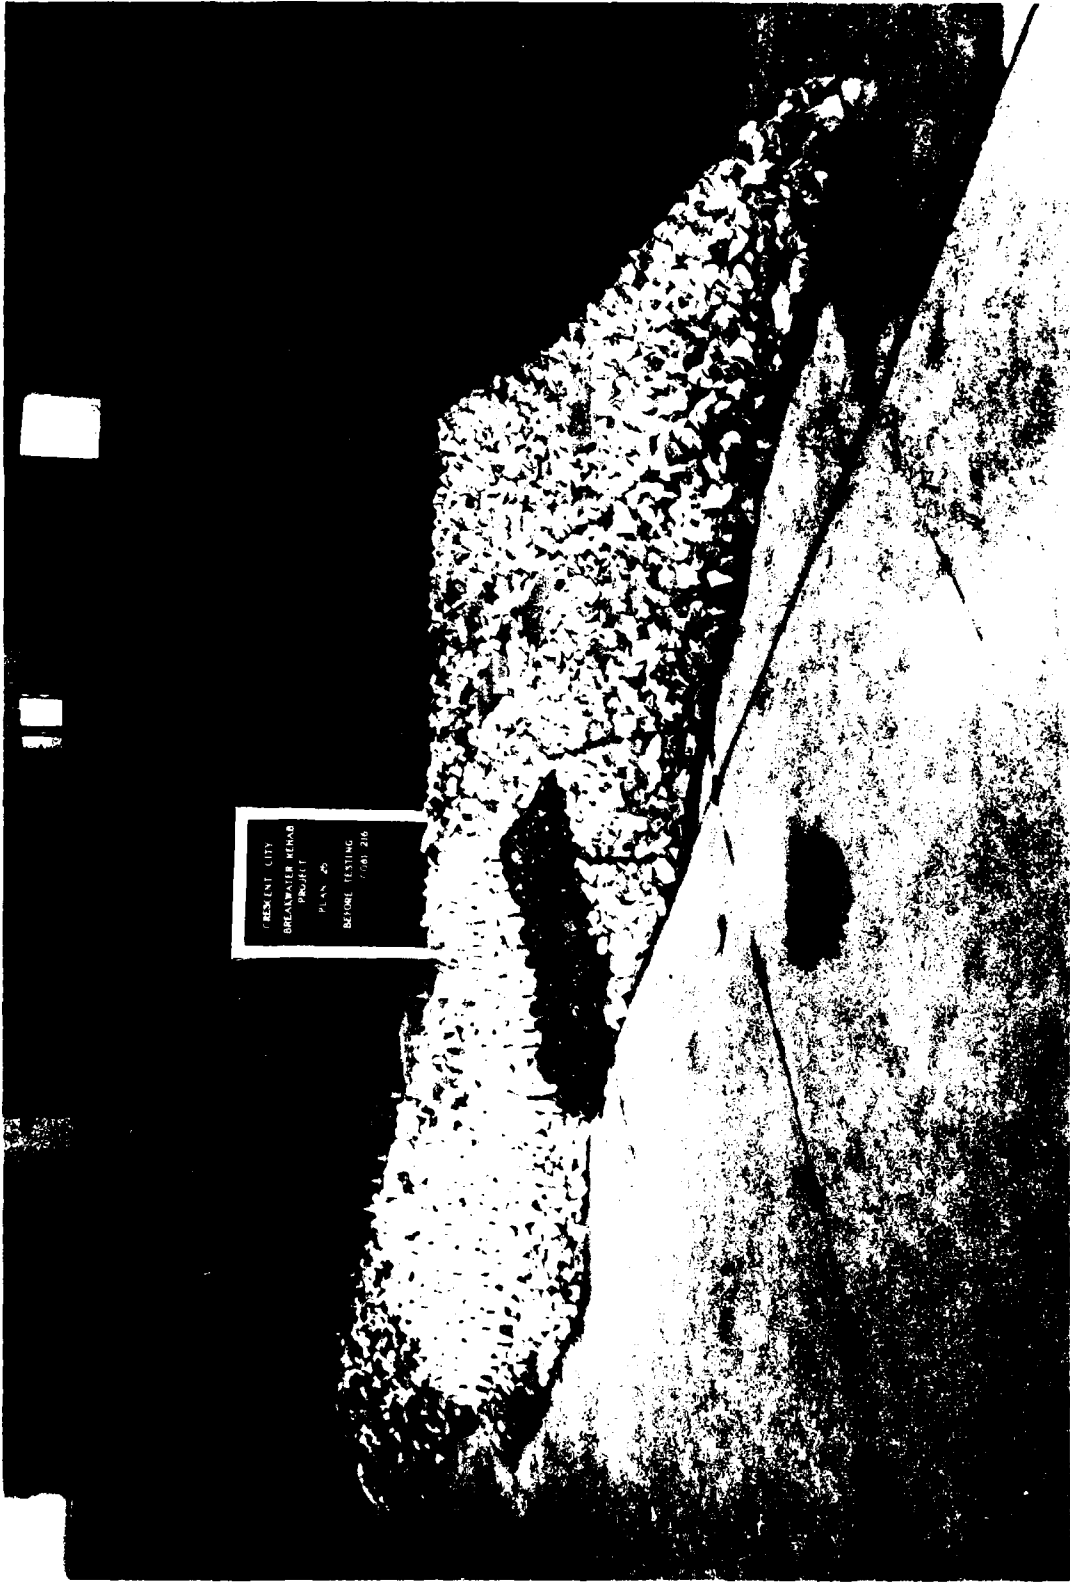
RESIDENT CITY  
BREAKWATER REHAB  
PROJECT  
PLAN 25  
BEFORE TESTING  
7/20/216

Photo 191. Seaward oblique view of Plan 25 before wave attack

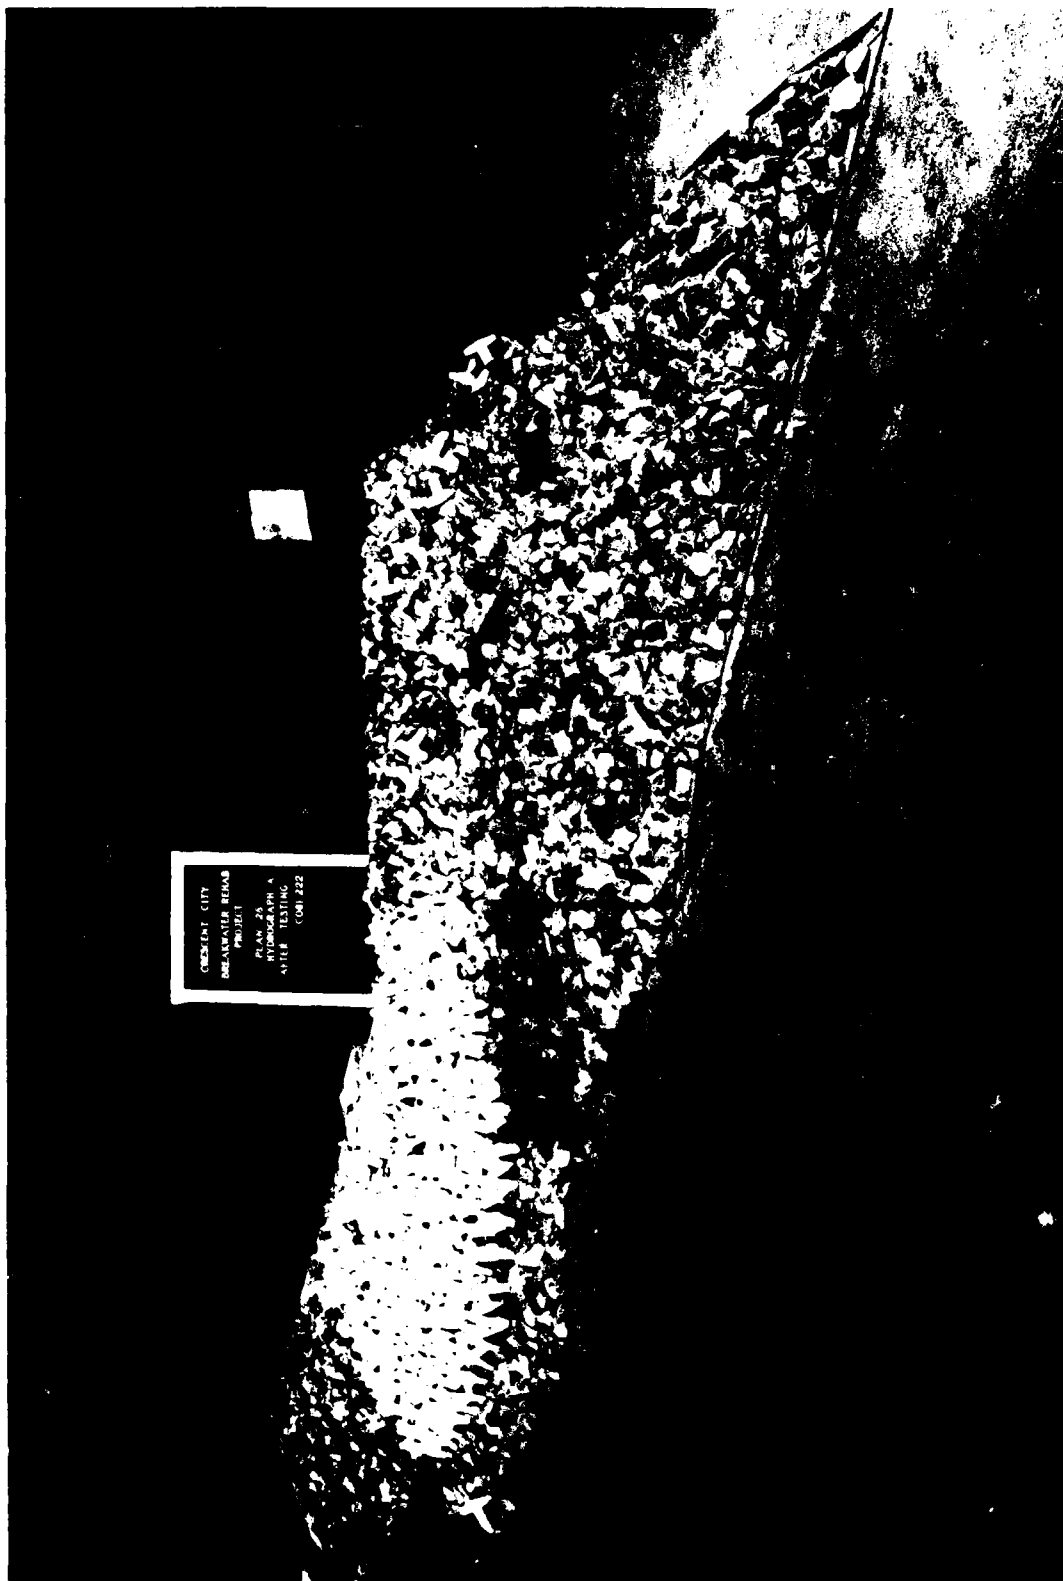
Photo 196. Sea-side view of Plan 25 after completion of Hydrograph A

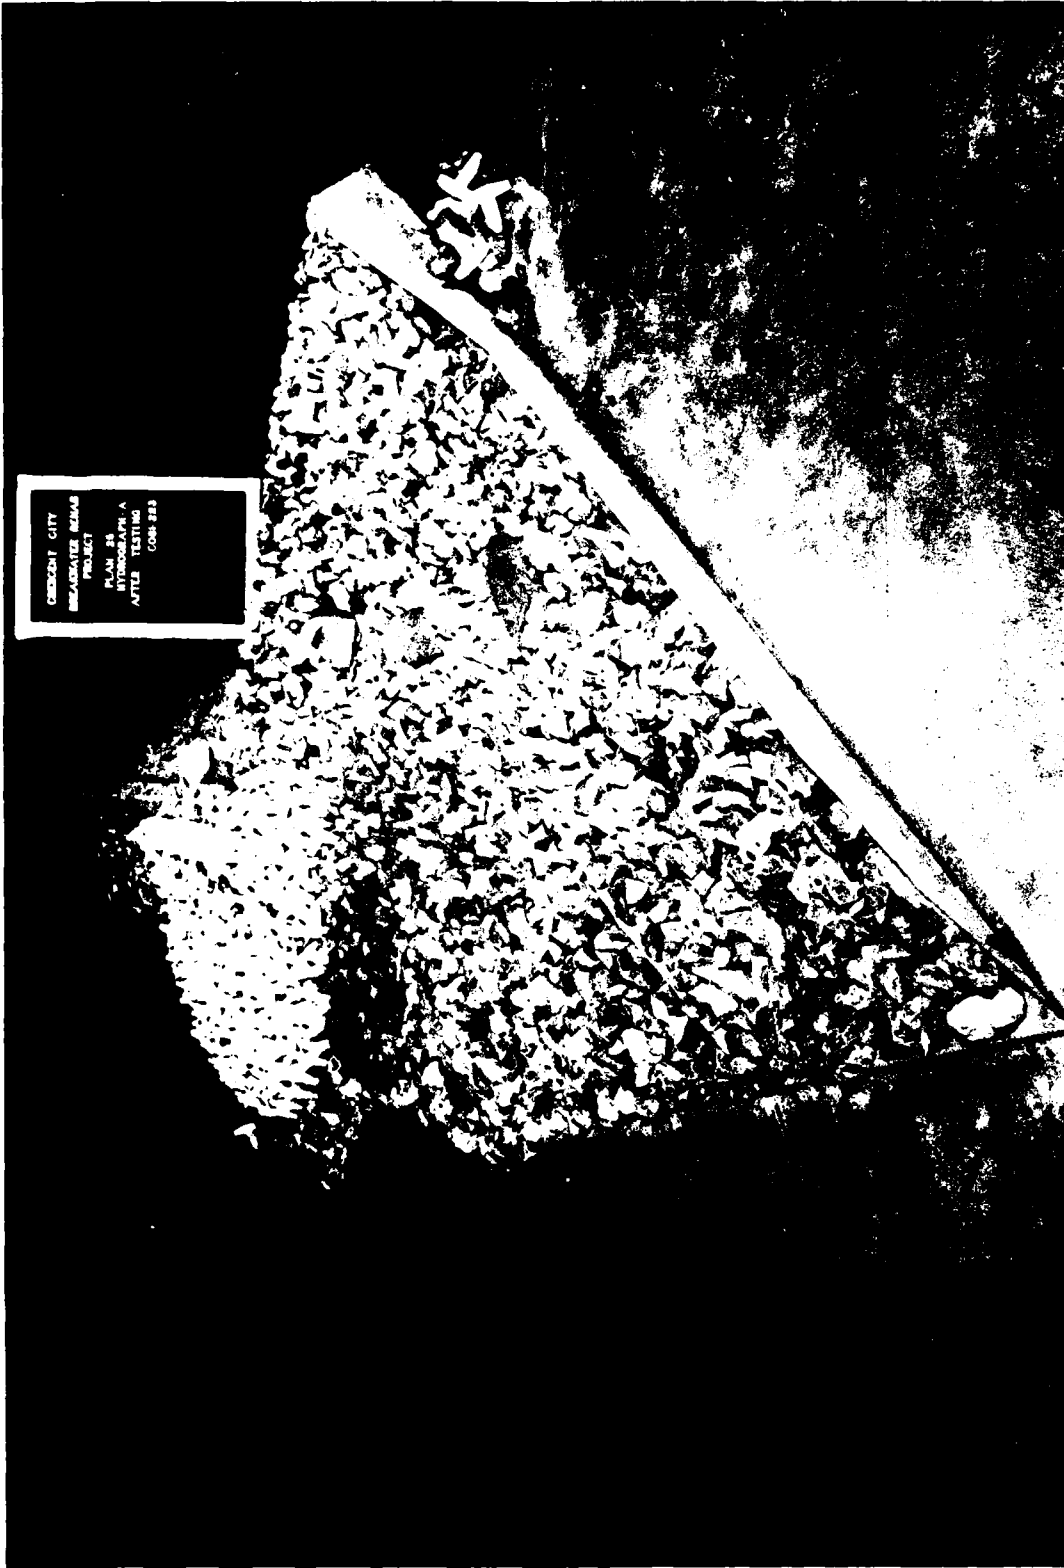
Photo 197. Seaward oblique view of Plan 25 after completion of Hydrograph A

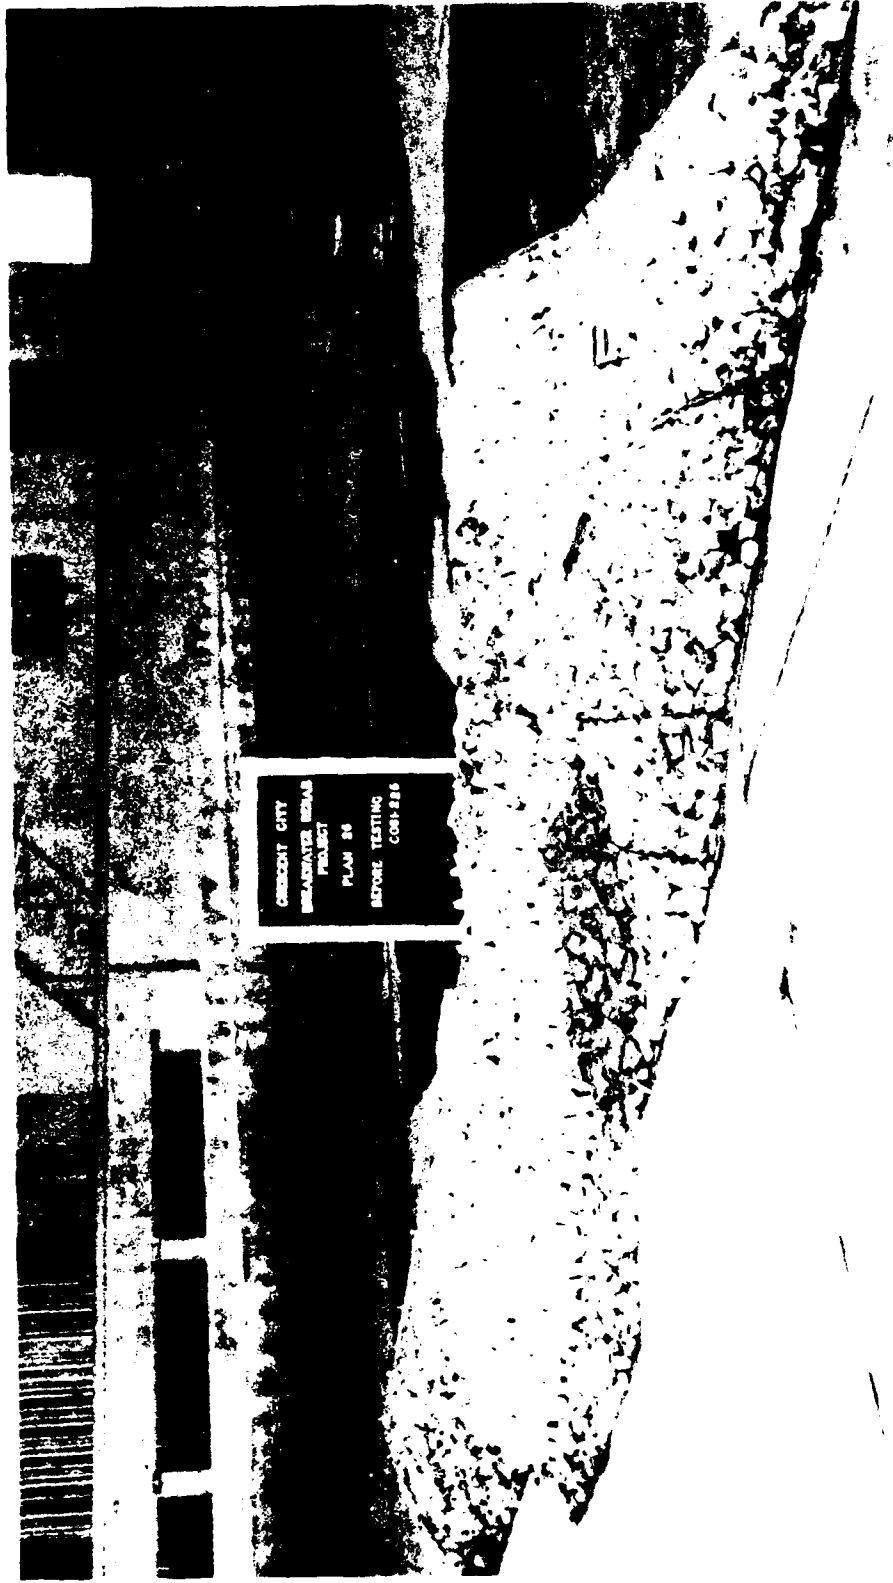
Photo 199. Sea-side view of Plan 26 before wave attack

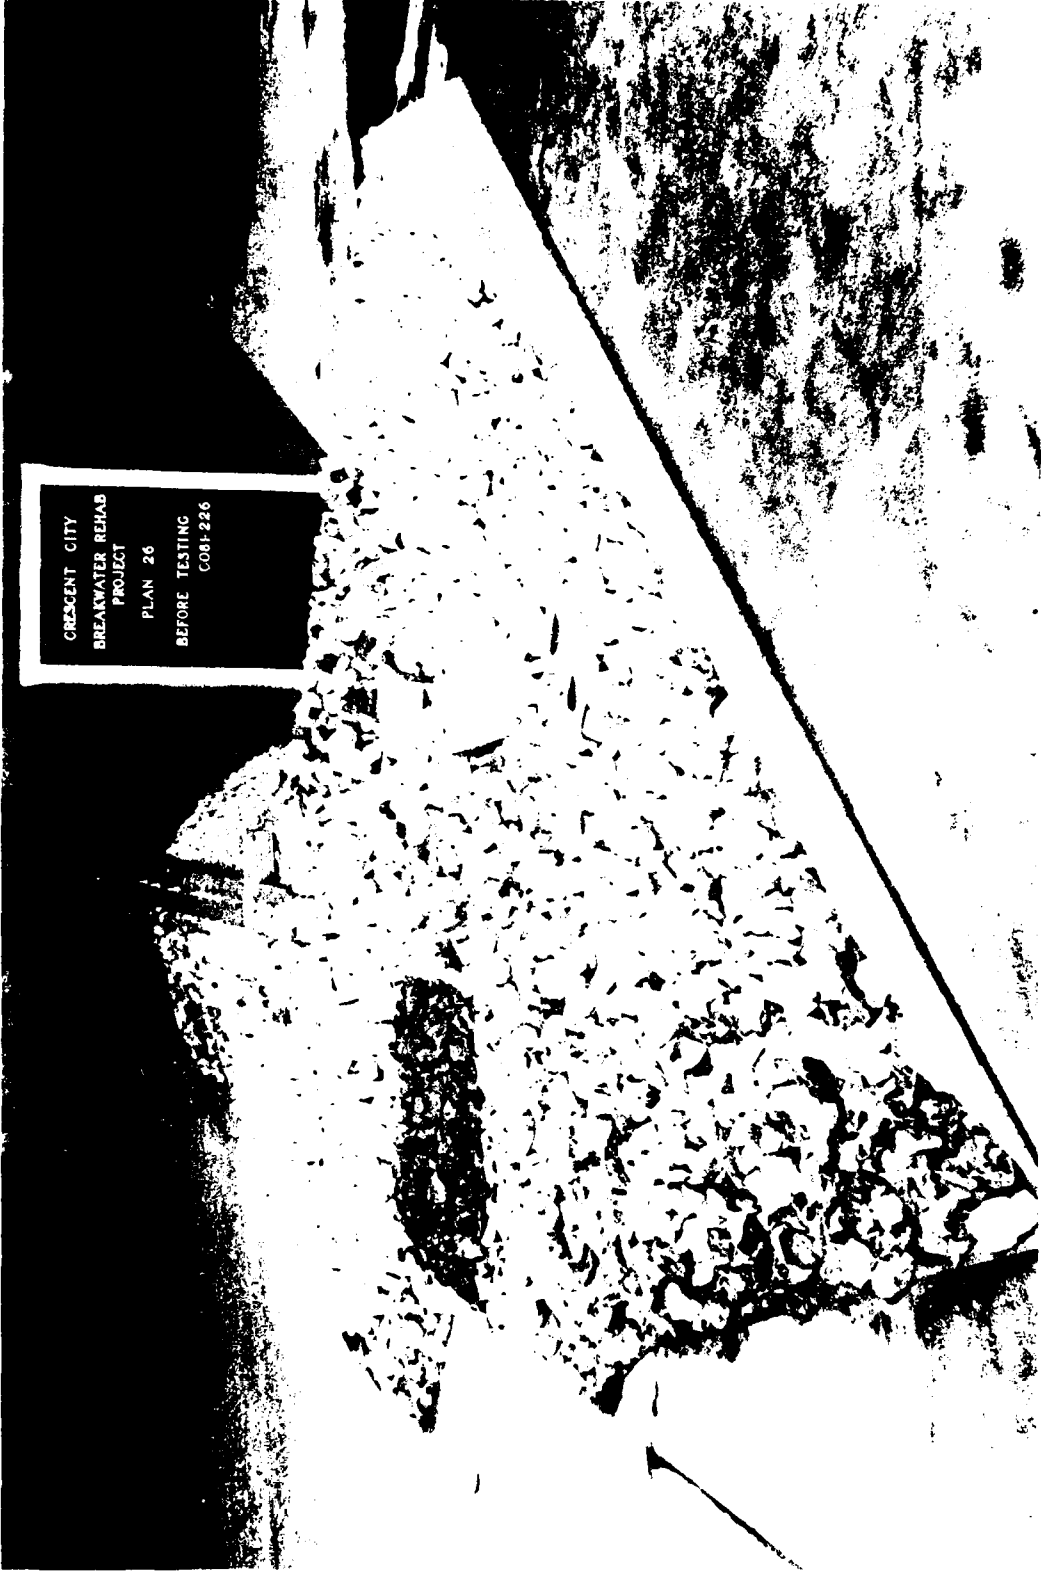
Photo 200. Seaward oblique view of Plan 26 before wave attack

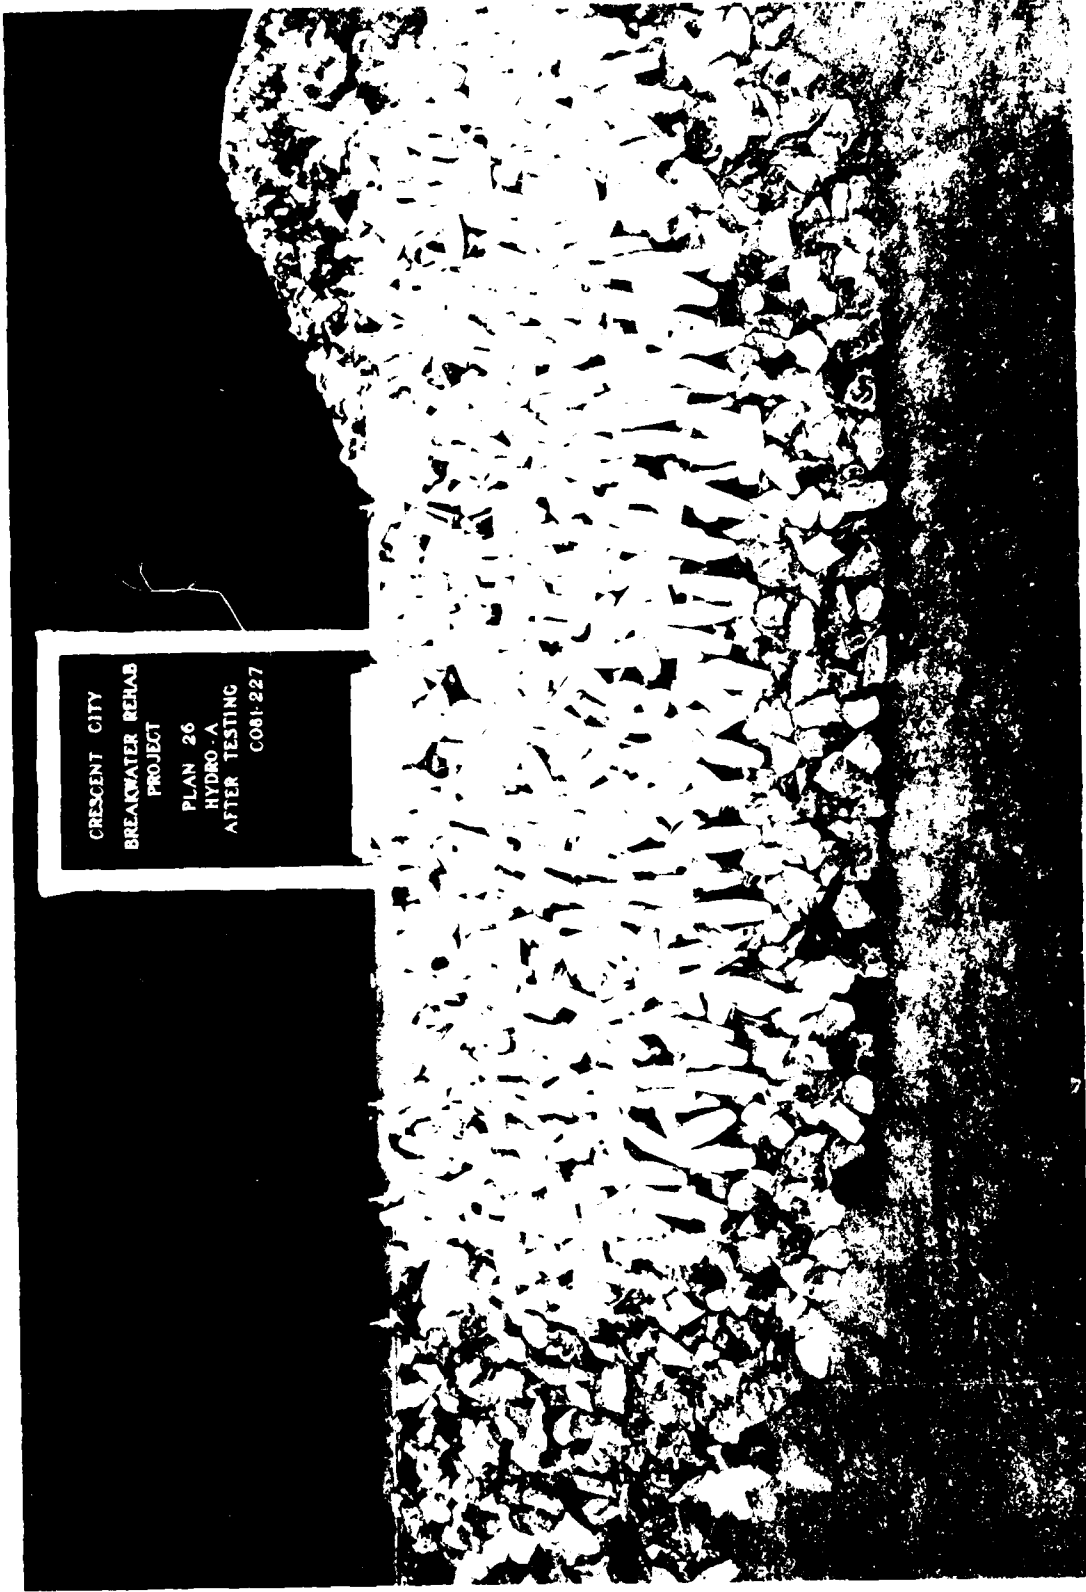
Photo 201. Seaward end view of Plan 26 before wave attack

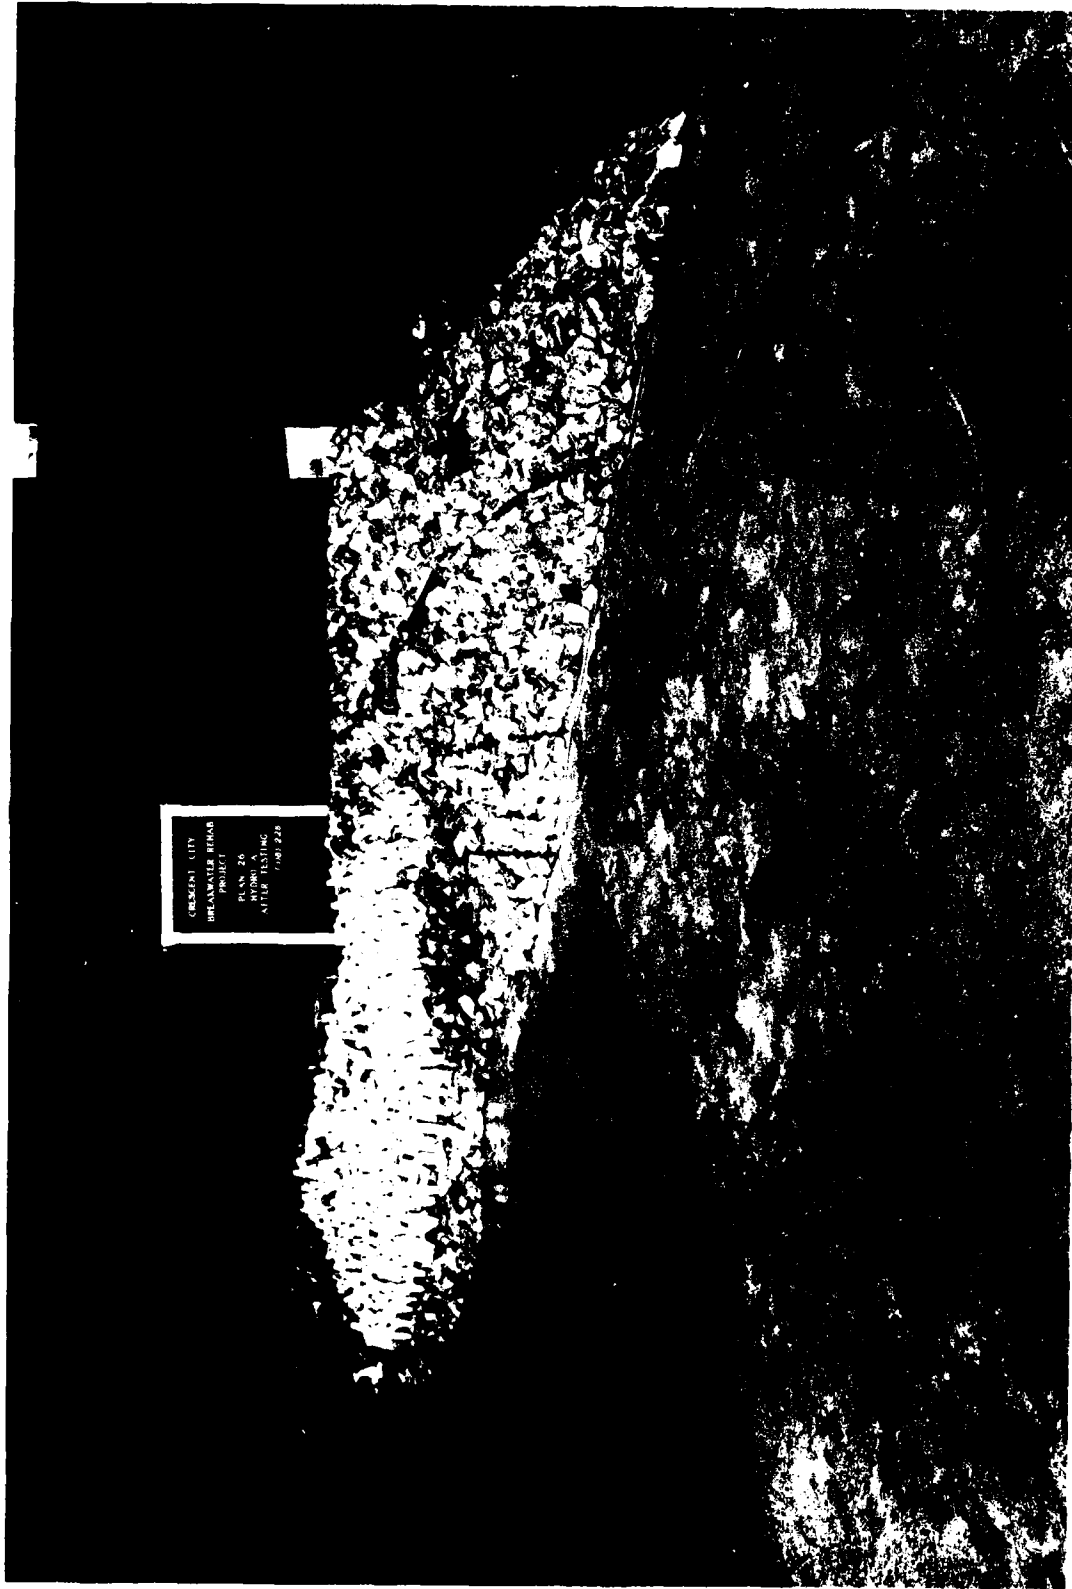
Photo 202. Sea-side view of Plan 26 after completion of Hydrograph A

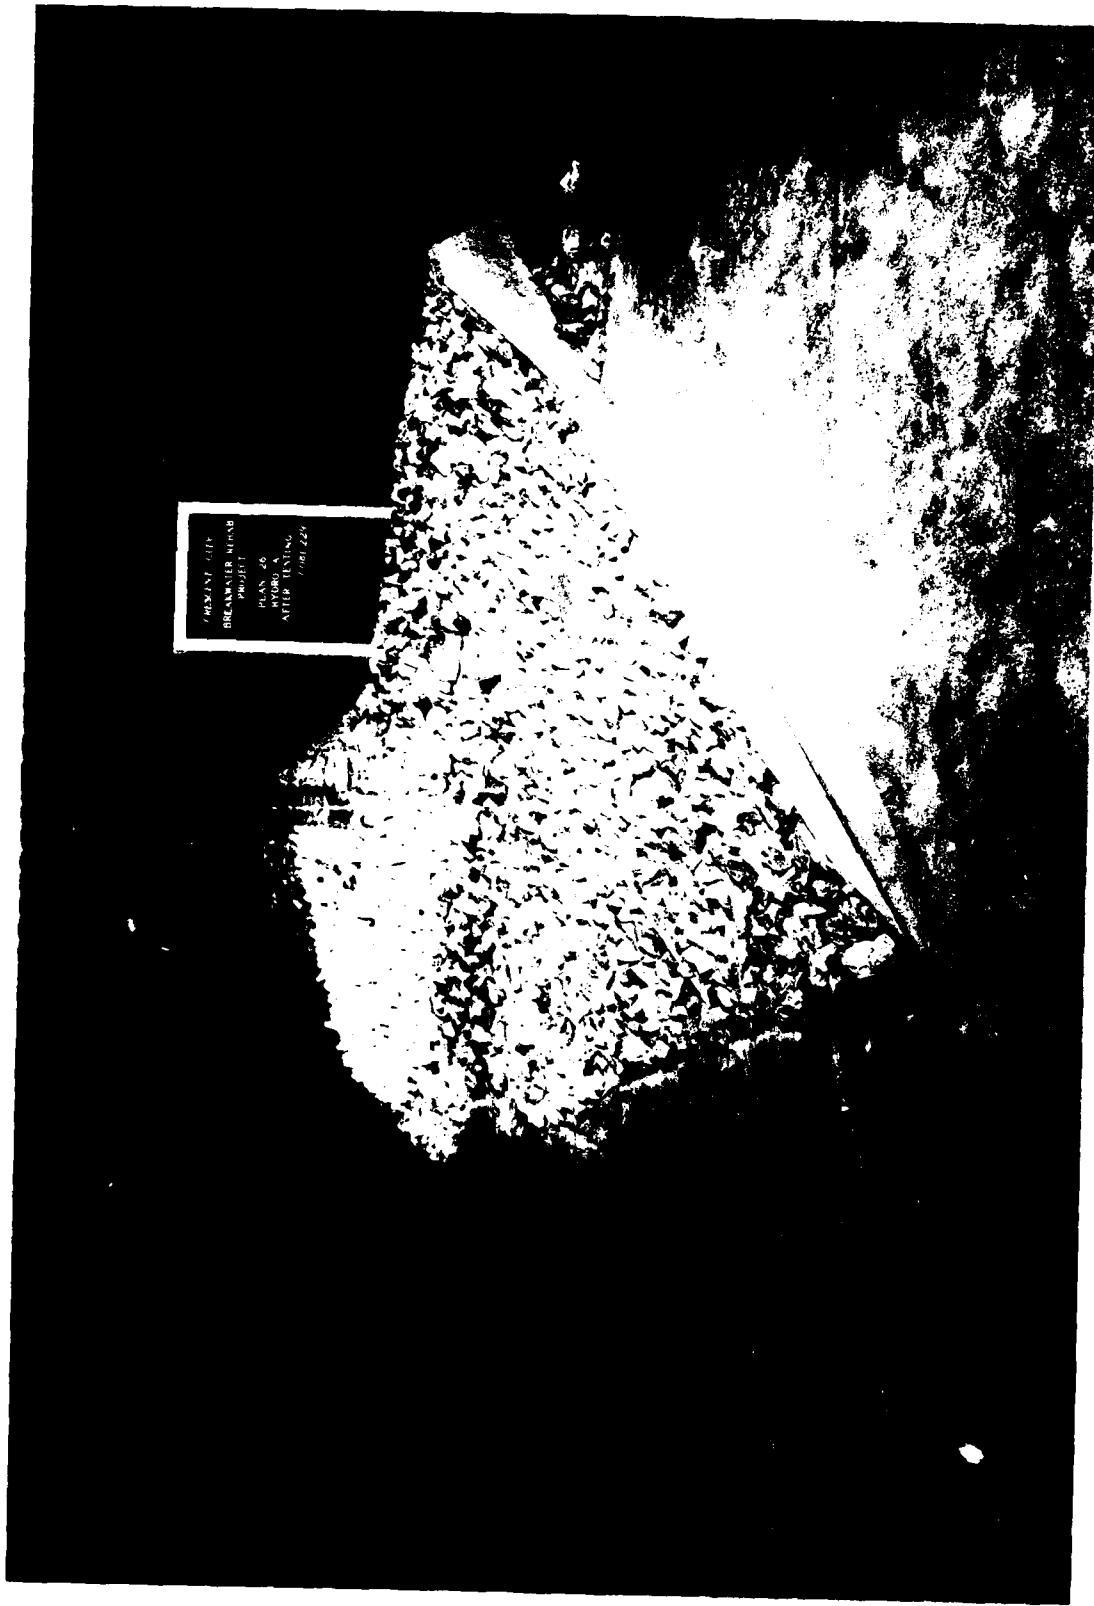
Photo 203. Seaward oblique view of Plan 26 after completion of Hydrograph A

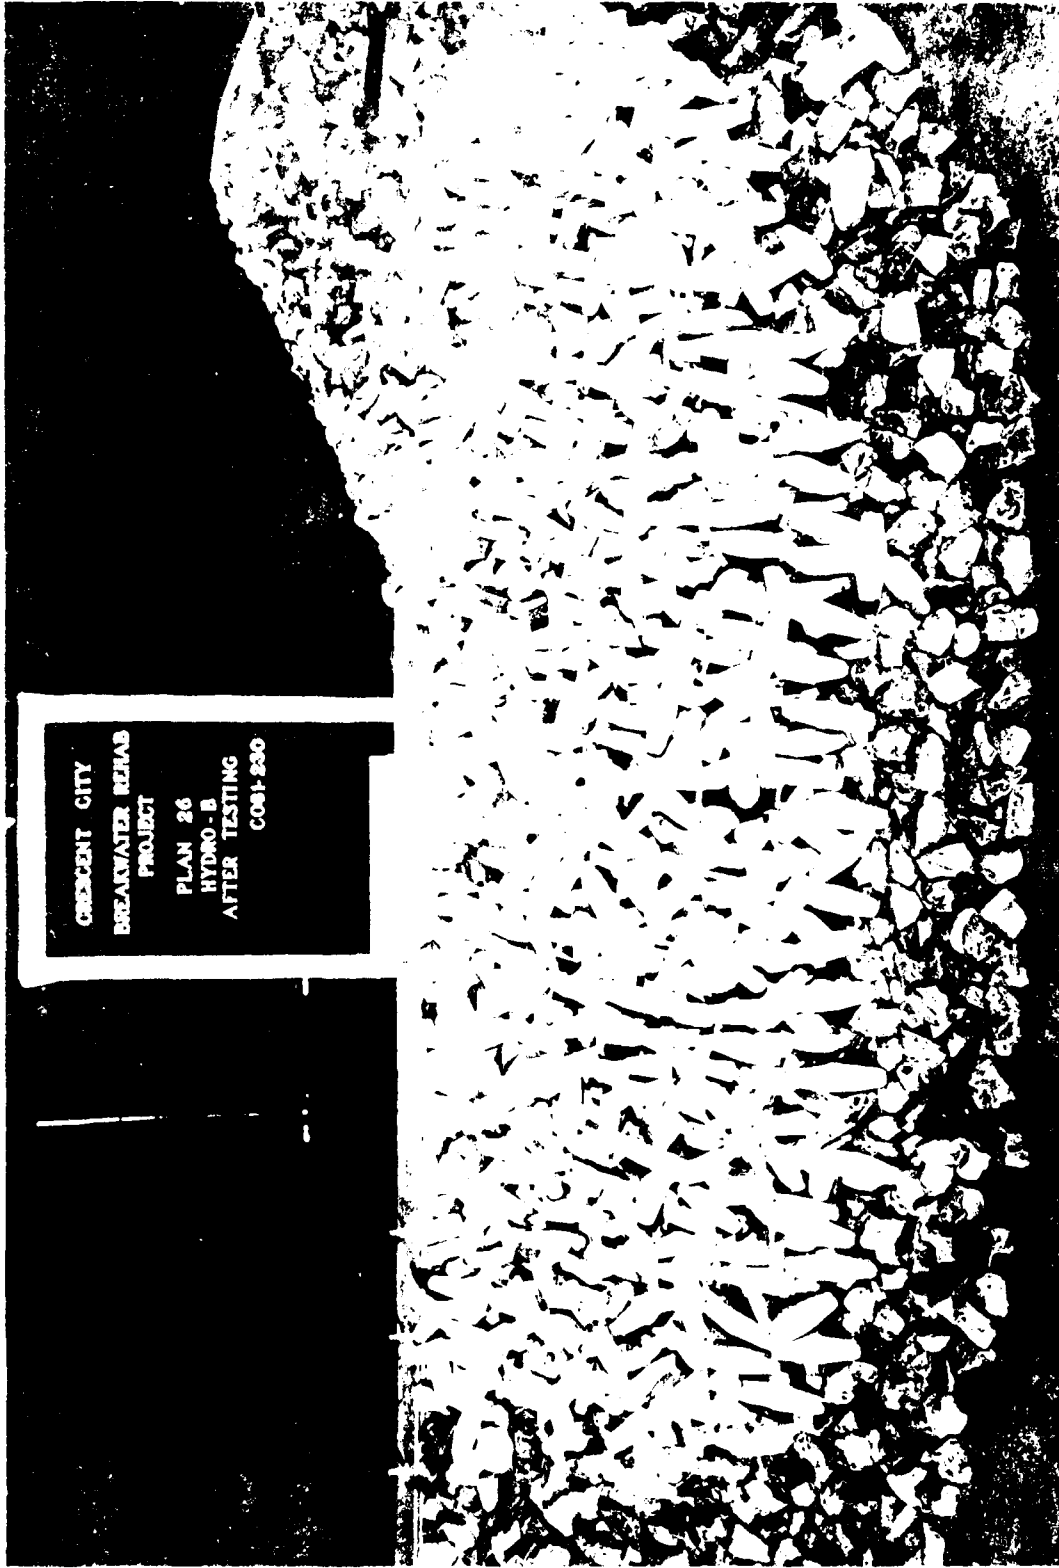
Photo 204. Seaward end view of Plan 26 after completion of Hydrograph A

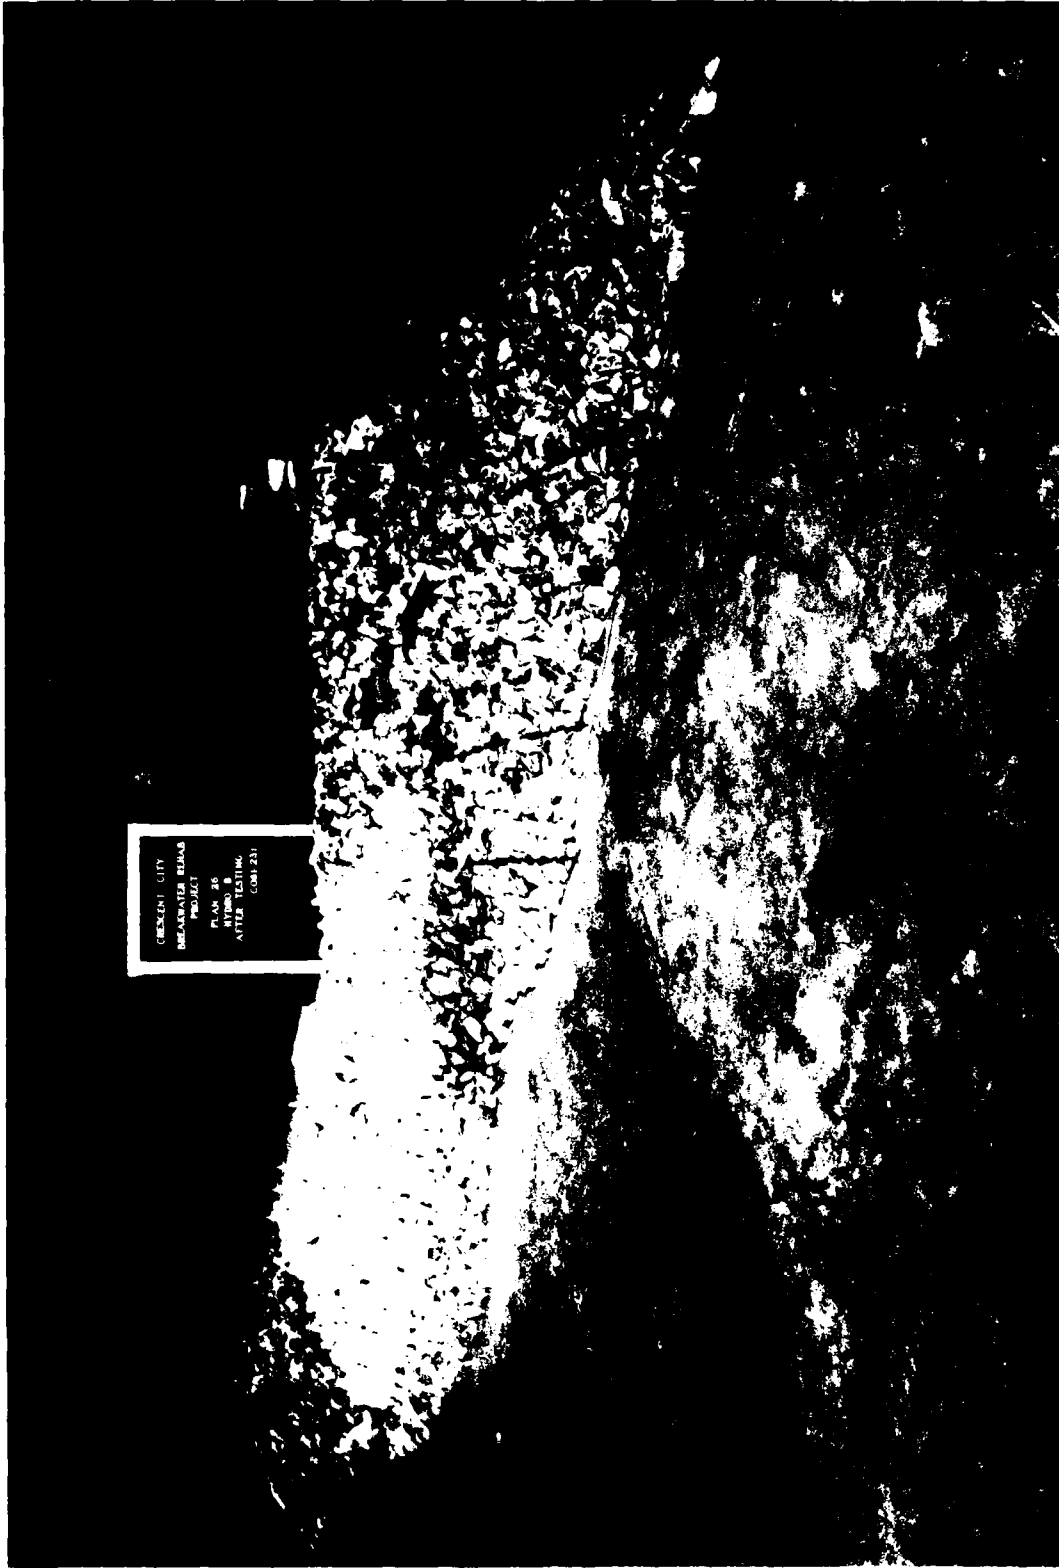
Photo 205. Sea-side view of Plan 26 after cumulative testing of Hydrographs A and B

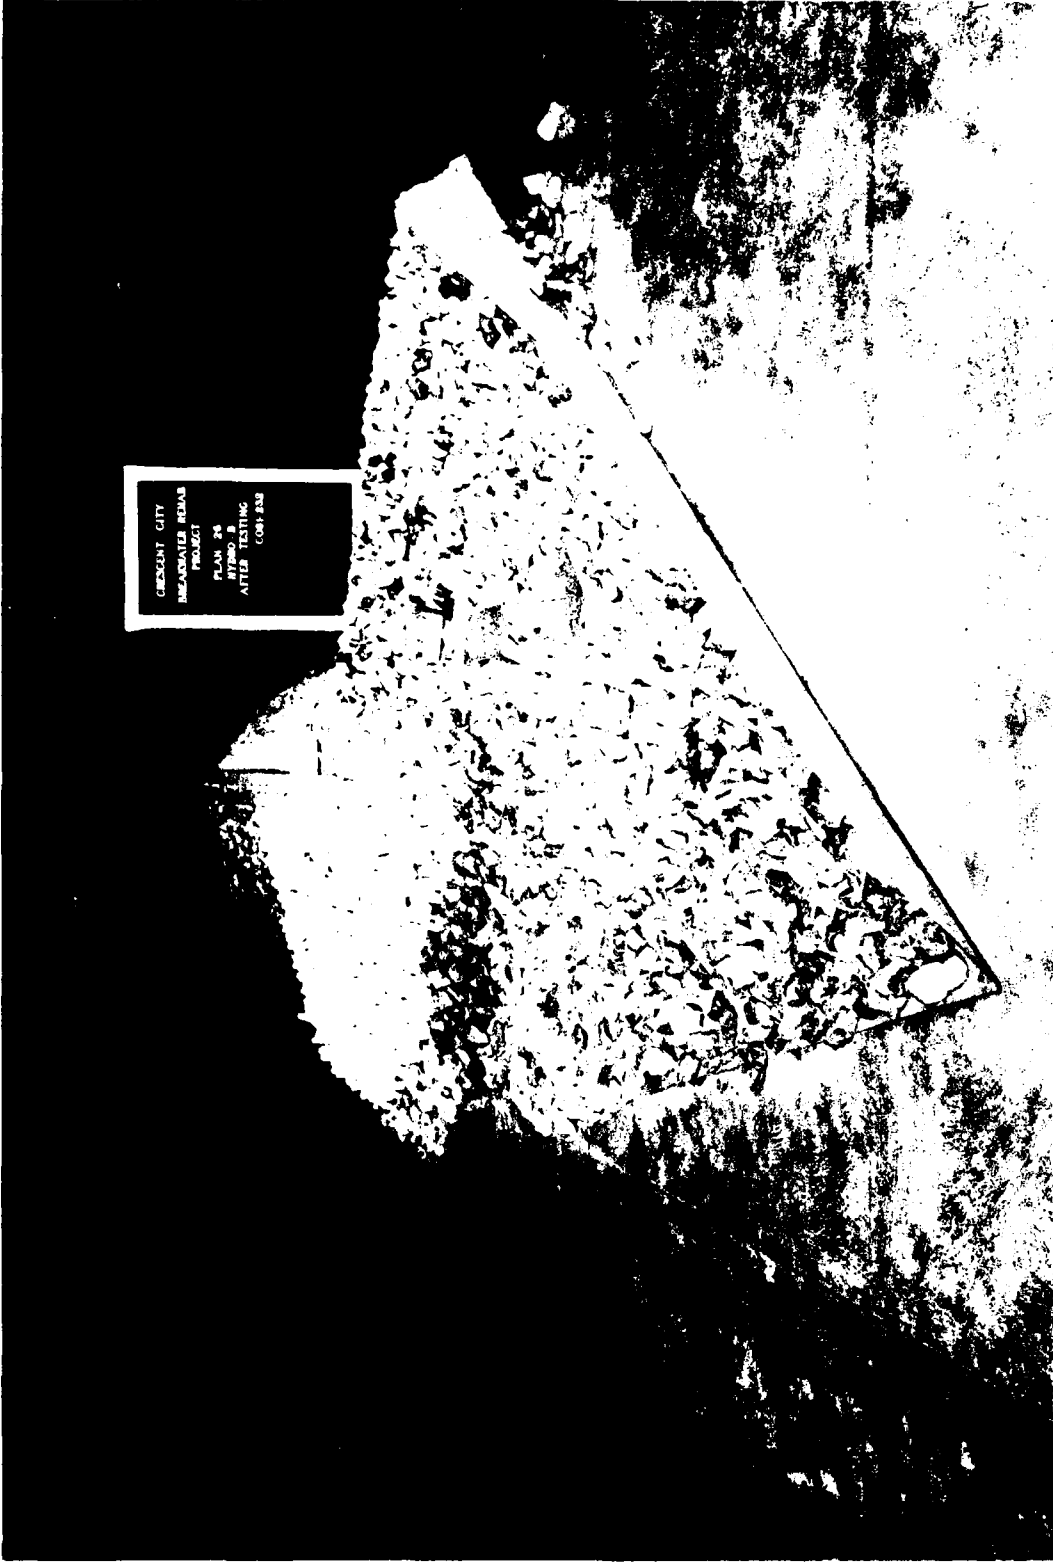
Photo 206. Seaward oblique view of Plan 26 after cumulative testing of Hydrographs A and B
