TECHNICAL REPORT CERC-85-8

# BREAKWATER REHABILITATION STUDY, CRESCENT CITY HARBOR, CALIFORNIA

## Coastal Model Investigation

November 1985

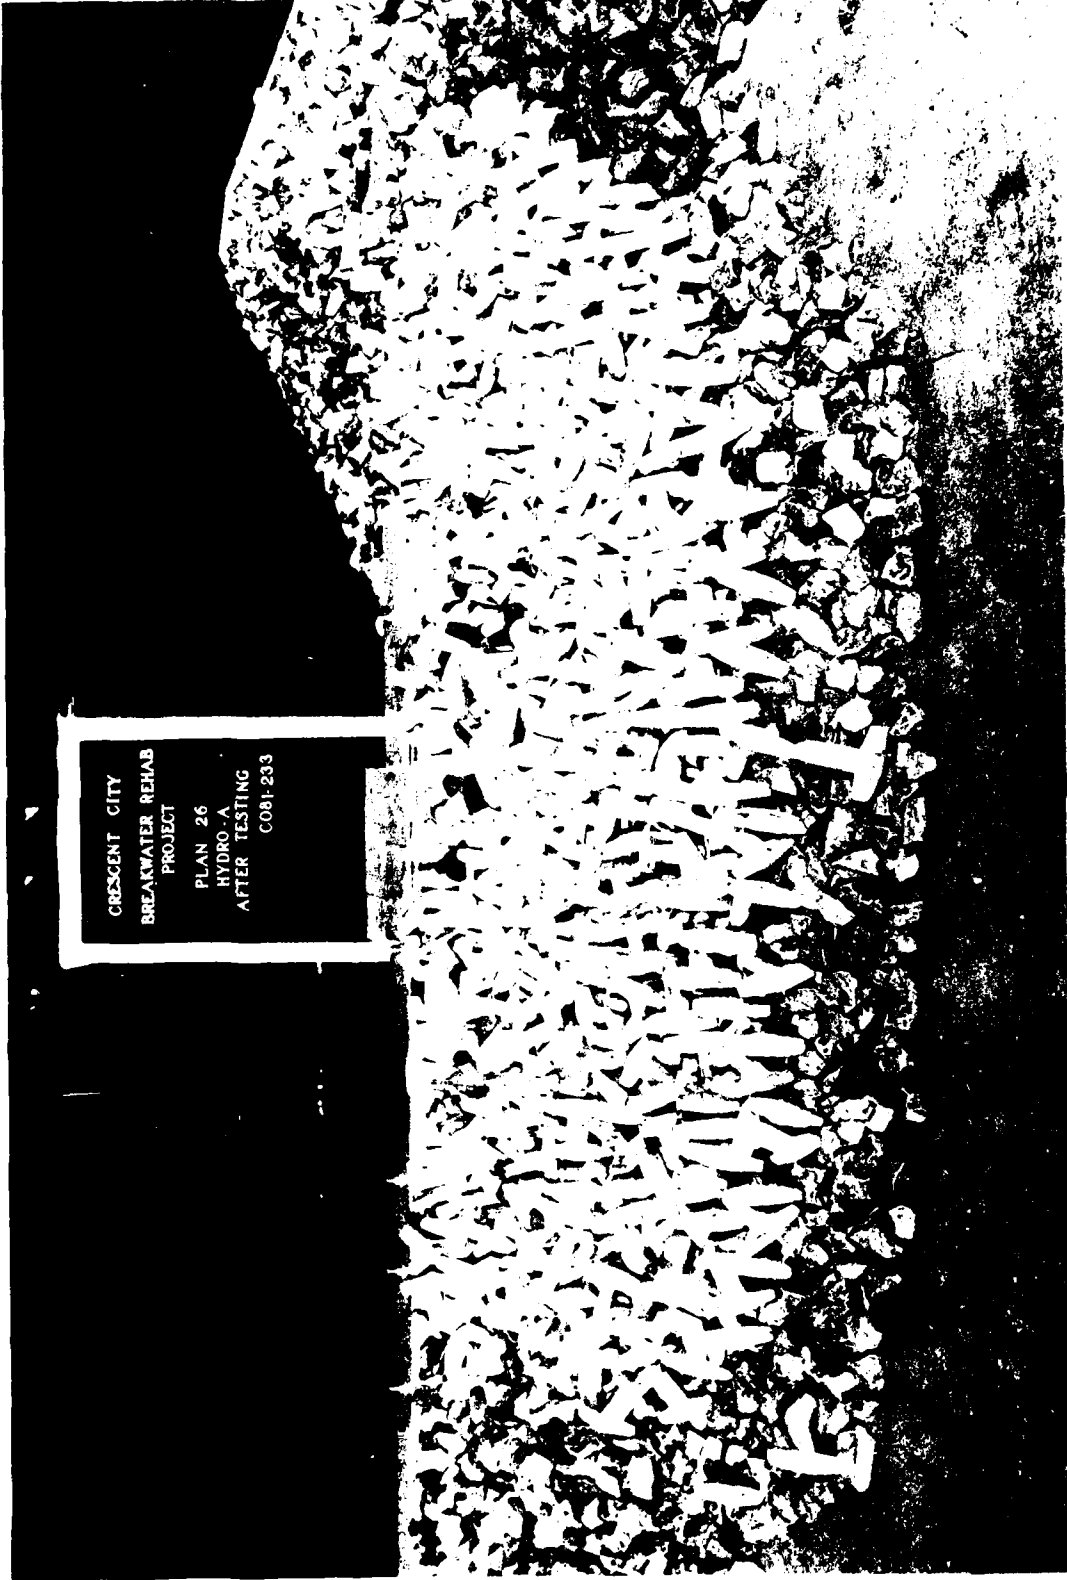
Photo 207. Seaward end view of Plan 26 after cumulative testing of Hydrographs A and B

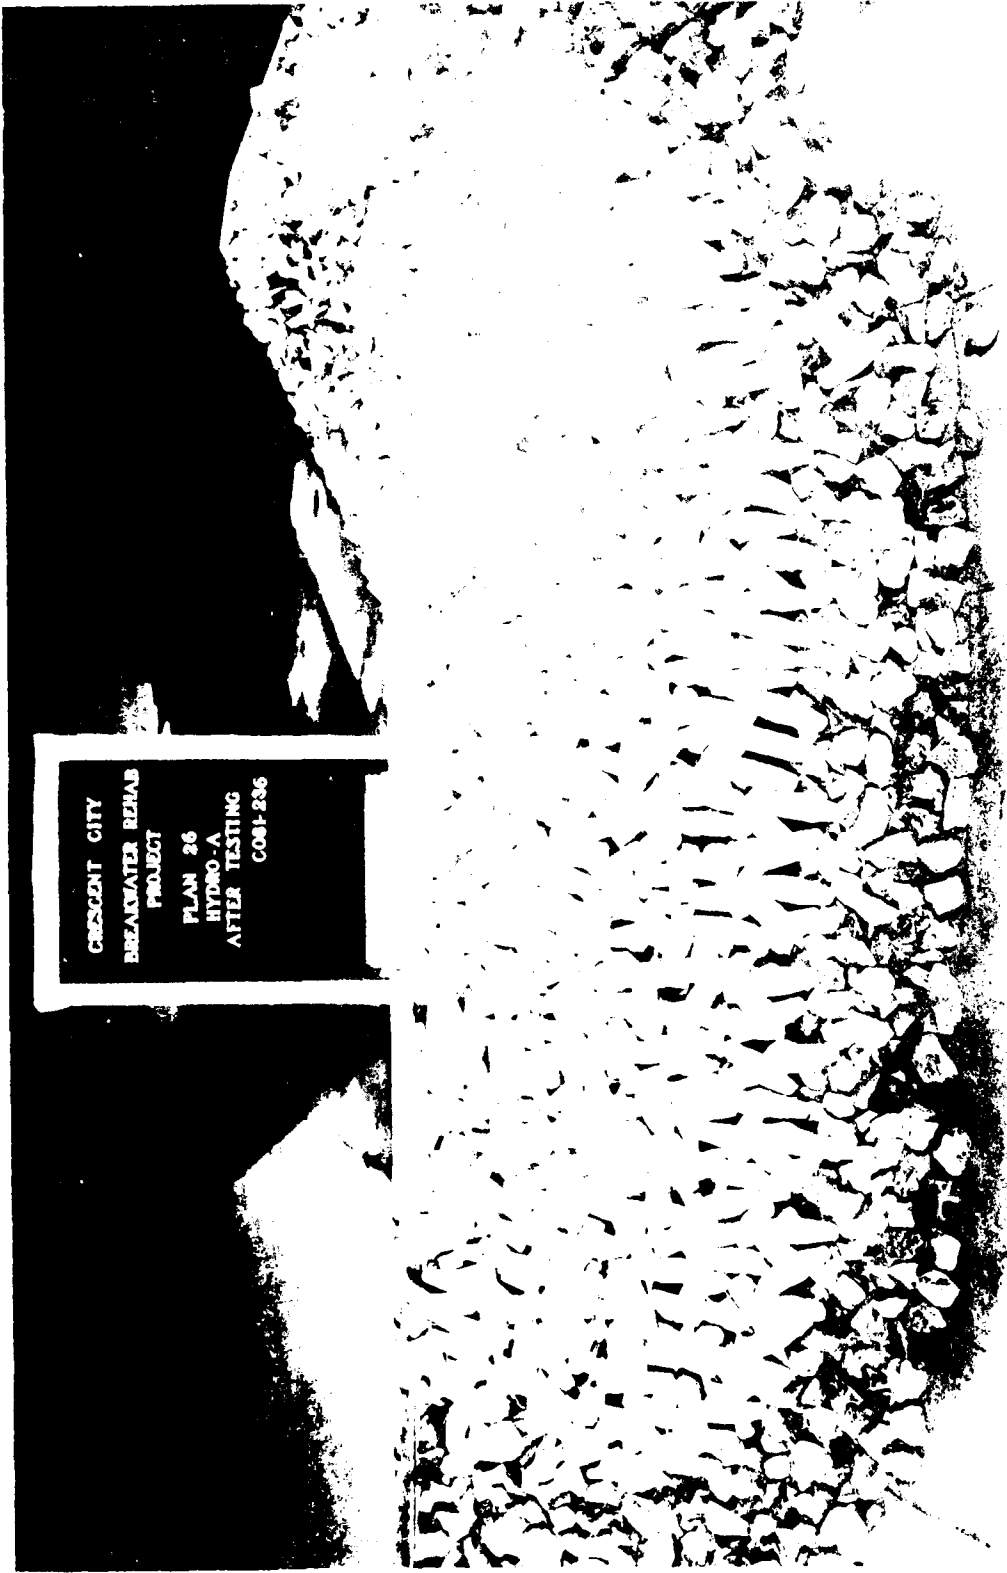
Photo 210. Seaward end view of Plan 26 after first repeat test with Hydrograph A

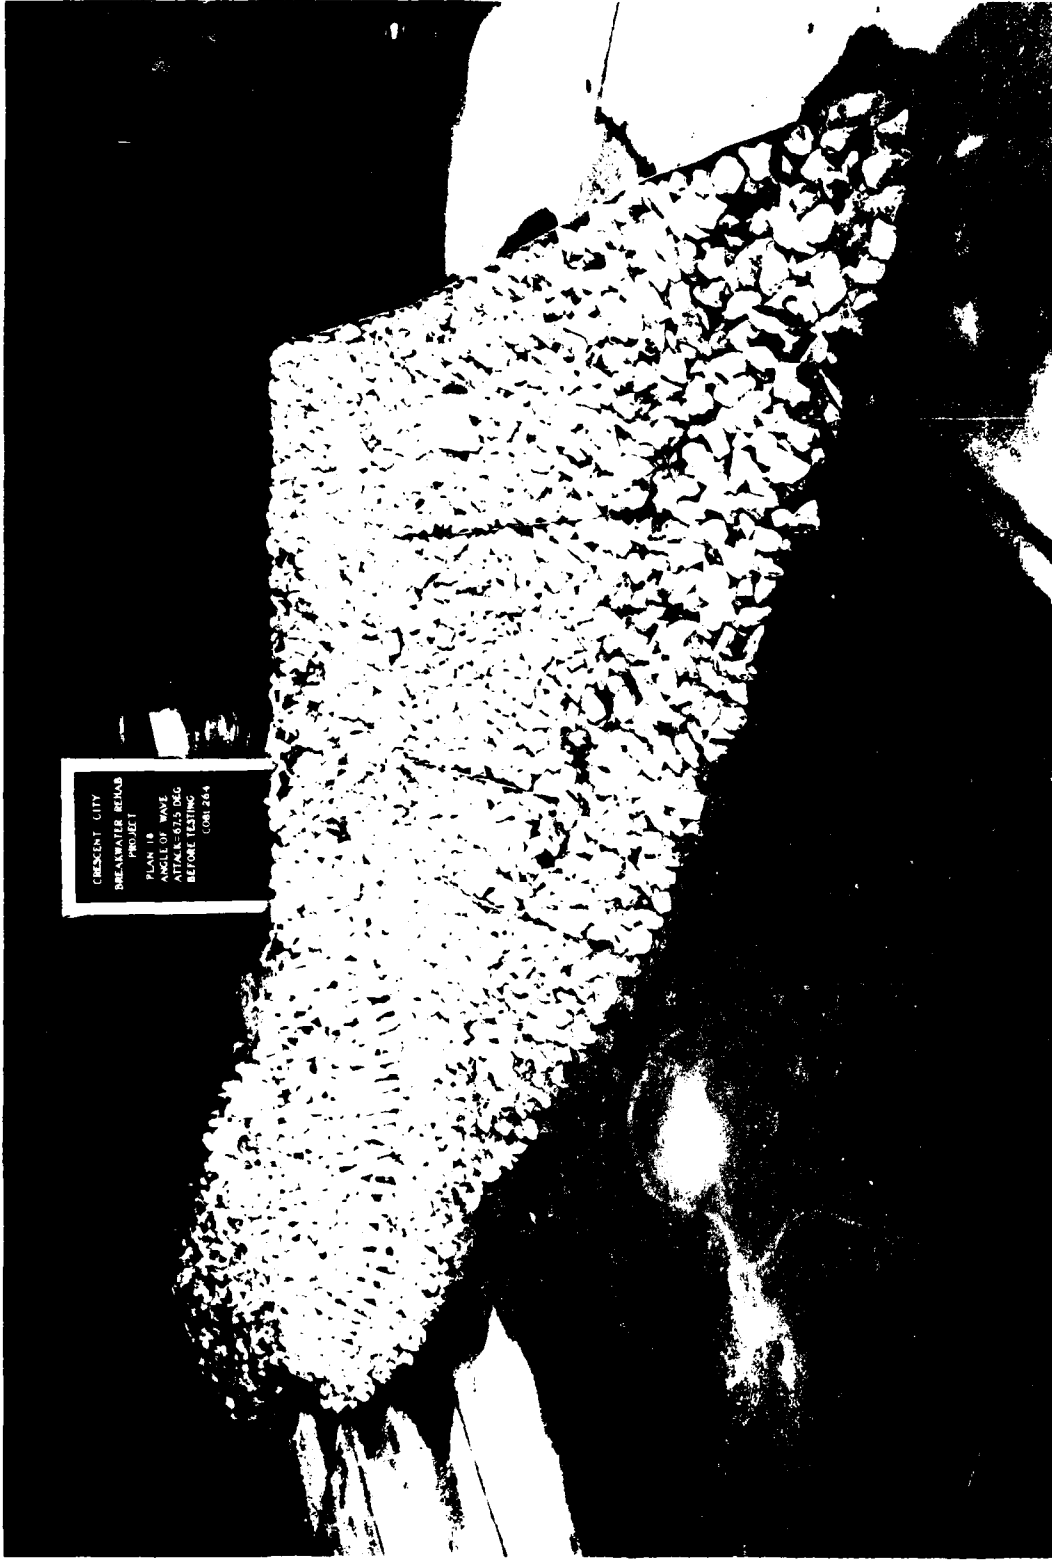
Photo 220. Sea-side view of Plan 18 before wave attack after modification to shoreward transition; 67.5-deg angle of wave attack

58. Plan 18 (Plate 30 and Photos 220-222) was constructed the same as for the 90-deg angle of wave attack except for a modification to the shoreward transition. Two rows of rehabilitation dolosse encompassed the existing units at the shoreward end. A total of 434 42-ton rehabilitation dolosse were placed. Subjection to Hydrograph A displaced three dolosse from the shoreward transition toe. The seaward transition suffered extensive damage during testing with 13 units being displaced. Photos 223-225 show the structure after testing with Hydrograph A. Plan 18 was rebuilt using 447 42-ton rehabilitation dolosse and subjected to Hydrograph B. The seaward transition again sustained extensive damage and the shoreward transition had moderate damage. Thus, Plan 18 proved to be unacceptable for the 67.5-deg angle of wave attack. Photos 226-228 show the structure after testing with Hydrograph B.

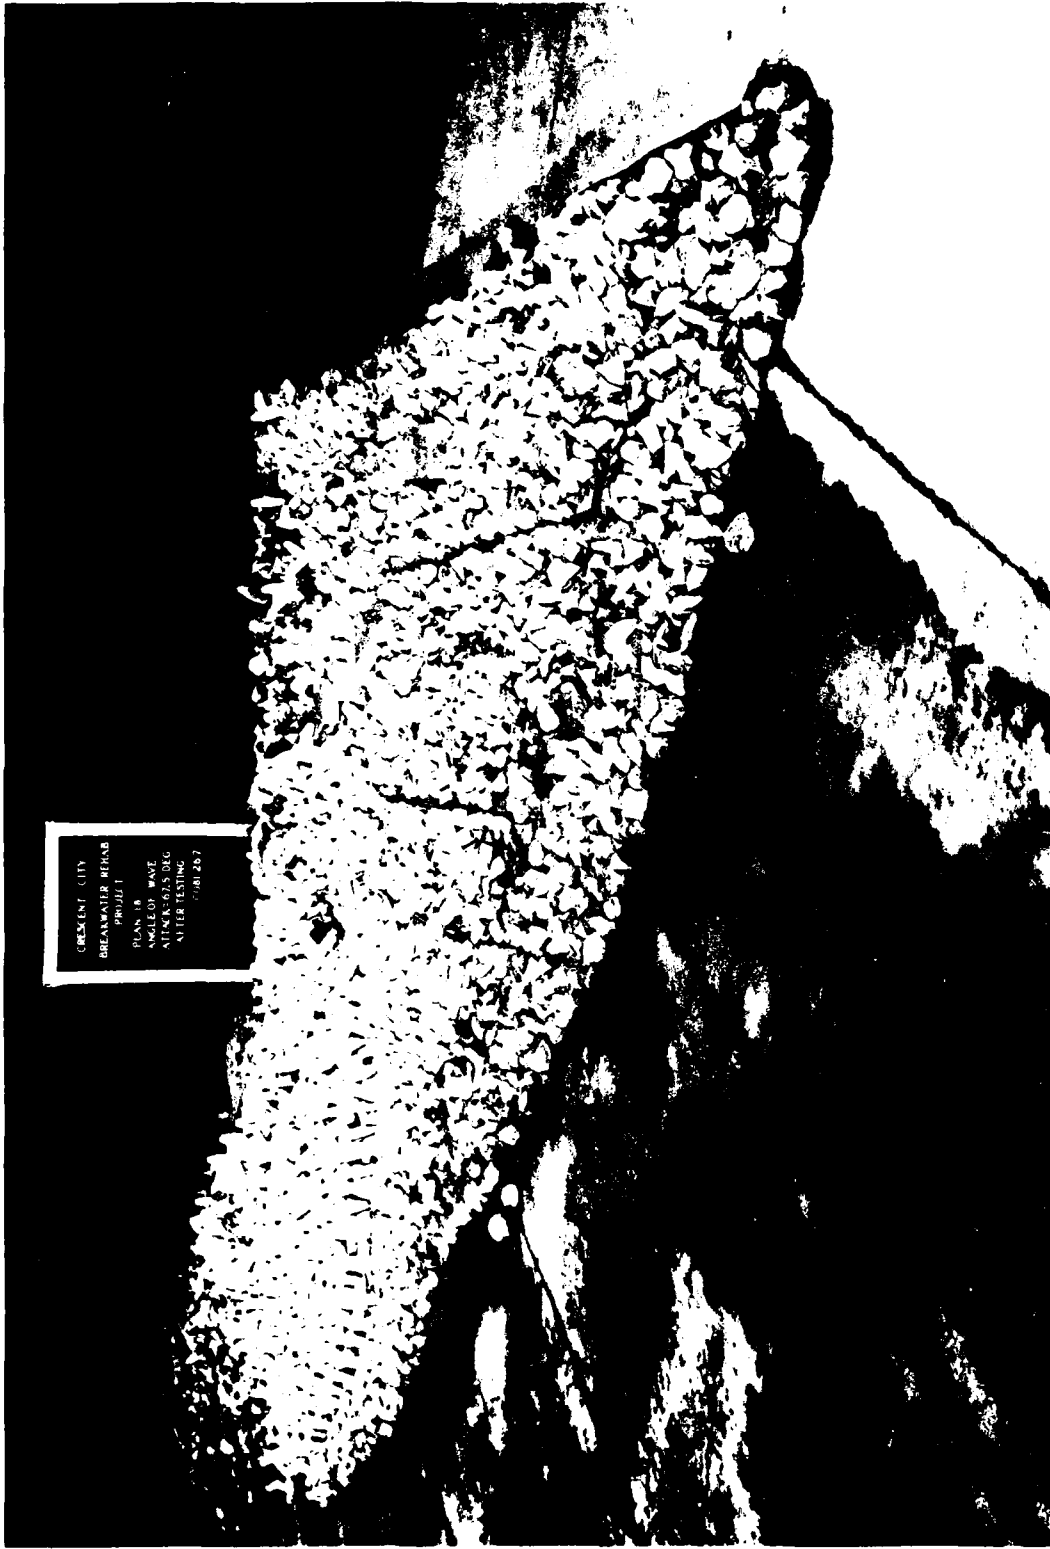
Photo 223. Sea-side view of Plan 18 after completion of Hydrograph A; 67.5-deg angle of wave attack

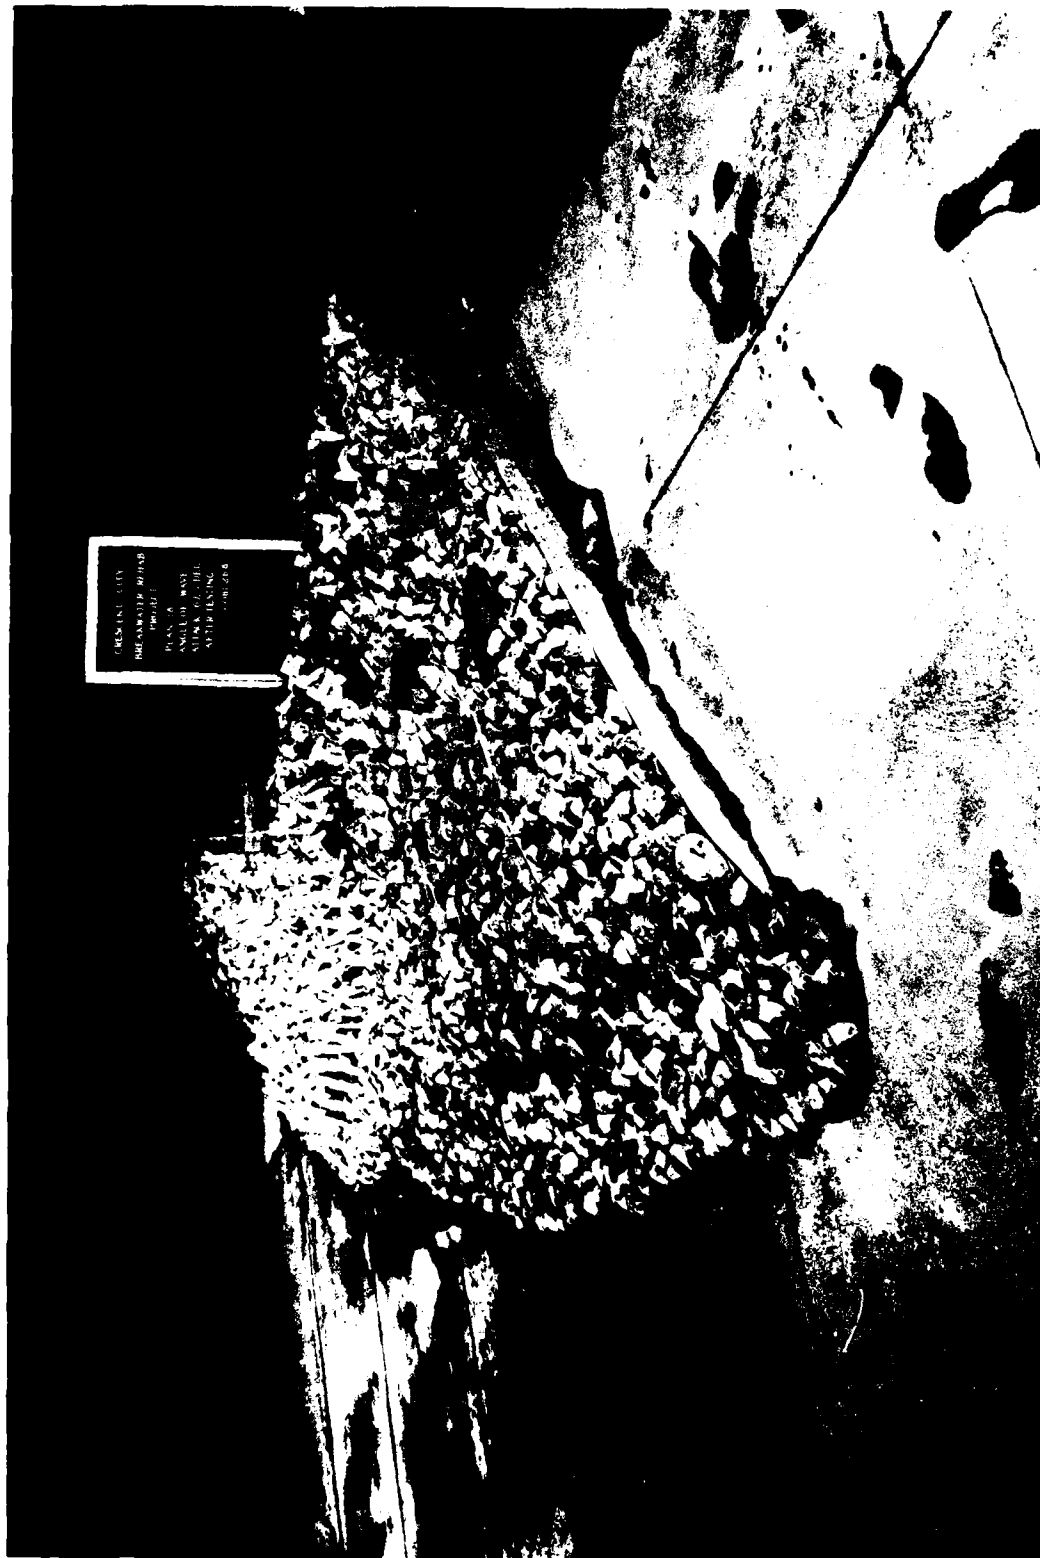
Photo 224. Seaward oblique view of Plan 18 after completion of Hydrograph A; 67.5-deg angle of wave attack

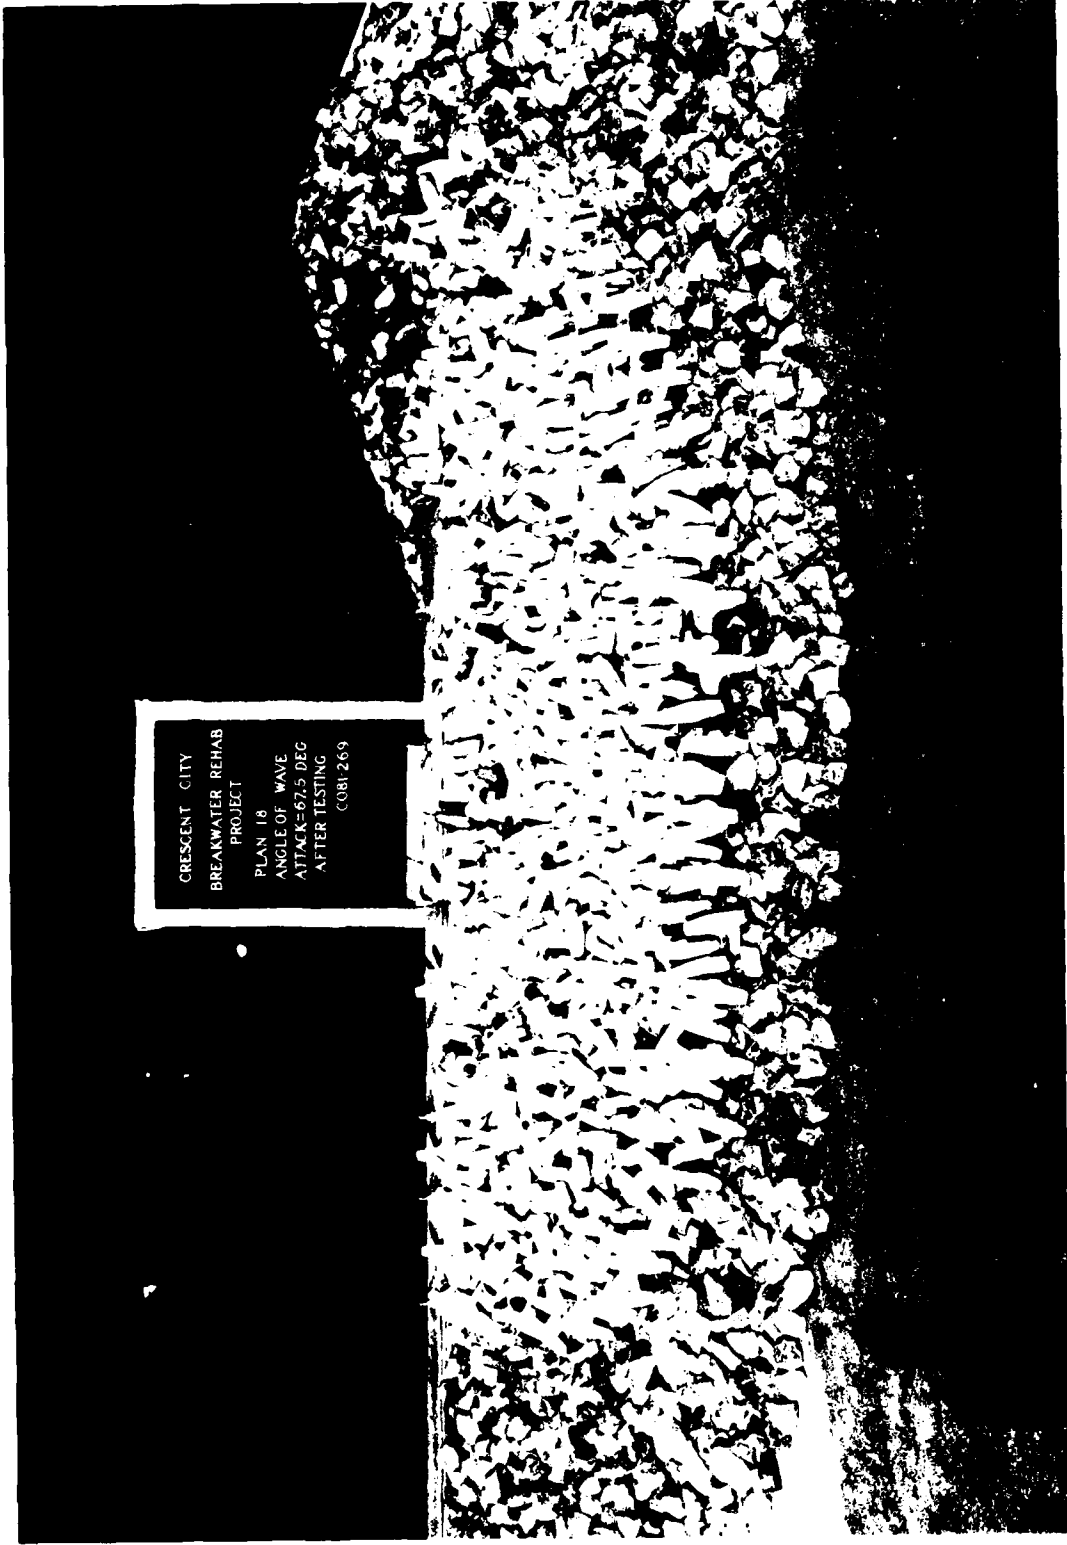
Photo 225. Seaward end view of Plan 18 after completion of Hydrograph A; 67.5-deg angle of wave attack

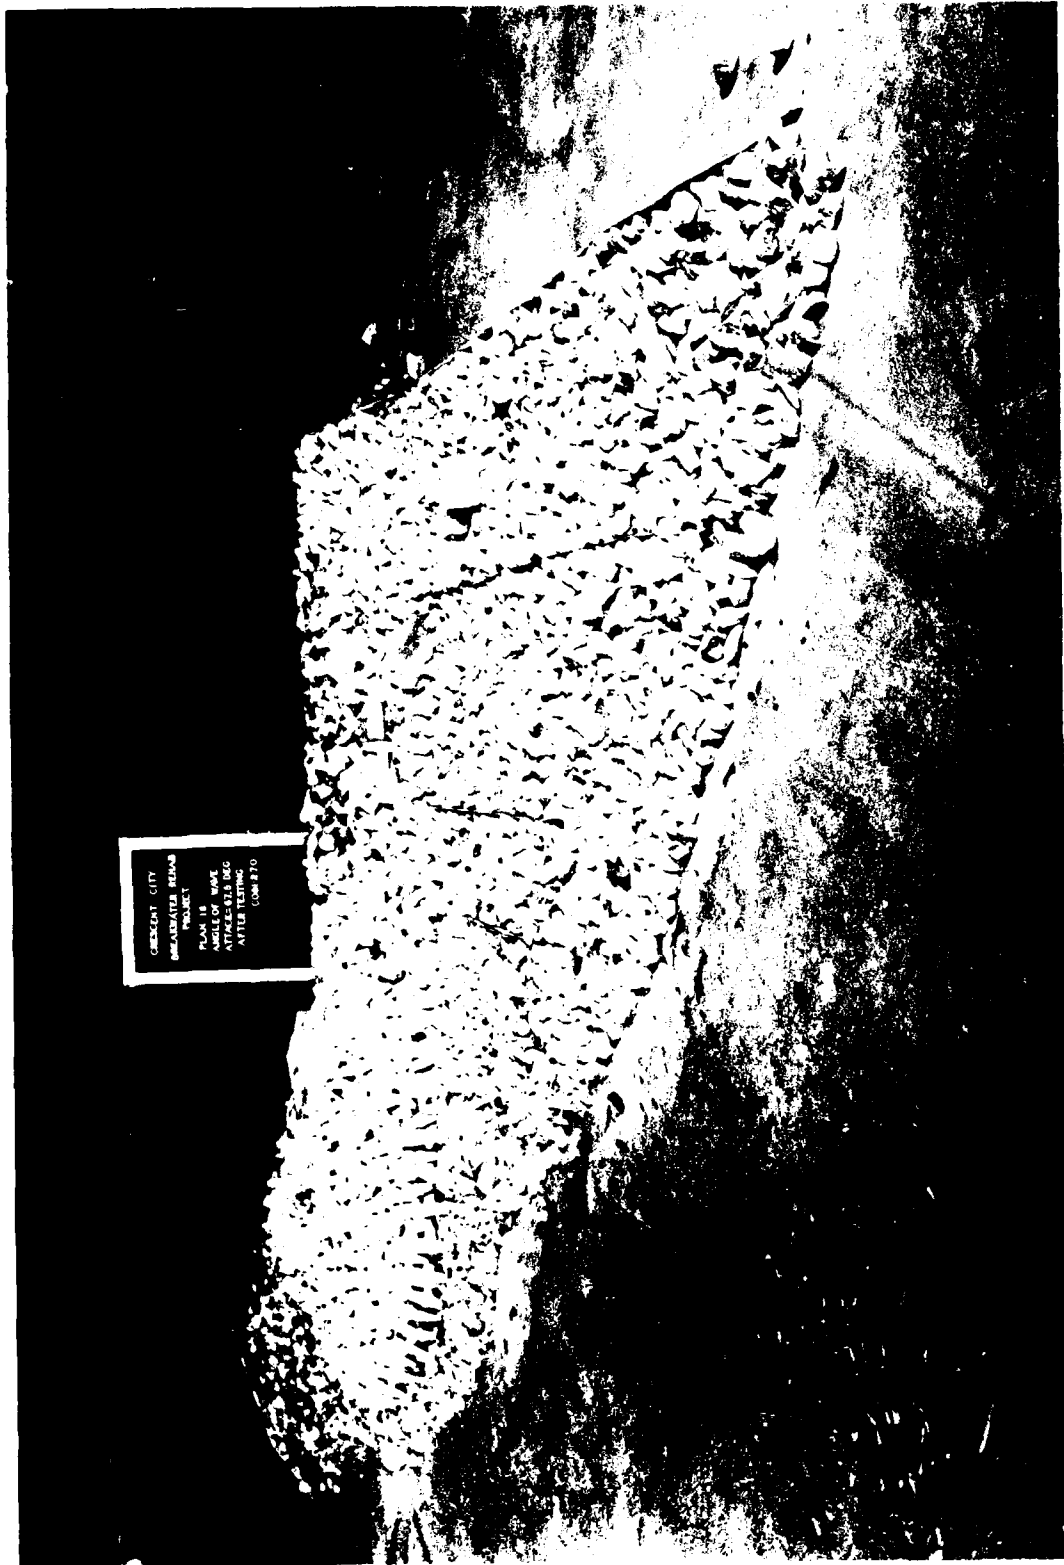
Photo 226. Sea-side view of Plan 18 after completion of Hydrograph B; 67.5-deg angle of wave attack

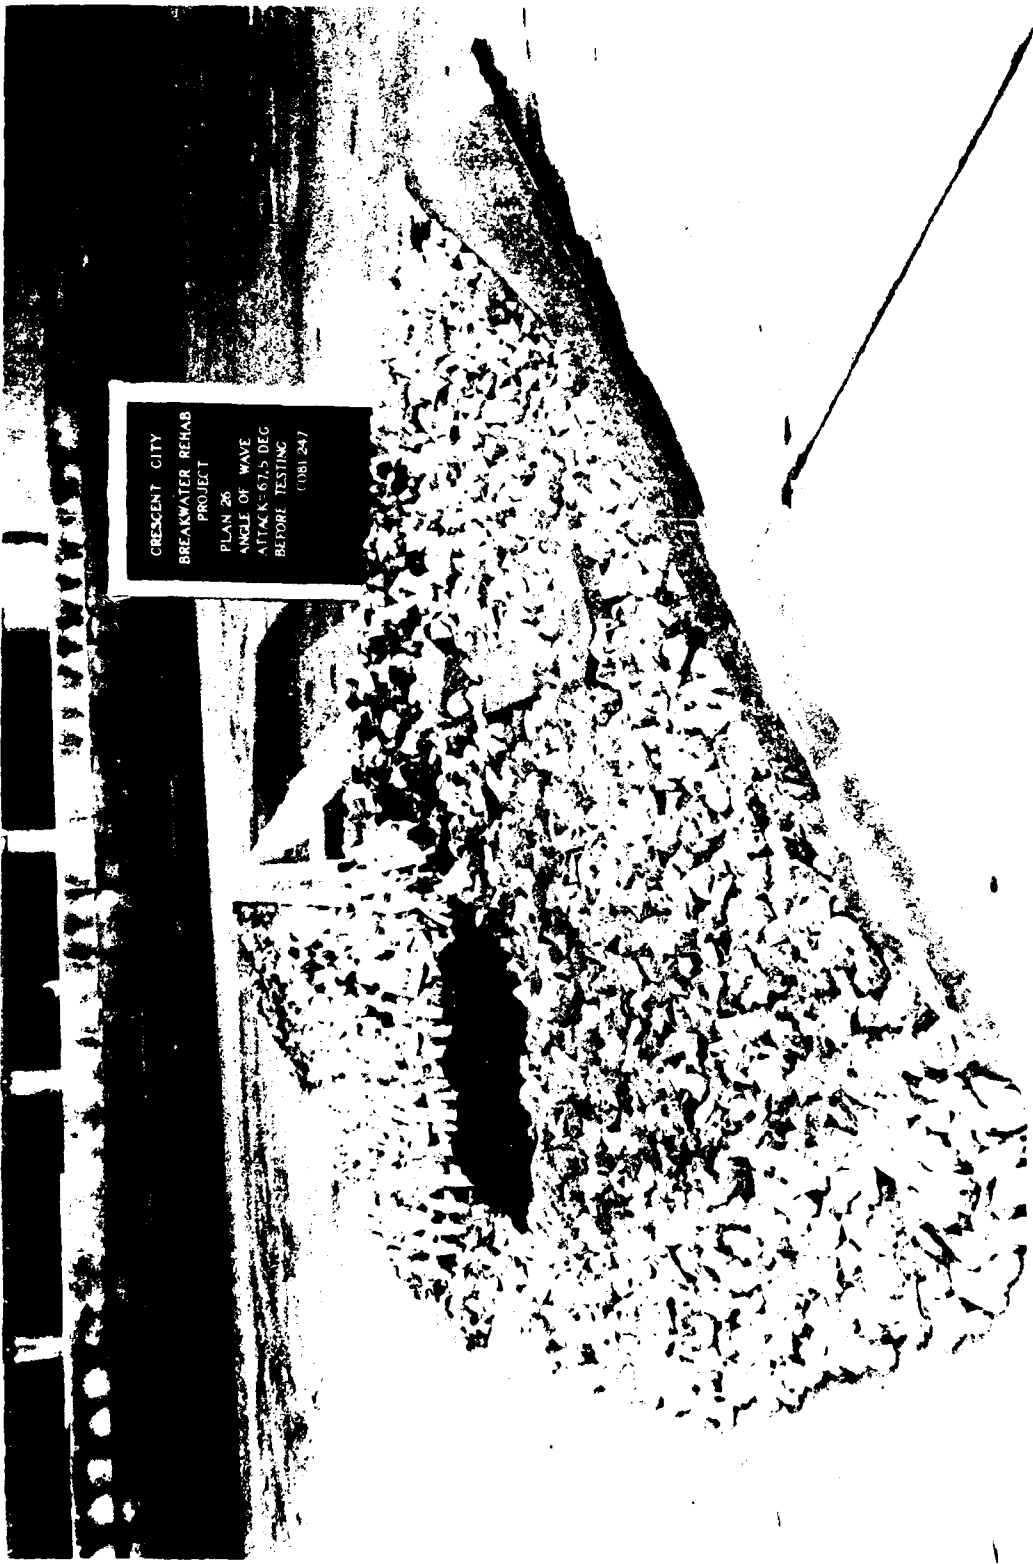
Photo 230. Seaward oblique view of Plan 26 before wave attack; 67.5-deg angle of wave attack

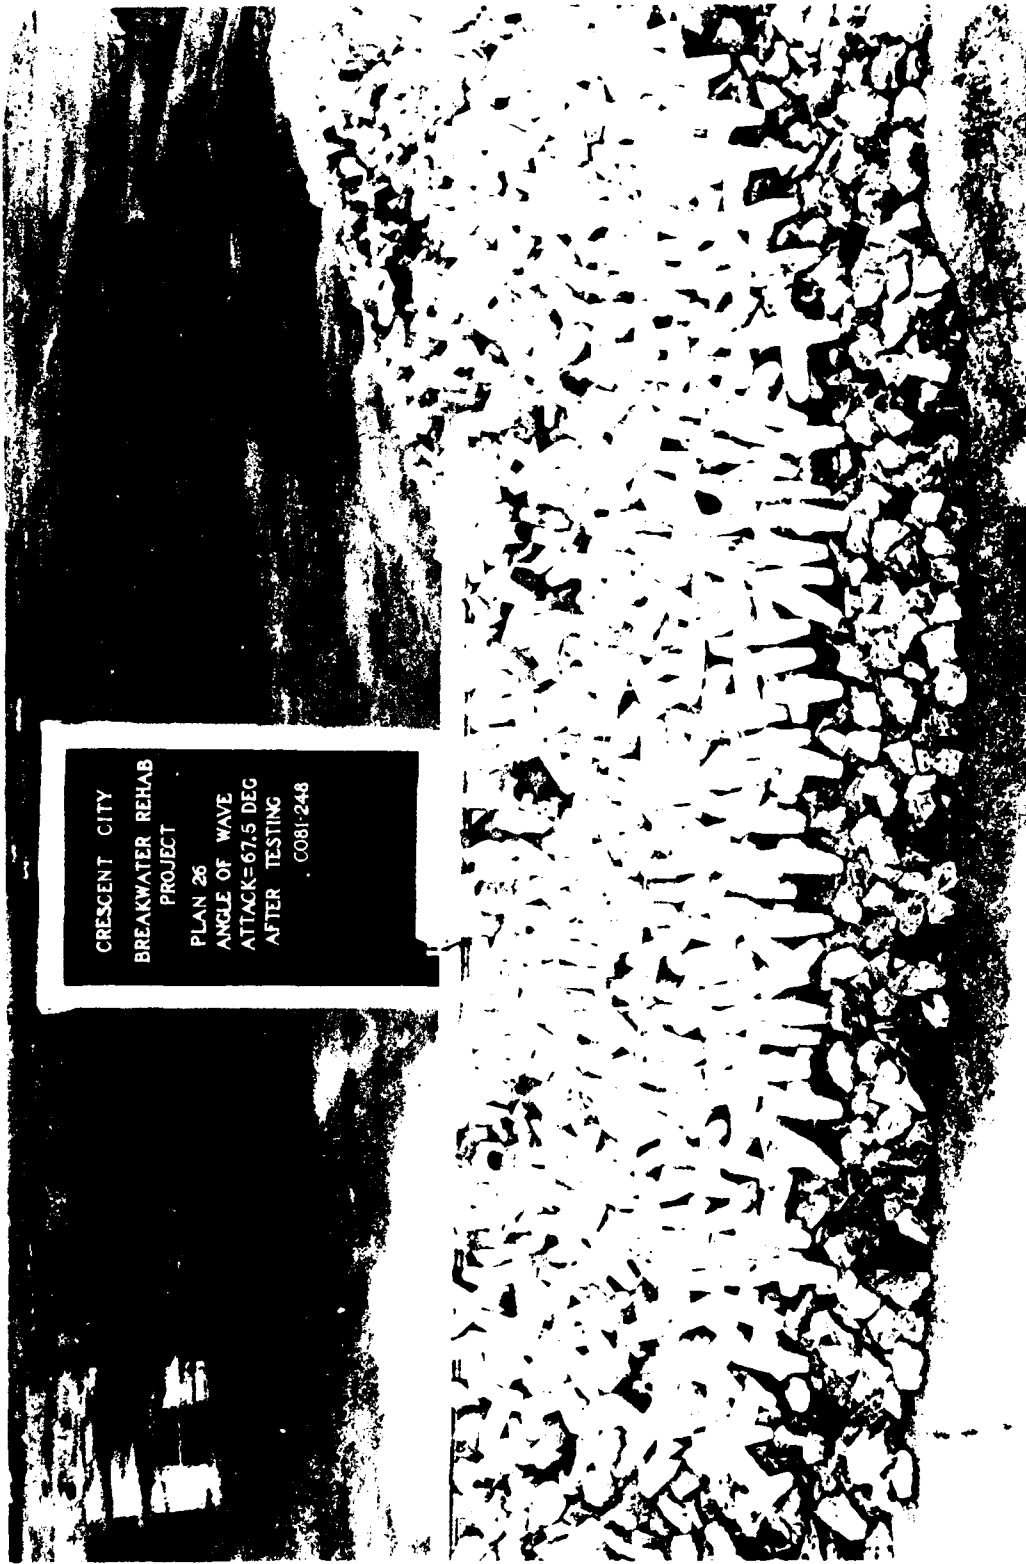
Photo 231. Seaward end view of Plan 26 before wave attack; 67.5-deg angle of wave attack

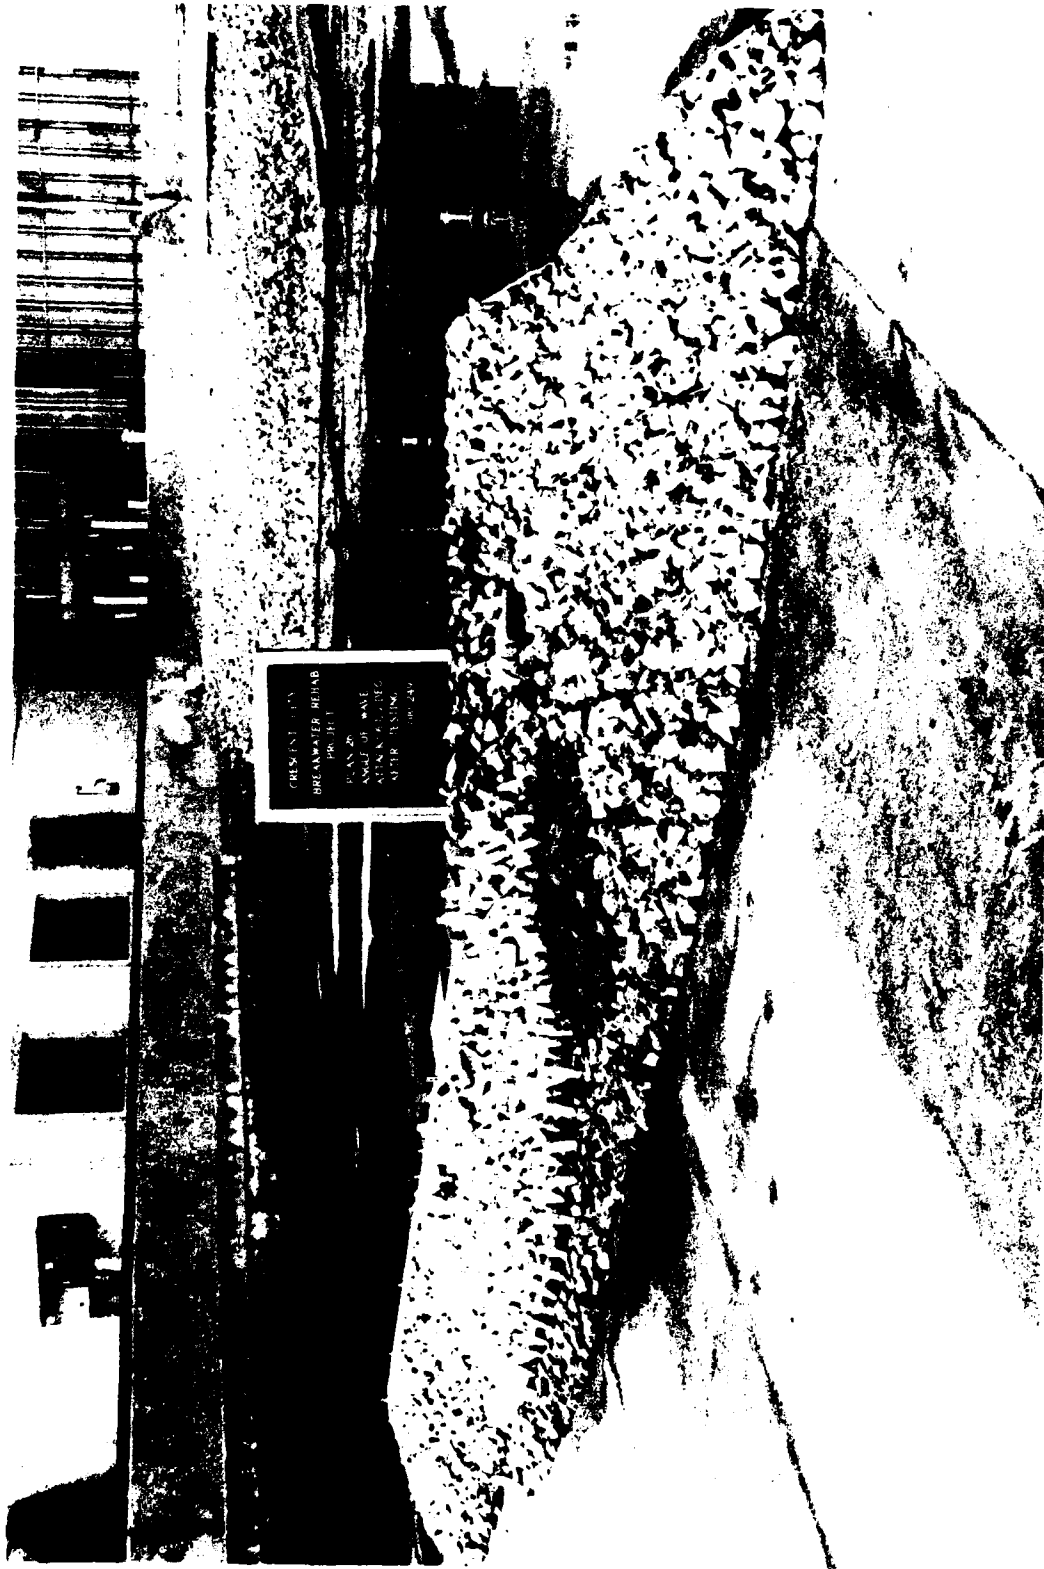
Photo 232. Sea-side view of Plan 26 after completion of abbreviated hydrograph; 67.5-deg angle of wave attack

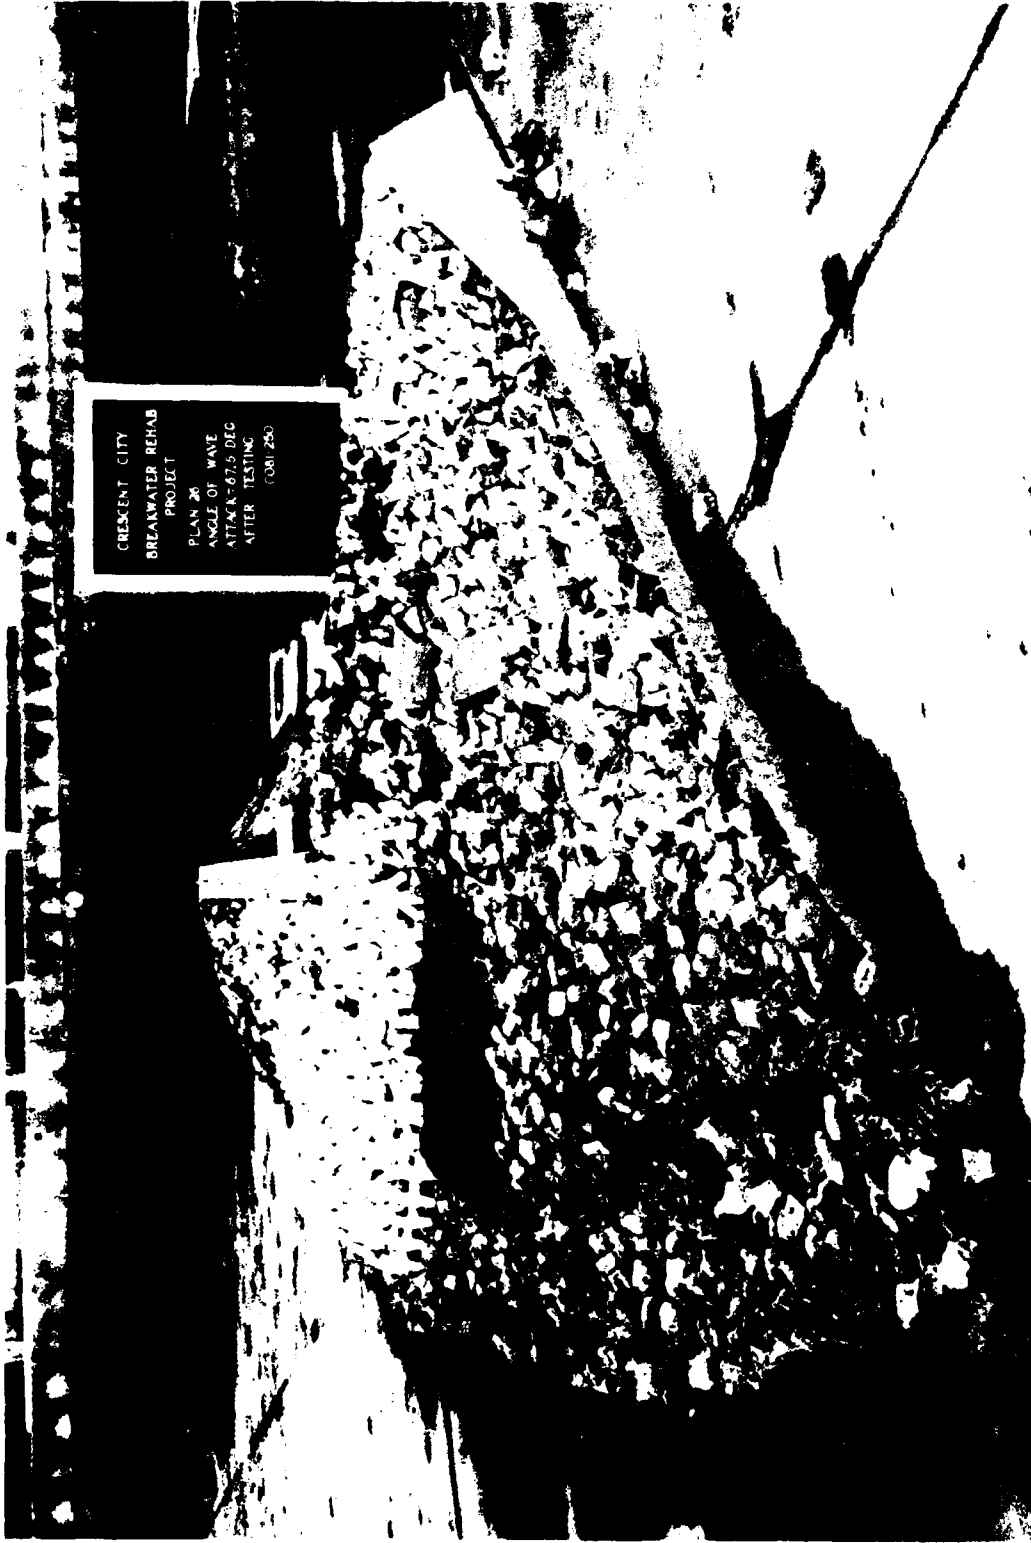
Photo 233. Seaward oblique view of Plan 26 after completion of abbreviated hydrograph; 67.5-deg angle of wave attack

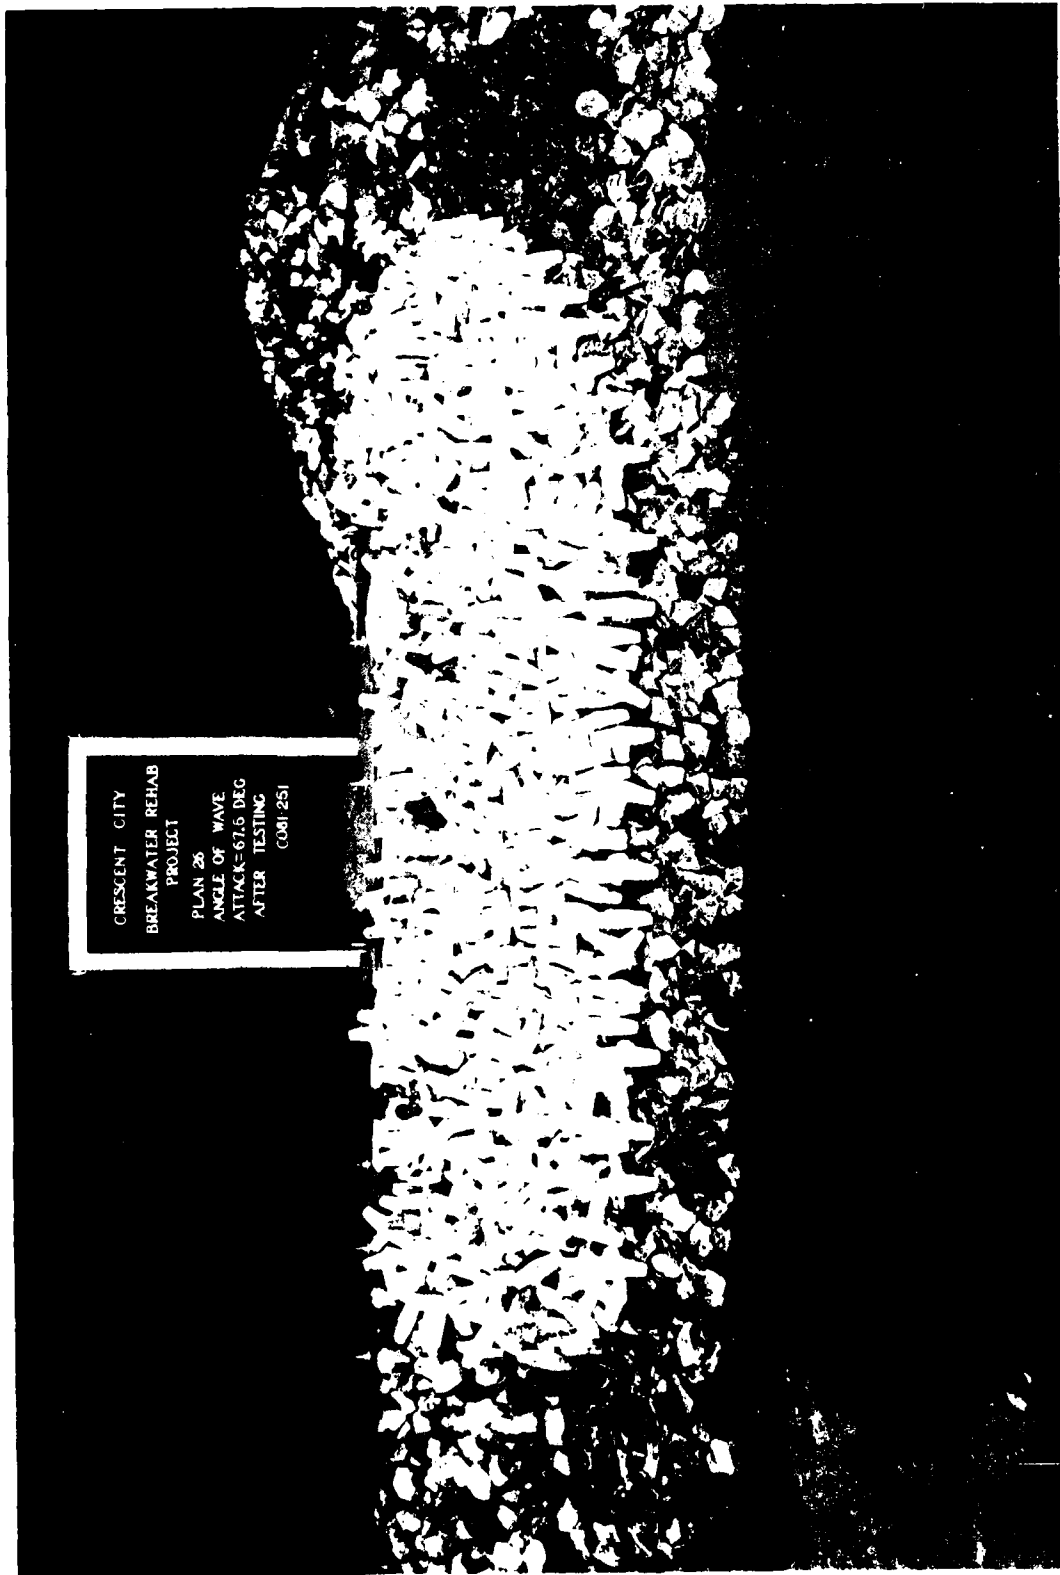
Photo 234. Seaward end view of Plan 26 after completion of abbreviated hydrograph; 67.5-deg angle of wave attack

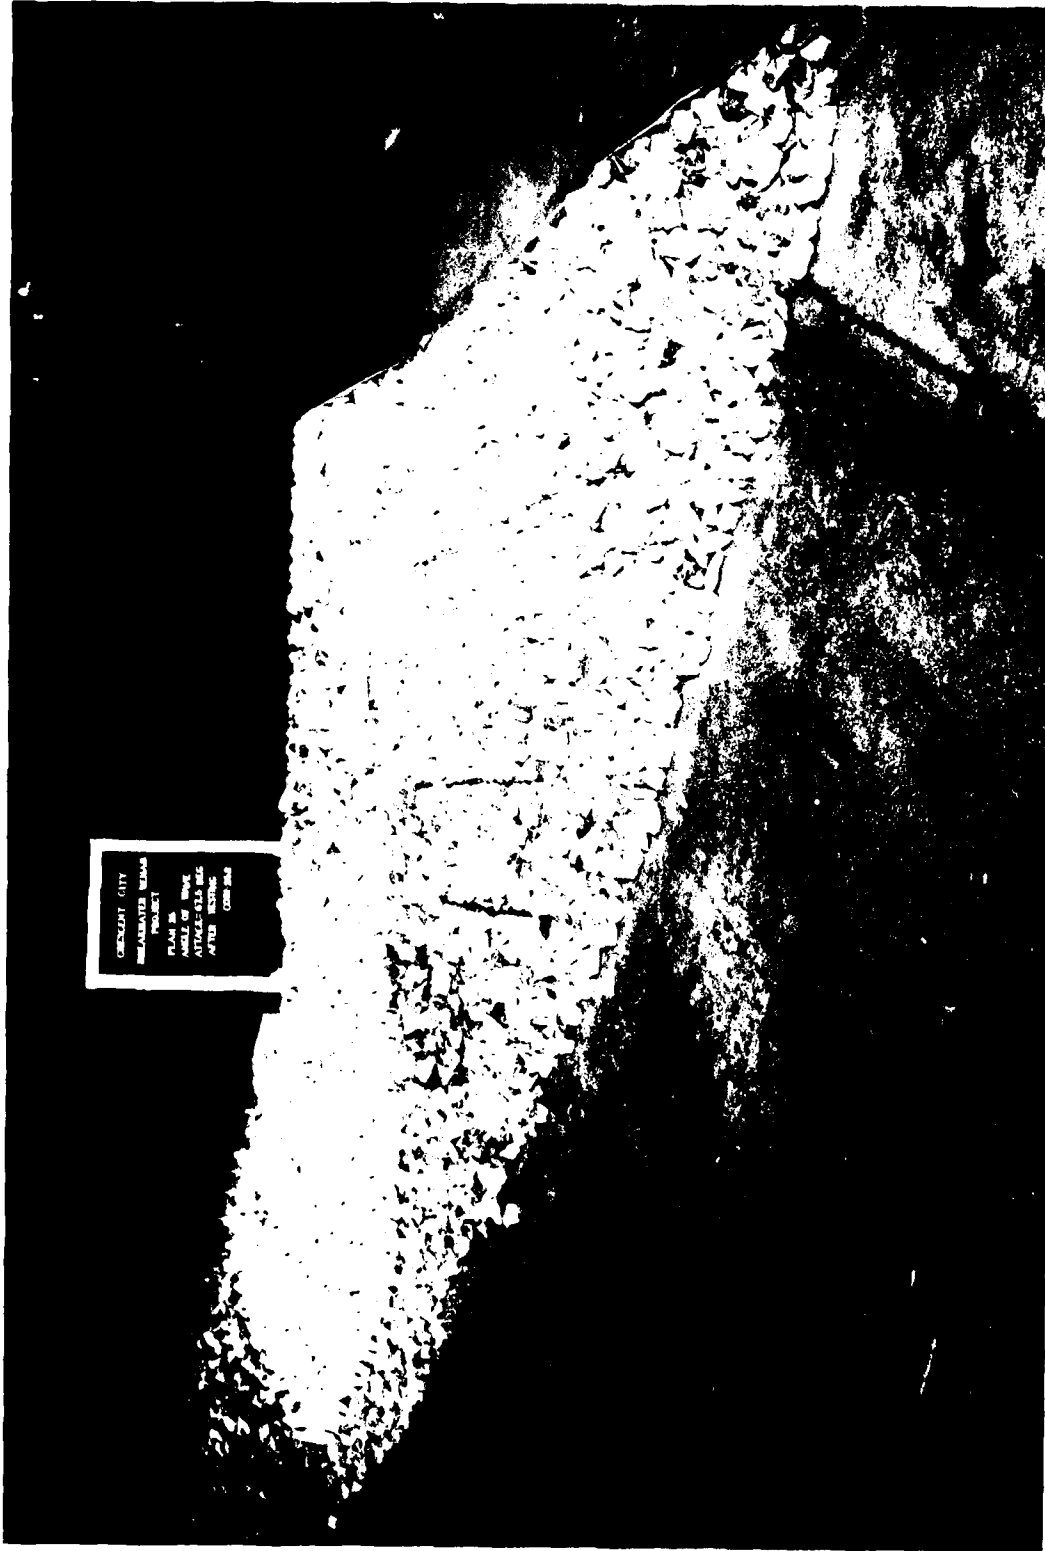
Photo 235. Sea-side view of Plan 26 repeat after completion of abbreviated hydrograph; 67.5-deg angle of wave attack
