TECHNICAL REPORT CERC-85-8

# BREAKWATER REHABILITATION STUDY, CRESCENT CITY HARBOR, CALIFORNIA

## Coastal Model Investigation

November 1985

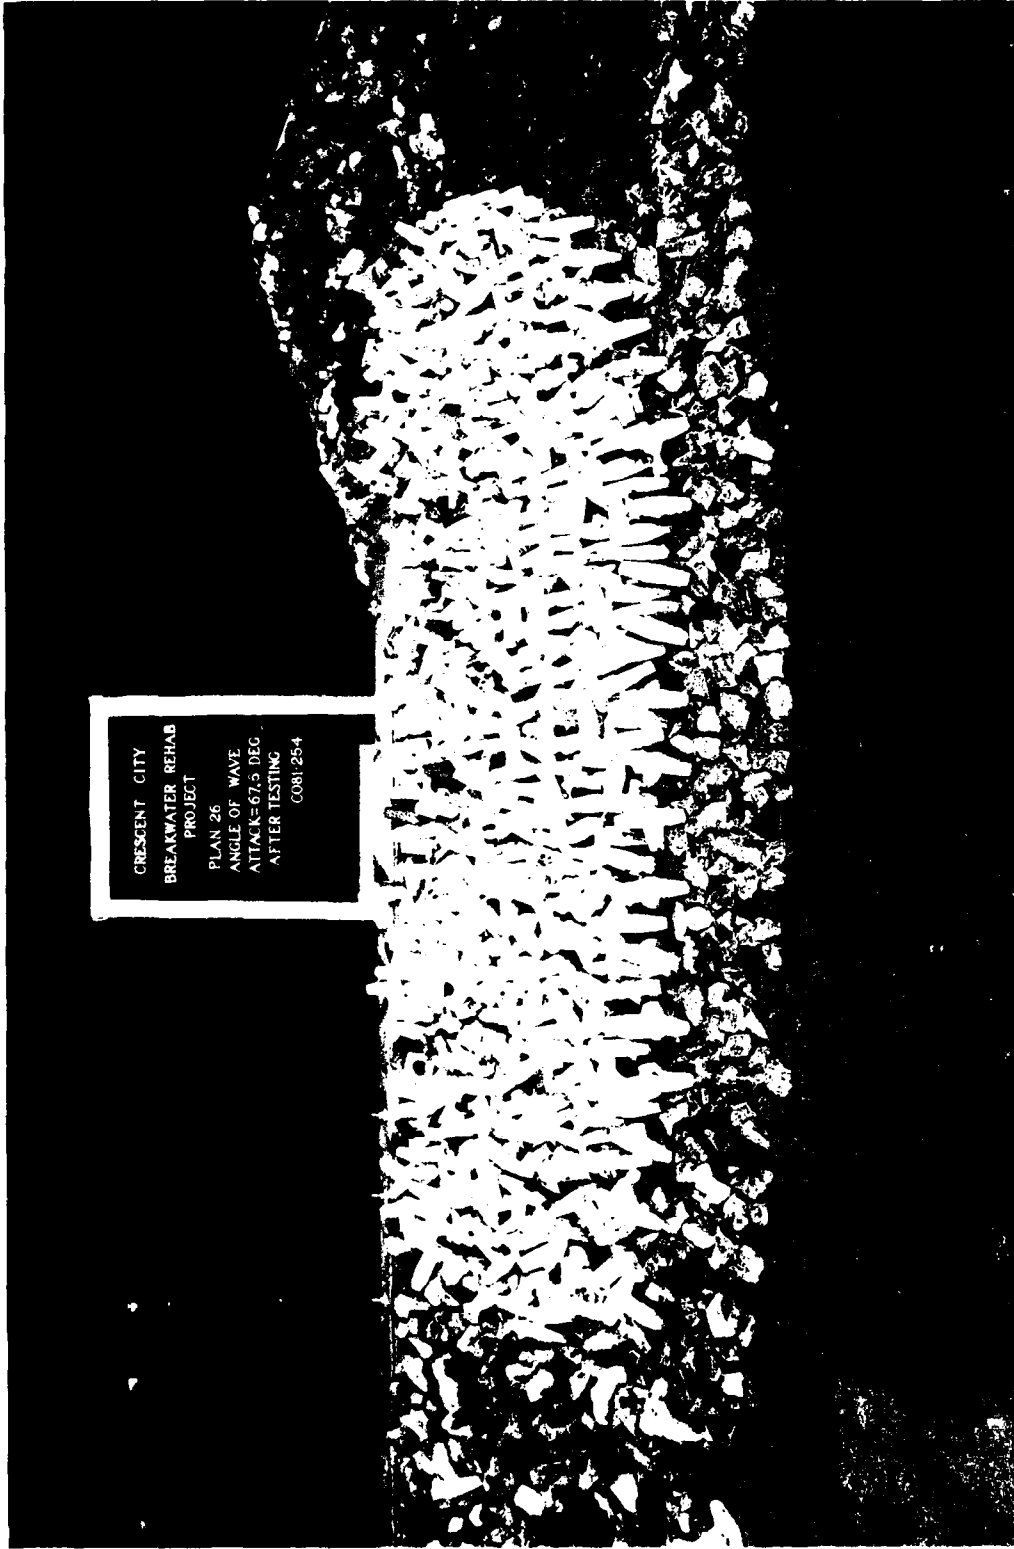
Photo 237. Seaward end view of Plan 26 repeat after completion of abbreviated hydrograph; 67.5-deg angle of wave attack

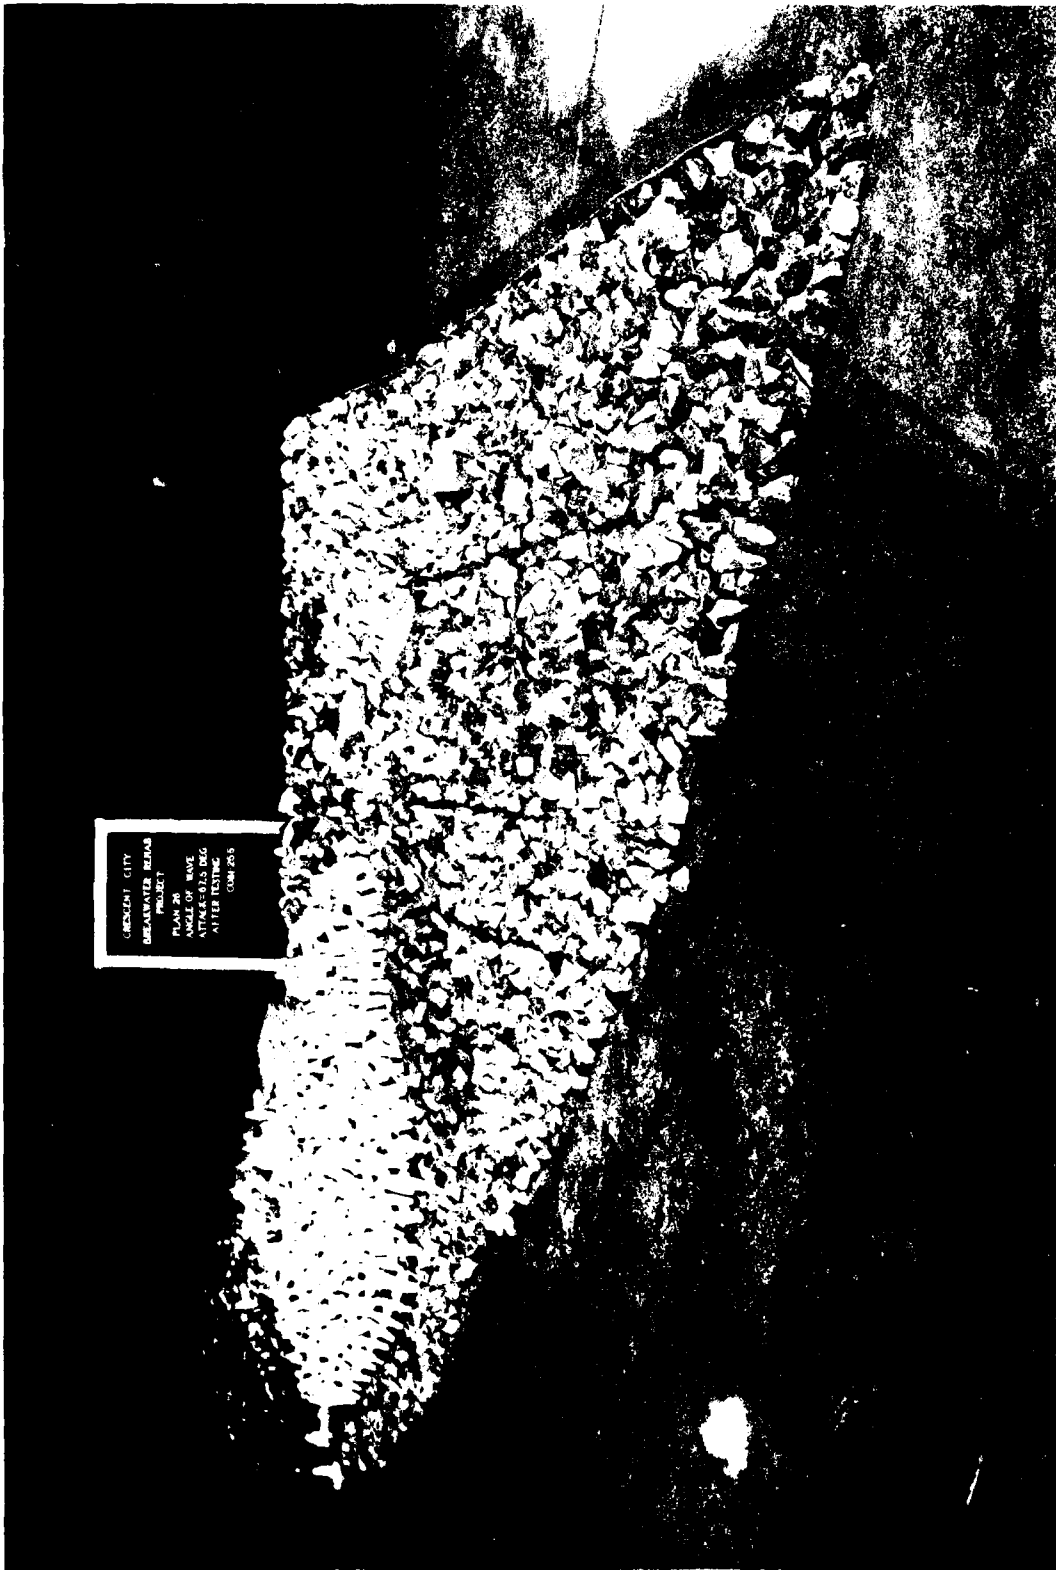
Photo 238. Sea-side view of Plan 26 after completion of Hydrograph A; 67.5-deg angle of wave attack

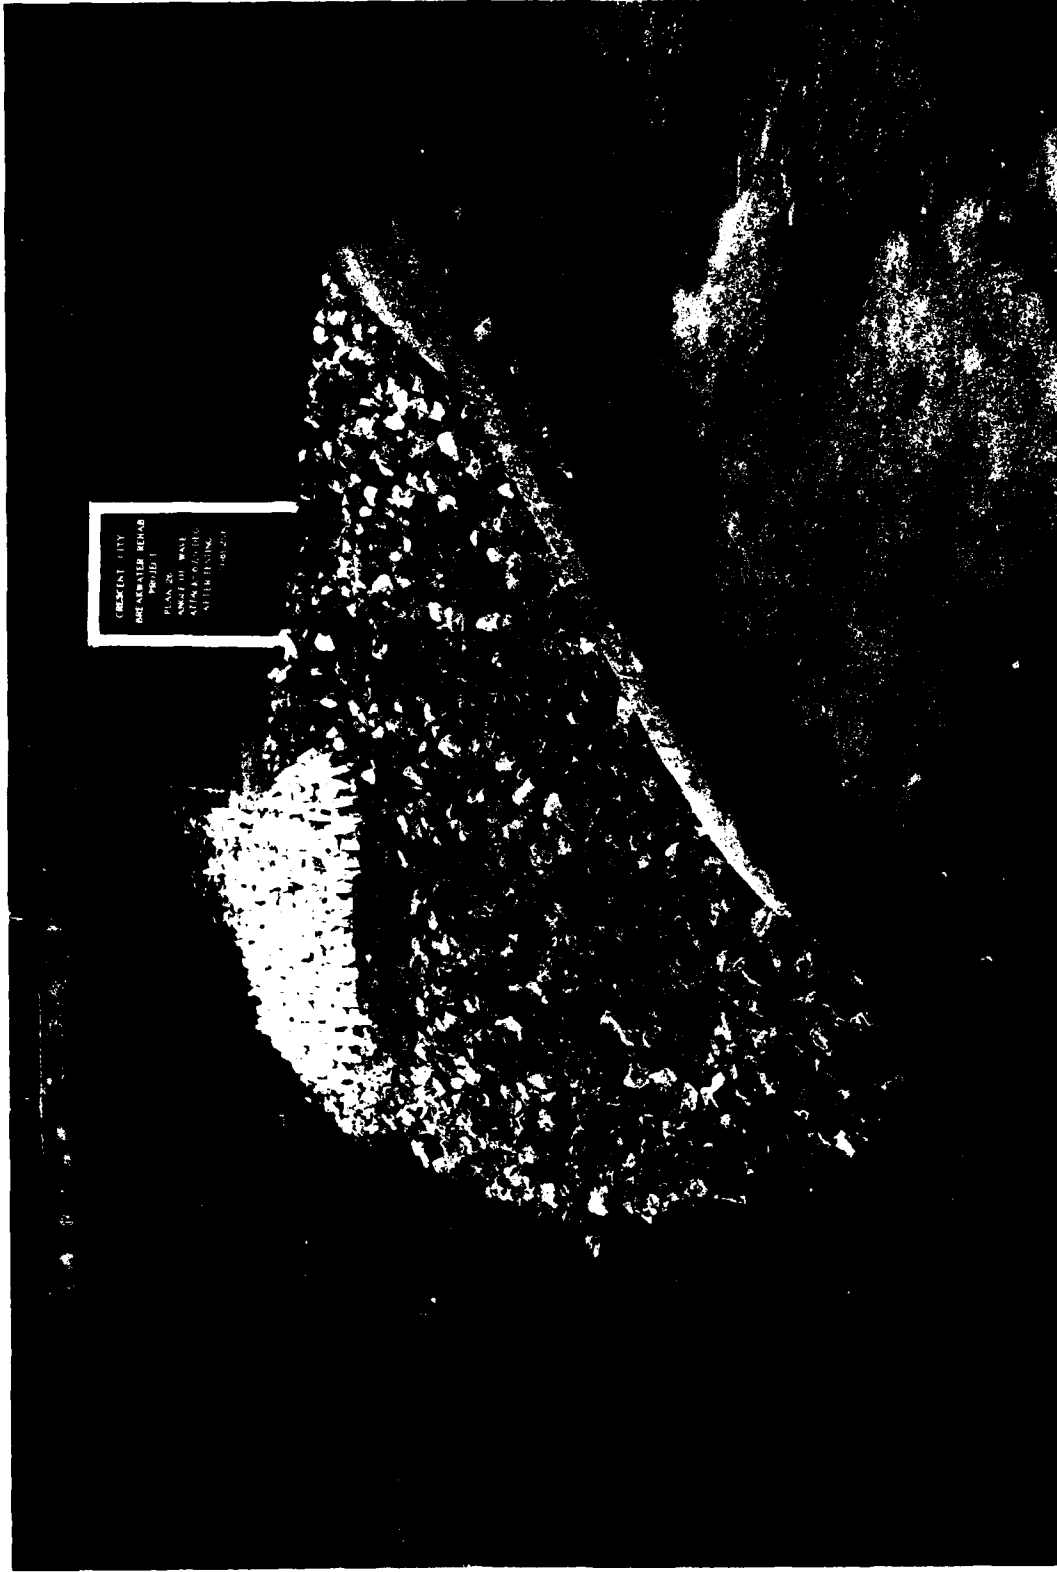
Photo 239. Seaward oblique view of Plan 26 after completion of Hydrograph A; 67.5-deg angle of wave attack

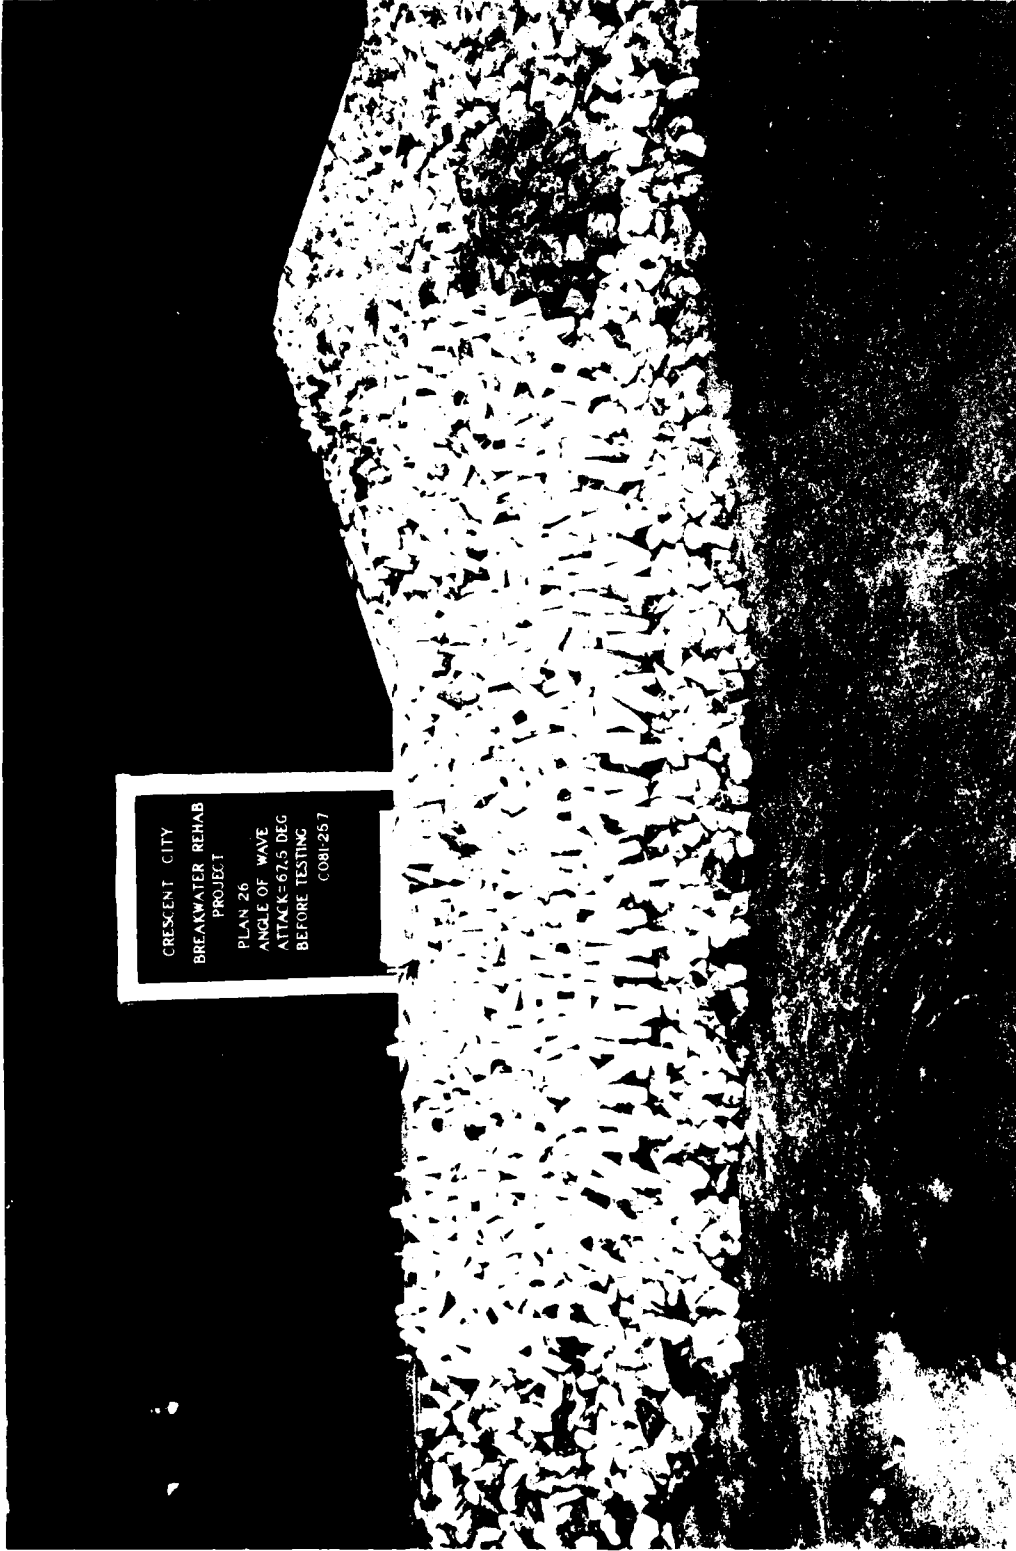
Photo 240. Seaward end view of Plan 26 after completion of Hydrograph A; 67.5-deg angle of wave attack

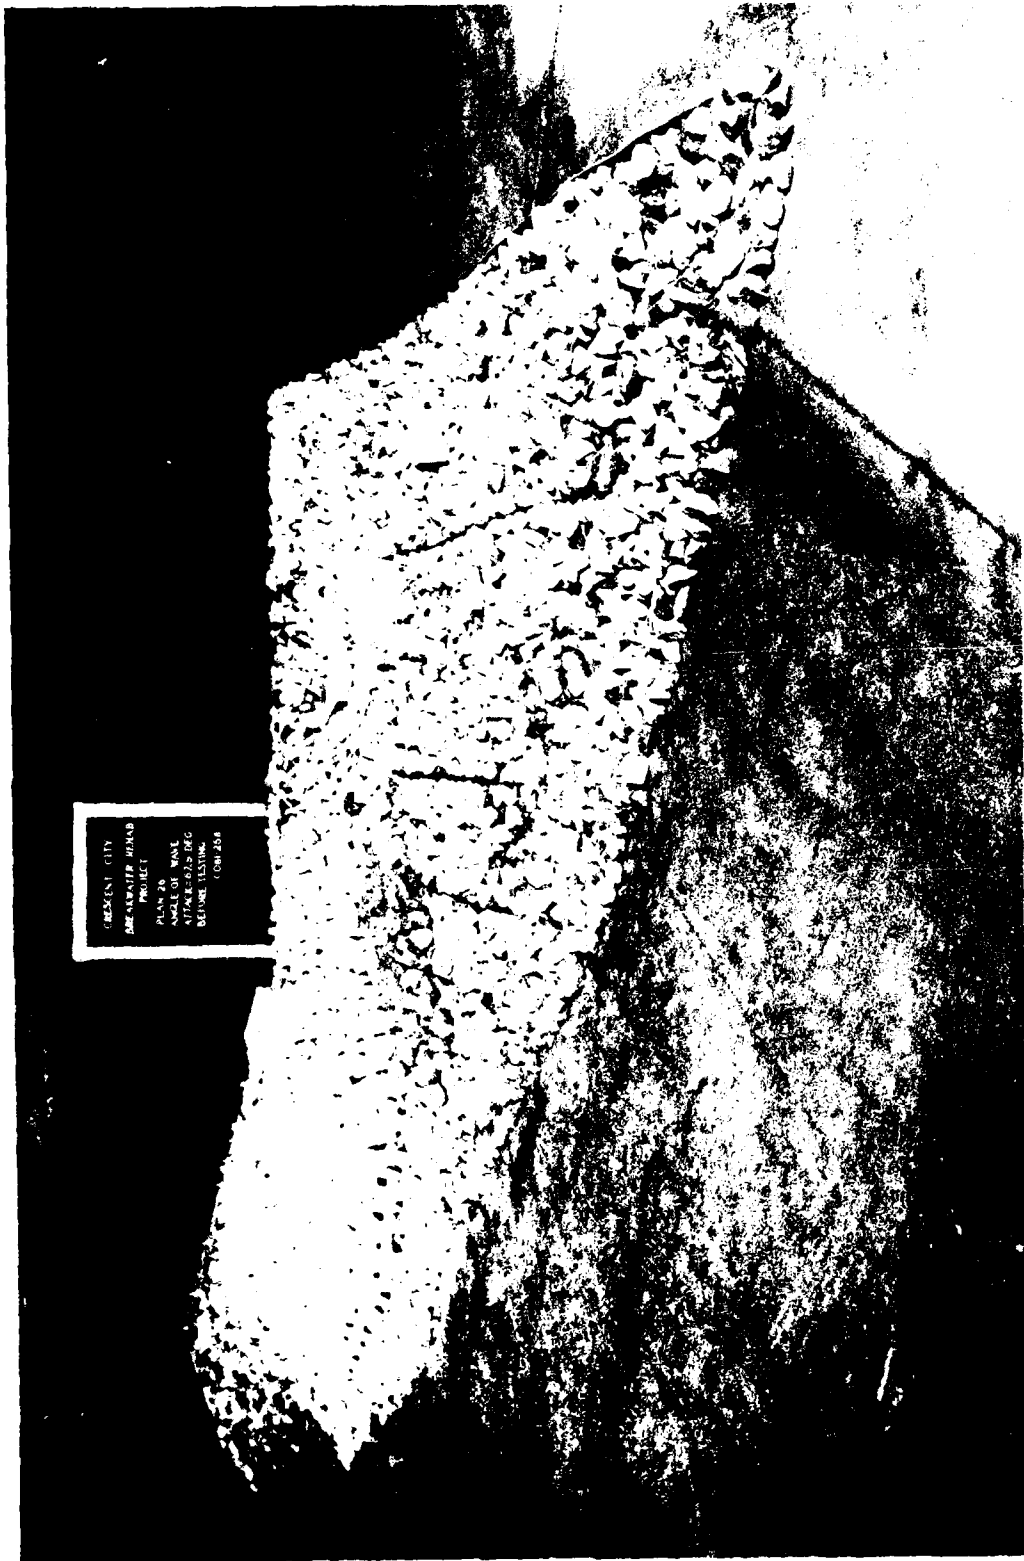
Photo 241. Sea-side view of Plan 26 before wave attack after modification to shoreward transition; 67.5-deg angle of wave attack

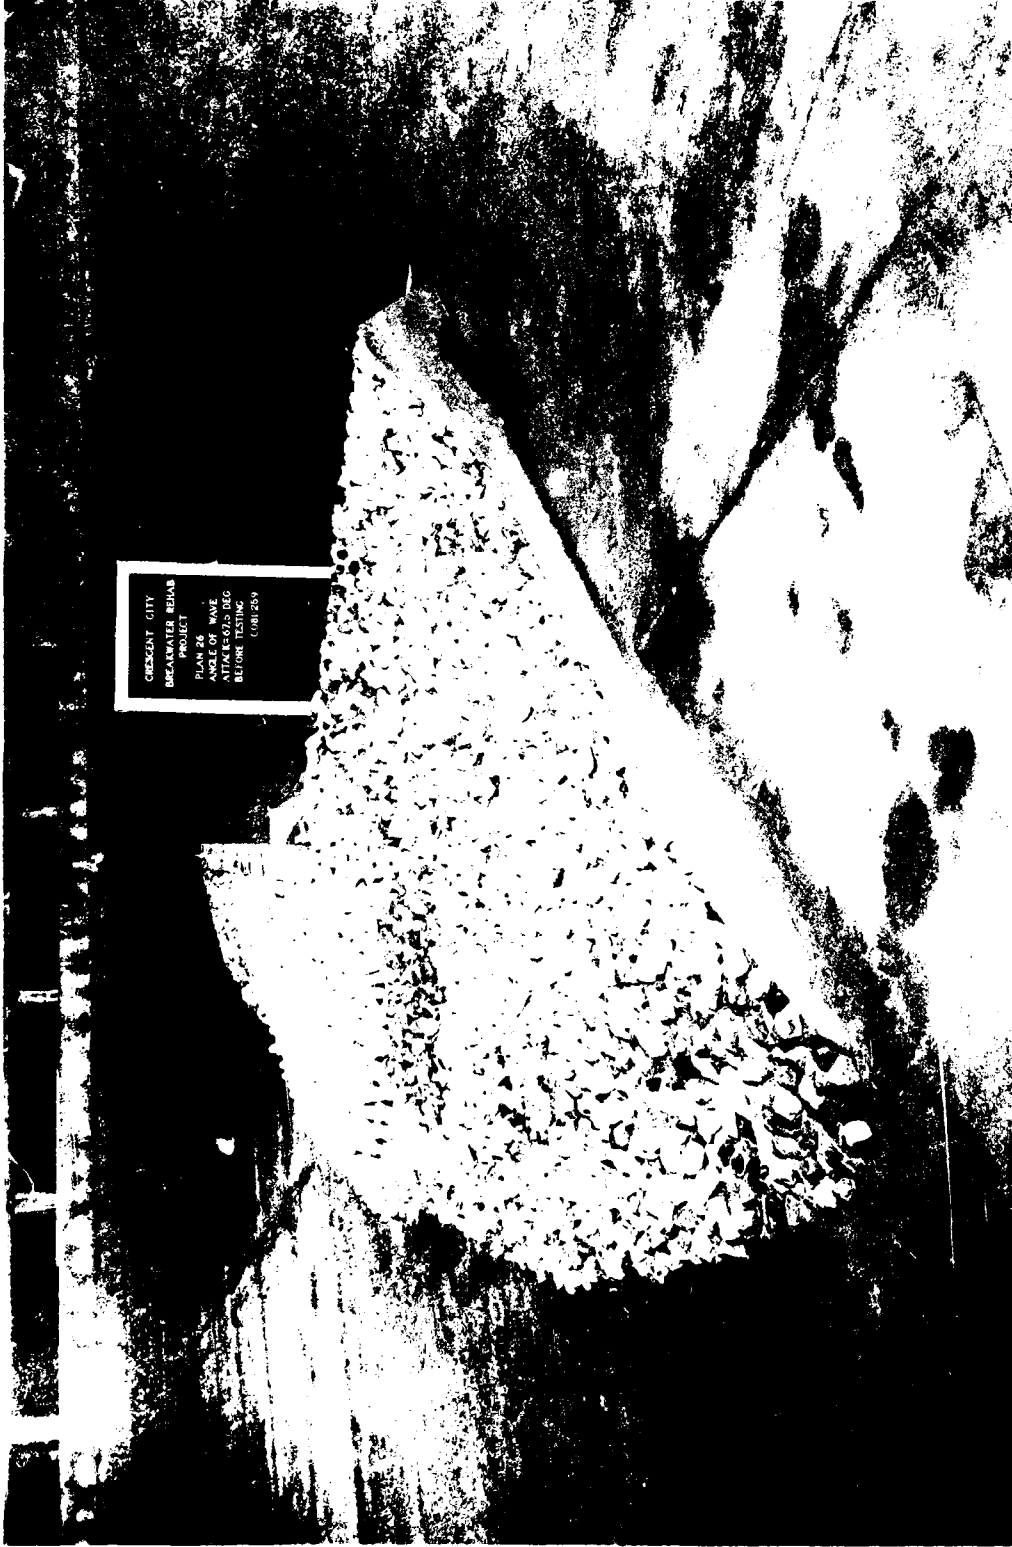
Photo 242. Seaward oblique view of Plan 26 before wave attack after modification to shoreward transition; 67.5-deg angle of wave attack

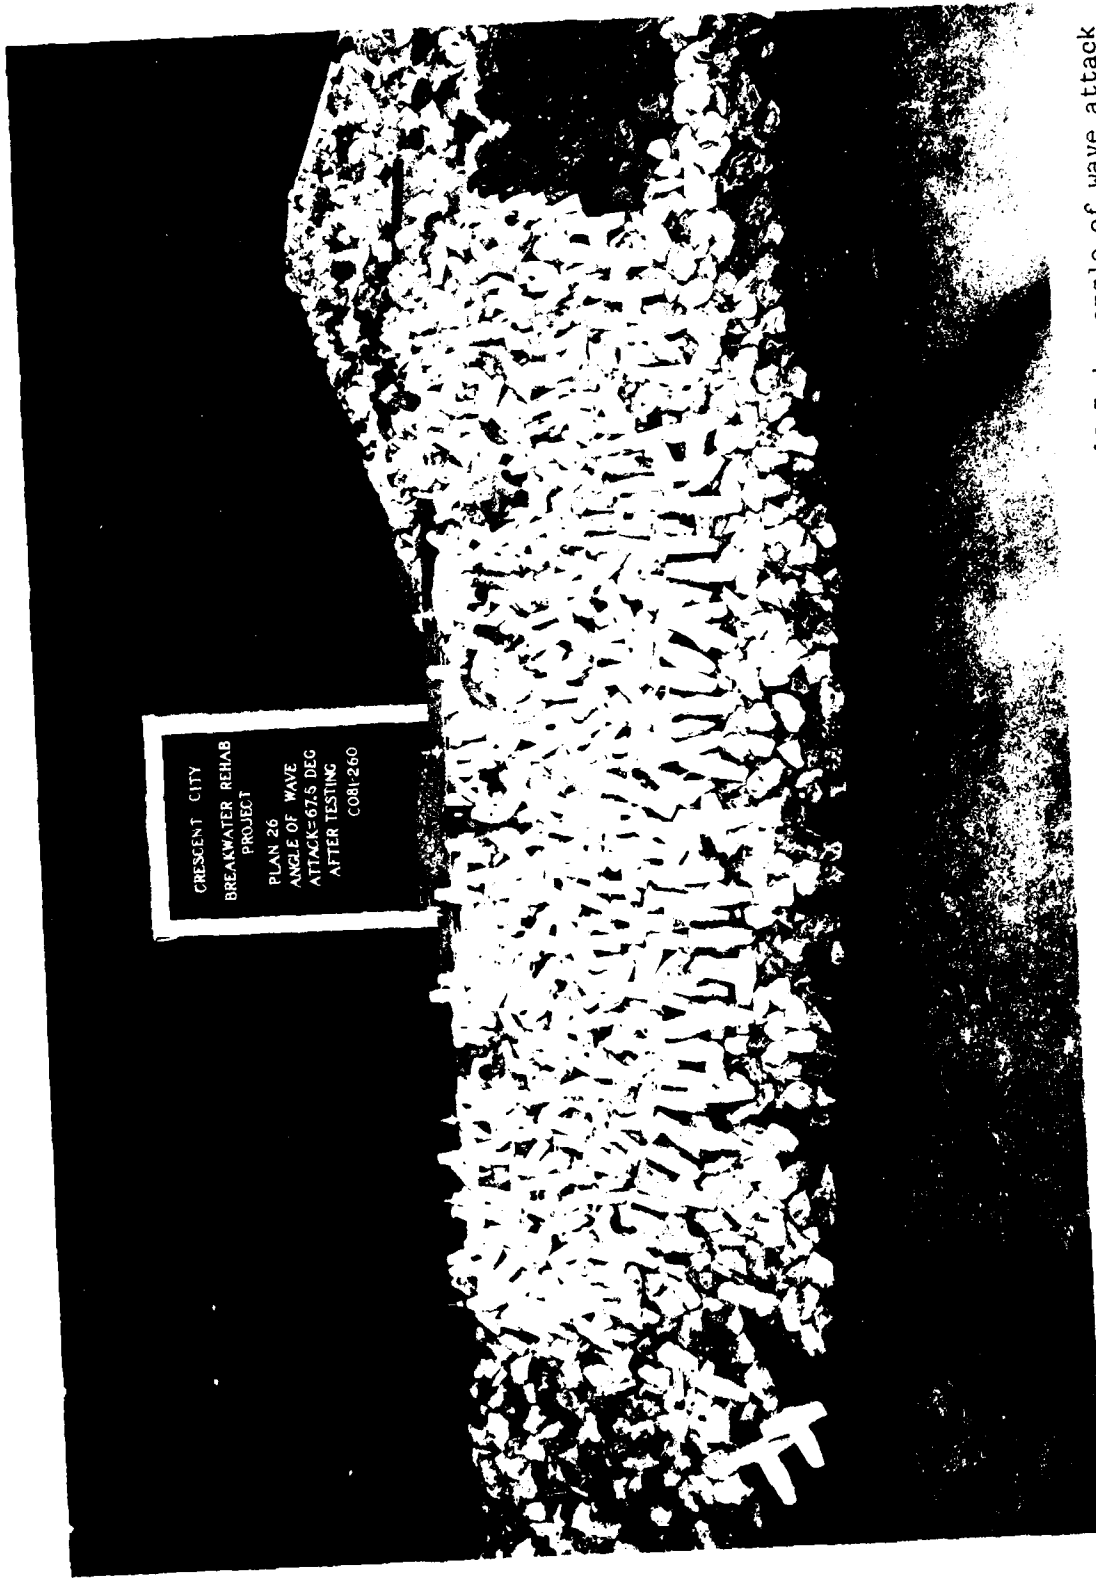
Photo 243. Seaward end view of Plan 26 before wave attack after modification to shoreward transition; 67.5-deg angle of wave attack

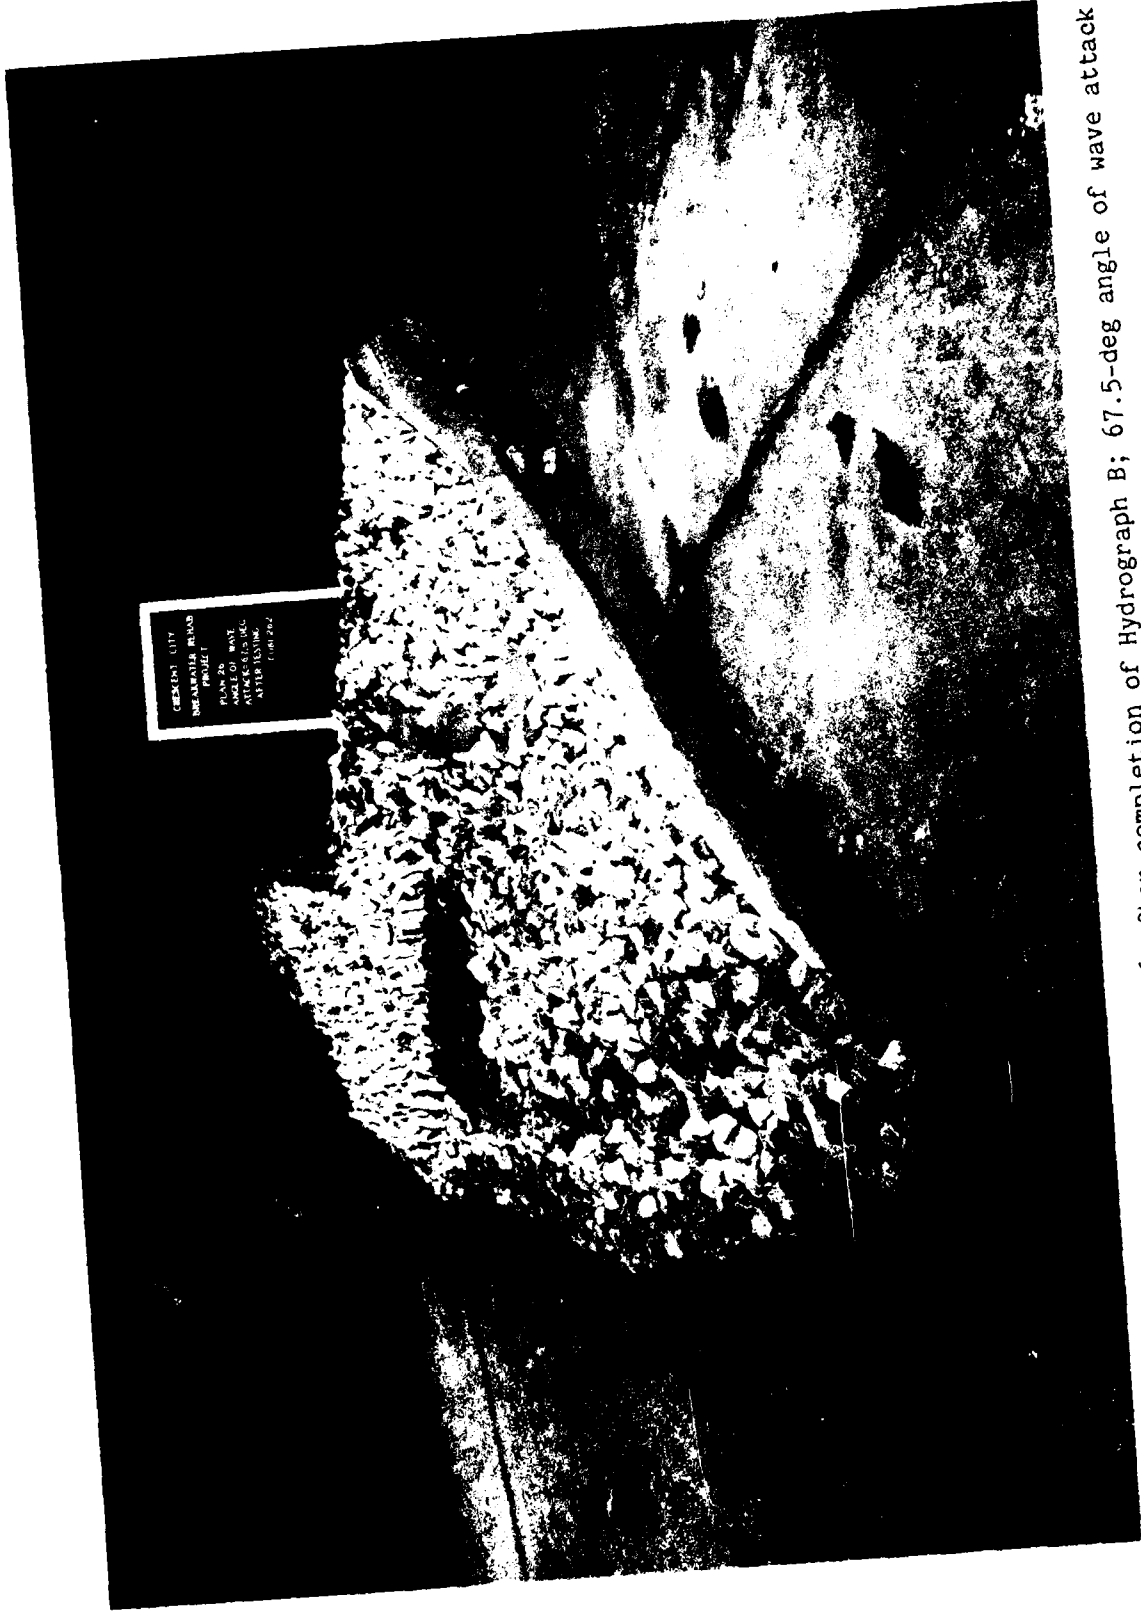
Photo 245. Seaward oblique view of Plan 26 after completion of Hydrograph B; 67.5-deg angle of wave attack

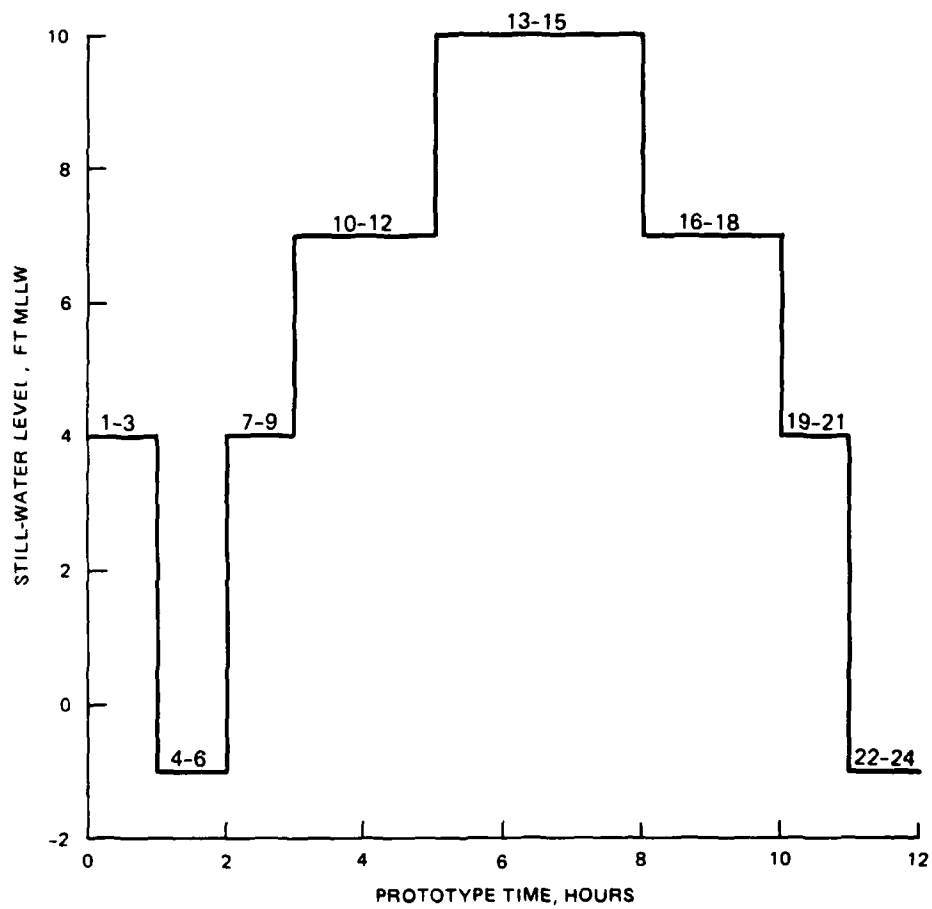
ABBREVIATED  
HYDROGRAPH

NOTES: NUMBERS INDICATE HYDROGRAPH  
STEP NUMBER  
TEST CONDITIONS FOR EACH STEP  
ARE GIVEN IN TABLE 1

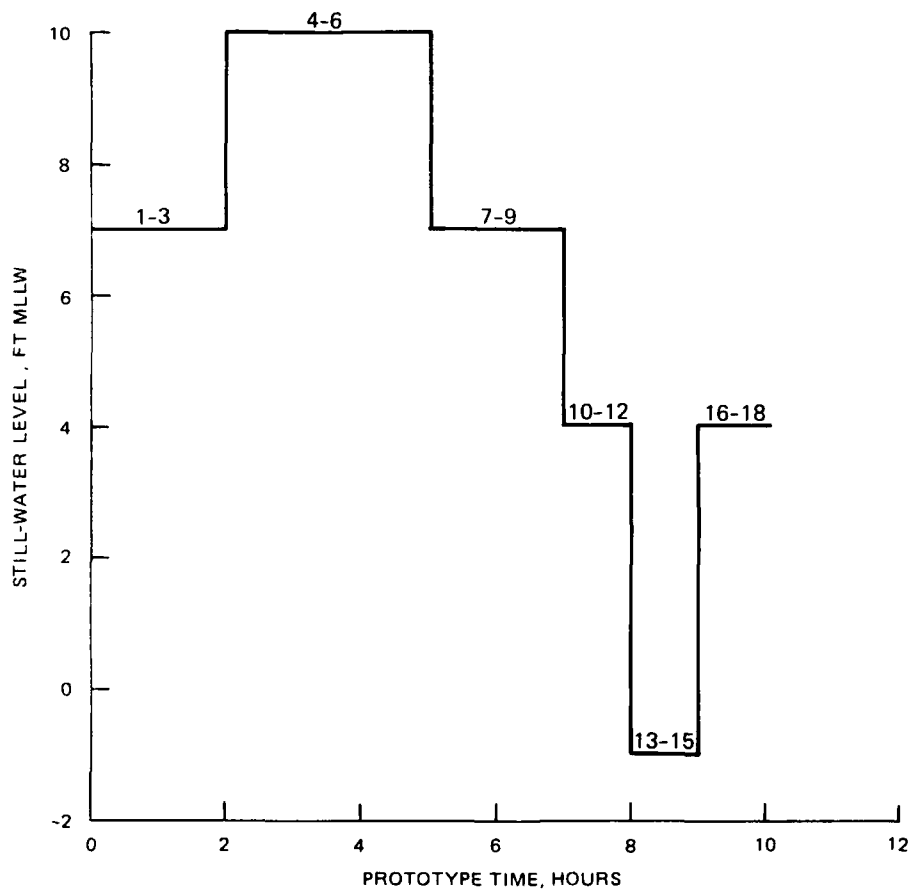
HYDROGRAPH A

NOTES: NUMBERS INDICATE HYDROGRAPH  
STEP NUMBER.  
TEST CONDITIONS FOR EACH  
STEP ARE GIVEN IN TABLE 2.

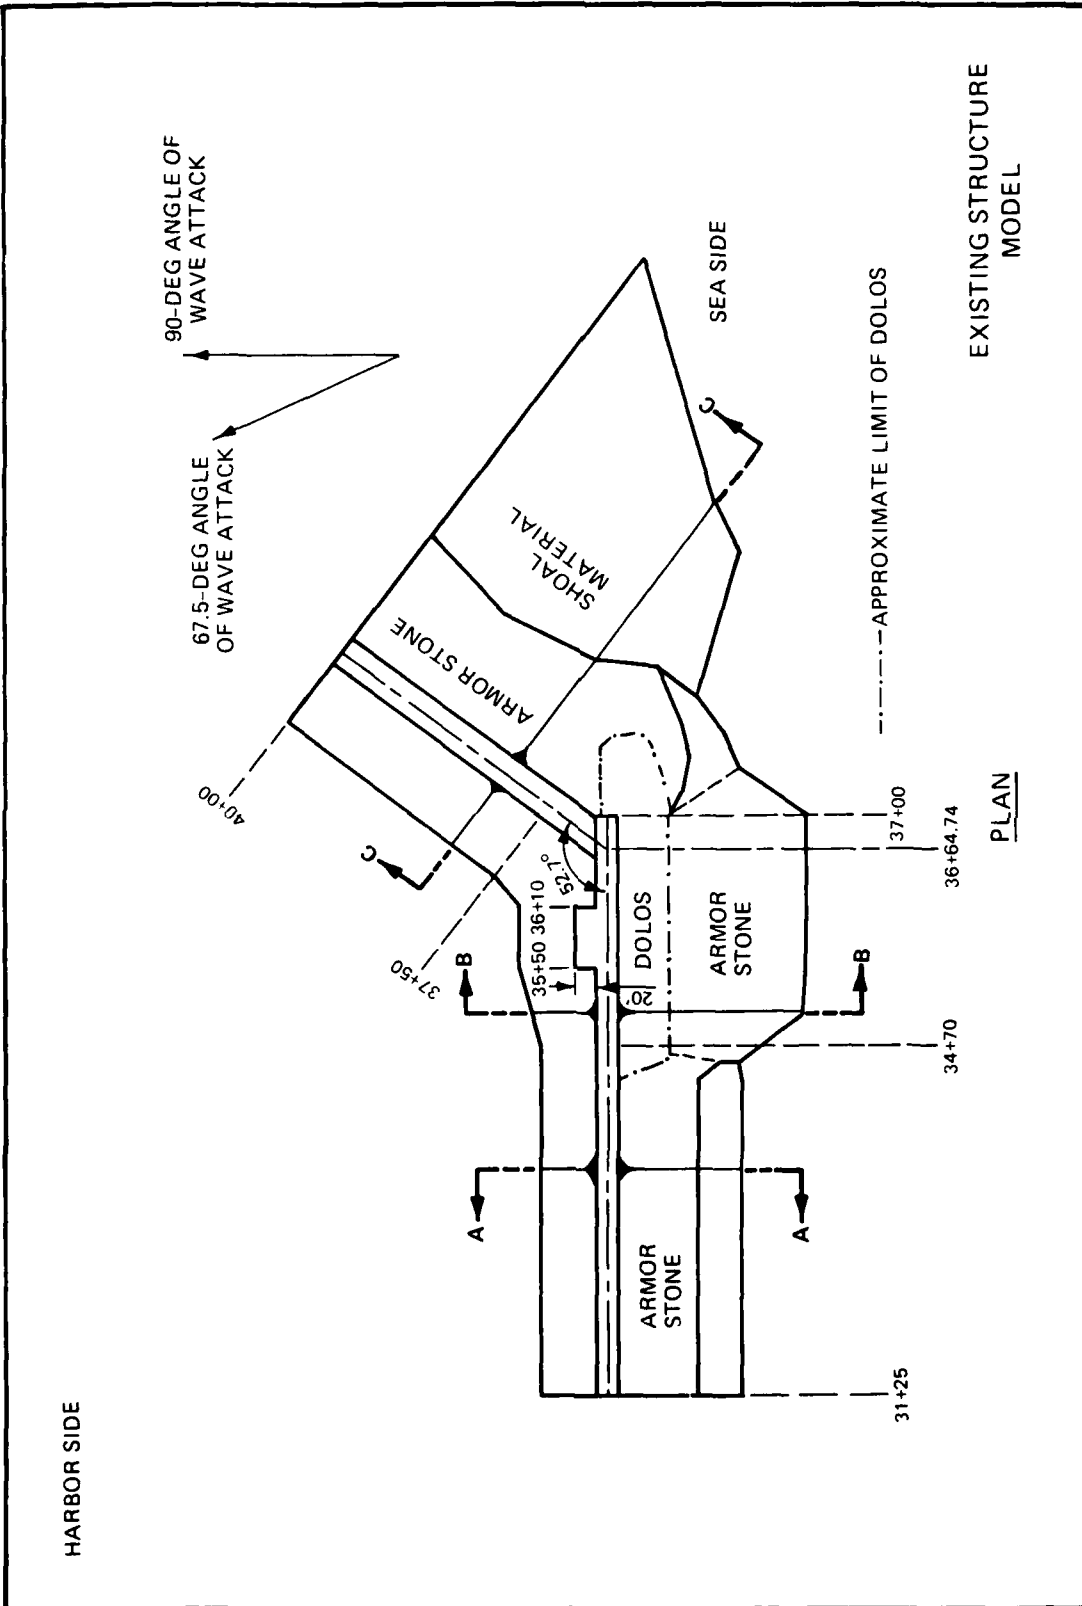
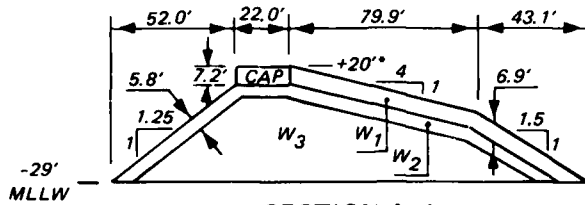
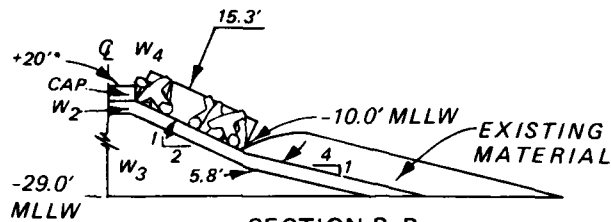
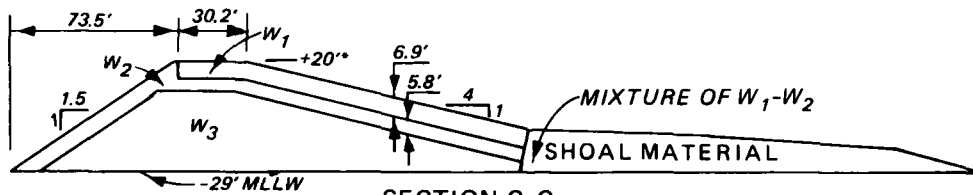
EXISTING STRUCTURE MODEL

PLAN

SECTION A-A

SECTION B-B

SECTION C-C

CROSS-SECTIONS FROM  
EXISTING STRUCTURE-MODEL

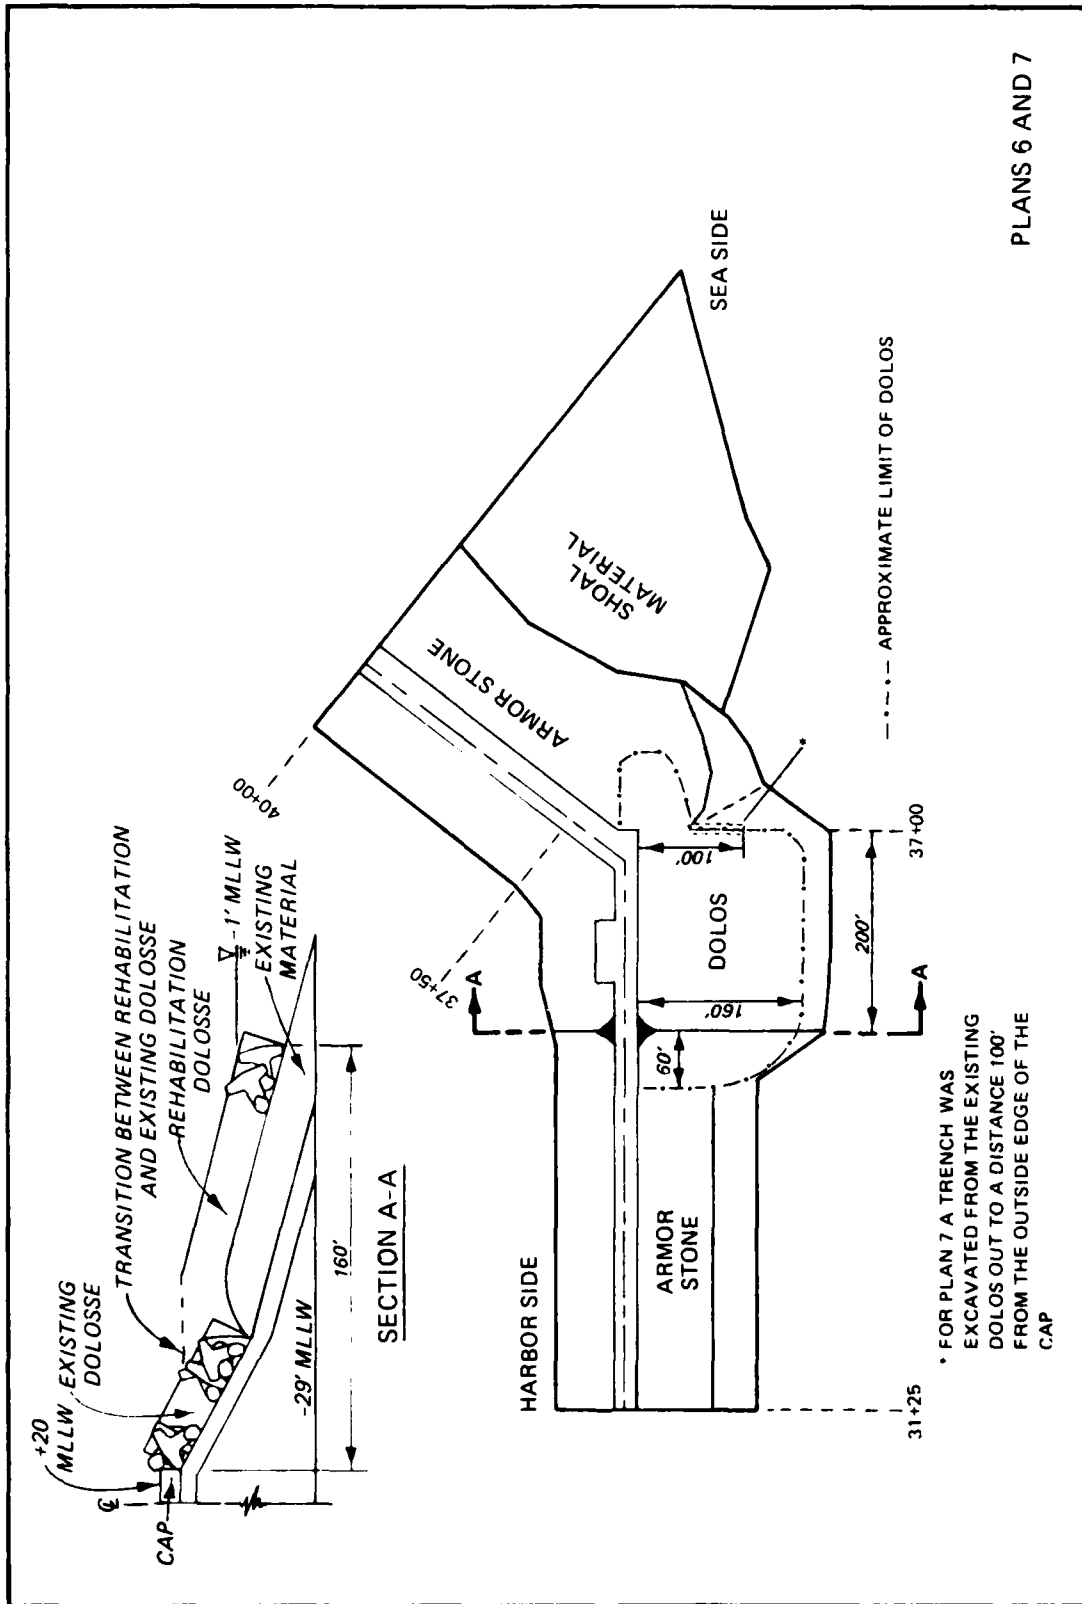
PLANS 6 AND 7

\* FOR PLAN 7 A TRENCH WAS EXCAVATED FROM THE EXISTING DOLOS OUT TO A DISTANCE 100' FROM THE OUTSIDE EDGE OF THE CAP

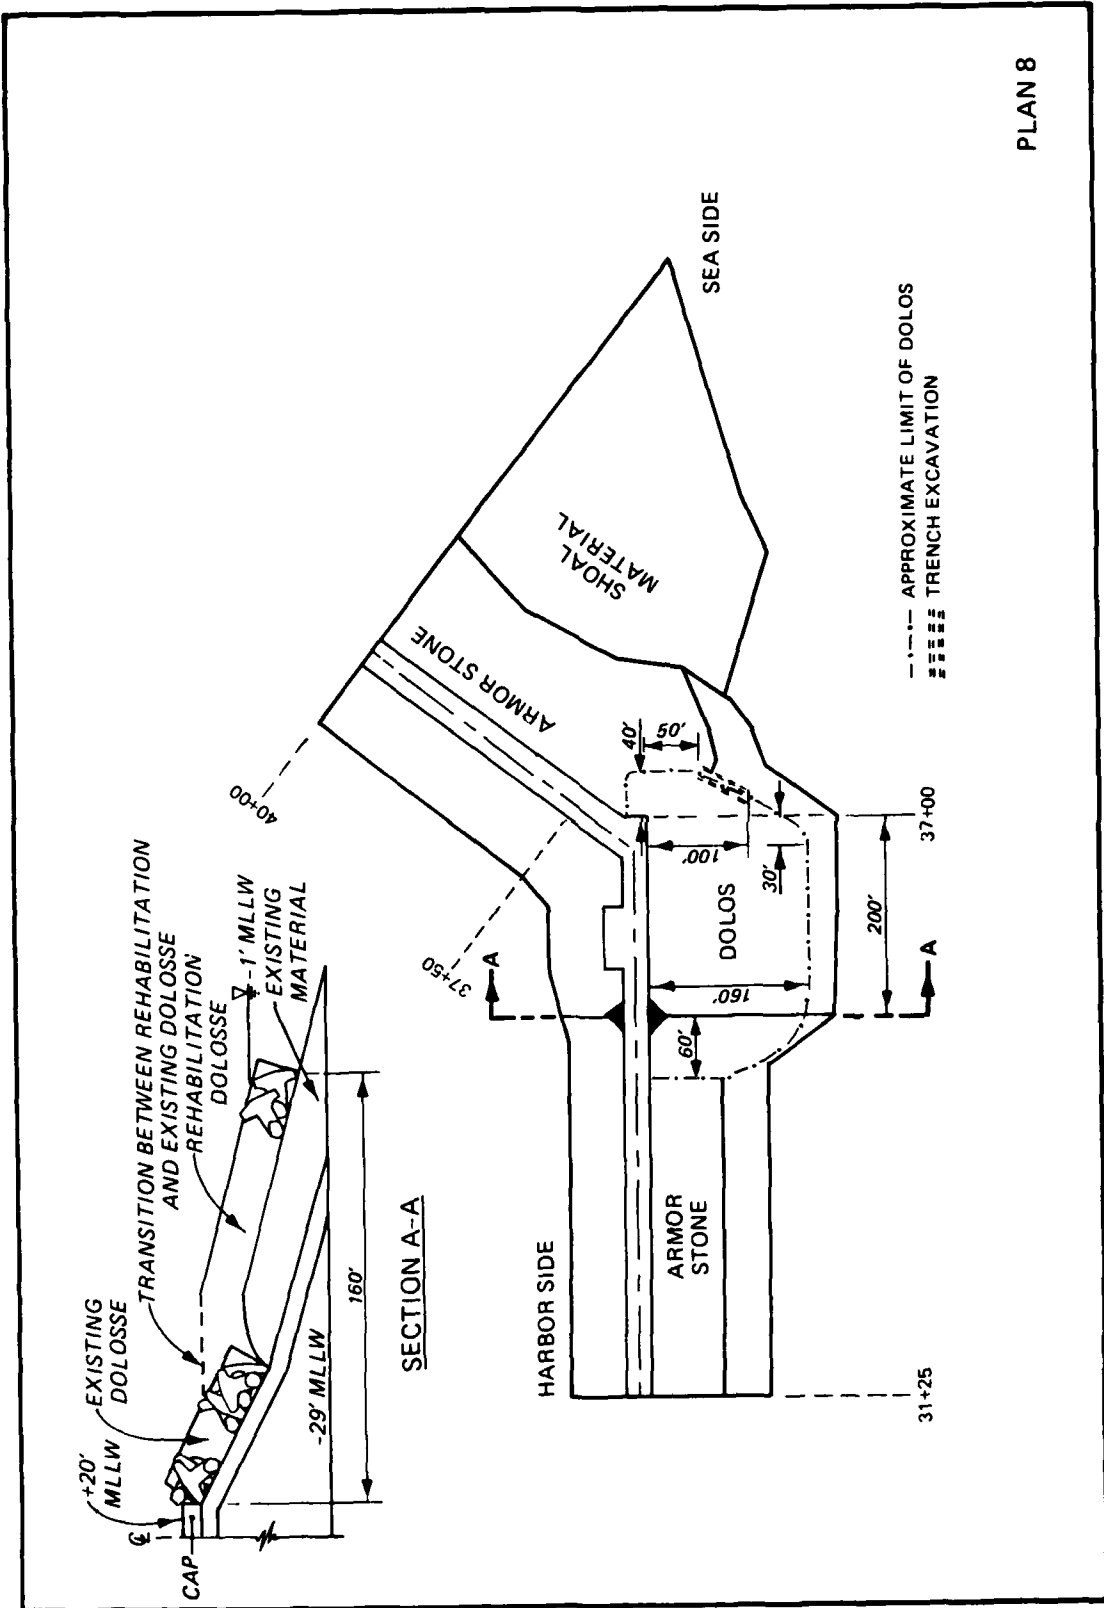
PLATE 12

PLAN 8

38. Plan 8 (Plate 12 and Photos 72-74) was tested in an effort to find a section that would encompass and provide protection to existing dolosse seaward of sta 37+00. A total of 334 rehabilitation dolosse were placed. A trench was excavated along part of the seaward transition to stabilize the toe and is shown in Plate 12. The existing dolosse seaward of the cap end still sustained damage; in addition, three rehabilitation units were displaced along the toe of the seaward transition. Photos 75-77 show the structure after testing.

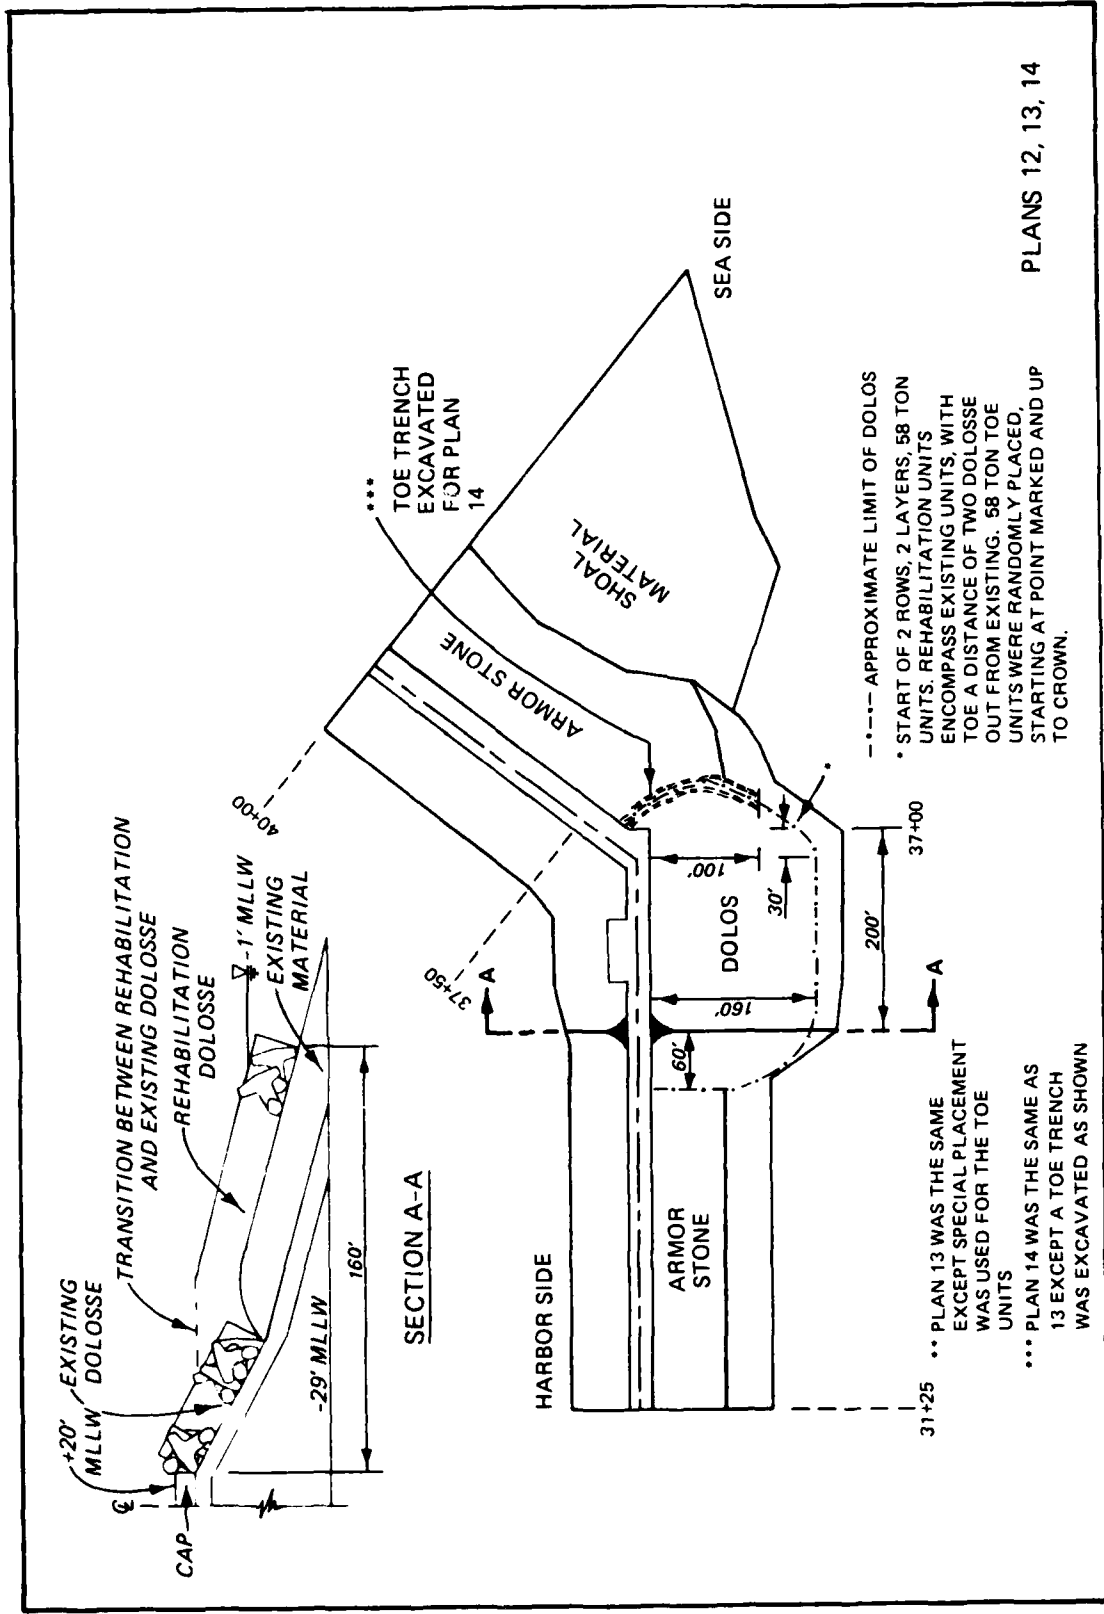
PLATE 16

PLANS 12, 13, 14

42. Plan 12 (Plate 16 and Photos 99-101) was constructed with two rows of 58-ton dolosse along the seaward transition of the elbow; the 58-ton units along the toe were randomly placed. It was hoped that the heavier units would stabilize this area without trenching. A total of 46 58-ton and 319 42-ton rehabilitation dolosse were placed. The seaward transition sustained severe damage during testing. Photos 102-104 show the structure after testing.

43. Plan 13 (Plate 16 and Photos 105-107) was similar to Plan 12, except some additional 58-ton dolosse were placed. Also, special placement was used for the toe units. A total of 65 58-ton and 313 42-ton rehabilitation units were placed. The seaward transition still sustained damage during testing. Photos 108-110 show the structure after testing.

44. Plan 14 (Plate 16 and Photos 111-113) was similar to Plan 13, except a trench was excavated along part of the seaward transition. A total of 61 58-ton and 312 42-ton rehabilitation units were placed. Again the seaward transition sustained damage during testing. Photos 114-116 show the structure after testing. At this time it was decided that the larger units exhibited more surface area for the waves to work on and were not a feasible alternative unless higher density concrete was used, which in effect, would increase the weight without increasing the surface area. Since high-density model units were not available to show this effect and the time limitation prevented making additional model units, future efforts concentrated on finding a stable section using the 42-ton dolosse.
