TECHNICAL REPORT CERC-85-8

# BREAKWATER REHABILITATION STUDY, CRESCENT CITY HARBOR, CALIFORNIA

## Coastal Model Investigation

November 1985

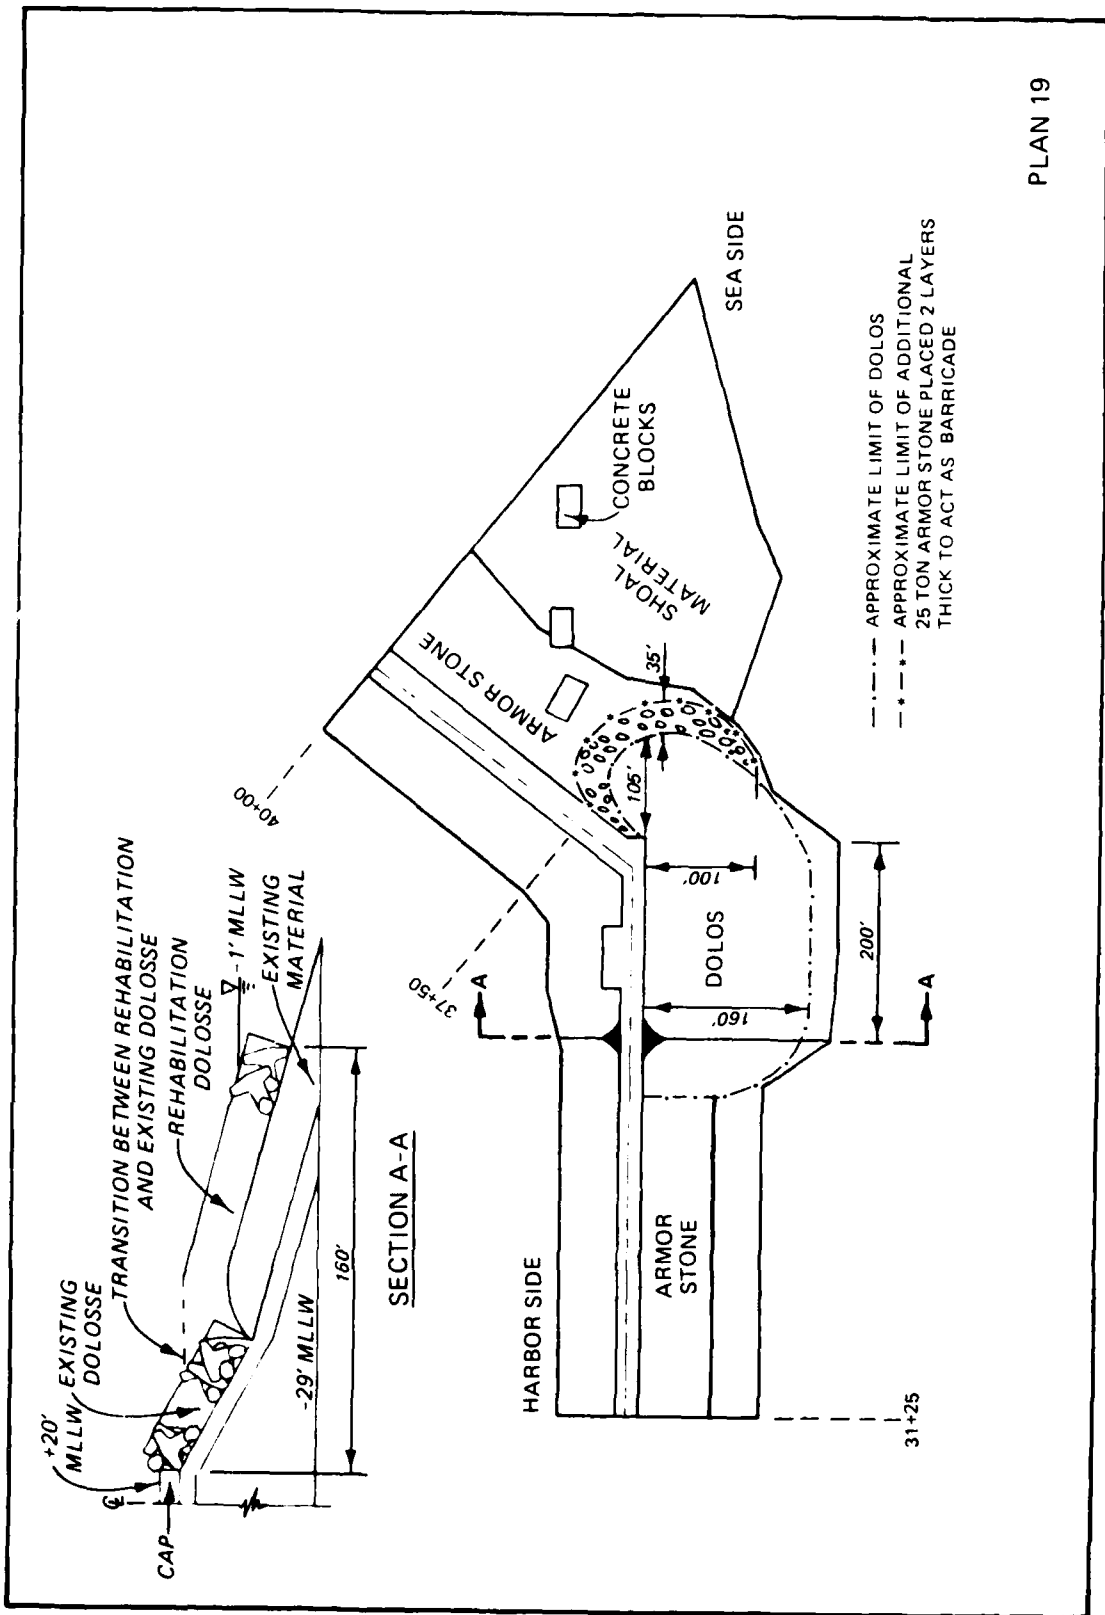
PLATE 21

PLAN 19

49. Plan 19 (Plate 21 and Photos 147-149) was similar to Plan 18, except a rock buttress was placed around the outer perimeter of the seaward transition. Also three concrete blocks were added to represent remnants of the deteriorated cap of the old breakwater extension. No trenching was used for this plan, and special placement was used for the dolos toe units. The rock buttress was placed before the rehabilitation dolosse and consisted of 25-ton armor stone two layers deep and approximately 35 ft wide. The total number of armor stones added was 188; assuming a specific weight of 170 pcf and a porosity factor of 0.63, the total weight of stone used was 4,700 tons with a volume of approximately 3,250 cu yd. A total of 408 42-ton rehabilitation dolosse were used. Plan 19 was subjected to the abbreviated hydrograph. The rock buttress sloughed off in the lower region of the seaward transition and was undamaged near the crown of the dogleg where the stone was protected

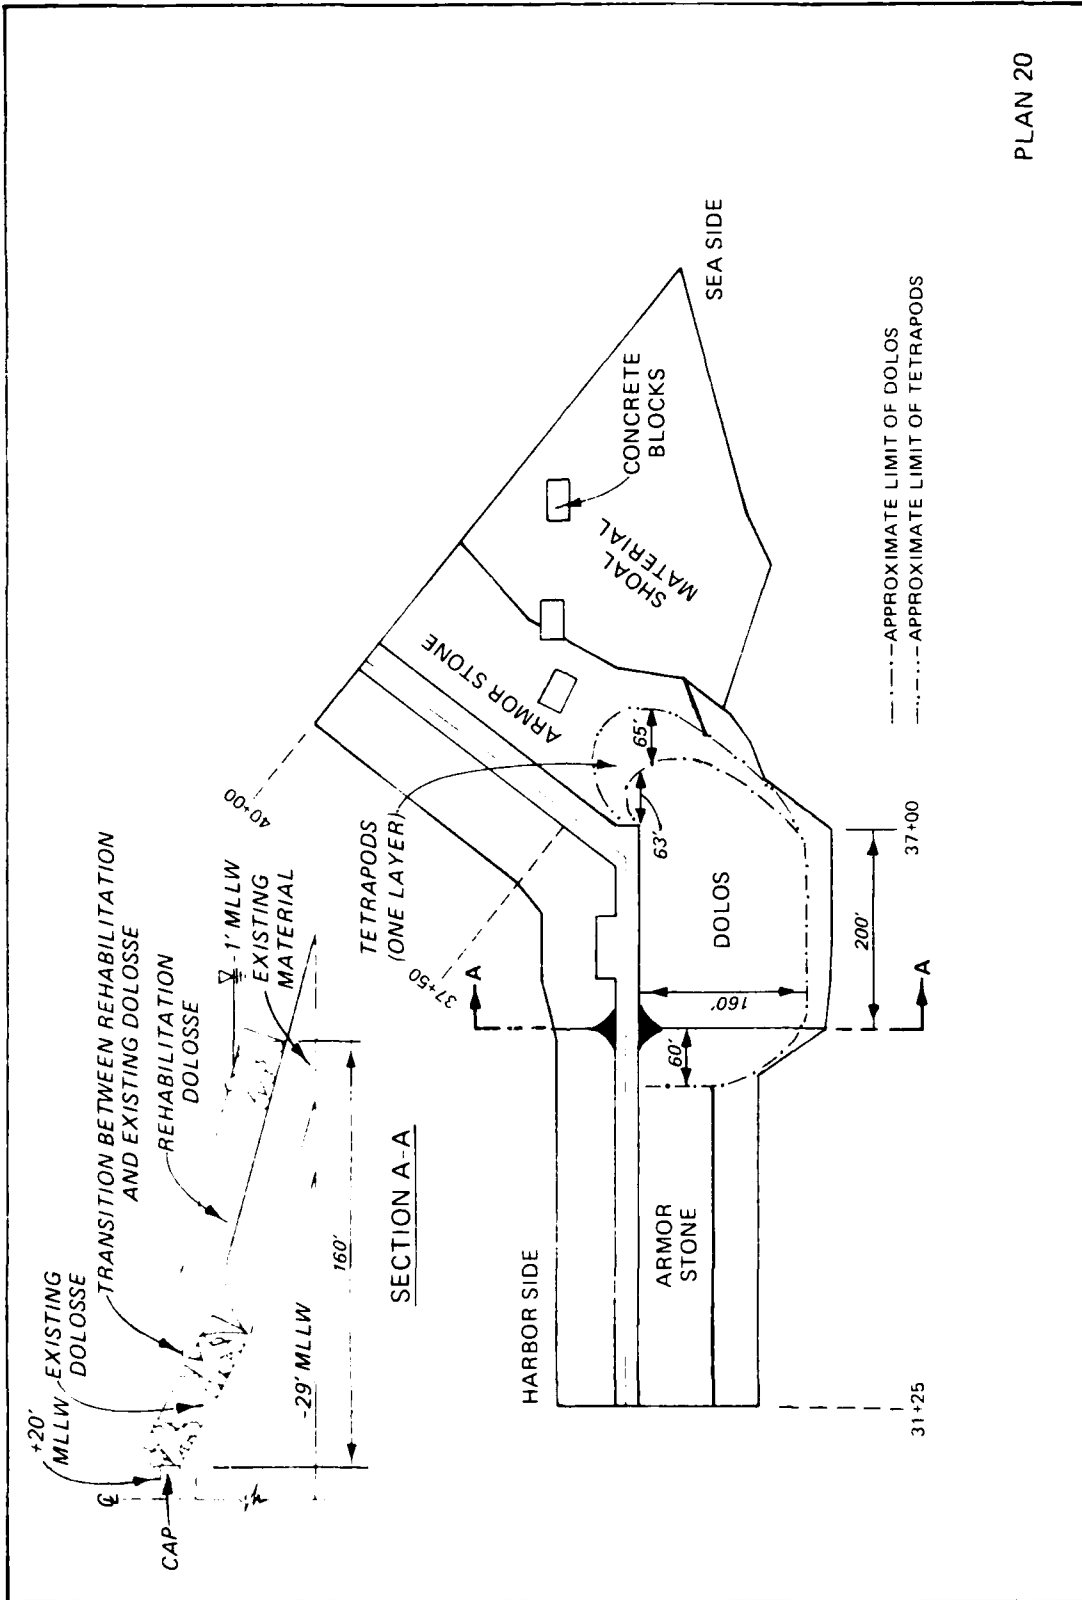
PLATE 22

PLAN 20

50. Plan 20 (Plate 22 and Photos 154-156) had about the same area of coverage as Plan 18; however, 74 rehabilitation dolosse were removed and replaced with 82 37-ton tetrapods (37-ton tetrapods were used since this was the model size tetrapod available nearest to the 42-ton dolos size). The tetrapods were placed in one layer. It was thought that the tetrapods might be a more appropriate shape for interfacing the existing stone. A total of 334 42-ton dolosse were used. The tetrapods suffered extensive damage. There was minimum movement of the dolosse during the abbreviated hydrograph, but since they had lost the protection afforded by the tetrapods it is likely damage would have progressed to this area for a longer duration storm. Photos 157-159 show the structure after testing.
