PROCEEDINGS OF THE FLOATING TIRE BREAKWATER WORKSHOP
HELD IN NIAGARA FALL. (U) COASTAL ENGINEERING RESEARCH
CENTER VICKSBURG MS C T BISHOP ET AL. NOV 85
CERC-TR-85-9

TECHNICAL REPORT CERC-85-9

PROCEEDINGS OF THE FLOATING TIRE BREAKWATER WORKSHOP 8-9 NOVEMBER 1984

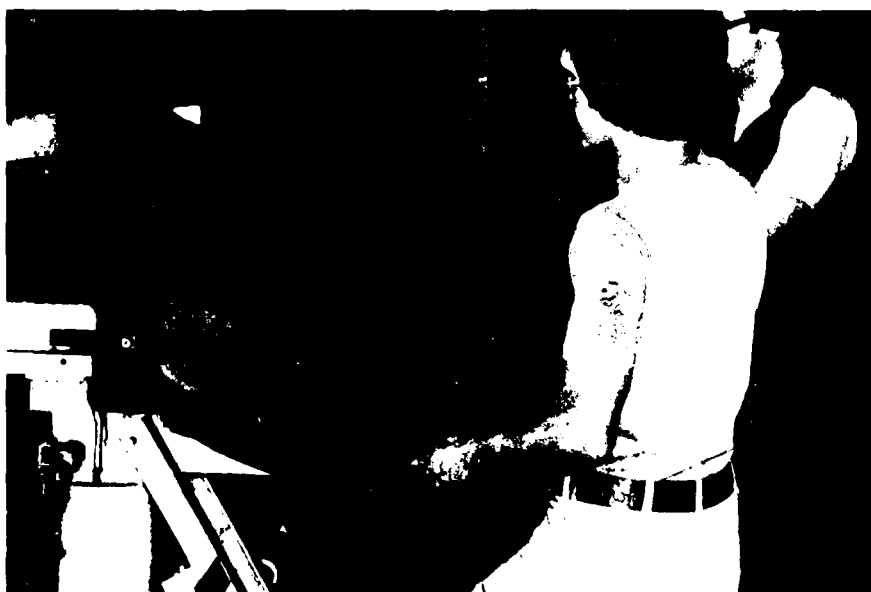
Figure 2. Punching hole in tread of truck tire

Using a pneumatically driven punch, holes were punched in each tire casing prior to inserting the foam components. The air compressor and punch were loaned to the project by Goodyear Research Division. For steel-belted tires, the holes were punched through the sidewall near the tread rather than directly through the tread surface. Two holes of approximately 3/4-inch diameter were punched in opposite ends of the casings (see Figure 2). These holes were used as water drain holes for drying the casing prior to foaming. It is noted that the foam agents will not cure properly in the presence of water; at the same time, punching holes in the casing to drain the water insures that the tire will be positively buoyant only if sufficient foam is applied to its interior. Figure 3 shows an example of an adequately foamed steel belted tire. The foam slug in this tire weighs approximately 3 lbs. Less foam is required for smaller, non-steel-belted tires.

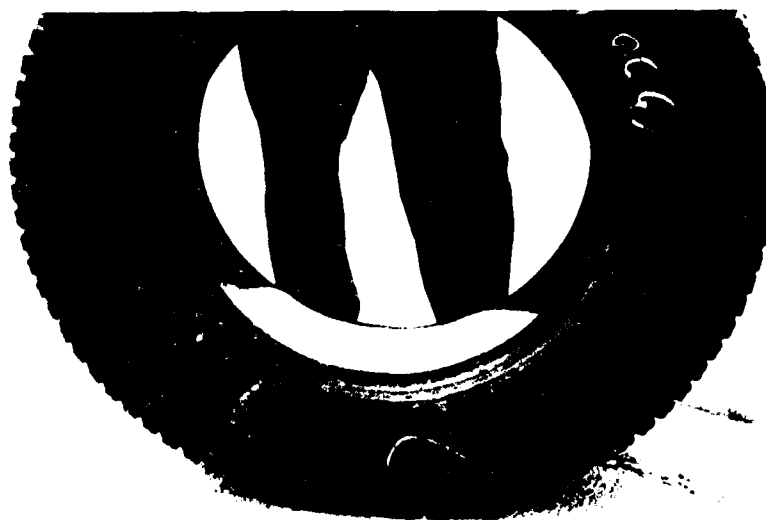
Figure 3. Cured foam slug in steel-belted truck tire

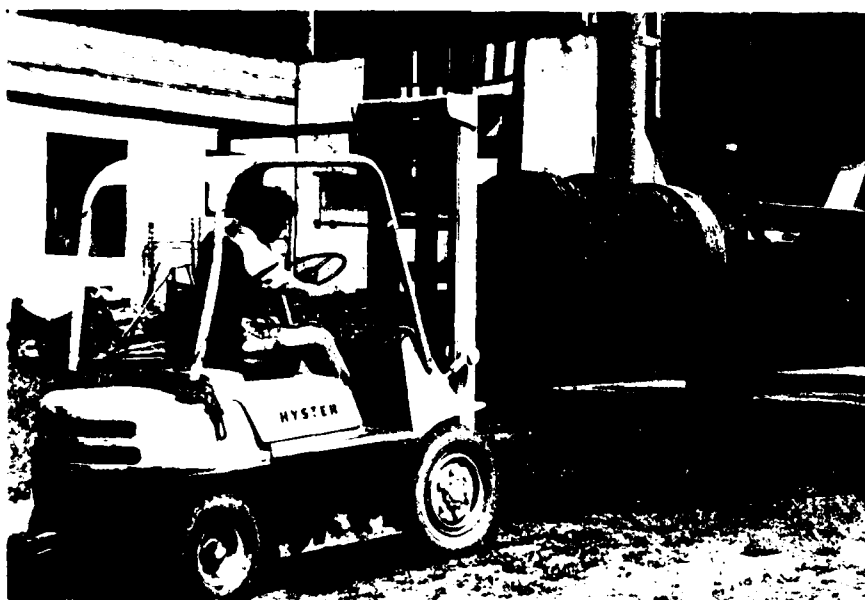
Figure 6. Threading truck tires onto steel pipe

Figure 6 shows the operation of tire cladding the steel tubes. The far end of the tube is resting on a fixed block and the center is supported by the cradle crane lifting cable.

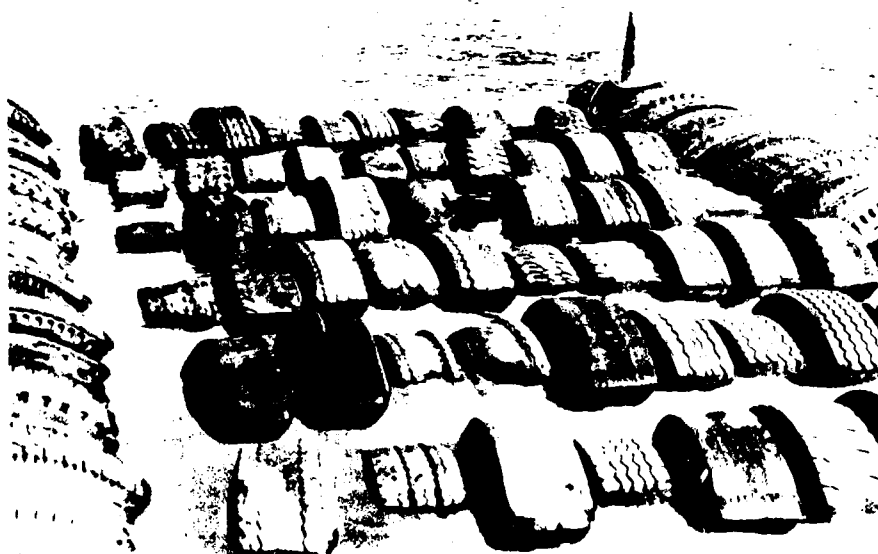
Figure 8. PT-1 assembly in the water

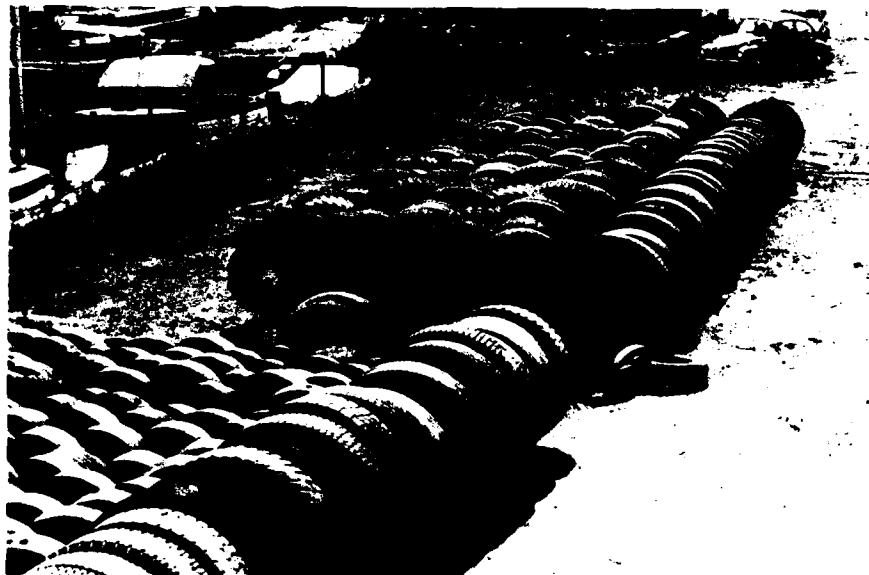
Figure 10. PGYM-1 assembly prior to launching

Figure 9 shows details of the truck tire maze stringers for the PGYM-1 design. Each stringer is of Goodyear modular design. This configuration positions the tire openings in the principal direction of wave advance (see Figure 10). It features a tightened bundling of the tires with neighboring tires providing some positive lift in the event a tire is insufficiently

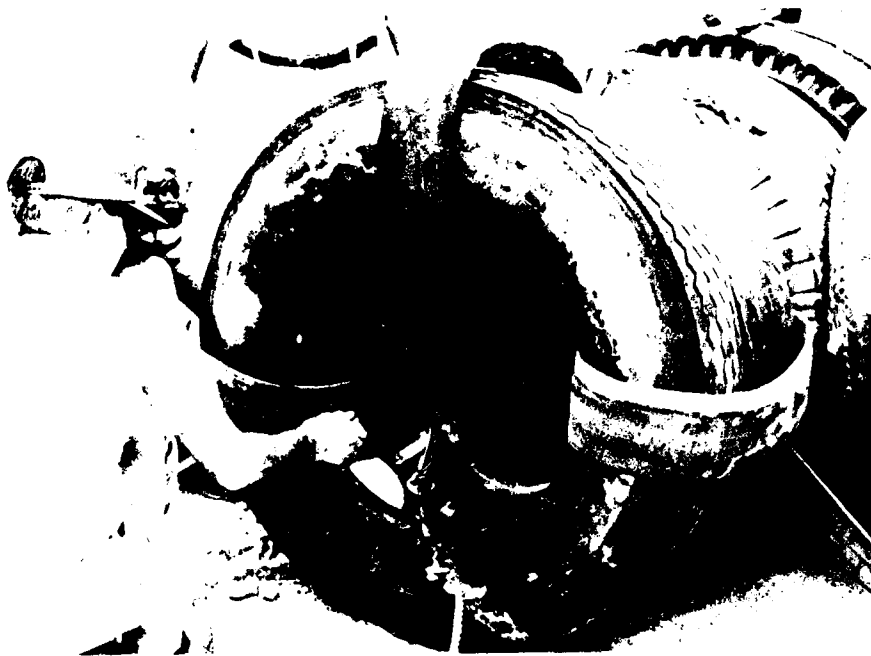
Figure 13. End tires covering steel retaining lugs

All subassemblies were fabricated at the marina and consisted of one tire-clad tube with attached tire maze and short loosely assembled joining belts connected to tires on the side later to be joined to the tire-clad tube of the next subassembly. Large-diameter truck tires were belted outside at the ends of the pipe to the first tire on the pipe. These tires provide some measure of damage protection should a boat come in contact with the breakwater in the regions of steel pipe end exposure. Figure 13 shows the short steel tire retaining lugs sandwiched between two end tires.

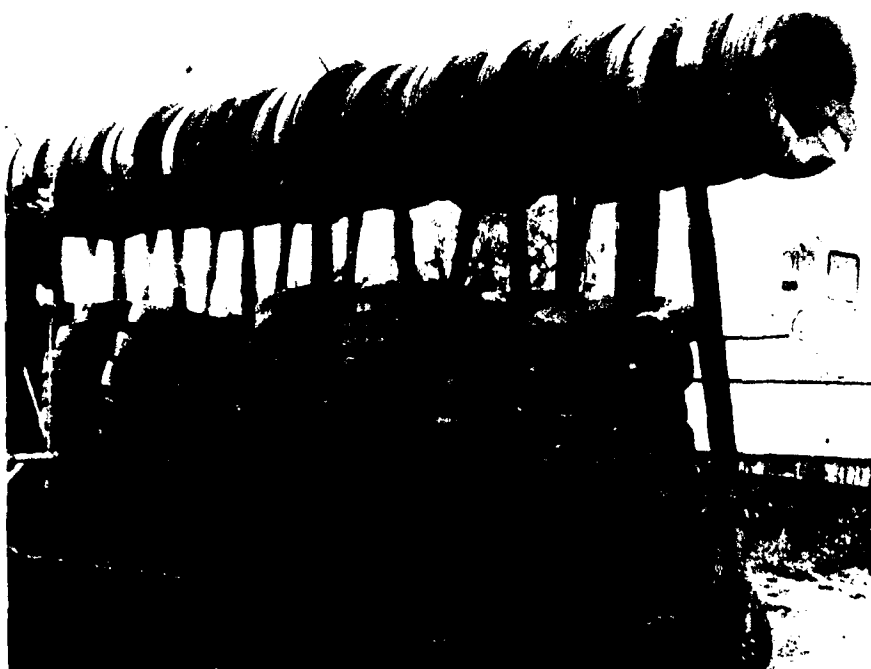
Figure 14. PT-1 section being moved to launching well

A subassembly, with mooring lines connected, was lifted with a travelling boat cradle crane by cabling around the tubes (Figure 14) and moved to a position over the launching well. Since the tire maze was assembled with the foam in the top of all tires, the tires came up on the correct side as the assembly was lowered into the water (see Figure 15). As the assembly was eased out of the launching well, a 16-ft.-long boat with outboard drive was lashed to each side. These boats were used to move the subassemblies approximately 3/4 miles to the installation area (see Figure 16). Steering of the assembly was accomplished primarily by increasing motor r.p.m. on one side or the other.

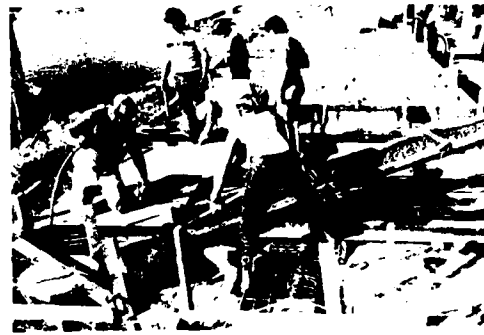
PHOTO 8. POURING SIDES AND
INTERNAL WALLS

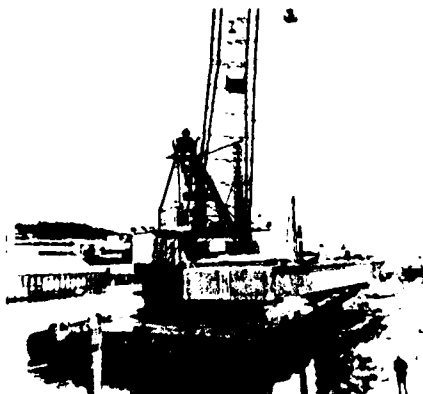
PHOTO 11. LAUNCHING OF
CONCRETE BREAKWATER

On May 28, 1982, the 140-ton units were lifted from the casting area and lowered into the waterway (Photograph 11). The longitudinal strain gages in the lower center edges of the B-float were monitored during the launching. A maximum strain of 1,700 microstrains was recorded, indicating that loads were about two-thirds of the yield strength of the reinforcing steel. After both units were launched, they were joined end-to-end with two flexible connectors (Photograph 12) and towed approximately 90 miles south to the West Point test site.

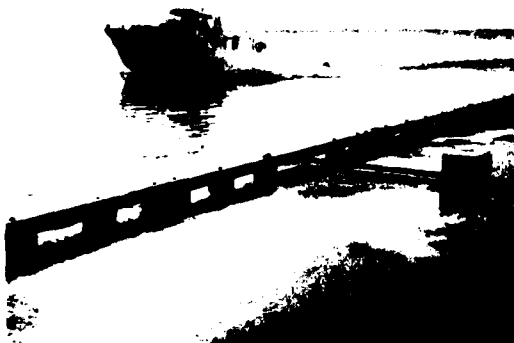
PHOTO 17. 41-FT COAST GUARD CUTTER PASSING THE BREAKWATERS (DURING A BOAT WAKE TEST)

Advantage was taken of calm periods to make repairs and to conduct additional tests. Four boat wake tests and an anchor line stiffness (pull) test were conducted at various points in the program. For two of the boat wake tests, 41-ft Coast Guard cutters were used to generate waves (Photograph 17). The other two tests used large (75-ft and 110-ft) tugboats. Boat-generated waves were in the 2- to 3-ft range. For the anchor stiffness test, a 4,000-hp tugboat was used to pull on the breakwater with varying loads, while surveying instruments measured displacements, and load cells in the anchor lines monitored anchor forces (Photograph 18). This test was conducted to obtain simultaneous measurements of breakwater lateral displacement and the resisting

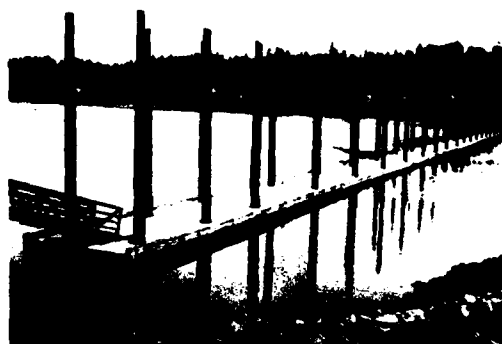
PHOTO 25. THE 16-FT-WIDE BY
600-FT-LONG EAST BAY BREAK-
WATER MOORED WITH PILINGS

While the Floating Breakwater Prototype Test Program was under way, two projects using floating breakwaters were designed and constructed by NPS. In 1983, a 600-ft-long breakwater was constructed for the 800-boat East Bay Marina at Olympia, Washington (Photograph 25). A year later, another floating breakwater, 1,600 ft long, was anchored at Friday Harbor, Washington (Photograph 26).

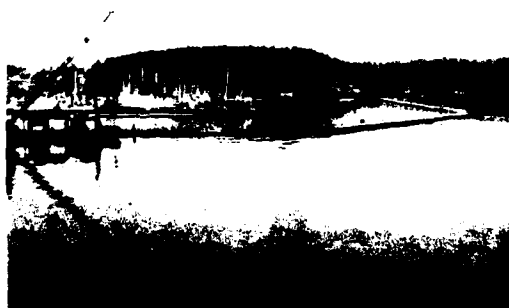
PHOTO 26. TEST UNITS NOW PART
OF THE FLOATING BREAKWATER AT
FRIDAY HARBOR, WASHINGTON
