MARINE CASUALTY REPORT

DRILL SHIP

GLOMAR JAVA SEA

CAPSIZING AND SINKING

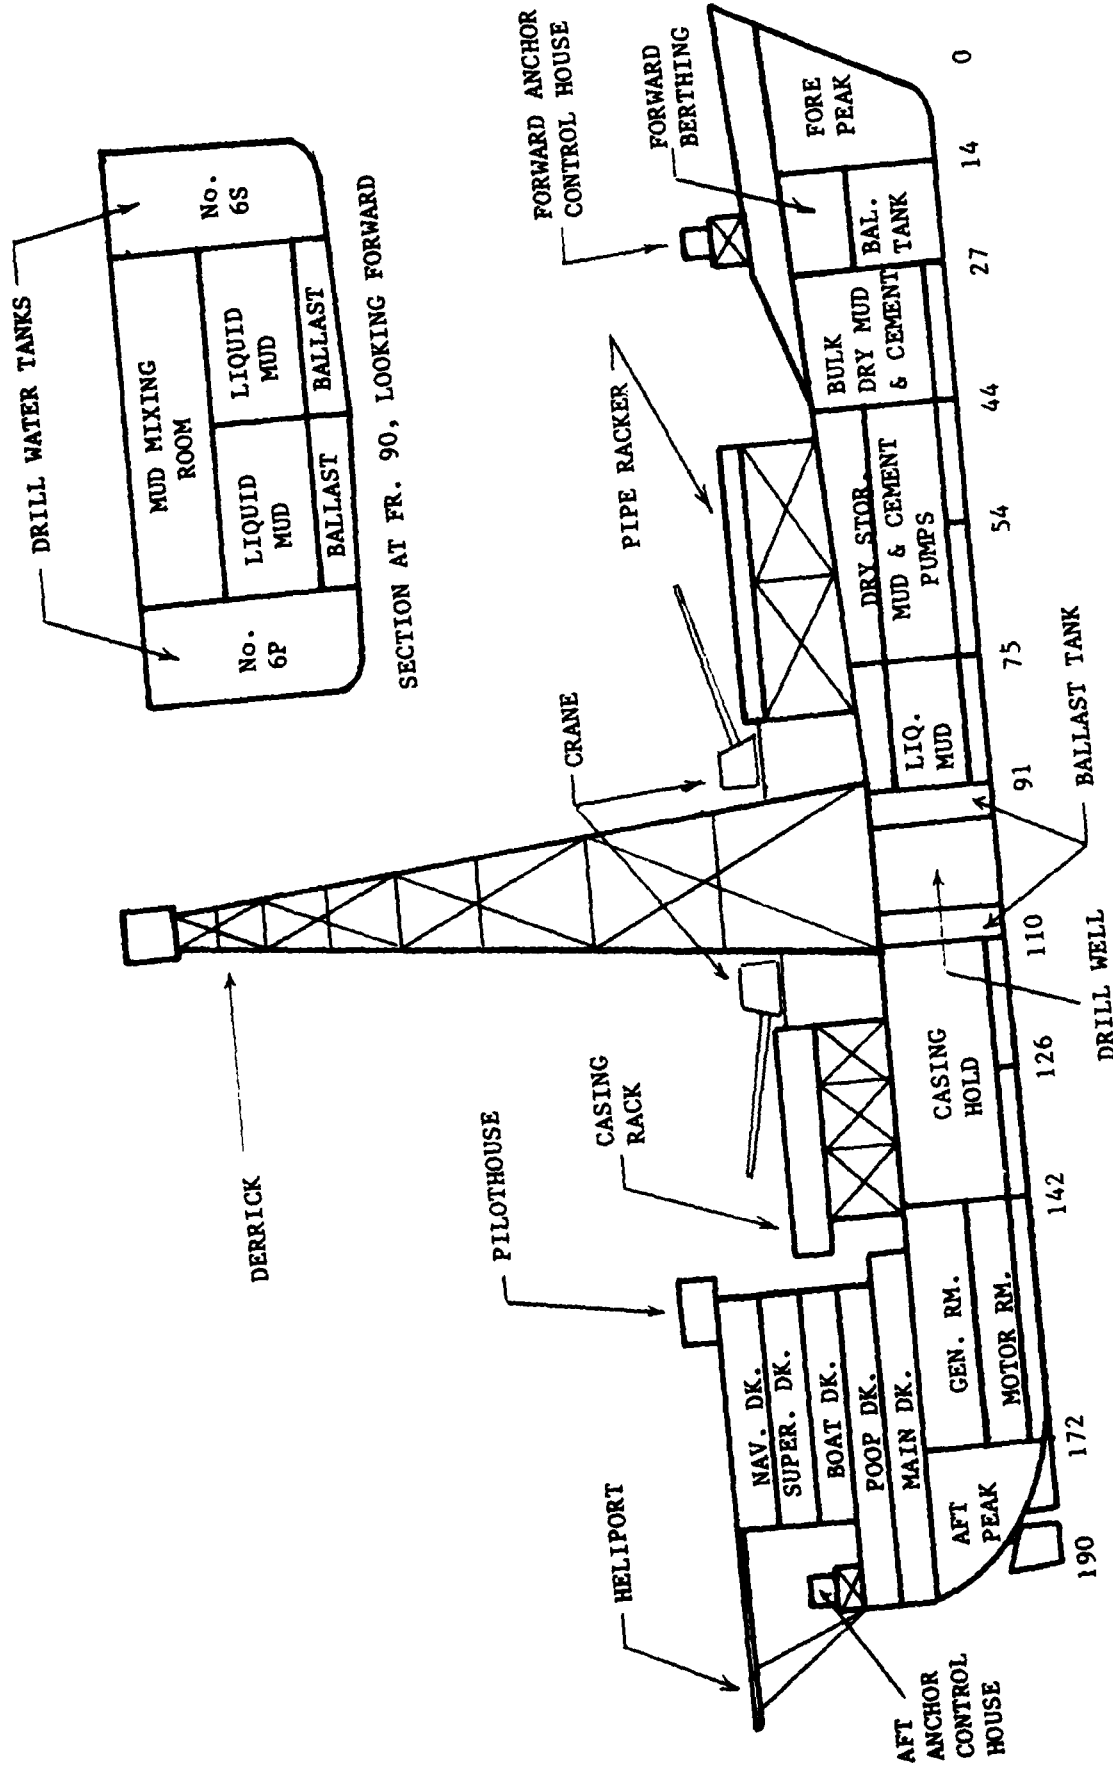
FIGURE 2: Drillship GLOMAR JAVA SEA, Inboard Profile

Above the main deck, aft, above the machinery spaces was a 5-level deckhouse topped by the pilothouse. Aft of the deckhouse cantilevered over the stern was the heliport. The main deck level of the house contained crew staterooms, change and shower rooms, the hospital, laundry, workshops, and the steward's storeroom. Aft of those spaces were the aft anchor chain lockers.

The poop deck (01) level contained the galley, messroom, freezer, and crew's lounge. Aft of those spaces were the aft anchor windlasses.

The boat deck (02) level contained crew staterooms including the Chief Engineer's room. The lifeboat davits and the aft anchor windlass control room were located on this deck.
