# DIEGO GARCIA FLEET MOORINGS UNDERWATER INSPECTION

## PROJECT EXECUTION PLAN

**DIEGO GARCIA  
FLEET MOORINGS  
UNDERWATER INSPECTION**

**PROJECT EXECUTION PLAN**

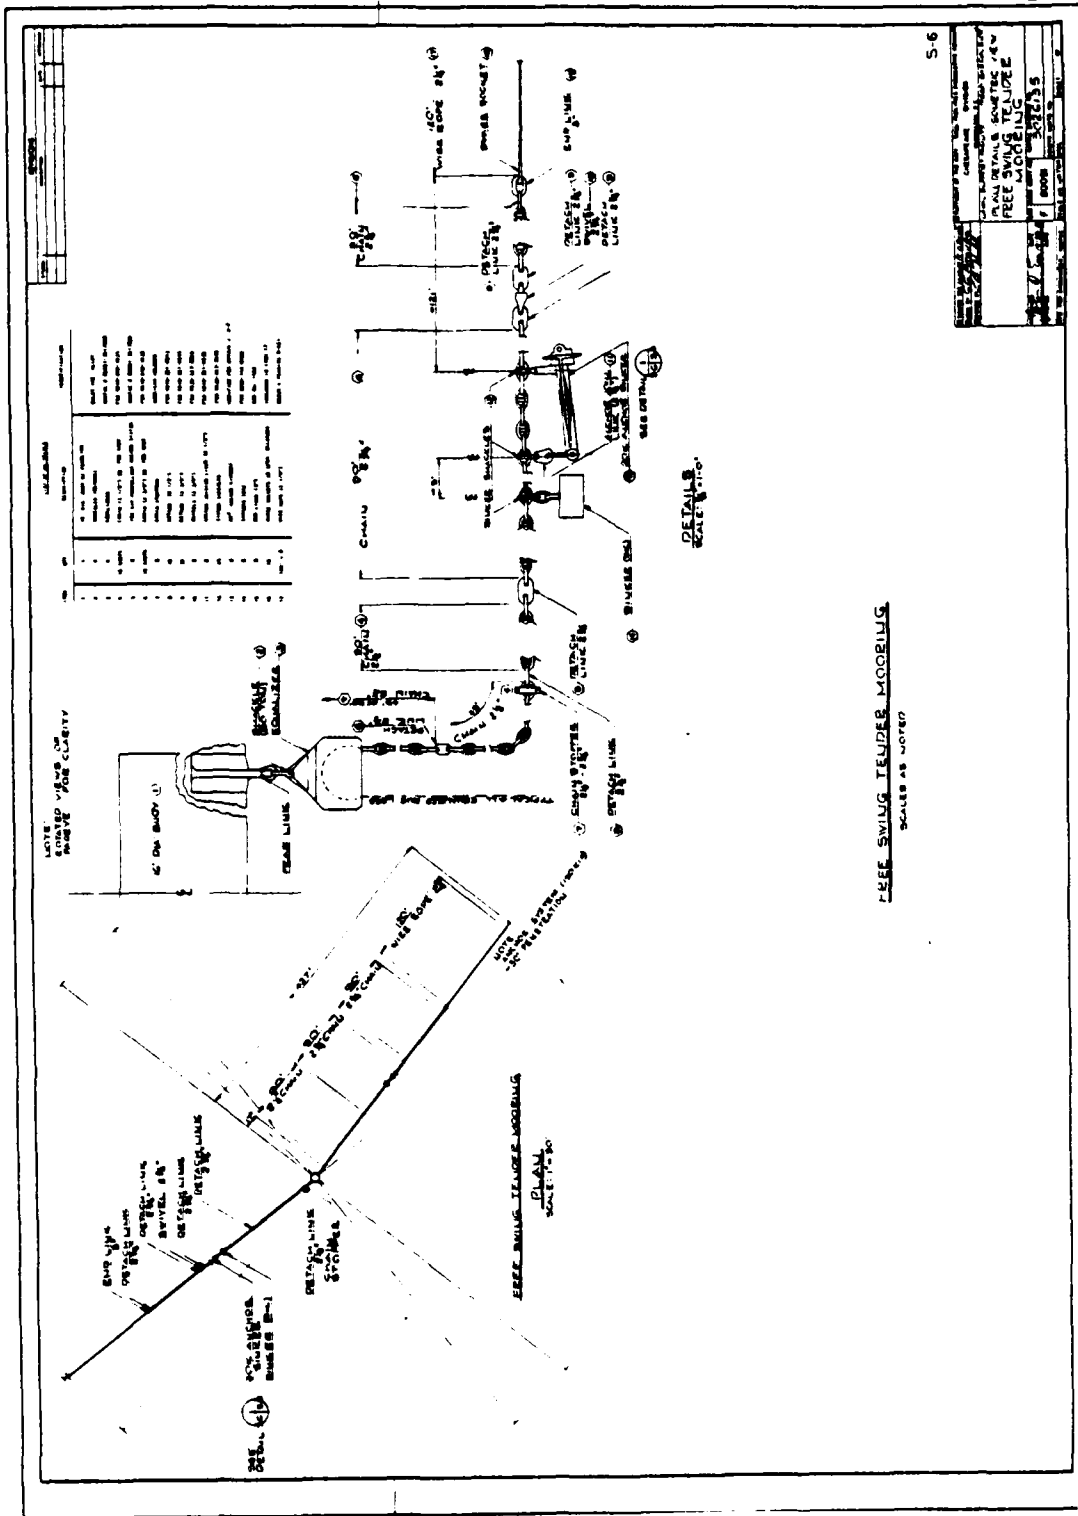
**Tender Free  
Swing Mooring  
Design**

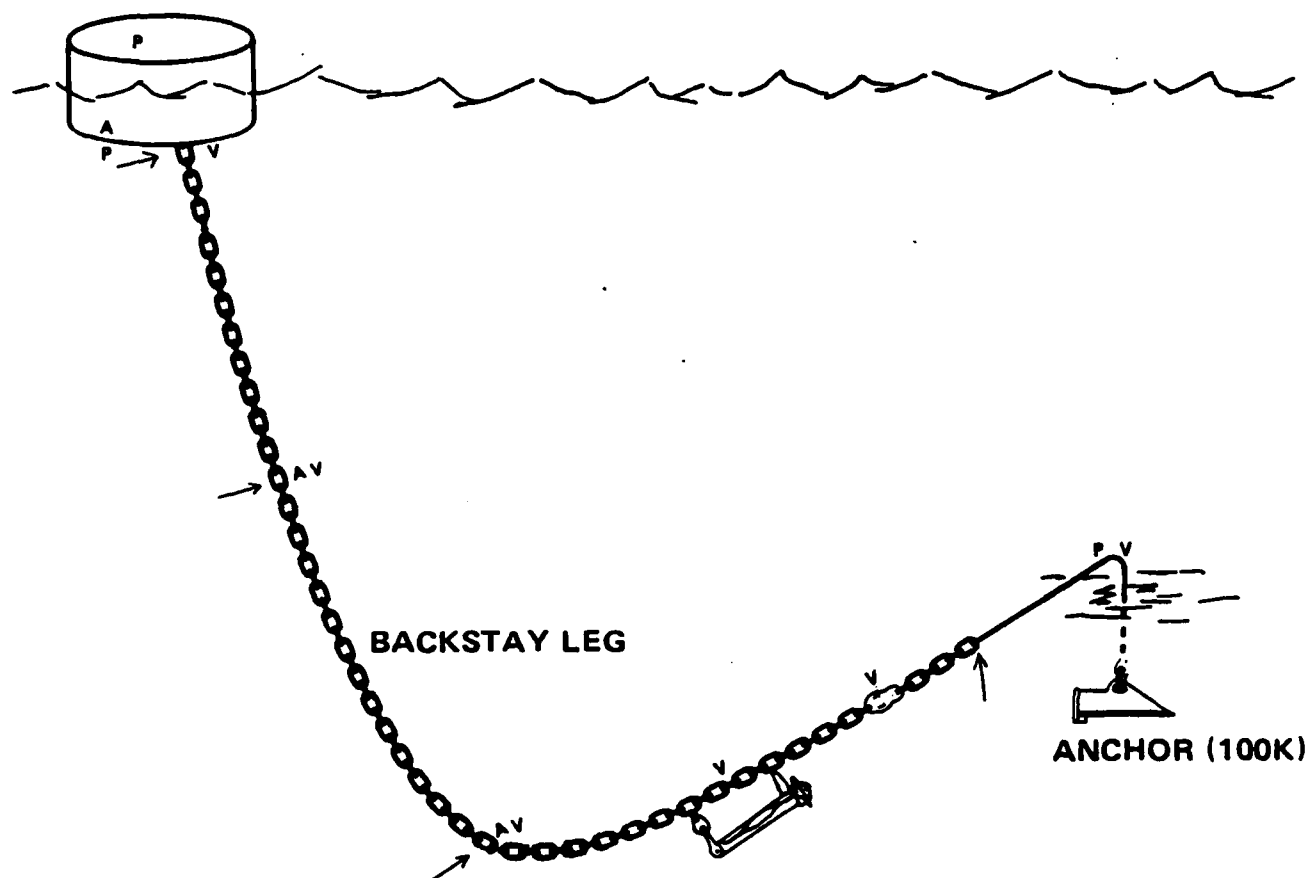
FIGURE 13. TENDER BOW/STERN MOORING BACKSTAY LEG INSPECTION POINTS

6.4.4 **Backstay Leg:** Each backstay leg was designed to be two shots (180') in length and is cathodically protected by continuity wire and two 250 pound anodes. A 20K stockless anchor clump is attached to each leg by two shackles about 135 feet below the buoy and a swivel is installed between the end of the ground leg chain and the anchor joining link connecting it to the 2 inch wire rope anchor pendant. The integrity of the continuity cable and the conditions of the anodes, sinker shackles, swivel, and anchor pendant shall be inspected using the same guidelines as provided for the ground leg inspection outlined in paragraph 6.2.3.

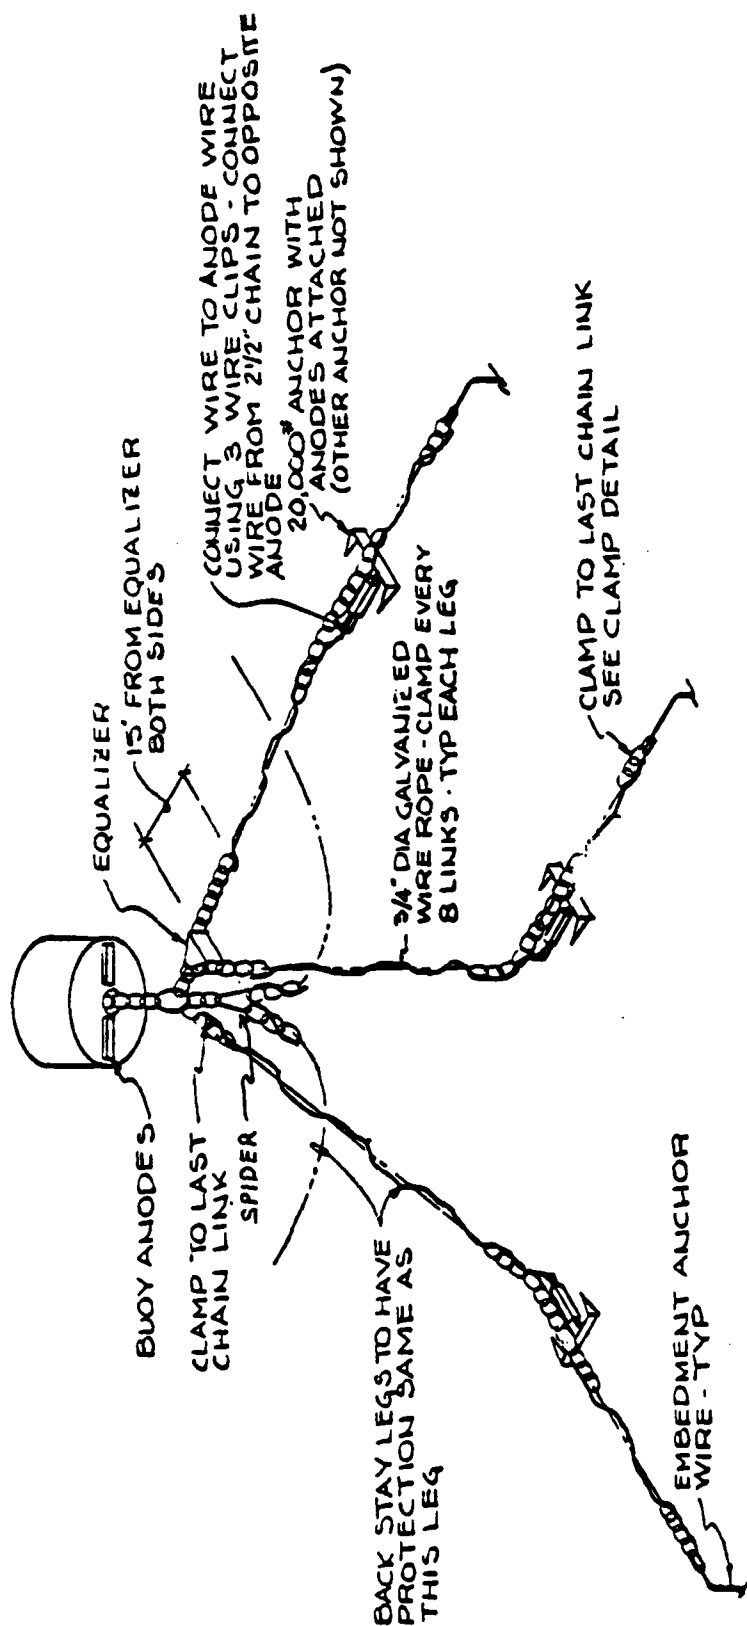
FIGURE 18. CATHODIC PROTECTION SYSTEM DIAGRAM

**9.0.3** Both Buoy Dolphin systems are cathodically protected. There are two anodes attached by brackets to the bottom of each buoy and two attached to the 20K anchor clump shackled to each chain leg. Wire rope continuity cable (3/4") is weaved through each of the five legs and clamped to the chain and to the anodes on the anchor clumps. Figure 18 is a diagram of the cathodic protection system attached to each of the Buoy Dolphin systems.

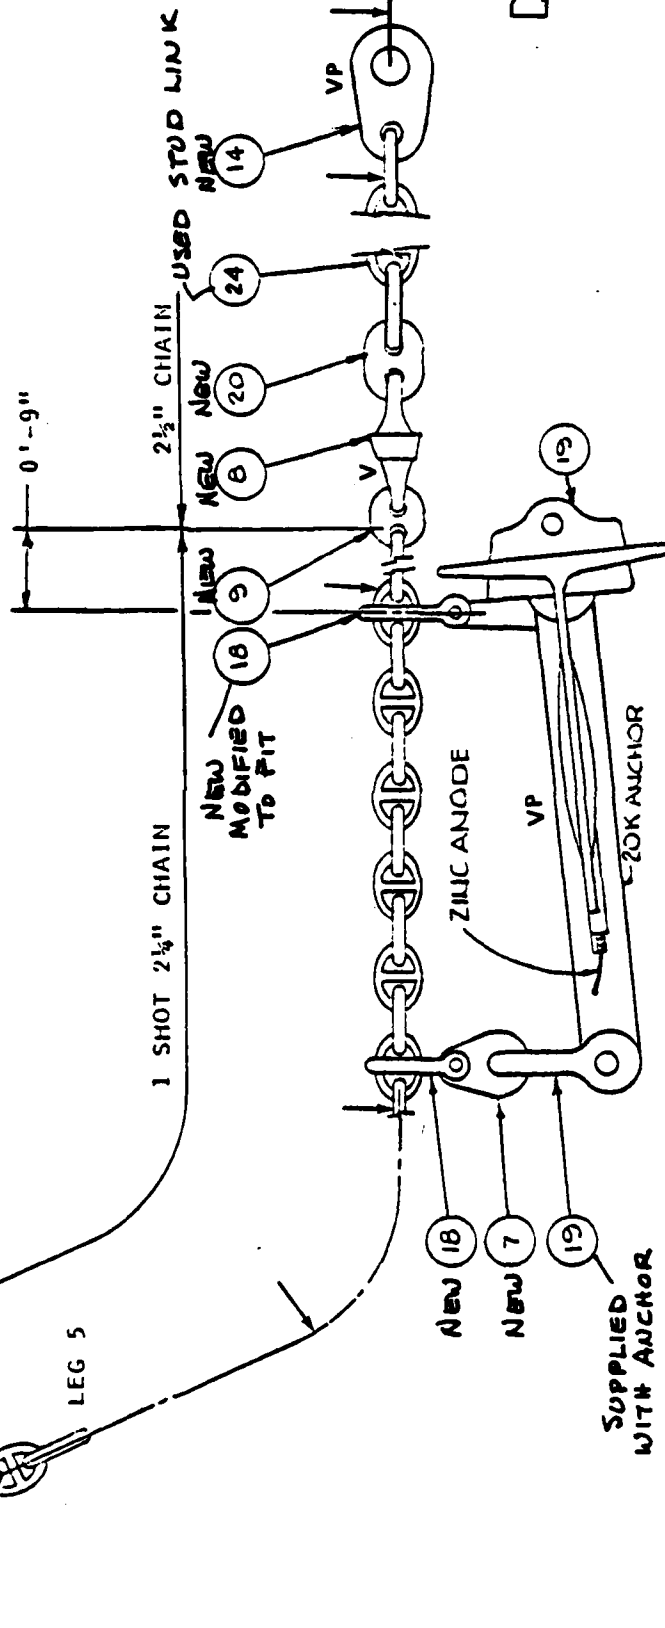
FIGURE 23. LEG - NORTH 5

MOORING LEG HARDWARE  
COMPONENTS
