DTNSRDC/SME-86/45 DOK-BLOK Hull Coating System General Shipyard Application Instructions

DTNSRDC-86/45 August 1986

DOK-BLOK HULL COATING SYSTEM GENERAL SHIPYARD
APPLICATION INSTRUCTIONS

N.A. Smith
H.S. Preiser

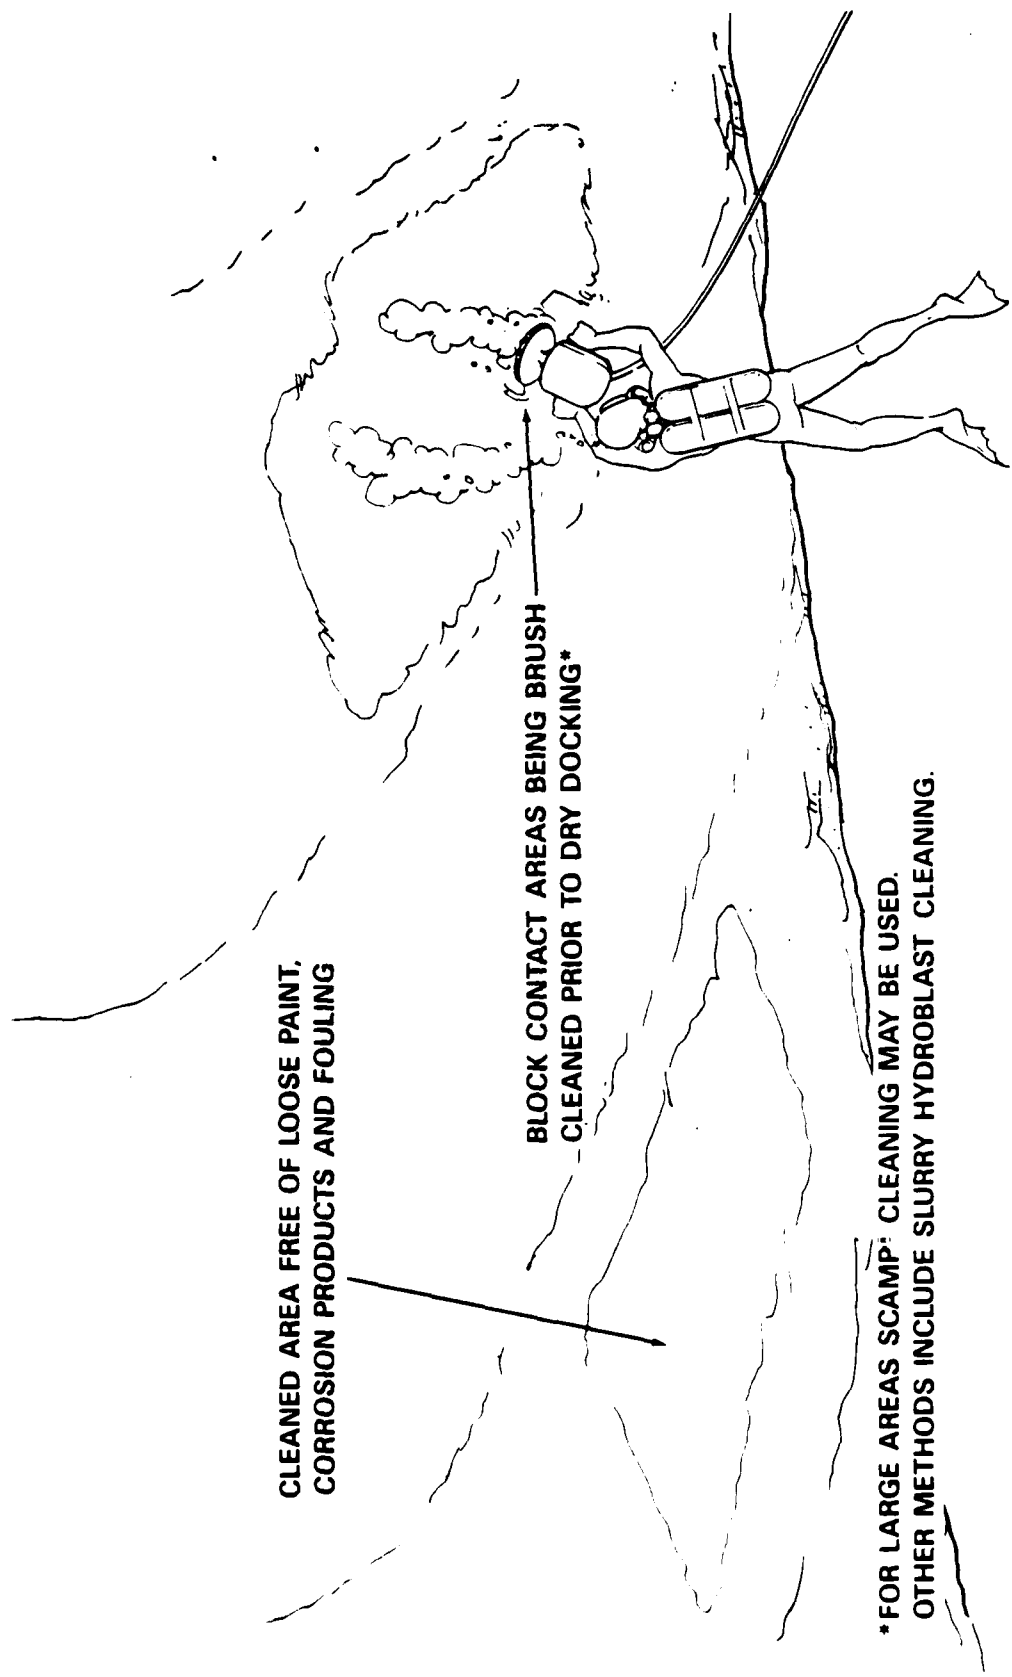
CLEANED AREA FREE OF LOOSE PAINT,
CORROSION PRODUCTS AND FOULING

BLOCK CONTACT AREAS BEING BRUSH
CLEANED PRIOR TO DRY DOCKING*

*FOR LARGE AREAS SCAMP® CLEANING MAY BE USED.
OTHER METHODS INCLUDE SLURRY HYDROBLAST CLEANING.

Fig. 2. Diver cleaning operations.

Pneumatically operated scrubbers and stiff, flat rotating wire brushes, as well as high pressure cavitating water jets have been found effective in removing all loose debris and for properly preparing the hull surface to receive the DOK-BLOK system. Hydroblasting with sand slurry is particularly effective. The purpose of this operation is to provide a stable substrate surface for the DOK-BLOK system by removing accumulated slimes, fouling growths, loose paint or corrosion products. Hogging lines may be tied around the ship to guide the diver while underwater. For large underwater areas a Scamp[®] machine may be used. See Fig. 2.
