Technical Report 85059

A COMPARISON OF THE FATIGUE PERFORMANCE OF WOVEN AND NON-WOVEN CFRP LAMINATES

Procurement Executive, Ministry of Defence
Farnborough, Hants

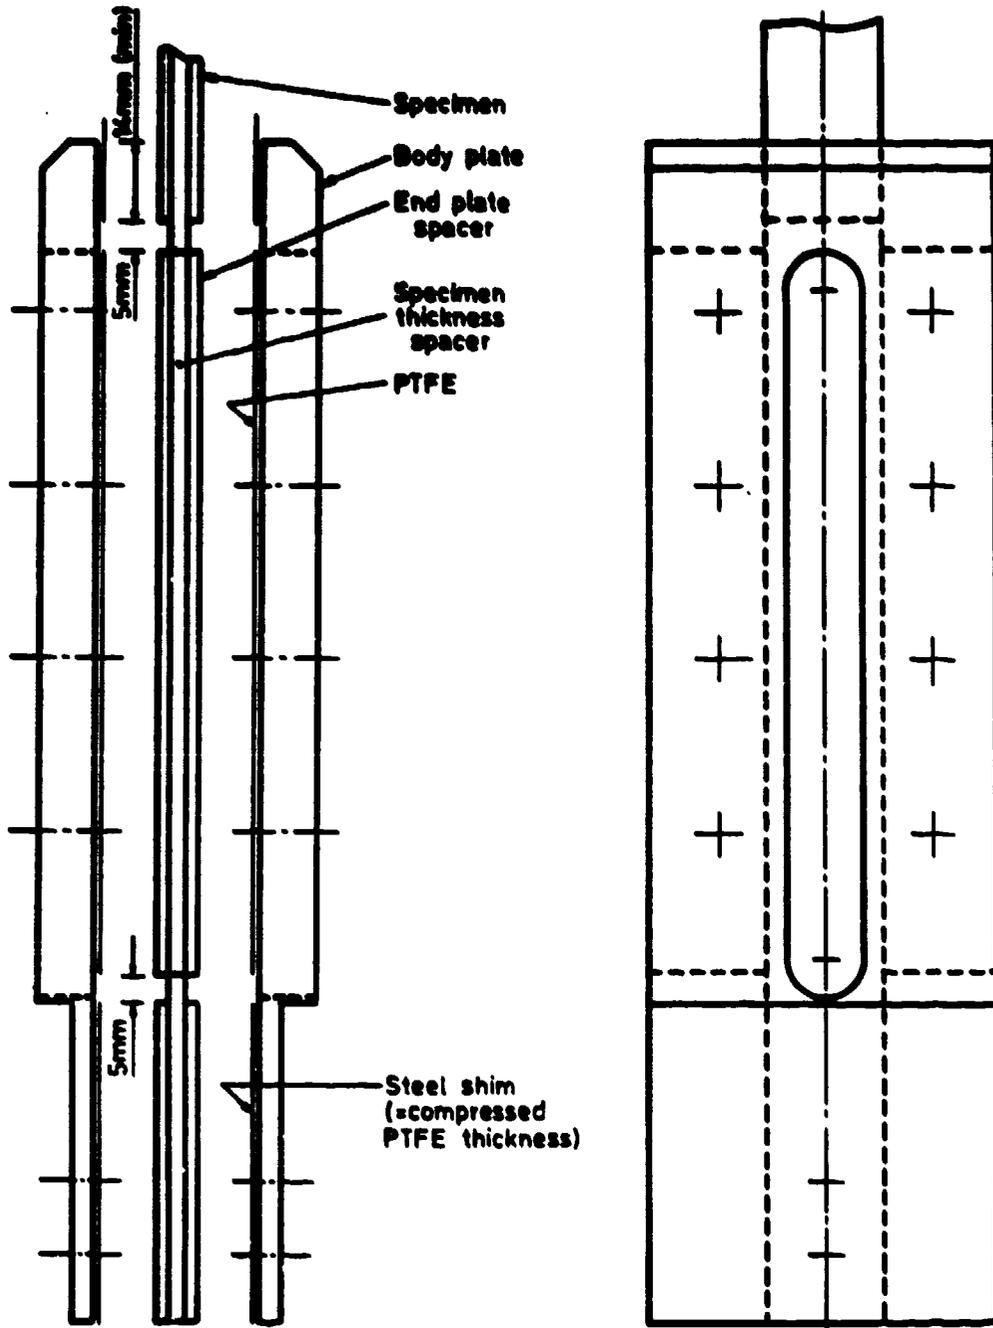
Fig 1 Anti-buckling guide used to support coupons during compressive testing

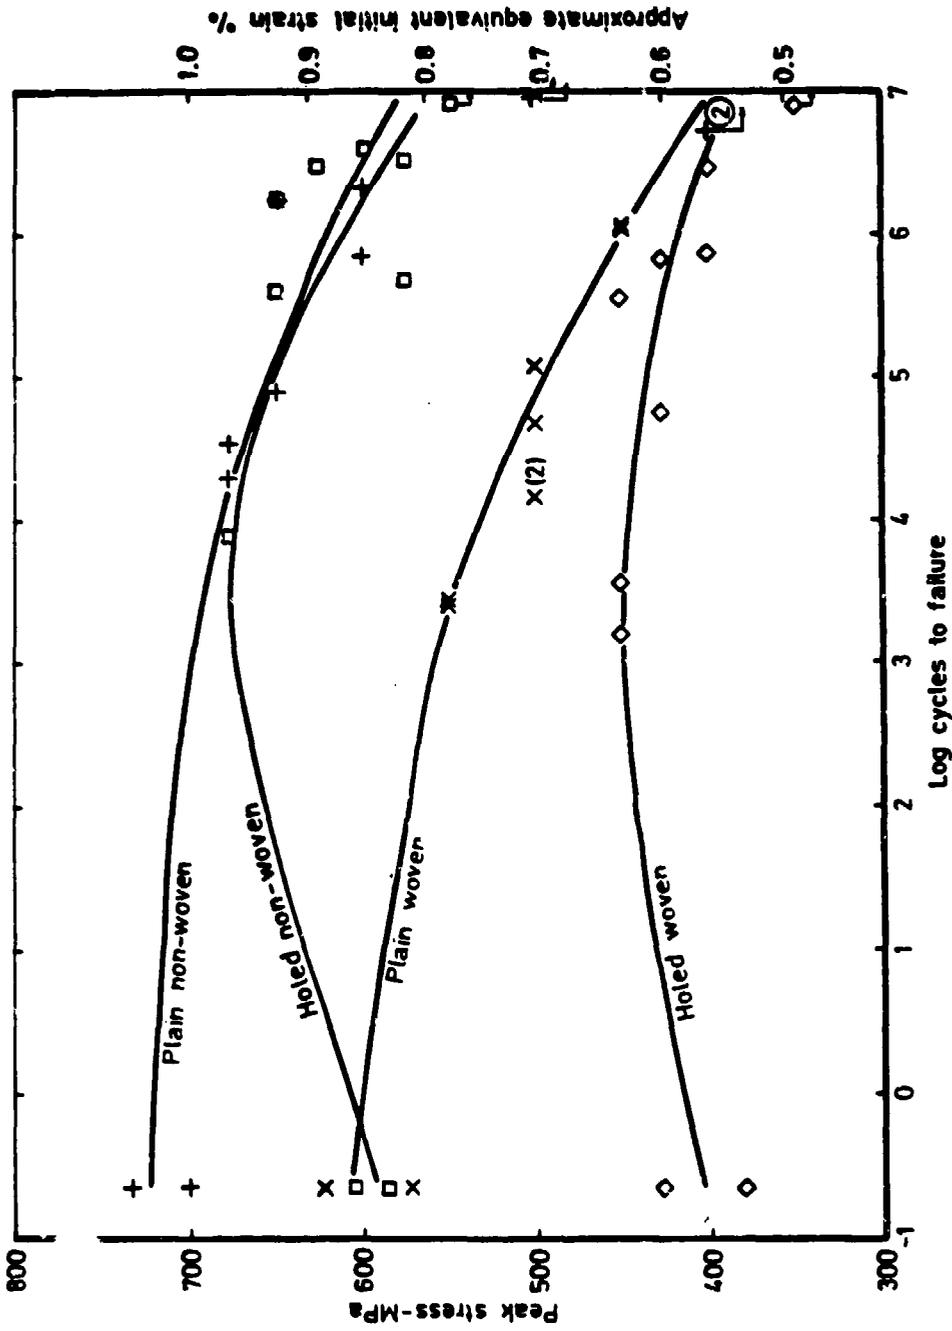
Fig 2 S-N plots of zero-tension fatigue data for layup A (0,90).
Horizontal arrows denote run-outs

In the tensile fatigue loading of the (0,90) material (lay-up A), both plain non-woven and woven coupons suffered losses in strength with increasing numbers of fatigue cycles, but the effect was more pronounced in the woven material (Fig 2). Thus the static strength difference observed between the non-woven and woven material, due to a combination of lower fibre volume fraction and greater fibre distortion in the woven material, became greater in fatigue loading. Optical microscopy and ultrasonic C-scanning revealed extensive transverse cracks across the 90° layers and delamination between layers, increasing with increasing numbers of fatigue cycles. In the non-woven material this effectively uncoupled the 90° layers from the 0° layers and the behaviour was then typical of unidirectional CFRP in fatigue. In the woven material however, the 90° tows remain interwoven with the 0° tows and thus continue to exert a stress concentrating influence on them. The C-scan revealed areas of damage at tow crossovers, probably involving 0° tow degradation, and this resulted in a steeper S-N curve than observed in the non-woven material.

The strength of the (0,90) holed coupons, both woven and non-woven, increased at first with increasing numbers of fatigue cycles, but fell after greater numbers of cycles (Fig 2). The initial increase in strength was only possible because of the manner in which the fatigue tests were performed, which involved the gradual increase of peak load from zero to maximum over about 2000 fatigue cycles. This was sufficient cyclic loading to develop damage zones around the holes and relieve the stress concentration leading to initially greater strengths. After only 10000 cycles the holed non-woven coupons were as strong as the plain coupons, but the holed woven coupons never quite attained the strength of the plain coupons, even after 10 million load cycles. Ultrasonic C-scanning revealed the development of longitudinal splitting and 0/90 delamination around the holes, this being the cause of the initial reduction in notch sensitivity. This was more apparent in the non-woven material, explaining why this material recovered more of its plain strength than the woven material. In the holed woven material the 90° tows can never become completely uncoupled from the 0° tows, because of their woven nature, and they continue to exert a stress concentrating influence at the tow crossover points. Indeed these points were the site of additional damage observed experimentally.

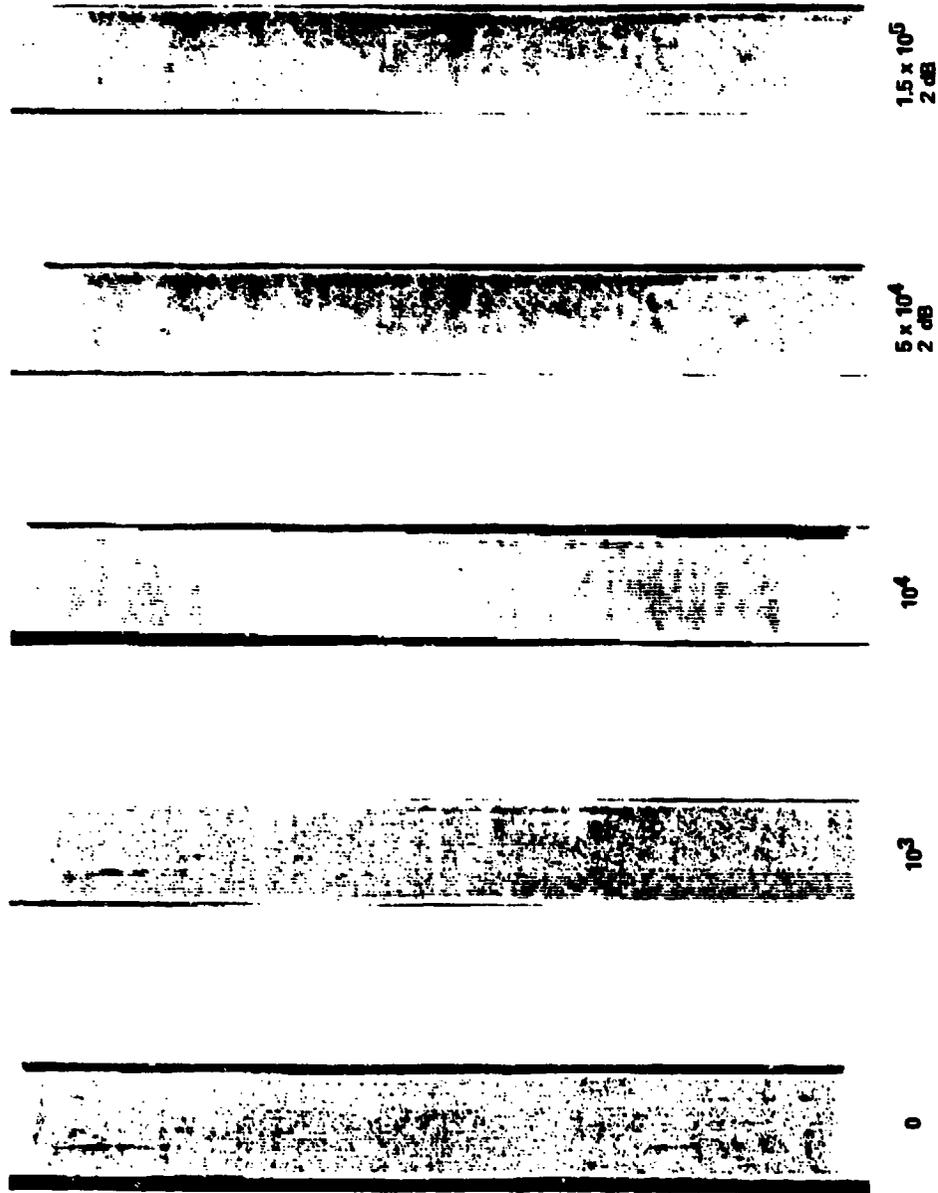
Fig 3 Ultrasonic C-scans of a non-woven plain coupon with layup A (0.90) tested in tensile fatigue at the stress level giving a mean life of 100000 cycles. Left to right, scans after: 0 cycles at 1 dB steps, 10000 cycles at 1 dB steps, 50000 cycles at 2 dB steps, 150000 at 2 dB steps

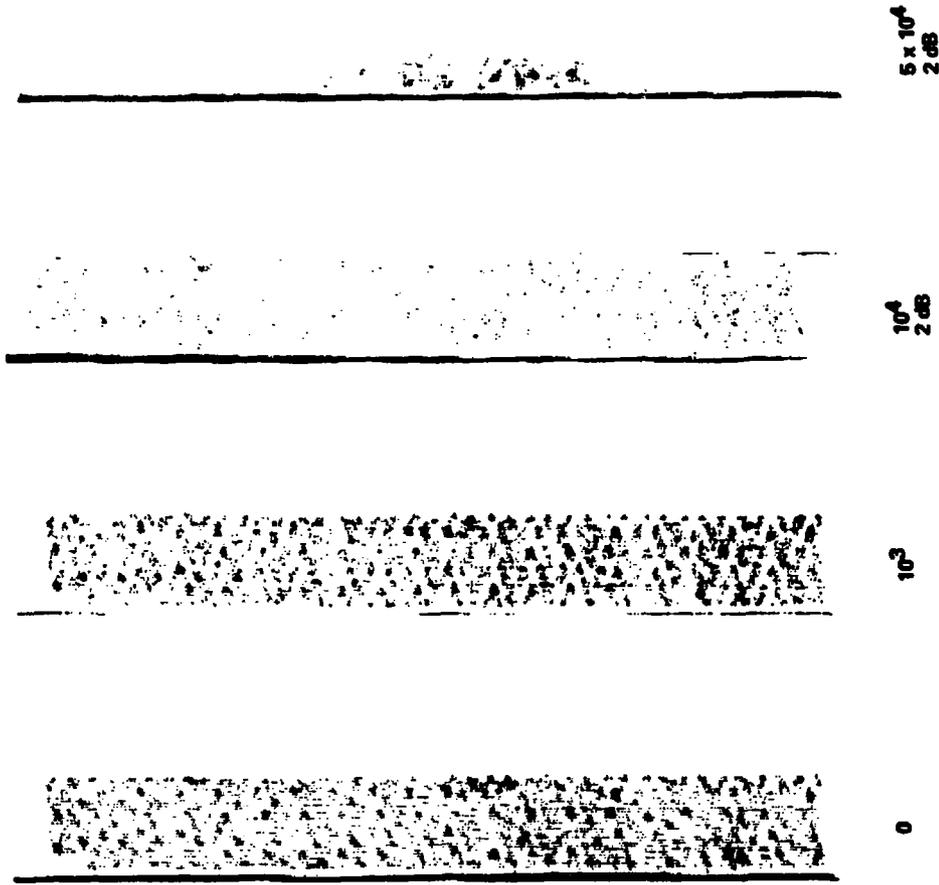
Fig 4 Ultrasonic C-scans of a woven plain coupon with layup A (0, 90) tested in tensile fatigue at the stress level giving a mean life of 100000 cycles. Left to right, scans after: 0 cycles at 1 dB steps, 1000 cycles at 1 dB steps, 10000 cycles at 2 dB steps, 50000 cycles at 2 dB steps

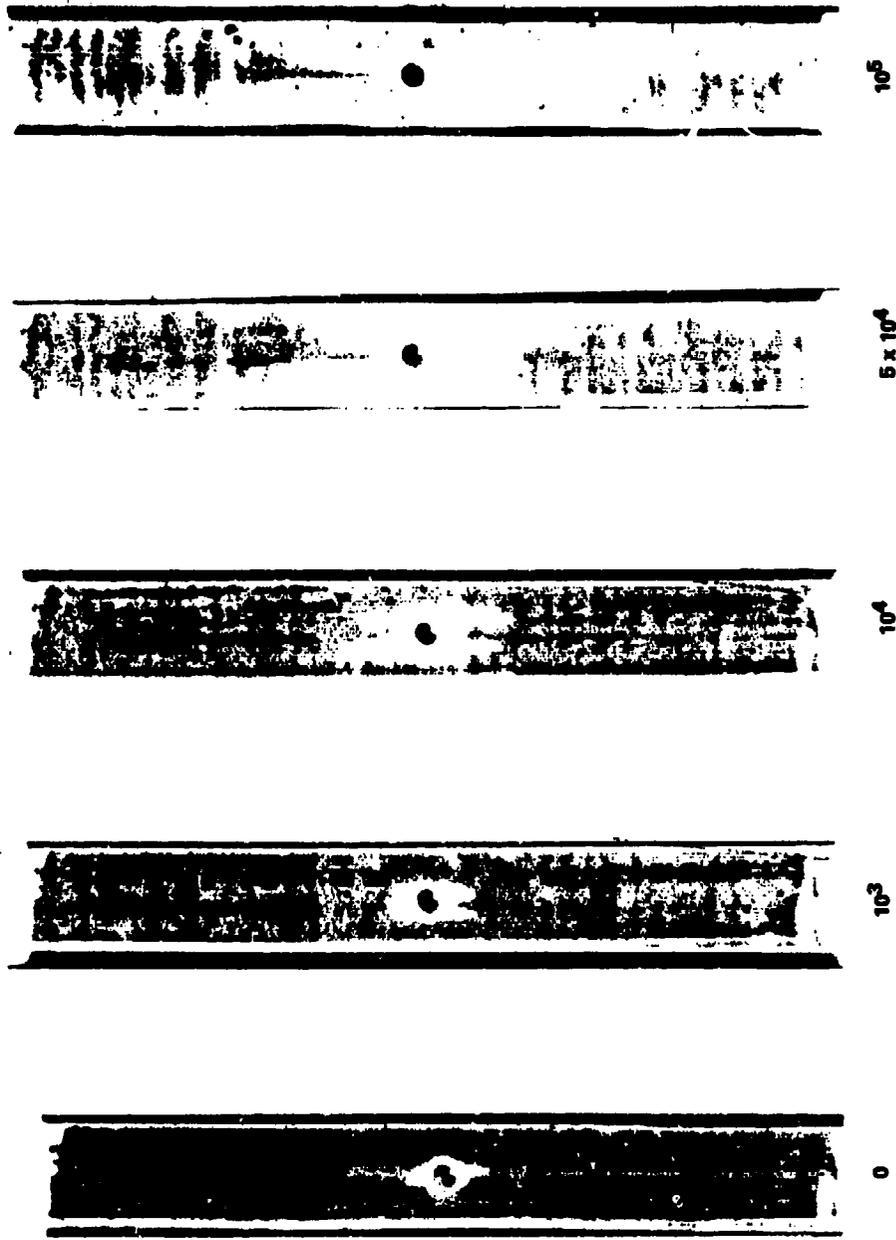
Fig 5 Ultrasonic C-scans of a non-woven holed coupon with layup A (0.90) tested in tensile fatigue at the stress level giving a mean life of 100000 cycles. Left to right, scans after: 0 cycles at 1 dB steps, 1000 cycles at 1 dB steps, 10000 cycles at 1 dB steps, 50000 cycles at 1 dB steps, 100000 cycles at 1 dB steps

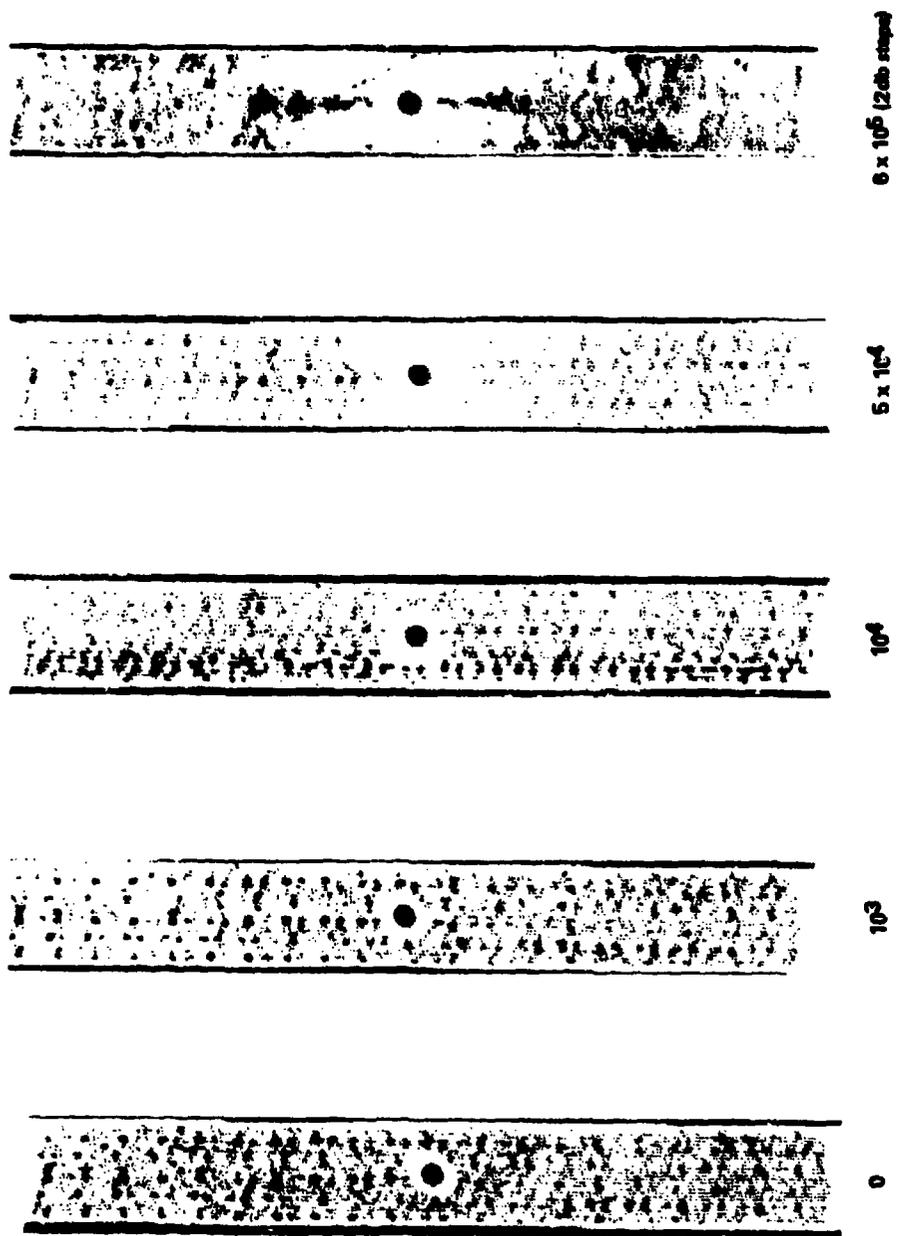
Fig 6 Ultrasonic C-scans of a woven hole coupon with layout A (0,90) tested in tensile fatigue at the stress level giving a mean life of 100000 cycles. Left to right, scans after: 0 cycles at 1 db steps, 1000 cycles at 1 db steps, 10000 cycles at 1 db steps, 50000 cycles at 1 db steps, 600000 cycles at 2 db steps

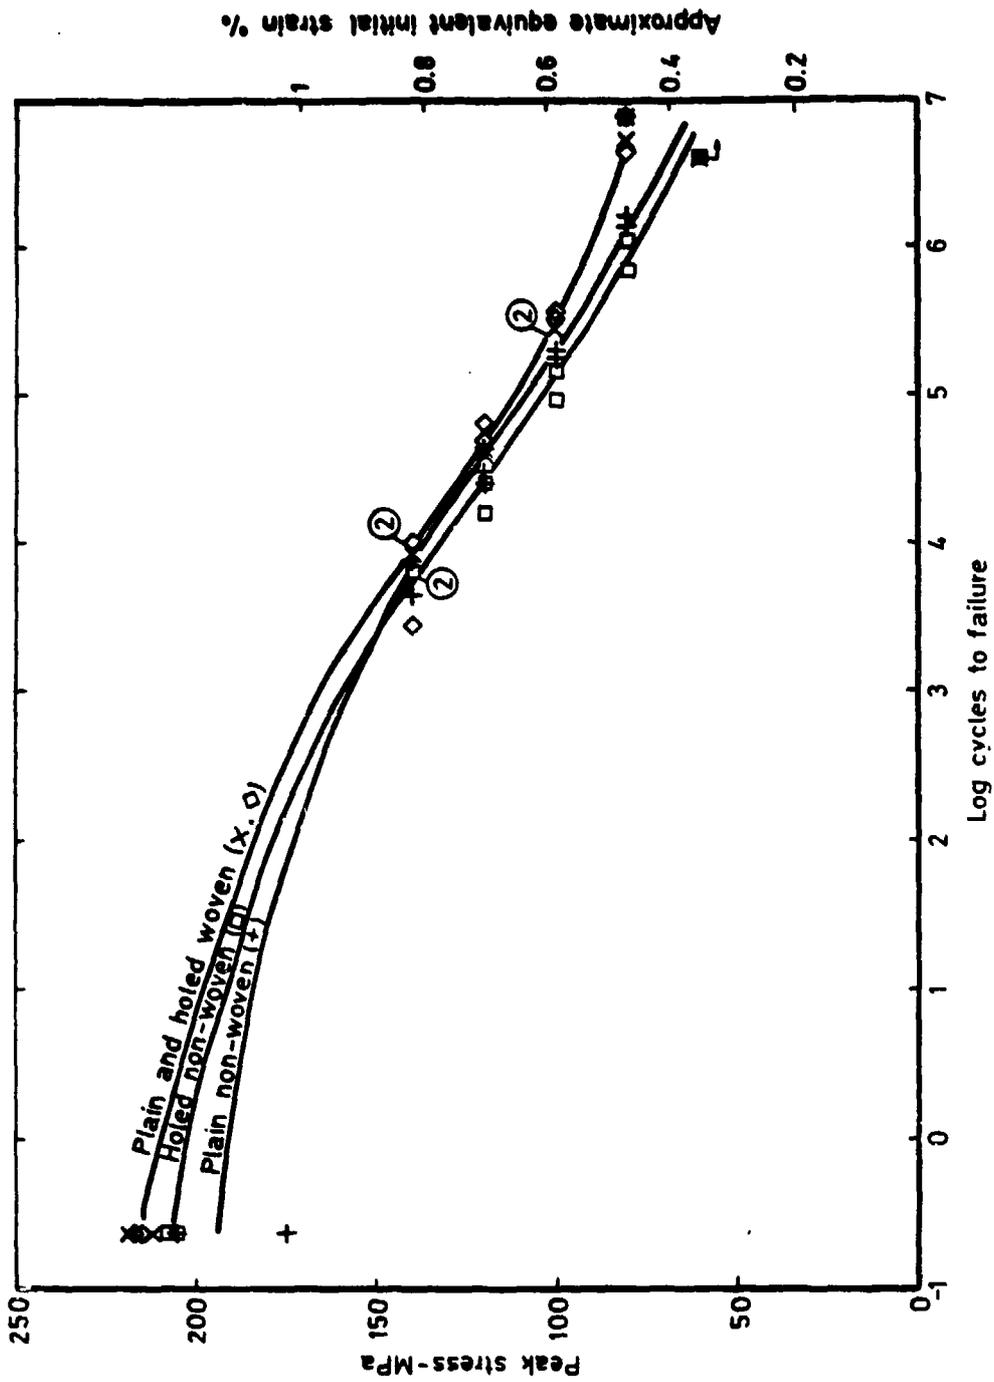
Fig 7 S-N plots of tensile fatigue data for layout B (.45). Horizontal arrows denote run-outs

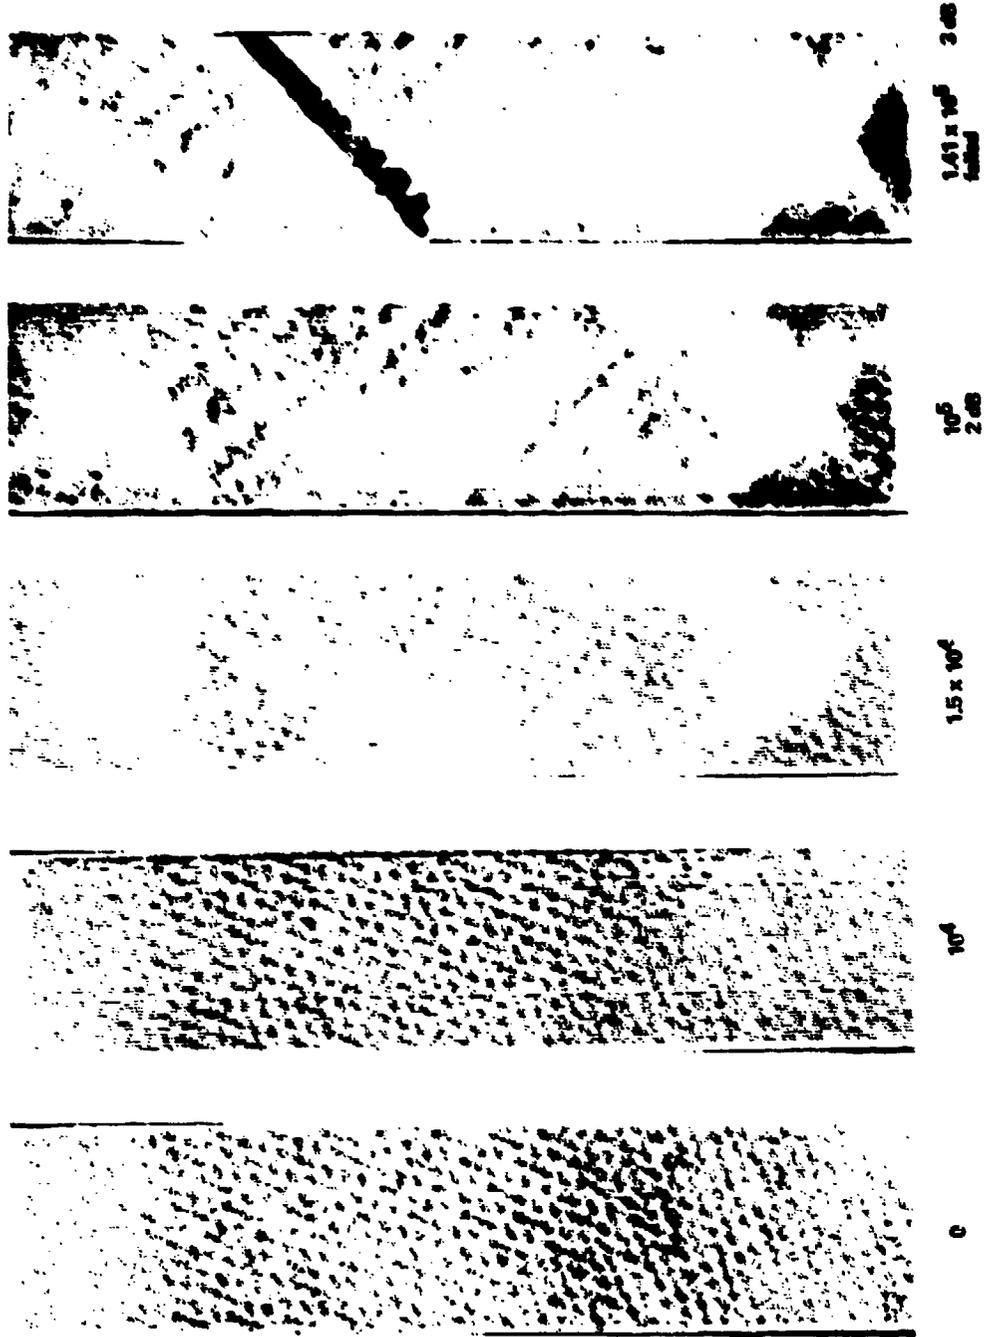
Fig 12 Ultrasonic C-scans of a woven plain coupon with layout B ($\pm.85$) tested in tensile fatigue at the stress level giving a mean life of 100000 cycles. Left to right, scans after: 0 cycles at 1 dB steps, 10000 cycles at 1 dB steps, 50000 cycles at 1 dB steps, 100000 cycles at 2 dB steps, 149000 cycles - failure at 3 dB steps

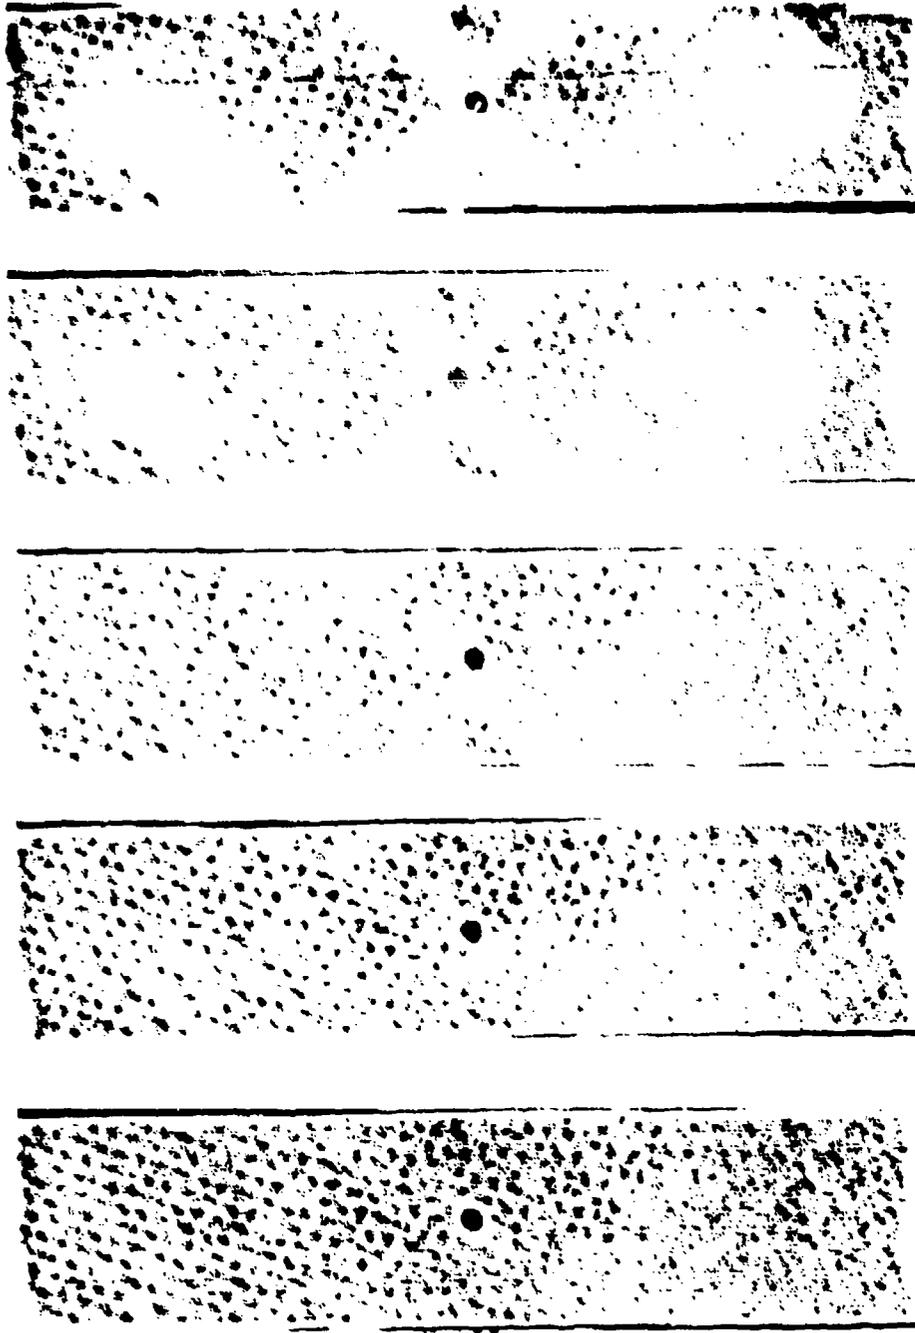
Fig 13 Ultrasonic C-scans of a woven hoid coupon with lay-up B (± 45) tested in tensile fatigue at the stress level giving a mean life of 100000 cycles. Left to right, scans after: 0 cycles at 1 dB steps, 1000 cycles at 1 dB steps, 10000 cycles at 1 dB steps, 50000 cycles at 1 dB steps, failure

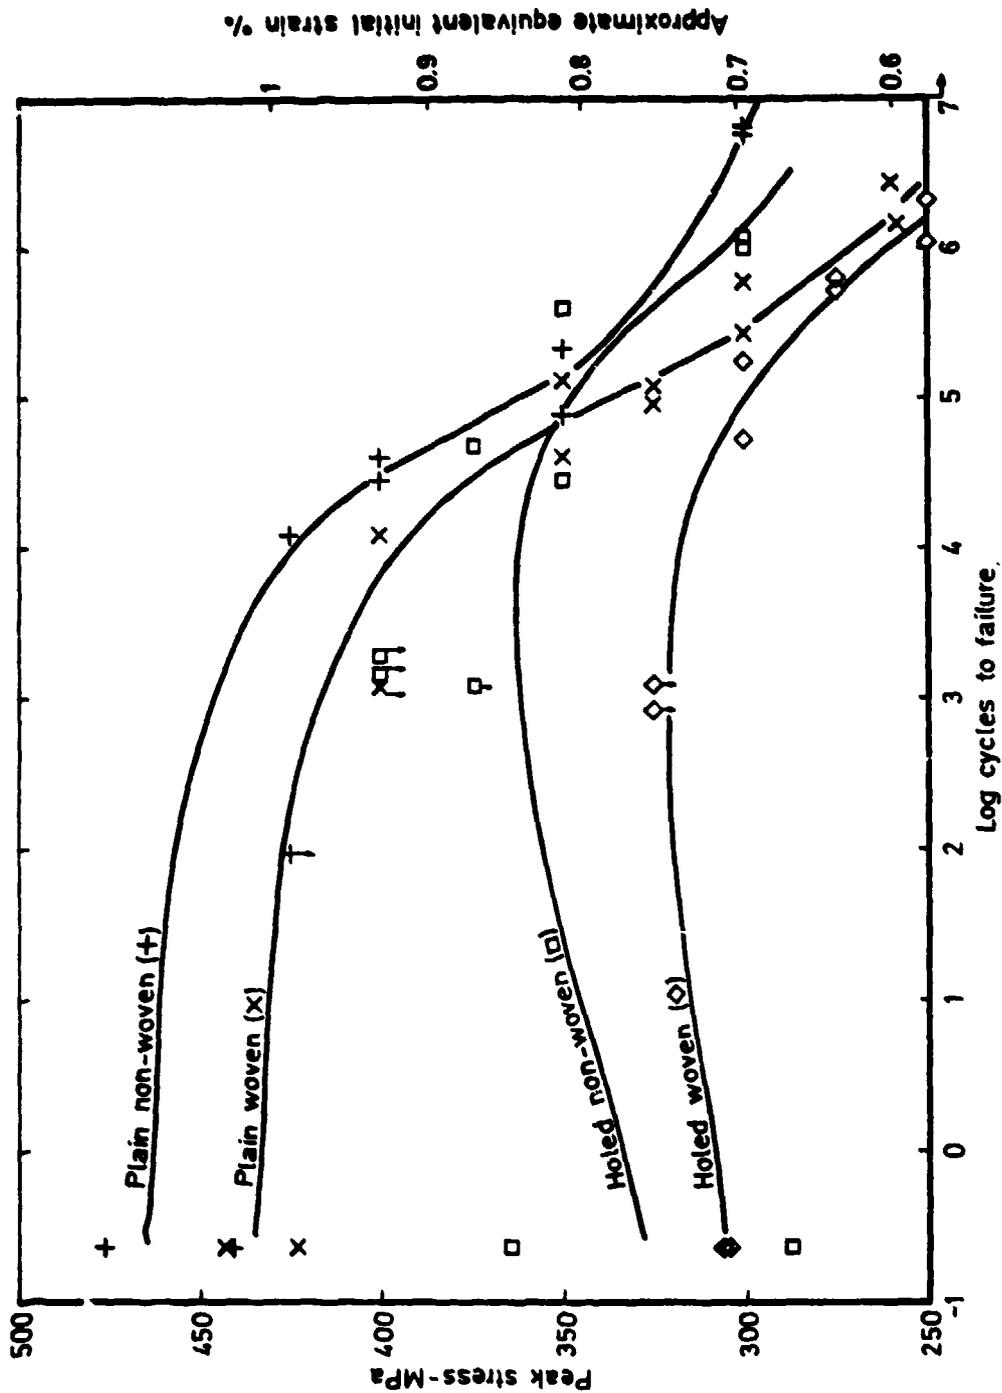
Fig 14 S-N plots of tensile fatigue data for layout C (±45,0,90). Vertical arrows denote run-outs and horizontal arrows run-outs

Tensile fatigue tests on coupons with a ($\pm 45, 0, 90$) lay-up (lay-up C) showed a substantial loss in strength with increasing numbers of cycles, for both woven and non-woven material (Fig 14). Ultrasonic C-scanning and optical microscopy revealed extensive longitudinal edge cracking, growing from the coupon edges towards the centres of their widths, probably the cause of the significant strength losses observed. The plain woven material appeared to suffer an even greater loss in strength at high lifetimes. This implies that the static differences attributed to lower fibre volume fraction and greater fibre distortion in the woven material continued to account for the lower fatigue strength except at long lifetimes when additional strength degradation mechanisms were operative in the woven material. The microstructural analysis again revealed considerable damage at the tow crossover points in the woven material, particularly at long lifetimes, and this undoubtedly resulted in a further reduction in the load bearing capacity of the 0° tows. This caused an additional loss in strength compared with the non-woven material in which the 0° and 90° plies became uncoupled and the stress concentrating effects of the 90° plies on the 0° plies relieved.

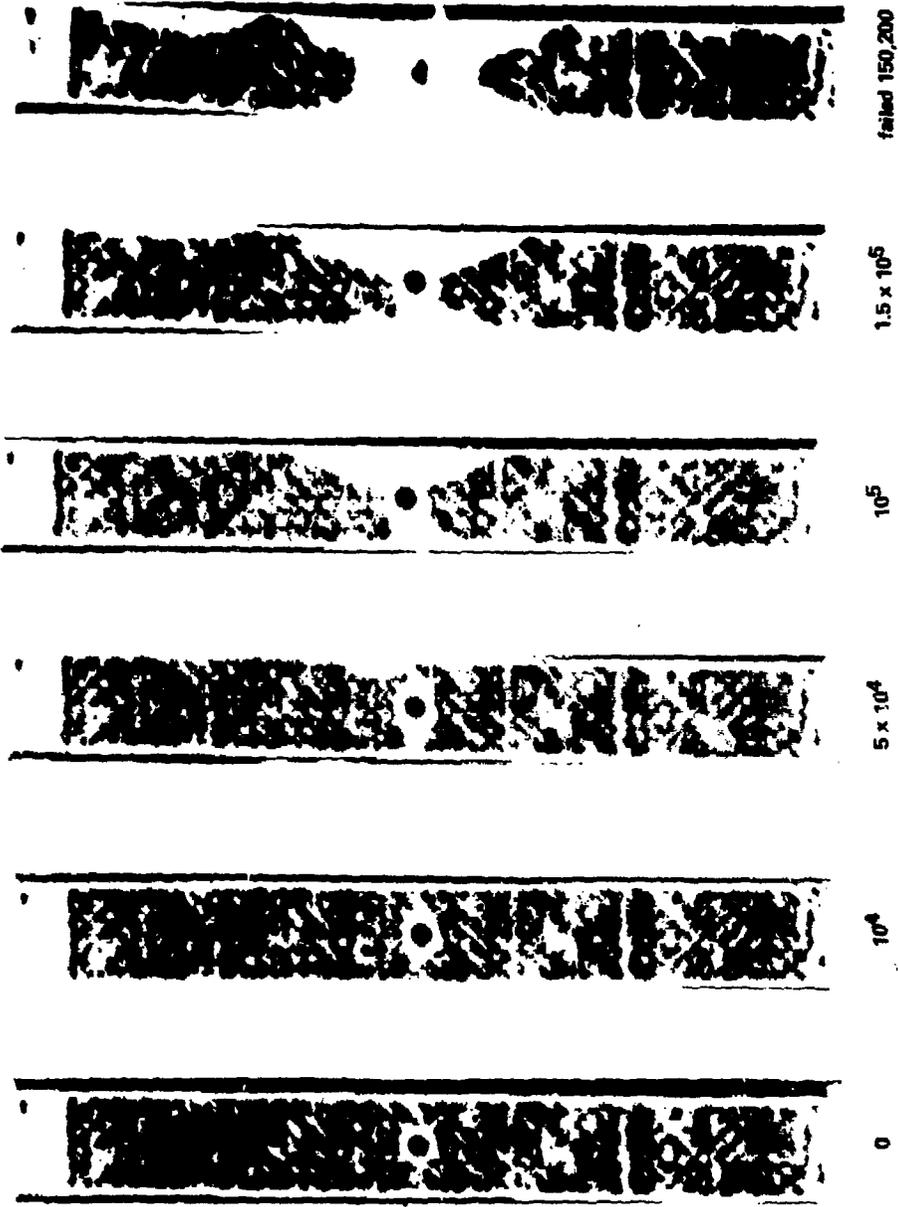
Fig 18 Ultrasonic C-scans of a non-woven holed coupon with Icyup C ($\pm 45, 0, 90$) tested in tensile fatigue at the stress level giving a mean life of 100000 cycles. Left to right, scans after: 0 cycles at 1 dB steps, 10000 cycles at 1 dB steps, 50000 cycles at 1 dB steps, 100000 cycles at 1 dB steps, 150000 cycles at 1 dB steps, 150200 cycles -- failure, at 1 dB steps

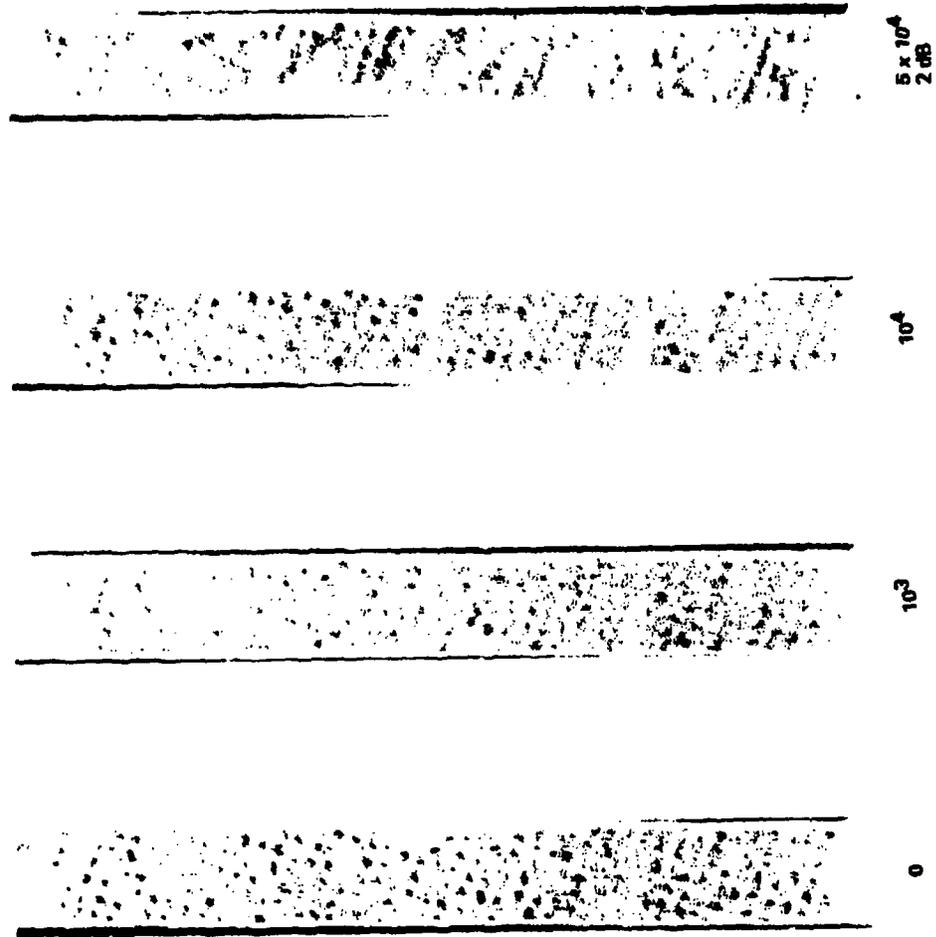
Fig 19 Ultrasonic C-scans of a woven plain coupon with layup C ($\pm 45,0,90$) tested in tensile fatigue at the stress level giving a mean life of 100000 cycles. Left to right, scans after: 0 cycles at 1 dB steps, 10000 cycles at 1 dB steps, 50000 cycles at 2 dB steps

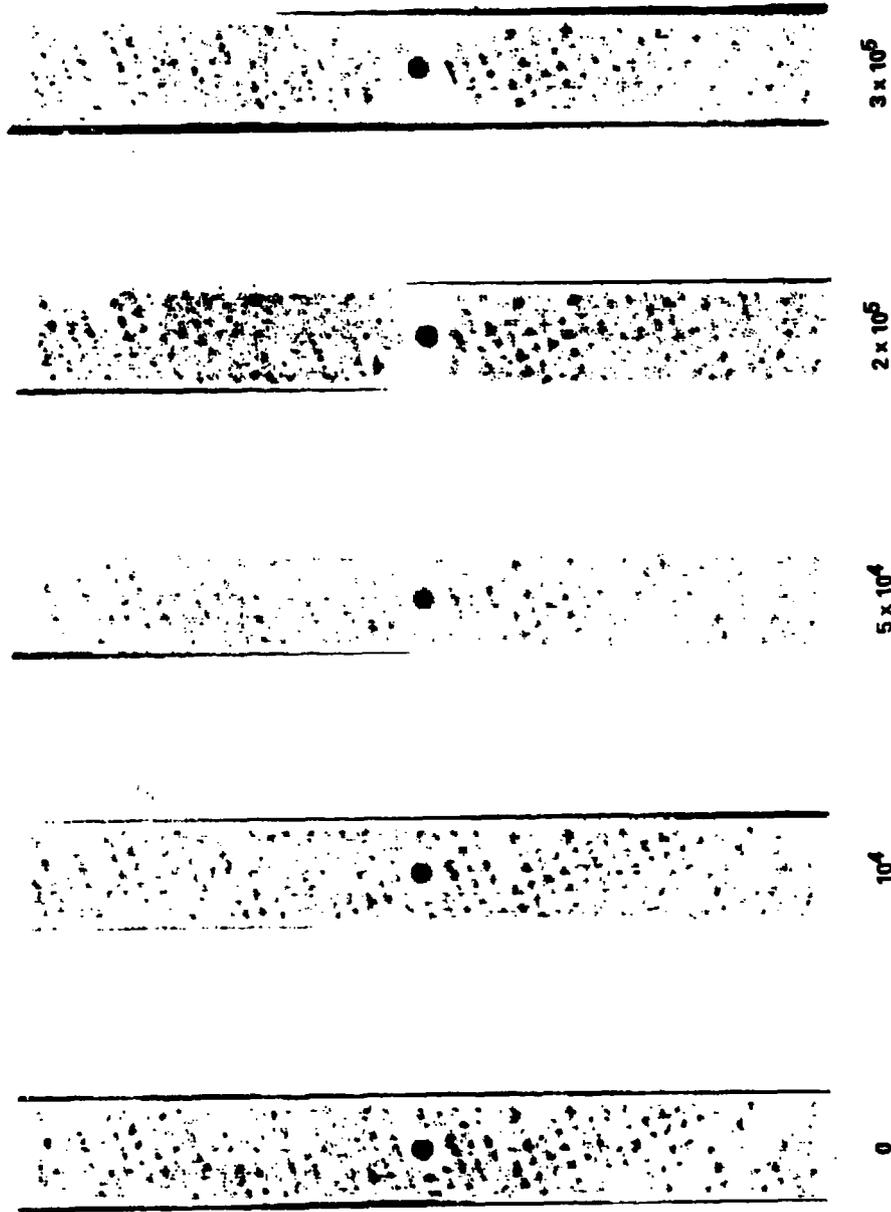
Fig 20 Ultrasonic C-scans of a woven hole coupon with layup C ($\pm 45,0,90$) tested in tensile fatigue at the stress level giving a mean life of 100000 cycles. Left to right, scans after: 0 cycles at 1 dB steps, 10000 cycles at 1 dB steps, 50000 cycles at 1 dB steps, 200000 cycles at 1 dB steps, 300000 cycles at 1 dB steps

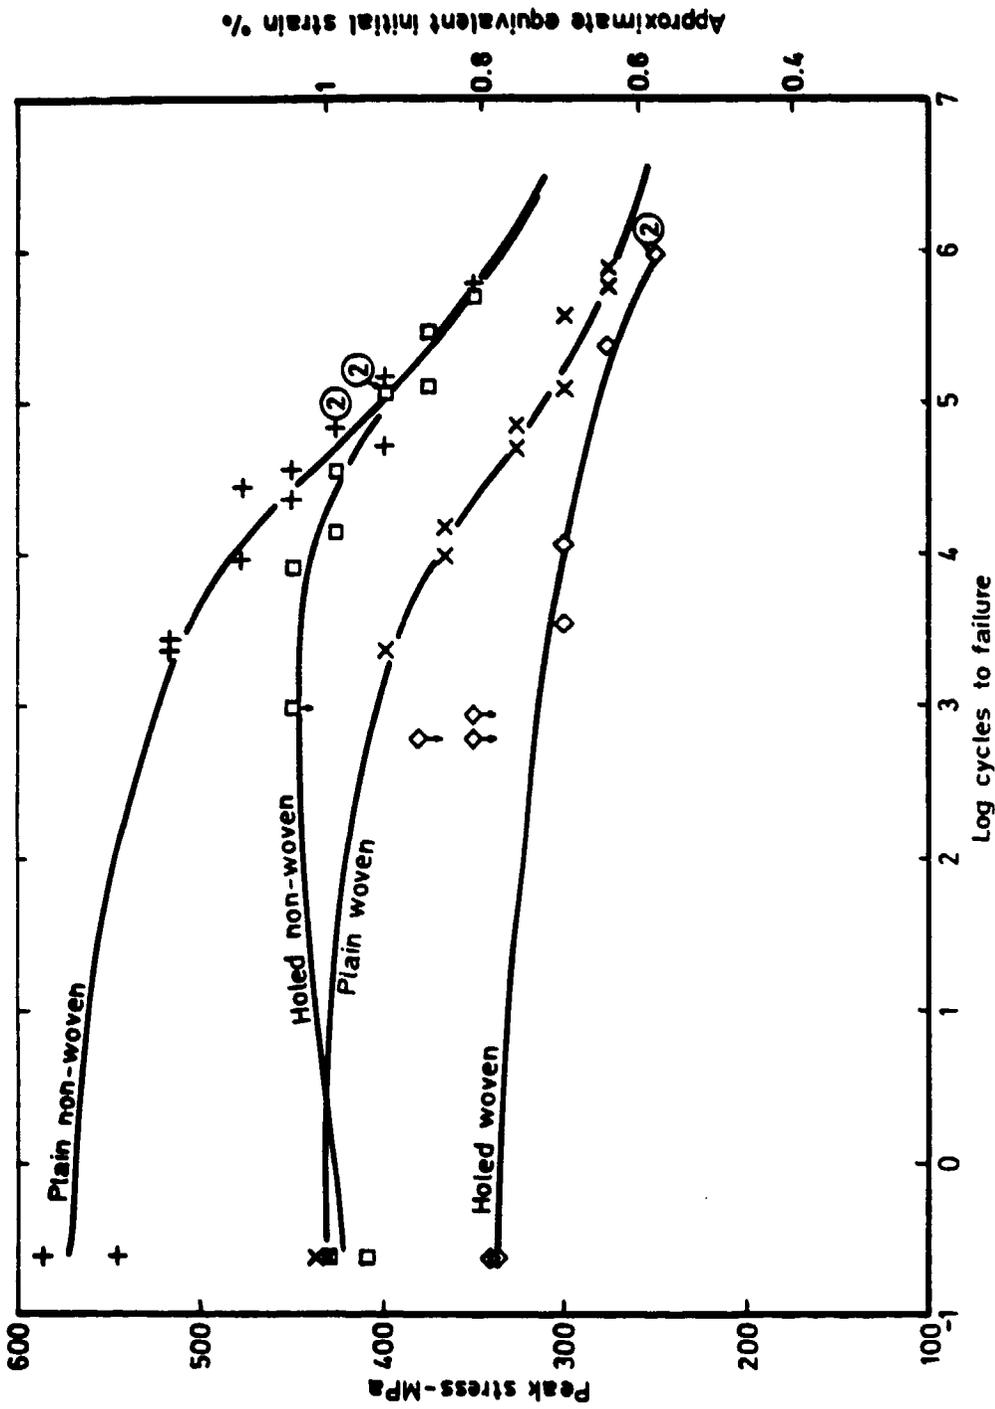
Fig 21 S-N plots of tensile fatigue data for layup D (0,90,45). Optical arrows denote run up failures

Results of the fatigue tests are given in Table 9 and also as a plot of peak net stress versus log-life (S-N plot) in Fig 21. Plain coupons all failed at random positions

Coupons with the ($0, 90, \pm 45$) lay-up (lay-up D) also showed a significant loss in strength with increasing numbers of tensile fatigue cycles (Fig 21). Microstructural analysis revealed less extensive longitudinal edge cracking than in lay-up C, but transverse cracks were formed across the 90° plies and initiated some layer delamination at large numbers of cycles. Considerable damage was also developed in the $\pm 45^\circ$ layers adding to the loss in strength observed. The strength of the woven material remained a similar fraction of that of the non-woven material even up to 1 million fatigue cycles. This implies that the principal cause for the difference between the strength of the plain woven and non-woven material remained greater fibre distortion and lower fibre volume fraction. This is somewhat surprising since the microstructural analysis revealed, as in coupons with lay-up C, the development of significant damage at the tow crossover points in the woven material after large numbers of fatigue cycles. The effect

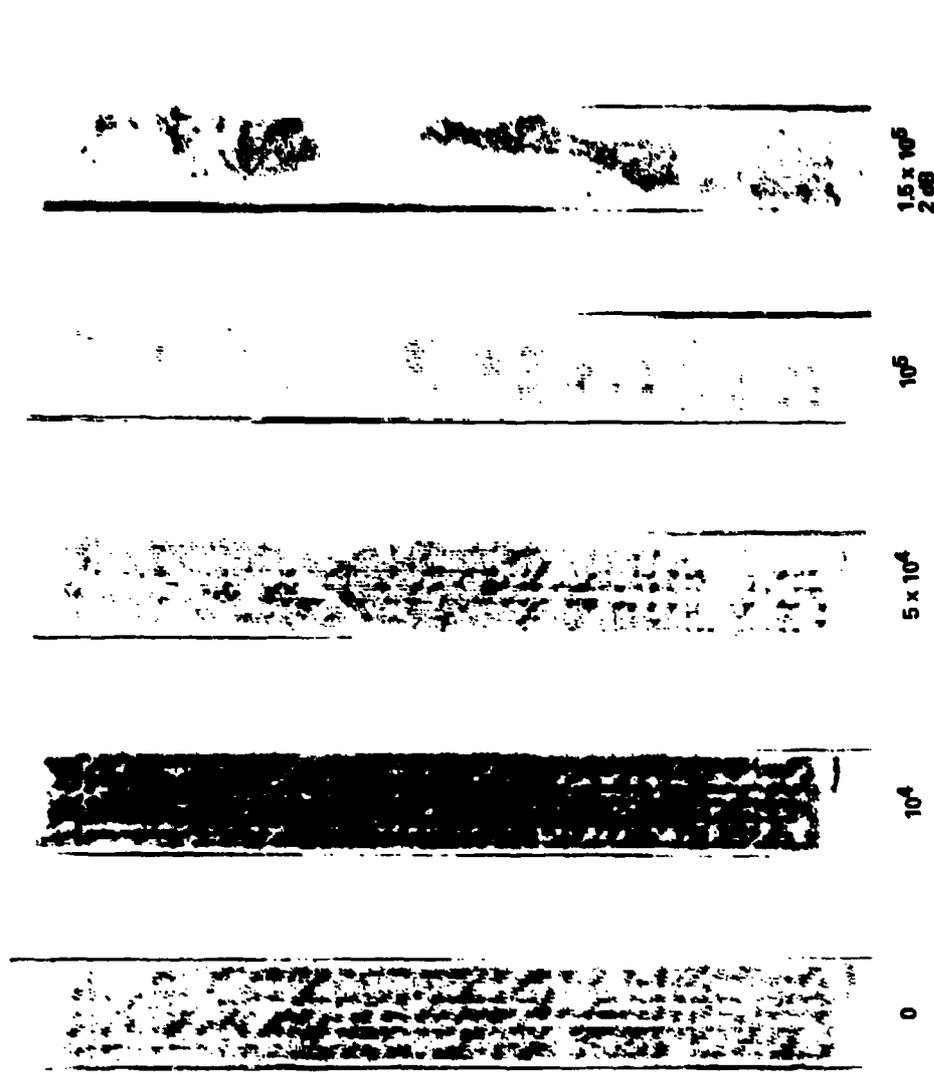
Fig 24 Ultrasonic C-scans of a non-woven plain coupon with layout D (0,90, ±45) tested in tensile fatigue at the stress level giving a mean life of 100000 cycles. Left to right, scans after: 0 cycles at 1 dB steps, 10000 cycles at 1 dB steps, 50000 cycles at 1 dB steps, 100000 cycles at 1 dB steps, 150000 cycles at 2 dB steps

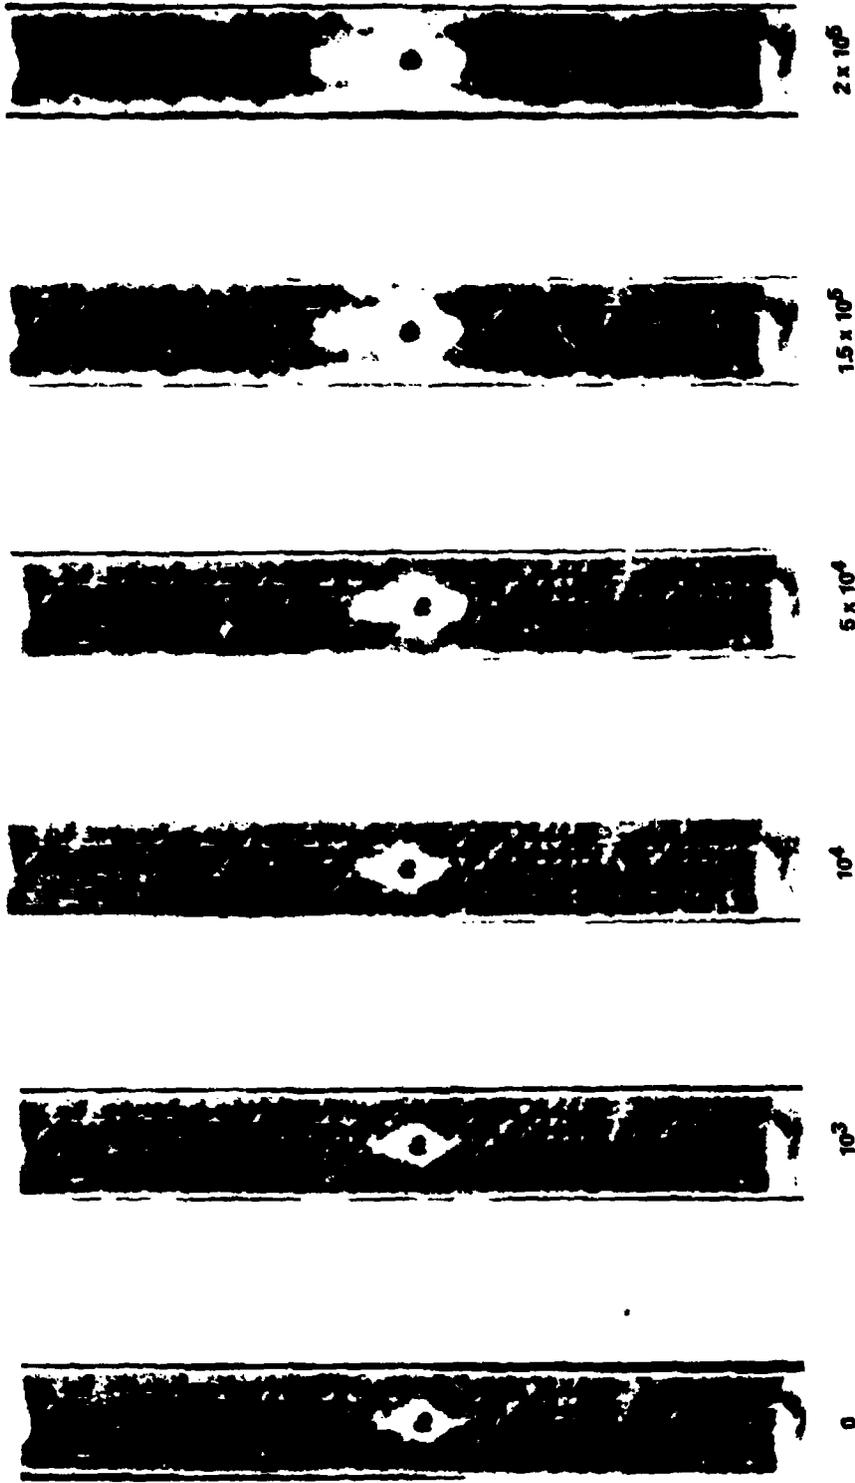
Fig 25

Ultrasonic C-scans of a non-woven holed coupon with layup D (0,90, ±45) tested in tensile fatigue at the stress level giving a mean life of 100000 cycles. Left to right, scans after: 0 cycles at 1 dB steps, 1000 cycles at 1 dB steps, 10000 cycles at 1 dB steps, 50000 cycles at 1 dB steps, 150000 cycles at 1 dB steps, 200000 cycles at 1 dB steps

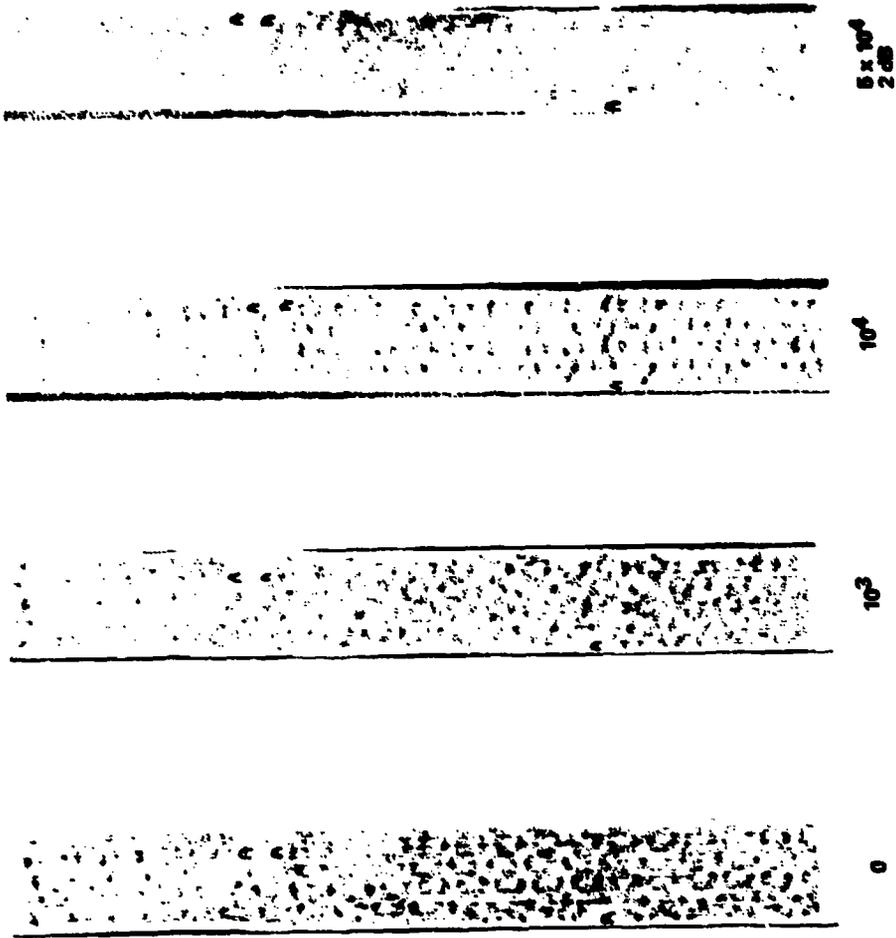
Fig 26 Ultrasonic C-scans of a woven plain coupon with layup D (0.90, ±45) tested in tensile fatigue at the stress level giving a mean life of 100000 cycles. Left to right, scans after: 0 cycles at 1 dB steps, 10000 cycles at 1 dB steps, 50000 cycles at 2 dB steps

Ultrasonic C-scanning of plain woven coupons revealed an overall lightening with increasing numbers of cycles and the gradual development of lighter spots along the lines of intersection of woven tows (Fig 26), as in coupons from lay-up C, but no transverse light lines. Edge lightening was apparent, but this was very limited and never extended more than 1-2 mm from the coupon edges. Holed coupons showed more interesting behaviour with some edge lightening developing after 50000 cycles (Fig 27) together with evidence of light spots, albeit less obvious than in the plain woven coupons. The light areas that developed around the holes, as in the non-woven coupons, eventually linked up with the edge lightening and spread longitudinally along the coupon edges but not above or below the hole. At large numbers of cycles some intense white spots formed away from the hole area.
