Technical Report 85059

A COMPARISON OF THE FATIGUE PERFORMANCE OF WOVEN AND NON-WOVEN CFRP LAMINATES

Procurement Executive, Ministry of Defence
Farnborough, Hants

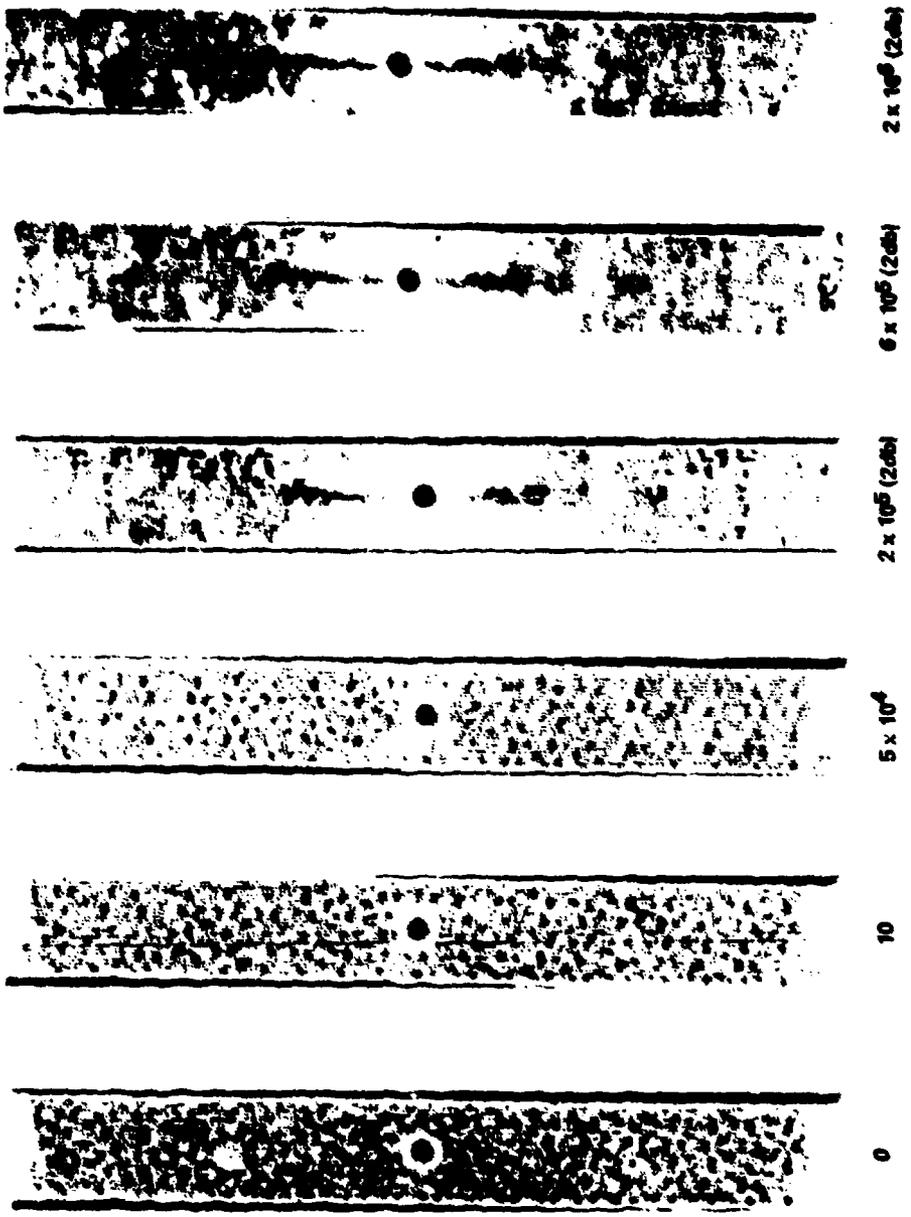
Fig 27 Ultrasonic C-scans of a grooved hole coupon with layup D (0.90, ±.46) tested in tensile fatigue at the stress level giving a mean life of 100000 cycles. Left to right, scans after: 0 cycles at 1 dB steps, 10000 cycles at 1 dB steps, 50000 cycles at 1 dB steps, 200000 cycles at 2 dB steps, 600000 cycles at 2 dB steps, 2000000 at 2 dB steps

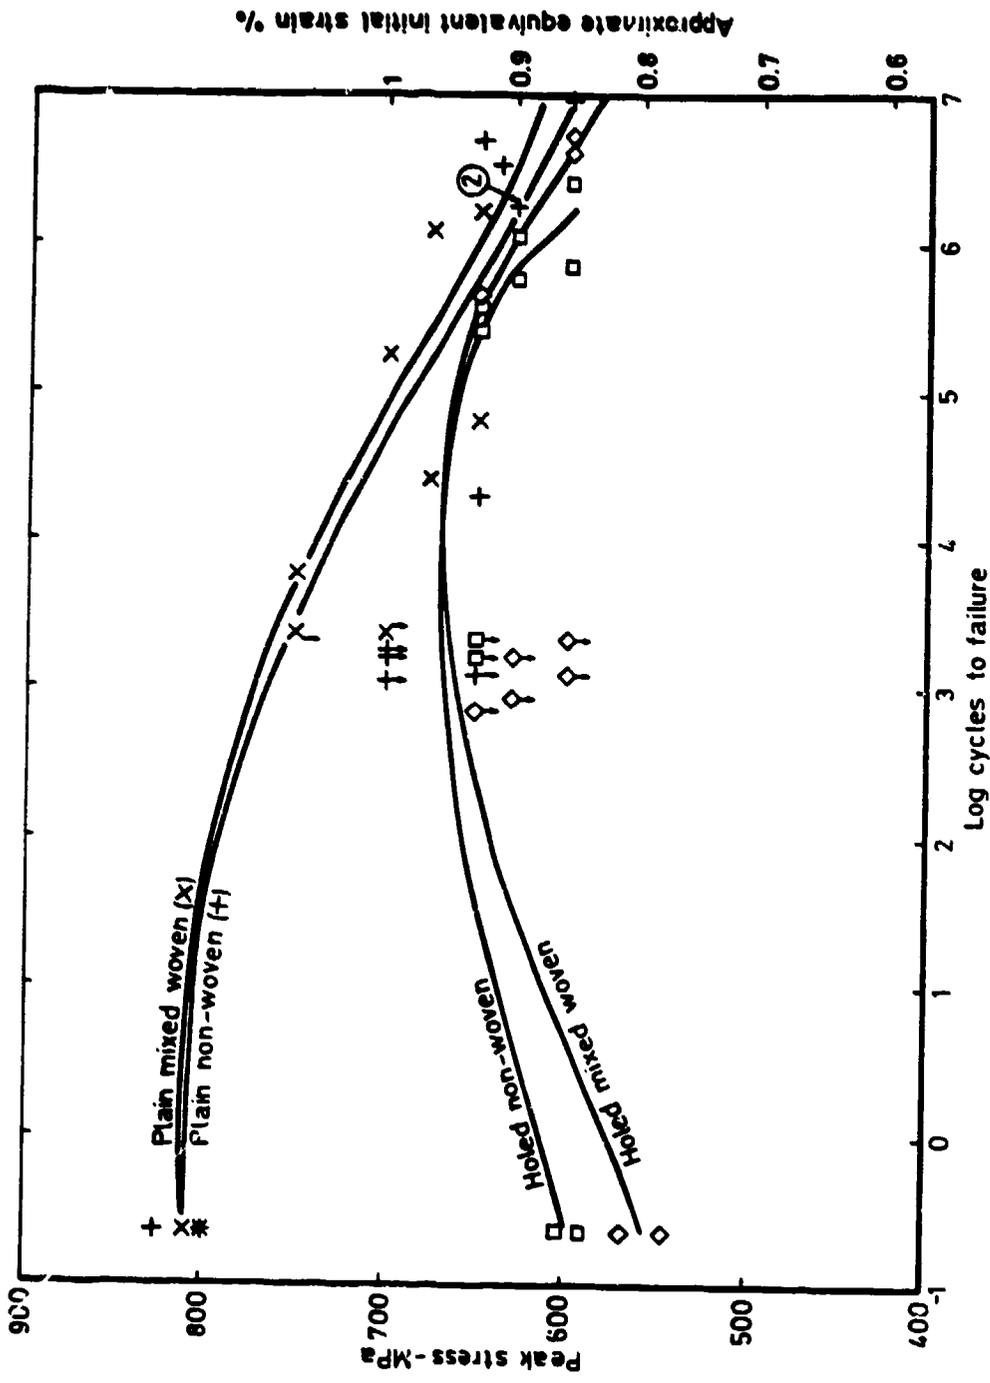
Fig 28 S-N plots of tensile fatigue data for layout E (145,02). A vertical arrow denotes run up failure

Results of the tensile fatigue tests are given in Table 10 and presented as S-N curves in Fig 28. All plain coupons failed at random positions along their lengths and holed non-woven coupons also failed away from the holes. Holed woven coupons failed through the holes at short lifetimes but those coupons surviving to long lifetimes failed away from the holes. Both woven and non-woven coupons showed evidence of edge splitting and delamination at long lifetimes.

The static tests on coupons with the $(\pm 45, 0_2)$ lay-up (lay-up E) showed there to be little difference in strength between the non-woven and mixed woven coupons, and a similar observation was made in the tensile fatigue tests (Fig 28). The plain coupons suffered a loss in strength of nearly 25% after 1 million load cycles in both the non-woven and mixed woven cases. Previous work had found a greater loss in strength in the non-woven material^{11,12}, but this was not the case in the present work. Microstructural analysis revealed the damage to be confined mainly to the $\pm 45^\circ$ layers, which carry only a small fraction of the applied load. Thus the coupons behaved in a similar manner to unidirectional material, and indeed the loss in strength during fatigue was comparable with that observed in unidirectional material. C-scans of the plain mixed woven coupons did reveal damage at tow crossover points in the $\pm 45^\circ$ layers, but since these layers carried only small loads the damage had no significant effect on the material strength.

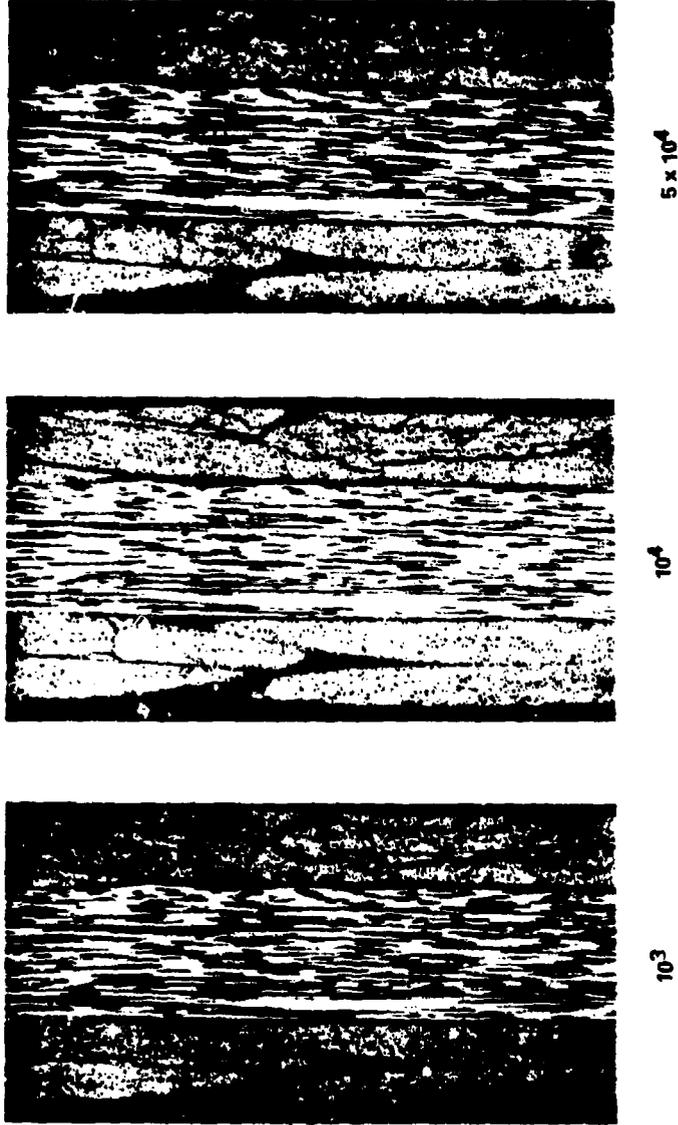
Fig 30 Optical micrographs of woven plain coupons with layup E ($\pm 45, 02$) tested in tensile fatigue at the stress level giving a mean life of 100000 cycles. Left to right, micrographs after: 10000 cycles, 10000 cycles, 50000 cycles

Optical microscopy of plain woven and non-woven coupons revealed $\pm 45^\circ$ delamination and translaminar cracking after only 1000 cycles (Fig 29). This became more extensive after 10000 and 100000 cycles (Figs 29 and 30). Above 100000 cycles there was evidence of fibre damage in the 0° fibres (Fig 30).

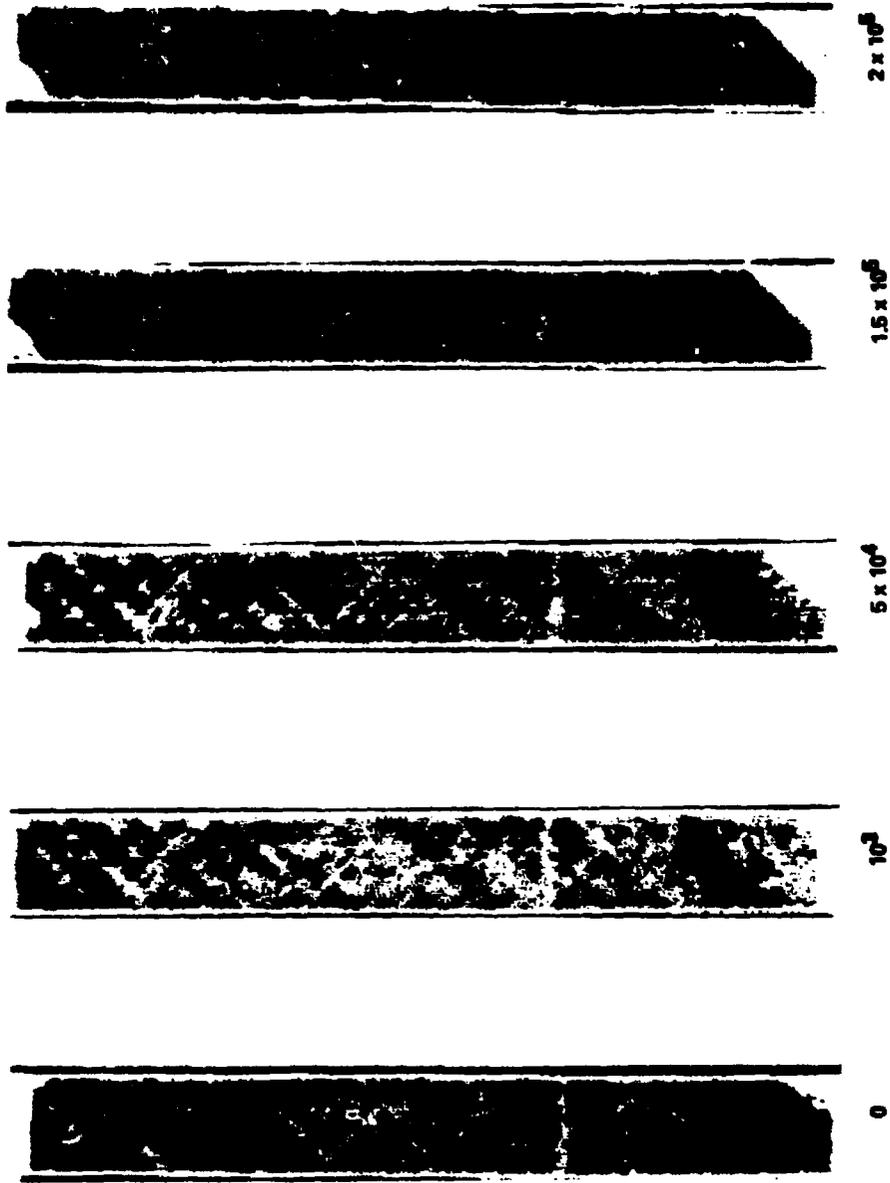
Fig 31 Ultrasonic C-scans of a non-woven plain coupon with layout E (± 45.02) tested in tensile fatigue at the stress level giving a mean life of 100000 cycles. Left to right, scans after: 0 cycles at 1 dB steps, 1000 cycles at 1 dB steps, 50000 cycles at 1 dB steps, 150000 cycles at 1 dB steps, 200000 cycles at 1 dB steps

Ultrasonic C-scanning of plain non-woven coupons revealed little apart from a slight lightening after 1000 cycles and some evidence of damage growth around the coupon ends after large numbers of cycles (Fig 31). Holed non-woven coupons revealed damage around the holes after 10000 cycles (Fig 32) which grew longitudinally to a distance of several hole diameters after one million cycles. Eventually the damage reached the coupon ends and had also grown across the coupon width (Fig 32).

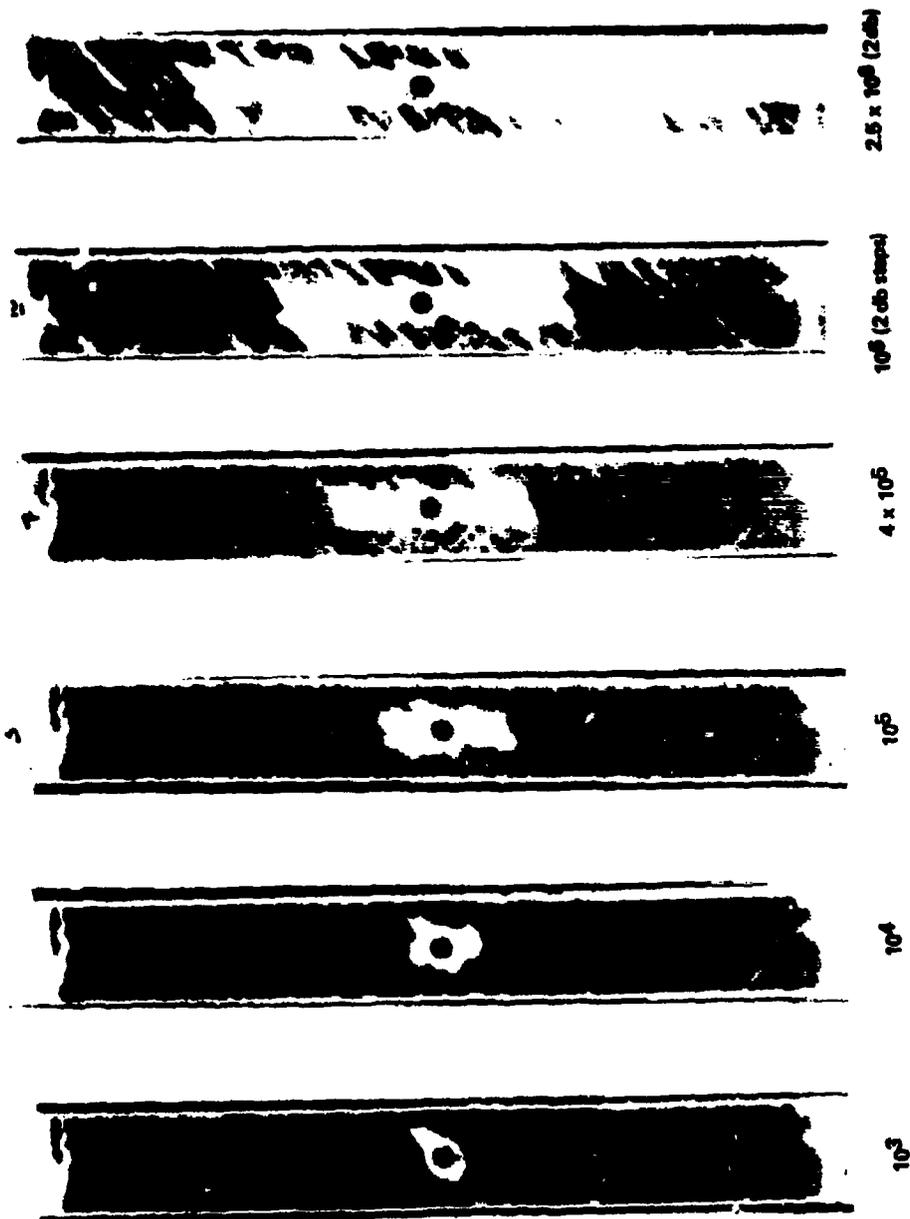
Fig 32 Ultrasonic C-scans of a non-woven holed coupon with layup E ($\pm 45,0/2$) tested in tensile fatigue at the stress level giving a mean life of 100000 cycles. Left to right, scans after: 1000 cycles at 1 db steps, 10000 cycles at 1 db steps, 100000 cycles at 1 db steps, 400000 cycles at 1 db steps, 1000000 cycles at 2 db steps, 2500000 cycles at 2 db steps

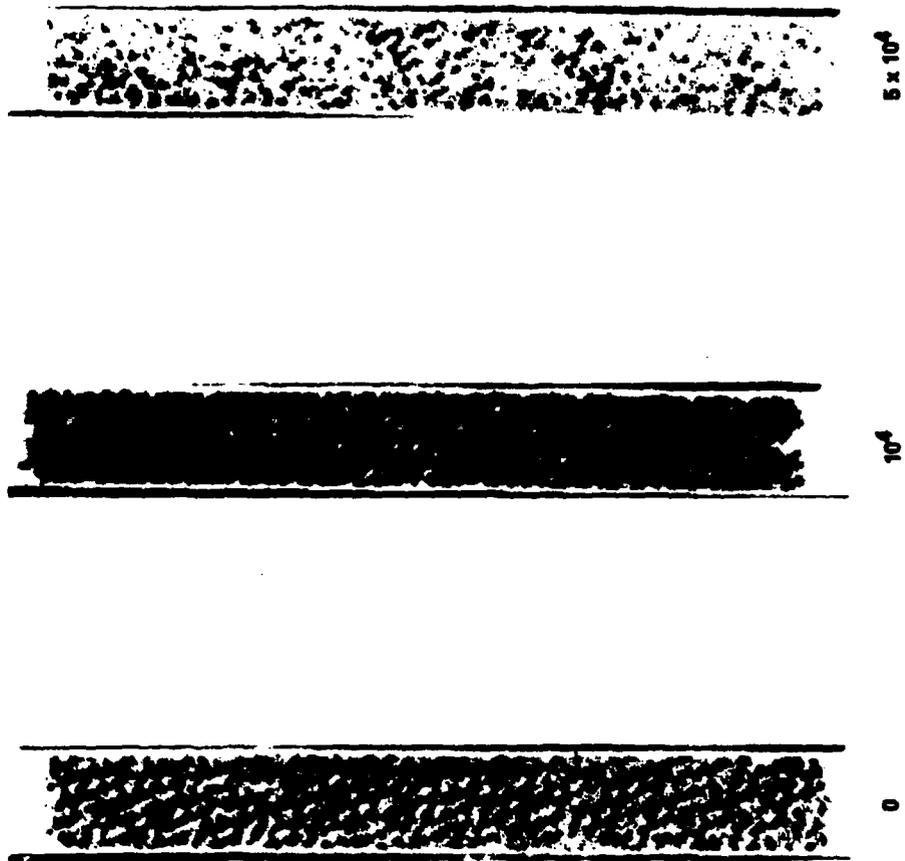
Fig 33 Ultrasonic C-scans of a woven plain coupon with layup E (± 45 DZ) tested in tensile fatigue at the stress level of 1.5×10^8 psi. Mean life of 100000 cycles. Left to right, scans after: 0 cycles at 1 dB step, 10000 cycles at 1 dB step, 50000 cycles at 1 dB step

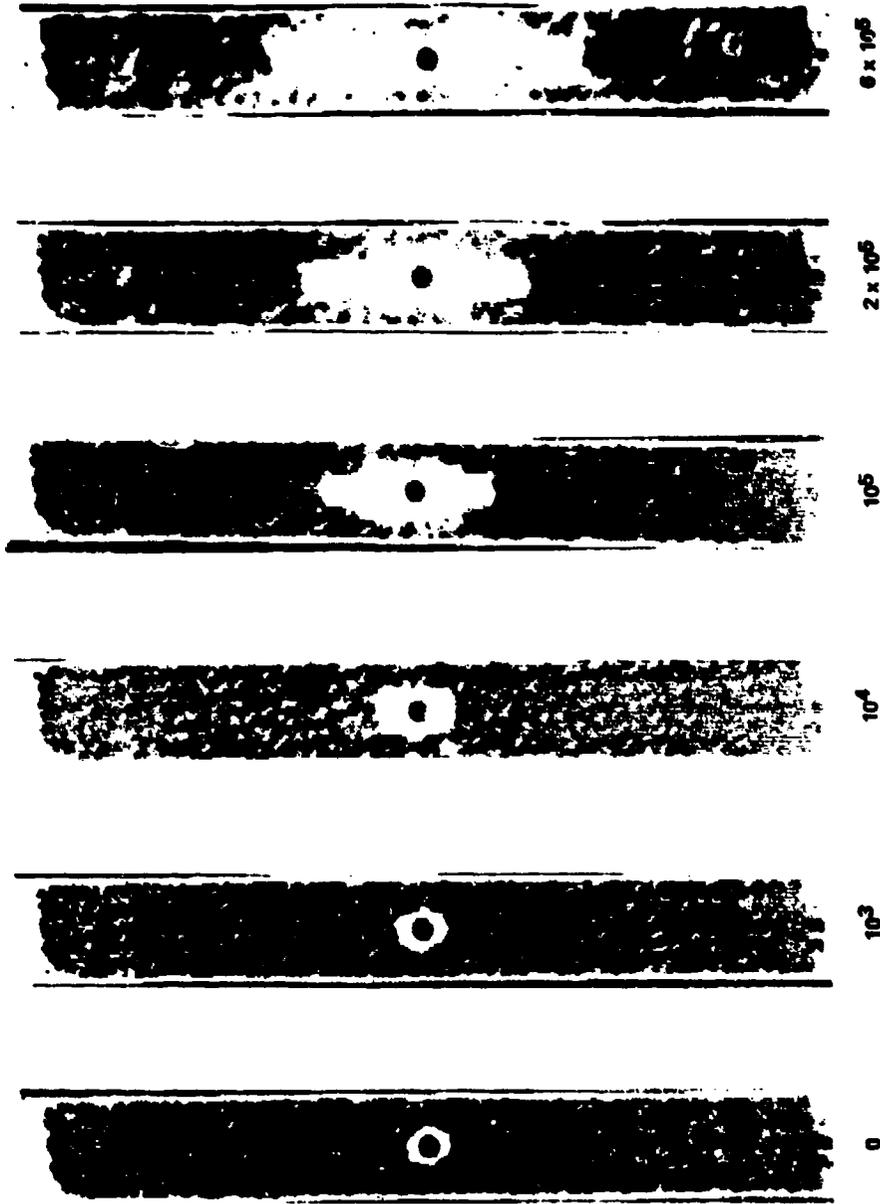
Fig 34 Ultrasonic C-scans of a woven holed coupon with layup E ($\pm 45, 02$) tested in tensile fatigue at the stress level giving a mean life of 100000 cycles. Left to right, scans after: 0 cycles at 1 dB steps, 1000 cycles at 1 dB steps, 10000 cycles at 1 dB steps, 100000 cycles at 1 dB steps, 200000 cycles at 1 dB steps, 600000 cycles at 1 dB steps

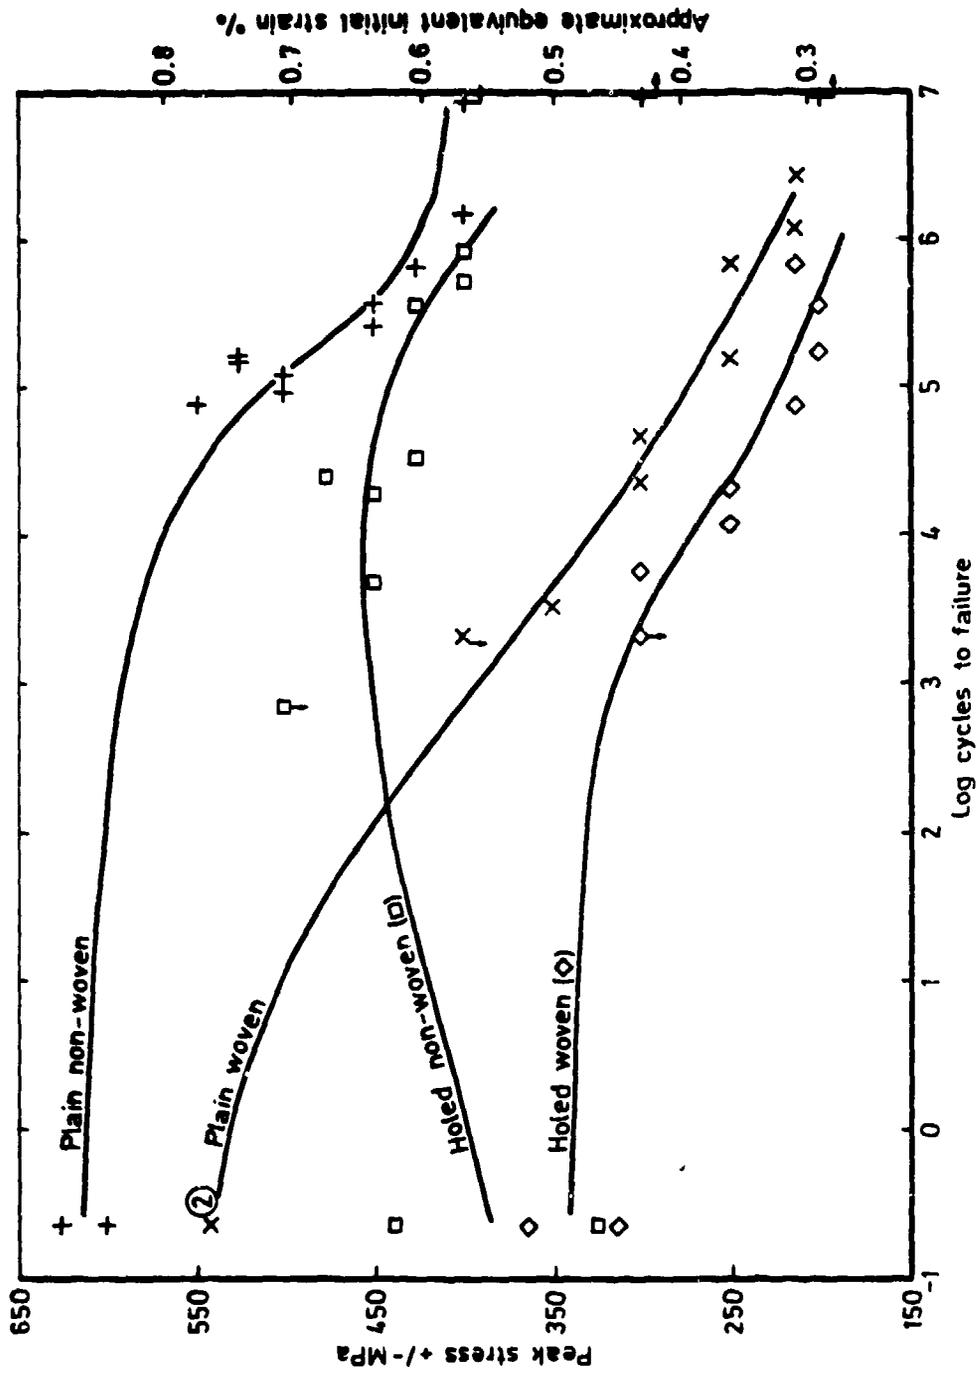
Fig 35 S-N plots of reversed axial fatigue data for layout A (0.90). Vertical arrows denote run up failures and horizontal arrows run-outs

During the reversed axial fatigue loading of plain coupons from lay-up A (0,90), a significant loss in strength was observed (Fig 35), much greater than observed during zero-tension loading. The loss in strength was greatest in the woven coupons, where after 1 million cycles the peak fatigue stress was less than half the static strength. Edge cracking was observed in plain non-woven coupons as well as translaminal 90° layer cracks early in the life, which spread to form 0/90 delamination at greater numbers of cycles. Although the plain woven coupons suffered a greater strength loss in reversed axial fatigue than the non-woven coupons, they developed less extensive damage; some edge cracking was visible and also 90° cracks, followed at long lifetimes by local 0/90 delamination confined to individual 0 fibre tows by the weave of the fabric. Damage was also visible at the tow crossover points as observed during the tensile fatigue work.

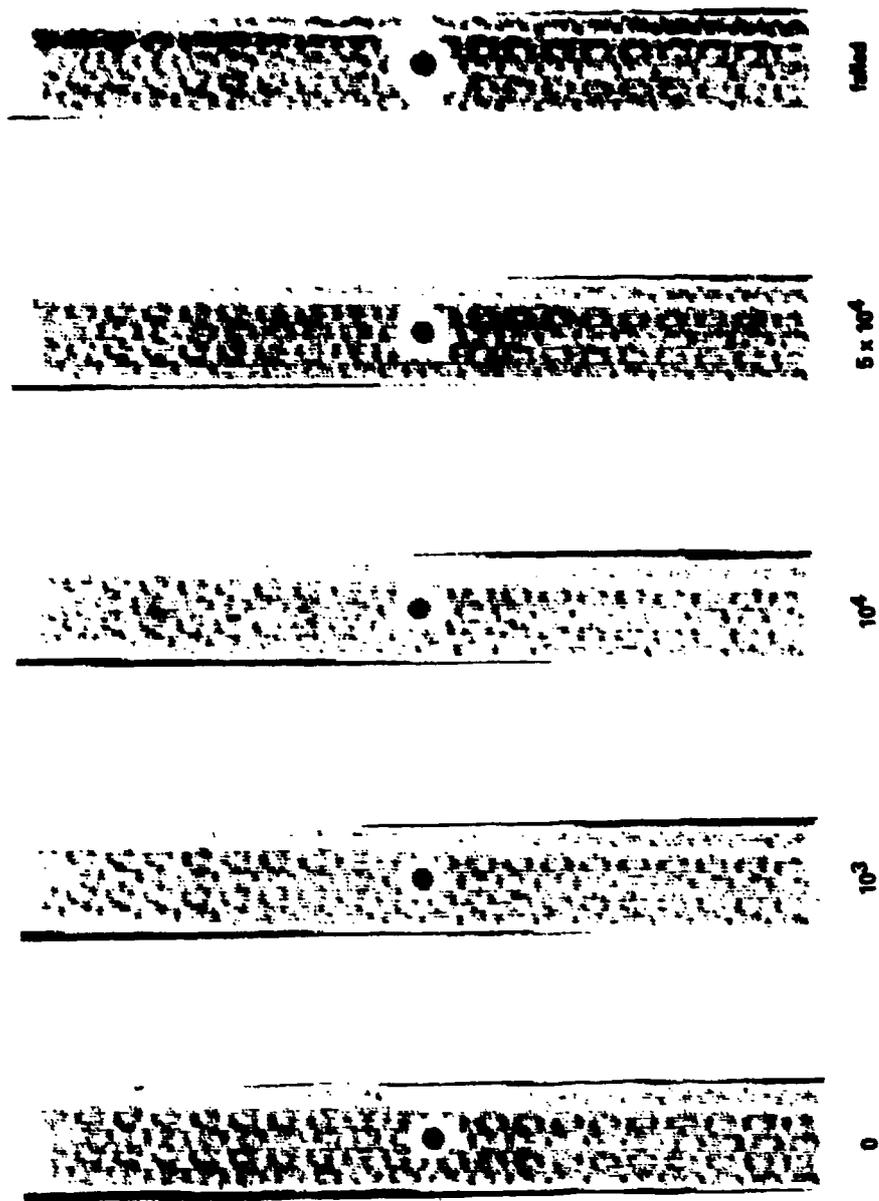
Fig 40 Ultra-sonic C-scans of a woven hole coupon with layup A (0,90) tested in reversed axial fatigue at the stress level giving a mean life of 100000 cycles. Left to right, scans after: 0 cycles at 1 dB steps, 10000 cycles at 1 dB steps, 10000 cycles at 1 dB steps, 50000 cycles at 1 dB steps, failure. Note the light line on the right side of the scans was due to a surface effect

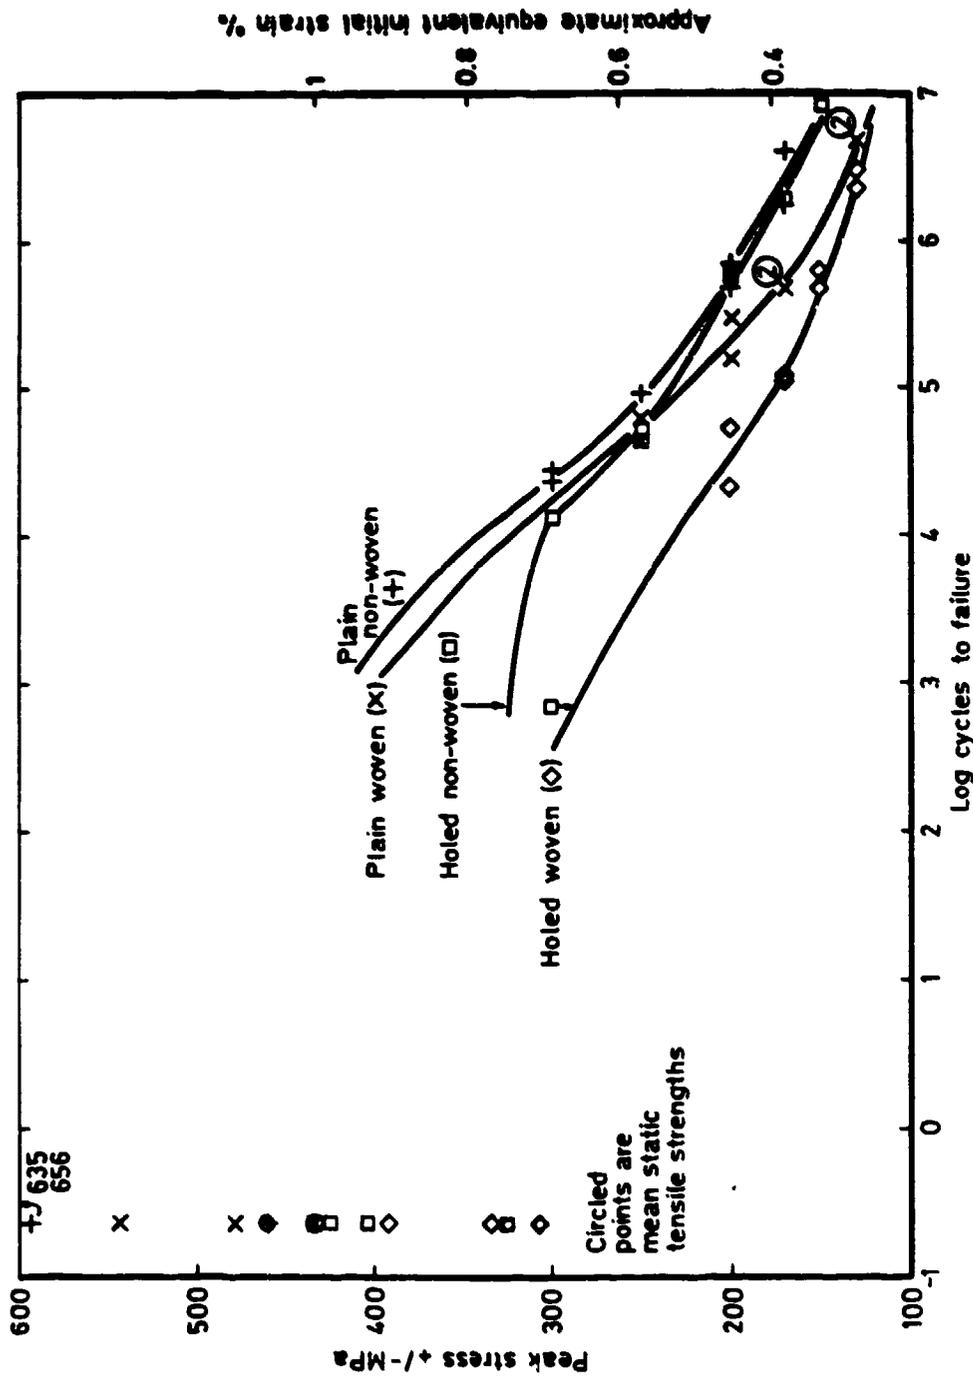
Fig 41 S-N plots of reversed axial fatigue data for layout C ($\pm 45, 0, 90$). Both tensile and compressive static data are presented at the 0.25 cycle point. Vertical arrows denote run up failures

Reversed axial fatigue tests on coupons with lay-up C (±45,0,90) yielded the S-N curves given in Fig 41. Since the tensile static strengths were less than the compressive

strengths these have also been plotted in Fig 41 as circled values. Thus in the reversed axial case the tensile excursion dominated at very short lifetimes. After only a small number of cycles however, compression behaviour prevailed and all coupons failed in compression at smaller stresses than in the tensile fatigue tests. All coupons exhibited steeply sloping S-N plots with a greater loss in strength than observed in tension alone. Static differences between plain woven and non-woven coupons were preserved in reversed axial fatigue, and indeed increased at long lifetimes. The peak fatigue stress for the plain non-woven material was reduced to about 195 MPa after 1 million cycles and 150 MPa for the plain woven material.

Unlike lay-up C, the static compressive strengths of plain coupons with lay-up D (0,90, ± 45) were similar to, perhaps slightly lower than, their tensile strengths. This was because lay-up D was not susceptible to the serious edge delamination effect observed in coupons with lay-up C. Hence the reversed axial fatigue S-N plots in Fig 41 were

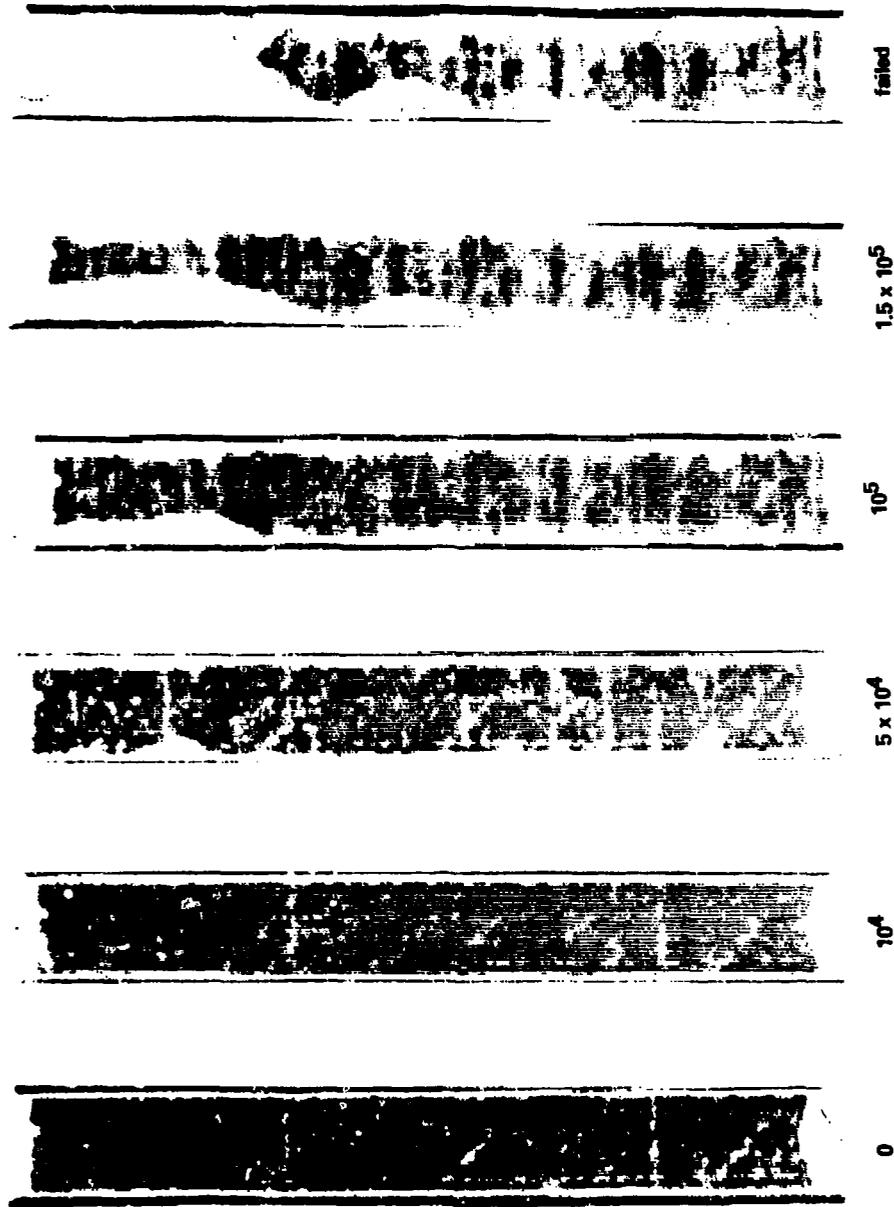
Fig 44 Ultrasonic C-scans of a non-woven plain coupon with layup C ($\pm 45,0,90$) tested in reversed axial fatigue at the stress level giving a mean life of 100000 cycles. Left to right, scans after: 0 cycles at 1 dB steps, 10000 cycles at 1 dB steps, 50000 cycles at 1 dB steps, 100000 cycles at 1 dB steps, 150000 cycles at 1 dB steps, failure

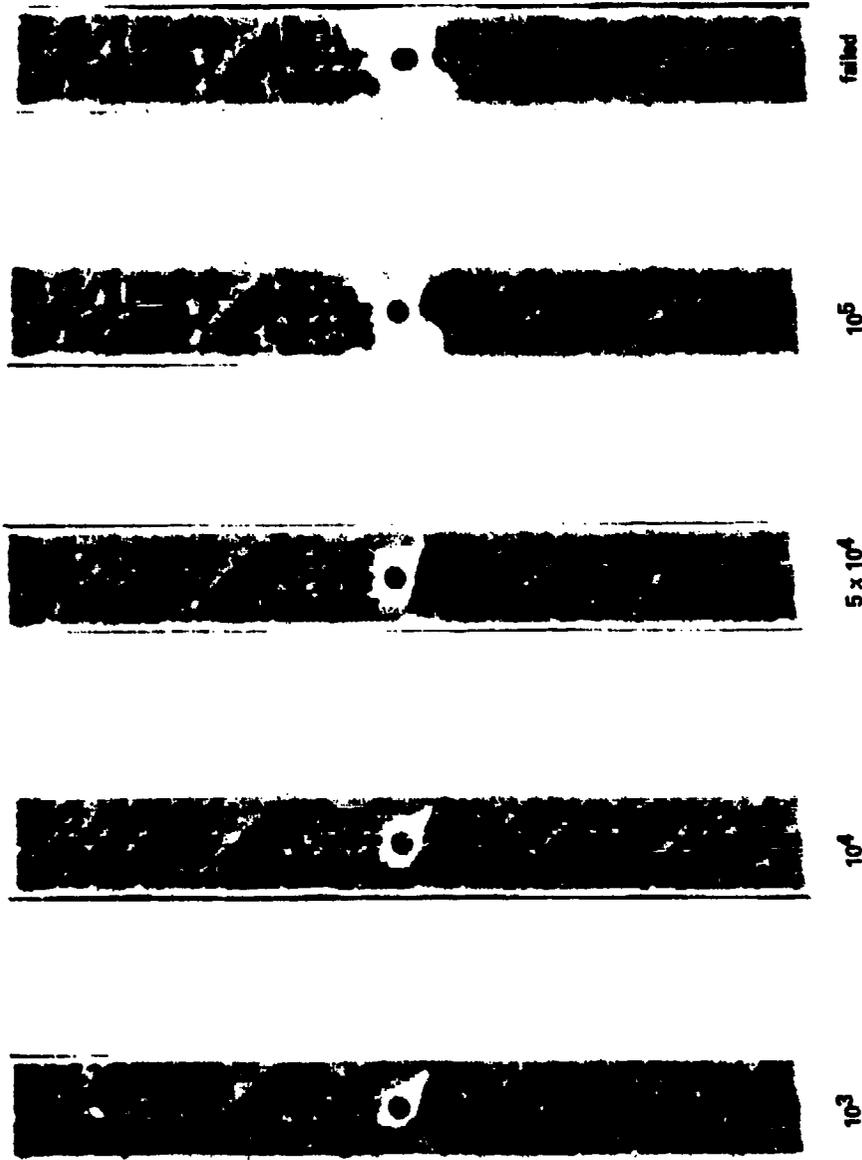
Fig 45 Ultrasonic C-scan of a non-woven holed coupon with layup C ($\pm 45/0/90$) tested in reversed axial fatigue at the stress level giving a mean life of 100000 cycles. Left to right, scans after: 1000 cycles at 1 dB steps, 10000 cycles at 1 dB steps, 50000 cycles at 1 dB steps, 100000 cycles at 1 dB steps, failure

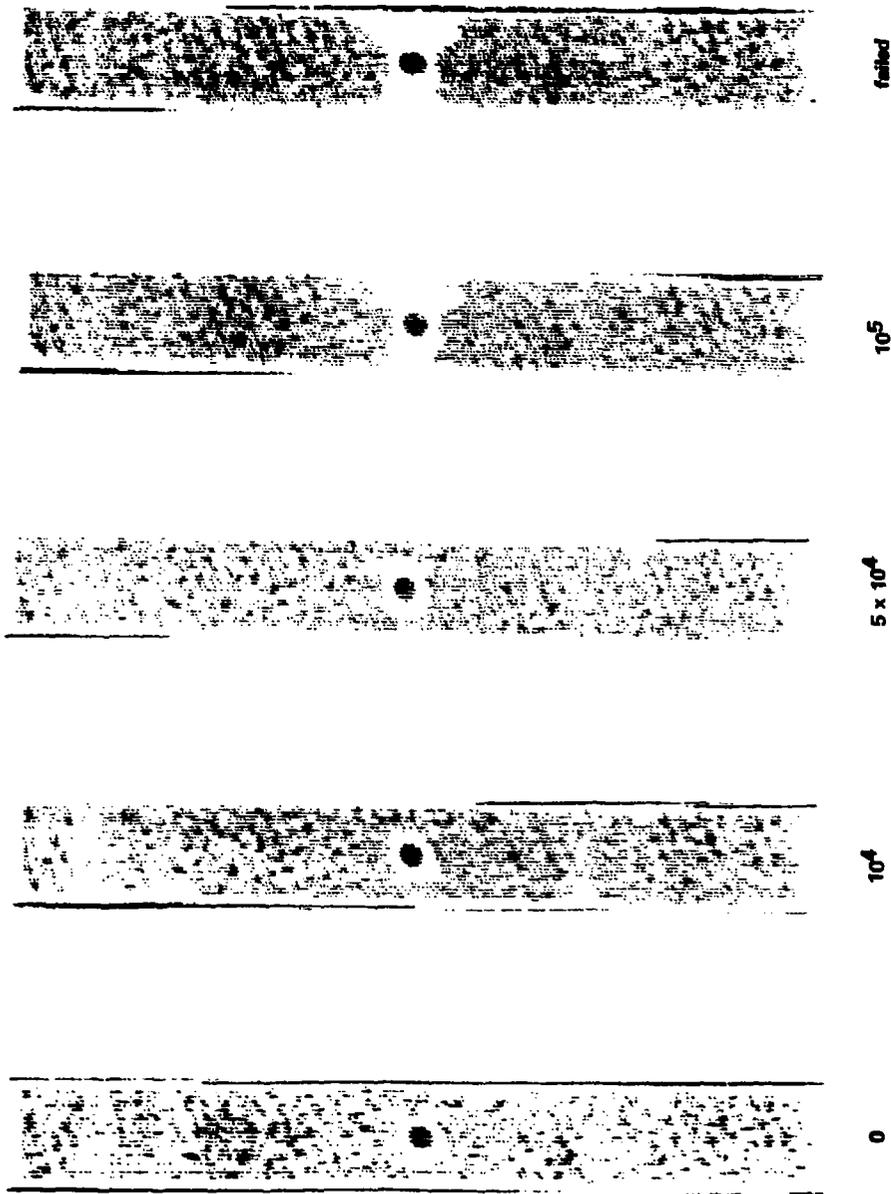
Fig 47 Ultrasonic C-scans of a woven hole coupon with layup C ($\pm 45,0,90$) tested in reversed axial fatigue at the stress level giving a mean life of 100000 cycles. Left to right, scans after: 0 cycles; at 1 dB steps, 10000 cycles at 1 dB steps, 50000 cycles at 1 dB steps, 100000 cycles at 1 dB steps, failure

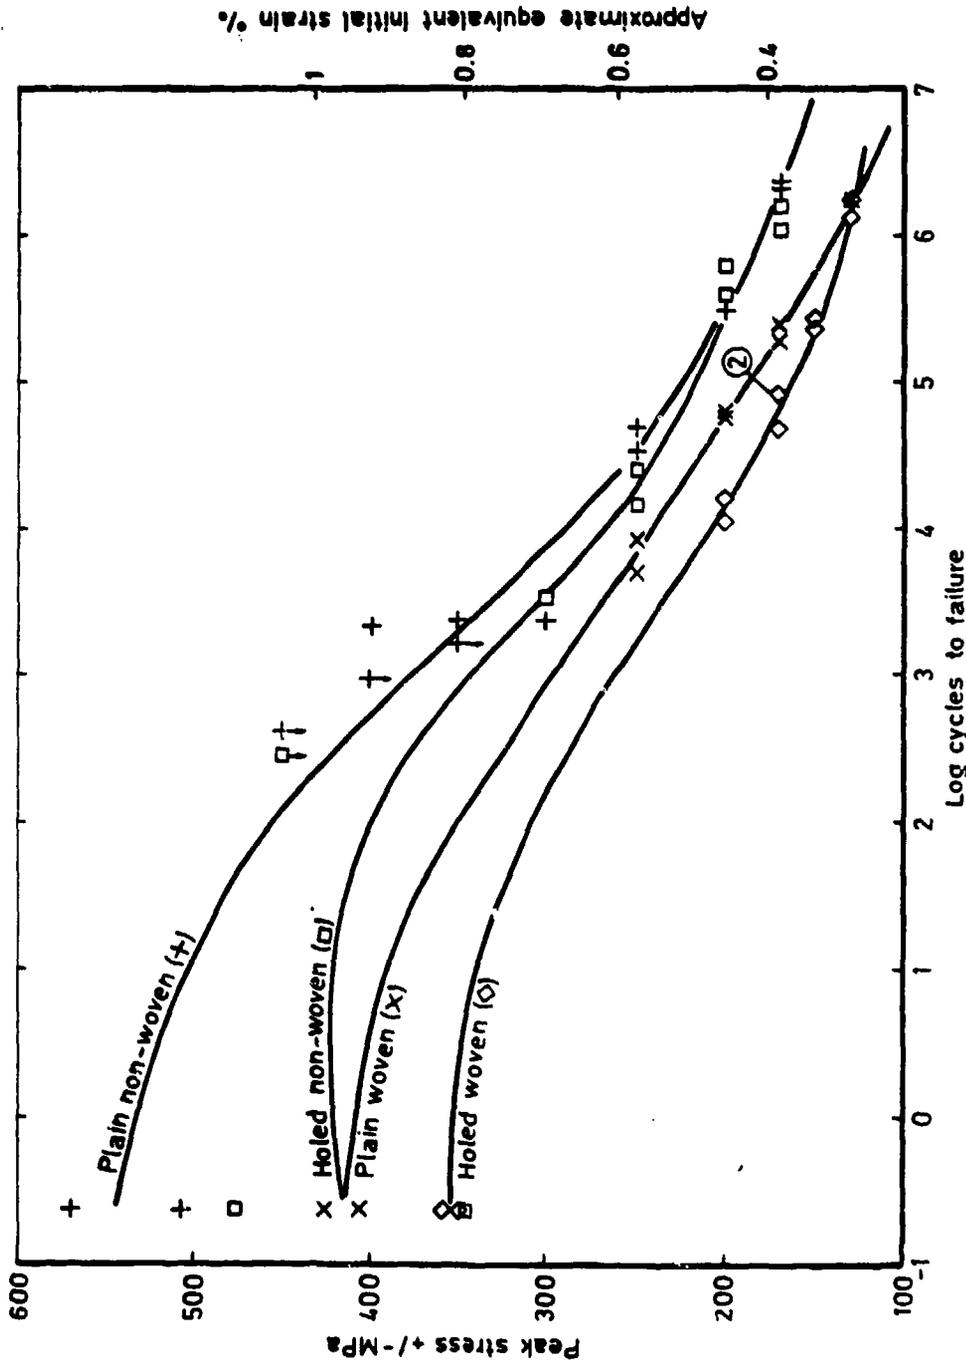
Fig 48 S-N plots of reversed axial fatigue data for layout D (0,90,45). Vertical arrows denote run up failures

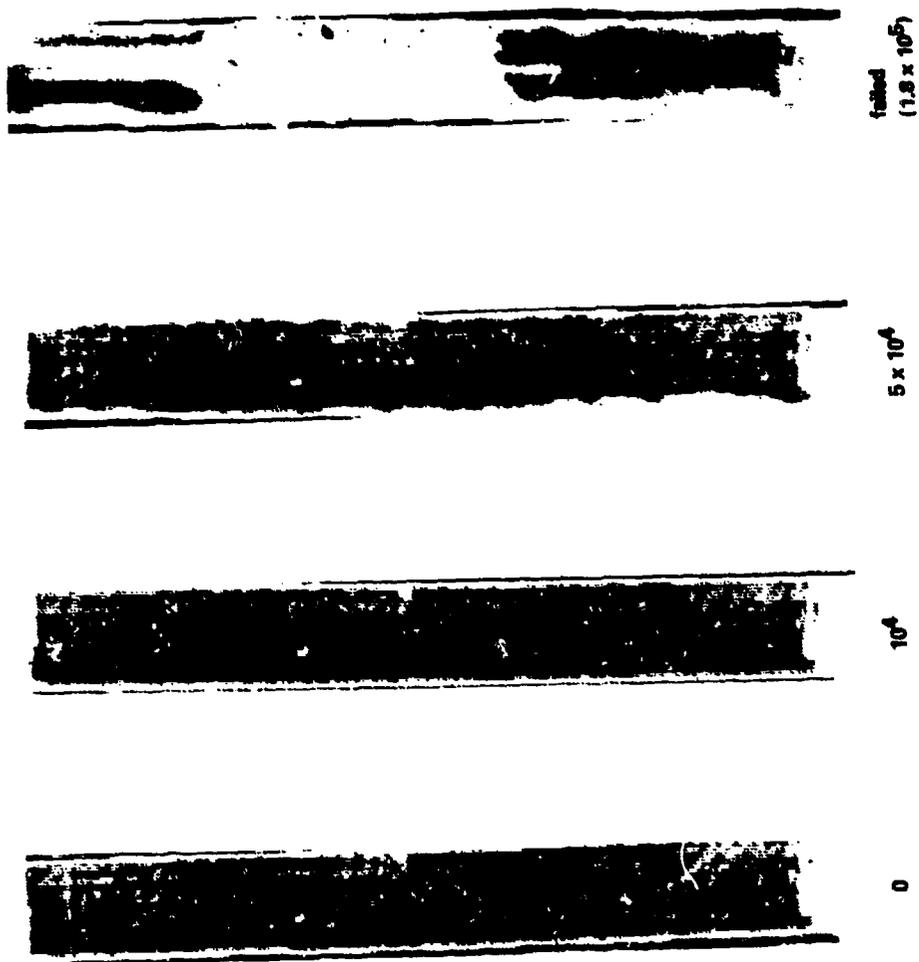
Fig 51 Ultrasonic C-scans of a non-woven plain coupon with layout D (0.90 ± 45) tested in reversed axial fatigue at the stress level giving a mean life of 100000 cycles. Left to right, scans after: 0 cycles at 1 dB steps, 10000 cycles at 1 dB steps, 50000 cycles at 1 dB steps, 180000 cycles at 1 dB — failure

Ultrasonic C-scanning of non-woven coupons tested at the stress level corresponding to failure after 100000 cycles revealed no transverse lightening as seen in coupons from lay-up C. After 10000 cycles some edge lightening was observed (Fig 51) and by 100000 cycles the light edge regions extended 1-2 mm in from the coupon edges. Some edge whitening developed in holed coupons after large numbers of cycles but no transverse lightening, although some lightening was visible around the holes (Fig 52). This eventually linked up with the edge lightening and commenced spreading longitudinally along the coupons.

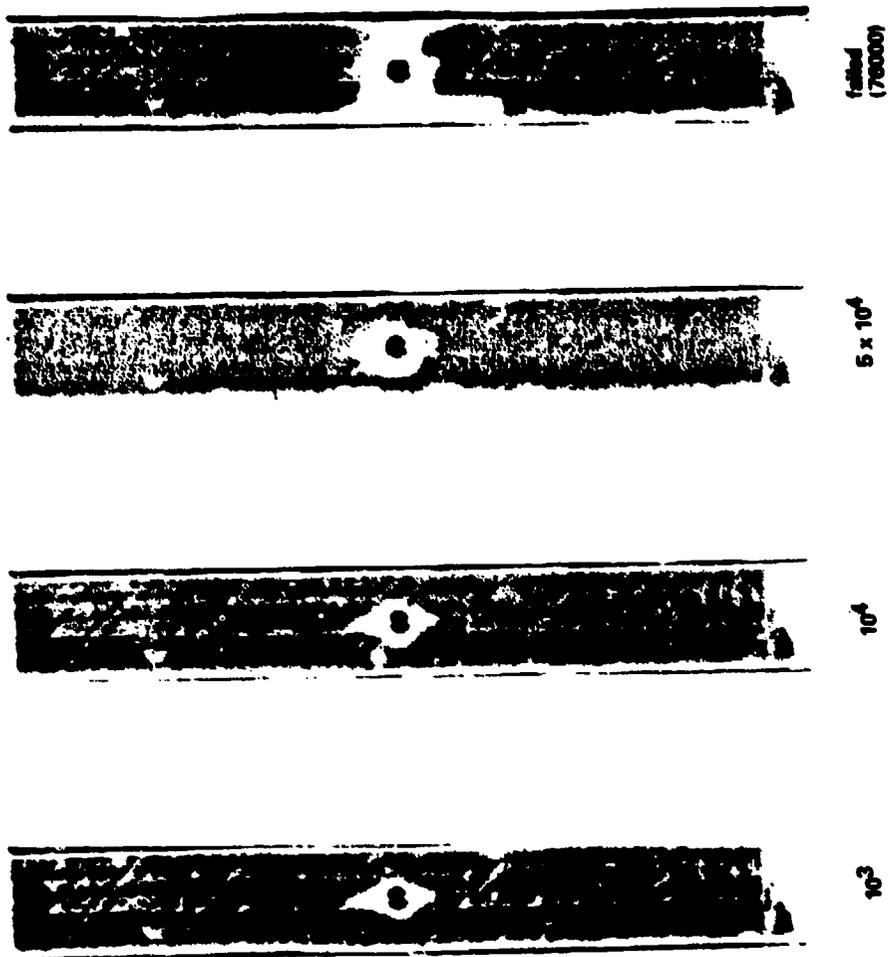
Fig 52 Ultrasonic C-scans of a non-screen holed coupon with layup D (0.90 \pm 46) tested in reversed axial fatigue at the stress level giving a mean life of 100000 cycles. Left to right, scans after: 1000 cycles at 1 dB steps, 10000 cycles at 1 dB steps, 50000 cycles at 1 dB steps, 76000 cycles at 1 dB steps, failure

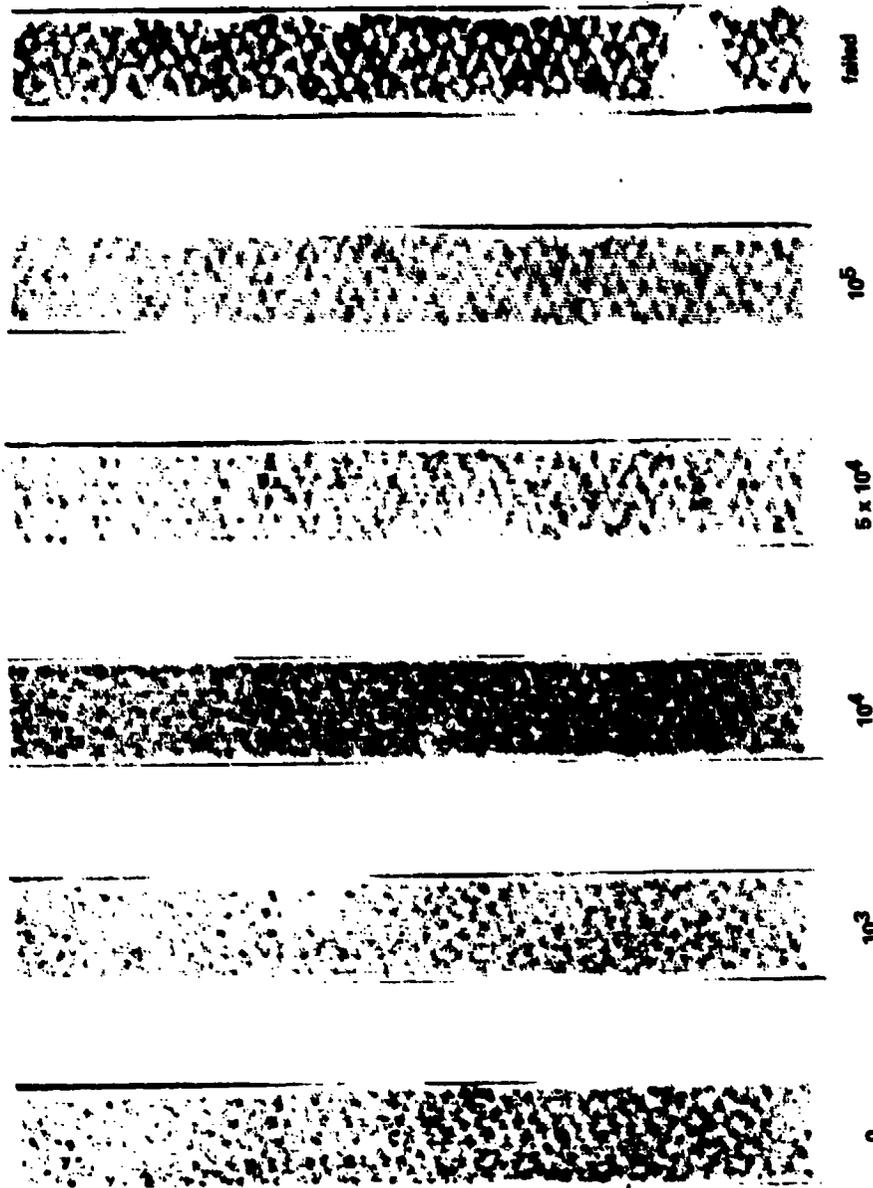
Fig 53 Ultrasonic C-scans of a woven plain coupon with layup D (0,90,±45) tested in reversed axial fatigue at the stress level giving a mean life of 100000 cycles. Left to right, scans after: 0 cycles at 1 dB steps, 1000 cycles at 1 dB steps, 10000 cycles at 1 dB steps, 50000 cycles at 1 dB steps, 100000 cycles at 1 dB steps, failure

Ultrasonic C-scanning of plain woven coupons revealed an overall lightening with increasing numbers of cycles and the gradual development of lighter spots at the tow crossover points in the weave (Fig 53) as in coupons from lay-up C. Edge lightening was observed, but this was very limited and never extended more than 2-3 mm from the coupon edges. Holed coupons showed similar behaviour with some edge lightening developing after 100000 cycles (Fig 54). There was also evidence of the development of light spots but less obvious than in the plain woven coupons. The light areas that developed around the holes, as in the non-woven coupons, eventually linked up with the edge lightening and spread a short distance longitudinally along the coupon edges.

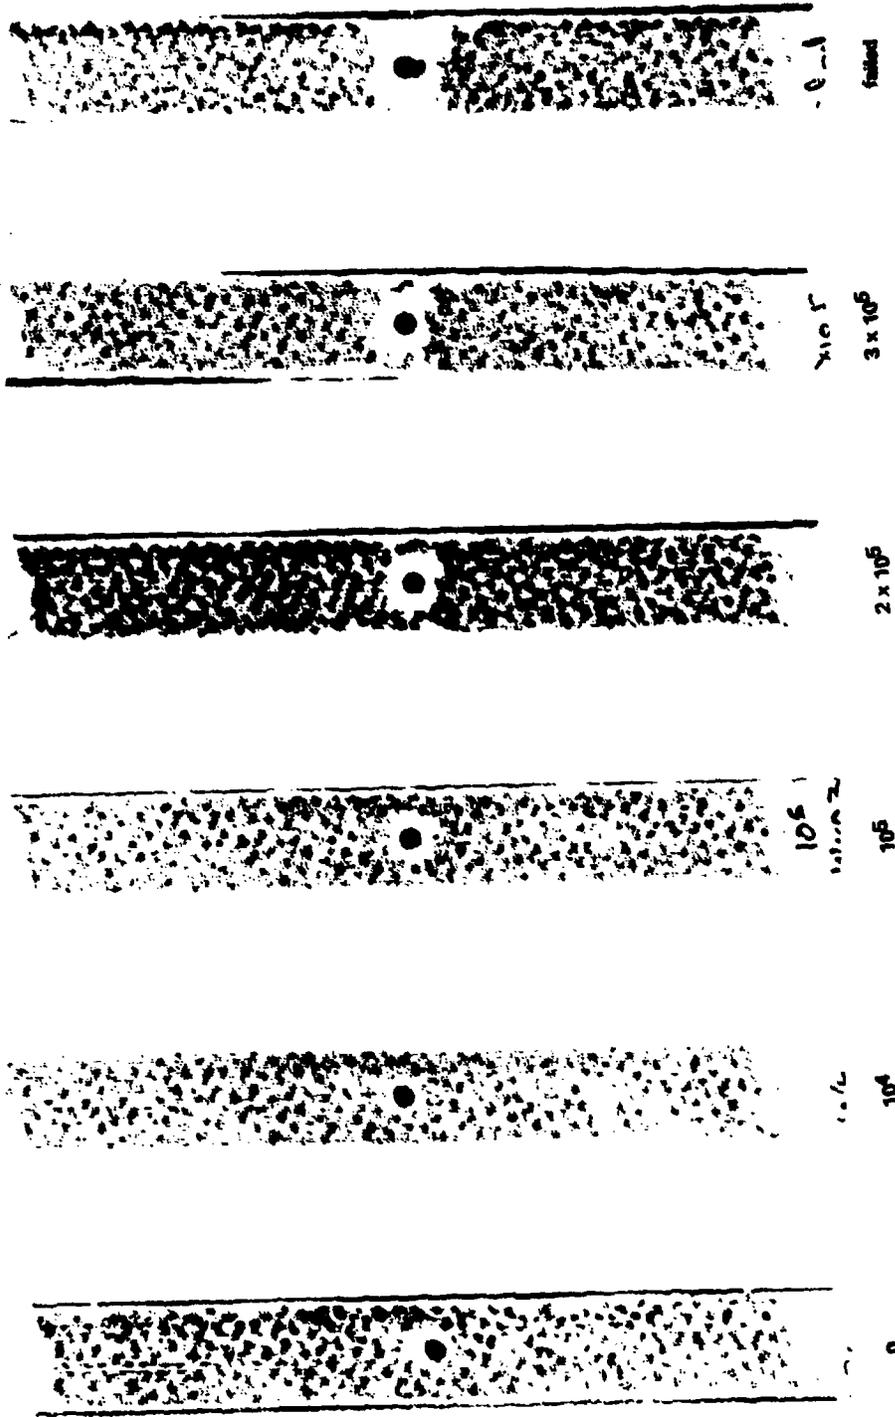
Fig 54 Ultrasonic C-scans of a woven holed coupon with layout D (0.60, ±.45) tested in reversed axial fatigue at the stress level giving a mean life of 100000 cycles. Left to right, scans after: 0 cycles at 1 dB steps, 10000 cycles at 1 dB steps, 100000 cycles at 1 dB steps, 200000 cycles at 1 dB steps, 300000 cycles at 1 dB steps, failure
