Technical Report 85059

A COMPARISON OF THE FATIGUE PERFORMANCE OF WOVEN AND NON-WOVEN CFRP LAMINATES

Procurement Executive, Ministry of Defence
Farnborough, Hants

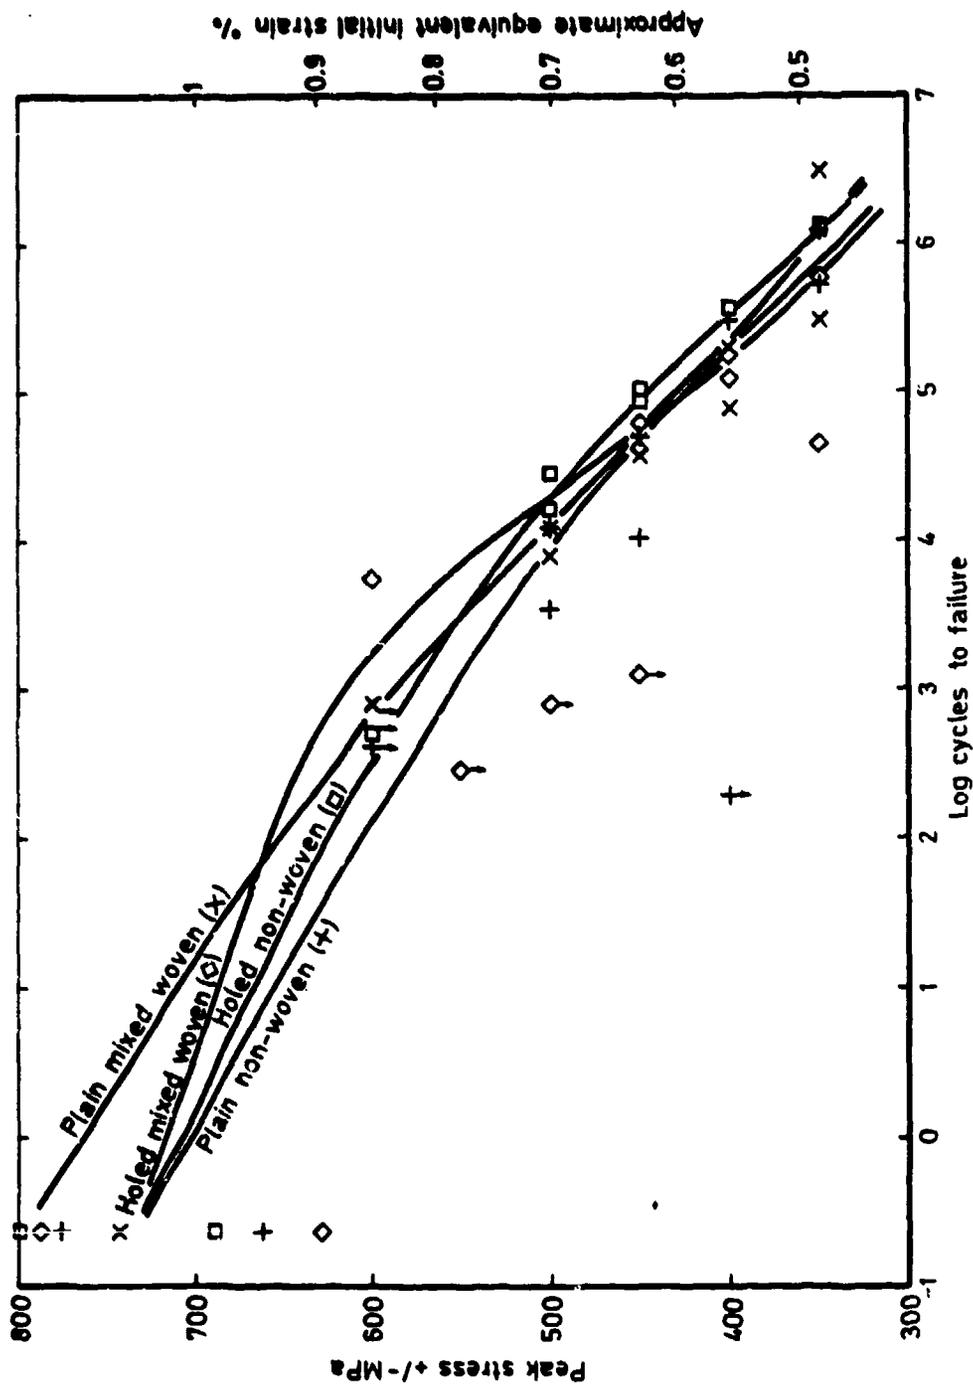
Fig 55 S-N plots of reversed axial fatigue data for layout E ($\pm 45,02$). Vertical arrows denote run up failures

Results of the reversed axial fatigue tests are given in Table 14 and presented as S-N curves in (Fig 55). All plain coupons failed at random positions along their lengths. Holed non-woven coupons sometimes failed at the holes but frequently away from the holes. Holed woven coupons also frequently failed away from the holes.

Reversed axial fatigue tests on coupons with lay-up E ($\pm 45, 0$), presented in Fig 55, yielded steep S-N plots with coupons failing in compression at significantly smaller stresses than in the tensile fatigue tests. Peak fatigue stresses were reduced to about 350 MPa after 1 million cycles for both the non-woven and mixed woven materials, which corresponds to a coupon strain of approximately 0.5%.

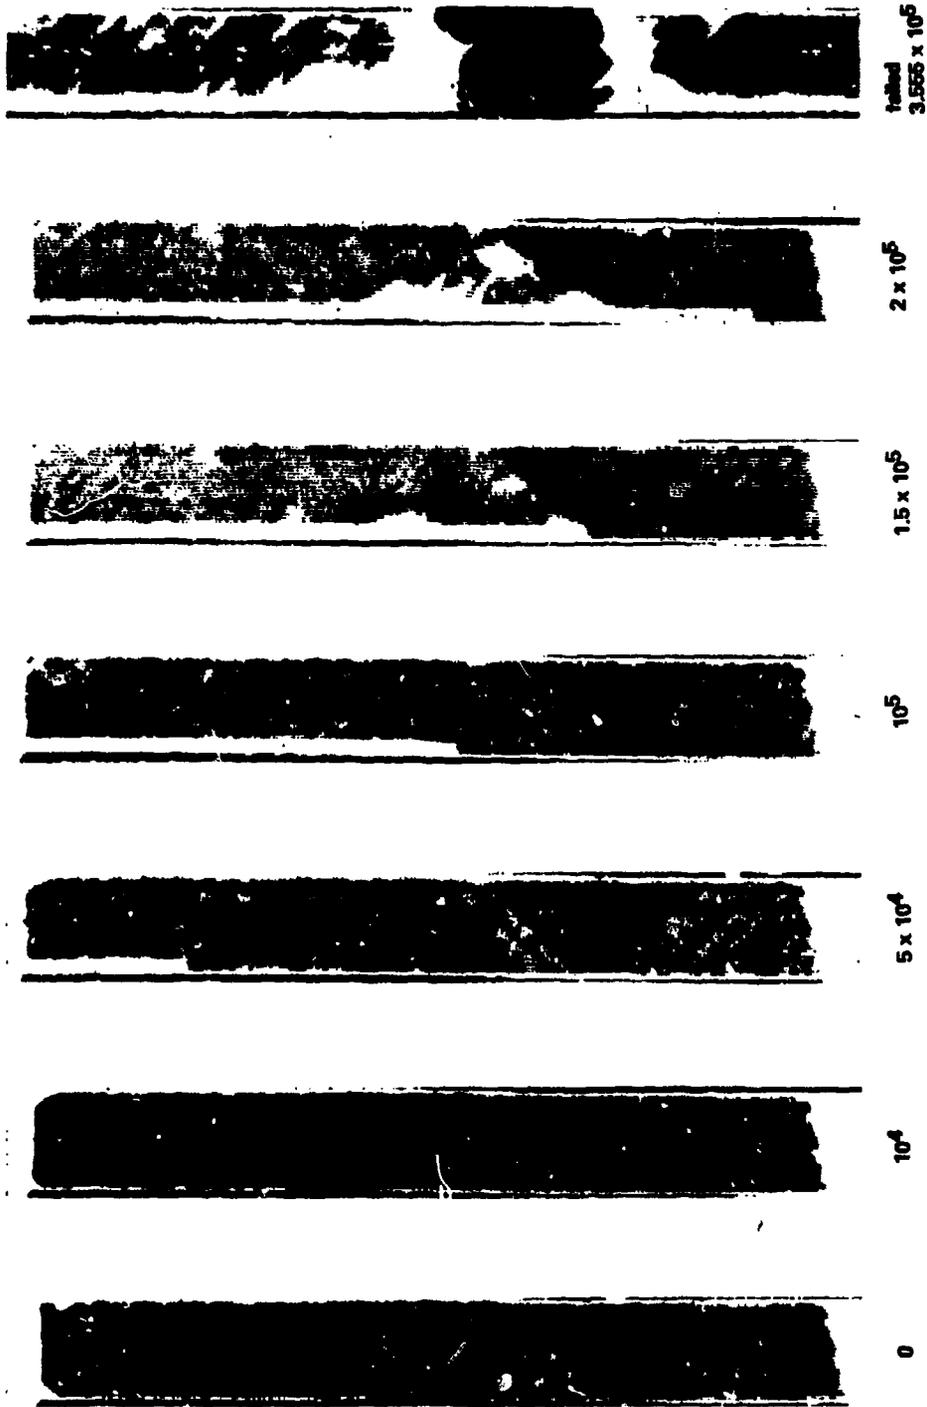
Fig 58 Ultrasonic C-scans of a non-woven plain coupon with layup E ($\pm 45,02$) tested in reversed axial fatigue at the stress level giving a mean life of 100000 cycles. Left to right, scans after: 0 cycles at 1 dB steps, 10000 cycles at 1 dB steps, 50000 cycles at 1 dB steps, 100000 cycles at 1 dB steps, 150000 cycles at 1 dB steps, 200000 cycles at 1 dB steps, 355500 cycles at 1 dB steps — failure

Ultrasonic C-scanning of plain non-woven coupons revealed edge damage which initiated from one end and grew along one edge (Fig 58). Eventually light areas were initiated within the coupon width away from the edges through which the coupon failed. Holed non-woven coupons revealed damage around the holes after 10000 cycles (Fig 59) which grew longitudinally to several hole diameters distance after 1 million cycles. Eventually the damage reached the coupon ends and had also grown across the coupon width.

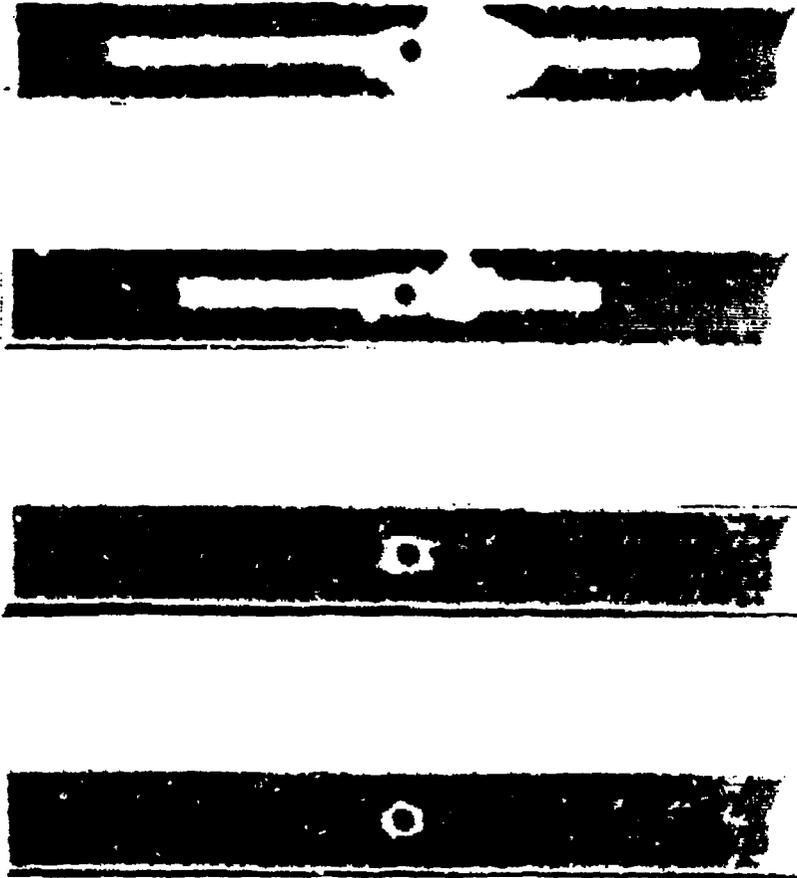
Fig 59 Ultrasonic C-scans of a non-woven holed coupon with layout E (s-45, 02) tested in reversed axial fatigue at the stress level giving a mean life of 100000 cycles. Left to right, scans after: 0 cycles at 1 dB steps, 1000 cycles at 1 dB steps, 16400 cycles at 1 dB steps, 100000 cycles at 1 dB steps -- failure

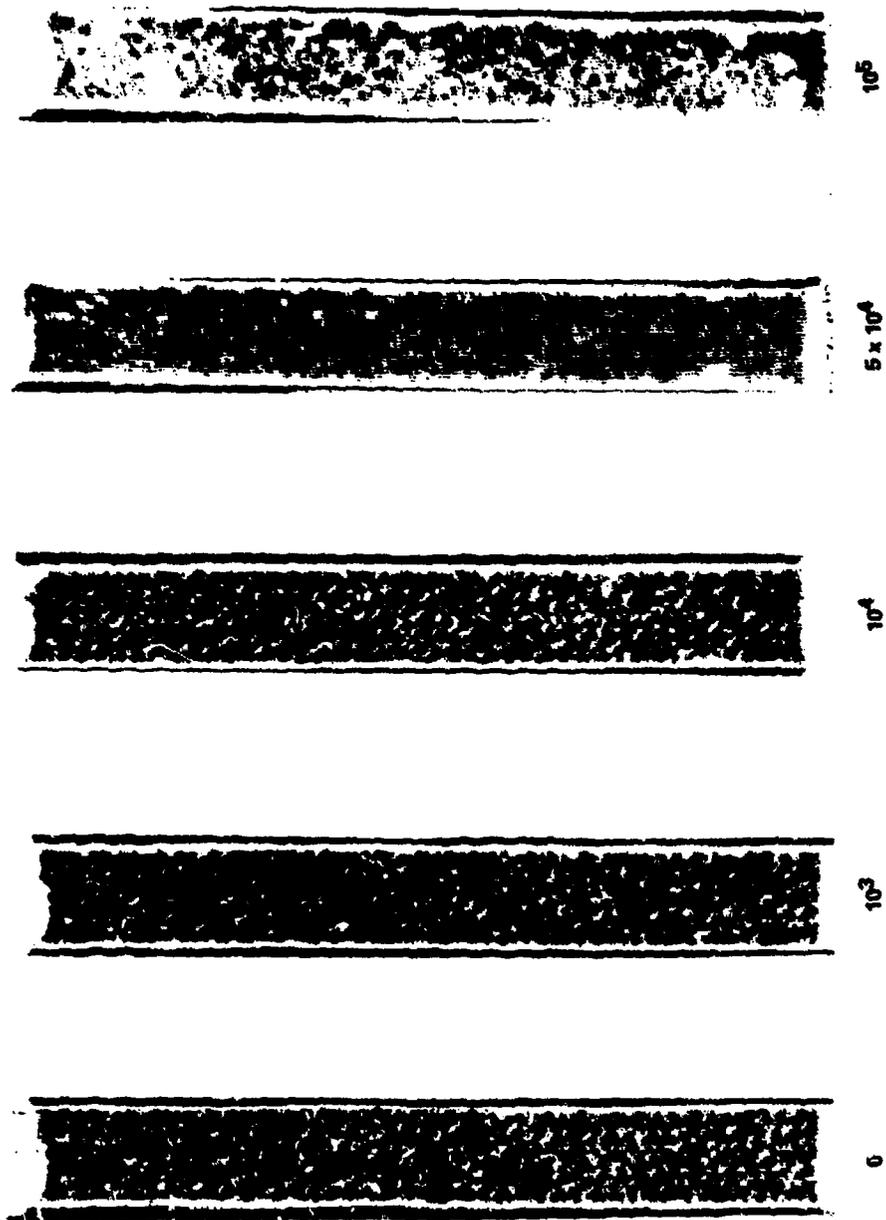
Fig 80 Ultrasonic C-scans of a woven plain coupon with layup E (-45, 0, 2) tested in reversed axial fatigue at the stress level giving a mean life of 100000 cycles. Left to right, scans after: 0 cycles at 1 dB steps, 1000 cycles at 1 dB steps, 10000 cycles at 1 dB steps, 50000 cycles at 1 dB steps, 100000 cycles at 1 dB steps
