AFWAL-TR-87-3072

COMPOSITE REPAIR OF CRACKED ALUMINUM
ALLOY AIRCRAFT STRUCTURE

September 1987

Final Report for Period October 1981 - April 1984

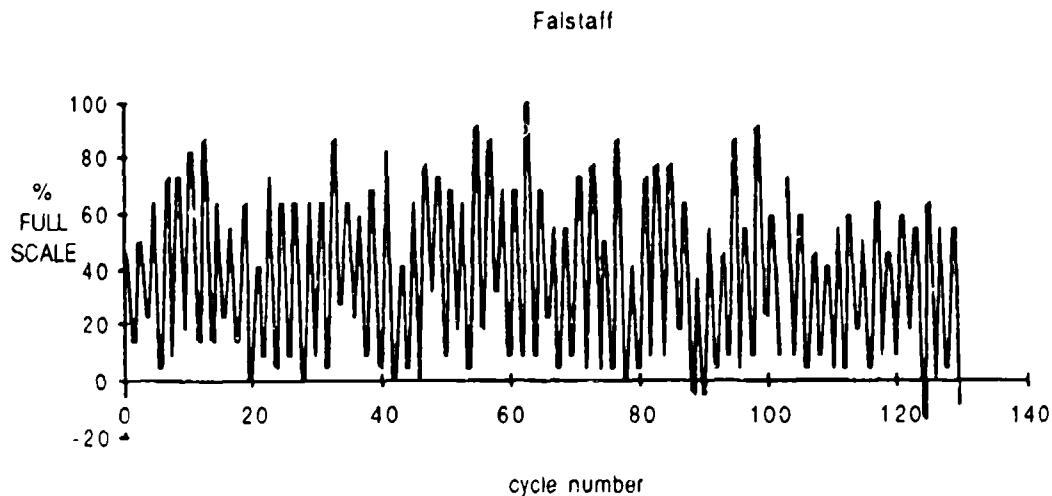
Figure 2. Falstaff Short Spectrum

Two different types of loading were used during the testing. The simpler loading was constant amplitude with an R ratio (minimum stress divided by maximum stress) of 0.1 and a maximum load of 20 KSI. The other loading is called Falstaff Flight Spectrum, an abbreviated version of the Falstaff Spectrum [2]. Figure 2 shows the loads seen by the specimen during one flight of the Falstaff Flight Spectrum. Maximum stress under this loading was 20 KSI and minimum load was -2.7 KSI. Guides were used on the specimens to prevent buckling during compression loads.

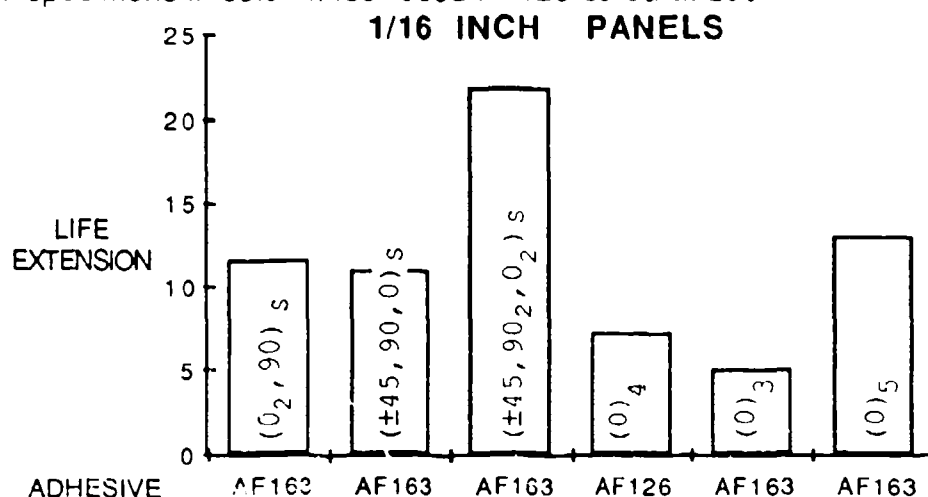
Figure 7. 1/16-Inch-Thick Spectrum Tests

The differences in the patches were much more pronounced under the Falstaff Flight spectrum loading. As shown in Figure 7, the $(\pm 45, 90_2, 0_2)_s$ patch clearly performed better than the others, yielding a life extension of 21.8 times. The life extension of unidirectional layups decreased significantly under the spectrum loading. The last two columns show data (0_3) and (0_5) patches, respectively. Even the (0_5) had a significantly lower life extension than the $(\pm 45, 90_2, 0_2)_s$ patch, unlike the constant amplitude case where the (0_4) patches

had performed roughly equivalently to the $(\pm 45, 90_2, 0_2)_s$ patch. The ARL repaired specimens in column four used AF126 cured at 250°F.

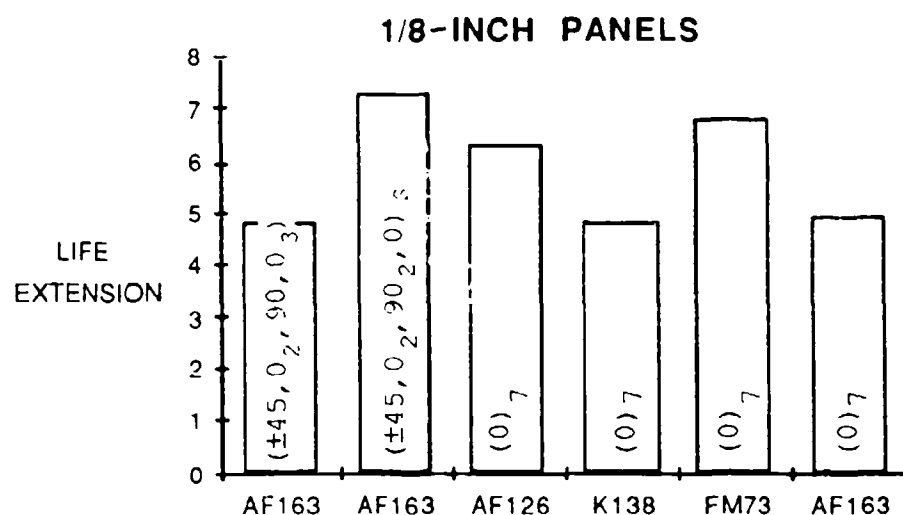
Figure 9. 1/8-Inch-Thick Spectrum Tests

The Falstaff flight spectrum loading of the 1/8-inch specimens shown in Figure 9 again showed a large relative drop in life extension with the unidirectional patch repairs. The top-performing patch here was the $(\pm 45, 0_2, 90_2, 0)_3$ patch, with an average life extension of 7.3 times, while the ARL repaired (0_7) using the AF126 adhesive and 250°F cure had an average life extension of 6.3 times. Column 4 shows the results of a (0_7) patch repair using K138 adhesive, 104°F cure, and an alternate aluminum preparation method. Here the aluminum was sand-blasted, cleaned, and treated with Micro Measurement Conditioner A-1 instead of being etched with the PANTA process. The average life extension for these specimens was 4.8 times, very close to that of the single (0_7) specimen using AF163 and a 250°F cure (4.9 times). Still another (0_7) specimen, this time repaired by the ARL with a 176°F cure and FM73 adhesive, showed a life extension of 6.8 times.

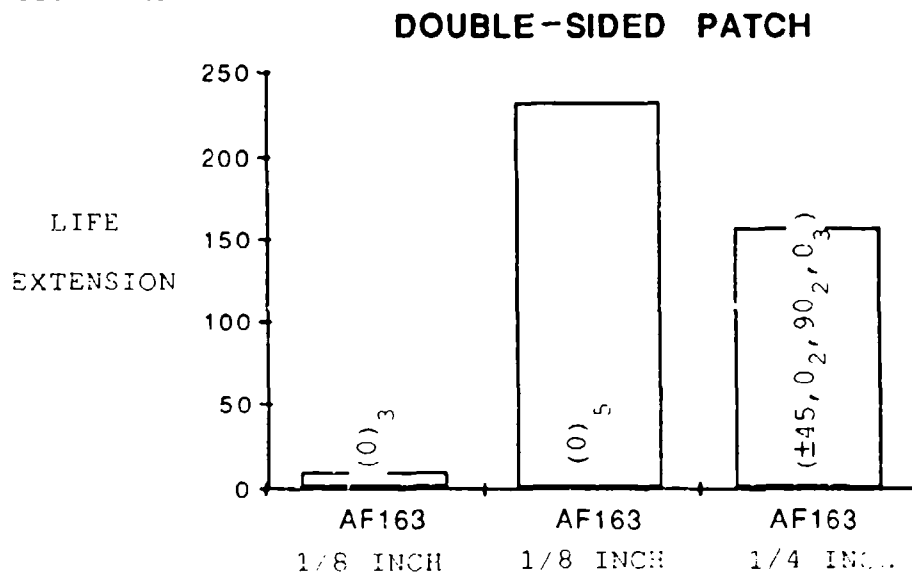
Figure 11. Results of Double Sided Patches

The repairs done using patches on both sides of the cracked specimen were extremely effective. Although crack lengths could not be monitored while the specimen was being tested without removing it from the test machine, the three double-sided 1/8-inch specimens and the one 1/4-inch specimen all cycled well past the best of the single side repaired specimens. For example, the 1/8-inch specimens ranged from a low of 288,000 constant amplitude cycles to a high of 1,244,000 cycles, but all these specimens failed outside the patched area. The 1/4-inch double-sided specimen cycled for 178,000 cycles. Figure 11 shows these results.
