USACERL TECHNICAL REPORT M-90/04 December 1989 Roofing Maintenance Management System

ROOFER: An Engineered Management System (EMS) for Bituminous Built-Up Roofs

This report gives instructions for using ROOFER, an engineered management system for bituminous built-up roofs that is designed to help military installations make the best use of roof maintenance and repair (M&R) funds.

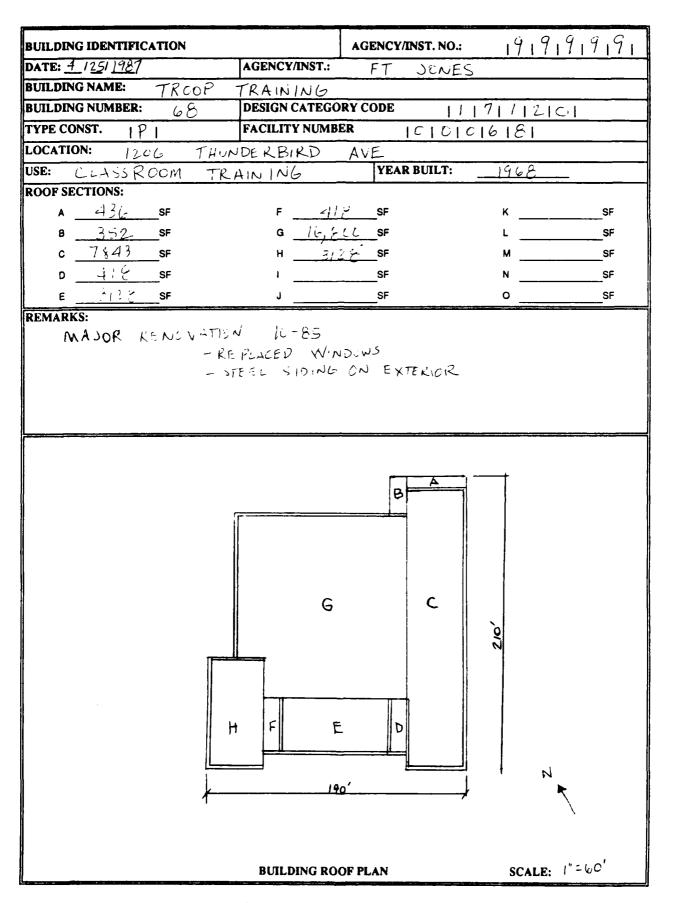
Figure 2. Completed Building Identification Sheet.

The Building Identification Sheet (Figure 2) is kept in the Building Folder and gives general information including building name, number, location, and occupancy. The Building Identification Sheet also lists each roof section and its area, and the date of original construction of the building. Although some of the information is not directly related to the roofing system, it does provide essential data for managing the network.

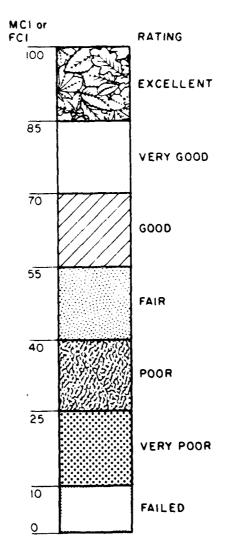
Figure 7. MCI and FCI and ratings.

The membrane and flashing components are rated separately by direct measurement of the distresses found in each component. Treating each component separately provides a more accurate assessment of component condition, needed repair, and waterproof integrity. MCI and FCI ratings are numerical indicators based on a scale of 1 to 100. The scale and associated ratings are shown in Figure 7.

Determine the corresponding descriptive condition ratings from Figure 7 for both indexes.

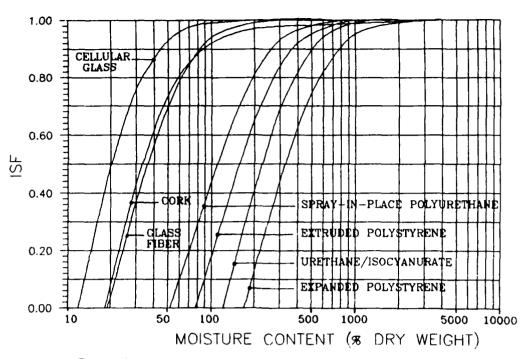
Figure 19. Insulation severity factor (ISF) vs moisture content for cellular glass, cork, glass fiber, polyurethane, polystyrene, and polyisocyanurate insulation.

Moisture affects the performance of roof insulation in varying degrees depending on the type of insulation. The Insulation Severity Factor (ISF) is a measure of the adverse effect of moisture on the thermal performance of an insulation. Curves that relate the ISF for various types of insulating materials to their moisture contents are presented in Figures 19 and 20. For example, fiberboard, with a moisture content of 20 percent has an ISF of 0.7. The same ISF is reached in urethane insulation at a moisture content of 305 percent and in 1 PCF polystyrene at a moisture content of 440 percent.

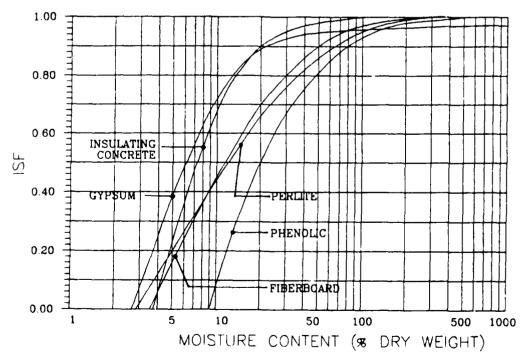
Figure 20. ISF vs moisture content for phenolic, insulating concrete, gypsum, perlite, and fiberboard insulation.

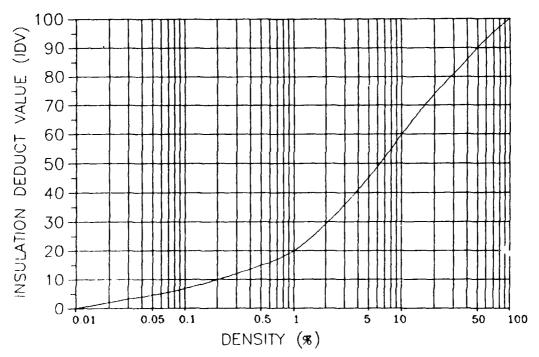
Figure 22. Insulation deduct value (IDV) vs problem density.

The Insulation Deduct Value (IDV) is then determined from Figure 22 and the ICI is calculated using the following equation:

where IDV = Insulation Deduct Value from Figure 22

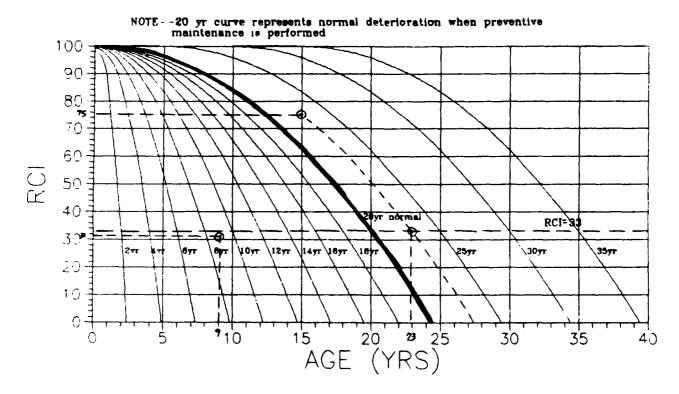
Figure 24. Deterioration curves for built-up roofs.

The deterioration rate and expected life for roof sections may vary greatly from that of a theoretically defined "normal" 20-year roof, depending on the previously mentioned factors. A series of curves were developed which represent roof section deteriorating at rates different from the "normal" 20-year roof (Figure 24). The curves falling below the "normal" curve represent roof sections deteriorating at a faster rate and predicted to fail before 20 years. The curves above the "normal" curve are performing better than a 20-year roof.

The deterioration curve for a roof section with an RCI equal to 31 at year 9 (example B) is also shown in Figure 24. The actual RCI is lower than the expected RCI of 86 for a roof section deteriorating at the "normal" rate. Interpolating from the deterioration curve, the EL of the roof section is determined to be 8.5 years. In this case, where the EL has already been reached (RCI<33), the EL is assumed to be equal to the age of the roof (EL = 9 years). From Equation 7, the RSL for the roof section of example B equals 0 years (9 - 9).

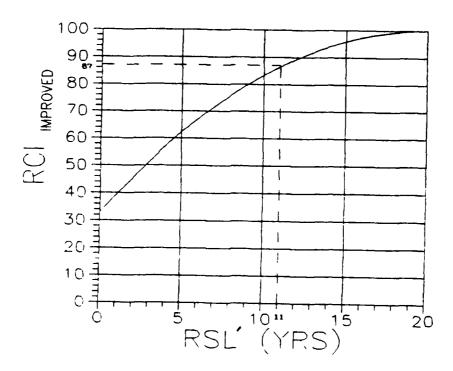
Figure 25. RCI_{improved} vs remaining service life.

Performing "major repairs" on a roof section improves the roof condition and increases the RCI. After repairs are completed, the roof section will be assumed to follow the "normal" deterioration rate. The Remaining Service Life assuming major repairs have been completed (RSL') can be determined from Figure 25 if the improved condition of the roof is known (RCI_{improved}). RCI_{improved} can be determined by recalculating the RCI with all medium and high severity distress values eliminated and assuming the ICI to be equal to 100. The ASL is the additional years of service which can be realized by a roof section, if the major repairs are performed and the RCI is improved. The ASL is calculated from the following equation:

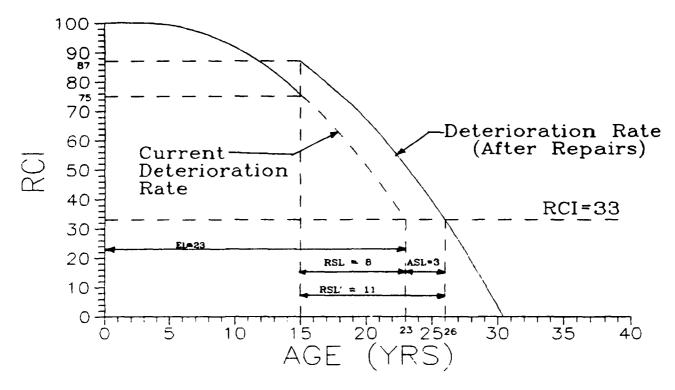
Figure 26. Relationship between age, EL, RSL, RSL', and ASL.

Figure 26 shows the relationship between age, EL, RSL, RSL', and ASL for Example A.

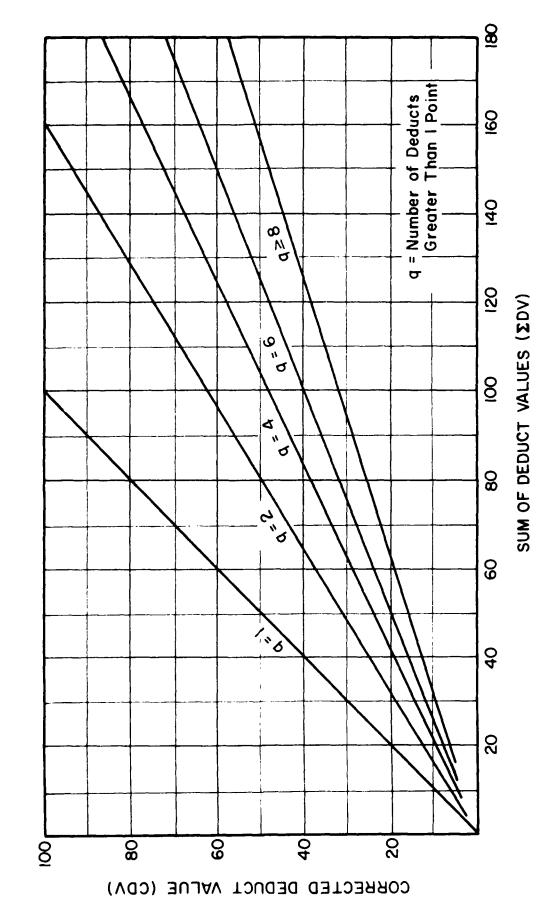
Corrected deduct values for flashing.

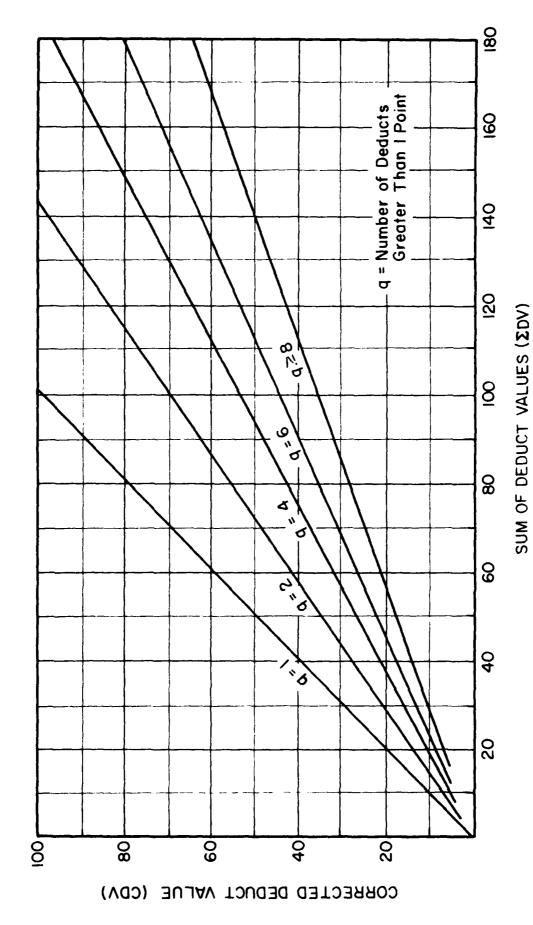
Corrected deduct values for membrane.
