AN INVESTIGATION OF USING
AERIAL INFRARED THERMOGRAPHY
FOR LOCATING SUBSURFACE
MOISTURE IN BUILT-UP ROOFING

THESIS

Presented to the Faculty of the School of Systems and
Logistics of the Air Force Institute of Technology
Air University

In Partial Fulfillment of the
Requirements for the Degree of
Master of Science in Engineering Management

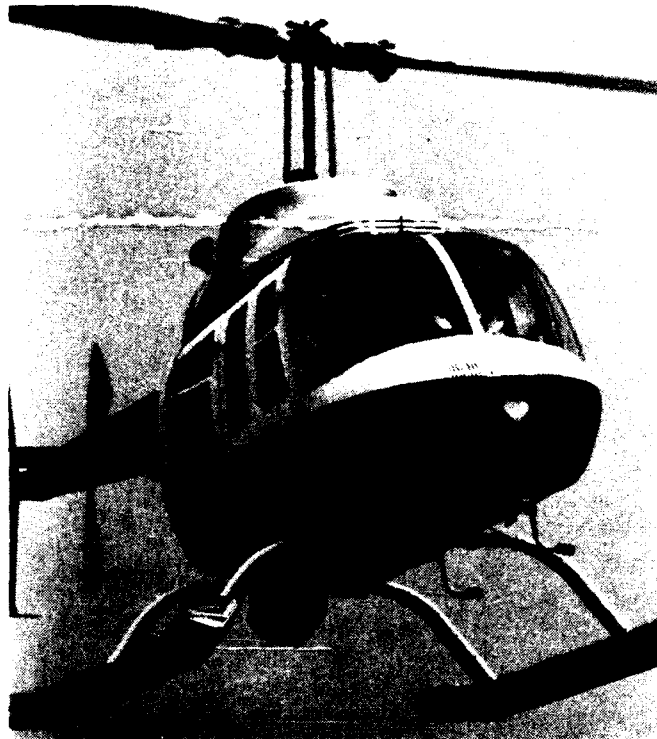
Figure 2. Helicopter with Gimbal Mounted Aerial IR Camera. (Courtesy of ISS Thermographic).

Helicopter vs Fixed-Wing. Some commercial companies use a helicopter for their aerial IR surveys and others use fixed-wing aircraft. The significant advantage of a helicopter is its ability to maneuver closer to a building and thus provide improved resolution. However, its primary disadvantage is its substantially higher cost. Fixed wing aircraft travel faster and are therefore more suitable for surveys located great distances from the IR company's location. According to Jay Vanier of UST, his IR equipment which is mounted on a fixed-wing aircraft has pinpointed moisture spots as small as 6 inches square from 1500 feet above roof level. This resolution is accurate enough for the researcher to conclude that there is not a significant enough difference to limit the focus of this research to helicopter surveys. Since overall cost is a significant element, fixed-wing surveys may be cheaper and in the best interest of the government if the results obtained are adequate.

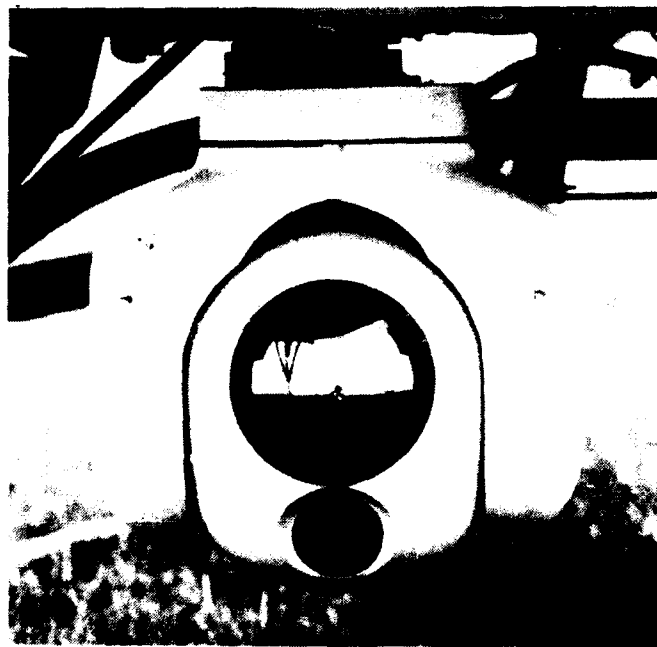
Figure 3. FLIR[™] 2000 A/B High-Resolution IR Camera with 4 Power Telephoto Lens. (Courtesy of ISS Thermographic).

The more recent IR cameras, from about 1984 to the present, are capable of very high resolution, and many are intended for aerial use. Several of the aerial IR cameras also have a built-in telephoto lens for multiplying the image (or zooming in) from 2 to 4 times the original size (14; 38:51). This capability gives the thermographer much greater detail of the roof while maintaining a safe distance (14). At 500 feet altitude for example, Wayne Tobiasson reported that the FLIR[™] 2000A aerial camera could spot an image 3 inches across from directly above a roof. At this height using the telephoto (4X) lens, the field of view is 61 feet wide by 28 feet across.
