REPAIR, EVALUATION, MAINTENANCE, AND
REHABILITATION RESEARCH PROGRAM

US Army Corps
of Engineers

PROCEEDINGS OF REMR WORKSHOP ON REPAIR
AND MAINTENANCE OF SHALLOW-DRAFT
TRAINING STRUCTURES

24-25 February 1987

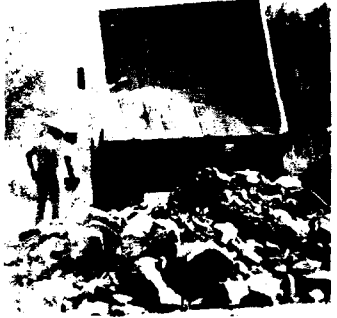
TOP — Use of end dumping to repair Dike 332.5(L) by US Army Engineer District, Little Rock.

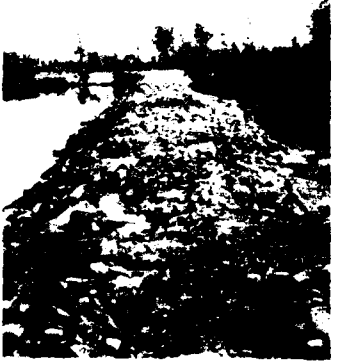
BOTTOM — Dike 333.6(L), repairs completed, US Army Engineer District, Little Rock.
