May 1991

Technical Report

SEAWATER HYDRAULICS: A MULTI-FUNCTION TOOL SYSTEM FOR U.S. NAVY CONSTRUCTION DIVERS

NAVAL CIVIL ENGINEERING LABORATORY PORT HUENEME CALIFORNIA 93043-5003

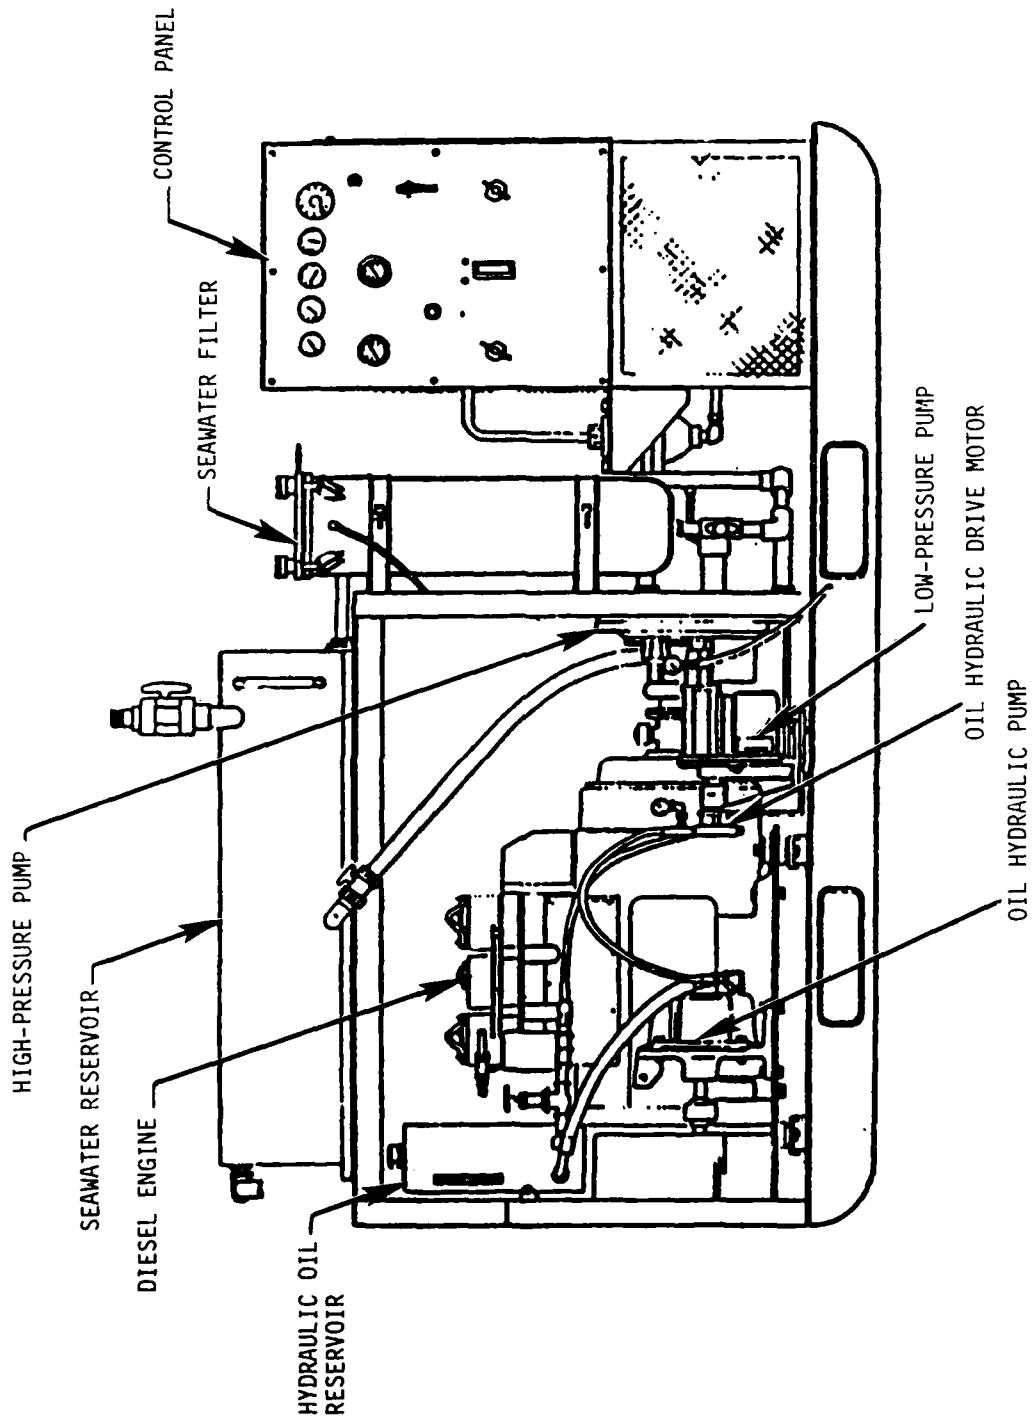
The prototype seawater hydraulic power source, Figure 1, uses a 30-horsepower diesel engine to drive a high-pressure seawater pump. The diesel engine also powers a small oil hydraulic system to drive a centrifugal low-pressure seawater pump. A flow controller on the oil hydraulic system is used to regulate the speed of the centrifugal pump.

The centrifugal pump supplies 200 psi water to a jet eductor pump suspended in the ocean. The jet eductor pump returns a larger volume of water to fill the 50-gallon reservoir. The seawater output from the jet eductor pump is passed through a 10-micron basket filter before filling the seawater reservoir. From the reservoir, filtered seawater is gravity fed to the high-pressure pump and distributed to the tools through

Figure 1. Prototype seawater hydraulic power source.

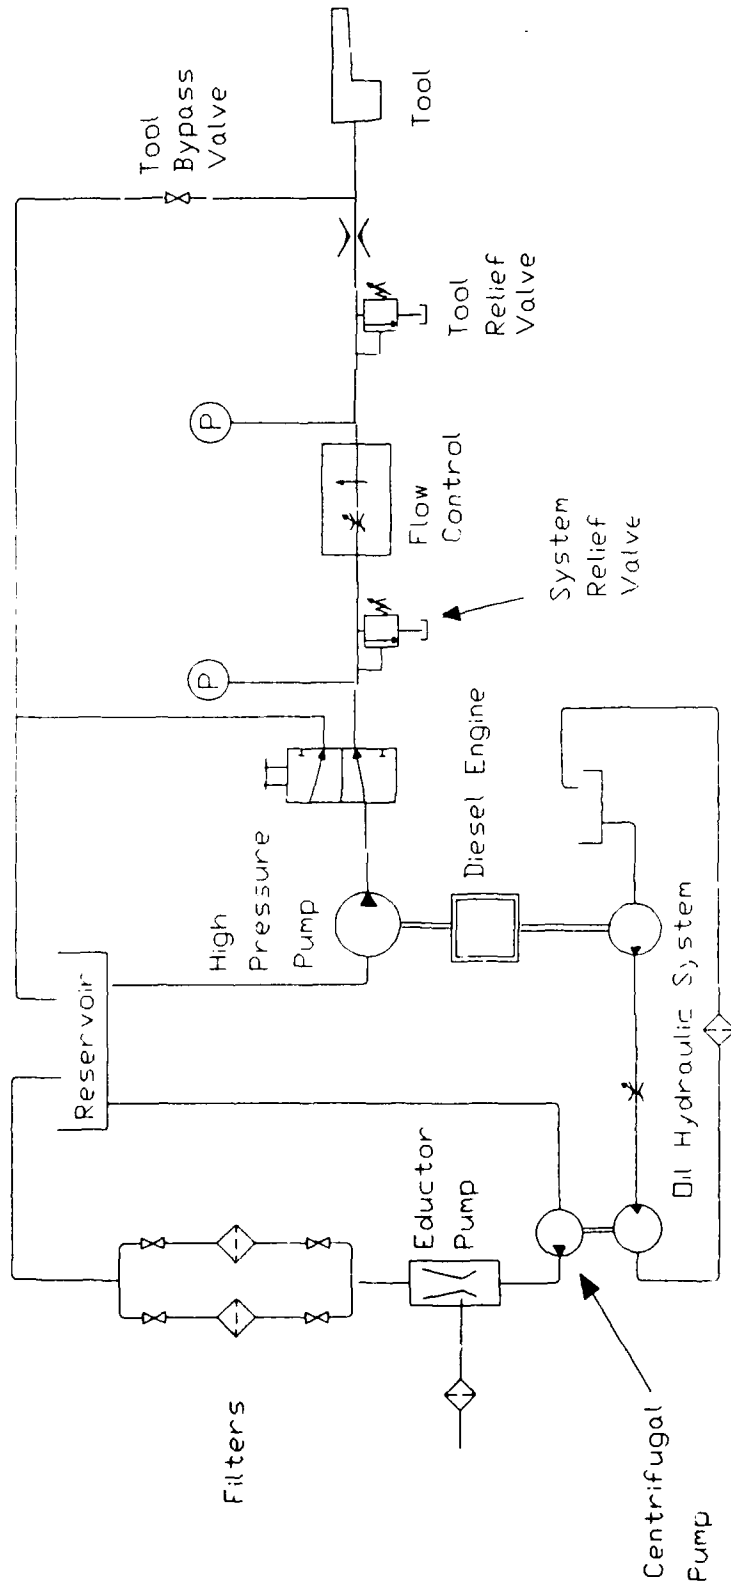
Figure 2. Seawater hydraulic power source flow diagram.

250 feet of 1/2-inch-diameter hose. One hose reel is attached to the power unit. A second hose reel is separate from the main power unit. The hydraulic circuit diagram is shown in Figure 2.

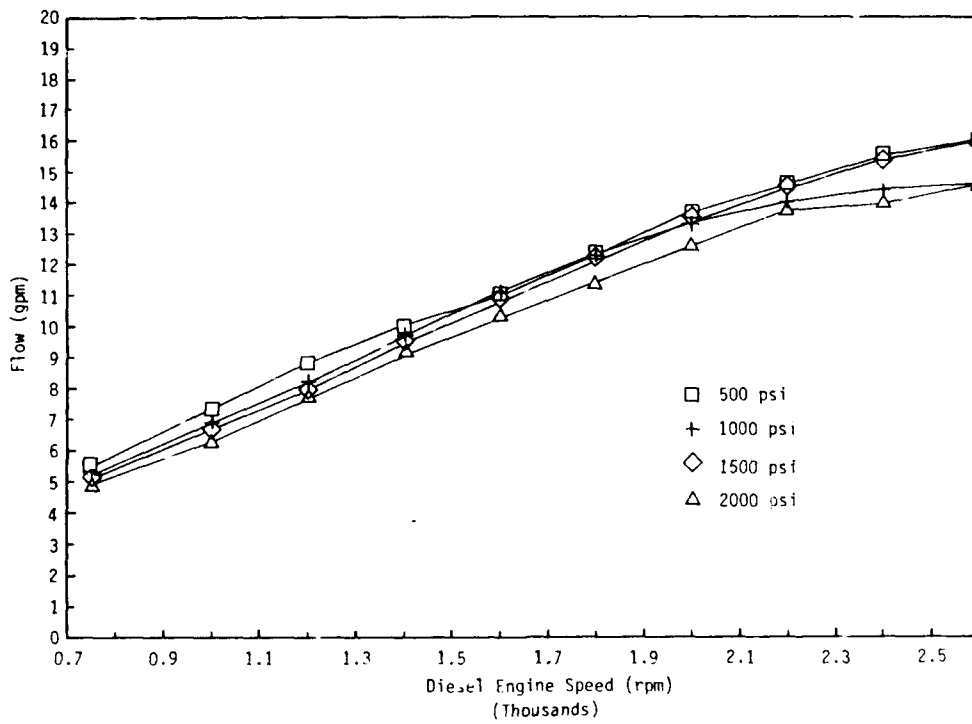
High-Pressure Pump Performance Test. This test was performed to determine the flowrate of the high-pressure pump at various diesel engine speeds and pump discharge pressures. The data were obtained from reading the system gages and plotted as the performance curves in Figure 3, with flow as a function of engine speed and pump discharge pressure.

The output flowrate of the pump increased linearly with an increase in diesel engine speed, decreasing slightly with an increase in pressure. The maximum flowrate of the pump was found to be 16 gpm at 500 psi at an engine speed of 2,600 rpm. The diesel engine speeds required to operate one tool (7 gpm) or two tools simultaneously (14 gpm) were 1,100 rpm and 2,400 rpm, respectively. At 14 gpm and 2,000 psi, the diesel was operating near maximum design horsepower with little reserve capacity available.

Figure 3. High-pressure pump performance.

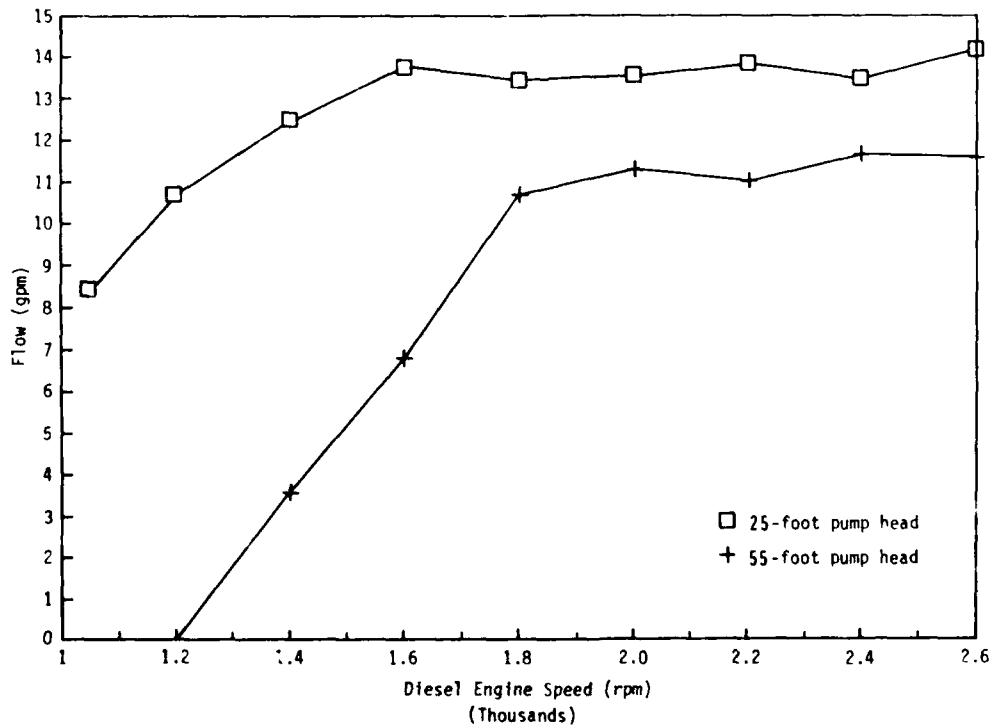
Although the design requirement is to lift water to a 50-foot height, the jet eductor pump was tested at an equivalent head of 55 feet to account for line losses. The resulting data, plotted in Figure 4, show the net flow output of the jet eductor pump as a function of pump head and diesel engine speed. From the data obtained, the engine speeds required for the jet eductor pump to lift 7 gpm and 14 gpm against a 50-foot head were determined.

At 1,400 rpm and a discharge head of 25 feet, the lift capacity of the eductor pump was 12.5 gpm. At a discharge head of 55 feet, this net flow dropped to 3.6 gpm.

Figure 4. Jet eductor pump performance.

The engine rpm required for the jet eductor pump to lift a net 7 gpm against a 55-foot pump head was about 1,600 rpm. The maximum net flowrate against a 55-foot discharge head was 11 gpm at diesel speeds above 2,000 rpm.

As seen in Figure 4, at a 55-foot lift, the jet eductor pump was not able to meet the design requirements even at a maximum engine speed of 2,600 rpm.

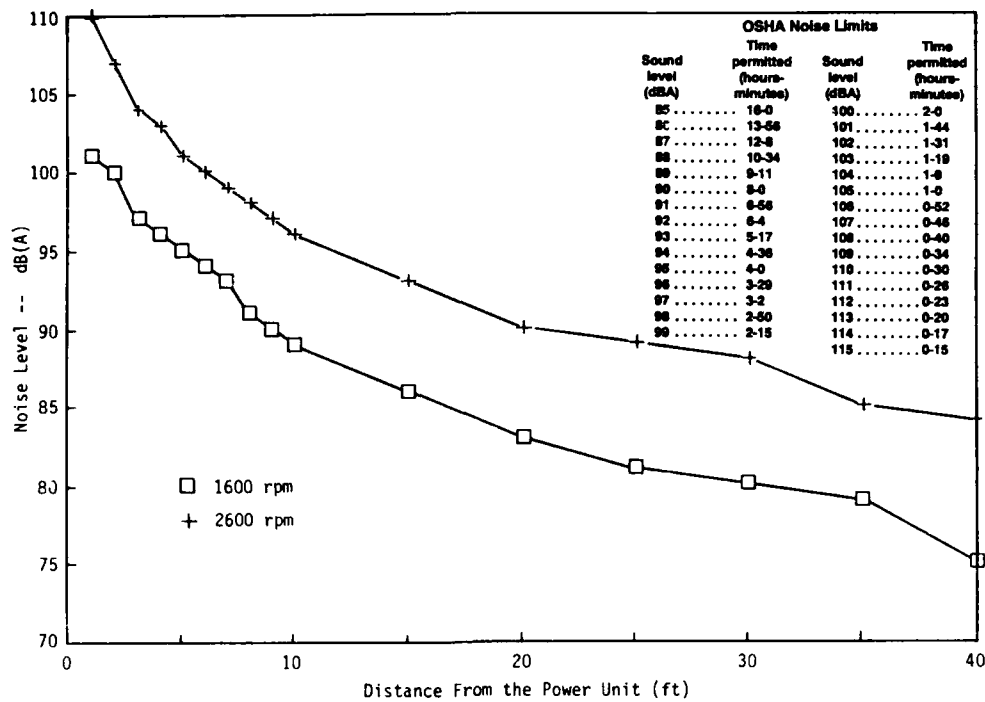
Noise level. Noise levels of the power source were measured using an integrated sound level meter on an "A" weighted scale at operating speeds of 1,600 and 2,600 rpm. The noise levels were plotted as a function of the distance from the power unit, and are shown in Figure 5. Occupational Safety and Health Administration (OSHA) noise limitations are also shown in Figure 5.

The noise level ranged from a minimum of 75 dB(A) at 40 feet from the power unit with the engine running at 1,600 rpm, to a maximum of 114 dB(A) at 1 foot from the power unit with the engine running at 2,600 rpm. Background noise level was 71 dB(A). The safe allowable exposure limits can be determined by using the OSHA table in Figure 5. For example, for individuals working within 5 feet of the power unit, the noise

Figure 5. Power unit noise output.

level is 100 dB(A) at 1,600 rpm and 105 dB(A) at 2,600 rpm. The OSHA table shows the length of time allowed without ear protection is 2 hours at 100 dB(A) and 1 hour at 105 dB(A). It is recommended that hearing protection be used at all times when working in close proximity to the power unit.

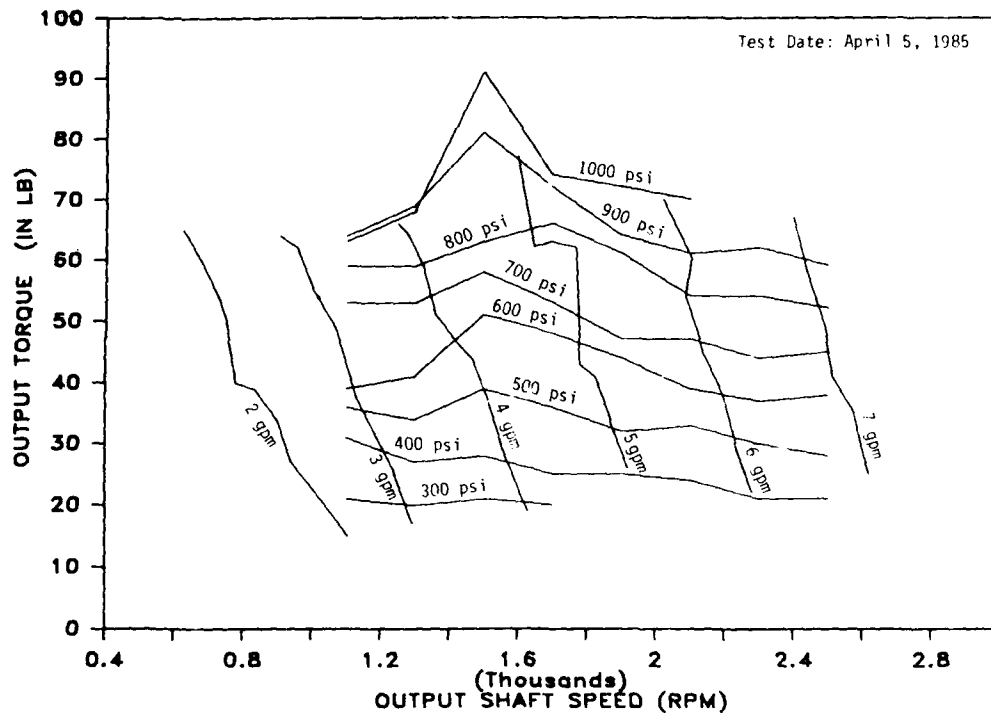
Initial Operating Characteristics. The performance of the RDT was measured with the tool installed on a Multi-Purpose Test Apparatus (MPTA), Figure 10. The MPTA provided for submerged measurements of torque and speed. Figure 11 is a plot of shaft torque versus speed for lines of constant flow and constant pressure.

Figure 11. Rotary disk tool: initial performance.

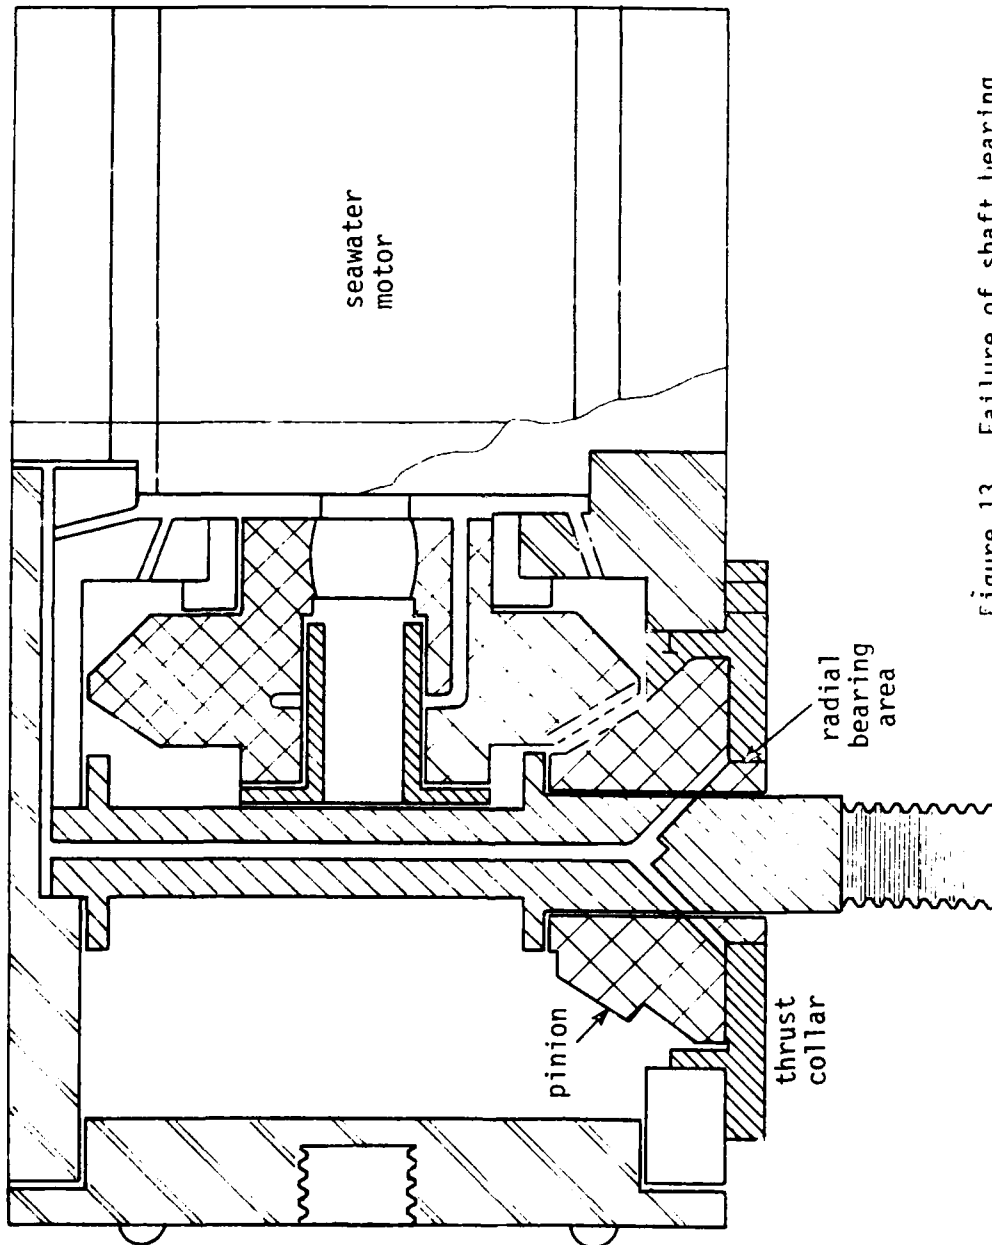
Early results showed rapid wear at the output shaft bearing in the area between the pinion and the thrust collar (Figure 13). The shaft bearing, thrust bearing, and pinion gear were designed as an integral unit. Investigation revealed that the radial bearing surface area was inadequately sized to handle the loads. The bearing was redesigned as a two-piece unit with a larger surface area for carrying the radial shaft loads (Figure 14).

Figure 13. Failure of shaft bearing.

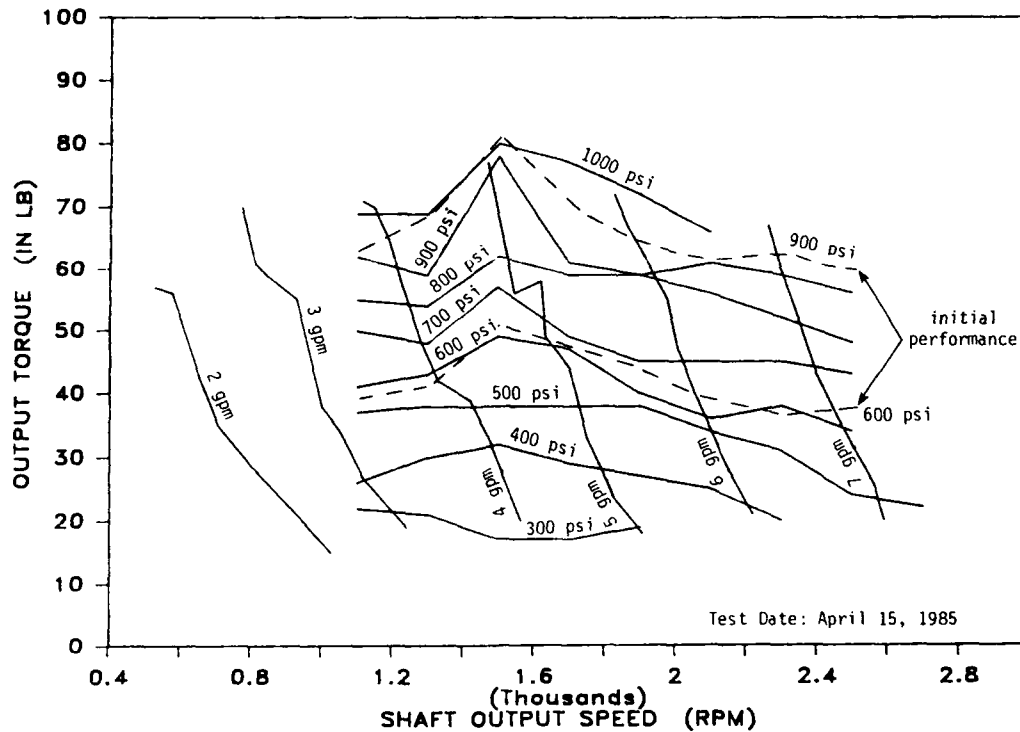
Post-Life Performance Test. With the endurance test complete, the tool performance was measured to check for any degradation in performance. This test was conducted in the same manner as the initial performance test (Figure 10). The results, displayed in Figure 15, show an insignificant decrease in tool performance when compared to the earlier results of Figure 11. It should be noted that the seawater motor at the end of the tests had only operated for half of its expected life. It is designed to operate for 250 hours at 80 percent of the rated power of 3 horsepower.

Figure 15. Rotary disk tool: final performance.

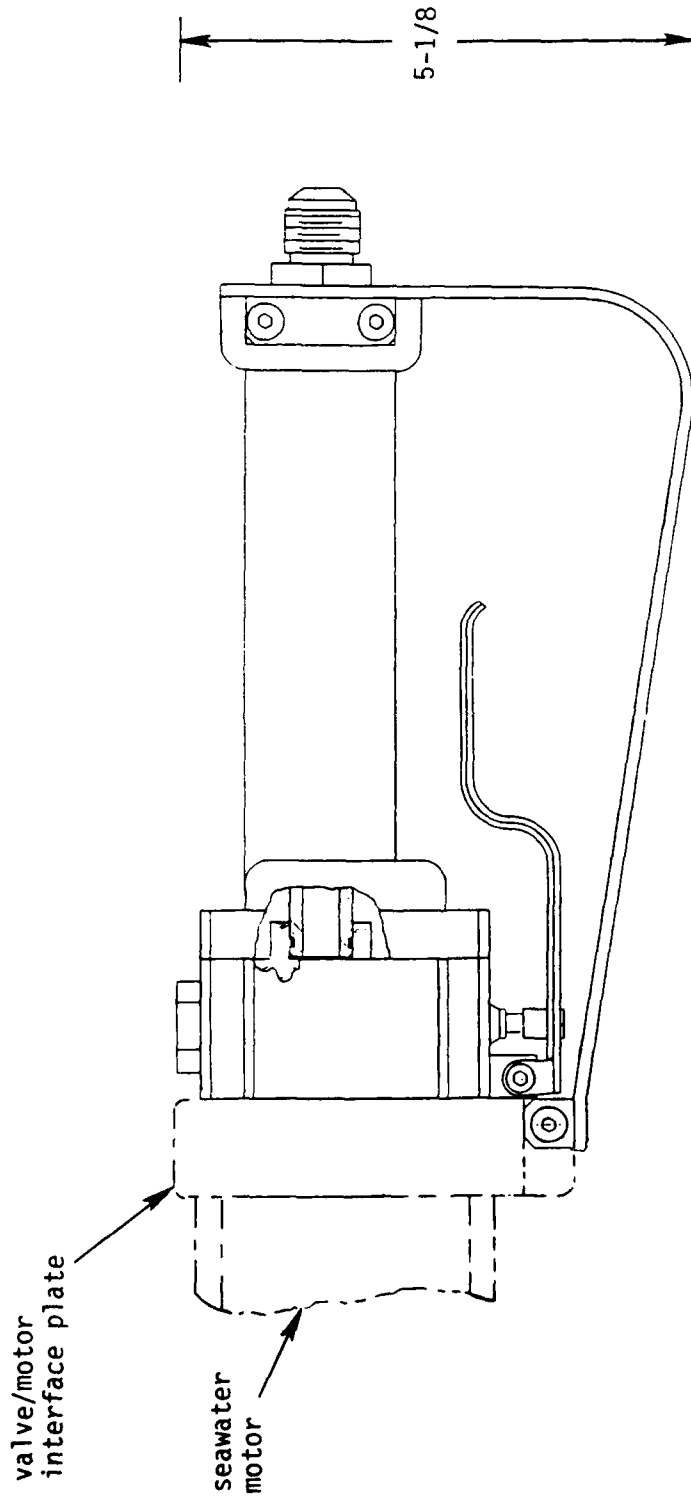
The modular control valve and handle assembly (Figure 18) provided a shorter trigger to allow two-finger operation and a full hand guard. The valve design is similar to the valve tested on the prototype rotary impact wrench.

Figure 18. MFTS control handle assembly.

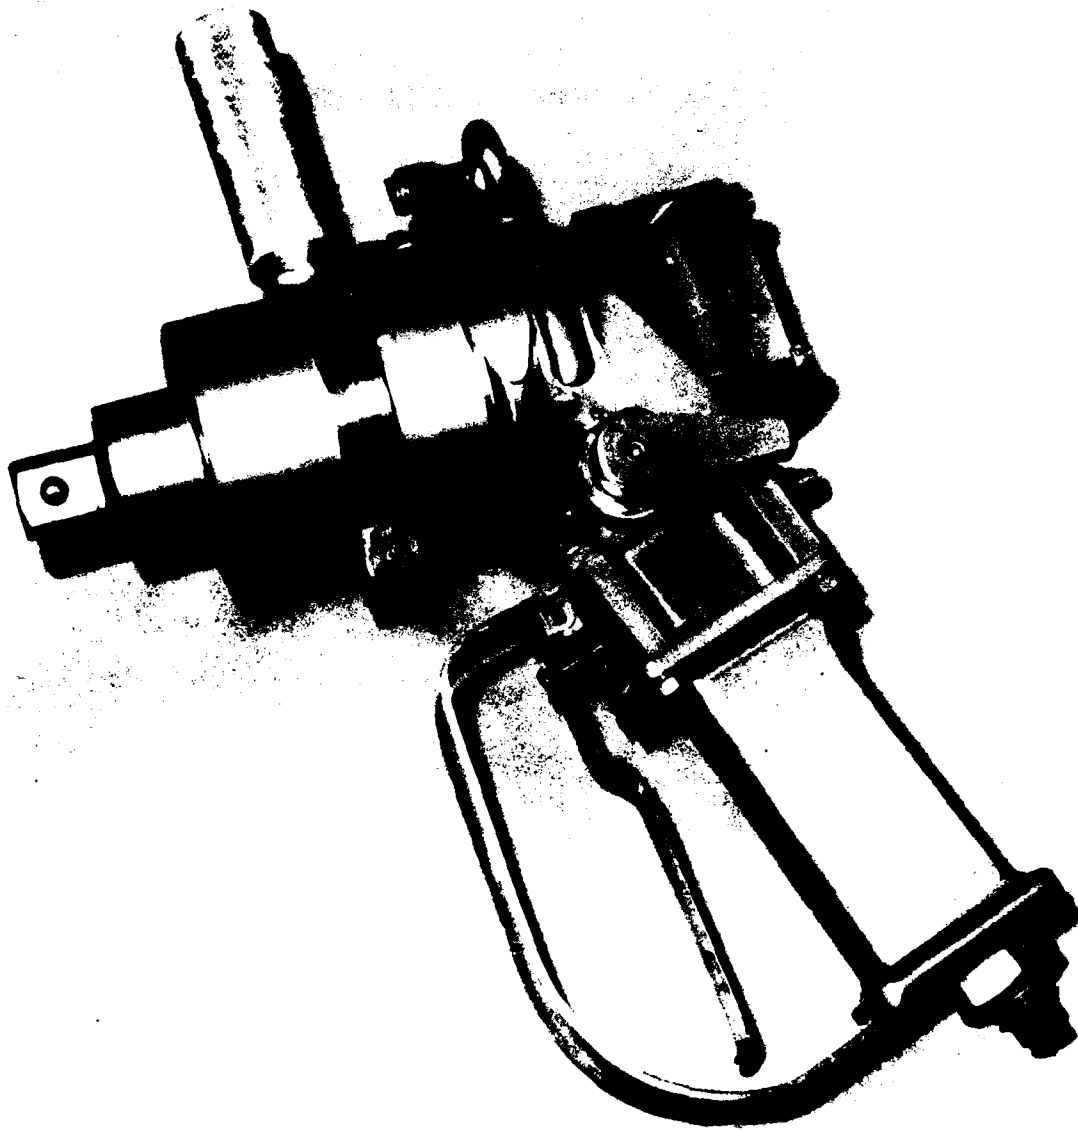
The seawater hydraulic rotary impact tool (Figure 19) uses a commercially available impact mechanism from a pneumatic impact wrench. The design of the tool centers around a cast Inconel backhead to which the seawater motor, the valve and handle, and the impact housing are attached (Figure 20). Integral with the backhead is the rotary reversing valve and the porting to control the direction of the 3-horsepower seawater motor. The reversing valve rotates 180 degrees and is operated by a handle on the left side of the tool.

Seawater enters at the bottom of the handle and is regulated by a poppet valve at the handle trigger. After being directed by the reversing valve through the seawater motor, the water passes back through the reversing valve and is exhausted just above the handle guard.

Figure 19. Seawater hydraulic powered rotary impact tool.

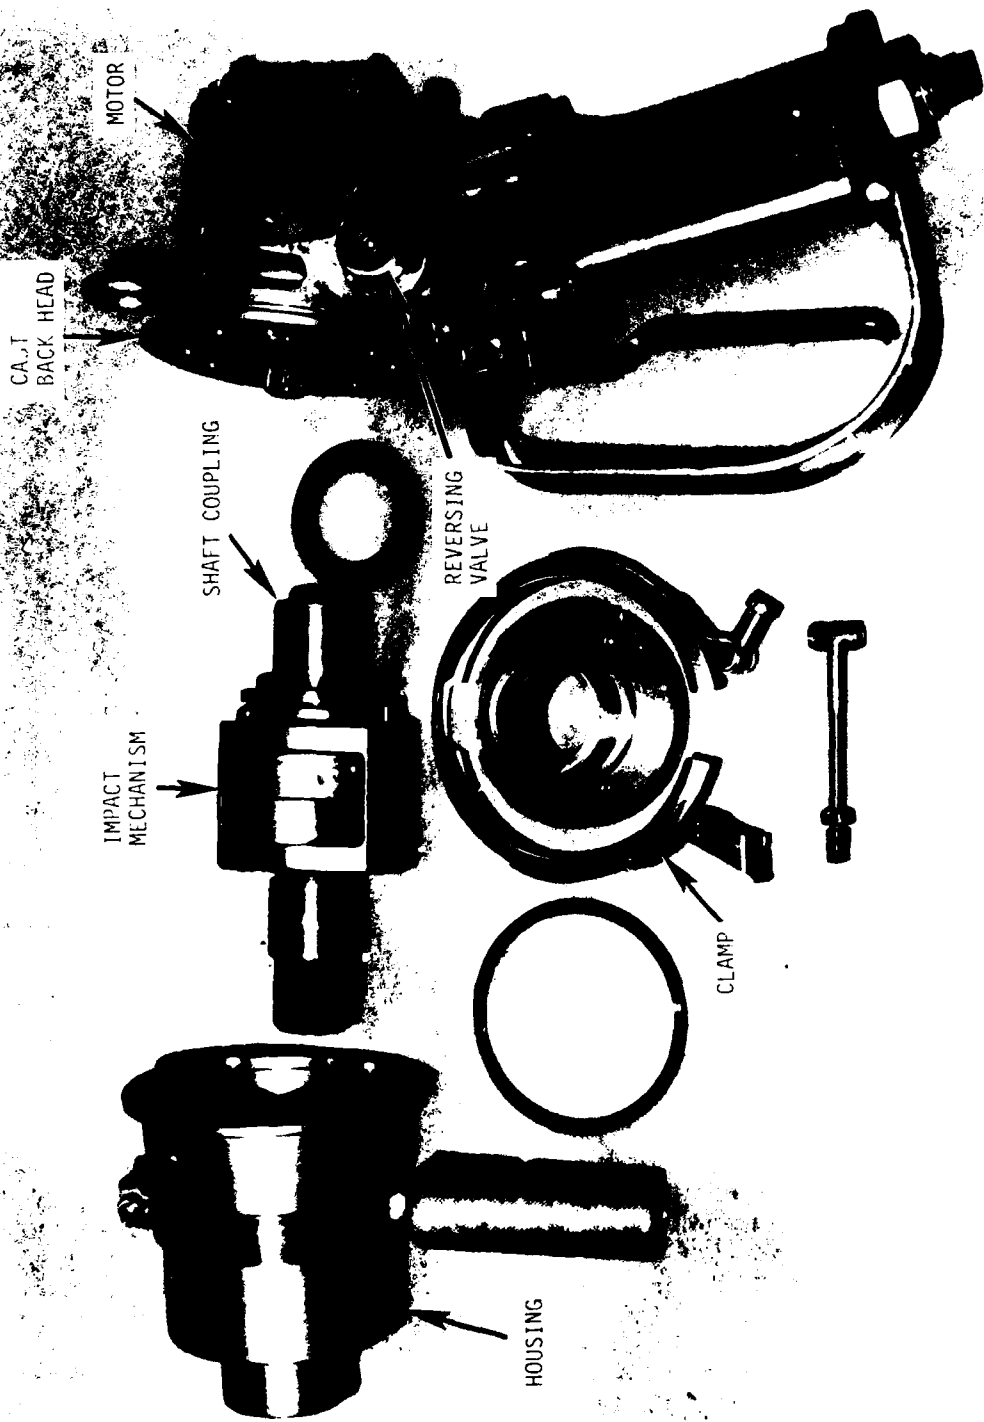
Figure 20. Exploded view of rotary impact tool.

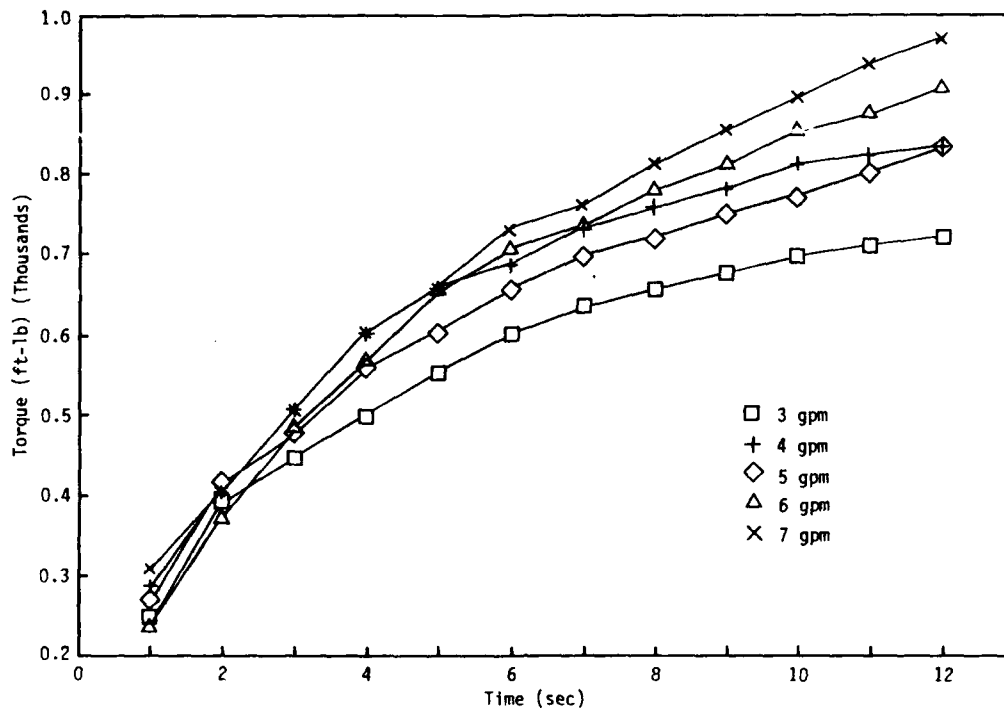
Figure 22. Impact wrench performance curve.

Initial Operating Characteristics. Tool performance was measured using the Skidmore Wilhelm impact tester. Figure 22 is a graph of torque as a function of impact time, in seconds, for five different flowrates. The hydraulic relief pressure was held constant at 750 psi during this test.

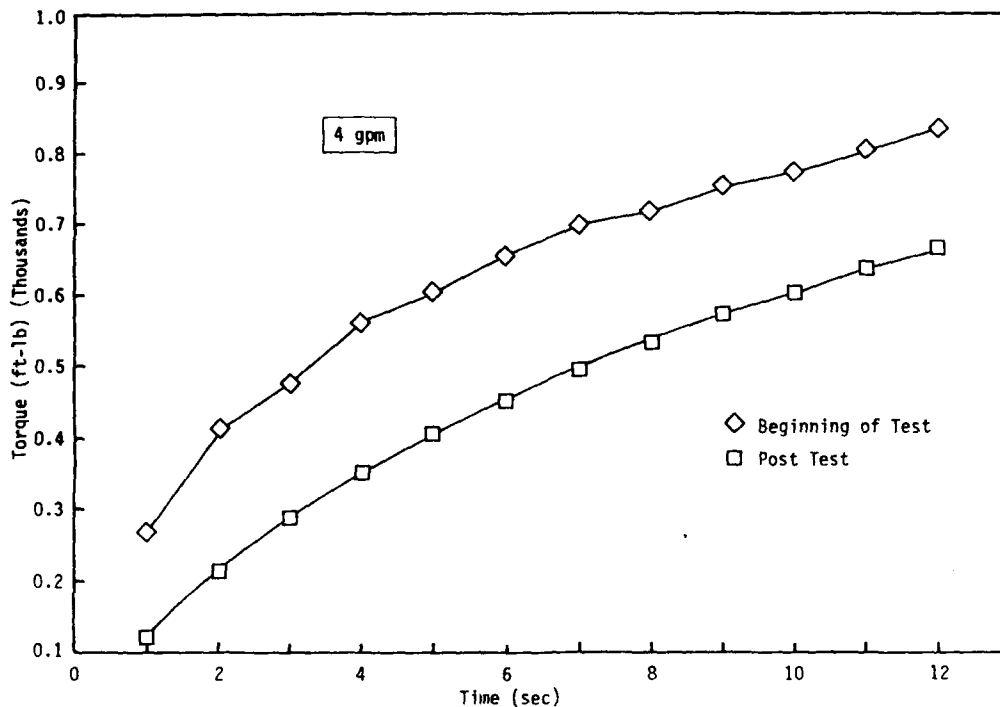
Figure 23. Impact wrench performance.

Post-Life Performance Test. Performance data were taken following life testing and compared with the initial data. A comparison of initial performance with post-life performance at a flowrate of 4 gpm, shown in Figure 23, reveals some deterioration in the performance of the tool. The initial performance data indicated that the 400 foot-pound torque could be achieved in 2 to 3 seconds. Post-life performance shows an increase to 4 to 5 seconds. The deterioration is attributed to increased leakage in the rotary reversing valve.

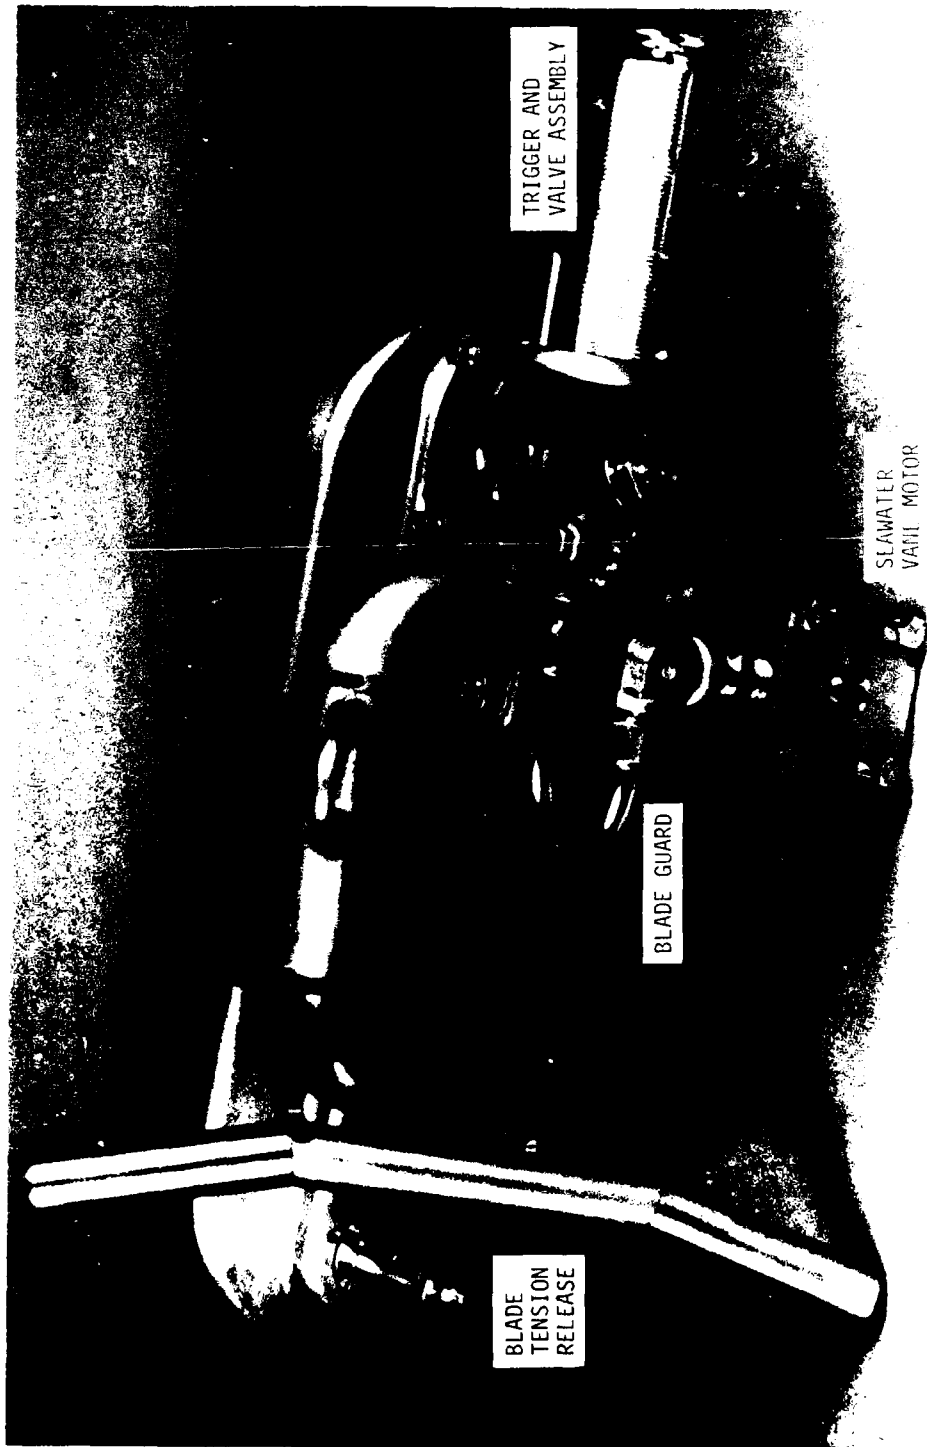
Figure 25. Seawater hydraulic bandsaw.

The MFTS seawater hydraulic bandsaw (Figure 25) is modeled after the oil hydraulic bandsaw currently used by the UCTs. The seawater bandsaw uses the same cutting section (chain, sprockets, and blade pulleys) as the oil hydraulic bandsaw. This section is taken from the commercially available Rockwell Porta Bandsaw. The gear box and motor are designed especially for seawater hydraulics. The gear box contains three levels of polyamide-imide gears, stainless steel pinions, and graphite bearings for a 20:1 gear reduction.

The seawater enters through a poppet valve to the 3-horsepower seawater hydraulic vane motor. The water is exhausted through the seawater motor into the gear box. A portion of the water is forced through the gear box to act as the lubricating fluid for the gears, pinions, and bearings. The excess is exhausted through ports in the top of the gear box. The water passing through the gear box is exhausted over the pulley drive chain to help it remain free from foreign particles. The pulleys have friction tape applied to them to allow the blade to slip when binding occurs so that the bandsaw does not twist in the divers hands. A blade guard retracts when the saw is put to the work. A quick-release lever relaxes tension on the following pulley to allow blade replacement. The blade is angled in the throat area to allow cuts up to 8 inches deep on materials up to 4.5 inches wide.

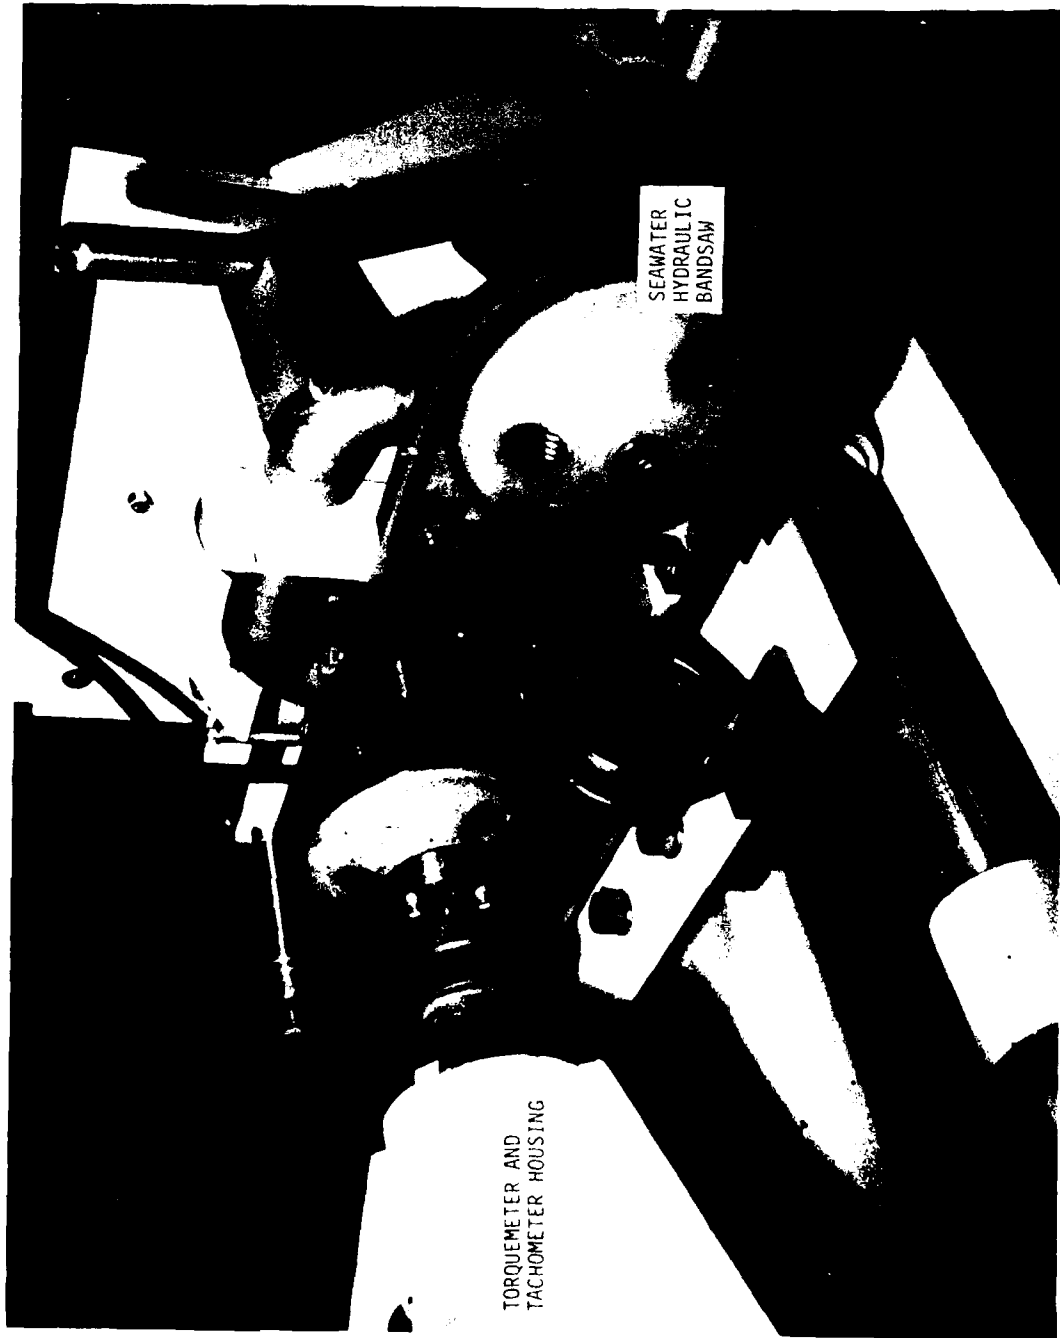
Figure 26. Seawater hydraulic bandsaw mounted on the multi-purpose test apparatus for performance testing.

The laboratory tests and evaluation of the seawater bandsaw were conducted at NCEL in the Seawater Hydraulics Laboratory and Ocean Systems Test Facility by NCEL personnel. The laboratory testing was conducted on the Multi-Purpose Test Apparatus (MPTA), a test stand designed to test seawater hydraulic tools submerged in water. The MPTA provided for submerged measurements of torque and speed, and remote operation. A photograph of the bandsaw in the MPTA is shown in Figure 26. The laboratory data can be found in Reference 10.

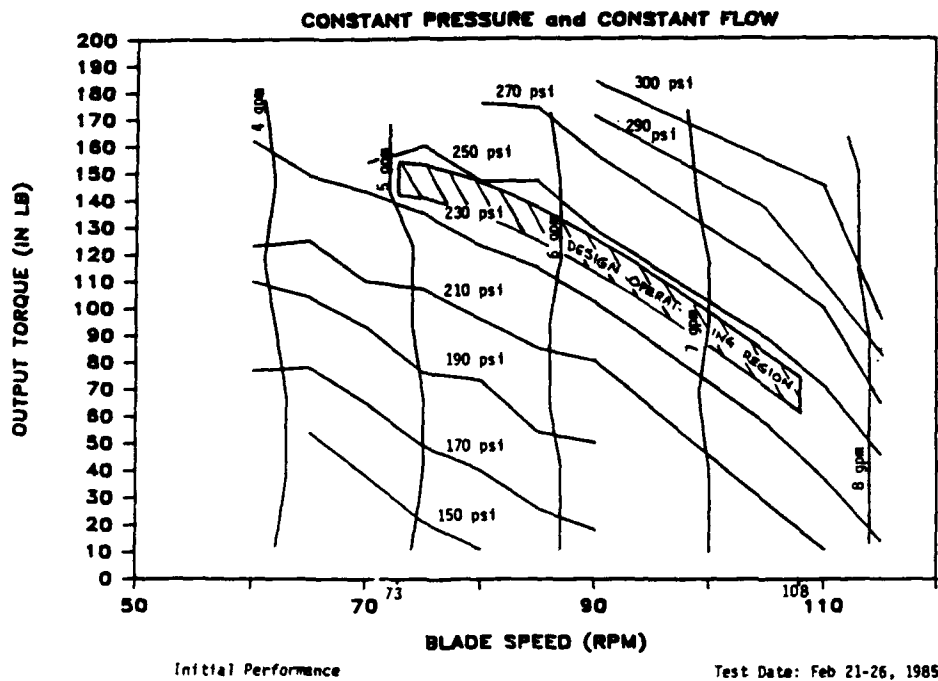
Figure 27. Initial bandsaw performance curves.

Initial Operating Characteristics. The performance of the bandsaw was measured with the tool installed on the MPTA. Figure 27 is a plot of shaft torque of the drive pulley versus speed for lines of constant pressure and constant flow. As expected, blade speed is dependent on flowrate and independent of pressure. This is a very desirable characteristic in the bandsaw where a constant blade speed results in more efficient cutting.

Performance data were obtained after the life testing to compare with the initial data. A comparison of Figure 27 and Figure 28 reveals an overall increase in the supply pressure required to yield a given torque. The lines of constant flow on both curves are very close, indicating that blade speed remains constant over the life of the tool.

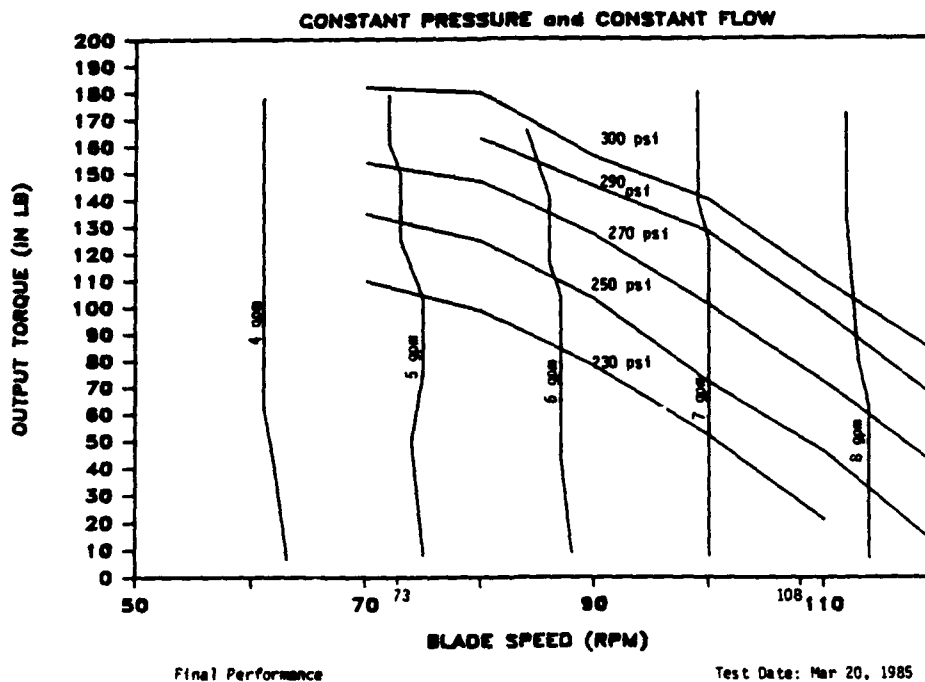
Figure 28. Final bandsaw performance curves.
