TECHNICAL REPORT HL-92-1

BRUSH CREEK, KANSAS CITY, MISSOURI

Hydraulic Model Investigation

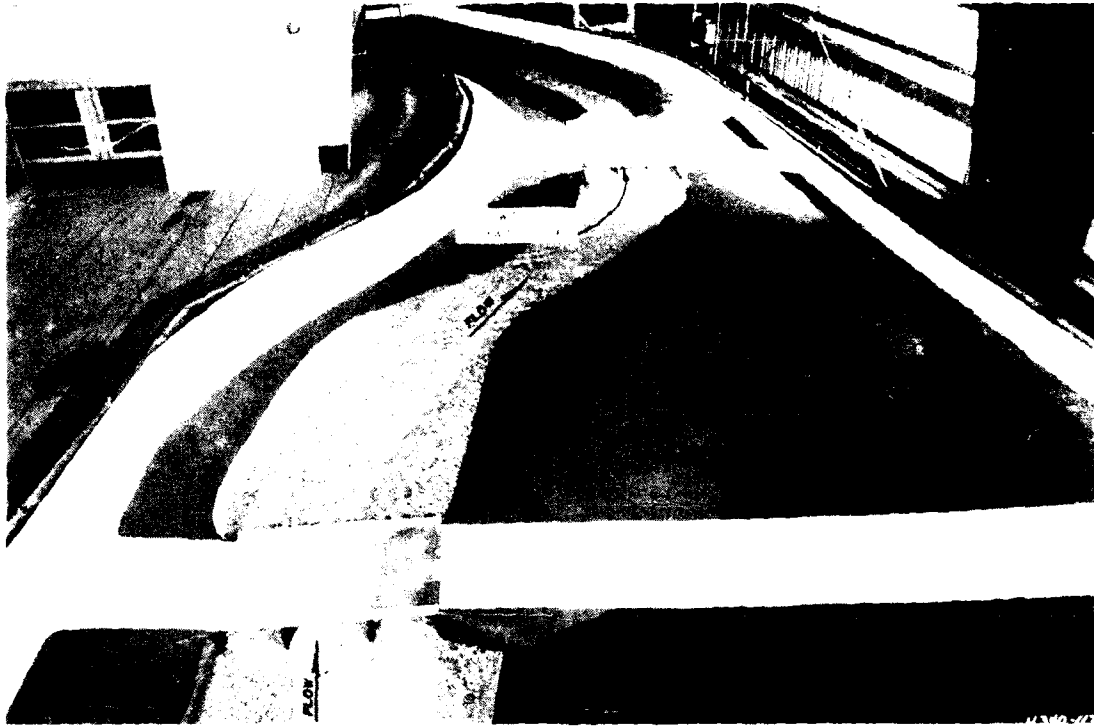
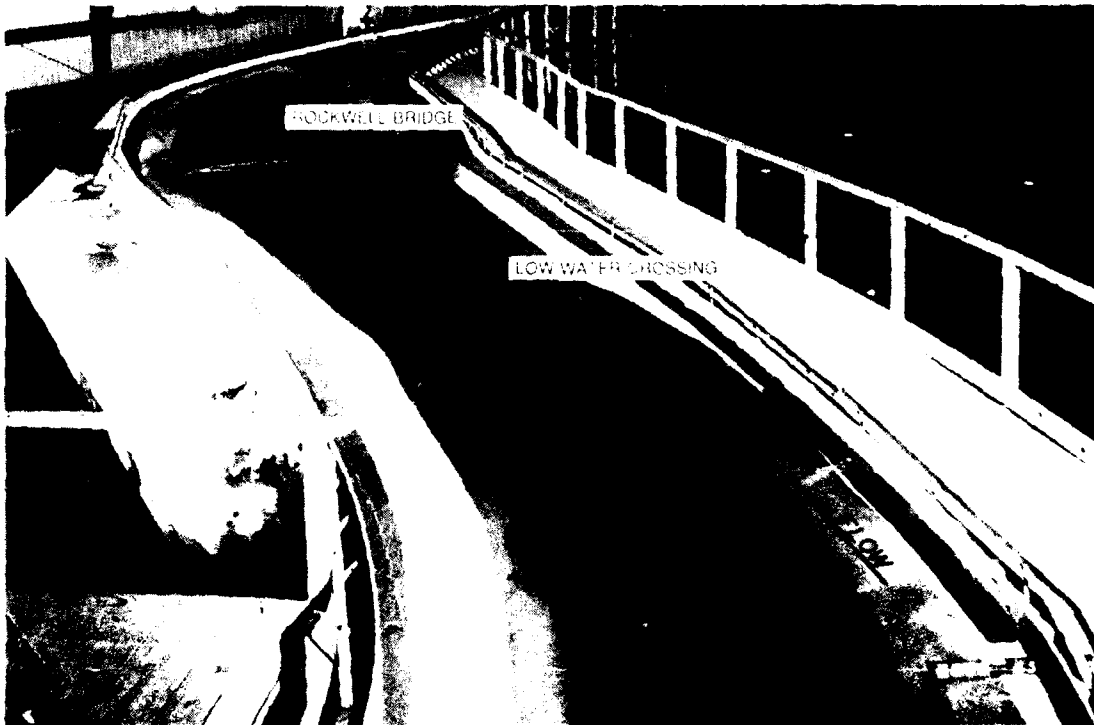
Photo 5. Existing conditions, 10-year flood (Sheet 1 of 4)

Photo 5. (Sheet 4 of 4)

18. Flow conditions observed at the State Line Road Bridge (Photo 4), the first bridge reproduced, indicated that the elevation of State Line Road is such that even a 10-year-frequency flow would overtop the roadway to the right (south) of the bridge (Photo 5a). It was also observed that the bridge would be overtopped with the 100- and 500-year-frequency flows (Photos 6a and 7a, respectively). During a major flood event, a significant amount of flow bypasses the bridge opening and reenters the channel further downstream. Water-surface profiles (Plate 2) showing the various degrees of restriction caused by the different bridges and tunnels were obtained for the 10-, 100-, and 500-year flood events using the discharges listed in Table 2. Flow conditions for the 10-, 100-, and 500-year frequency events are shown in Photos 5, 6, and 7, respectively.

19. The Ward Parkway Bridge (Photo 8) created an obstruction to the flow with nearly a 10-ft drop in water surface through and downstream of the bridge with the 100- and 500-year flow events. The 10-year flow safely passed underneath the Ward Parkway Bridge (Photo 5a). However, flows of 100 and

20. The low-water crossing (Photo 9), formerly 51st Street, has been barricaded to prevent vehicular traffic. Channel paving begins here and extends downstream. A conduit through the low-water crossing passes only very low flows. At higher flows, the low-water crossing becomes submerged, as shown in Photo 5b with the 10-year flood. Other flows are shown in Photos 6b and 7b. Upstream water-surface elevations were not influenced by the low-water crossing because it quickly became submerged and presented no major blockage to the flow.

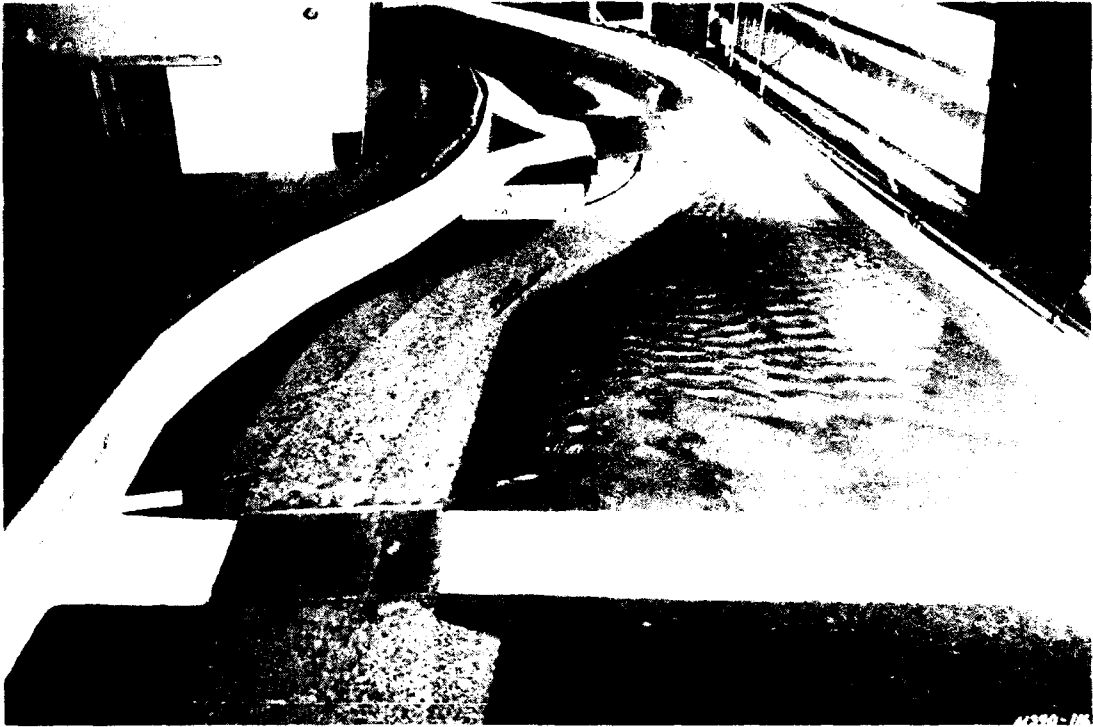
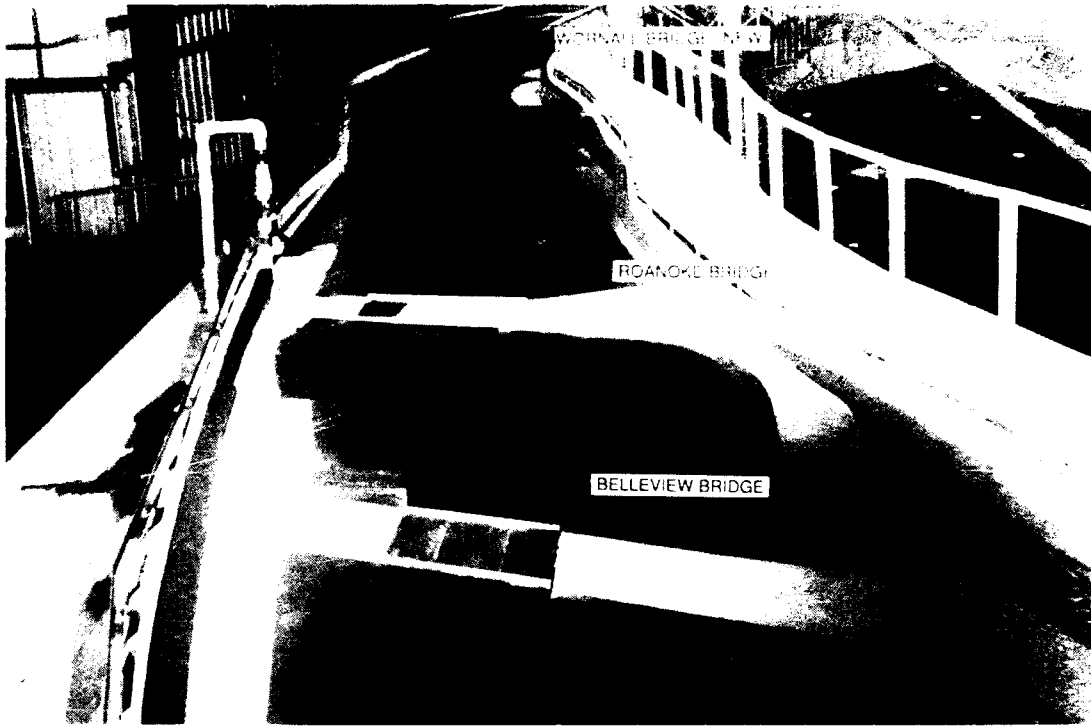
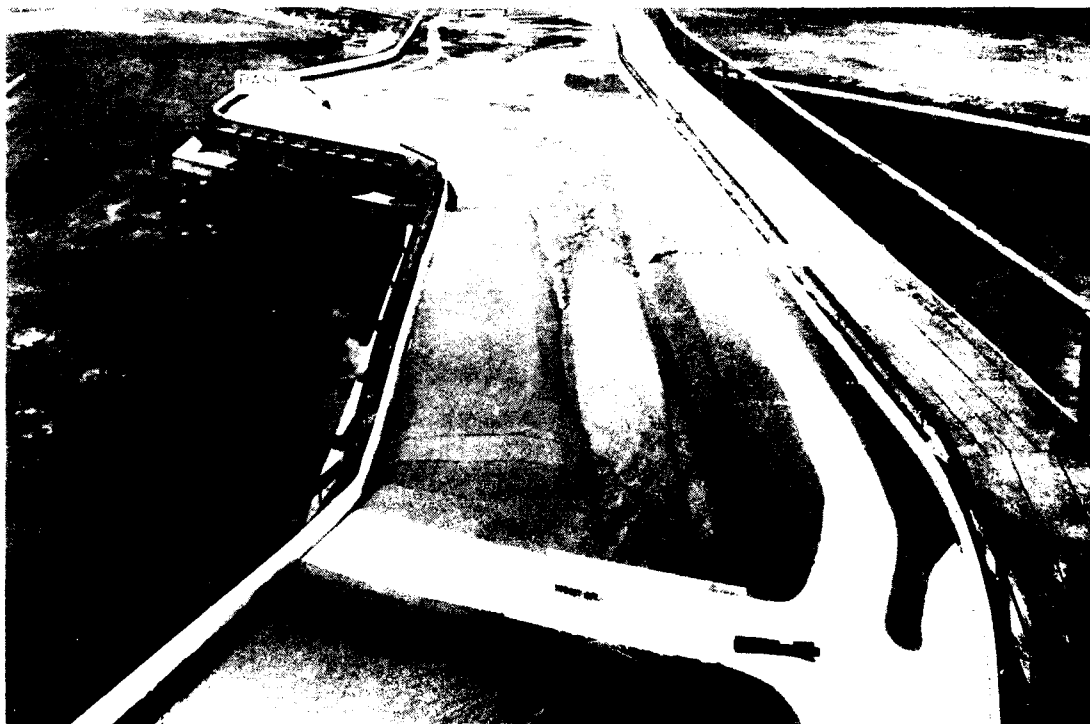
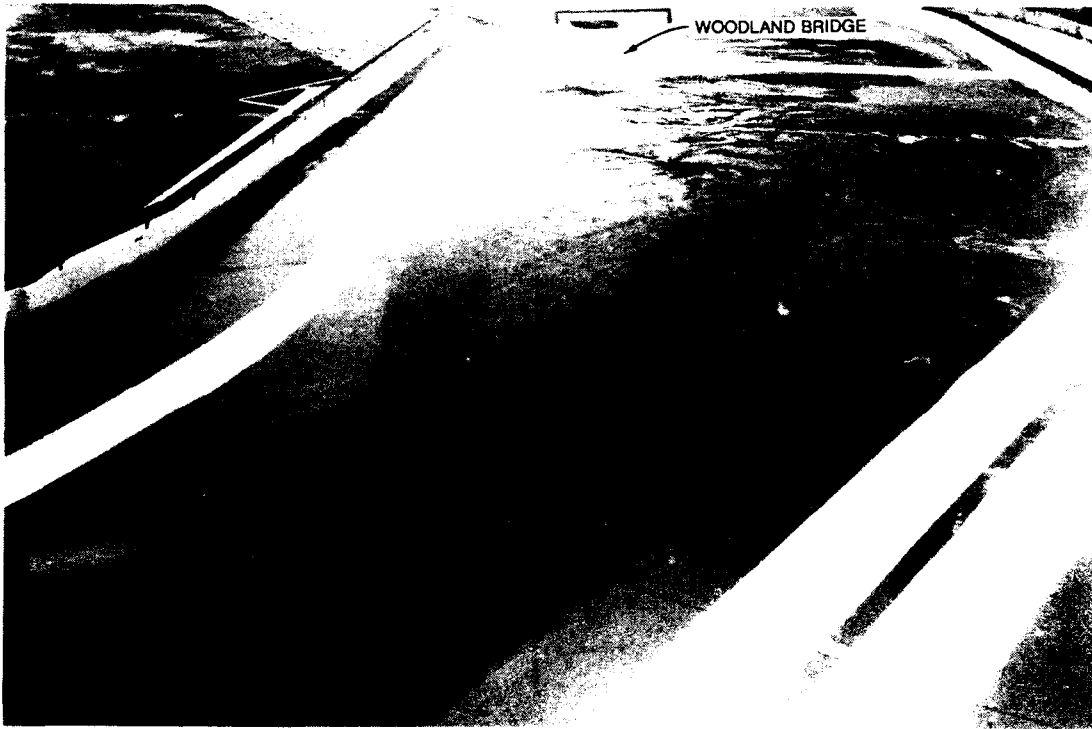
Photo 6. Existing conditions, 100-year flood (Sheet 1 of 4)

Photo 6. (Sheet 4 of 4)

500 years were obstructed by the bridge (Photos 6a and 7a, respectively). Under these conditions, water flowed over and around the bridge and re-entered the channel downstream.

23. The new Wornall Road Bridge (Photo 3) has streamlined piers and unconfined openings underneath and is less restrictive to flow conditions than the old Wornall Road Bridge (Photo 2). While the new bridge has less head loss, conditions downstream create a backwater effect and the new bridge becomes submerged at the 100- and 500-year discharges (Photos 6c and 7c, respectively).

side of the channel. Portions of this bridge also became submerged at the 100- and 500-year discharges (Photos 6d and 7d, respectively).

25. The J. C. Nichols Parkway Bridge (Photo 14) also has streamlined piers and unconfined openings underneath. This bridge passes the 100-year flow. However, the roadway on the left side was overtopped at the 100-year flow (Photo 6d).

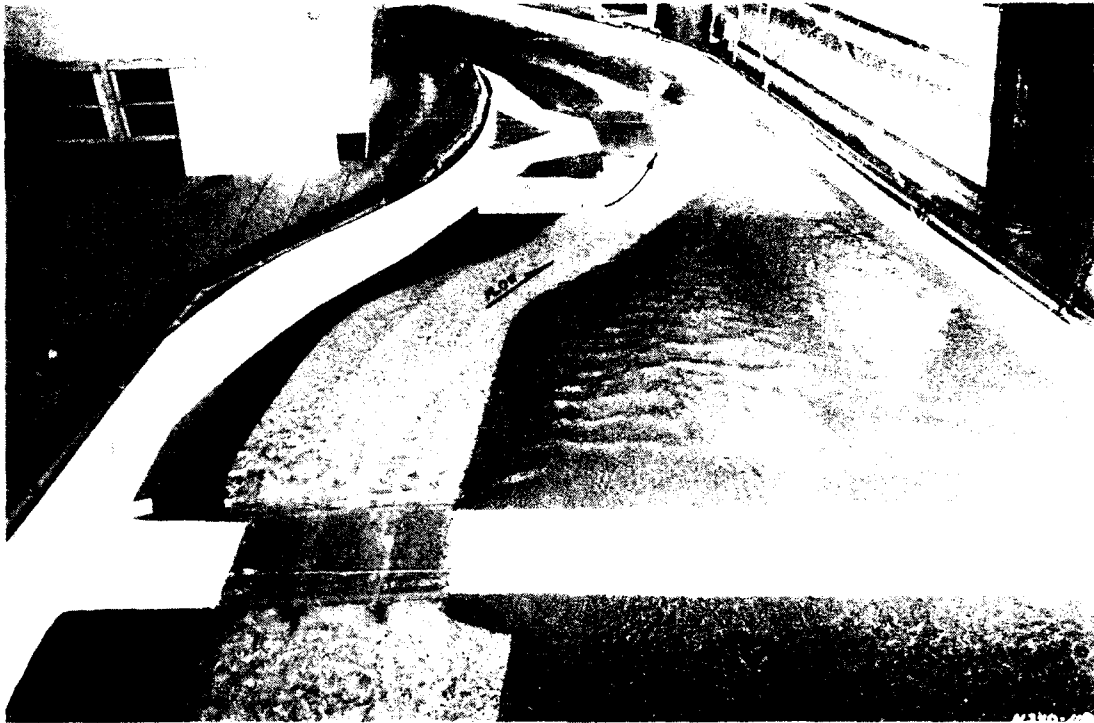
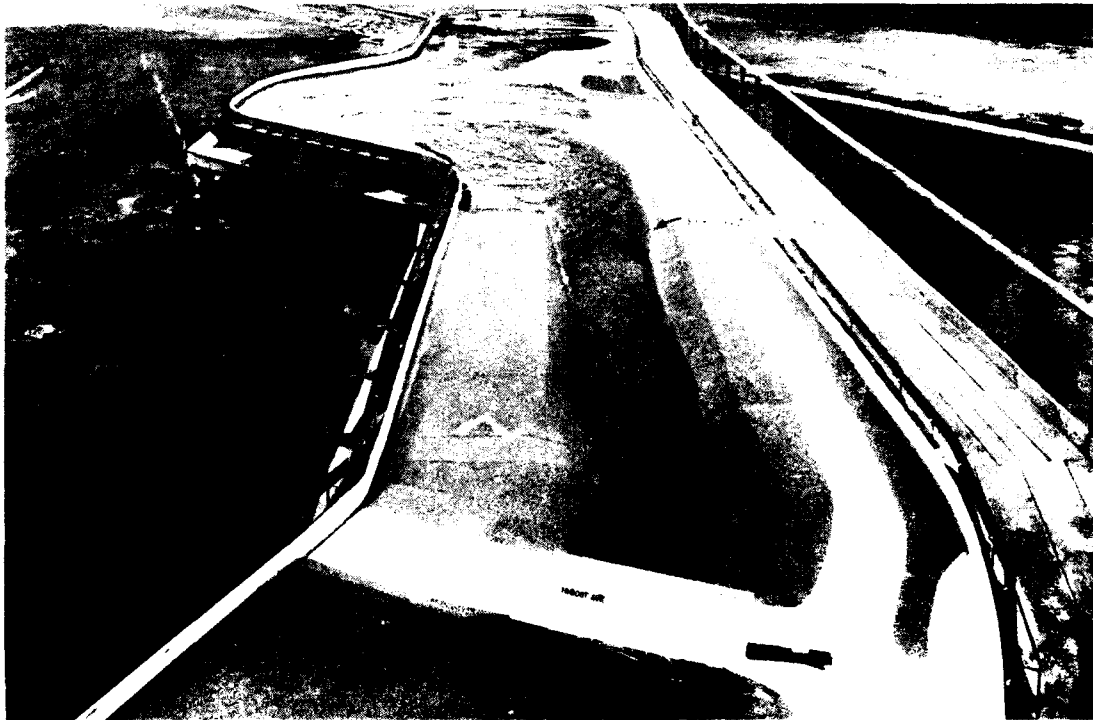
Photo 7. Existing conditions, 500-year flood (Sheet 1 of 4)

Photo 7. (Sheet 4 of 4)

26. The Main Street Bridge (Photo 15) presents a narrow flow opening, but the elevations of the bridge and roadway were high enough that they were not overtopped even with the 500-year flow (Photo 7d). However, the Kansas City Public Service (KCPS) Railroad bridge (Photo 16) was very restrictive for all flows (Photos 5d, 6d, 7d), due to the low steel elevation and the bridge abutments located in the channel. The combined effects of both these bridges raised upstream water-surface elevations in the vicinity of the Plaza approximately 4 ft.

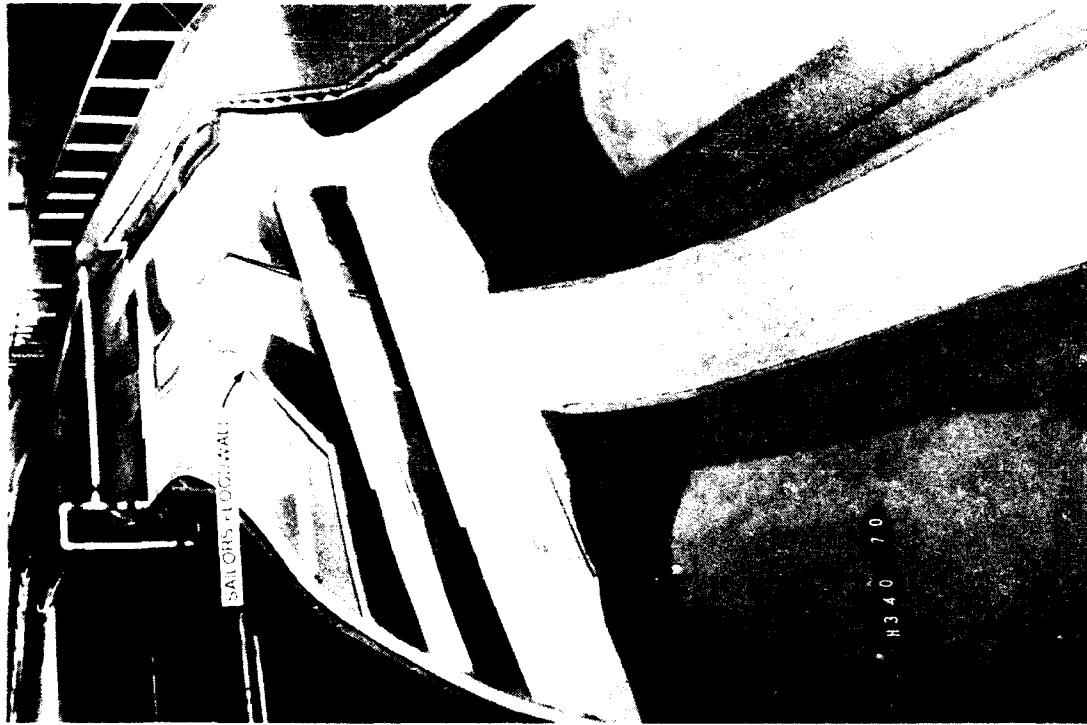
a. Sta 39+00 to sta 70+00

b. Sta 70+00 to sta 94+00

Photo 22. Corps BCP-9 Plan (Continued)

c. Sta 94+00 to sta 114+00

Photo 22. (Concluded)

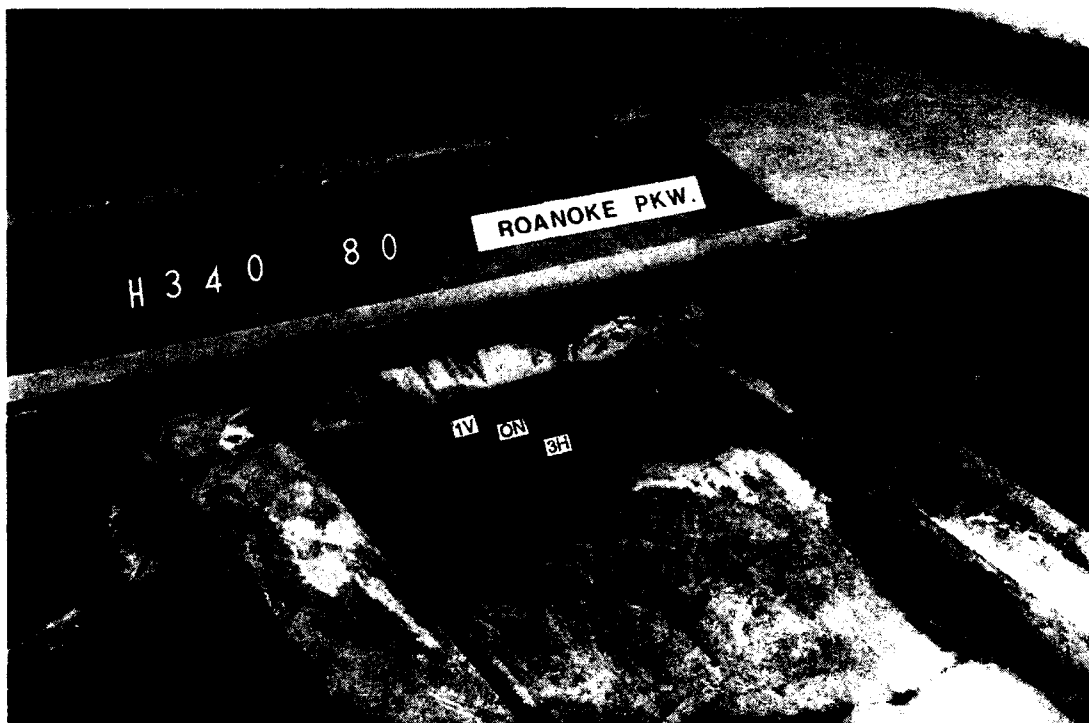
Photo 27. Transition into BCP-9 Plan (1V on 3H slope)

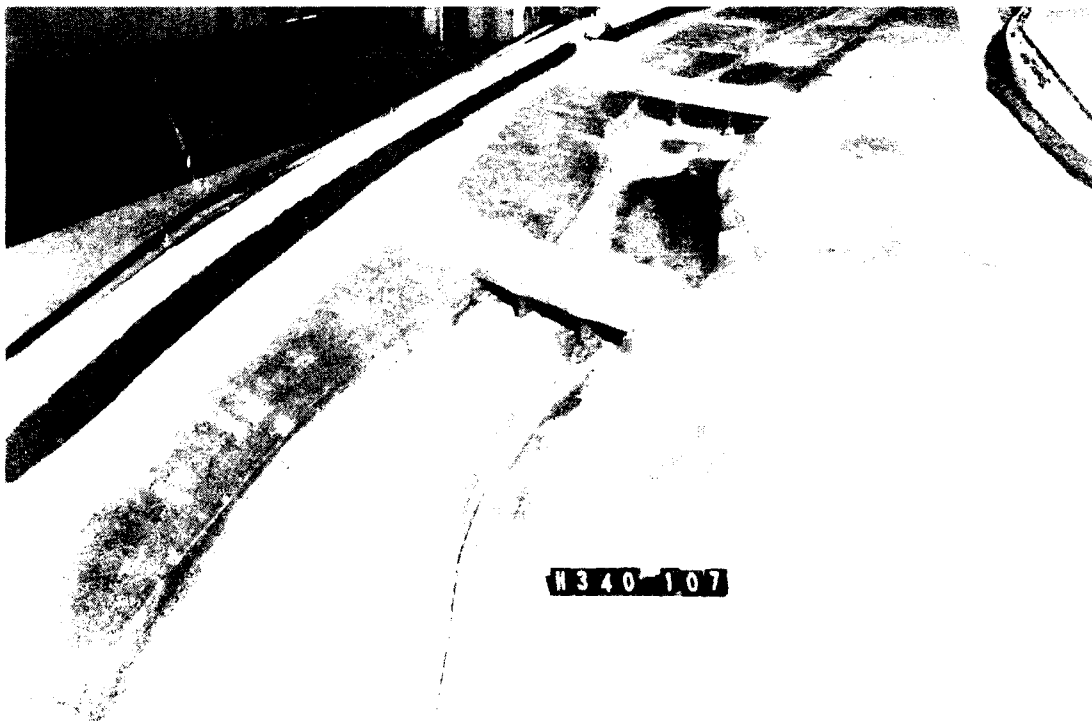
a. Sta 20+00 to sta 31+00

b. Sta 34+00 to sta 40+00

Photo 35. City upstream plan

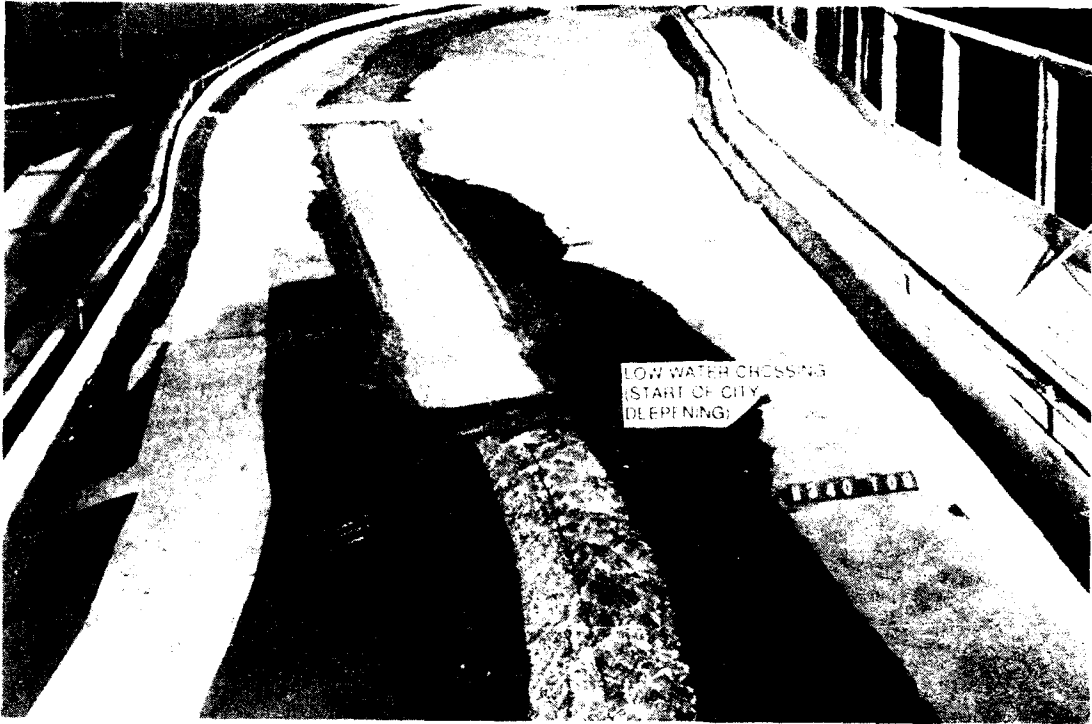
a. Sta 18+00 to sta 36+00

b. Sta 31+00 to sta 40+00

Photo 37. City upstream deepening plan, 10-year flood

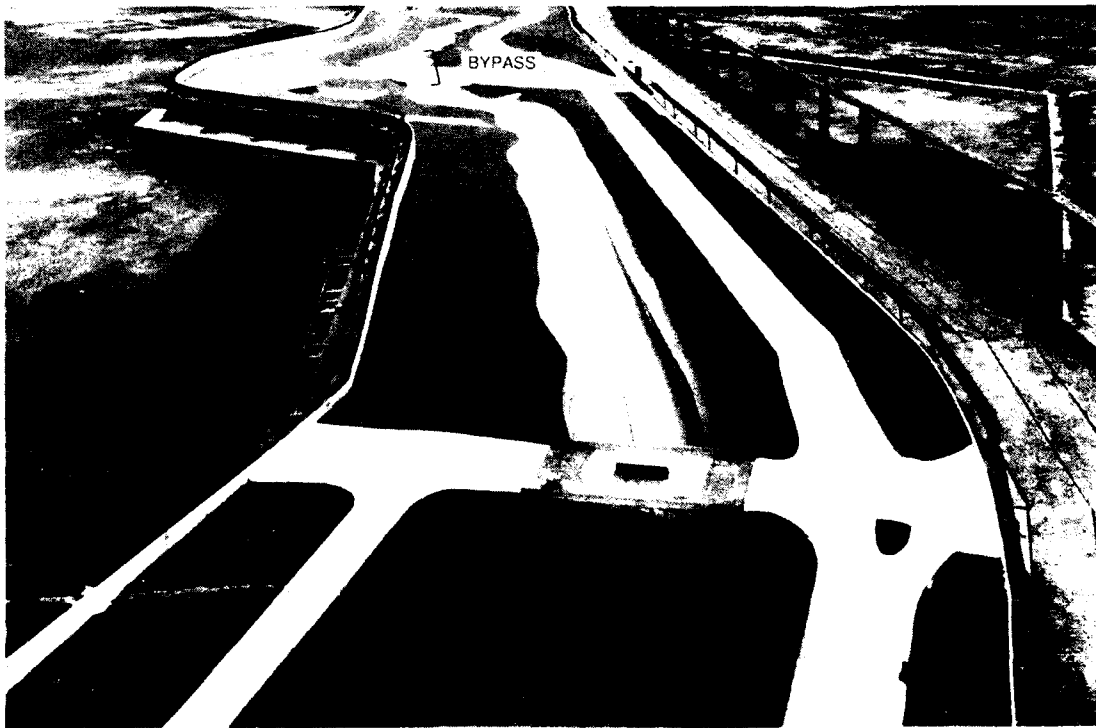
Photo 40. Park Plan (Continued)

b. Sta 60+00 to sta 84+00

c. Sta 81+00 to sta 112+00

d. Sta 112+00 to sta 147+00

turned the flow some 90 deg, and flooding frequently occurred (Photos 5f, 6f, and 7f). The Park Plan calls for bypassing the existing tunnel with a straightened open channel (Photo 40d). Two new bridges will span the channel on Paseo Boulevard (Photo 58). Dam 4 initially was to be located under the downstream bridge.

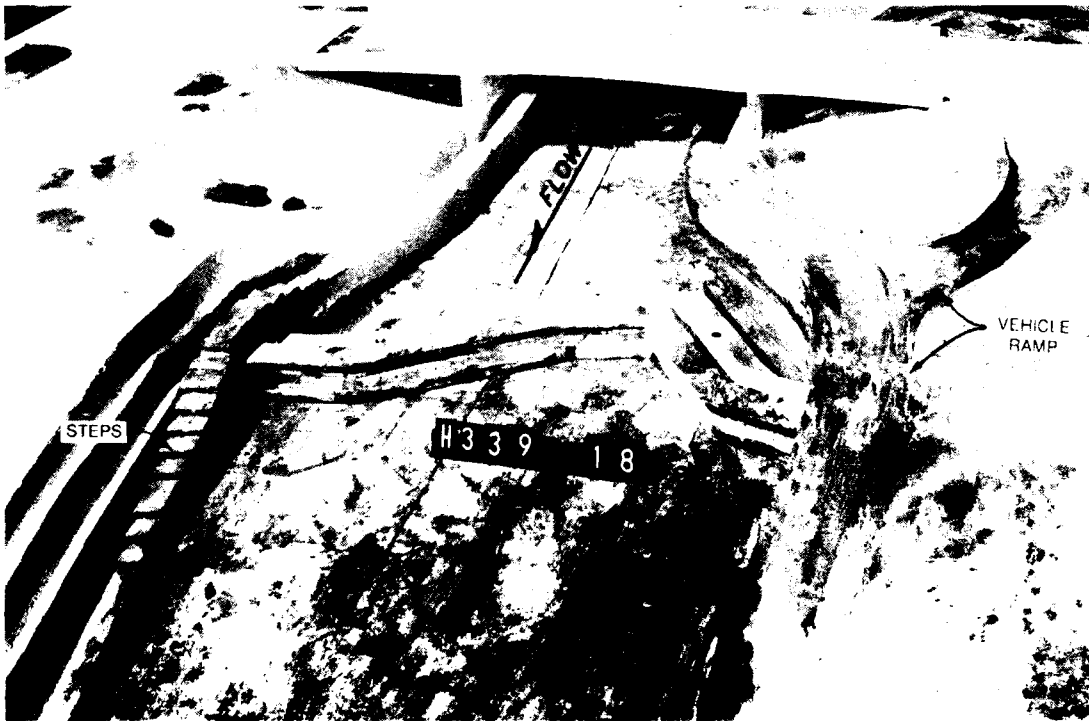
Photo 42. Irregular dam 1, sta 68+65

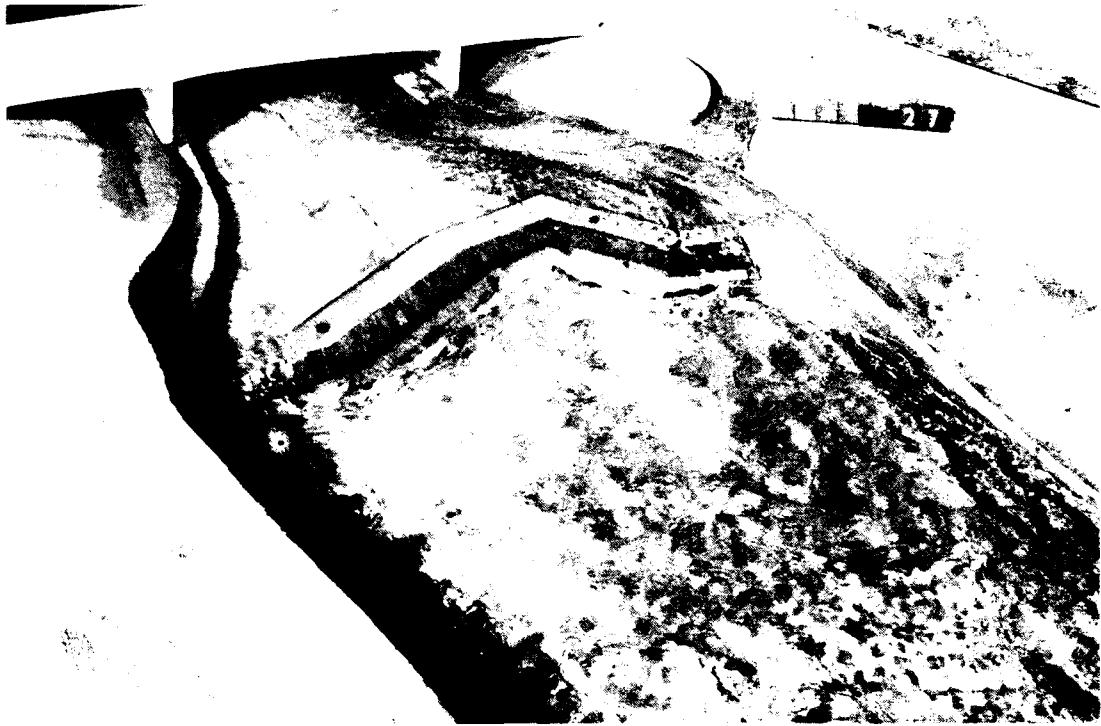
Photo 43. Flow conditions at irregular dam 1 (sta 68+65) (Continued)

a. 10-year flood

b. 100-year flood

c. 500-year flood

66. Some concern was expressed as to what effect the irregular shape of the dam would have on flow conditions. Flow conditions for the 10-, 100-, and 500-year flows, shown in Photo 43, indicated that no adverse effects would be caused by the irregular shape. Therefore, the irregular dam concept can be used throughout the Park Plan.

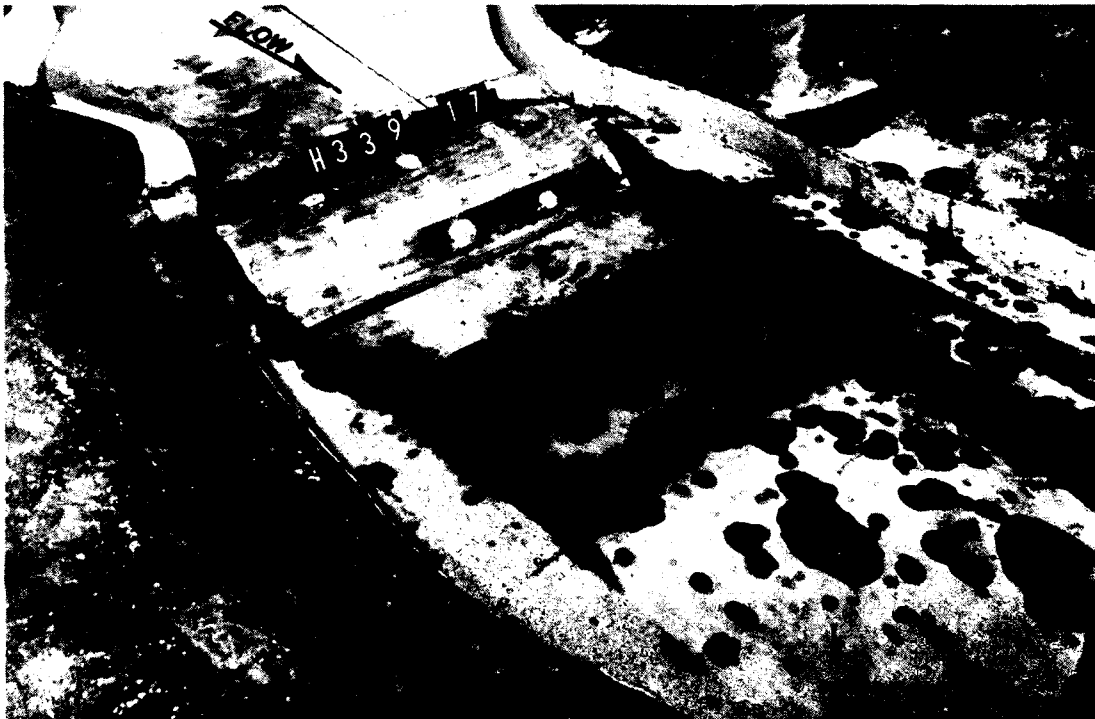
Photo 46. Drop 1, type 1 design stilling basin

69. Type 1 design. An uncontrolled hydraulic jump formed downstream of Roanoke Parkway that had great potential for scour and erosion. To dissipate the energy of the hydraulic jump, a drop structure was needed. Traditional straight drop structures, such as the Saint Anthony Falls type, could not be used because of the high design unit discharge (210 cfs/ft for a 100-year flood) required in this situation. In previous work at the US Army Engineer Waterways Experiment Station involving high unit discharge drop structures on the Santa Ana River, a general design was developed. This type of drop structure (Photo 46) was installed downstream of Roanoke to dissipate energy and improve flow conditions. Details and design information for the type 1 design drop structure are shown in Plate 17. Flow conditions at the drop structure, shown in Photo 47, indicated that the hydraulic jump was contained within the structure and energy dissipation was greatly improved over existing conditions. Downstream water-surface conditions were also improved. Although the drop structure was designed for a 100-year event, satisfactory performance was observed at 500-year discharge conditions.

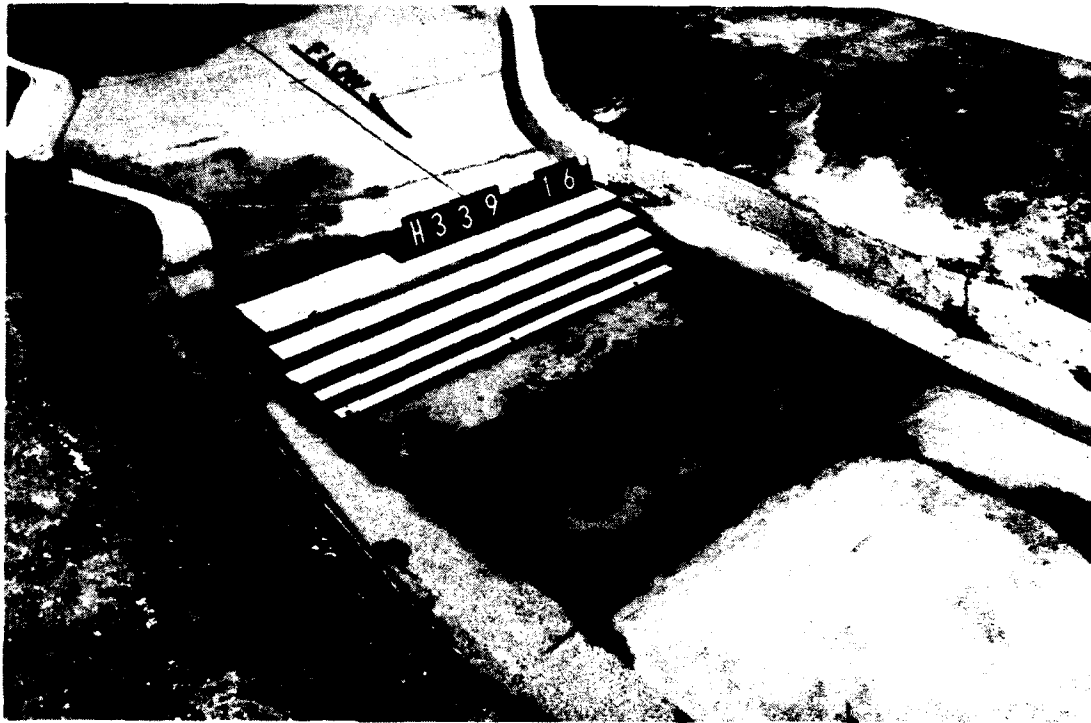
Photo 48. Drop 1, type 2 design stilling basin

70. Type 2 design. In spite of satisfactory performance of the type 1 drop structure, the parabolic curve of the trajectory did not conform to the overall aesthetics of the Park Plan. The curve was broken into steps of approximately 2 ft in height as shown in Photo 48. All other dimensions remained the same (Plate 17). Flow conditions shown in Photo 49 indicated that the stepped trajectory (type 2 design) did not perform as well as the parabolic trajectory (type 1 design).

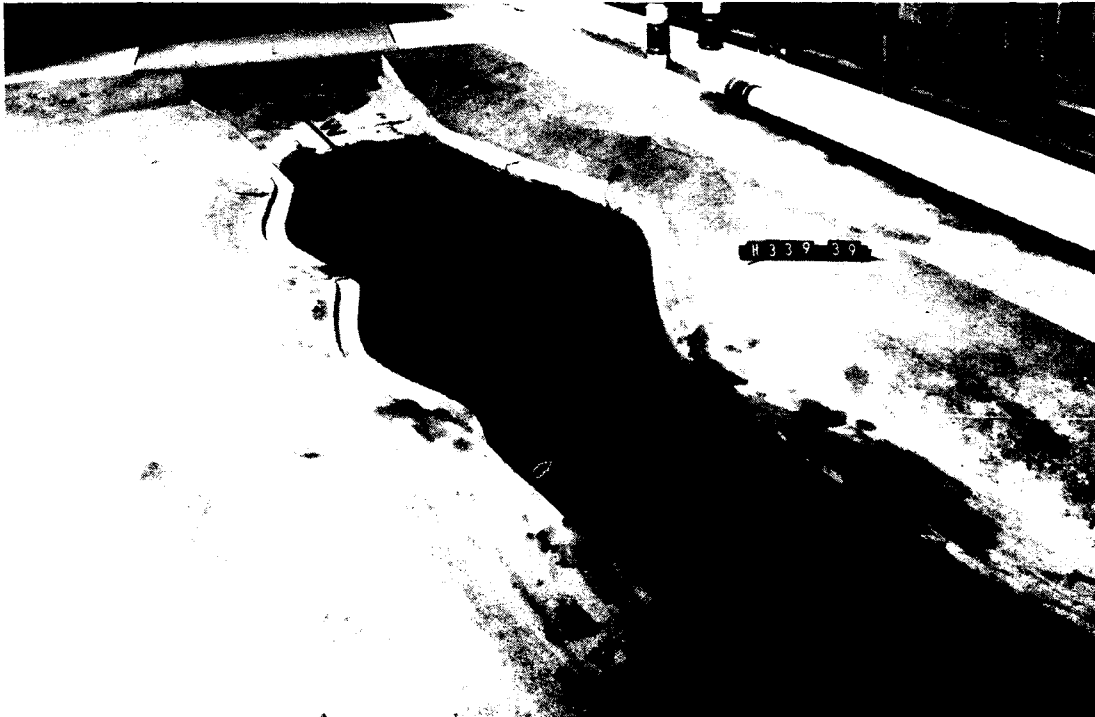
Photo 50. Drop 1, type 4 design stilling basin

72. Type 4 design. Although the type 3 design provided adequate energy dissipation, the roller formed by the hydraulic jump created a significant safety hazard for anyone attempting to float the stream during high flows. Therefore, the drop structure was redesigned with a series of horizontal steps 2 ft high. The steps were arched or horseshoe shaped in the upstream direction for aesthetic reasons. A shallow upstream pool was also added. This was designated the type 4 design and is shown in Photo 50. A plan view and center-line profile of the type 4 design are shown in Plate 19. As expected, flow conditions and energy dissipation were not as good as was observed with the previous design. However, the strong reverse roller was eliminated, which greatly improved safety. Flow conditions with the type 4 design are shown in Photo 51 for the 10-, 100-, and 500-year floods. A subsequent modification was made by placing blocks approximately 4 ft high on the steps at the side-walls. These blocks directed the flow to the center of the channel and dampened the large oblique standing waves previously created. Next, the upstream pool was narrowed with straight walls on both sides of the channel in an

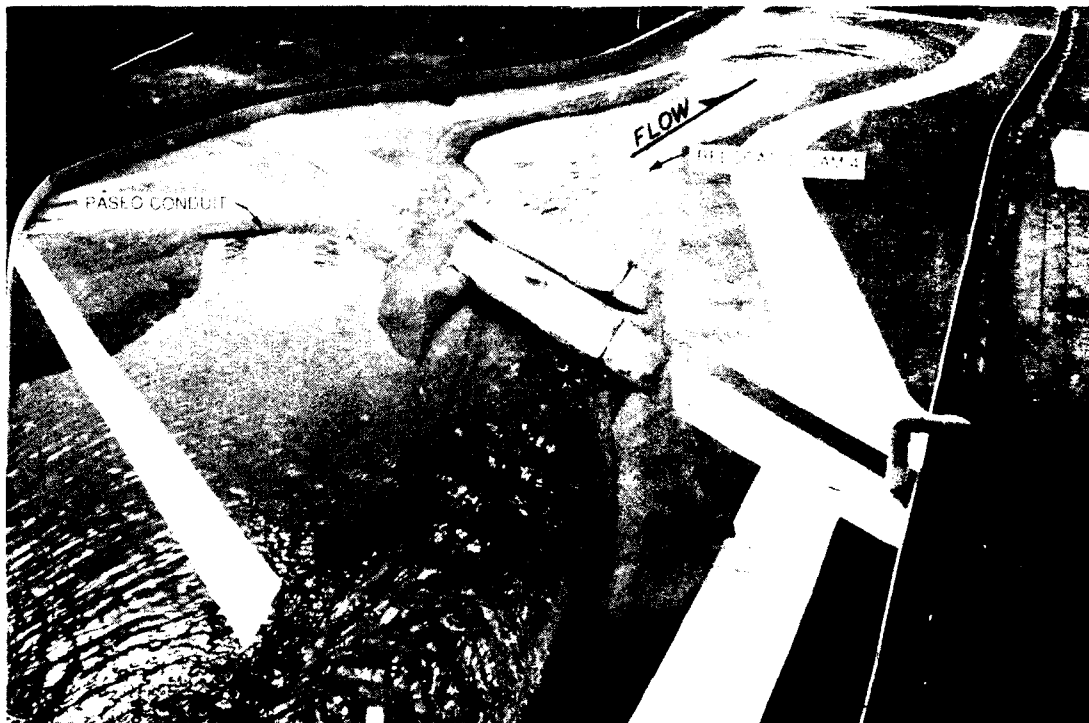
Photo 60. Flow conditions at Paseo realignment with new Paseo bridges, sta 123+00 to sta 147+00 (Continued)

a. 10-year flood

b. 100-year flood

c. 500-year flood

77. Although flow conditions were improved, the 500-year flood still overtopped the left bank and flooded the low area in the vicinity of the Brush Creek Boulevard-Paseo intersection. This flooding was due to the location of dam 4, which restricted the flow underneath the bridges. Also, the curved alignment of the channel upstream of the Paseo bridges contributed to the problem. Relocation of dam 4 downstream to sta 131+50 improved the situation, but additional refinement was needed. The channel upstream of the Paseo bridges was straightened to remove any curvature. The combination of these modifications, shown in Photo 59, greatly improved the flow conditions in the Paseo area. Flow conditions for the 10-, 100-, and 500-year floods, shown in Photo 60, reveal that the flood impact in this area was greatly reduced when compared with previous conditions.
