WL-TR-91-4032
DOT/FAA/CT-91/23
VOL II, Part 2

COMPOSITE FAILURE ANALYSIS HANDBOOK
VOL II - TECHNICAL HANDBOOK
PART 2 - ATLAS OF FRACTOGRAPHS

February 1992

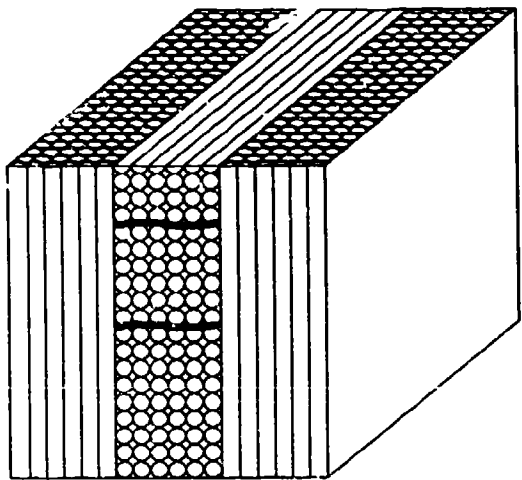
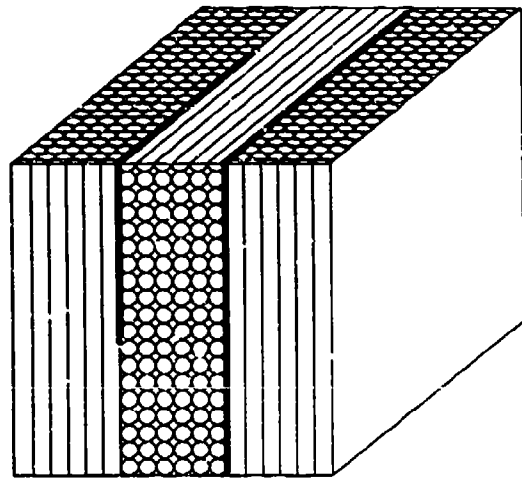
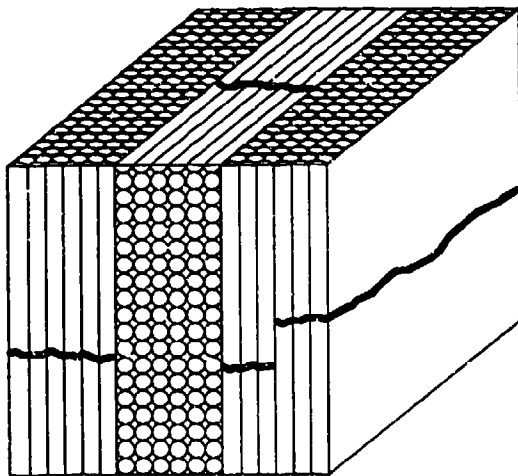
Figure 1-3. The Basic Fracture Modes

(a) Intralaminar Fracture

(b) Interlaminar Fracture

(c) Translaminar Fracture

Fractures in continuous fiber reinforced composites can be divided into three basic fracture types; interlaminar, intralaminar, and translaminar. Each of these failure types are schematically illustrated in Figure 1-3. As with the intergranular and transgranular terminology commonly used with metals, each of these classifications describes the plane of fracture with respect to the microstructural constituents of the material. Translaminar fractures are those oriented transverse to the laminated plane in which conditions of fiber fracture are generated. Interlaminar fractures, on the other hand, describe failures oriented between plies whereas intralaminar fractures are those located internally within a ply. Translaminar fractures involve significant fiber fracture, while interlaminar or intralaminar fractures occur in the laminate plane, principally fracturing matrix resin and therefore breaking few or no fibers.

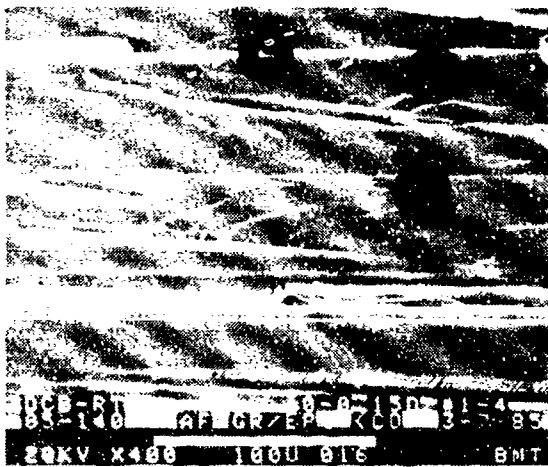
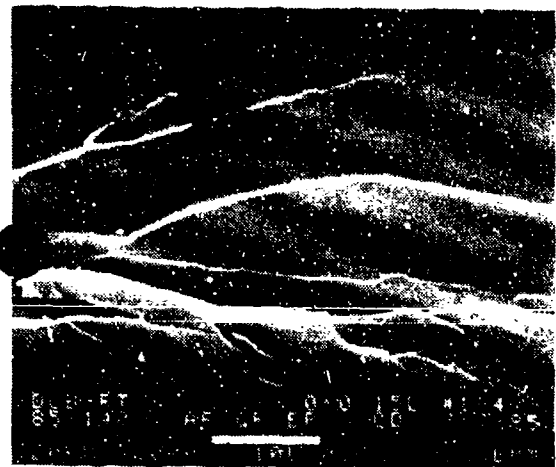
Mechanically induced crack direction

- M Matrix fracture
- F Fiber matrix separation
- R River markings

Figure 1-12. SEM Fractographs of Mode I Deamination Between 0/0 Degree Plies

The river markings, presented in Figure 1-12, are analogous to the cleavage fracture features commonly recognized in brittle materials such as metals, ceramics, and polymers. It has been determined through extensive studies that such features result from progressive joining of adjacent microscopic fracture planes during crack growth. More specifically, each line segment represents a local step formed when the thin ligament separating two adjacent planes is fractured during crack growth. The amount of strain energy involved in fracture is considered to be proportional to the areas of fracture surface created and the amount of plastic deformation at the crack tip. As a result, a large number of locally displaced fracture planes that initiate at the fiber/matrix interface represent a higher energy condition than a single continuous fracture surface. Since crack propagation tends to occur along the path requiring the least energy, there is a tendency for the planes to coalesce together. Thus the multitude of microplanes that initiate at the fiber/matrix interface link up as the crack propagates, resulting in a coalescence of the steps to form a branched pattern, or river marks.

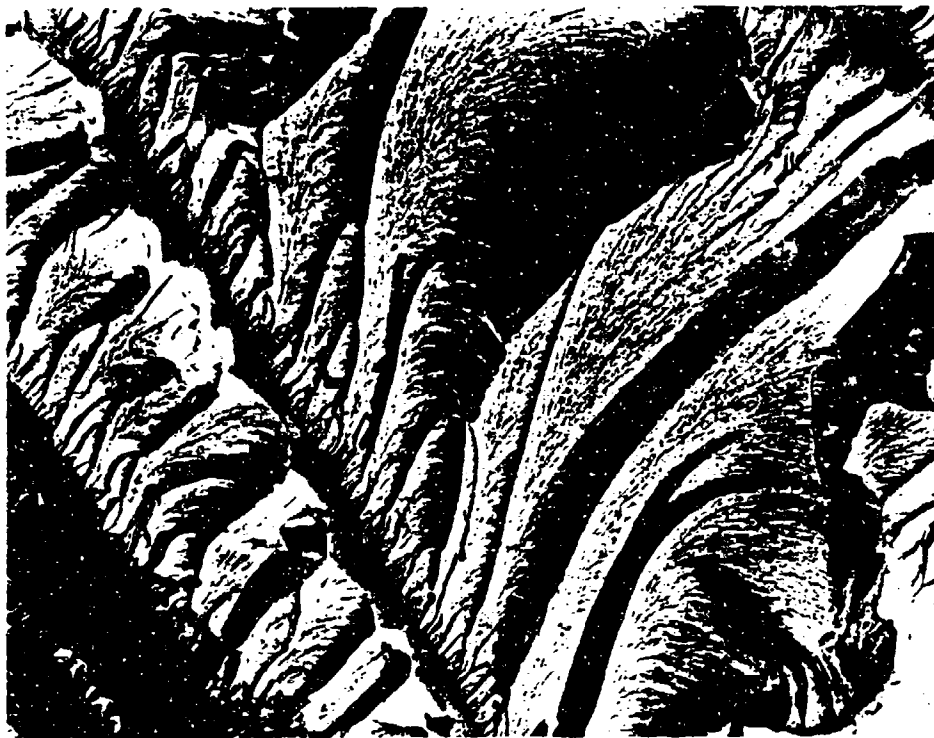
Figure 1-14. TEM Image of Resin Microplane With River Marks and Resin Microflow

Close inspection of the resin microplanes reveals a distinctly textured morphology referred to as resin microflow. Microflow is discernable at high magnifications and usually requires tilting of the specimen in the electron microscope (Figures 1-13 and 1-14) for this subtle feature to become visible. In many ways, the textured appearance is identical to the cleavage feathers characteristic of metallic fractures as shown in Figure 1-7. These feathery patterns exhibit a distinctive chevron type appearance, with the pointed end of the chevron oriented toward the origin of propagation. This chevron pattern results from the inherent tendency of a propagating crack to take the shortest path to a free surface. On a microscopic scale, these chevrons tend to rotate from the direction of overall crack growth toward adjacent free surfaces such as microplanes, transverse cracks, or fiber/matrix interfaces. However, by examining the direction and orientation of the microflow patterns in the center of each microplane, the localized direction of crack propagation can be determined.

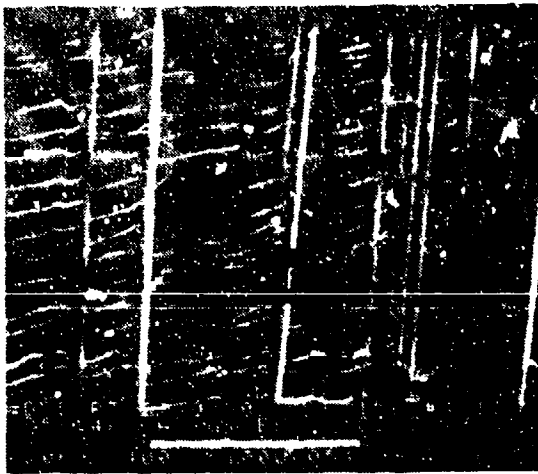
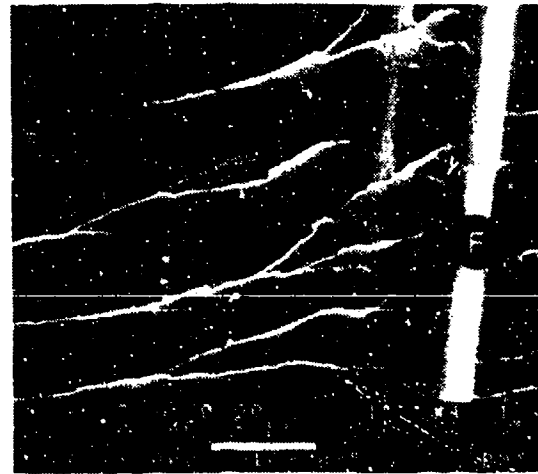
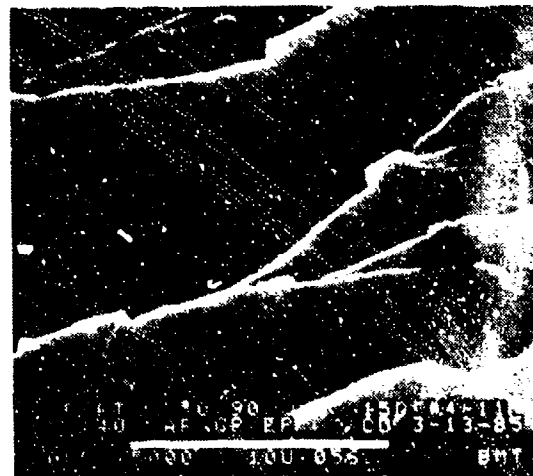
- M Matrix fracture
- F Fiber matrix separation
- R River markings
- T Textured microflow

Figure 1-15. SEM Photomicrographs of Mode I Delamination Between 0/90 Degree Plies

significant variations in the fracture topography can occur at the microscopic scale, depending upon the number of fibers exposed by the fracture and their orientation relative to the direction of microscopic crack growth (Figures 1-15 and 1-16). Cracking often occurs in the resin rich region between plies, particularly between plies of large angular differences (that is, 0° and 90°). Fractures which occur at the interface between plies exhibit relatively large areas of flat-resin fracture with distinct river marks in a fairly consistent microscopic direction. Alternatively, fractures which occur within a ply exhibit variable and often seemingly inconsistent localized microscopic directions of fracture. River marks and microflow are oriented in a wide variety of directions across the fracture surface. Variations in the direction of microscopic crack propagation can often be averaged together to obtain a more accurate estimate of the overall direction of crack propagation (Figure 1-17).

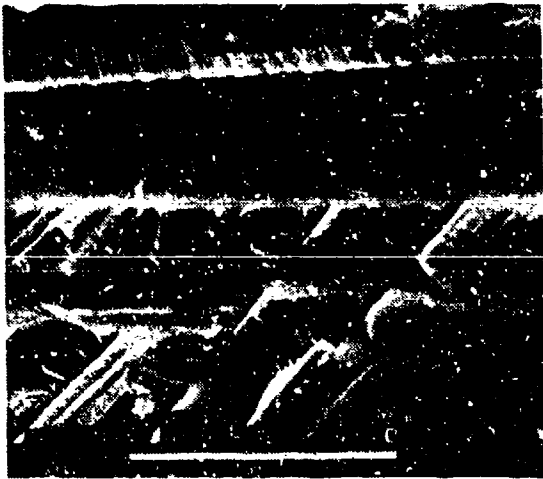
- M Matrix fracture
- F Fiber matrix separation
- R River markings
- T Textured microflow

Figure 1-16. SEM Photomicrographs of Mode I Delamination Between 0/+45 Degree Plies

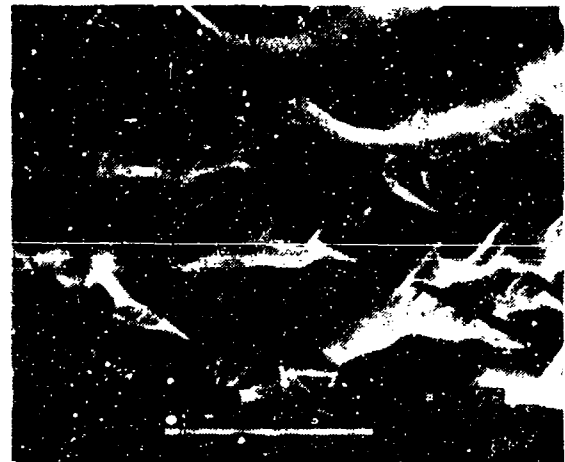
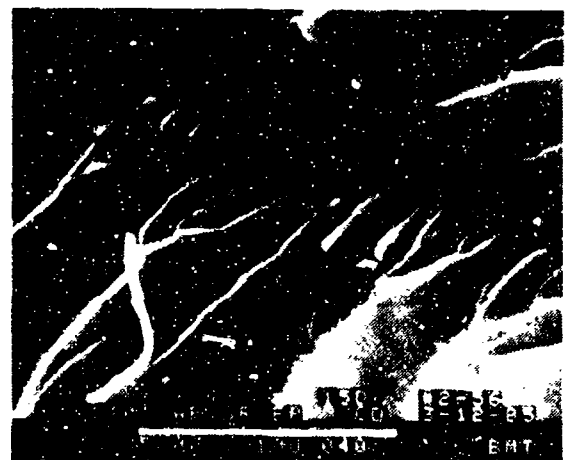
- M Matrix fracture
- F Fiber matrix separation
- R River markings
- T Textured microflow

Figure 1-17. SEM Fractographs of Mode I Delamination Between +45/+45 Degree Plies

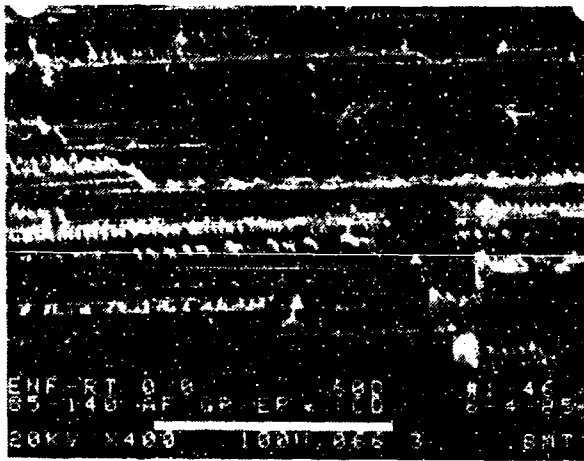
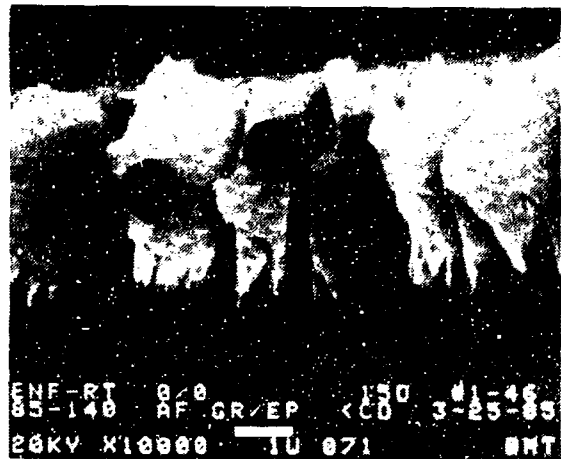
- F Fiber-matrix separation
- H Hackles
- R River markings
- T Textured microflow

Figure 1-19. SEM Photomicrographs of Mode II Delamination Between 0/0 Degree Plies

Under detailed SEM examination (Figure 1-19), the rows of curved vertical platelets are found in the cohesive resin fracture regions between fibers. As described by Mohr's circle, during in-plane shear loading the principle tensile stresses are oriented at forty-five degrees to the plane of applied shear, as shown in Figure 1-20. Since matrix fracture occurs in a microscopic plane normal to resolved tensile stress, a series of distinct inclined microcracks (Figure 1-21) are formed ahead of the main crack front. Increased strain or loading causes these small parallel microcracks to grow and coalesce, resulting in the formation of a series of upright curved platelets. Based upon these observations, the directions of applied shear (clockwise or counterclockwise moment) can be determined by examining the direction of platelet tilt. Concave areas are found on the mating fracture surfaces, opposite the these platelets (Figure 1-22). High magnification inspection of the platelets and the concave regions reveals small river marks and microflow, also indicative of resolved tensile separation. Several terms have been used to describe each of these features including lacerations or hackles for the upright platelets and scallops for the concave areas. For this document, the more common use of hackles to describe platelets and scallops to describe depressed concave areas is used.

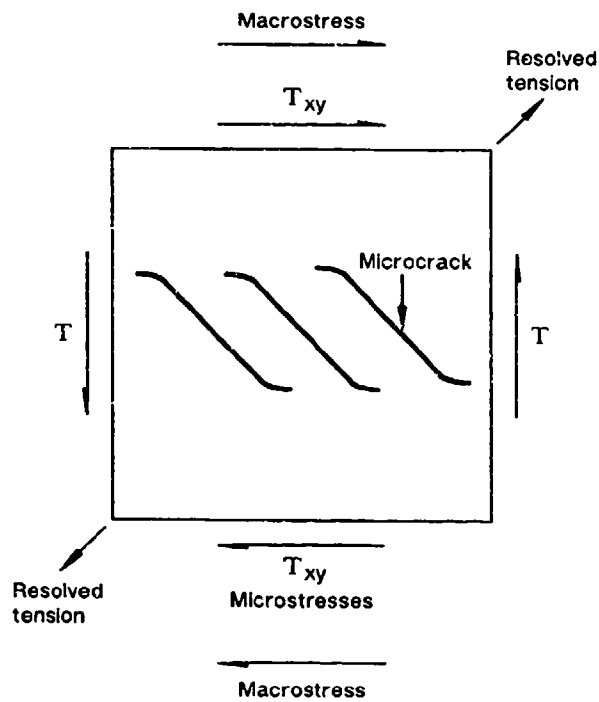
Figure 1-20. Free Body Diagram of Resolved Tensile Stresses and Inclined Microcracks

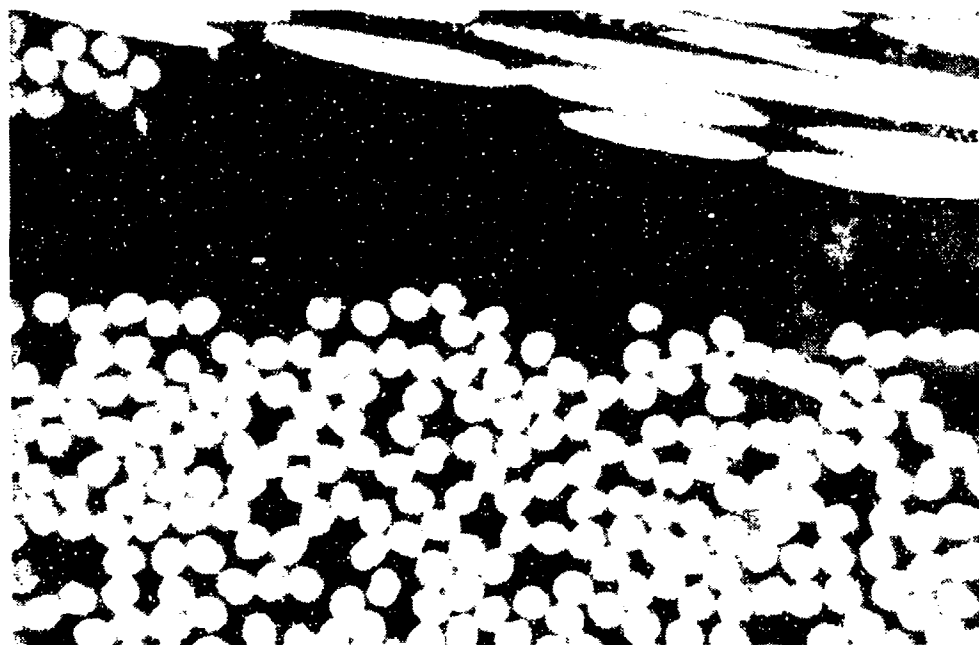
Figure 1-21. Microstructure of Cracks Found in Short Beam Shear Specimen Tested at 132°C (270 °F)

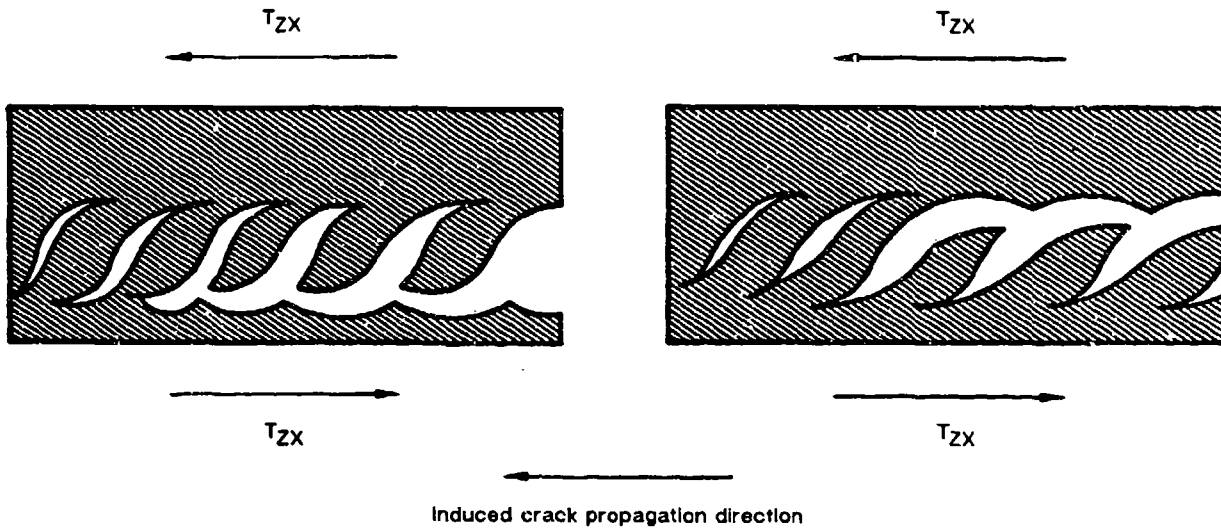
Mechanism A
 Hackle formation coincident with
 the direction of crack propagation

Mechanism B
 Formation of hackles opposite
 to the direction of crack propagation

Figure 1-23. Possible Hackle Separation Mechanisms

Separation of hackles can result in two possible relationships (mechanisms A and B) between hackle tilt and the direction of crack propagation, depending on which fracture surface retains the hackle (Figure 1-23). In mechanism A, separation occurs such that the hackles are retained on the side in which the direction of crack propagation coincides with the direction of the local shear component. This condition produces hackles tilted in the direction of crack propagation, and normal to the direction of resolved tension (45 degrees). Conversely, in mechanism B, separation occurs such that hackles are retained on the side in which the direction of crack propagation opposes the direction of the local shear component. In this condition, the tilt of hackles oppose the direction of crack propagation.

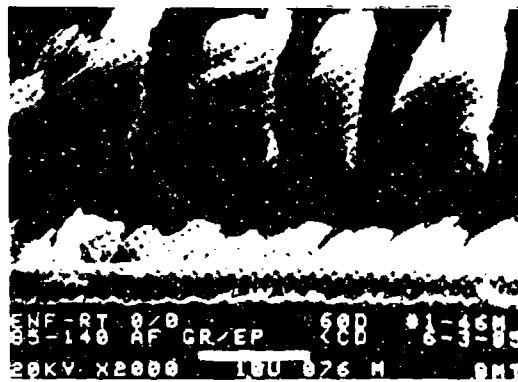
Figure 1-24. Orthogonally Shaped Symmetrical Hackles

The orientation of fiber reinforcement at, or adjacent to, the delamination plane can have a significant effect on the morphology of both hackles and scallops that must be considered when determining the direction of crack propagation. Surface fibers oriented parallel to the direction of crack growth tend to form orthogonal shaped hackles and scallops (Figure 1-24), whereas fibers intersecting the fracture surface at an angle to the direction of growth tend to form roughly triangular asymmetric hackles and scallops (Figure 1-25). In the first case, a distinct branched

morphology generally exists on both sides of the hackles and scallops where they intersect adjoining areas of fiber/matrix separation. Since this symmetry and the orthogonal shape of these features correspond to propagation parallel to the direction of exposed fibers, these features provide a relatively rapid and easy means of identifying the direction parallel to which crack growth occurred. In the second case, when the asymmetric features are identified, the tilt of the triangular hackles is predominantly parallel to the direction of crack propagation.

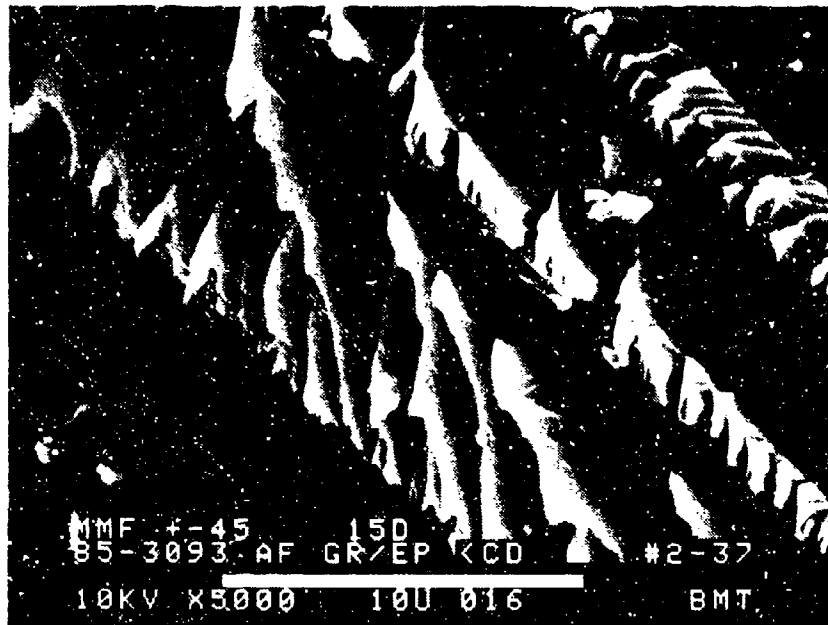
Figure 1-27. Interlaminar Mixed Mode Flexural (MMF, Tension and Shear) Specimen Fracture Morphology

Mixed Mode Delaminations. Interlaminar mixed mode delaminations commonly fail in a mixed mode loading condition, in which neither pure tension nor shear are operative. Failures due to complex loading such as flexure and compression buckling tend to exhibit delamination fracture morphologies that appear somewhat different to those found for the pure loading conditions presented in the above paragraphs. Since resin fracture separation occurs by resolved tensile forces in both pure shear and tension, so does fracture due to a mixed load state. The extent to which each of the predominant features exist (flat regions with river marks or vertical hackles) depends upon the ratio of Mode I to Mode II macroscopic stress. Therefore, delaminations with a predominance of Mode I tension mainly exhibit river marks and flat fracture topographies, with a tendency toward a slight tilt in each of the resin fracture microplanes, indicative of the slight rotation of the resolved tensile component (Figure 1-26). For these types of fractures, river marks and resin microflow are still useful for defining the localized crack growth direction and for use in crack mapping. As the percentage of Mode II increases, the tilt of these resin microplanes also increases relative to the rotation of the resolved tensile component. At percentages of Mode II above approximately 30%, these platelets take on an appearance of hackles, where there is pronounced separation between each hackle, and scallops present on the mating surface. Figure 1-27 presents the fracture morphology at approximately 43% Mode II shear and 57% Mode I tension. This fracture surface was generated with a Mixed Mode Flexural (MMF) specimen. Note the formation of the hackles, although they are not as vertical or upright as those found for pure shear fracture specimens. As indicated in the above paragraph on pure shear, hackles can be used to define the direction parallel to crack propagation. Precisely what percentage of Mode II or which fractographic features can be used to define crack growth directions have not been determined. Further studies on controlled crack growth specimens across the spectrum of mixed mode must be performed to gain a firm understanding of the validity of determining crack growth directions in a mixed mode loading state.

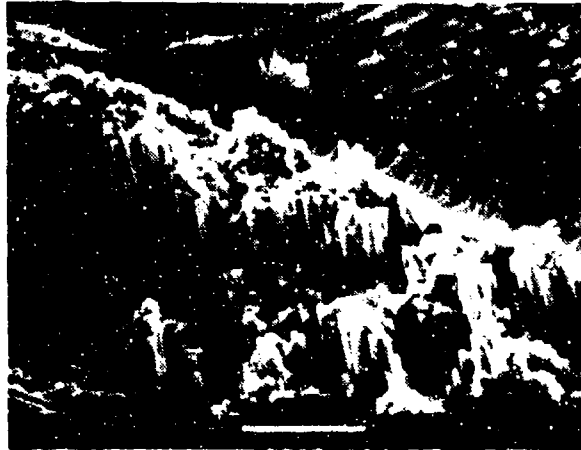
Note: Fracture is primarily fiber dominated with some adjacent matrix fracture.

Figure 1-29. Translamellar Fracture Morphology

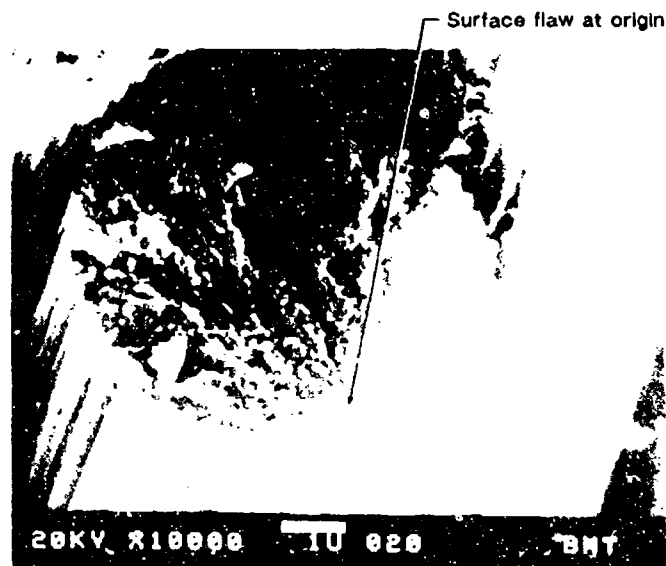
Figure 1-30. Typical Tensile Fiber Fracture Characteristics

Tension failure does not usually progress by a well defined crack front. Due to flaw sensitivity, the fracture process involves a series of zones in which all the fiber breaks within each zone originate at a single fiber. Thus, the crack front actually consists of numerous isolated fracture zones (at different planes) that coalesce and propagate in the overall growth direction. This phenomena produces the distinct fracture zones commonly referred to as fiber bundles. Fiber ends tend to fracture in a variety of directions, although they are often noticeably biased in a single overall direction. Through extensive SEM mapping of the fiber ends (Figure 1-31) the macroscopic growth direction can be determined. Extreme caution must be exercised in the evaluation of isolated fibers that protrude from the main surface. To increase accuracy, many areas of crack growth should be evaluated during the crack mapping process; particularly bundles which fracture on a plane relatively close to the overall fracture plane.

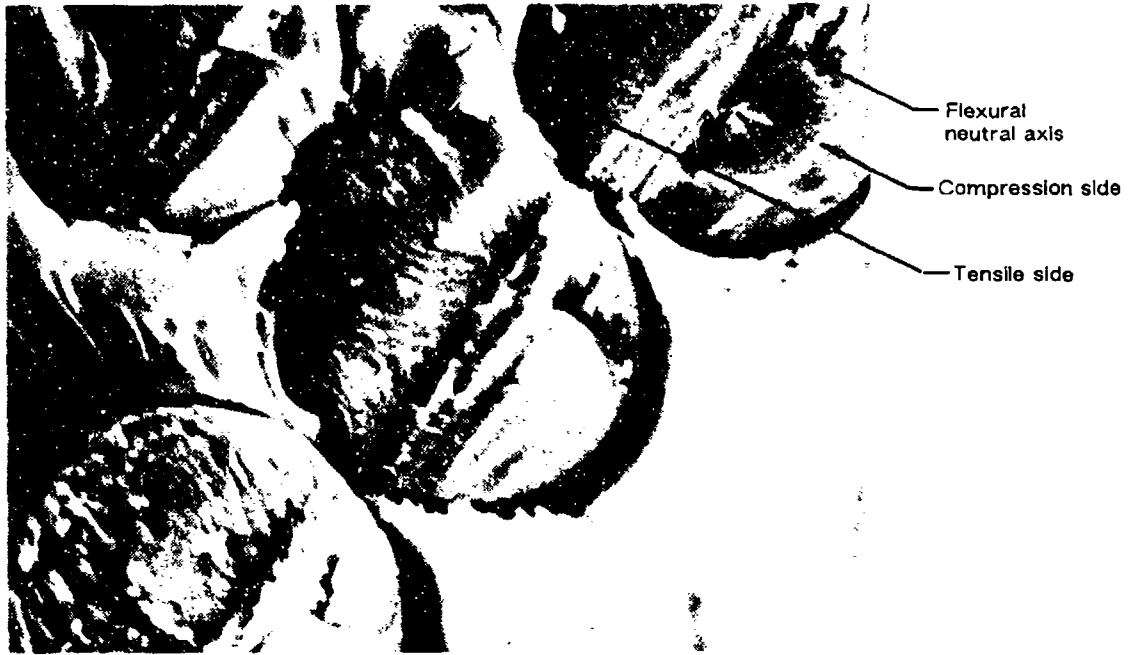
Figure 1-36. Typical Flexural Fracture Morphology Found on the Fiber Ends From a Compression Failure

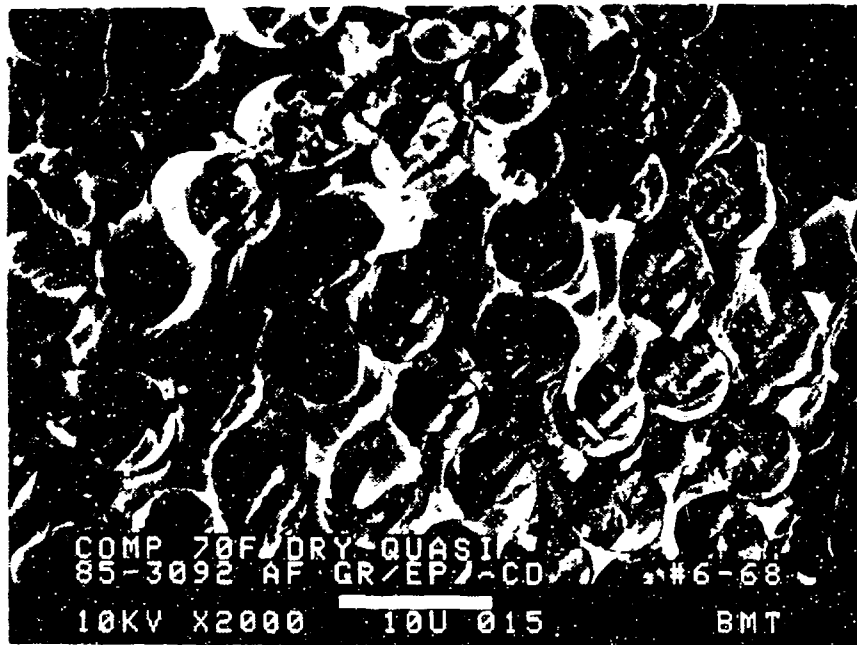
Figure 1-37. Fiber End Fracture Morphology From Compression Buckling Failure

The neutral axis lines are commonly found parallel to one another in a given region, indicating that microbuckling occurs on a local scale in a concerted manner and in a unified direction, as presented in Figure 1-37. Preliminary controlled crack growth studies have shown that the neutral axis lines are often biased at an angle parallel to the direction of induced crack propagation. This indicates that flexural fiber collapse, and thus crack propagation on a

microscopic scale, often occurs transverse to the gross overall crack direction; therefore, neutral axis lines cannot be used to determine the direction of crack propagation.

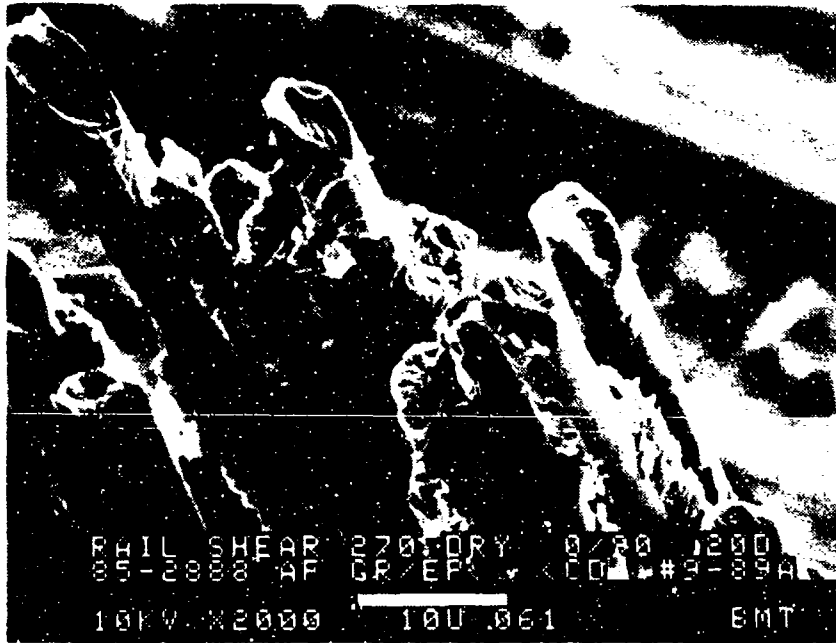
270°F, dry

←
Crack direction

Figure 1-38. Slant or Shear-Type Fracture From Compression-Induced Translaminar Failure

Laminates which have superior constraint in the through-thickness direction or excellent fiber/matrix interfacial strength are not as subject to localized delaminations or microbuckling of the plies. In this case, the fibers fracture on a microscale due to shear, with individual fiber ends exhibiting a slant type fracture, as shown in Figure 1-38.

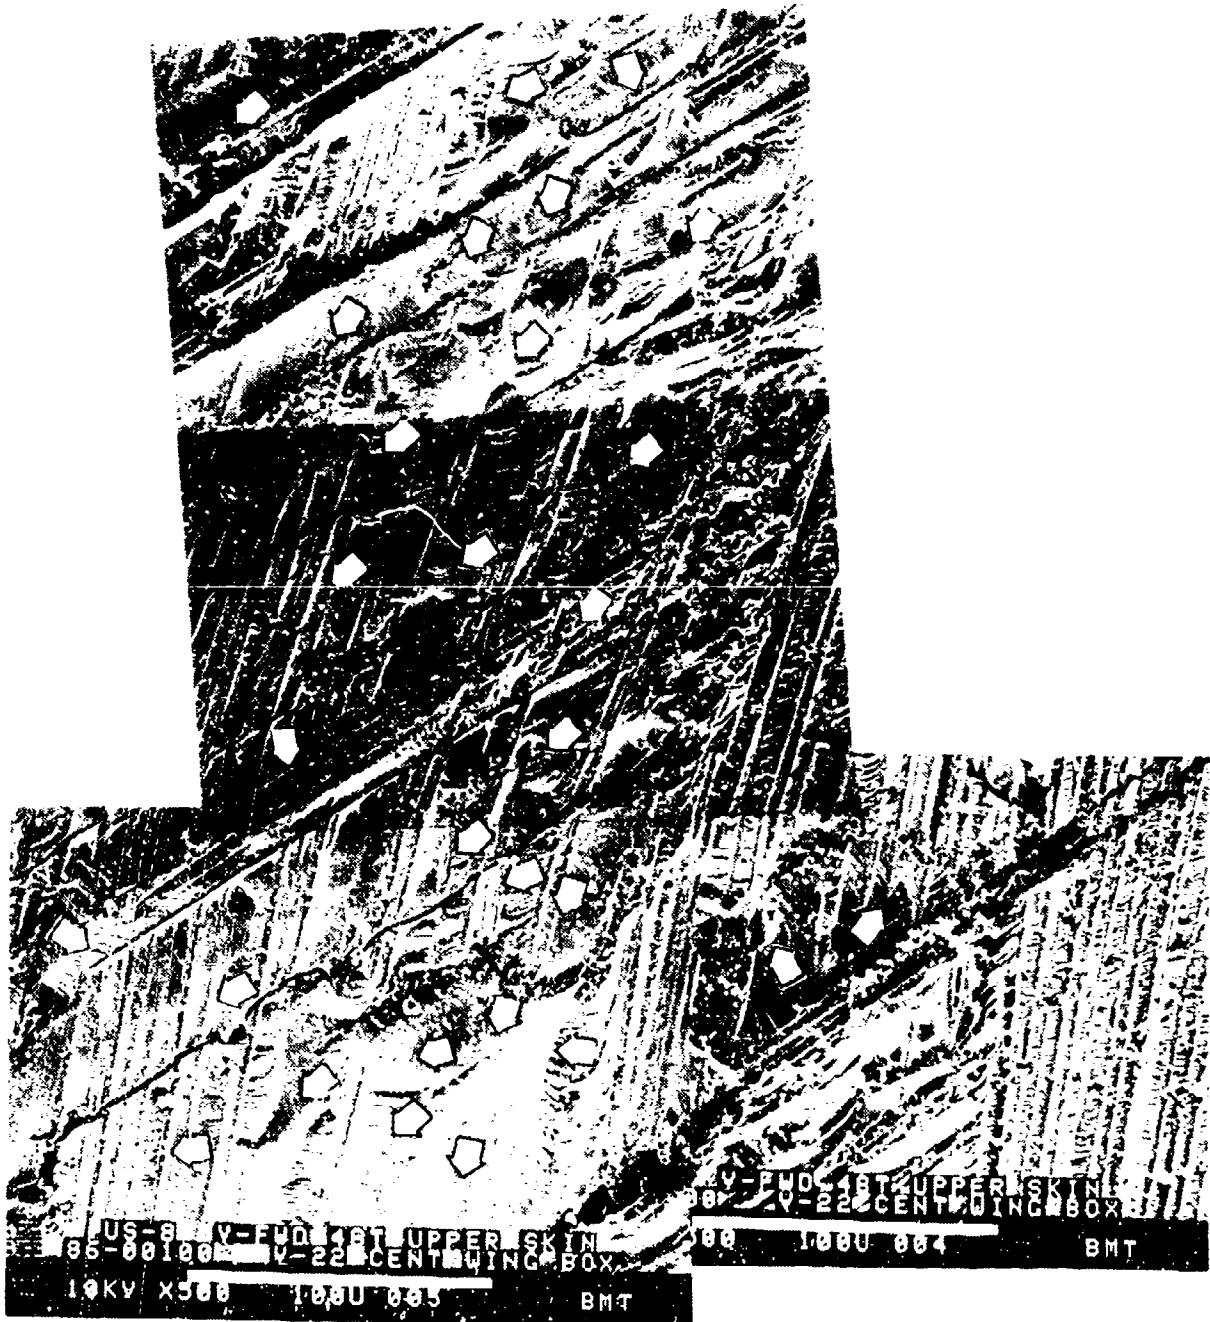
Figure 1-39. SEM Photographic Montage Showing Crack Propagation Direction Mapping

Performance of the actual crack mapping process involves the interpretation of the identifiable microscopic fracture surface features as related to localized crack growth directions. Most optical microscope crack mapping requires magnifications in the range of 200X to 800X. This magnification is required to resolve the fine river marks and hackle features between the closely spaced fibers. Resin rich fracture areas such as those found between plies (or between tows for woven laminates) can be fairly easily mapped toward the lower end of this magnification range due to the larger features present. Caution should be taken when mapping these isolated resin rich regions, with direct substantiation by examination of the surrounding regions which have more fiber reinforcements. Since the fracture process actually involves a continual repetition of crack initiation at the fiber/matrix interface and subsequent crack growth in the matrix toward the next fiber, the fracture features can often be overwhelming and confusing. On a microscopic scale, the fracture details such as river marks and resin microflow are often found oriented in a variety of directions, even for delaminations with well defined crack fronts and macroscopic growth directions (Figure 1-39). As a result, accuracy during crack mapping is maximized by determining as many localized crack growth directions in a given area as economically feasible. This often requires mapping as many as 10 to 20 locations per square inch. This can be done by scanning the surface by stage translation and focussing at the same time. Once an "average" direction of the microscopic features has been obtained using the methods of determination of crack propagation described above, an arrow denoting this direction should be placed on the photocopy. For tension dominated growth regions, single-headed arrows and for shear dominated growth regions, double-headed arrows should be drawn on the map. By creating these maps for the entire fracture surface, the overall average microscopic crack growth directions, and possibly the origin location, can be determined.

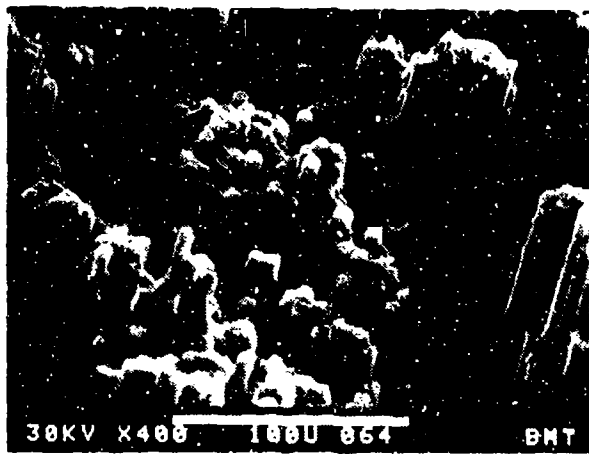
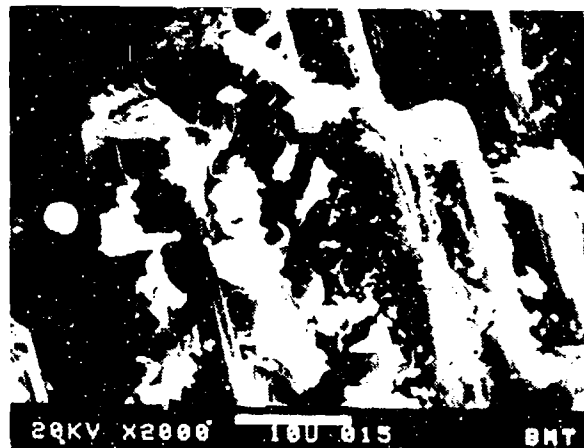
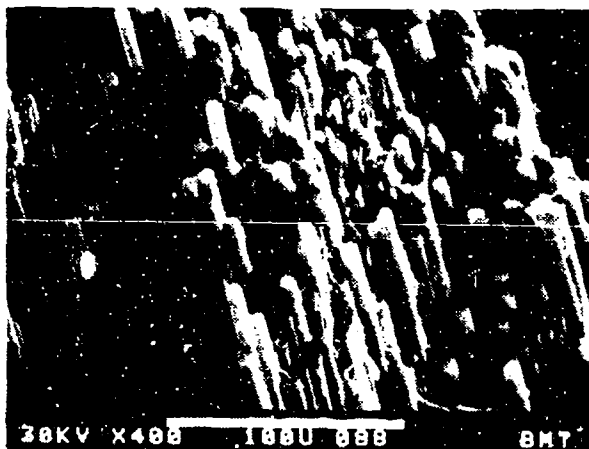
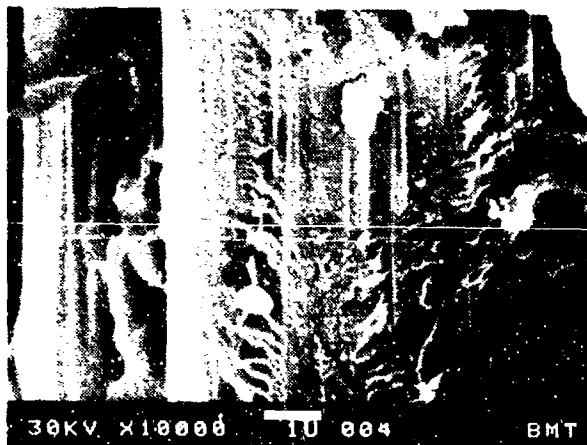
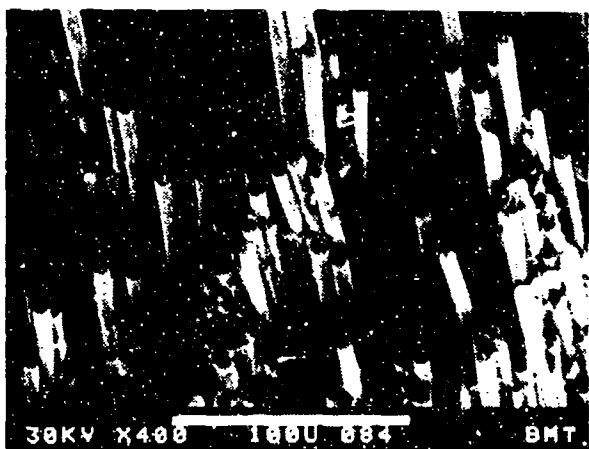
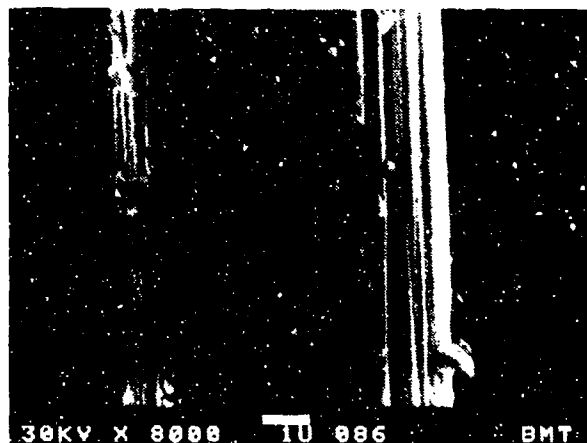
-65° test condition

70° test condition

270° F wet condition

Figure 1-41. SEM Micrographs of Translaminar Fracture Conditions at Different Temperatures

However, translaminal fractures generated under hot/wet environmental conditions approaching the glass transition temperature exhibit greater levels of fiber pullout, combined with significantly less resin adhering to the fiber surface. Additionally, similar fractures generated under dry conditions at -65°F reveal very limited amounts of fiber pullout, with extensive amounts of residual resin on the fiber surface. In general, these observations are in agreement with published literature and illustrate the significant reduction in matrix shear strength or fiber-to-matrix interfacial strength that tends to occur under elevated-temperature and high absorbed moisture conditions. Figure 1-41 illustrates the tendency toward increased fiber/matrix separation and individual fiber pullout in wet specimens experiencing an increase in temperature.

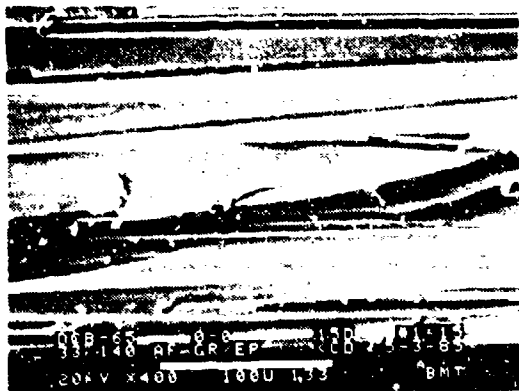
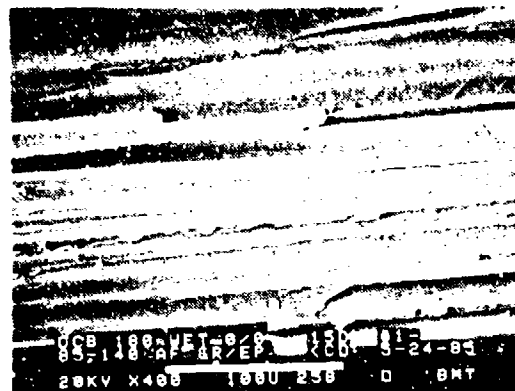
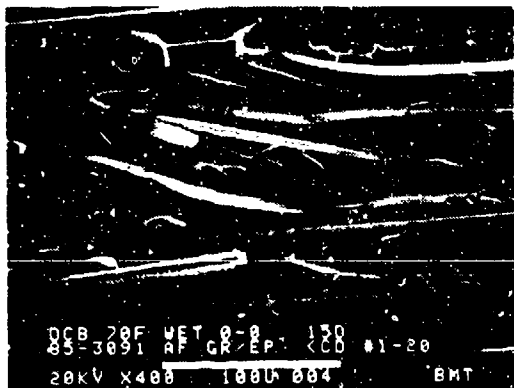
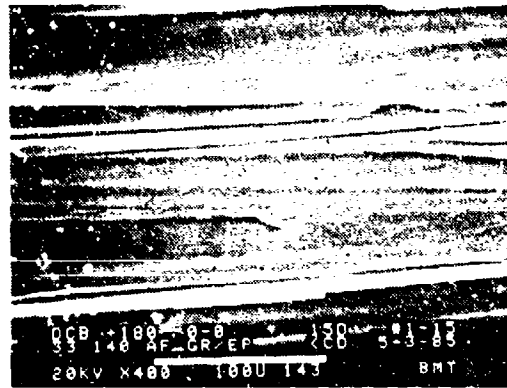
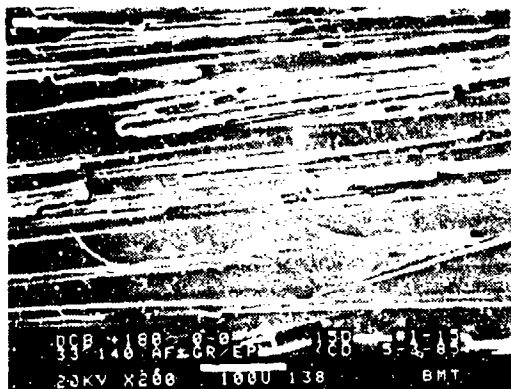
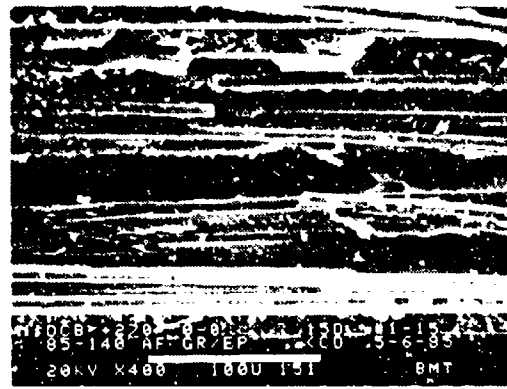
←
Mechanically induced crack direction

Figure 1-42. Low Magnification Series of Characteristic 0/0 Degree Interface Mode I Fractures at Each Environmental Condition

For delamination fractures, similar tendencies are evident for conditions of increasing amounts of absorbed moisture and temperature. Fractures in 177°C (350°F) cure epoxy systems which occur at temperatures below approximately 90°C (194°F) are very similar in appearance to the room temperature fractures. However, above this temperature range, increased fiber/matrix separation is evident and the fracture plane tends to occur within, or adjacent to, densely packed fiber regions within the lamina, resulting in a fiber-dominated fracture appearance, with small, localized regions of resin fracture (Figures 1-42 and 1-43).

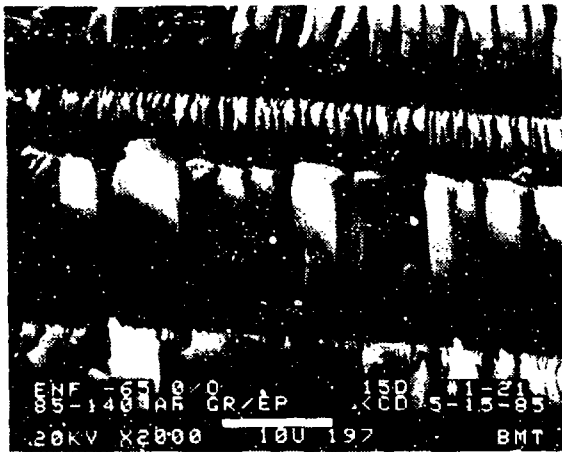
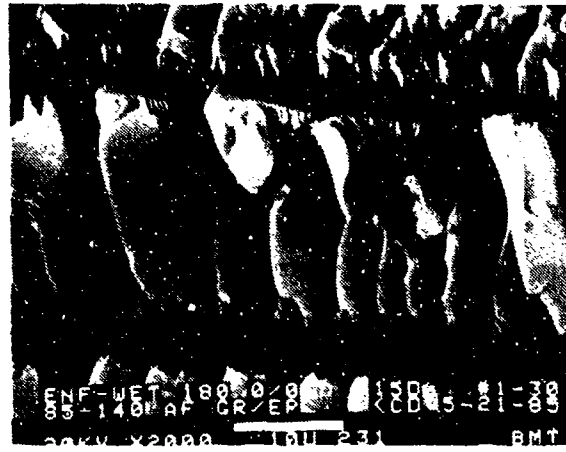
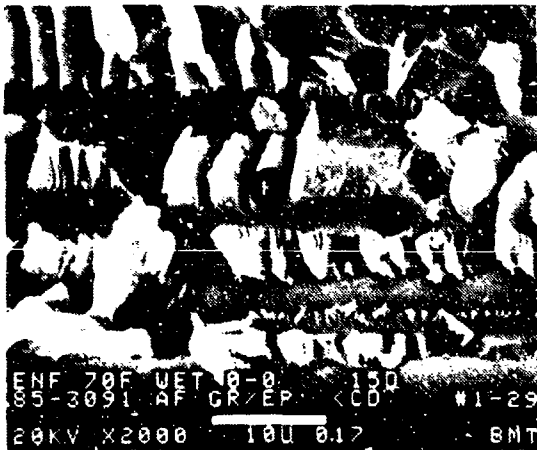
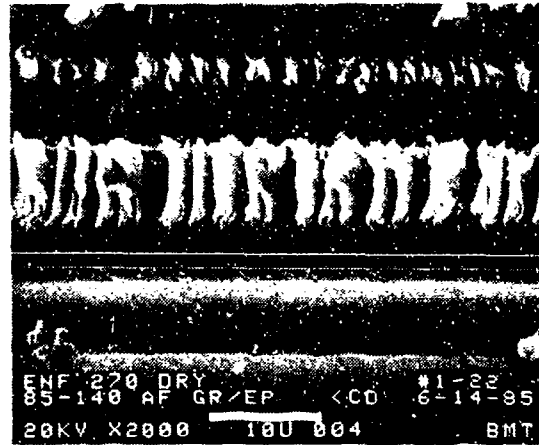
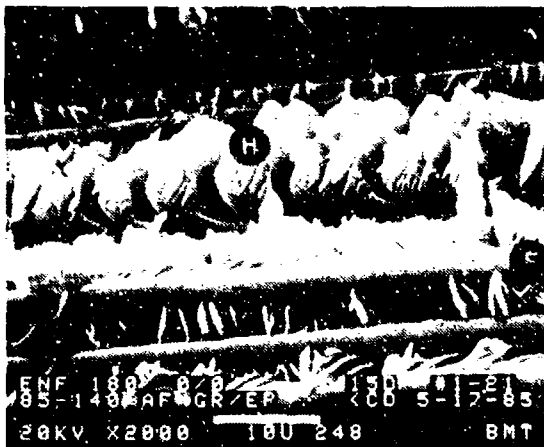
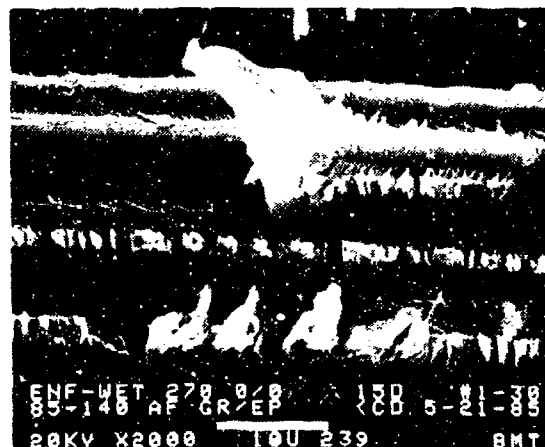
← Mechanically Induced crack direction

Figure 1-43. High Magnification Series of 0/0 Degree Interface Mode II (Shear) Fractures Showing Features of Fiber-Matrix Separation

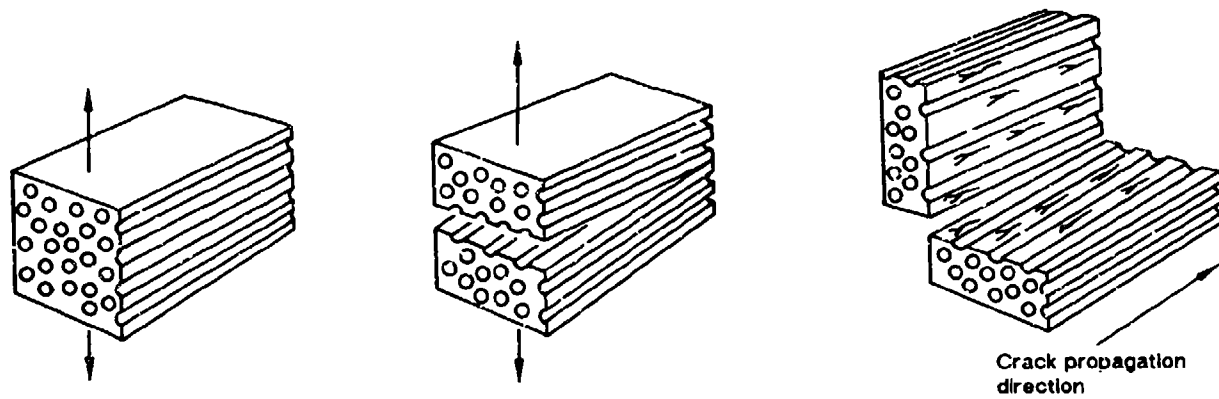
Figure 2-1. Double-Cantilever Beam Test Type

The primary features observed in fracture surfaces generated by interlaminar Mode I tension double cantilever beam testing (Figure 2-1) are as follows:

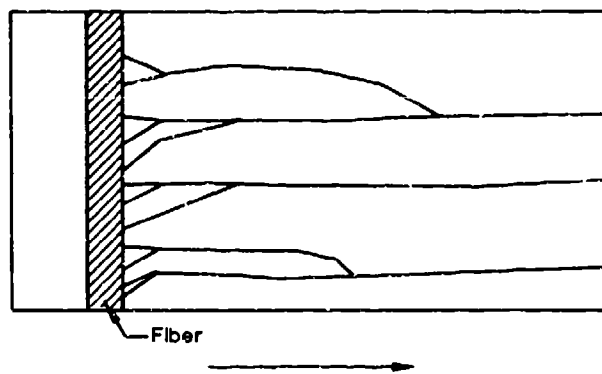
Figure 2-2. Overall Crack-Growth Direction by River Markings

Crack growth direction (CD) can be determined by examining the matrix between fibers. River mark coalescence and the radiating nature of the resin microflow are two fracture surface features which can be used to identify the direction of crack growth (Figures 2-2 and 2-3). Care must be taken to examine many locations on the fracture surface for accuracy and reliability of crack growth direction determination, since various conditions can cause localized crack growth in a direction other than the overall macroscopic crack growth direction.

Where the overall cracking progresses in a direction parallel to the fibers, river marks are concentrated adjacent to the fibers where cracking tends to continually reiterate on a microscale. In other cases, where overall cracking progresses in a direction other than parallel to the fibers, these river marks are concentrated on the side of the fiber away from the origin of the failure. In all cases, Mode I tension interlaminar fracture is characterized by river patterns on the fracture surfaces that are oriented at an angle or parallel to the direction of macroscopic fracture.

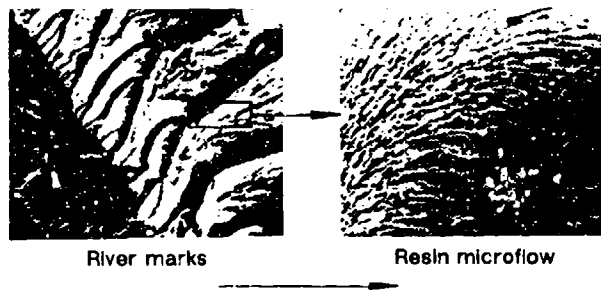
Figure 2-3. Overall Crack-Growth Direction by Resin Microflow

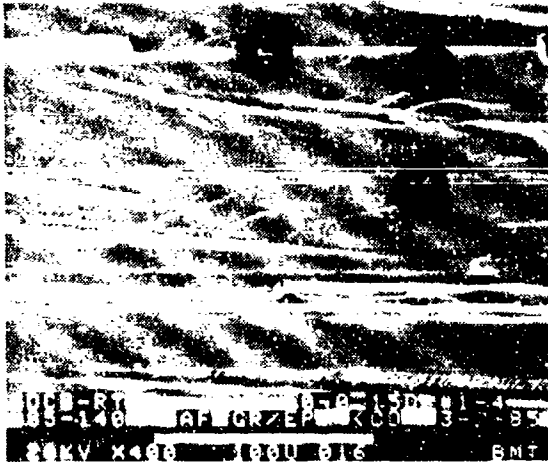
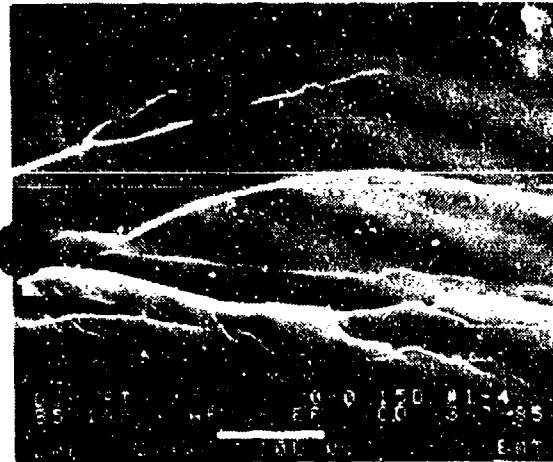
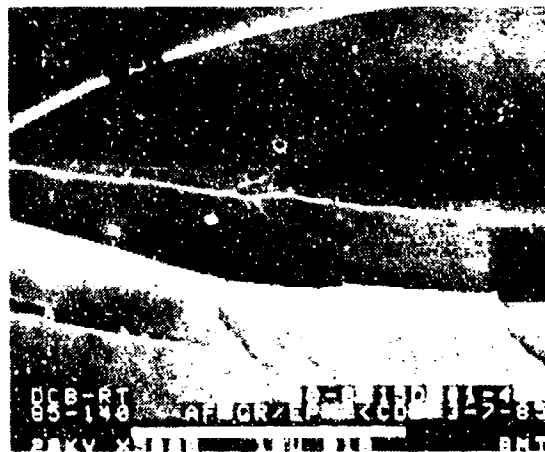
Fracture type	Interlaminar mode I tension
Ply layup	[0]24
Test type	DCB
• Test conditions	21°C dry
• Fracture between	0/0 plies
Material	Hercules 3501-6/177°C cure AS4 fibers

←
Mechanically induced
crack direction
