WL-TR-91-4032
DOT/FAA/CT-91/23
VOL II, Part 2

COMPOSITE FAILURE ANALYSIS HANDBOOK
VOL II - TECHNICAL HANDBOOK
PART 2 - ATLAS OF FRACTOGRAPHS

February 1992

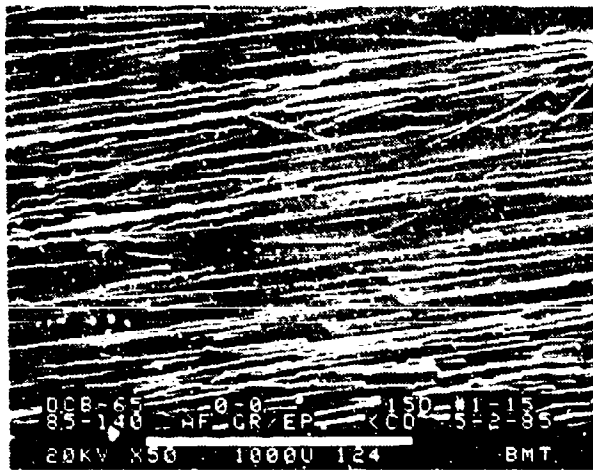
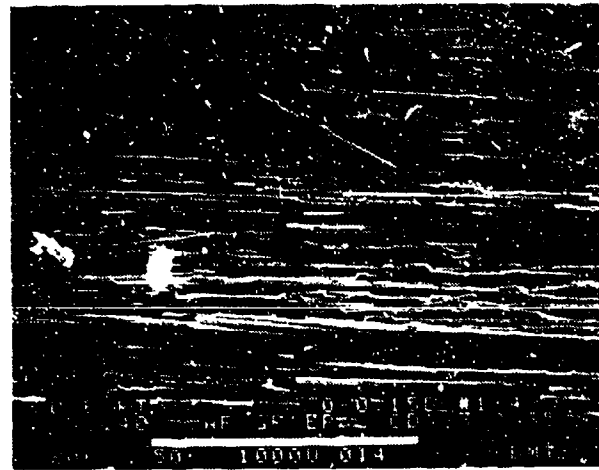
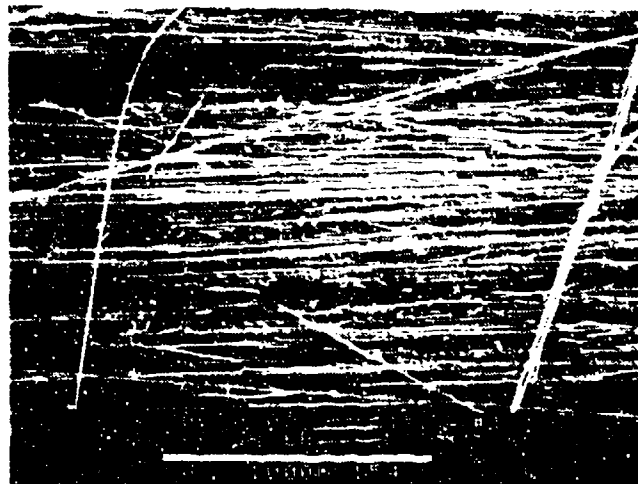
Figure 2-7. SEM Photographs of Interlaminar Mode I Tension, 0/0 Fracture, -65, 70 and 270 F/Dry (50X)

Fracture type	Interlaminar mode I tension
Ply layup	[0] 24
Test type	DCB
• Test conditions	Dry
• Fracture between	0/0 plies
Material	Hercules 3501-6/177° C cure AS4 fibers

-55°F, dry

70°F, dry

270°F, dry

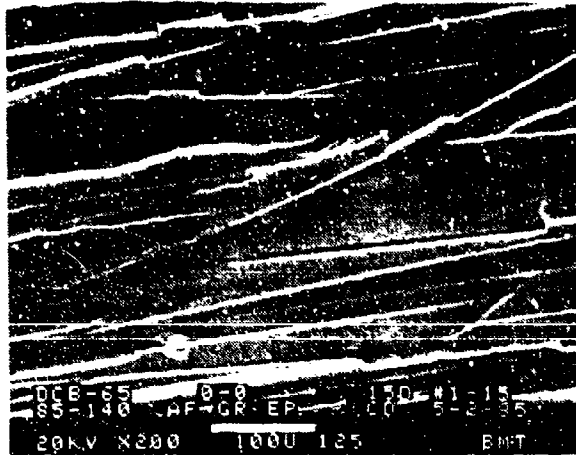
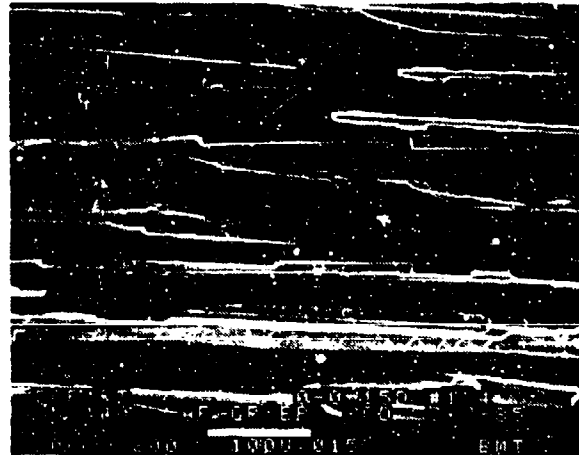
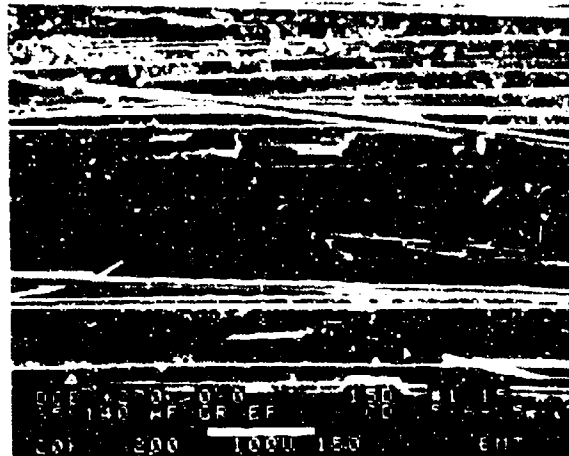
Figure 2.8. SEM Photographs of Interlaminar Mode I Tension, 0/0 Fracture, -65, 70, and 270 F/Dry (200X)

Fracture type	Interlaminar mode I tension
Ply layup	[0] 24
Test type	DCB
• Test conditions	Dry
• Fracture between	0/0 plies
Material	Hercules 3501-6/177° C cure AS4 fibers

-65° F, dry

70° F, dry

270° F, dry

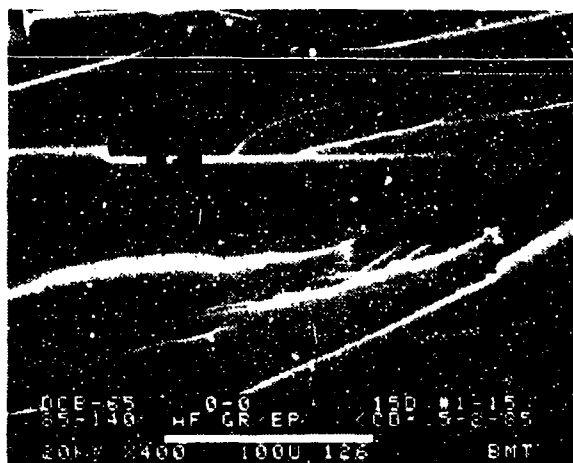
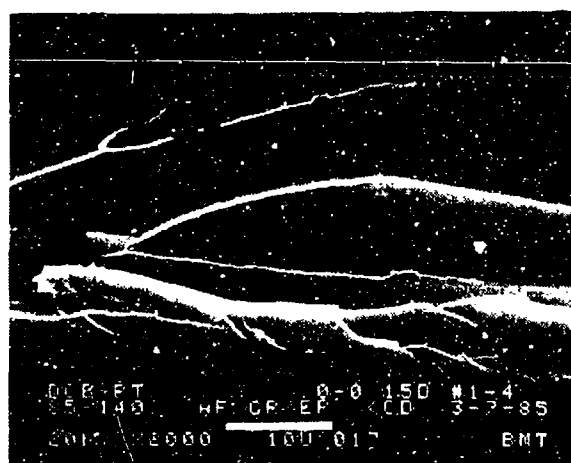
Figure 2-9. SEM Photographs of Interlaminar Mode I Tension, 0/0 Fracture, -65 and 70 F/Dry

Fracture type	Interlaminar mode I tension
Ply layup	[0] 24
Test type	DCB
• Test conditions	Dry
• Fracture between	0/0 plies
Material	Hercules 3501-6/177°C cure AS4 fibers

- F Fiber matrix separation
- R River markings
- M Matrix fracture

-65°F, dry

70°F, dry

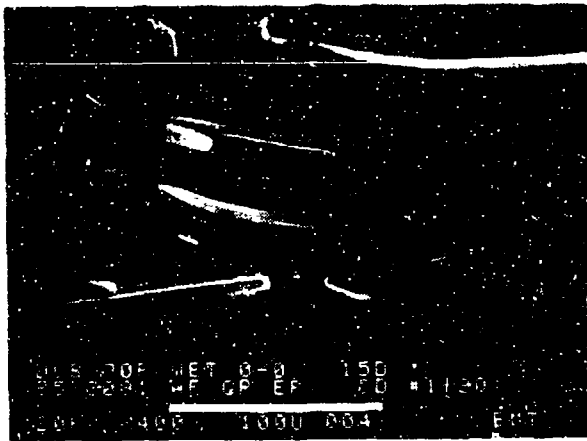
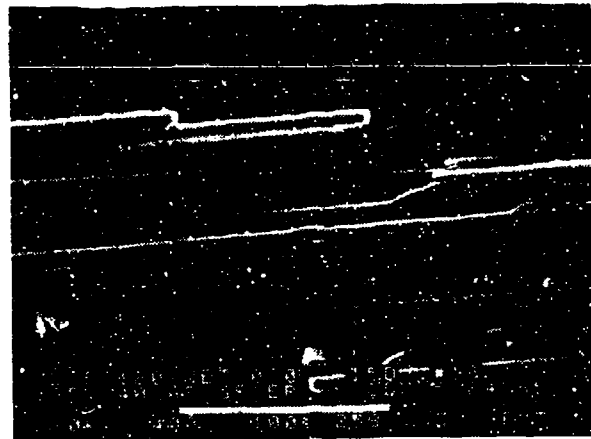
Figure 2-11. SEM Photographs of Interlaminar Mode I Tension, 0/0 Fracture, 70 and 180 F/Wet

Fracture type	Interlaminar mode I tension
Ply layup	[0] 24
Test type	DCB
• Test conditions	Wet
• Fracture between	0/0 plies
Material	Hercules 3501-6/177°C cure AS4 fibers

70°F, wet

180°F, wet

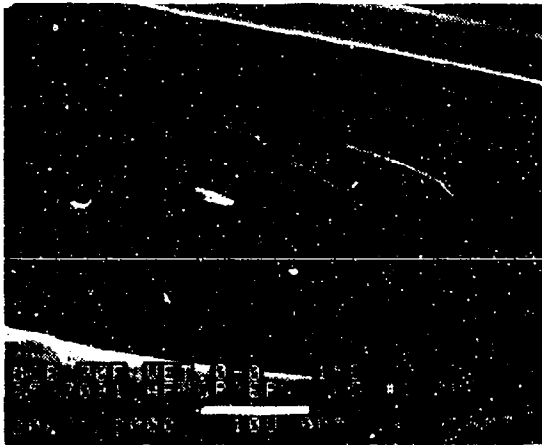
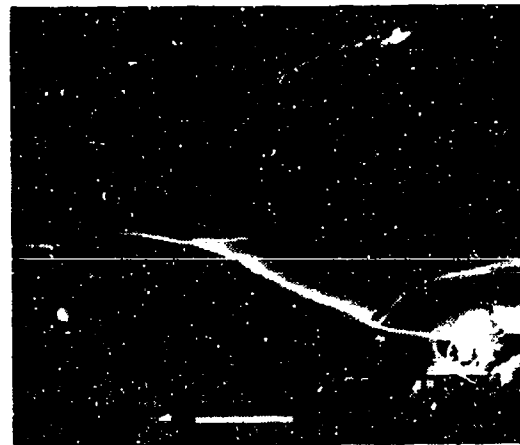
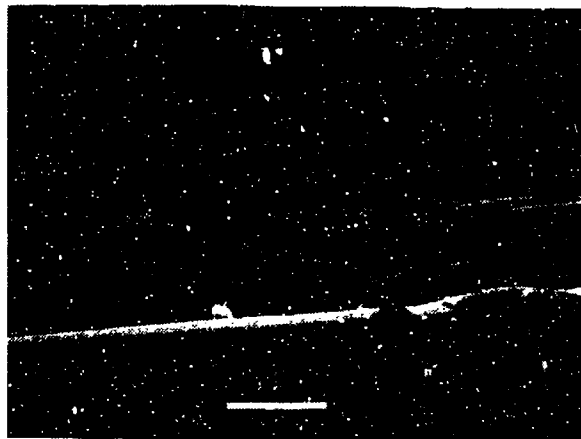
Figure 2-12. SEM Photographs of Interlaminar Mode I Tension, 0/0 Fracture, 70 F/Wet, 180 F/Dry, and 180 F/Wet

Fracture type	Interlaminar mode I tension
Ply layup	[0] 24
Test type	DCB
• Test conditions	Dry/wet
• Fracture between	0/0 plies
Material	Hercules 3501-6/177°C cure AS4 fibers

70°F, wet

180°F, dry

180°F, wet

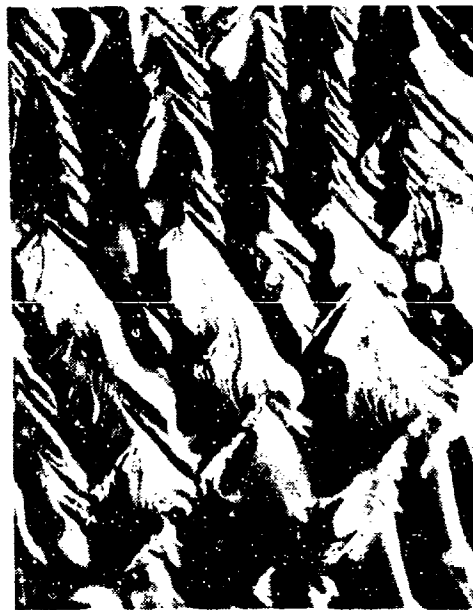
Figure 2-13. Photographs of Interlaminar Mode I Tension, +45/-45 Fracture, 70 F/Dry

Fracture type	Interlaminar mode I tension
Ply layup	[+45, -45] 12S
Test type	DCB
• Test conditions	21°C dry
• Fracture between	+45/-45 plies
Material	Hercules 3501-6/177°C cure AS4 fibers

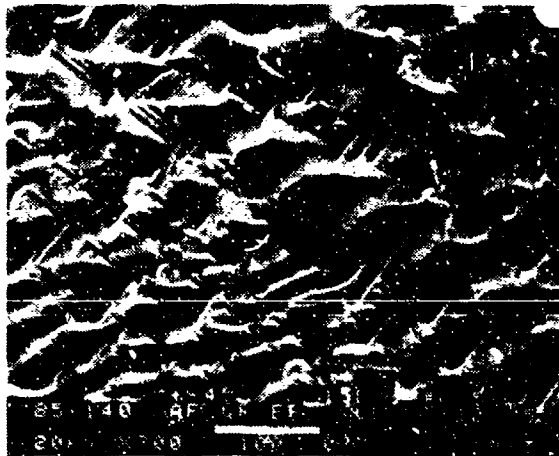
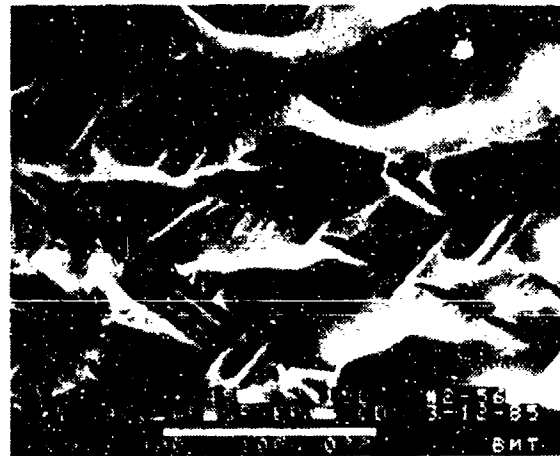
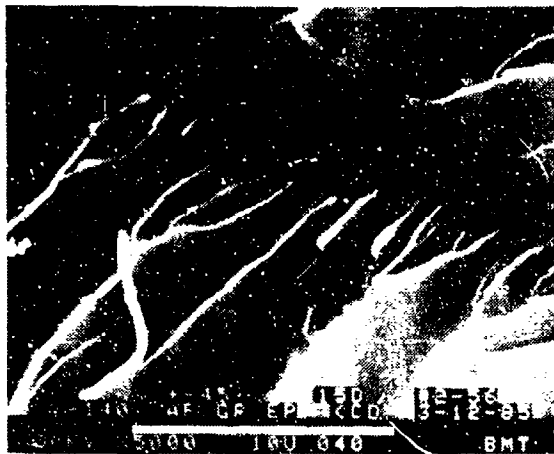
Figure 2-14. SEM Photographs of Interlaminar Mode I Tension, +45/-45 Fracture, 70 F/Dry

Fracture type	Interlaminar mode I tension
Ply layup	[+45, -45] 12S
Test type	DCB
• Test conditions	21°C dry
• Fracture between	+45/-45 plies
Material	Hercules 3501-6/177°C cure AS4 fibers

- Legend:
- F Fiber matrix separation
 - M Matrix fracture
 - R River markings
 - T Textured microflow

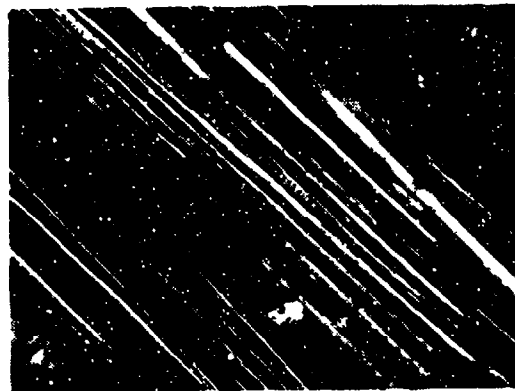
Figure 2-15. Photographs of Interlaminar Mode I Tension, +45/-45 Fracture, -65, 70, and 270 F/Dry

Fracture type	interlaminar mode I tension
Ply layup	[+45, -45] 12S
Test type	DCB
● Test conditions	Dry
● Fracture between	+45/-45 plies
Material	Hercules 3501-6/177°C cure AS4 fibers

-65°F, dry

70°F, dry

270°F, dry

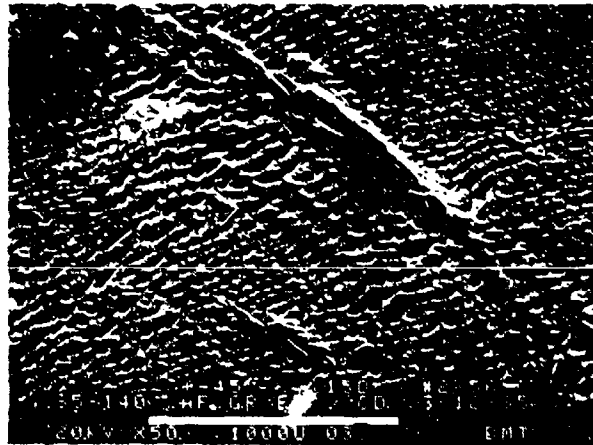
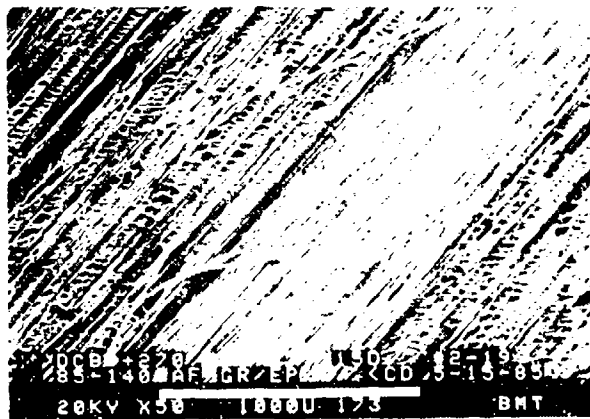
Figure 2-16. SEM Photographs of Interlaminar Mode I Tension, +45/-45 Fracture, -65, 70, and 270 F/Dry (50X)

Fracture type	Interlaminar mode I tension
Ply layup	[+45,-45] 12S
Test type	DCB
• Test conditions	Dry
• Fracture between	+45/-45 plies
Material	Hercules 3501-6/177°C cure AS4 fibers

-65°F, Dry

70°F, Dry

270°F, Dry

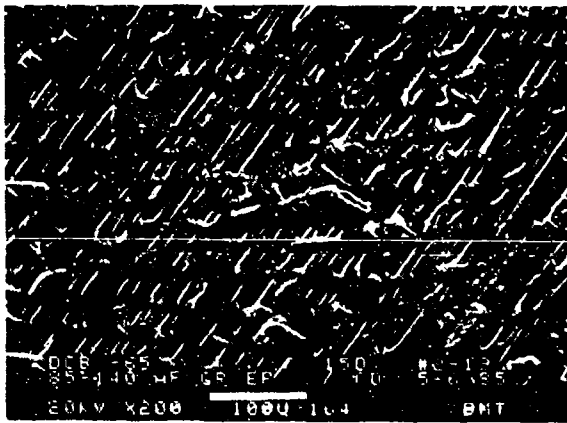
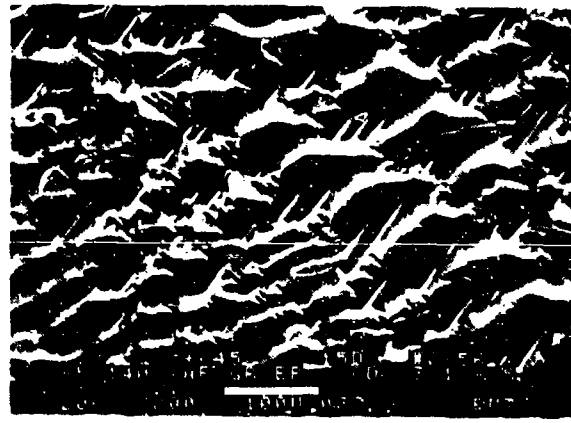
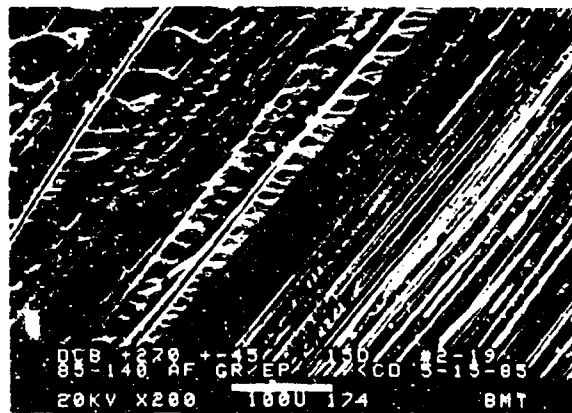
Figure 2-17. SEM Photographs of Interlaminar Mode I Tension, +45/-45 Fracture, -65, 70, and 270 F/Dry (200X)

Fracture type	Interlaminar mode I tension
Ply layup	[+45,-45] 12S
Test type	DCB
• Test conditions	Dry
• Fracture between	+45/-45 plies
Material	Hercules 3501-6/177°C cure AS4 fibers

-65°F, Dry

70°F, Dry

270°F, Dry

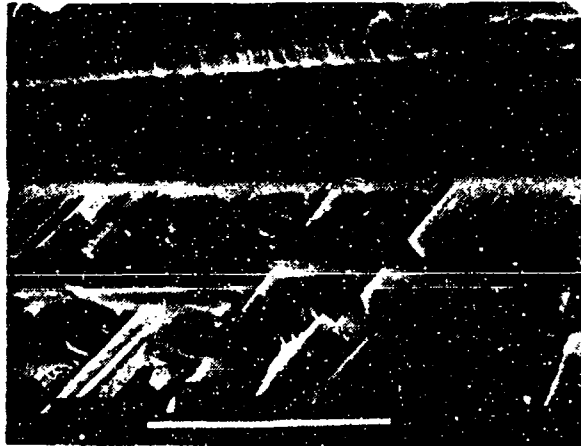
Fracture type	Interlaminar mode I tension
Ply layup	[0.45] _{12S}
Test type	DCB
• Test conditions	Wet
• Fracture between	0/45 plies
Material	Hercules 3501-6/177°C cure AS4 fibers

- F Fiber matrix separation
- M Matrix fracture
- R River markings
- T Textured microflow

Figure 2-22. SEM Photographs of Interlaminar Mode I Tension, 0/45 Fracture, 70 F/Wet

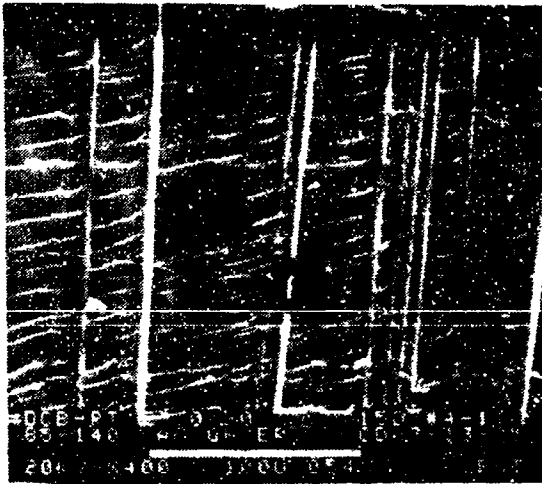
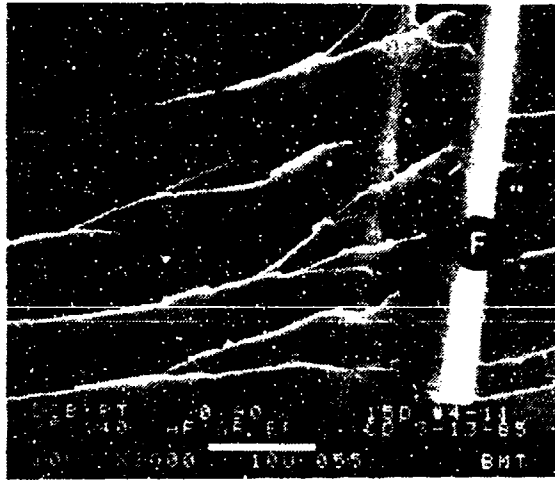
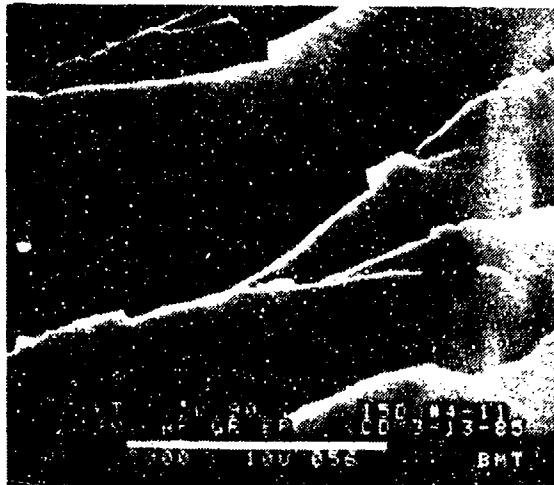
Fracture type	Interlaminar mode I tension
Ply layup	[0, 90] _{12S}
Test type	DCB
• Test conditions	21°C, dry
• Fiber end fracture	
Material	Hercules 3501-6/177°C cure AS4 fibers

- F Fiber matrix separation
- M Matrix fracture
- R River markings
- T Textured microflow

Figure 2-24. SEM Photographs of Interlaminar Mode I Tension, 0/90 Fracture, 70 F/Dry

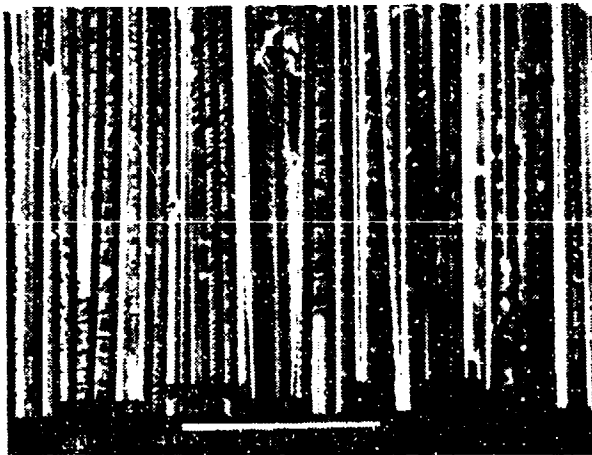
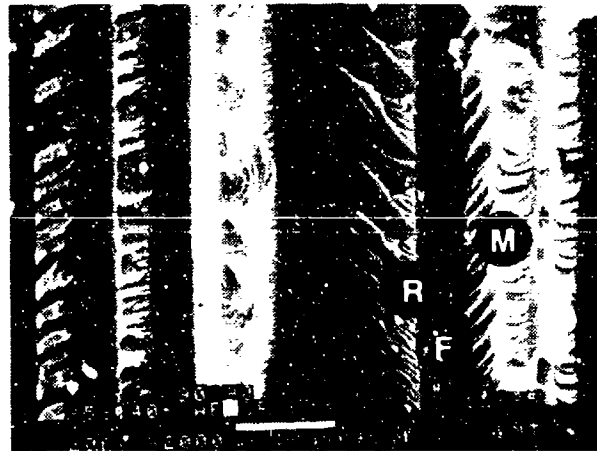
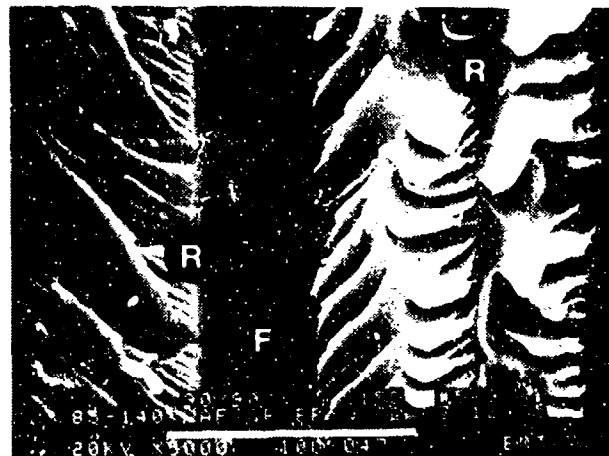
Fracture type	Interlaminar mode I tension
Ply layup	[90]24
Test type	DCB
• Test conditions	21°C, dry
• Fracture between	0/90 plies
Material	Hercules 3501-6/177°C cure AS4 fibers

- F Fiber matrix separation
- M Matrix fracture
- R River markings

Figure 2-27. SEM Photographs of Interlaminar Mode I Tension, 90/90 Fracture, 70 F/Dry

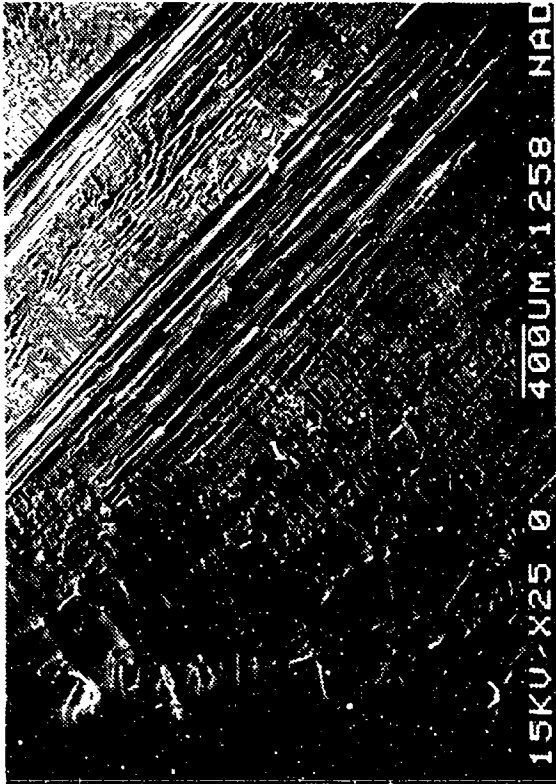
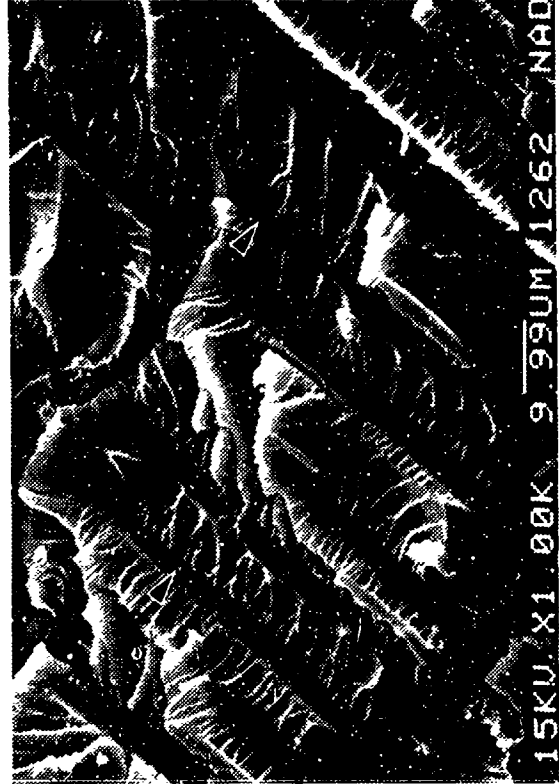
Figure 2-28. Optical and SEM Photographs of Mode I DCB Interlaminar Fracture in Filament Wound GFR/Ep [-45/-45] *ss*, Room Temperature Ambient
 (a) Macro photograph
 (b) Initiation in Pre-crack
 (c) River Patterns in Mode I Area
 CD = Crack-propagation direction
 R = River patterns

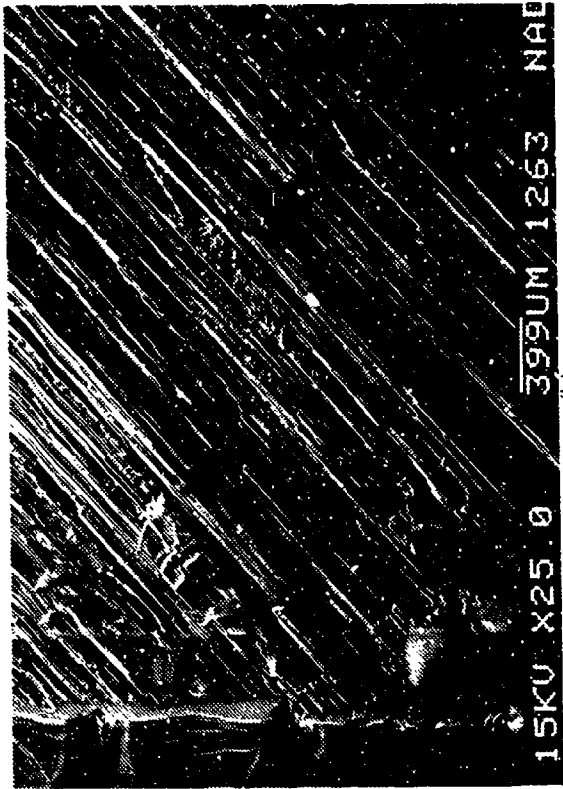
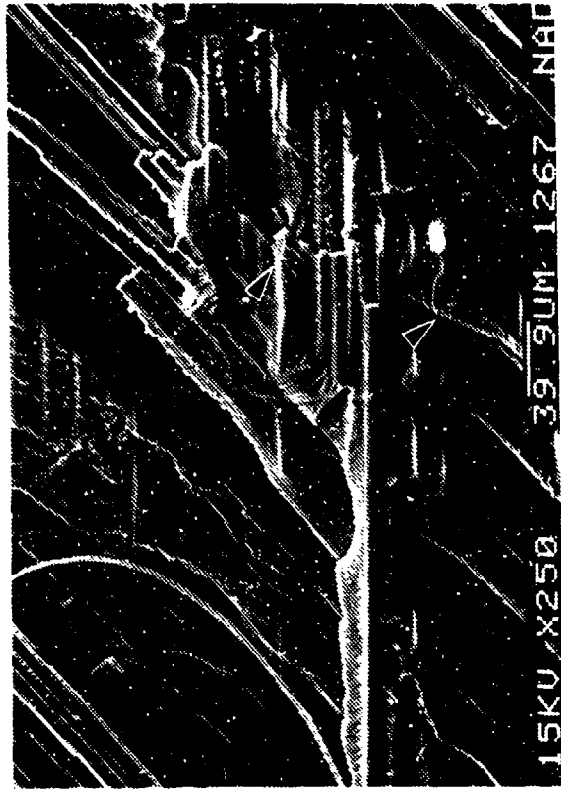
Figure 2-29. Optical and SEM Photographs of Mode I DCB Interlaminar Fracture in Filament Wound Gr/Ep - [+45/0/-45]_{4s}, Room Temperature Ambient
 (a) Macro photograph
 (b) Initiation in Precrack Region
 (c) River Patterns in Mode I Tension Fracture

CD = Crack propagation direction
 R = River patterns

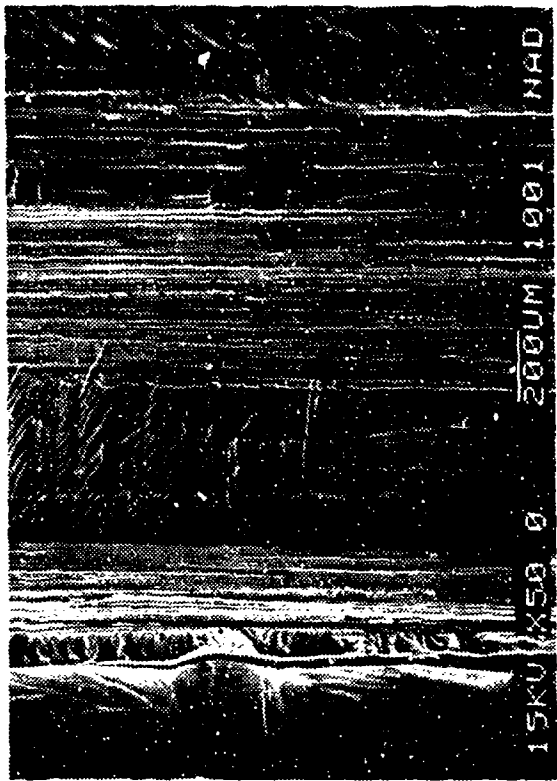
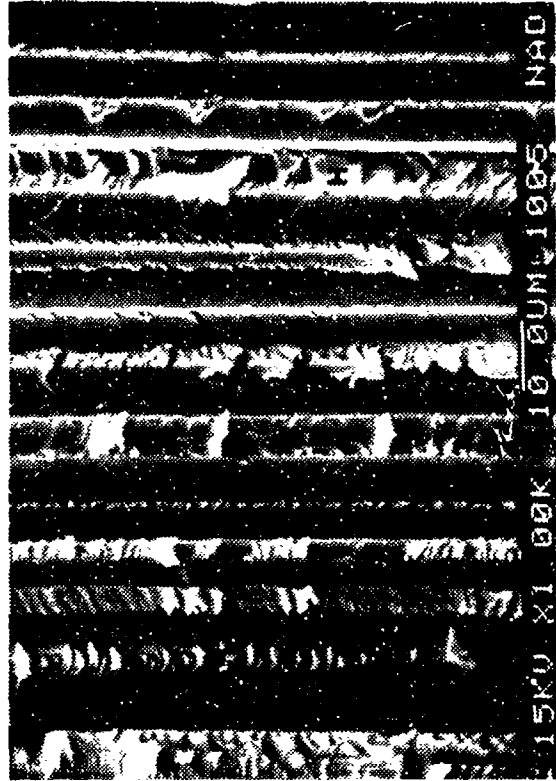
Figure 2-30. Optical and SEM Photographs of Mode I DCB Interlaminar Fracture in Filament Wound GFR/Ep [0/90] 6S, Room Temperature Ambient
 (a) Macro photograph
 (b) Initiation in Pre-crack Region
 (c) Local Hackles in 90 Degree Ply

CD = Crack-propagation direction
 H = Hackles

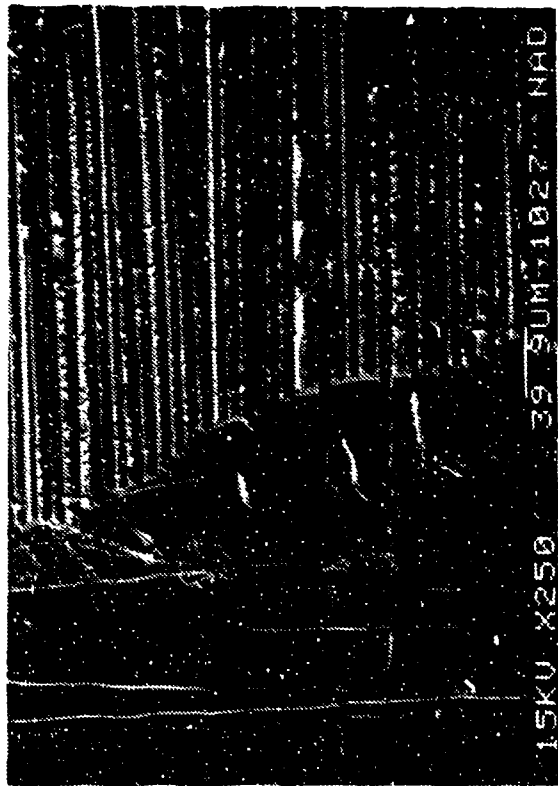
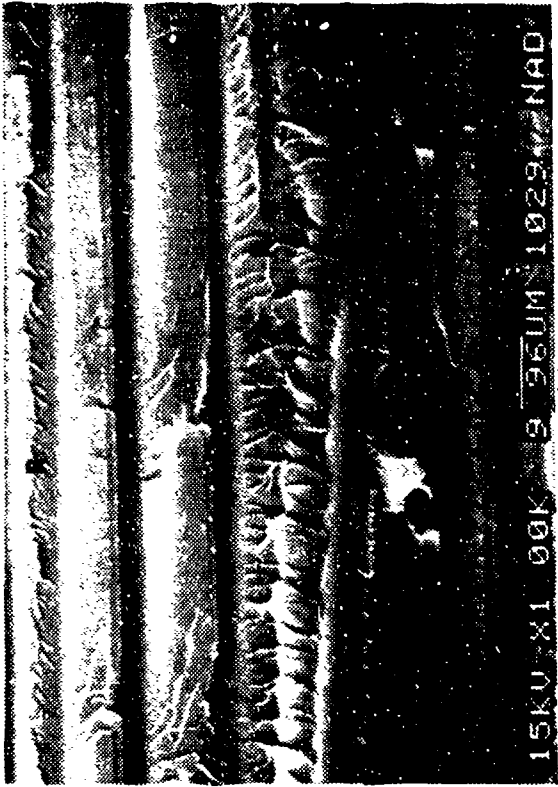
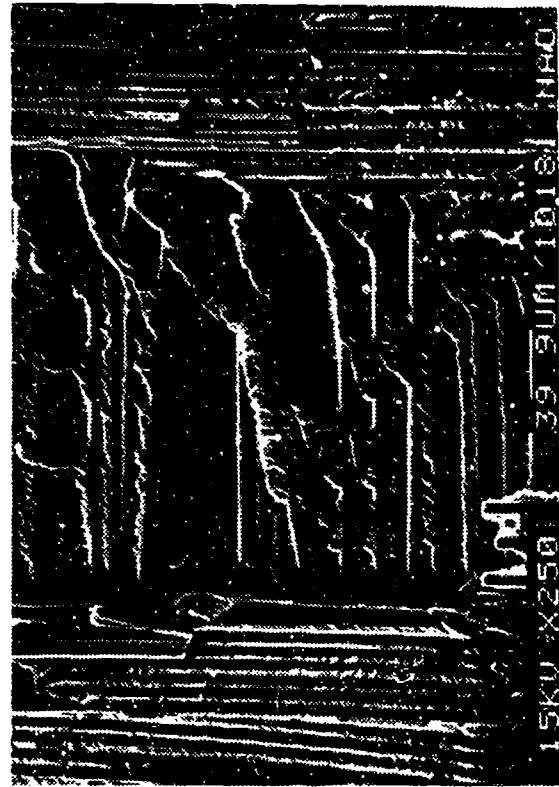
Figure 2-30. (Continued)
 (d) Precrack/Crack-Growth Interface
 (e) River Patterns in Epoxy
 (f) River Patterns in Epoxy Away From Interface
 CD = Crack-propagation direction
 R = River patterns

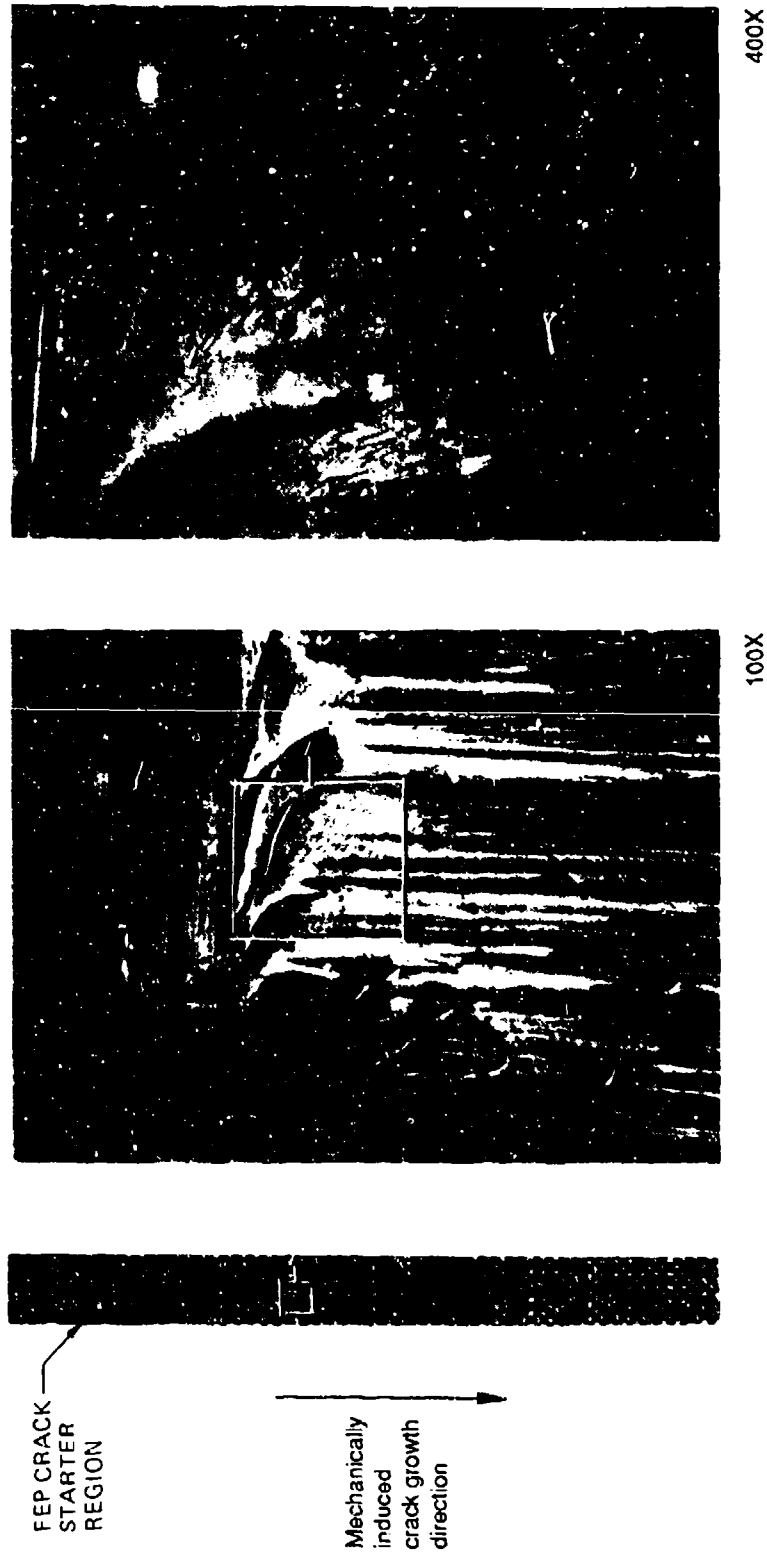
Figure 2-31. Optical Photomicrographs of Interlaminar Mode I Tension, Room Temperature, Fabric Fracture, $[0/90]_s$

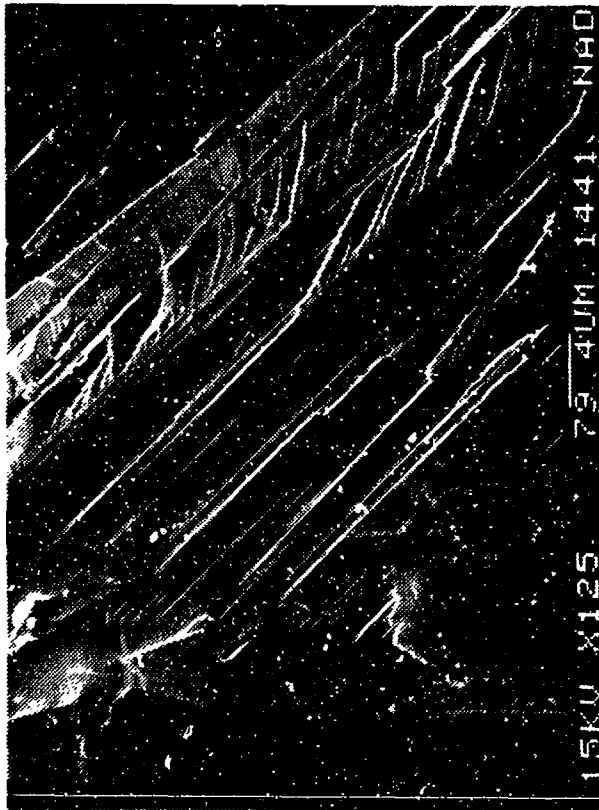
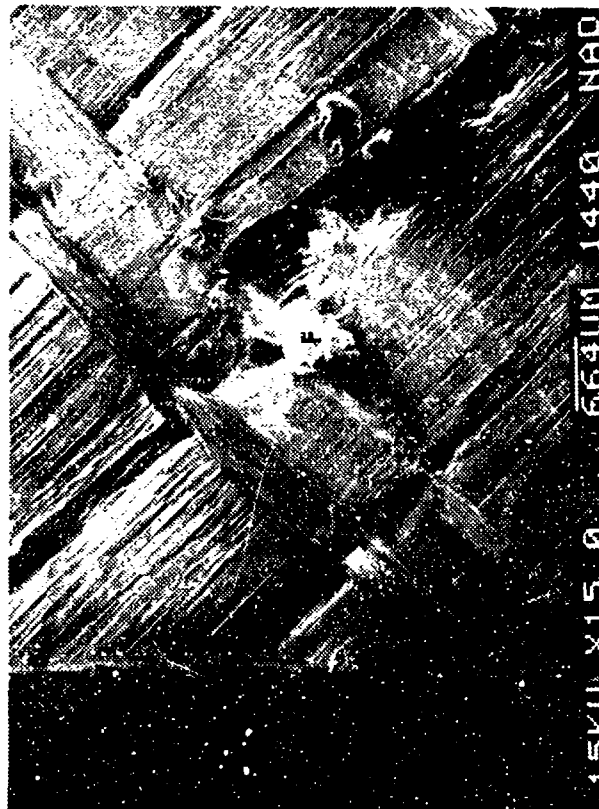
Figure 2-34. SEM Photographs of Mode I DCB Interlaminar Fracture in 3-D Weave Gr/Ep - [+45/-45]_{6s}

(b) River Patterns in Precrack Region

CD = Crack-propagation direction
 F = Frayed carbon fibers used in weave
 R = River patterns

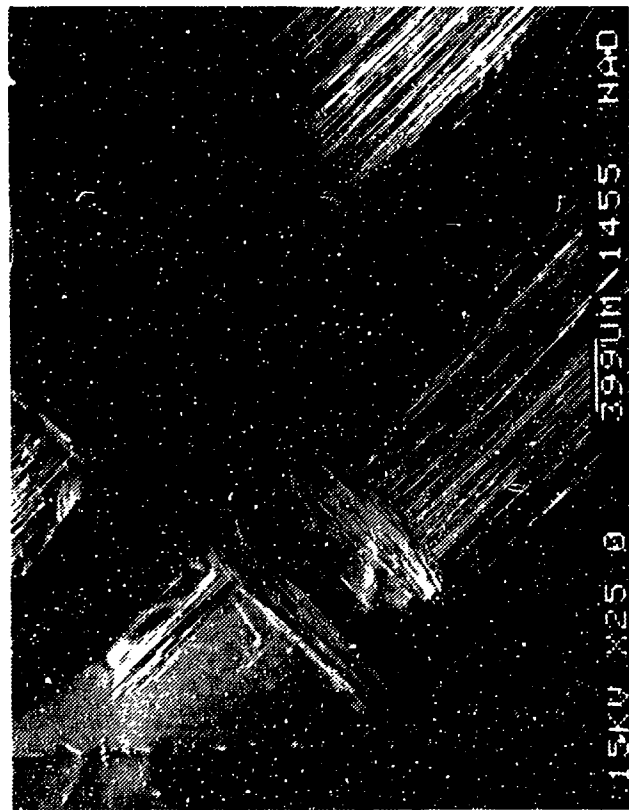
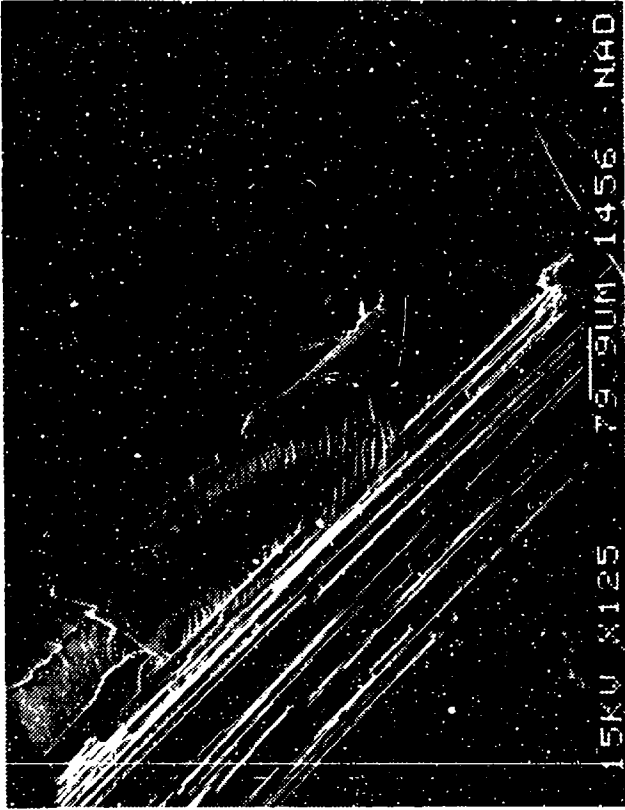
Figure 2-35. SEM Photographs of Mode I DCB Interlaminar Fracture in 3-D Weave Gr/Ep - [+45/0/-45]_{4s}
 (a) Initiation in Precrack Region of Coupon
 (b) River Patterns in Precrack Region

CD = Crack propagation direction
 R = River patterns

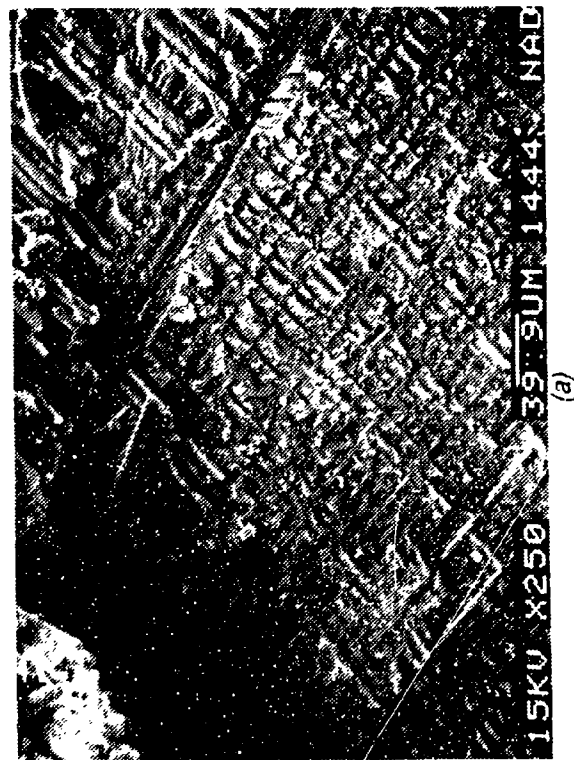
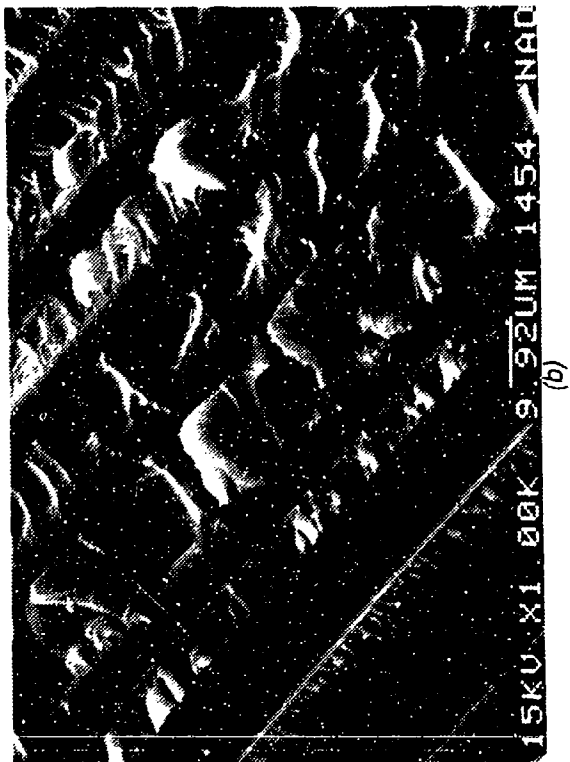
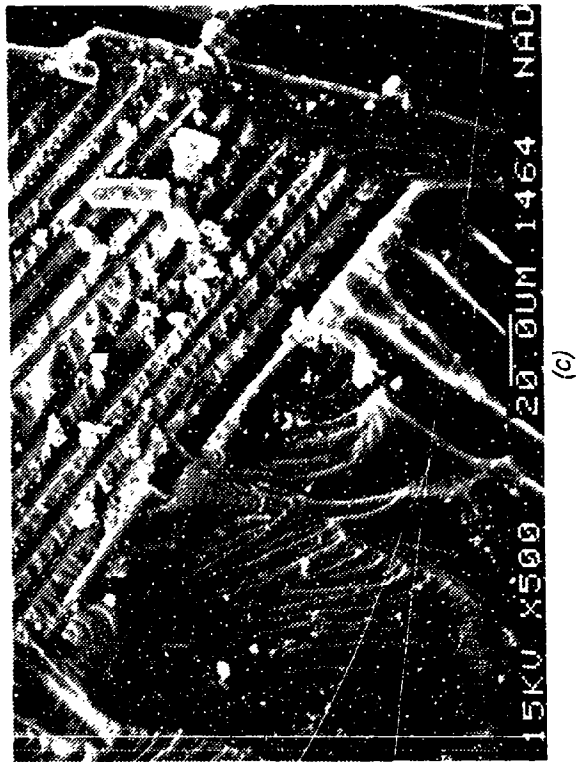
Figure 2-36. SEM Photographs of Mode I DCB Interlaminar Fracture in 3-D Weave Gfr/Ep
 (a) Crack-Growth Region in [+45/-45]_{ss}
 (b) Higher Magnification of (a) Showing Hackles
 (c) Fractured Resin Pocket and Hackles in Crack-Growth Region of [+45/0/-45]_{4s}

CD = Crack-propagation direction
 F = Frayed carbon fibers
 H = Hackles
 P = Resin pocket
 R = River patterns

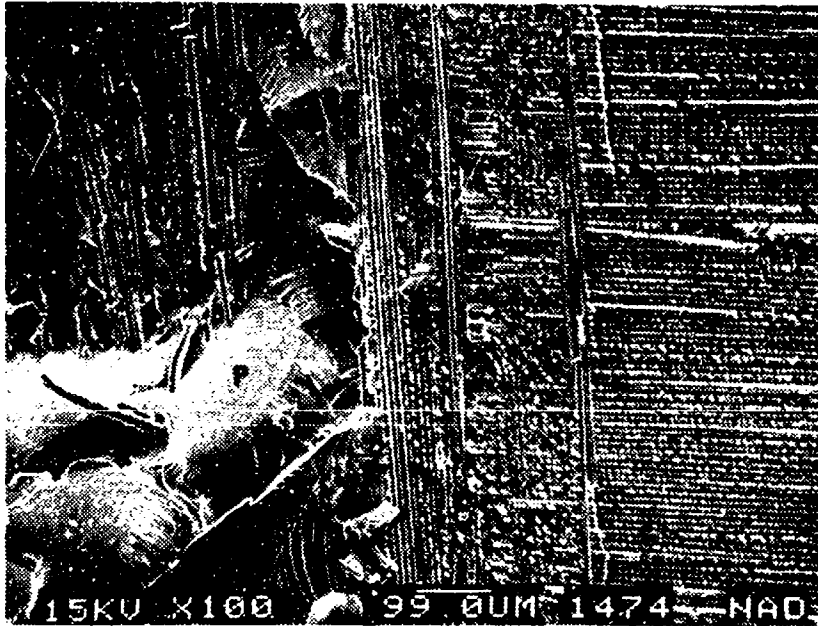
Figure 2-37. SEM Photographs of Mode I DCB Fracture in 3-D Weave Gr/Ep - [0/90]_{6S} in Crack-Growth Region
CD = Crack-propagation direction
P = Resin pocket adjacent to carbon fiber used in weave

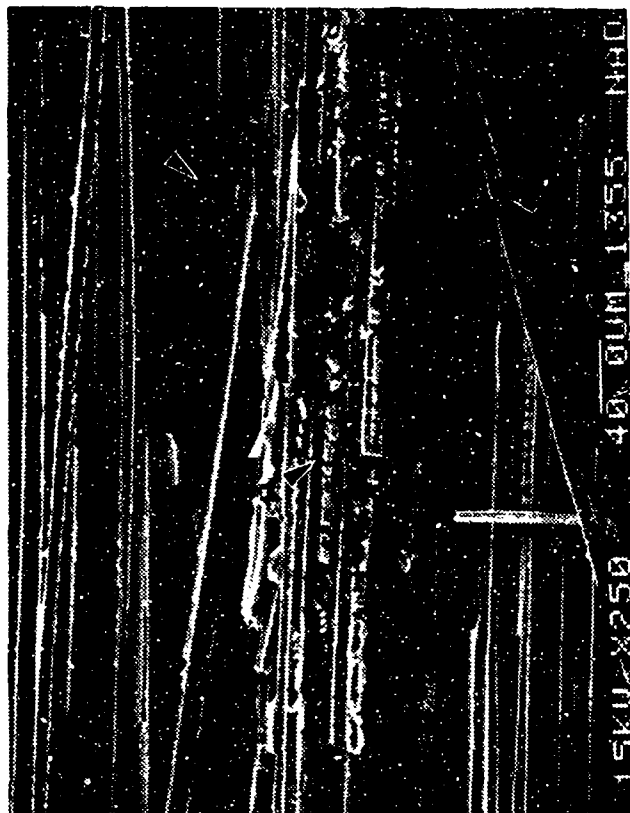
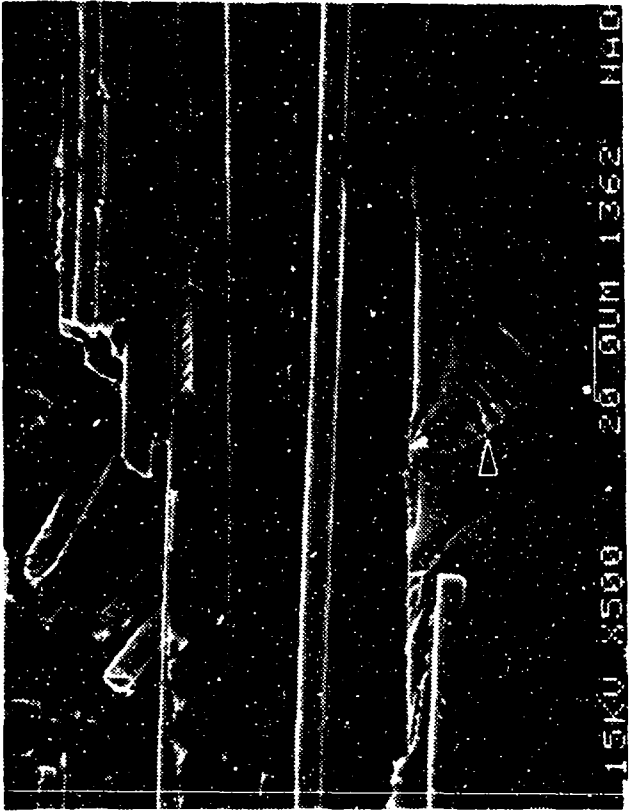
Figure 2-38. (Continued)
 (d) Impact Center
 (e) Broken Fibers in Impact Area
 Note river patterns in resin
 CD = Crack propagation direction
 H = Heckles (cusps)
 R = River patterns

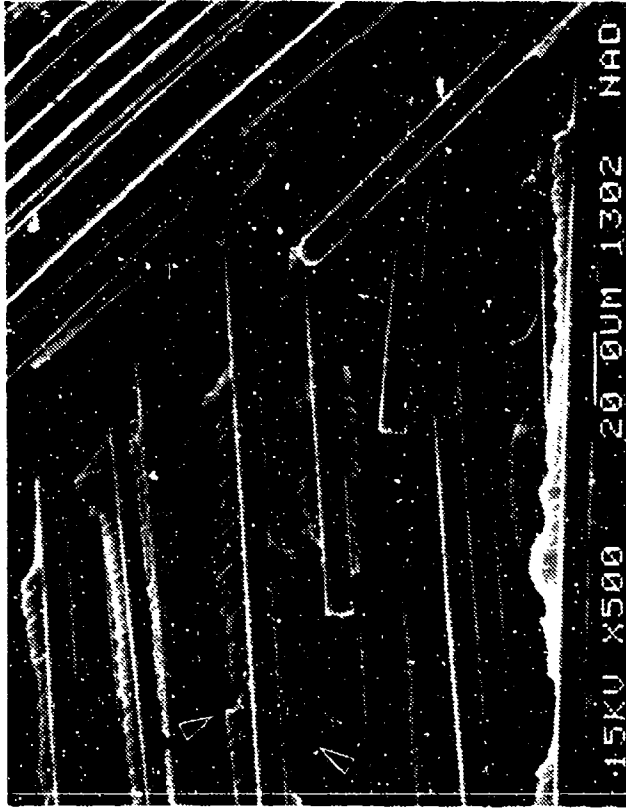
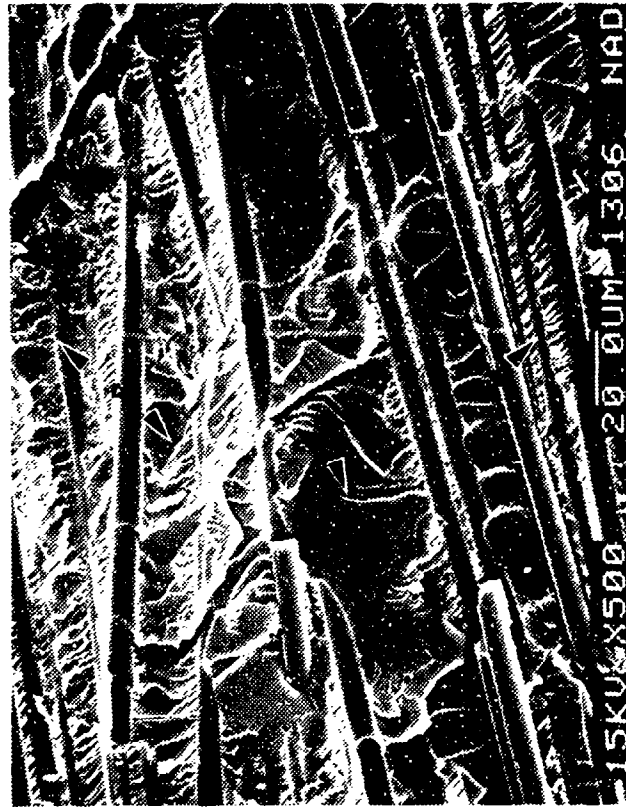
Figure 2-39. (Continued)
 (d) Impact Center
 (e) Interlamellar Fracture Away From Impact

CD = Crack propagation direction
 H = Hackles (cusps)
 R = River patterns

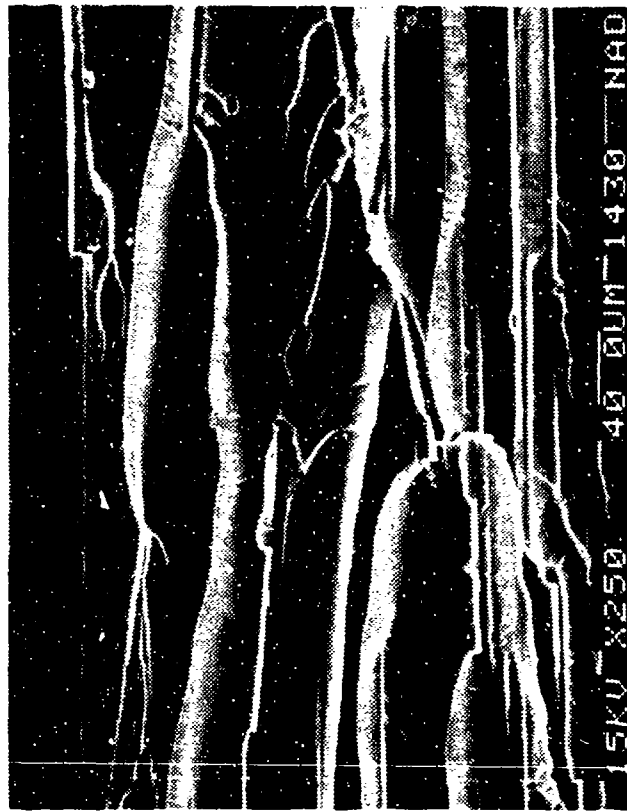
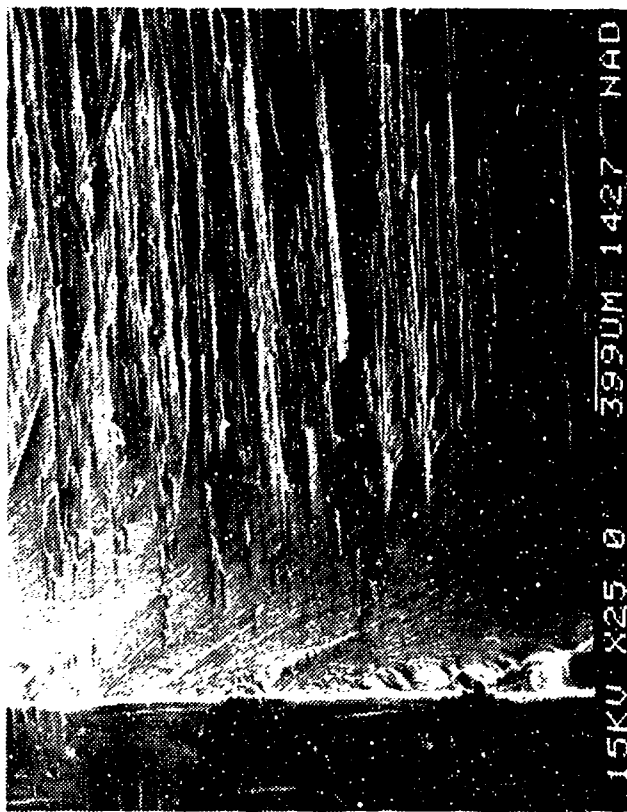
Figure 2-40. SEM Photographs of Mode I DCB Interlaminar Fracture in Gr/Ep - [0]_{24T}, Water Immersed Before Test

(a) Initiation in Pre-crack Region

(b) River Patterns in Crack-Growth Region

CD = Crack-propagation direction

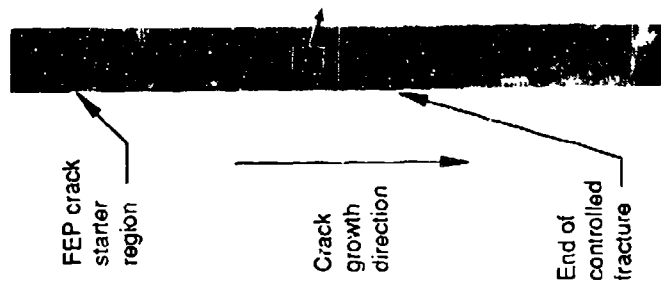
Figure 2-41. Optical Photomicrographs of Interlaminar Mode I Tension, 0/90 Fracture, Water Immersed (160 F) After Test

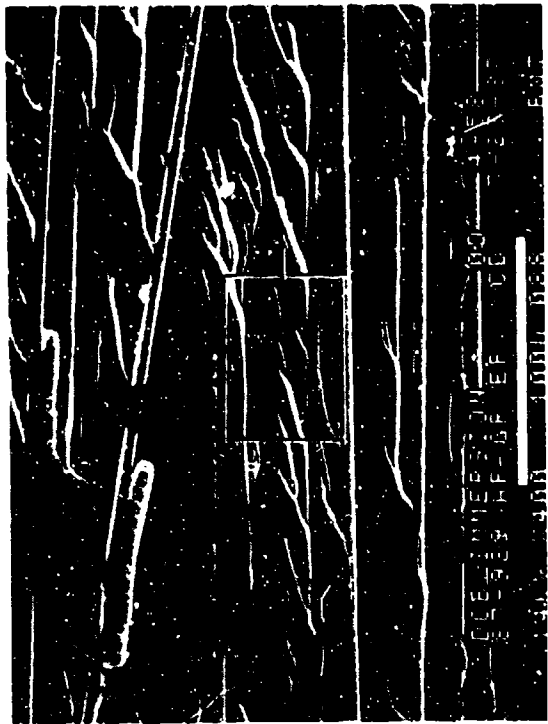
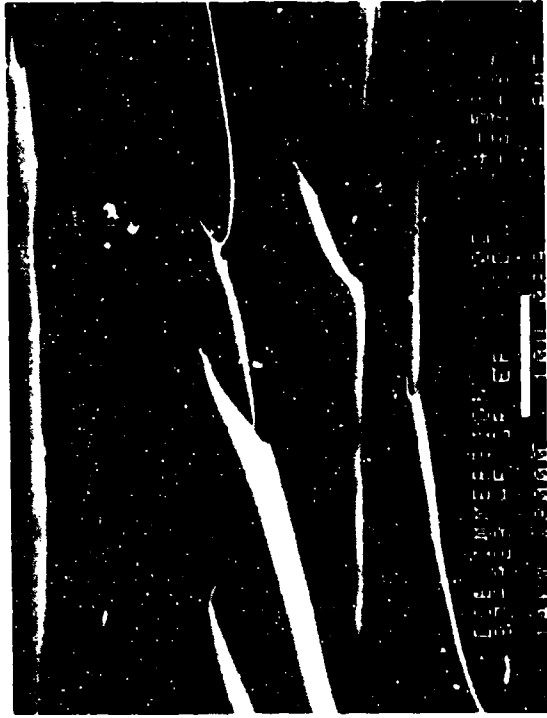
- M matrix fracture
- F fiber matrix separation
- R rivermarks

Mechanically induced
crack direction

Figure 2-42. SEM Fractographs of Interlaminar Mode I Tension, 0/90 Fracture, Water Immersed (160 F) After Test
