WL-TR-91-4032
DOT/FAA/CT-91/23
VOL II, Part 2

COMPOSITE FAILURE ANALYSIS HANDBOOK
VOL II - TECHNICAL HANDBOOK
PART 2 - ATLAS OF FRACTOGRAPHS

February 1992

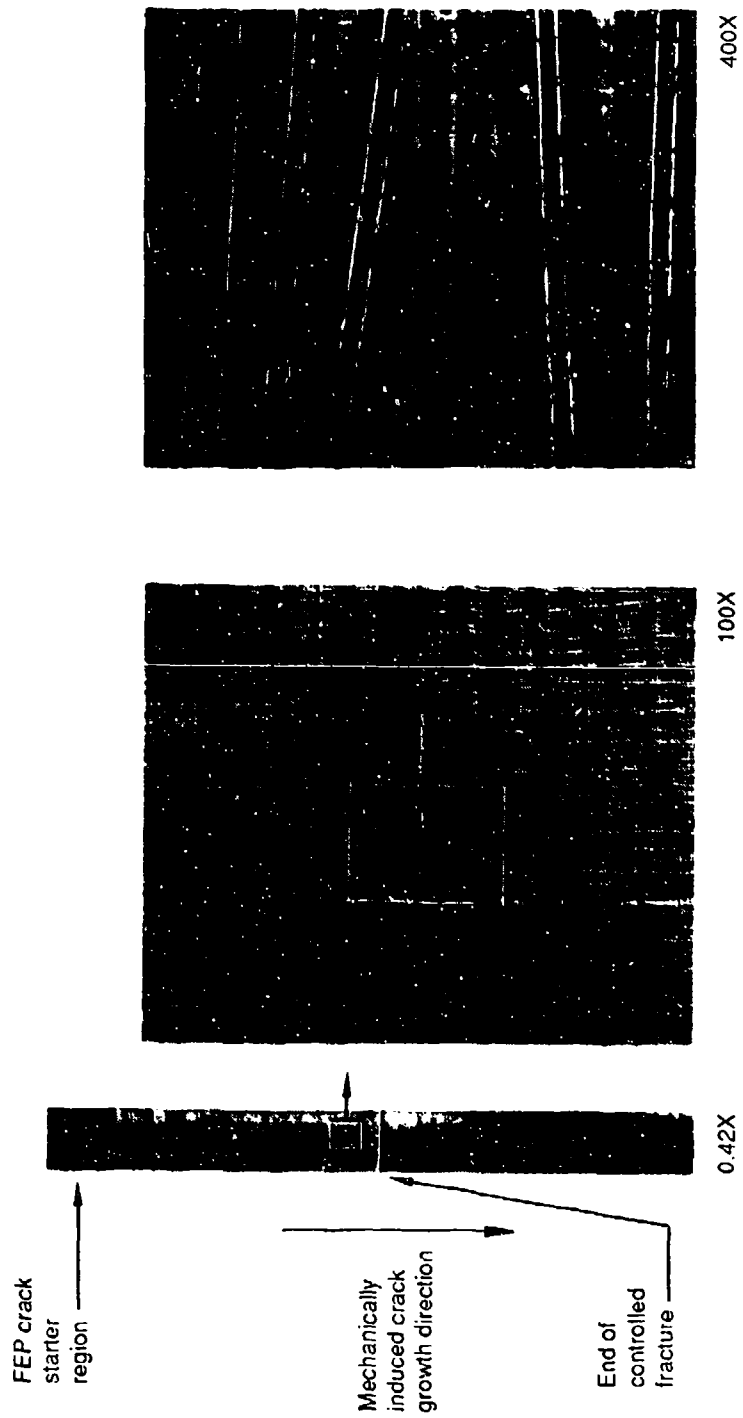
Figure 2-43. Optical Photomicrographs of Interlaminar Mode I Tension, 0/90 Fracture, Exposure to Humidity (160 F) After Test

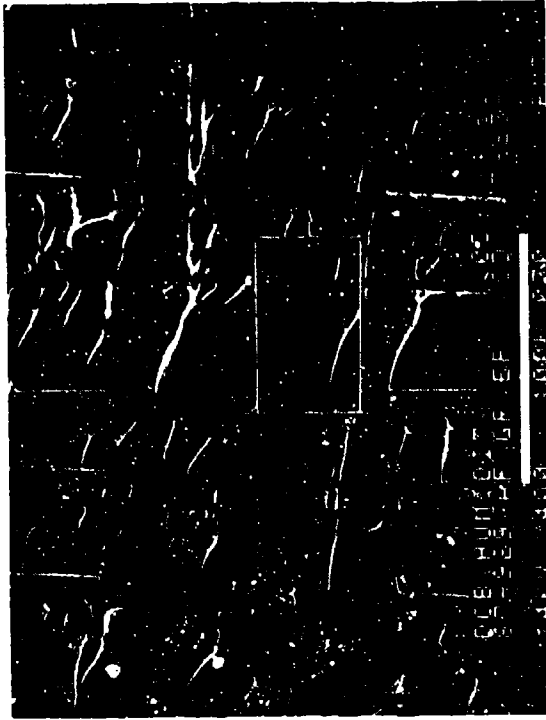
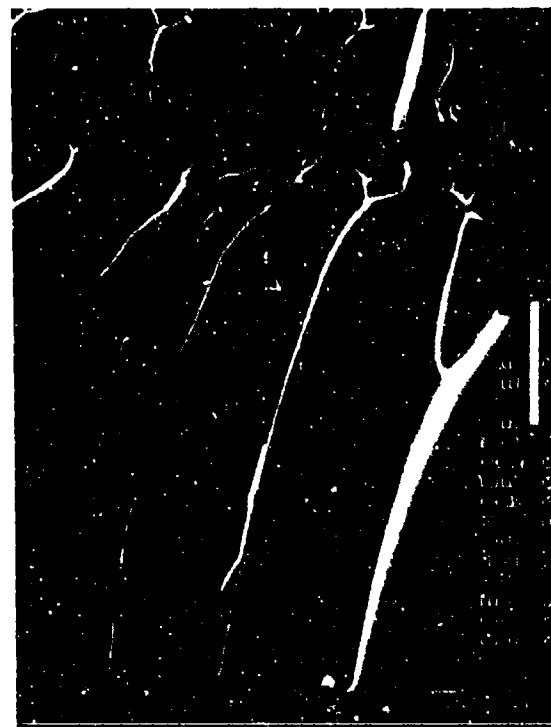
- M matrix fracture
- F fiber matrix separation
- R rivermarks

Mechanically induced
crack direction

Figure 2-44. SEM Fractographs of Interlaminar Mode I Tension, 0/90 Fracture, Exposure to Humidity (160 F) After Test

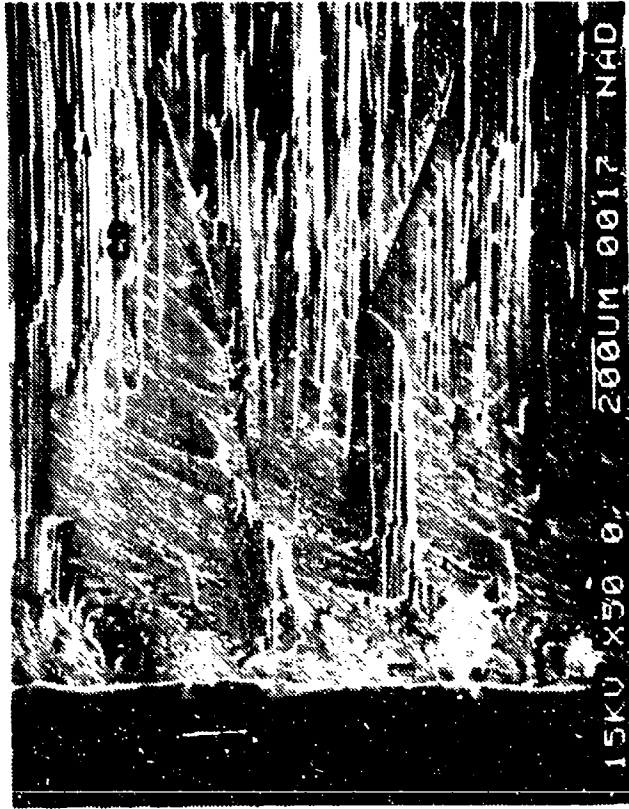
Figure 2-45. Optical and SEM Photographs of Mode I DCB Interlaminar Fracture in Undercured Gr/Ep - [0]₂zr
 (a) Macro photograph showing Regions I, II, and III
 (b) Initiation in Region I Adjacent to Armalcor (A)

CC = Crack-propagation direction

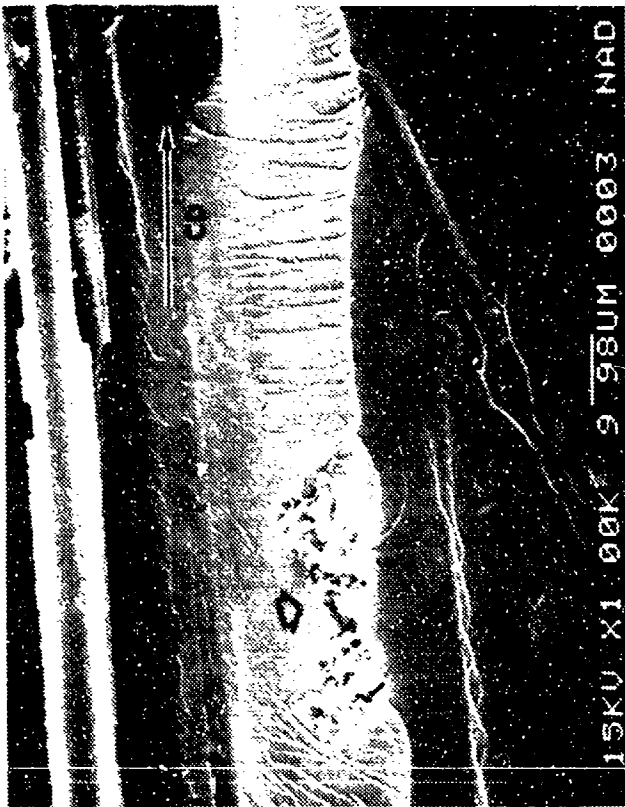
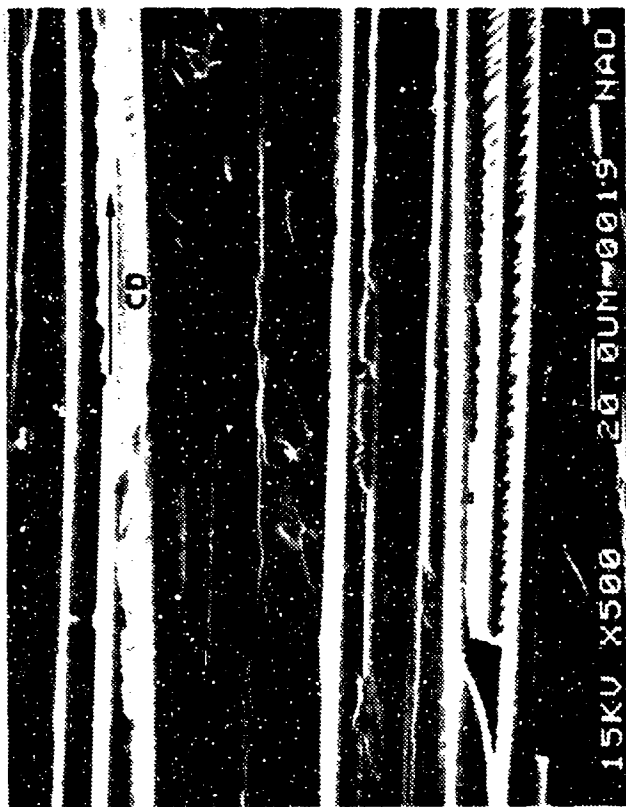
Figure 2-45. (Continued)
 (c) River Patterns Indicating Crack-Propagation Direction
 (d) Porosity (Arrows)

CD = Crack-propagation direction

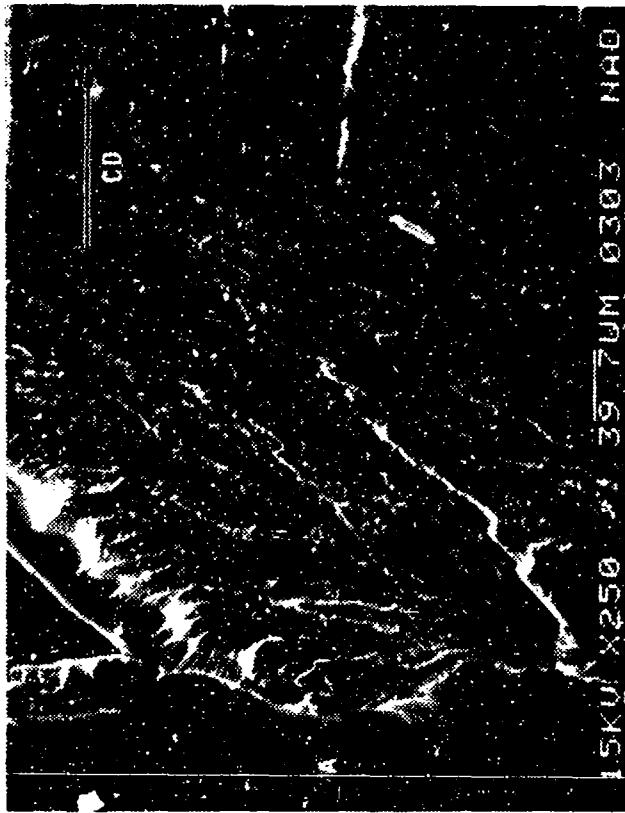
Figure 2-46. Optical and SEM Photographs of Mode I DCB Interlaminar Fracture in Undercured Gr/Ep - [+45/0/-45]_{4s}

(b) Local Fracture Initiating in Region I

A = Armation Insert

CD = Crack-propagation direction

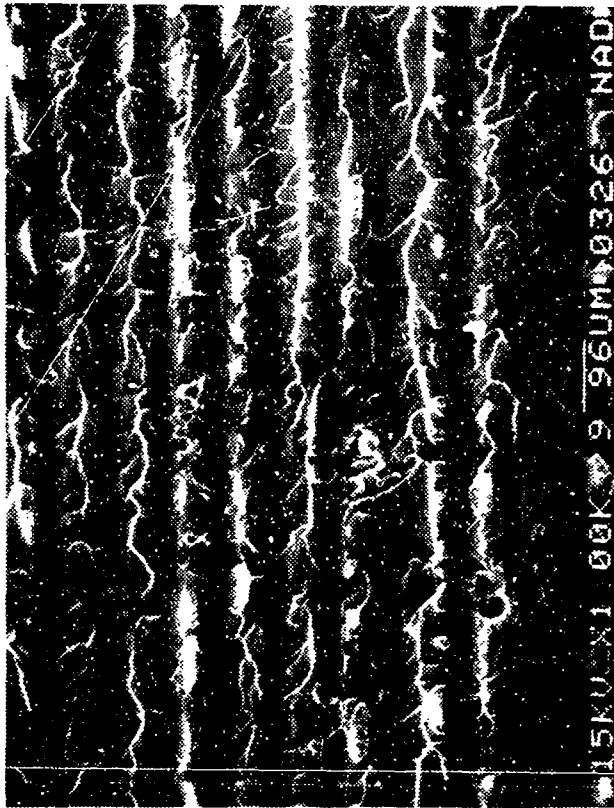
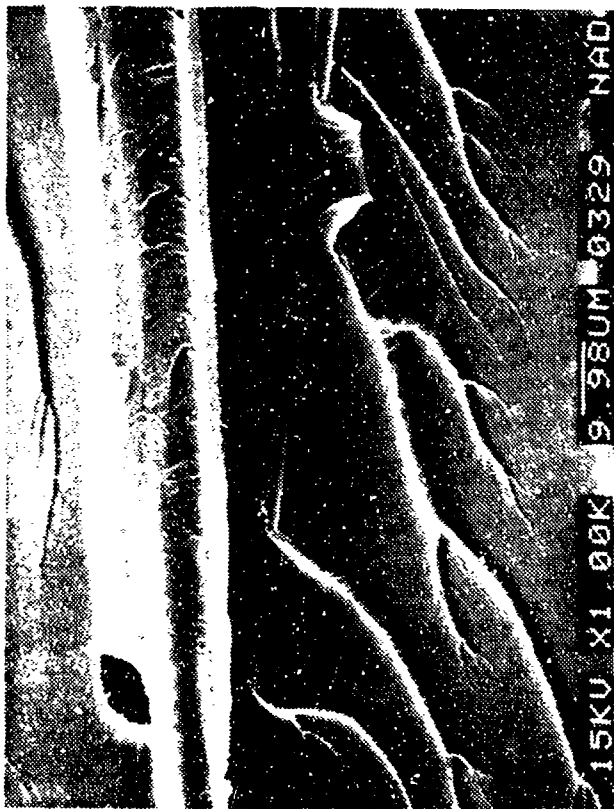
Figure 2-46. (Continued)
(c) River Patterns in Fractured Epoxy
(d) Local Porosity in Specimen

CD = Crack-propagation direction

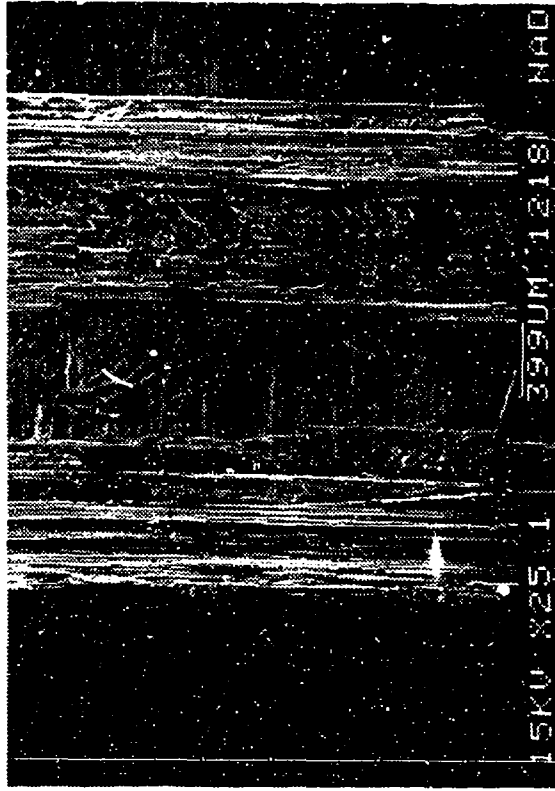
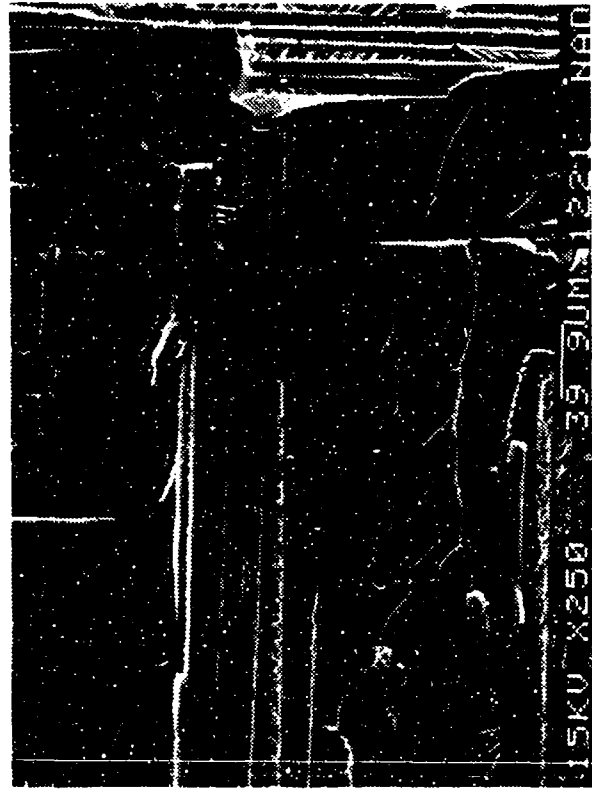
Figure 2-47. Optical and SEM Photographs of Mode I DCB Interlaminar Fracture in Undecured Gr/Ep - [0/90]_{as}
 (a) Macrophotograph
 (b) Initiation in Precrack Region
 (c) River Patterns (R) in Region II

CD = Crack-propagation direction

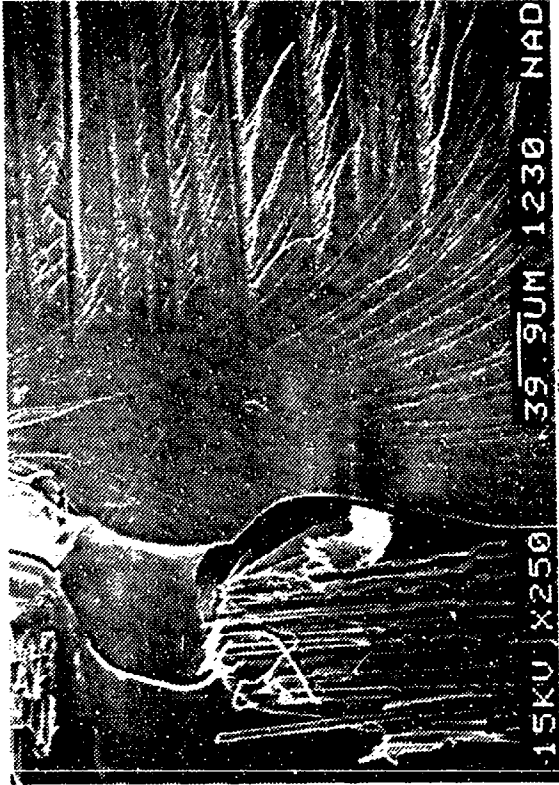
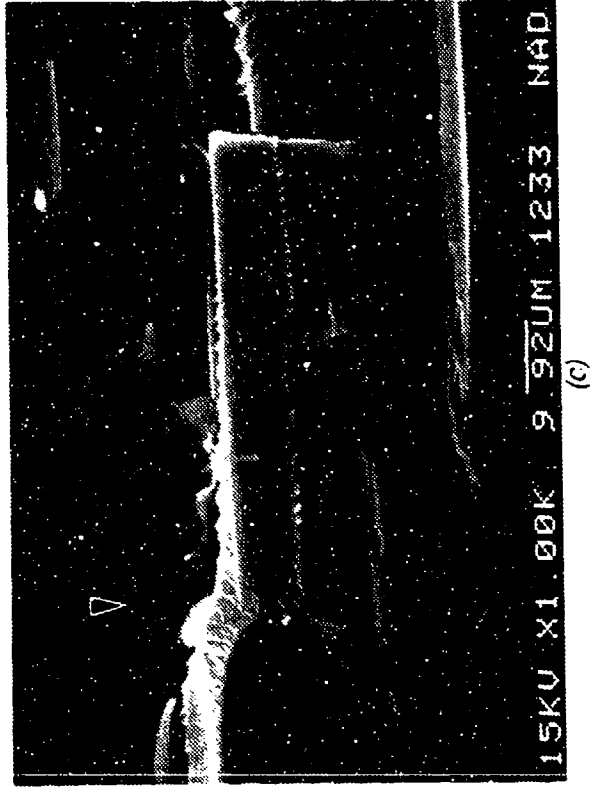
Figure 2-48. Optical and SEM Photographs of Mode I DCB Interlaminar Fracture in Overcured Gr/Ep - [0]_{24T}
 (a) Macrophotograph
 (b) Initiation in Precrack Region
 (c) River Patterns (R) in Region II
 CD = Crack-propagation direction

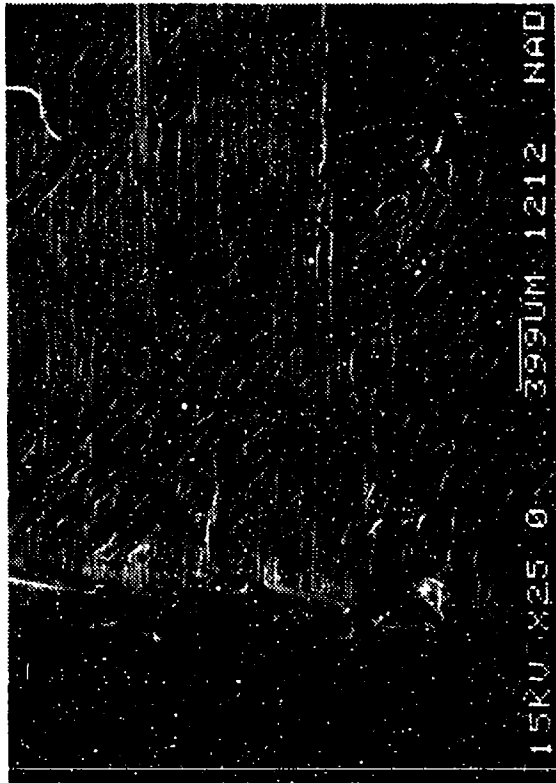
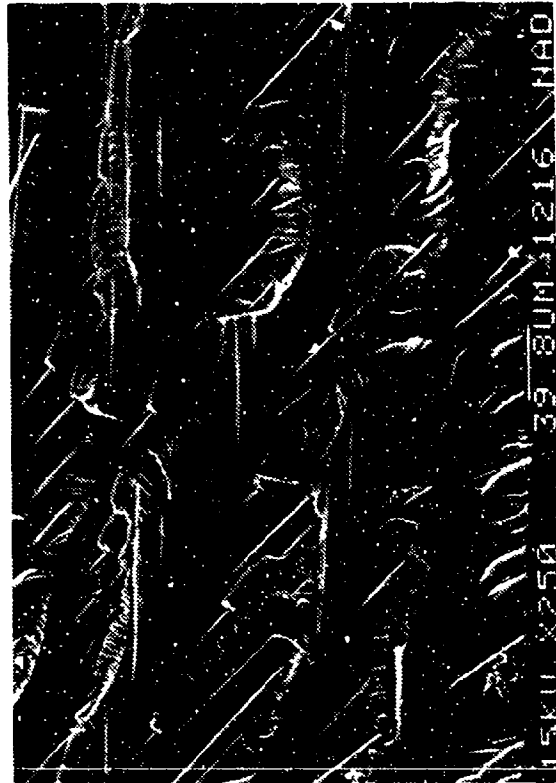
Figure 2-49. Optical and SEM Photographs of Mode I DCB Interlaminar Fracture in Overcured Gr/Ep - [+45/0/-45] _{4s}

- (a) Macro photograph
- (b) Initiation in Precrack Region
- (c) River Patterns (R) in Mode I Region

CD = Crack-propagation direction

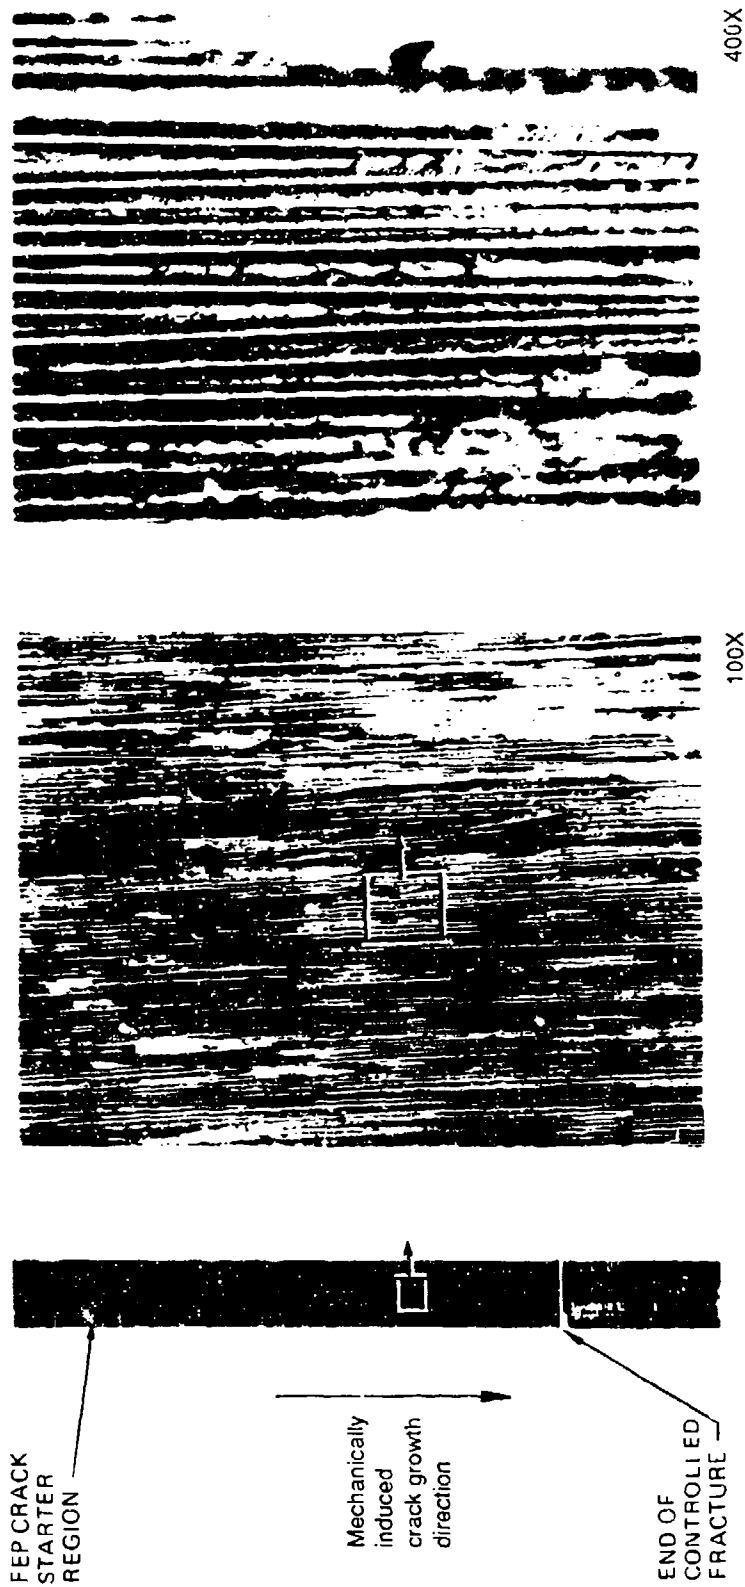
Figure 2-50. Optical Photomicrographs of Interlaminar Mode I Tension, 0/90 Fracture of Low Resin Content Specimen

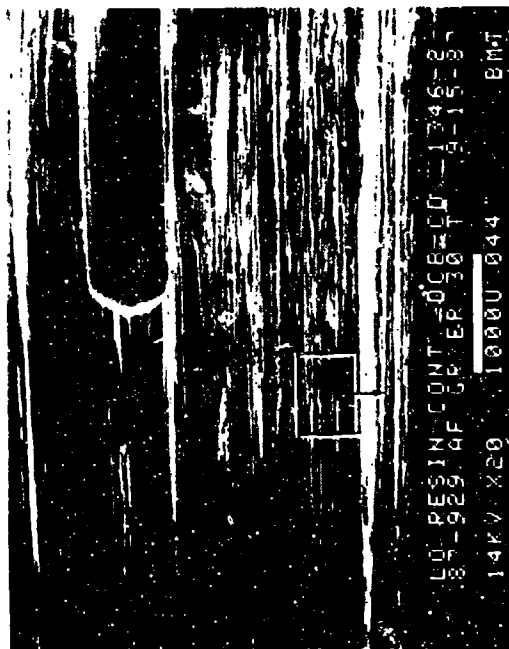
30 degree tilt 20X

- M matrix fracture
- F fiber/matrix separation
- R rivermarks

Mechanically induced
crack direction

Figure 2-51. SEM Fractographs of Interlaminar Mode I Tension, 0/90 Fracture of Low Resin Content Specimen

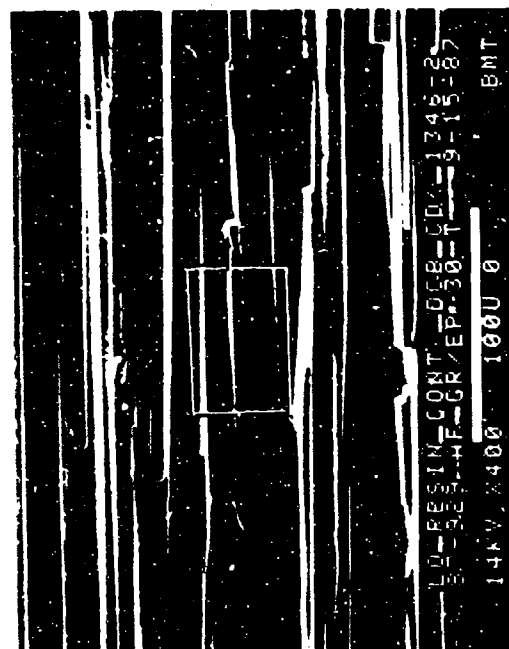
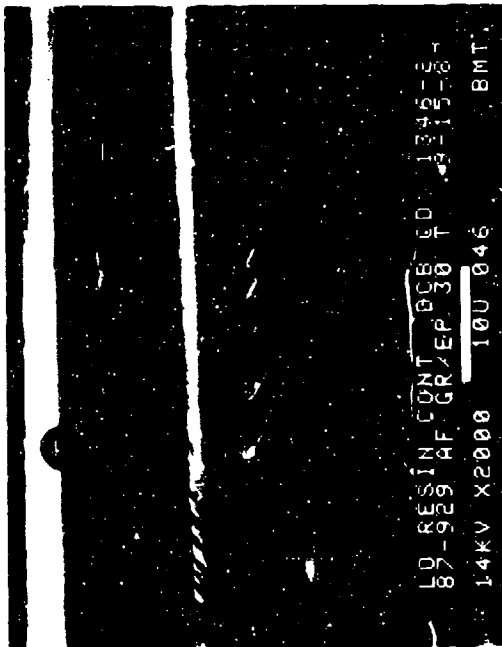
30 degree tilt 400X

30 degree tilt 2,000X

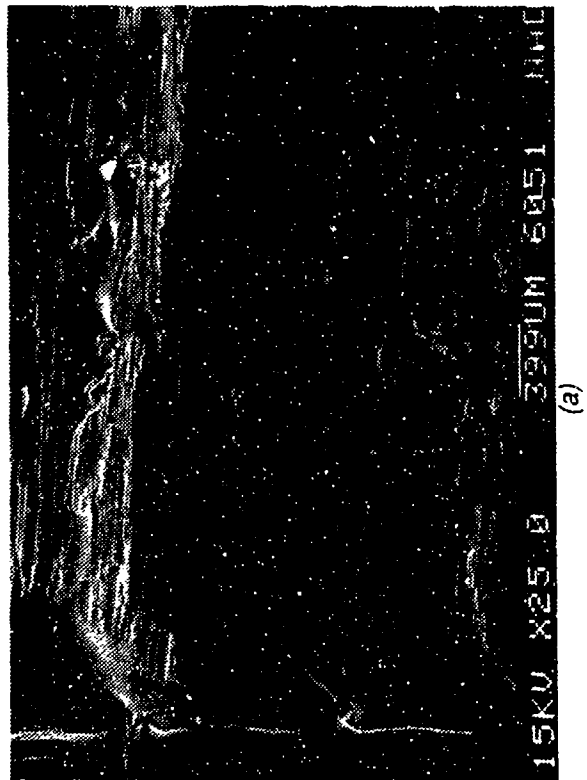
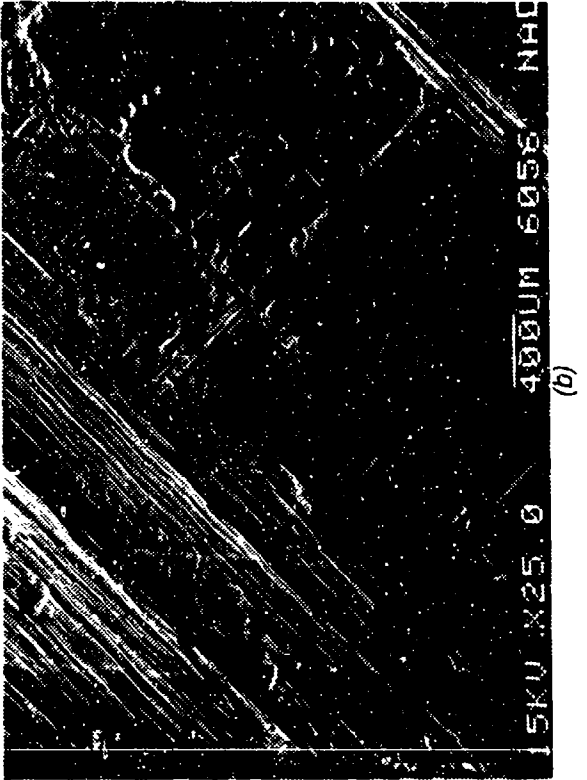
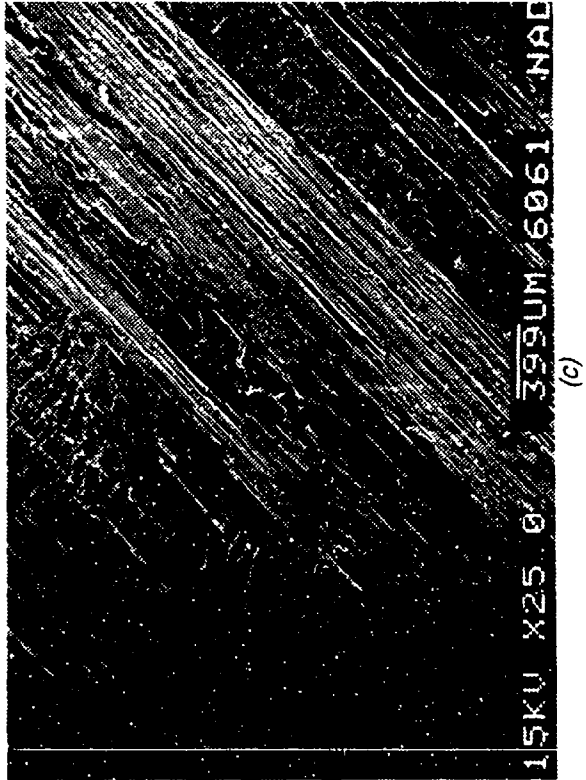
Figure 2-53. SEM Photographs of Mode I DCB Interlaminar Fracture in High Resin Content Gr/Ep, Conditioned 180 F Dry (a), (b), and (c) Initiation in Precrack Regions of [0]_{2T}, [+45/-45]_{4S}, and [+45/0/-45]_{6S} Coupons, Respectively

CD = Crack-propagation direction

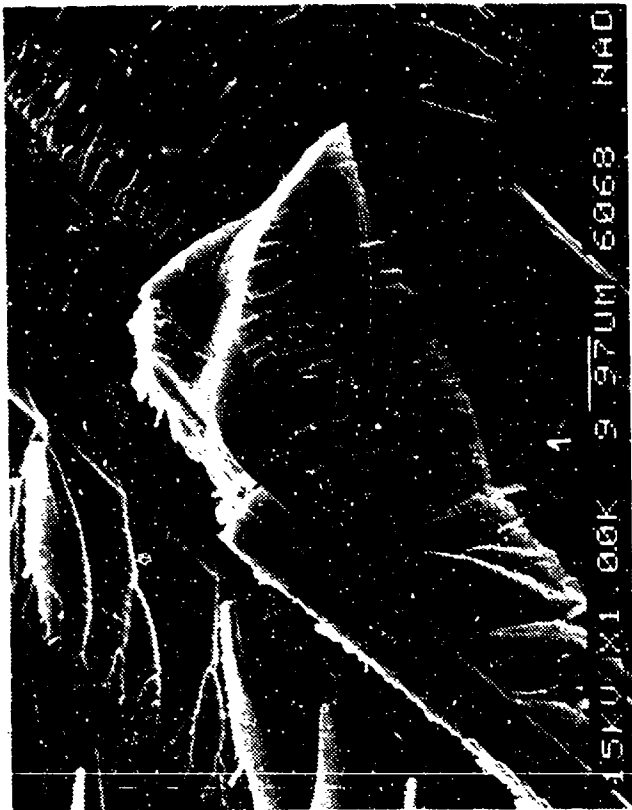
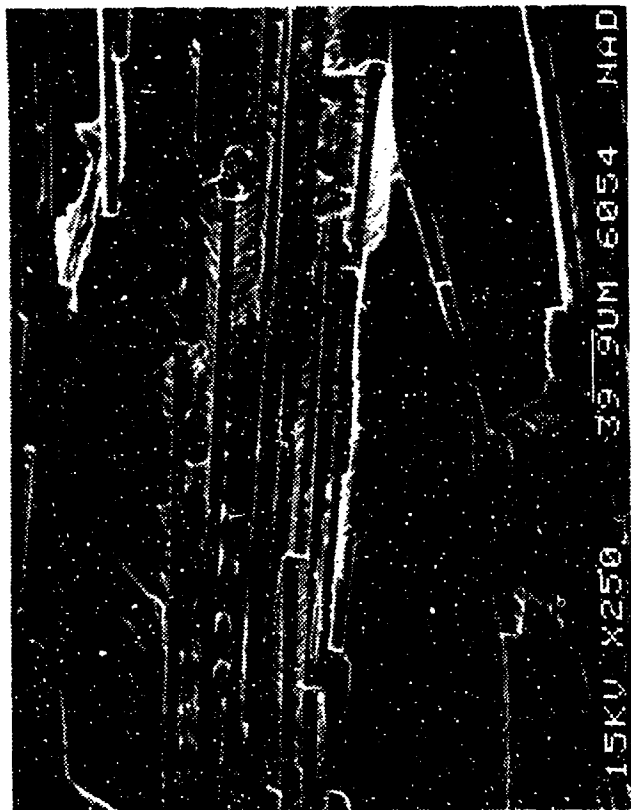
Figure 2-54. SEM Photographs of Mode I DCB Interlaminar Fracture Details in High Resin Content Gf/Ep, Conditioned 180 F Dry After Test

CD = Crack-propagation direction

R = River patterns

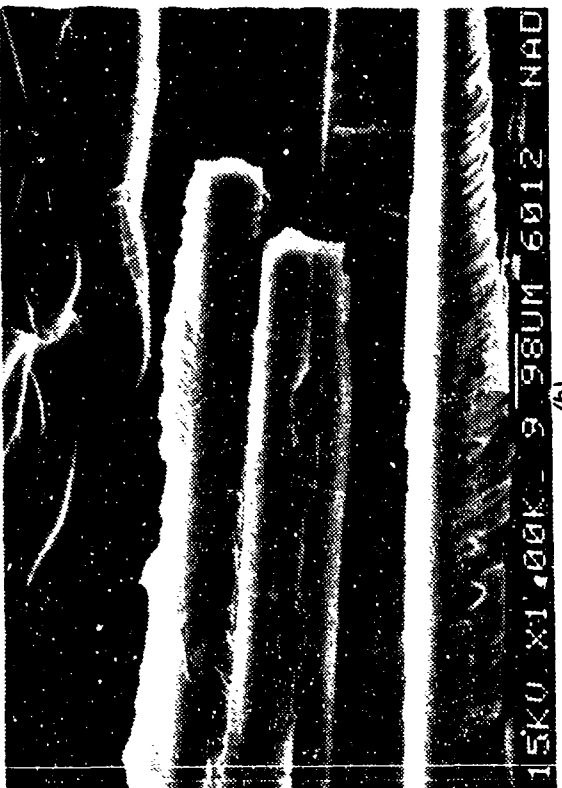
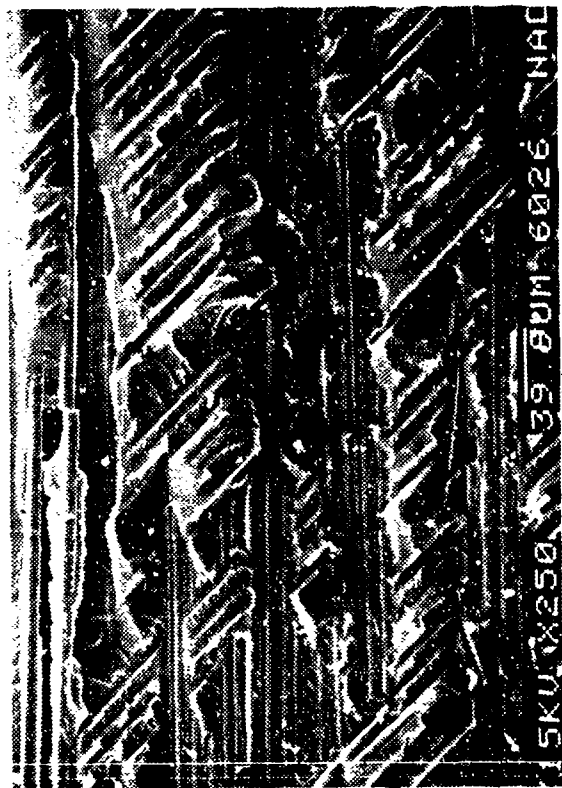
Figure 2-55. SEM Photographs of Mode I DCB Interlaminar Fracture in Overcured Gr/Ep, Cor. conditioned 180 F/Wet After Test

(a) Crack-Growth Region in [C, 24T Coupon

(c) Crack-Growth Region in [+45/0/-45]_{4s} Coupon

CD = Crack-propagation direction

R = River patterns

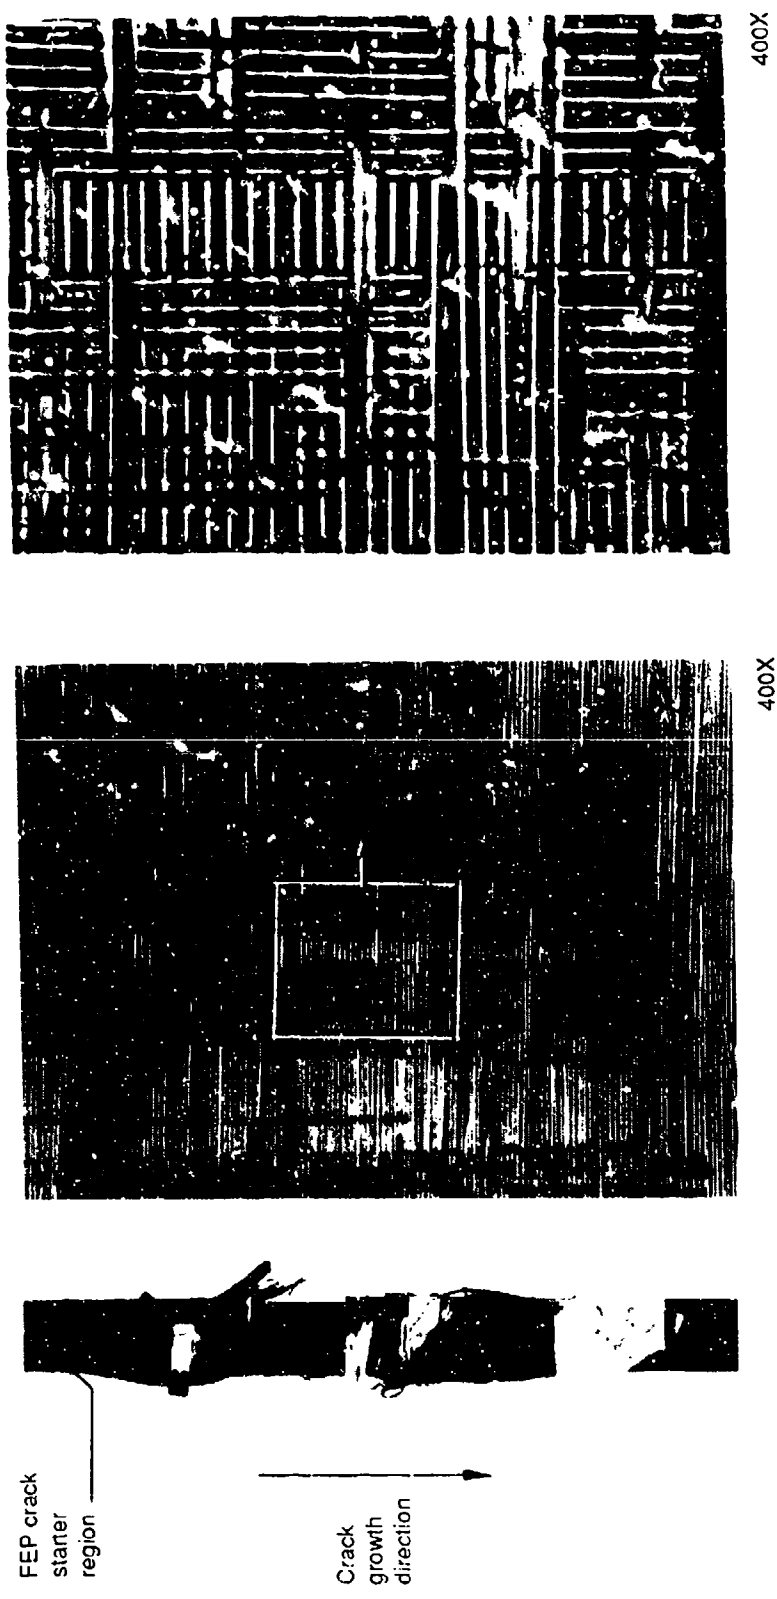
Figure 2-56. Optical Photomicrographs of Interlaminar Mode I Tension, 0190 Fracture, 2000 F Exposure for 5 Minutes After Test

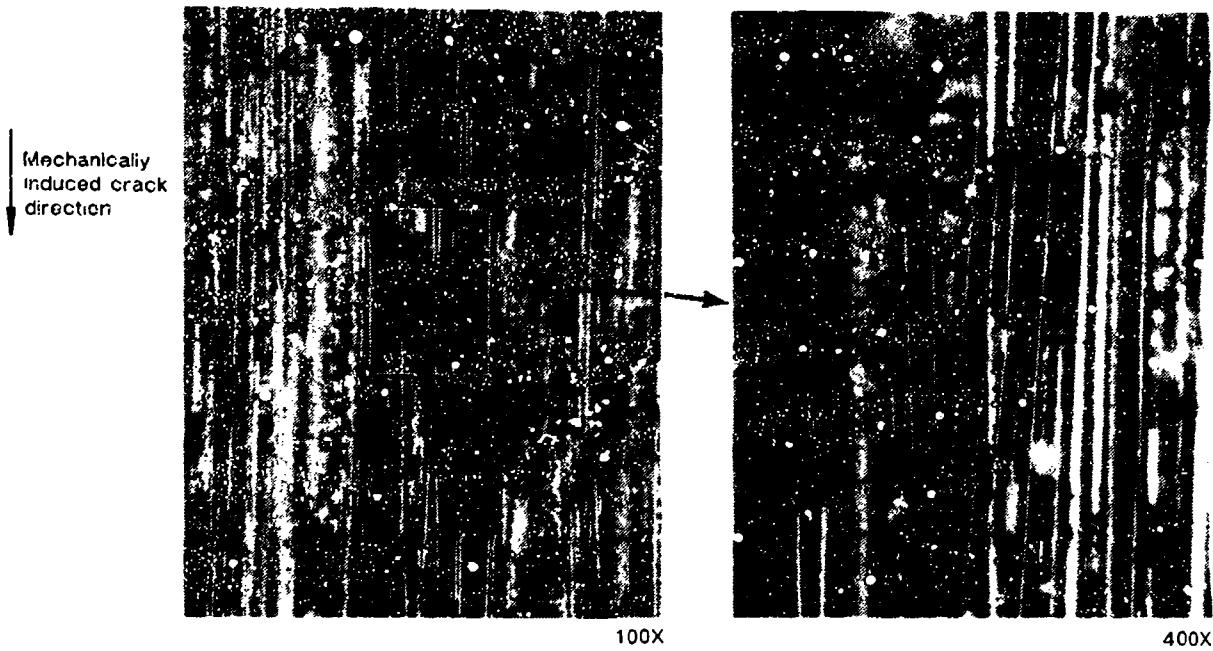
Fracture type	Interlaminar mode II shear
Ply layup	[0] 24
Test type	ENF
• Test conditions	21°C, dry
• Fracture between	0/0 plies
Material	Hercules 3501-6/177° C cure AS4 fibers

Figure 2-59. Photographs of Interlaminar Mode II Shear, 0/0 Fracture, 70 F/Dry

Table 2-2 shows the test matrix for the end-notched flexural (ENF) test type. Figure 2-58 shows the ENF test geometry. The fractographs from the interlaminar shear testing are shown in Figures 2-59 through 2-99. These figures are arranged in the same order that the corresponding tests are listed in Table 2-2.

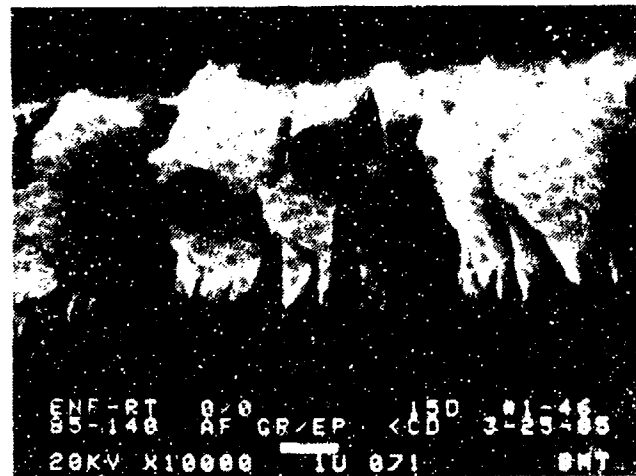
Fracture type	Interlaminar mode II shear
Ply layup	[0] 24
Test type	ENF
• Test conditions	21°C, dry
• Fracture between	0/0 plies
Material	Hercules 3501-6/177° C cure AS4 fibers

Mechanically induced crack direction

Figure 2-60. SEM Photographs of Interlaminar Mode II Shear, 0/0 Fracture, 70 F/Dry

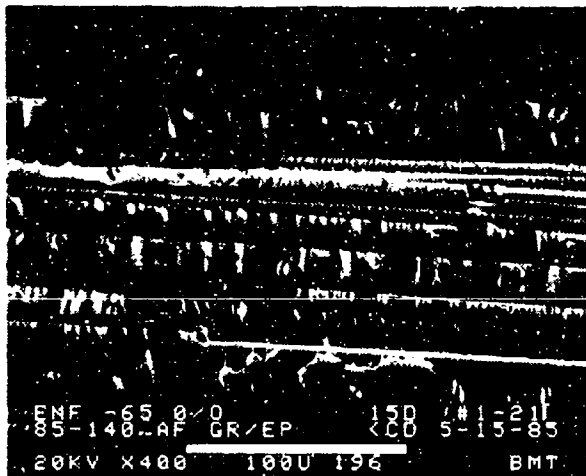
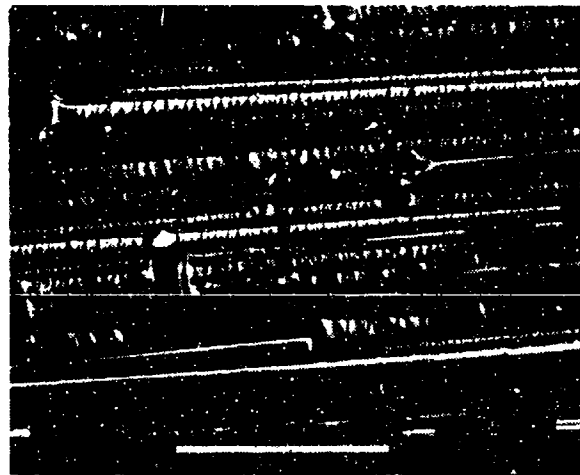
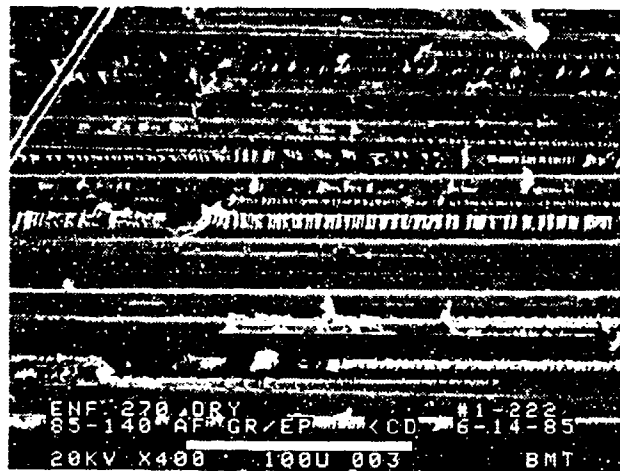
Fracture type	Interlaminar mode II shear
Ply layup	[0] 24
Test type	ENF
• Test conditions	Dry
• Fracture between	0/0 plies
Material	Hercules 3501-6/177° C cure AS4 fibers

-65°F, dry

70°F, dry

270°F, dry

Figure 2-62. SEM Photographs of Interlaminar Mode II Shear, 0/0 Fracture, -65, 70, and 270 F/Dry (400X)

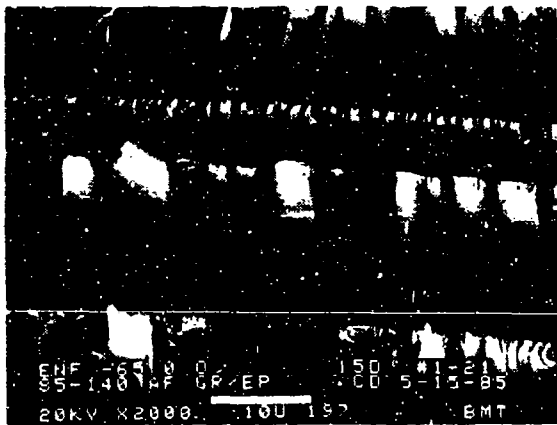
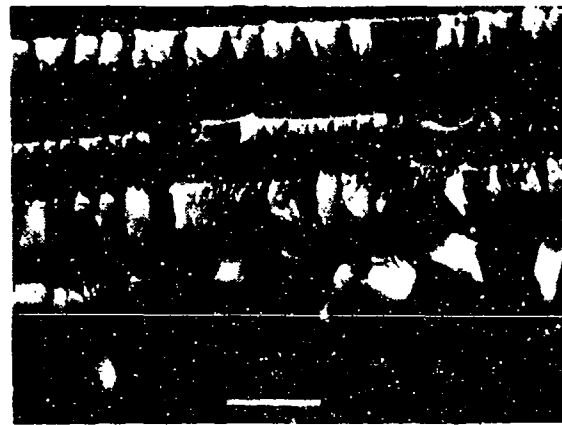
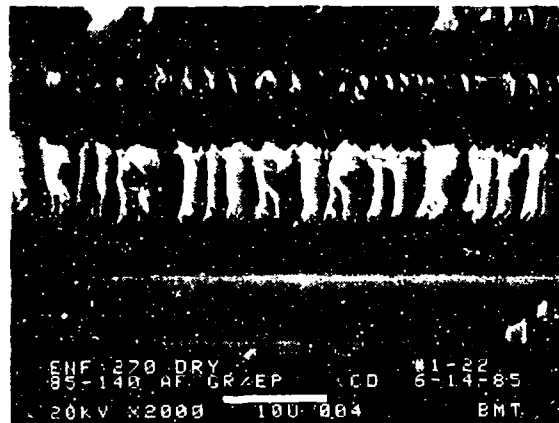
Fracture type	Interlaminar mode II shear
Ply layup	[0] 24
Test type	ENF
• Test conditions	Dry
• Fracture between	0/0 plies
Material	Hercules 3501-6/177°C cure AS4 fibers

-65°F, dry

70°F, dry

270°F, dry

Figure 2-63. SEM Photographs of Interlaminar Mode II Shear, 0/0 Fracture, -65, 70, and 270 F/Dry (2000X)

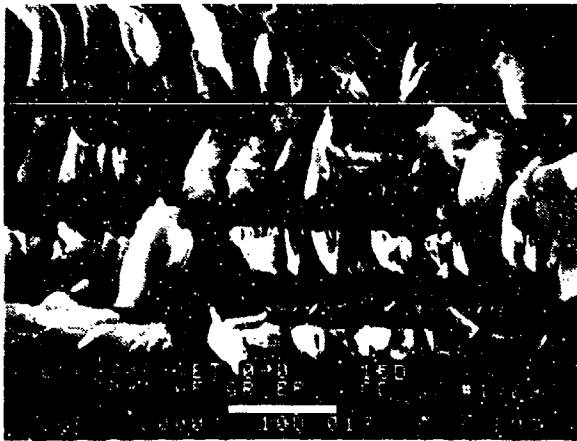
Fracture type	Interlaminar mode II shear
Ply layup	[0] 24
Test type	ENF
• Test conditions	Wet
• Fracture between	0/0 plies
Material	Hercules 3501-6/177° C cure AS4 fibers

70°F, wet

180°F, wet

Figure 2-65. SEM Photographs of Interlaminar Mode II Shear, 0/0 Fracture, 70 and 180 F/Wet

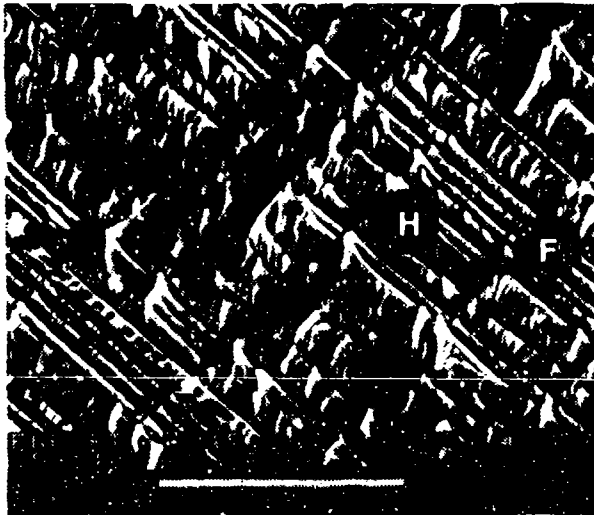
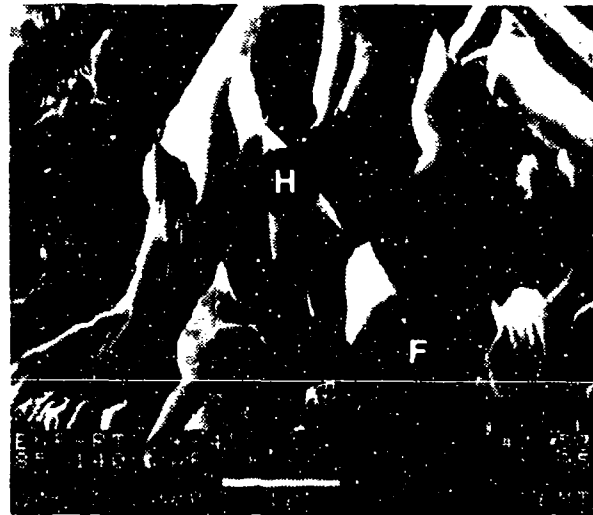
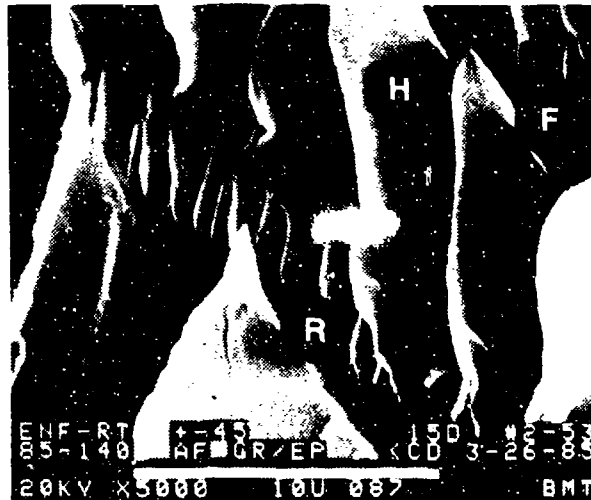
Fracture type	Interlaminar mode II shear
Ply layup	[+45/-45] 12S
Test type	ENF
• Test conditions	21°C, dry
• Fracture between	+45/-45 plies
Material	Hercules 3501-6/177°C cure AS4 fibers

Mechanically induced crack direction

- F Fiber matrix separation
- H Hackles
- R River markings

Figure 2-67. SEM Photographs of Interlaminar Mode II Shear, +45/-45 Fracture, 70 F/Dry

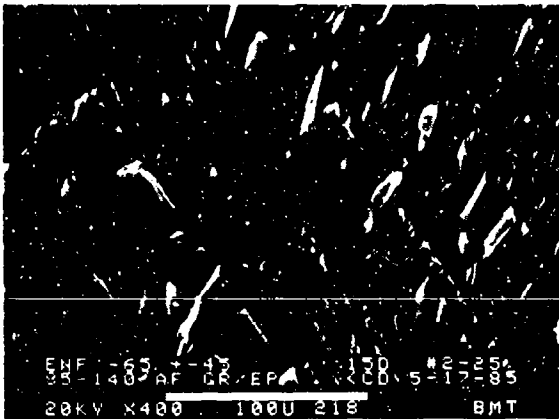
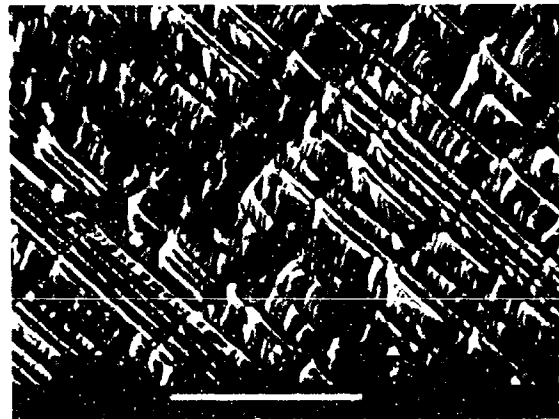
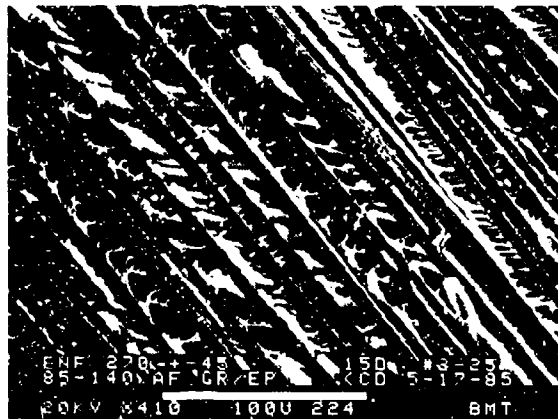
Fracture type	Interlaminar mode II shear
Ply layup	[+45, -45] ₂ S
Test type	ENF
● Test conditions	Dry
● Fracture between	+45/-45 plies
Material	Hercules 3501-6/177°C cure AS4 fibers

-65°F, dry

70°F, dry

270°F, dry

Figure 2-69. SEM Photographs of Interlaminar Mode II Shear, +45/-45 Fracture, -65, 70 and 270 F/Dry (400X)

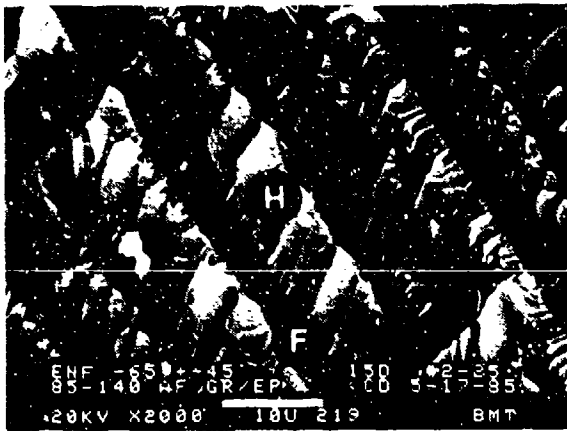
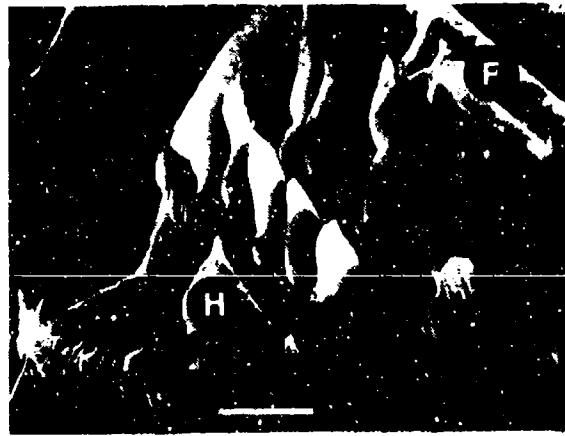
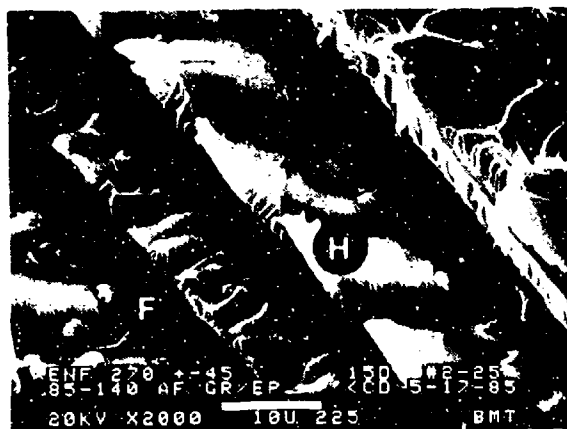
Fracture type	Interlaminar mode II shear
Ply layup	[+45/-45] 12S
Test type	ENF
• Test conditions	Dry
• Fracture between	+45/-45 plies
Material	Hercules 3501-6/177°C cure AS4 fibers

- F Fiber matrix separation
- H Hackles

-65°F, dry

70°F, dry

270°F, dry

Figure 2-70. SEM Photographs of Interlaminar Mode II Shear, +45/-45 Fracture, -65, 70 and 270 F/Dry (2000X)

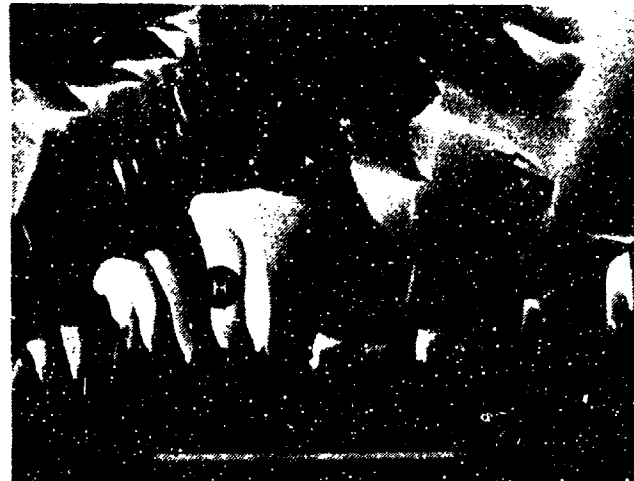
Fracture type	Interlaminar mode II shear
Ply layup	[0, 45] _{12S}
Test type	ENF
● Test conditions	RT
● Fracture between	0/45 plies
Material	Hercules 3501-6/177°C cure AS4 fibers

- F Fiber matrix separation
- H Hackles
- R River markings
- T Textured microflow

Figure 2-72. SEM Photographs of Interlaminar Mode II Shear, 0/45 Fracture, 70 F/Dry

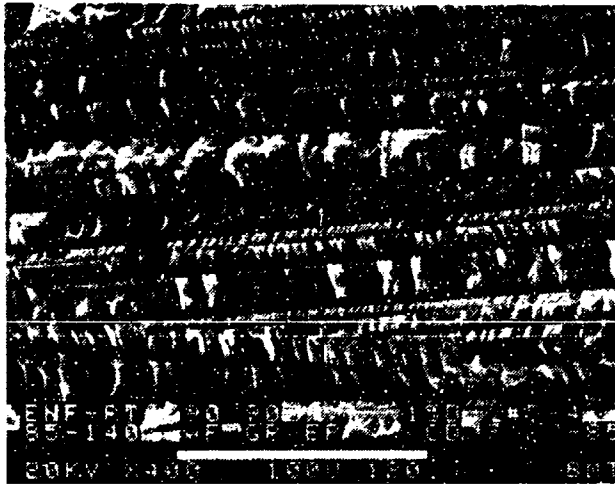
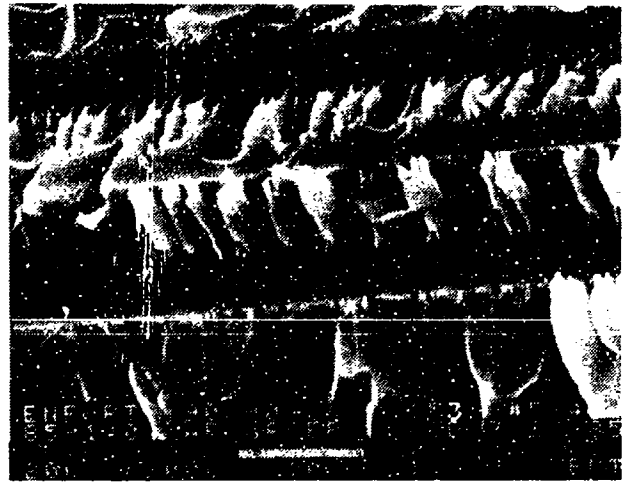
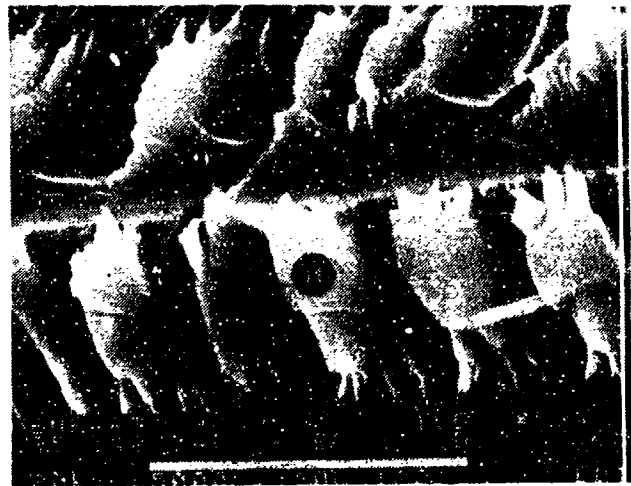
Fracture type	Interlaminar mode II shear
Ply layup	[90] 24
Test type	ENF
• Test conditions	21°C, dry
• Fracture between	90/90 plies
Material	Hercules 3501-6/177°C cure AS4 fibers

- F Fiber matrix separation
- H Hackles
- R River markings

Figure 2-75. SEM Photographs of Interlaminar Mode II Shear, 90/90 Fracture, 70 F/Dry
