WL-TR-91-4032
DOT/FAA/CT-91/23
VOL II, Part 2

COMPOSITE FAILURE ANALYSIS HANDBOOK
VOL II - TECHNICAL HANDBOOK
PART 2 - ATLAS OF FRACTOGRAPHS

February 1992

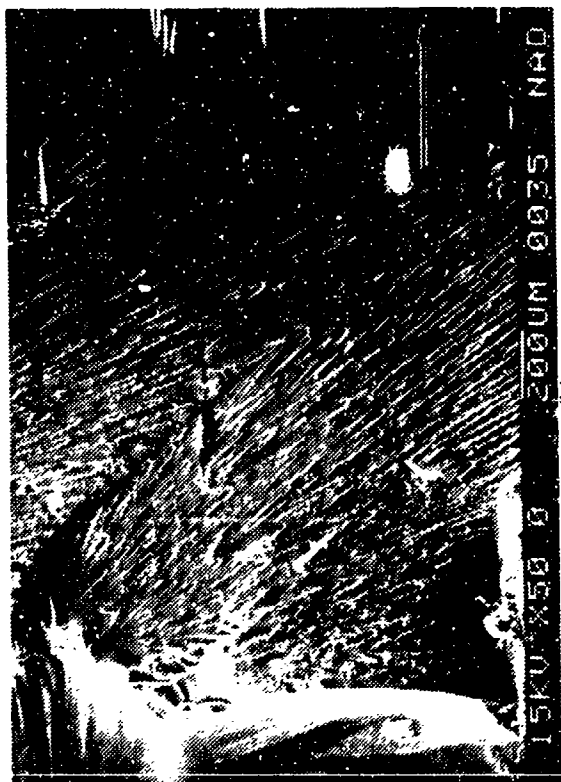
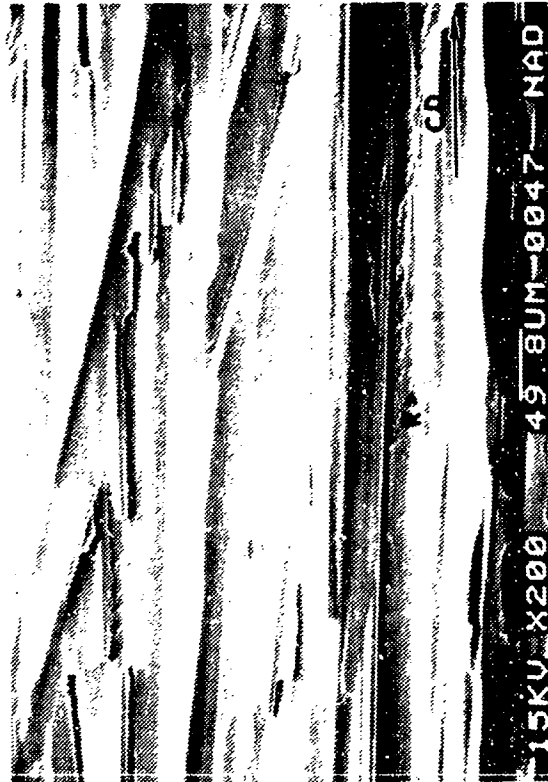
Figure 2-76. Optical and SEM Photographs of Mode II ENF Interlaminar Shear Fracture in Filament Wound Gr/Ep - [0]_{24T}, Room Temperature Ambient
 (a) Macro photograph
 (b) Low Magnification SEM Photograph of Initiation
 (c) River Patterns at Larger Crack Lengths

CD = Crack-propagation direction
 R = River patterns

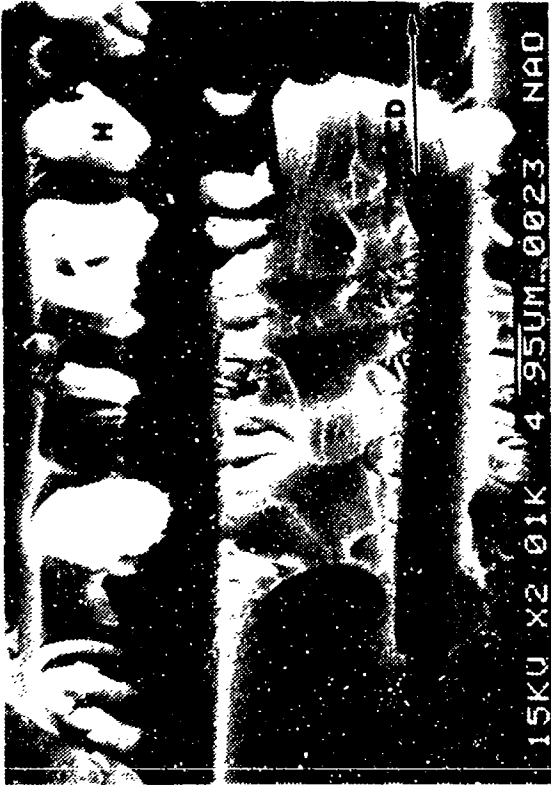
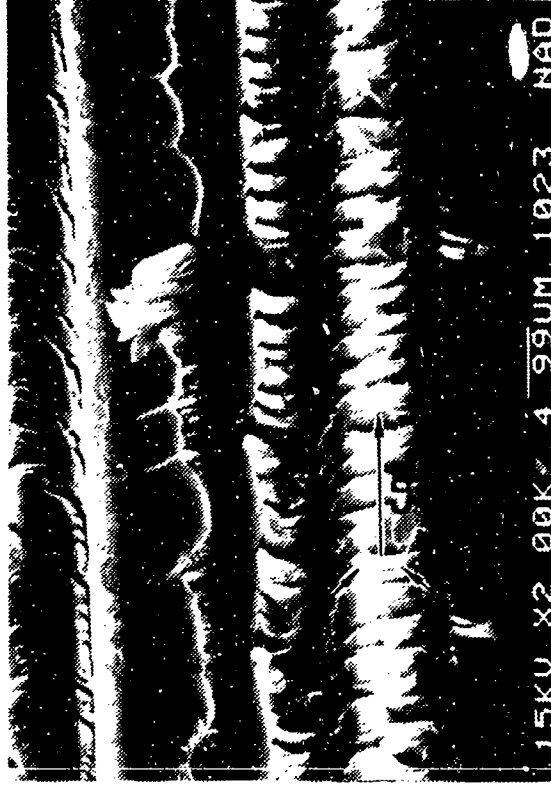
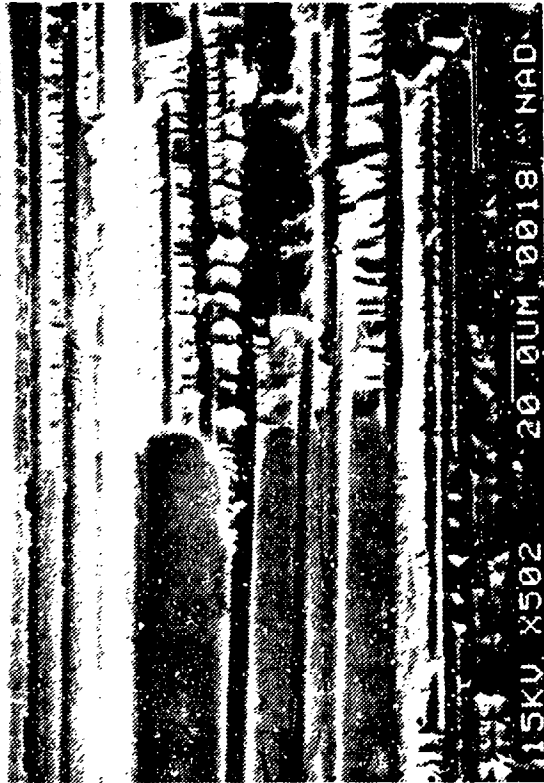
Figure 2-76. (Continued)
 (d) Region I/Region II Boundary
 (e) Hackles (H) and Scallops (S) in Region II
 (f) River Patterns (R) at Roots of Hackles
 CD = Crack-propagation direction

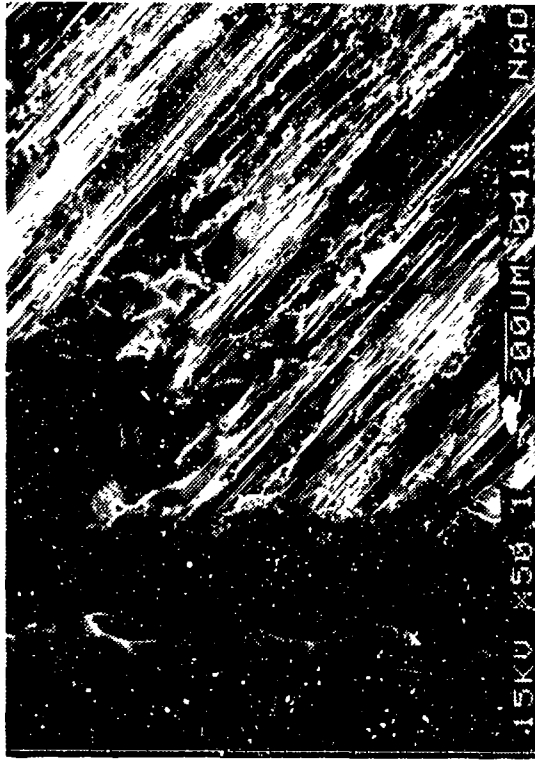
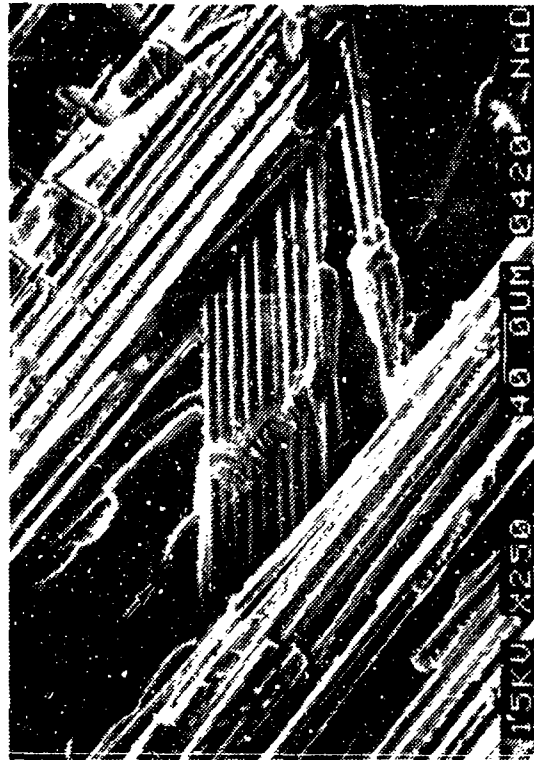
Figure 2-77. Optical and SEM Photographs of Mode II ENF Interlaminar Shear Fracture in Filament Wound GFR/Ep - [J45/0/-45]_{4s}, Room Temperature Ambient
 (a) Macro photograph of Fracture
 I = Precrack, II = Crack-growth region, III = Laboratory overload
 (b) Fracture Initiation in Region I
 (c) River Patterns (Arrows) in Region I

CD = Crack-propagation direction

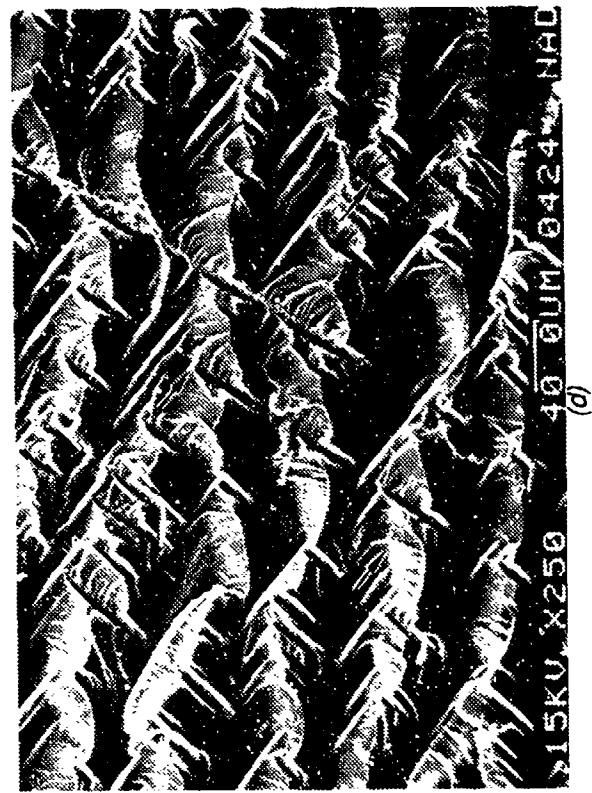
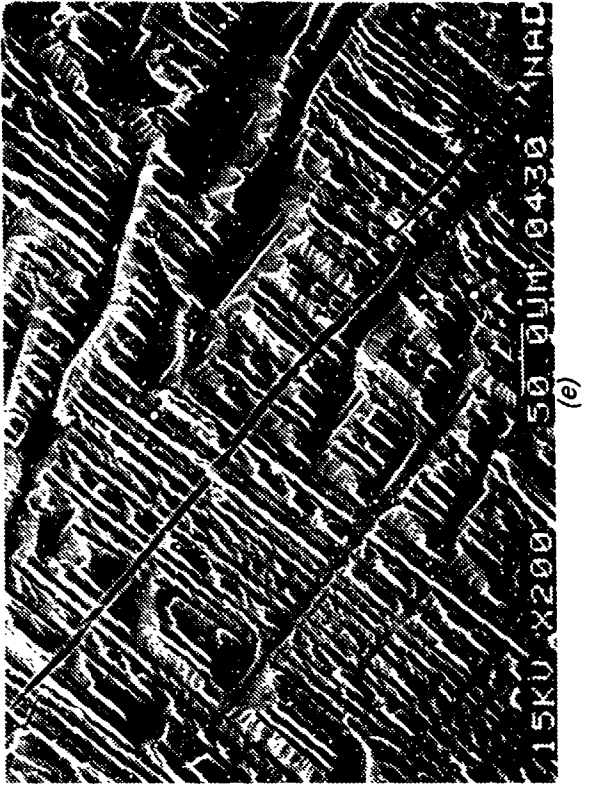
Figure 2-77. (Continued)
 (d) River Patterns (Arrows) in Resin Between 0 and 45 Degree Plies
 (e) Cracks in Ply
 (f) Hackles (H) and Scallops (S) in Mode II Shear Region

CD = Crack propagation direction

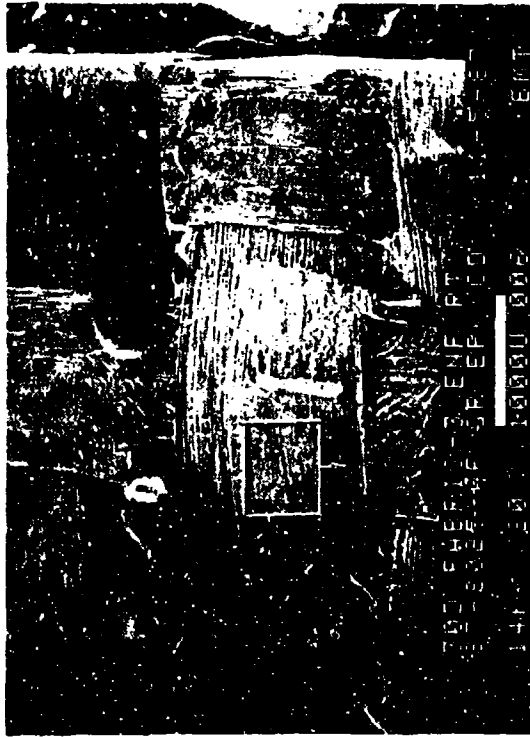
30 degree tilt 20X

Legend:
 H hackles
 S scallops
 Mechanically induced
 crack direction

30 degree tilt 400X

45 degree tilt 2,000X

Figure 2-79. SEM Fractographs of Interlaminar Mode II Shear, Room Temperature, 0/90 Fabric Fracture

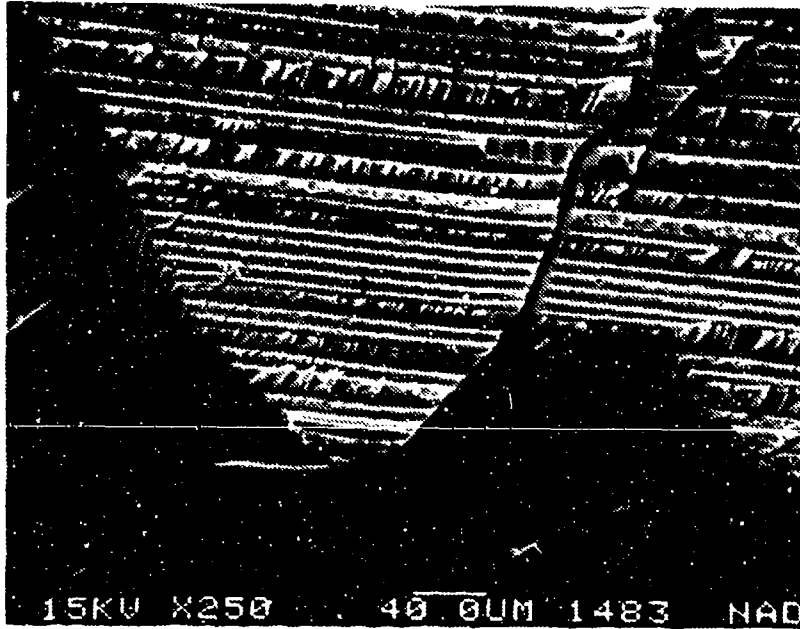
Figure 2-80. SEM Photograph of Mode II ENF Interlaminar Shear Fracture in 3-D Weave Gr/Ep - [+45/0/-45]_{4S} in Crack-Growth Region

Note: Arrows indicate mixed-mode interlaminar fracture features.

CD = Crack-propagation direction

P = Resin pocket adjacent to weave

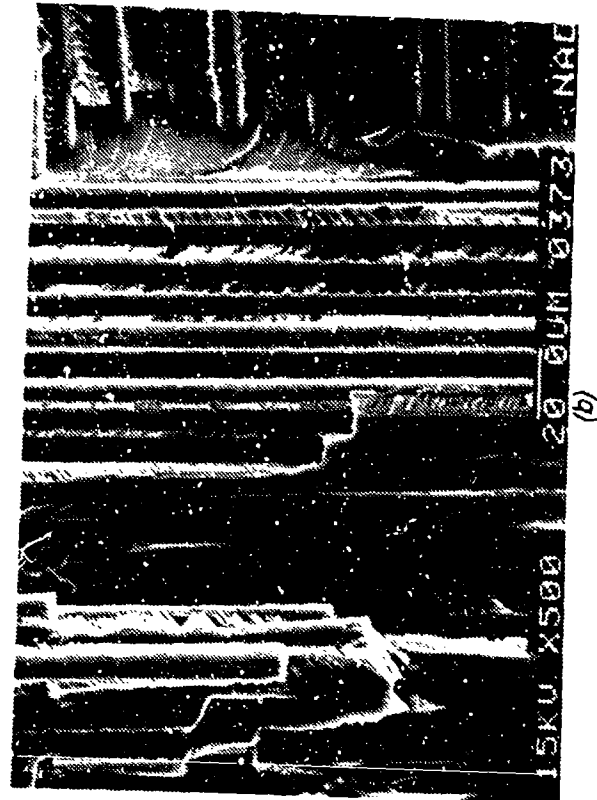
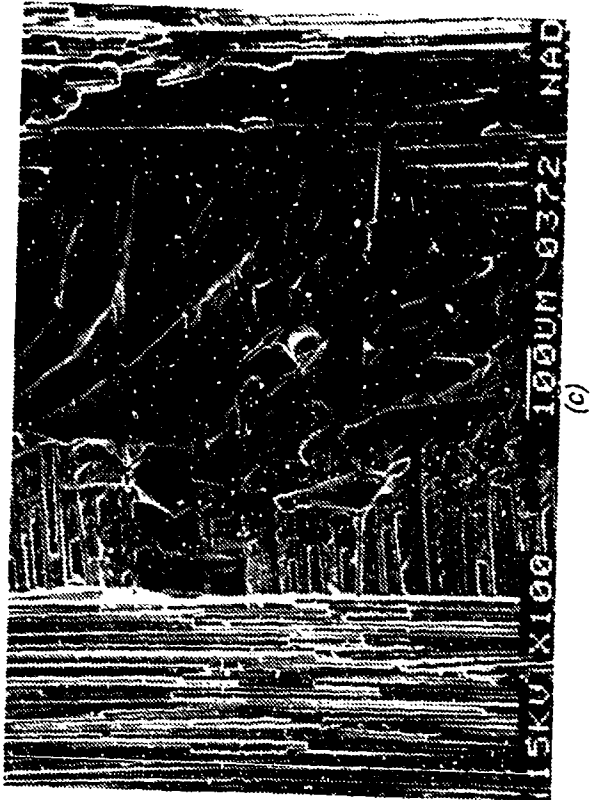
Figure 2-81. Optical and SEM Photographs of Mode II ENF Interlaminar Shear Fracture in Gr/Ep - [0/90]ss, Impact Damaged Before Test
 (a) Macrograph of Fracture (Arrow)
 (b) Local Fracture in 90 Degree Ply in Region I (Arrow)
 (c) River Patterns in 0 Degree Ply in Region I (Arrow)

CD = Crack propagation direction

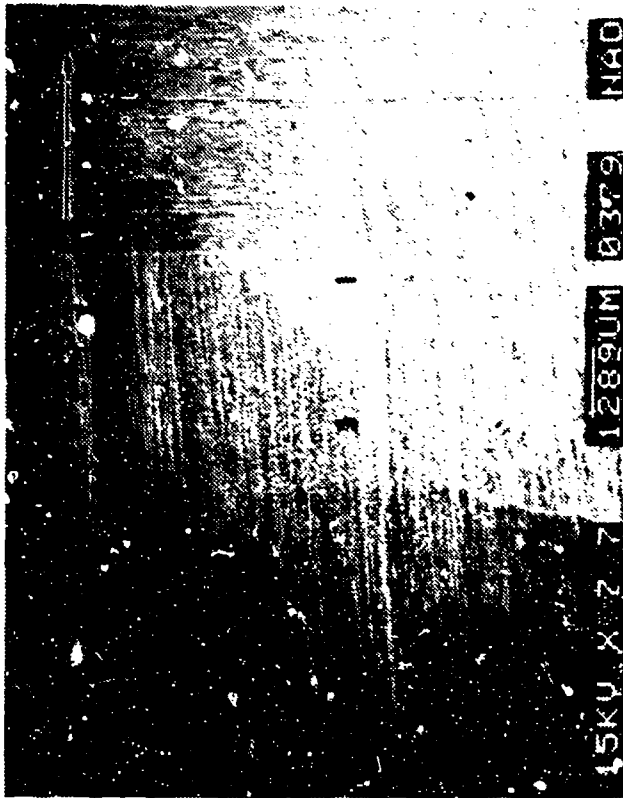
Figure 2-81. (Continued)
 (d) Interface Between Mode I (T), Mode II (S), and Impact (I) Fracture Areas
 (e) Mode I/Mode II Interface Regions

CD = Crack propagation direction

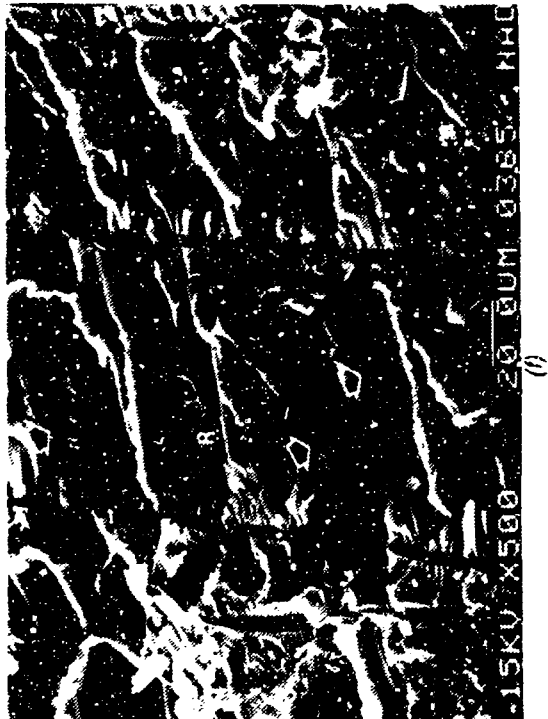
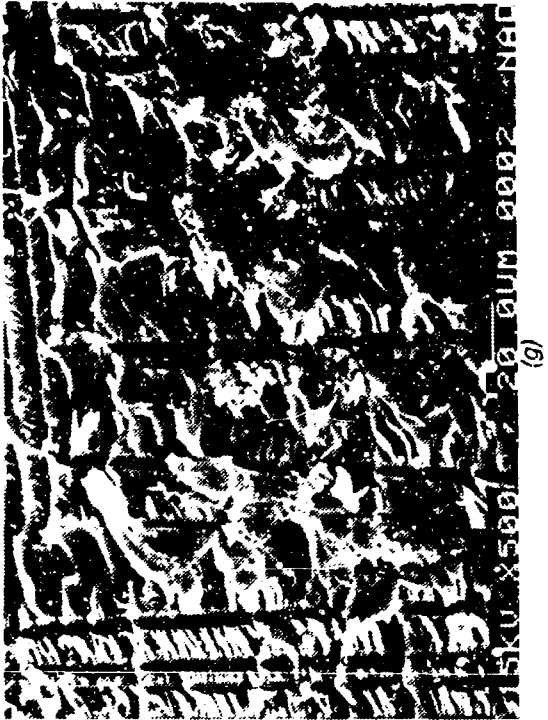
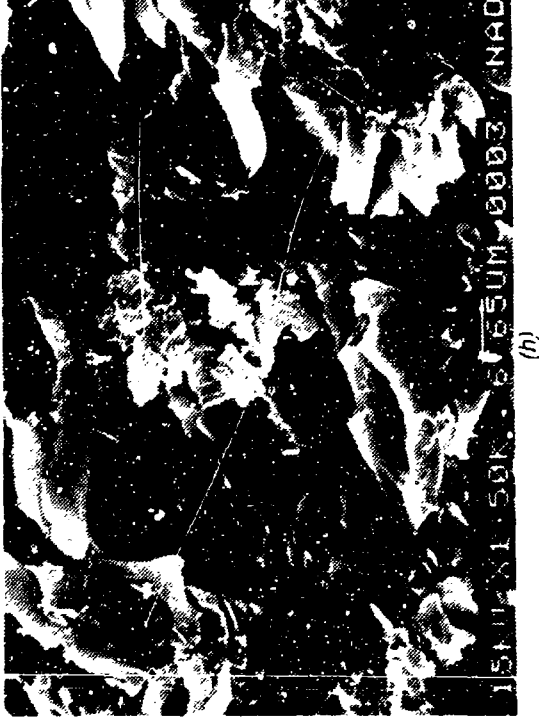
Figure 2-81. (Continued)
 (f) Smooth Resin Surface With River Patterns (R) and Crushed Resin (C) in Impacted Region
 (g) Hackles (H) and Delamination Fracture in Impact Area
 (h) Details of Delamination Fracture Shown in (g)
 Note river patterns oriented along CD
 CD = Crack propagation direction

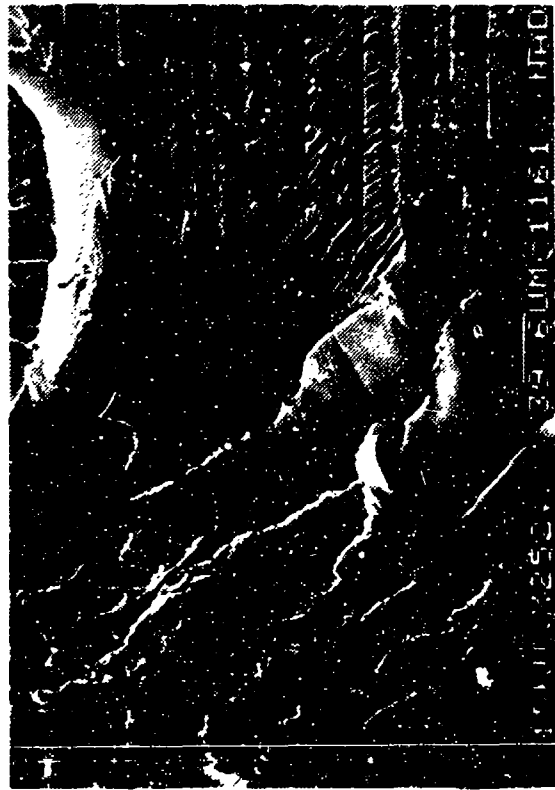
Figure 2-82. Optical and SEM Photographs of Mode II ENF Interlaminar Shear Fracture in Gr/Ep - [0] _{24T} Water Immersed Before Test

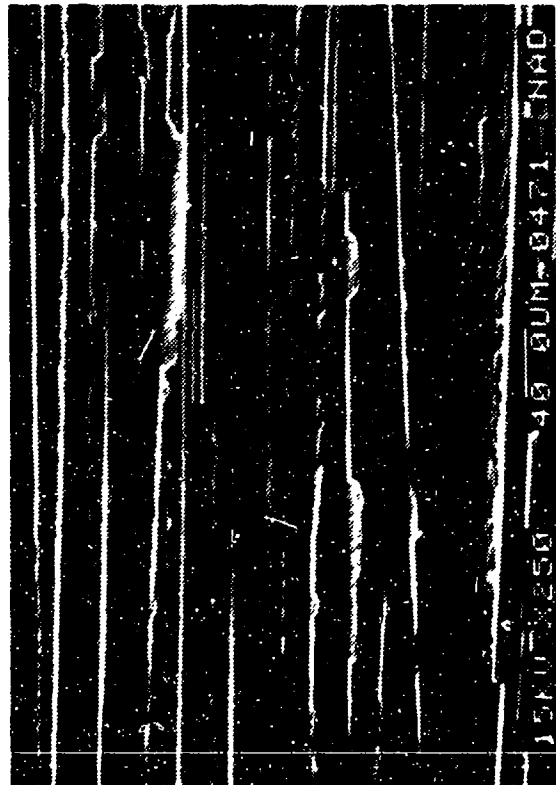
Figure 2-83. Optical and SEM Photographs of Mode II ENF Interlaminar Shear Fracture in Gr/Ep - [0/90] es. Water immersed Before Test
 (a) Macro photograph Showing Regions I, II, and III (Precrack, Mode II Shear, and Laboratory Overload)
 (b) Initiation Occurring at Resin-Rich Areas Adjacent to Armalon (A) Insert
 (c) River Patterns (Arrows) in Mode I Fracture
 CD = Crack propagation direction

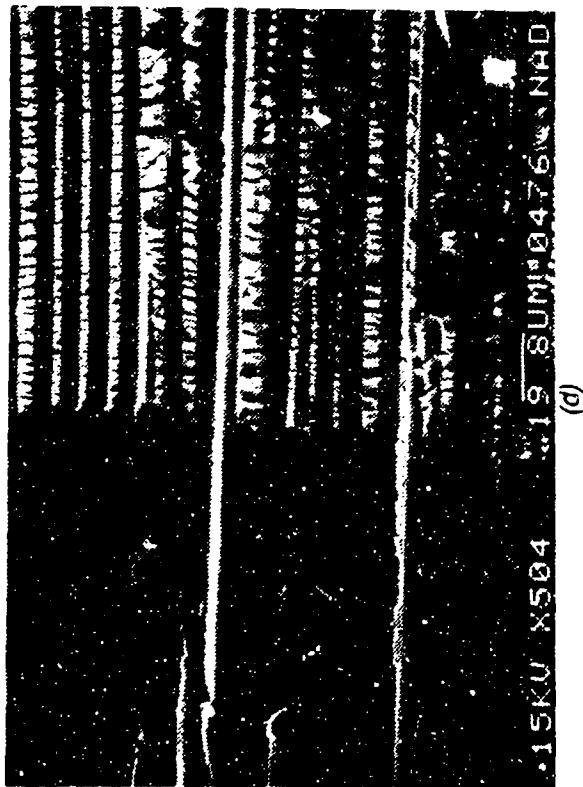
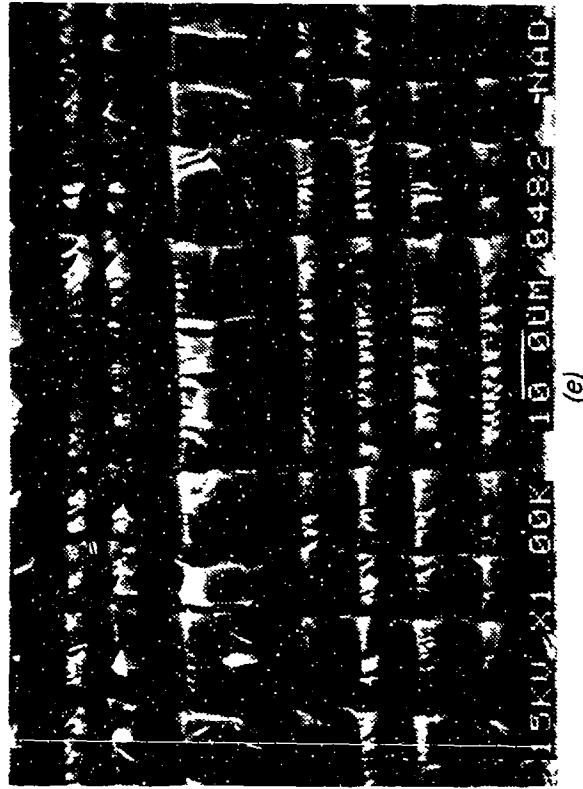
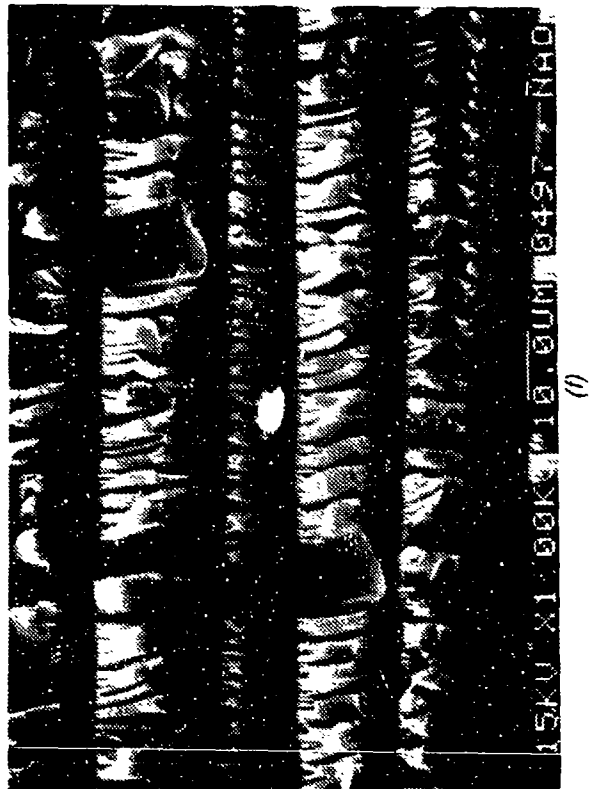
Figure 2-83. (Continued)
 (d) Mode I/Mode II Interface
 (e) Cracks Found in Mode II Fracture Region
 (f) Mode II Hackles (H) and Scallops (S)
 CD = Crack propagation direction

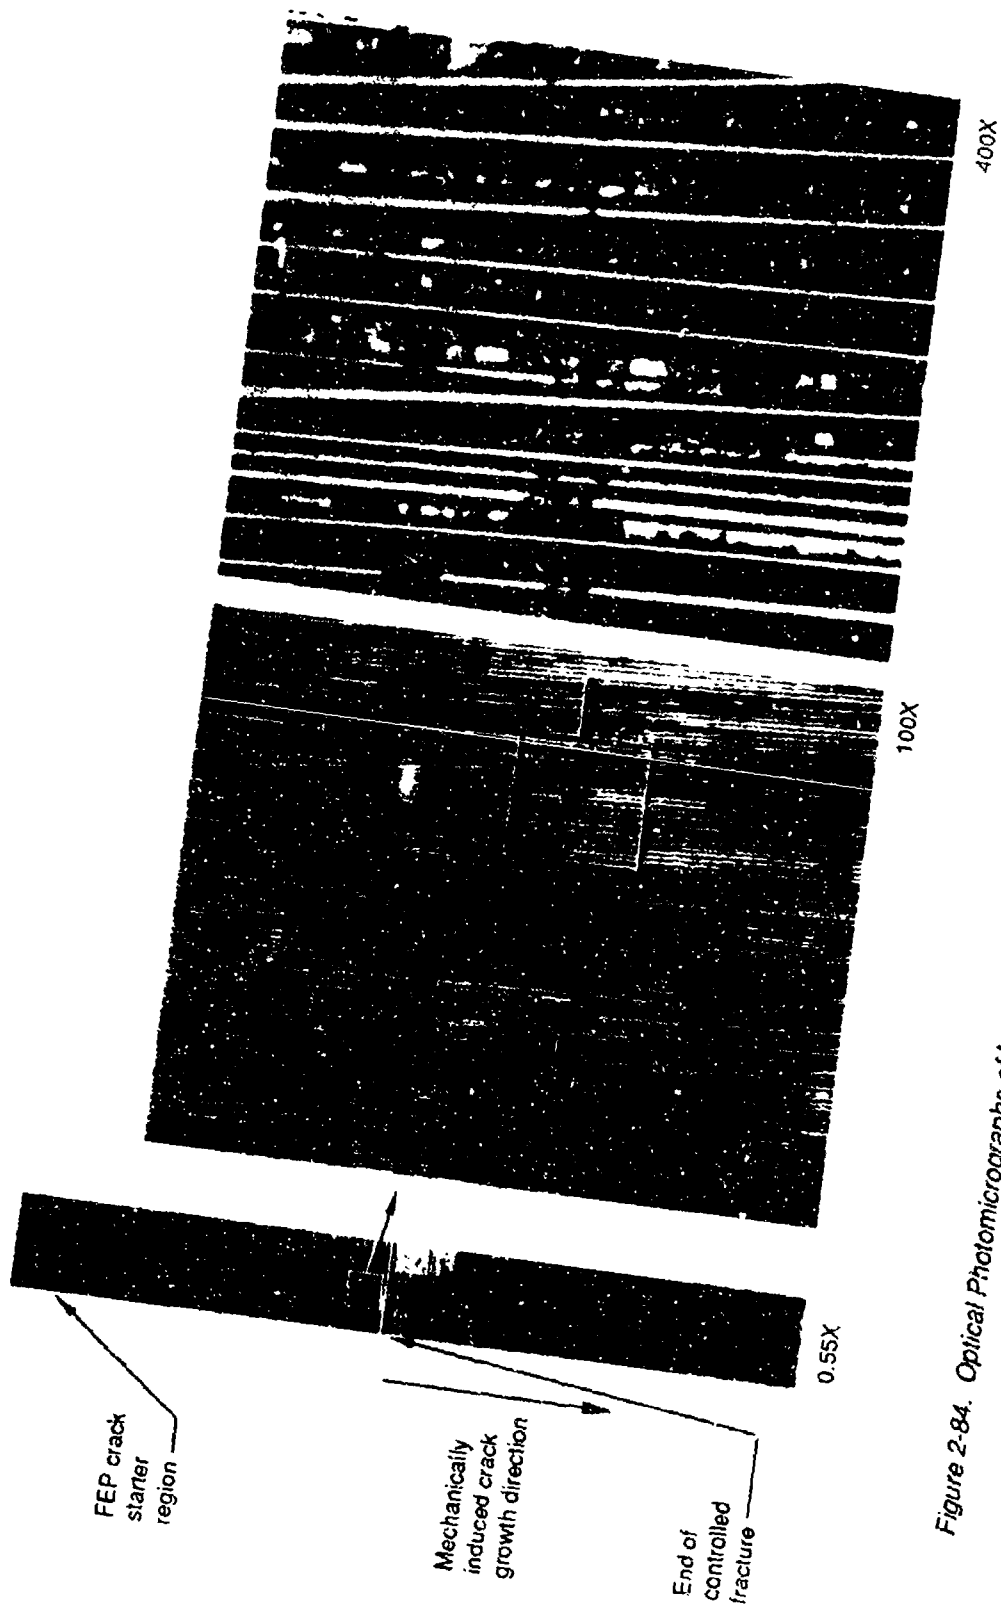
Figure 2-84. Optical Photomicrographs of Interlaminar Mode II Shear, 0/90 Fracture, Water Immersion (160 F) After Test

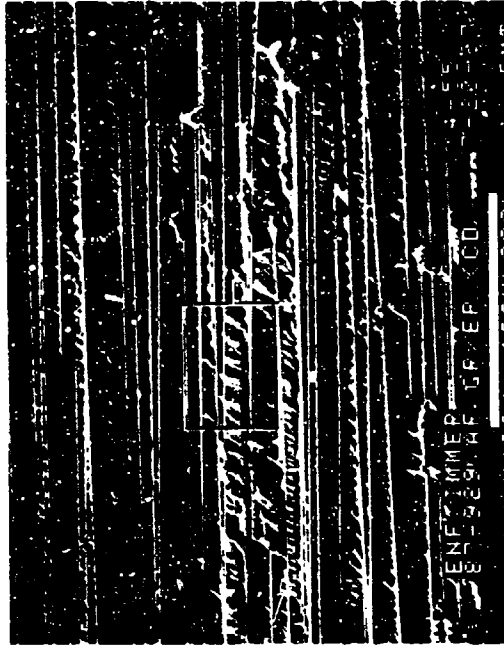
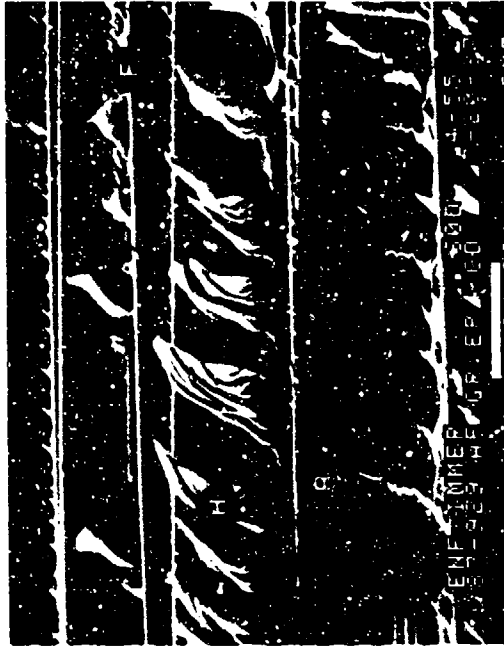
- F fiber matrix separation
- H hackles
- R rivermarks

Mechanically induced crack direction

Figure 2-85. SEM Fractographs of Interlaminar Mode II Shear, 0/90 Fracture, Water Immersion (160 F) After Test

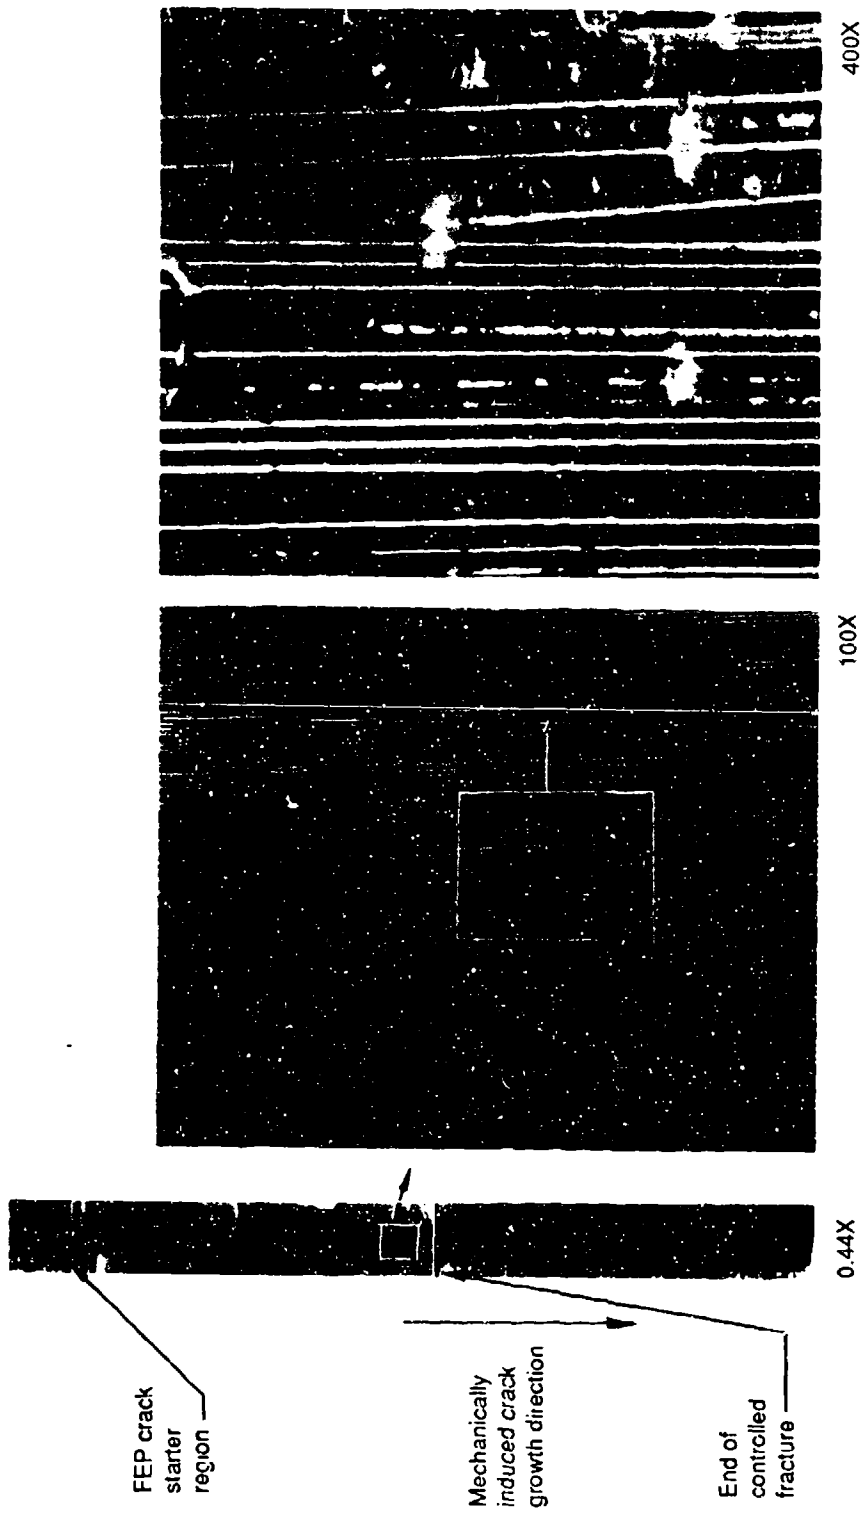
Figure 2-86. Optical Photomicrographs of Interlaminar Mode II Shear, 0/90 Fracture, Exposure to Humidity (160 F) After Test

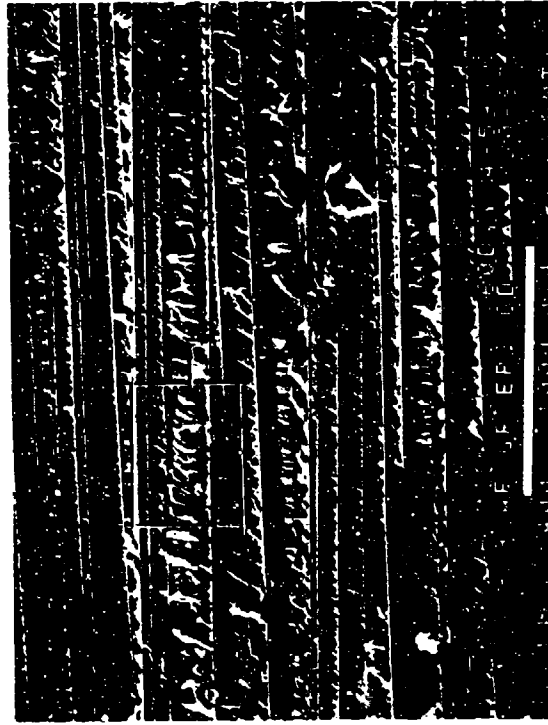
- F fiber matrix separation
- H hackles
- R rivermarks

Mechanically induced crack direction

Figure 2-87. SEM Fractographs of Interlaminar Mode II Shear, 0/90 Fracture, Exposure to Humidity (160 F) After Test

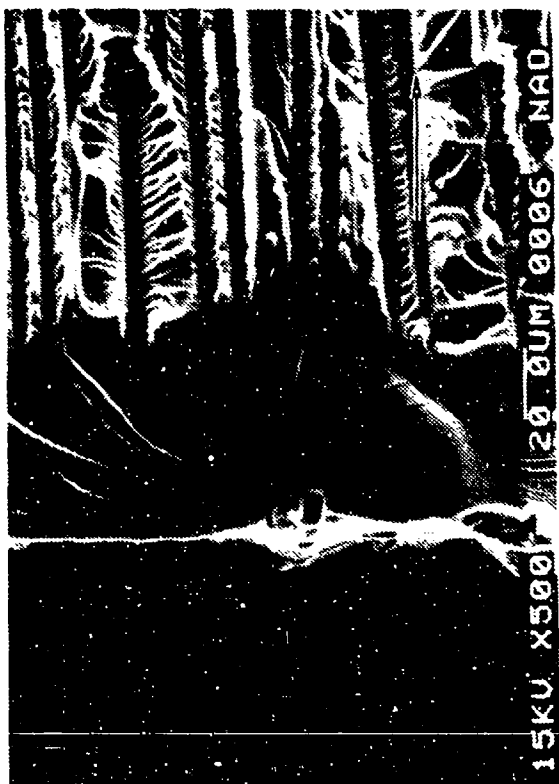
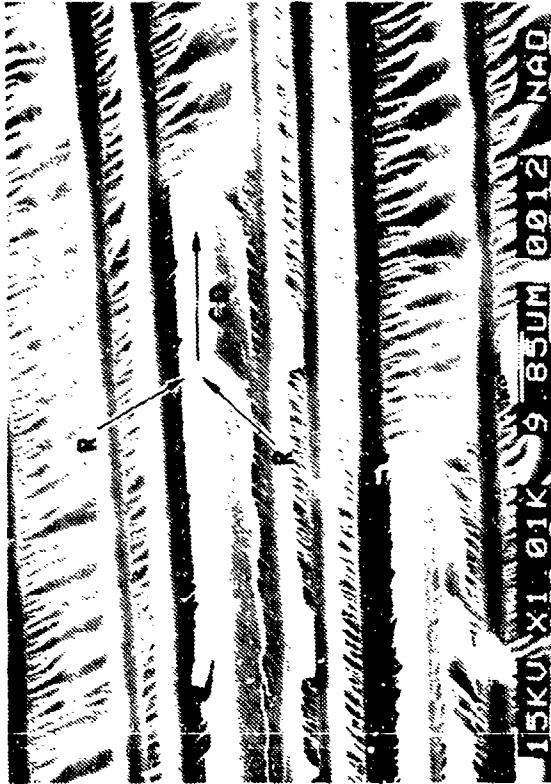
Figure 2-88. Optical and SEM Photographs of Mode II ENF Shear Interlaminar Fracture in Undercured Gr/Ep - [0]_{24T}
 (a) Macrofracture of Fracture
 (b) Initiation Site in Region I
 (c) River Patterns (R) in Region I

CD = Crack-propagation direction

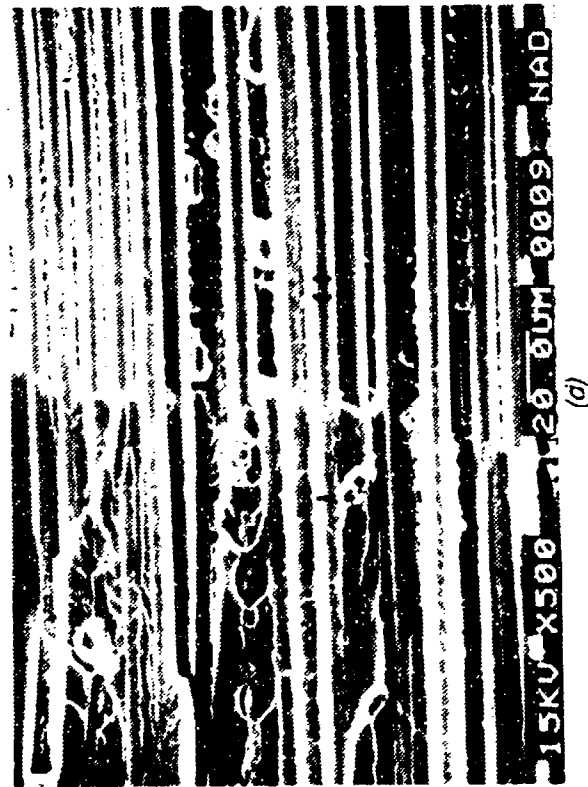
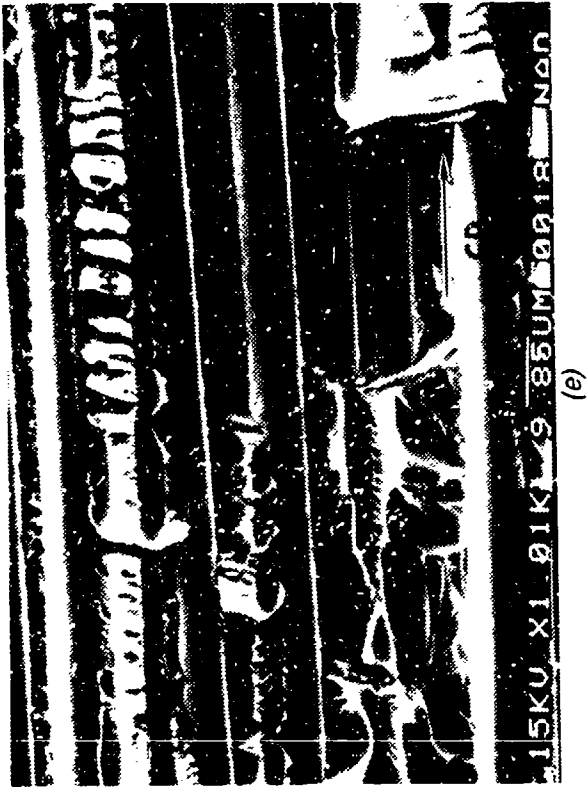
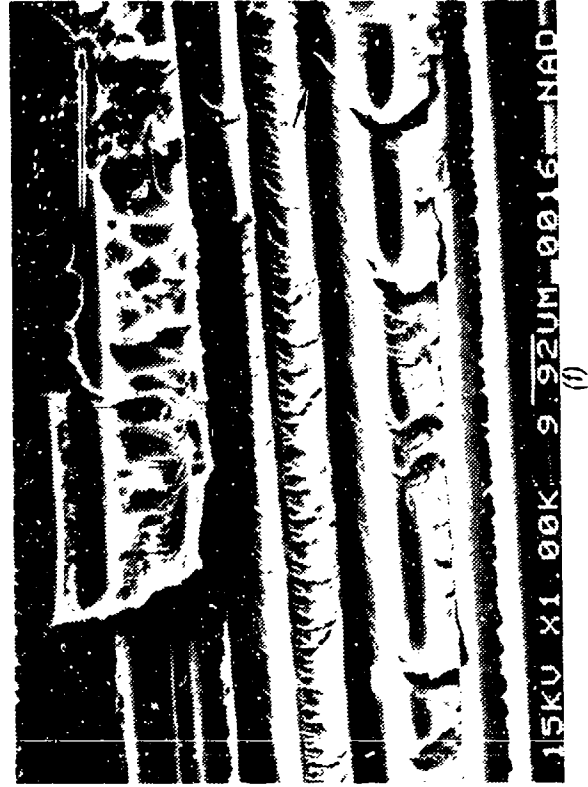
Figure 2-88. (Continued)
 (d) Region I/II Interface
 (e) Hackles (H) and Scallops (S) in Region II
 (f) V-Shaped Tears (Arrow) in Region II

CD = Crack propagation direction

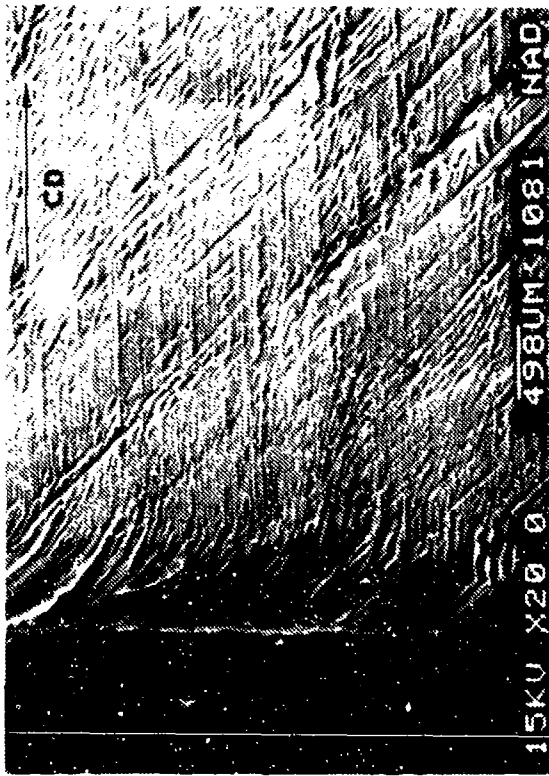
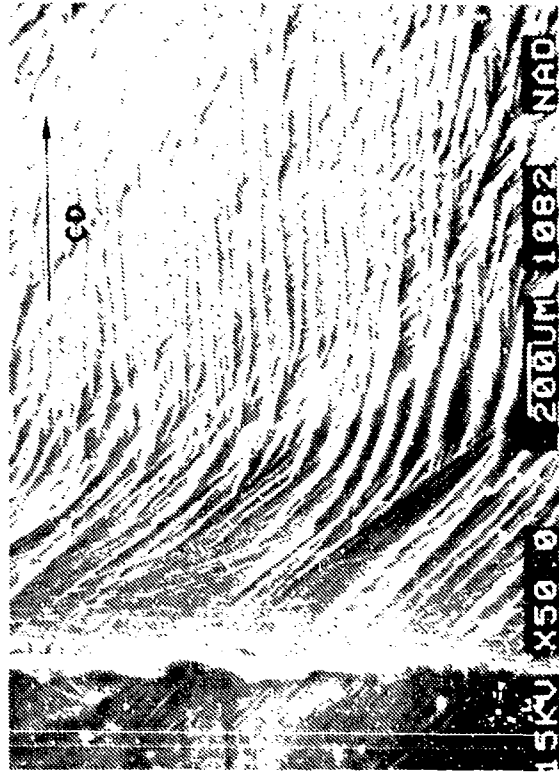
Figure 2-89. Optical and SEM Photographs of Mode II ENF Shear Interlaminar Fracture in Undercured Gr/Ep - [+45/0/-45]_s
 (a) Macro photograph Showing Regions I, II, and III
 (b) Local Initiation sites in Region I
 (c) River Patterns in Region I

CD = Crack-propagation direction

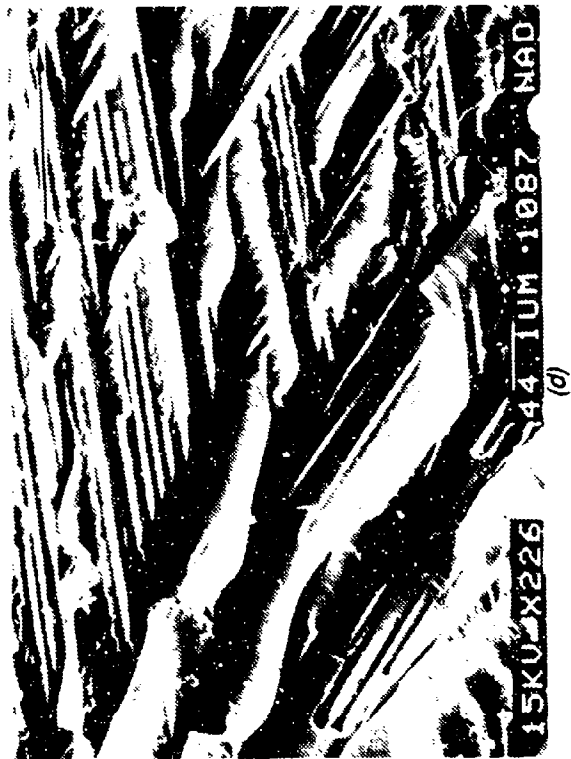
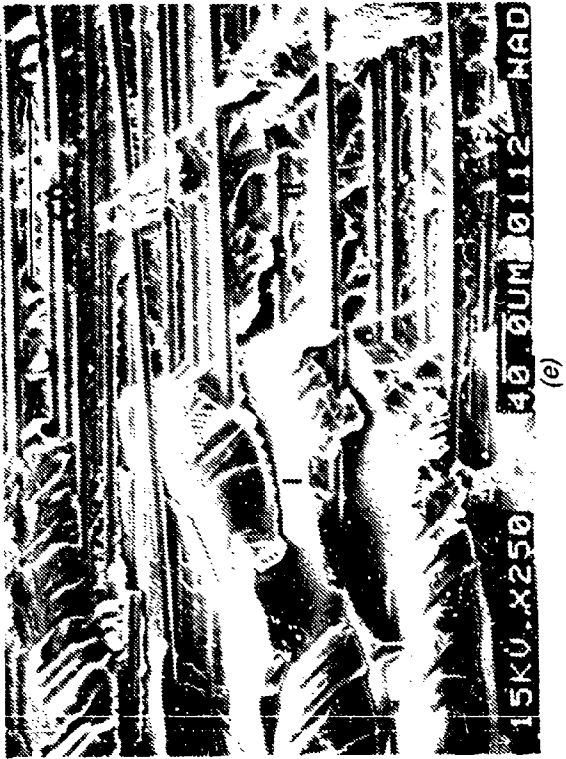
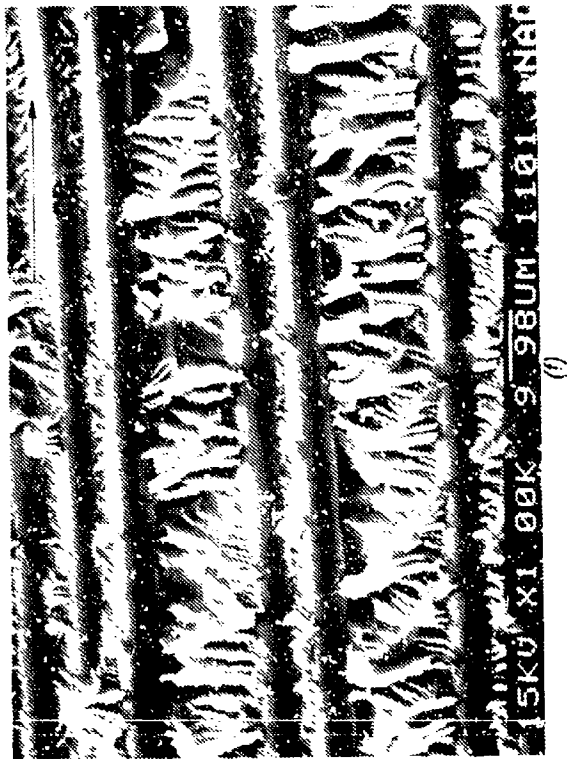
Figure 2-89. (Continued)
 (d) River Patterns in Resin Between 0 and 45
 Degree Plies

(e) Mode I/Mode II Interface

(f) Hackles (H) in Region II

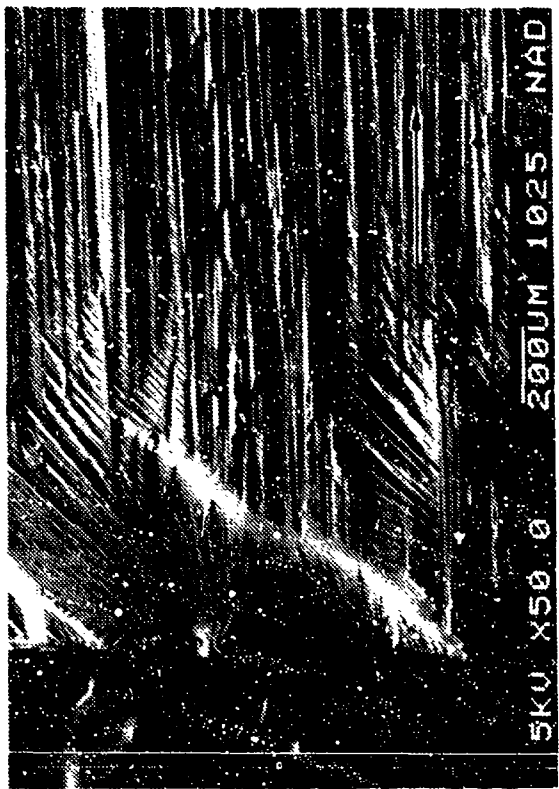
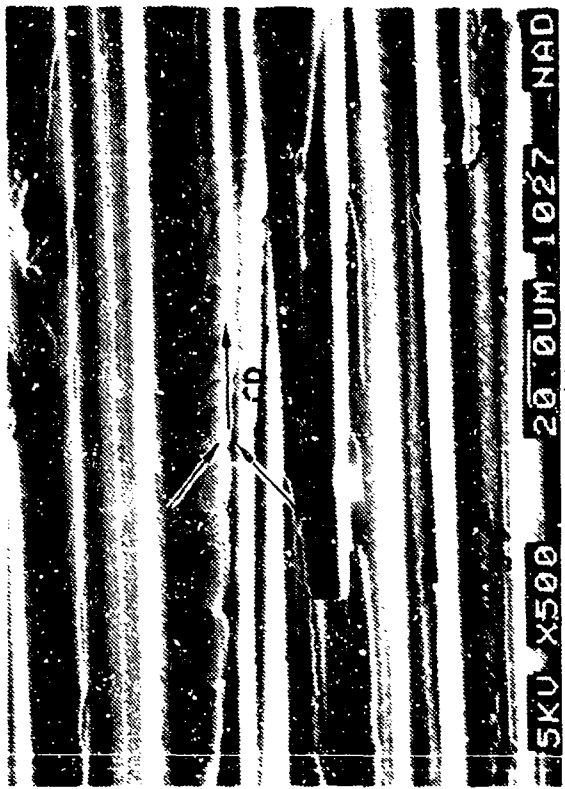
Figure 2-90. Optical and SEM Photographs of Mode II ENF Shear Interlaminar Fracture in Overcured Gr/Ep - [0]_{24T}
 (a) Macrograph of Fracture
 (b) Initiation Site in Region I
 (c) Mapping of CD With River Patterns (Arrows)

CD - Crack propagation direction

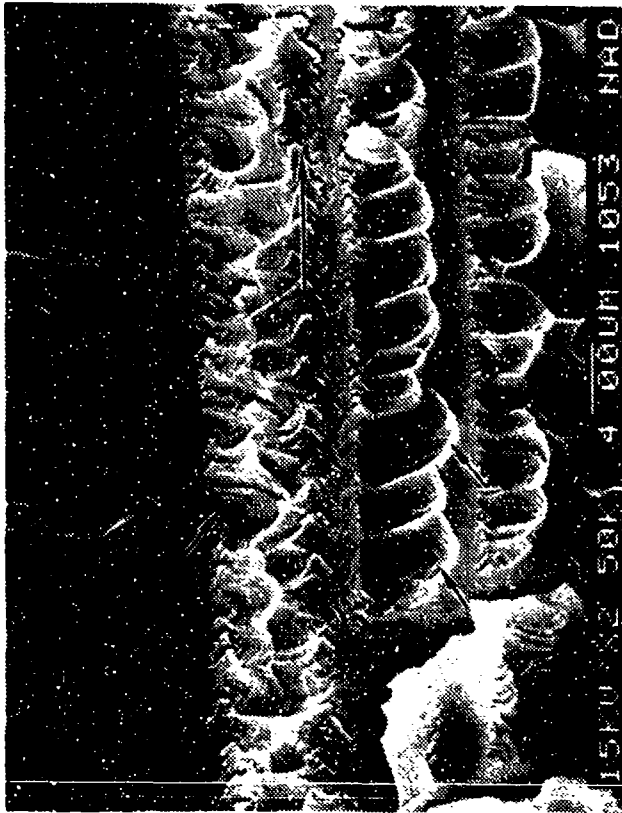
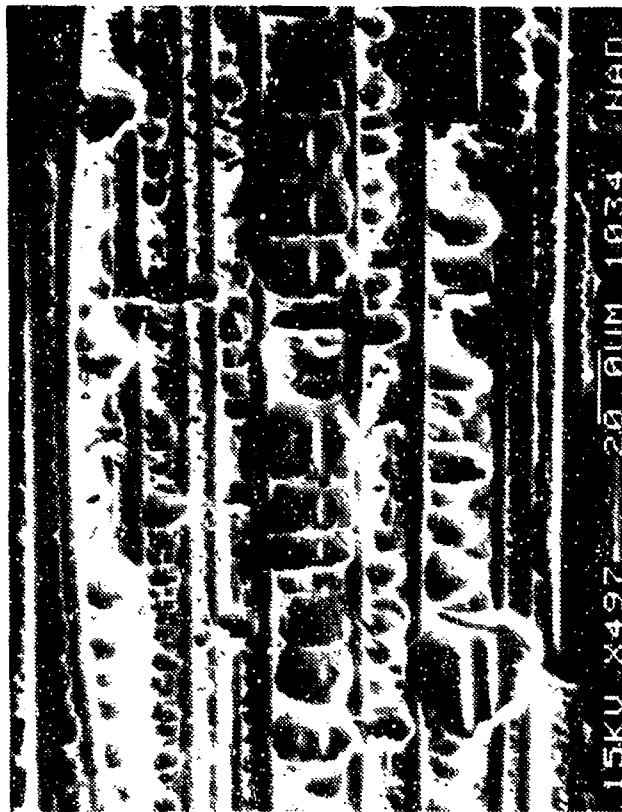
Figure 2-90. (Continued)
 (d) Hackles (H) and Scallops (S) in Region II
 (e) Microflow Lines in Scallops in Region II

CD = Crack propagation direction

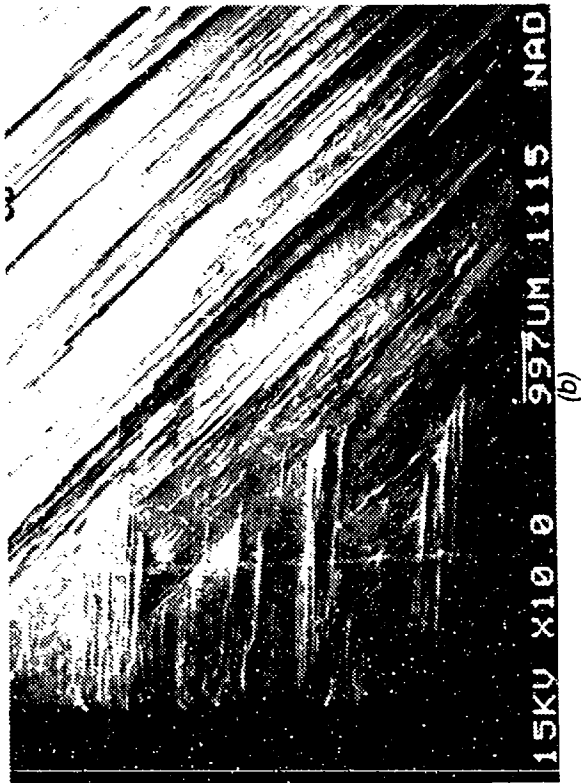
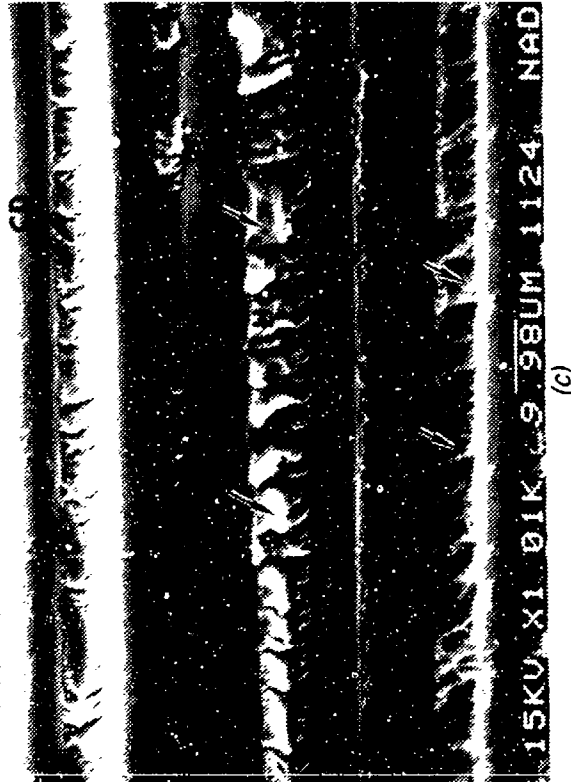
Figure 2-91. Optical and SEM Photographs of Mode II ENF Shear Interlaminar Fracture in Overcured Gr/Ep - [+45/0/-45] _s
 (a) Macro photograph Showing Regions I, II, and III (Precrack, Crack-Growth, Laboratory Overload)
 (b) Initiation in Resin Between 0 and 45 Degree Plies
 (c) Hackles (H) and Scallops (S) in Region II

CD = Crack-propagation direction
