WL-TR-91-4032
DOT/FAA/CT-91/23
VOL II, Part 2

COMPOSITE FAILURE ANALYSIS HANDBOOK
VOL II - TECHNICAL HANDBOOK
PART 2 - ATLAS OF FRACTOGRAPHS

February 1992

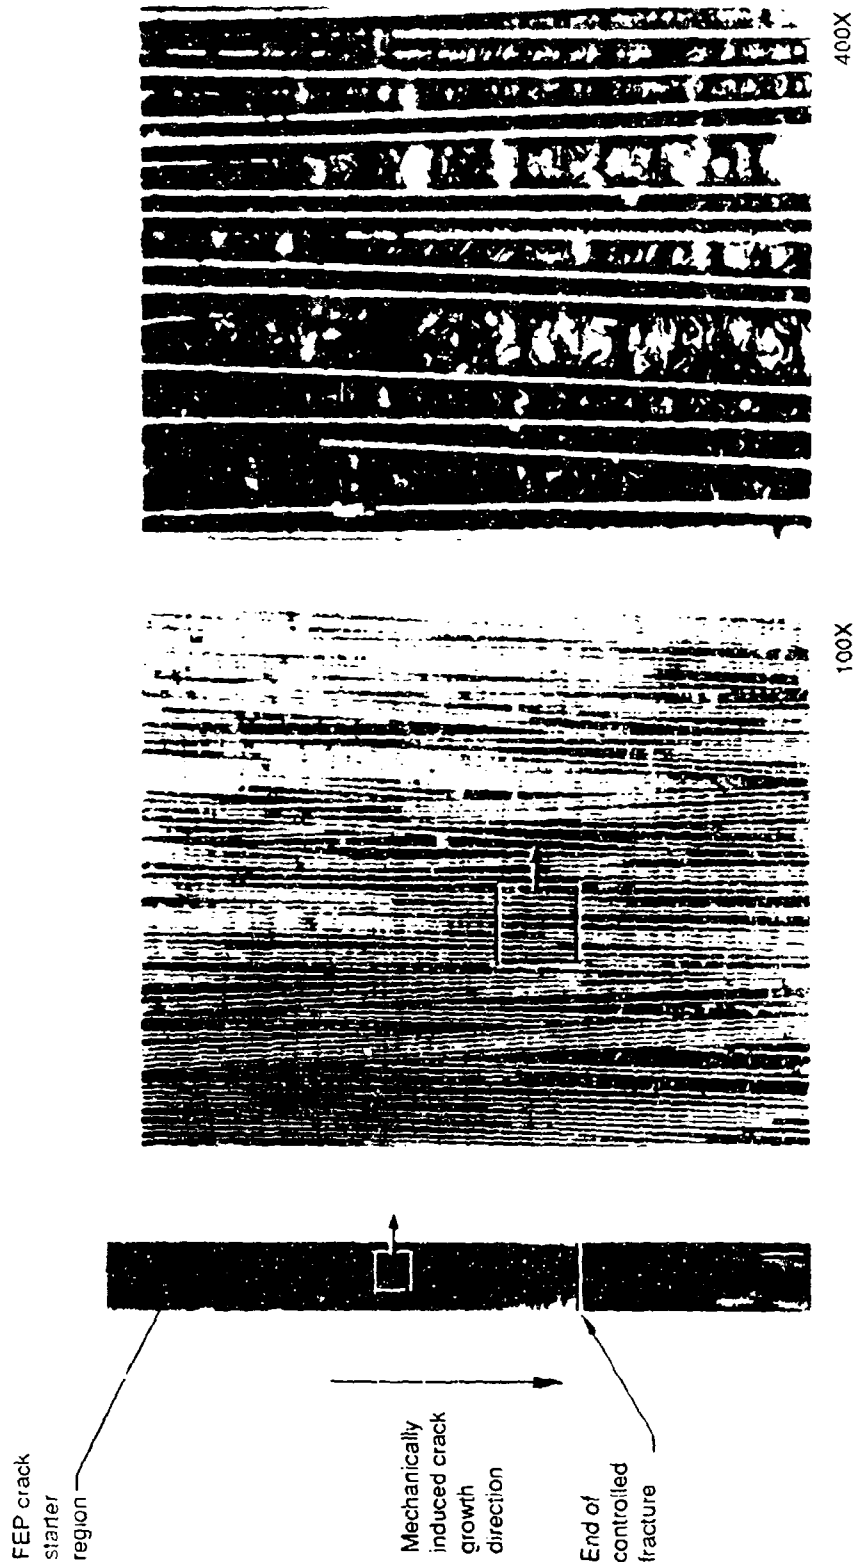
Figure 2-92. Optical Photomicrographs of Interlaminar Mode II Shear, 0/90 Fracture of Low Resin Content Specimen

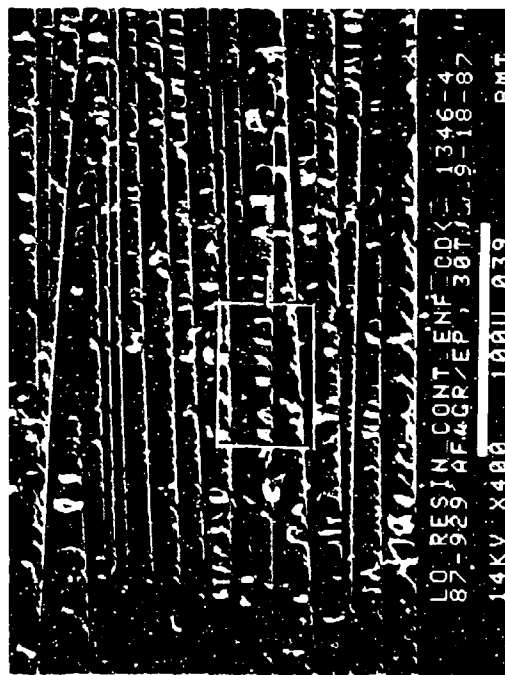
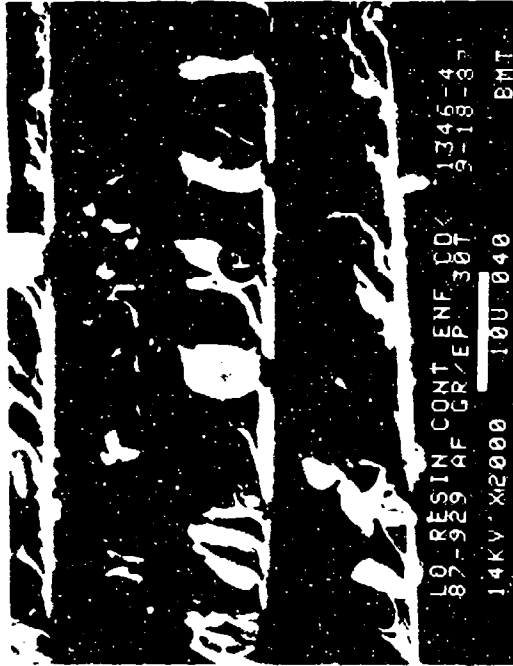
- F fiber/matrix separation
- H hackles
- R rivermarks

Mechanically induced
crack direction

Figure 2-93. SEM Fractographs of Interlaminar Mode II Shear, 0/90 Fracture of Low Resin Content Specimen

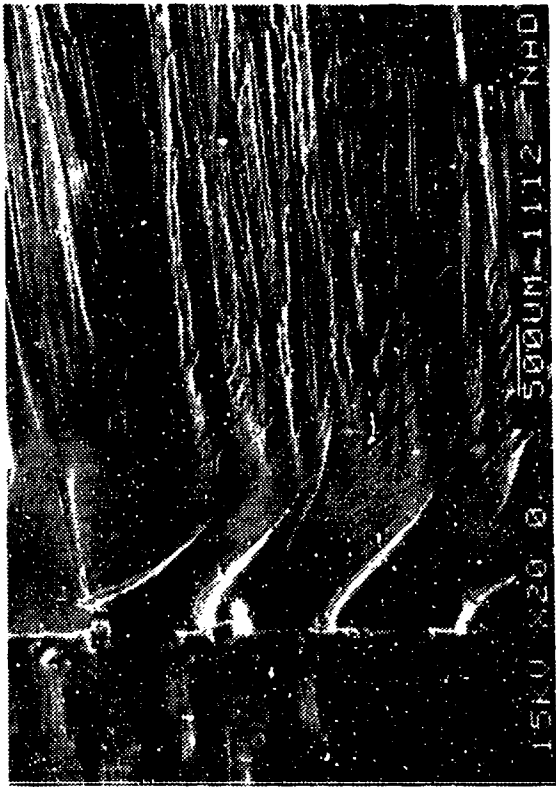
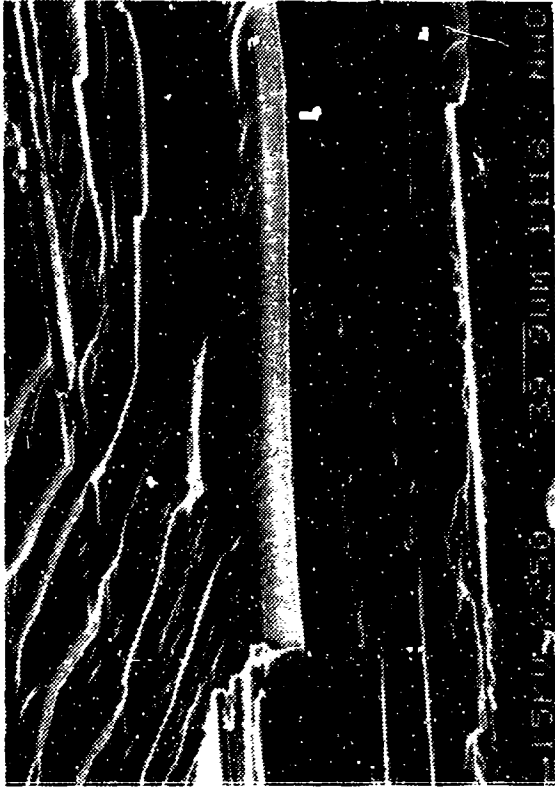
Figure 2-94. Optical and SEM Photographs of Mode II ENF Shear Interlaminar Fracture in High Resin Content Gr/Ep - [0]_{24T}
 (a) Macro photograph Showing Region I, II, and III
 (b) Local Initiation in Region I
 (c) River Patterns Indicate CD

CD = Crack-propagation direction

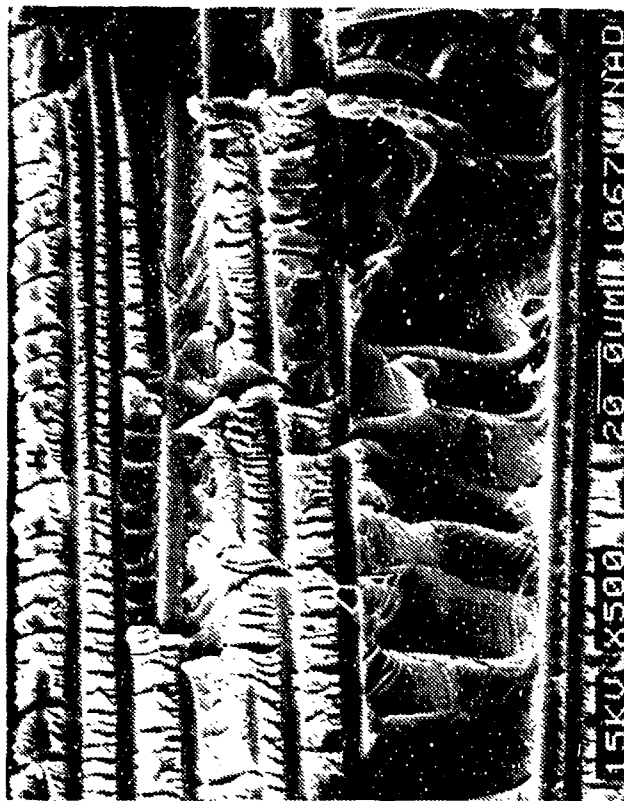
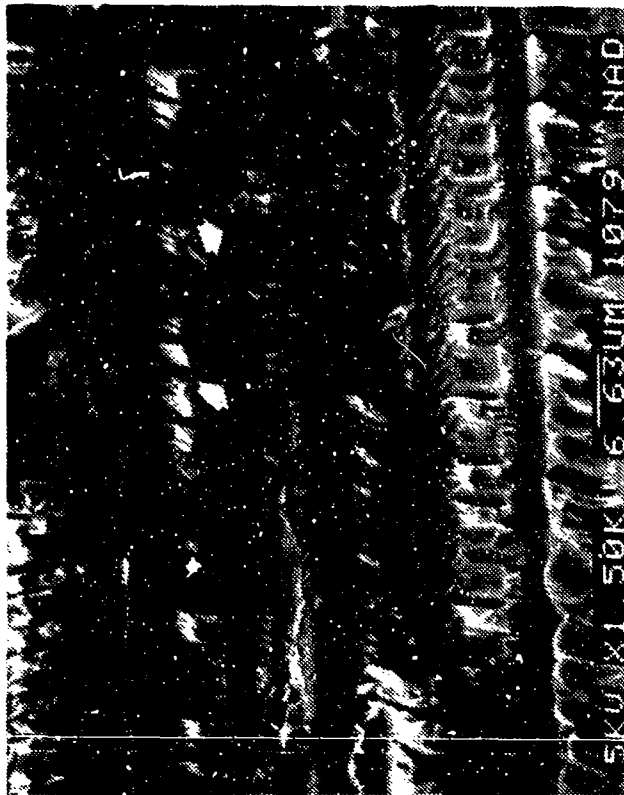
Figure 2-94. (Continued)
 (d), (e) Mode II Shear Fracture in Region II
 Note hackles (H), scallops (S), resin micro-flow
 (Arrows) and S-shaped cracks

CD = Crack-propagation direction

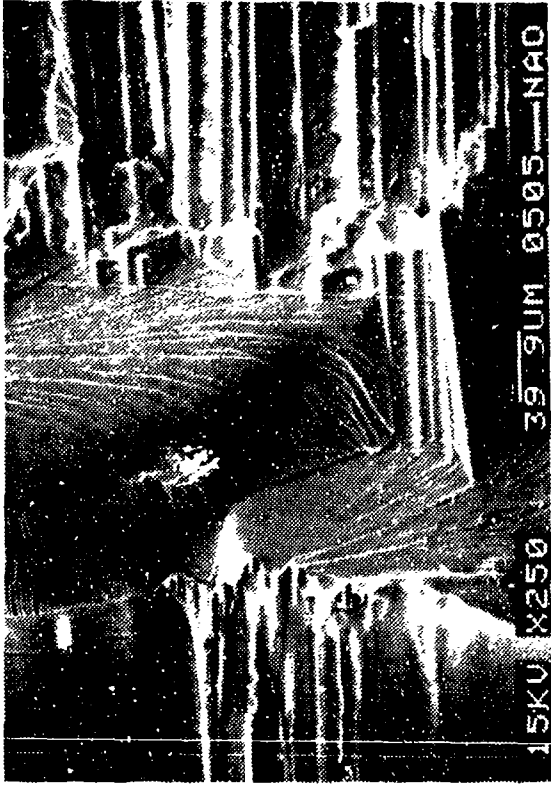
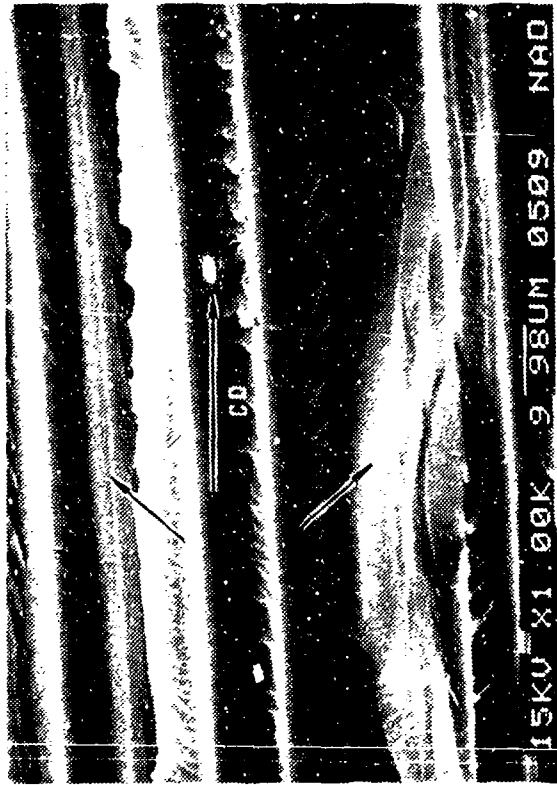
Figure 2-95. Optical and SEM Photographs of Mode II ENF Interlaminar Shear Fracture in High Resin Content Gr/Ep - [0/90]_{6s}
 (a) Macro photograph showing Regions I, II, and III (Pre-crack, Mode II Shear, Laboratory Overload)
 (b) Initiation of tearing in Mode I Resin-Rich Areas
 (c) River Patterns (Arrows) in Mode I Tension Fracture Area That Can Be Used to Map CD
 CD = Crack-propagation direction.

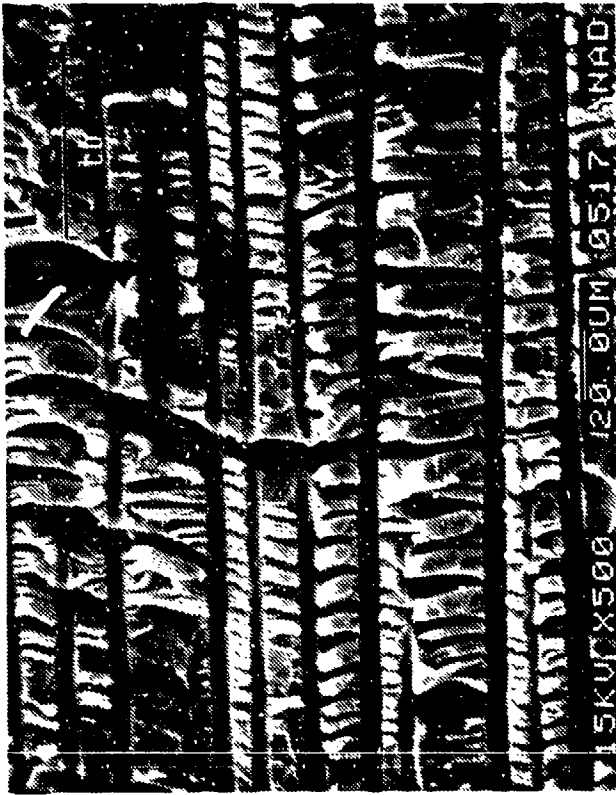
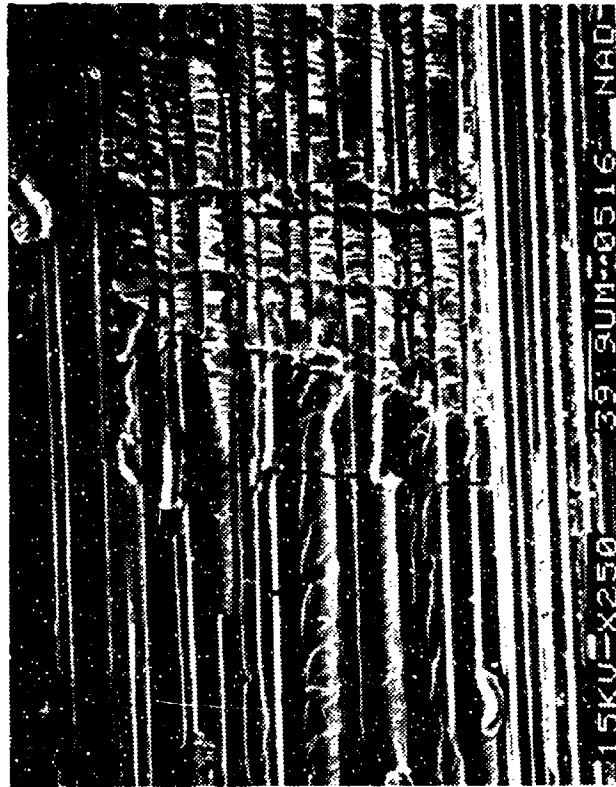
Figure 2-95. (Continued)
 (d) Mode I/Mode II Interface
 (e) Hackles (H) and Scallops (S) in Mode II Fracture
 CD = Crack-propagation direction

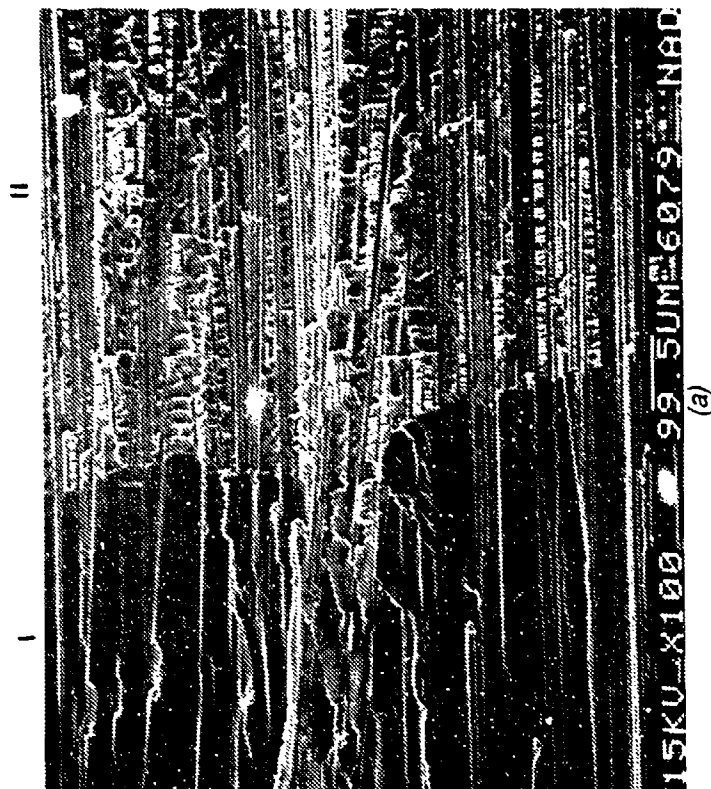
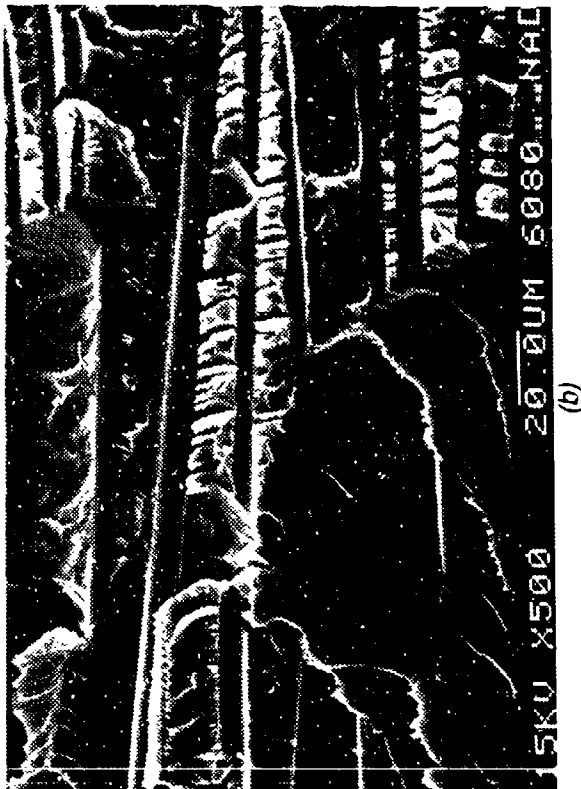
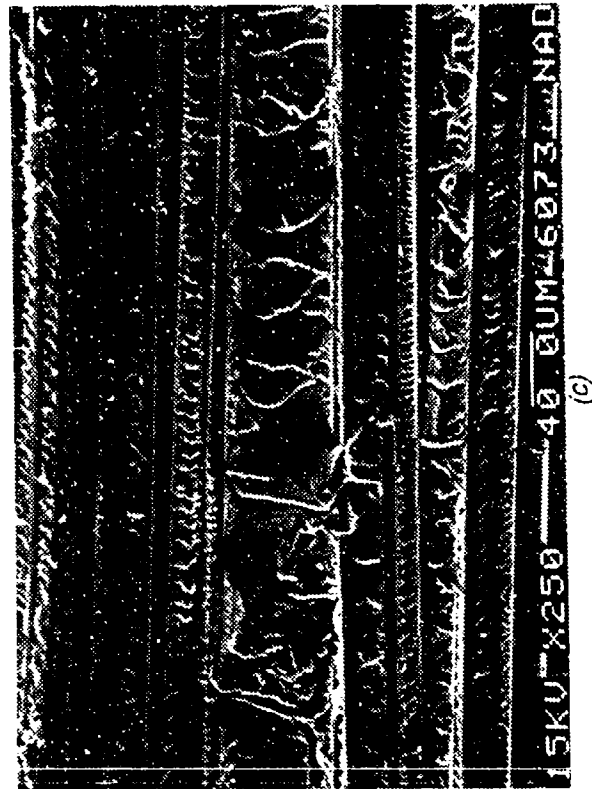
Figure 2-96. SEM Photographs of Mode II ENF Interlaminar Shear Fracture in High Resin Content Gr/Ep, Conditioned 180 F/Dry After Test

(a) Precrack to Crack-Growth Transition Region in [0]_{24T} Coupon
 I = Precrack, II = Crack-growth

(b) Details of Fracture in (a)
 R = River patterns, H = Hackles, S = Scallops

(c) Hackles (H) in Crack-Growth Region of [0/90]_{es} Coupon

CD = Crack-propagation direction

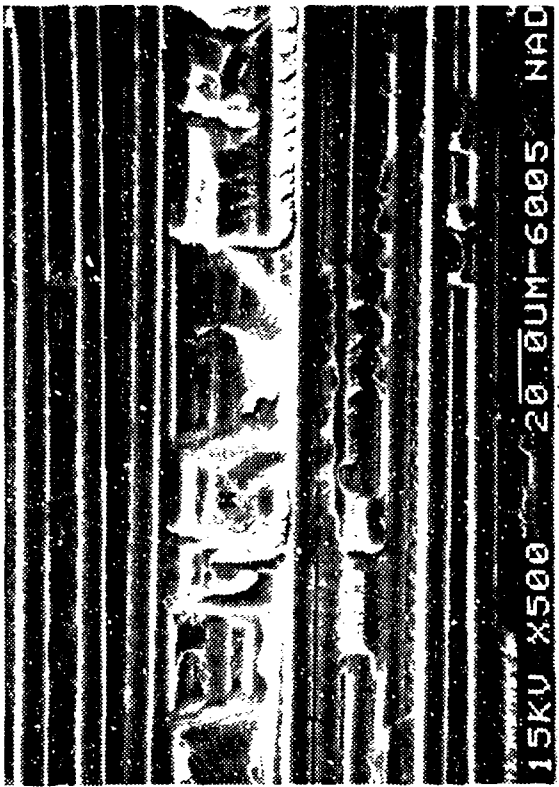
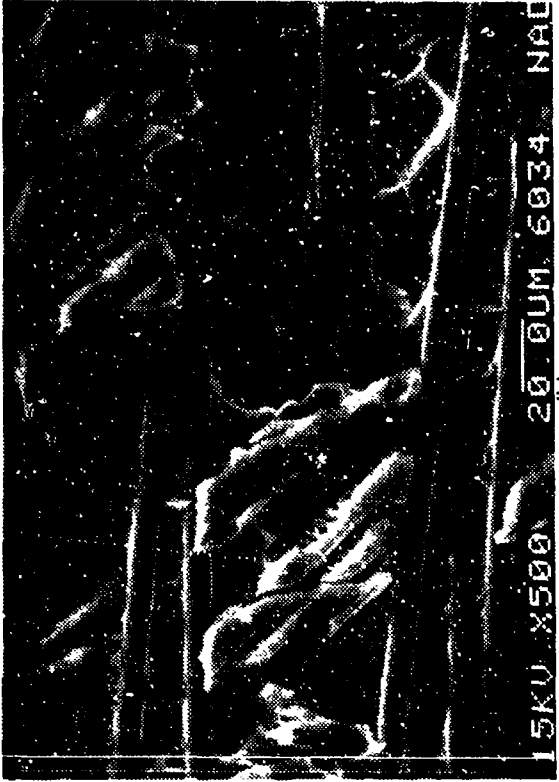
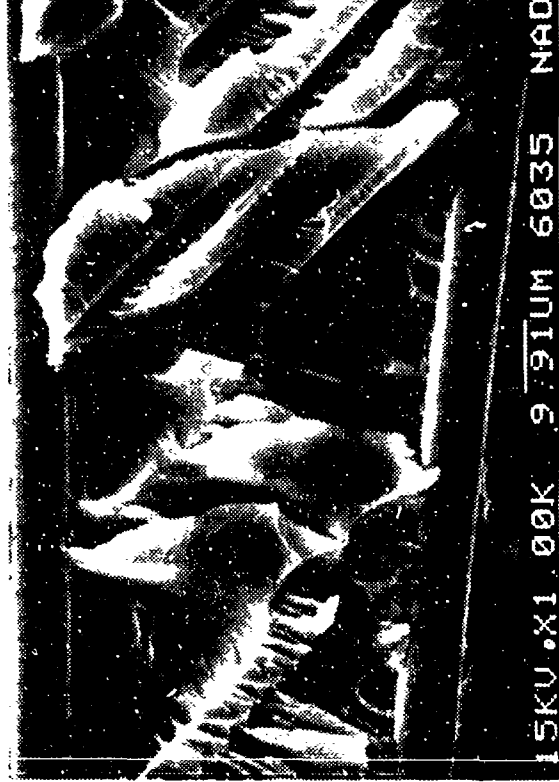
Figure 2-97. SEM Photographs of Mode II ENF Interlaminar Shear Fracture in Overcured Gr/Ep, Conditioned 180 F/Wet After Test

(a), (b) Crack-Growth Regions in $[0]_{24T}$ and $[+45/0/-45]_{4S}$ Coupons, Respectively

Note random river patterns on hackles

CD = Crack-propagation direction

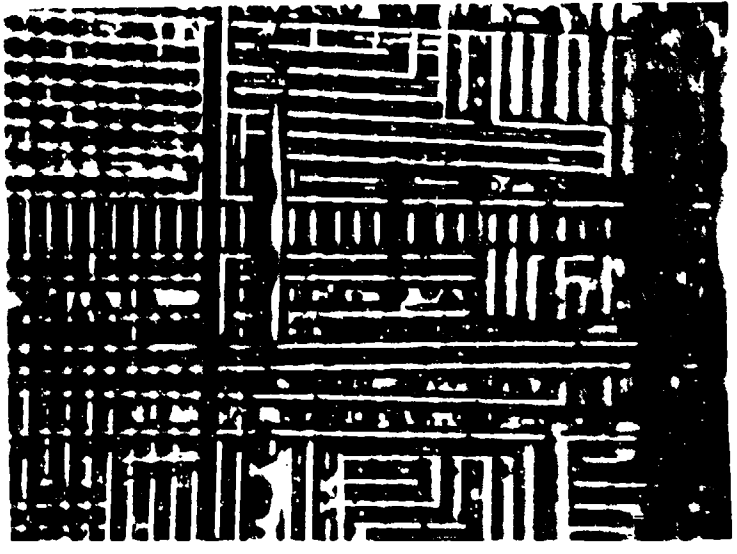
FEP crack
starter
region

Crack
growth
direction

Figure 2-98. Optical Photomicrographs of Interlaminar Mode II Shear, 0.90 Fracture, 2000 F Exposure for 5 Minutes After Test

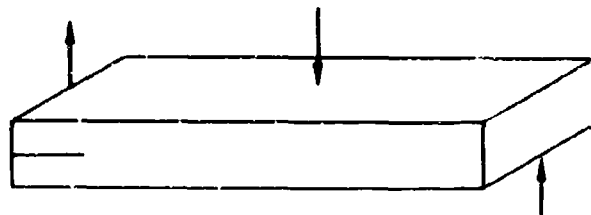
The mixed mode flexural (MMF) test geometry, shown in Figure 2-100, produces 57 percent Mode I tension and 43 percent Mode II shear at the crack tip. The macroscopic fracture surface characteristics are as follows:

Figure 2-100. Mixed Mode Flexural Test Type

1. Macroscopically flat surface
2. Microscopically rough resin fracture with a predominance of hackles and scallops
3. Small localized regions of flat resin fracture exhibiting only river marks and resin microflow.

SEM examination of mixed-mode interlaminar failures indicates that these are characterized by mixtures of hackles or scallops and river patterns that are generally interspersed between the hackles. The river patterns can be used to map local fracture origins and direction as for pure Mode I tension. Processing variations (overcure or undercure), material form (filament winding versus tape), or post-processing variables (impact-damage) do not significantly alter the fracture characteristics.

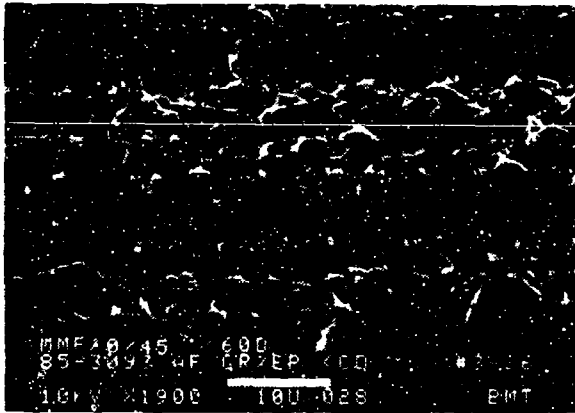
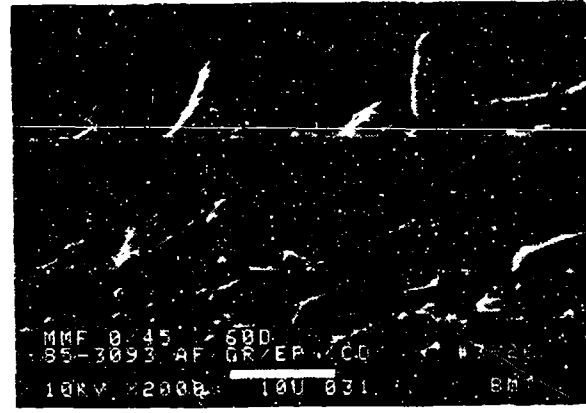
Fracture type	Interlaminar mixed mode (I and II)
Ply layup	[0, 45] _{12S}
Test type	Mixed-mode flexure (MMF)
• Test conditions	21°C, dry
• Fracture between	0/45 plies
Material	Hercules 3501-6/177°C cure AS4 fibers

←
Mechanically induced crack direction

Figure 2-103. SEM Photographs of Interlamina: Mode I and Mode II, 0/45 Fracture, 70 F/Dry

The test matrix for MMF testing is provided in Table 2-3 and the related fractographs are shown in Figures 2-101 through 2-117. These figures are arranged in the same order that the corresponding tests are listed in Table 2-3.

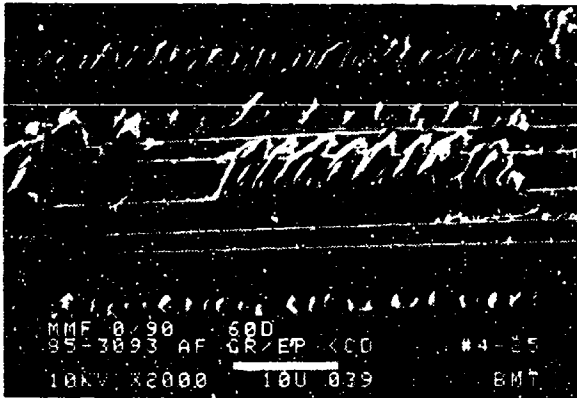
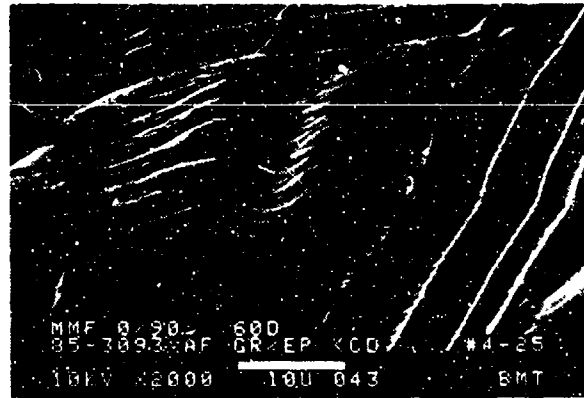
Fracture type	Interlaminar mixed mode (I and II)
Ply layup	[0, 90] ₁₂ S
Test type	Mixed-mode flexure (MMF)
• Test conditions	21°C, dry
• Fracture between	0/90 plies
Material	Hercules 3501-6/177°C cure AS4 fibers

←
Mechanically induced crack direction

Figure 2-104. SEM Photographs of Interlaminar Mode I and Mode II, 0/90 Fracture, 70 F/Dry

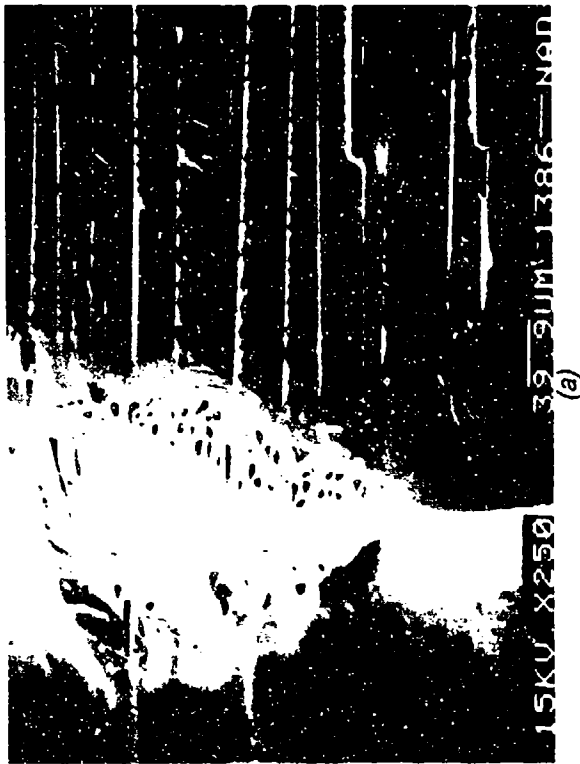
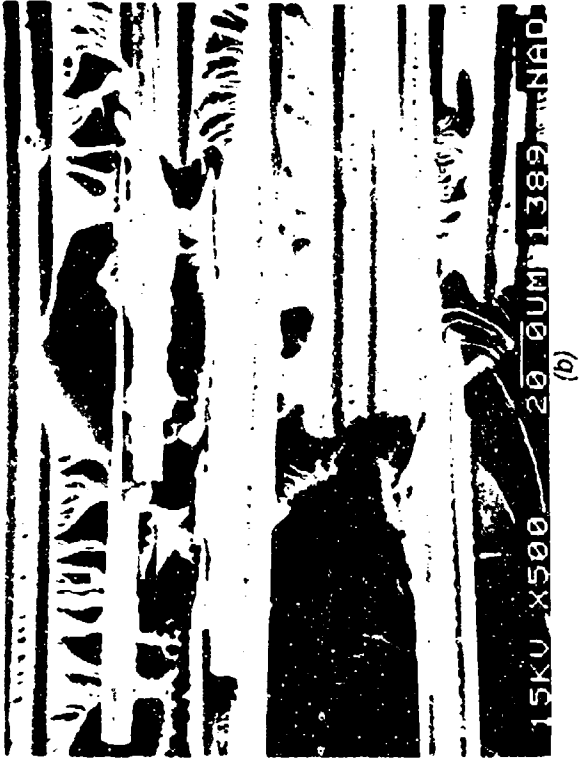
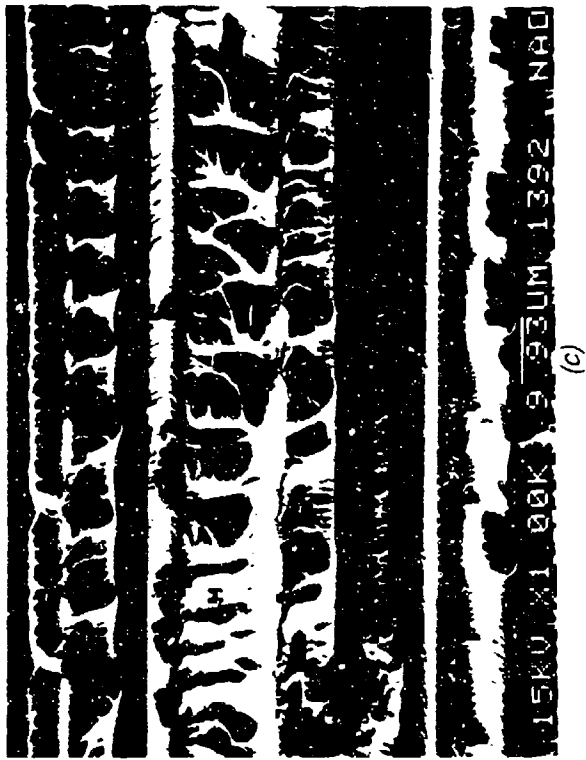
Figure 2-105. SEM Photographs of Mode I and Mode II MMF Interlaminar Fracture in Filament Wound Gr/Ep - [0]_{24T}
 (a) River Patterns (R) at Initiation Site (Pre-crack Region)
 (b) Pre-crack to Crack-Growth Transition Region (Mode I Tension to Mixed Mode I Tension and Mode II Shear)
 (c) Hackles (H) and River Patterns (R) in Crack-Growth Region

CD = Crack-propagation direction

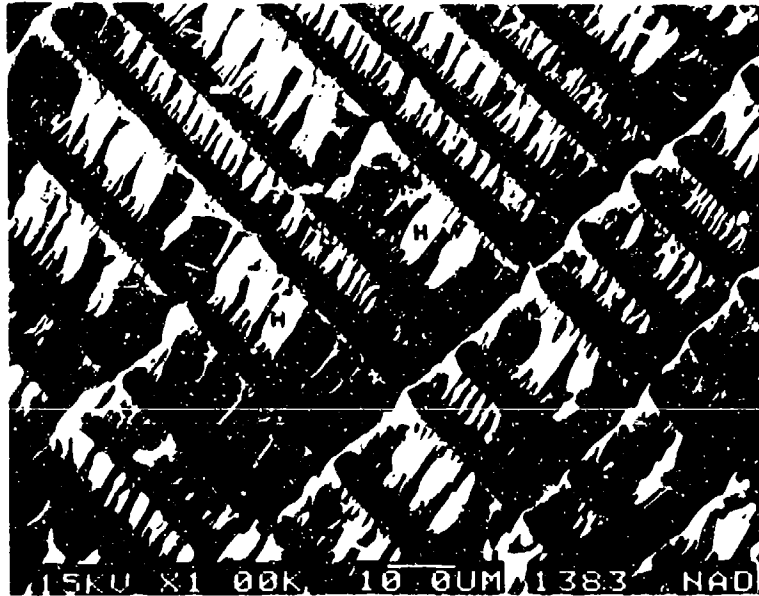
Figure 2-106. SEM Photograph of Mode I and Mode II MMF interlaminar Fracture in Crack-Growth Region of Filament Wound Gr/Ep - [+45/0/-45]_{4s}

CD = Crack-propagation direction
H = Hackles
R = River patterns

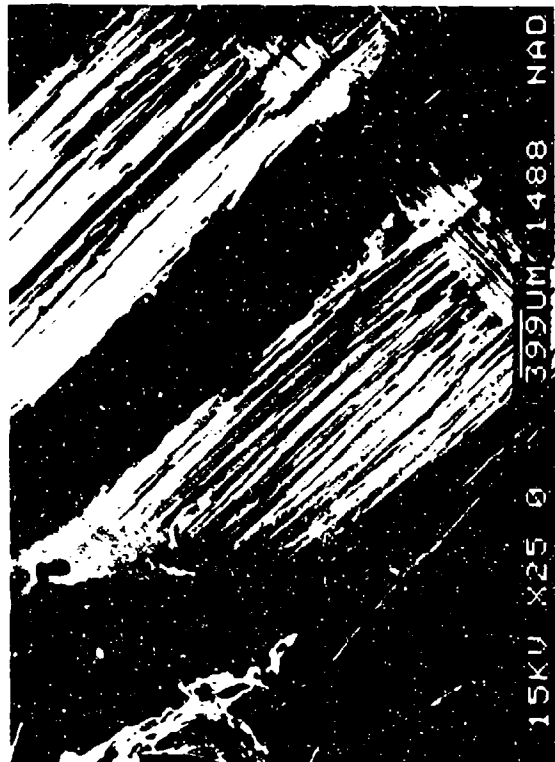
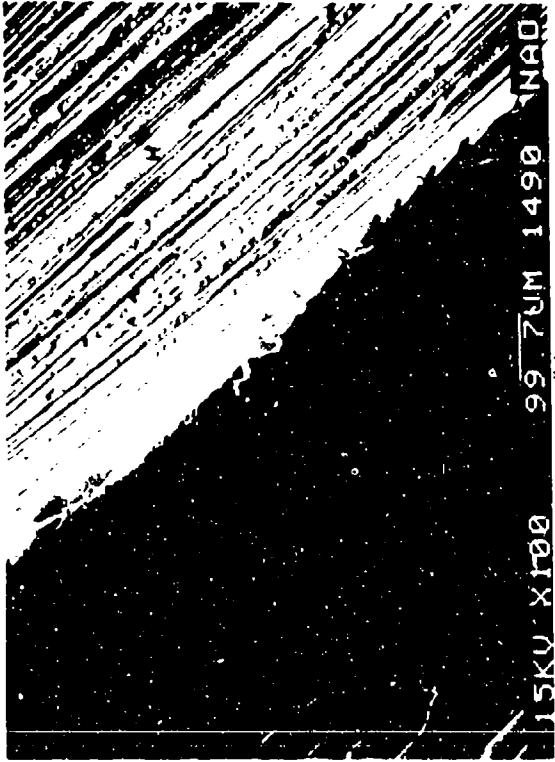
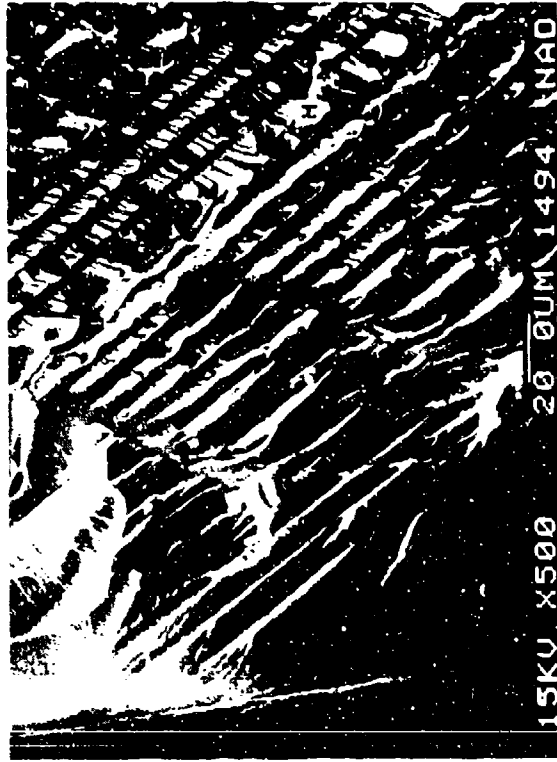
Figure 2-107. SEM Photographs of Mode I and Mode II MMF Interlaminar Fracture in 3-D Weave Gr/Ep - [+45/0/-45] as

- (a) Initiation in Precrack Region of Coupon
- (b) Hackles (H) and River Patterns (R) in Precrack Region
- (c) Hackles (H) and River Patterns (R) in Crack-Growth Region

CD = Crack-propagation direction

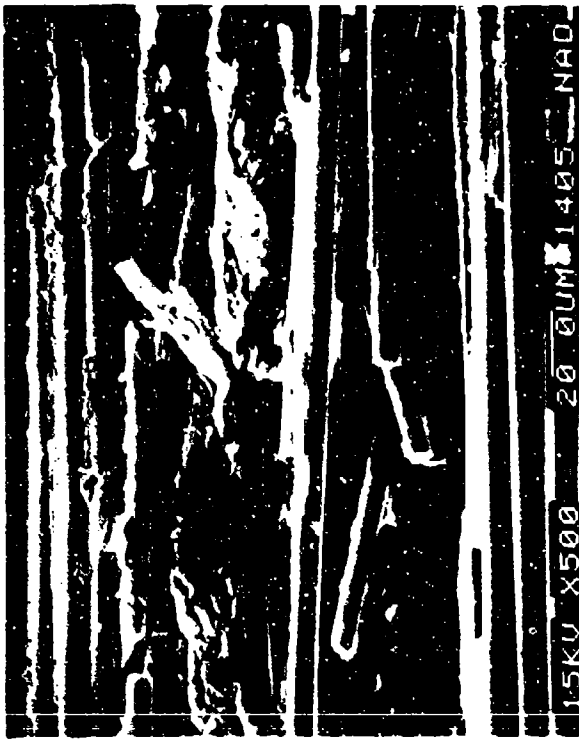
Figure 2-108. SEM Photographs of Mode I and Mode II MMF Interlaminar Fracture in Impact Damaged Gr/Ep - [0]_{24T}

- (a) River Patterns in Precrack Initiation Region
- (b) Impact Damage Area in Crack-Growth Region

Note broken fibers and crushed resin

CD = Crack-propagation direction

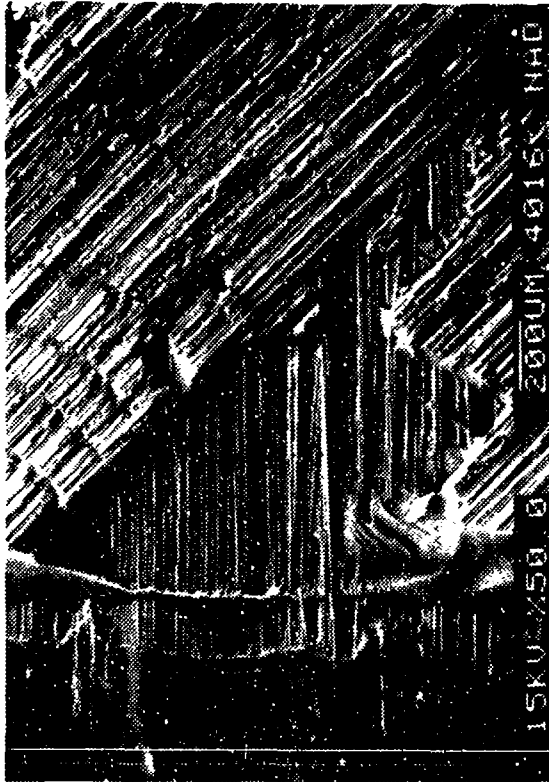
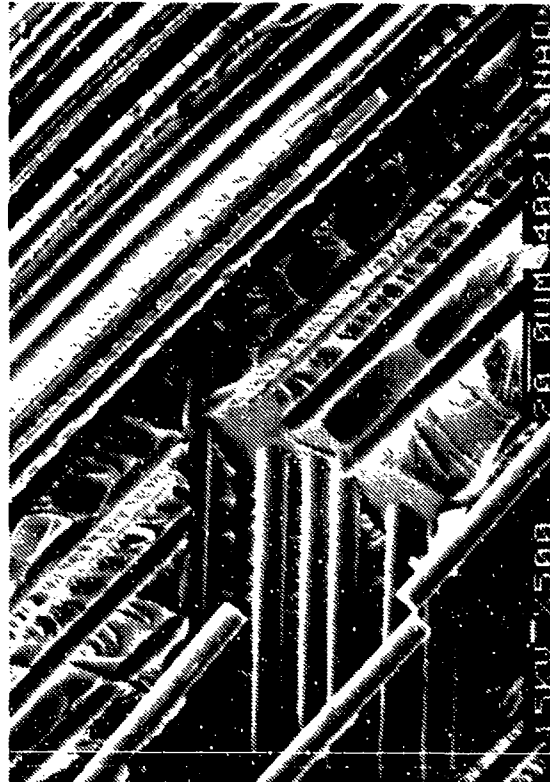
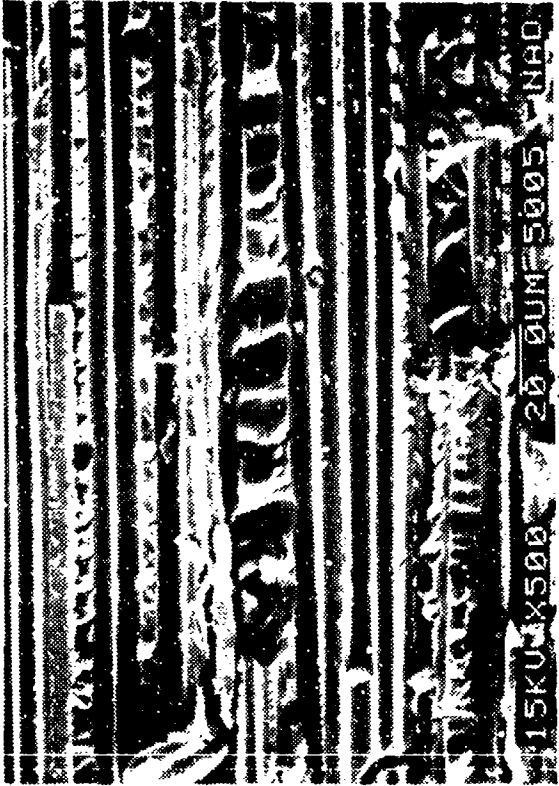
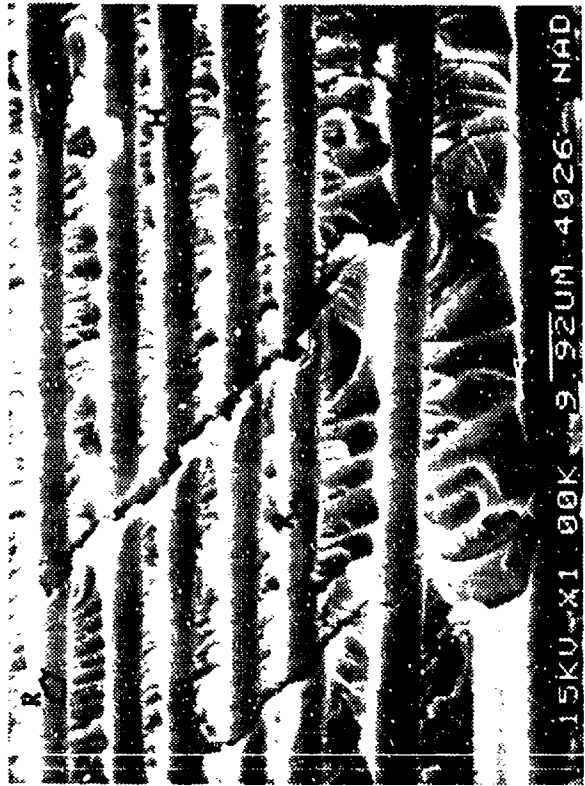
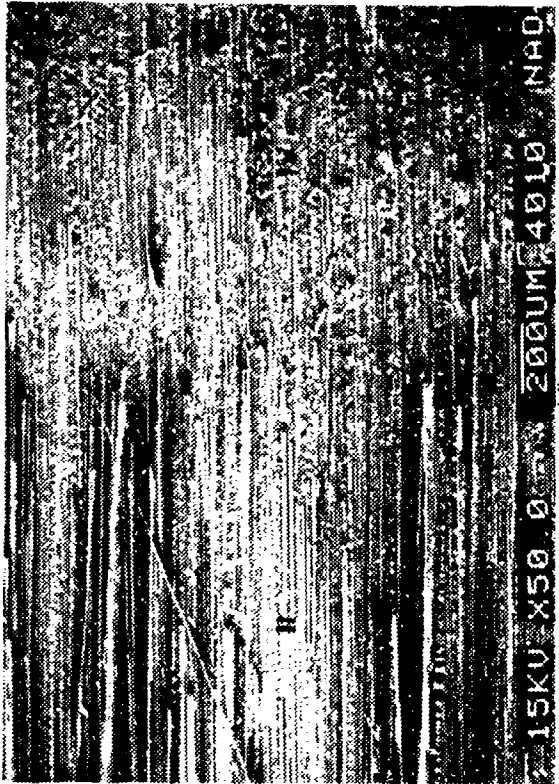
Figure 2-109. Optical and SEM Photographs of Mode I and Mode II MMF Impact Damaged Grr/Ep - [+45/0/-45]_{4S}
 (a) Macrograph Showing Regions I, II, III and IV (Pre-crack, Crack Growth Under Mode I Tension and Mode II Shear, Laboratory Overload, Impact Damage)
 (b) Initiation in Resin-Rich Areas
 (c) River Patterns in the Mode I Fracture Region

Figure 2-109. (Continued)
 (d) Interface Between the Mixed-Mode Region II and the Impact Region IV
 (e) Crushed Resin and Debris in the Impact Damaged Area
 (f) Mode I Tension and Mode II Shear Fracture Region
 Note the presence of river patterns (R), hackles (H), scallops (S) and localized cracks

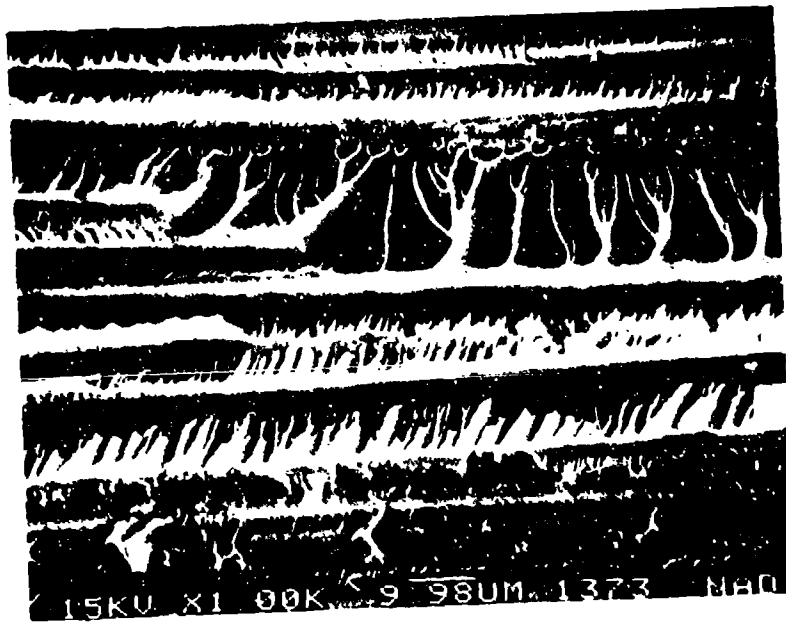
Figure 2-110. SEM Photograph of Mode I and Mode II MMF Interlaminar Fracture in Gr/Ep - [0]_{24T}, Water Immersion Before Test
Note hackles and river patterns
CD = Crack-propagation direction
H = Hackles
R = River patterns

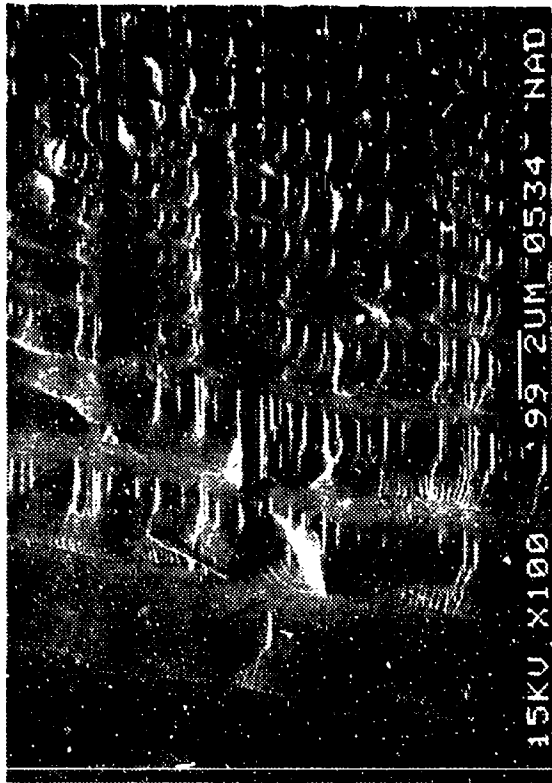
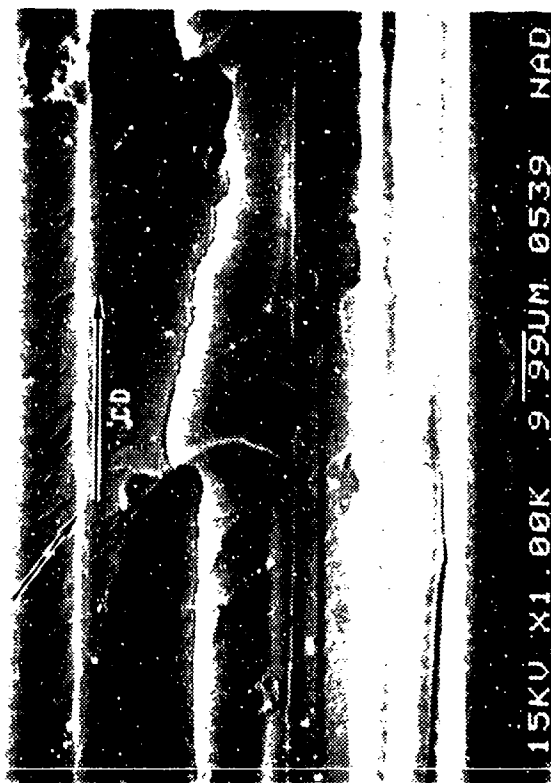
Figure 2-111. Optical and SEM Photographs of Mode I and Mode II MMF Interlaminar Fracture in Undercured Gr/Ep - [0]_{24T}
 (a) Macrograph Showing Regions I, II, and III (Pre-crack, Mode I and II Growth, and Laboratory Overload)
 (b) Mode I Tension Fracture Initiation in Resin-Rich Areas
 (c) River Patterns (Arrows) on Fractured Epoxy

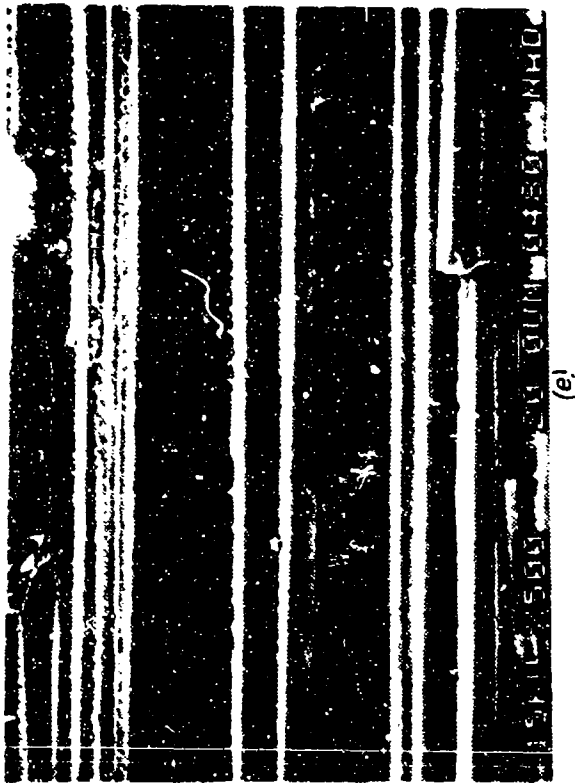
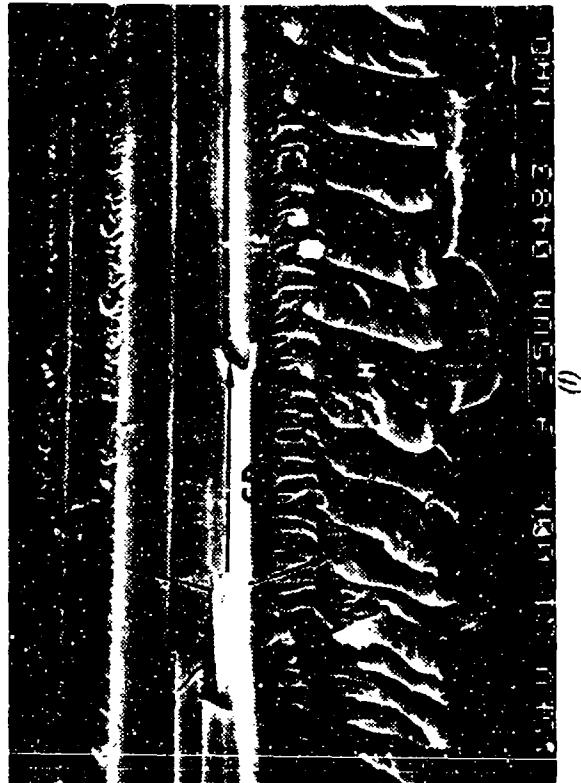
Figure 2-111. (Continued)
 (d) Local Porosity (P) in Region I
 (e) Interface Between Mode I and Mixed-Mode Regions
 (f) River Patterns (Arrows) and Hackles (H) in the Mixed-Mode Region
 CD = Crack-propagation direction

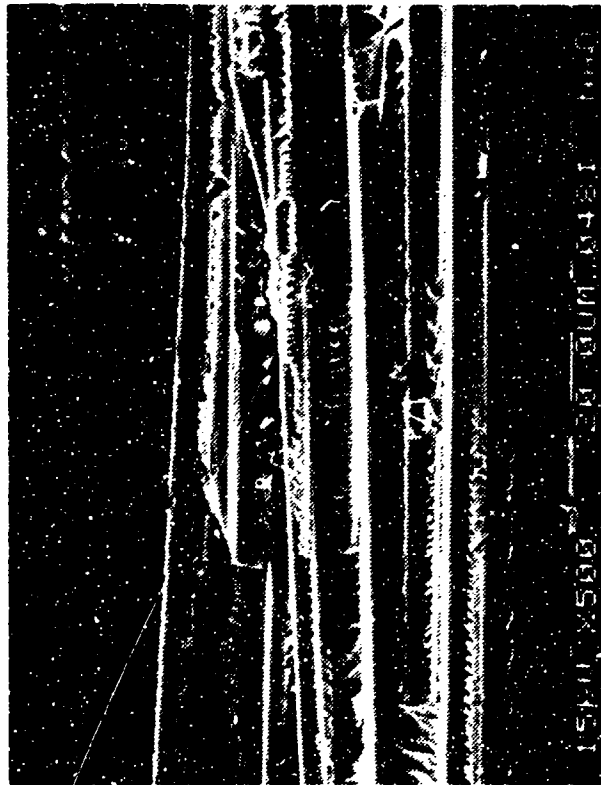
Figure 2-111. (Continued)

Note: The river patterns can be used to establish direction of fracture.

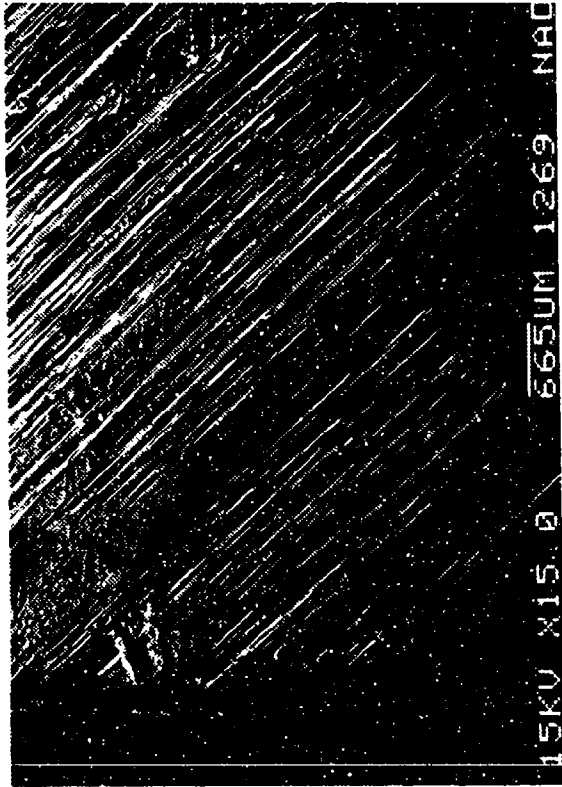
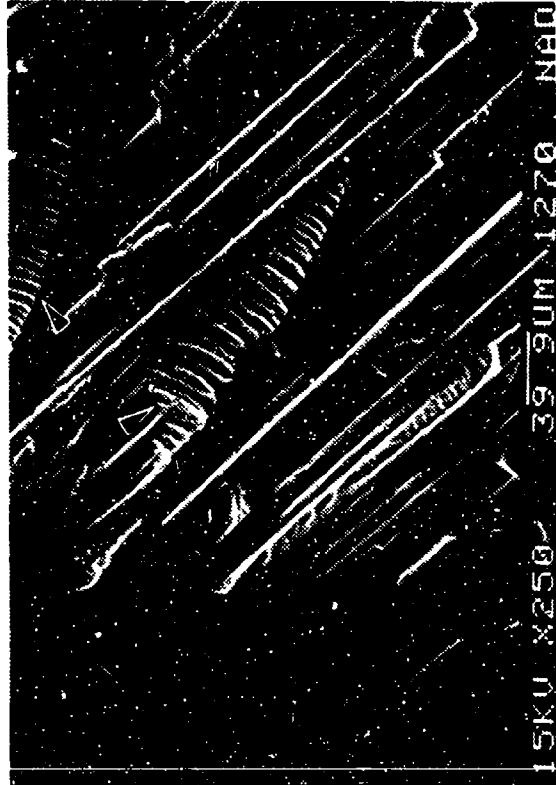
Figure 2-112. Optical and SEM Photographs of Mode I and Mode II MMF Interlaminar Fracture in Undercured Gr/Ep - [+45/0/-45] ₄₅

- (a) Macro photograph
- (b) Initiation in Precrack
- (c) High Magnification Photograph of Precrack Showing River Patterns (R)

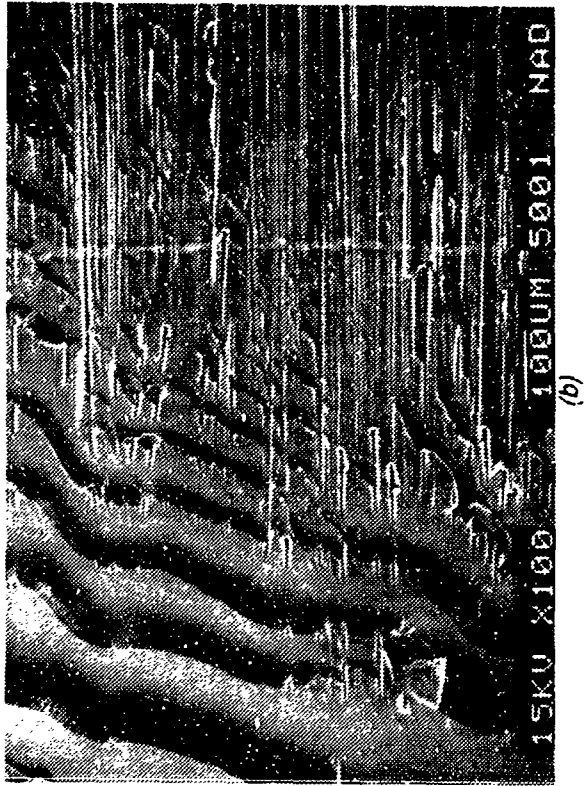
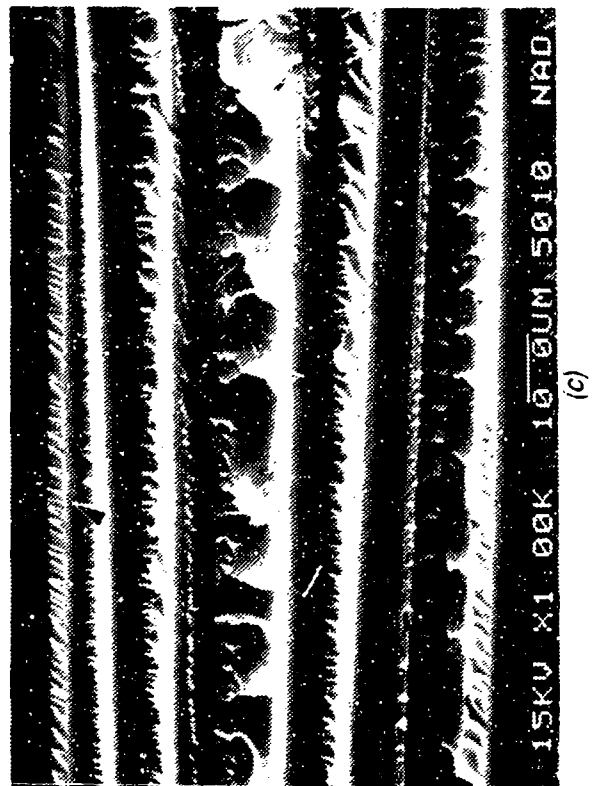
Figure 2-113. Optical and SEM Photographs of Mode I and Mode II MMF Interlaminar Fracture in Overcured Gr/Ep - [0]₂₄T
 (a) Macrograph Showing Regions I, II, and III (Pre-crack, Crack-Growth Under Mode I Tension and Mode II Shear, and Laboratory Overload)
 (b) Initiation in Resin-Rich Areas
 (c) Mode I River Patterns (Arrows)
