WL-TR-91-4032
DOT/FAA/CT-91/23
VOL II, Part 2

COMPOSITE FAILURE ANALYSIS HANDBOOK
VOL II - TECHNICAL HANDBOOK
PART 2 - ATLAS OF FRACTOGRAPHS

February 1992

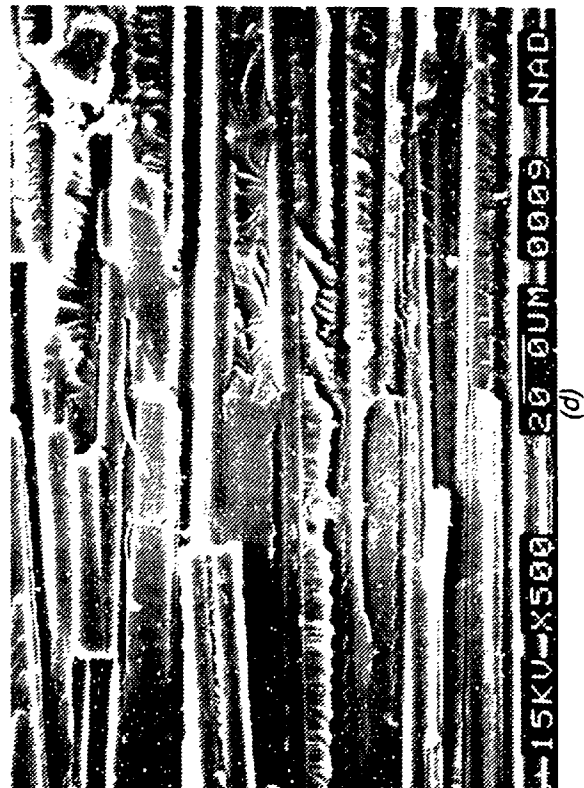
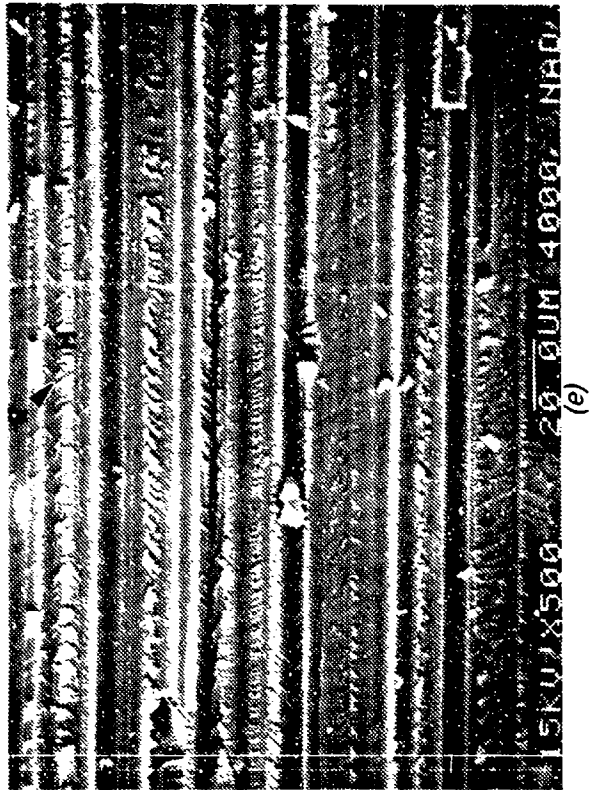
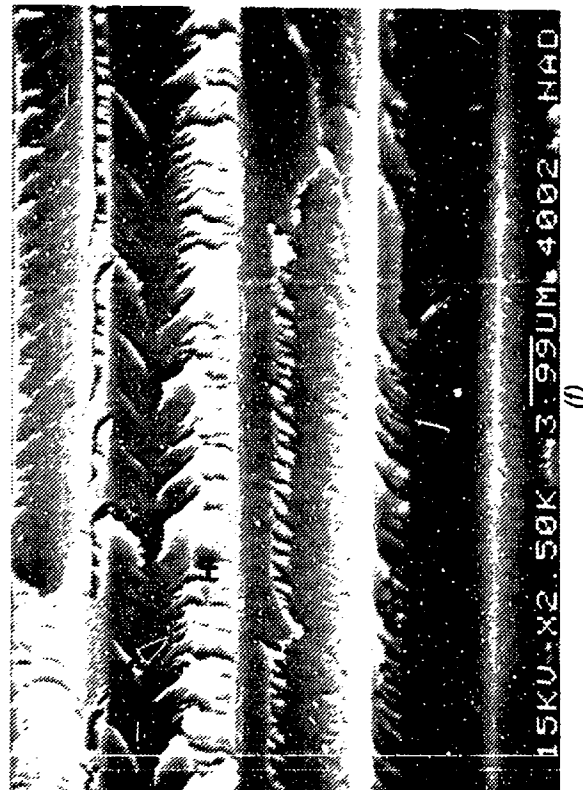
Figure 2-113. (Continued)
 (d) Interface Between Mode I and Mixed-Mode Regions
 (e), (f) River Patterns (R) and Hackles (H) in the Mixed-Mode Fracture Surface

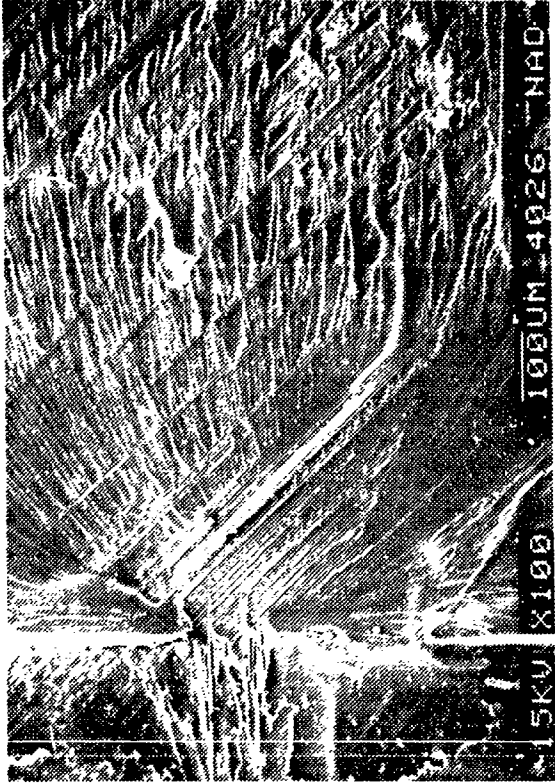
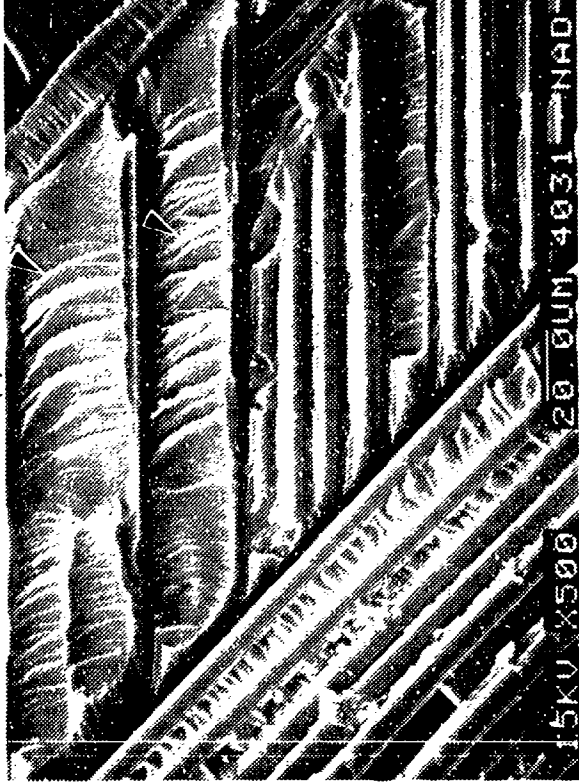
Figure 2-114. Optical and SEM Photographs of Mode I and Mode II MMF Interlaminar Fracture in Overcured Gr/Ep -

(a) Macrograph Showing Growth Regions I, II, and III (Precrack, Crack-Growth Under Mode I Tension and Mode II Shear, Laboratory Overload)

(c) Mode I River Patterns (Arrows)

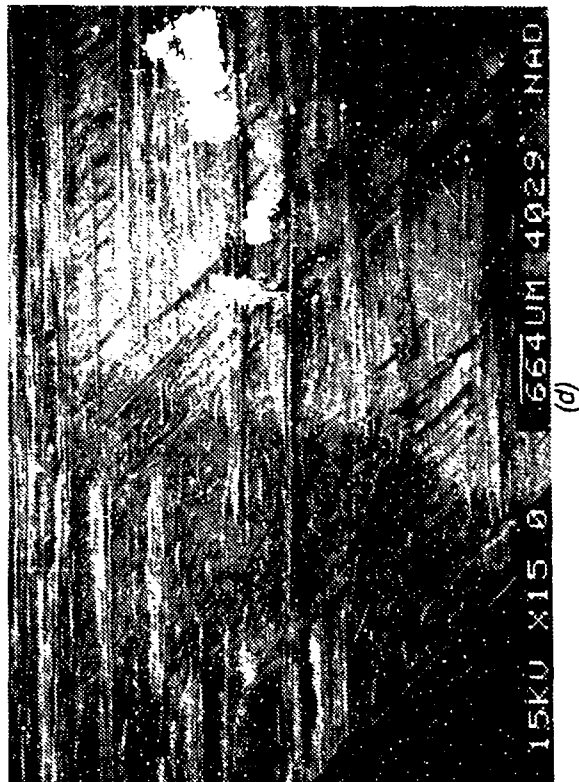
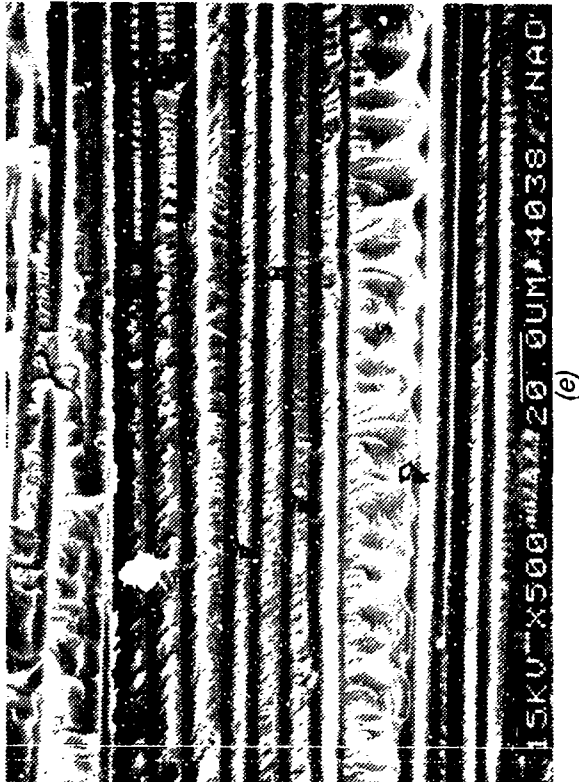
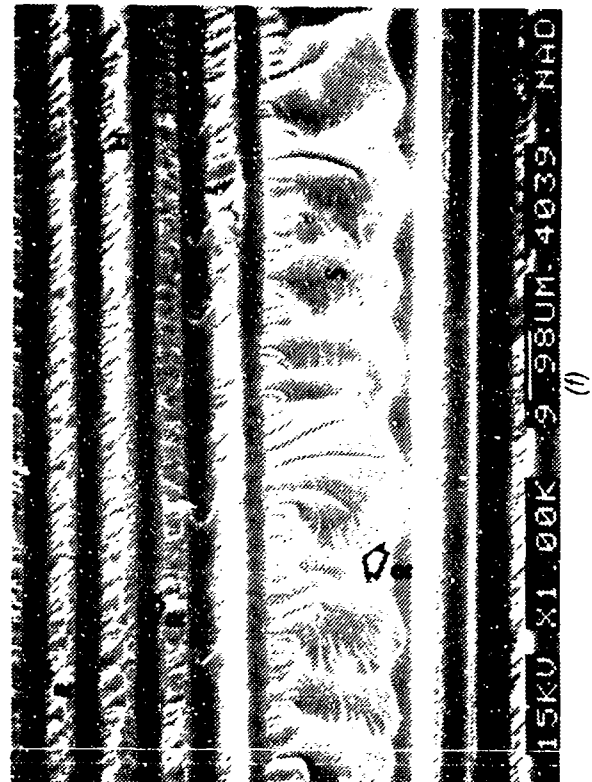
Figure 2-114. (Continued)
 (d) Interface Between Mode I and Mixed-Mode Regions
 (e), (f) River Patterns (R), Hackles (H), and Scallops (S) in the Mixed-Mode Fracture Surface
 CD = Crack-propagation direction

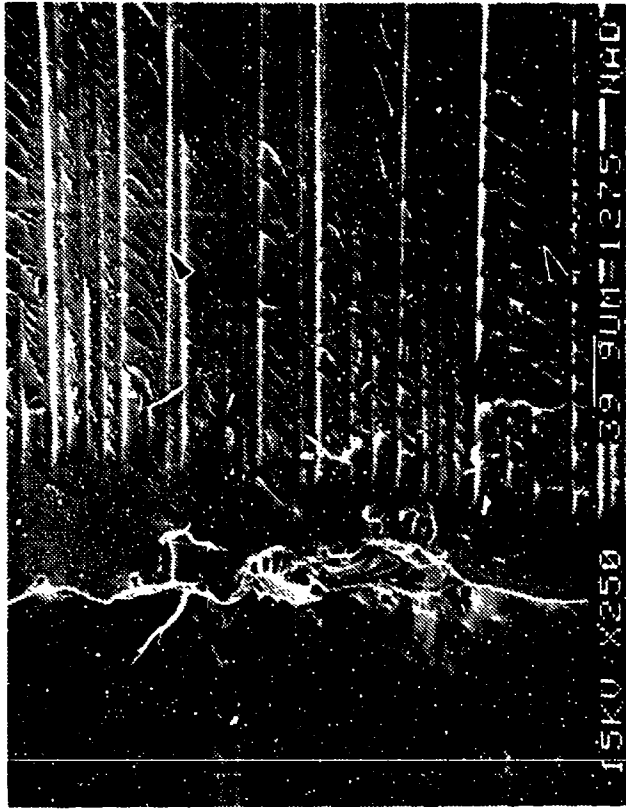
Figure 2-115. Optical and SEM Photographs of Mode I and Mode II MMF Interlaminar Fracture in High Resin Content Gr/Ep - [0]₂T

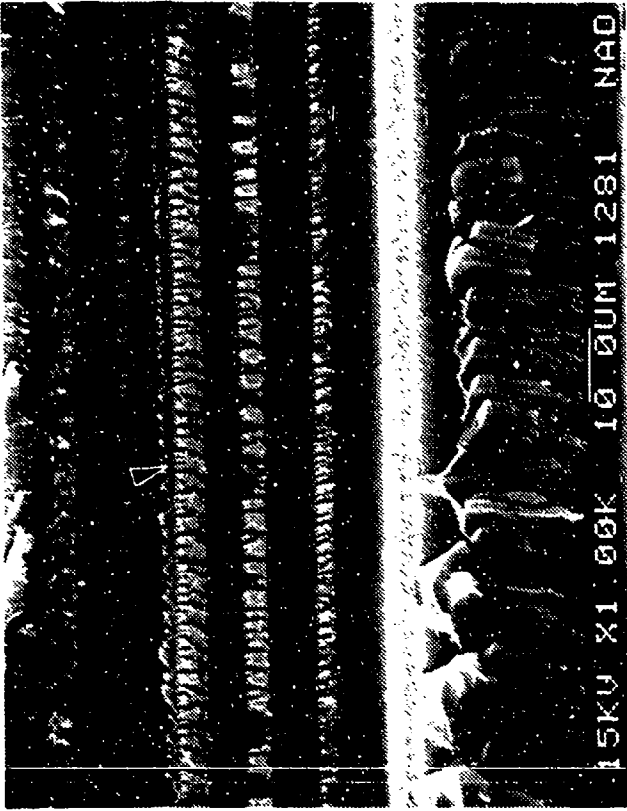
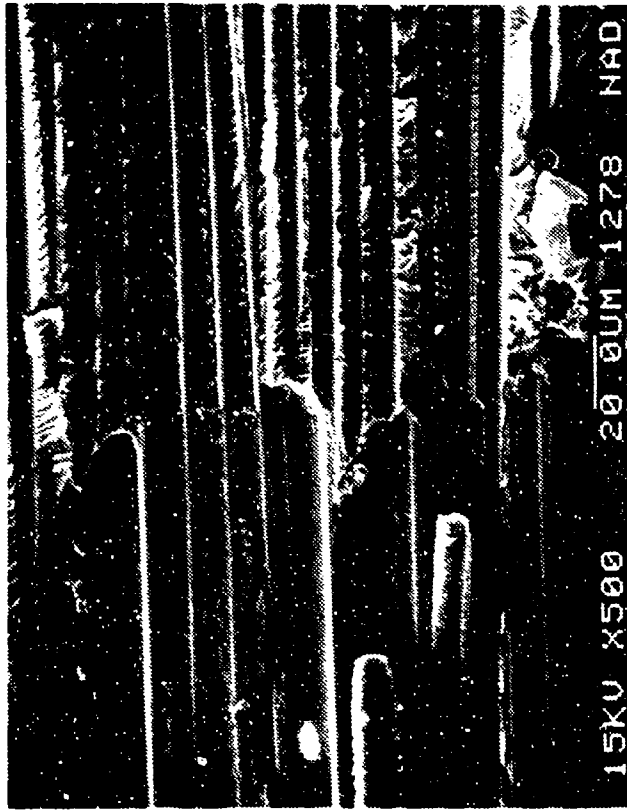
Figure 2-115. (Continued)
 (c) Mode I/Mixed-Mode Interface
 (d) Mixed-Mode Region

CD = Crack-propagation direction
 H = Hackles (Cusps)
 R = River patterns

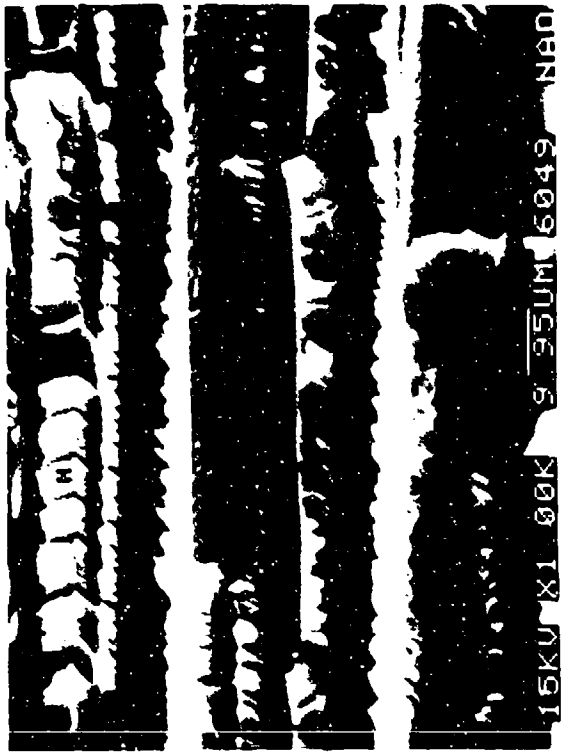
Figure 2-116. SEM Photographs of Mode I and Mode II MMF Interlaminar Fracture in High Resin Gr/Ep - [0]_{24T} Conditioned 180 F Dry After Test

- (a) Initiation in Pre-crack Region
- (b) Mode I Tension to Mixed-Mode Tension and Shear Transition
- (c) Mixed-Mode Failure

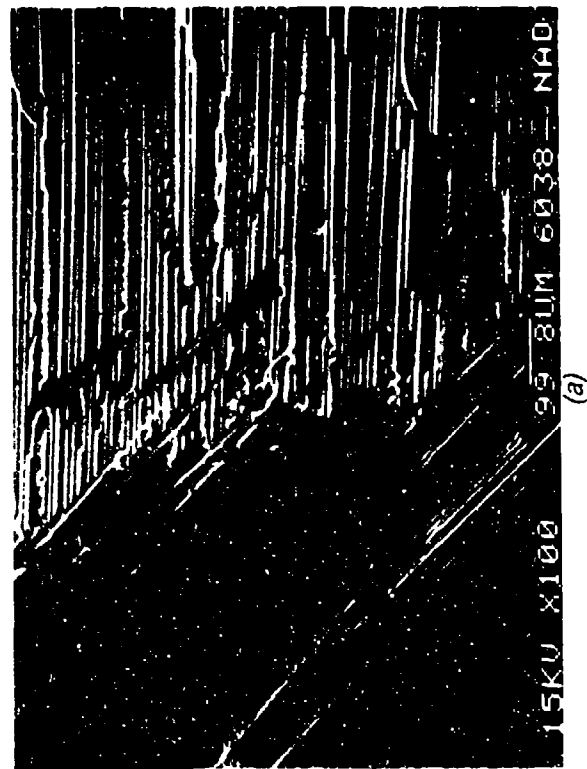
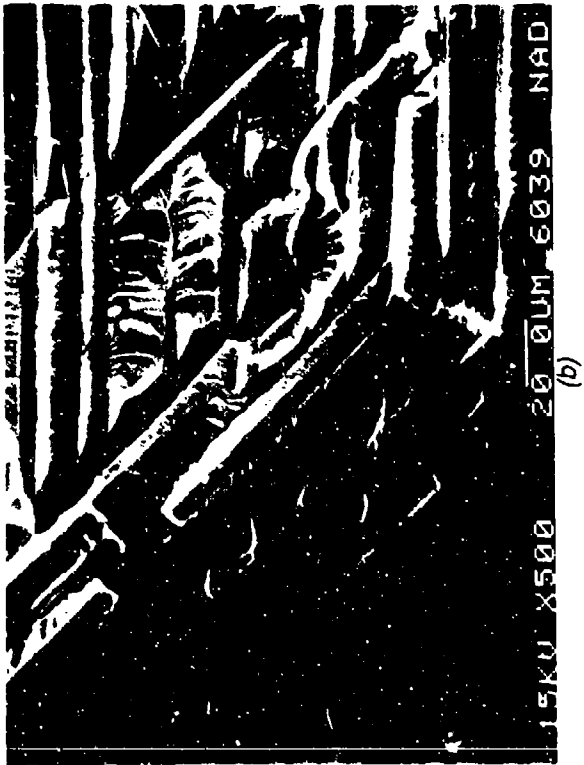
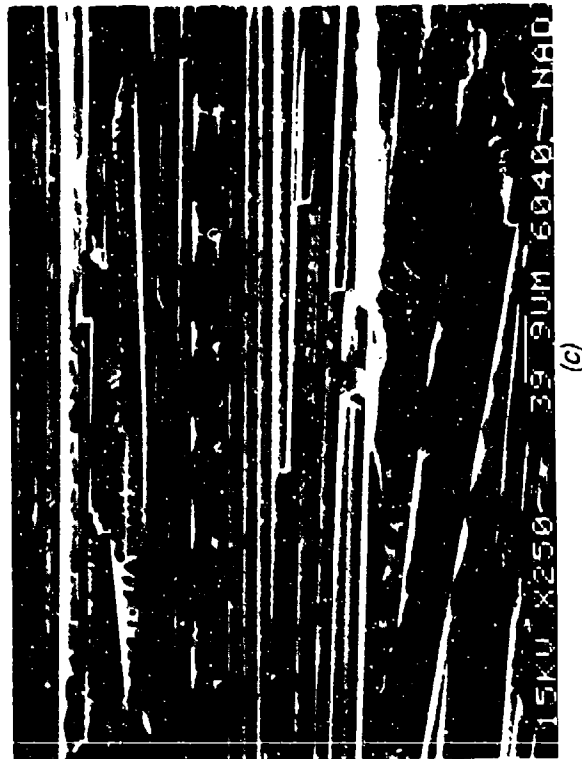
Figure 2-117. SEM Photographs of Mode I and Mode II MMF Interlaminar Fracture in Overcured Gr/Ep - [+45/0/-45] _{as}, Conditioned 180 F/Wet After Test
 (a) Mode I Tension to Mixed-Mode Transition
 (b) Detail in Transition Region
 (c) Mixed-Mode Fracture

CD = Crack-propagation direction
 H = Hackles
 R = River patterns

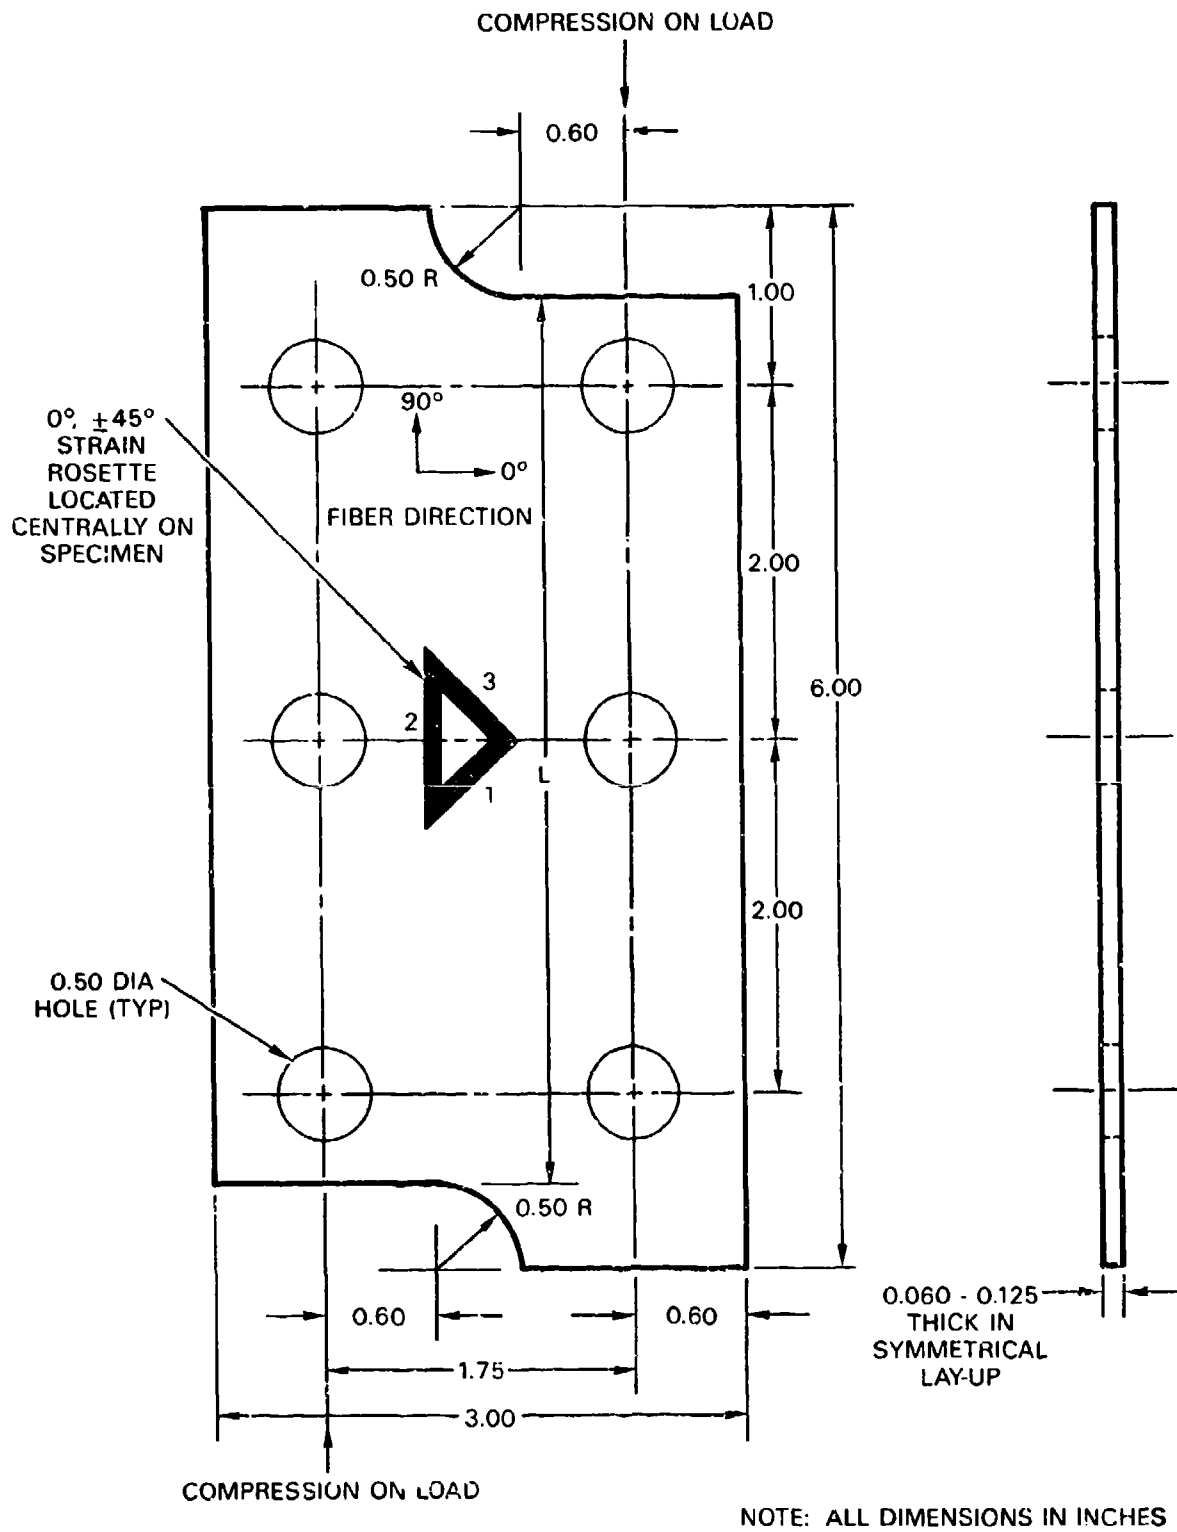
Figure 2-118. Rail-Shear Specimen

Table 2-4 shows the test matrix used for characterized in-plane shear failures in Gr/Ep. The test matrix includes baseline Gr/Ep, processing variations, and post-failure variables. The rail-shear test specimen is shown in Figure 2-118. The in-plane shear fractographs are provided in Figures 2-119 through 2-122. This contribution was made by Northrop.

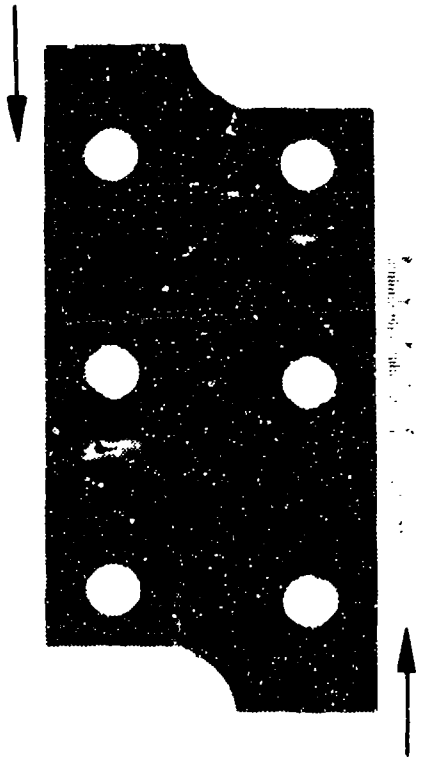
Figure 2-119. Optical and SEM Photographs of AS4/3501-6 Gr/Ep - [0/90]_{es} . In-Plane Shear-Tested (Bacelane)
 (a) Macro photograph of Rail-Shear Specimen
 Note: Arrows indicate loading direction.
 (b) Close-Up View of in-Plane Shear Region
 CD = Crack-propagation direction

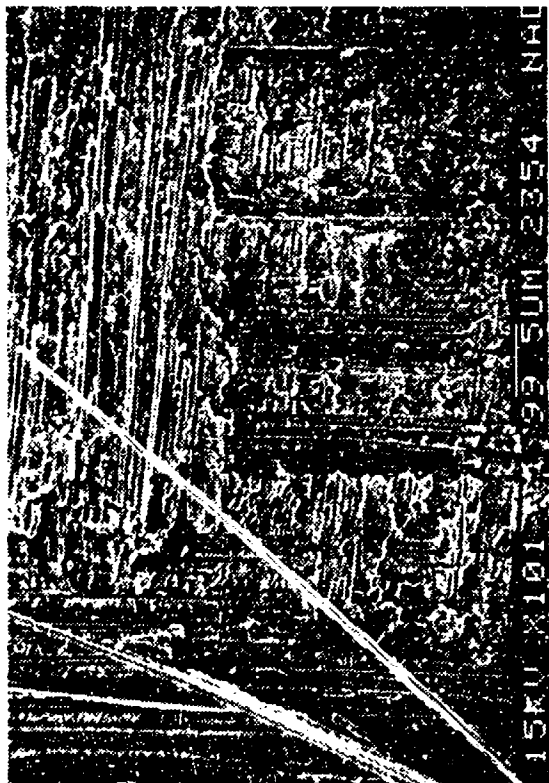
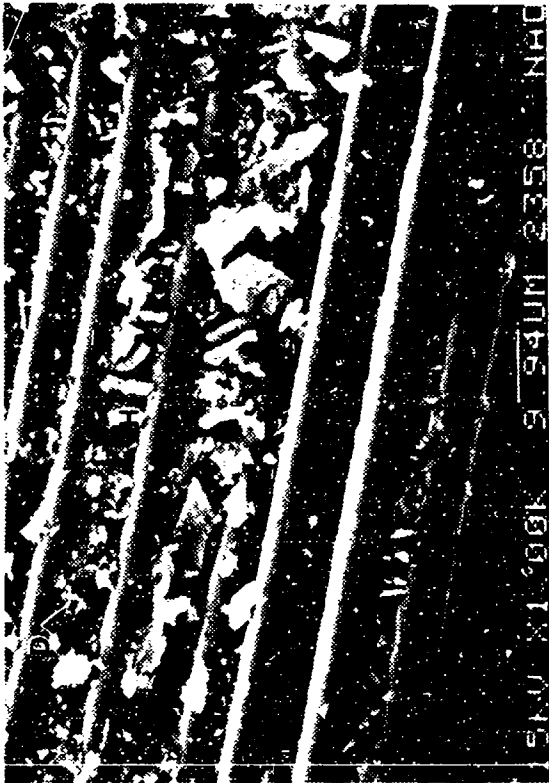
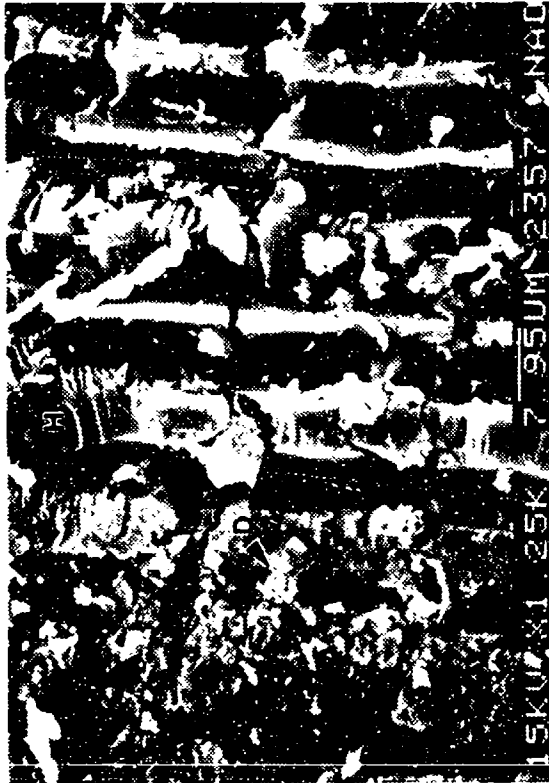
Figure 2-119. (Continued)
 (c) Delaminated Fracture Surface of Region
 Exposed by Sectioning Outer Plies
 (d), (e) Fracture in 90 and 0 Degree Plies

CD = Crack-propagation direction
 D = Compression debris
 H = Hackles

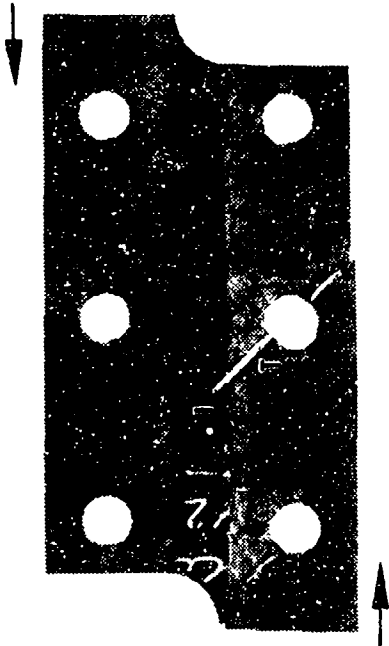
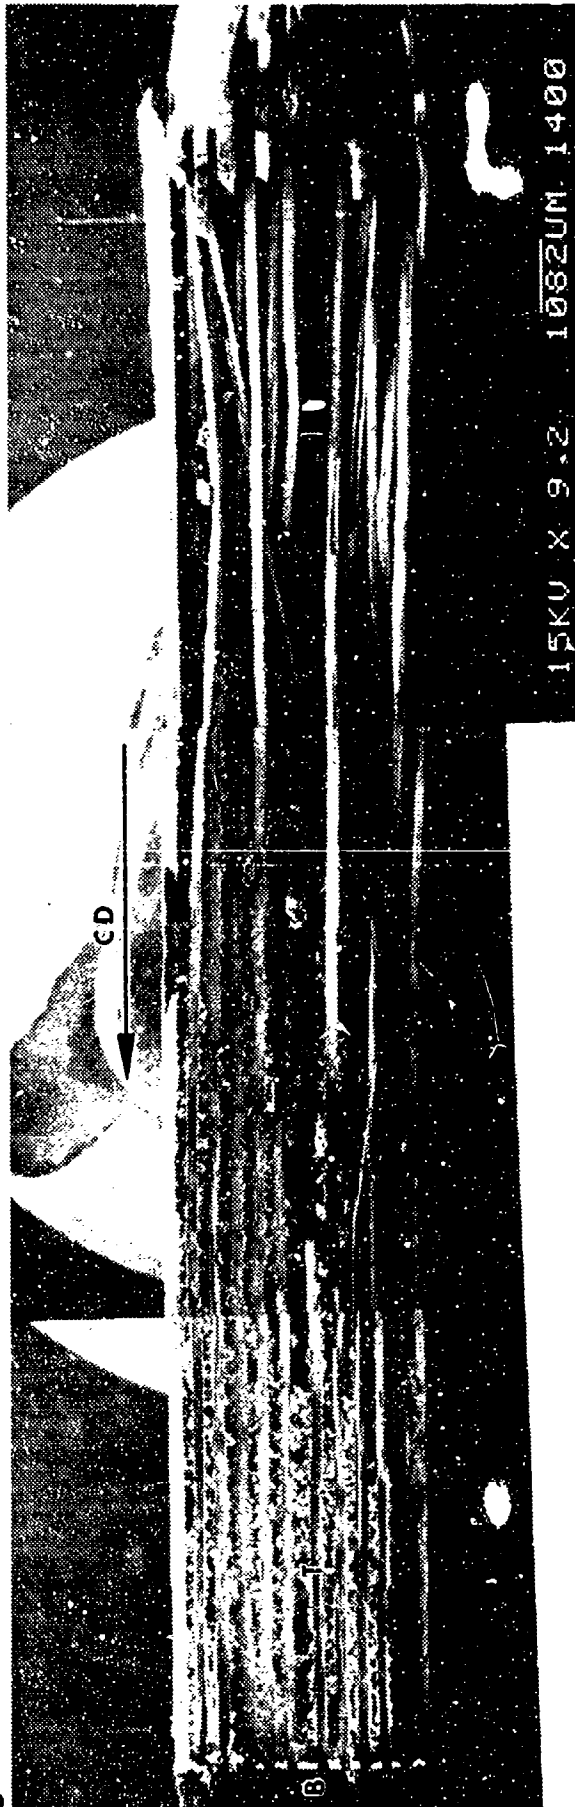
Figure 2-12c. Optical and SEM Photographs of AS43501-6 Gr/Ep - [+45/-45]_{6s}, In-Plane Shear Tested (Baseline)

(a) Macro photograph of Rail-Shear Specimen

(b) Close-up View of Fracture Viewed End-On

- B = Bolt-hole
- CD = Crack-propagation direction
- I = In-plane shear region
- T = Secondary transverse tensile fracture

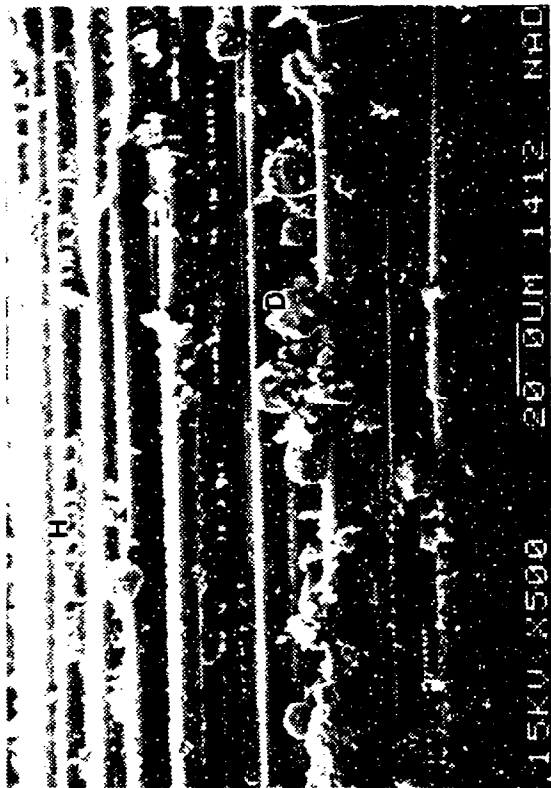
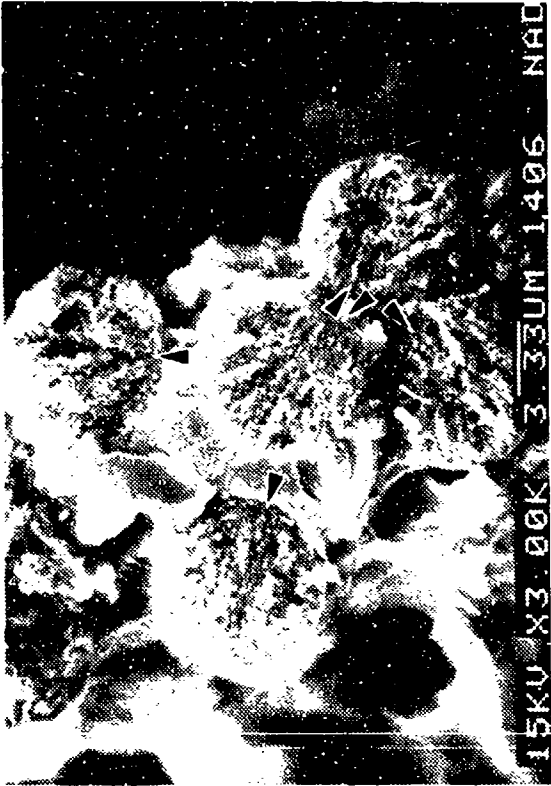
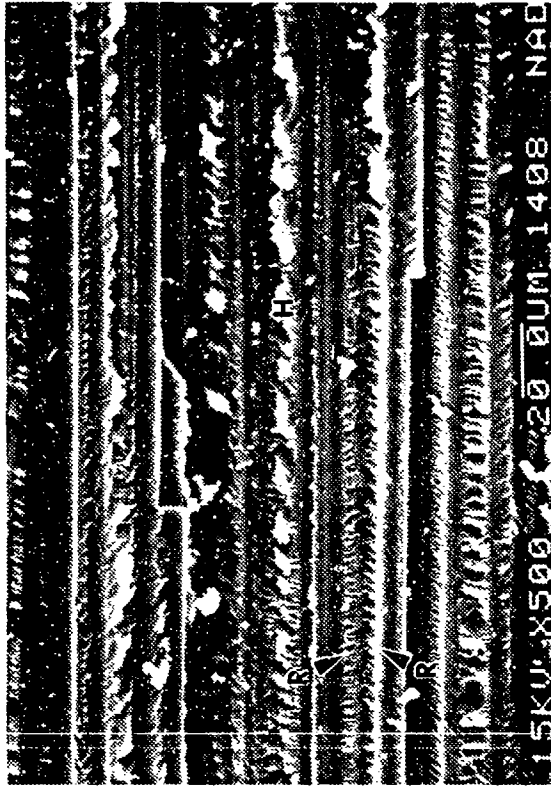
Figure 2-120. (Continued)
 (c) Fracture in +45 Degree Ply Showing Hackles (H) and Compression Debris (D)
 (d) Fracture in -45 Degree Ply Showing Tensile Fiber Breaks
 Note DAF radials (arrows)
 (e) Transverse Tensile Fracture in Secondary Failure Region Showing Rivers (R) and Hackles (H)
 Note rivers oriented away from bolt-hole

CD = Crack-propagation direction
 D = Compression debris
 H = Hackles
 R = Rivers

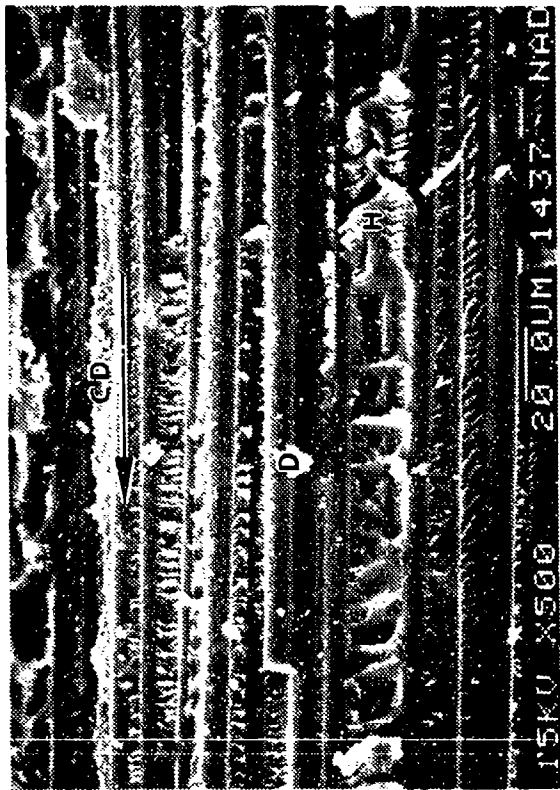
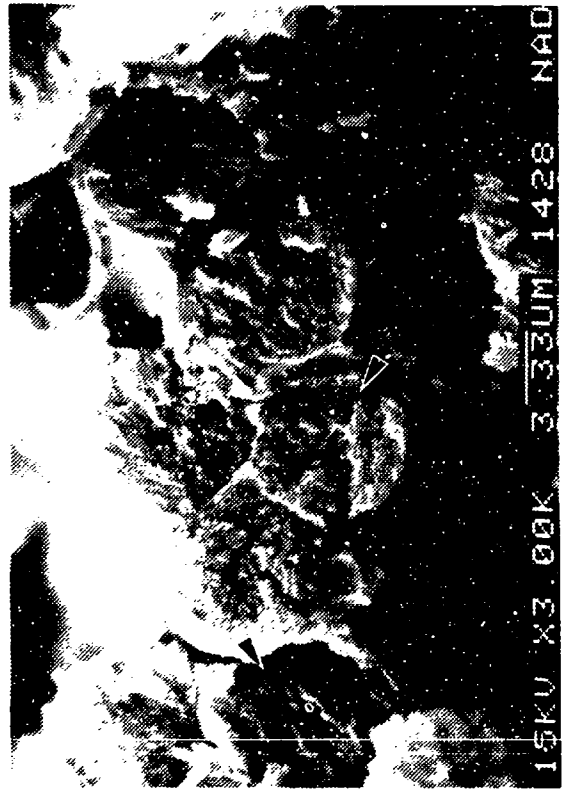
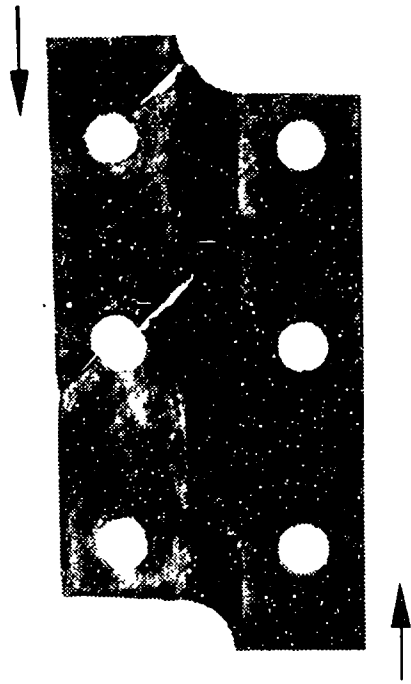
Figure 2-121. Optical and SEM Photographs of AS4/3501-6 Undercured Gr/Ep - [+45/-45]_{6s} In-Plane Shear Tested

(b) Fracture in +45 Degree Ply Showing Hackles (H) and Compression Debris (D)

(c) Fracture in -45 Degree Ply Showing Tensile Fiber Breaks

CD = Crack-propagation direction

I = In-plane shear region

T = Secondary transverse tensile fracture

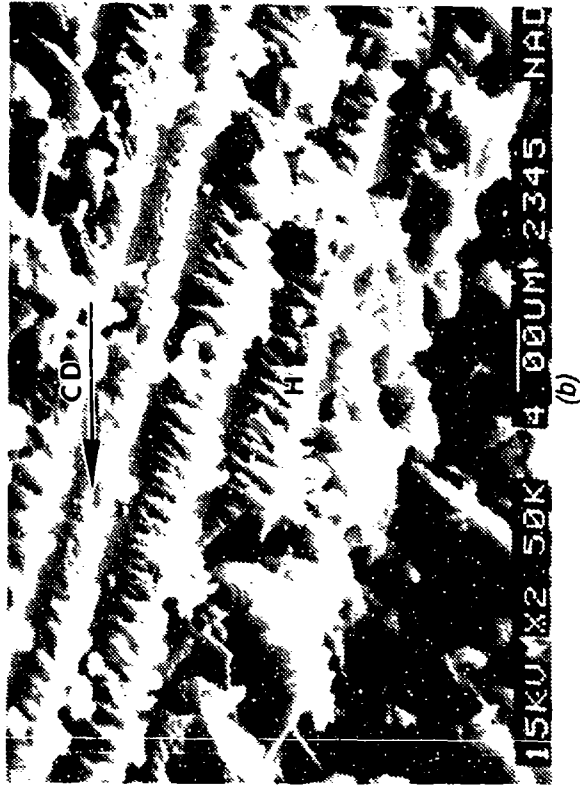
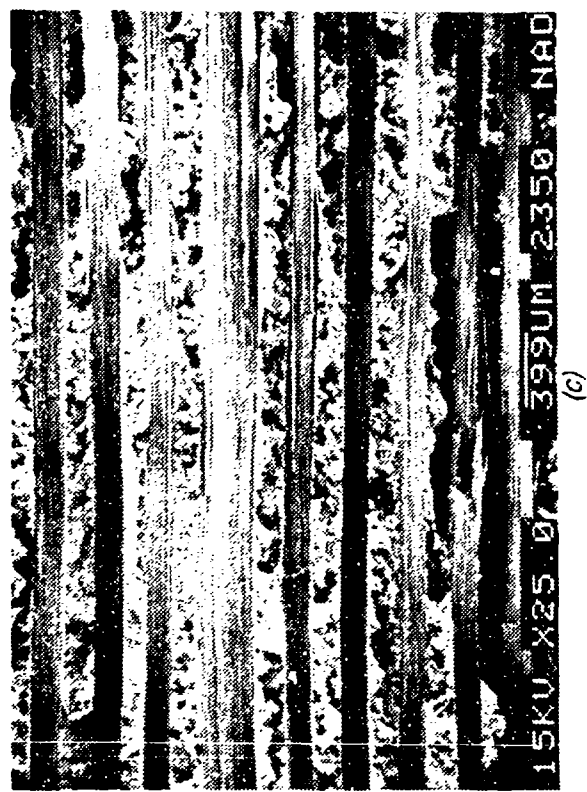
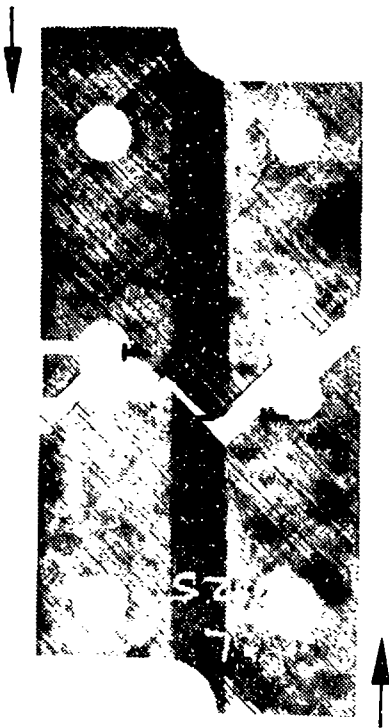
Figure 2-122. Optical and SEM Photographs of AS4/3501-6 Overcured Gr/Ep - [+45/-45]_{6s}, In-Plane Shear Tested
 (a) Macrograph of Rail-Shear Specimen
 Note arrows indicating loading direction
 (b) Fracture in +45 Degree Ply Showing Hackles (H)
 (c) Transverse Tensile Fracture in Secondary Failure Region

CD = Crack-propagation direction
 I = In-plane shear region
 T = Secondary transverse tensile fracture

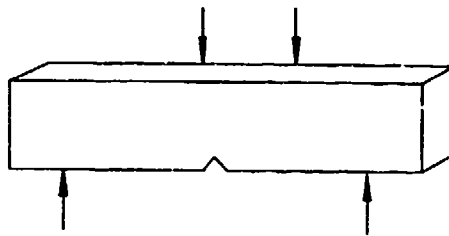
Figure 2-123. Four-Point Bend Tension Test Specimen

Figure 2-123 depicts the translaminar tension test configuration, and Figure 2-124 shows typical orientations of fibers and radial patterns of adjacent fibers at both low and high magnifications. Table 2-5 is the test matrix for the translaminar tension test specimens. Translaminar tension fractographs are shown in Figures 2-125 through 2-147. These figures are arranged in the same order that the corresponding tests are listed in Table 2-5.

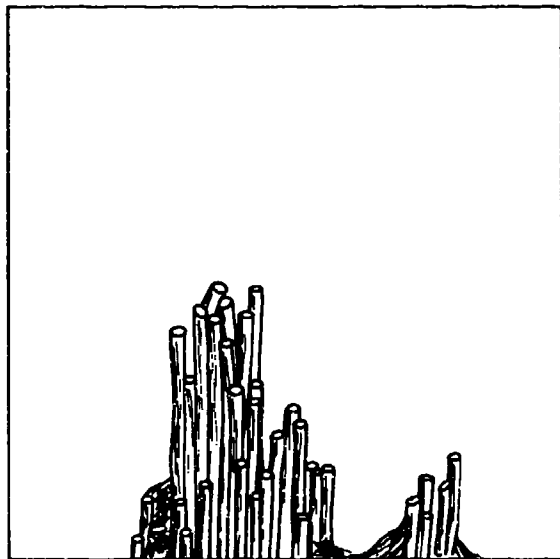
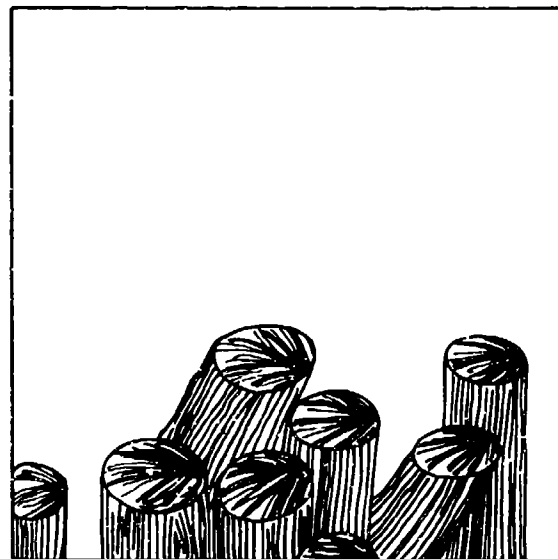
Low magnification

High magnification

←
Overall crack growth direction

Figure 2-124. Fracture of Adjacent Fibers

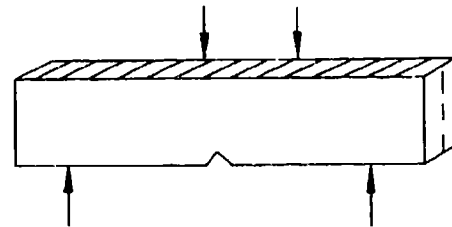
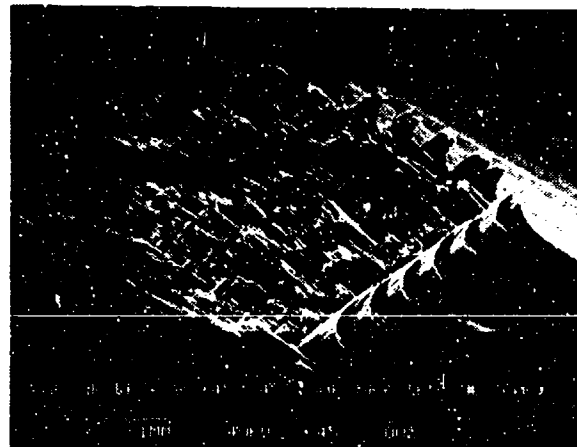
Fracture type	Translaminar mode I tension
Ply layup	[+45, -45] 16S
Test type	Four-point bend
• Test conditions	Dry
• Fiber end fracture	
Material	Hercules 3501-6/177°C cure AS4 fibers

Mechanically induced crack direction

Figure 2-125. SEM Photographs of Translaminar Mode I Tension, +45/-45 Fracture, -65, 180, and 270 F/Dry (Fiber Pullout)

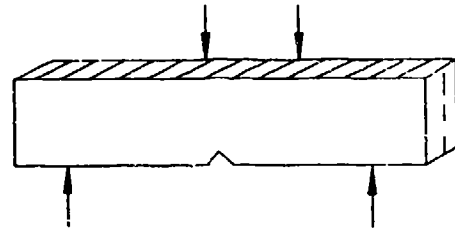
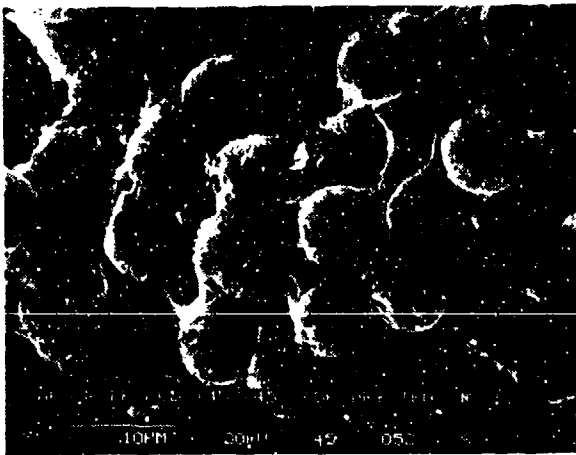
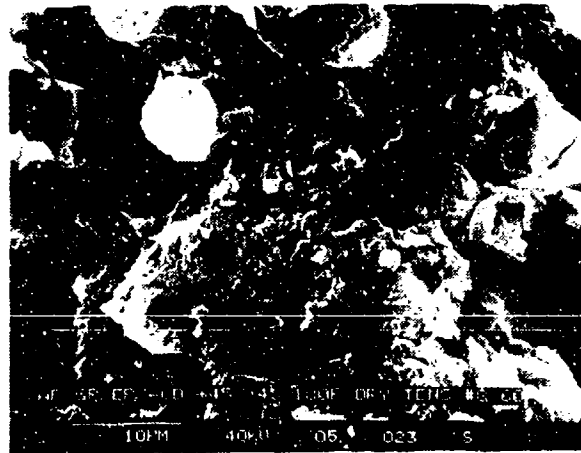
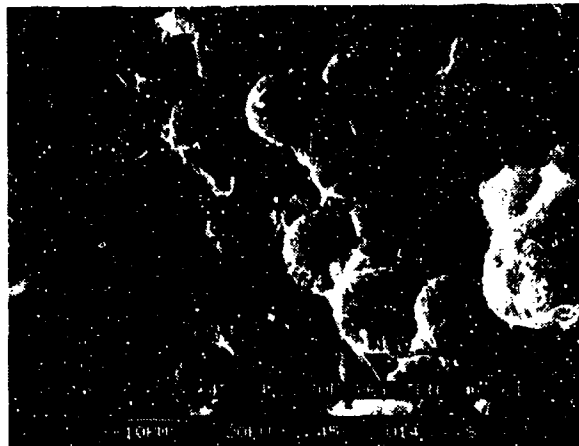
Fracture type	Translaminar mode I tension
Ply layup	[+45, -45] _{16S}
Test type	Four-point bend
• Test conditions	Dry
• Fiber end fracture	
Material	Hercules 3501-6/177°C cure AS4 fibers

←
Mechanically induced crack direction

Figure 2-126. SEM Photographs of Translaminar Mode I Tension, +45/-45 Fracture, -65, 180, and 270 F/Dry (Fiber Breakage)

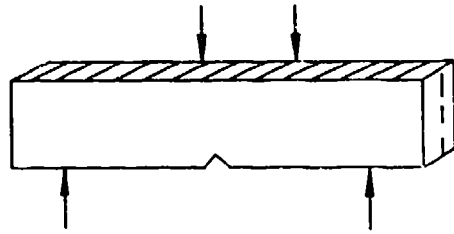
Fracture type	Translaminar mode I tension
Ply layup	[+45, -45] 16S
Test type	Four-point bend
• Test conditions	Wet
• Fiber end fracture	
Material	Hercules 3501-6/177°C cure AS4 fibers

Figure 2-127. SEM Photographs of Translaminar Mode I Tension, +45/-45 Fracture, 70, 180, and 270 F/Wet (50X)

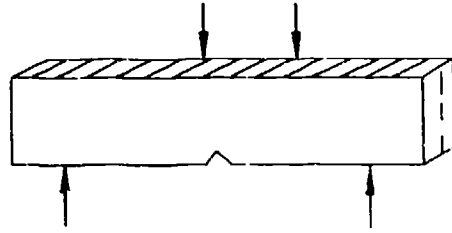
Fracture type	Translaminar mode I tension
Ply layup	[+45, -45] _{16S}
Test type	Four-point bend
• Test conditions	Wet
• Fiber end fracture	
Material	Hercules 3501-6/177°C cure AS4 fibers

Mechanically induced crack direction

Figure 2-128. SEM Photographs of Translaminar Mode I Tension, +45/-45 Fracture, 70, 180, and 270 F/Wet (2000X)

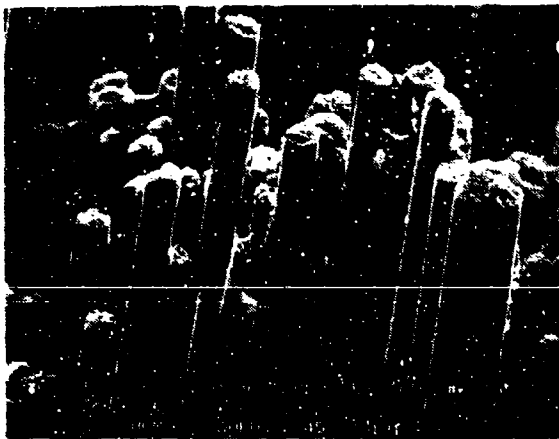
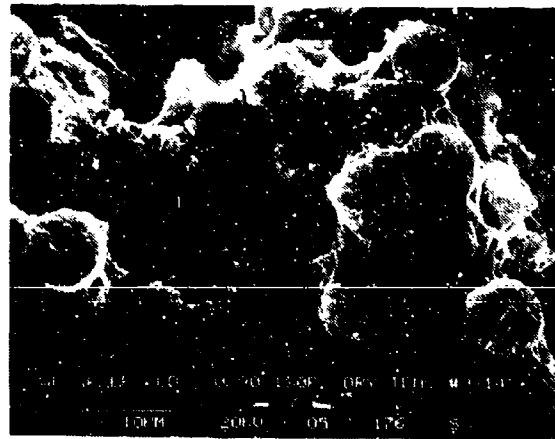
Figure 2-129. SEM Photographs of Translaminar Mode I Tension, 0/90 Fracture, 180 F/Dry (Various Magnifications)

Fracture type	Translaminar mode I tension
Ply layup	[0, 90] ₁₆
Test type	Four-poin. bend
• Test conditions	82°C, dry
• Fiber end fracture	
Material	Hercules 3501-6/177°C cure AS4 fibers

Mechanically Induced crack direction

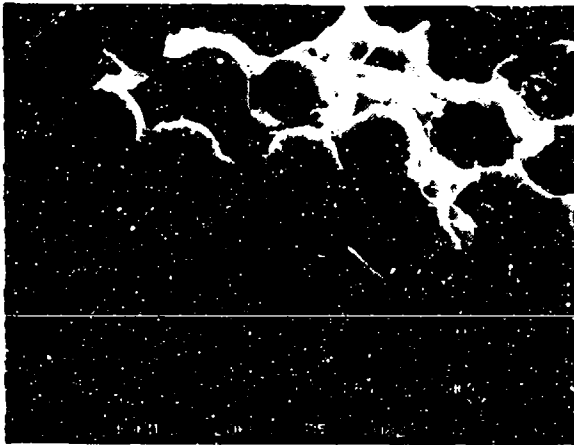
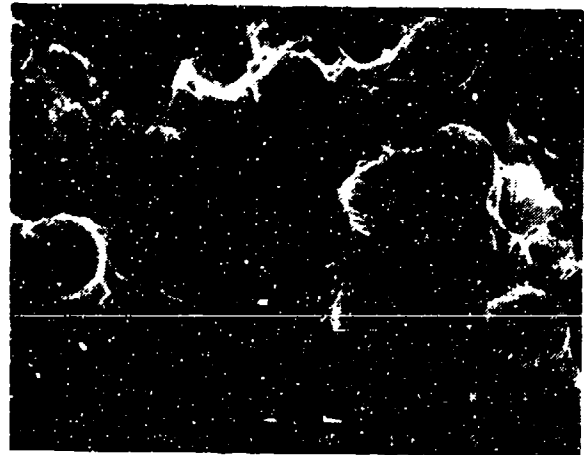
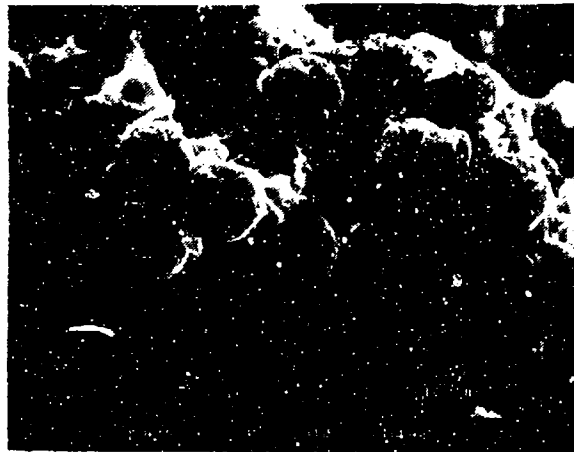
Figure 2-131. SEM Photographs of Translaminar Mode I Tension, 0/90 Fracture, -65, 180, 270 F/Dry (High Magnification)

Fracture type	Translaminar mode I tension
Ply layup	[0, 90]16S
Test type	Four-point bend
• Test conditions	Dry
• Fiber and fracture	
Material	Hercules 3501-6/177°C cure AS4 fibers

-65°F, dry

180°F, dry

Mechanically induced crack direction

270°F, dry

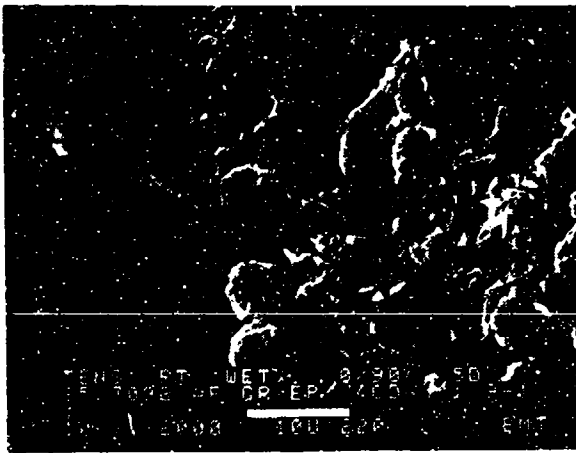
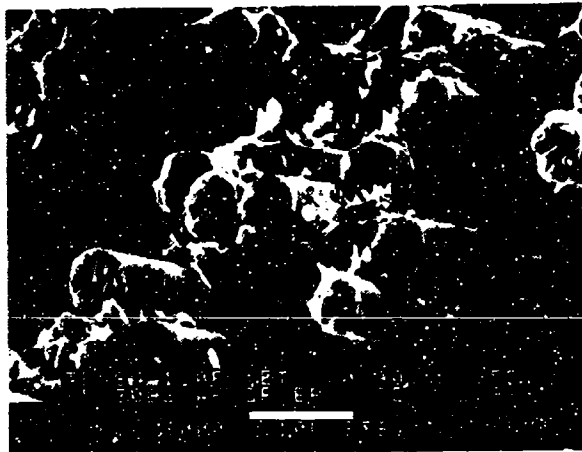
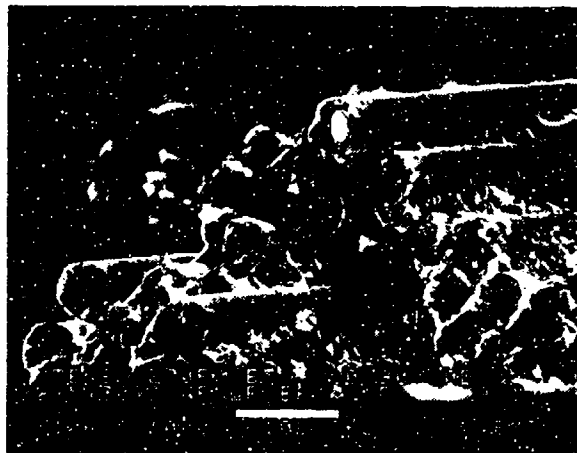
Figure 2-133. SEM Photographs of Translaminar Mode I Tension, 0/90 Fracture, 70, 180, 270 F/Wet (2000X)

Fracture type	Translaminar mode I tension
Ply layup	{0, 90} ₁₆ S
Test type	Four-point bend
• Test conditions	Wet
• Fiber end fracture	
Material	Hercules 3501-6/177°C cure AS4 fibers

70°F, wet

180°F, wet

← Mechanically induced crack direction

270°F, wet

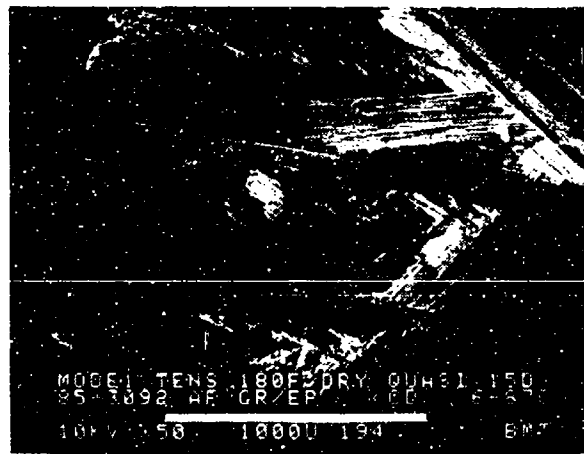
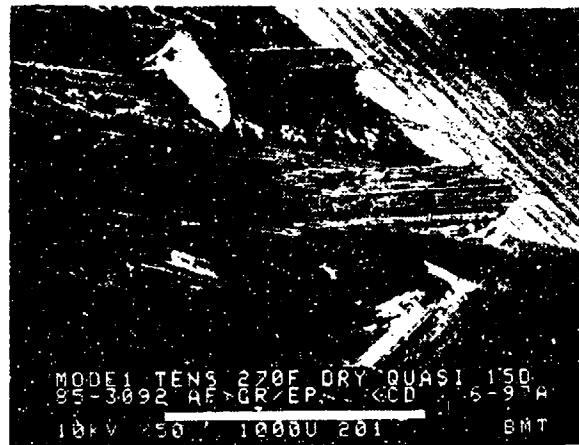
Figure 2-134. SEM Photographs of Translaminar Mode I Tension, 0/45/90 Fracture, -65, 180, 270 F/Dry (50X)

Fracture type	Translaminar mode I tension
Ply layup	[0, 45, 90] _{16S}
Test type	Four-point bend
• Test conditions	Dry
• Fiber end fracture	
Material	Hercules 3501-6/177°C cure AS4 fibers

-65°F, dry

180°F, dry

Mechanically induced crack direction

270°F, dry

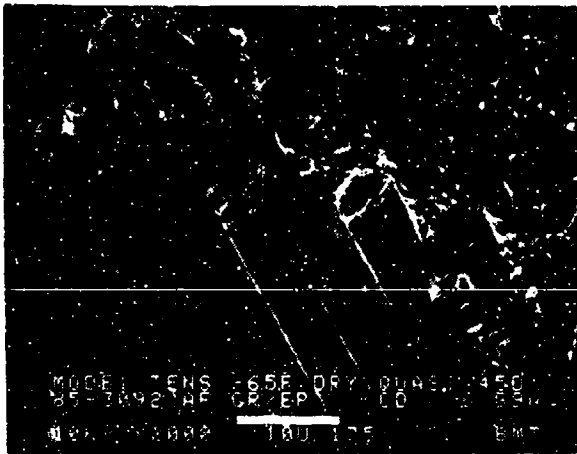
Figure 2-135. SEM Photographs of Translaminar Mode I Tension, 0/45/90 Fracture, -65, 180, 270 F/Dry (2000X)

Fracture type	Translaminar mode I tension
Ply layup	[0, 45, 90] _{16S}
Test type	Four-point bend
• Test conditions	Dry
• Fiber end fracture	
Material	Hercules 3501-6/177°C cure AS4 fibers

-65°F, dry

180°F, dry

Mechanically induced crack direction

270°F, dry

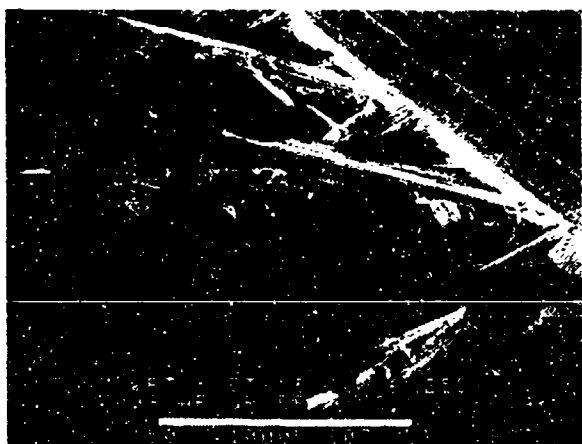
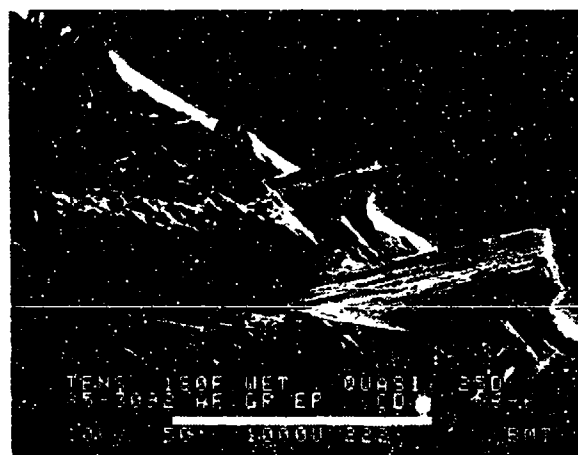
Figure 2-136. SEM Photographs of Translaminar Mode I Tension, 0/45/90 Fracture, 70, 180, 270 F/Wet (50X)

Fracture type	Translaminar mode I tension
Ply layup	[0, 45, 90] _{16S}
Test type	Four-point bend
• Test conditions	Wet
• Fiber end fracture	
Material	Hercules 3501-6/177°C cure AS4 fibers

70°F. wet

180°F. wet

← Mechanically Induced crack direction

270°F. wet
