WL-TR-91-4032
DOT/FAA/CT-91/23
VOL II, Part 2

COMPOSITE FAILURE ANALYSIS HANDBOOK
VOL II - TECHNICAL HANDBOOK
PART 2 - ATLAS OF FRACTOGRAPHS

February 1992

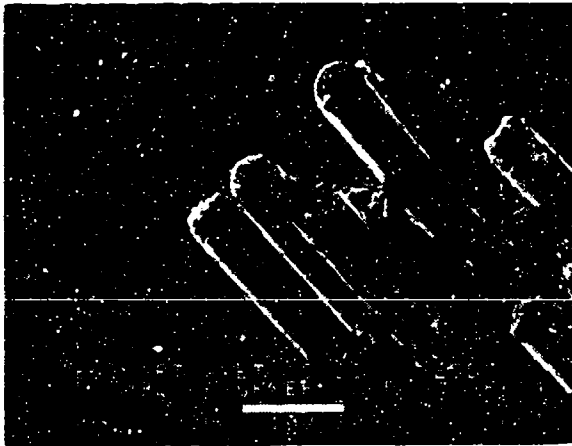
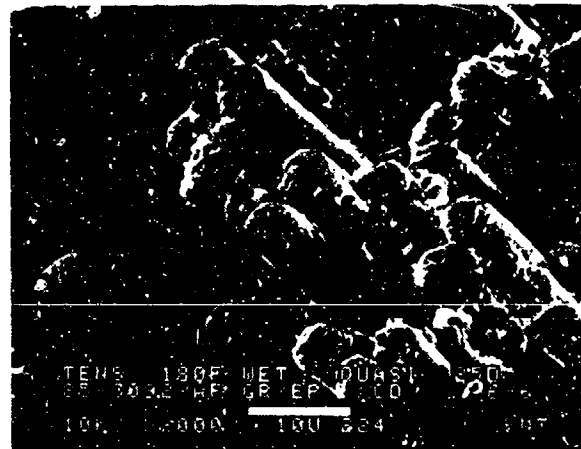
Figure 2-137. SEM Photographs of Translaminar Mode I Tension, 0/45/90 Fracture, 70, 180, 270 F/Wet (2000X)

Fracture type	Translaminar mode I tension
Fiber layup	[0, 45, 90] _{16S}
Test type	Four-point bend
• Test conditions	Wet
• Fiber end fracture	
Material	Hercules 3501-6/177°C cure AS4 fibers

Mechanically induced crack direction

70°F, wet

180°F, wet

270°F, wet

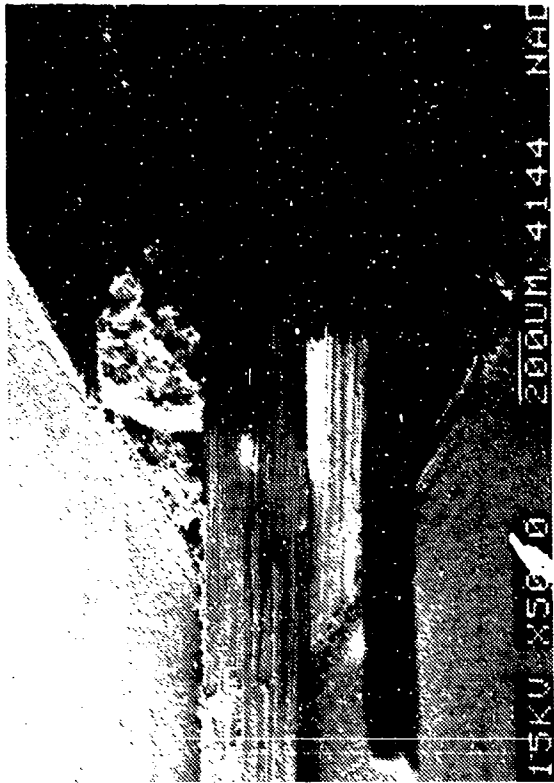
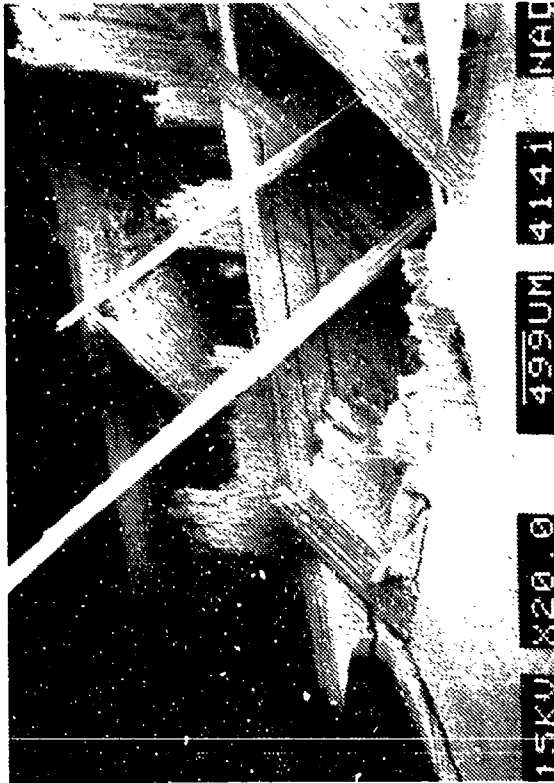
Figure 2-138. Optical and SEM Photographs of Translaminar Tension Fracture in Filament Wound Gr/Ep - 32 Ply/Quasi-Isotropic

(a) Macro photograph of Fractured Fragments
 (b), (c) Normal and Oblique Views of Fracture Near the Apex

CD = Crack-propagation direction

(b)

(c)

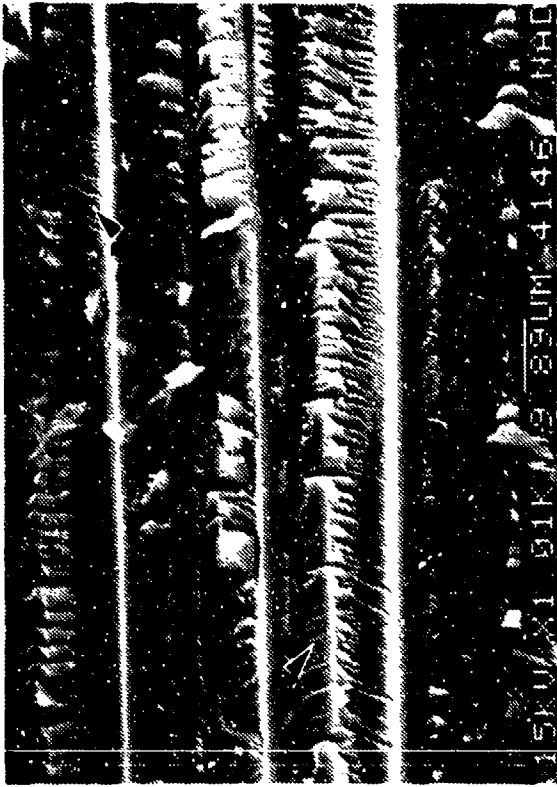
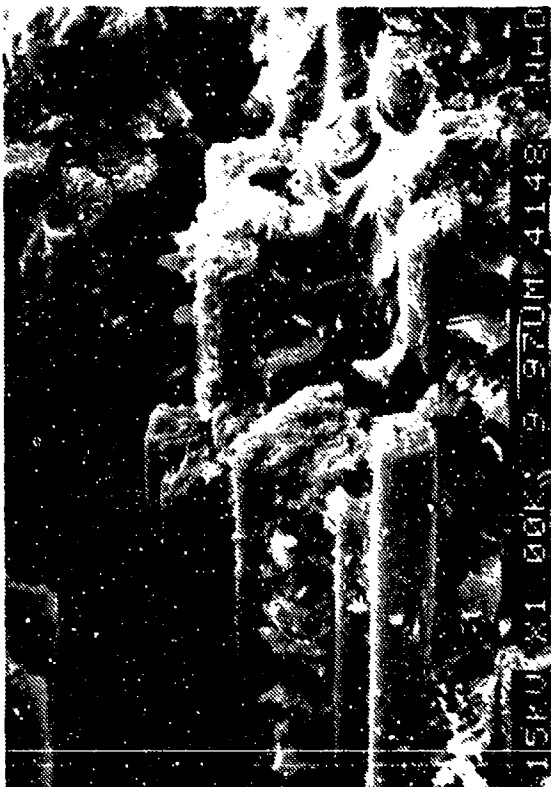
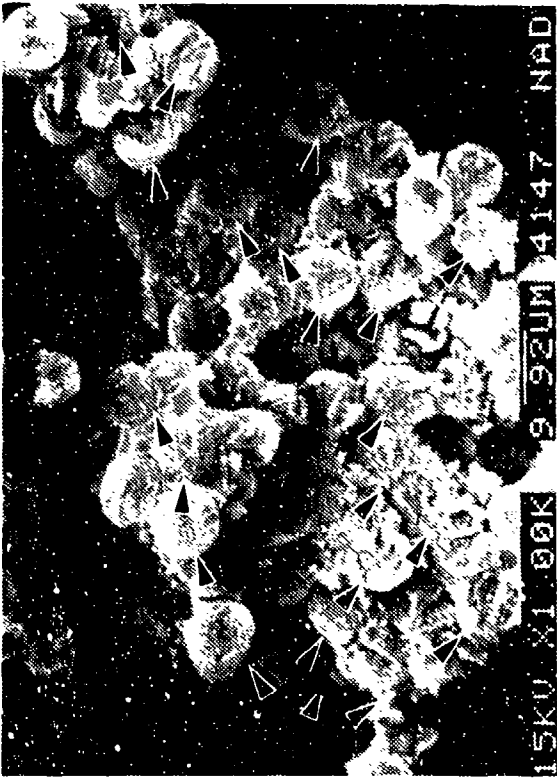
Figure 2-138. (Continued)
 (d) Arrows Point to DAF Radial Lines on Fractured Fiber-Ends and Indicate Local Fracture Path Parallel to Fracture
 (e), (f) Fracture Features Present in Ply Orientation
 Note hackles (H) and river patterns (R)
 CD = Crack-propagation direction

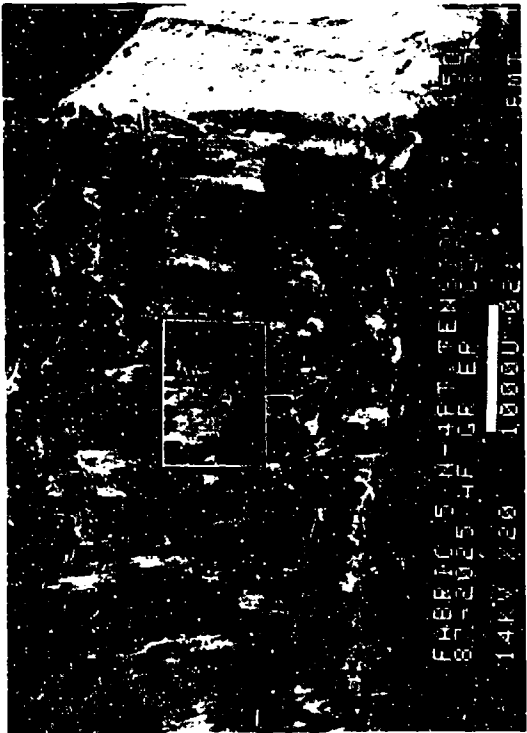
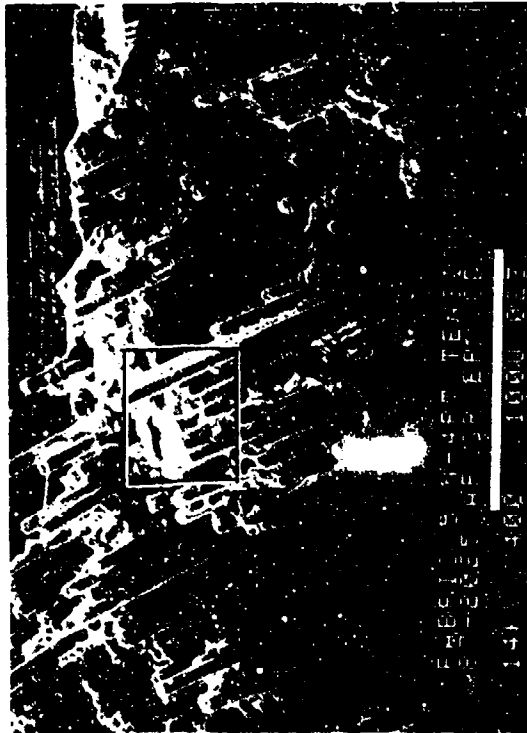
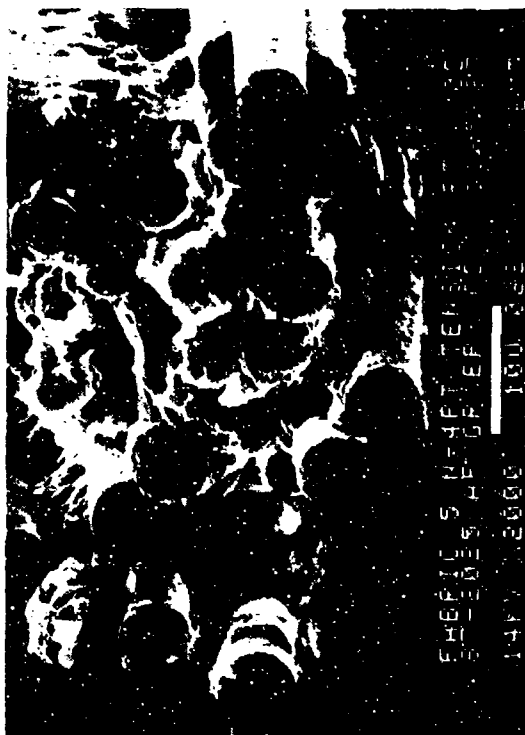
Figure 2-139. SEM Fractographs of Translamellar Tension, Room Temperature, 0/90 Fabric Fracture

45 degree tilt 20X (a)

45 degree tilt 400X (b)

45 degree tilt (c) Typical fracture along the fibers 2,000X

0 degree tilt (d) Illustration of crack mapping using the radial patterns on the fiber ends 2,000X

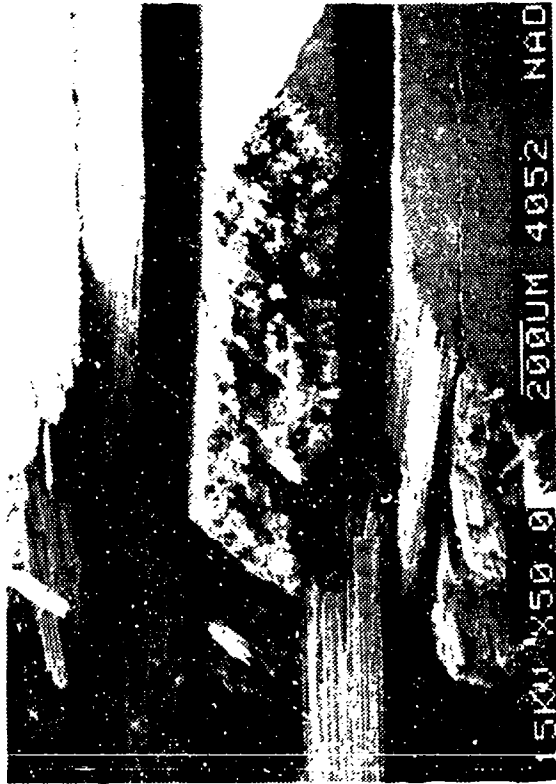
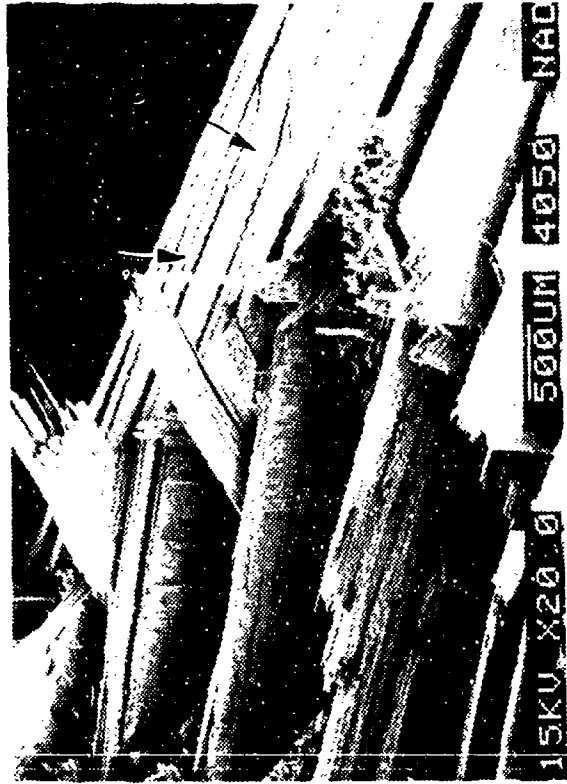
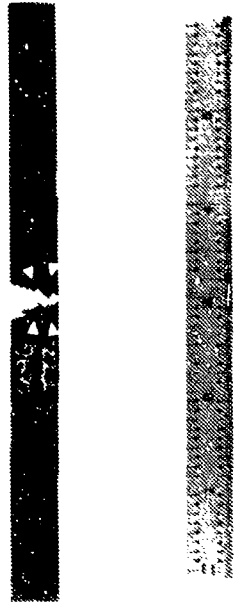
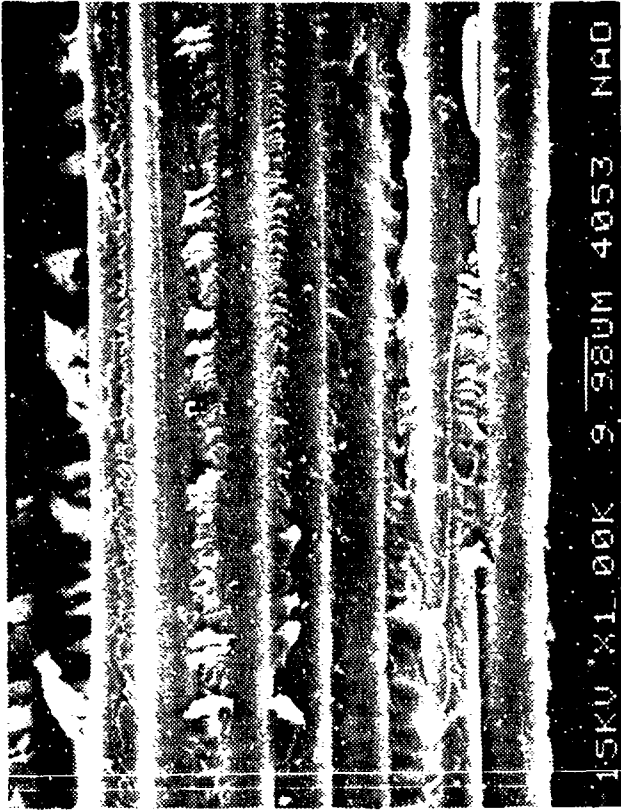
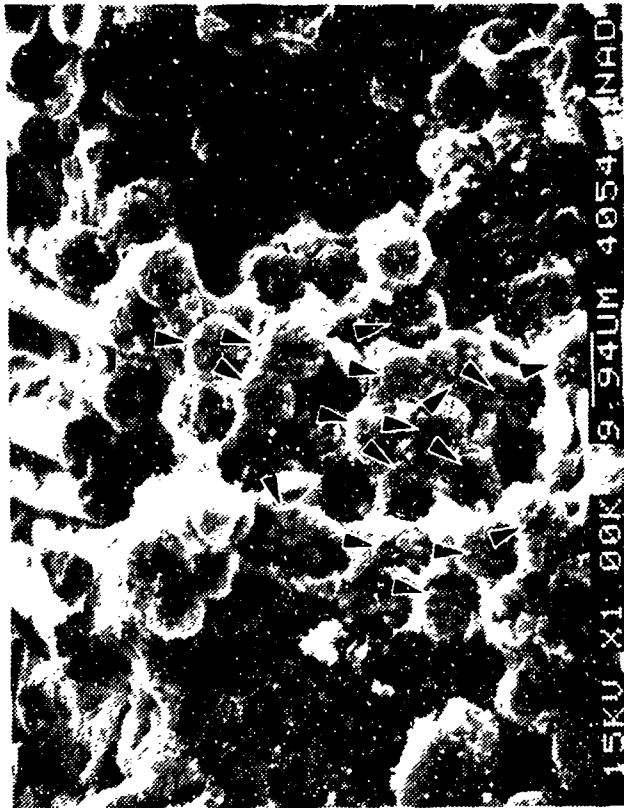
Figure 2-140. Optical and SEM Photographs of Translaminar Tension Fracture in Impact Damaged Gr/Ep -32 Ply/Quasi-Isotropic

- (a) Macro photograph of Fractured Fragments
- Arrows indicate damage zone
- (b), (c) Normal and Oblique Views of Fracture Near the Apex
- 1 = Impact point
- CD = Crack-propagation direction

Figure 2-140. (Continued)
 (d) Arrows Point to DAF Radial Lines on Fractured Fiber-Ends and Indicate Local Fracture Path
 (e) Fracture Features Present in Ply Oriented Parallel to Fracture
 H = Hackles
 R = River patterns
 CD = Crack-propagation direction

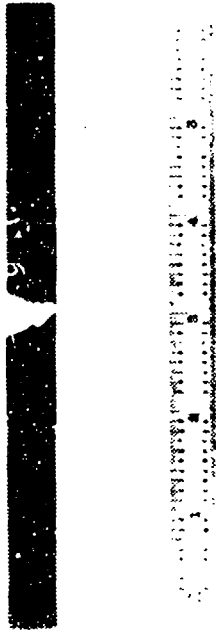
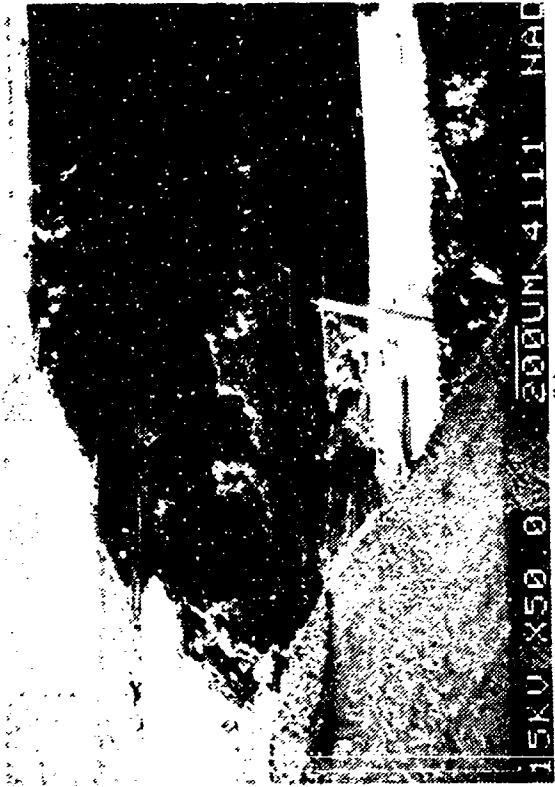
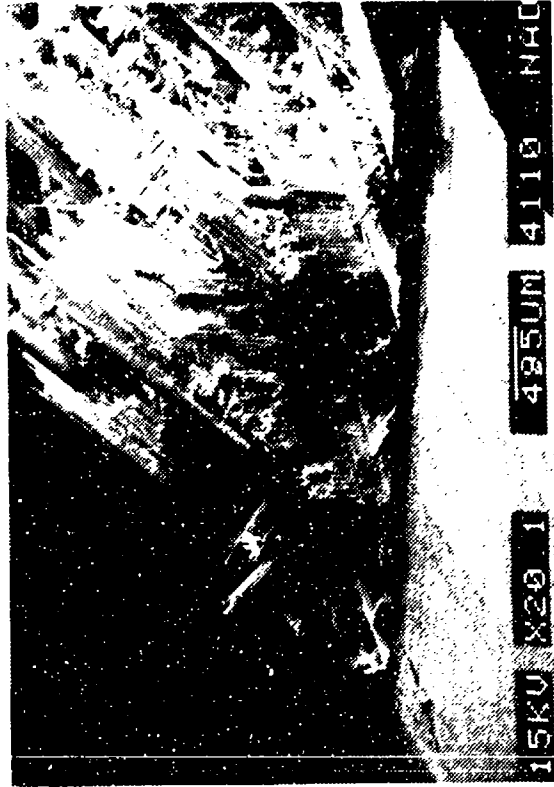
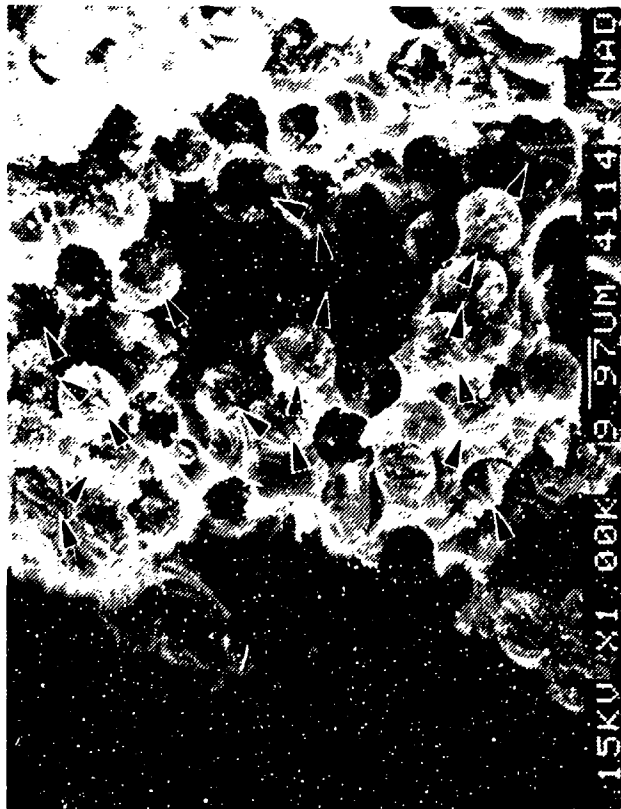
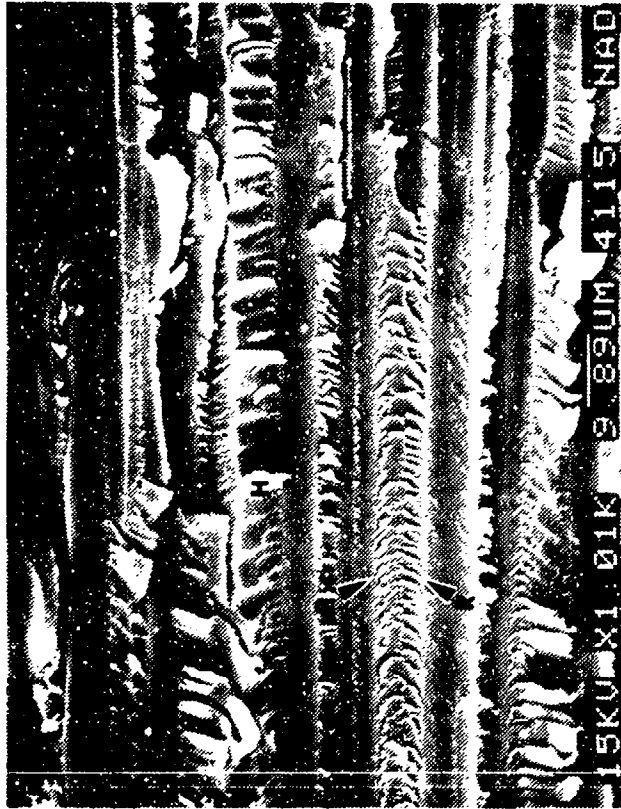
Figure 2-141. Optical and SEM Photographs of Translamellar Tension Fracture in Gr/Ep-32 Ply/Quasi-Isotropic, Water Immersed Before Test
 (a) Macro photograph of Fractured Fragments
 (b), (c) Normal and Oblique Views of Fracture Near the Apex

Figure 2-141. (Continued)
 (d) Arrows Point to DAF Radial Lines on Fractured Fiber-Ends and Indicate Fracture Path
 H = Hackles
 R = River patterns
 CD = Crack-propagation direction

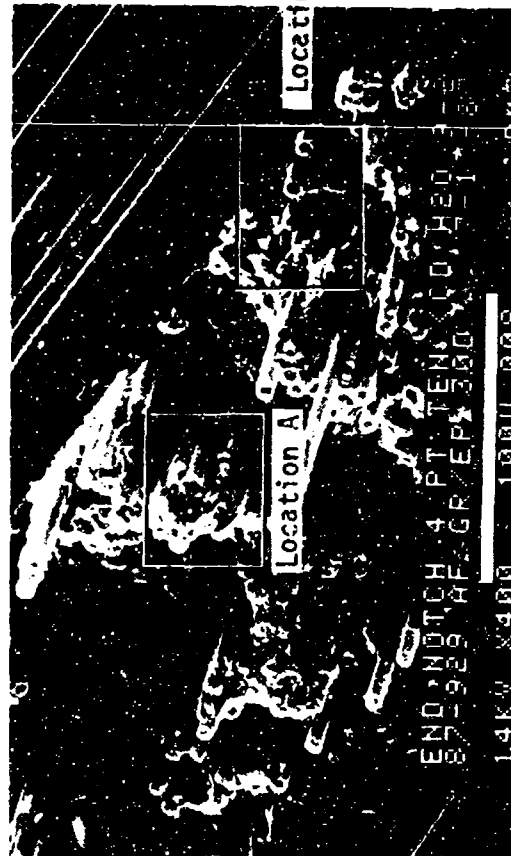
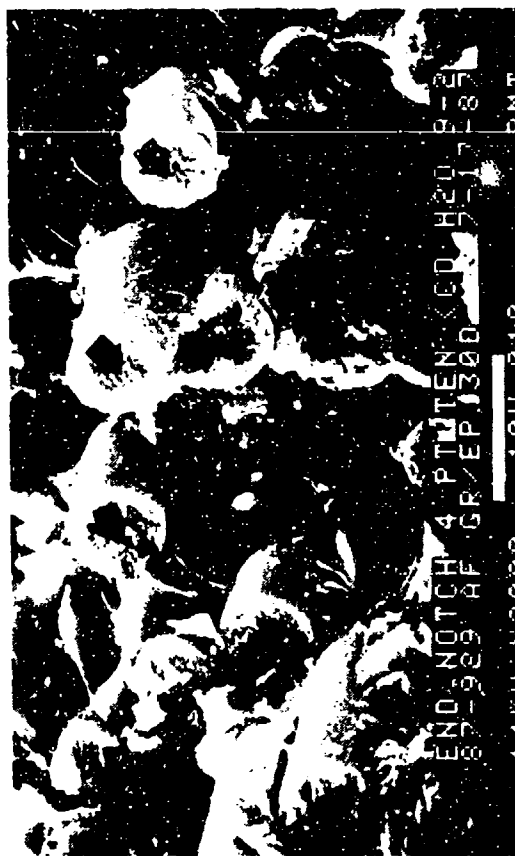
Figure 2-142. SEM Fractographs of Translaminar Tension, 0°/90 Fracture, Water Immersion (160 F) After Test

Note:
 Location a is magnified in (c)
 Location b is magnified in (d)

30 degree tilt (c) Typical fracture along the fibers 2,000X

30 degree tilt (d) Illustration of crack mapping using the radial patterns on the fiber ends 2,000X

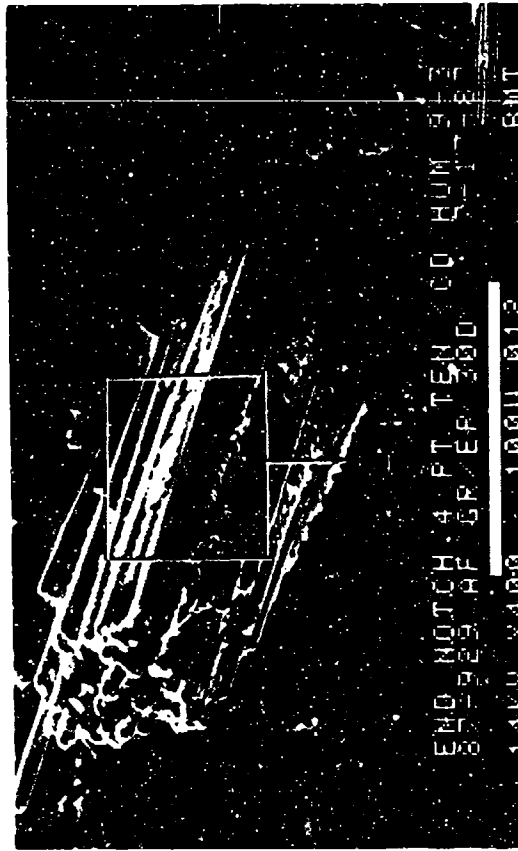
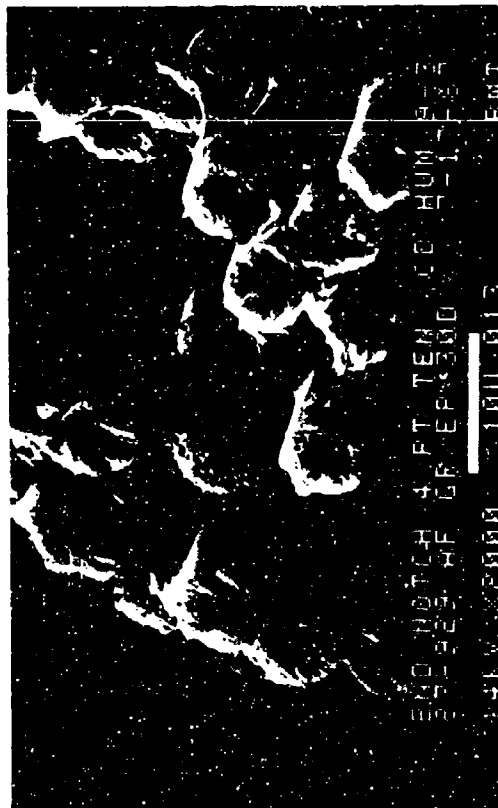
Figure 2-143. SEM Fractographs of Translaminar Tension, 0/90 Fracture, 100% Relative Humidity (160 F) Exposure After Test

30 degree tilt (c) 2,000X

30 degree tilt (d) 2,000X

Illustration of crack mapping using
the radial patterns on the fiber ends

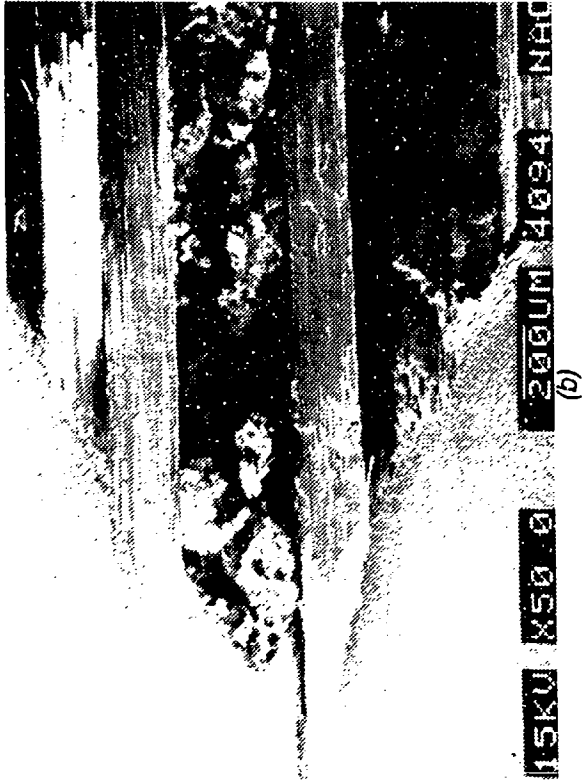
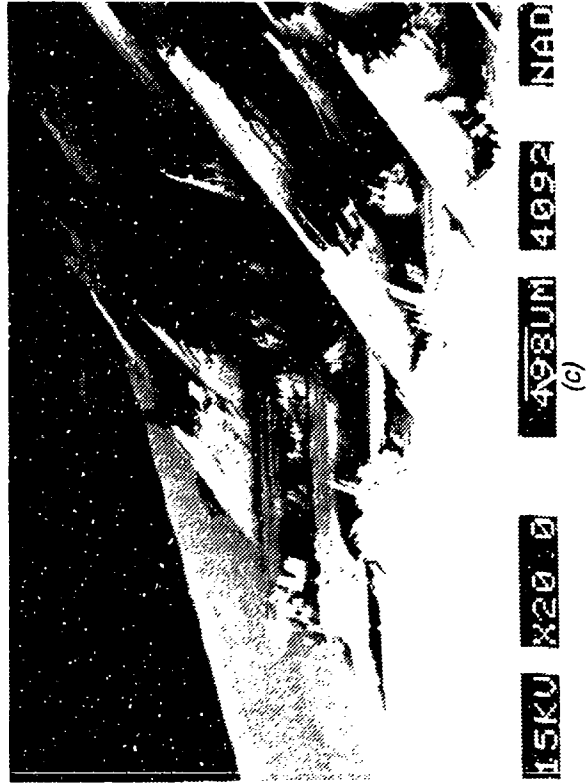
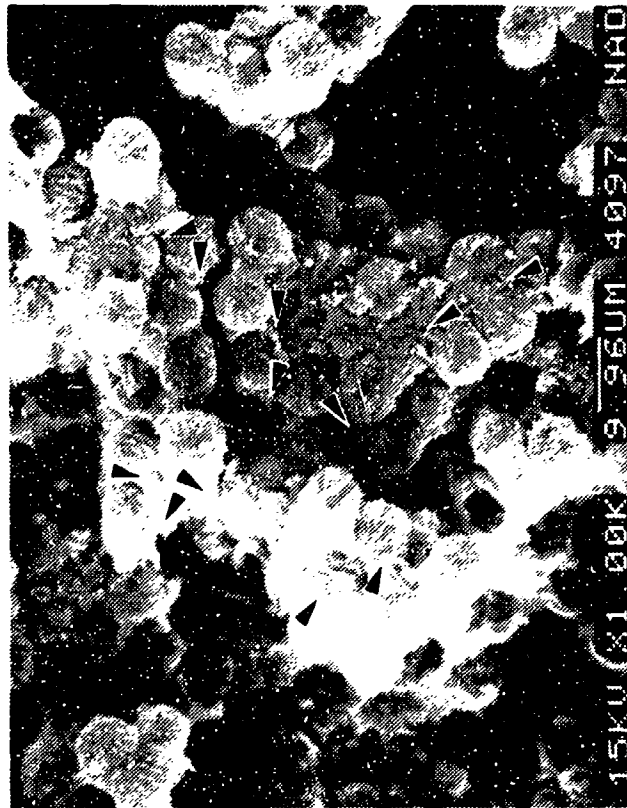
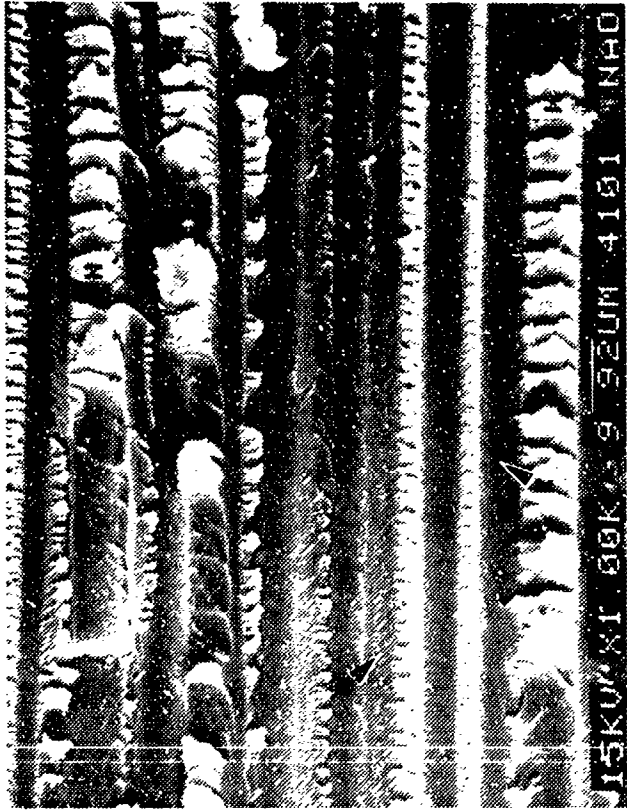
Figure 2-144. Optical and SEM Photographs of Translaminar Tension Fracture in Undercured Gr/Ep -32 Ply/Quasi-Isotropic
 (a) Macro photograph of fractured fragments
 (b), (c) Normal and Oblique Views of Fracture Near the Apex

Figure 2-144. (Continued)
 (d) Arrows Point to DAF Radial Lines on Fractured Fiber-Ends and Indicate Fracture Path
 (e) Fracture Features Present in Ply Oriented Parallel to Fracture

H = Hackles
 R = River patterns
 S = Scallops

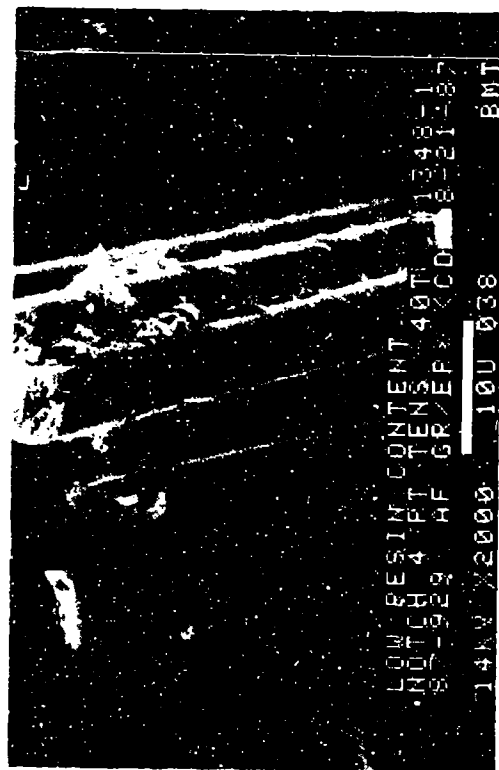
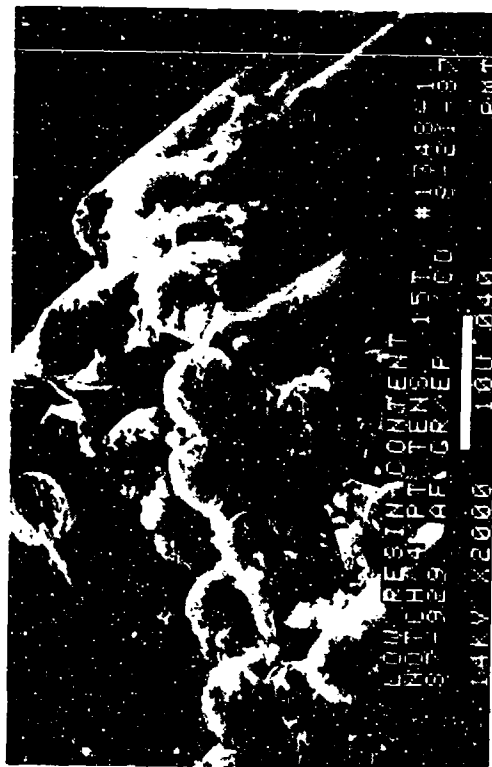
Figure 2-145. SEM Fractographs of Translaminar Tension, 0/90 Fracture, Low Resin Content

40 degree tilt (c) Typical fracture along the fibers 2,000X

15 degree tilt (d) Illustration of crack mapping using the radial patterns on the fiber ends 2,000X

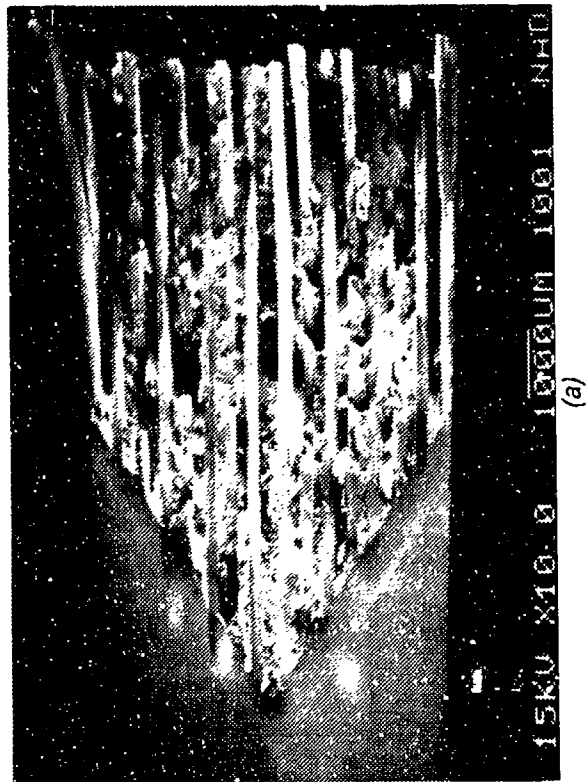
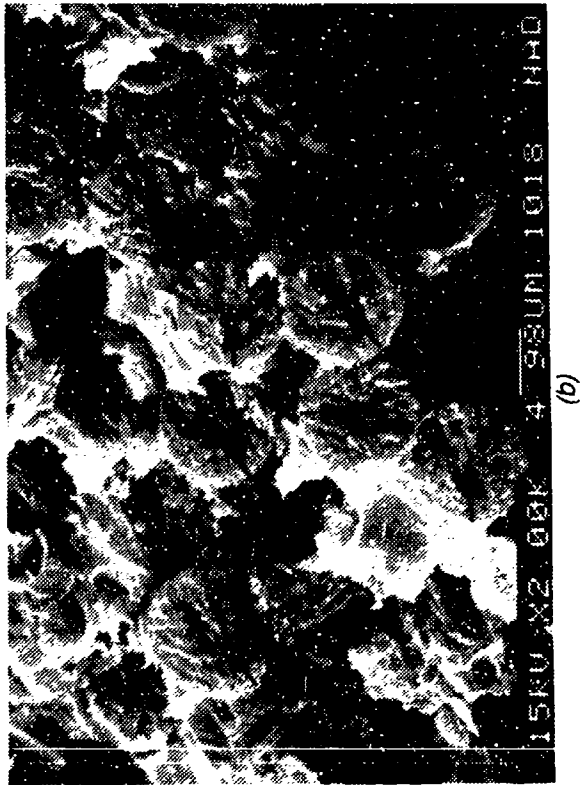
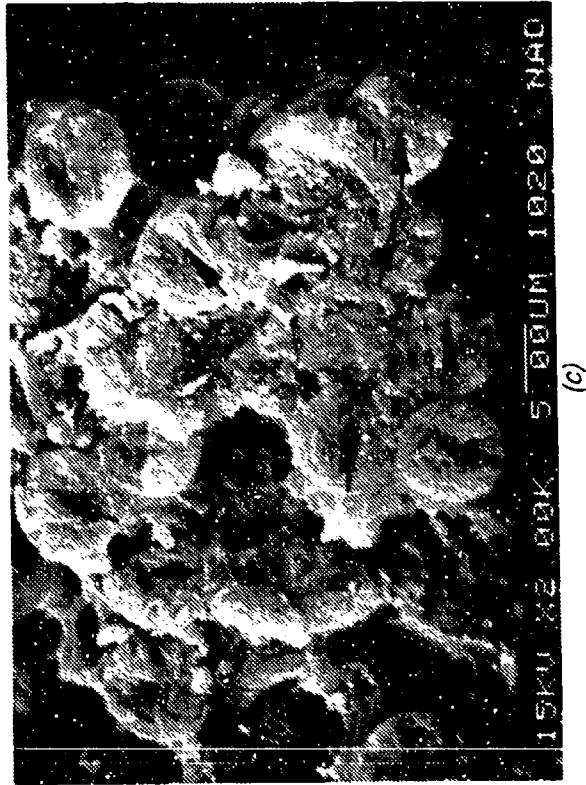
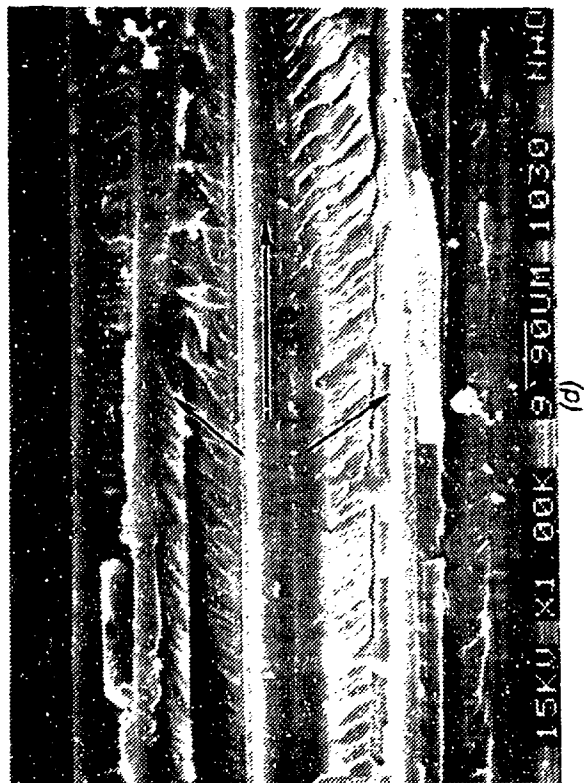
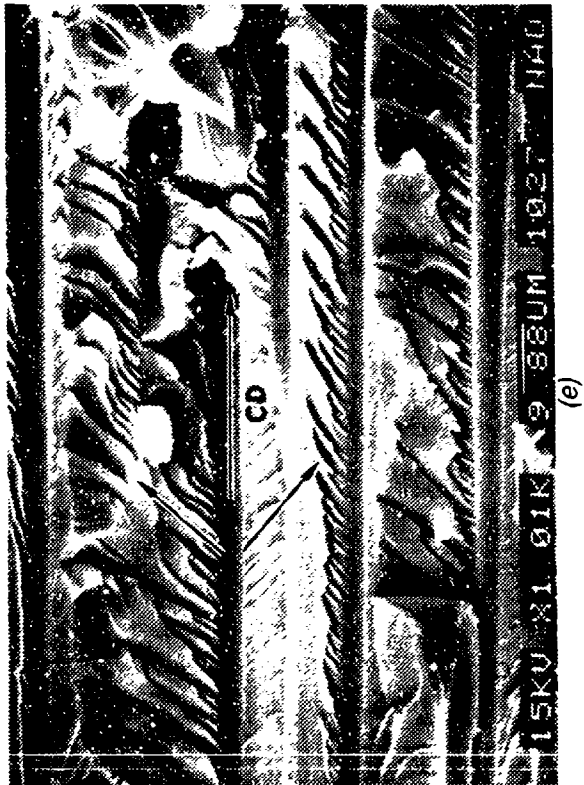
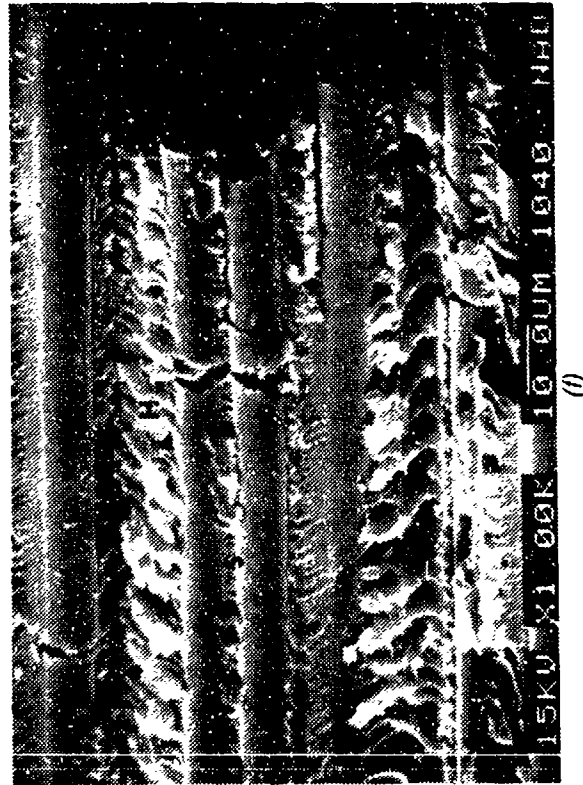
Figure 2-146. SEM Photographs of Translaminar Tension Fracture in High Resin Content Gr/Ep - 32 Ply Quasi-Isotropic (a), (b) River Patterns (Arrows) in Fractured Epoxy Region of a 90 Degree Ply (c) Hackles (H), Scallops (S), and Broken Fibers in a 45 Degree Ply

Figure 2-146. (Continued)
 (d), (e) River Patterns (Arrows) Present in the
 Fractured Epoxy Regions of a 90 Degree Ply
 (f) Hackles (H), Scallops (S), and Broken Fibers in a
 45 Degree Ply

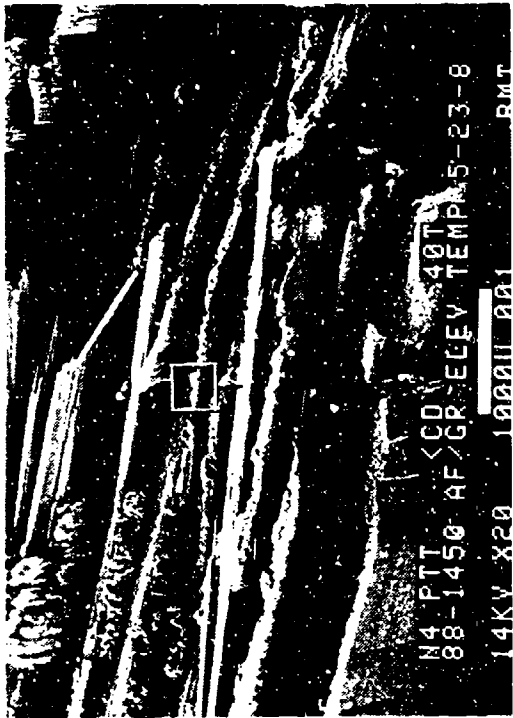
Figure 2-147. SEM Fractiographs of Translaminar Tension, 0/90 Fracture, 2000 F Exposure for 5 Minutes After Test

40 degree tilt (a) 20X

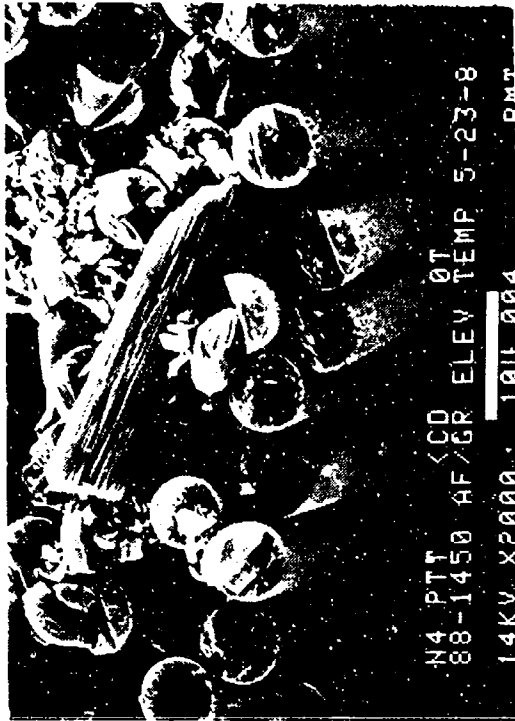
40 degree tilt (b) 400X

0 degree tilt (c) 2,000X

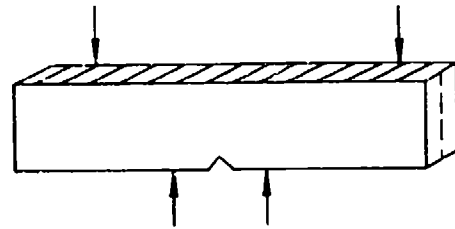
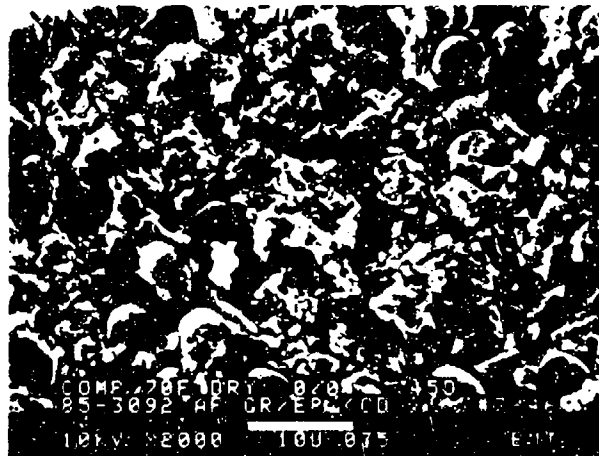
Figure 2-150. SEM Photographs of Translaminar Mode I Compression, 0/0 Fracture, 70 F/Dry

Fracture type	Translaminar mode I compression
Ply layup	[0] 32
Test type	Four-point bend
• Test conditions	21°C, dry
• Fiber end fracture	
Material	Hercules 3501-6/177°C cure AS4 fibers

←
Mechanically induced crack direction

The test matrix for this section is provided in Table 2-6. Figures 2-150 through 2-173 are the translaminar compression fractographs. The reader should note that the low-magnification SEM photomicrographs reveal both compression fracture (flat) and tension fracture (fibers protruding). This is because the flexural nature of the test specimen, where cracking is initiated at the notch in compression. The high magnification photographs are from the compression fracture region. The fractography figures are arranged in the same order that the corresponding tests are listed in Table 2-6.

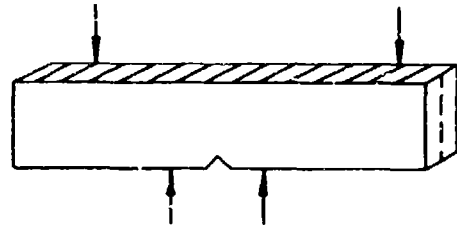
Figure 2-151. SEM Photographs of Translaminar Mode I Compression, 0/0 Fracture.
-65, 180, 270 F/Dry (20X)

Fracture type	Translaminar mode I compression
Ply layup	[0] 32
Test type	Four-point bend
• Test conditions	Dry
• Fiber end fracture	
Material	Hercules 3501-6/177°C cure ASA fibers

-65°F, dry

180°F, dry

270°F, dry

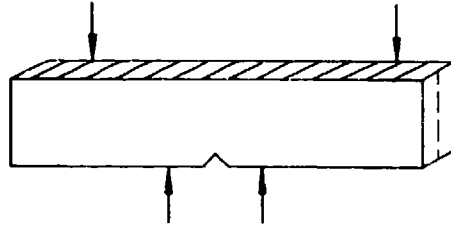
Figure 2-152. SEM Photographs of Translaminar Mode I Compression, 0/0 Fracture, -65, 180, 270 F/Dry (400X)

Fracture type	Translaminar mode I compression
Ply layup	[0] 32
Test type	Four-point bend
● Test conditions	Dry
● Fiber end fracture	
Material	Hercules 3501-6/177°C cure AS4 fibers

-65°F, dry

180°F, dry

270°F, dry

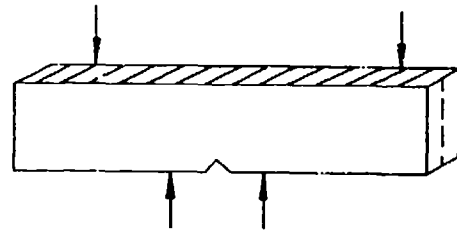
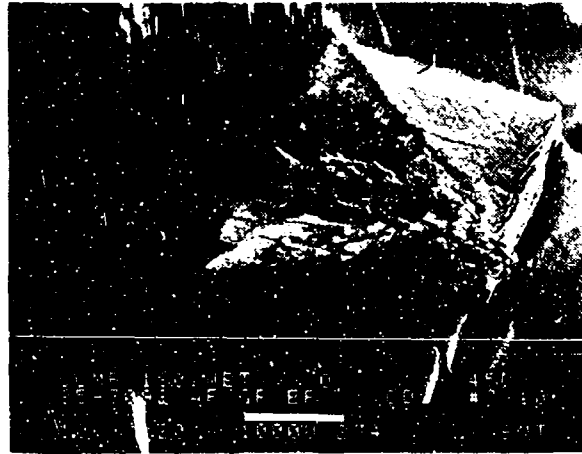
Figure 2-153. SEM Photographs of Translaminar Mode I Compression, 0/0 Fracture, 70, 180, 270 F/Wet (20X)

Fracture type	Translaminar mode I compression
Ply layup	[0] 32
Test type	Four-point bend
• Test conditions	Wet
• Fiber end fracture	
Material	Hercules 3501-6/177°C cure AS4 fibers

70°F, wet

180°F, wet

270°F, wet

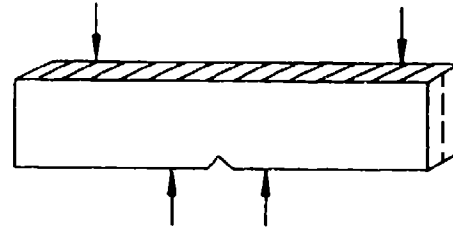
Figure 2-154. SEM Photographs of Translaminar Mode I Compression, 0/0 Fracture, 70, 180, 270 F/Wet (400X)

Fracture type	Translaminar mode I compression
Ply layup	[0] ₃₂
Test type	Four-point bend
• Test conditions	Dry
• Fiber end fracture	
Material	Hercules 3501-6/177°C cure AS4 fibers

70°F, wet

180°F, wet

270°F, wet

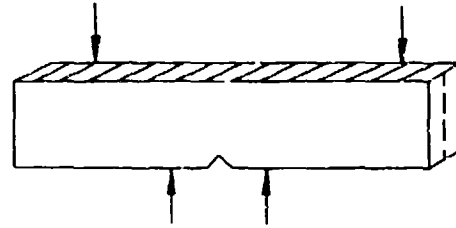
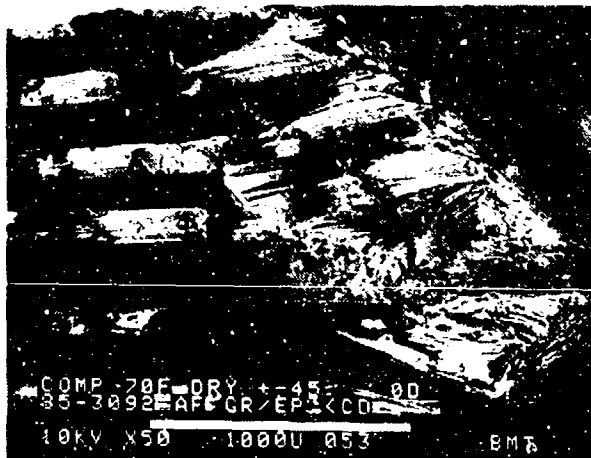
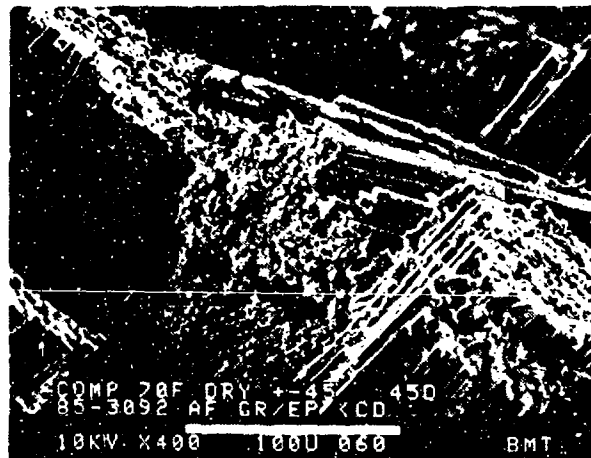
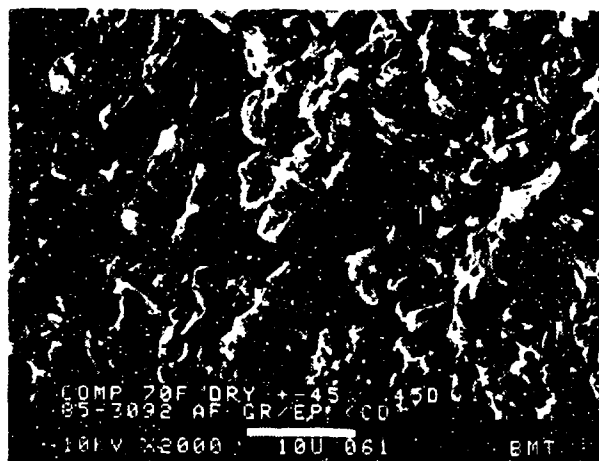
Figure 2-155. SEM Photographs of Translaminar Mode I Compression, +45/-45 Fracture, 70 F/Dry

Fracture type	Translaminar mode I compression
Ply layup	[+45, -45] 16S
Test type	Four-point bend
• Test conditions	21°C, dry
• Fiber end fracture	
Material	Hercules 3501-6/177°C cure AS4 fibers

Mechanically induced crack direction

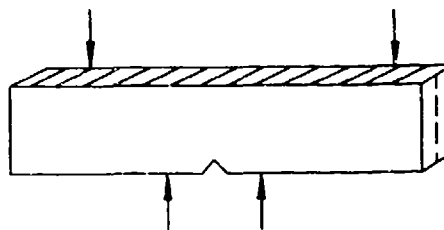
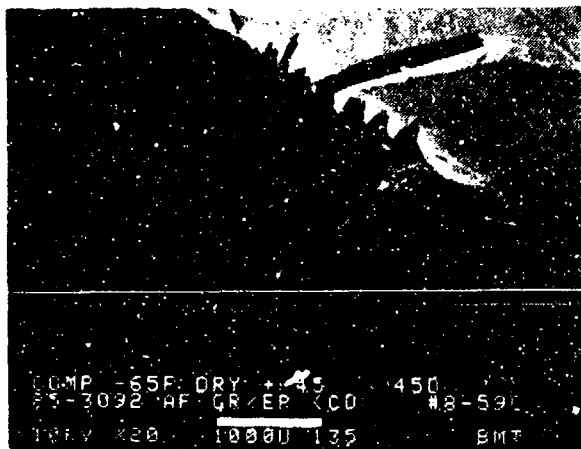
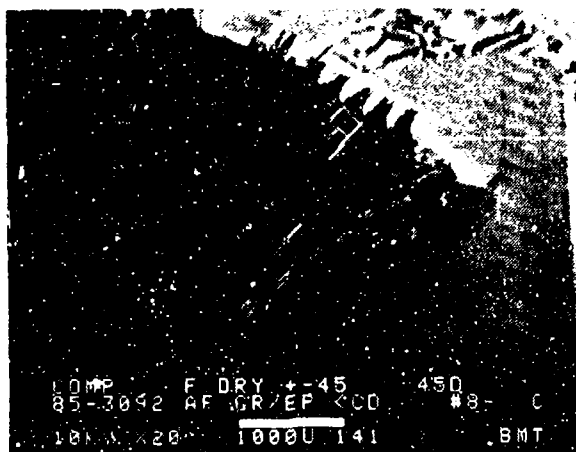
Figure 2-156. SEM Photographs of Translaminar Mode I Compression, +45/-45 Fracture, -65, 180, 270 F/Dry (20X)

Fracture type	Translaminar mode I compression
Ply layup	[+45, -45] 16S
Test type	Four-point bend
• Test conditions	Dry
• Fiber end fracture	
Material	Hercules 3501-6/177°C cure AS4 fibers

-65°F, dry

180°F, dry

270°F, dry

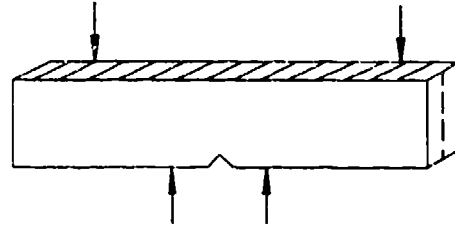
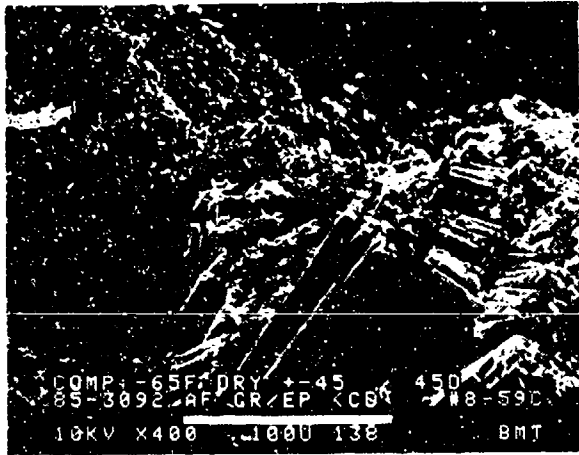
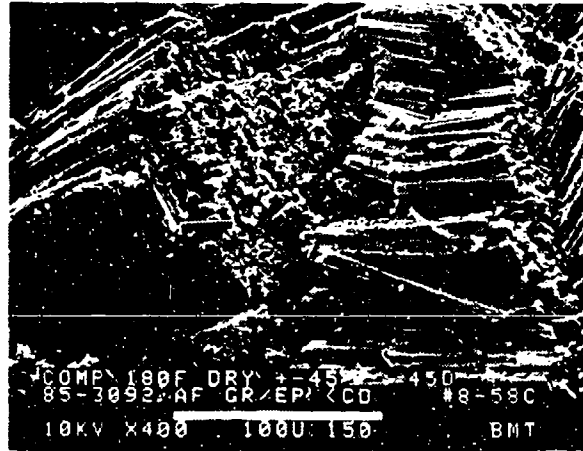
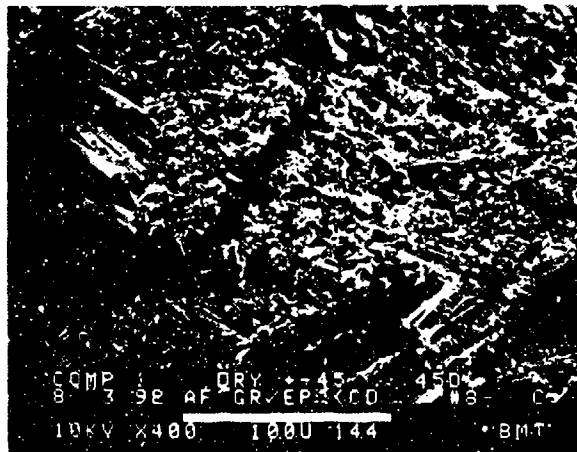
Figure 2-157. SEM Photographs of Translaminar Mode I Compression, +45/-45 Fracture, -65, 180, 270 F/Dry (400X)

Fracture type	Translaminar mode I compression
Ply layup	[+45, -45] 16S
Test type	Four-point bend
• Test conditions	Dry
• Fiber end fracture	
Material	Hercules 350i; -6/177°C cure AS4 fibers

-65°F, dry

180°F, dry

270°F, dry

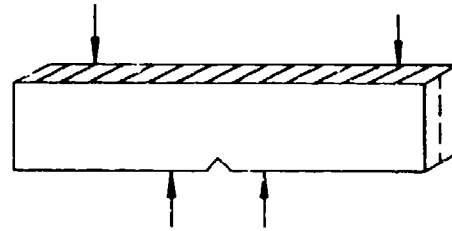
Figure 2-158. SEM Photographs of Translaminar Mode I Compression, +45/-45 Fracture, 70, 180, 270 F/Wet (20X)

Fracture type	Translaminar mode I compression
Ply layup	[+45, -45] 16S
Test type	Four-point bend
• Test conditions	Wet
• Fiber end fracture	
Material	Hercules 3501-6/177°C cure AS4 fibers

-65°F, wet

180°F, wet

270°F, wet

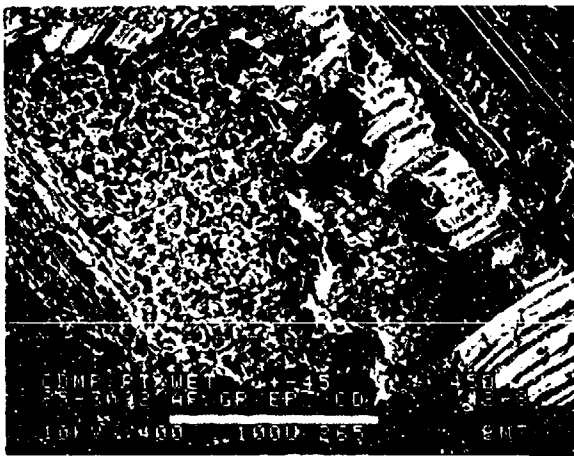
Fracture type	Translaminar mode I compression
Ply layup	[+45, -45] 16S
Test type	Four-point bend
• Test conditions	Dry
• Fiber end fracture	
Material	Hercules 3501-6/177°C cure AS4 fibers

70°F, wet

180°F, wet

270°F, wet

Figure 2-159. SEM Photographs of Translaminar Mode I Compression, +45/-45 Fracture, 70, 180, 270 F/Wet (400X)

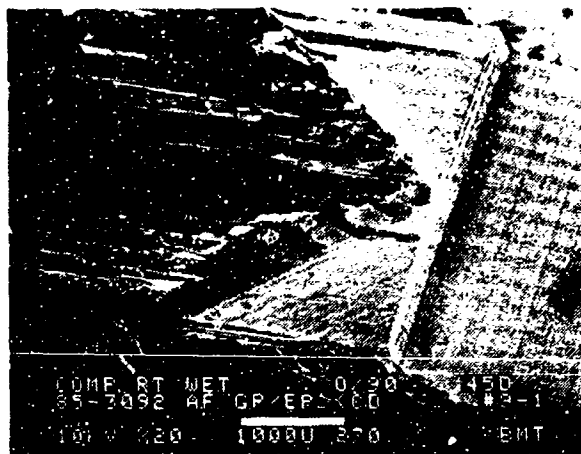
Fracture type	Translaminar mode I compression
Ply layup	{0, 90}16S
Test type	Four-point bend
• Test conditions	Wet
• Fiber end fracture	
Material	Hercules 3501-6/177°C cure AS4 fibers

70°F, wet

180°F, wet

270°F, wet

Figure 2-163. SEM Photographs of Translaminar Mode I Compression, 0/90 Fracture, 70, 180, 270 F/Wet (20X)

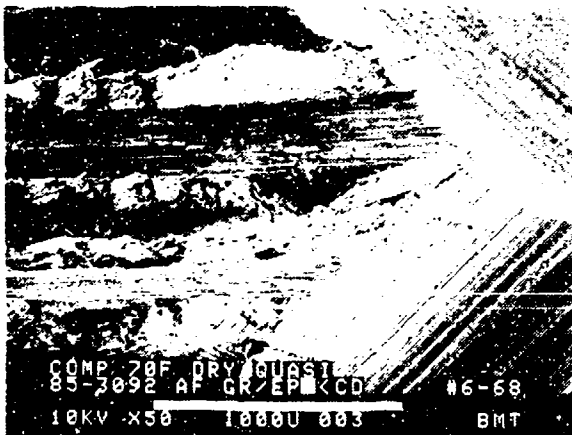
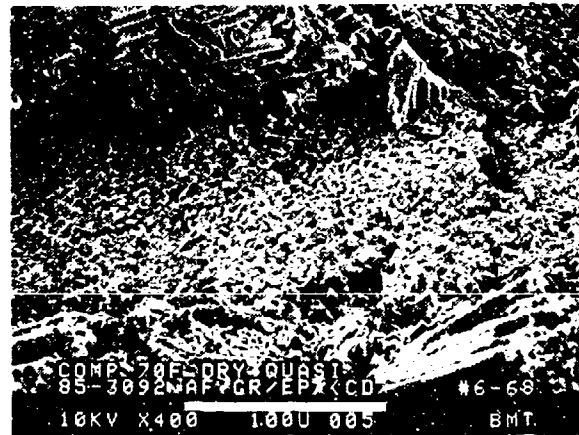
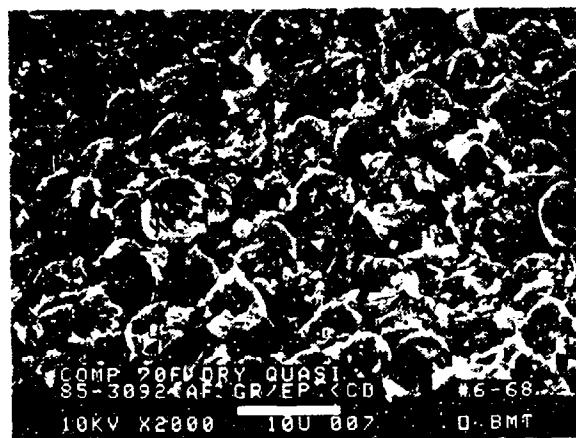
Fracture type	Translaminar mode I compression
Ply layup	[0, 45, 90] 16S
Test type	Four-point bend
● Test conditions	21°C, dry
● Fiber end fracture	
Material	Hercules 3501-6/177°C cure AS4 fibers

Figure 2-165. SEM Photographs of Translaminar Mode I Compression, 0/45/90 Fracture, 70 F/Dry
