WL-TR-91-4032
DOT/FAA/CT-91/23
VOL II, Part 2

COMPOSITE FAILURE ANALYSIS HANDBOOK
VOL II - TECHNICAL HANDBOOK
PART 2 - ATLAS OF FRACTOGRAPHS

February 1992

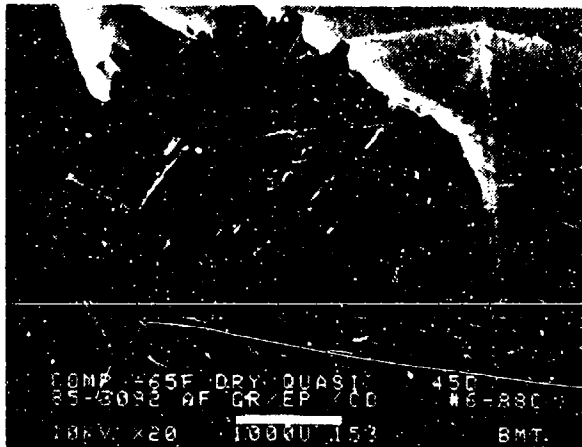
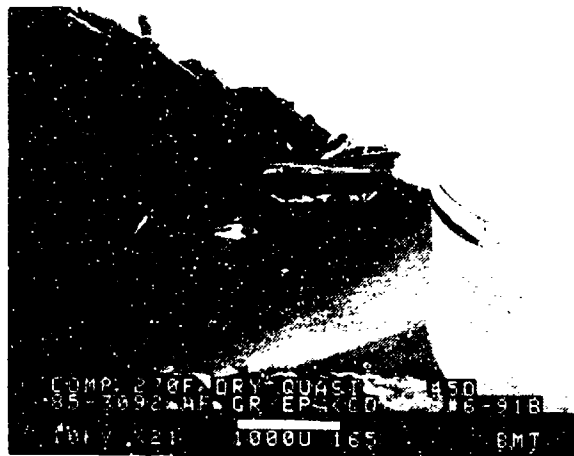
Fracture type	Translaminar mode I compression
Ply layup	[0, 45, 90] _{16S}
Test type	Four-point bend
● Test conditions	Dry
● Fiber end fracture	
Material	Hercules 3501-6/177°C cure AS4 fibers

-65°F, dry

180°F, dry

270°F, dry

Figure 2-166. SEM Photographs of Translaminar Mode I Compression, 0/45/90 Fracture, -65, 180, 270 F/Dry (20X)

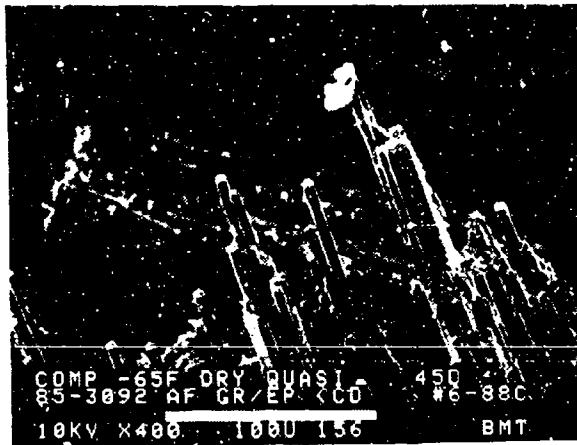
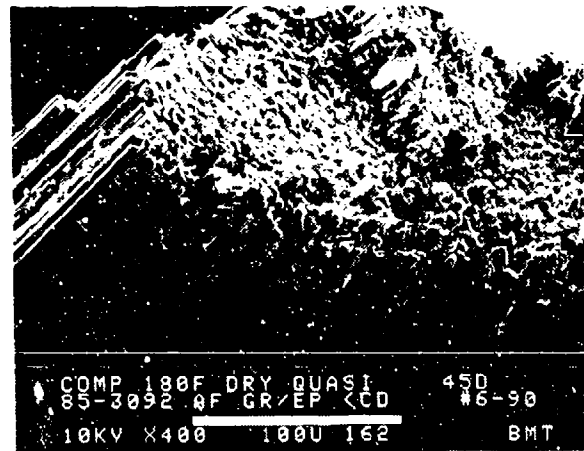
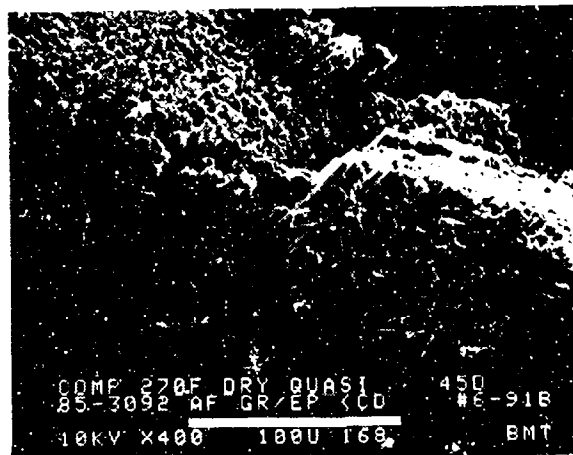
Fracture type	Translaminar mode I compression
Ply layup	[0, 45, 90] _{16S}
Test type	Four-point bend
• Test conditions	Dry
• Fiber end fracture	
Material	Hercules 3501-6/177°C cure AS4 fibers

-65°F, dry

180°F, dry

270°F, dry

Figure 2-167. SEM Photographs of Translaminar Mode I Compression, 0/45/90 Fracture, -65, 180, 270 F/Dry (400X)

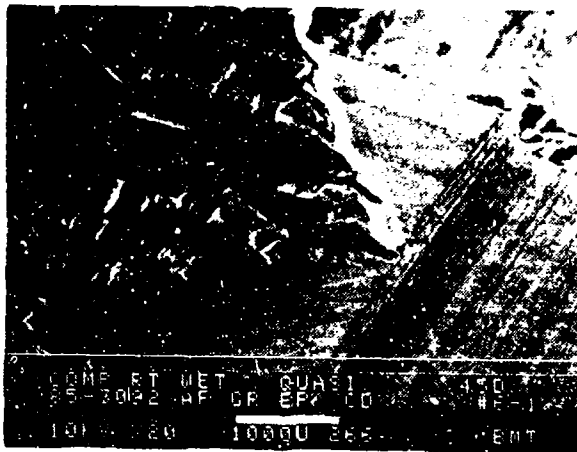
Fracture type	Translaminar mode I compression
Ply layup	[0, 45, 90] _{16S}
Test type	Four-point bend
• Test conditions	Wet
• Fiber end fracture	
Material	Hercules 3501-6/177°C cure AS4 fibers

70°F, wet

180°F, wet

270°F, wet

Figure 2-168. SEM Photographs of Translaminar Mode I Compression, 0/45/90 Fracture, 70, 180, 270 F/Wet (20X)

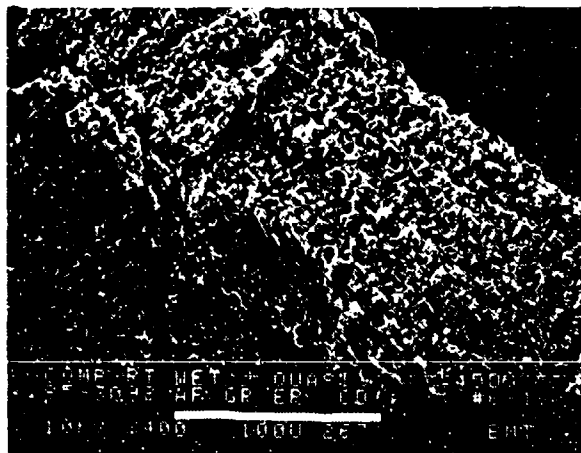
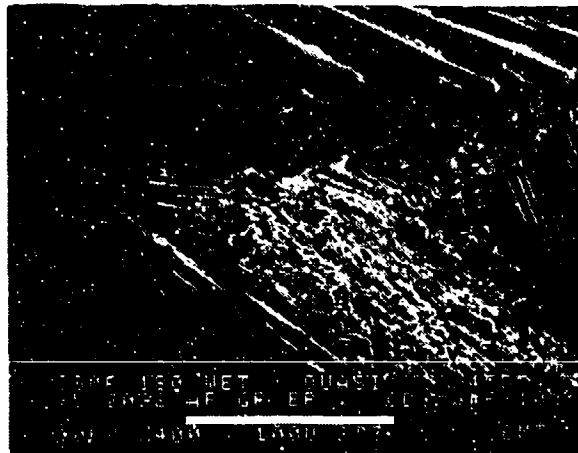
Fracture type	Translaminar mode I compression
Ply layup	[0, 45, 90] 16S
Test type	Four-point bend
• Test conditions	Wet
• Fiber end fracture	
Material	Hercules 3501-6/177°C cure AS4 fibers

Figure 2-169. SEM Photographs of Translaminar Mode I Compression, 0/45/90 Fracture, 70, 180, 270 F/Wet (400X)

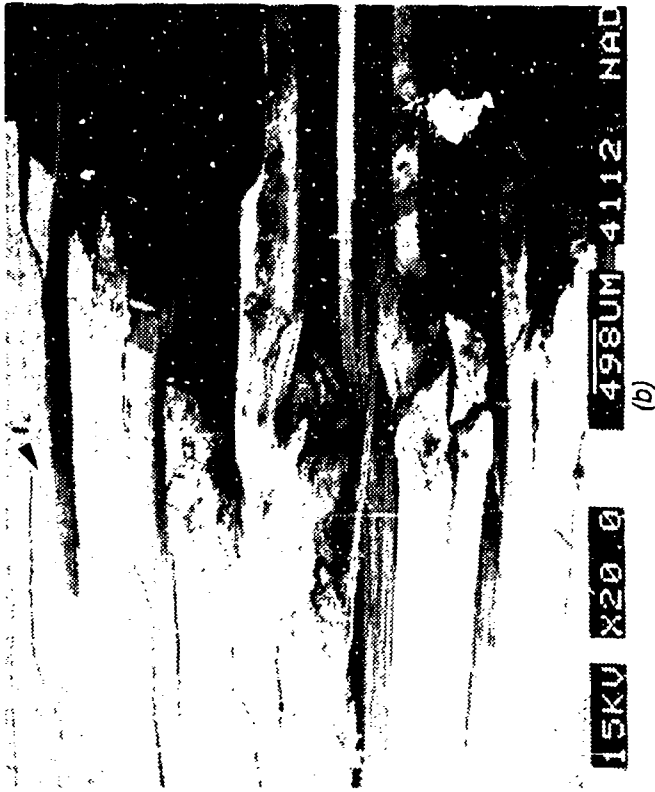
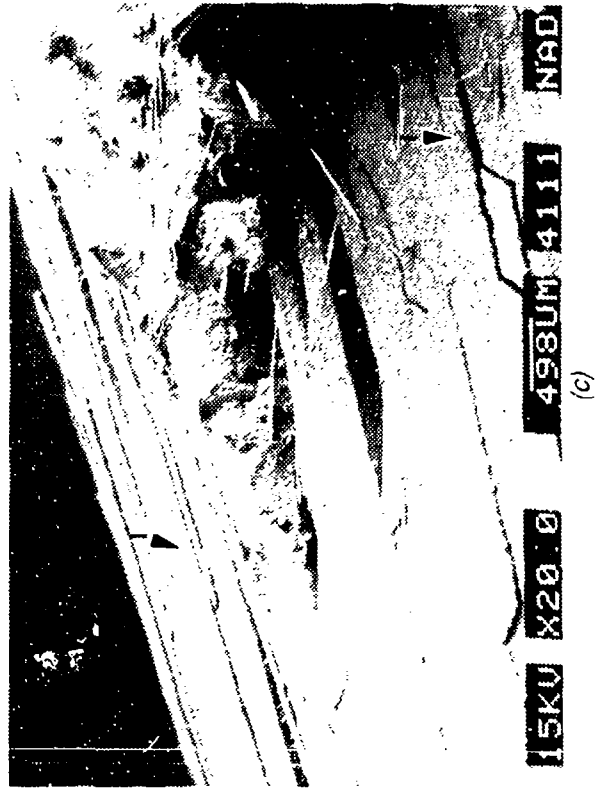
Figure 2-170. Optical and SEM Photographs of Translaminar Mode I Compression Fracture in Impact Damaged Gr/Ep - 32 Ply Quasi-Isotropic

(a) Macro photograph of fractured fragments
 Note damage zone shown by arrows
 (b), (c) Normal and Oblique Views of Fracture Near the Apex
 I = impact damage

Visual inspection revealed extensive buckling damage around the point of impact. Failure of the panel occurred in a band approximately 1.0 to 1.5 inches wide across the full width of the panel (Figure 2-217). TTU indicated a delamination which was exposed for further examination to determine the mode of failure in the vicinity of the impacted area. An examination was conducted under the optical microscope. In the region immediately surrounding the impact site (0.3 inch in diameter), the features were predominantly hackle formations indicating Mode II shear failure. The outer perimeter of the impact site was predominantly covered with rivermarks and resin microflow indicating Mode I tension failure (Figure 2-218). The crack initiated at the impact site and propagated radially through the specimen from the tool side in both interlaminar and translaminar fracture modes (Figure 2-219). Figure 2-220 shows CAI fractography performed by Boeing on a [0/45/90]_{8s} laminate. Additional CAI test fractography of a [0/45/90]_{8s} Gr/Ep laminate is shown in Figure 2-170.

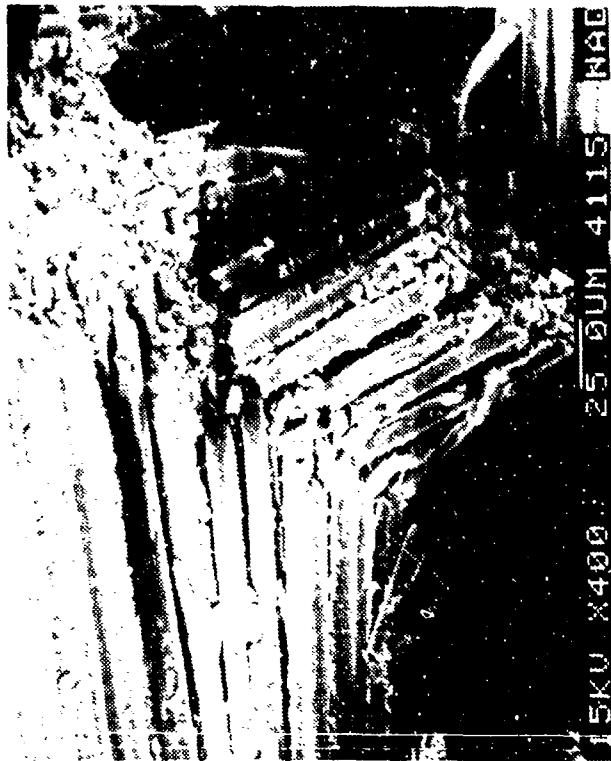
Figure 2-170. (Continued)
(d) Microbuckling Features (Chop Marks) on Fractured Fiber Ends
(e) Broken Fibers

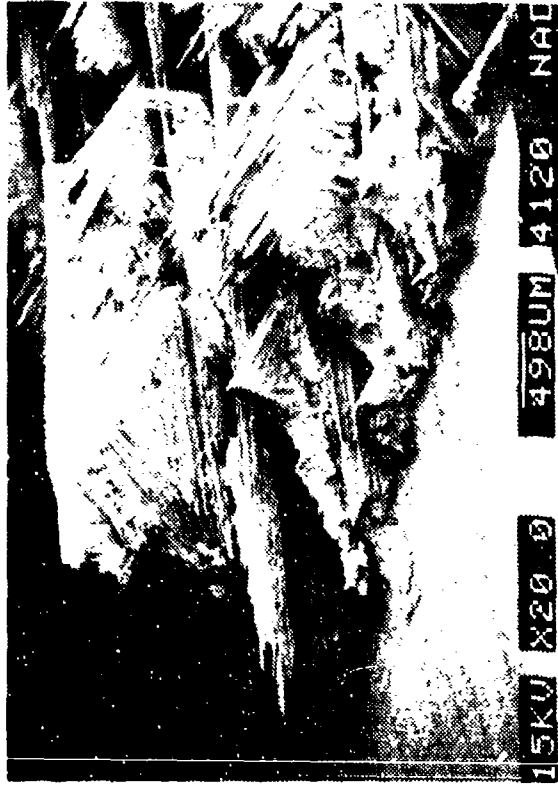
Figure 2-171. Optical and SEM Photographs of Translaminar Mode
I Compression Fracture in Gr/Ep - 32 Ply
Quasi-Isotropic, Water Immersed Before Test
(a) Macro photograph of Fractured Fragments
(b), (c) Normal and Oblique Views of Fracture Near
the Apex

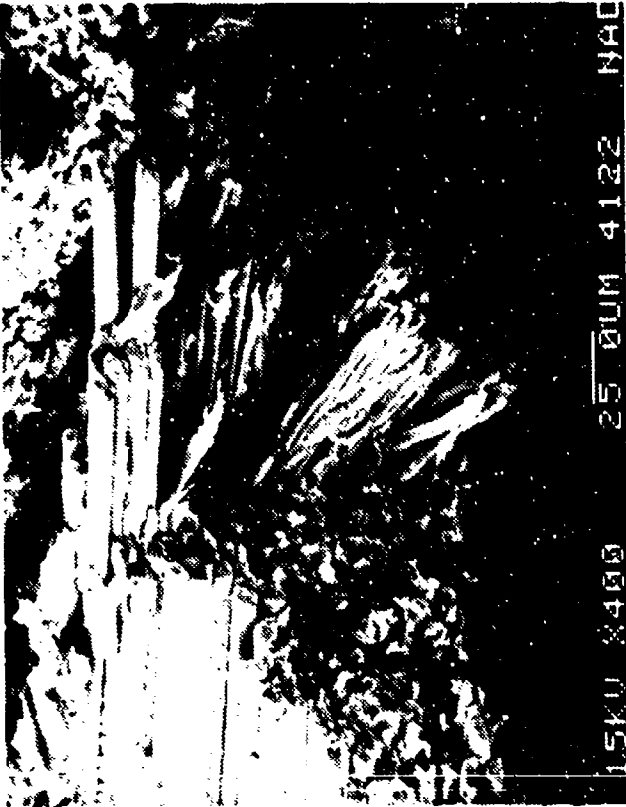
Figure 2-171. (Continued)
(d) Microbuckling Features (Chop Marks) on Fractured Fiber Ends
(e) Broken Fibers

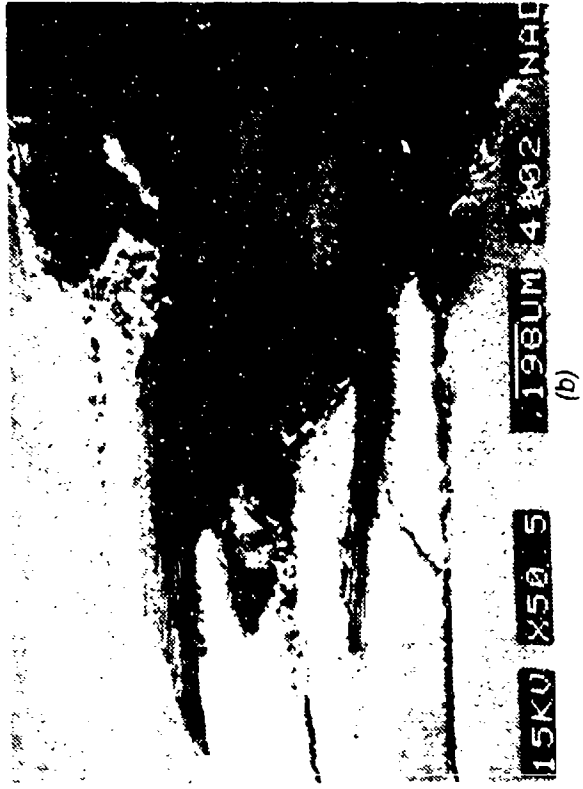
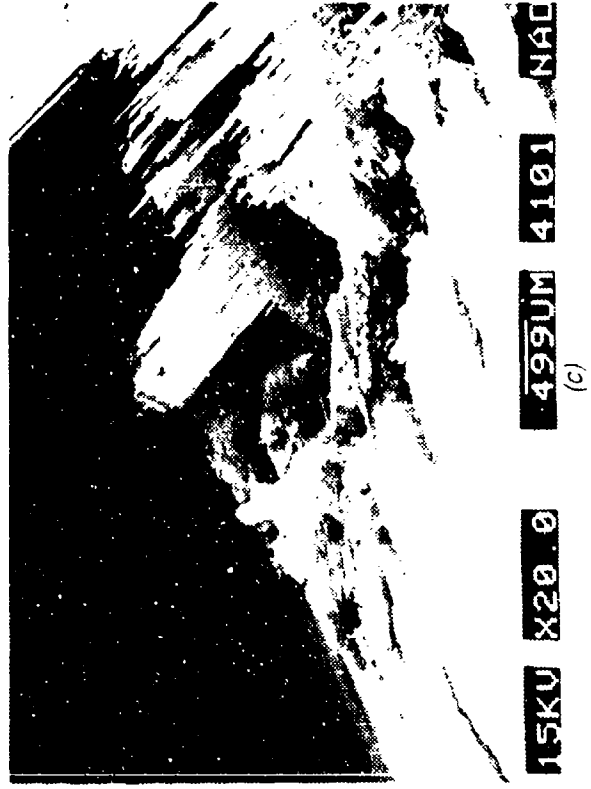
Figure 2-172. Optical and SEM Photographs of Translaminar Mode
 i Compression Fracture in Overcured Gr/Ep - 32 Ply
 Quasi-Isotropic
 (a) Macrograph of Fractured Fragments
 (b), (c) Normal and Oblique Views of Fracture Near
 the Apex

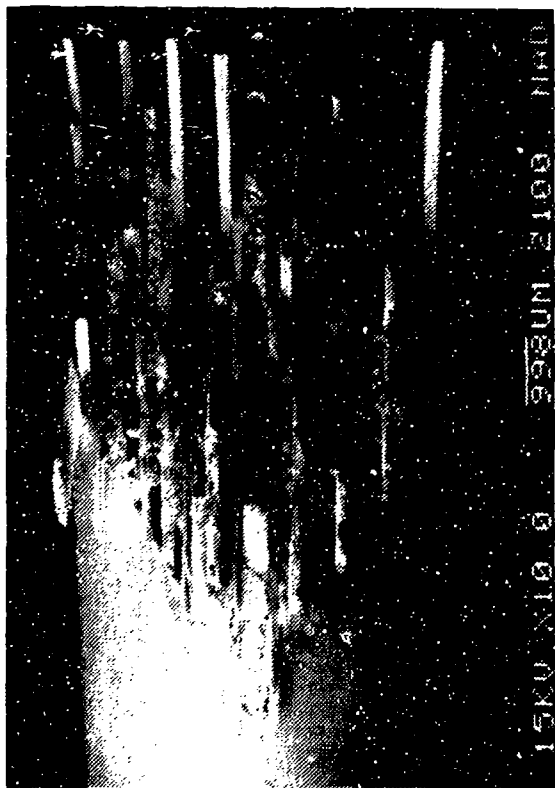
Figure 2-173. Optical and SEM Photographs of Translaminar Mode I Compression Fracture in High Resin Content Gr/Ep - 32 Ply Quasi-Isotropic

(a) Macro photograph of the Fracture and Apex

(b) Fracture Near the Apex

Note the flat fracture surface and the post fracture damage

(c) High Magnification of (b) Showing Crushed Fibers

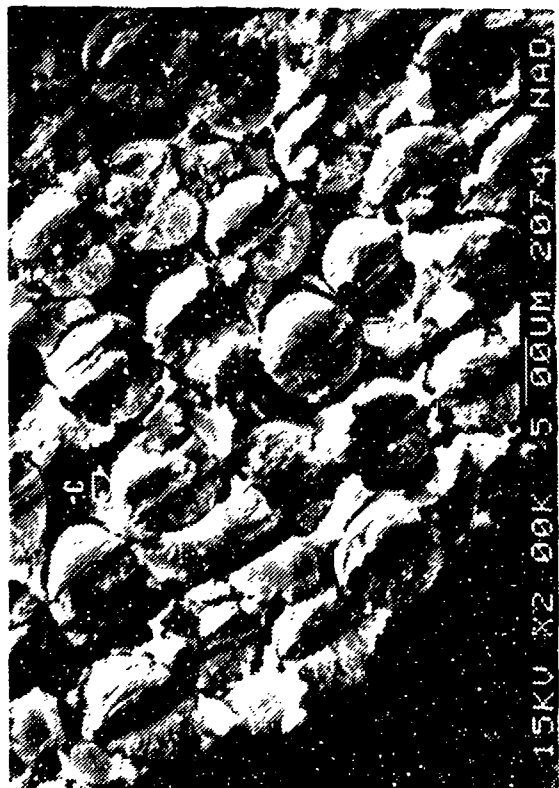
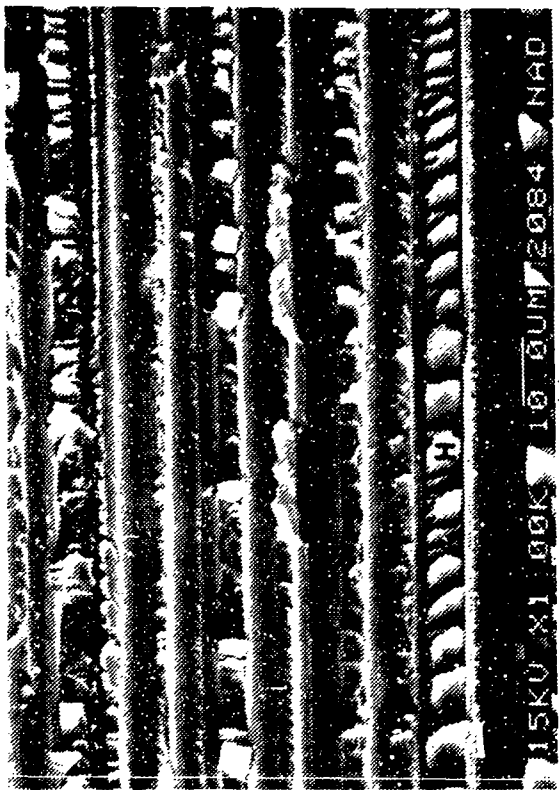
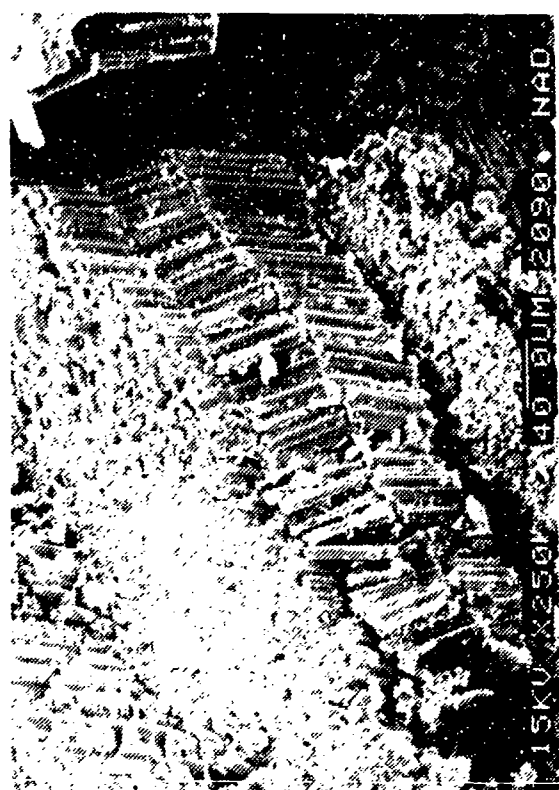
Figure 2-173. (Continued)
 (d) Flexural Fracture Features
 Note: Chop marks (C) on individual fiber ends are typical of flexural fractures in compression.
 (e) Hackles (H) and Scallops (S) in a 90 Degree Ply
 (f) Multiple Fiber Breaks Due to Microbuckling

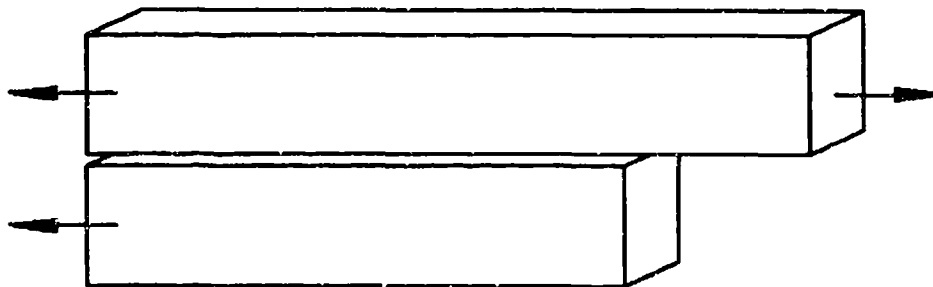
Figure 2-174. Side-Notched Rail Shear Type Test

As with compression dominated fractures, fractographic features by which the direction of fracture can be identified, do not exist. Figure 2-174 shows the side-notched rail shear test configuration and Table 2-7 provides the test matrix for the translaminar shear testing. Figures 2-175 through 2-184 are the corresponding fractographs.

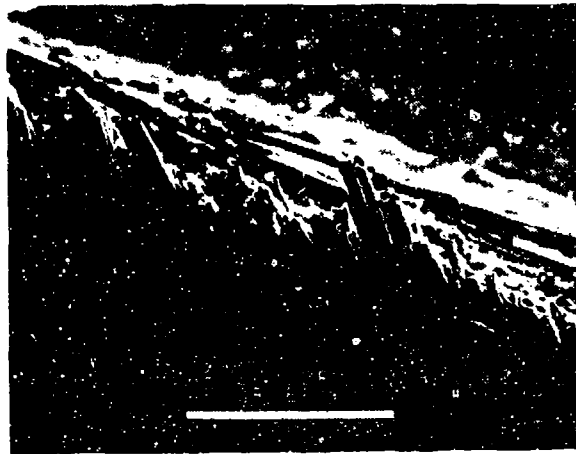
Fracture type	Translaminar mode II shear
Ply layup	[0, 90] _{16S}
Test type	Side-notched rail shear
• Test conditions	Dry
• Fiber end fracture	
Material	Hercules 3501-6/177°C cure AS4 fibers

Figure 2-176. SEM Photographs of Translaminar Mode II Shear, 0/90 Fracture, -65, 180, 270 F/Dry (400X)

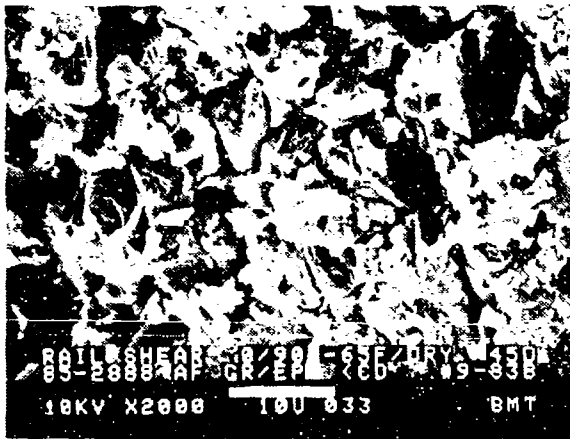
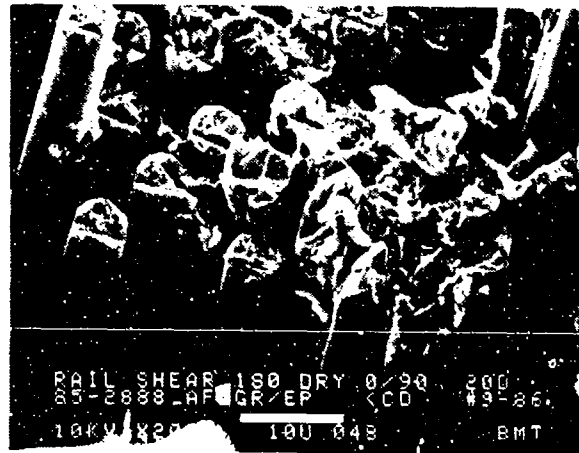
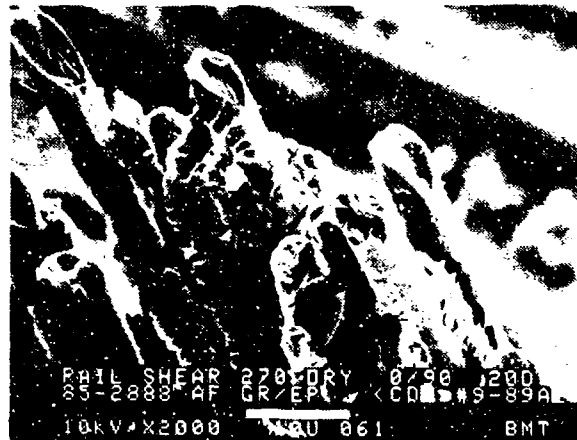
Fracture type	Translaminar mode II shear
Ply layup	[0, 90] _{16S}
Test type	Side-notched rail shear
• Test conditions	Dry
• Fiber end fracture	
Material	Hercules 3501-6/177°C cure AS4 fibers

Figure 2-177. SEM Photographs of Translaminar Mode II Shear, 0/90 Fracture, -65, 180, 270 F/Dry (2000X)

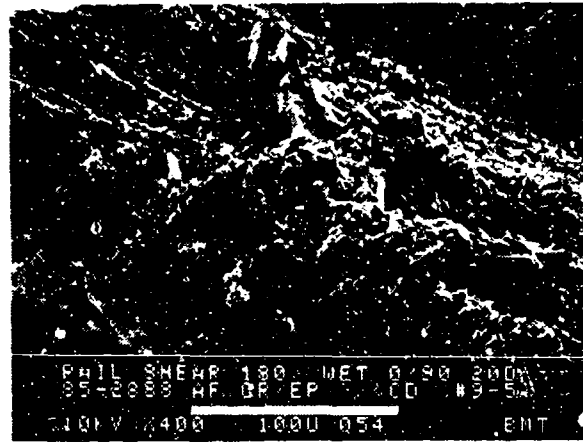
Fracture type	Translaminar mode II shear
Ply layup	[0, 90] _{16S}
Test type	Side-notched rail shear
• Test conditions	Wet
• Fiber end fracture	
Material	Hercules 3501-6/177°C cure AS4 fibers

Figure 2-178. SEM Photographs of Translaminar Mode II Shear, 0/90 Fracture, 70, 180, 270 F/Wet (400X)

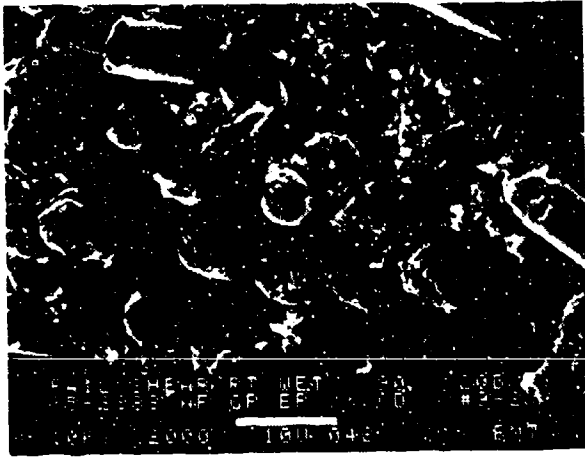
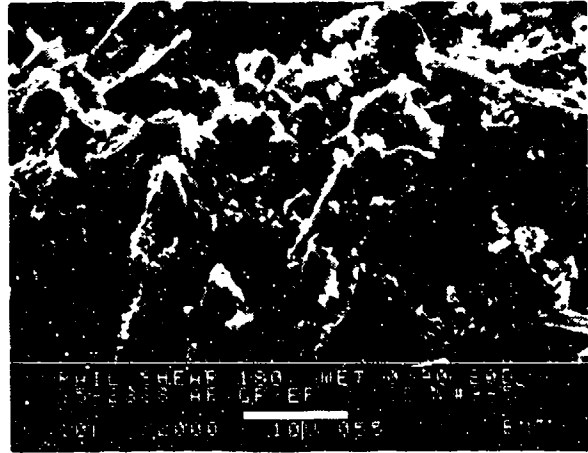
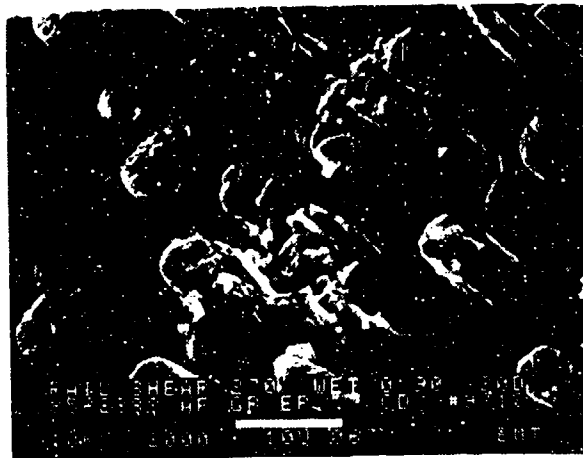
Fracture type	Translaminar mode II shear
Ply layup	[0, 90] _{16S}
Test type	Side-notched rail shear
• Test conditions	Wet
• Fiber end fracture	
Material	Hercules 3501-6/177°C cure AS4 fibers

Figure 2-179. SEM Photographs of Translaminar Mode II Shear, 0/90 Fracture, 70, 180, 270 F/Wet (2000X)

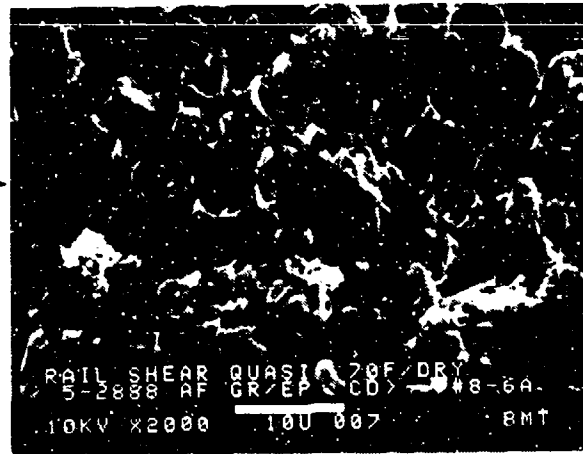
Fracture type	Translaminar mode II shear
Ply layup	[0, 45, 90] _{16S}
Test type	Side-notched rail shear
• Test conditions	21°C, dry
• Fiber end fracture	
Material	Hercules 3501-6/177°C cure AS4 fibers

Figure 2-180. SEM Photographs of Translaminar Mode II Shear, 0/45/90 Fracture, 70 F/Dry

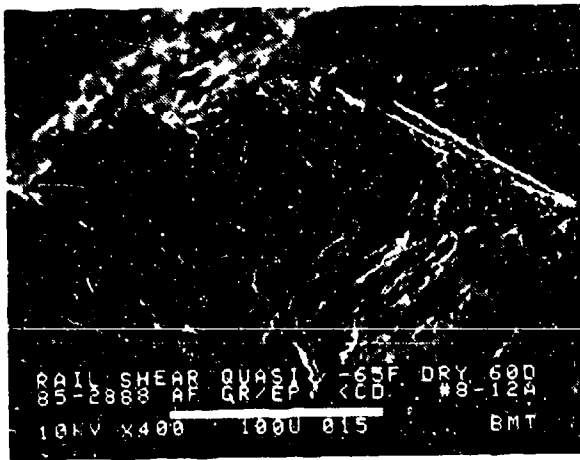
-65°F. dry

Fracture type	Translaminar mode II shear
Ply layup	[0,45, 90] _{16S}
Test type	Side-notched rail shear
• Test conditions	Dry
• Fiber end fracture	
Material	Hercules 3501-6/177°C cure AS4 fibers

Figure 2-181. SEM Photographs of Translaminar Mode II Shear, 0/45/90 Fracture, -65, 180, 270 F/Dry (400X)

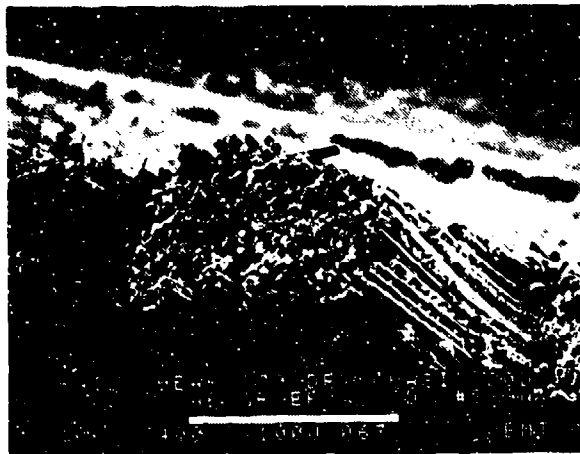
180°F. dry

270°F. dry

Fracture type	Translaminar mode II shear
Ply layup	[0, 45, 90] _{1,1,1} S
Test type	Side-notched rail shear
• Test conditions	Dry
• Fiber end fracture	
Material	Hercules 3501-6/177°C cure AS4 fibers

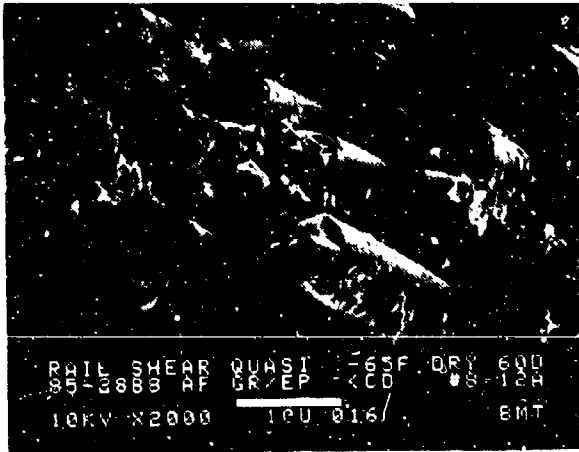
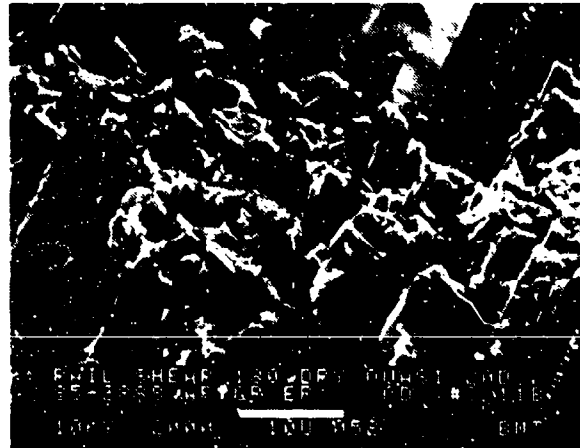
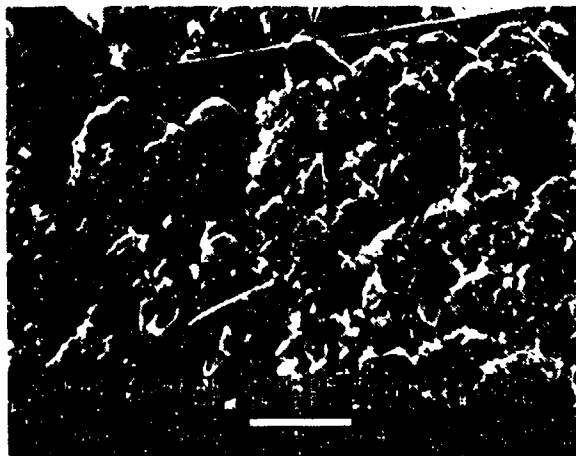
Figure 2-182. SEM Photographs of Translaminar Mode II Shear, 0/45/90 Fracture, -65, 180, 270 F/Dry (2000X)

-65°F, dry

180°F, dry

270°F, dry

Fracture type	Translaminar mode II shear
Ply layup	[0, 45, 90] 16S
Test type	Side-notched rail shear
• Test conditions	Wet
• Fiber end fracture	
Material	Hercules 3501-6/177°C cure AS4 fibers

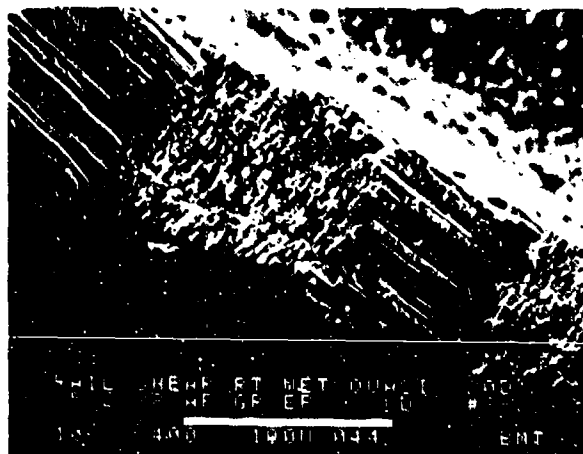
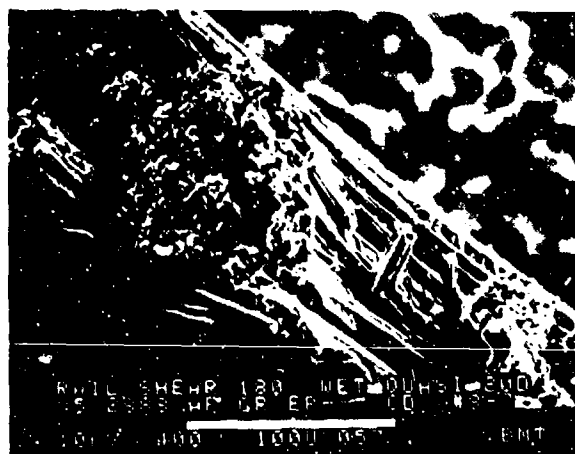
Figure 2-183. SEM Photographs of Translaminar Mode II Shear, 0/45/90 Fracture, 70, 180, 270 F/Wet (400X)

70°F, wet

180°F, wet

270°F, wet

Fracture type	Translaminar mode II shear
Ply layup	[0, 45, 90] _{16S}
Test type	Side-notched rail shear
• Test conditions	Wet
• Fiber end fracture	
Material	Hercules 3501-6/177°C cure AS4 fibers

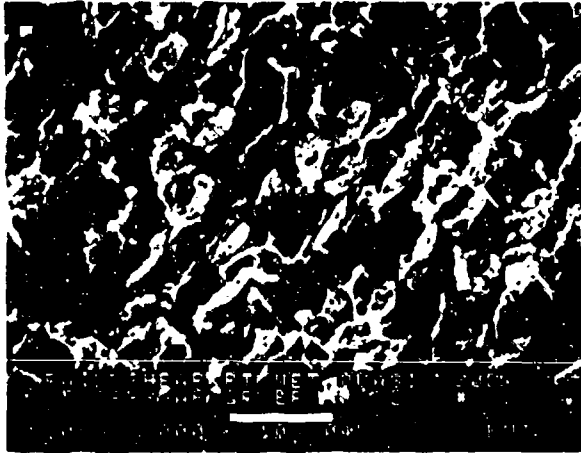
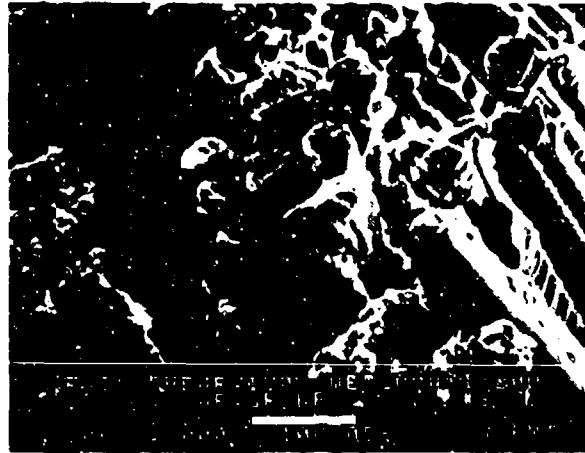
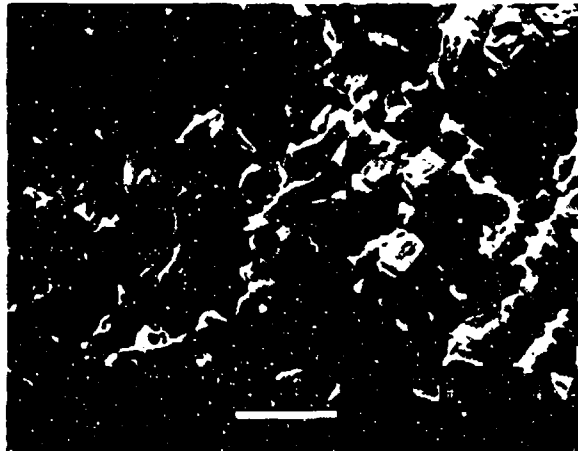
Figure 2-184. SEM Photographs of Translaminar Mode II Shear, 0/45/90 Fracture, 70, 180, 270 F/Wet (2000X)

70°F. wet

180°F. wet

270°F. wet

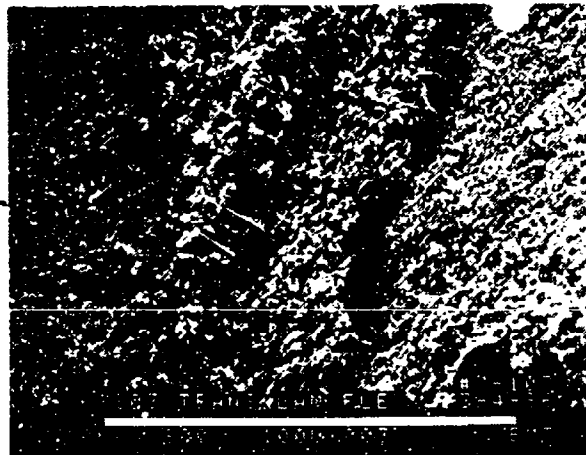
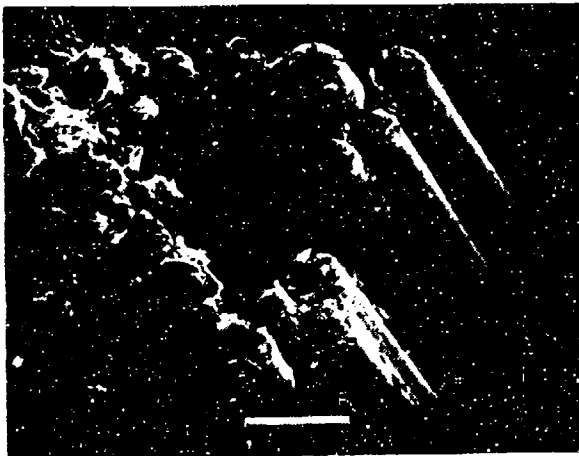
Figure 2-186. SEM Photographs of Translaminar Flexure, 0/0 Fracture, 70 F/Dry

Fracture type	Translaminar flexure
Ply layup	[0] ₃ 2
Test type	Laminar flexure
• Test conditions	20°C, dry
• Fiber end fracture	
Material	Hercules 3501-6/177°C cure AS4 fibers

Compression Fracture Region

Tensile Fracture Region

The primary features observed in unnotched specimens which fail because of flexural loading are as follows:

1. Macroscopic identification of rough (tensile) and smooth (compressive) fracture regions
2. Distinct separation between tension and compression regions (as indicated by a neutral axis region)
3. Tensile fractures tend to initiate along the outer surface and progress toward the neutral line (as indicated by analysis of fiber end radials).

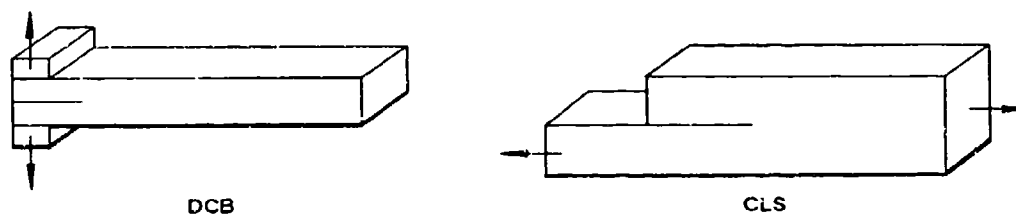
Figure 2-187. Double Cantilever Beam (DCB) for Mode I Fractures and Cracked-Lap Shear (CLS) for Mode II Fractures

Figure 2-187 shows the test configuration of double cantilever beam (DCB) for Mode I fractures and cracked-lap shear (CLS) for Mode II fractures. Figures 188, 189 and 190 are Mode I DCB constant amplitude fatigue fractographs contributed by Boeing. Figures 191, 192 and 193 are Mode I DCB variable amplitude (Spectrum) fatigue fractographs contributed by Northrop. Figures 194 through 197 are Mode II CLS constant amplitude fatigue fractographs contributed by Boeing.

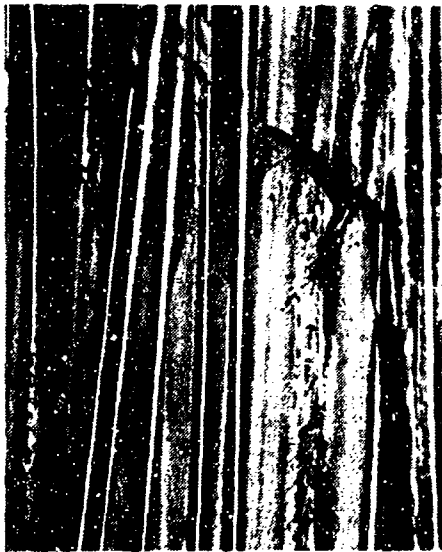
Fracture type	Interlaminar fatigue mode I tension
Ply layup	{0}24
Test type	Fatigue DCB
• Test conditions	21°C, dry
• Fracture between	0/0 plies
Material	Hercules 3501-6/177°C cure AS4 fibers

Static growth

Figure 2-189. Optical Photographs of Interlaminar Fatigue Mode I Tension, 0/0 Fracture, 70 F/Lry (400X and 1000X)

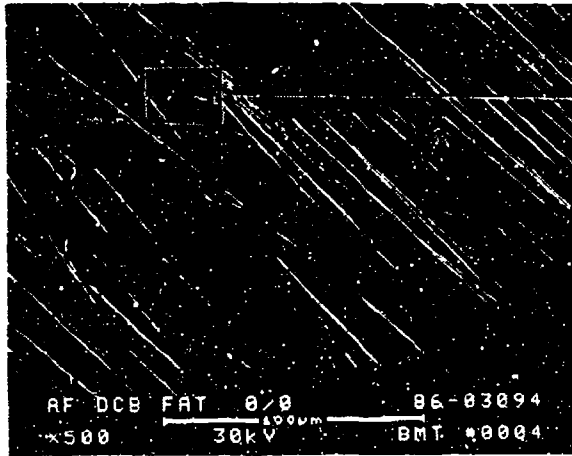
Fracture type	Interlaminar fatigue mode I tension
Ply layup	[0] ₂₄
Test type	Fatigue DCB
• Test conditions	21°C, dry
• Fracture between	0/0 plies
Material	Hercules 3501-6/177°C cure AS4 fibers

Figure 2-190. SEM Photographs of Interlaminar Fatigue Mode I Tension, 0/0 Fracture, 70 F/Dry (500X and 5000X)

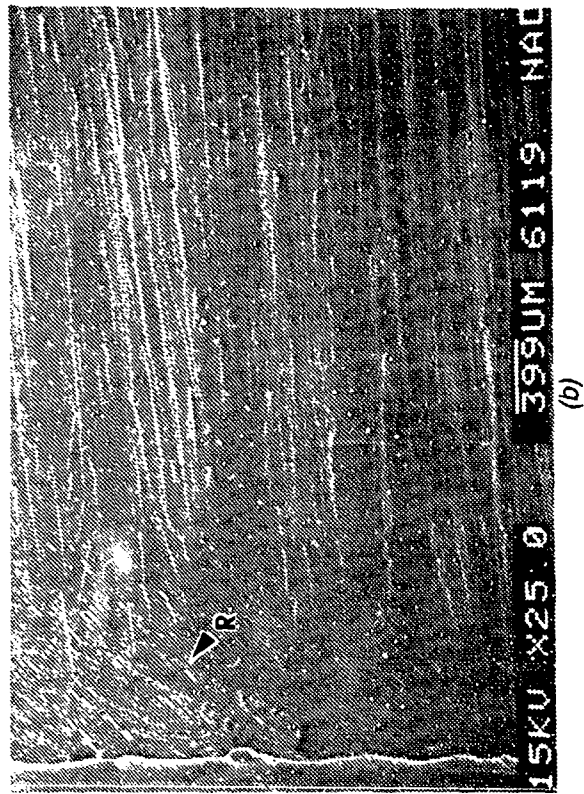
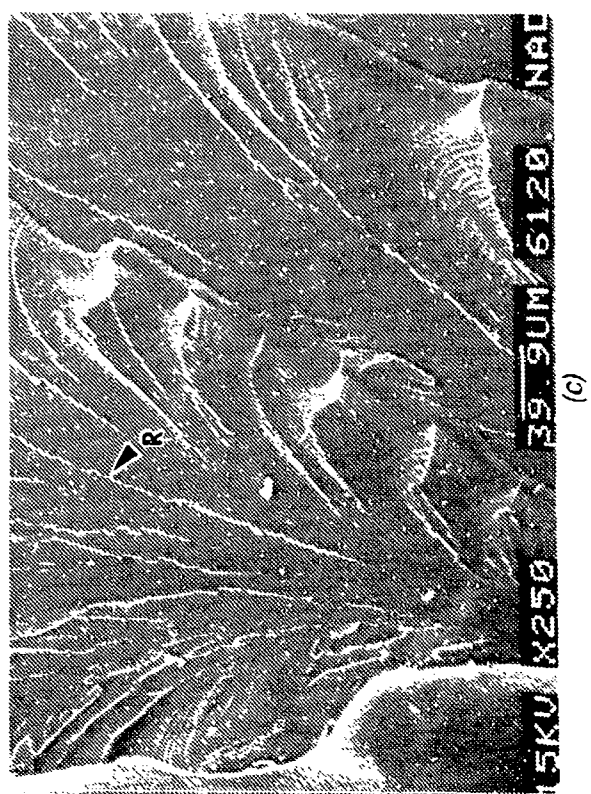
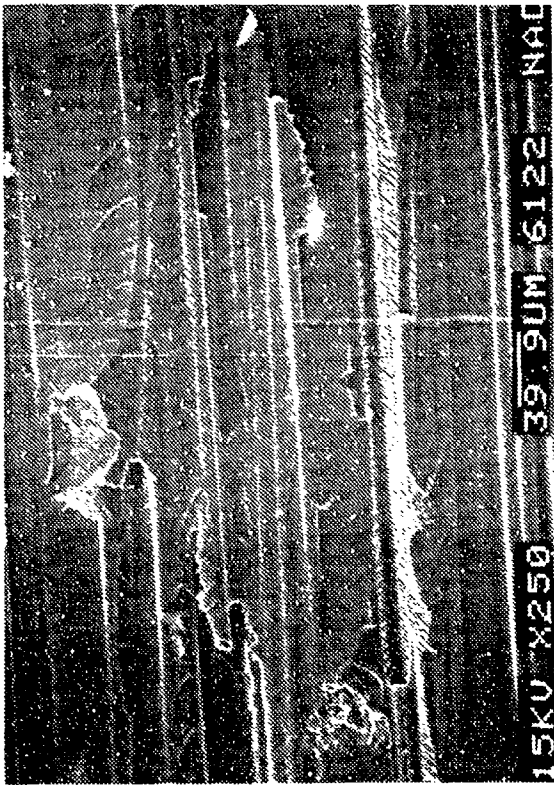
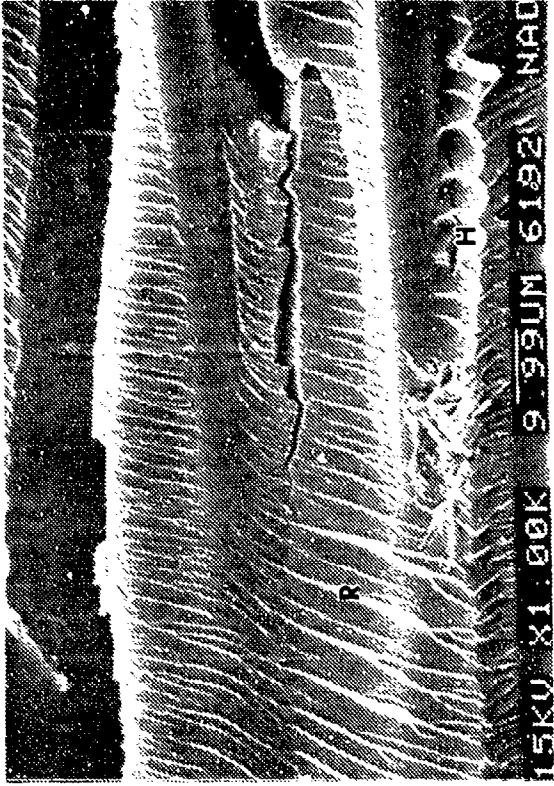
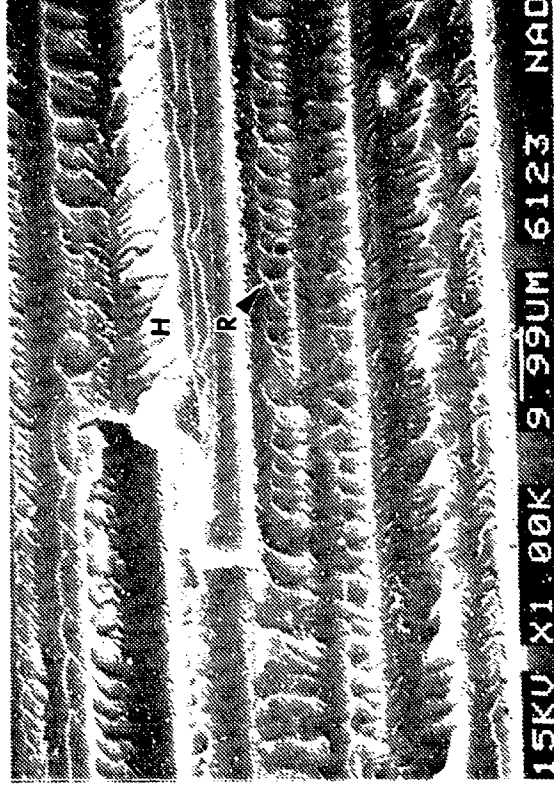
Figure 2-191. Optical and SEM Photographs of Interlaminar Mode I DCB Spectrum Fatigue Fracture in AS4/3501-6 Gr/Ep - [0]_{24T}
 (a) Macro photograph
 (b), (c) Initiation in Resin Rich Areas

CD = Crack-propagation direction
 R = River patterns

(d) Low Magnification Photograph of Crack-Growth Region

(e), (f) Fracture Details

H = Hackles

R = River patterns

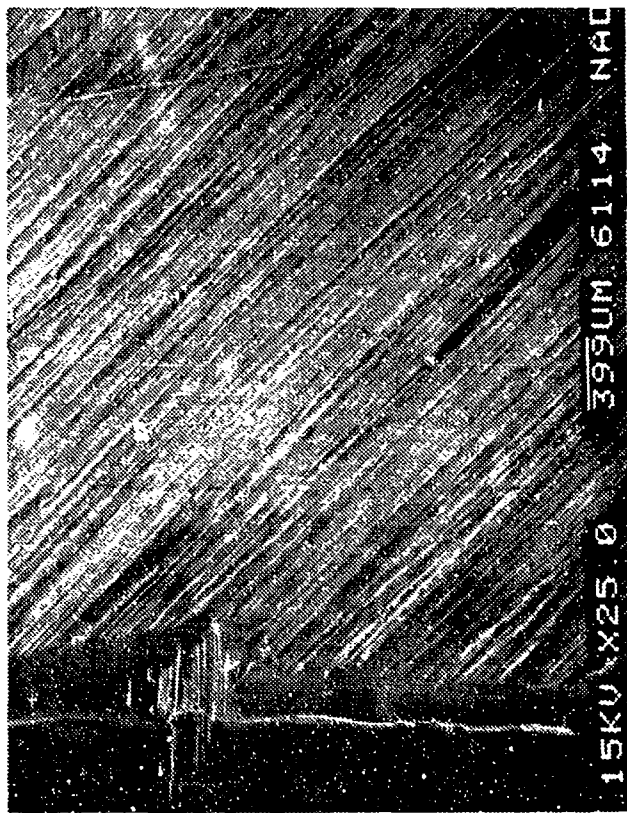
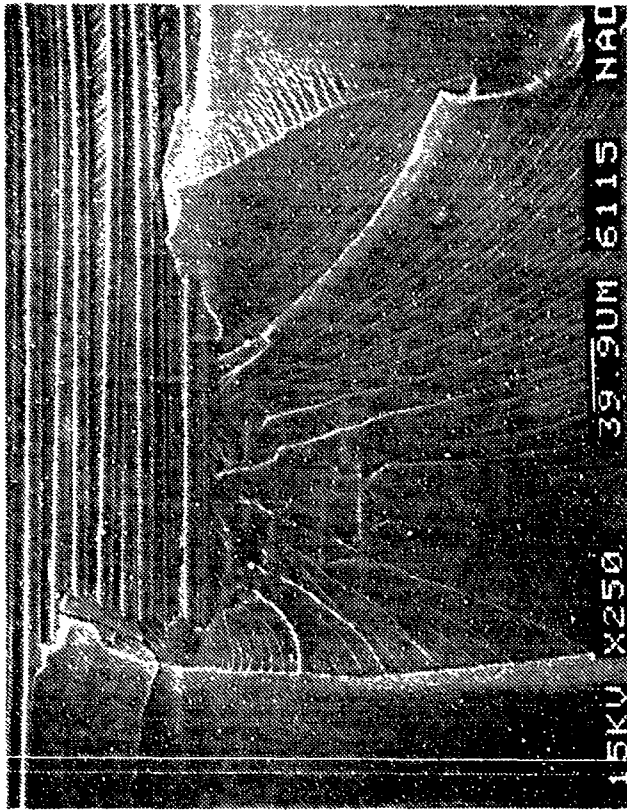
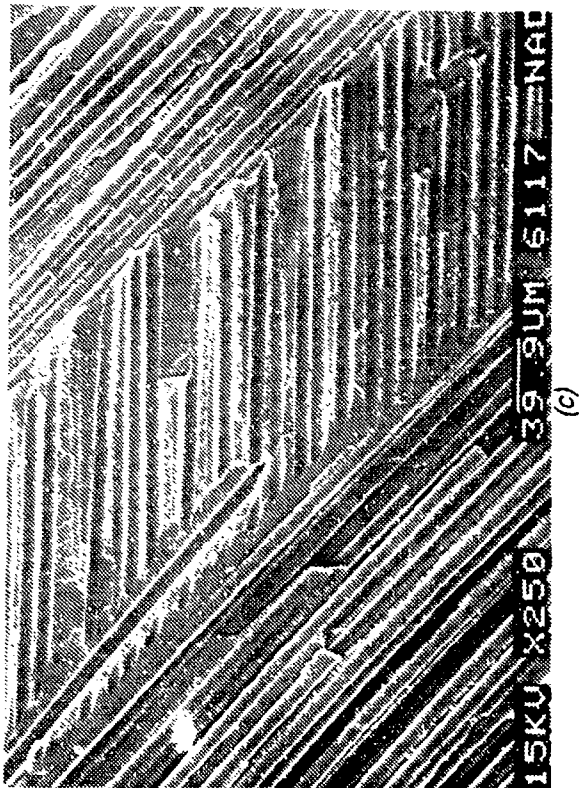
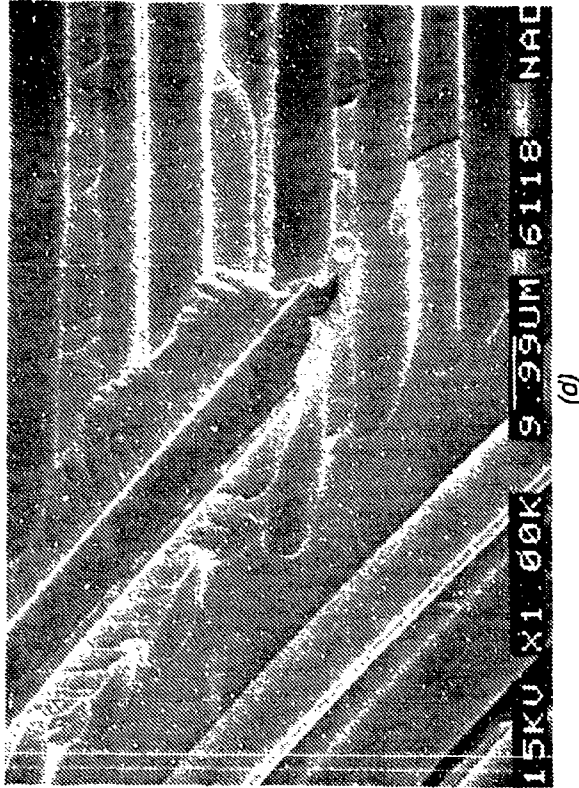
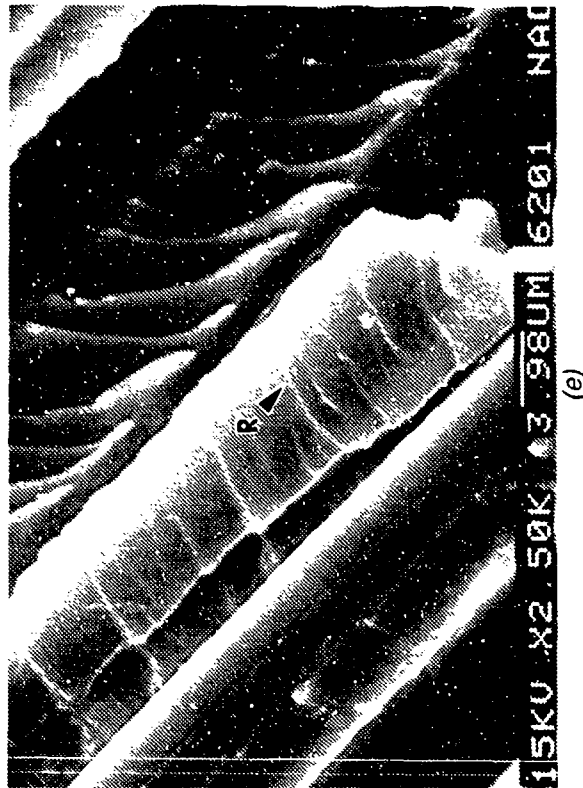
Figure 2-192. SEM Photographs of Interlaminar Mode I DCB Spectrum Fatigue Fracture in

(a) Macrograph of Fracture

(b) Initiation in Resin-Rich Area in Precrack Region

Figure 2-192. (Continued)
 (c), (d) Low and Intermediate Magnification Photographs Showing Fracture Traversing from 45 Degree Ply to 0 Degree Ply and Back in Crack-Growth Region
 (e) High Magnification Photograph Showing Regular Array of Rivers (R) Oriented Toward CD
