WL-TR-91-4032
DOT/FAA/CT-91/23
VOL II, Part 2

COMPOSITE FAILURE ANALYSIS HANDBOOK
VOL II - TECHNICAL HANDBOOK
PART 2 - ATLAS OF FRACTOGRAPHS

February 1992

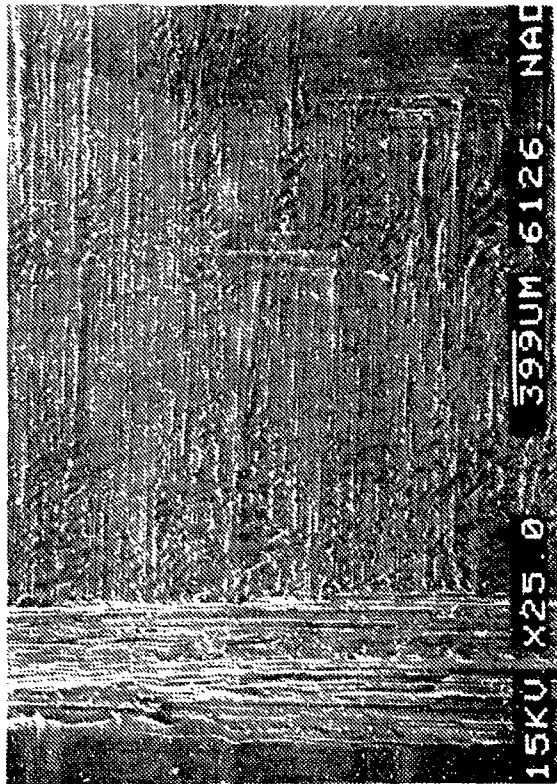
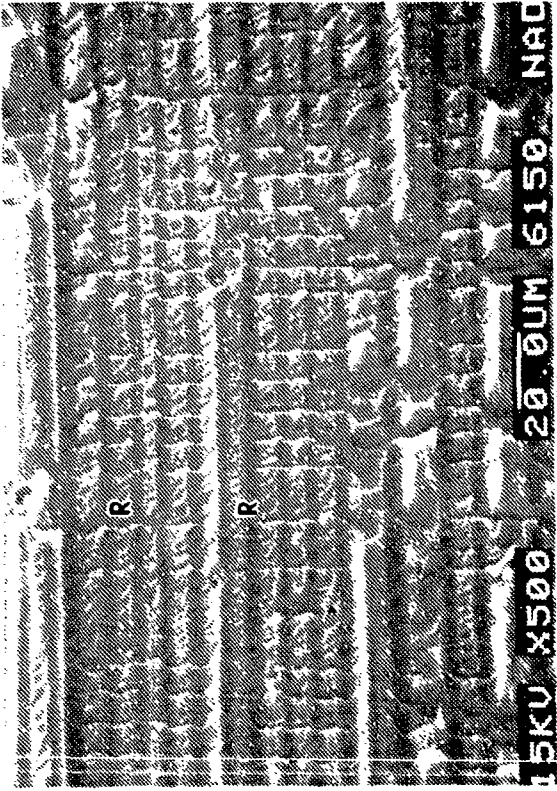
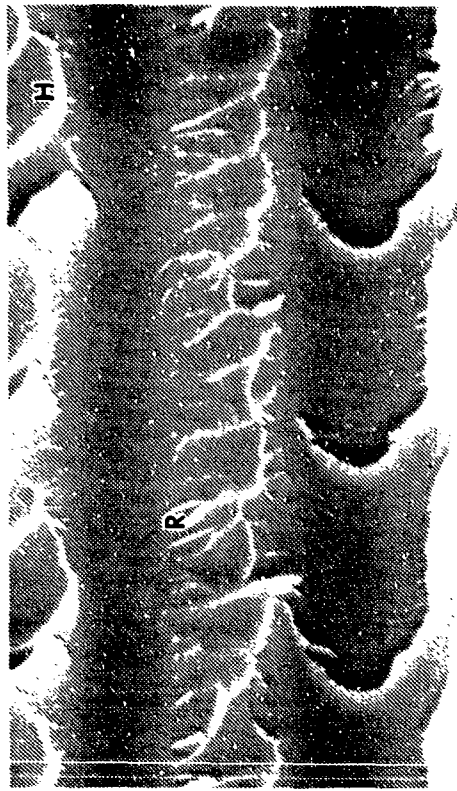
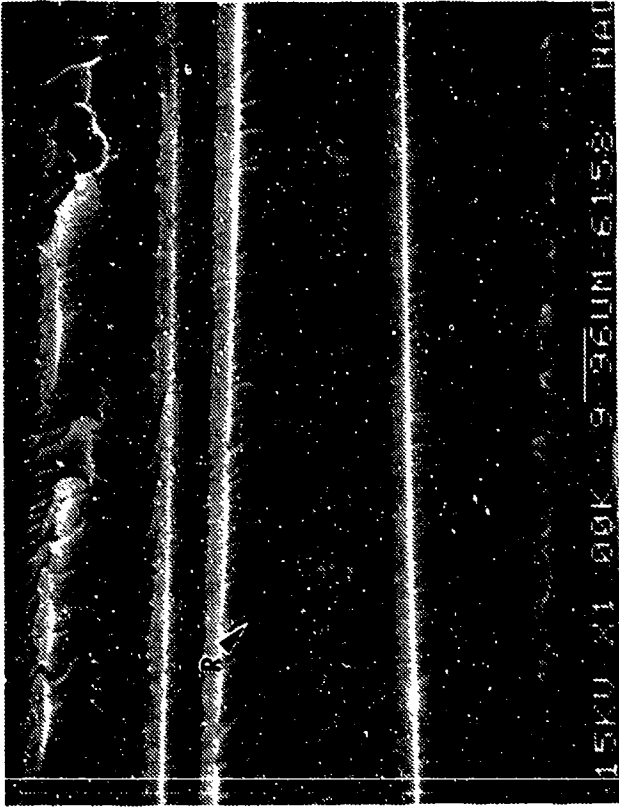
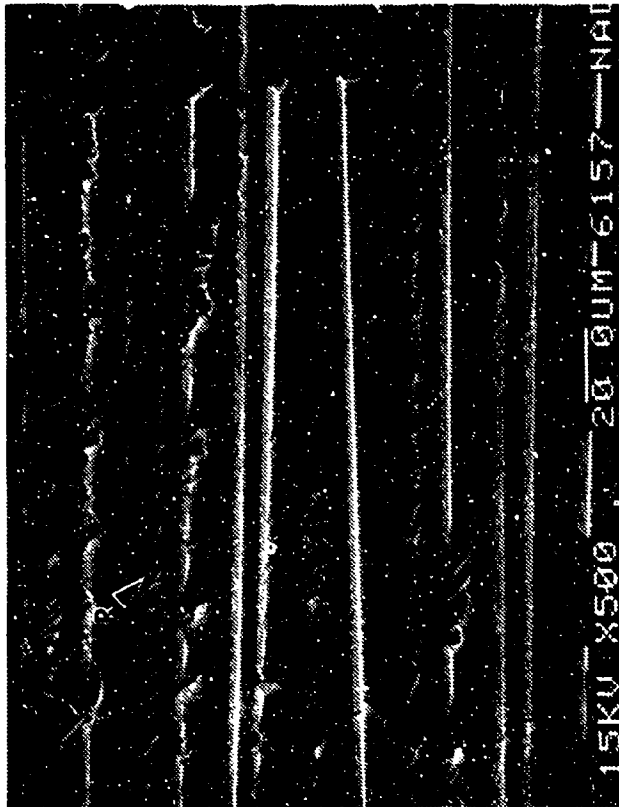
Figure 2-193. SEM Photographs of Interlaminar Mode I DCB Spectrum Fatigue Fracture in AS4/3501-6 Gr/Ep - [0/90]_{6S}
 (a) Macro photograph of Fracture
 (b), (c) Fracture Details in Spectrum Fatigue Region
 Close to 90 Degree Fibers

Figure 2-193. (Continued)
 (d), (e) Crack-Growth Region Close to 0 Degree Fibers

Figure 2-187 shows the test configuration of double cantilever beam (DCB) for Mode I fractures and cracked-lap shear (CLS) for Mode II fractures. Figures 188, 189 and 190 are Mode I DCB constant amplitude fatigue fractographs contributed by Boeing. Figures 191, 192 and 193 are Mode I DCB variable amplitude (Spectrum) fatigue fractographs contributed by Northrop. Figures 194 through 197 are Mode II CLS constant amplitude fatigue fractographs contributed by Boeing.

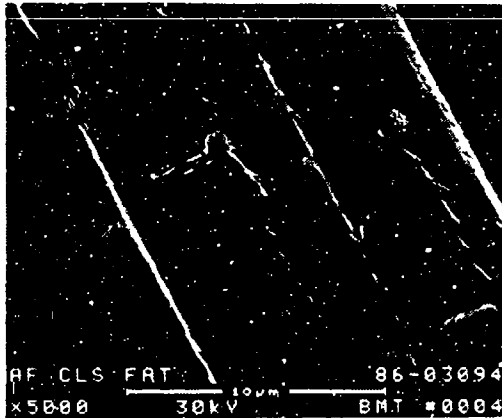
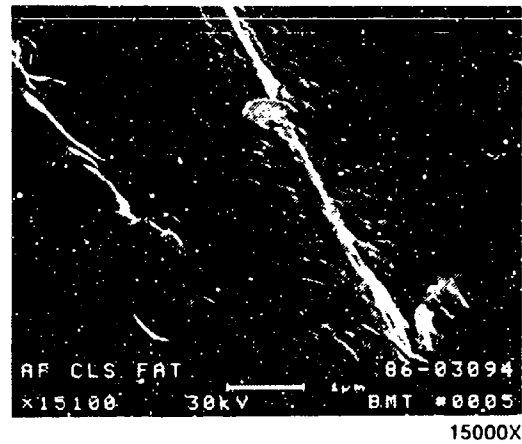
Fracture type	Interlaminar fatigue mode II shear
Ply layup	[0] 24
Test type	Fatigue CLS (80% to 20% G _{II} C)
• Test conditions	21°C, dry
• Fracture between	0/0 plies
Material	Hercules 3501-6/177°C cure AS4 fibers

Figure 2-196. SEM Photographs of Interlaminar Fatigue Mode II Shear, 0/0 Fracture, 70 F/Dry (5000X and 15000X)

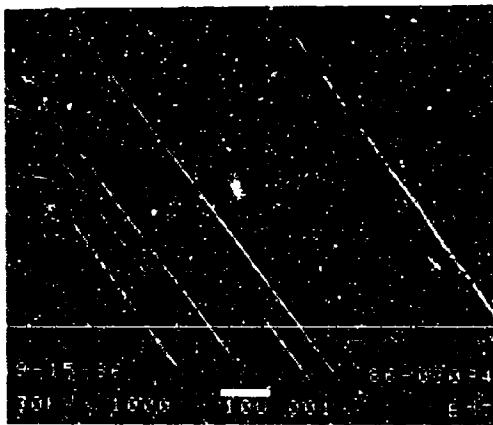
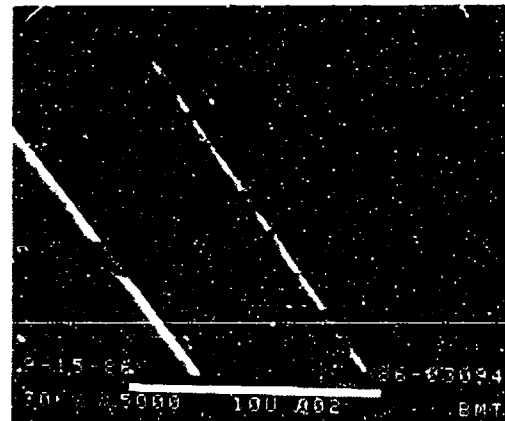
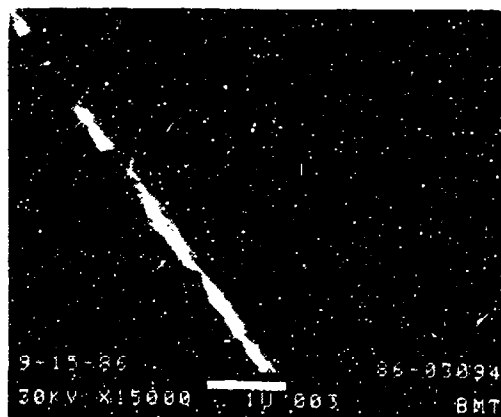
Fracture type	Interlaminar fatigue mode II shear
Ply layup	[0] 24
Test type	Fatigue CLS (80% to 40% GIIIC)
• Test conditions	21°C, dry
• Fracture between	O/O plies
Material	Hercules 3501-6/177°C cure AS4 fibers

Mechanically induced crack direction

Figure 2-197. SEM Photographs of Interlaminar Fatigue Mode II Shear, O/O Fracture, 70 F/Dry (1000X, 5000X and 15000X)

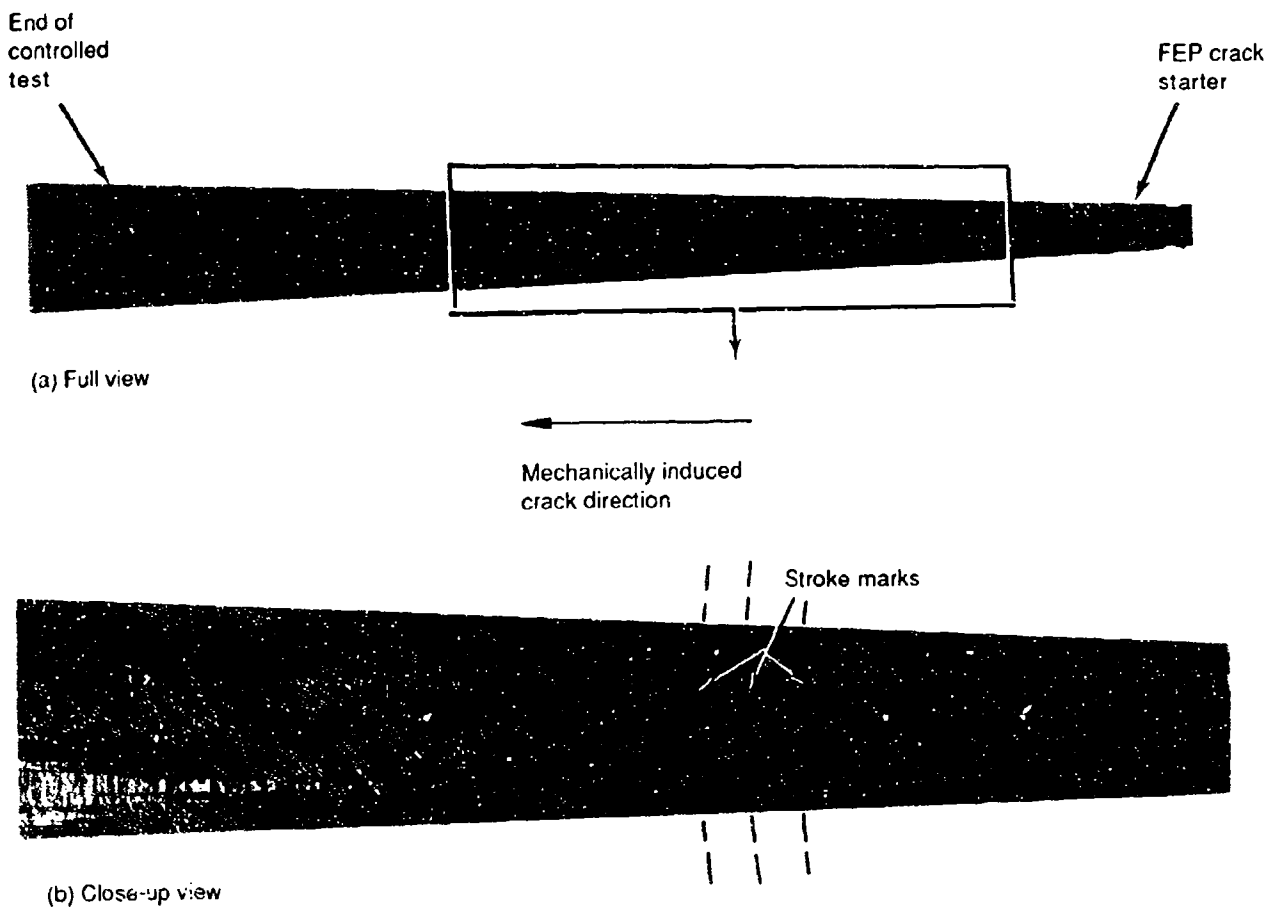
Figure 2-196. Macrophotographs of Interlaminar Mode I Tension, RT/Dry Creep, 0/90 Fracture

Visual observation revealed a smooth, glassy surface typical of an interlaminar Mode I tension fracture. There were visible crack arrest marks ("beach marks") running perpendicular to the mechanically induced crack direction (Figure 2-198). The spacing between these marks was quite consistent due to the constant loading rate throughout the creep test. Optical fractography focused on what appeared to be a striped fracture region. Due to the re-initiation of the crack, the location just after crack arrest appeared much rougher than the region just prior to it (Figure 2-199). The river marks were more readily observed in the region prior to the crack arrest.

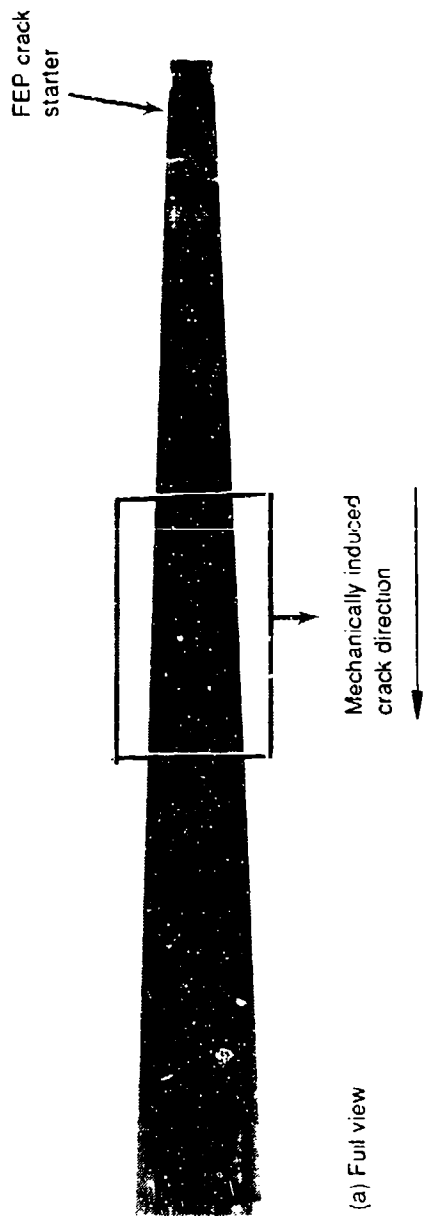
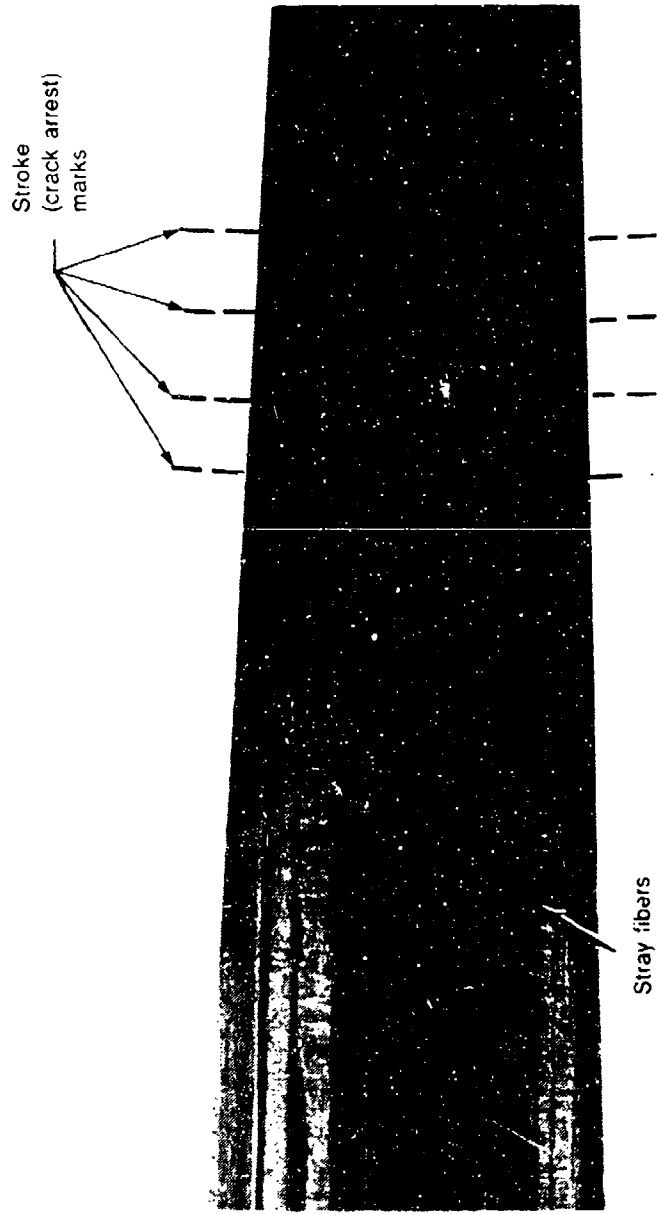
Figure 2-202. Macrophotographs of Interlaminar Mode I Tension, 270 F//Dry Creep, 0/90 Fracture

Visual observation revealed a smooth, glassy fracture surface similar to that of the RT specimen. Crack arrest marks were again observed (Figure 2-202). However, there were fragments of loose fibers on the fracture surface. These fibers may have separated from the resin matrix prematurely due to poor adhesion. The fracture topography at the region before and after the crack arrest was smooth (Figure 2-203), unlike that of the fracture created at RT. The SEM analysis confirmed the observations made during the optical analysis (Figure 2-204).

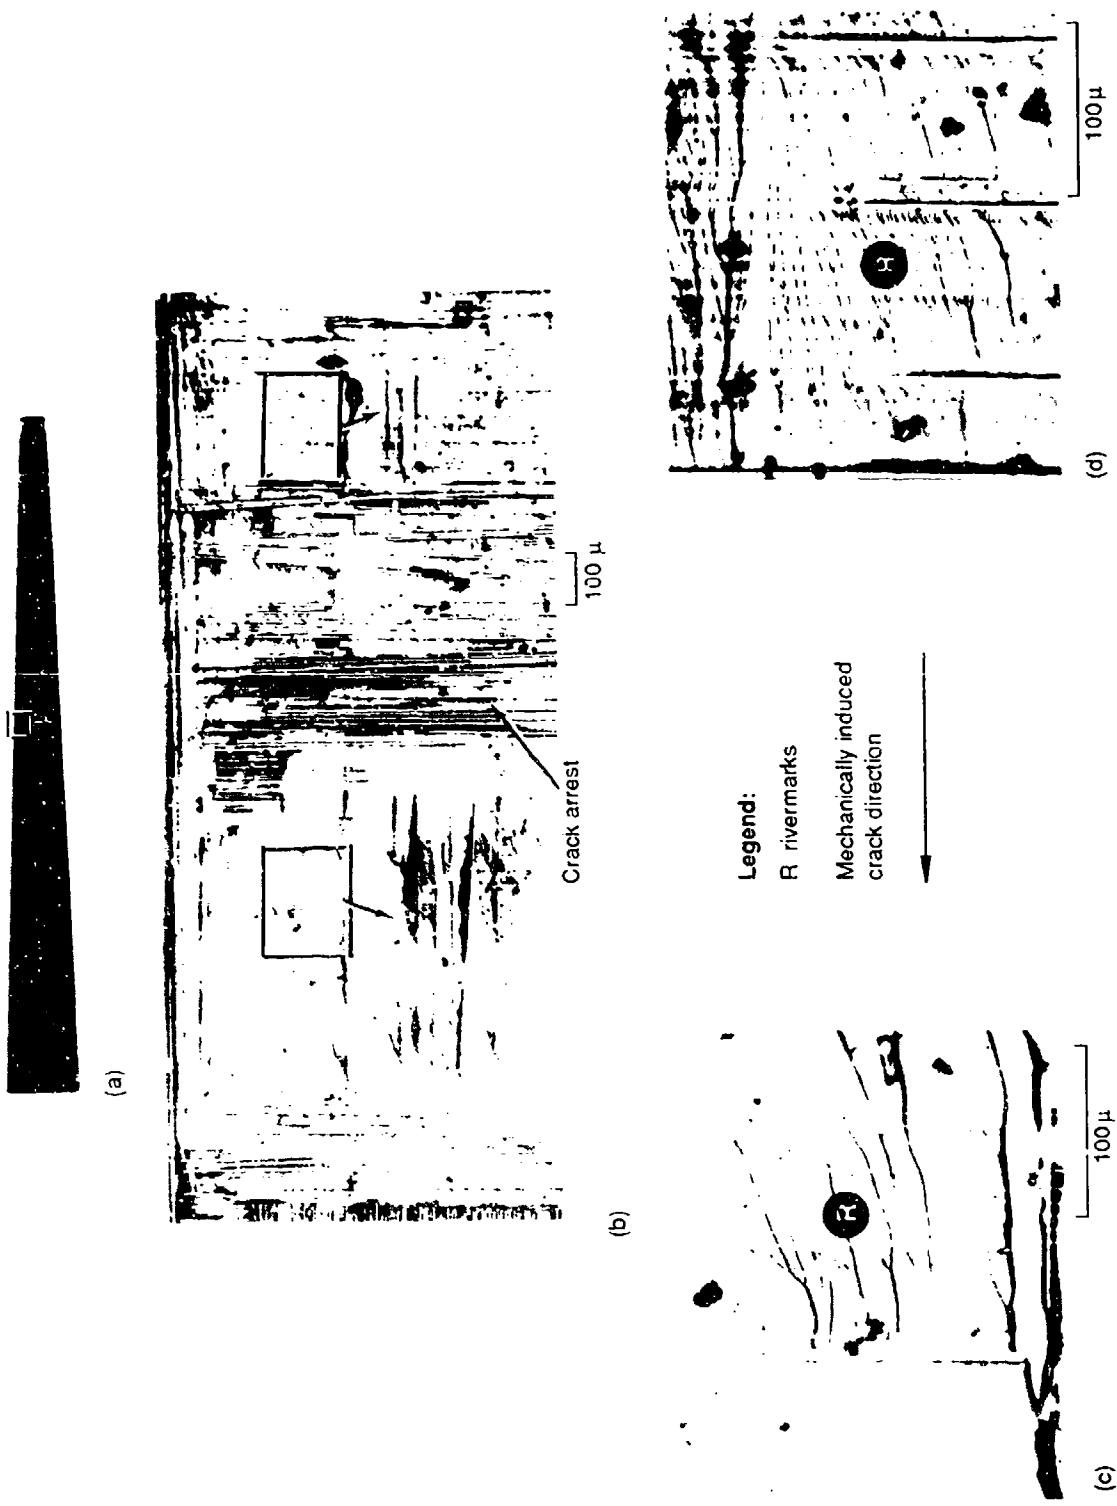
Figure 2-203. Optical Photomicrographs of Interlaminar Mode I Tension, 270 F/Dry Creep, 0/90 Fracture

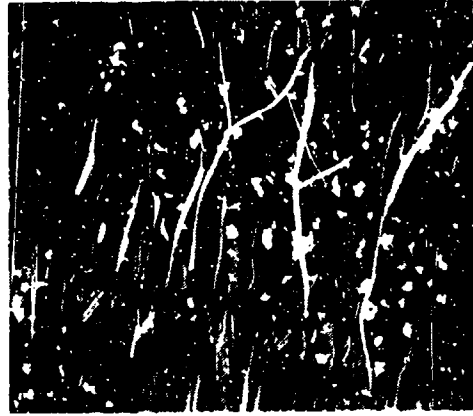
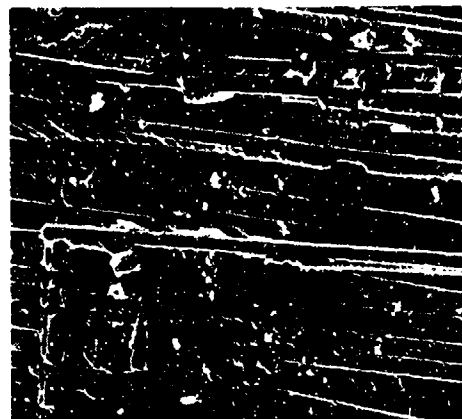
Legend:
 R rivermarks
 F fiber/matrix fracture
 Mechanically induced crack direction

Figure 2-204. SEM Fractographs of Interlaminar Mode I Tension, 270 F/Dry Creep, 0/90 Fracture

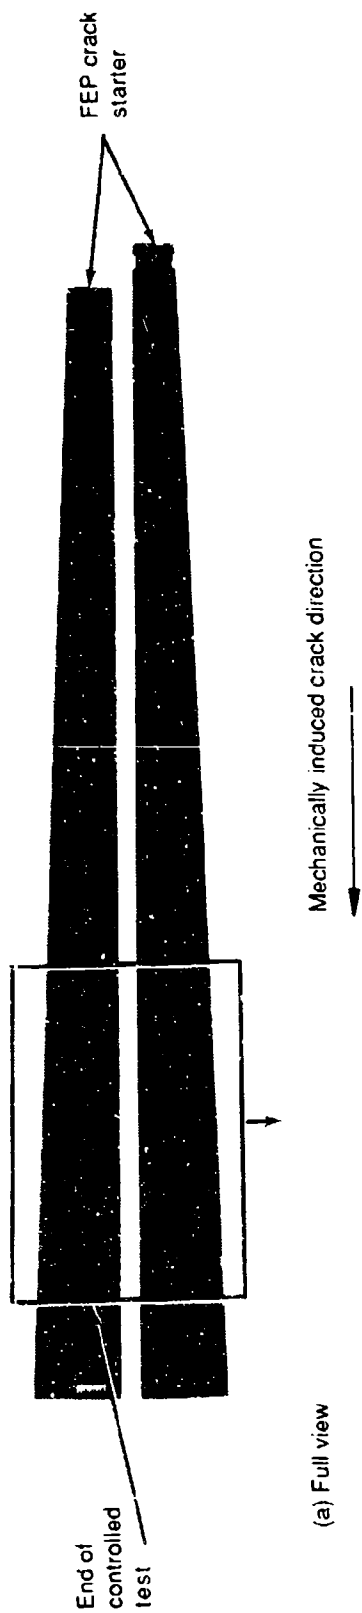
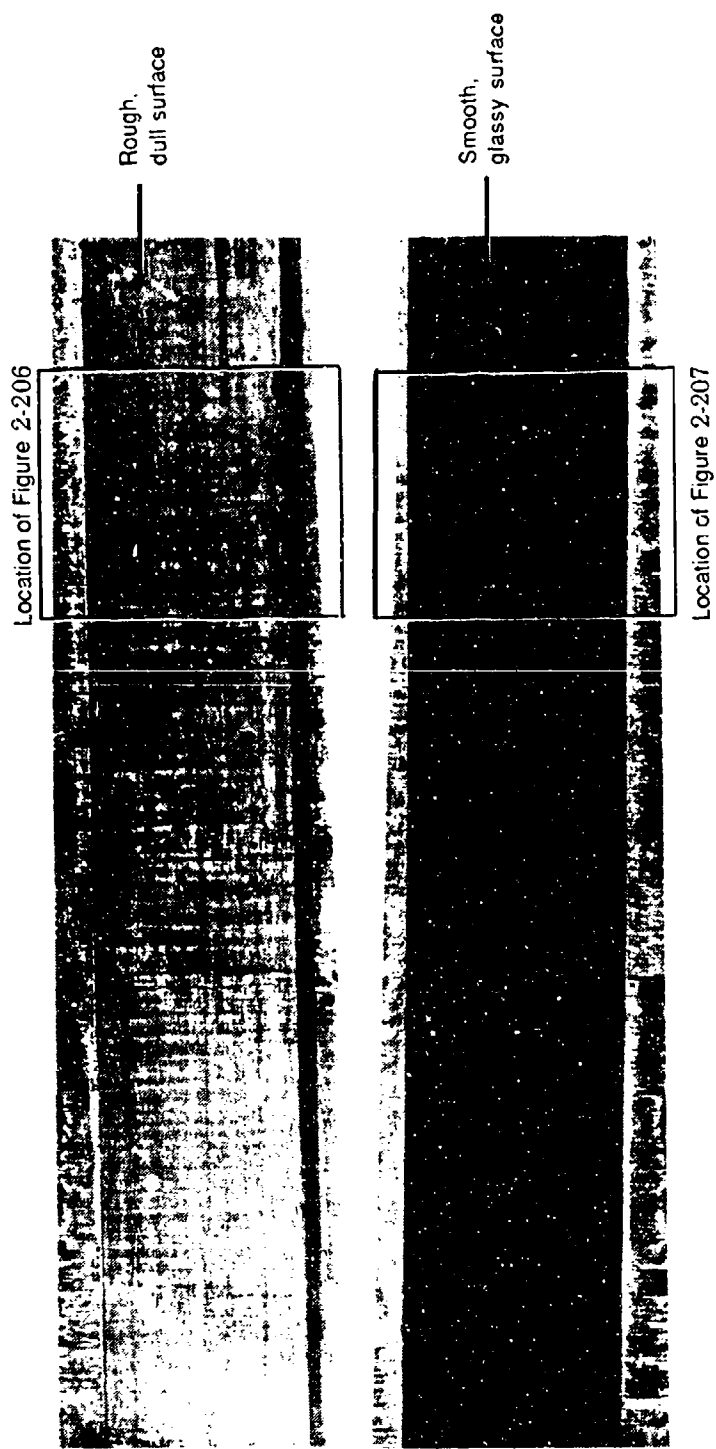
Figure 2-205. Photomicrographs of Interlaminar Mode II Shear, RT/Dry Creep, 0/90 Fracture

Visually, the mating fracture surfaces looked somewhat different: one surface was smooth and glassy, while the other was rough and dull (Figure 2-205). Crack arrest marks were observed on the fracture surfaces at the ends of and at the center of the specimen. SEM fractographs revealed that the glassy surface consisted largely of scallops with some hackles (Figure 2-206), and the rough surface exhibited mainly hackles with some scallops (Figure 2-207).

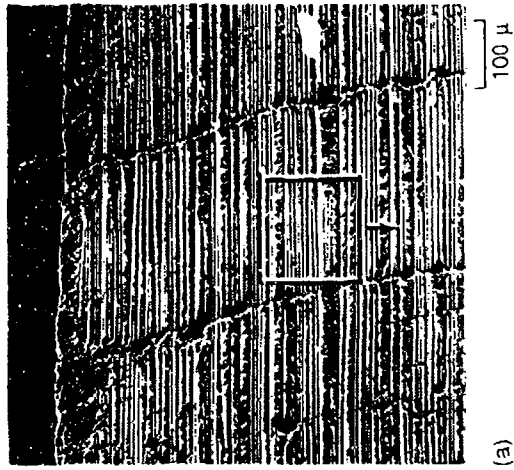
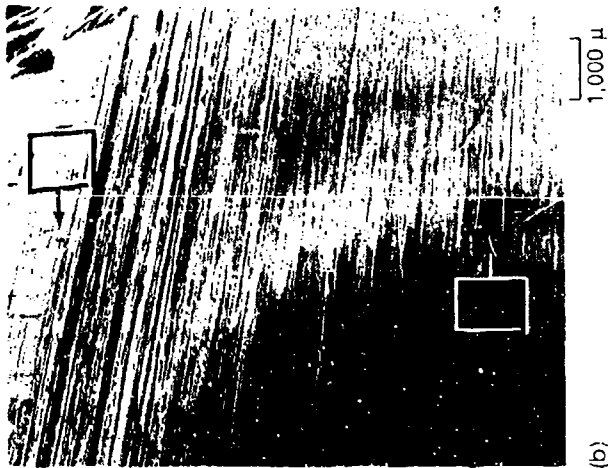
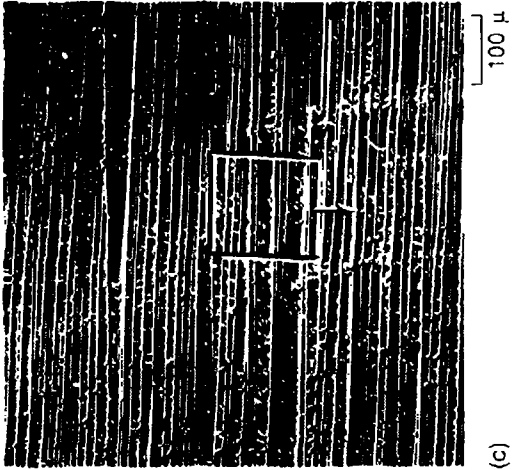
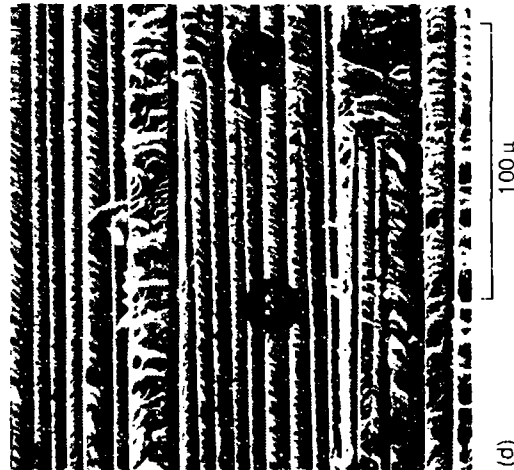
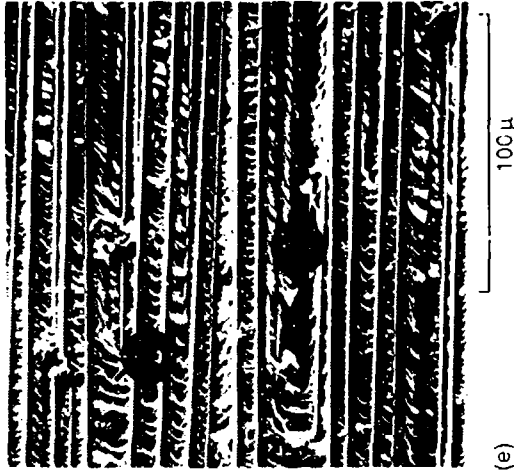
Legend:
 H hackles
 F fiber/matrix separation
 S scallops
 Mechanically induced crack direction

Figure 2-207. SEM Fractographs of Interlaminar Mode II Shear, RT/Dry Creep, 0/90 Fracture Showing Glassy Surface (Area Shown in Figure 2-205b)

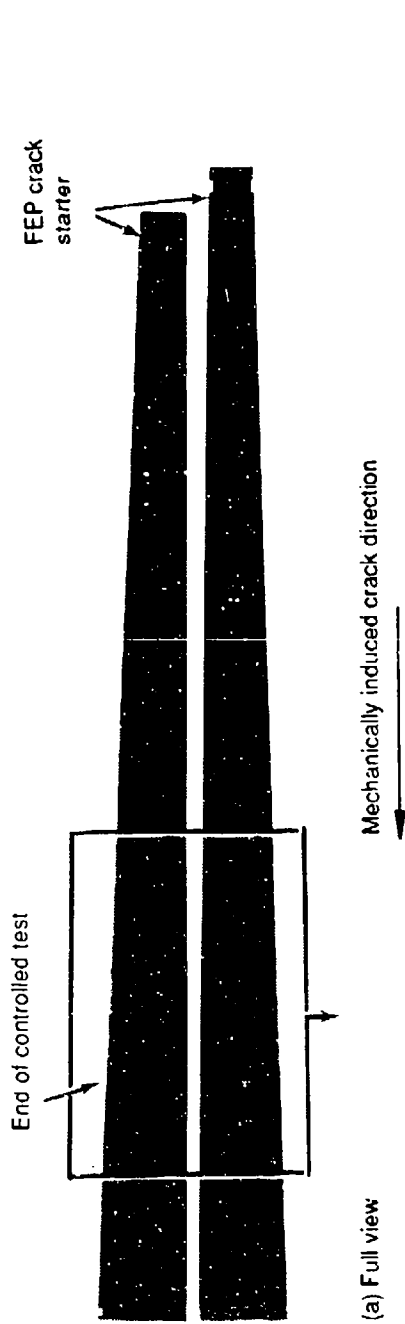
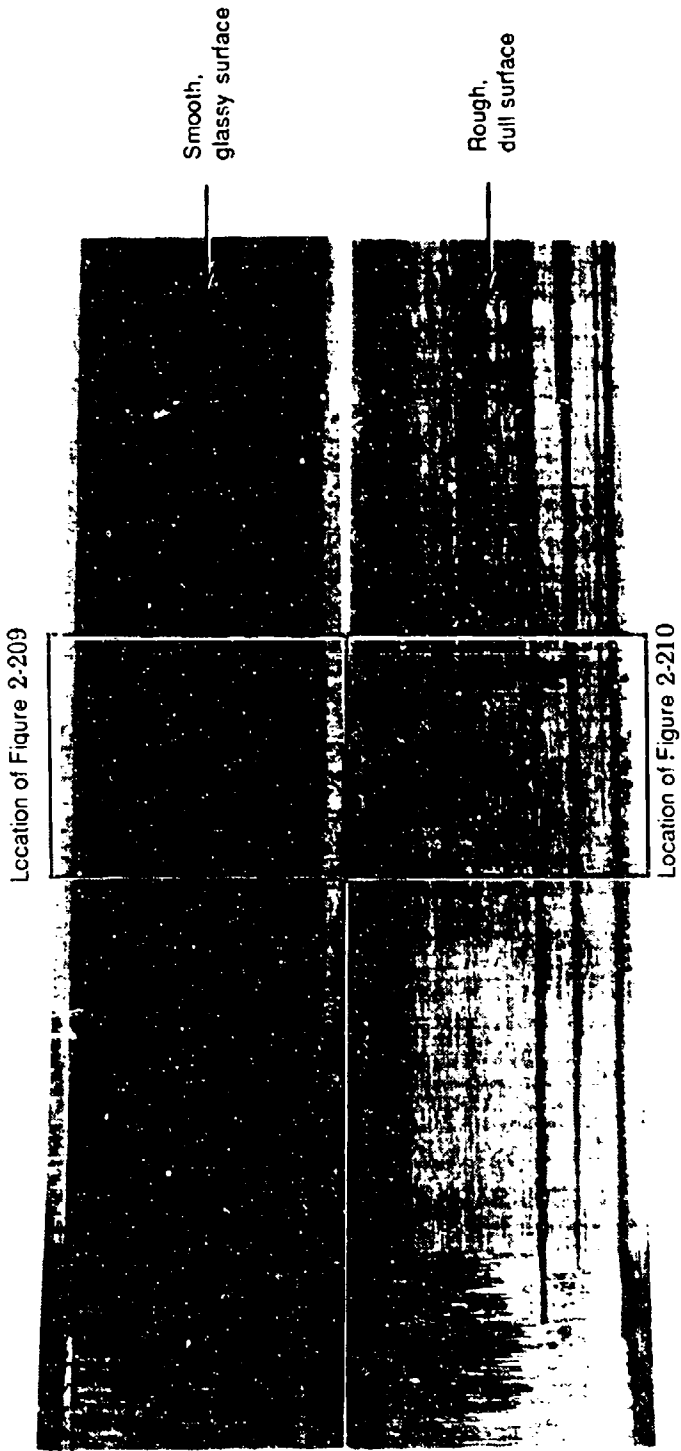
Fracture 2-208. Photomicrographs of Interlaminar Mode II Shear, 270 F/Dry Creep, 0/90 Fracture

Visual examination revealed a fracture with a smooth and glassy surface on one of the mating sides and a rough and dull surface on the other side (Figure 2-208). This was similar to the

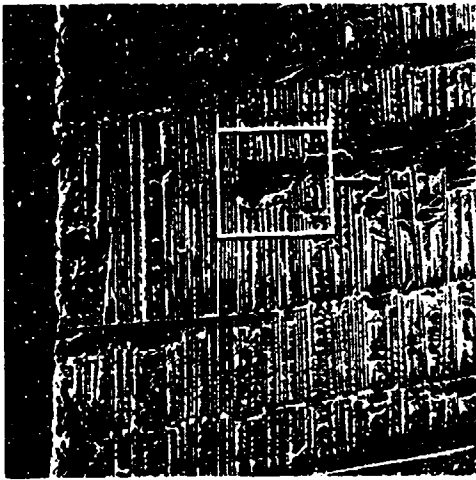
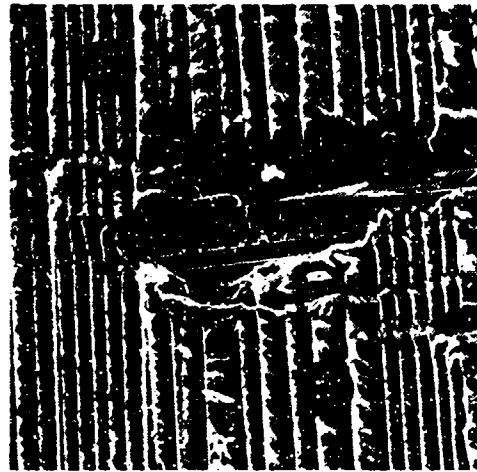
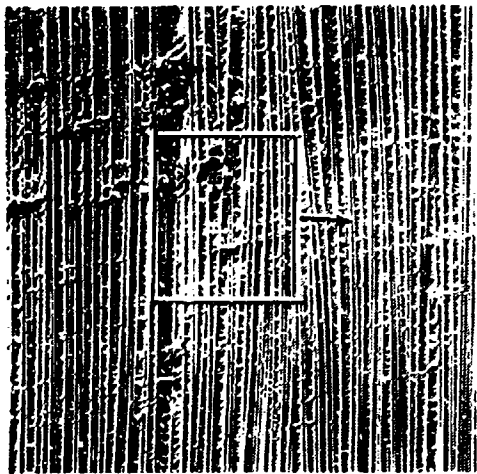
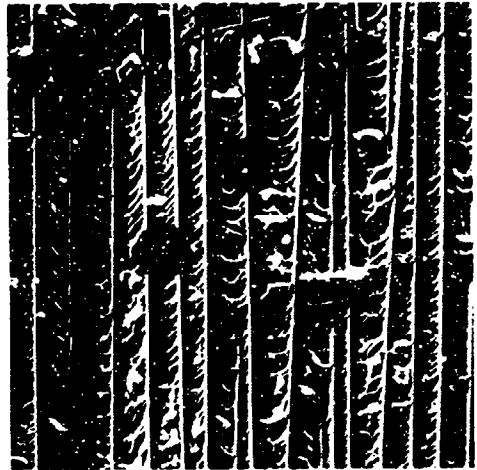
Legend:
 H hackles
 F fiber/matrix separation
 S scallops
 Mechanically induced crack direction

Figure 2-209. SEM Fractographs of Interlaminar Mode II Shear, 270 F/Dry Creep, 0/90 Fracture Showing Glassy Surface (Area Shown in Figure 2-208b)

fracture surfaces created at room temperature. The glassy surface exhibited mostly scallops (with some hackles, Figure 2-209), and the rough surface consisted mostly of hackles (with some scallops, Figure 2-210). Optical and SEM analyses showed no significant features to distinguish the RT and 270°F creep specimens.

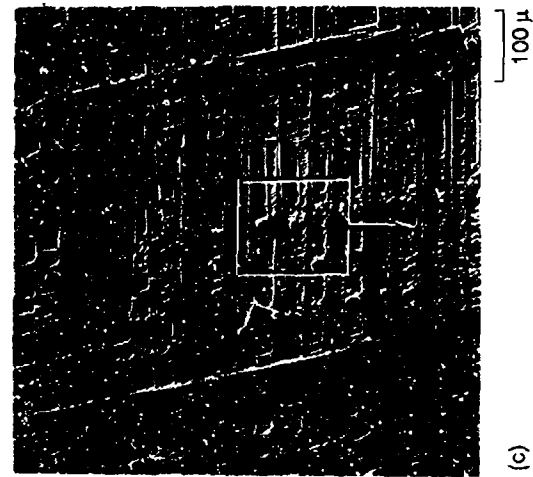
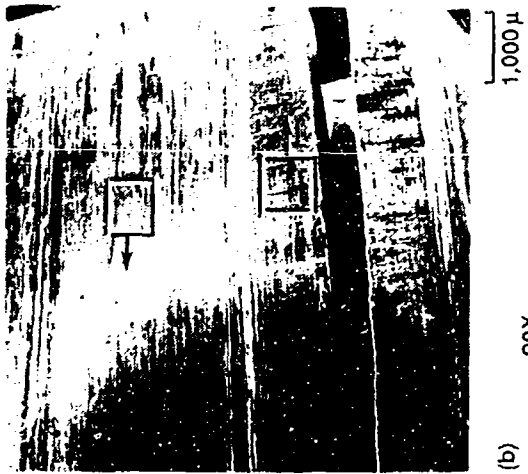
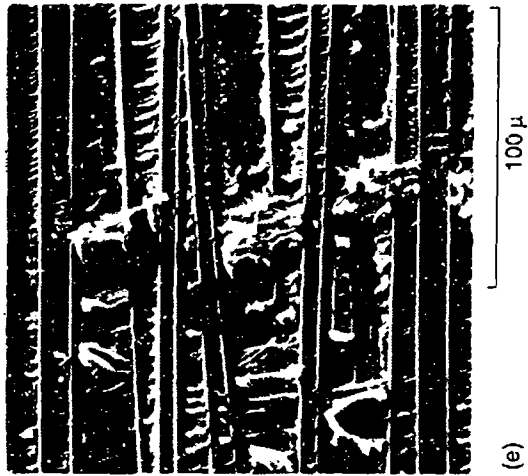
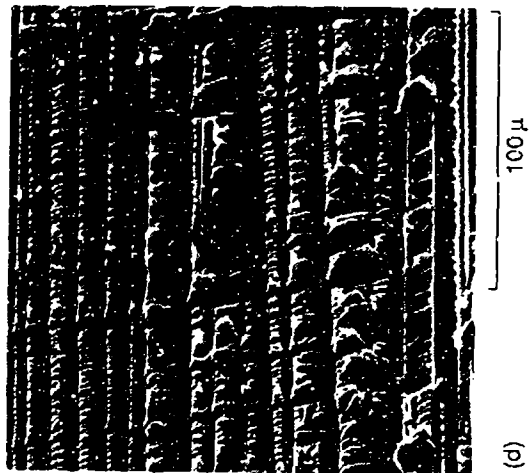
Mechanically induced
crack direction

Figure 2-210. SEM Fractographs of Interlaminar Mode II Shear, 270 F/Dry Creep, 0/90 Fracture Showing Rough Surface
(Area Shown in Figure 2-208b)

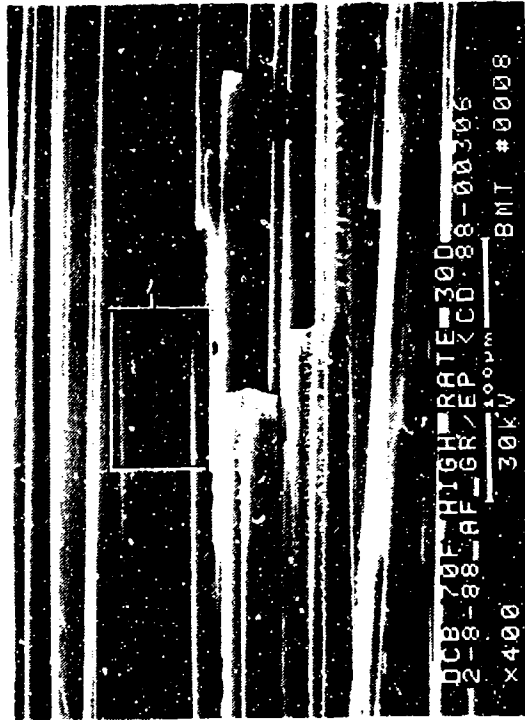
Figure 2-212. SEM Fractographs of Interlaminar Mode I Tension, High Rate, Room Temperature Fracture (Region I of Figure 2-211)

To illustrate the different rates of fracture, two regions on the specimen were documented and analyzed. Region I was created by the initial projectile, and Region II was created by a second projectile penetration. SEM analysis showed that Region I experienced a lower energy fracture than Region II, as evidenced by its rougher surface and more mixed mode fracture (Figure 2-212). This may be a result of the initially delaminated portion driving the crack at a higher rate. There were also many fiber splinters and many areas of 90 degree intralaminar fracture in Region II (Figure 2-213).

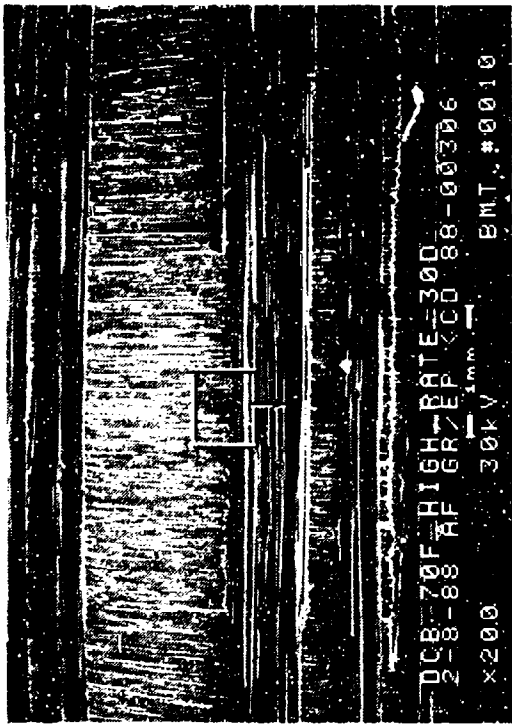
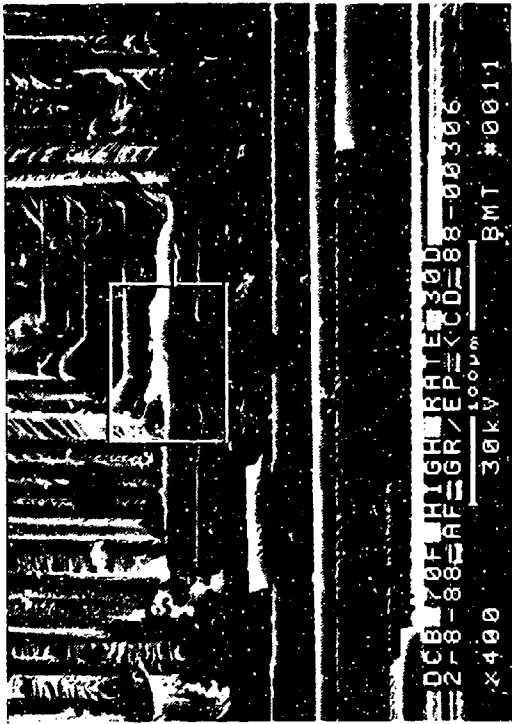
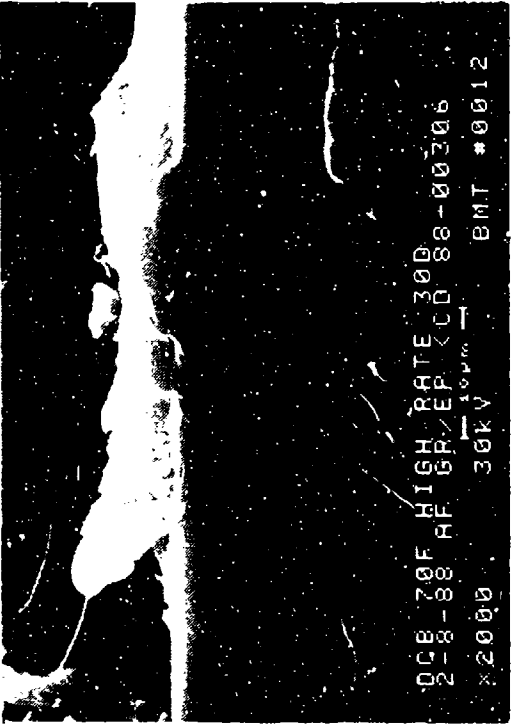
- Legend:**
- R rivermark
 - H hackle
 - F fiber matrix separation
 - M matrix fracture
- Mechanically induced crack direction
-

Figure 2-213. SEM Fractographs of Interlaminar Mode I Tension, High Rate, Room Temperature Fracture (Region II of Figure 2-211)

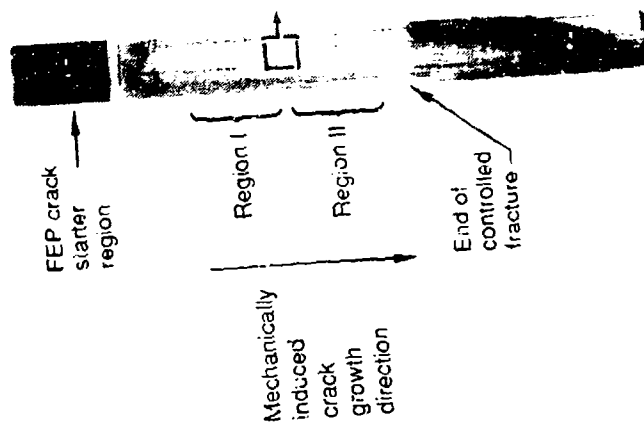
Figure 2-214. Optical Photomicrographs of Interlaminar Mode II Shear, High Rate, Room Temperature Fracture Between the 0/90 Plies

Optical microscopy of the fracture surface showed a difference between the high rate specimen and the typical ENF specimen tested at constant rate (Figure 2-214). Due to the very rapid fracture, hackles were formed in various tilts and shapes; at slower crack growth rates, the hackles tend to form parallel to one another. Regions created by initial and secondary projectile penetration (resulting in different crack growth rates) exhibited no distinctly different features (Figures 2-215 and 2-216).

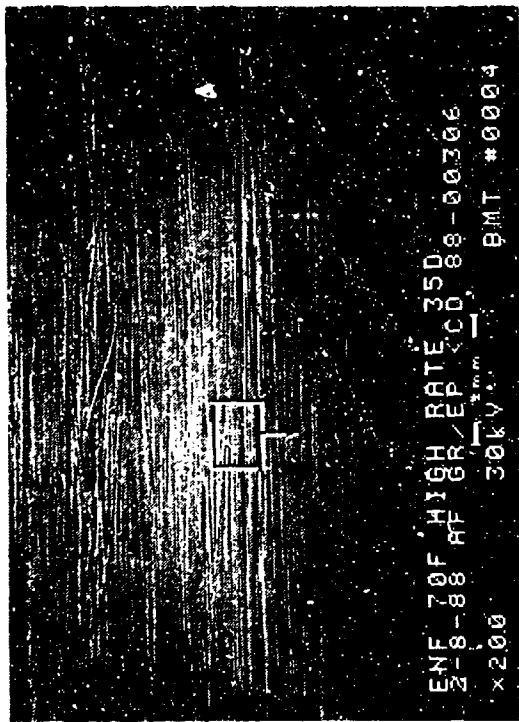
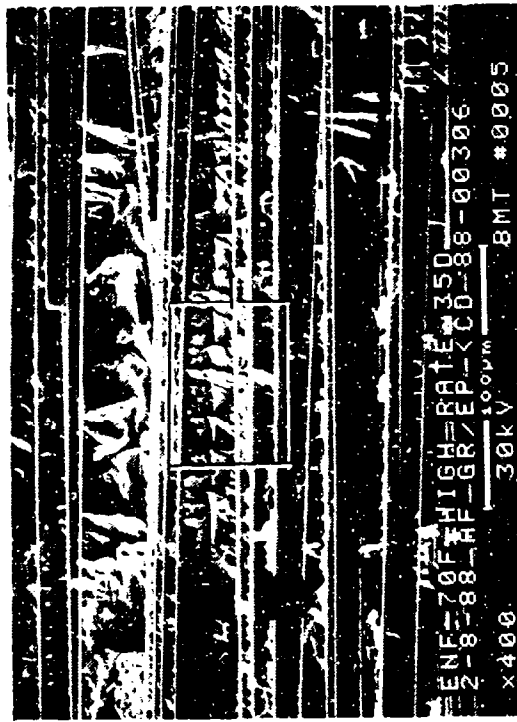
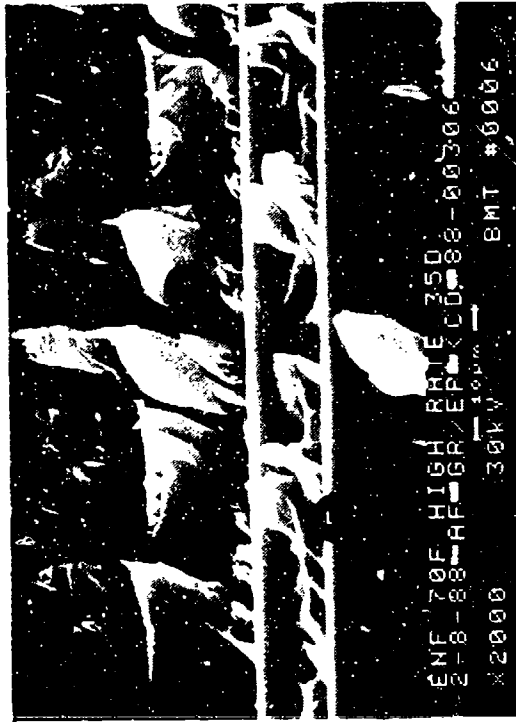
- F fiber matrix separation
- H hackle
- S scallop
- M matrix fracture

Figure 2-215. SEM Fractographs of Interlaminar Mode II Shear, Room Temperature, High Rate Fracture (Region I of Figure 2-214)

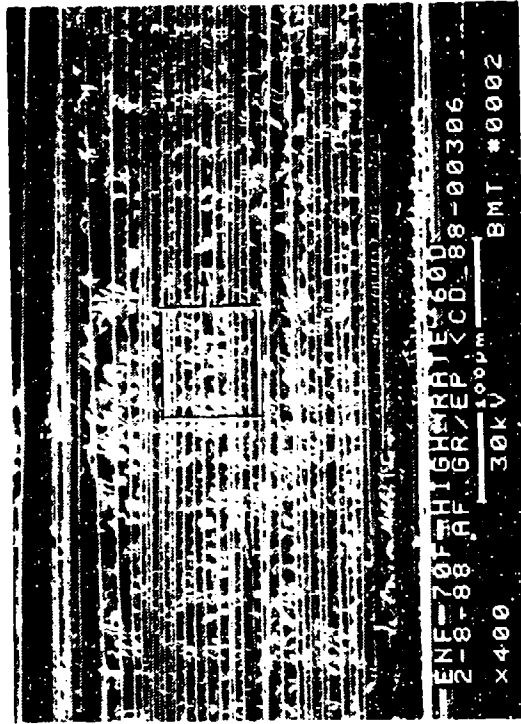
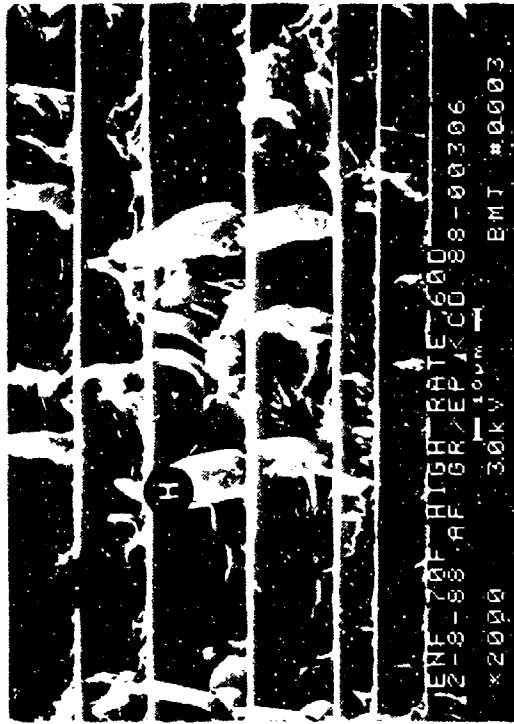
- F fiber matrix separation
- H hackle
- S scallop
- M matrix fracture

Figure 2-216. SEM Fractographs of Interlaminar Mode II Shear, Room Temperature, High Rate Fracture (Region II of Figure 2-214)

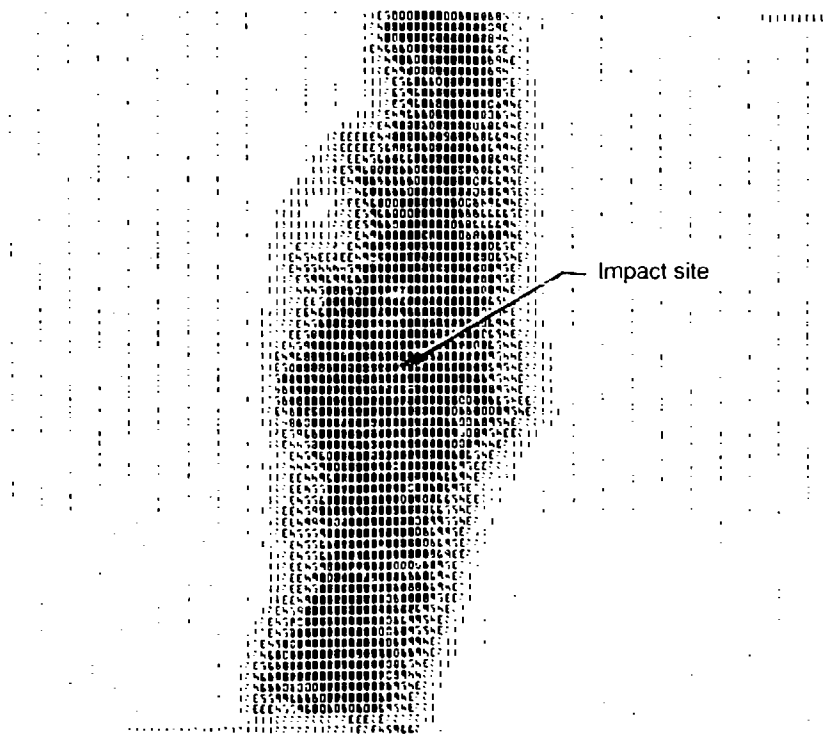
Figure 2-217. Extent of Impact Damage Identified by Through Transmission Ultrasonic (TTU) Scan of Impact Specimen

Visual inspection revealed extensive buckling damage around the point of impact. Failure of the panel occurred in a band approximately 1.0 to 1.5 inches wide across the full width of the panel (Figure 2-217). TTU indicated a delamination which was exposed for further examination to determine the mode of failure in the vicinity of the impacted area. An examination was conducted under the optical microscope. In the region immediately surrounding the impact site (0.3 inch in diameter), the features were predominantly hackle formations indicating Mode II shear failure. The outer perimeter of the impact site was predominantly covered with rivermarks and resin microflow indicating Mode I tension failure (Figure 2-218). The crack initiated at the impact site and propagated radially through the specimen from the tool side in both interlaminar and translaminar fracture modes (Figure 2-219). Figure 2-220 shows CAI fractography performed by Boeing on a [0/45/90]_{8s} laminate. Additional CAI test fractography of a [0/45/90]_{8s} Gr/Ep laminate is shown in Figure 2-170.

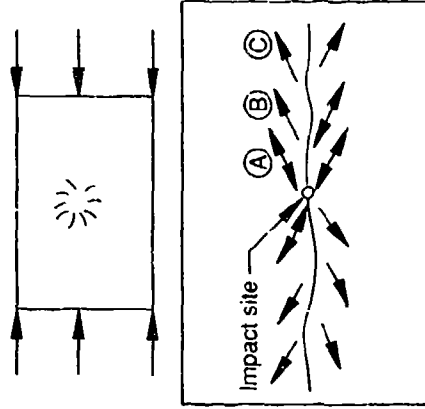
Key to crack growth direction arrows:
 ↑ Mode I tension
 ↗ ↘ Mode II shear

Figure 2-218. Optical Photomicrographs of Interlaminar Fracture of Compression-After-Impact, RT/Dry, [0/+45/90/-45]_{4s} Specimen

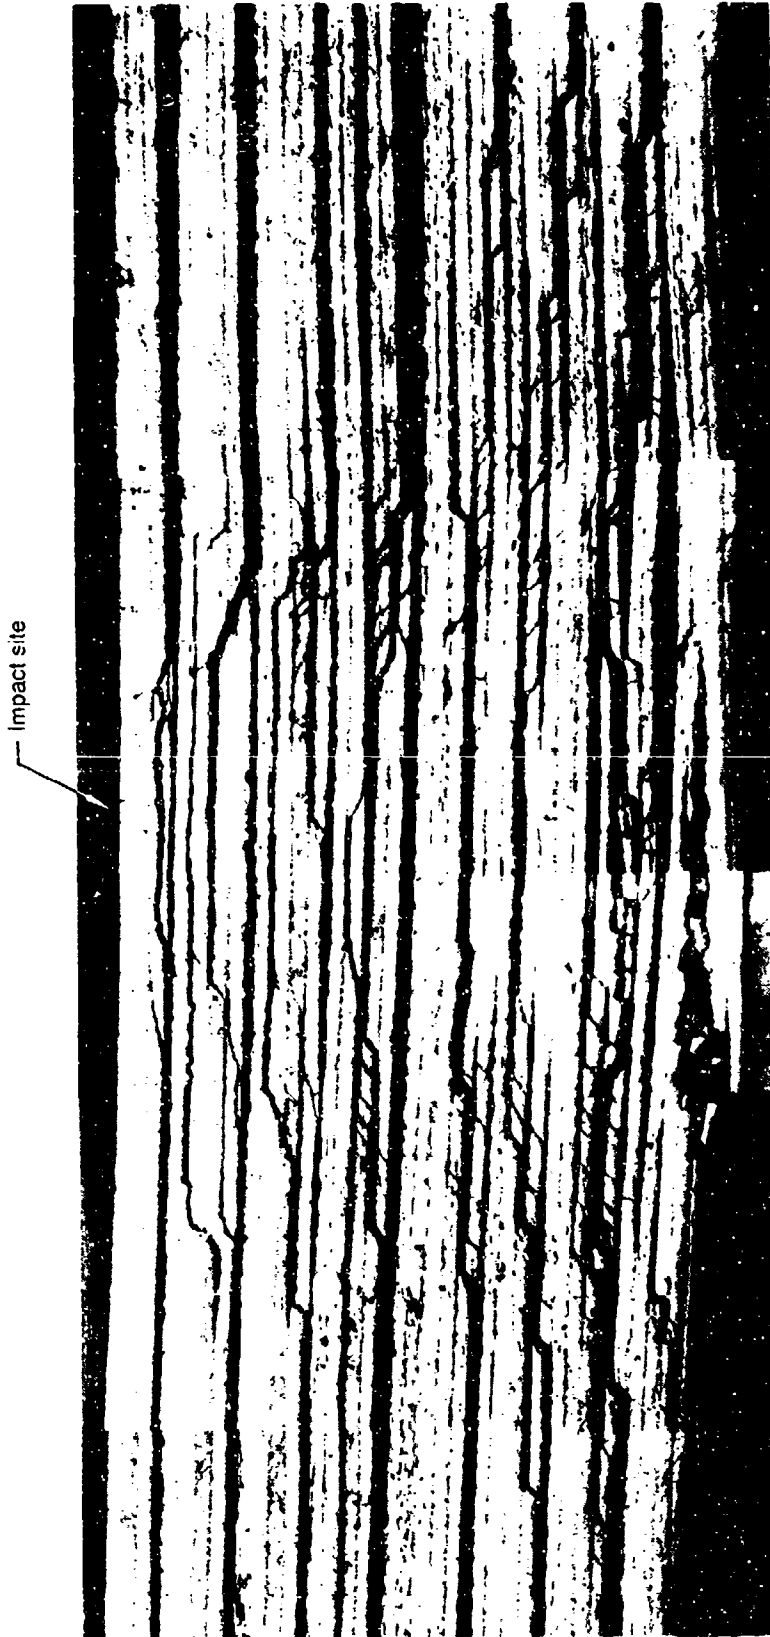
Figure 2-219. Cross-Sectional View of Compression-After-Impact, RT/Dry, [0/+45/90/-45]_s Specimen
