WL-TR-91-4032
DOT/FAA/CT-91/23
VOL II, Part 2

COMPOSITE FAILURE ANALYSIS HANDBOOK
VOL II - TECHNICAL HANDBOOK
PART 2 - ATLAS OF FRACTOGRAPHS

February 1992

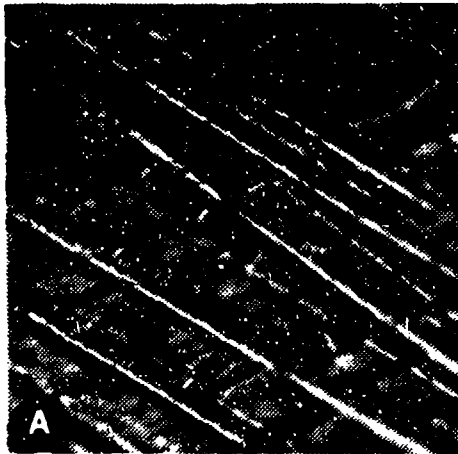
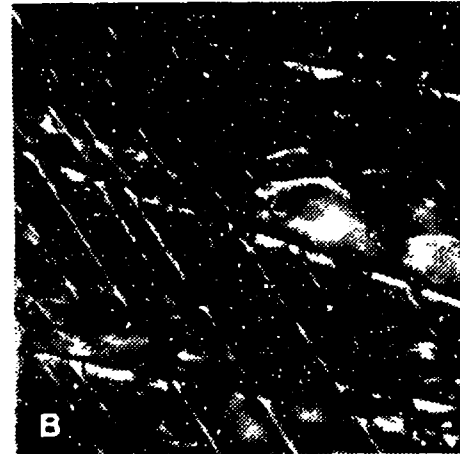
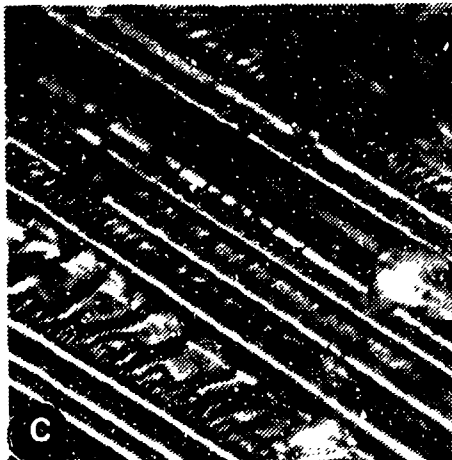
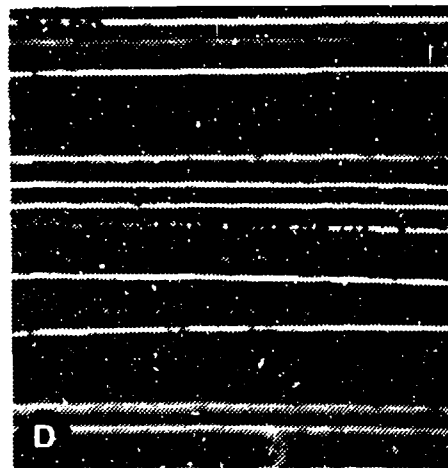
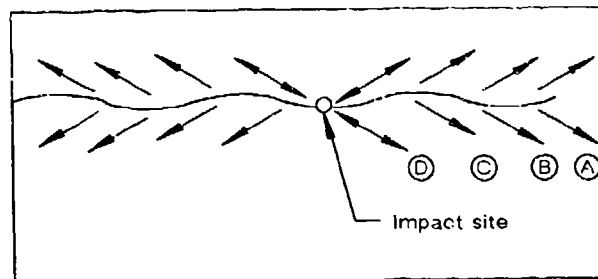
Fracture type	Interlaminar/translaminar
Ply layup	[0, 45, 90] _{gS}
Test type	Compression after impact
• Test conditions	Dry
• Fracture between	0/45/90 plies
Material	Hercules 3501-6/177°C cure AS4 fibers

Figure 2-220. SEM Photographs of Interlaminar/Translaminar Compression After Impact, 0/45/90 Fracture

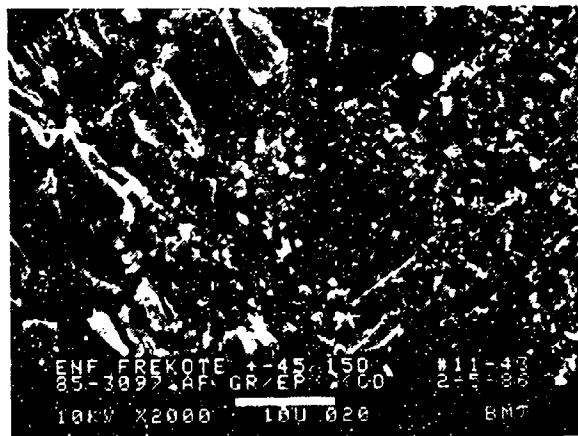
Fracture type	Interlaminar mode I tension
Ply layup	[0, 45] 12S
Test type	DCB with Frekote contamination
• Test conditions	21°C, dry
• Fracture between	0, 45 plies
Material	Hercules 3501-6/177°C cure AS4 fibers

Fracture type	Interlaminar mode II shear
Ply layup	[+ 45, -45] 12S
Test type	ENF with Frekote contamination
• Test conditions	21°C, dry
• Fracture between	+45/-45 plies
Material	Hercules 3501-6/177°C cure AS4 fibers

Figure 2-222. SEM Photographs of Interlaminar Mode I Tension and Mode II Shear, 0/45 and 45/45 Fractures, Frekote Contamination, 70 F/Dry

Figures 2-221 and 2-222 show photomicrographs of contaminants, Teflon and Frekote. When photomicrographs exhibit fractured resin particulate in the regions of contamination, it becomes more difficult to identify smooth adhesive separation. This contribution was made by Boeing.

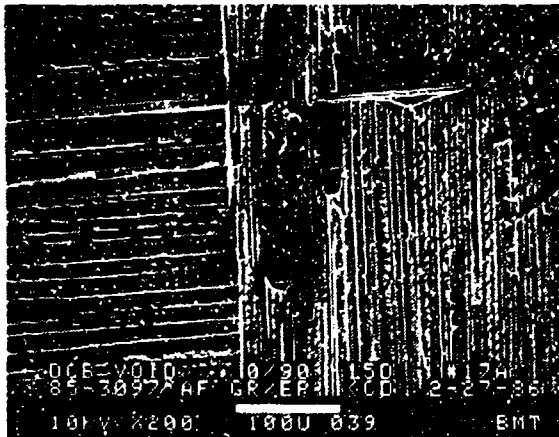
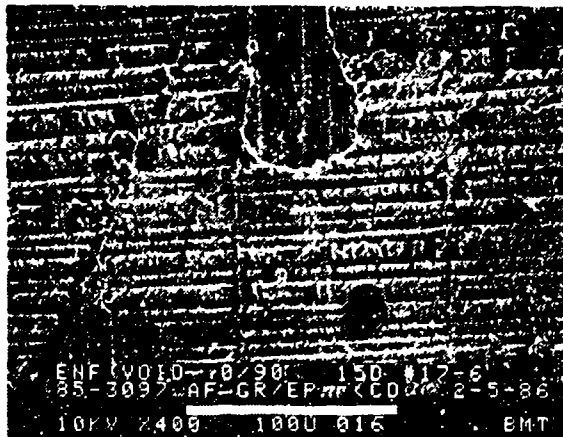
Fracture type	Interlaminar mode I tension
Ply layup	[0, 90] 12S
Test type	DCB—high void content
• Test conditions	21°C, dry
• Fracture between	0/90 plies
Material	Hercules 3501-6/177°C cure AS4 fibers

Figure 2-223. SEM Photographs of Interlaminar Mode I Tension and Mode II Shear, 0/90 Fractures, With Voids, 70 F/Dry

Figure 2-223 shows microphotographs of two test types of voids, DCB and ENF. This contribution was made by Boeing.

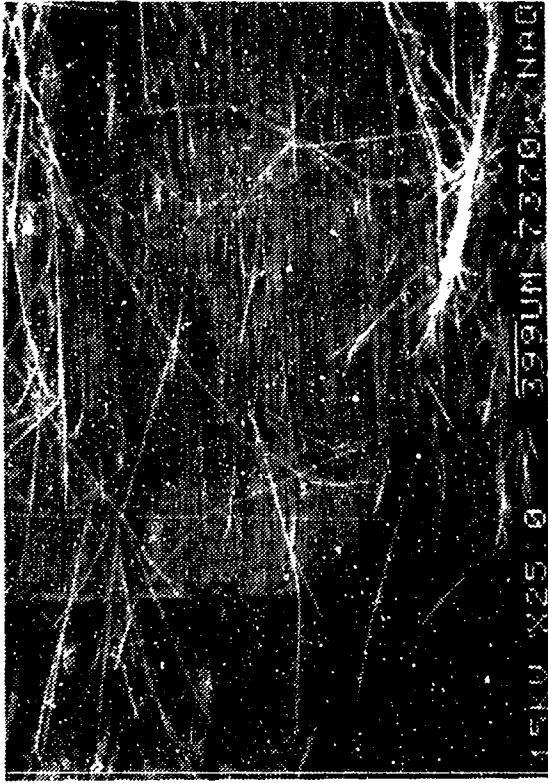
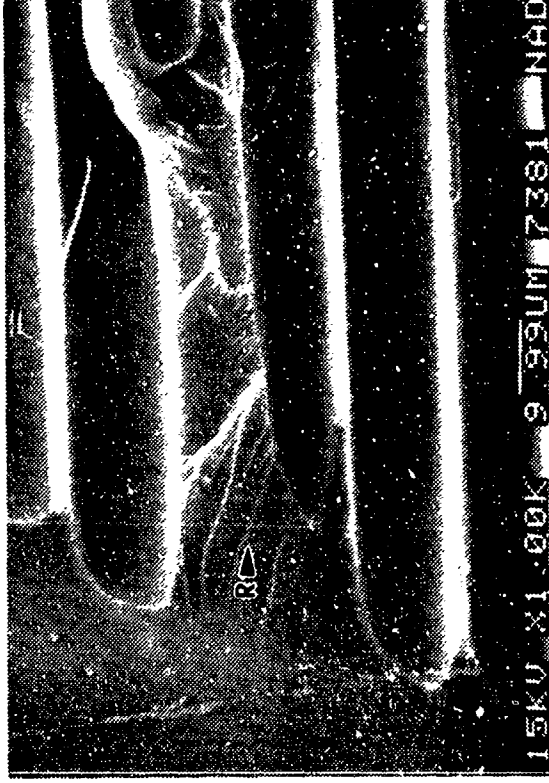
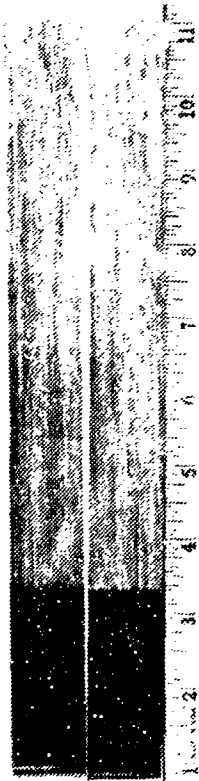
Figure 3-1. Optical and SEM Photographs of Mode I DCB Interlaminar Tension Fracture in 49/3501-6 Kevlar/Ep - [0]₂T, Room Temperature Ambient
 (a) Macro photograph of Fracture
 (b) Fiber Pull-Out
 (c) River Patterns (R) in Fractured Resin

CD = Crack-propagation direction

Fractographs of 49/3501-6 Kevlar/epoxy are provided for interlaminar testing in Figures 3-1 through 3-9 and for translaminar testing in Figures 3-10 through 3-15. This contribution was made by Northrop.

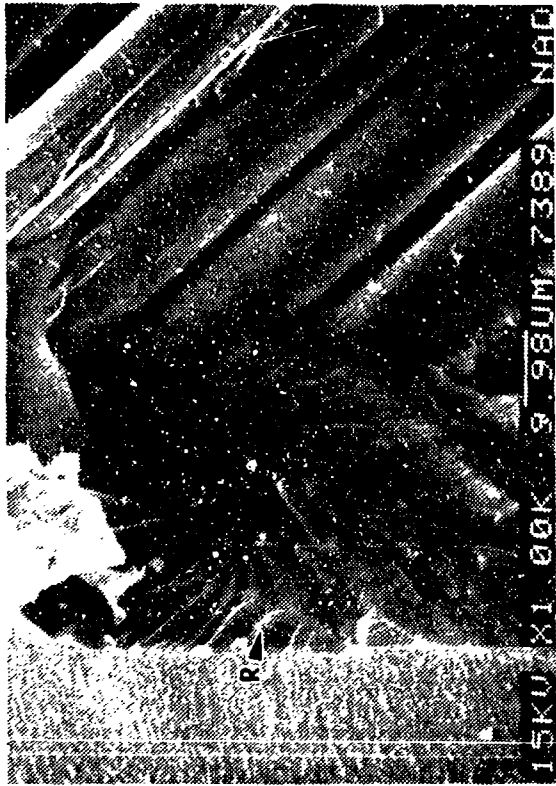
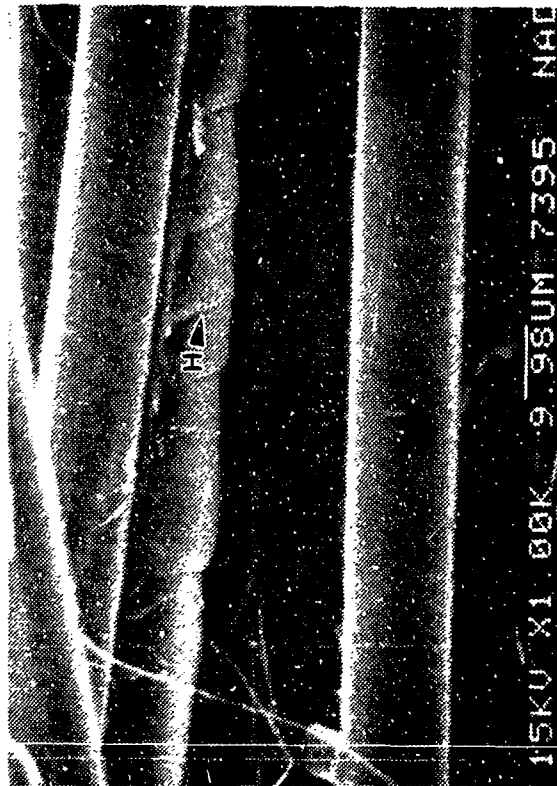
- (a) Macro photograph of Fracture
- (b) River Patterns (R) at Initiation Site
- (c) Hackles (H) in Fractured Resin

CD = Crack-propagation direction

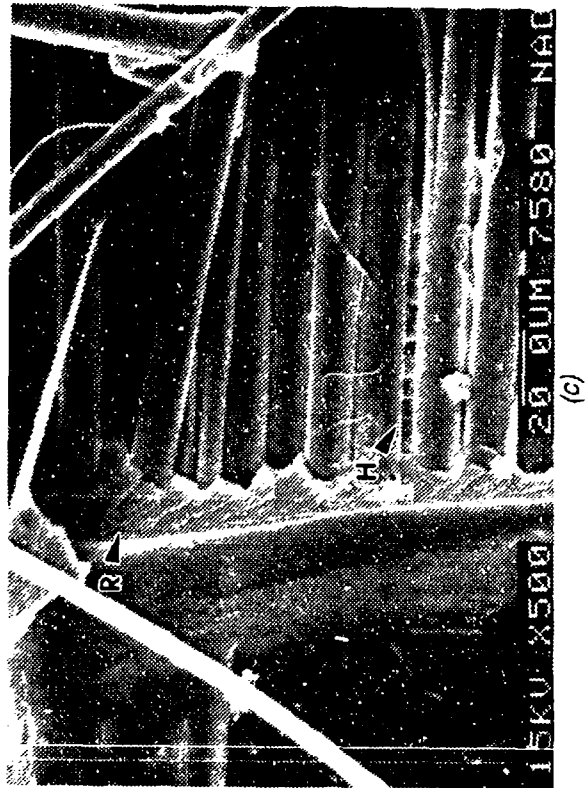
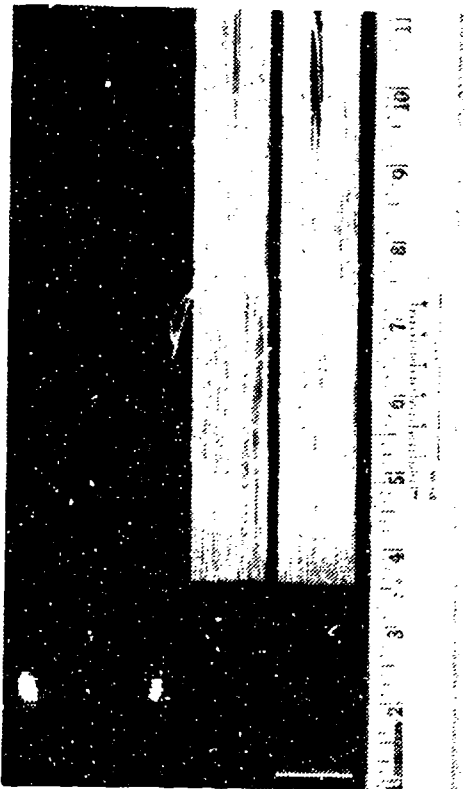
Figure 3-3. Optical and SEM Photographs of Mode I DCB Interlaminar Tension Fracture in 49/3501-6 Kevlar/Ep - [0]_{2AT}, Conditioned 180 F Dry, ~ Weeks Before Test

(a) Macro photograph of Fracture

(c) River Patterns (R) and Hackles (H) in Pre-crack Region

CD = Crack-propagation direction

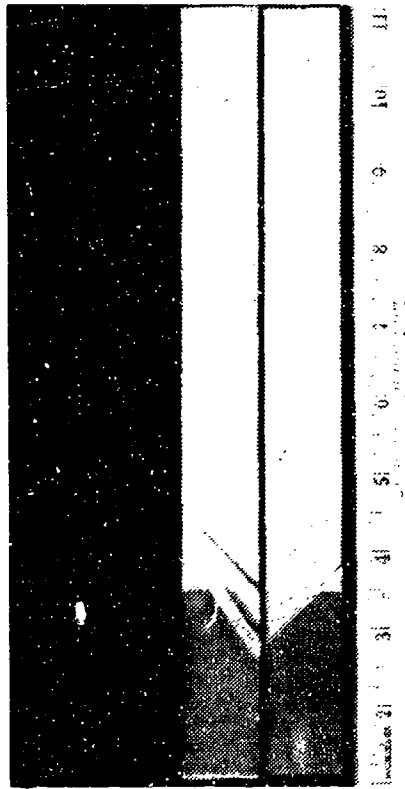
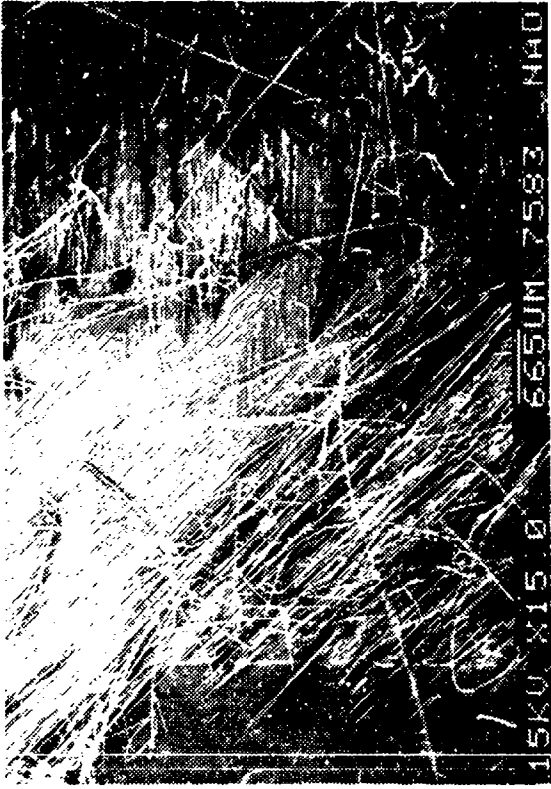
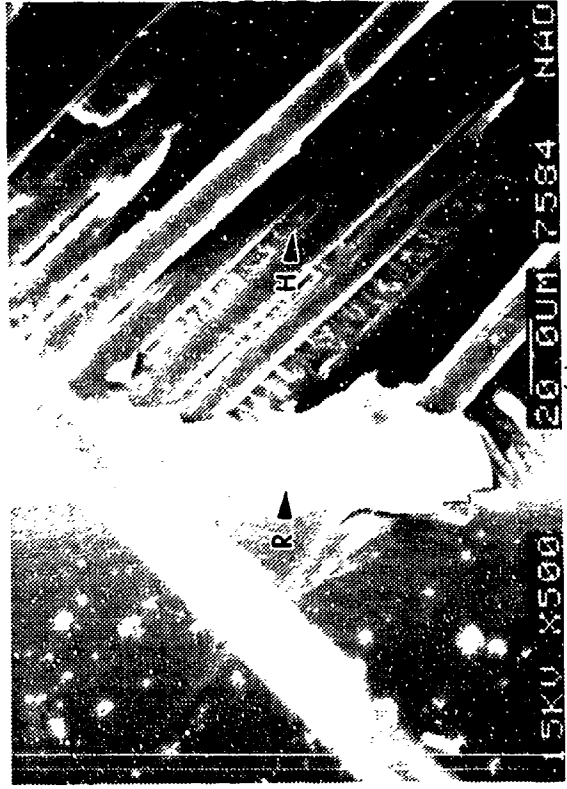
Figure 3-4. Optical and SEM Photographs of Mode I DCB Interlaminar Tension Fracture in 49/3501-6 Kevlar/Ep - [+45/0/-45]_{4s}, Water Immersed Before Test
 (a) Macro photograph of Fracture
 (b) Fiber Pull-Out
 (c) Rivers (R) and Hackles (H) in Fractured Resin
 CD = Crack propagation direction

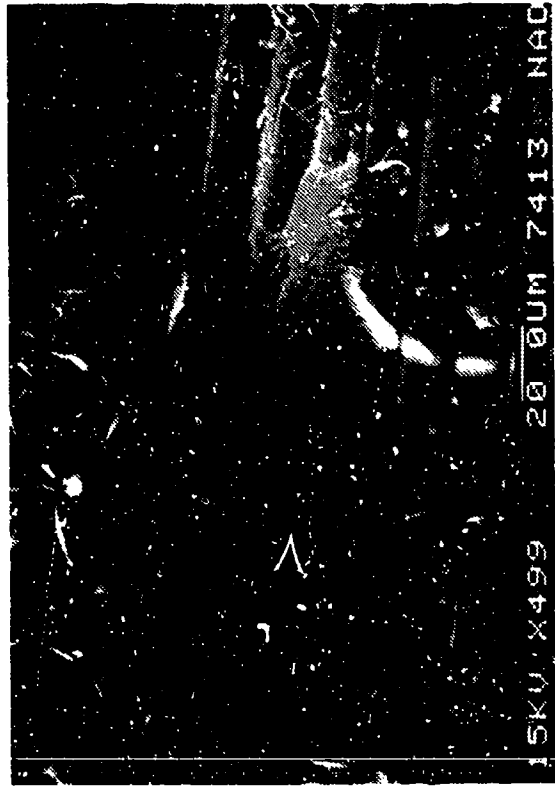
Figure 3-5. Optical and SEM Photographs of Mode II ENF Interlaminar Shear Fracture in 49/3501-6 Kevlar/Ep - [0]_{24T}, Room Temperature Ambient
 (a) Macro photograph of Fracture
 (b) Pre-crack Region Showing Fibrils
 (c) River Patterns in Pre-crack Region (Arrow)

CD = Crack-propagation direction

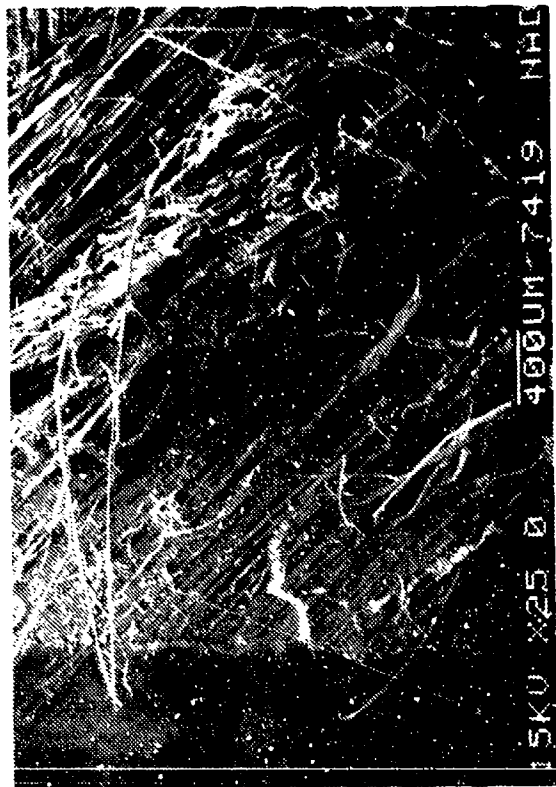
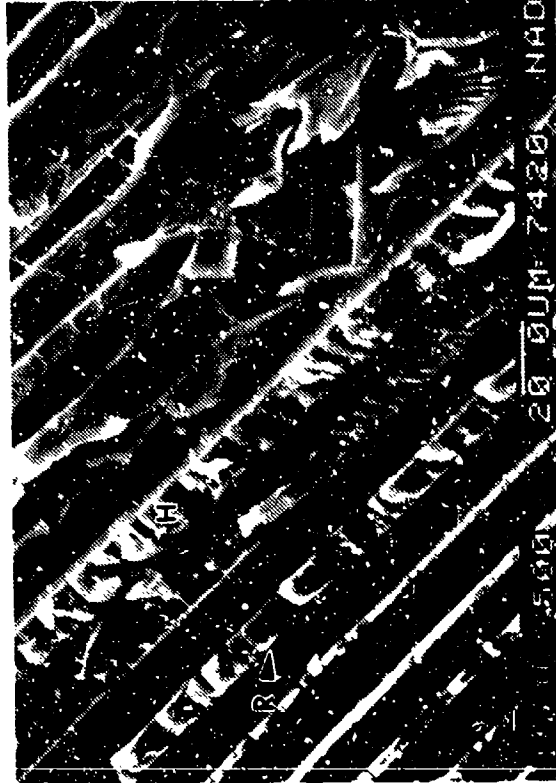
Figure 3-6. Optical and SEM Photographs of Mode II ENF Interlaminar Shear Fracture in 49/3501-6 Kevlar/Ep - [+45/0/-45]_{4s} . Room Temperature Ambient

(a) Macrograph of Fracture

R = Rivers

C/D = Crack propagation direction

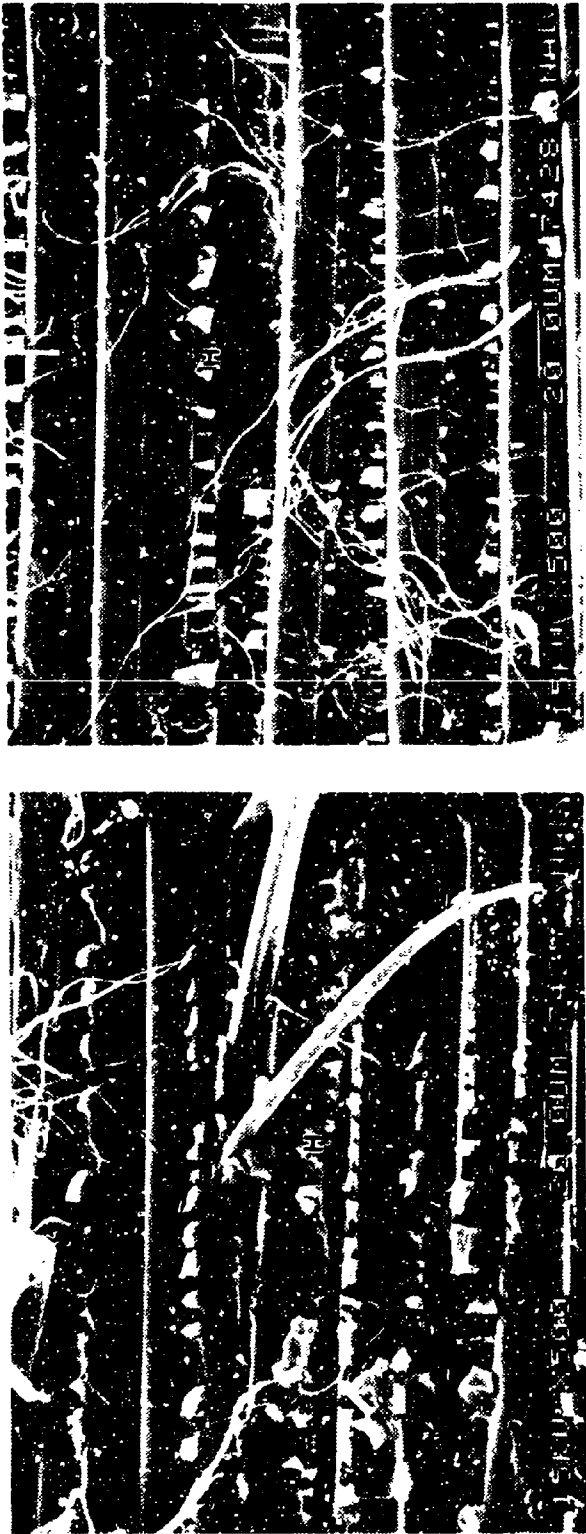
Figure 3-7. SEM Photographs of Mode II ENF Shear Crack-Growth Regions in
 49/3501-6 Kevlar/Ep, Room Temperature Ambient
 (a) $[0]_{24T}$ Specimen
 (b) $[-45/0/-45]_{4S}$ Specimen

CD = Crack-propagation direction
 H = Hachies

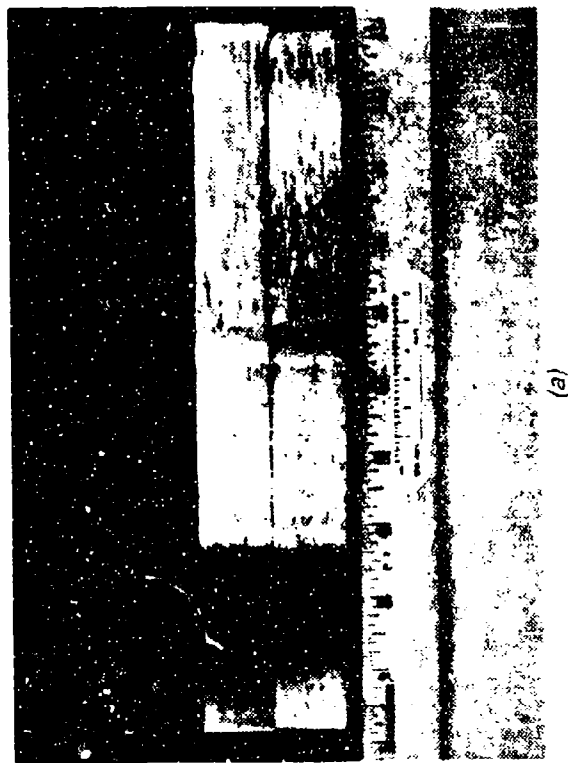
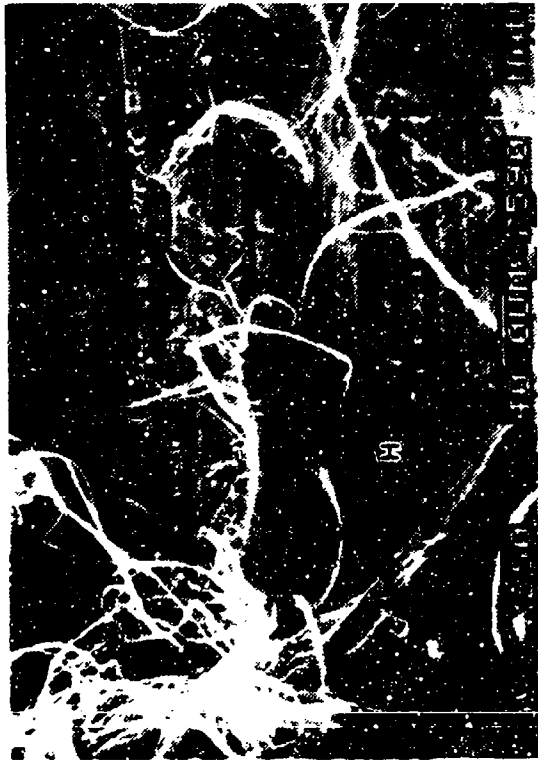
Figure 3-8. Optical and SEM Photographs of Mode II ENF Interlaminar Shear Fracture in 49/3501-6 Kevlar/Ep - [0]_{24T}. Conditioned 180 F Dry
 (a) Macro photograph of Fracture
 (b) Precrack Region Showing Fibrils
 (c) Crack-Growth Region Showing Hackles (H)

CL = Crack propagation direction

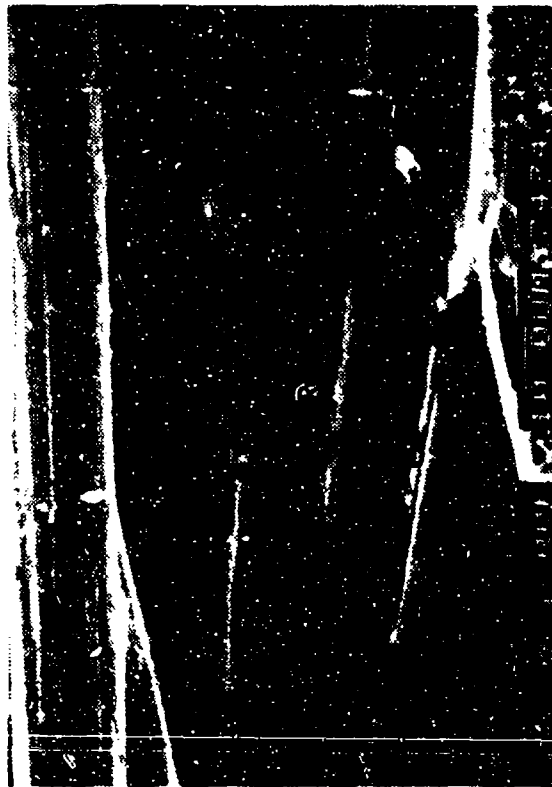
Figure 3-9. Optical and SEM Photographs of Mode I and Mode II MMF Interlaminar Fracture in 49/3501-6 Kevlar/Ep. [0] _{24T}. Room Temperature Ambient
 (a) Macrophotograph of Fracture
 (b) Fibril Formation in Crack-Growth Region
 H - 1 tracks
 (c) River Patterns (R) in Crack-Growth Region Oriented Toward CD
 CD = Crack propagation direction

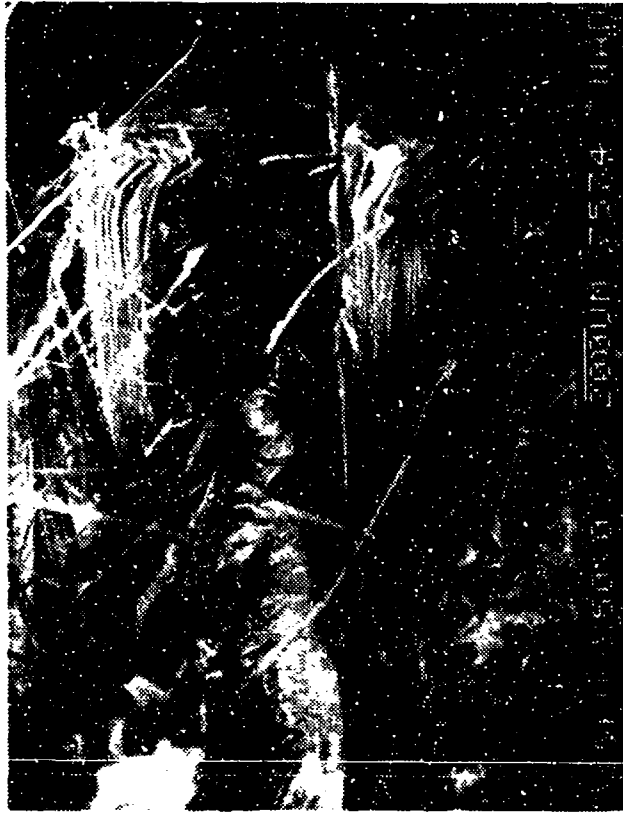
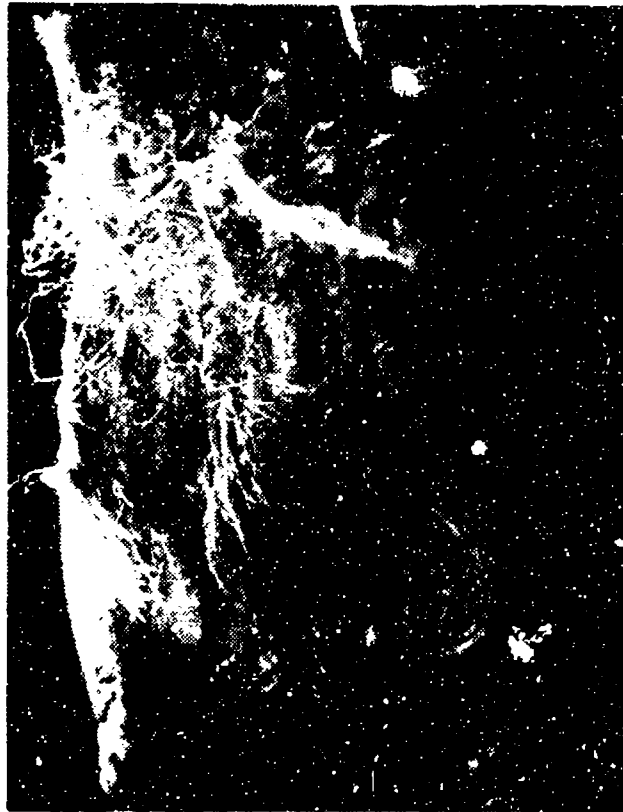
Figure 3-11. SEM Photographs of Mode I Translaminar Tension Fracture in 49/3501-6 Kevlar/Ep - [90/0]_{8s}, Conditioned 180 F Dry
(a) Dense Tangles of Fibrils
(b) Buckling of Plies

CD = Crack-propagation direction

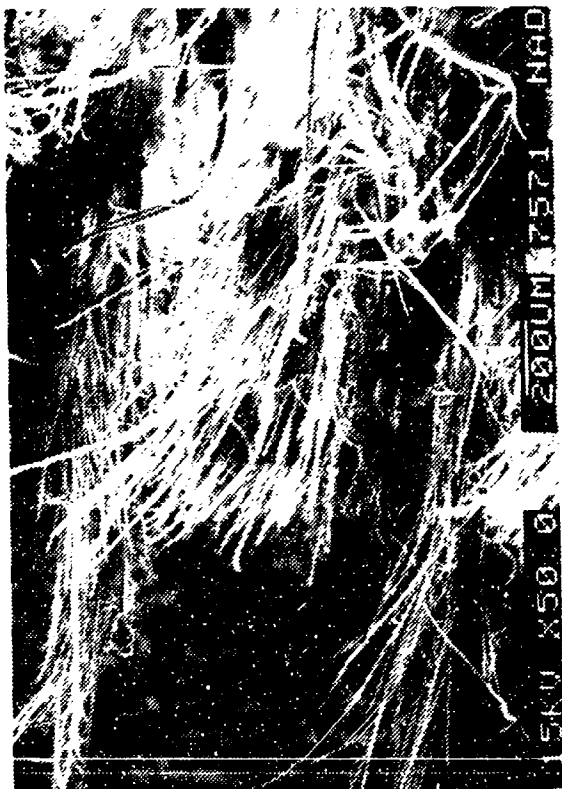
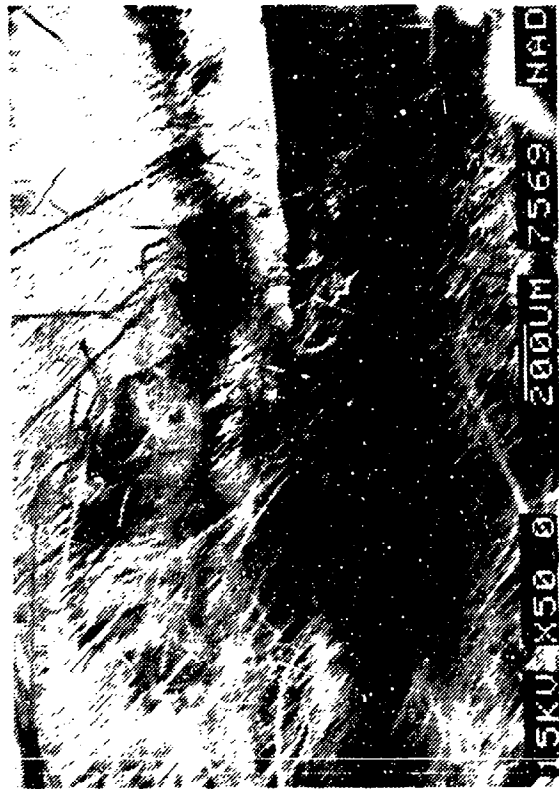
Figure 3-12. SEM Photographs of Mode I Translaminar Compression Fracture in 49/3501-6 Kevlar/Ep - [90/0] as. Room Temperature Ambient
 (a) Macrophotograph
 C = Compression region
 T = Tension region
 (b) Fiber Ends in Compression Region
 (c) Tension Fracture Region
 CD = Crack propagation direction

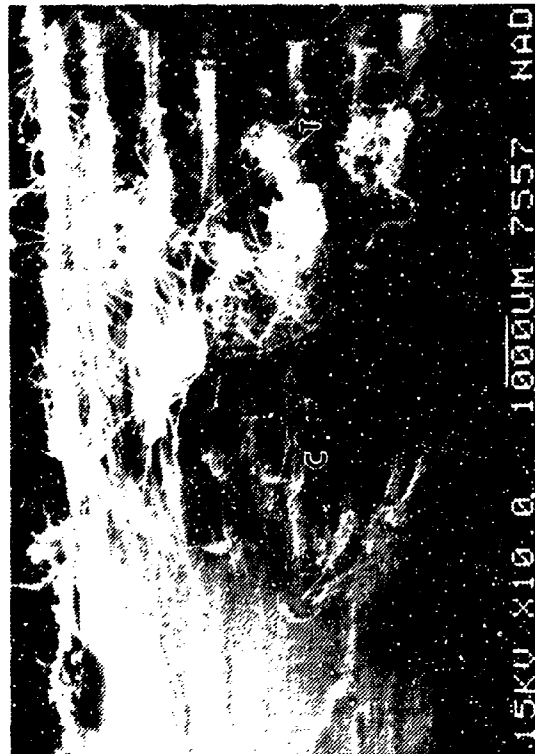
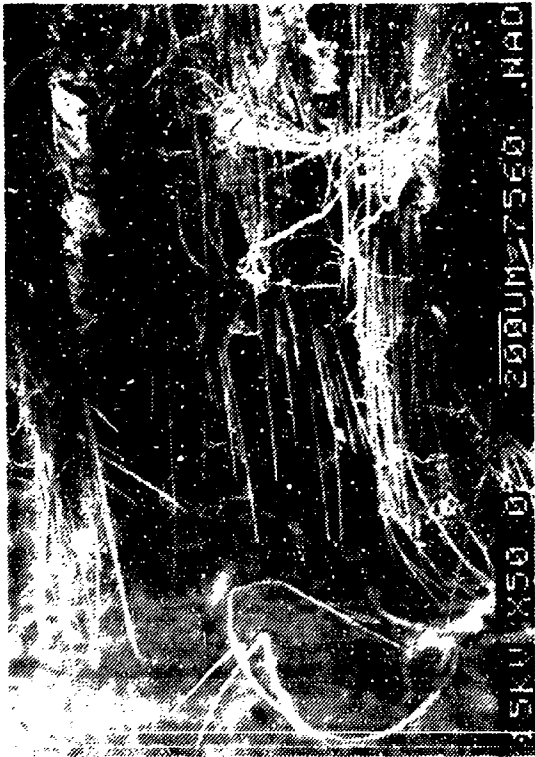
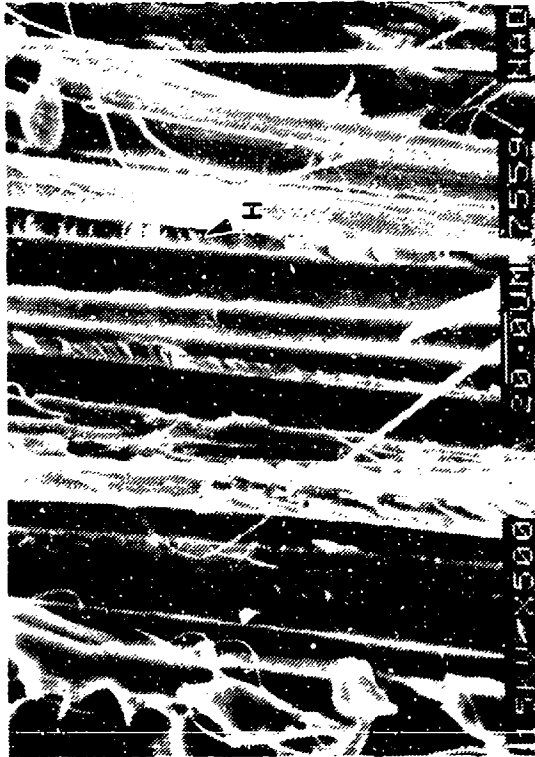
Figure 3-13. SEM Photographs of Mode I Translamellar Compression Fracture in 49/3501-6 Kevlar/Ep-32 Ply/Quasi-Isotropic, Room Temperature Ambient

(b) Fiber Ends in Compression Region
 (c) Hackles (H) in Tension Fracture Region

CD = Crack-propagation direction

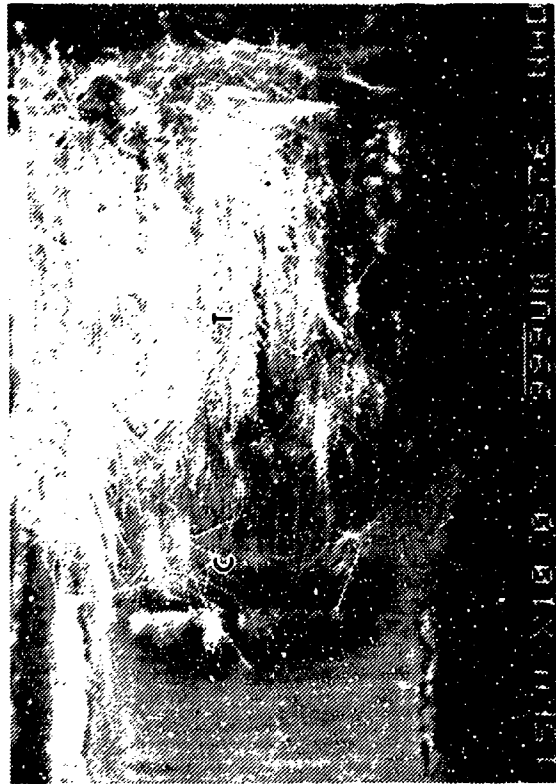
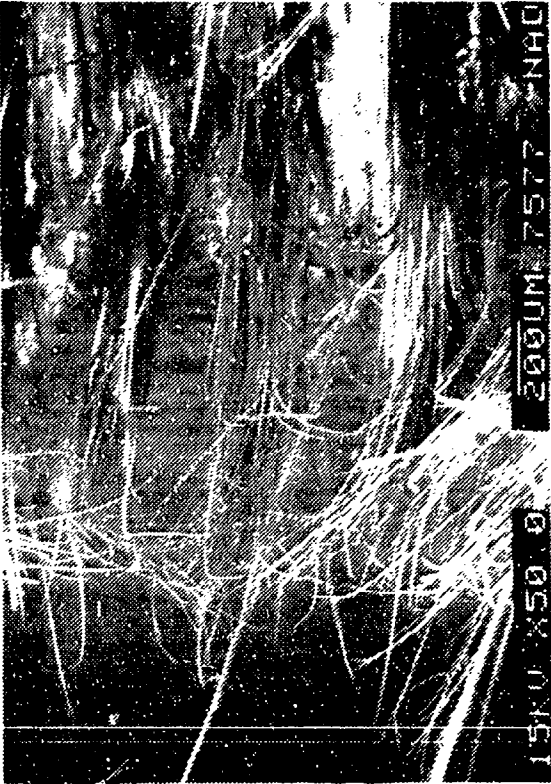
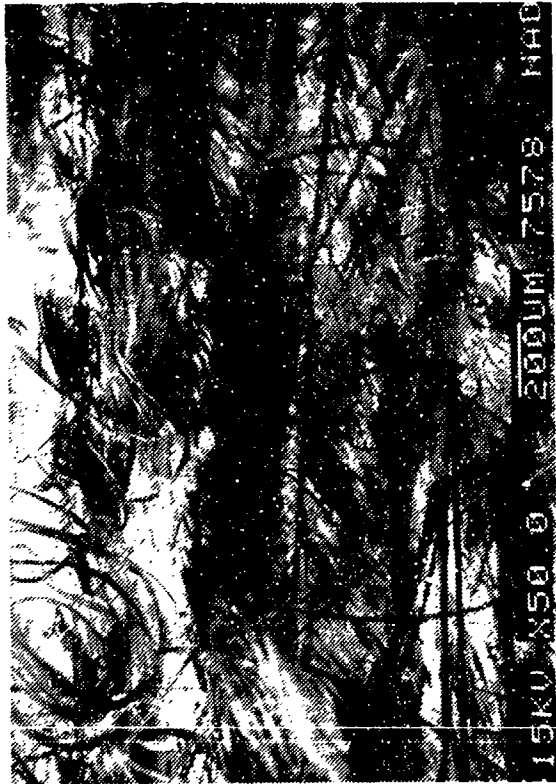
Figure 3-14. SEM Photographs of Mode I Translaminar Compression Fracture in 49/3501-6 Kevlar/Ep-[90/0]_{ss}, Water Immersed Before Test
 (a) Macro photograph
 C = Compression region
 T = Tension region
 (b) Fiber Ends in Compression Region
 (c) Tension Fracture Region
 CD = Crack propagation direction

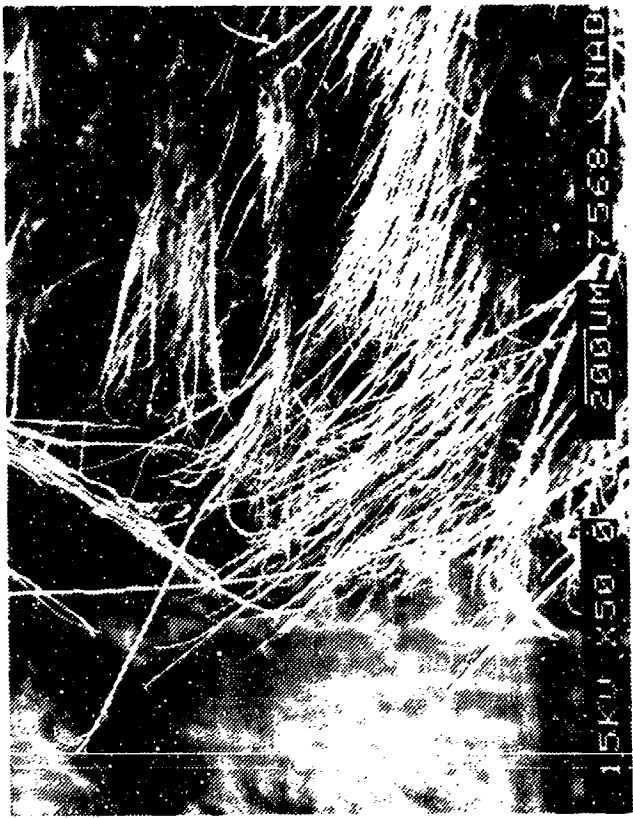
Figure 3-15. SEM Photographs of Mode I Translaminar Compression Fracture in 49/3501-6 Kevlar/Ep - 32 Ply/Quasi-Isotropic, Water Immersed Before Test

CD = Crack propagation direction

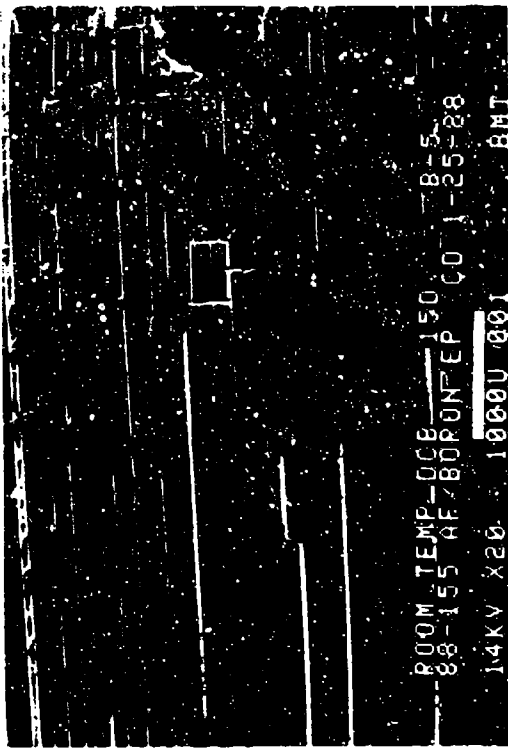
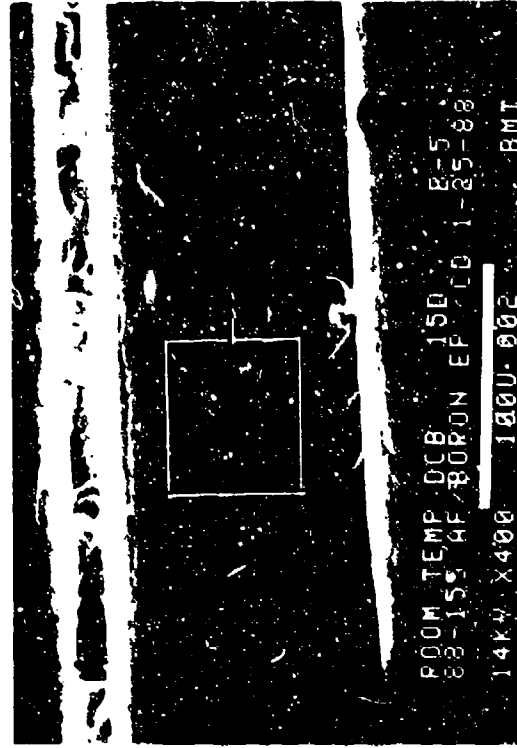
- B boron-tungsten filament
- R rivermark

Mechanically induced
crack direction

Figure 4.2. SEM Fractographs of: Room Temperature/Dry, Interlaminar Mode I Tension, 0/90 Fracture in Boron/Epoxy

SEM analysis showed both river marks and resin microflow lines on the fracture surface (Figure 4-2). This indicated that the crack direction could be identified from these microscopic features.

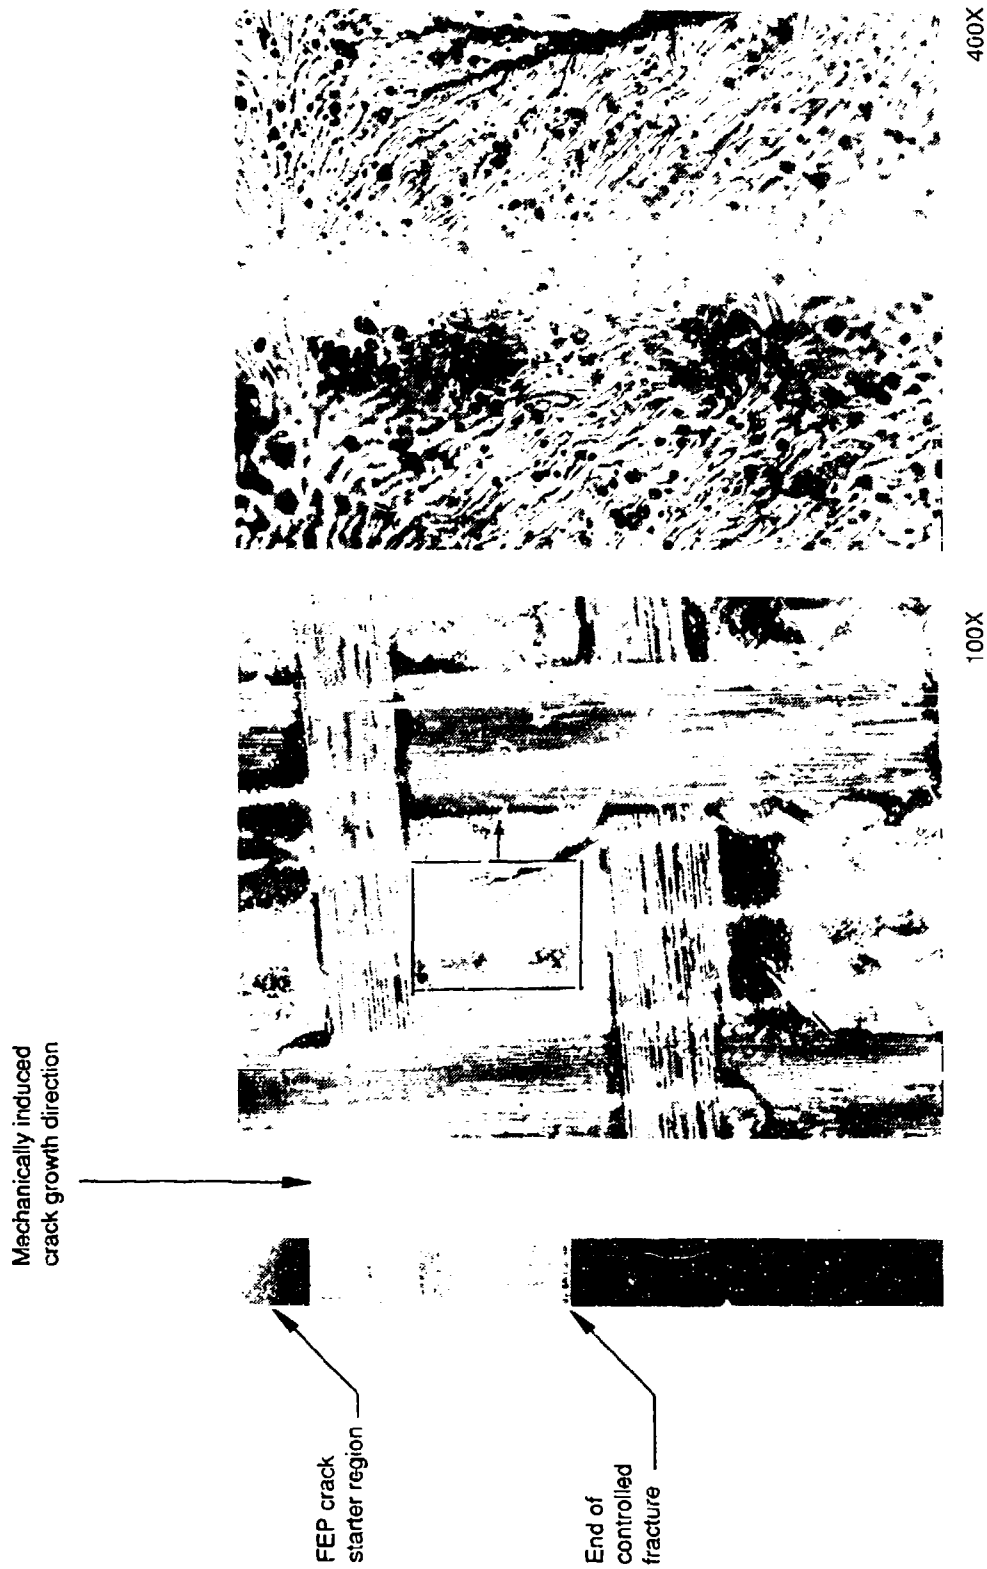
Figure 4-3. Optical Photomicrographs of 270 FWet, Interlaminar Mode I Tension, 0/90 Fracture in Boron/Epoxy

Visual examination revealed a fracture surface on only one or two stepped planes. This was in contrast to the RT specimen, which fractured over many stepped planes. The 270°F/wet condition made the resin ductile and prevented a multiple-plane fracture. The optical photomicrograph showed resin microflow lines similar to those observed in the RT/dry specimen (Figure 4-3).

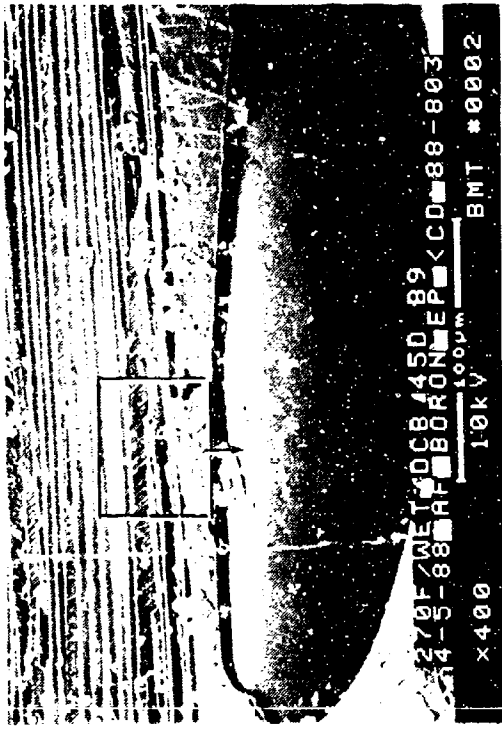
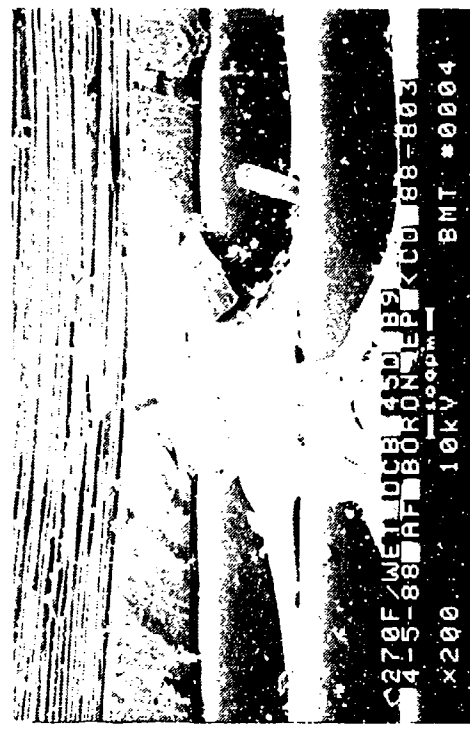
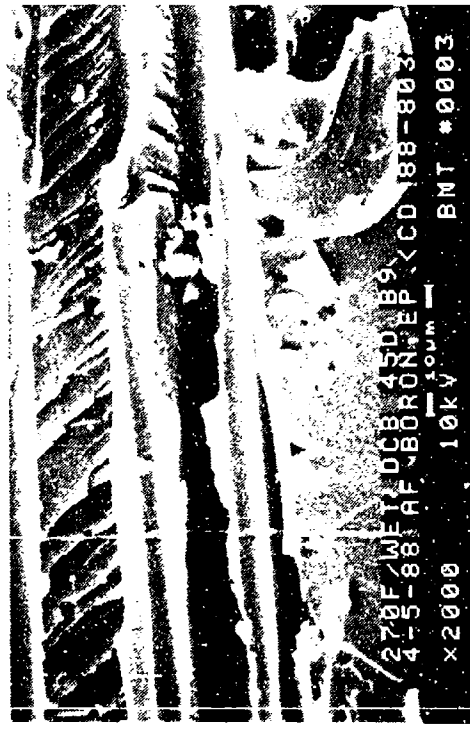
Mechanically induced crack direction

Figure 4-4. SEM Fractographs of 270 F/Wet, Interlaminar Mode I Tension, 0/90 Fracture in Boron/Epoxy

Figure 4-4 shows the SEM fractographs of the interlaminar Mode I tension specimen exposed to humidity and tested at 270°F. The fracture surface showed river marks in some regions. The major difference between the RT/dry and 270°F/wet specimens was the latter's very poor adhesion at the fiber/matrix interface.

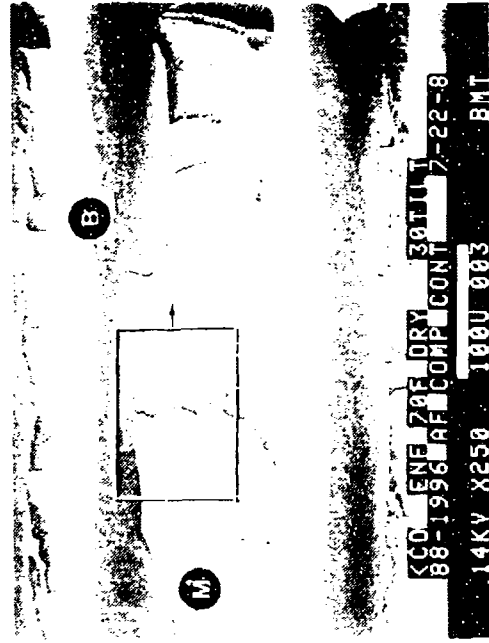
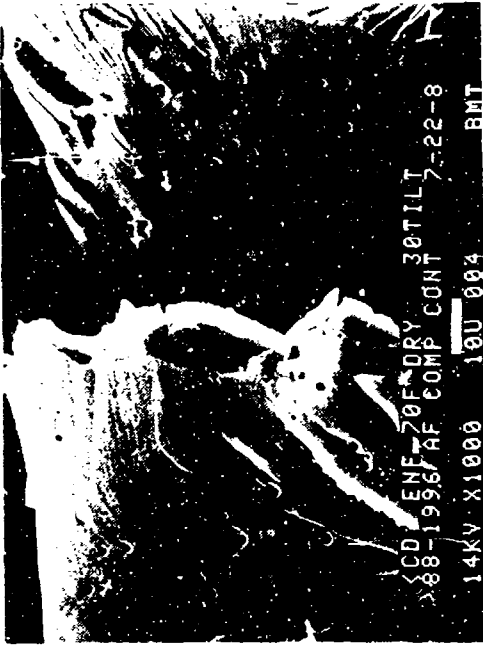
Figure 4-5. SEM Fractographs of Room Temperature/Dry, Interlaminar Mode II Shear, 0/90 Fracture in Boron/Epoxy

30 degree tilt (a) 50X

30 degree tilt (b) 250X

Mechanically induced crack direction

30 degree tilt (c) 1,000X

Under visual examination, the fracture surface was dull and milky due to the formation of hackles. This appearance was similar to that observed in previous work on the carbon-fiber reinforced epoxy system. Due to difficulties in creating a large area of interlaminar Mode II shear fracture surface for this material system, we were unable to provide a macrophotograph of the specimen. However, SEM analysis was performed on the available specimen. The fracture feature revealed resembled the hackles typically observed in the model material system, AS4/3501-6 (Figure 4-5).

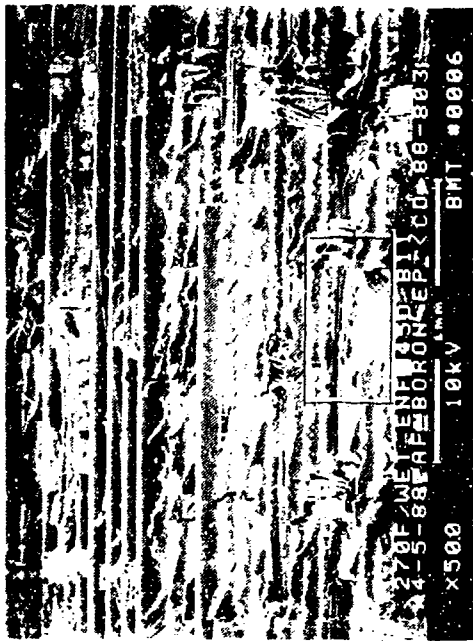
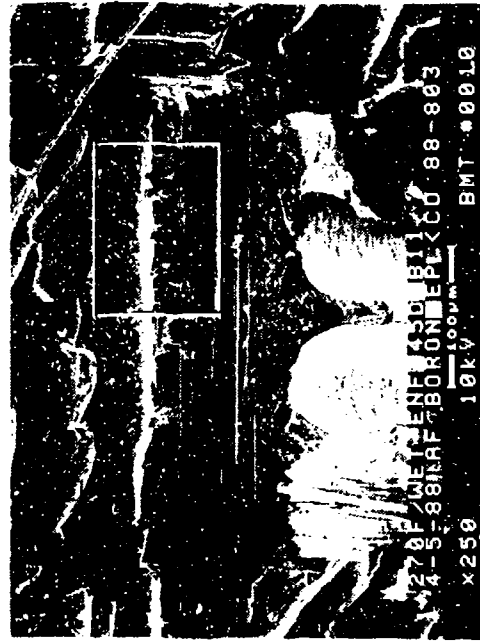
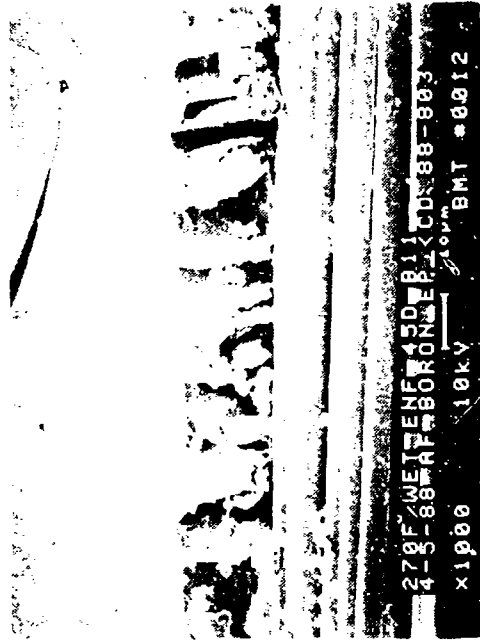
Figure 4-7. SEM Fractographs of 270 F/Wet, Interlaminar Mode II Shear, 0/90 Fracture in Boron/Epoxy

Mechanically induced
crack direction

Figure 4-7 illustrates the SEM fractograph of the interlaminar Mode II shear specimen exposed to humidity and tested at 270°F. The fracture surface showed hackles throughout the specimen. Poor fiber/matrix adhesion was observed, which is typical for shear fractures.

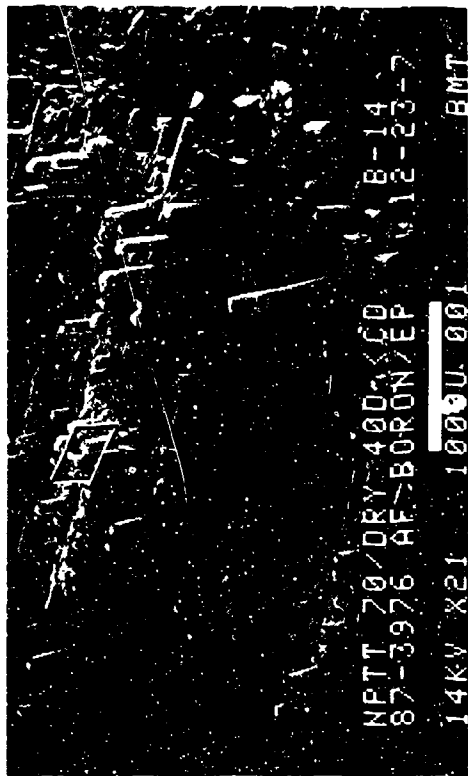
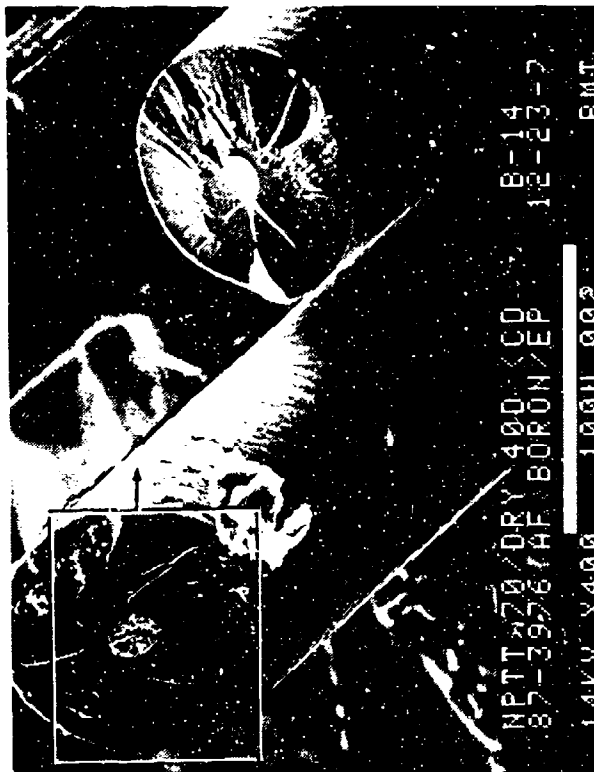
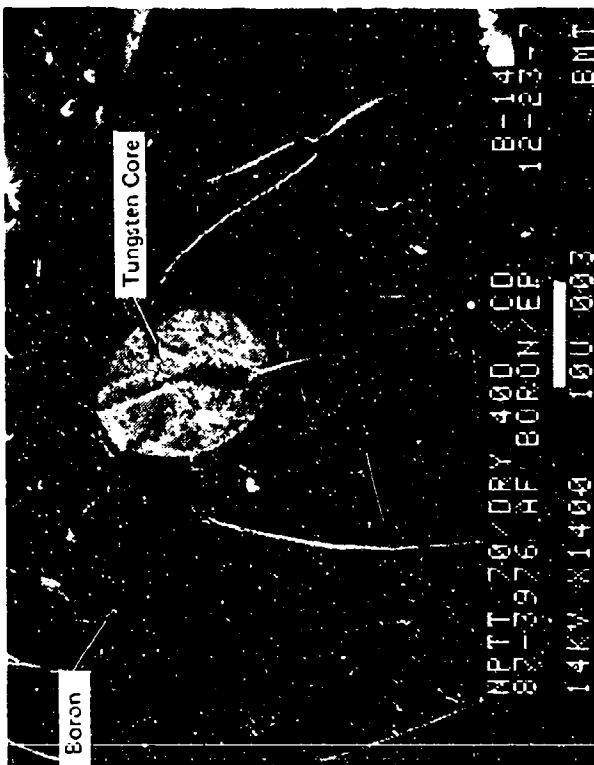
Figure 4-8. SEM Fractographs of Room Temperature/Dry, Translaminar Tension, 0/90 Fracture in Boron/Epoxy

Mechanically induced crack direction

The SEM analysis showed that the adhesion at the interface between the boron fibers and the epoxy matrix was poor at the time of the fracture. This was also evidenced by the fiber pullouts (Figure 4-8).
