WL-TR-91-4032
DOT/FAA/CT-91/23
VOL II, Part 2

COMPOSITE FAILURE ANALYSIS HANDBOOK
VOL II - TECHNICAL HANDBOOK
PART 2 - ATLAS OF FRACTOGRAPHS

February 1992

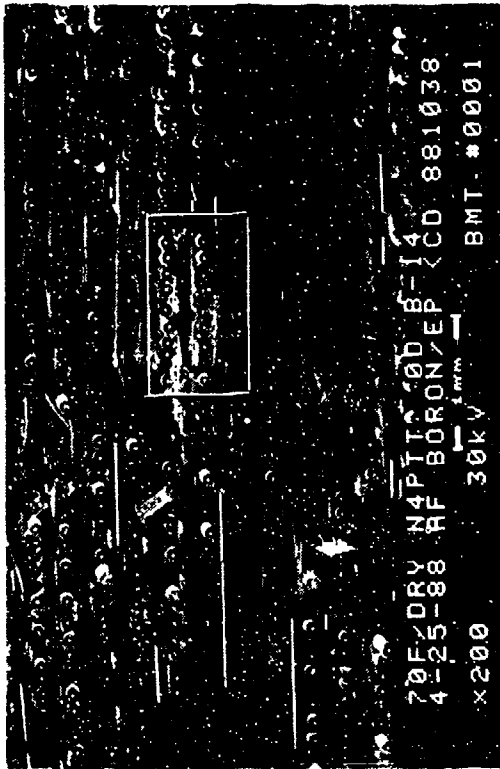
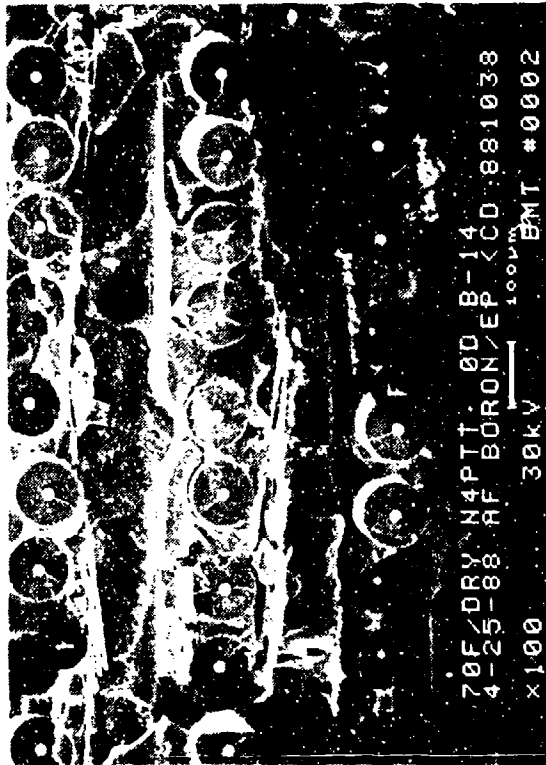
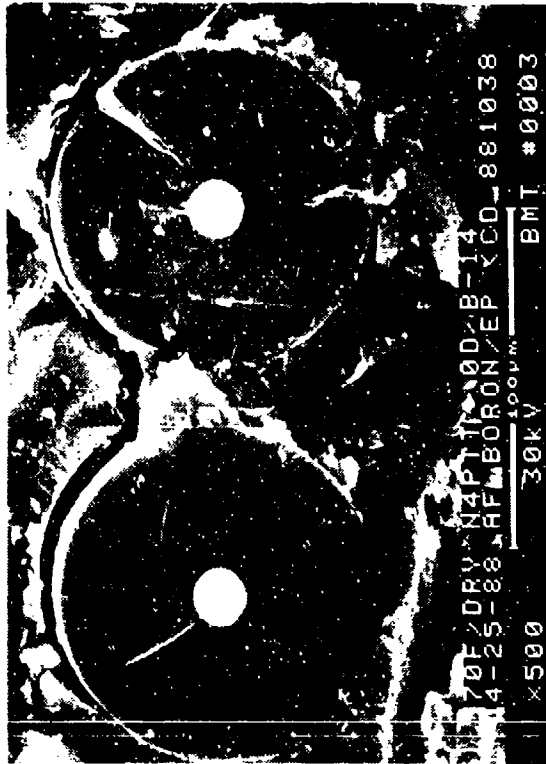
Figure 4-9. SEM Fractographs of Room Temperature/Dry, Translaminar Tension, 0/90 Fracture in Boron/Epoxy (0 Degree Tilt)

- P fiber pullout
- F fiber end fracture
- M matrix fracture

Mechanically induced
crack direction

Unlike those in glass and carbon fibers, the radial patterns on the boron fiber ends initiated at the tungsten core/boron interface (Figure 4-9). This phenomenon may be due to the lower interfacial shear strength of the tungsten core/boron interface in comparison with the boron fiber/epoxy interface. The fracture features radiating from the center of the boron-tungsten fiber could not be used to determine the crack surface and propagate from one fiber to another, and the average of the individual crack directions indicated the overall crack direction.

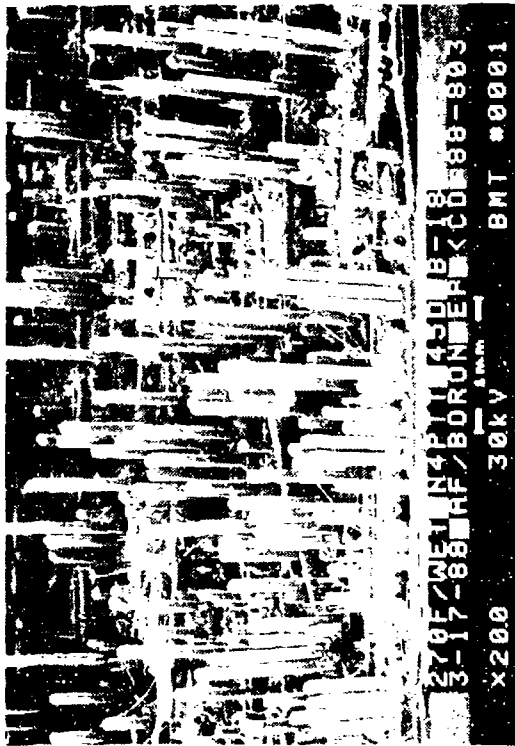
Figure 4-10. SEM Fractographs of 270 F/Wet, Translaminar Tension, 0/90 Fracture in Boron/Epoxy (45 and 0 Degree Tilts)

Mechanically induced crack direction
 ↓

Interlaminar resin fracture (i.e. rivermarks)

Visual examination revealed a fracture surface with numerous protruding fibers. Under the wide-field microscope, it was evident that the fracture was fiber-dominated. The fracture surface exhibited many holes in the matrix, indicative of extensive fiber pullout (poor fiber/matrix adhesion). Additionally, the fibers pulled away from the matrix were much longer than those in the RT/dry specimen. This also indicated poor fiber/matrix adhesion (Figure 4-10).

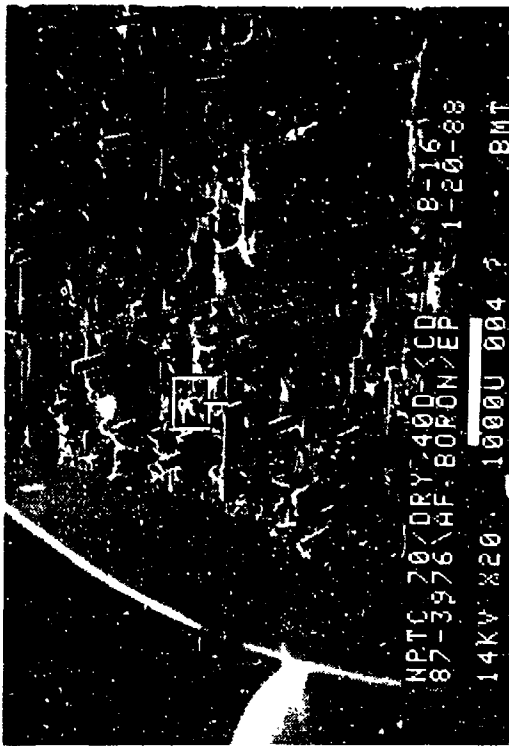
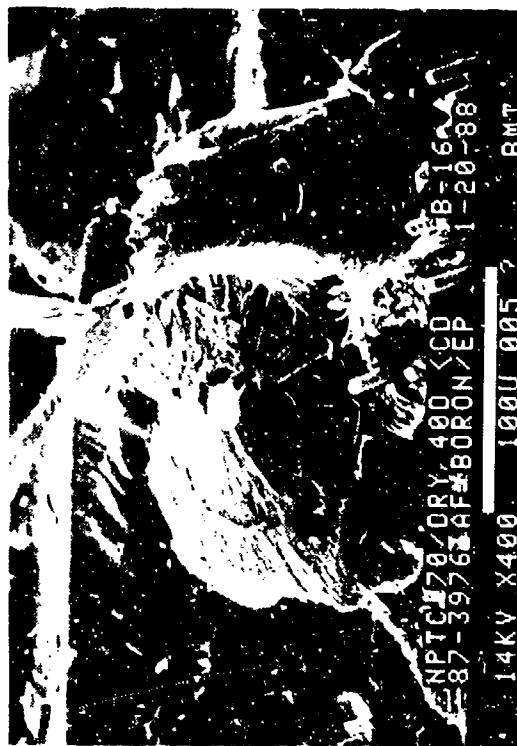
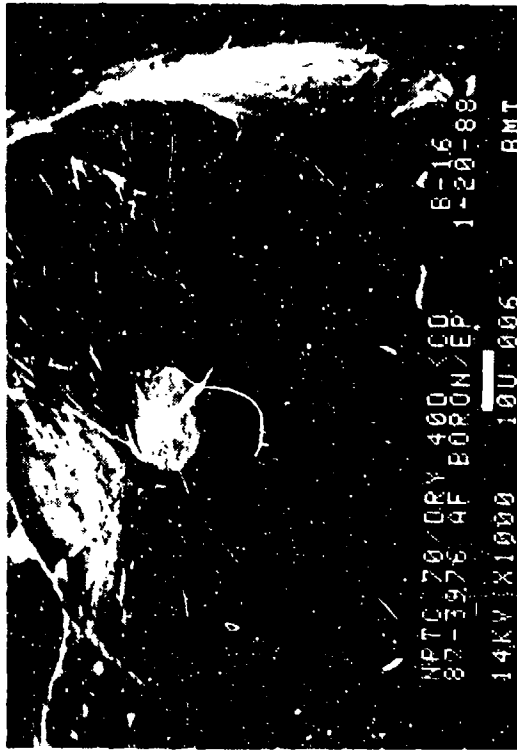
Figure 4-11. SEM Fractographs of Room Temperature/Dry, Translaminar Compression, N190 Fracture in Boron/Epoxy (40 Degree Tilt)

Mechanically induced
crack direction

Visual observation revealed numerous protruded boron-tungsten filaments. SEM analysis shown in Figures 4-11 and 4-12 confirmed the visual result. Unlike the glass and carbon fibers, the boron-tungsten fibers exhibited similar fracture features in both tension and compression specimens. This may be due to the higher ductility of the boron-tungsten fibers in comparison with the glass and carbon fibers. This eliminates the microbuckling effects (from compression) typically exhibited in fibers with higher stiffness. The neutral axes observed on the glass and carbon fiber ends were not present on the boron-tungsten translaminar compression specimen tested under RT/dry condition.

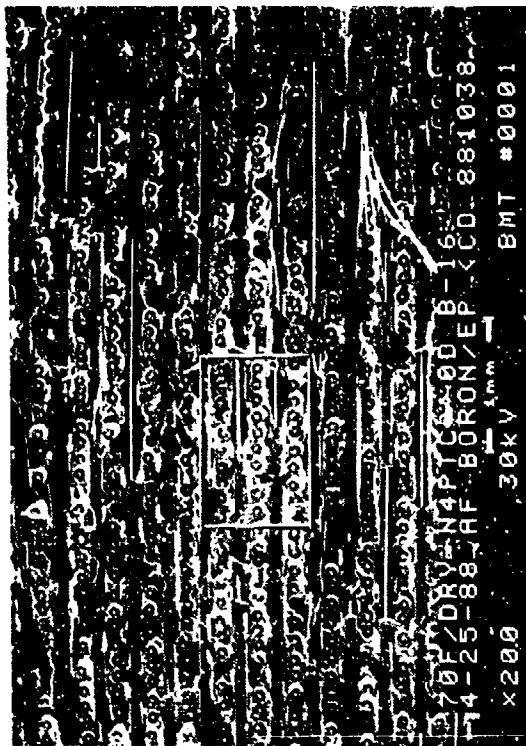
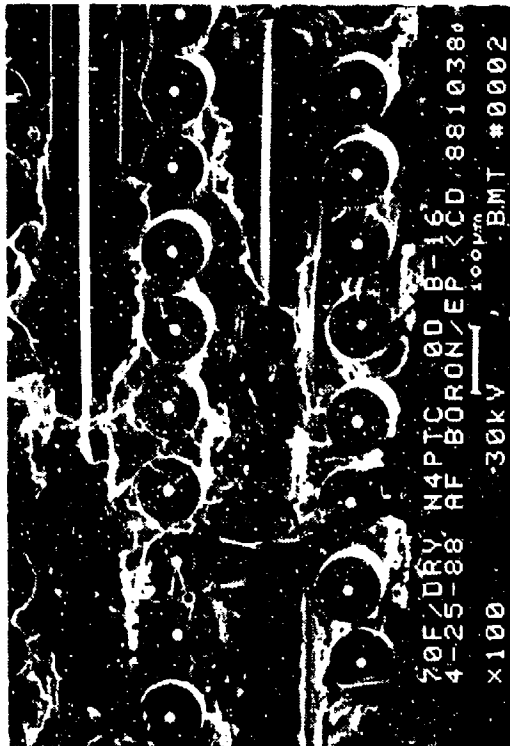
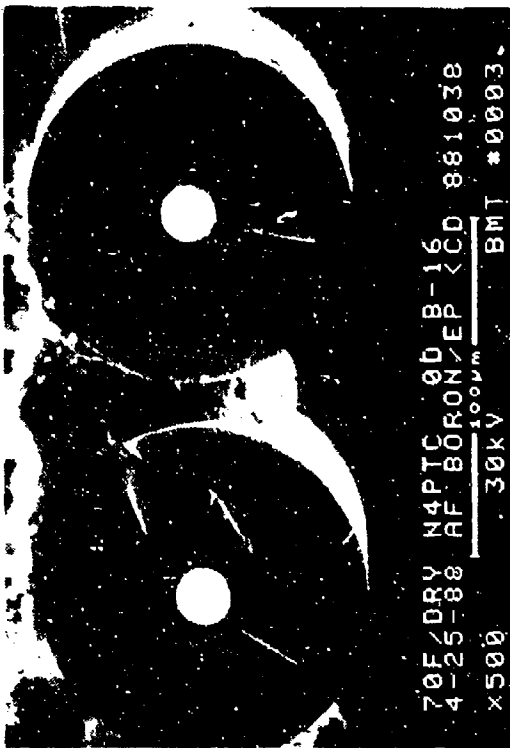
Figure 4-12. SEM Fractographs of Room Temperature/Dry, Translaminar Compression, 0/9C Fracture in Boron/Epoxy (0 Degree Tilt)

Mechanically induced
crack direction

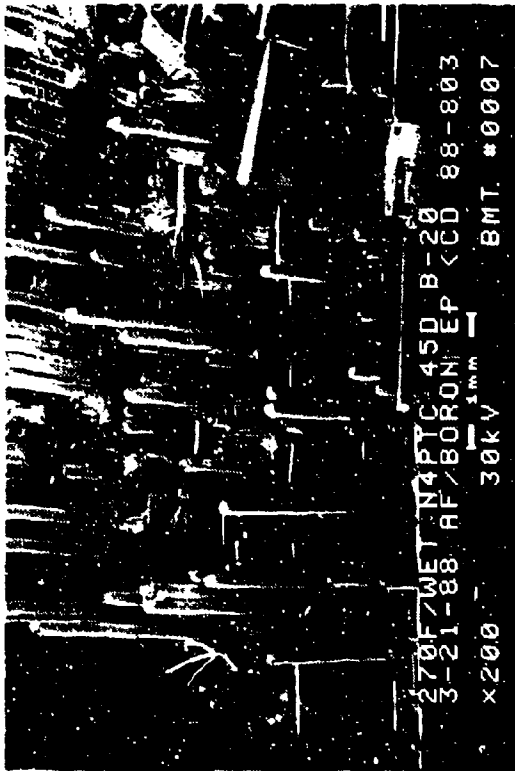
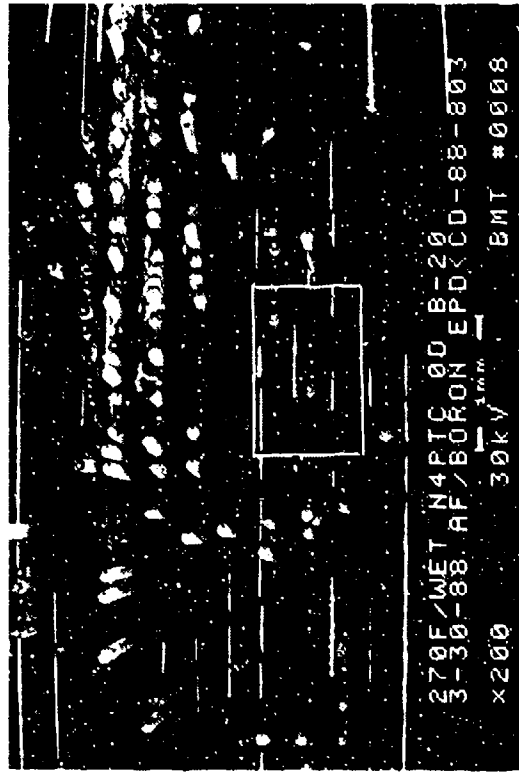
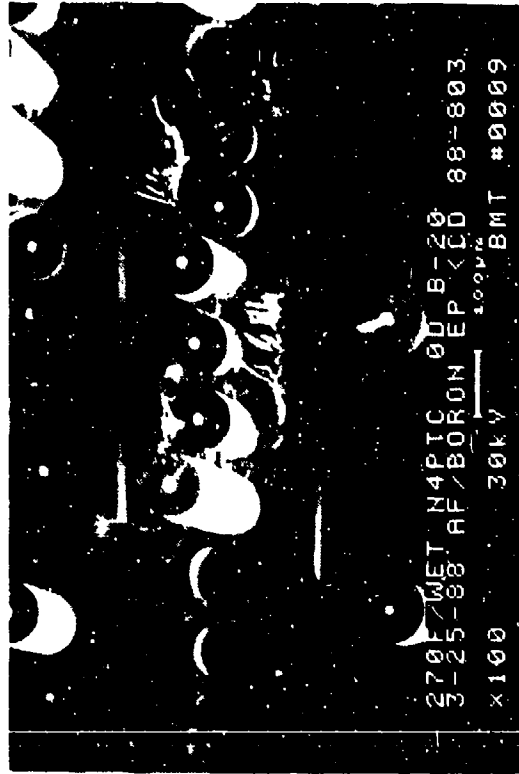
Figure 4-13. SEM Fractographs of 270 FWet, Translaminar Compression, 0/90 Fracture in Boron/Epoxy

Mechanically induced
crack direction

Visual examination revealed a fracture surface with numerous protruding fibers, similar to the fracture surface of the tension specimen. The ends of the boron filaments exhibited radial patterns similar to those of the translaminar compression RT/dry specimen (Figure 4-13). Boron fiber pullouts exhibited little residual resin on the fiber due to weak fiber/matrix adhesion; also, the boron fiber surface was not as smooth as is typical of carbon fiber (Figure 4-14). This is due to the chemical deposition process of boron onto the tungsten core. The neutral axes typically observed on glass and carbon fiber ends, a result of microbuckling, were not present on the boron-tungsten translaminar compression specimen tested under 270°F/wet conditions.

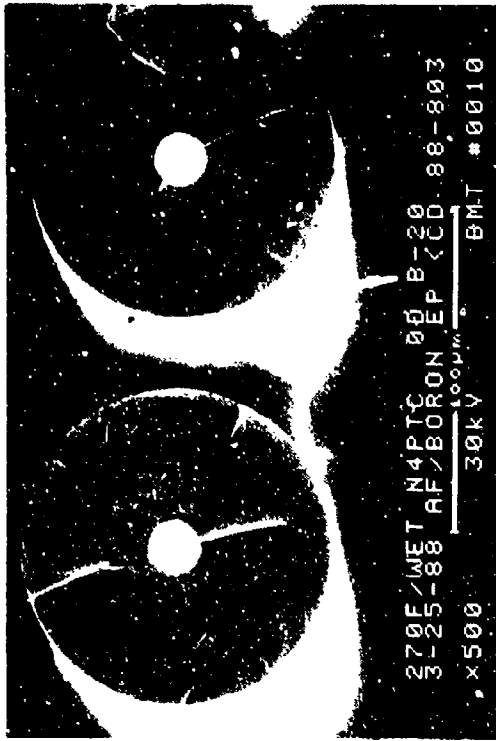
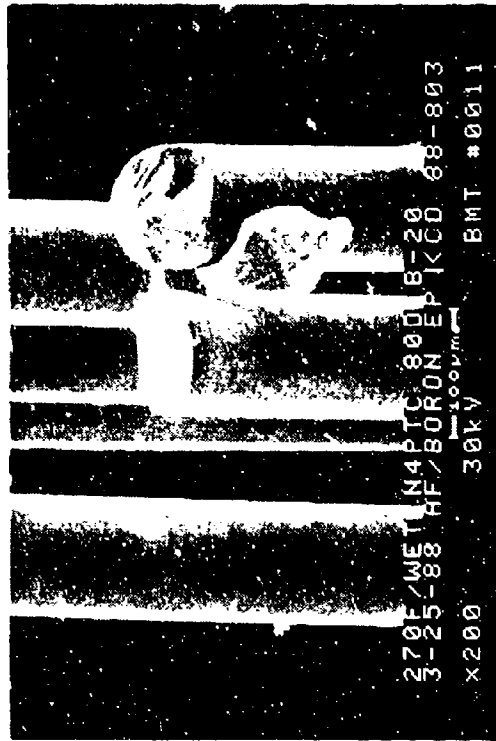
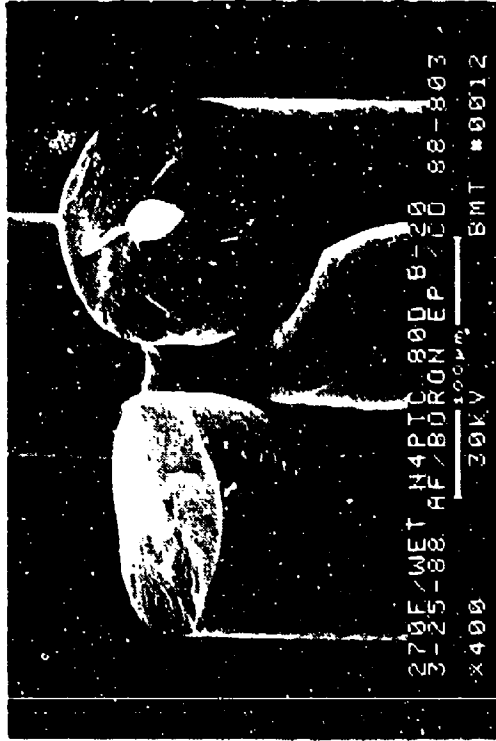
Figure 4-14. SEM Fractographs of 270 F/Wet, Translaminar Compression, 0/90 Fracture in Boron/Epoxy (High Magnification)

Mechanically induced
crack direction

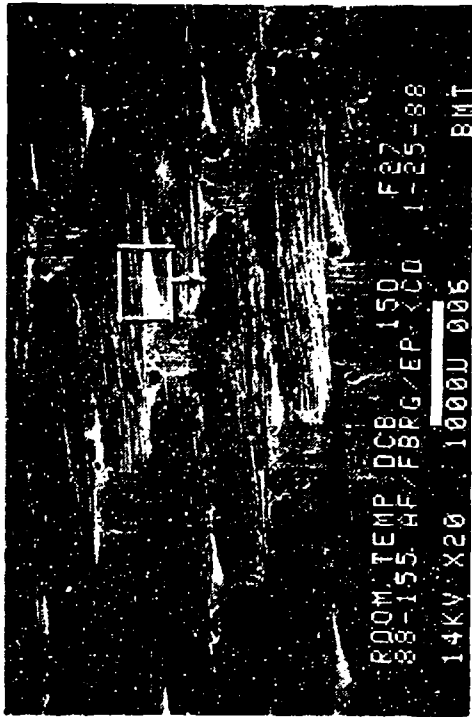
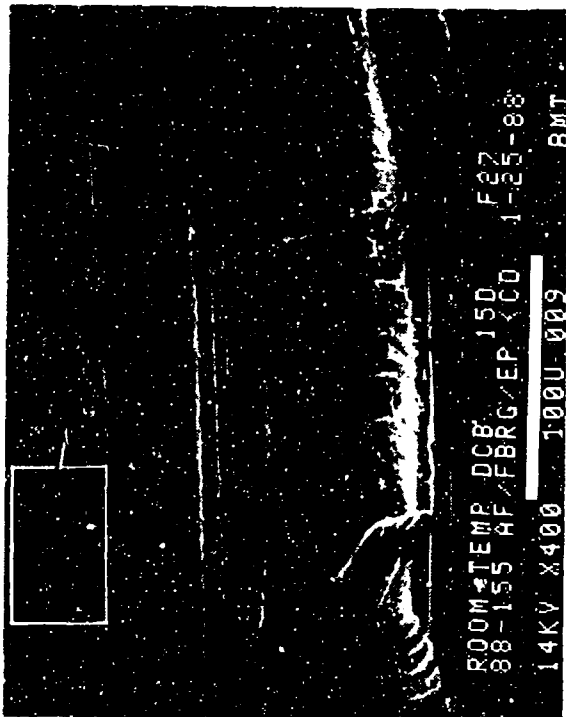
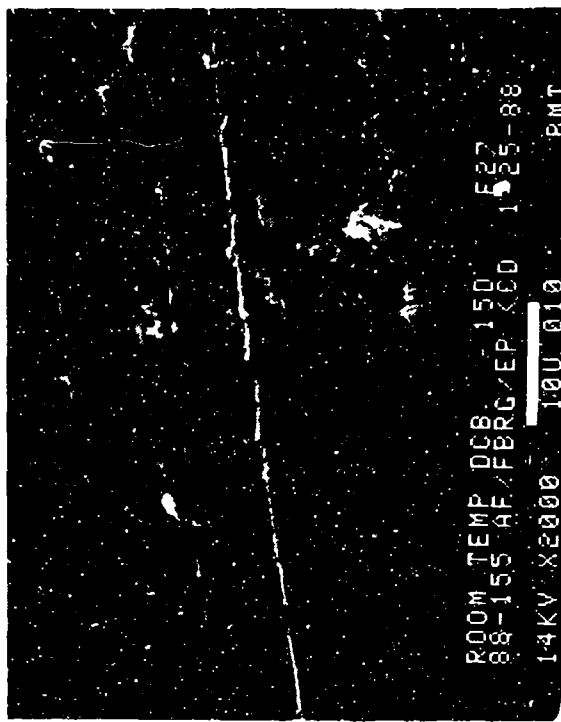
Figure 5-1. SEM Fractographs of Room Temperature/Dry, Interlaminar Mode I Tension, 0/90 Fracture in Fiberglass/Epoxy

Legend:
 F fiber matrix separation
 R rivermark
 Mechanically induced crack direction

Visual observation of the fracture revealed a smooth, glassy surface. Optical photomicrographs were not taken because of the transparency of the fiberglass/epoxy. Cleavage markings (river marks), typically seen in Mode I tension fractures of carbon fiber reinforced epoxies were observed under the SEM (Figure 5-1). These features were usually observed at the nodes where the weaves overlap one another. The fiber/matrix adhesion appeared to be poor at some locations. This is due to the low inherent interfacial shear strength at the fiberglass/epoxy interface.

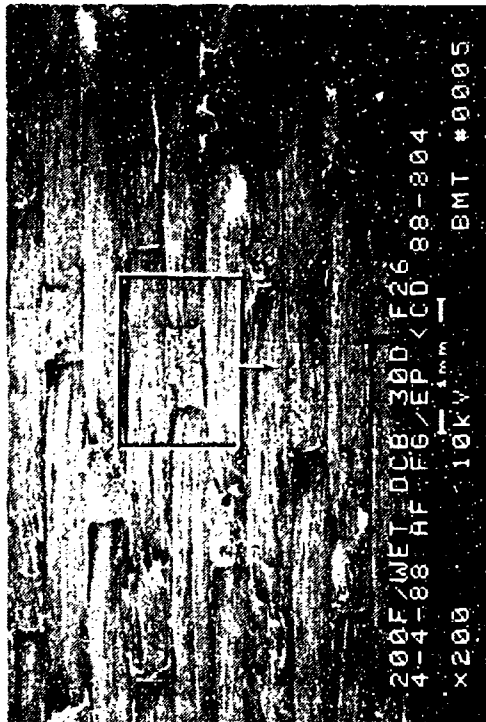
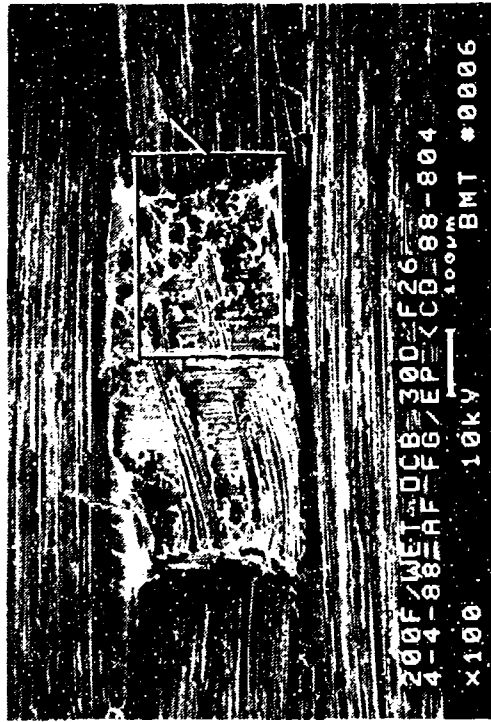
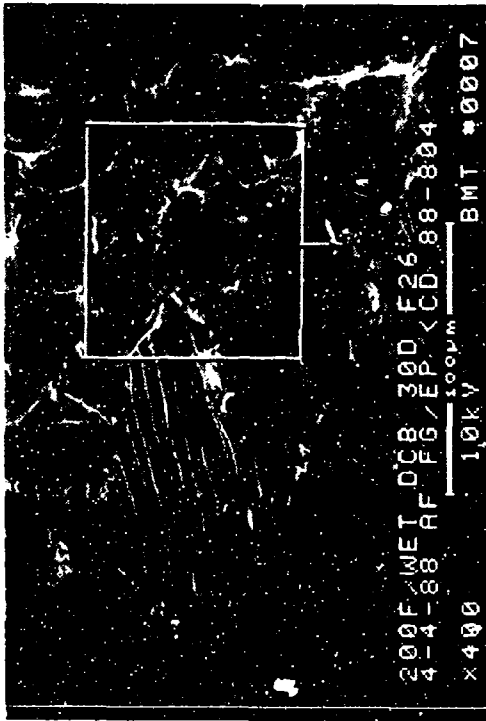
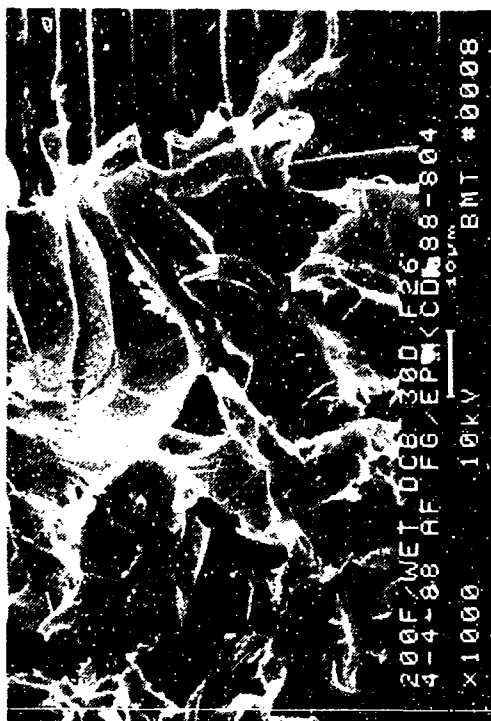
Figure 5-2. SEM Fractographs of 200 F/Wet, Interlaminar Mode I Tension, 0/90 Fracture in Fiberglass/Epoxy

← Mechanically induced crack direction

Figure 5-2 shows the SEM fractographs of the interlaminar Mode I tension, 200°F/wet specimen. Fiber/matrix adhesion was poor as evidenced by the smoothness of the fiber surface. Unlike the RT/dry specimen, this specimen, did not exhibit well-defined river marks indicating the crack direction. Instead, the surface showed taffy-pull hackles commonly seen in ductile resin matrices such as thermoplastics.

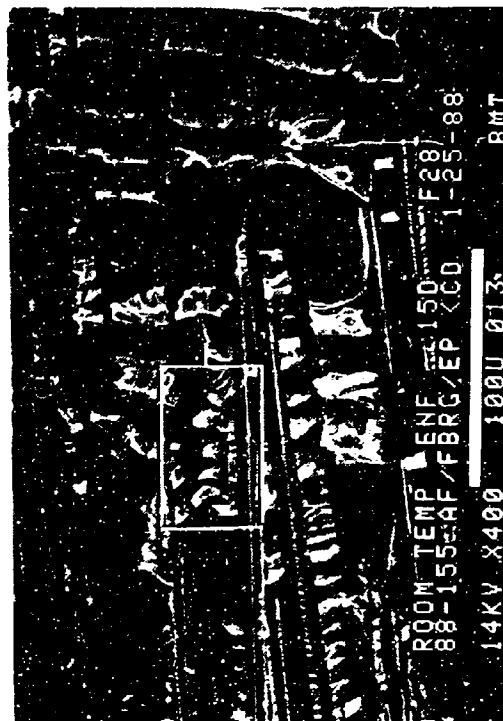
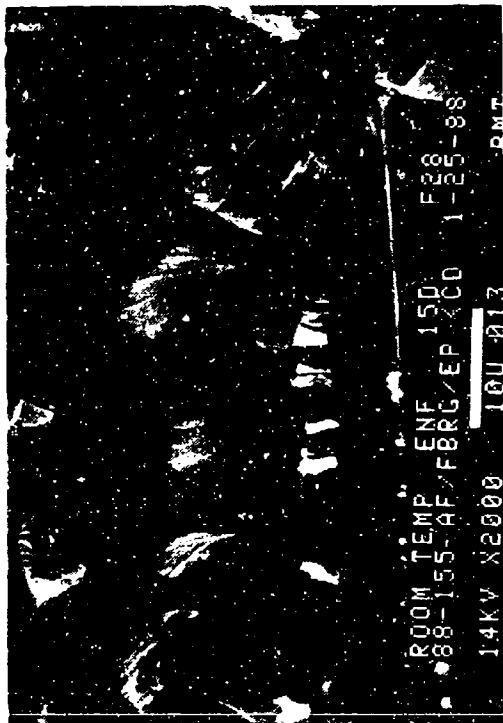
Figure 5-3. SEM Fractographs of Room Temperature/Dry, Interlaminar Mode II Shear, 0/90 Fracture in Fiberglass/Epoxy

Legend:
 F fiber/matrix separation
 H hackle

Mechanically induced
 crack direction

SEM analysis (Figure 5-3) revealed a rough fracture surface consisting of large numbers of hackles, which appear similar to the platelets seen in Mode II shear fractures of carbon fiber reinforced epoxies. There was poor adhesion of the fiber/matrix interface at some locations, which was due to the low inherent interfacial shear strength.

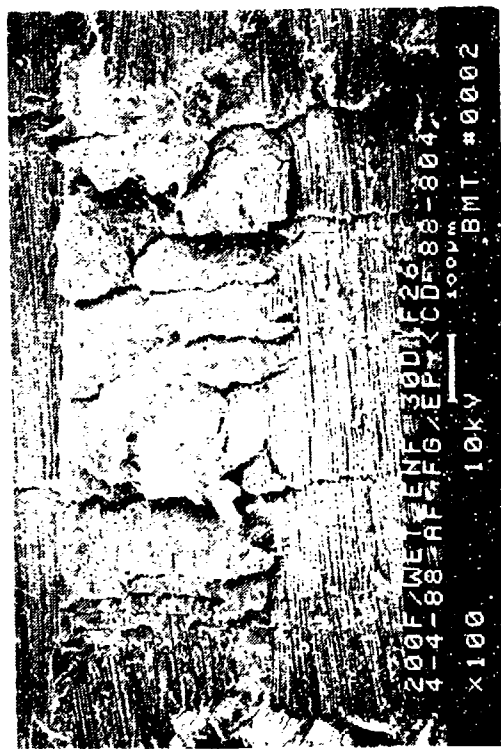
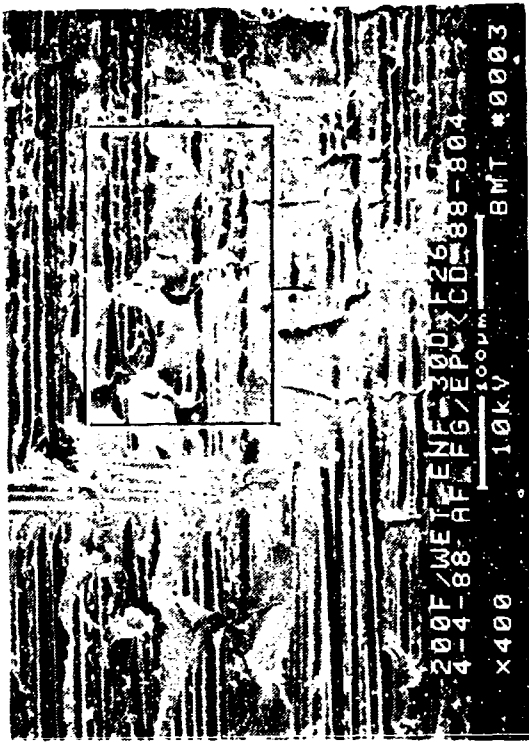
30 degree tilt (a) 20X

30 degree tilt (c) 100X

30 degree tilt (b) 400X

Figure 5-4 shows the SEM fractograph of the fracture surface which appeared rough and showed hackles as observed in the RT/dry specimen. These hackles were much larger, but fewer in number than those seen in the RT specimens.

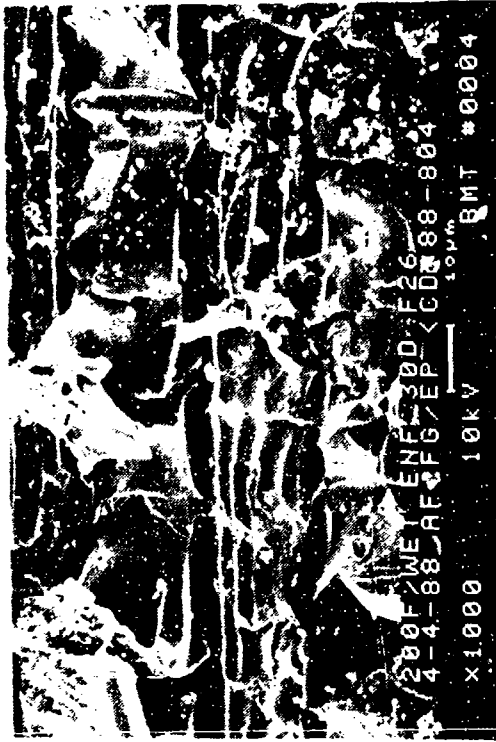
30 degree tilt (d) 1,000X

← Mechanically induced crack direction

Figure 5-4. SEM Fractographs of 200 F/Wet, Interlaminar Mode II Shear, 0:90 Fracture in Fiberglass/Epoxy

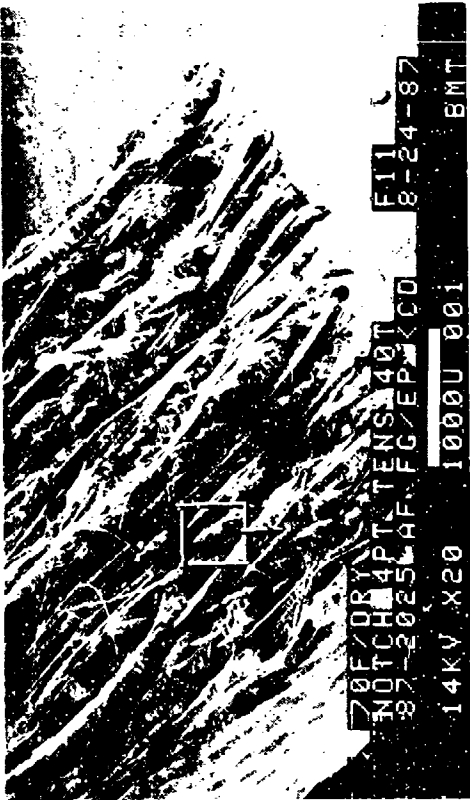
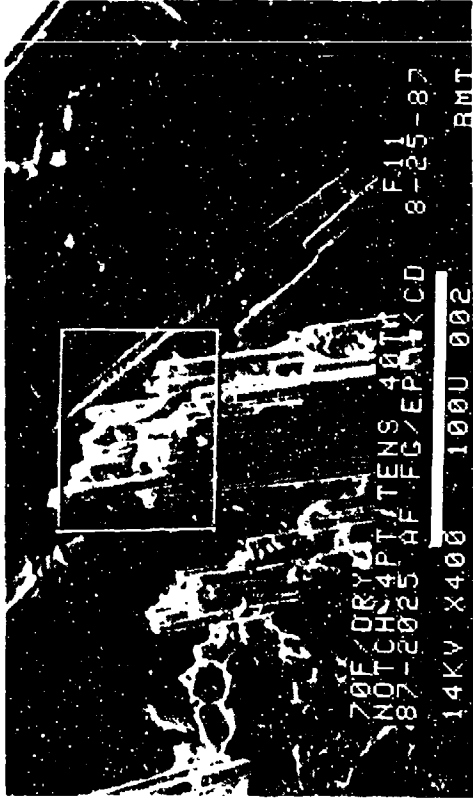
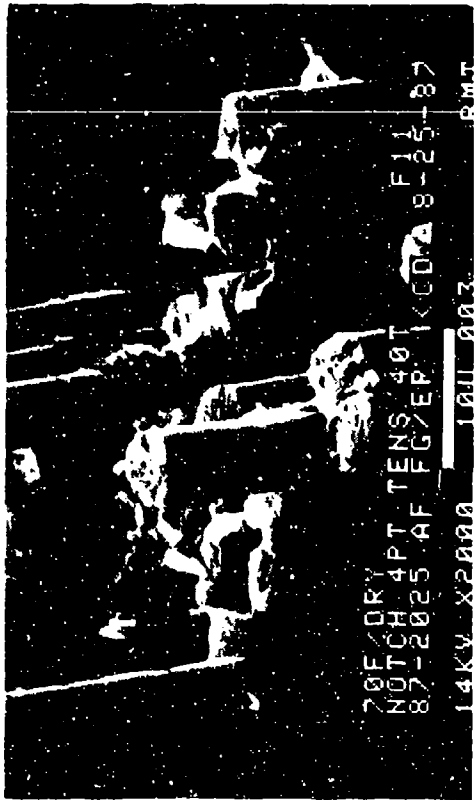
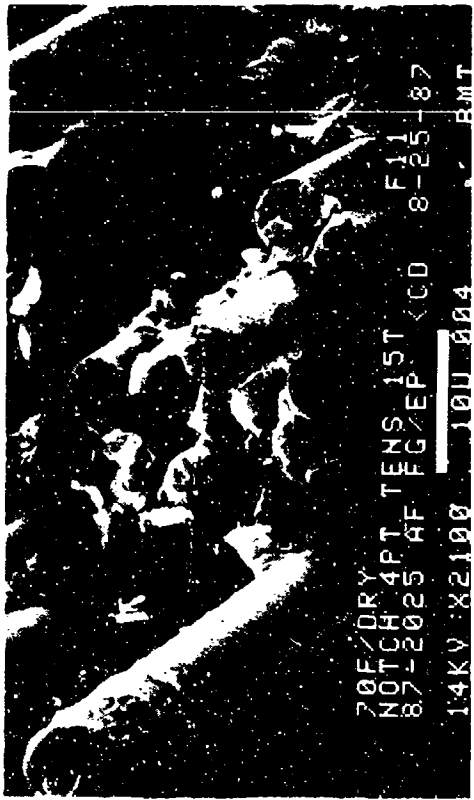
Mechanically induced crack direction

Figure 5-5. SEM Fractographs of 70 F/Dry, Translaminar Tension, 0/90 Fracture in Fiberglass/Epoxy

Mechanically induced
crack direction

Figure 5-5. SEM Fractographs of 70 F/Dry, Translaminar Tension, 0/90 Fracture in Fiberglass/Epoxy (Concluded)

Visual and optical observation revealed a rough topography with protruding fibers of different lengths and directions (Figure 5-5). The surface of the fiber/matrix interface was smooth due to the fibers being pulled away from the matrix. There was evidence of fiber dominated fracture in the large percentage of fiber pullouts. Similar to the carbon fibers, the radial patterns were observed on the glass fiber ends and can be used to determine crack growth direction.

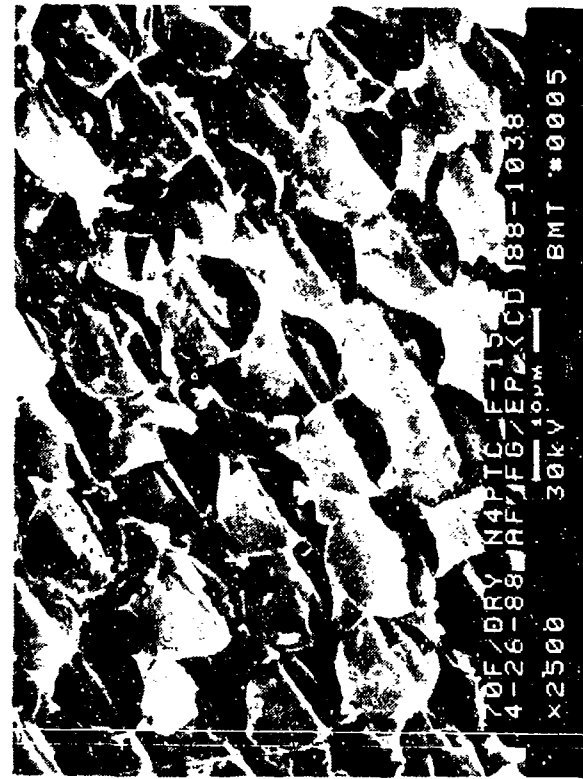
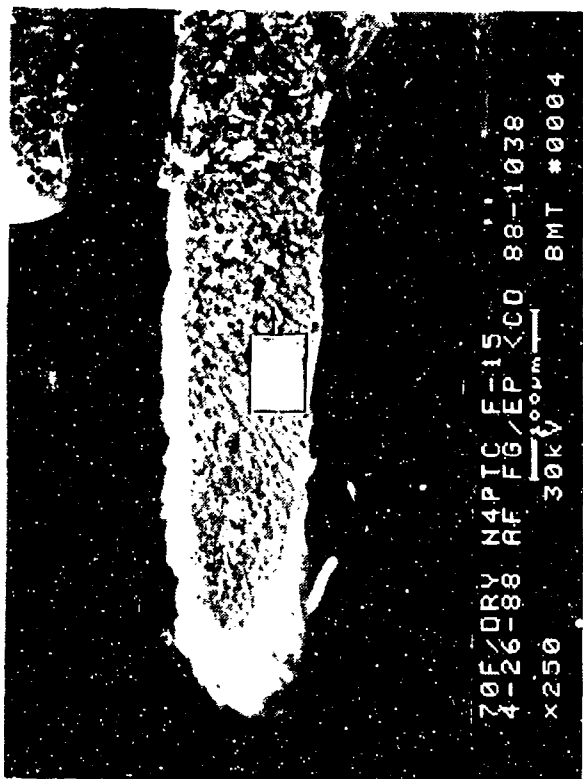
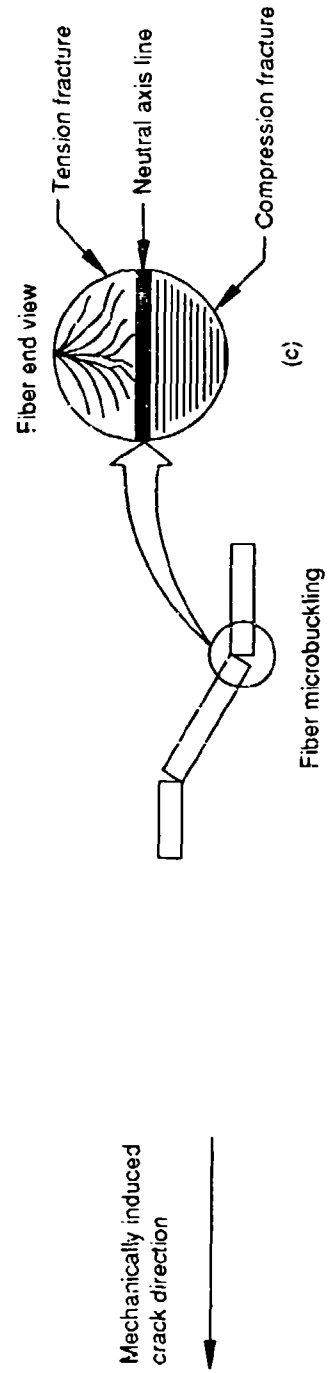
Figure 5-6. SEM Fractographs and Diagram of 70 F/Dry, Translaminar Compression, 0/90 Fracture in Fiberglass/Epoxy (0 Degree Tilt)

Visual and optical observations revealed a surface with uniform protruding fibers. The fiber/matrix interface showed good adhesion. Figures 5-6 and 5-7 show the SEM fractographs. A neutral axis line dividing the tension and compression regions on the fiber ends was observed.

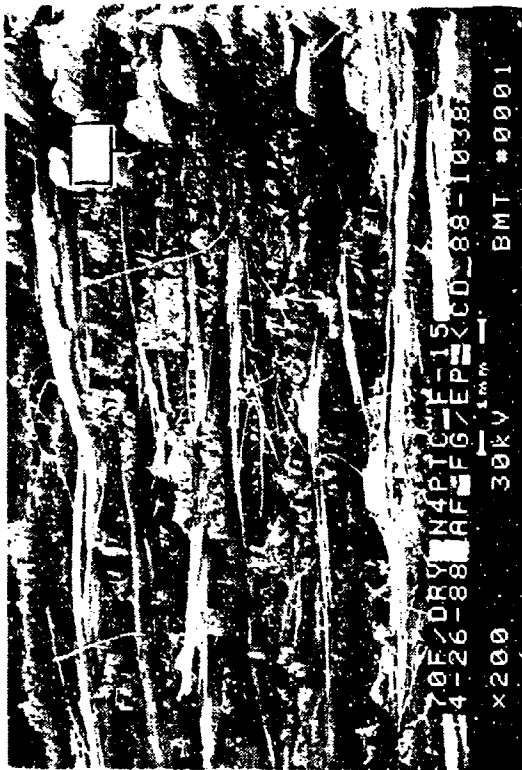
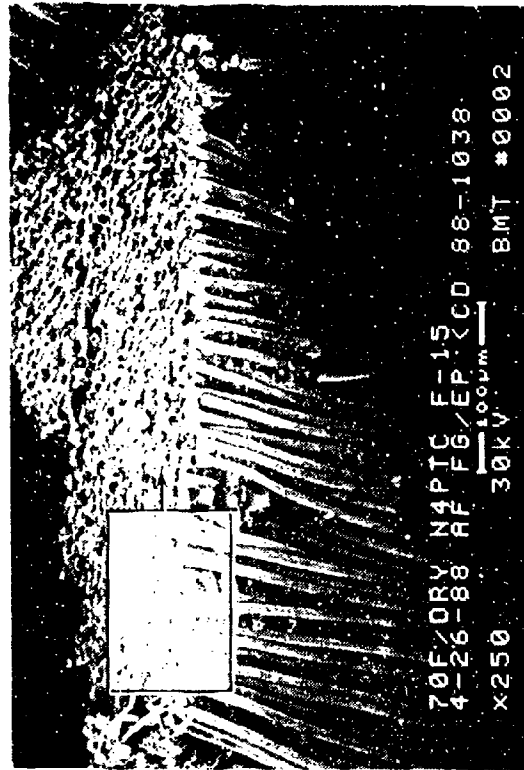
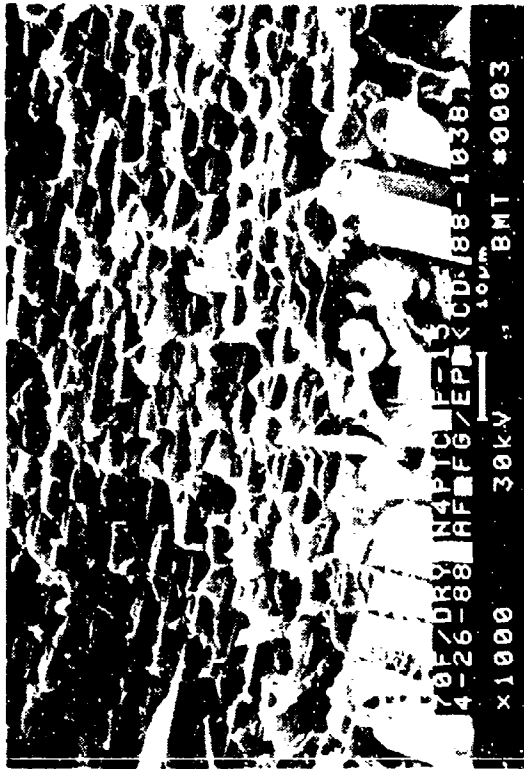
Mechanically induced
crack direction

Figure 5-7. SEM Fractographs of 70 F/Dy, Translaminar Compression, 0/90 Fracture in Fiberglass/Epoxy (45 Degree Tilt)

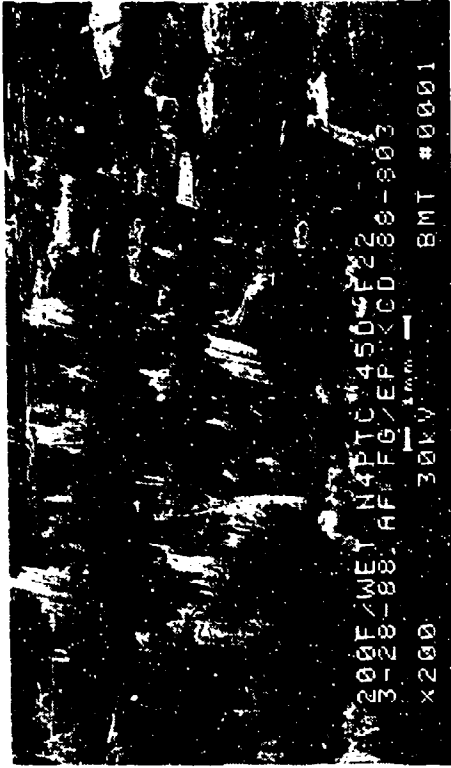
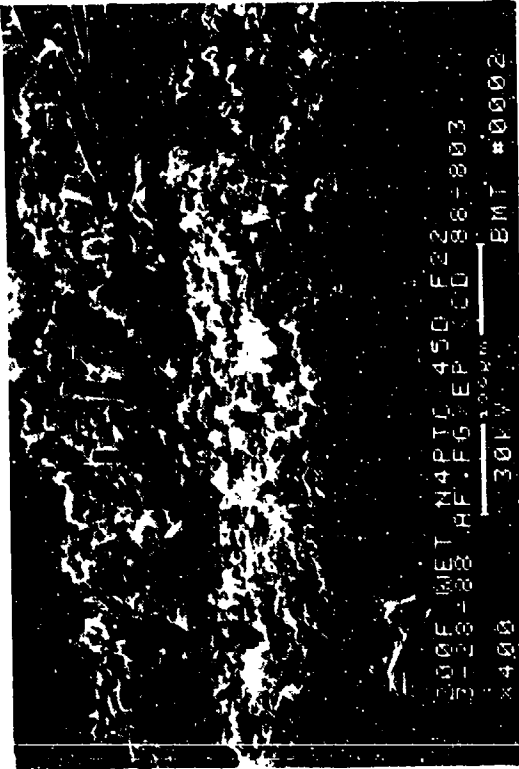
Region representing the compression damage

Mechanically induced crack direction

Figure 5-8. SEM Fractographs of 200 F/Wet, Translamellar Compression, 0/90 Fracture in Fiberglass/Epoxy (45 Degree Tilt)

Optical observation of the 200°F/wet specimen revealed a fracture surface like that typically seen in RT/dry translaminar compression specimens. The compression damage occurred in the region just outside of the notch. The typical fracture of a translaminar compression specimen exhibited a flat surface with "chop" marks on the fiber ends (Figure 5-8). Compressively fractured fiber ends show two distinct regions separated by a neutral axis line. This line does not represent any kind of crack direction (Figure 5-9).

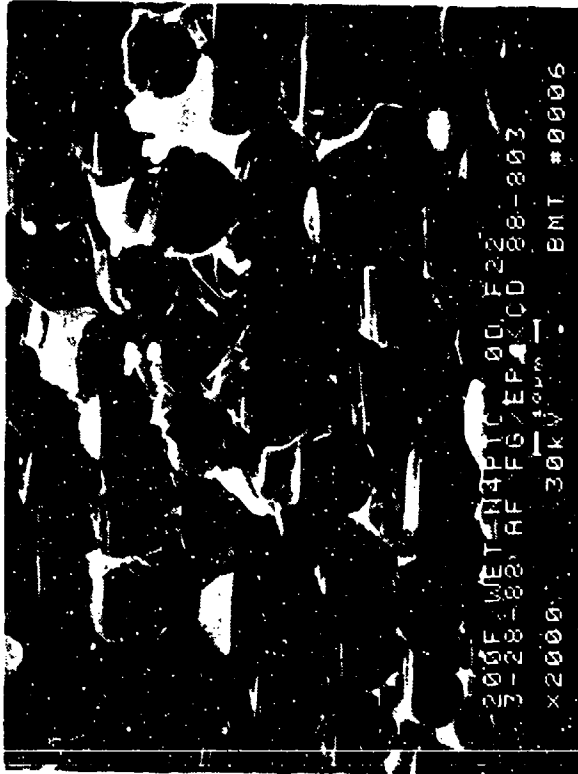
Mechanically induced crack direction

Figure 5-9. SEM Fractographs of 200 F/Wet, Translaminar Compression, 0/90 Fracture in Fiberglass/Epoxy (Higher Magnification)

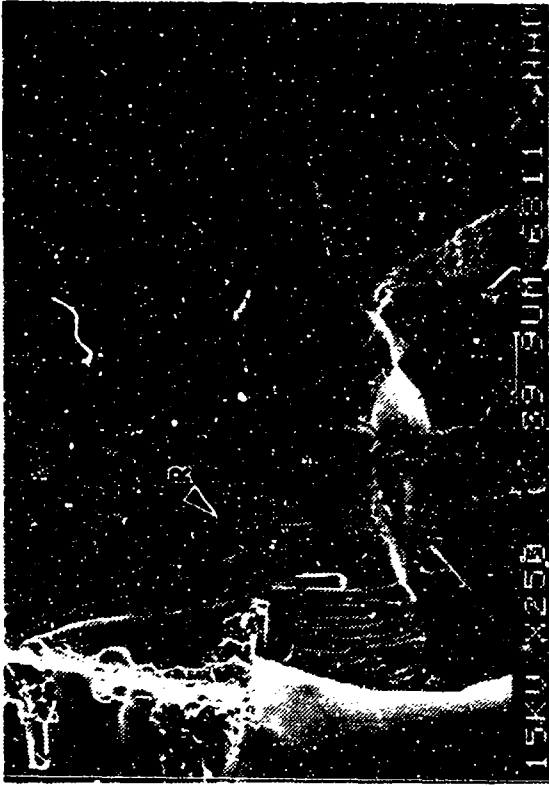
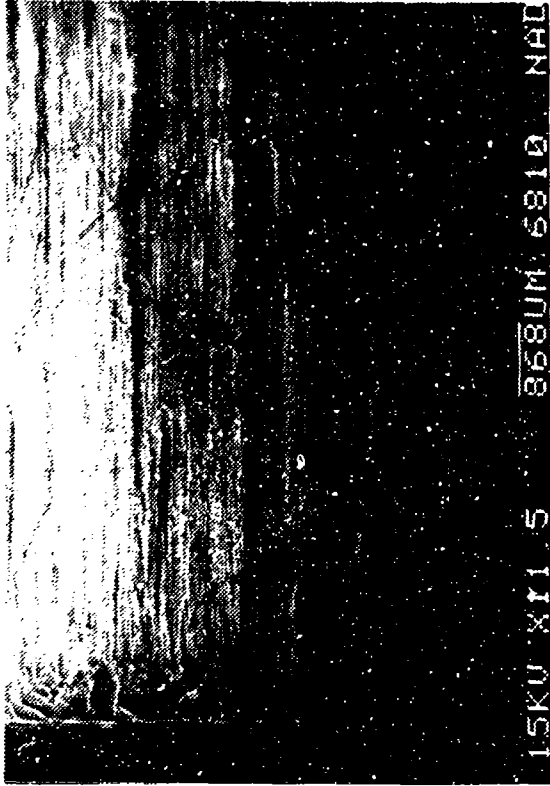
Figure 6-1. Optical and SEM Photographs of Mode I DCB Interlaminar Tension Fracture in AS4/5250-3 Gr/BMI - [0]_{24T}, Room Temperature Ambient
 (a) Macro photograph of Fracture
 (b), (c) Higher Magnification of Initiation Area
 R = River patterns

CD = Crack-propagation direction

Figures 6-1 through 6-4 provide interlaminar fractographs and Figures 6-5, 6-6 and 6-7 provide translaminar fractographs. This contribution was made by Northrop.

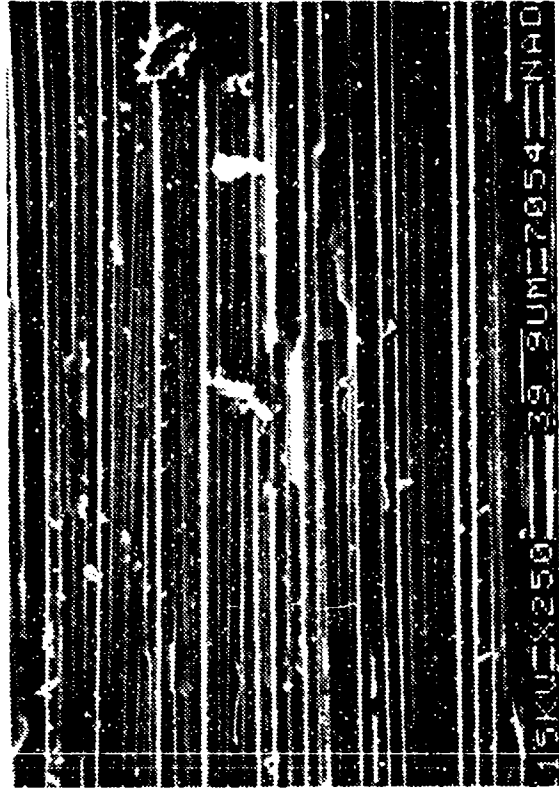
Figure 6-2. Optical and SEM Photographs of Mode I DCB Interlaminar Tension Fracture in AS4/5250-3 Gr/BMI - [0]_{24T}, Water Immersed Before Test
 (a) Macro photograph of Fracture
 (b) Precrack Region
 (c) Crack-Growth Region

CD = Crack-propagation direction

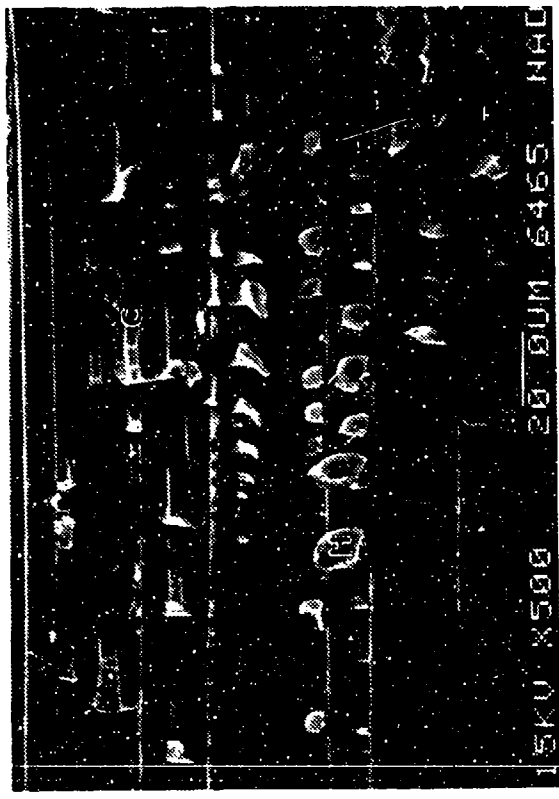
Figure 6-3. Optical and SEM Photographs of Mode II ENF Interlaminar Shear Fracture in AS4/5250-3 Gr/BMI-[0]_{24T}, Room Temperature Ambient

- (a) Macrograph Showing Regions I, II, and III (Pre-crack, Crack-Growth, and Laboratory Overload)
- (b) River Patterns (R) in Initiation Region in Pre-crack
- (c) Hackles (H) and Cusps (C) in Crack-Growth Region

CD = Crack propagation direction

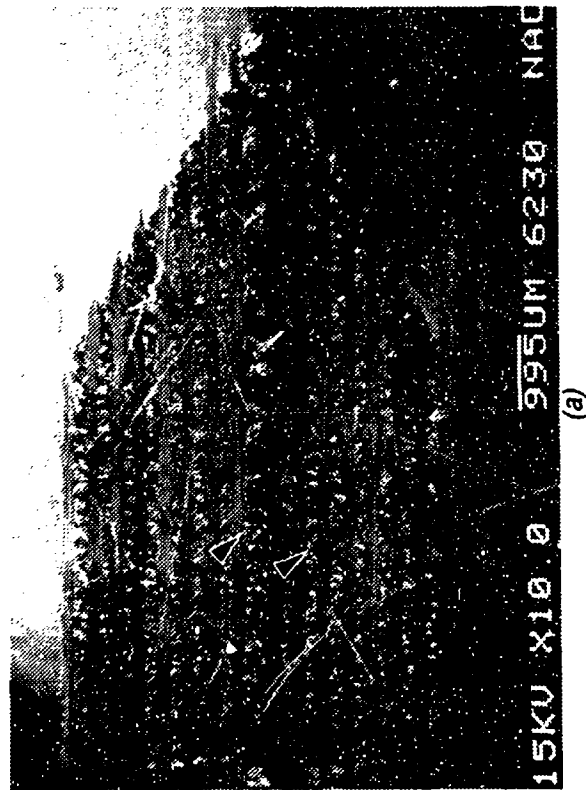
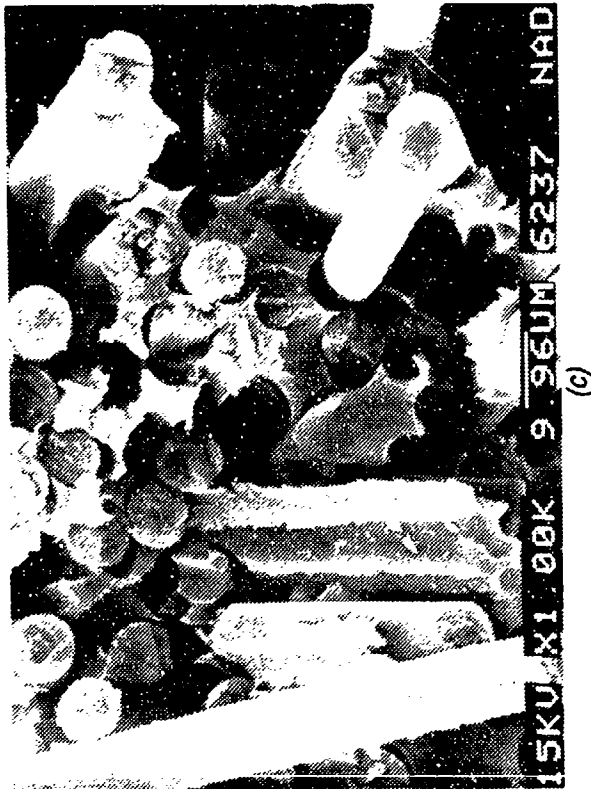
Figure 6-5. SEM Photographs of Mode I Translaminar Tension Fracture in AS4/5250-3 Gr/BMI - [90/0]_{as}, Room Temperature Ambient

(a) Normal View of Fracture

(b) Oblique View of Fracture

The translaminar fracture features of Gr/BMI are very similar to Gr/Ep. Translaminar tension failures can be mapped by DAF radials on fractured fiber ends, as in Gr/Ep. There are no significant fracture characteristics that can be used to map crack directions in compression failures.

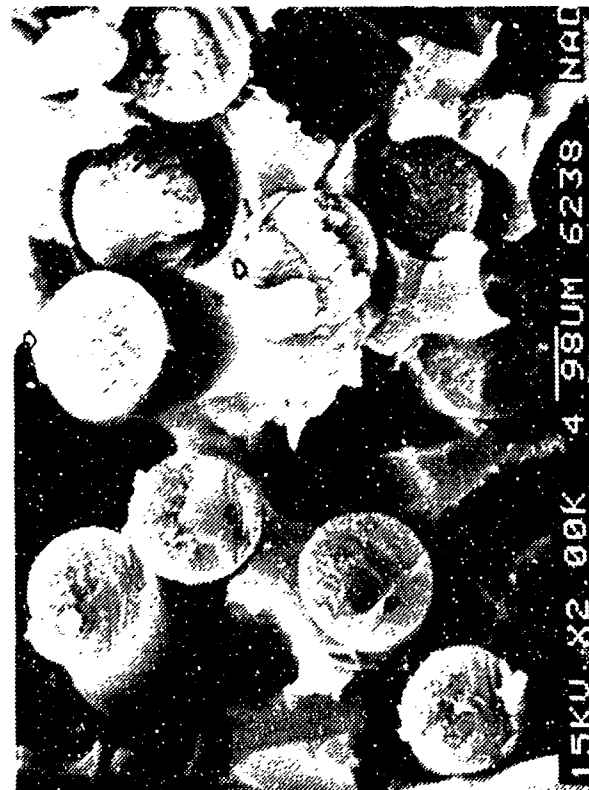
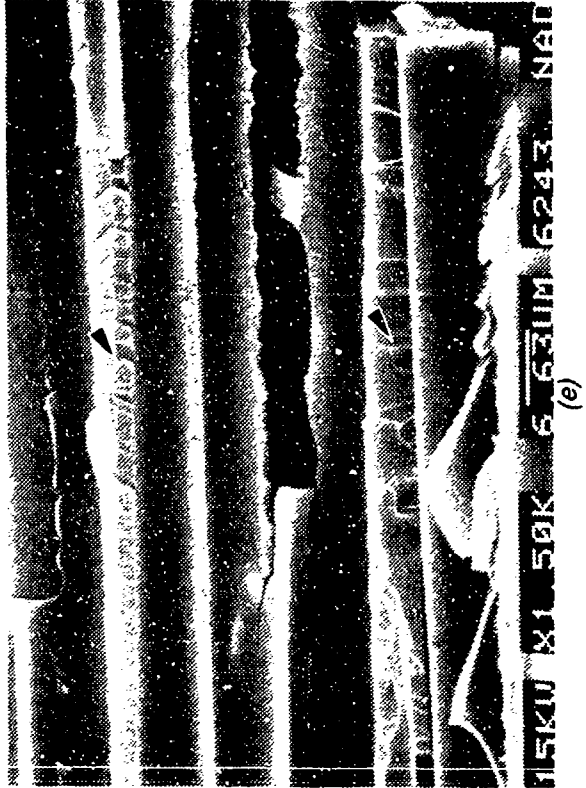
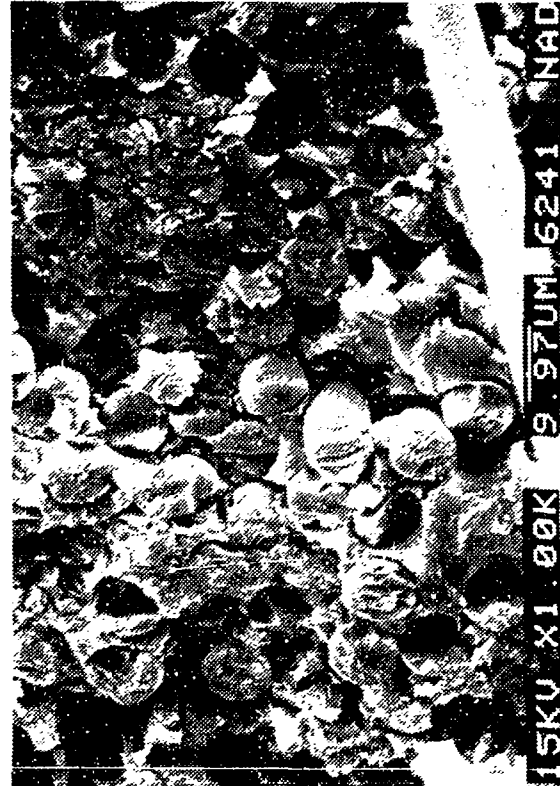
Figure 6-5. (Continued)
 (d) Chop Marks (Solid Arrows) and DAF Radials
 (Hollow Arrows) on Fiber Ends
 (e) Resin Fracture in 90 Degree Ply (Tension Region)
 Note river patterns (arrow)
 (f) Chop Marks on Fiber Ends in Compression Region

CD = Crack-propagation direction
