WL-TR-91-4032
DOT/FAA/CT-91/23
VOL II, Part 2

COMPOSITE FAILURE ANALYSIS HANDBOOK
VOL II - TECHNICAL HANDBOOK
PART 2 - ATLAS OF FRACTOGRAPHS

February 1992

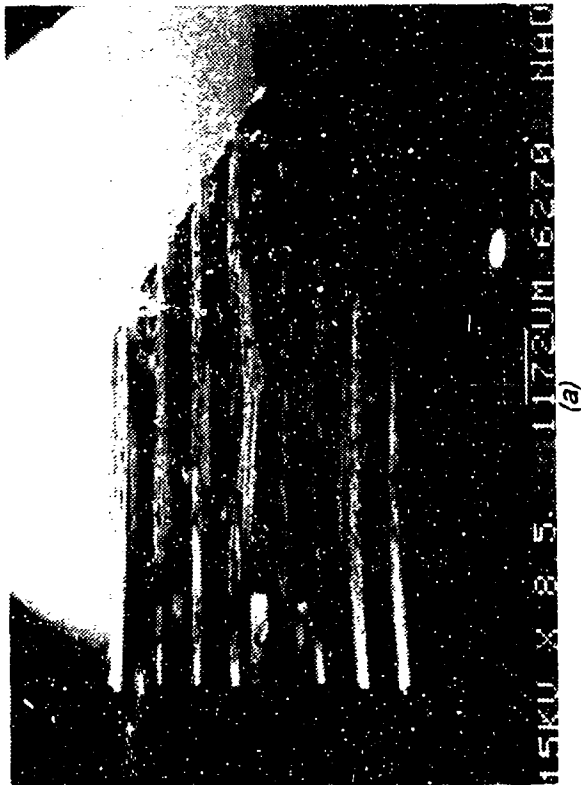
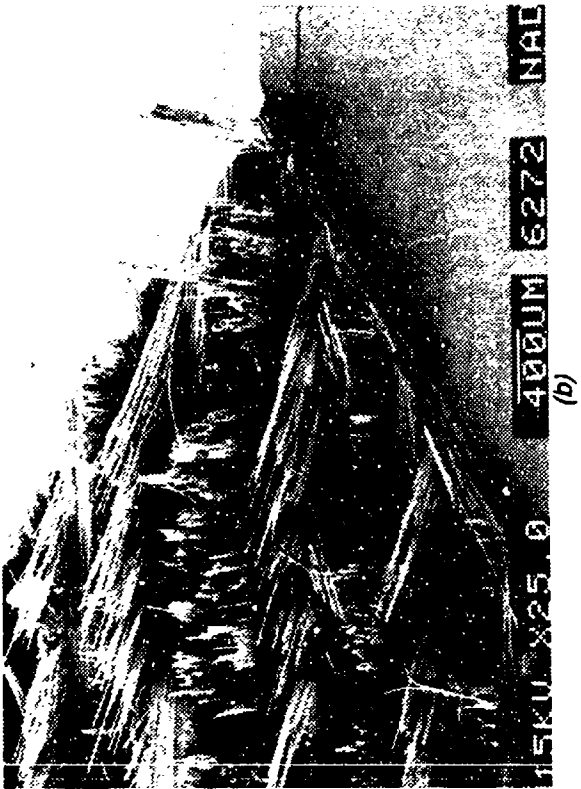
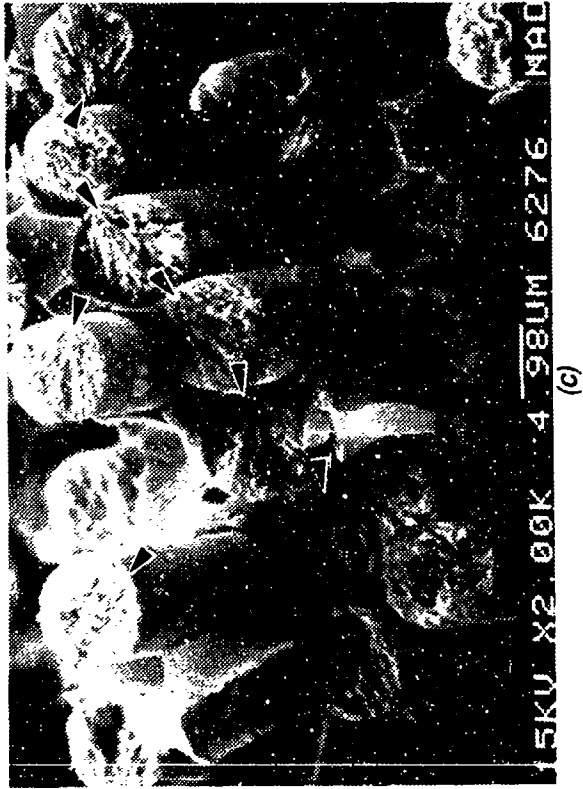
Figure 6-6. SEM Photographs of Mode I Translaminar Tension Fracture in AS4/5250-3 Gr/BMI - 32 Ply Quasi-Isotropic, Room Temperature Ambient (a), (b) Normal and Oblique Views of Fracture (c) DAF Radials (Arrows) on Fractured Fiber Ends (0 Degree Ply, Tension Region)

C = Compression region
T = Tension region
CD = Crack-propagation direction

Figures 6-1 through 6-4 provide interlaminar fractographs and Figures 6-5, 6-6 and 6-7 provide translaminar fractographs. This contribution was made by Northrop.

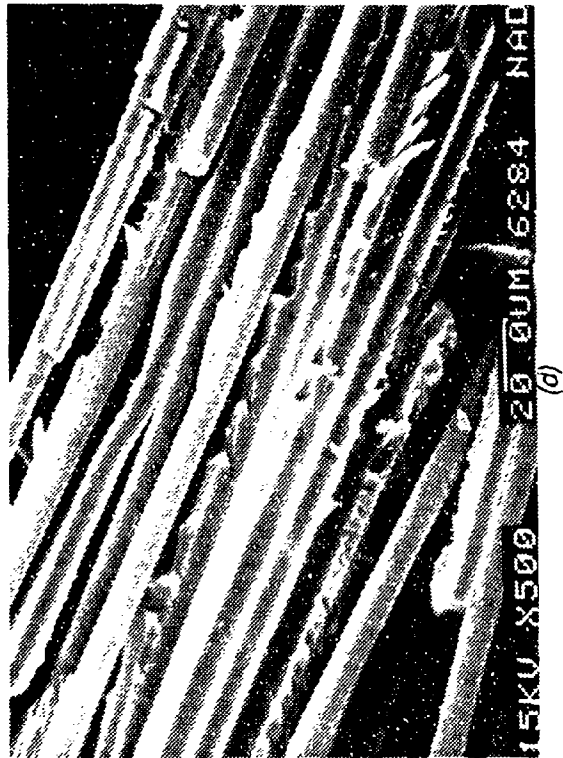
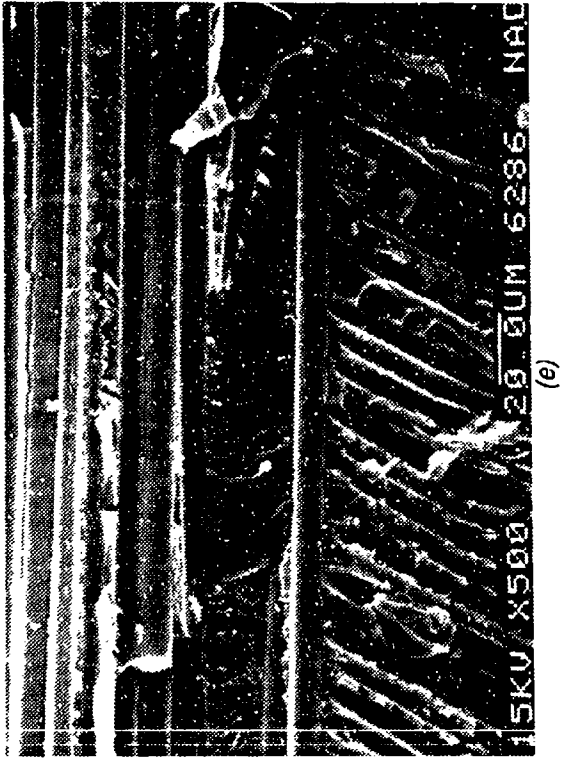
Figure 6-6. (Continued)
 (c), (e) Peel Fracture in 45 and 90 Degree Plies
 (f) Chop Marks (Arrows) on Fiber Ends in
 Compression Region

CD = Crack-propagation direction

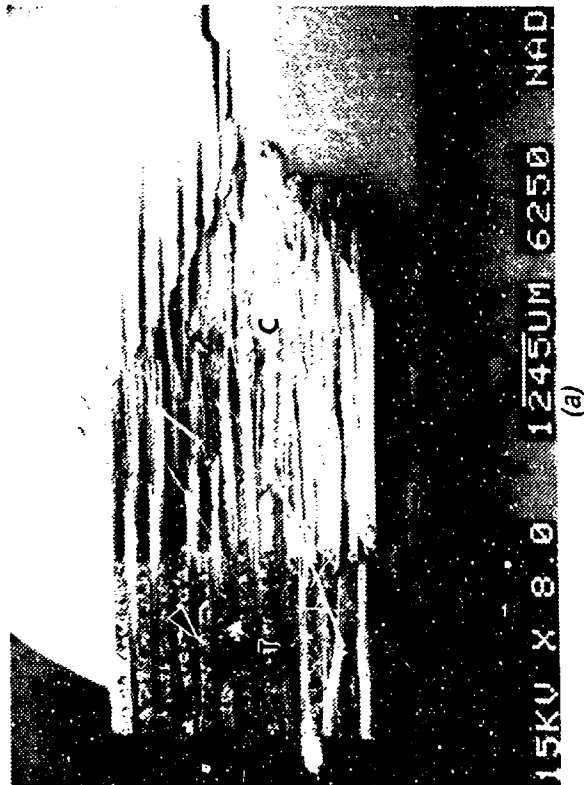
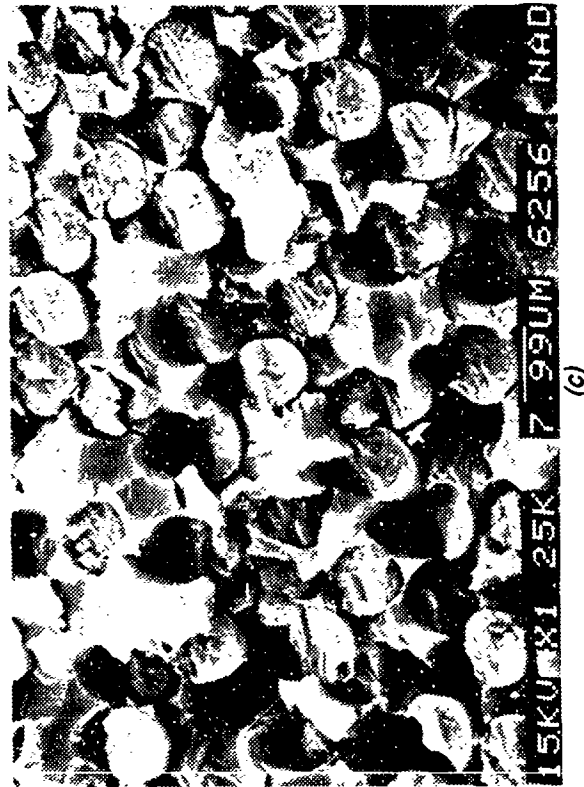
Figure 6-7. SEM Photographs of Mode I Translaminar Compression Fracture in AS4/5250-3 Gr/BMI - [90/0] _{ss}, Room Temperature Ambient

(a) Normal View of Fracture
 Note: Arrow indicates chevrons.
 C = Compression region
 T = Tension region

(b) Oblique View of Fracture
 Note: longitudinal splits close to apex of notch (arrow)

(c) Chop Marks on 0 Degree Fiber Ends in Compression Region

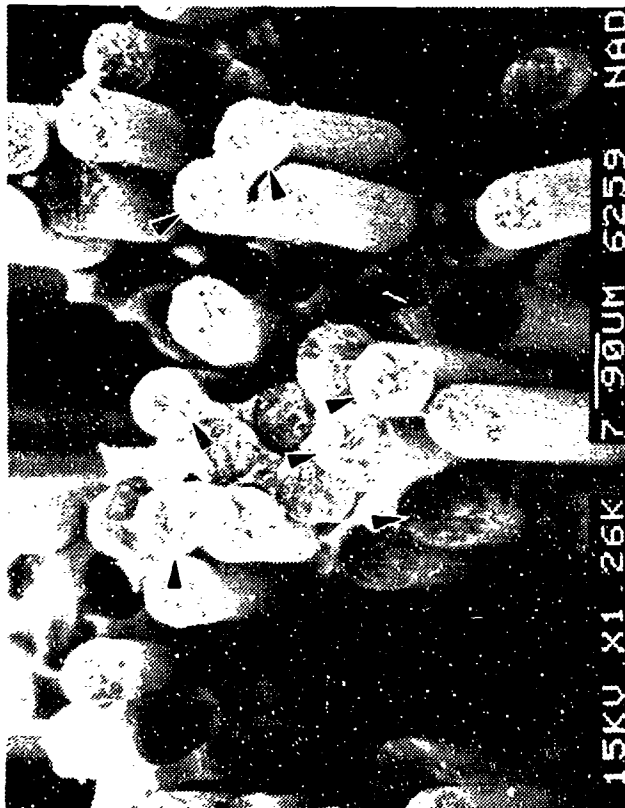
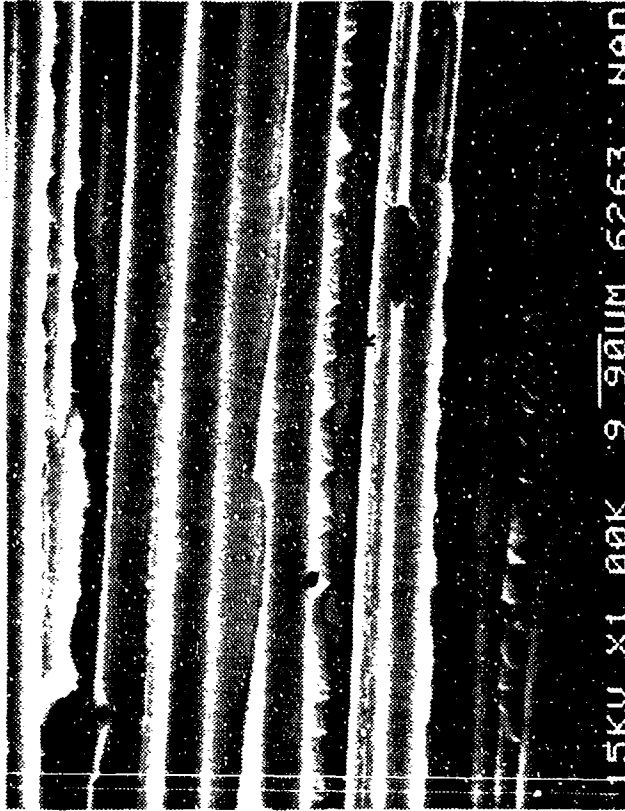
Figure 6-7. (Continued)
 (d) DAF Radials (Arrows) on Fractured Fiber Ends in Tension Region
 (e) Fracture Features Present in 90 Degree Ply Oriented Parallel to Fracture
 H = Hackles
 R = River patterns
 CD = Crack-propagation direction

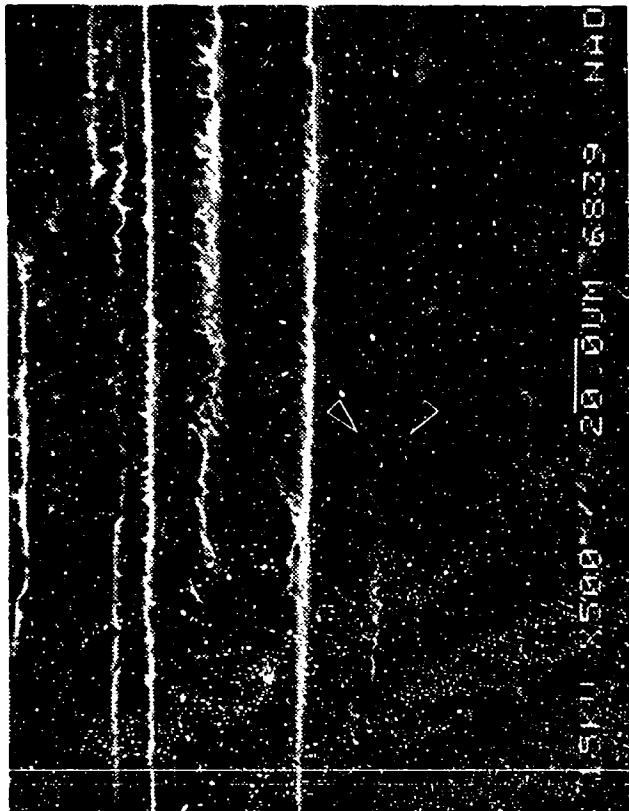
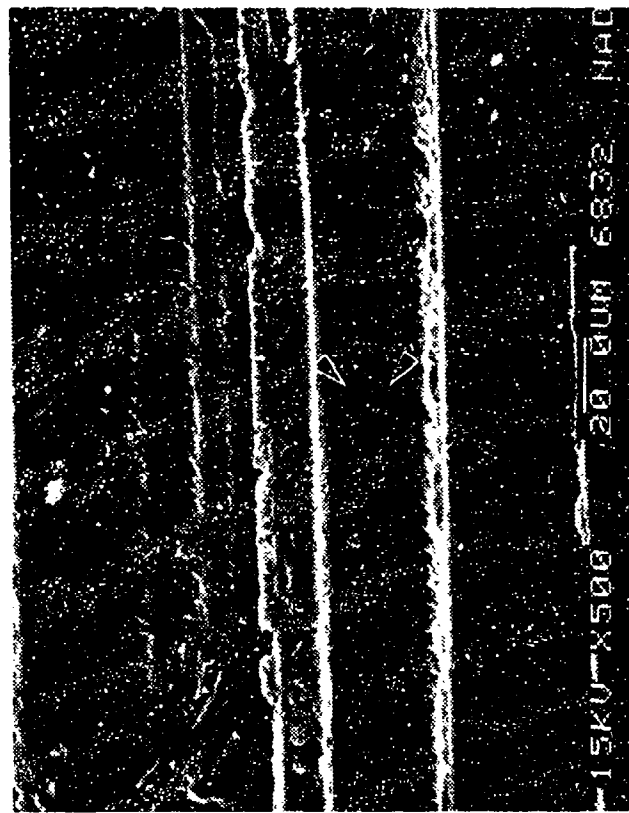
Figure 7-1. (Continued)
(c). (d) Mating Fracture Surfaces Showing Fractured Fibrils (Arrows)

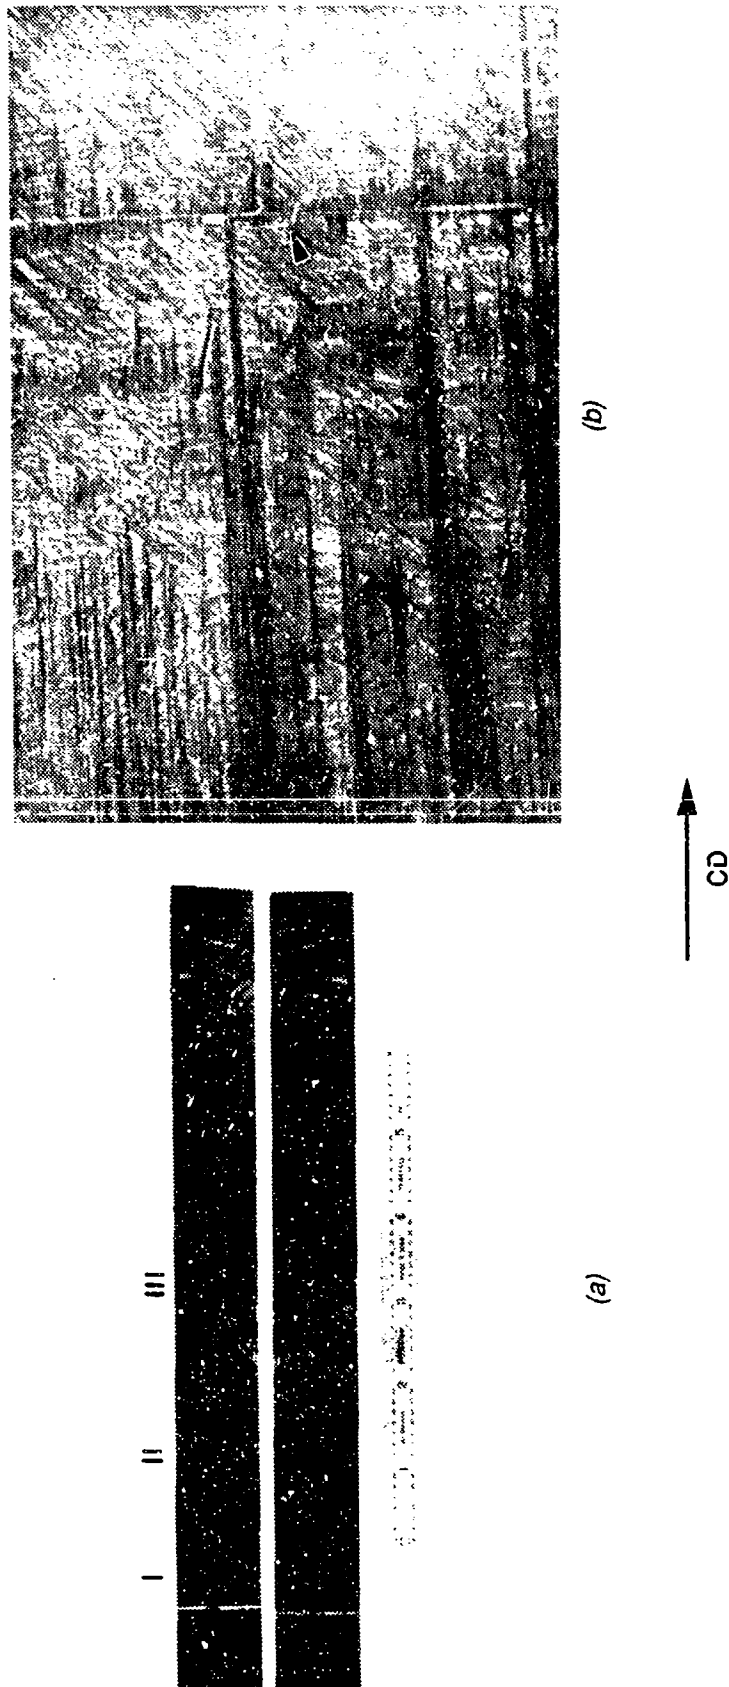
Figure 7-2. Optical and SEM Photographs of Mode I DCB Interlaminar Fracture in AS4/APC-2 Gr/PEEK - [+45/0/-45]_{4s}, Mode I DCB, Room Temperature Ambient
 (a) Macrograph Showing Regions I, II, and III
 (b) Ribs (Arrows) Oriented Toward CD

CD = Crack-propagation direction

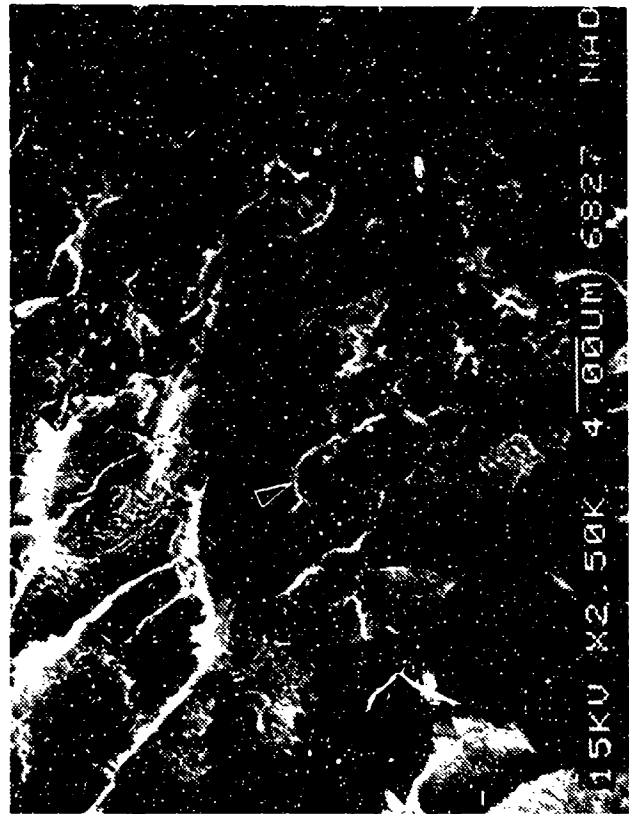
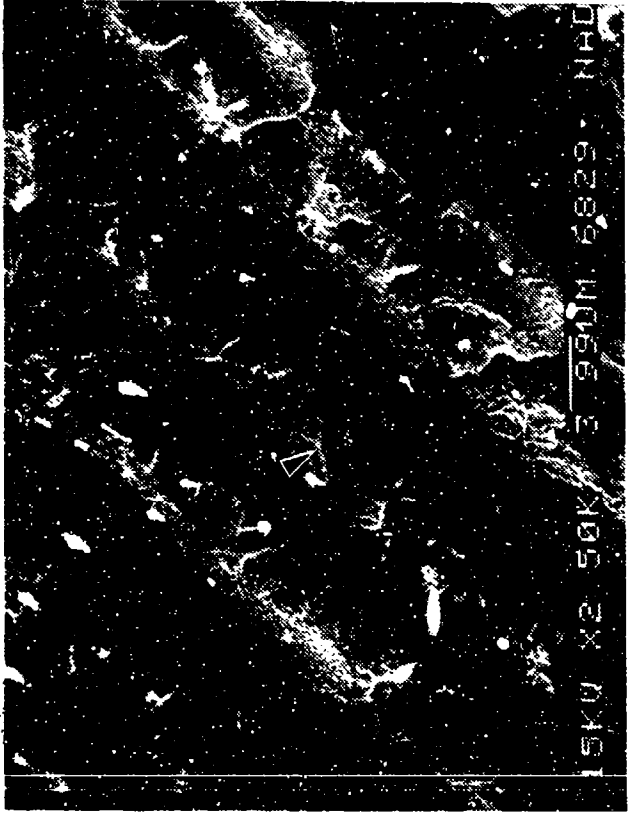
Figure 7-2. (Continued)
(c), (d) Mating Fracture Surfaces Showing Fractured Fibrils (Arrows)

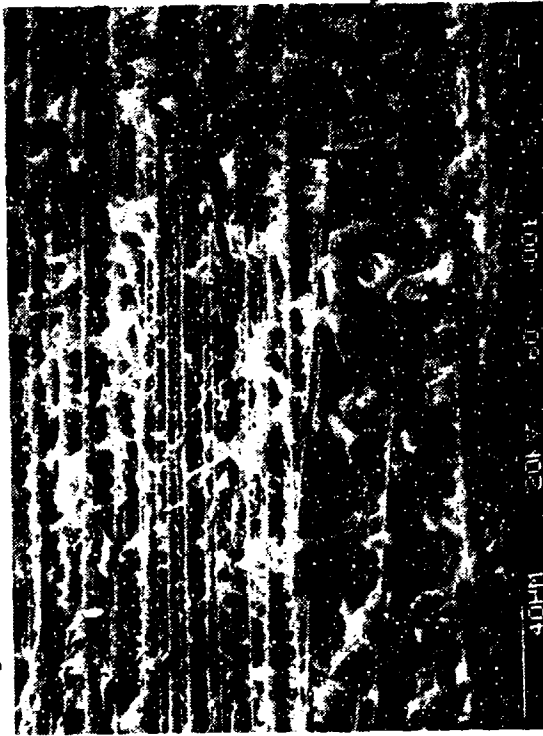
60 degree tilt 400X

Legend:
 D ductile matrix fracture
 F fiber
 Mechanically induced crack direction

60 degree tilt 2,000X

Figure 7-3. SEM Fractographs of 270/F Wet, Interlaminar Mode I Tension, 0/90 Fracture in ASA/APC-2

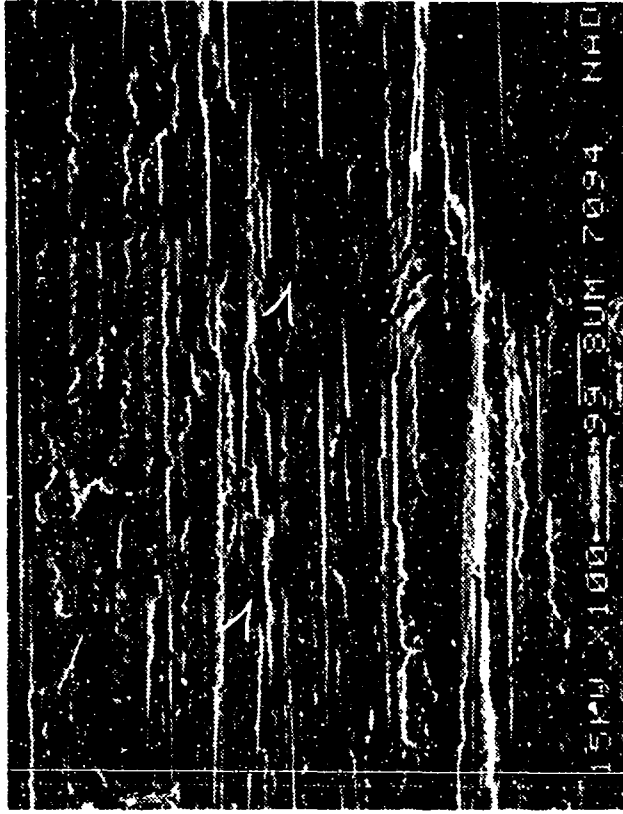
Figure 7-4. Optical and SEM Photographs of Mode I DCB Interlaminar Tension Fracture in AS4/APC-2 Gr/PEEK - [0]_{24T}, Conditioned 180 F/Dry
 (a) Macro photograph of Fracture Showing Regions I, II, and III
 (b) Rib (Arrows)
 Note: Arrows indicate ribs oriented toward CD.

CD = Crack propagation direction

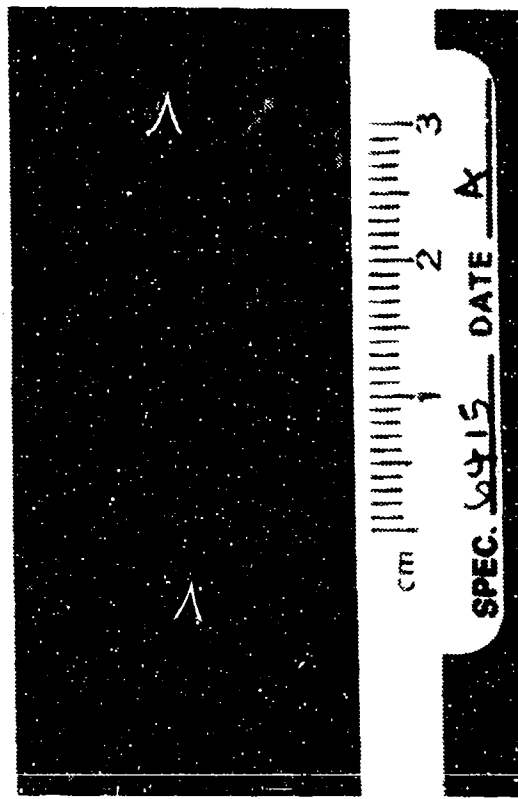
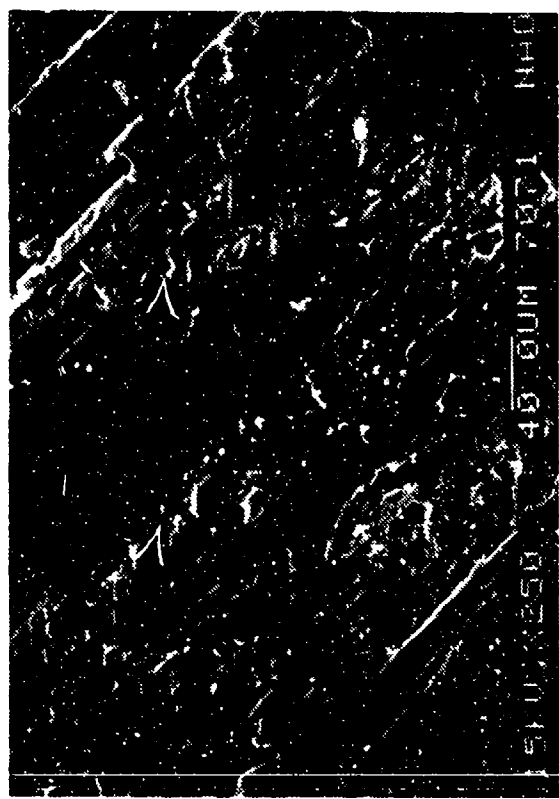
Figure 7-5. Optical and SEM Photographs of Mode I DCB Interlaminar Tension Fracture in AS4/APC-2 Gr/PEEK - [+45/0/-45]_{4s}, Conditioned 180 F/Dry
 (a) Macrograph of Fracture Showing Regions I, II, and III (Pre-crack, Crack-Growth, and Laboratory Overload)
 Note: Arrows indicate ribs oriented toward CD.
 (b), (c) Ribs (Arrows)
 CD = Crack-propagation direction

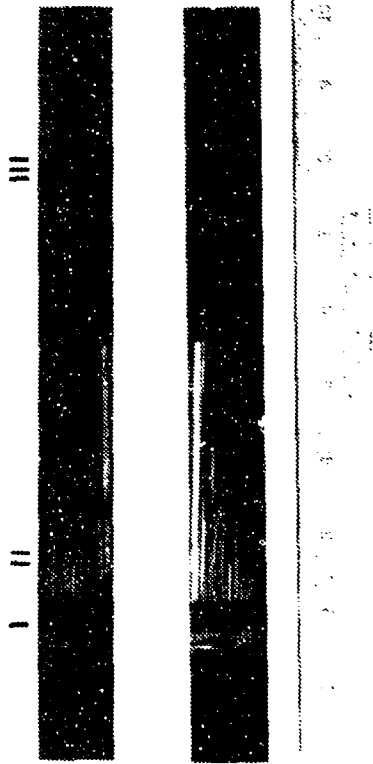
Figure 7-6. Optical and SEM Photographs of Mode I DCB Interlaminar Tension Fracture in AS4/APC-2 Gr/PEEK - [90/0]_{6s}, Conditioned 180 F/Dry Overload
 (a) Macro photograph of Fracture Showing Regions I, II, and III (Pre-crack, Crack-Growth, Laboratory Overload)
 (b), (c) Ribs (Arrows) Oriented Toward CD

CD = Crack-propagation direction

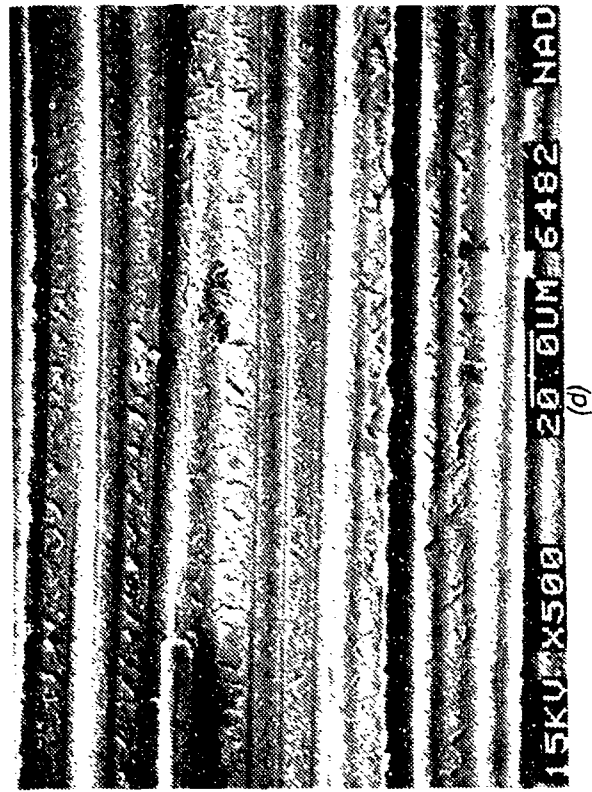
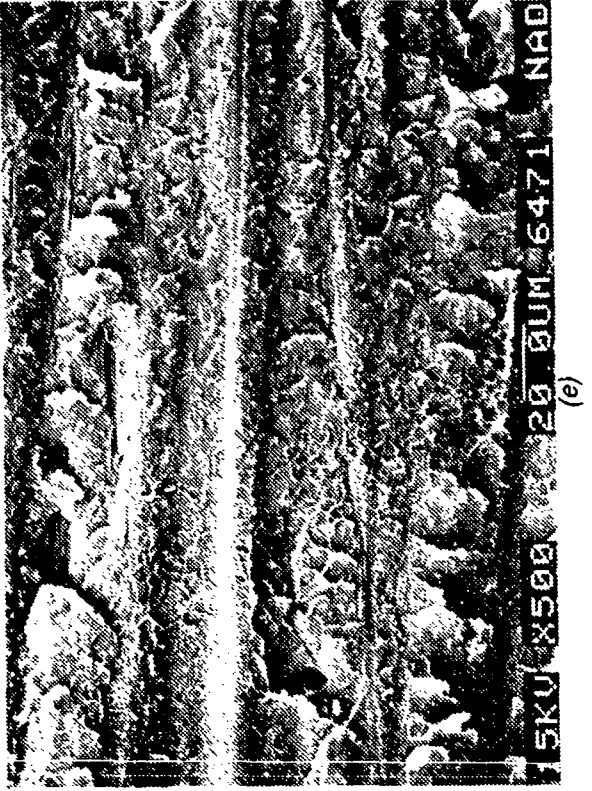
Figure 7-7. (Continued)
 (d), (e) Region I Fracture
 (f) Peel Fracture in Region I

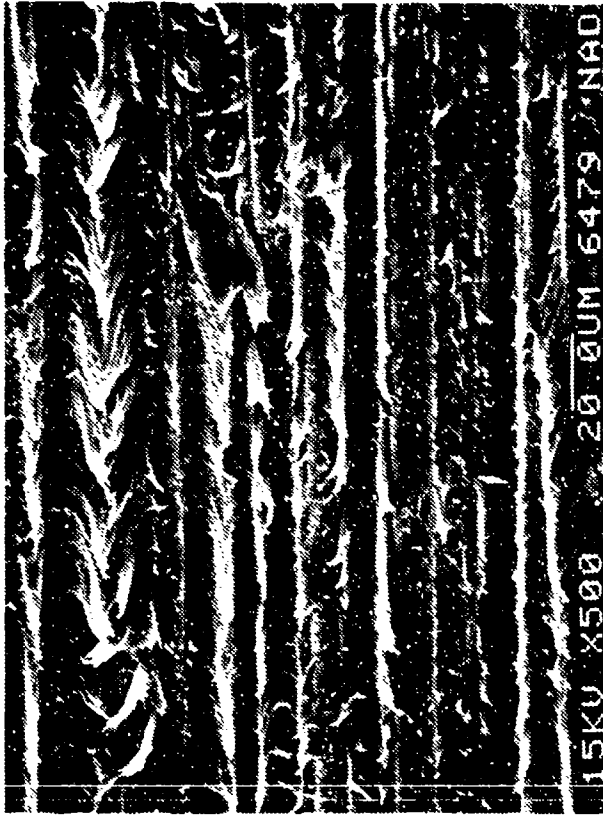
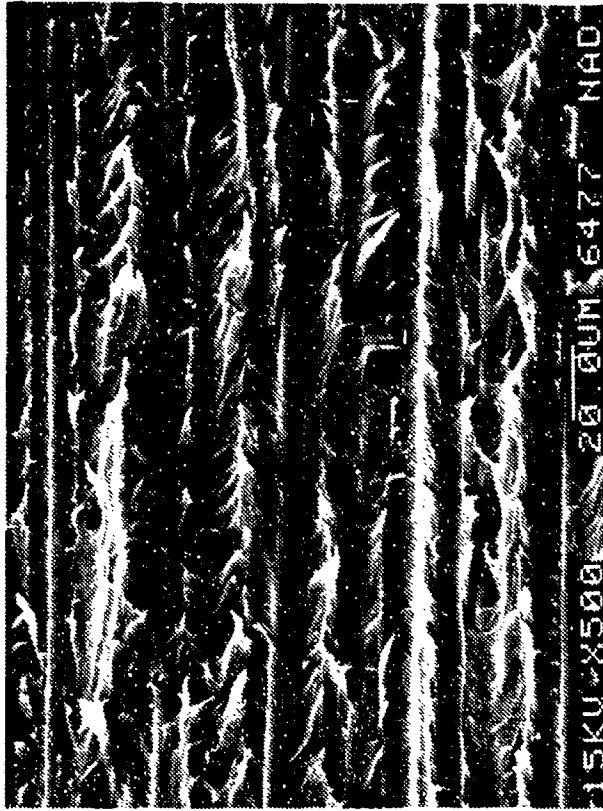
Figure 7-7. (Continued)
(g), (h) Shear Fracture Region in Mating Halves

Note orientation of drawn fibrils (arrows)

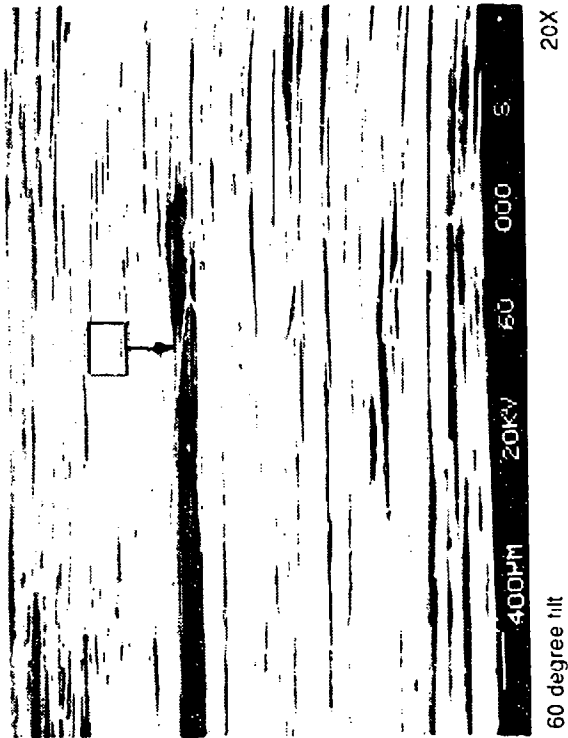
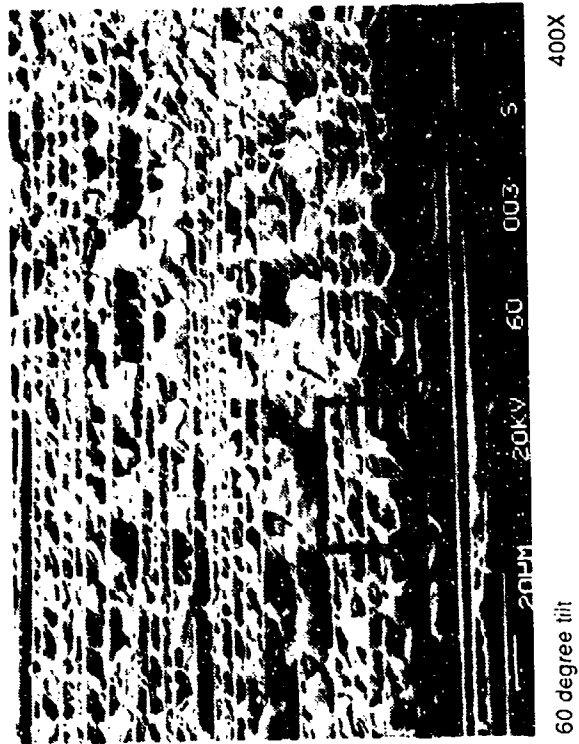
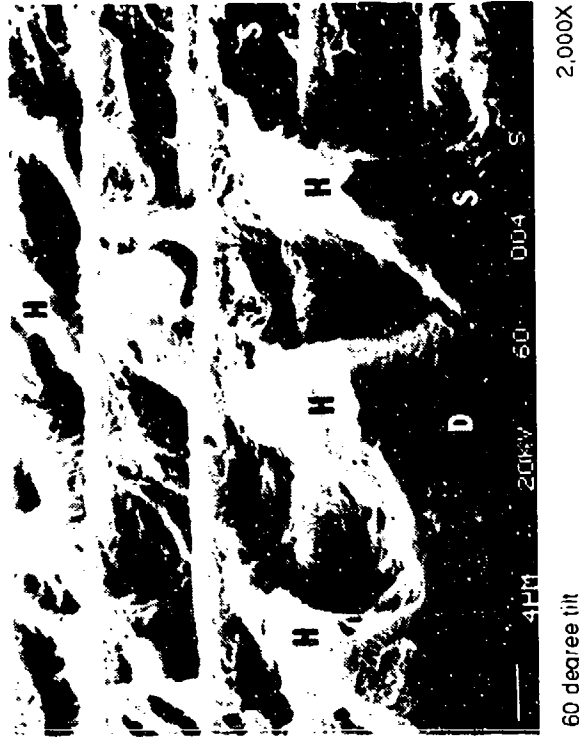
Legend:

- D ductile overload
- H hackle
- S ductile shear

Figure 7-8. SEM Fractographs of 270/F Wet, Interlaminar Mode II Shear, 0/90 Fracture in AS4/APC-2

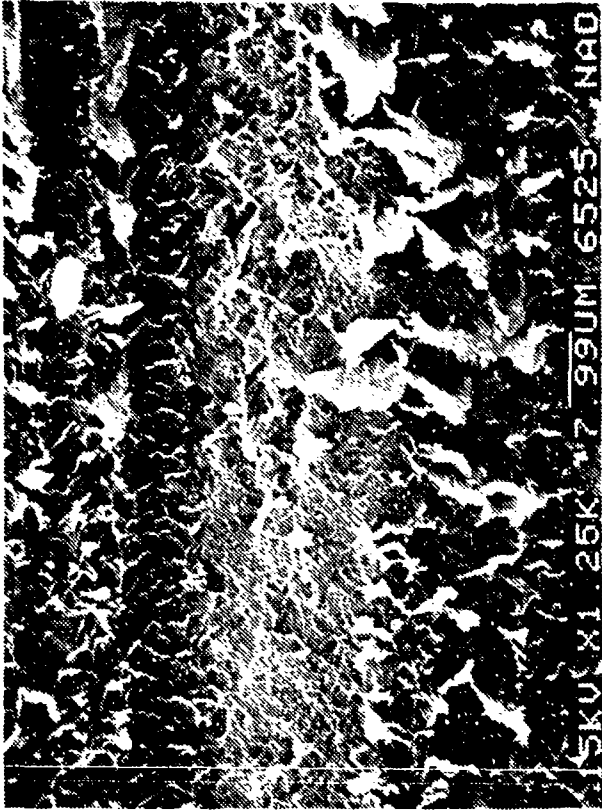
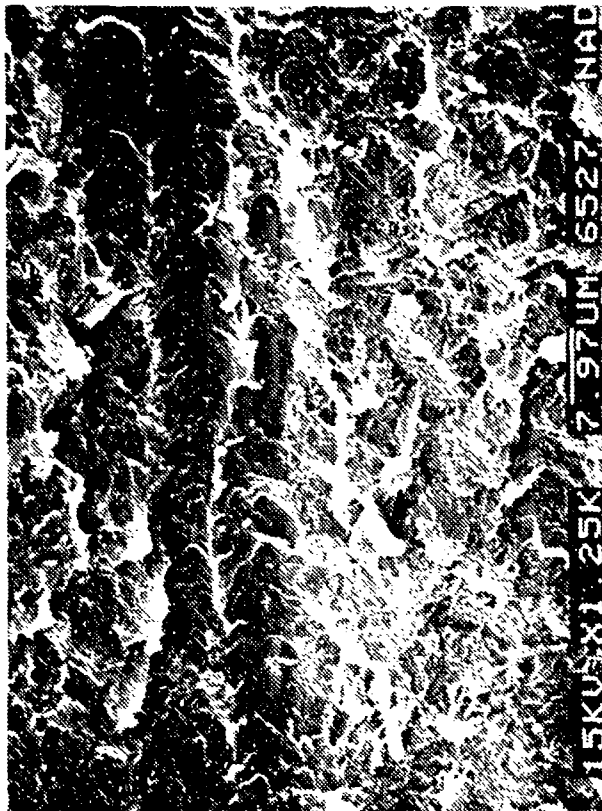
Figure 7-9. (Continued)
 (c), (d) Shear Fracture Region in Mating Fracture Halves
 Note orientation of drawn fibrils (arrows)

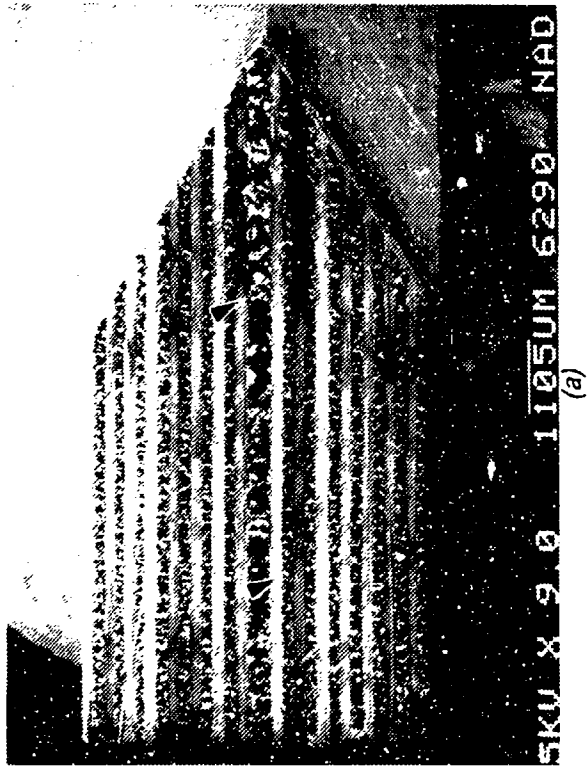
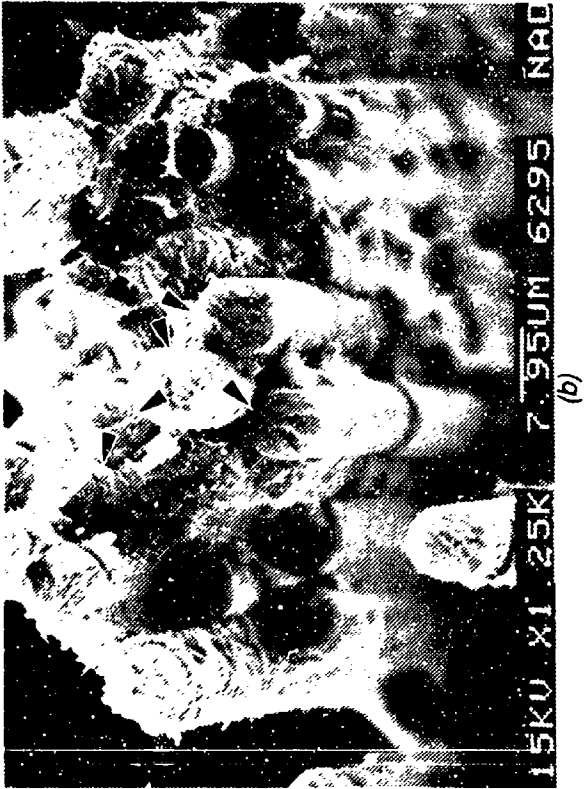
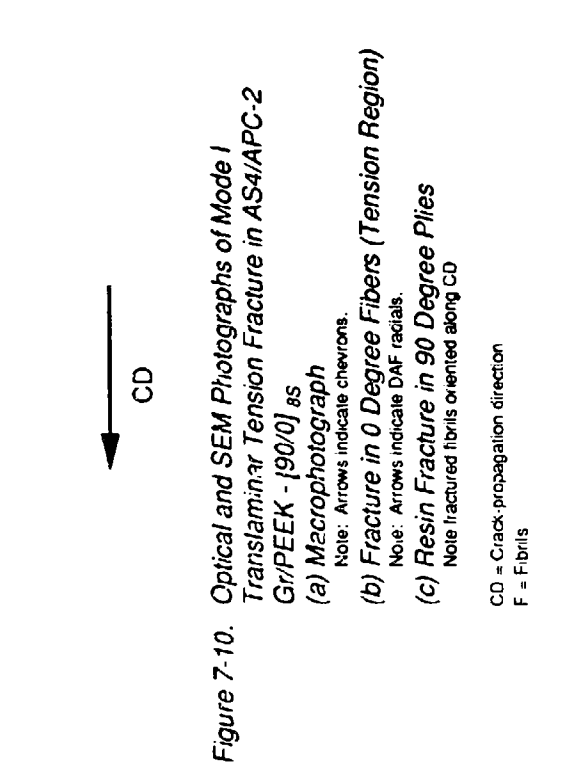
Figure 7-10. Optical and SEM Photographs of Mode I Translaminar Tension Fracture in AS4/APC-2 Gr/PEEK - [90/0] as

- (a) Macro photograph
Note: Arrows indicate chevrons.
- (b) Fracture in 0 Degree Fibers (Tension Region)
Note: Arrows indicate DAF radials.
- (c) Resin Fracture in 90 Degree Plies
Note: Fractured fibrils oriented along CD

CD = Crack propagation direction
F = Fibrils

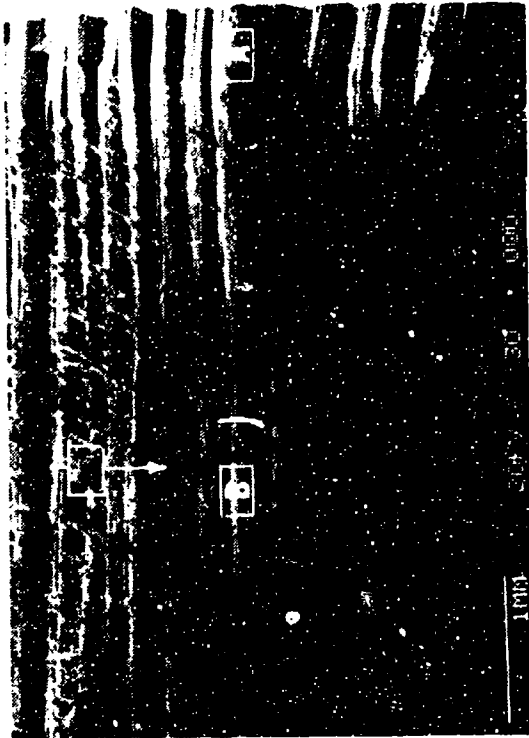
30 degree tilt 20X

Mechanically induced
crack direction

0 degree tilt 400X

0 degree tilt 2,000X

Figure 7-11. SEM Fractographs of 270/F Wet, Translaminar Tension, 0/90 Fracture in AS4/APC-2

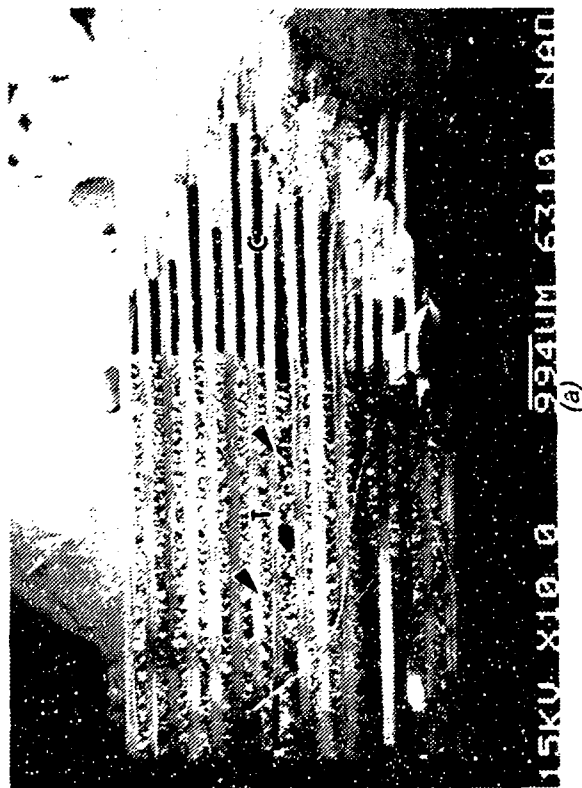
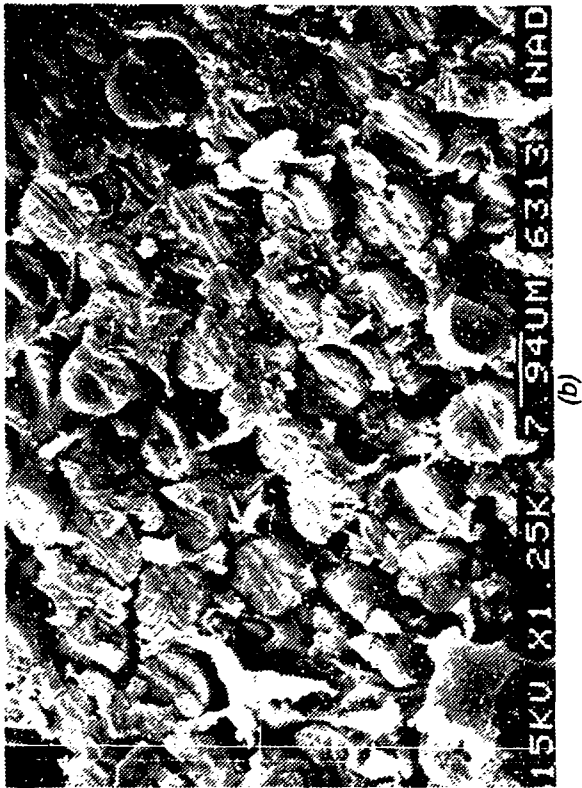
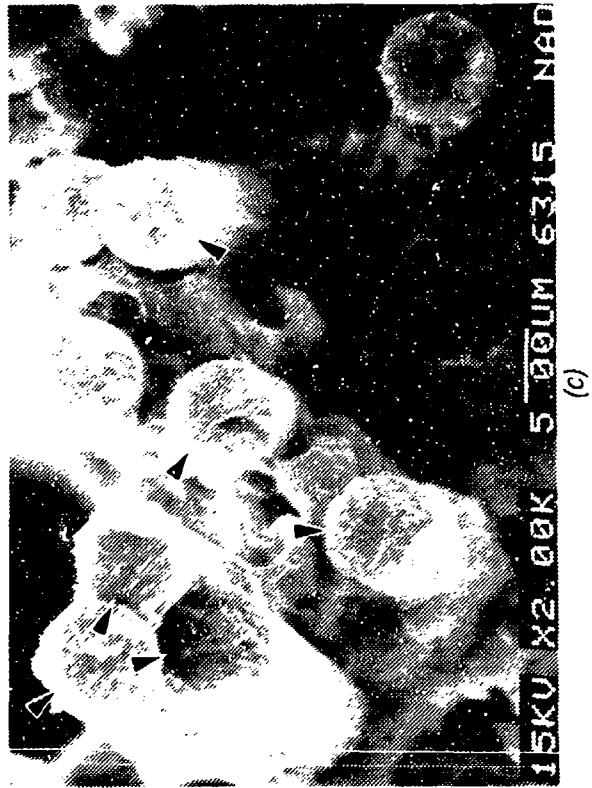
Figure 7-12. Optical and SEM Photographs of Mode I Translaminar Compression Fracture in AS4/APC-2 Gr/PEEK - [90/0]_{as}, Room Temperature Ambient

(a) Macro photograph
 C = Compression region
 T = Tension region
 Note: Arrows indicate chevrons.

(b) Chop Marks on Fractured 0 Degree Fibers (Compression Region)
 (c) DAF Radials on Fractured 0 Degree Fibers (Tension Region)

CD = Crack-propagation direction

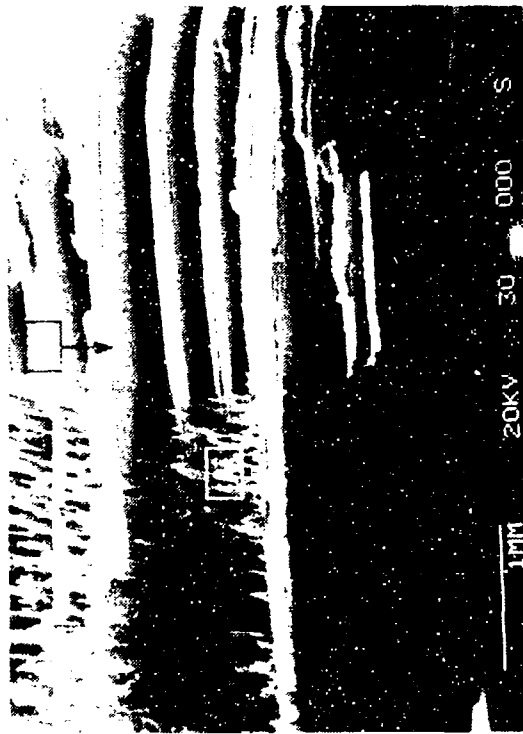
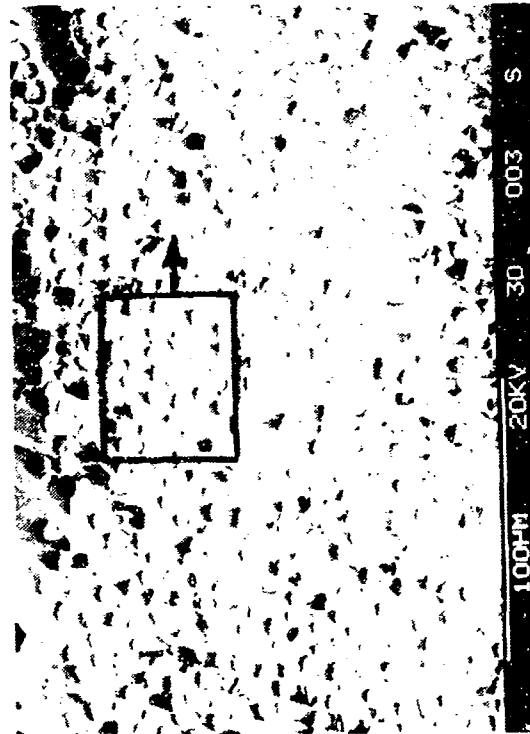
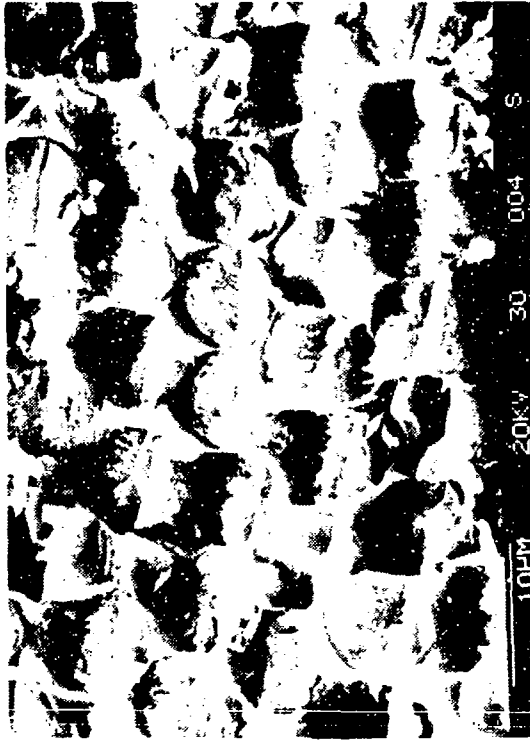
30 degree tilt 20X

Mechanically induced
crack direction

30 degree tilt 400X

30 degree tilt 2,000X

Figure 7-13. SEM Fractographs of 270/F Wet, Translaminar Compression, 0/90 Fracture in AS4/APC-2

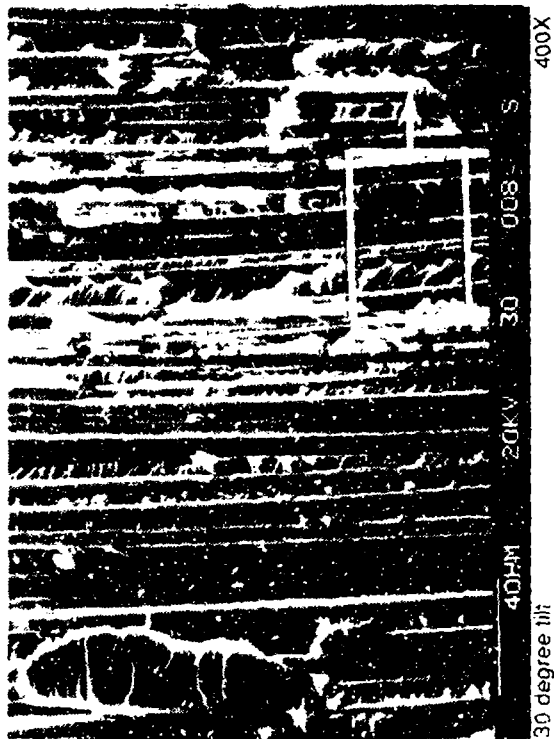
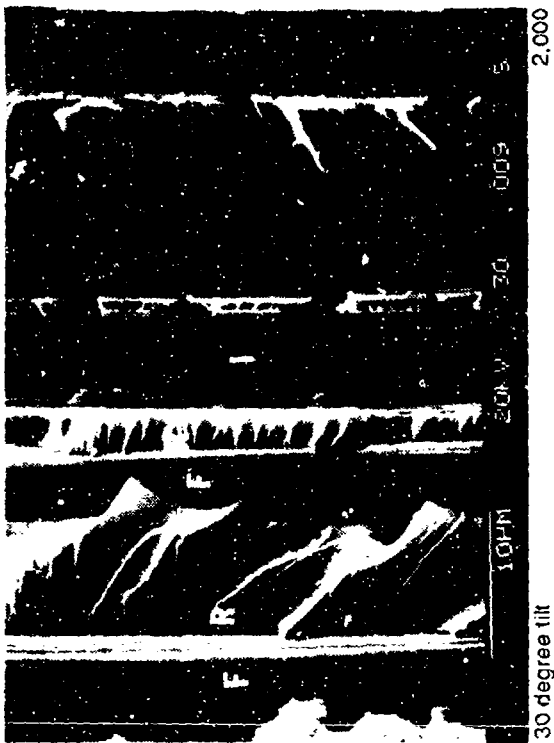
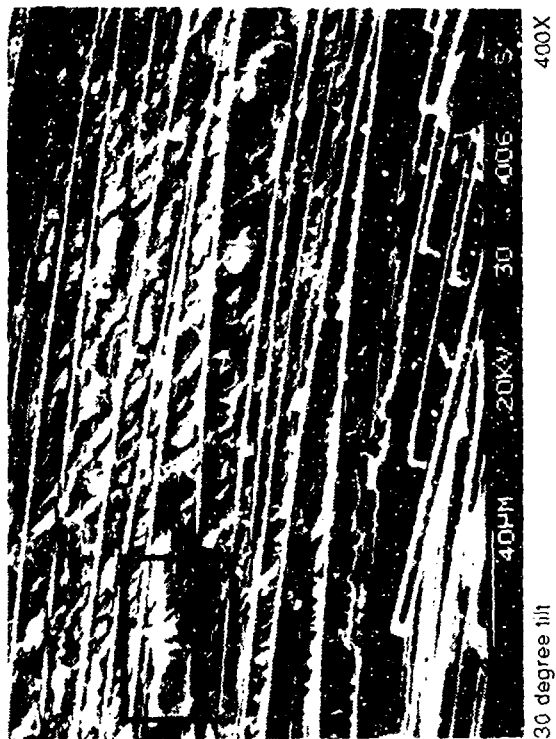
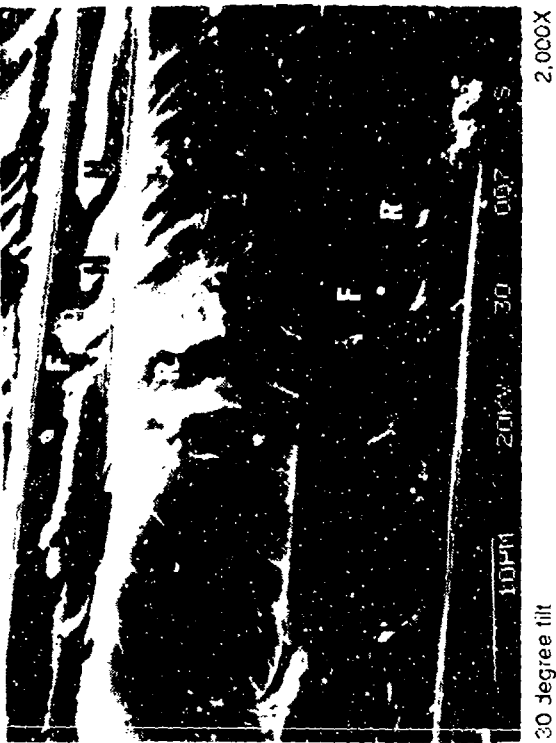
Legend: F fiber; H hackle; I fiber imprint; R rivermarks
 Figure 8-1. SEM Fractographs of Room Temperature, Mode I Interlaminar Tension Fracture in C3K 8-HS/PMR-15

Specimens tested at room temperature (RT) exhibited a reflective interlaminar surface when examined optically. SEM fractography of tows oriented perpendicular to the mechanically induced crack propagation direction revealed river marks indicating a crack growth direction consistent with the mechanically induced crack direction (Figure 8-1). Fractures at tows oriented parallel to the mechanically induced crack propagation direction were characterized by a mixed-mode morphology with poorly formed hackles in the matrix indicating shear propagation due to the influence of fabric reinforcement. Resin-rich regions between tows exhibited river marks indicating crack propagation from one tow toward the center of the adjacent tow, regardless of the mechanically induced crack propagation direction. Fiber/matrix adhesion was poor, as most fibers were bare.

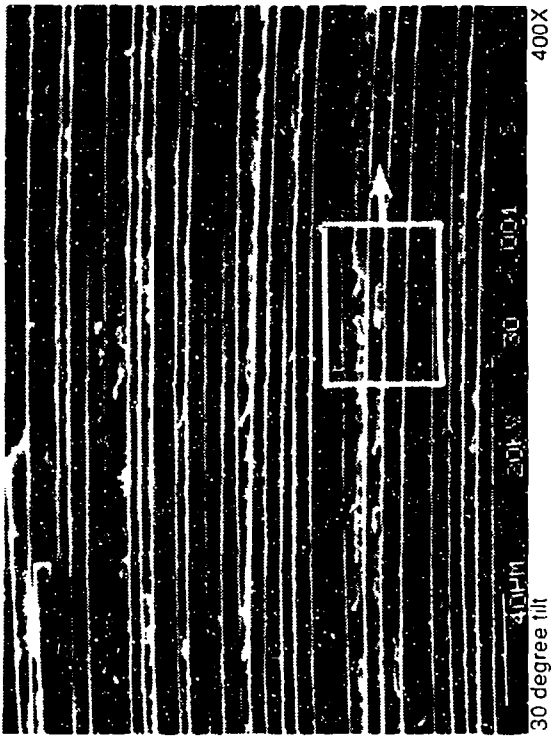
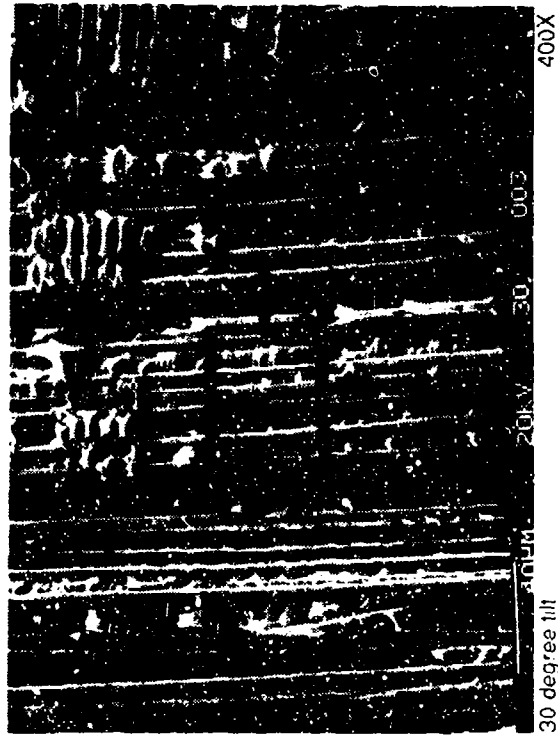
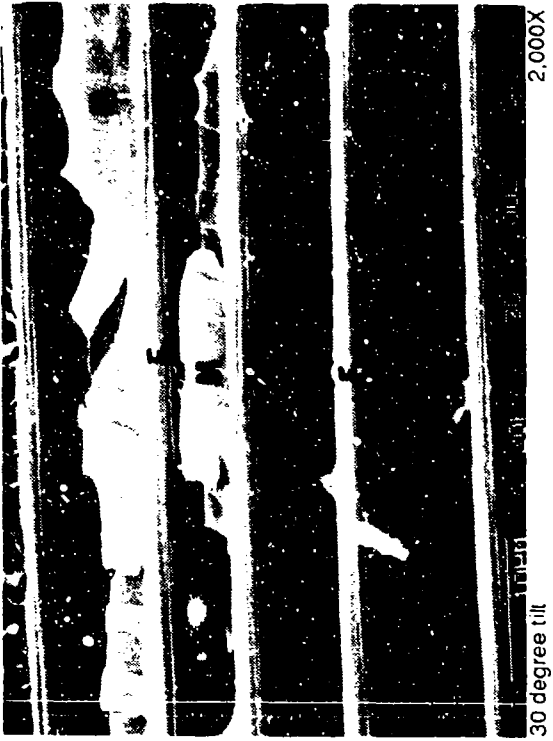
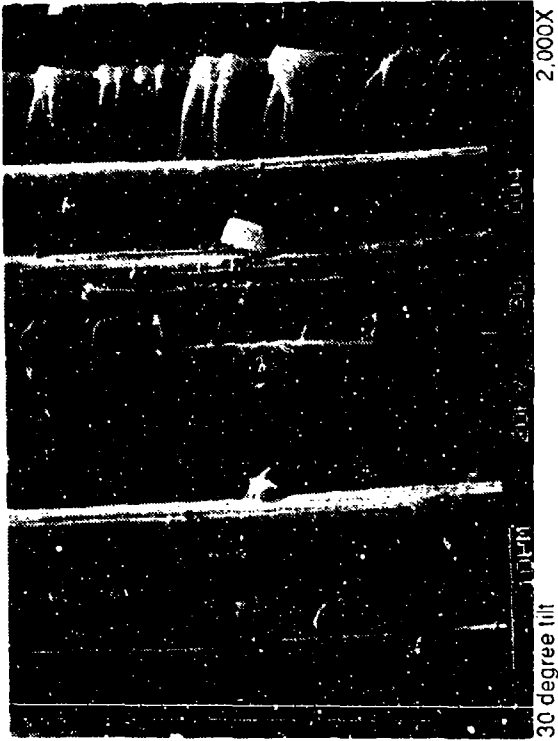
Mechanically induced crack direction →

Legend: F fiber; M matrix failure; R rivermarks
 Figure 8-2. SEM Fractographs of 500 F/Dry, Mode I Interlaminar Tension Fracture in C3K 8-HS/PMR-15

Specimens tested at 500°F exhibited a slightly reflective interlaminar surface when examined optically. SEM fractography of tows oriented perpendicular to the mechanically induced crack propagation direction revealed river marks which indicated propagation in directions both consistent with and opposite to the overall propagation direction (Figure 8-2). Fractures at tows oriented parallel to the mechanically induced crack propagation direction were characterized by featureless matrix fracture having the appearance of shear failure. Fiber/matrix adhesion was good.
