WL-TR-91-4032
DOT/FAA/CT-91/23
VOL II, Part 2

COMPOSITE FAILURE ANALYSIS HANDBOOK
VOL II - TECHNICAL HANDBOOK
PART 2 - ATLAS OF FRACTOGRAPHS

February 1992

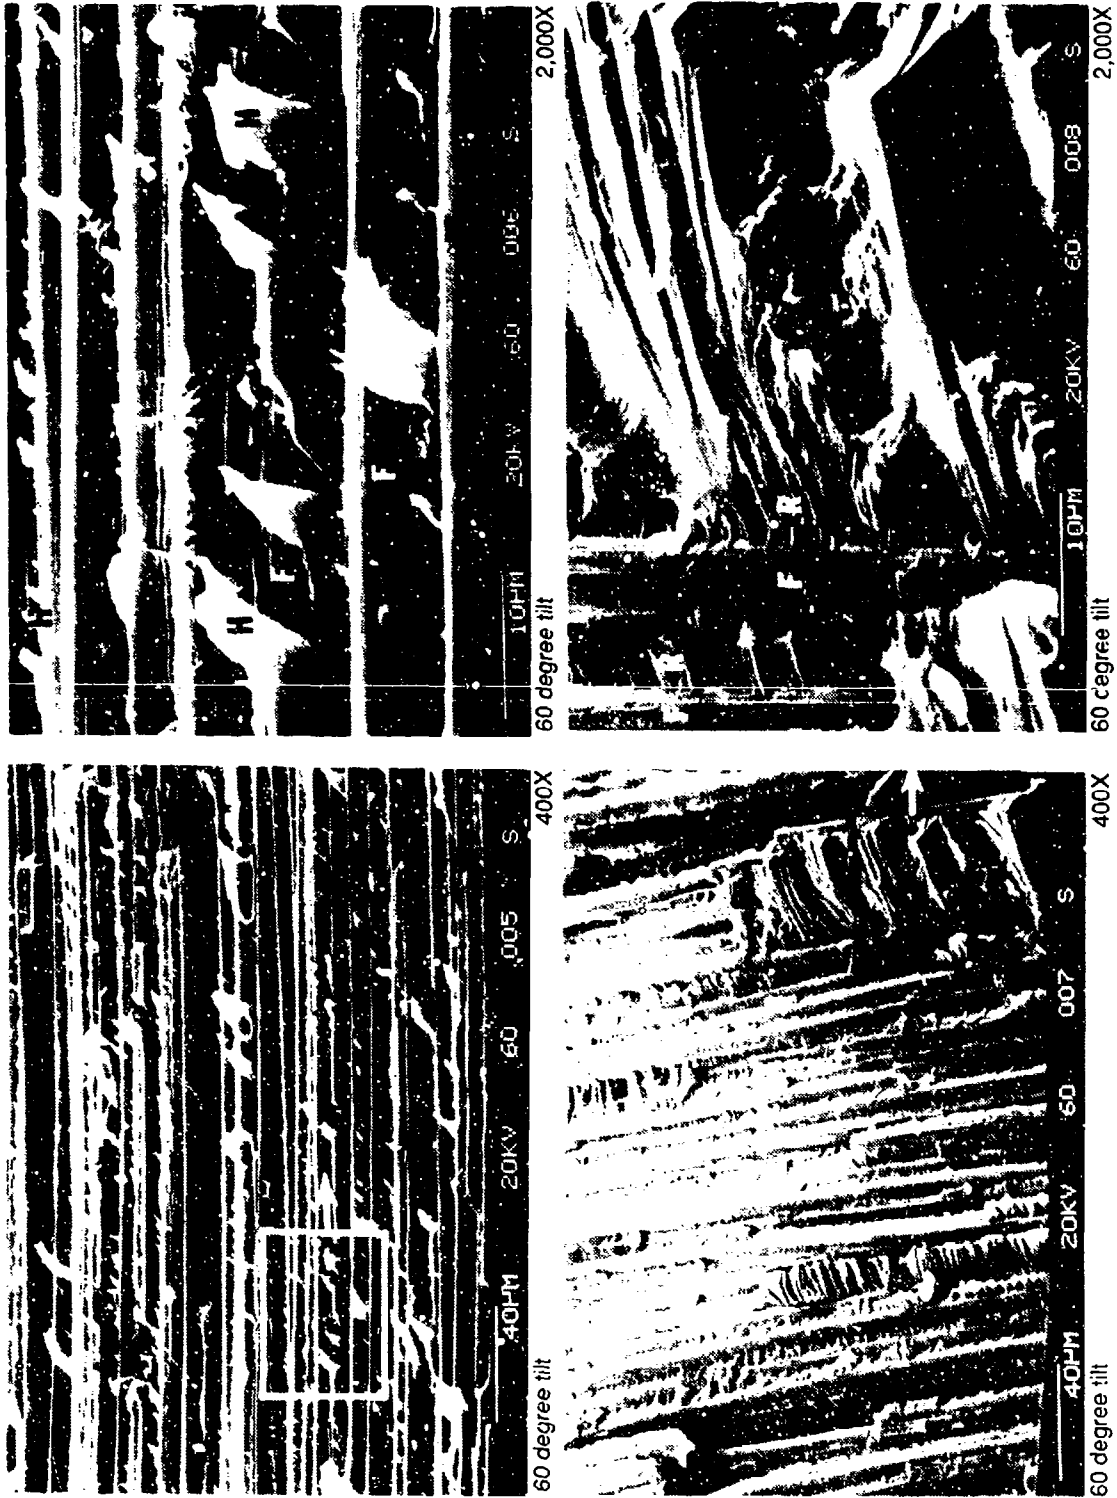
Mechanically induced crack direction

Legend: F: fiber; H: hackle; R: rivermark

Figure 8-3. SEM Fractographs of Room Temperature, Mode II Interlaminar Shear Fracture in C3K 8-HS/PMR-15

Specimens tested at RT exhibited a matte surface regularly associated with shear fracture when examined optically. SEM fractography of tows oriented parallel to the mechanically induced crack propagation direction revealed hackles and scallops, indicative of shear fracture (Figure 8-3). Fractures at tows oriented perpendicular to the mechanically induced crack

propagation direction were characterized by mixed-mode morphology. The cleavage features associated with the observed hackles did not indicate crack propagation in the mechanically induced direction. The fiber matrix adhesion was poor.

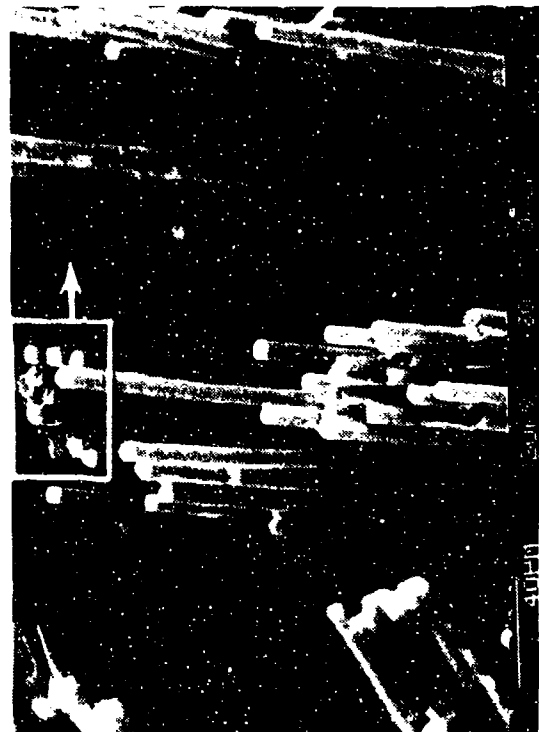
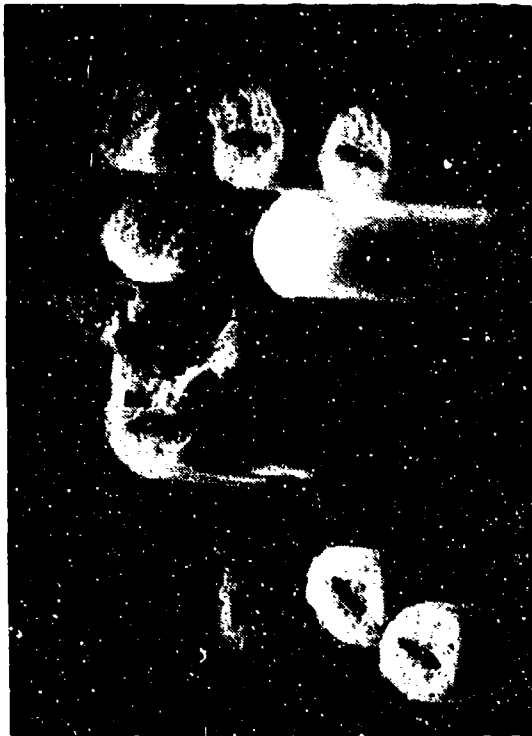
F fiber fracture

M matrix fracture

Mechanically induced
crack direction

Figure 8-5. SEM Fractographs of Room Temperature/Dry, Translaminar Tension Fracture in C3K 8-HS/PMR-15

Specimens tested at RT appeared predominantly rough and jagged due to protruding ± 45 degree fibers when examined optically, and this appearance is typical of translaminar tensile fracture. SEM fractography of the tensile portion of the fracture surface revealed fiber end features with fan patterns showing an overall propagation direction consistent with the mechanically induced crack growth direction (Figure 8-5). River marks and resin microflow in the resin-rich areas of the tensile zone also indicated a crack growth direction consistent with the mechanically induced crack growth direction.

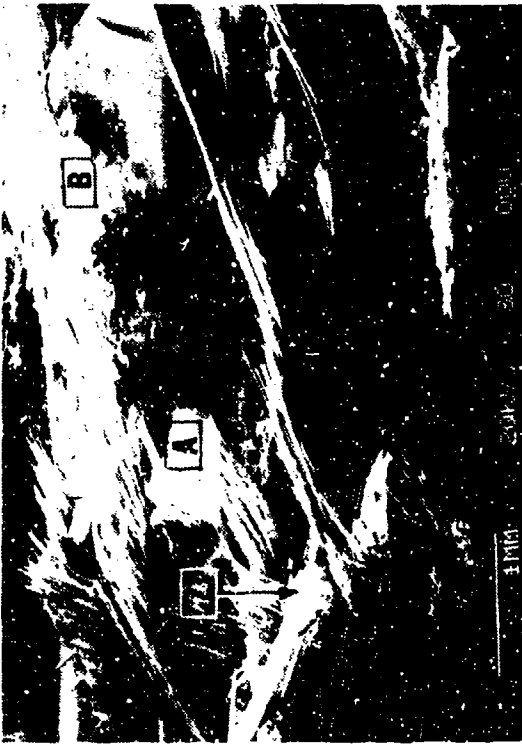
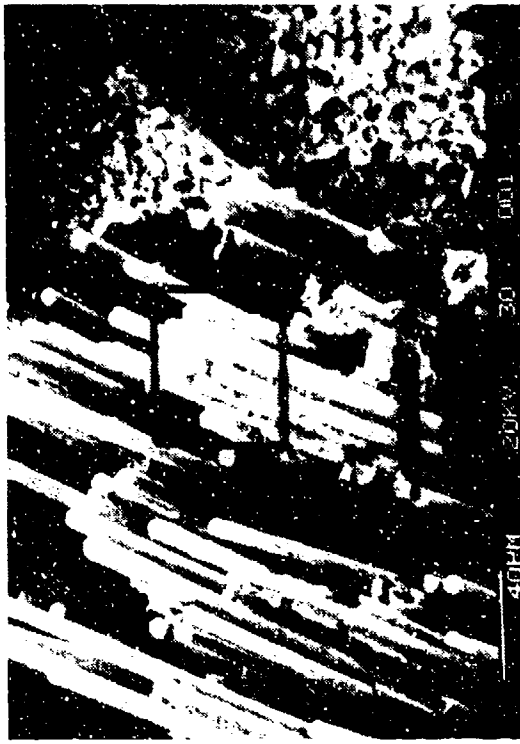
Mechanically induced
crack direction

Figure 8-6. SEM Fractographs of 500 F/Dry, Translaminar Tension Fracture in C3K 8-HS/PMR-15

Specimens tested at 500°F exhibited rough translaminar tensile characteristics over a quarter of the surface when examined optically, and the remainder of the surface appeared compressive. SEM fractography of the tensile region revealed small bundles of fibers on the fracture plane, due to fiber pullout (Figure 8-6). Radial patterns found on fiber end fractures indicated a crack growth direction consistent with the mechanically induced crack growth direction. Microbuckling and typical compressive fiber end fractures were observed on the compressive portion of the fracture surface. Fiber/matrix adhesion was fair.

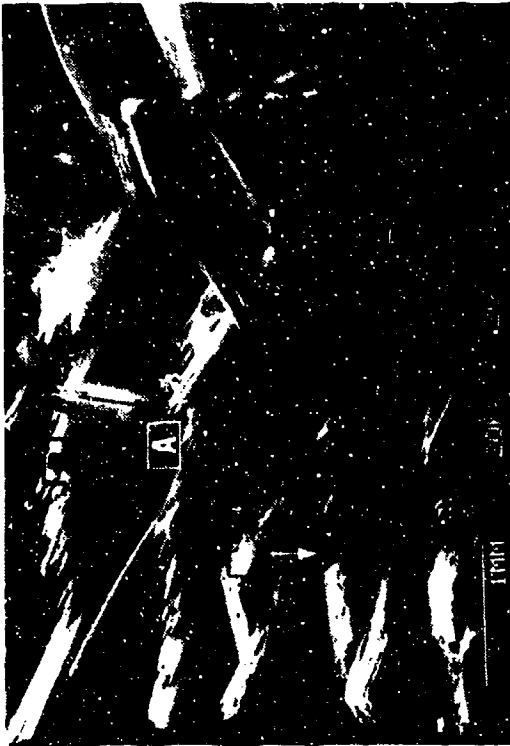
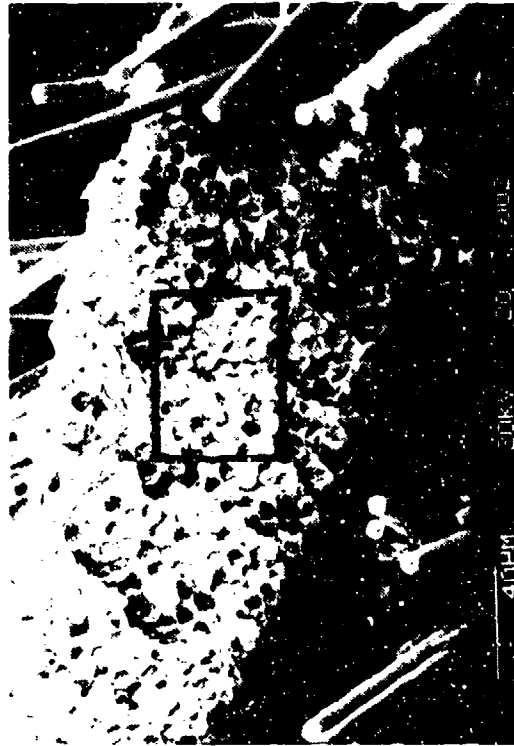
- C compression
- N neutral axis
- T tension

Mechanically induced
crack direction

Figure 8-7. SEM Fractographs of Room Temperature/Dry, Translaminar Compression Fracture in C3K 8-HS/PMR-15

Optical examination of specimens tested at RT revealed both tensile and compressive regions, as was found on the translaminar tension specimens (Figure 8-7). The compressive zone in this specimen was approximately a third of the fracture surface with the remainder being tensile. The compressive loading appeared to have initiated a tensile crack on the opposite edge surface which propagated toward the notch and intersected the compressive damage. SEM examination of the tensile portion revealed fiber end fractures that indicated propagation toward the compressive zone. The compressive region revealed a debris-covered surface with fiber end fractures containing both tensile and compressive zones. Resin-rich fractures in the tensile zone

revealed river marks, indicating propagation opposite to the mechanically induced crack direction, as expected.

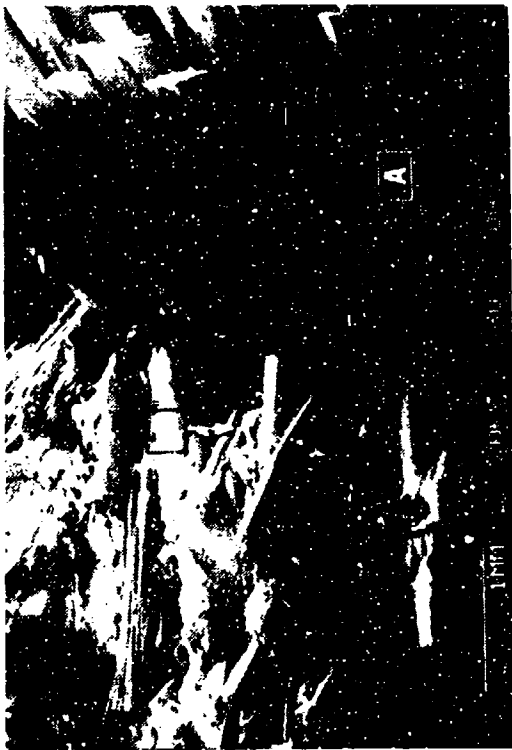
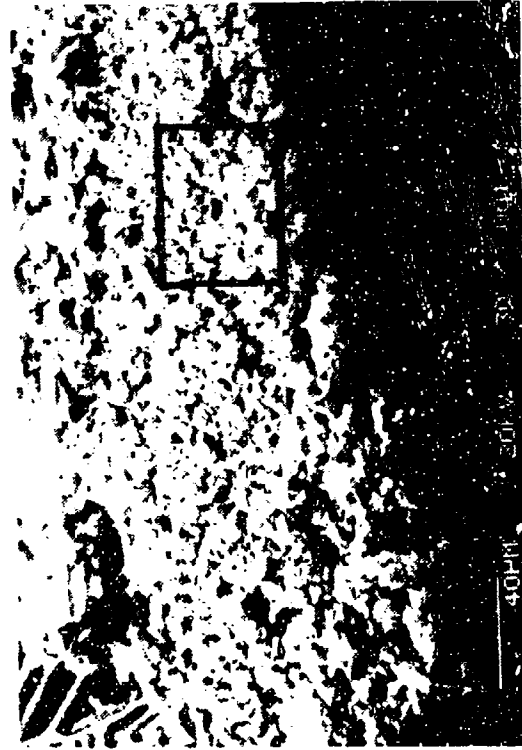
Mechanically induced
crack direction

2,000X

30 degree tilt

Figure 8-8. SEM Fractographs of 500 F/Dry, Translaminar Compression Fracture in C3K 8-HS/PMR-15

Optical examination of specimens tested at 500°F revealed a rough, partly compressive and partly shear fracture. Compressive failure was found on approximately half of the fracture and was located on the notched portion (as intended). Compressive fracture occurred predominantly on the 0 and 90 degree plies, while the shear portion of the fracture occurred on the 45 degree plies. SEM examination of the compression portion of the fracture revealed fiber end fractures which had been obliterated by fracture debris (Figure 8-8). Microbuckling was observed. Hackles were found on the shear portion of the fracture. Fiber/matrix adhesion was poor.

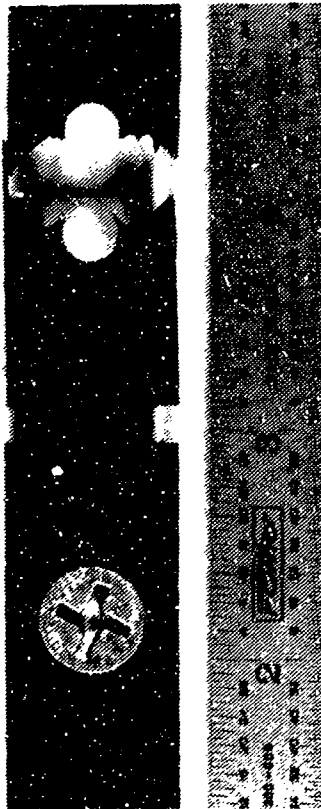
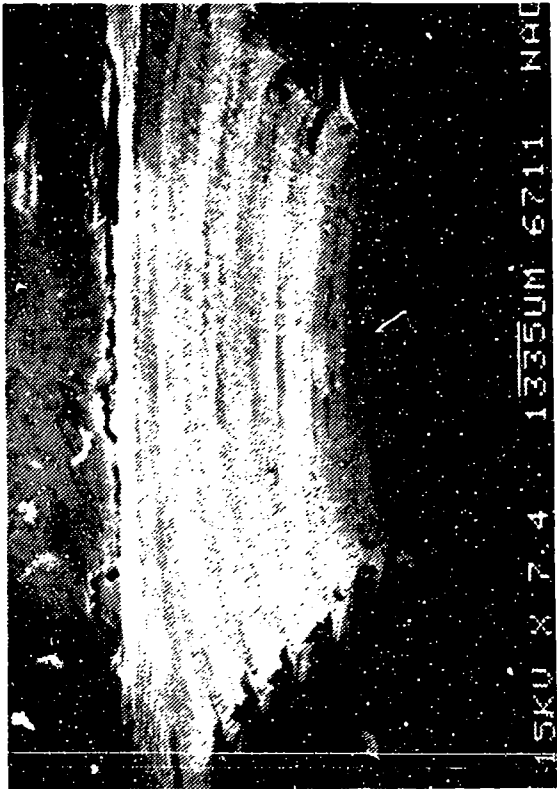
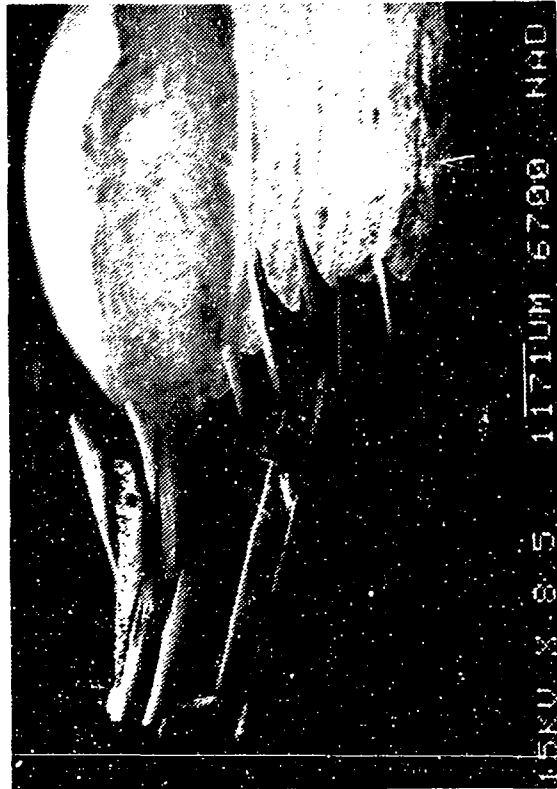
Figure 9-1. Optical and SEM Photographs of Tension Failure in a AS4/3501-6 Gr/Ep Bolted Joint
 (a) Macro photograph of Failed Joint
 (b), (c) Macro photographs of Failed Adherends
 Note compression damage (arrows)

Fractographic evaluation of the bolted Gr/Ep joints indicates that varying failure modes occur in these specimens, and examination of individual plies can be used to establish the failure trends in these joined structures. The fractographs relating to bolted joints are provided in Figures 9-1 through 9-6. This contribution was made by Northrop.

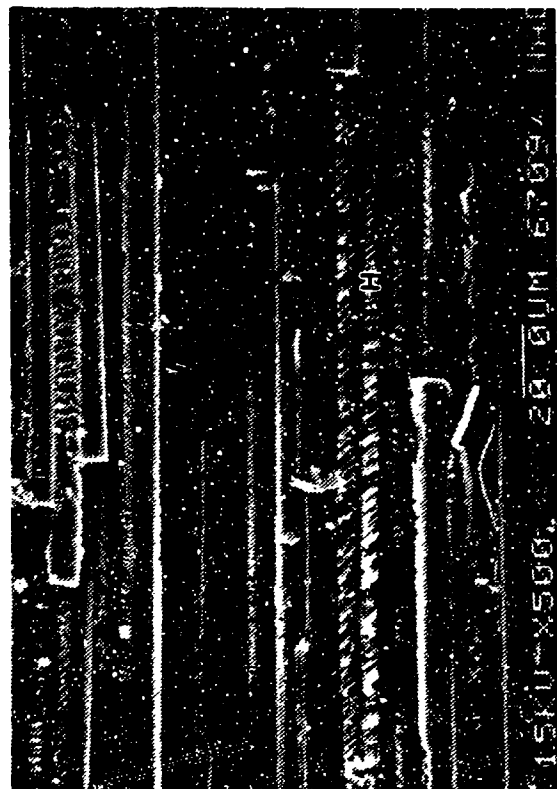
(d)

Figure 9-1. (Continued)
(d), (e) Hackles (H) in 90 and 45 Degree Plies
(f) DAF Radials on 0 Degree Fibers

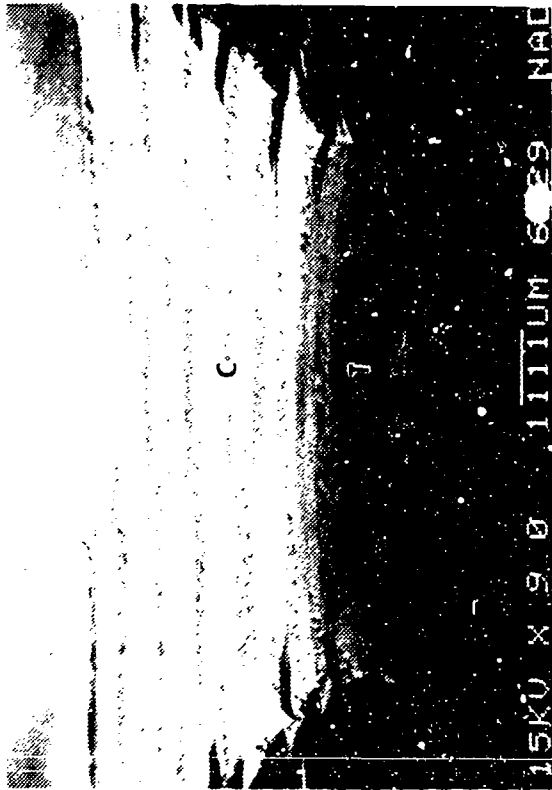
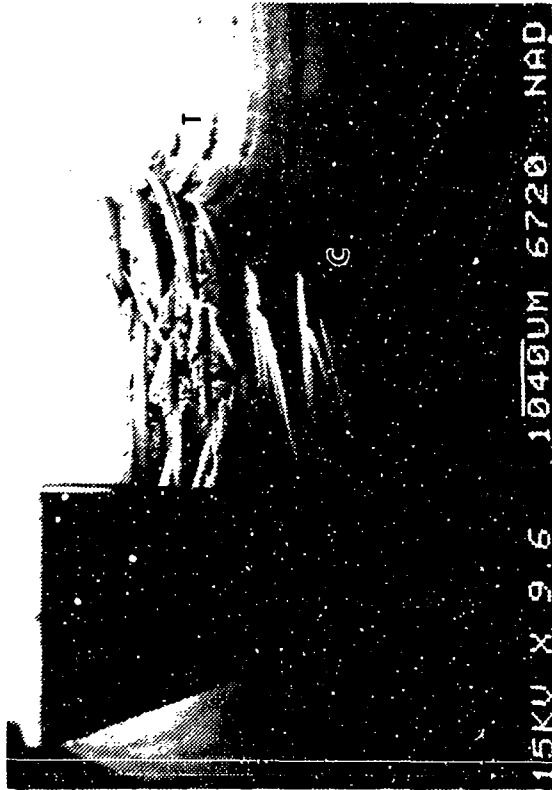
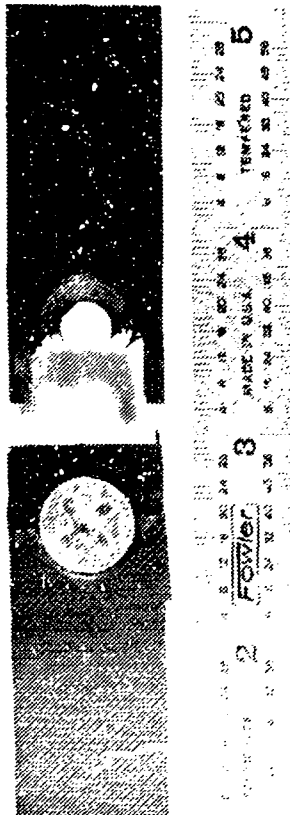
Figure 9-2. Optical and SEM Photographs of Tension-Cleavage Failure in a AS4/3501-6 Gr/Ep Bolted Joint
 (a) Macro photograph of Joint
 (b), (c) Macro photographs of Peripheral Regions of Bolt-Hole in Mating Halves

C = Compression failure
 T = Tension failure

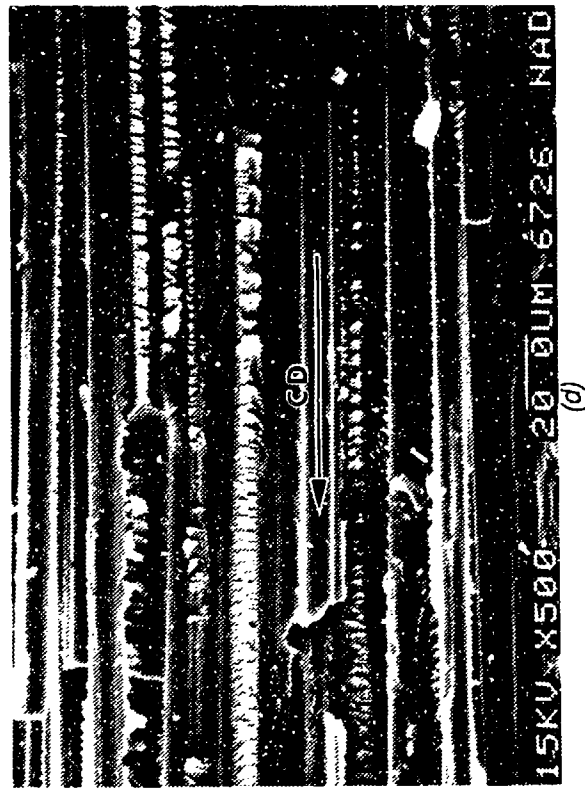
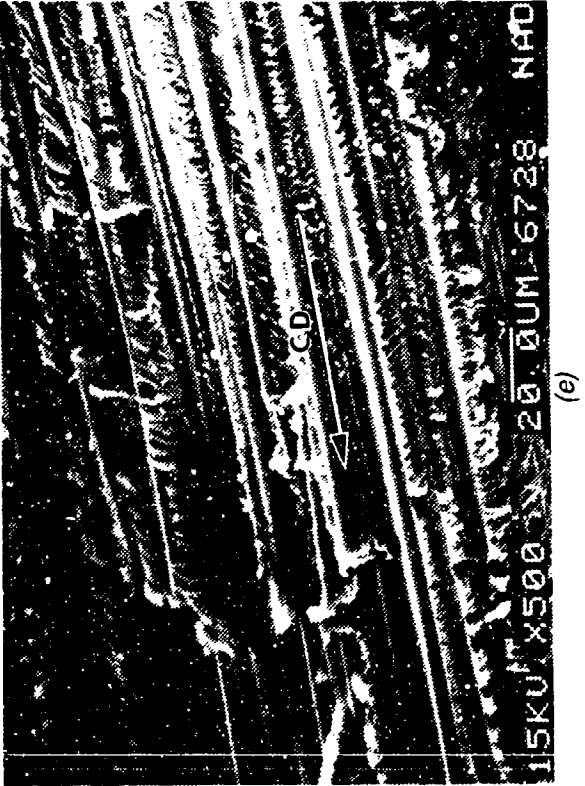
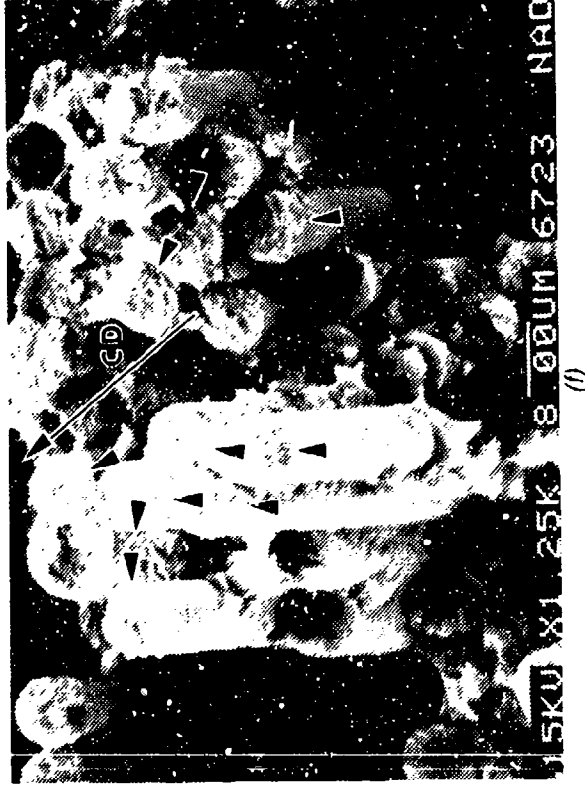
Figure 9-2. (Continued)
 (d) Transaminar Fracture in 90 Degree Ply in Tensile Fracture Region
 (e) Fracture in 45 Degree Ply
 (f) Tensile Fracture in 0 Degree Ply
 Note DAF radials (arrows)
 CD = Crack propagation direction

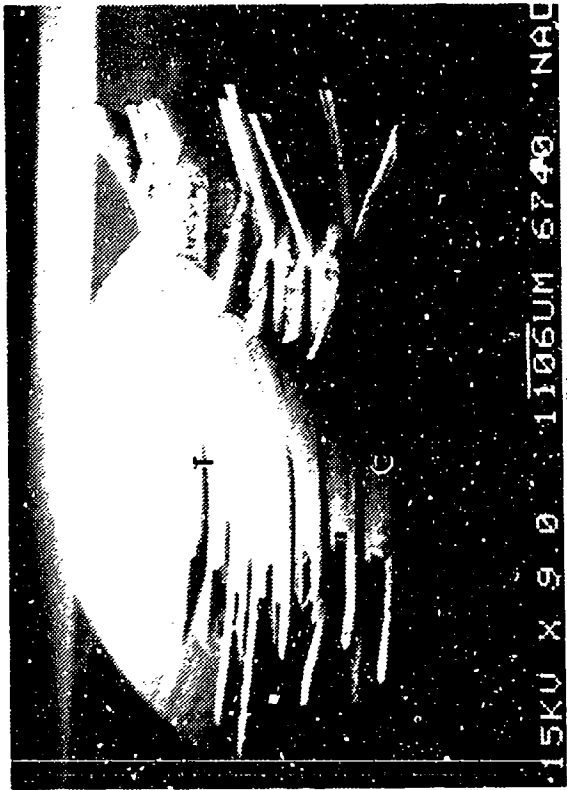
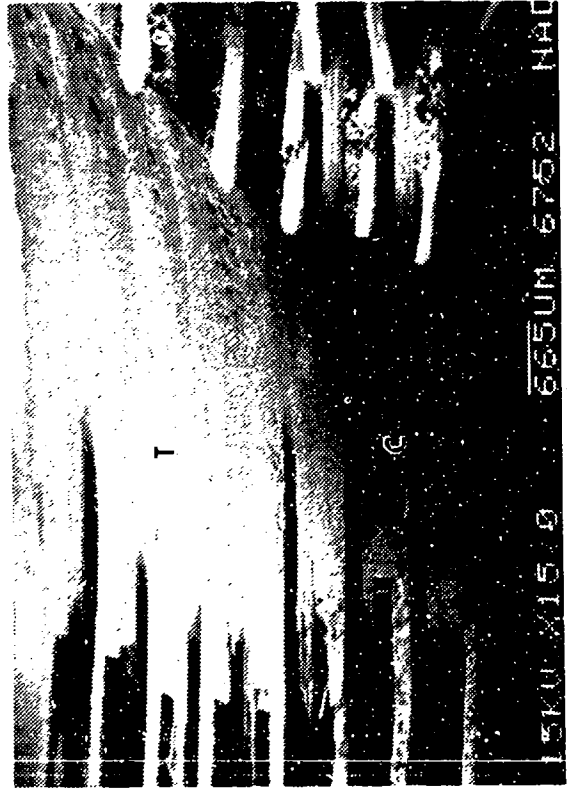
(b)

Figure 9-3. Optical and SEM Photographs of Shear-Out Failure in a AS4/3501-6 Gr/Ep Bolted Joint
 (a) Macro photograph of Failed Joint
 (b), (c) Macro photographs of Failed Adherends
 Note compression (C) and tension (T) regions

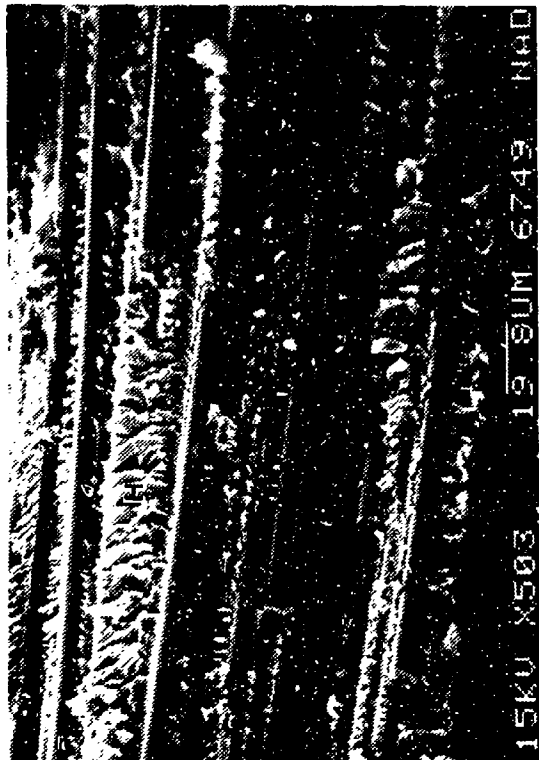
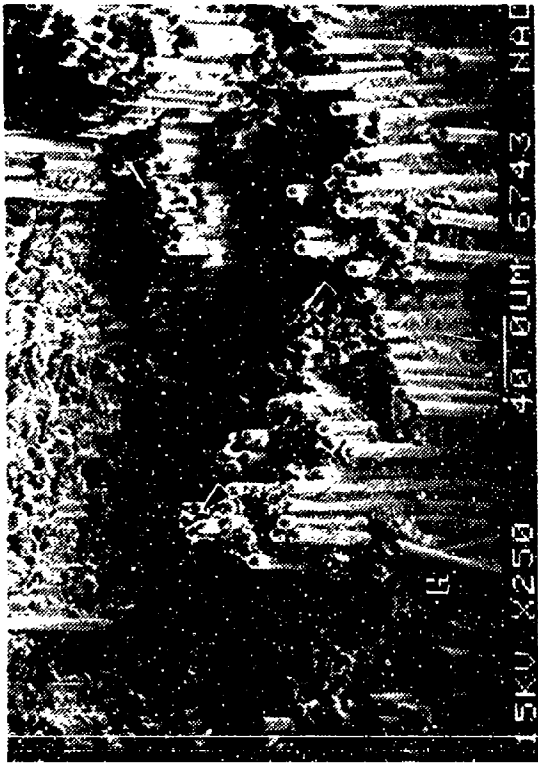
Figure 9-3. (Continued)
(d) Hackles (H) in 45 Degree Plies
(e) DAF Radials (Arrows) and Hackles (H) in 0 Degree Plies
(f) Peel Characteristics in 90 Degree Plies

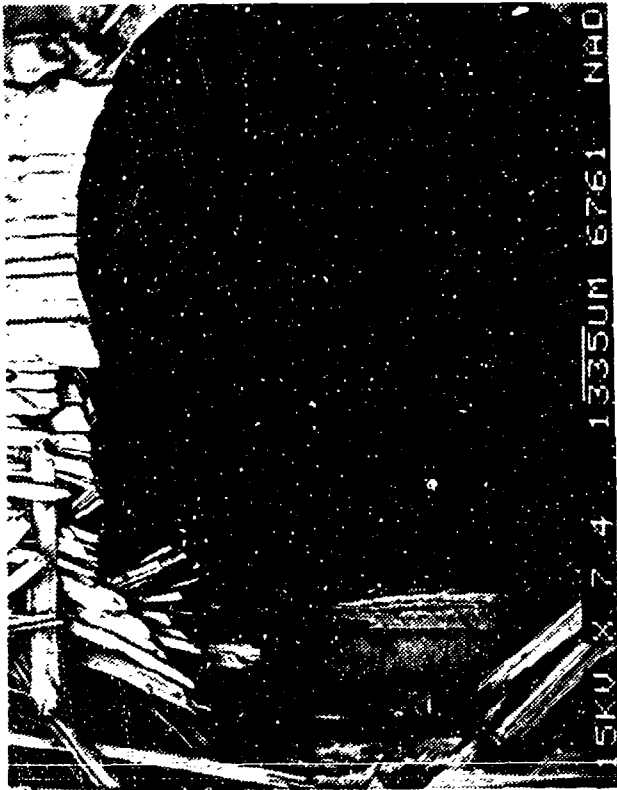
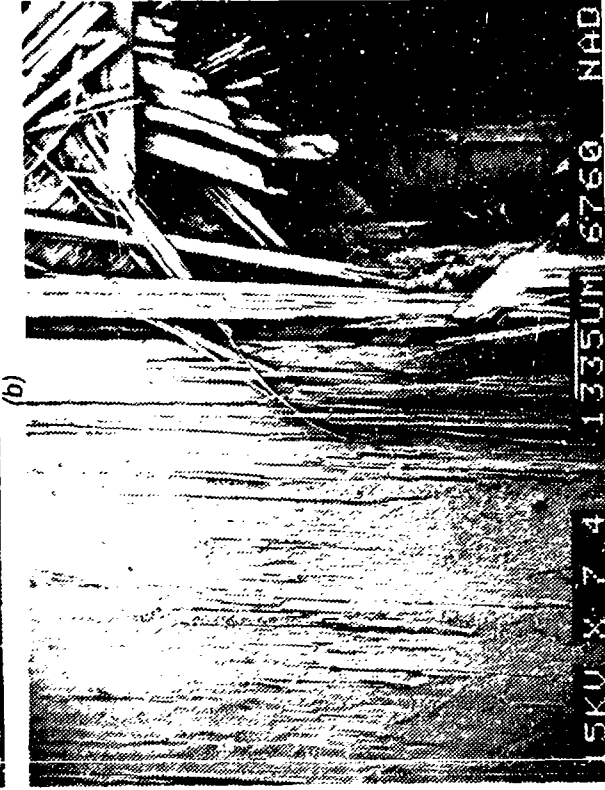
Figure 9-4. Optical and SEM Photographs of Bearing Failure in a AS4/3501-6 Gr/Ep Bolted Joint
(a) Macro photograph of Failed Joint
(b) Detail Near Bolt-Hole
(c) Fractured Adherends

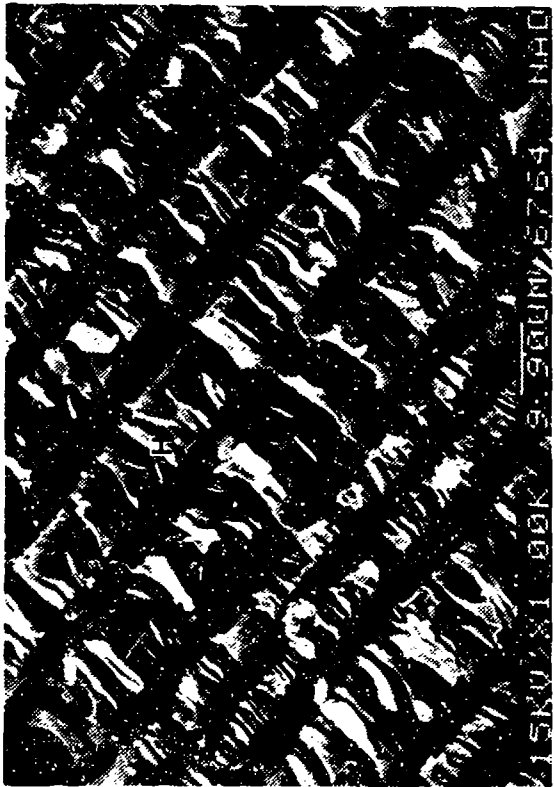
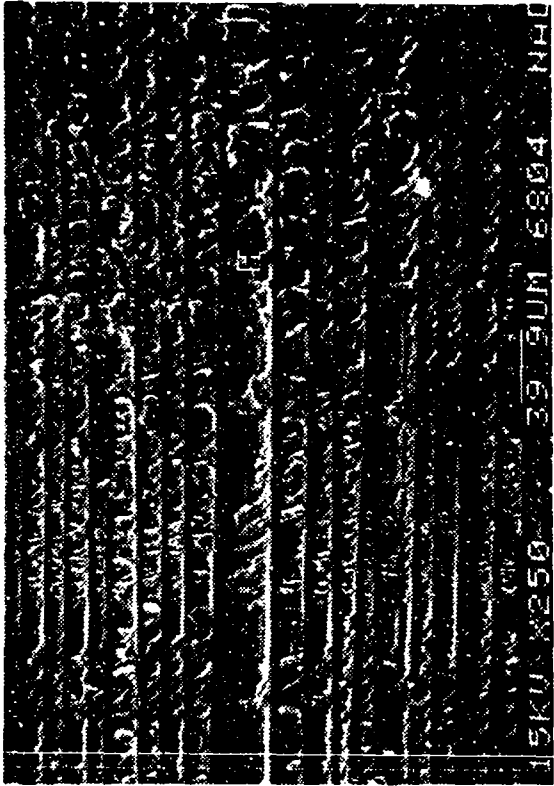
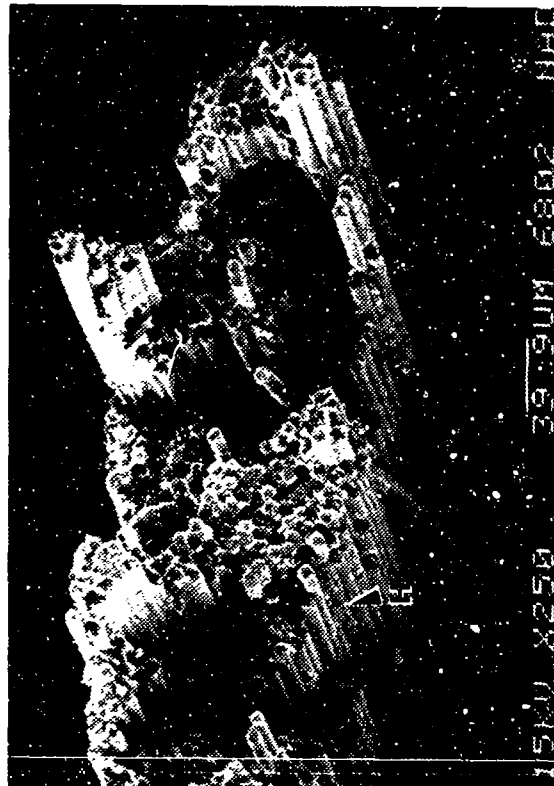
(d)

Figure 9-4. (Continued)
(d), (e), (f) Hackles (H) in 45, 90, and 0 Degree Plies

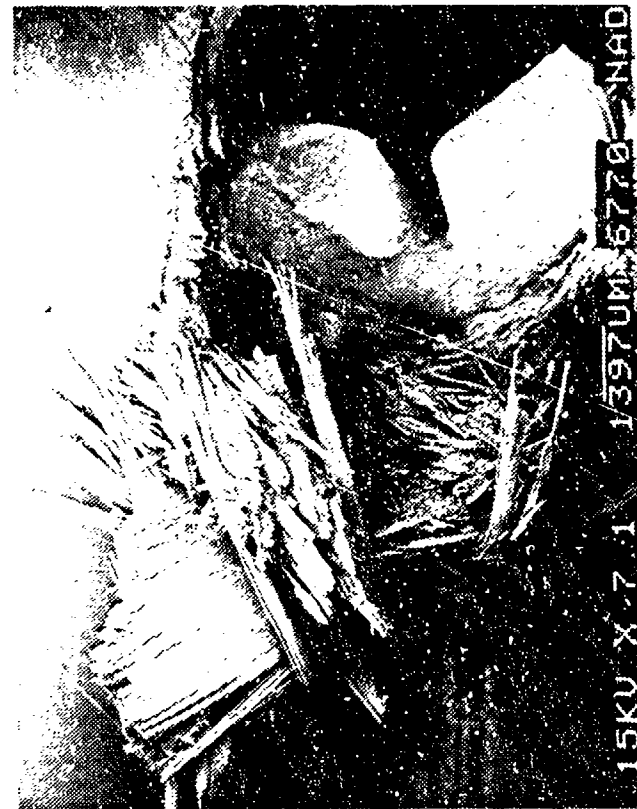
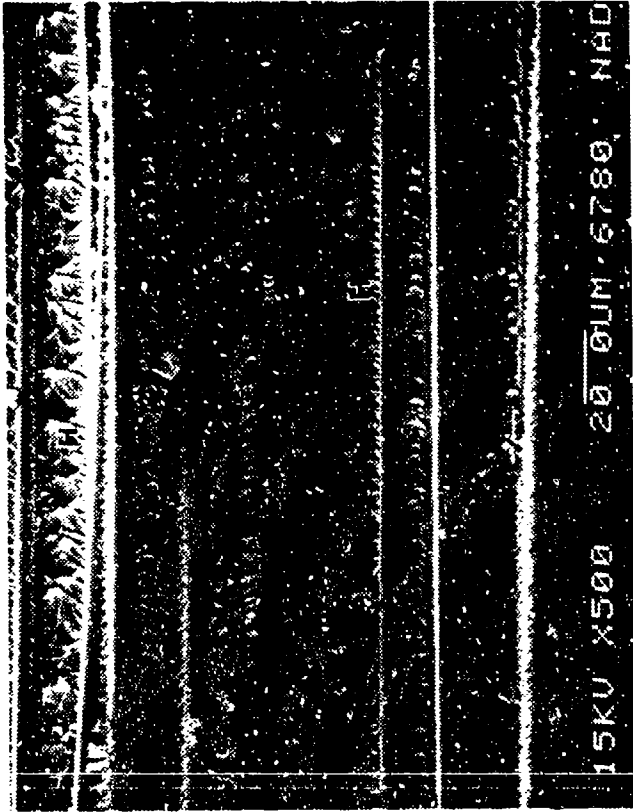
Figure 9-5. (Continued)
(c) Fracture Detail in Fiber Crush Region
(d) Shear Fracture in Delamination Region
Note hackles (H)

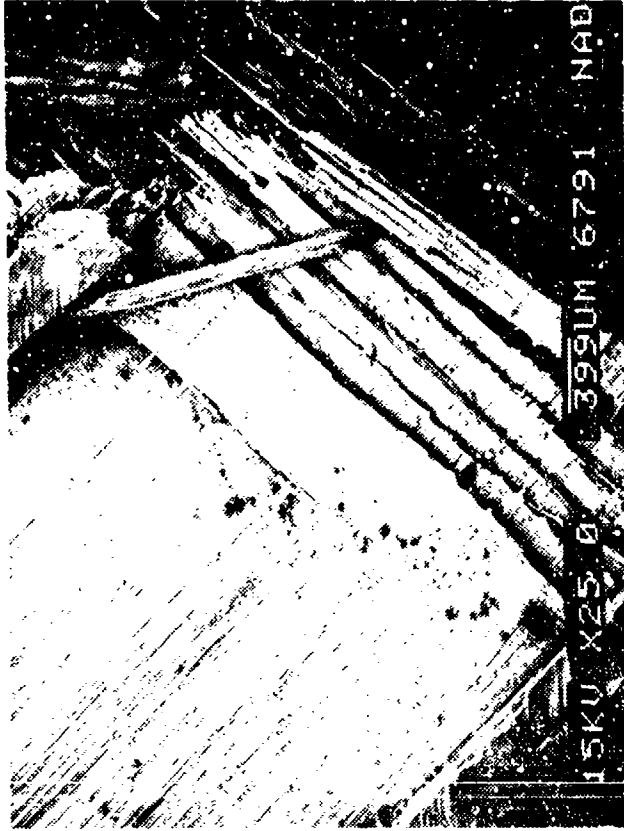
Figure 9-6. Optical and SEM Photographs of Bolt Failure in a AS4/3501-6 Gr/Ep Bolted Joint
(a) Macro photograph showing delamination in adherend (Arrow)
(b) Peel fracture in surface delamination (Low Magnification)

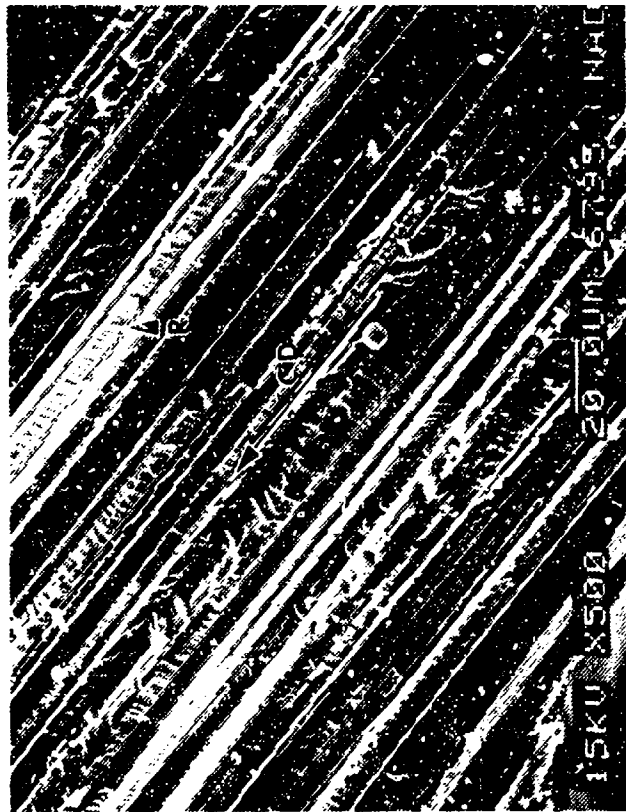
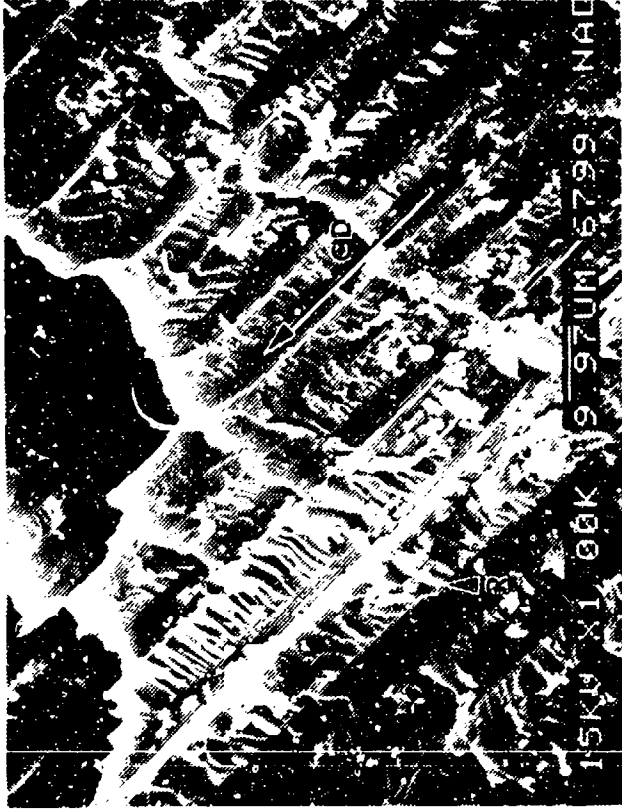
Figure 9-6. (Continued)
 (c) Peel Fracture in Surface Delamination (Intermediate Magnification)
 (d) Peel Fracture in an Internal Delamination

Note arrays of rivers (R) oriented along CD
 CD = Crack propagation direction

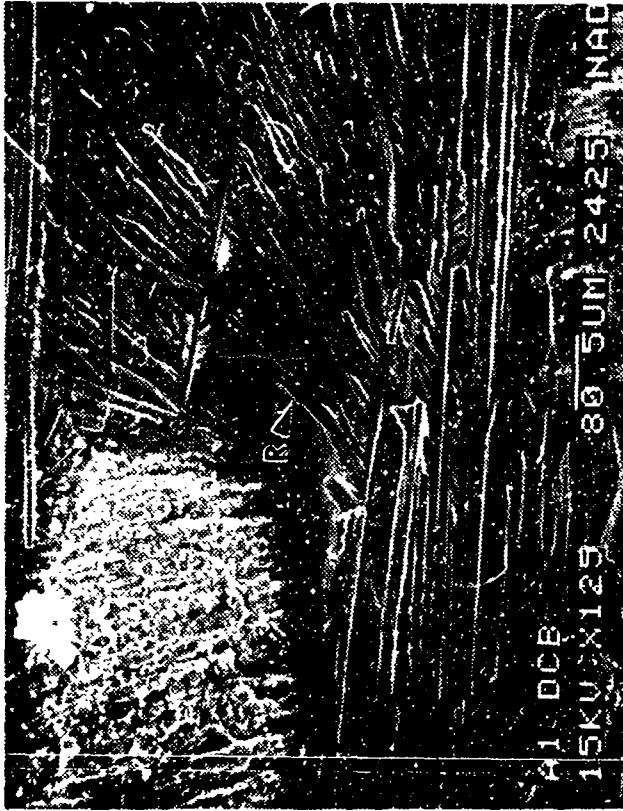
Figure 10-1. (Continued)

- (d) River Patterns (R) in Fractured Adhesive in Cohesive Failure Area
- (e) River Patterns (R) in Fractured Epoxy in Adhesive Failure Region

CD = Crack propagation direction
 S = Strium

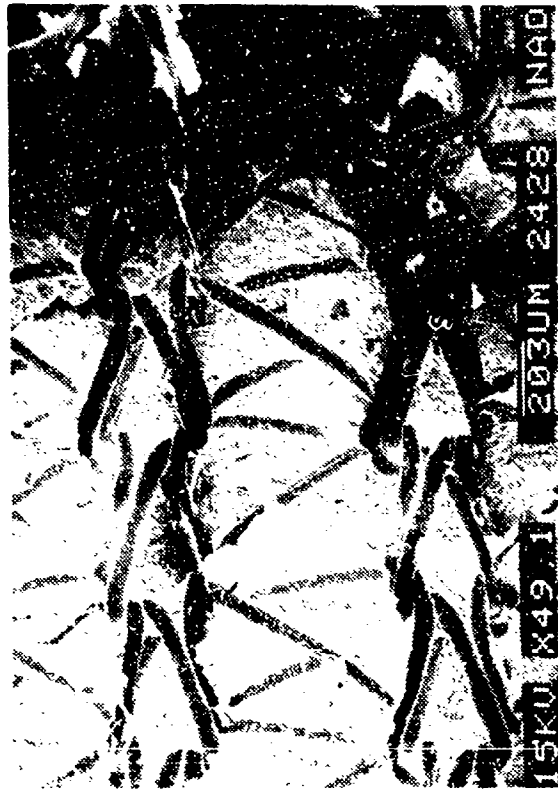
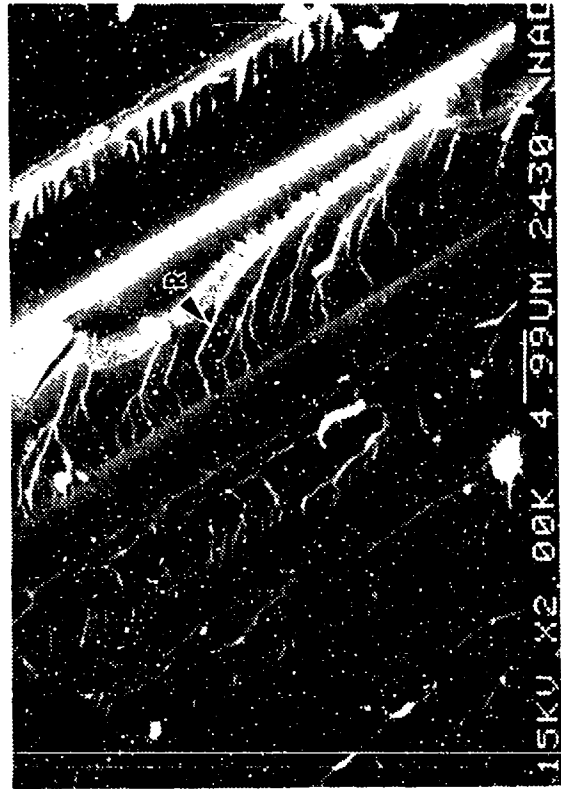
Figure 10-2. Optical and SEM Photographs of Failure in Unidirectional Gr/Ep Bonded to Quasi-Isotropic Gr/Ep With FM 300 Adhesive and Tested Under Mode I Tension

(a) Macrophotograph
 (b), (c) Adhesive Failure Region

- A - Adhesive failure
- C - Cohesive failure
- CD - Crack-propagation direction
- R - River patterns
- S - Scrim

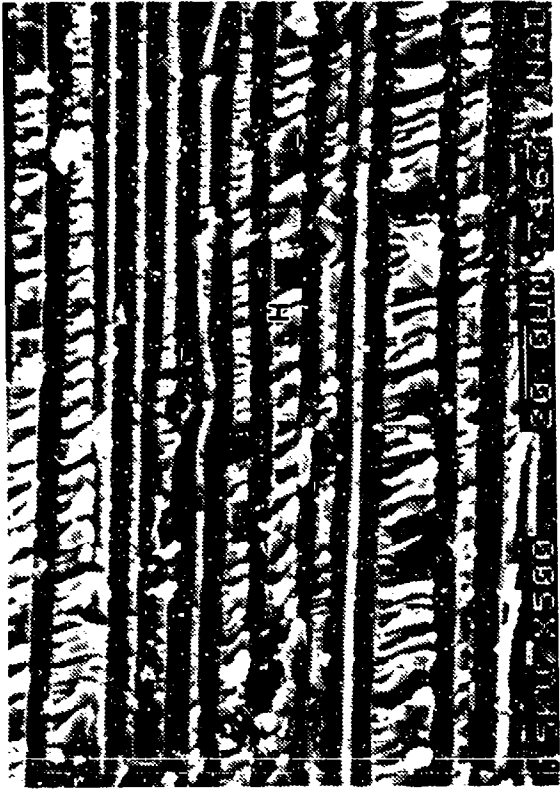
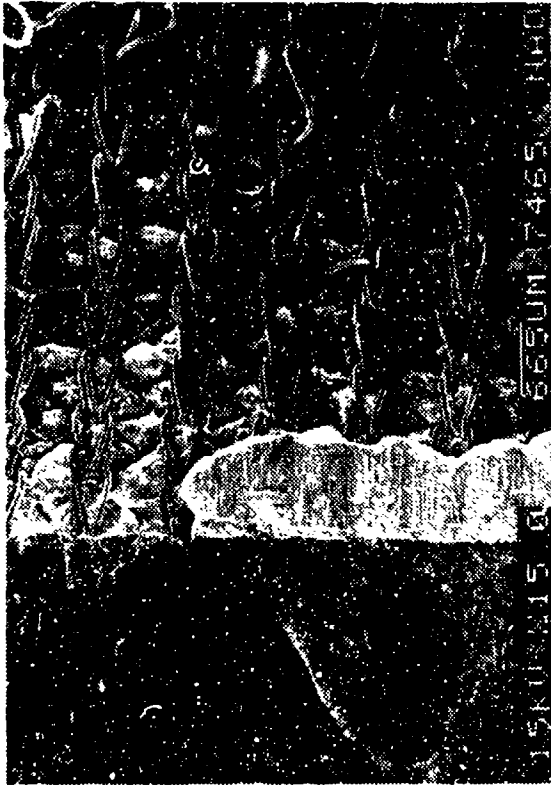
Figure 10-3. (Continued)
 (d), (e) Cohesive Failure in FM 300 Adhesive
 (f) Hackles (H) in Fractured Adherends in Adhesive Failure Region

CD - Crack propagation direction
 S = Scram

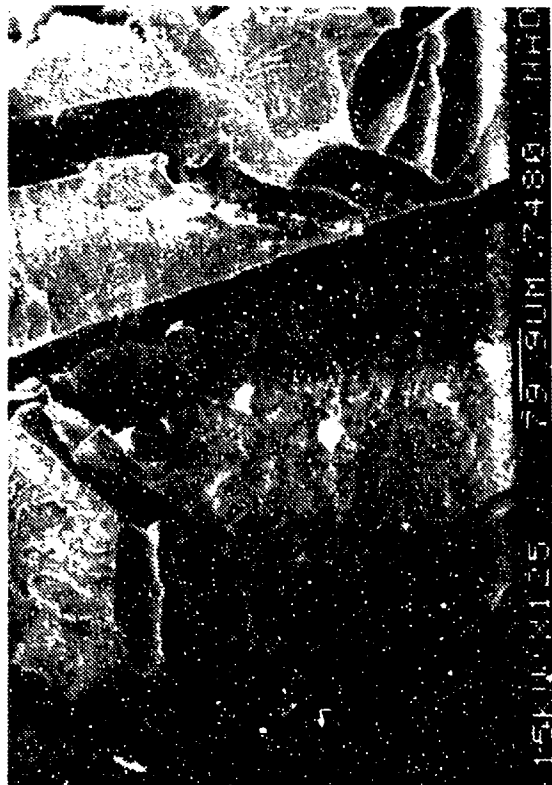
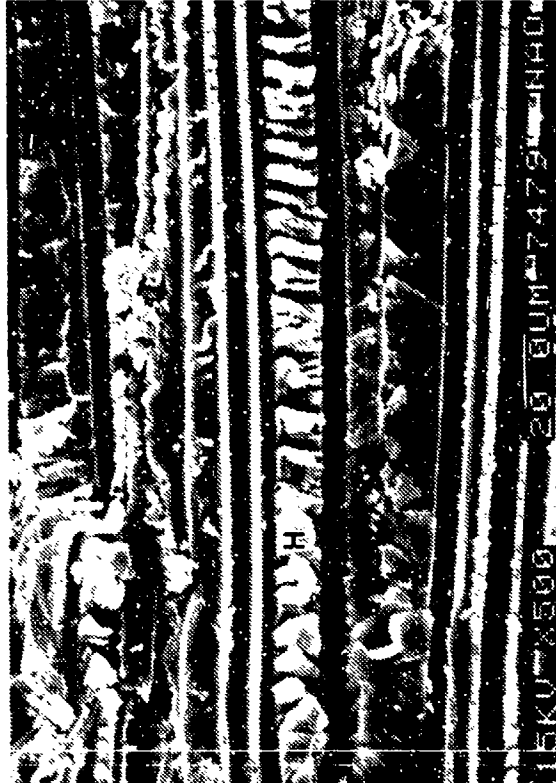
Figure 10-4. (Continued)
 (d). (e) Cohesive Failure in FM 300 Adhesive
 (f) Hackles (H) in Fractured Adherends in Adhesive Failure Region

CD = Crack-propagation direction

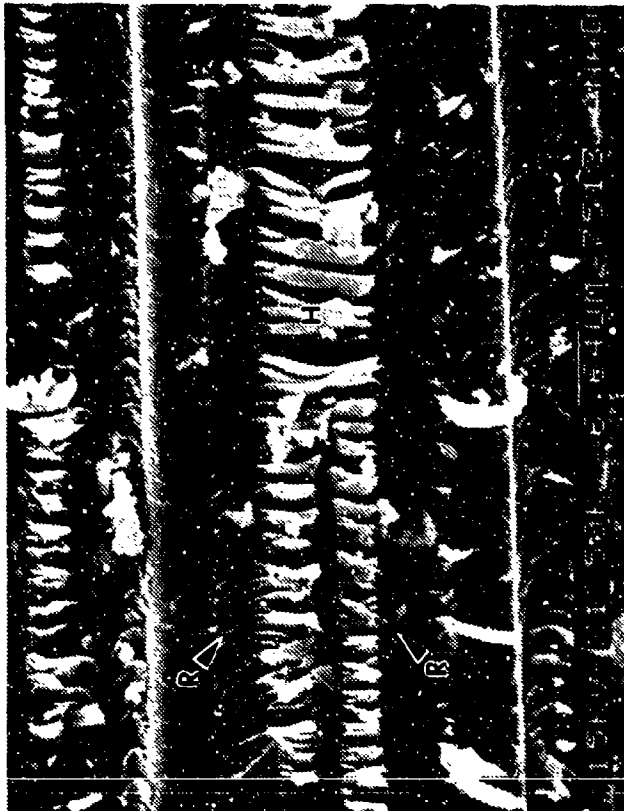
Figure 10-5. (Continued)
 (d) Hackles in 45 Degree Ply
 (e) Hackles and Rivers in 0 Degree Ply

H = Hackles
 R = Rivers
 CD = Crack-propagation direction.

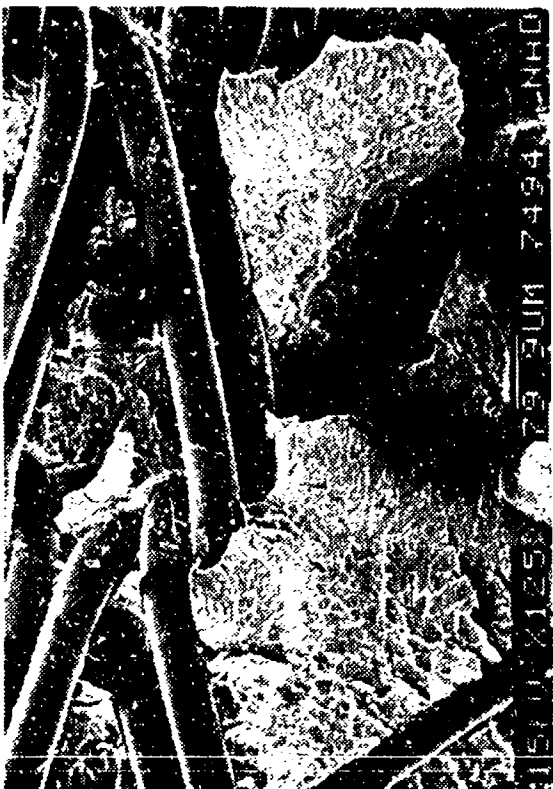
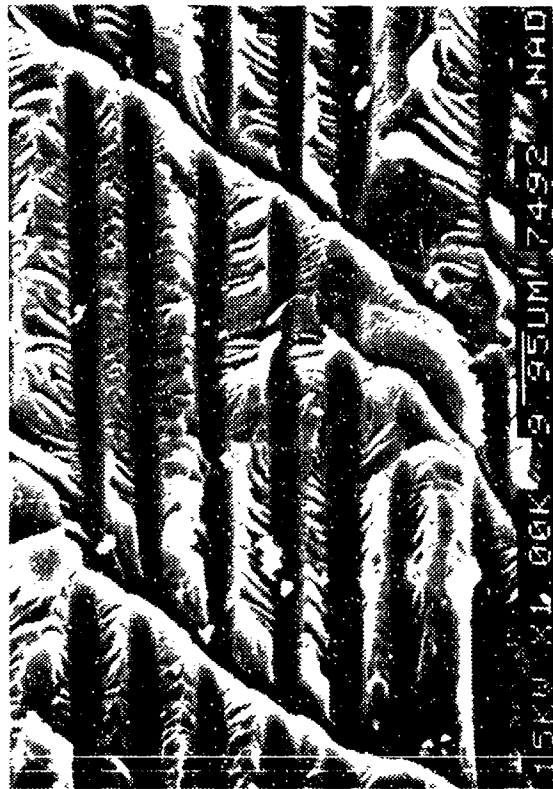
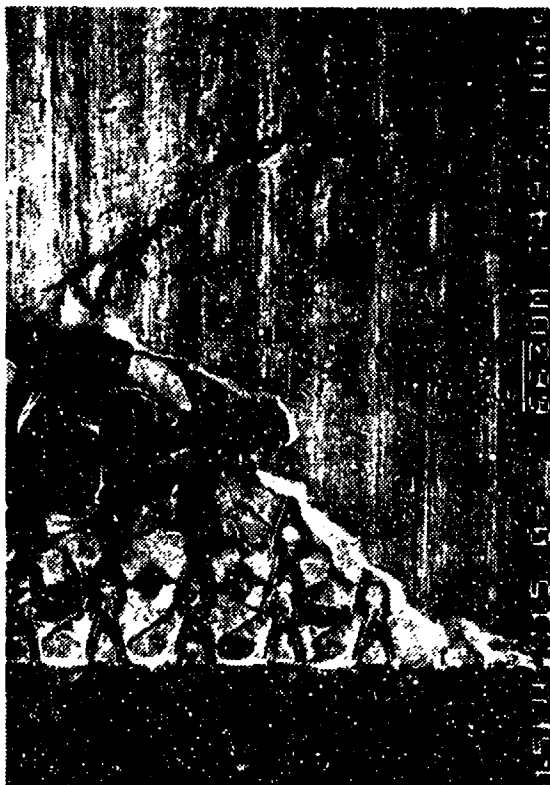
Figure 10-6. (Continued)
(d), (e) Cohesive Failure in FM 300 Adhesive
(f) Peel Characteristics in Fractured Adherends
CD = Crack-propagation direction
