WL-TR-91-4032
DOT/FAA/CT-91/23
VOL II, Part 2

COMPOSITE FAILURE ANALYSIS HANDBOOK
VOL II - TECHNICAL HANDBOOK
PART 2 - ATLAS OF FRACTOGRAPHS

February 1992

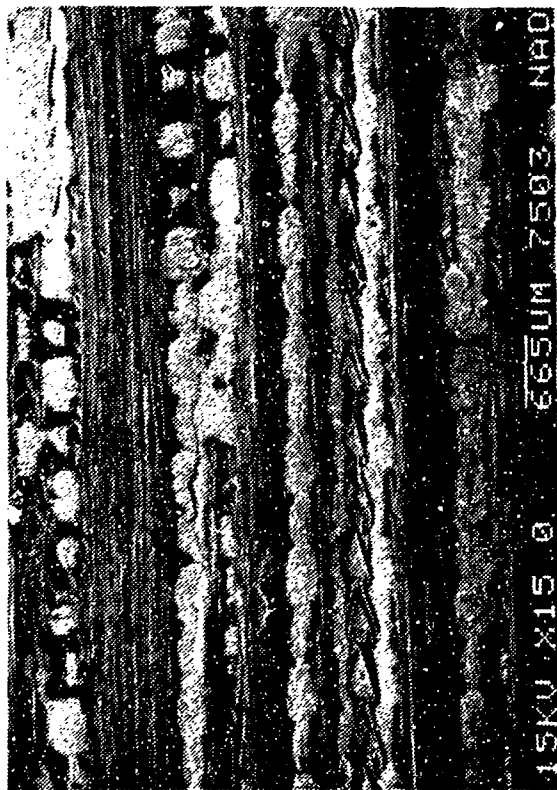
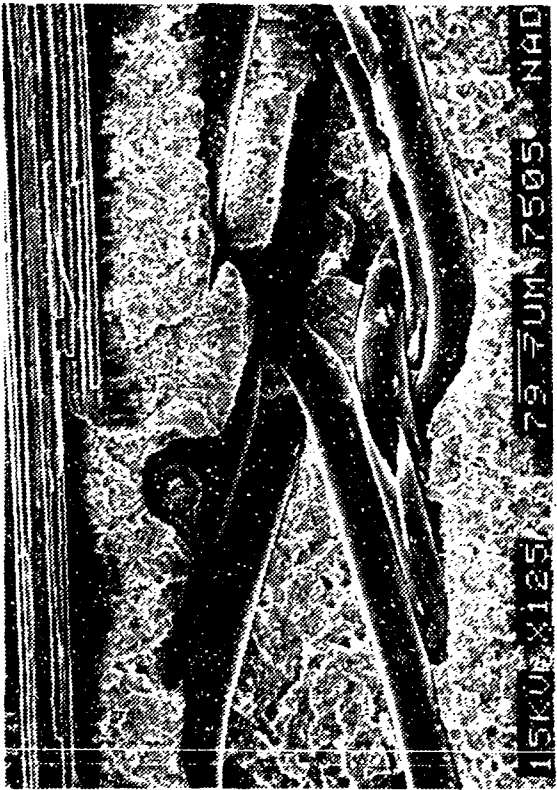
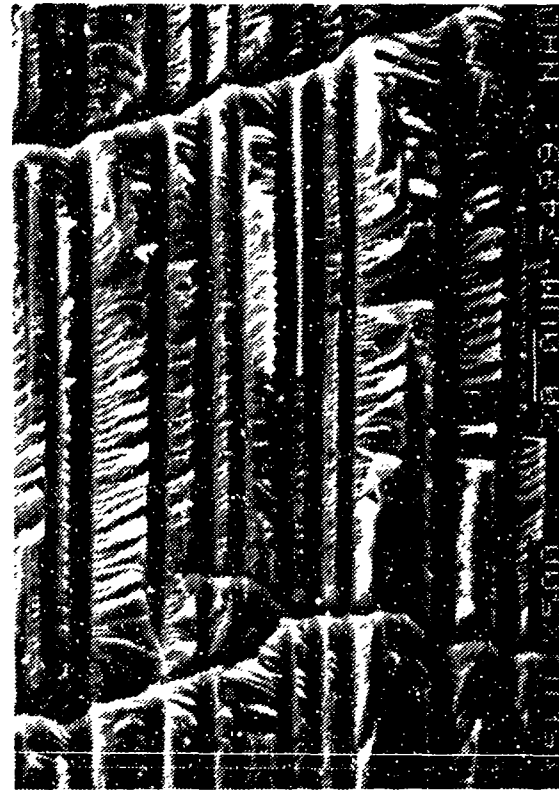
Figure 10-7. (Continued)
 (d), (e) Cohesive Failure in FM 300 Adhesive
 (f) Peel Characteristics in Fractured Adherend
 CD = Crack-propagation direction

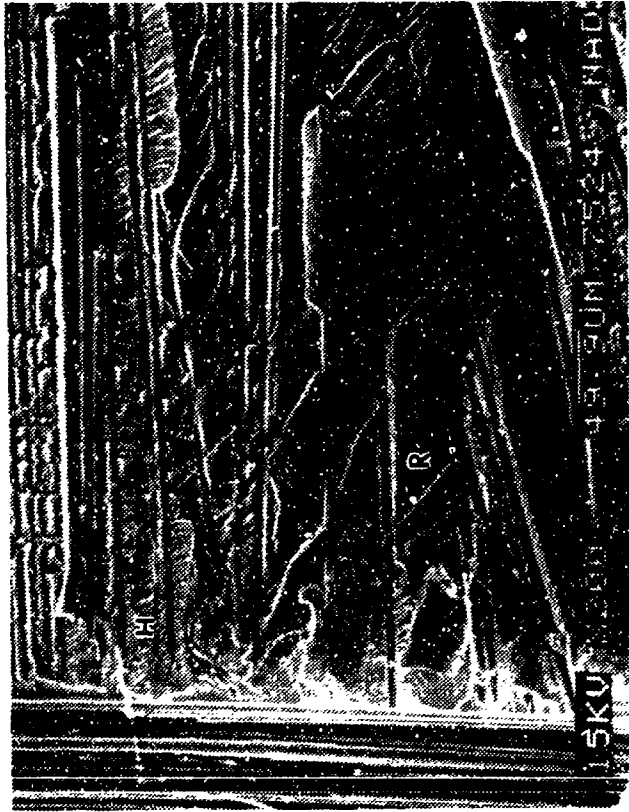
Figure 10-8. (Continued)
 (d) Cohesive Failure of Adhesive (Arrow) in Mixed Mode Failure Region
 (e) Hackles (H) and Rivers (R) in Adhesive Failure Region

CD = Crack-propagation direction

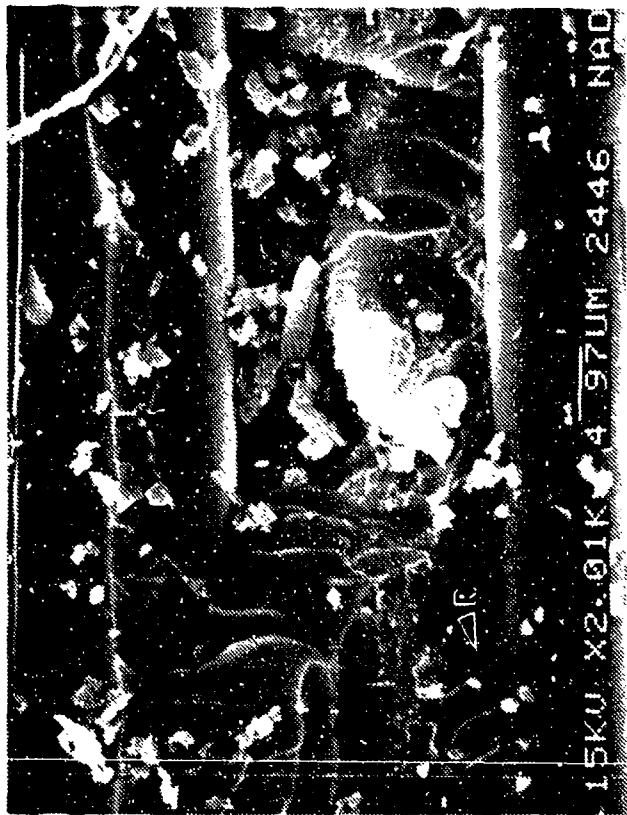
Figure 10-9. (Continued)
 (c) Low Magnification (4X) Photograph Showing Details in Cohesive Failure Region
 (d) River Patterns (R) in Adhesive Failure Region

C = Cohesive failure
 CD = Crack-propagation direction

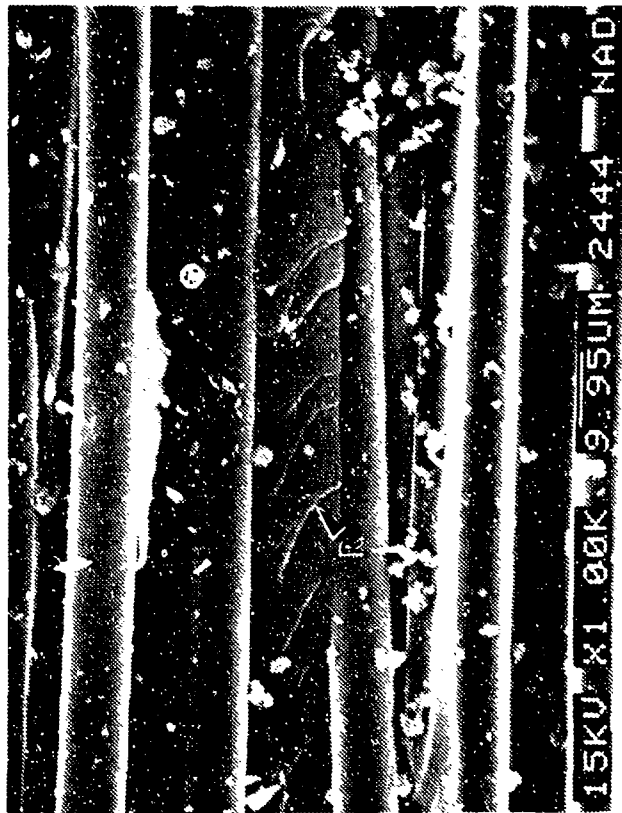
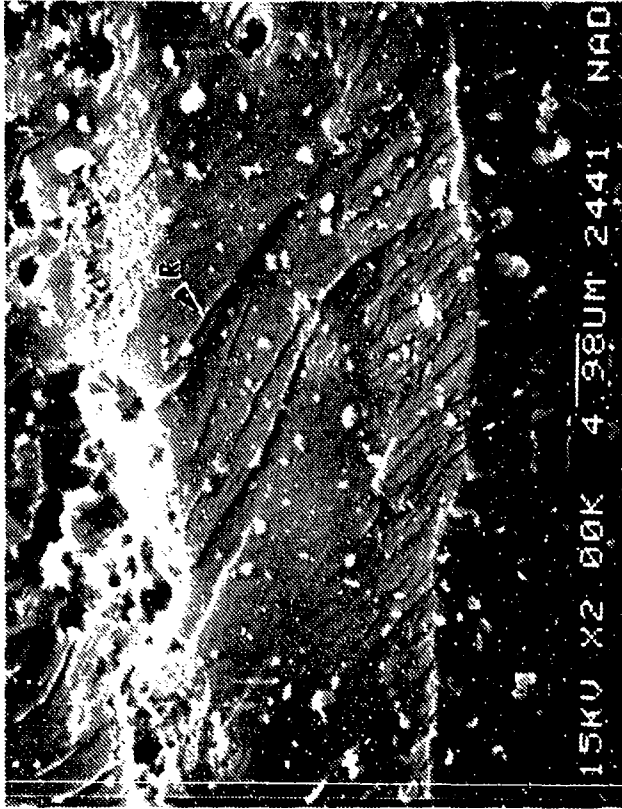
Figure 10-10. (Continued)
 (c) Adhesive Failure Area
 (d) Cohesive Failure Area

CD = Crack-propagation direction
 R = River patterns

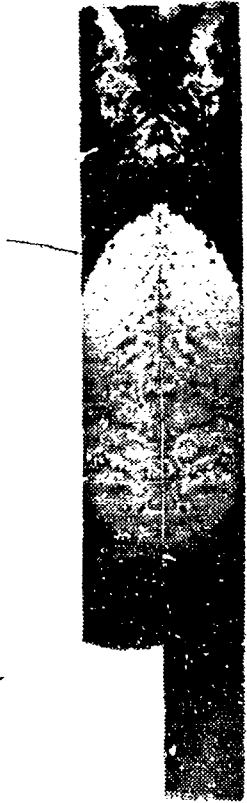
Figure 10-12. Optical and SEM Photographs of Fracture in Unidirectional Gr/BMI Bonded to Quasi-Isotropic Gr/BMI Using EA 9673 Adhesive, Large Lap/Strap Ratio, Tested Under Mode I Tension and Mode II Interlaminar Shear
 (a) Macro photograph of Fracture
 (b), (c) Low Magnification (4X) Photographs Showing Cohesive (C) and Adhesive (A) Failure Characteristics

CD = Crack-propagation direction

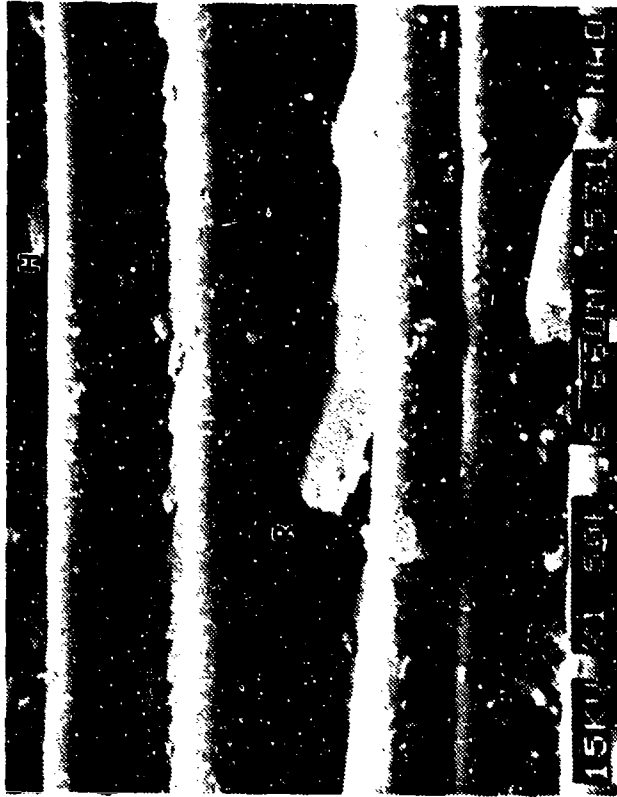
Figure 10-12. (Continued)
 (d) Cohesive Failure of Adhesive
 (e) Hackles (H) and Rivers (R) in Fractured Adherend
 CD = Crack-propagation direction
