COMPOSITE FAILURE ANALYSIS HANDBOOK  
VOL I - PROGRAM OVERVIEW

R.J. Kar  
Northrop Corporation  
One Northrop Avenue  
Hawthorne, California 90250-3277

February 1992

13. ABSTRACT (Maximum 200 words)  The objective of this program was to create a comprehensive handbook for use in conducting failure analysis investigations on failed composite structure. This program builds upon previous efforts as documented in the "Compendium of Post-Failure Analysis Techniques for Composite Materials," AFWAL-TR-86-4137. The purpose of creating this handbook was to document the techniques, the fractographic and material property data and case history studies currently being utilized in the analysis of failed composite structure. The major tasks on this program included: (1) procedural guidelines for field investigation techniques; (2) an expanded fractographic data base for carbon/epoxy materials tested under known conditions, (3) a fractographic data base for resin based composite materials other than carbon/epoxy; (4) fractographic documentation of composite material and processing defects; (5) documentation of fracture characteristics in adhesive and mechanical joint failures; (6) compilation

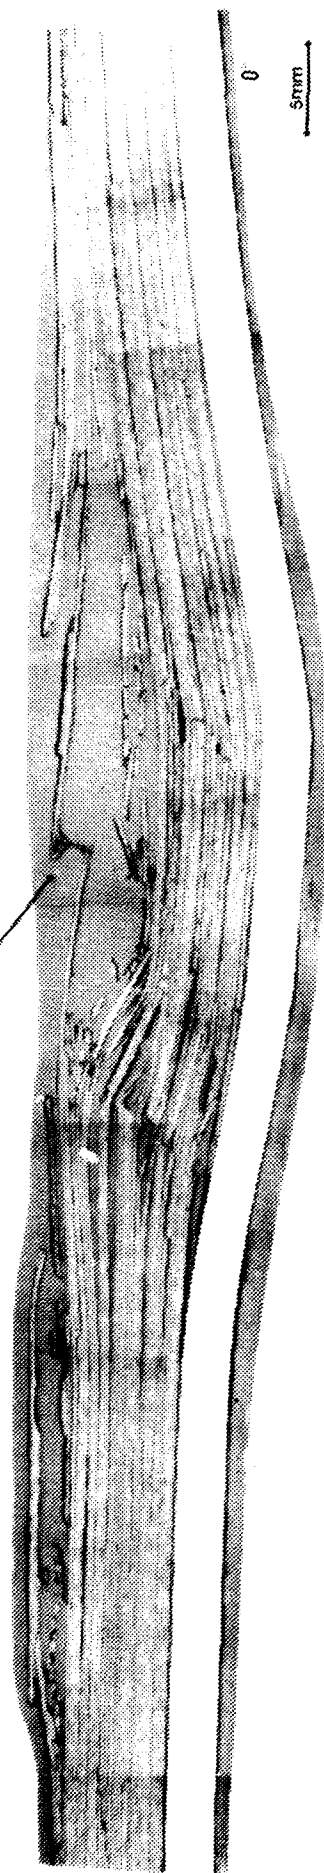
Figure 3-18. Photographic Collage of Impact and PIC Multispar Panel (NAD Specimen No. 2)

Figure 3-18 shows a similar photographic collage of NAD Specimen No. 2, part of a multi-spar Gr/Ep panel that had been impacted and PIC tested. The materialographic sections were prepared as before, normal to the fracture in the direction of the 0, 45, and 90 degree plies, and oriented so that the fractures were in profile. The effect of the bolted joint on the fracture characteristics could be determined by this technique. As shown in Figure 3-18, mechanical joining of the composite to a spar had resulted in the plane of maximum delamination (caused by impact) being shifted closer to the top face of the panel rather than the bottom face, as is normally observed in impact failures.

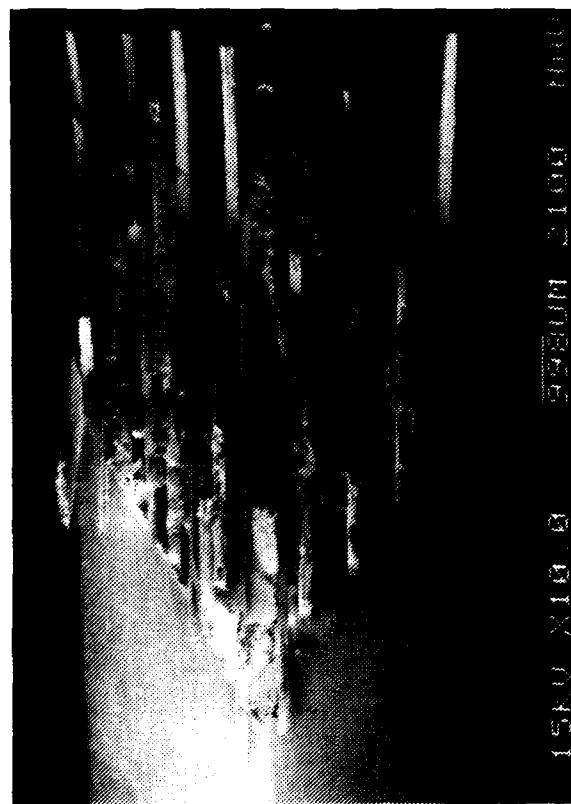
Figure 3-27. SEM Photographs of Mode I Translaminar Compression Fracture in High Resin Content Gr/Ep - 32 Ply Quasi-Isotropic  
(a) Macro photograph of the Fracture and Apex  
(b) Fracture Near the Apex  
Note the flat fracture surface and the post fracture damage  
(c) High Magnification of (b) Showing Crushed Fibers

**Mode I Compression High Resin Content Gr/Ep - 32/Quasi.** Figure 3-27 presents photographs illustrating macroscopic and microscopic translaminar compression fracture features in 32 ply/quasi-isotropic Gr/Ep processed with high resin content.

Figure 3-27a shows the fracture surface and the apex of the notch machined to initiate crack-propagation under translaminar Mode I compression. Translaminar compression fracture was typified by fiber buckling, fiber-end fracture, resin shear fracture, and post-fracture damage.

Evaluation of the fractured surface revealed a flat topography and post-fracture damage (Figures 3-27b and 3-27c). As shown in Figure 3-27d, flexural fracture was observed as a result of translaminar compression. Fractured fiber ends were decorated with "chop" marks that are typical of failure due to compression microbuckling. The crack-propagation direction could not be determined through observation of these fracture features.

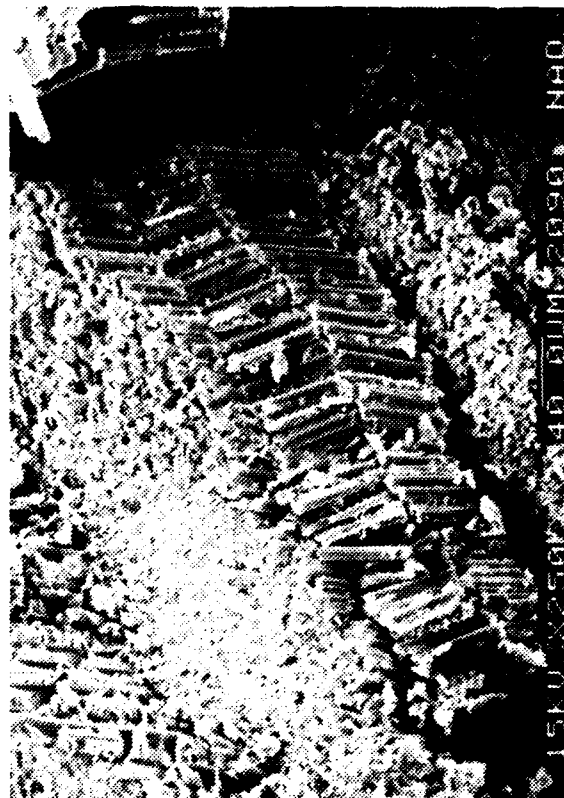
Figure 3-27. (Continued)

(d) Flexural Fracture Features

Note chop marks (C) on individual fiber ends typical of flexural fracture in compression

(f) Multiple Fiber Breaks Due to Microbuckling

Hackles and scallops were observed in the fractured epoxy in plies oriented parallel to the crack-propagation direction (Figure 3-27e). Multiple fiber breaks were also observed in all the plies, as illustrated in Figure 3-27f, and this is typical of failure due to compression microbuckling.

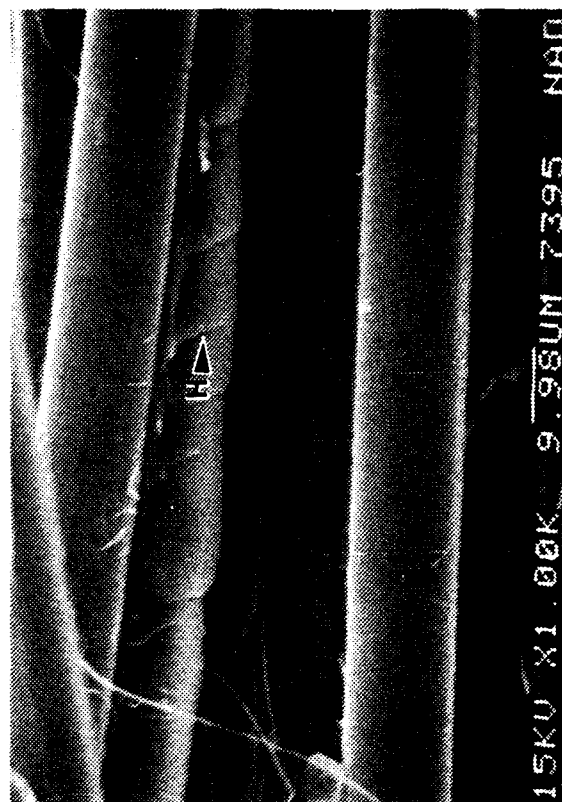
Figure 3-29. Optical and SEM Photographs of Mode I DCB Interlaminar Fracture in 49/3501-6 Kevlar/Ep - [+45/0/-45]<sub>s</sub>, Room Temperature Ambient  
 (a) Macro photograph  
 (b) River Patterns (R) at Initiation Site  
 (c) Hackles (H) in Fractured Resin

SEM examination revealed that fracture could be mapped by stray river patterns present in resin-rich areas (Figures 3-28c, and 3-29b). Fractured resin associated with pulled fibers exhibited occasional hackles (Figure 3-29c) indicating that locally the applied loads were mixed (tension and shear) in nature.

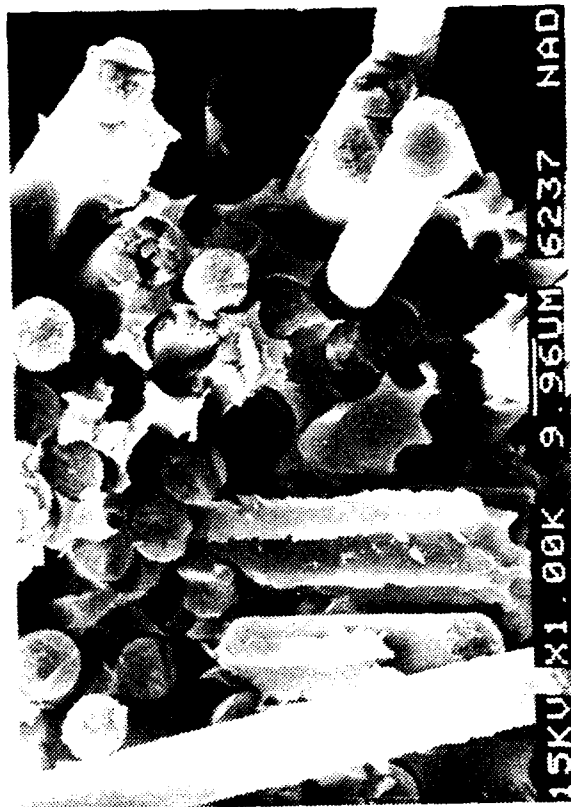
Figure 3-34. SEM Photographs of Mode I Translaminar Tension Fracture in AS4/5250-3 Gr/BMI - [90/0]<sub>as</sub>

(a) Normal Views of Fracture

(b) Oblique View of Fracture

(c) Fiber Pull-Out and Separation From Resin in Tension Region of Fracture

CD = Crack-propagation direction

T = Tension region

An evaluation of the translaminar fracture characteristics for this system indicated that the fracture features on broken fiber ends were similar to that in Gr/Ep; namely, DAF radials in

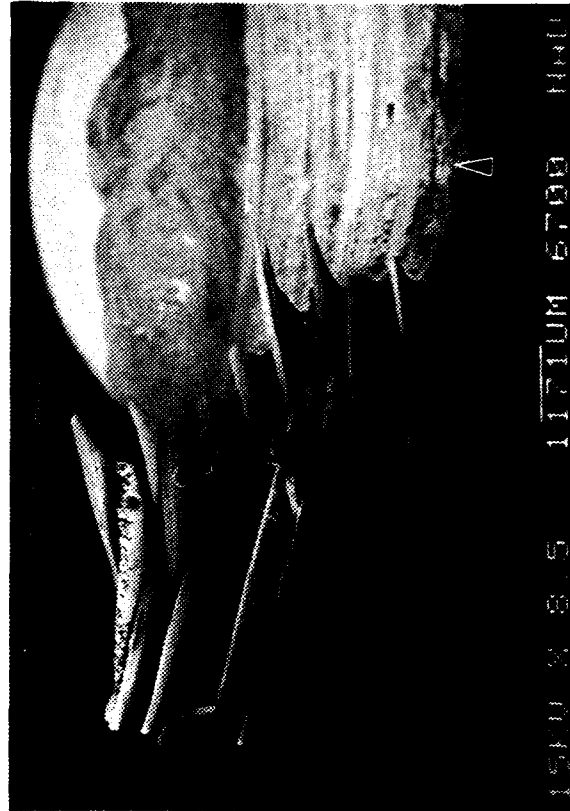
Figure 3-39. Optical and SEM Photographs of Tension Failure in AS4/3501-6 Gr/Ep Bolted Joint

(a) Macro photograph of Failed Joint

(b), (c) Macro photographs of Failed Adherends  
Note compression damage (arrows)

Figure 3-39 illustrates fracture characteristics for tension failure. Net-section tension failures occur in mechanically-joined composite specimens with small  $w/d$  and large  $e/d$  ratios ( $w$  = composite width,  $d$  = fastener diameter, and  $e$  = distance of fastener from edge). This failure mode was achieved using  $w/d$  and  $e/d$  ratios of 3 and 3, respectively, using 32-ply quasi-isotropic AS4/3501-6 Gr/Ep adherends, and a tension head "Hi-Lok" titanium fastener with a head diameter of 0.25 inches. In this type of failure, fracture occurs due to insufficient specimen width.

Figures 3-39b and 3-39c show macrographs of mating halves of the adherends in the vicinity of the machined hole. Examination of peripheral regions of the bolt-hole revealed compression characteristics indicating that failure in the joint region was a compression dominated event.

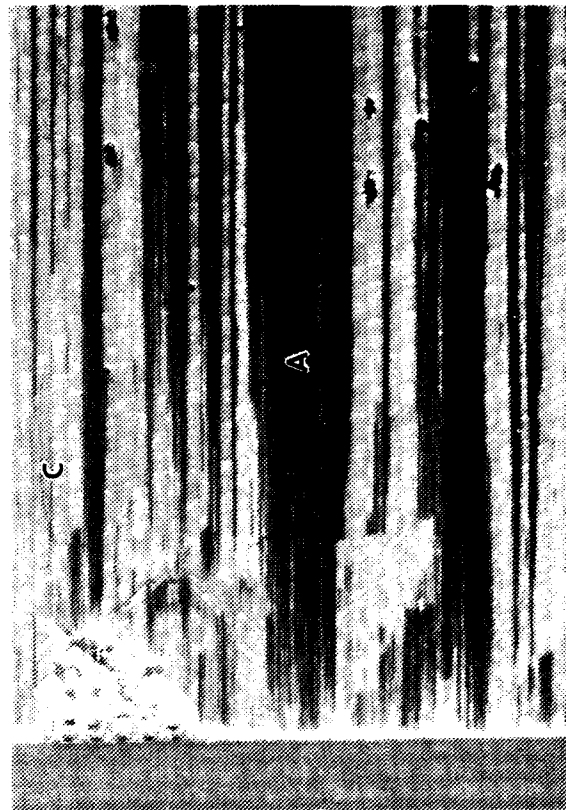
Figure 3-50. Optical and SEM Photographs of Fracture in Unidirectional AS4/3501-6 Gr/Ep Adherends Bonded With FM 300 Adhesive and Tested Under Mode I Tension and Mode II Interlaminar Shear  
(a) Macro photograph of Fracture  
(b), (c) Low Magnification (4X) Photographs Showing Cohesive (C) and Adhesive (A) Failure Characteristics

Figure 3-50 illustrates failure characteristics in unidirectional Gr/Ep adherends bonded with FM-300 adhesive, and tested under mixed loads (Mode I tension plus Mode II interlaminar shear). Application of peel resulted in a mixed cohesive-adhesive failure with no clear transition from one failure mode to the other. SEM examination of the fractured adhesive in the cohesive areas revealed no features indicative of crack-propagation direction. The fractured adherend in the adhesive failure areas exhibited peel characteristics (hackles plus river patterns).

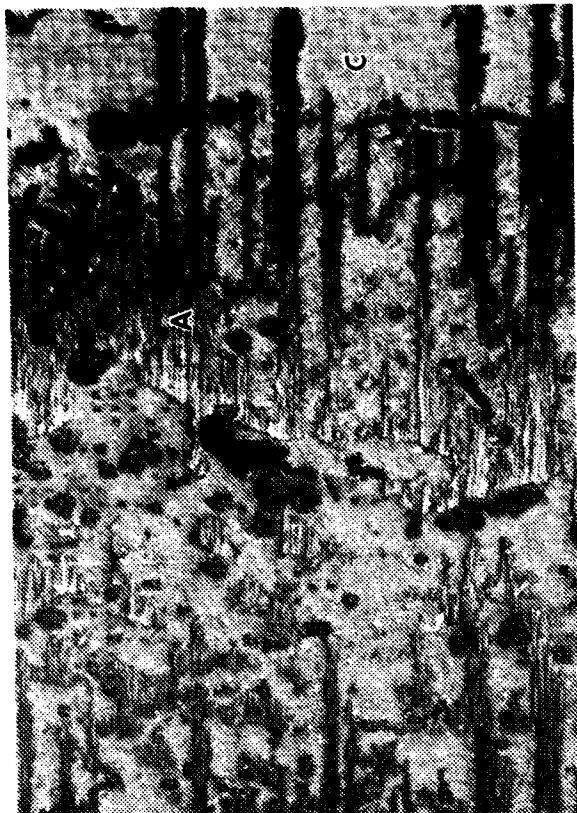
Figure 3-51. Optical Photographs of Failure in Unidirectional AS4/5250-3 Gr/BMI Adherends Bonded With EA 9673 Adhesive and Tested Under Interlaminar Mode I Tension

(b), (c) Low Magnification (4X) Photographs Showing Details in Cohesive and Adhesive Failure Regions

Figure 3-51 and 3-52 illustrate failure characteristics in unidirectional Gr/BMI adherends bonded with EA 9673 adhesive, and tested under interlaminar Mode I tension in a manner similar to the Gr/Ep coupons. On a macroscopic scale failure initiated in a mixed cohesive-adhesive mode (Figures 3-51a and 3-51b). With increasing crack length, there was a transition to a cohesive failure mode, and eventually to an adhesive failure mode. The fracture direction could be established as in the Gr/Ep specimens through mapping of the rivers in the adhesive or cohesive failure areas (Figure 3-52).

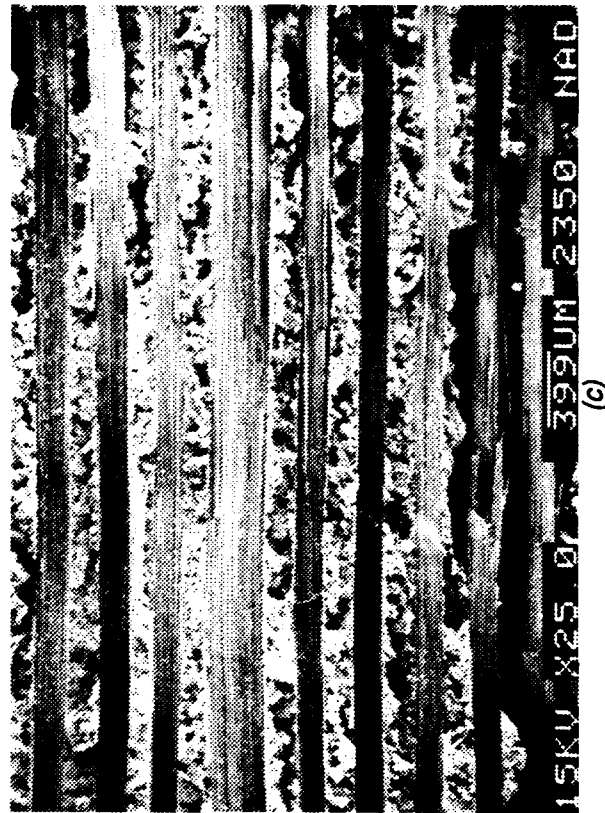
Figure 3-60. Optical and SEM Photographs of AS4/3501-6 Overcured Gr/Ep - [+45/-45]<sub>6s</sub>, In-Plane Shear Tested  
 (a) Macro photograph of Rail-Shear Specimen  
 Note arrows indicating loading direction  
 (b) Fracture in +45 Degree Ply Showing Hackles (H)  
 (c) Transverse Tensile Fracture in Secondary Failure Region

CD = Crack-propagation direction  
 I = In-plane shear region  
 T = Secondary transverse tensile fracture

Figure 3-60 shows macroscopic and microscopic fracture features in AS4/3501-6 Gr/Ep - [+45/-45]<sub>6S</sub>, that was overcured (overcure process details are given in Reference 5). On a macroscopic scale, overcuring appeared to have resulted in more severe catastrophic fracture in the rail-shear specimen, than for the baseline. On a microscopic scale, the fracture characteristics were similar, as is illustrated in Figures 3-60b and 3-60c.

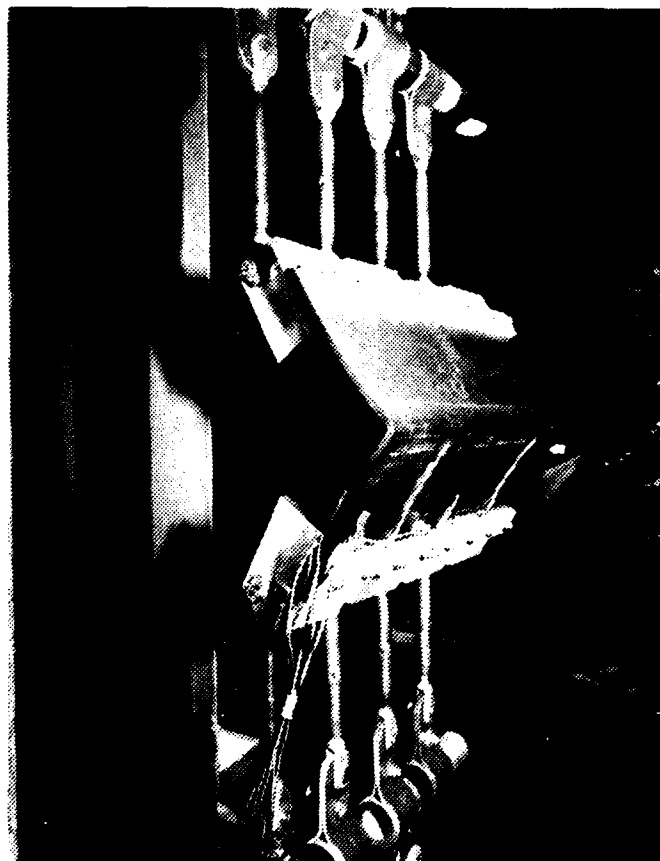
**Figure 3-74. Failure Testing of Gr/Ep Composite Stringer**  
 (a) Schematic of Test Configuration  
 (b) Photograph of Part Being Tested

Figures 3-74a and 3-74b show a schematic of the test setup for failure testing of the stringer, and a photograph of the part being failure tested. The part was strain gaged on the inner and outer faces of one of the legs (labeled 1 through 6 in Figure 3-73b), and tested under interlaminar tensile loading. The load history, and measured strains are shown in Table 3-21.

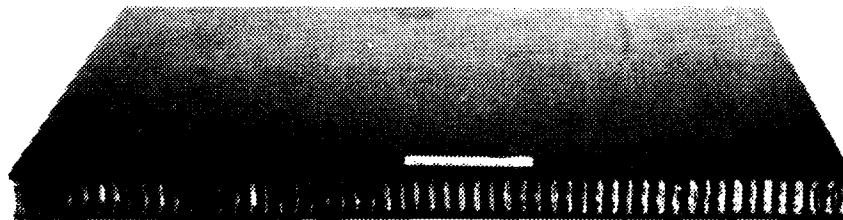
**Figure 3-75. Gr/Ep-Al Honeycomb Structure**  
 (a) Schematic Diagram  
 (b) Photograph of As-Fabricated Part

Figures 3-75a and 3-75b show a schematic diagram of the Gr/Ep-Al honeycomb structure, and a photograph of the fabricated part. The specimen (6 inches x 10 inches x 0.625 inches) consisted of two AS4/3501-6 Gr/Ep skins (16-ply, quasi-isotropic 0-, 45-, and 90-degree ply orientations), that contained porosity. Porosity was introduced in the skins by loss of cure pressure during processing. The skins were then secondarily bonded to 5052 Al honeycomb using FM-300 adhesive as per Northrop Process Specification MA 133 (Reference 13).
