# Field Assessment Techniques for Bank Erosion Modeling

Final Report

Colin R. Thorne
Department of Geography,
University of Nottingham,
Nottingham NG7 2RD, UK
Tel. (0602) 484848

Research Contract R&D 6560-EN-09

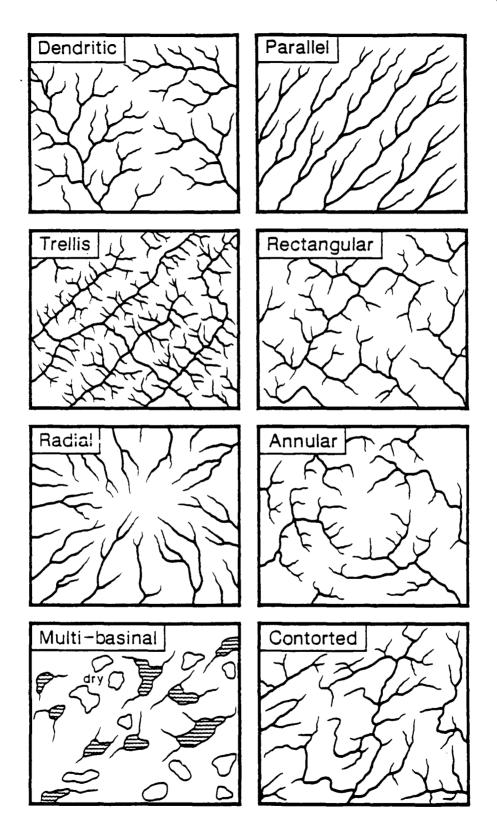
Figure 1. Basic Drainage Patterns (Adapted from Howard, 1967)

Drainage Pattern defines the plan shape of the channel network. Eight common types of pattern have been identified (Howard, 1967) as indicative of the underlying terrain. These are shown in Fig. 1. and are described overleaf.

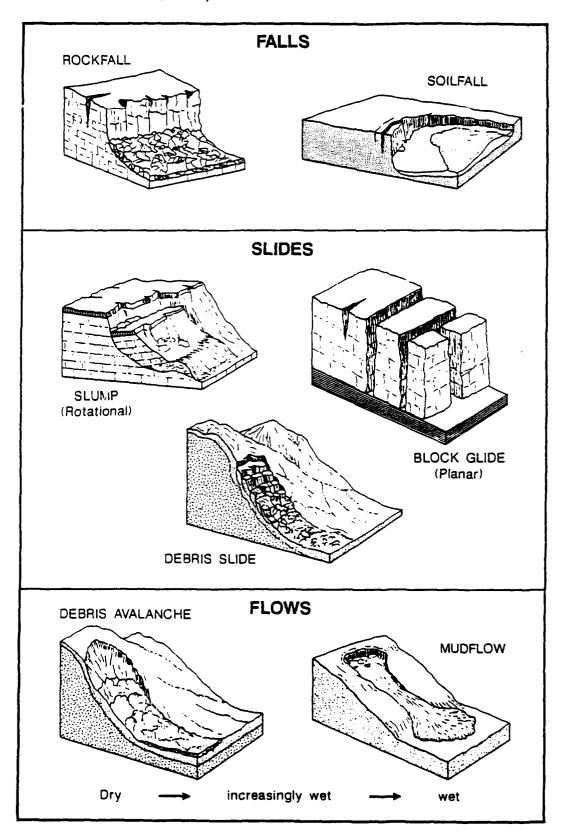
Figure 2. Typical Valley Side Failure Modes (Developed from Varnes, 1958).

Failure Type defines the mechanism of valley side failure. The type of failure determines the shape of the valley side after failure, controls the volume of material involved in each failure and may help to identify the cause of the instability. Sketches of typical failure modes are shown in Fig. 2.

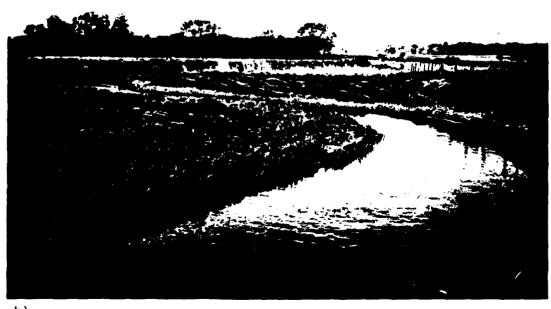
Figure 3. a) Upland river with a narrow flood plain and frequent coupling of channel and active erosion of valley side. b) Lowland river with broad flood plain and uncoupled channel and hillslope processes.

Valley Floor Type and Valley Floor Data note the presence or absence of a flat valley floor and its width in relation to the width of the channel. Rivers with fragmentary or narrow valley floors are closely coupled to hillslope run-off and erosion processes operating on the valley sides and are also liable to destabilization by valley side slope failures and sediment inputs. This is not true of rivers with broad flood plains. (Fig. 3 a and b).

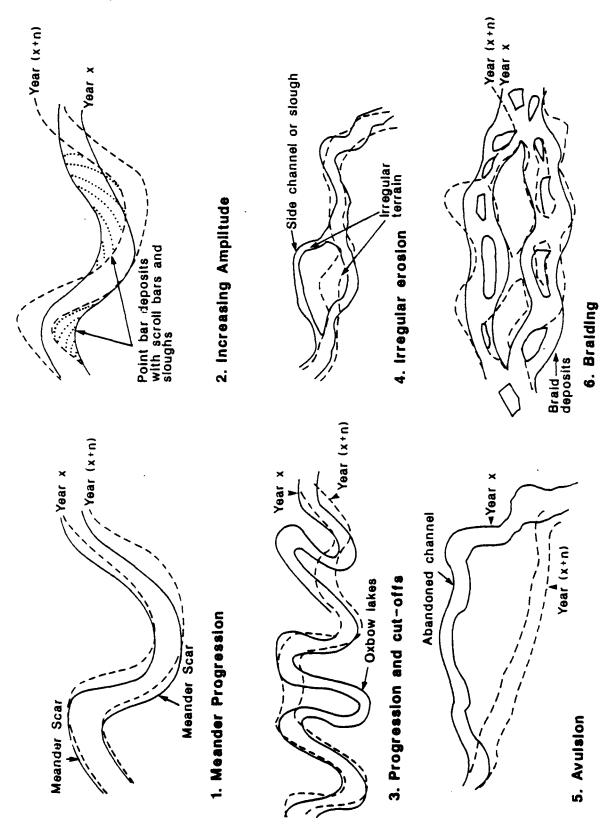
Figure 9. Types of lateral activity and typical associated flood plain features

Lateral Activity records the type of channel planform evolution currently taking place (Fig. 9). Meander progression (down valley movement of the bend) occurs when bank erosion in meander bends is concentrated at the outer bank between the bend apex and the downstream crossing. Increasing amplitude occurs when the meander grows laterally as well as progressing downstream. In mature, meandering rivers progression leads to some bends being destroyed by neck and chute cut-offs. Irregular erosion occurs where variability (for example, due to local contrasts in flood plain sediment erodibility) disrupts the regular pattern of lateral activity. An avulsion is the rapid abandonment of the river's historic course in favor of a new Avulsions usually occur during floods. Braiding occurs by apparently random shifting of sub-channels (anabranches), to produce impinging flow, intense local bank erosion and a dynamic, unpredictable plan shape to the bank lines.

Flood Plain Features are associated with different types of lateral activity (Fig. 9). Meander scars are steep scarp slopes left in the flood plain by meander progression. Scroll bars are low, curved ridges in the flood plain which are found inside and parallel with meander loops. Swales or sloughs are low troughs running between the scrous. Bars and swales are produced by point bar migration on the advancing, convex bank, during meander growth through increased amplitude. Oxbow lakes are crescent-shaped lakes which were once part of a meander but which were cut-off and abandoned due to meander progression. Abandoned channels are unsilted reaches of the channel left behind after an avulsion. Braided deposits give the flood plain an uneven, hummocky topography, with frequent abandoned channels, vegetated braid bars and sloughs.

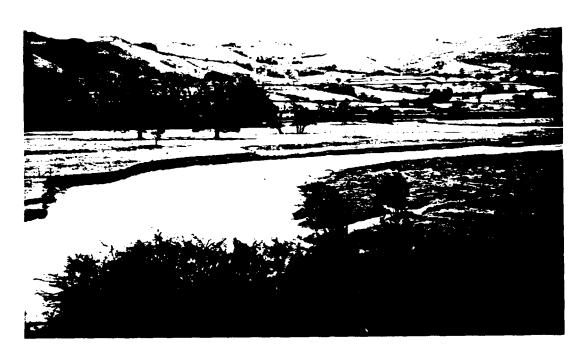
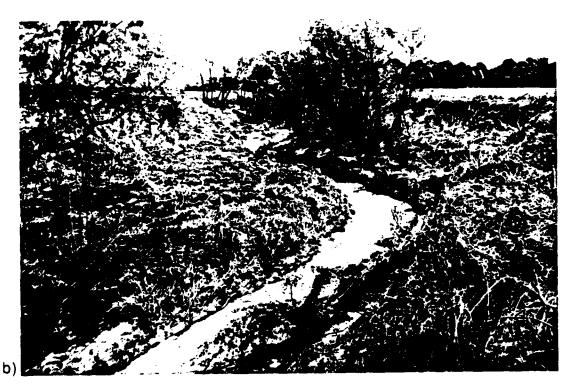
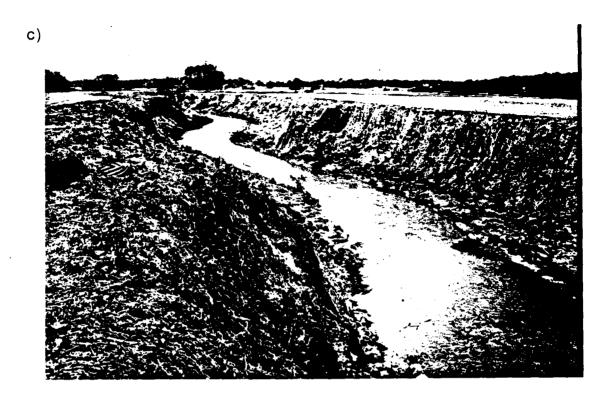
Figure 10. Examples of: a) a shifting river in dynamic equilibrium; b) an over-wide channel, and; c) a channel which is too narrow

Present Status defines whether or not the channel width is adjusted to the present flow regime. Adjusted channels have stable widths over time, although they may still be laterally active if they erode one bank and deposit sediment at the other (Fig. 10a). This is termed 'dynamic equilibrium'. Over-wide rivers are broad and shallow with shifting bars. They have stable banks and accumulated sediment shelves at the toes of both banks, producing a composite, "two-stage channel" type of cross-sectional shape (Fig. 10b). Narrow rivers have low aspect ratios, active erosion of both banks, no sediment stored at either bank toe and more trapezoidal cross-sections (Fig. 10c).

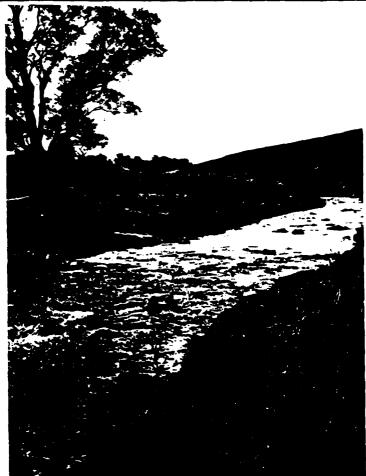
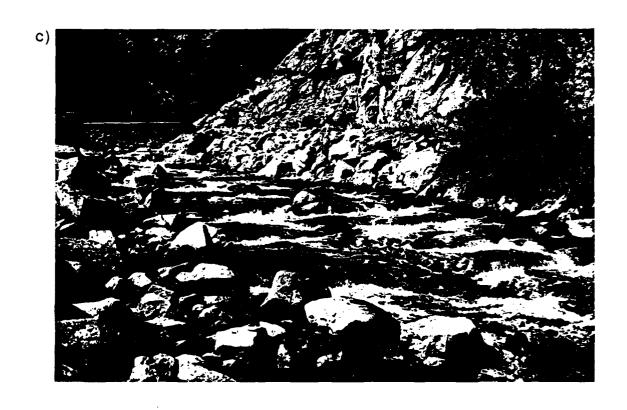
Figure 11. Types of flow in natural rivers. a) Uniform tranquil; b) Pool and Riffle; c) Tumbling/Step-Pool

Flow Type defines the regime of flow in the channel according to the principles of free surface flow (Fig. 11). Uniform/Tranquil flow lacks major changes in flow velocity with distance along the channel and is sub-critical. Uniform/Shooting flow lacks major changes in flow velocity along the channel and is super-critical. Pools and riffles are alternating bed features producing non-uniform flow. Pools are areas of deep, slow flow with a gentle water surface slope. Riffles are areas of shallow, fast flow with a steep water surface slope. Steep + Tumbling flow occurs in high gradient streams with coarse bed material which disrupts the water surface and produces local super-critical flow between and over Steep + Step/pool flow is found in very steep channels with boulders arranged in periodic steps across the channel and plunge pools in between.

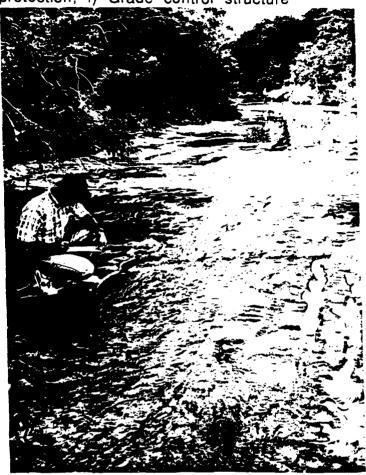
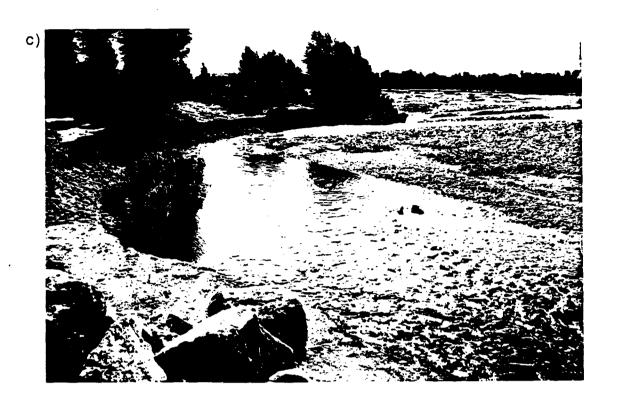
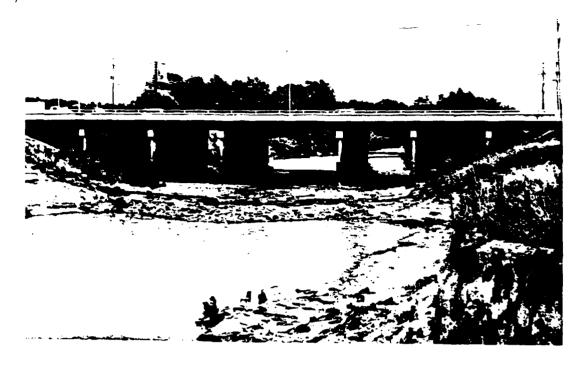
Figure 12. Types of bed control in rivers. a) Bedrock; b) Boulders; c) Gravel armour; d) Cohesive materials; e) Bridge protection; f) Grade control structure

Control Types defines the nature of the bed controls (Fig. 12). Natural examples are bed rock outcrops, coarse sediments which form an immobile armor layer, and fine sediments which are strongly cohesive. Where natural controls like these are absent, weirs or cut-off walls may be constructed to prevent bed degradation. Such grade control structures are vital where severe degradation is occuring and natural controls are either absent or unreliable. Foundations and protection constructed at bridges and culvert crossings may also act as bed controls.

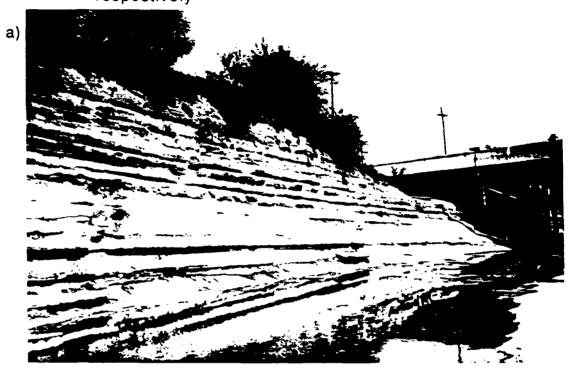
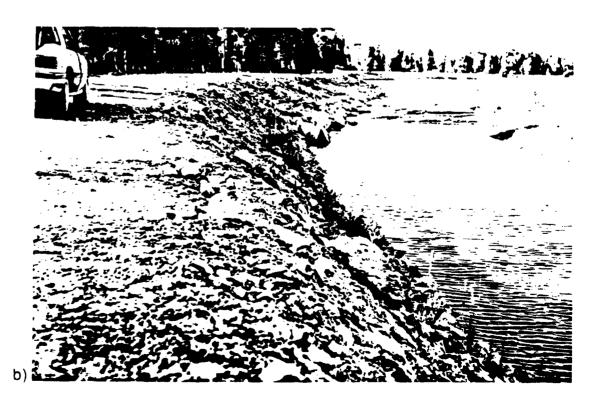
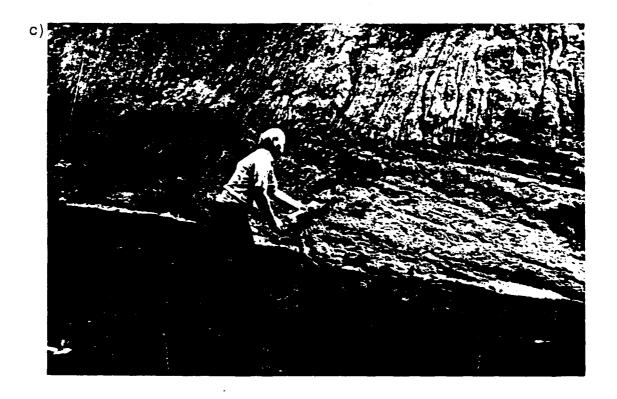
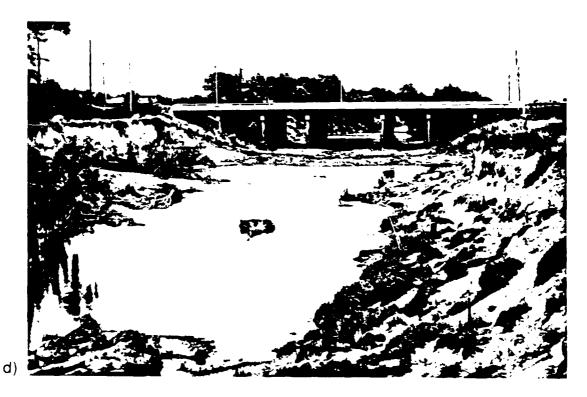
Figure 13. Types of width control in rivers. a) Bedrock;
b) Revetment; c) Cohesive materials d) Bridge
abutments. For boulders, gravel armour and
dykes/groynes see Figs. 12b, 12c and 19d,
respectively

Control Types define the nature of the width controls (Fig. 13). Natural examples are bed rock outcrops, coarse sediments which form an immobile armour on the bank, and fine sediments which are strongly cohesive. Controls due to fine sediments are often associated with clay plugs and back swamp deposits in the flood plain left by earlier depositional activity. Where natural controls like these are inadequate, dyke fields and/or revetments may be used to control river width and bank line movement. Such training structures are a vital part of bank protection schemes in systems where width is unstable and natural controls are either absent or unreliable.

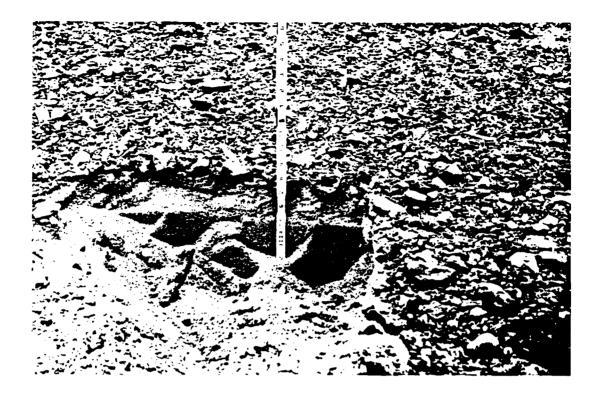
Figure 14. Armor layer in a gravel-bed river

Bed Armor identifies whether a coarse surface layer is present (Fig. 14). An armor layer limits the availability of bed sediments for transport and the potential for bed scour. Two types of armor have been identified: static armor is much coarser than the underlying sediment and is immobile under all but catastrophic flood flows; mobile armor is a little coarser than the underlying sediment and is moved by moderate events below bankfull flow.

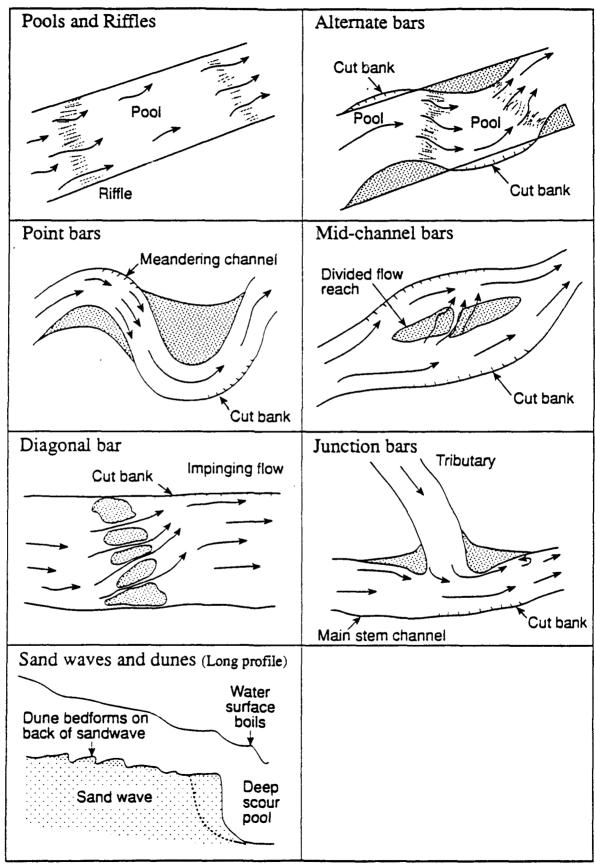
Figure 15. Bar type classification

Bar Types describes the shape (morphology) of any bars (Fig. 15). Bars represent major topographic features in the channel bed and are intimately related to flow patterns and sediment transport distributions. They may be responsible for diversion of the flow so that it attacks one or both banks, promoting bank erosion, toe scour and bank line retreat.

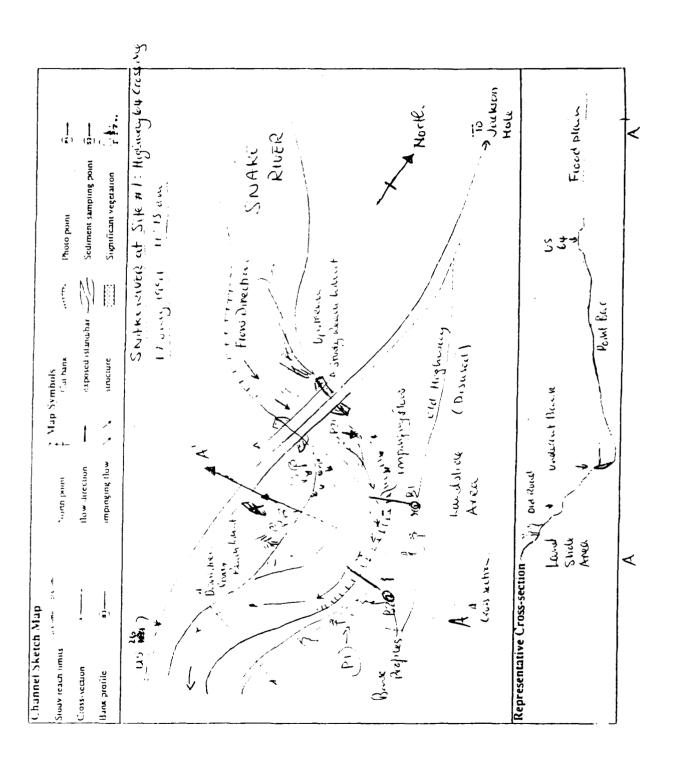
Figure 16. Example sketch map and representative cross-section: Snake River near Jackson Hole, Wyoming

Channel Sketch Map and Representative Cross-section are spaces provided for a visual representation of the channel in the study reach. An example for a reach of the Snake River, Wyoming is shown in Fig. 16. The aims are to show the shape and features of the channel and record the sampling points for bed and bar sediment samples. Also, photographs showing: i) views upstream and downstream along the study reach ii) right and left banks, and iii) special features of the channel should be taken and photo points and orientations marked on the map so that they can be relocated and repeated precisely in any future re-surveys. This greatly enhances their value as a guide to bed scour, bank erosion, channel changes and system instability. Fig. 17 shows examples of site photographs from the study reach on the Snake River.

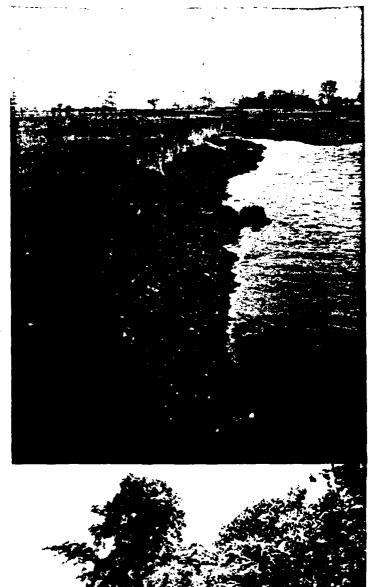
Figure 18. Bank Types: a) Noncohesive; b) Cohesive; c) Composite; and d) Layered a)

Type establishes the overall classification of the bank as being noncohesive, cohesive, composite or layered (Fig. 18). There are basic differences between banks formed in different materials, or combinations of materials. Noncohesive banks are formed in sands, gravels, cobbles and boulders that lack intrinsic cohesion. Cohesive banks are formed in silts and clavs which are cohesive. Composite banks consist of a single cohesive layer underlain by a single noncohesive layer. banks are common in rivers with noncohesive bed material (sand or gravel) which are flowing through alluvial flood plain deposits consisting of bed material overlain by overbank fines. Layered banks consist of layers of noncohesive and cohesive materials laid down during a past aggradational phase. Often the layers are of uneven thickness and this can be very significant to bank erosion and hydrology.

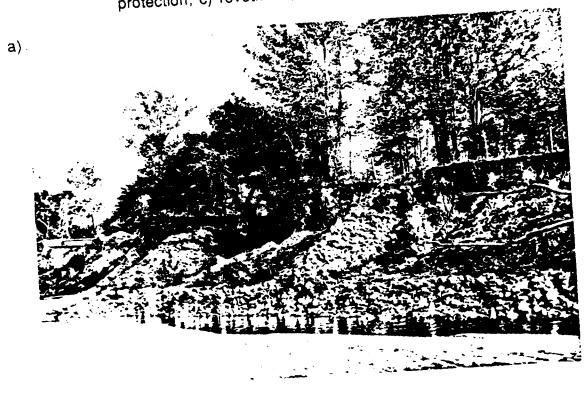
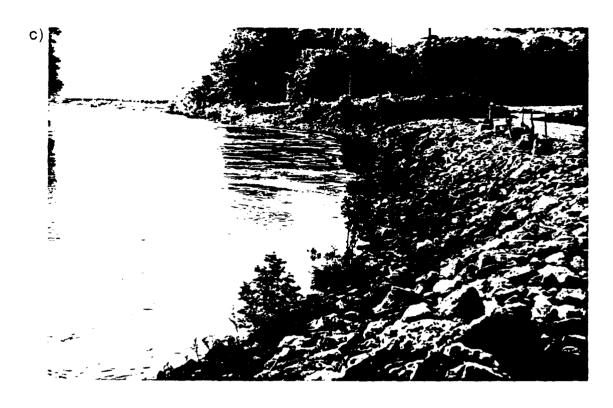
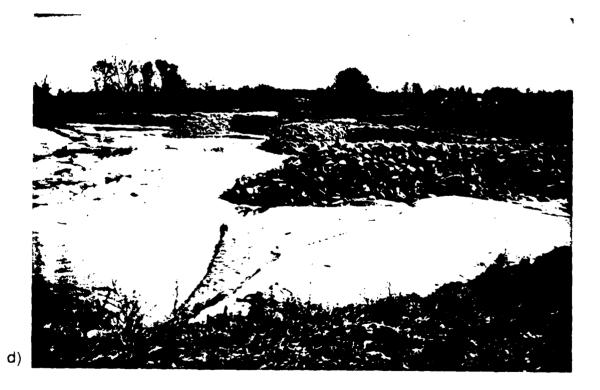
Figure 19. Types of bank protection: a) Hard points; b) Toe protection; c) revetment; and d) dyke fields

Protection Status establishes whether the bank is unprotected or has been subject to engineering stabilization (Fig. 19). Where a bank has been protected the condition and effectiveness of the structure should be described in the Notes and Comments space.

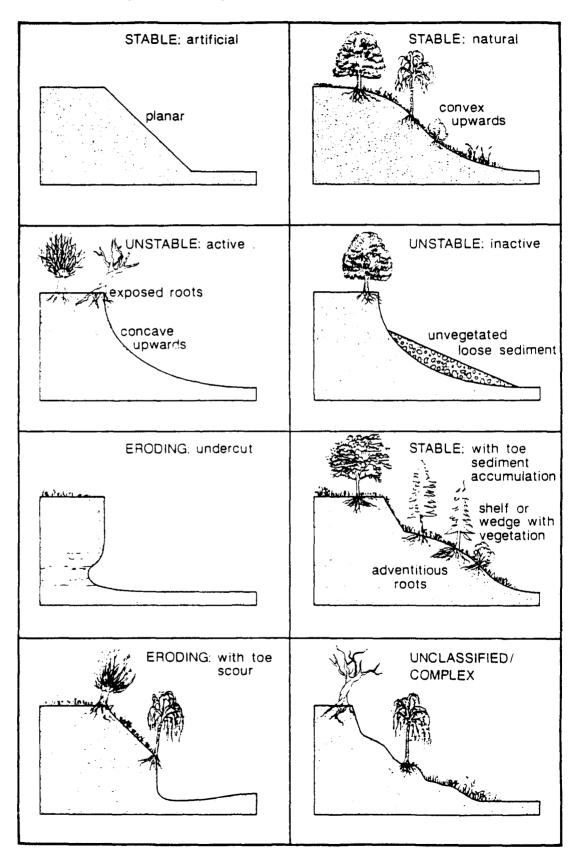
Figure 20. Typical bank profiles

Bank Profile Shape augments the height and slope data by specifying the form of the bank profile. This can be a good indicator of the dynamic nature of current bank retreat, stability or advance. Typical bank profiles and their interpretations are shown in Fig. 20.

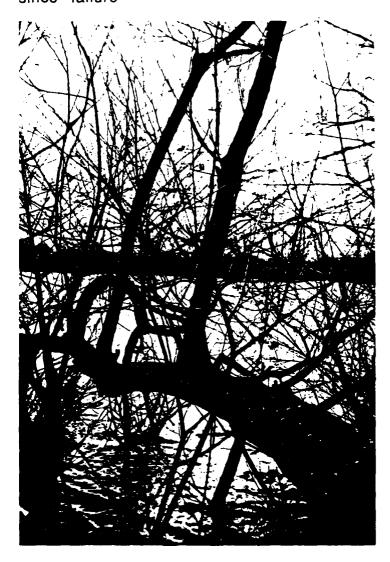
Fallen trees which are not dead produce new stems which grow vertically from the downed trunk (Fig. 23). Breaking off such a stem and counting the annual rings is a good way to gauge the time elapsed since the failure.

Figure 23. New stems shooting upwards from a downed tree.

Counting rings in the stems gauges the time elapsed since failure

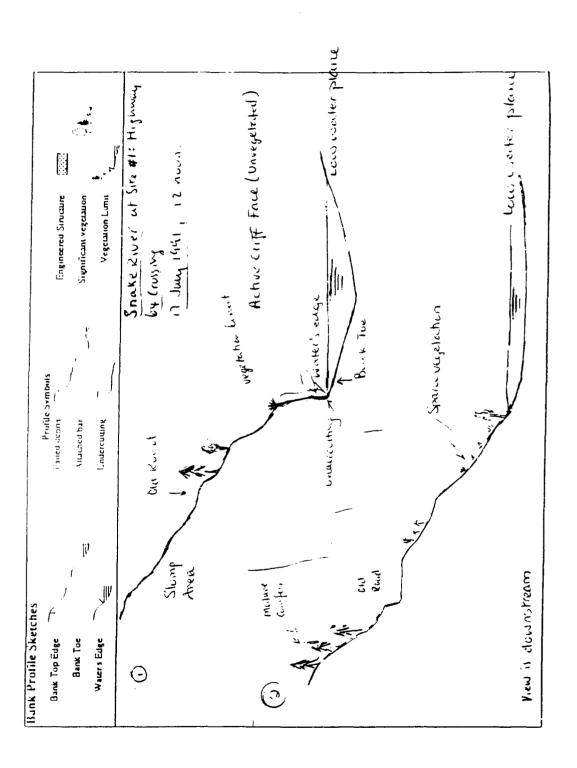
Bank Profile Sketches are spaces provided for a visual representation of the left bank in the study reach (Fig. 25). The aims are to show the slope profile break points, the geotechnical/sedimentary features and any engineered structures on the bank, and to record any sediment sampling points in different bank layers. Also, photographs showing important bank features should be taken and photo points and orientations marked on the sketch so that they can be relocated and repeated precisely in any future re-surveys. This greatly enhances their value as a guide to bank condition, erosion, bank-line changes and system instability.

Figure 25. Example bank profile sketch

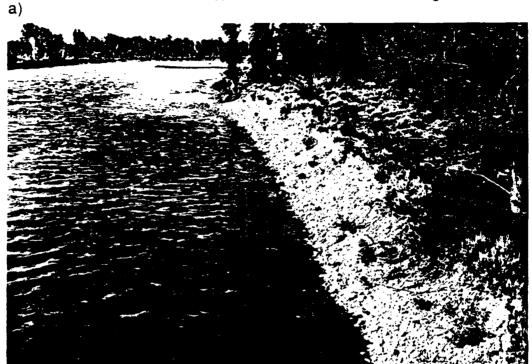
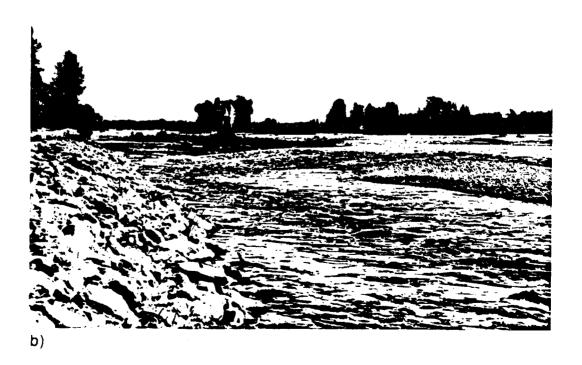
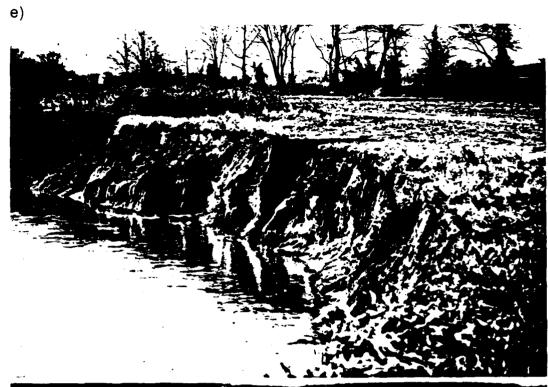
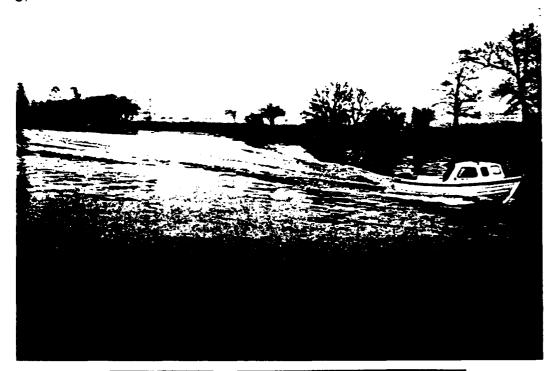
Processes attempts to identify the processes responsible for bank erosion (Fig. 26). This is not an easy task and often

Figure 26. Bank erosion processes observed in the field.

- a) Parallel flow; b) impinging flow; c) piping;
- d) freeze/thaw; e) sheet erosion+rilling/gullying; f) wind waves; g) vessel forces and resulting erosion

Parallel Flow erosion is the detachment and removal of intact grains or aggregates of grains from the bank face by flow along the bank. Evidence includes: observation of high flow velocities close to the bank; near-bank scouring of the bed; under-cutting of the toe/lower bank relative to the bank top; a fresh, ragged appearance to the bank face; absence of surficial bank vegetation.

Piping is the caused by groundwater seeping out of the bank face. Grains are detached and entrained by the seepage flow (also termed sapping) and may be transported away from the bank face by surface run-off generated by the seepage, if there is sufficient volume of flow. Piping is especially likely in high banks or banks backed by the valley side, a terrace, or some other high ground. In these locations the high head of water can cause large seepage pressures to occur. Evidence includes: pronounced seep lines, especially along sand layers or lenses in the bank: pipe shaped cavities in the bank; notches in the bank associated with seepage zones and layers; run-out deposits of eroded material on the lower bank. Note that the effects of piping erosion can easily be mistaken for those of wave and vessel force erosion. (see papers by Hagerty and Hagerty, 1989 and by May, 1982).

Freeze/thaw is caused by sub-zero temperatures which promote freezing of the bank material. Ice wedging cleaves apart blocks of soil. Needle-ice formation loosens and detaches grains and crumbs at the bank face. Freeze/thaw activity

seriously weakens the bank and increases its erodibility. Evidence includes: periods of below freezing temperatures in the river valley; a loose, crumbling surface layer of soil on the bank; loosened crumbs accumulated at the foot of the bank after a frost event; jumbled blocks of loosened bank material.

Wind waves cause velocity and shear stresses to increase and generate rapid water level fluctuations at the bank. They cause measurable erosion only on large rivers with long fetches which allow the build up of significant waves. Evidence includes: large channel width or long, straight channel and an acute angle between eroding bank and longstream direction; a wave-cut notch just above normal low water plane; a wave-cut platform or run-up beach around normal low-water plane. Note that it is easy to mistake the notch and platform produced by piping and sapping for one cut by wave action (see papers by Hagerty and Hagerty, 1989 and May, 1982).

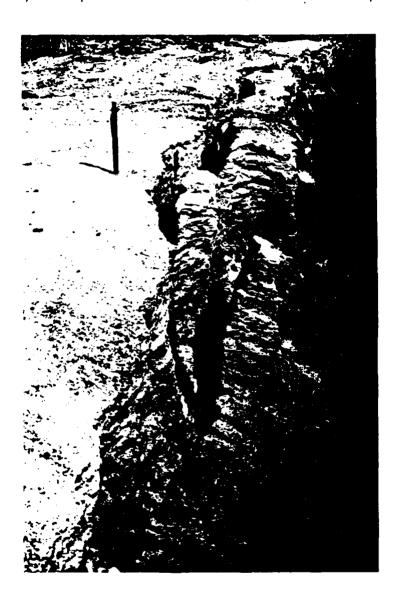
i) example 'other' failure mode - cattle trampling

Interpretation rests on recognition of the geometry of the bank which results from different mechanisms. Some guidance is given here.

Soil/rock fall occurs only on a steep bank, where grains, grain assemblages or blocks fall into the channel. Such failures are found on steep, eroding banks of low operational cohesion. Soil and rock falls often occur when a stream undercuts the toe of a sand, gravel or deeply weathered rock bank. Evidence includes: very steep bank; debris falling into the channel; failure masses broken into small blocks; no rotation or sliding failures.

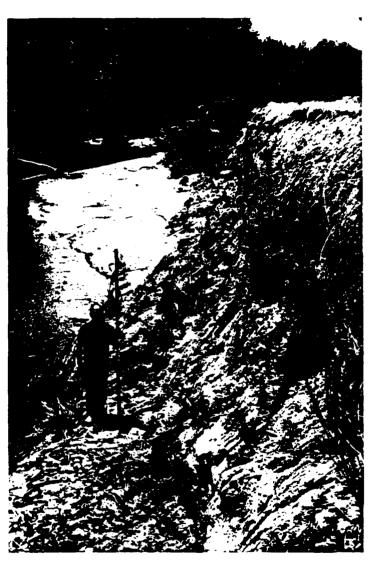
Figure 28. Typical bank toe profiles: a) Concave upwards (active erosion); b) Planar (temporary storage) and; c) convex upwards (net accumulation)

Banks which have net toe erosion (under-cutting) are certain to become less stable and to retreat more rapidly in the future unless a more resistant bank material is encountered or steps are taken to stabilize the bank (Fig. 28a). When stabilizing such banks, special steps must be taken in the design to either eliminate or allow for serious toe scour.

Banks which have neither net toe erosion or deposition will continue to retreat at about a constant rate because, on average, failed material is removed by basal clean-out about as quickly as it is generated by bank erosion and failure (Fig. 28b). Only the usual degree of toe scour protection is needed on such banks.

Banks with net toe deposition should show increased stability and a reduced rate of retreat, all else being equal (Fig. 28c). This is achieved through bank shelf building - the accumulation of a low angle sediment wedge at the bank toe. Hence the degree of bank shelf development is a good indicator of the tendency of the bank towards stability. Given the opportunity, vegetation invades the stable toe area and shelf quite quickly. Therefore, toe vegetation can be used as a guide to the age and permanence of a bank shelf. Banks with developing, permanent shelves should not normally require structural bank protection.

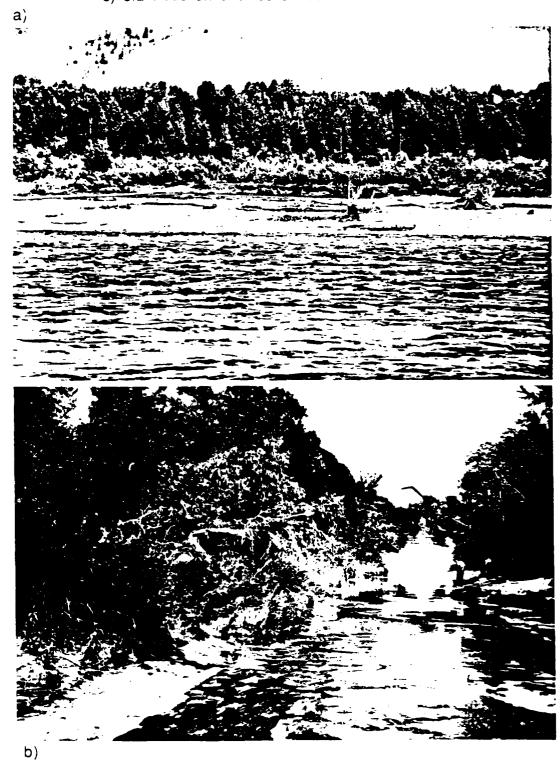
Age can be a useful guide to the recent history of undercutting or sediment accumulation (Fig 29). Old and mature vegetation clearly can only develop on a stable bank shelf. A lack of vegetation or a predominance of young, immature plants hints at a recently deposited shelf that may be a temporary feature, being destroyed at high flow.

Figure 29. Bank Shelf vegetation of different ages. a) Immature vegetation on a shelf in front of mature flood plain forest; b) mature vegetation on bench on left bank; c) old trees on shelves on both banks
