U.S. ARMY
MATERIEL COMMAND

FINAL
CONTAMINATION ASSESSMENT REPORT
SANITARY SEWER - RAILYARD AND ADMINISTRATION AREAS
VERSION 3.2

August 1988
Contract No. DAAK11-84-D-0017
TASK NO. 10

LITIGATION TECHNICAL SUPPORT AND SERVICES
ROCKY MOUNTAIN ARSENAL

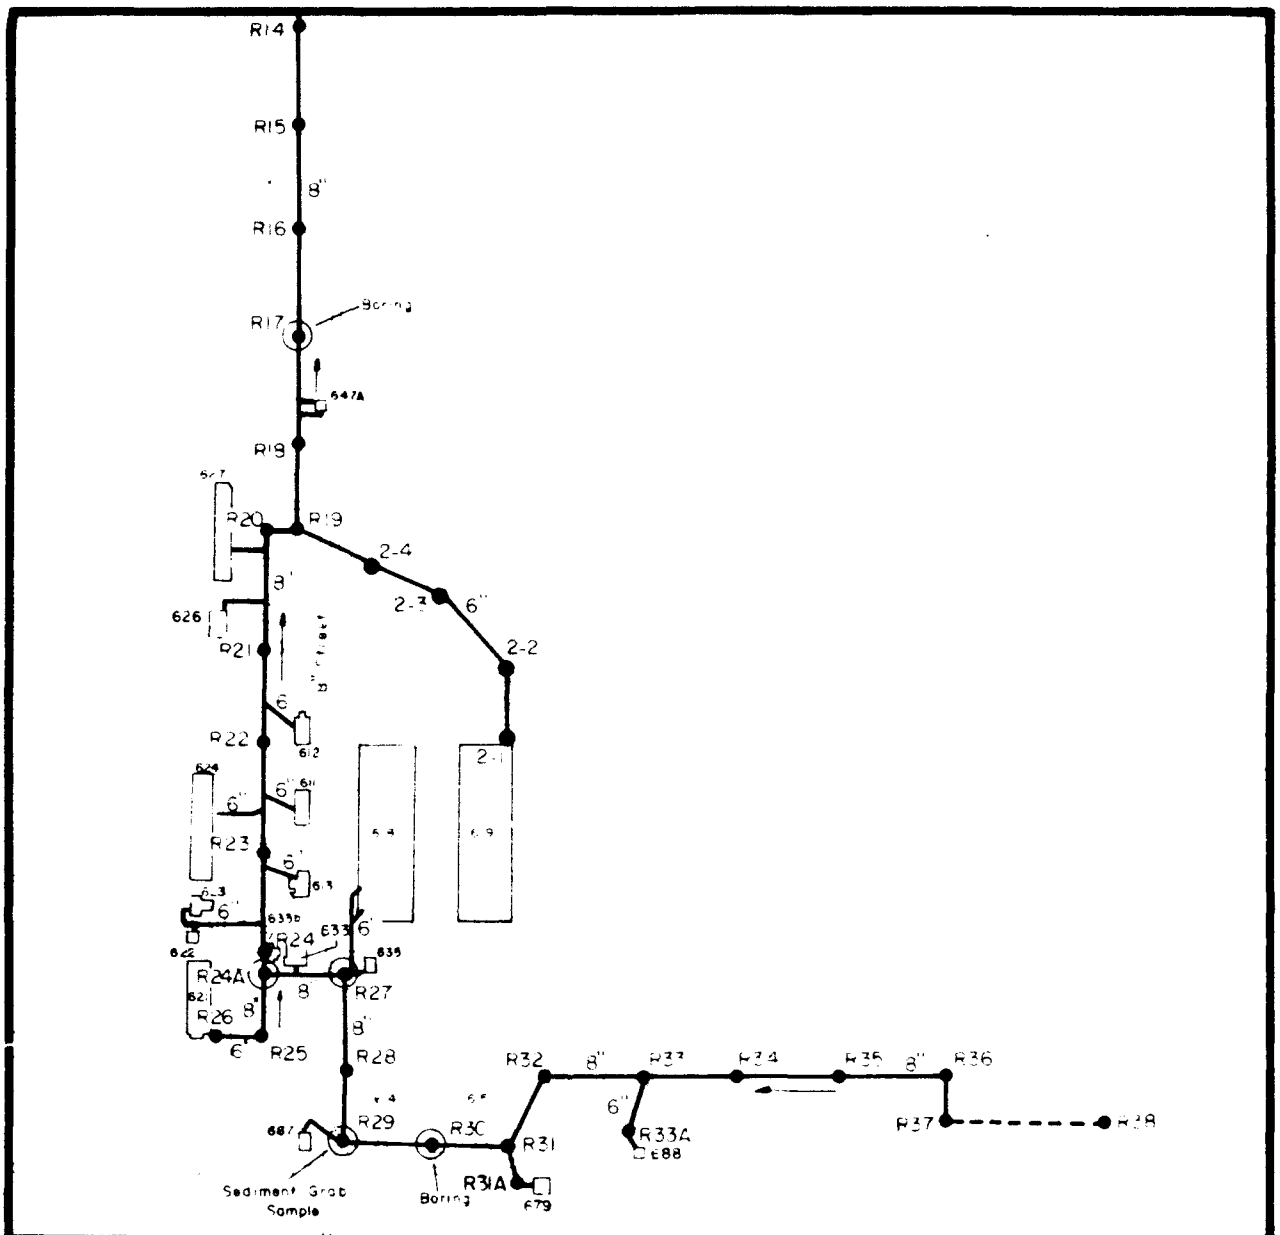
FIGURE SS-RA-2a
 Location Map for Buildings Connected to
 Sanitary Sewer in Railyard Area
 Rocky Mountain Arsenal, Task 10
 Prepared by: Ebasco Services Incorporated

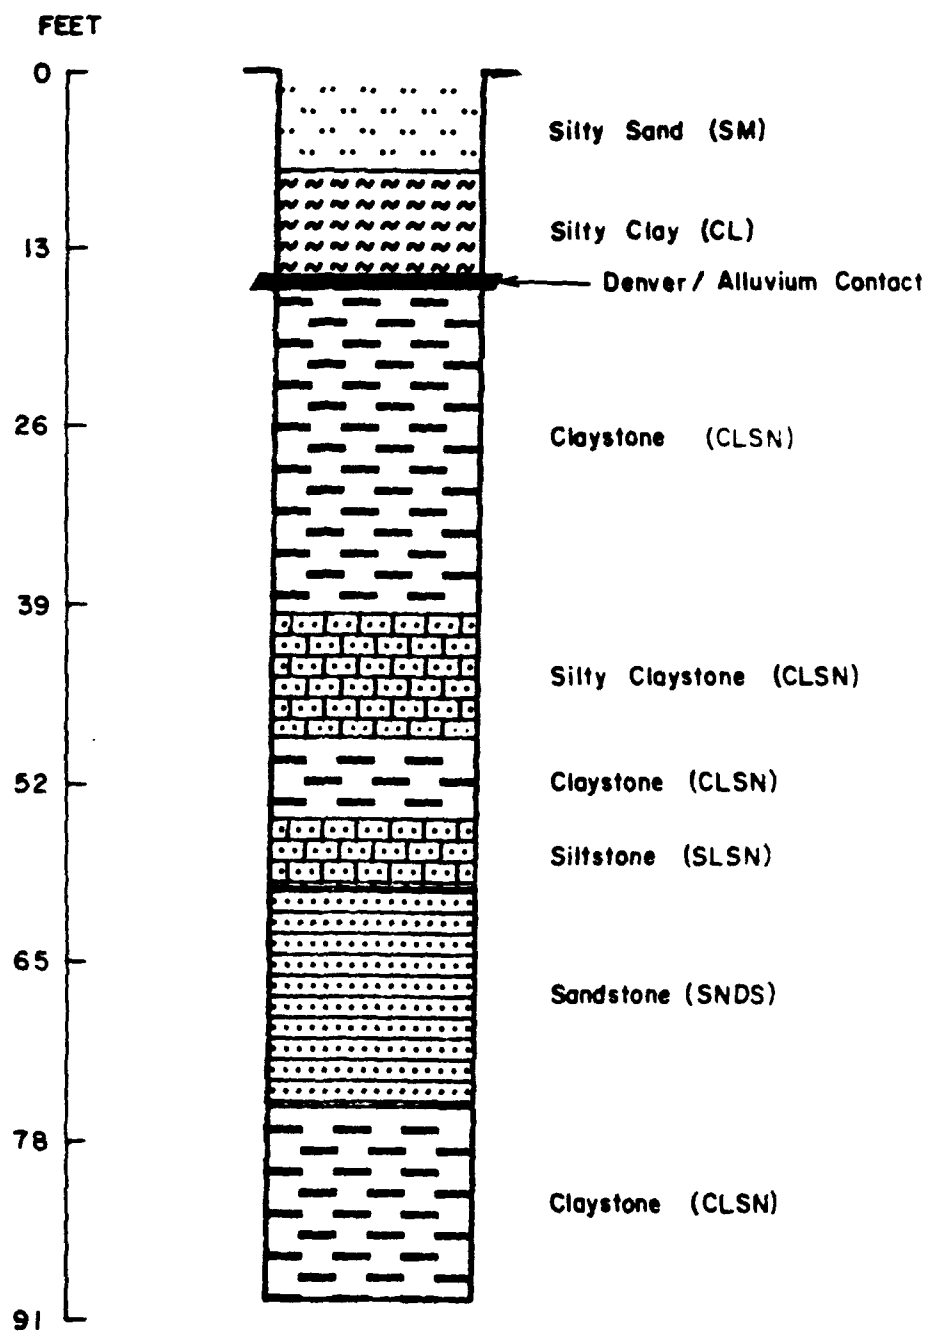
FIGURE SS-RA-4b
 Field Boring Profile for Well 35051
 Rocky Mountain Arsenal, Task 10
 Prepared by: Ebasco Services Incorporated

The eastern portion of the sewer system lies primarily in Section 35. Here the alluvium ranges in thickness from 0 ft near the center of the section, where the Denver Formation crops out, to 45 ft in Wells 35045 and 35019. Borelogs show that eolian and alluvial materials in this area are composed primarily of silty sand with lesser clay, as shown in Well 35051 (Figure SS-RA-4b).
