# Flightdeck Automation Issues: An Aviation Safety Reporting System Analysis

DOT/FAA/CT-TN95/11

Technical Report Documentation Page

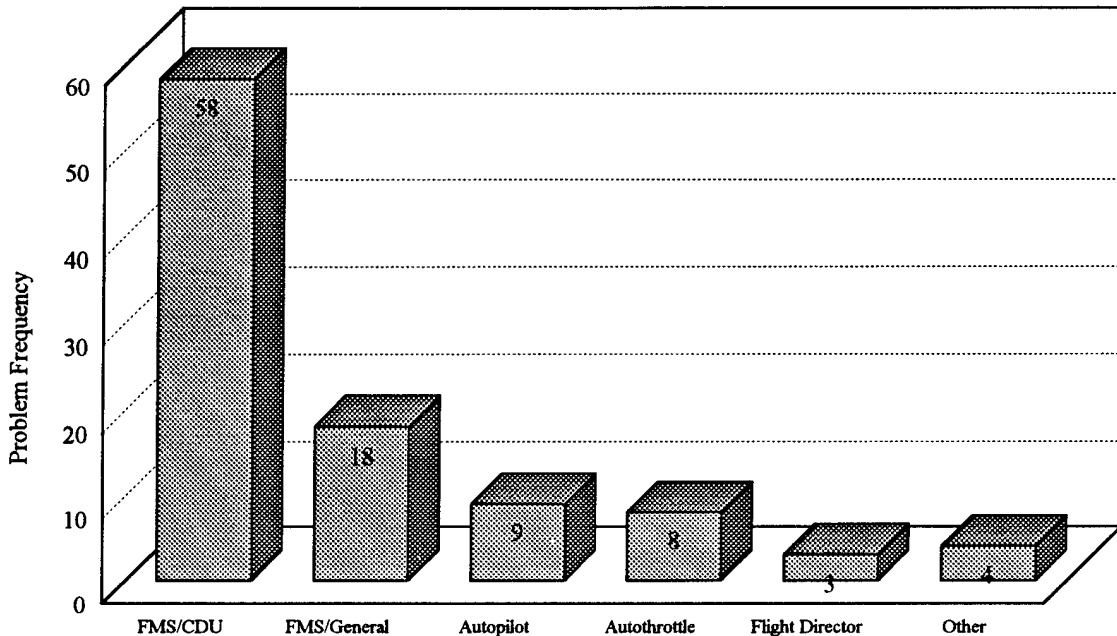
FIGURE 1. AUTOMATION EQUIPMENT

The FMS is comprised of many interconnecting systems. Figure 1 denotes the breakdown of the ASRS reports into individual FMS components. The FMS Control Display Unit (CDU) was directly involved in over half (58 percent) of the incidents reported. A separate class (FMS/General) was created to indicate those reports where the specific FMS component was inconclusive; 18 percent of the incident reports fell in this category. The remaining reports were directly attributed to either the autopilot (9 percent), autothrottle (8 percent) and flight director (3 percent) systems.

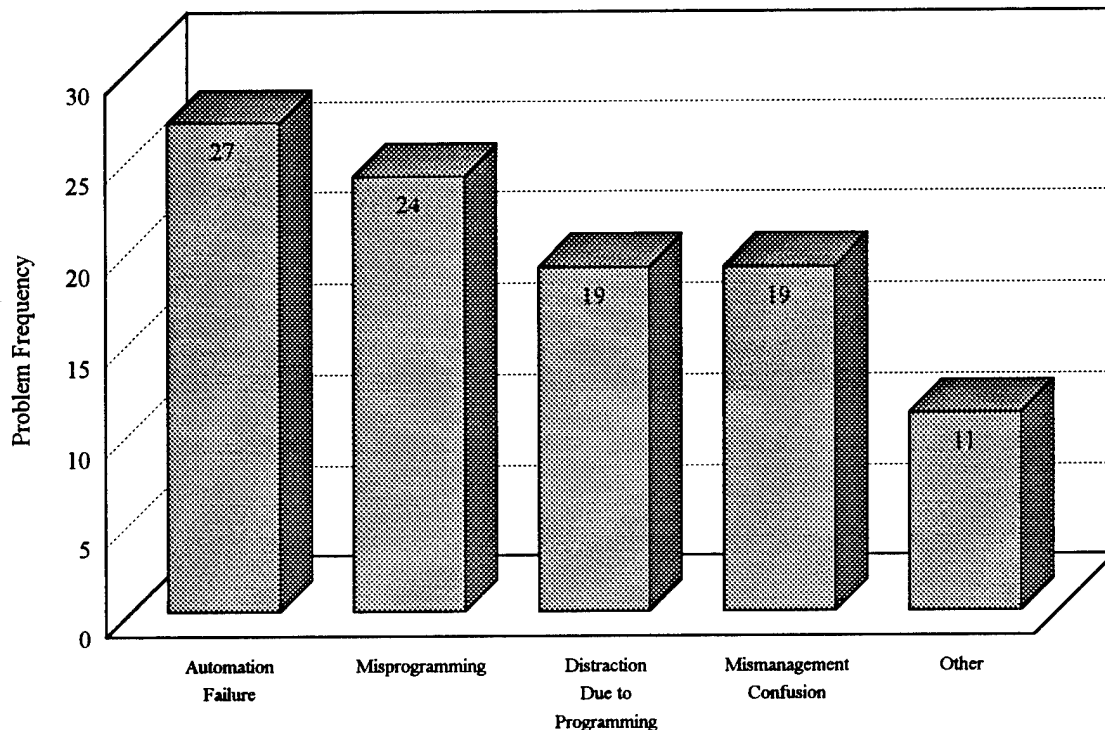
FIGURE 2. AUTOMATION PROBLEMS

Figure 2 illustrates the results of the detailed analysis. Although the problems are separated in unique categories, crews reported monitoring deficiencies, complacency, etc., throughout each problem area. In order of their percentage, the following major problems are noted as follows: (1) Automation Failure (27 percent), (2) Misprogramming (24 percent), (3) Distraction due to Programming (19 percent), and (4) Mismanagement and Confusion (19 percent).

In retrospect, observing the various classifications of automation problems (figure 2) one can see the association with related literature. For instance, Sheridan's (Sheridan, 1991) concept of human-centered automation portrays the pilot undergoing four supervisory activities amidst automation. Sheridan addresses each activity in a conceptual framework, where each function is related to and is dependent upon another. The four supervisory activities of human-centered automation are: Planning, Deciding, Monitoring, and Intervening.

Each supervisory activity is represented across the automation problems shown in figure 2. The first two activities, Planning and Deciding, deal with the abilities of the crews to understand the performance characteristics of the navigation systems and how to program them to achieve specified mission goals. Not surprisingly, these behaviors are manifested within the majority of automation incident problems; i.e., approximately 62 percent of the problems reported were directly attributed to the programming (24 percent, Misprogramming; 19 percent, Distraction due to Programming) and overall mismanagement (19 percent, Mismanagement/Confusion) of the navigation systems.

The third supervisory activity, Monitoring, is the ability of the crew to attend to the automation systems, and to derive information about the current state of the aircraft. Although not uniquely addressed in figure 2, each automation problem contained incidents where the crews exhibited monitoring deficiencies.

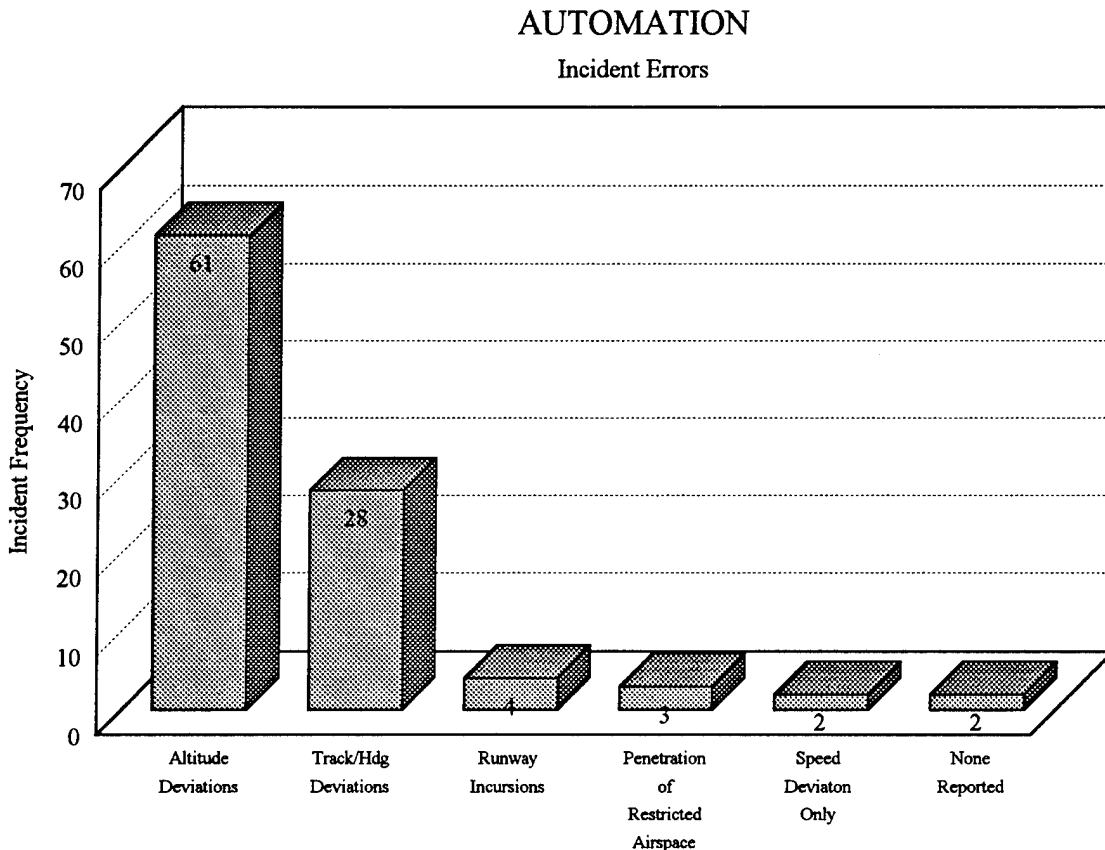
FIGURE 3. INCIDENT ERRORS

This section will describe incident errors which are the byproducts of the automation problems discussed in section 5.2.2. Examples of incident errors are altitude, heading, and speed deviations. The classification of incident errors are provided in figure 3.

The majority (89 percent) of incident errors were a result of an altitude or track deviation. Recognizing that automation systems are designed to maintain controlled flight, the propensity for these types of errors is not difficult to infer. The real question is: What circumstances, under controlled flight, are causing these deviations?

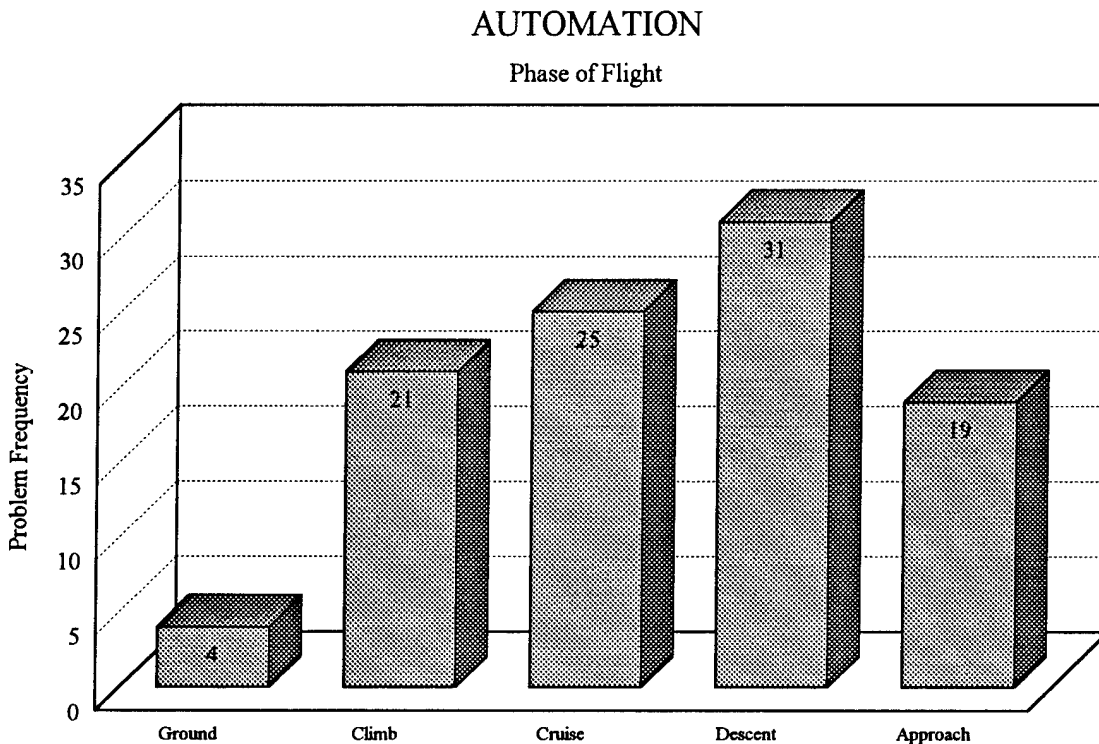
FIGURE 4. PHASE OF FLIGHT

With regards to figure 4, the cruise portion of flight resulted in only 25 percent of the reported incidents. It appears that more incidents (71 percent) were occurring in expected high workload conditions (climb, descent, and approach) than during expected low workload conditions (cruise).

The ability of pilots to remain vigilant throughout the flight depends on a variety of factors. For example, periods of low workload, such as those endured over long oceanic flights may contribute to a lack of vigilance. Conversely, vigilance may also decrease in periods of extreme workload conditions. To help visualize this, two figures were created and are provided below. The first provides overall error percentages by phase of flight (figure 4), and the second (figure 5), reveals the types of automation problems occurring during each phase.

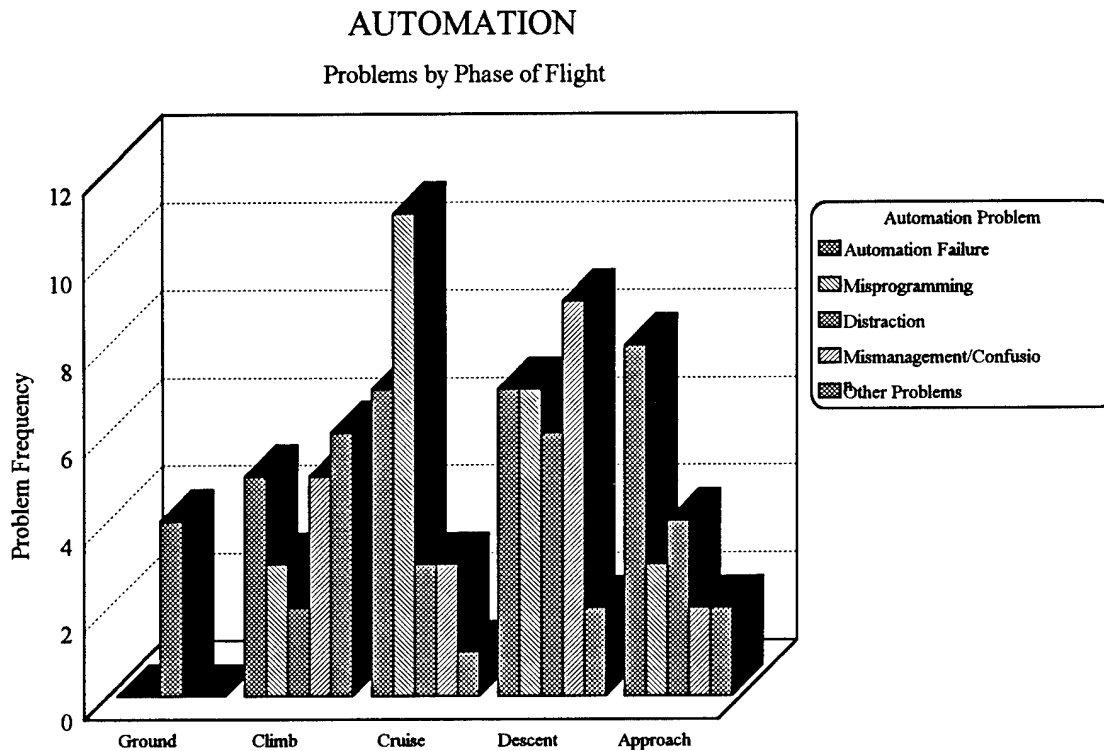
FIGURE 5. PROBLEMS BY PHASE OF FLIGHT

Moreover, almost half of the reported incidents during cruise flight were due to misprogramming of the FMS on the ground (see figure 5, the high peak). The crews were not aware (lack of monitoring?) of the programming error until later in cruise flight. What makes it even more interesting is that the crews were sometimes informed by air traffic control (ATC); almost always resulting in a gross navigational error.

During the descent and approach phase, the crews are working the radios, receiving last minute updates on arrival runways, Automated Terminal Information Service (ATIS), etc., in addition to monitoring the flight management system. It could be quite easy for the crews to ignore the automation in order to attend to other flight duties. However, as reported by the pilots themselves, excessive workload demands were only found in 6 percent of the reports (see section 5.3.6, Further Automation Issues). The factors most responsible for errors occurring in the post-cruise regime were: automation failure (28 percent); mismanagement, confusion (22 percent); misprogramming (20 percent) and distraction due to programming (18 percent).
