NASA
Reference
Publication
1161

Evaluation of Multilayer Printed Wiring Boards by Metallographic Techniques

*An Illustrated Guide to the
Preparation and Inspection
of Plated-Through Hole
Test Coupons Based on the
Requirements of MIL-P-55110D*

Jane Jellison

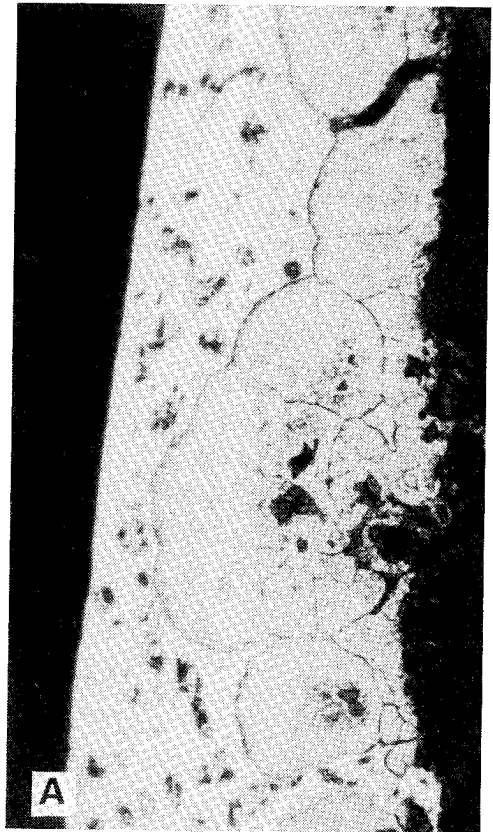
Figure 9. Examples of plating nodules in barrel plating.

- A. NODULES ASSOCIATED WITH BRITTLE PLATING PROBABLY RESULT FROM PLATING BATH COMPOSITION PROBLEMS. THE NODULES WOULD BE ACCEPTABLE; THE CRACKS ARE NOT. ETCHED, 500X.
- B. NODULES IN ONE PLATING LAYER ON ONE SIDE OF THE BOARD MAY RESULT FROM IMPROPER POSITIONING OF ELECTRODES DURING PLATING. ETCHED, 50 X.
- C. HIGHER MAGNIFICATION VIEW OF HOLE ILLUSTRATED IN B. ETCHED, 175 X.

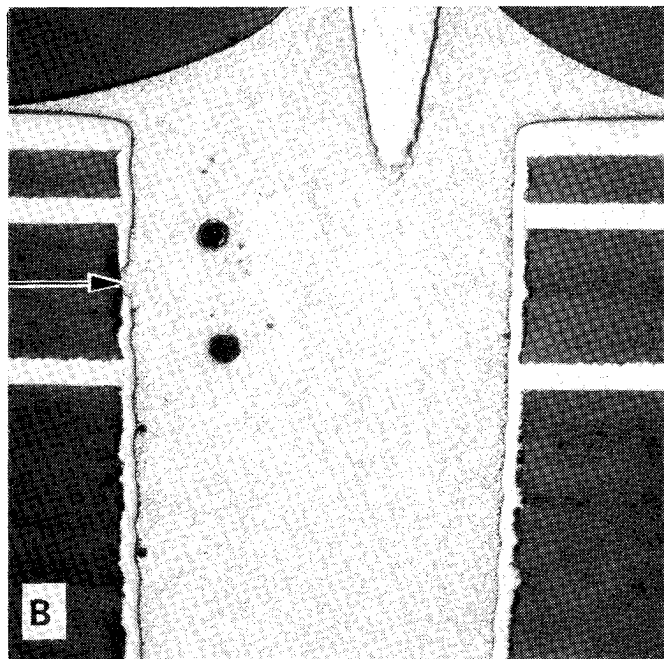
A. PLATING VOIDS IN THE SAME PLANE (a-a) ARE FORBIDDEN. NOTE ALSO SEPARATIONS (b) AND PLATING NODULES (c). UNETCHED, 80X.

B. ISOLATED PLATING VOIDS (ARROW) ARE ACCEPTABLE IF NO MORE THAN THREE PRESENT IN ONE HOLE. UNETCHED, 50X.

C. PLATING VOID RESULTING FROM NON-BRIDGING OF DELAMINATION. SOLDER HAS WICKED INTO DELAMINATION DURING REFLOW. ETCHED, 200X.

Figure 18. Examples of plating voids. The coupon illustrated in A should be rejected for plating voids and separations; that in B is acceptable for plating voids but has rejectable separations; C is rejectable for delaminations.

Plating voids on both sides of a hole, Figure 18a, imply potential circumferential separation, with consequent open circuits. Isolated voids, Figure 18b, probably represent round, localized gas bubbles, and are permitted if they meet the criteria listed above. Some plating voids reflect problems with the laminate and not with the actual plating process itself. The delamination at the innerplane/laminate interface illustrated in Figure 18c has caused a discontinuity, probably circumferential, in the barrel plating. The cause for rejection of this coupon might be listed as plating voids in the same plane or at a conductor interface, but corrective action should be directed toward the lamination process.

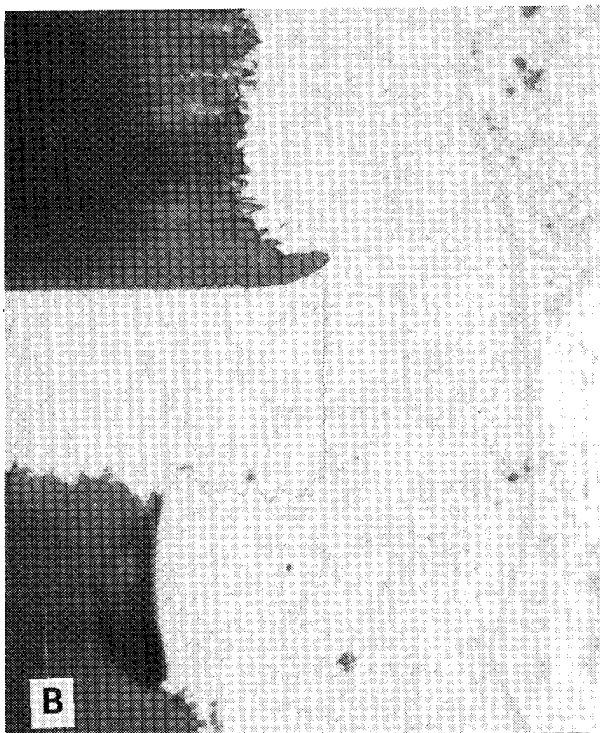
A. ETCHBACK EFFECTIVE ON BOTH SIDES OF INTERNAL CONDUCTOR. ETCHED, 400X.

B. ETCHBACK EFFECTIVE ON ONE SIDE. ETCHED, 400X.

C. SHADOWING ON BOTH SIDES. ETCHED, 200X.

Figure 20. Etchback should be effective on at least one side of each internal conductor.

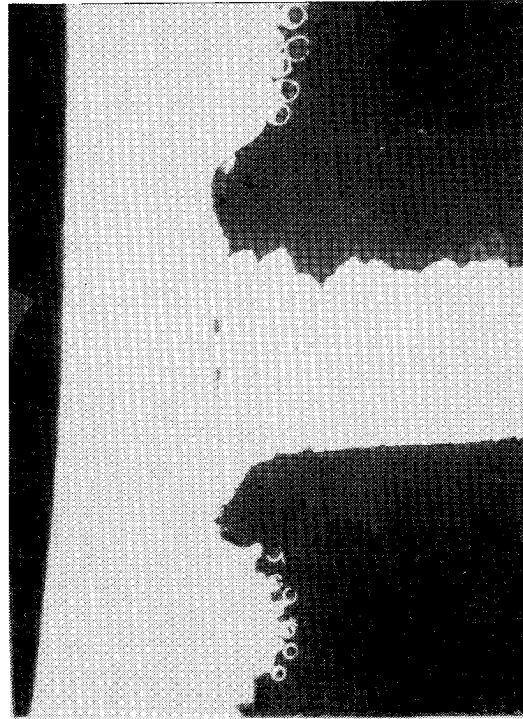
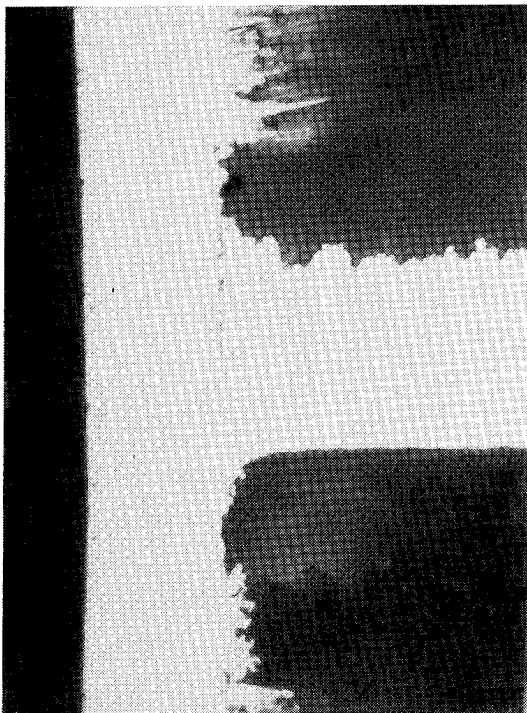
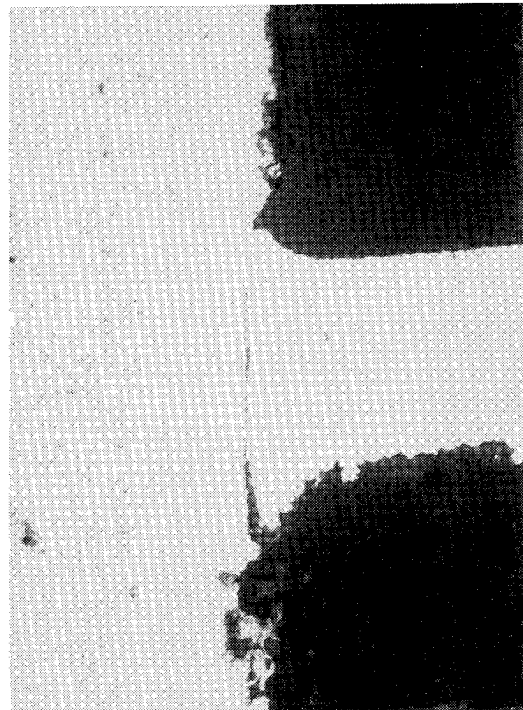
GOOD: NO VISIBLE DEFECTS

MARGINAL (?) ~ 10% DEFECTIVE

MODERATELY SEVERE: 10 – 50% DEFECTIVE

SEVERE: > 50% DEFECTIVE

Figure 36. Examples of defect levels at barrel/innerplane junctions. All unetched, at 400X.

The "fine line" defect is characterized by the presence of a narrow faint line which extends across the full thickness of the foil. Defects associated with resin smear are not necessarily continuous, and often manifest themselves as dark spots or discontinuous lines at the barrel plating/innerplane junctions. Figure 36 illustrates four such defects affecting from virtually none to almost all of the junction, with the first one clearly acceptable, the last two clearly rejectable, and the second one perhaps open for debate. Just about every intermediate condition has been seen. It becomes a matter of judgement which coupons to accept and which to reject. For example, the junction shown in Figure 37 has a few isolated spots of contamination which are plainly seen in the unetched condition, but most of the junction is sound. In contrast, the junction illustrated in Figure 38 has a linear defect (in this case caused by epoxy smear) extending more than halfway across the junction. A small, rounded defect is considered less likely to propagate into an actual separation than is a linear flaw—much as minor porosity in a weld is not as severe a defect as is a crack. For non-linear defects, it comes down to a matter of whether the remaining cross-sectional area of the joint is sufficient to withstand the applied stress expected in service. The hole containing the junction shown in Figure 37 may be considered acceptable if that is the worst defect that it contains, while the hole shown in Figure 38 should be rejected.
