MEASUREMENT OF POLYETHYLENE PIPE PARAMETERS DURING AN OCEAN DEPLOYMENT

Final Report

November 15, 1978

General Electric Company  
Re-entry & Environmental Systems Division  
Philadelphia, Pennsylvania

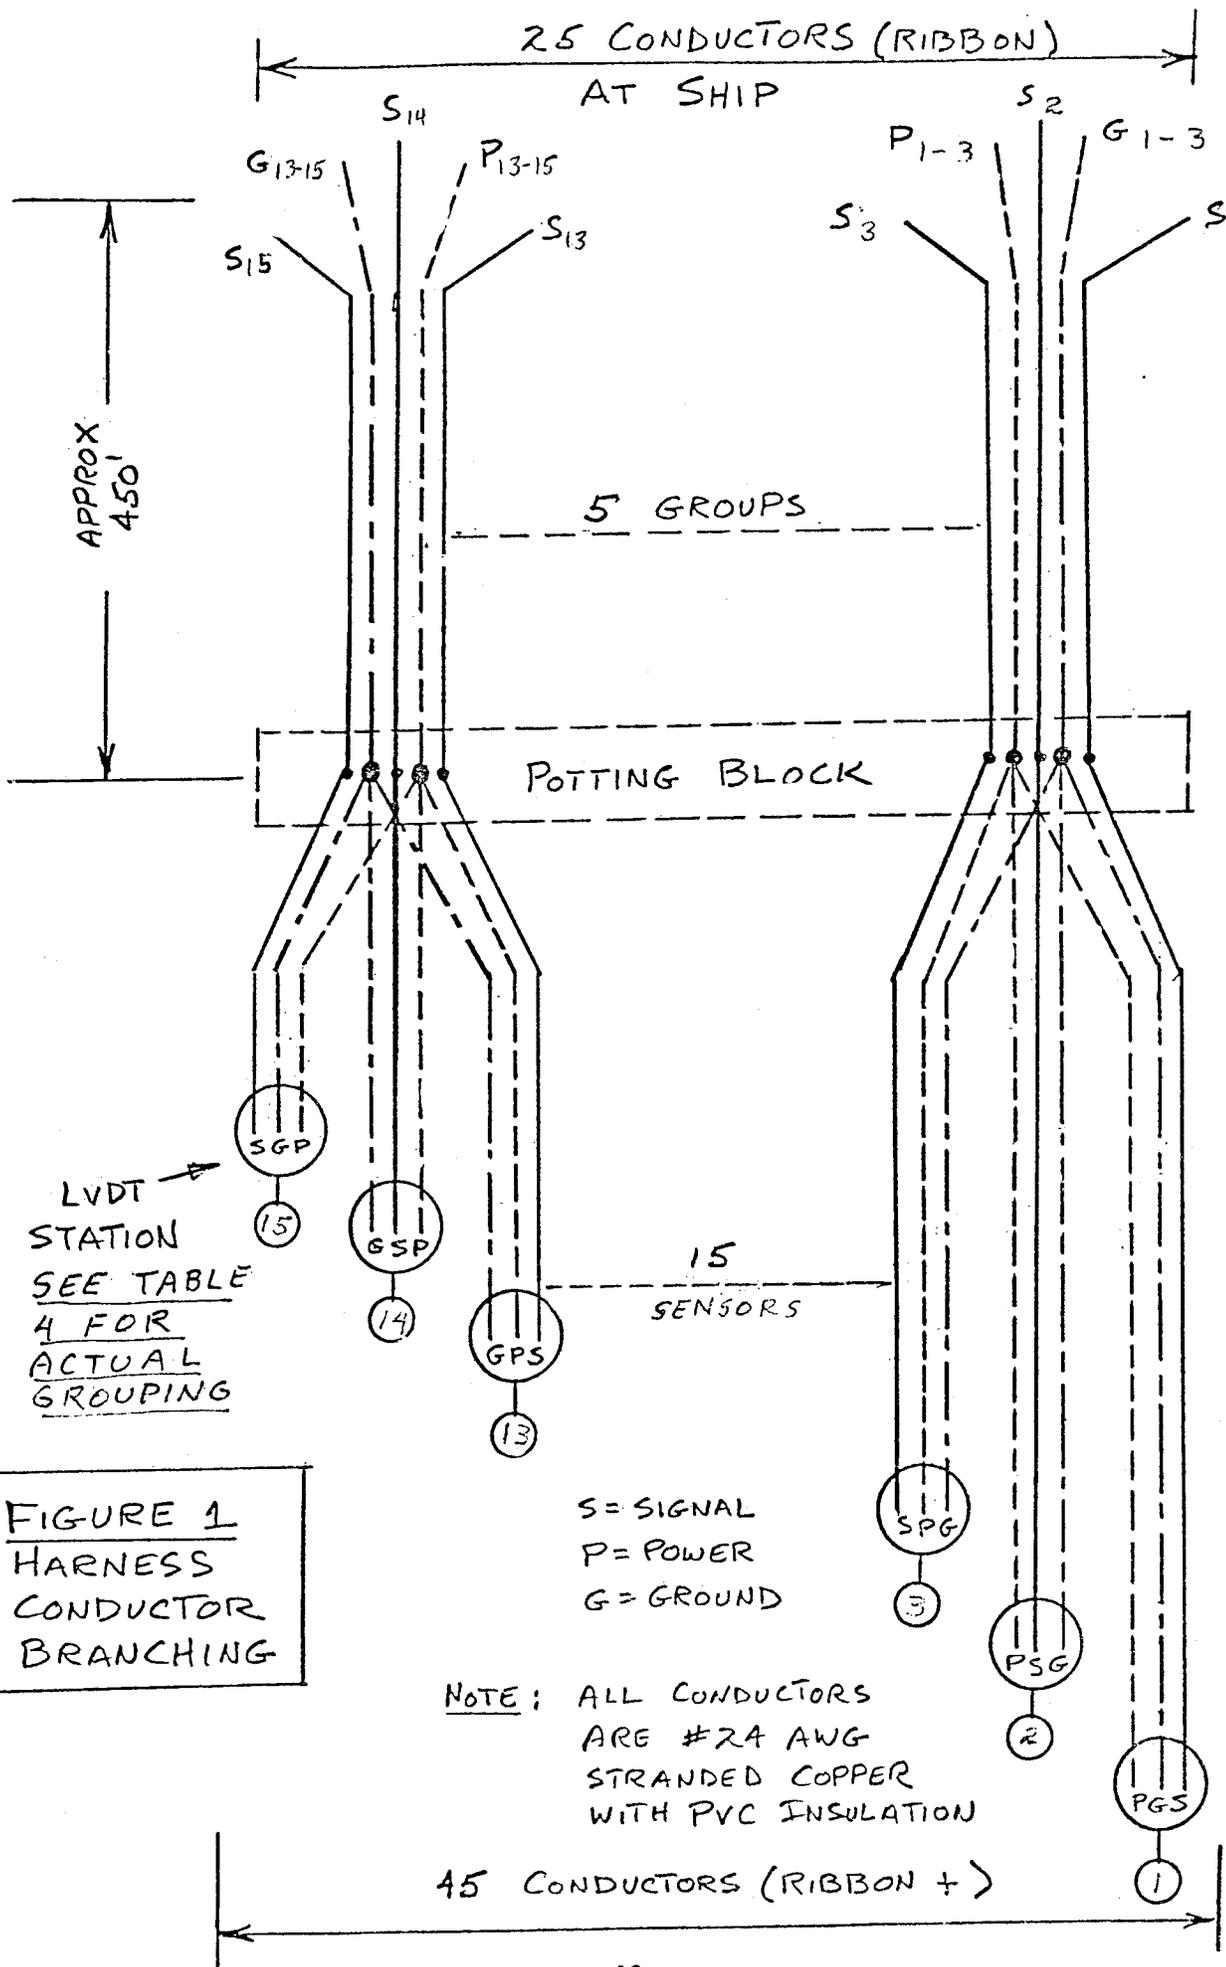
**FIGURE 1**  
**HARNES**  
**CONDUCTOR**  
**BRANCHING**

S = SIGNAL  
 P = POWER  
 G = GROUND

**NOTE:** ALL CONDUCTORS  
 ARE #24 AWG  
 STRANDED COPPER  
 WITH PVC INSULATION

at each desired sensor location. This provided a harness for eight sensors, all with independent leads. The 22 conductor end of the stripped off "scrap", i.e., that end which had been near the bottom, was then reversed and aligned with the 25 conductor (upper) end of the eight sensor harness. This piece of cable was cut and stripped to provide another independent harness for the remaining seven sensors. The upper 450 ft. piece of 25 conductor cable and the two harnesses were wired together in such a way that each power and ground lead in the upper cable supplied three sensors, i.e., 3 signals, 1 common power, 1 common ground, while all sensor leads were still independent in the lower harnesses. The joint area was potted into a urethane block which could be mechanically fixed to the pipe. This arrangement is shown schematically in Figure 1. In this way, maximum use was made of the available cable, and the number of solder joints was reduced to a minimum.

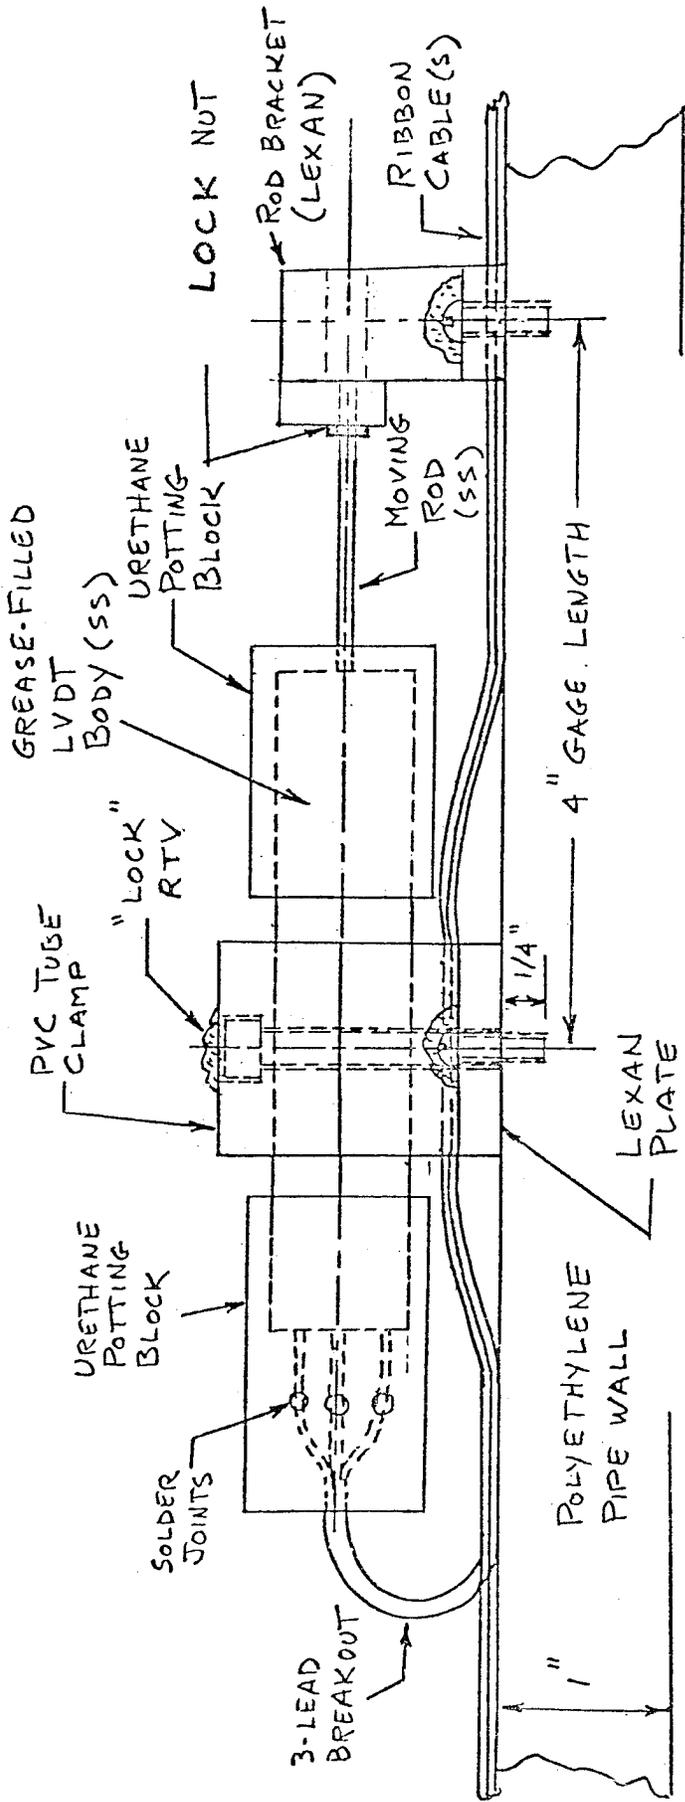
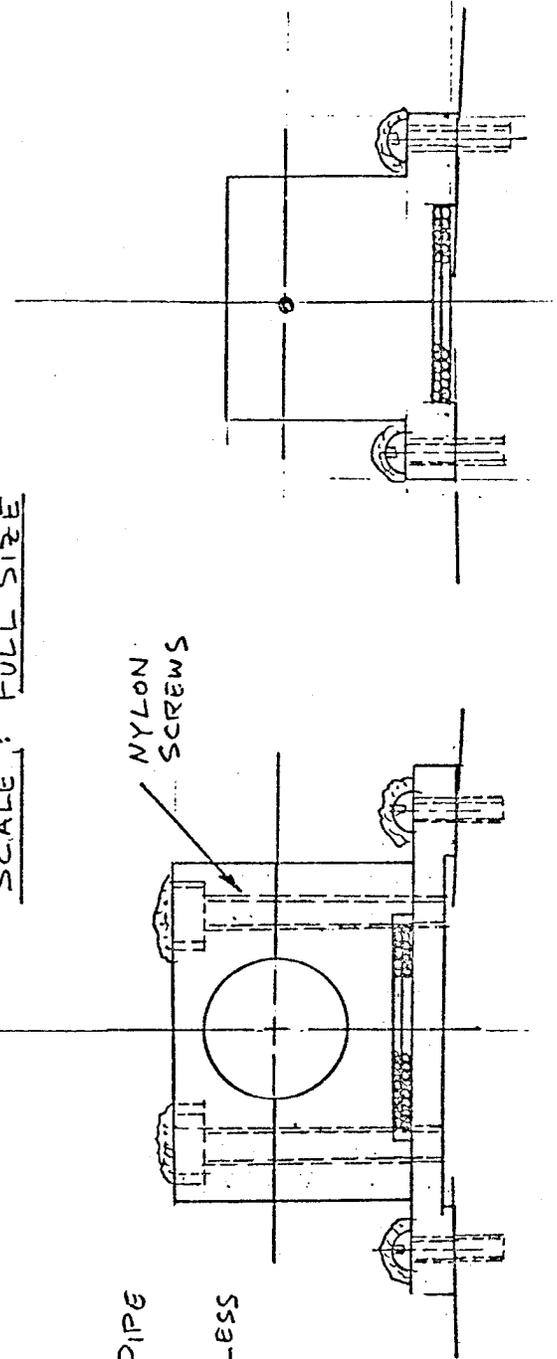
FIGURE 2- TYPICAL LVDT INSTALLATION

SCALE: FULL SIZE

ATTACHMENT TO PIPE  
WITH 4 #8  
SELF-TAP STAINLESS  
STEEL SCREWS

MYLON  
SCREWS

A full description can be found in Attachment 1. The four sensor leads were cut short, stripped, and soldered to the applicable harness leads. The sensor power ground lead and signal ground lead were commoned at this point. The sensors were then clamped to the harness by the mounting clamp as shown in Figure 2. The solder joints and harness wires were then potted to the sensor body (see Figure 2). The opposite end of the sensor body was also potted to preclude the possibility of sea water seeping between the sensor shell and coil spool. As the sensors were attached to each harness, they were identified 1 thru 15 with sensors 15 at the intended top of the array and 1 at the bottom.

Figure 2 illustrates the installation details of the LVDT sensor unit. To accomplish the installation, a drill jig was used to provide alignment and location of the four mounting screws. The LVDT body was mounted first. Then the core was screwed into its mounting bracket and the assembly was slid into position and fastened to the pipe. Both LVDT body and core mounting brackets were attached with self tapping screws in blind holes.

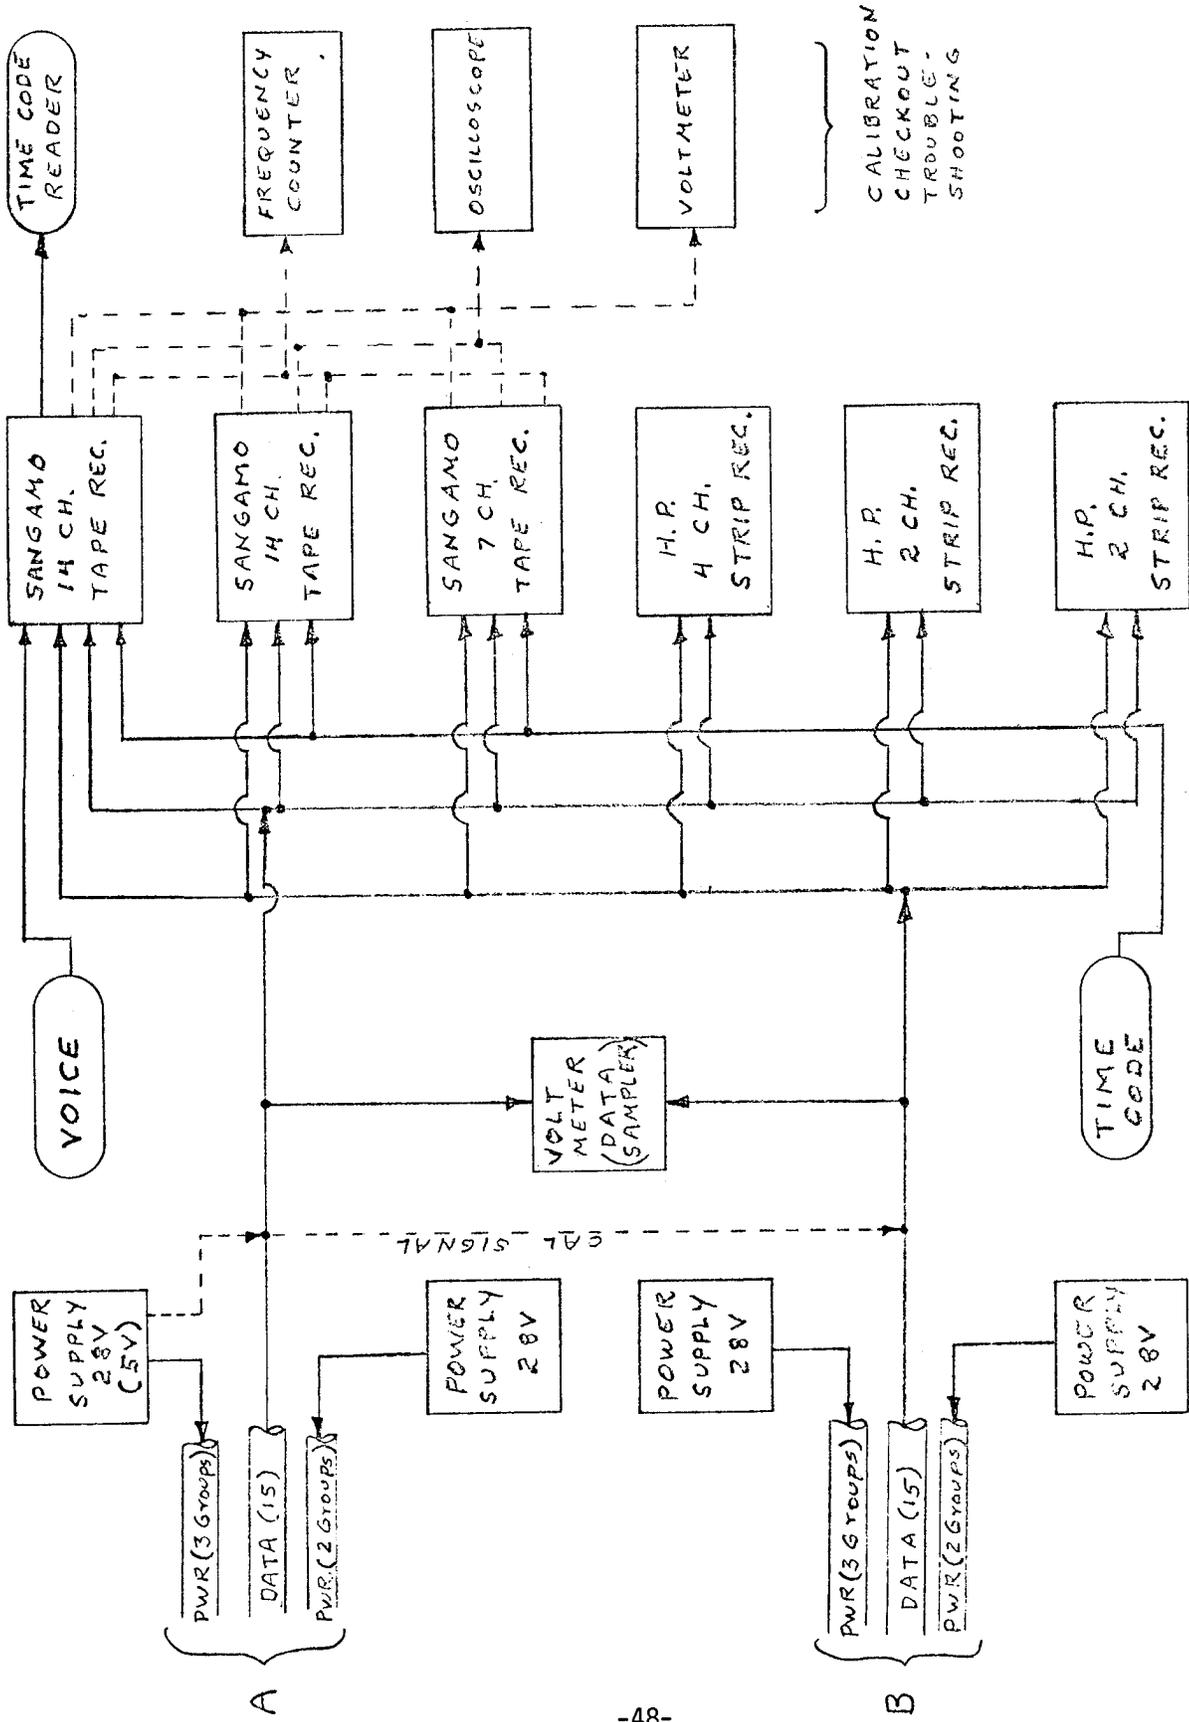
FIGURE 3 - SHIPBOARD DATA SYSTEM

A block diagram of the data recording system installed aboard the "Trojan" is shown in Figure 3. Recorders 1, 2, and 3 were 14 channel tape recorders. Recorder 3, as used, had only seven channel capability in the main frame. The other seven channels were available through an additional chassis which was not used in this operation. Voice annotation was recorded on Recorder 1 edge track, and time code was recorded on one data channel of each recorder. IRIG B time code was used. This provided a thirty-two data channel tape recording system. The three chart recorders provided eight additional channels of hard copy data for real-time viewing and evaluation.

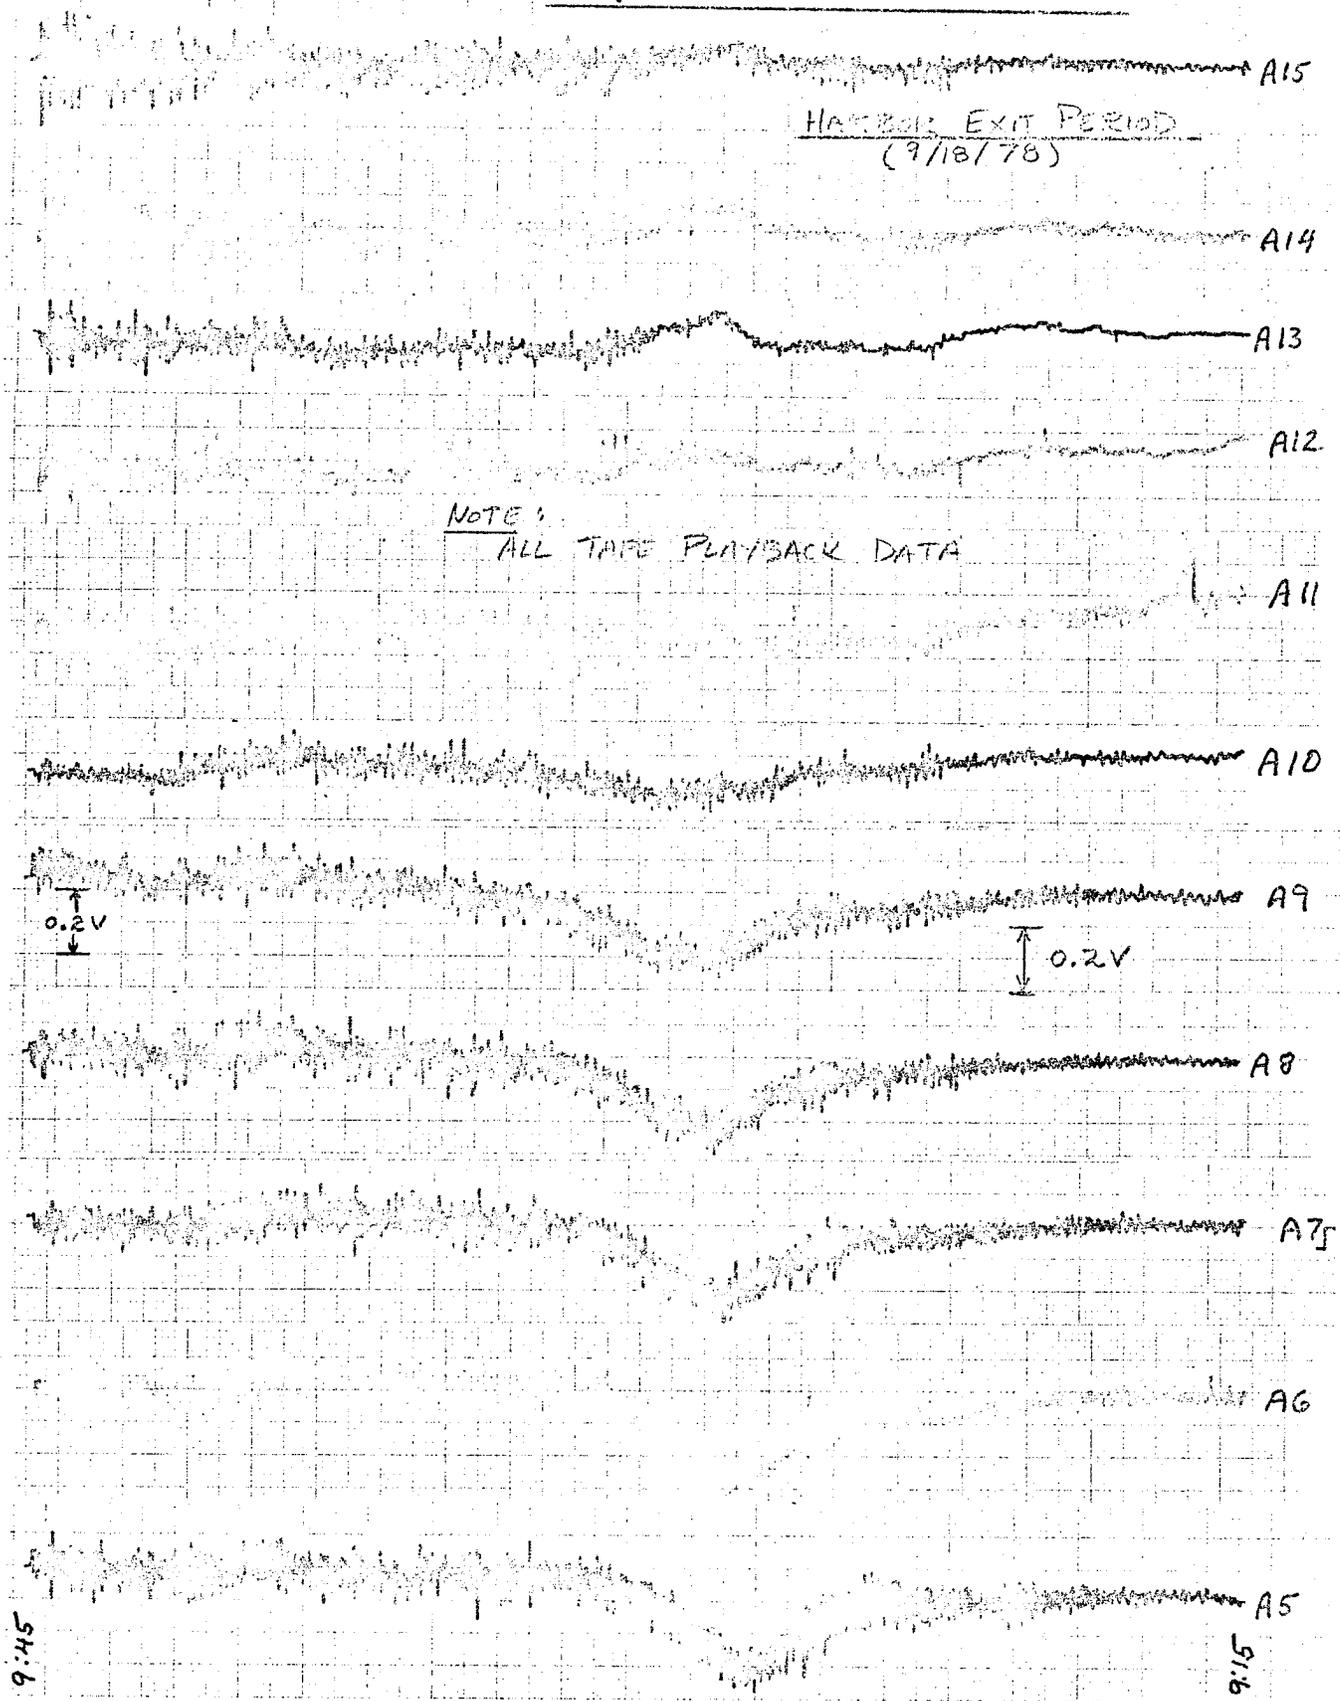
Figure 4 - LVDT OUTPUTS

The data illustrated in Figure 4 were taken from tape 1-1 for the time period the pipe was rounding the sea wall. The strains due to bending the pipe while

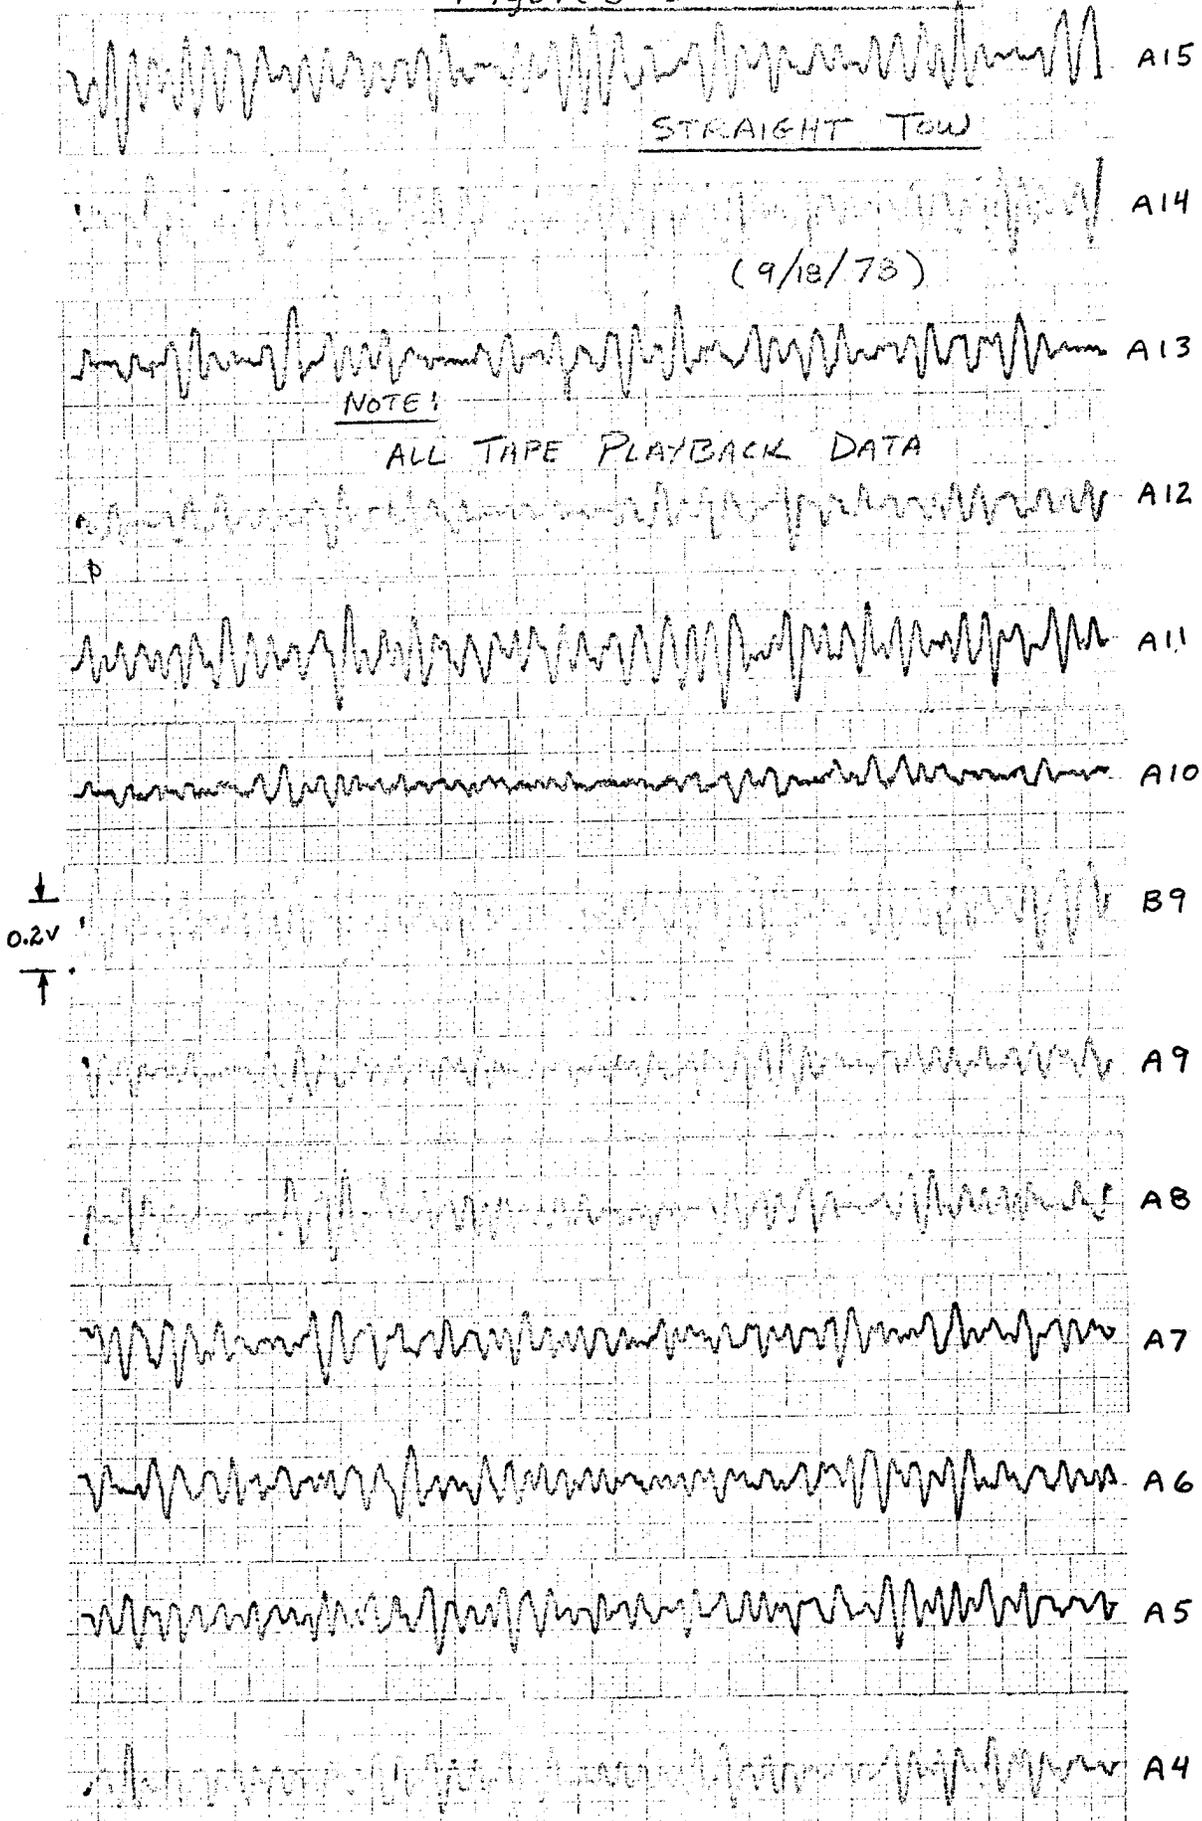
Figure 5-LVDT OUTPUTS

Figure 5 illustrates data from the end of tape 1-1 (1030 to 1033). The sensors are all working well.

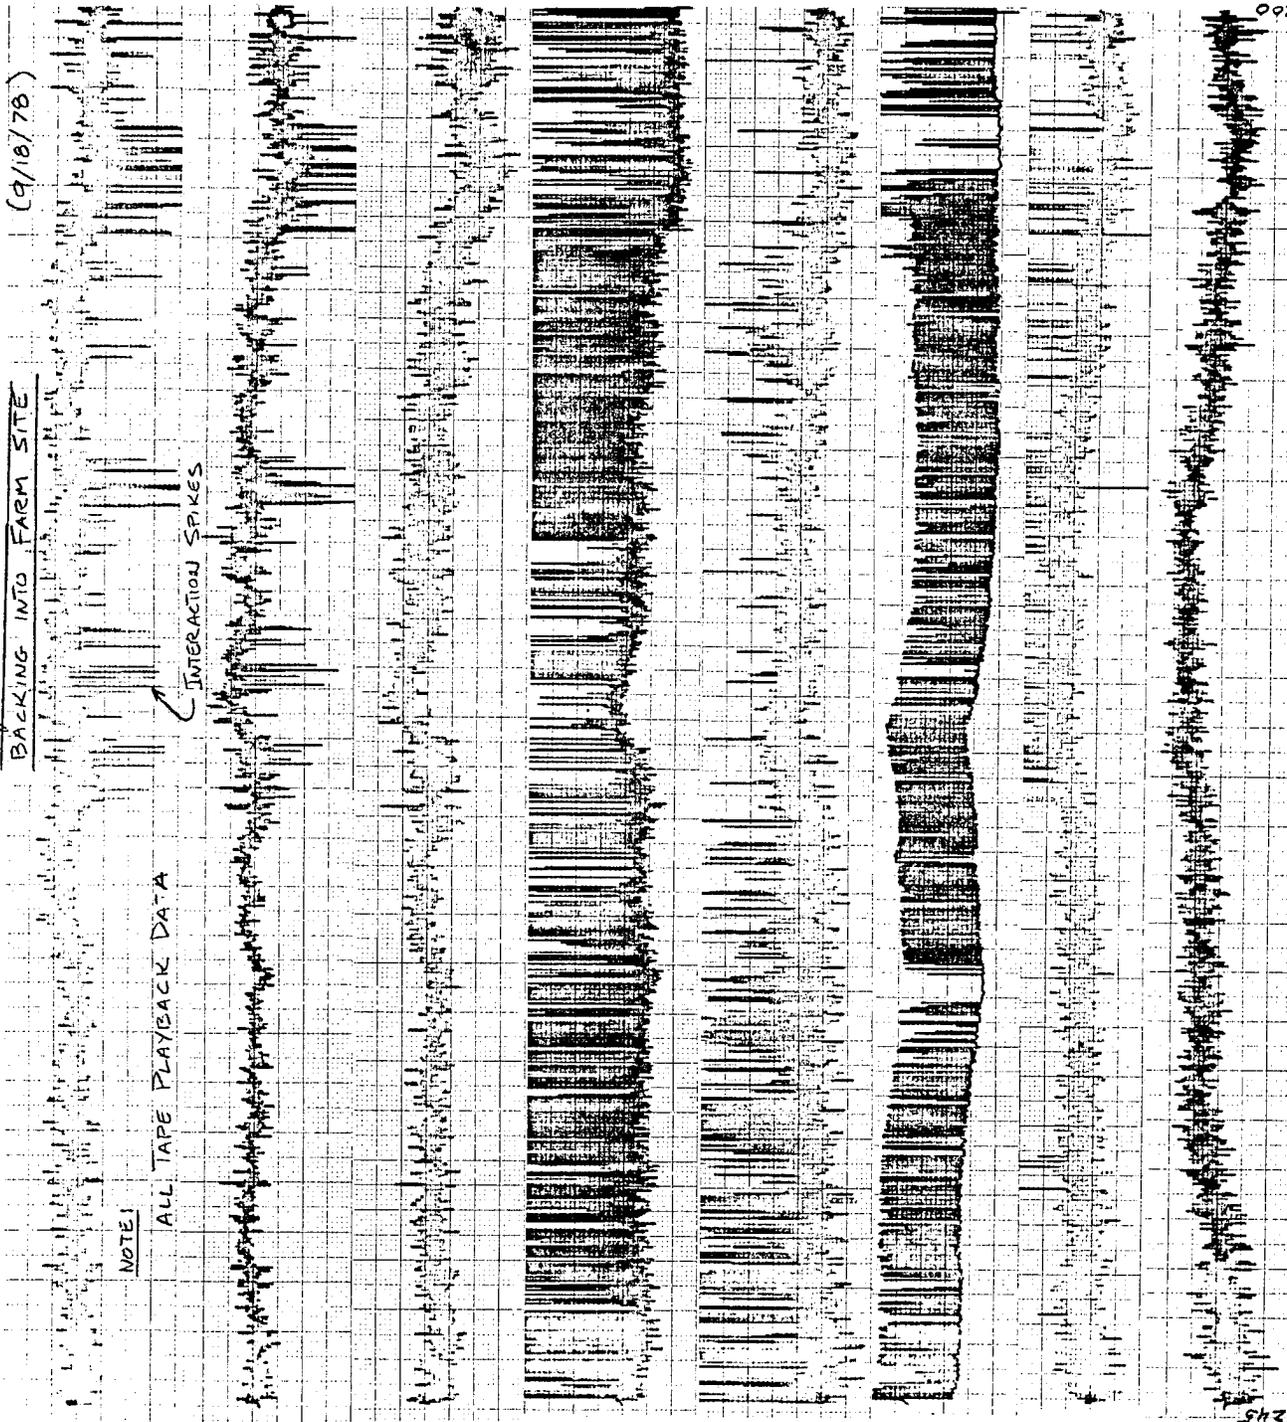
Figure 6a - LVDT OUTPUTS  
BACKING INTO FARM SITE

(9/18/78)

During this interval, some sensor malfunctions in the "A" harness began to appear. Figure 6 illustrates pipe tension, bending and wave motion as the "Trojan" backed into the farm area and moored to the machinery buoy. Noise spikes such as on the A13 and A12 traces are probably interactive power fluctuations caused by an intermittent in power supplying their stable-mate A5. A list of sensor common power groups is presented in Table 4 and should be very useful in identifying possible interactions. We have concluded that recorder problems are effecting A8, A9 and possibly A6 at this time. By the end of tape 1-2, sensor channels A1, A6, A8, and A9 had probably failed. The other sensors were either working or were recorded on tapes we could not review. No failure analysis has been conducted to define the potential causes of apparent sensor failures.

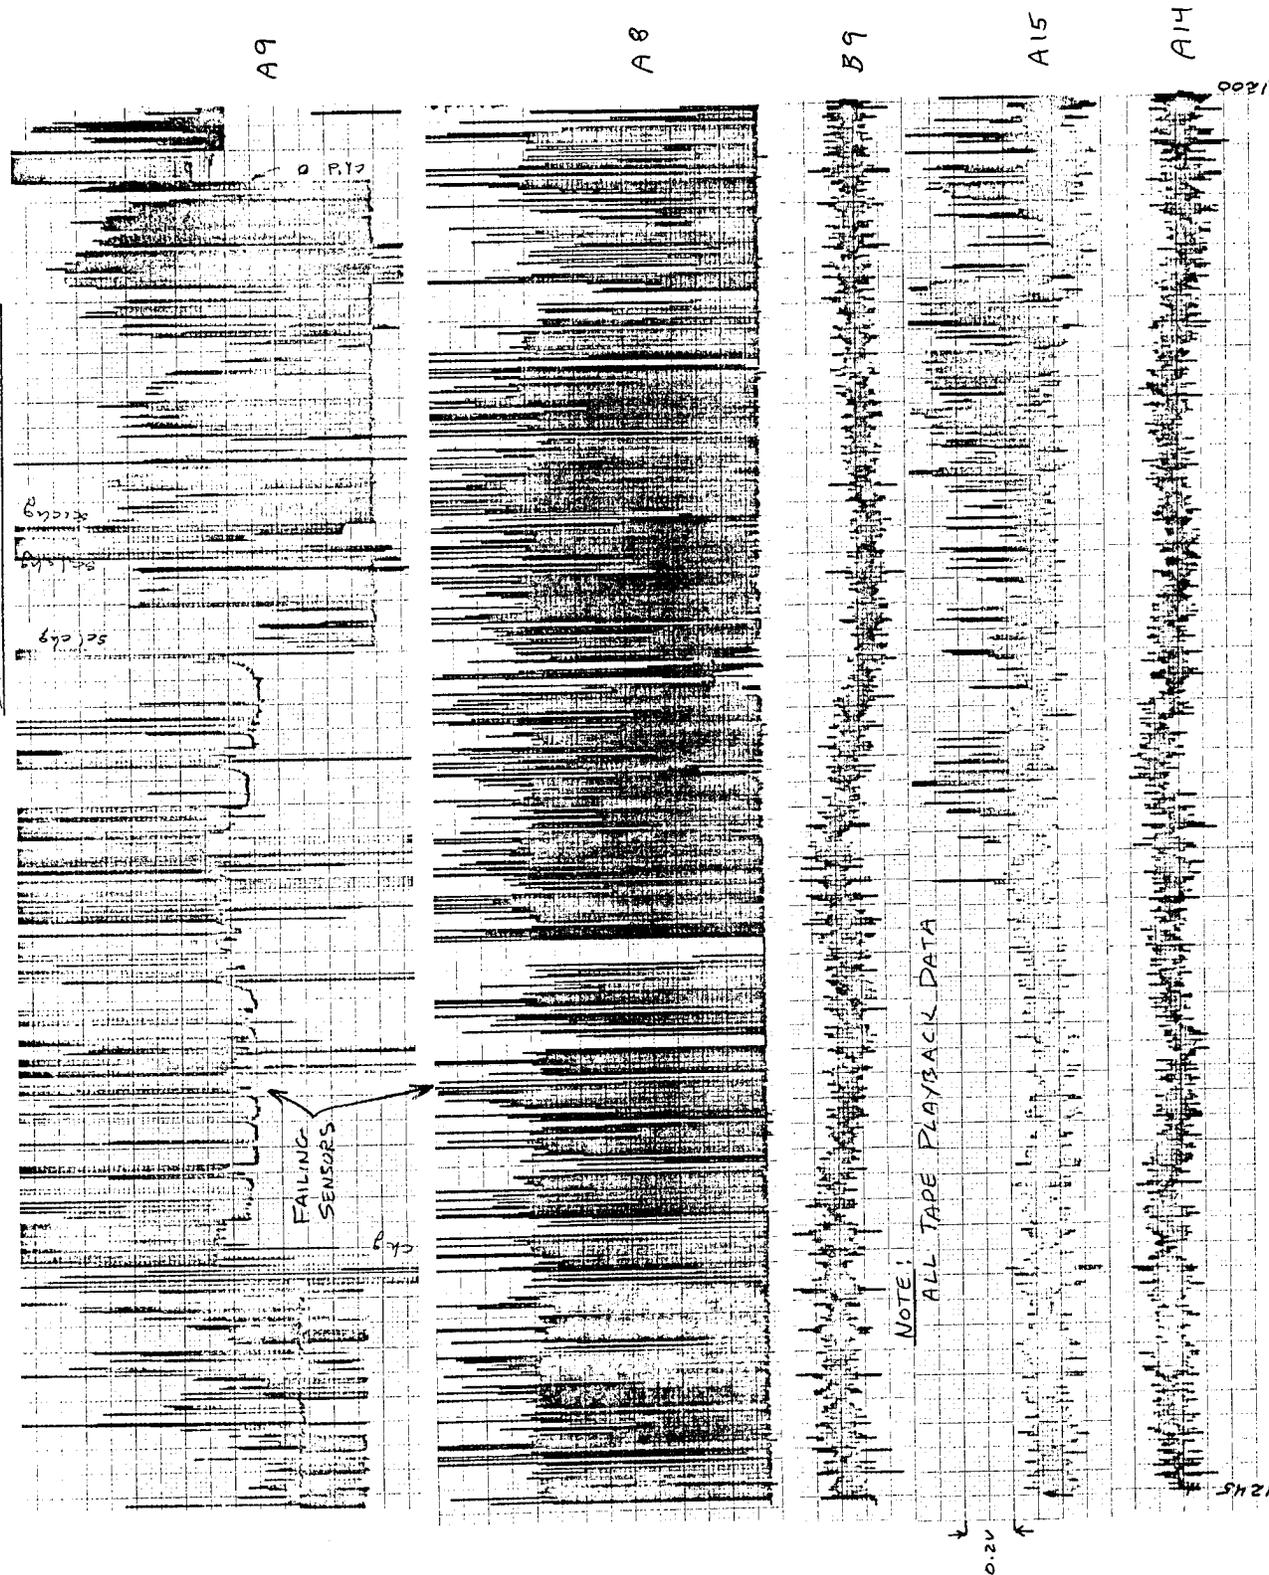
Figure 66 - LVDT OUTPUTS  
BACKING INTO FARM SITE (9/10/78)

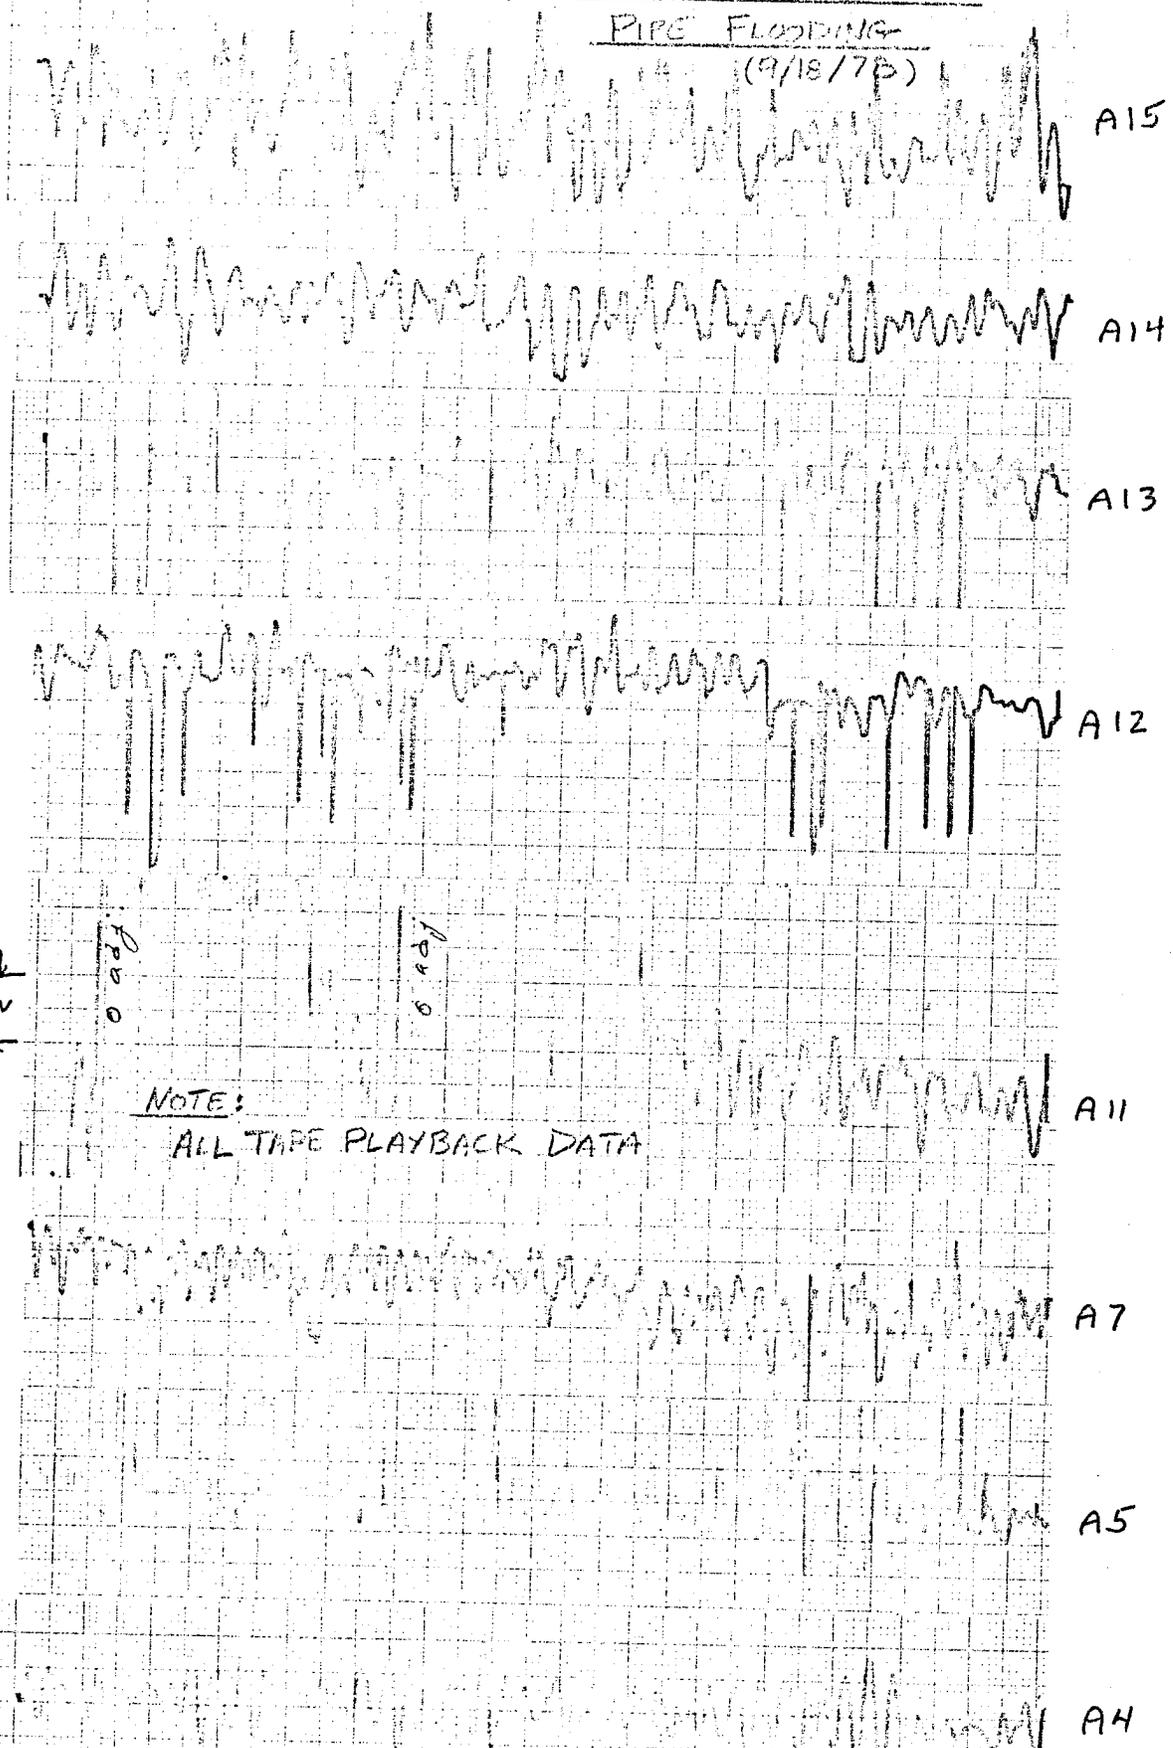
Figure 7- LVDT OUTPUTS

PIPE FLOODING

(9/18/75)

TIME CORRECTION  
20:54:06 = 15:46:00

(NOTE: INCORRECT TIME READINGS - SEE TEXT)

The time code reading at the beginning of this tape is 2050 but is erroneous. At 1546, the time code generator was reset to the correct time. The relationship is 1546 = 2054:06. Figure 7 illustrates a data sample at the beginning

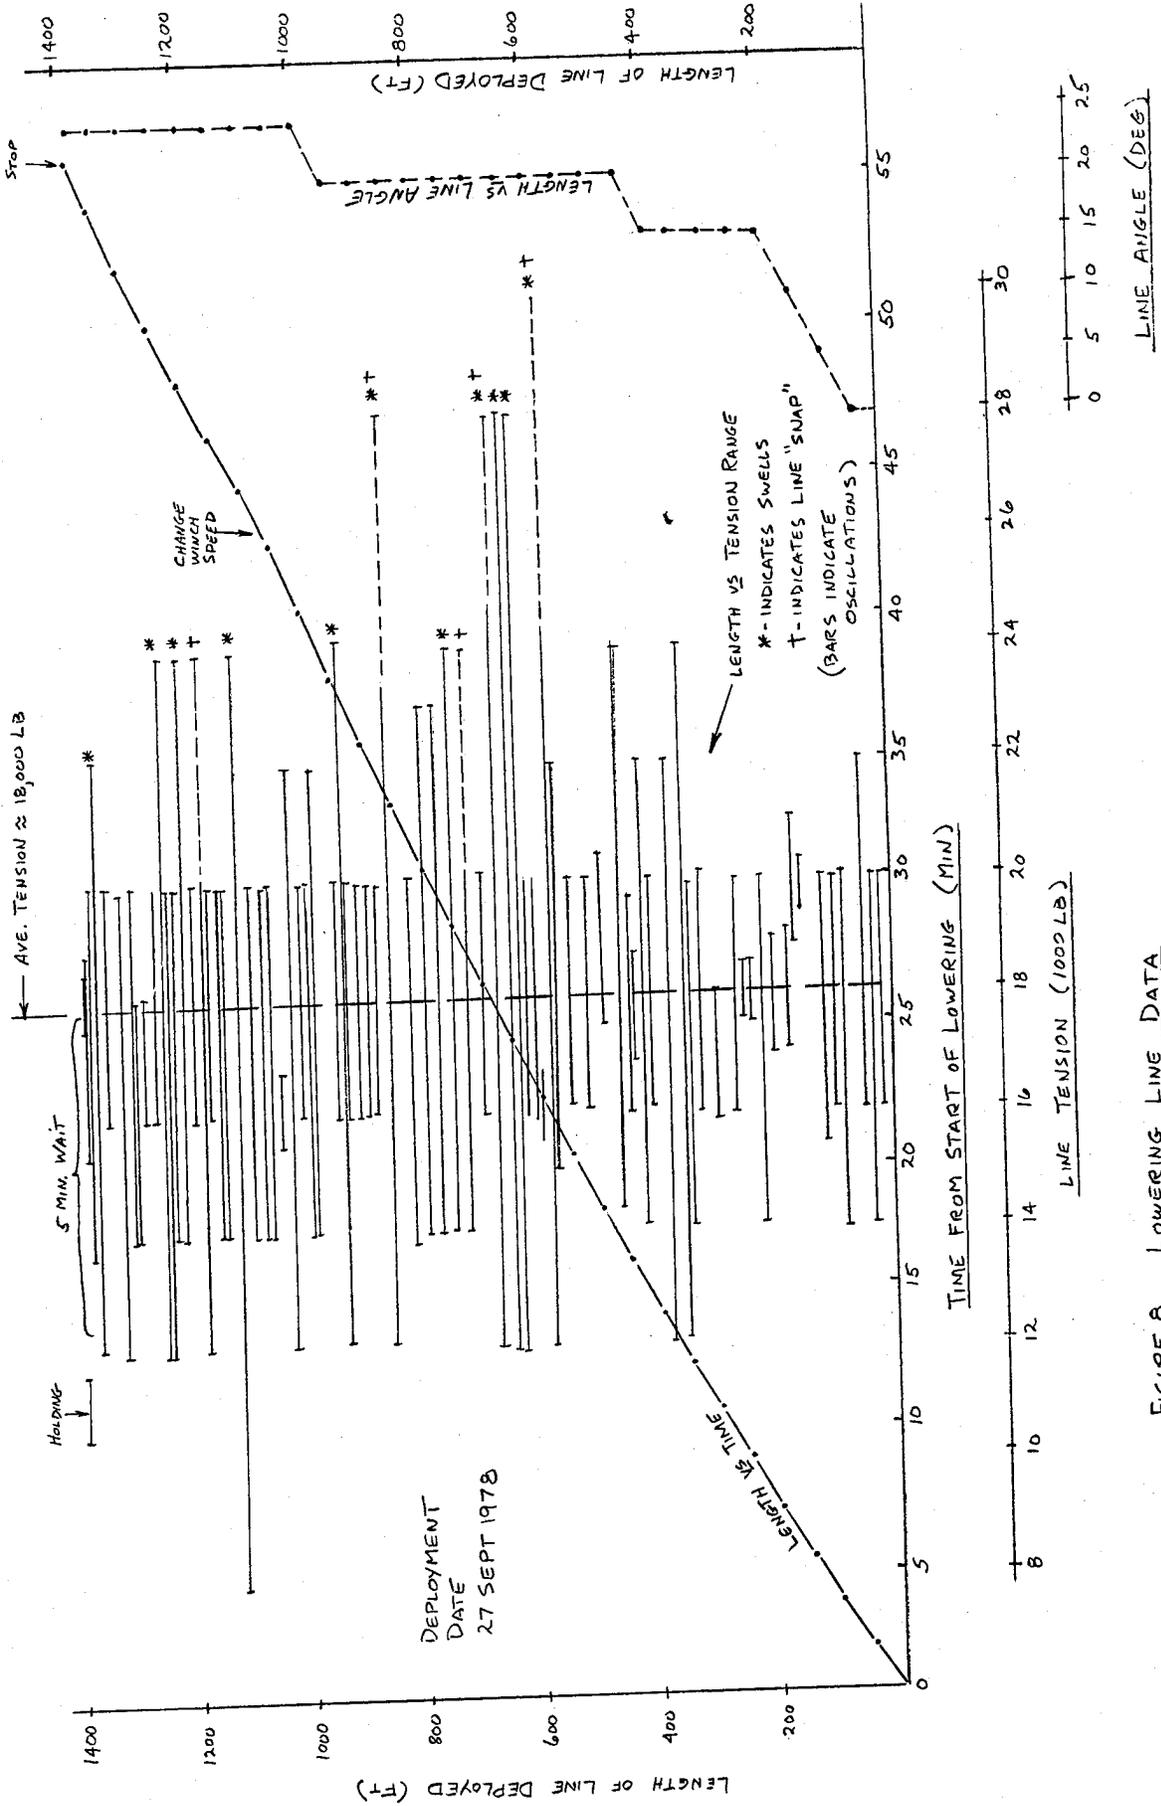
FIGURE 8 LOWERING LINE DATA

are presented in the chart of Figure 8 which shows tension, line angle, and time from start of lowering as functions of length of line deployed. It is seen that the average values of tension held at around 17,000-18,000 lbs. during most of the one-hour lowering operation. Variations were generally on the order of  $\pm 2,000$  lbs. with a few larger variations of up to  $\pm 10,000$  lbs. observed with passage of unusually large swells or with "jumping" or slipping of individual cable turns on the payout drum. Fluctuation periods of two seconds were "typical". The transient tension excursions observed had no detectable effect on the overall smoothness of the lowering operation. The final "holding" tension at the end of the payout, prior to cutting the lowering line to complete the upending operation, was 11,000  $\pm 500$  lbs. Line angles ( $0^\circ$  referenced to vertical) during the operation varied from  $0^\circ$  at the initial lowering, to a maximum value of  $25^\circ$ . The line angle rapidly reached  $15^\circ - 20^\circ$  shortly after the start of the operation. There appears to be no clear correlation between tension and line angle but it could easily be masked by the transients in the tension data.

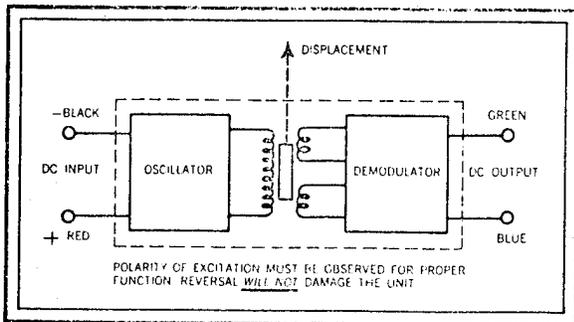
CIRCUIT DIAGRAM

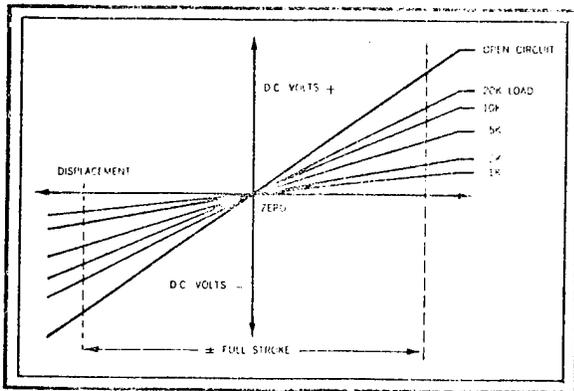
DISPLACEMENT VS. OUTPUT DIAGRAM

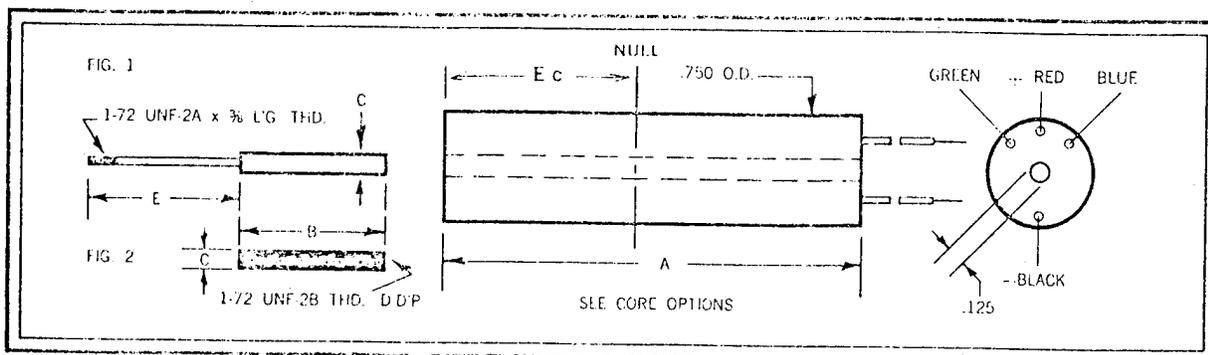
DIMENSIONAL DIAGRAM
