NRL REPORT NO. R-3239

# FLIGHT TESTS OF A GROUND SPEED INDICATOR OVER MEASURED RUNS

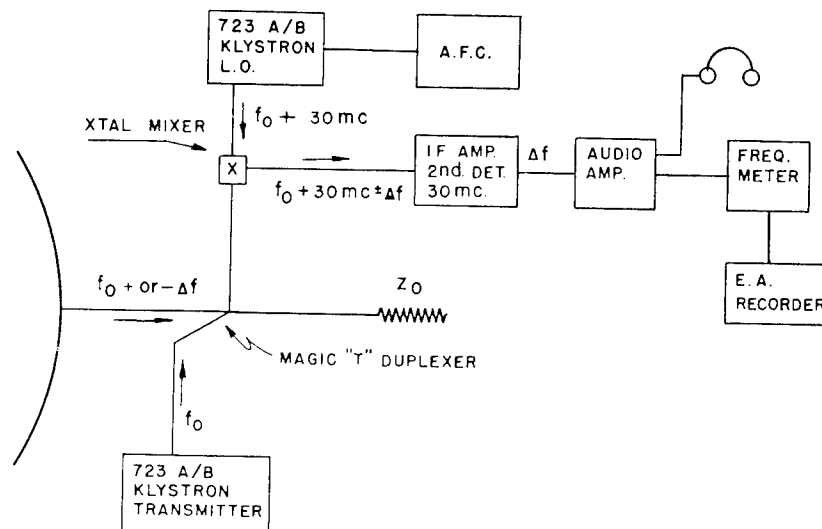
transmitter and local oscillator tubes are 723 A/B klystrons. The receiver incorporates a 30-megacycle intermediate-frequency strip followed by a diode detector and audio amplifiers. In order to suppress low-frequency microphonic noise, a low-pass filter having a cut-off frequency of 1000 cycles per second was employed. The over-all audio-frequency response curve is flat within 1 db over the useful range from 1000 to 2000 cycles per second, but drops off sharply on either side of this range. The radar system has been tested for performance and has been found to compare favorably with standard pulse radars when the differences in power output, antenna gain, etc., are taken into consideration. Figure 1 is a block diagram of the system.

Fig. 1 - Block Diagram of Equipment
