**WL-TR-97-4054**

**PROCEEDINGS OF THE 1996 USAF  
AIRCRAFT STRUCTURAL INTEGRITY  
PROGRAM CONFERENCE**

**USAF Aircraft Structural Integrity Program Conference  
Hyatt Regency San Antonio  
San Antonio, Texas**

**FINAL REPORT FOR PERIOD 3-5 DECEMBER 1996**

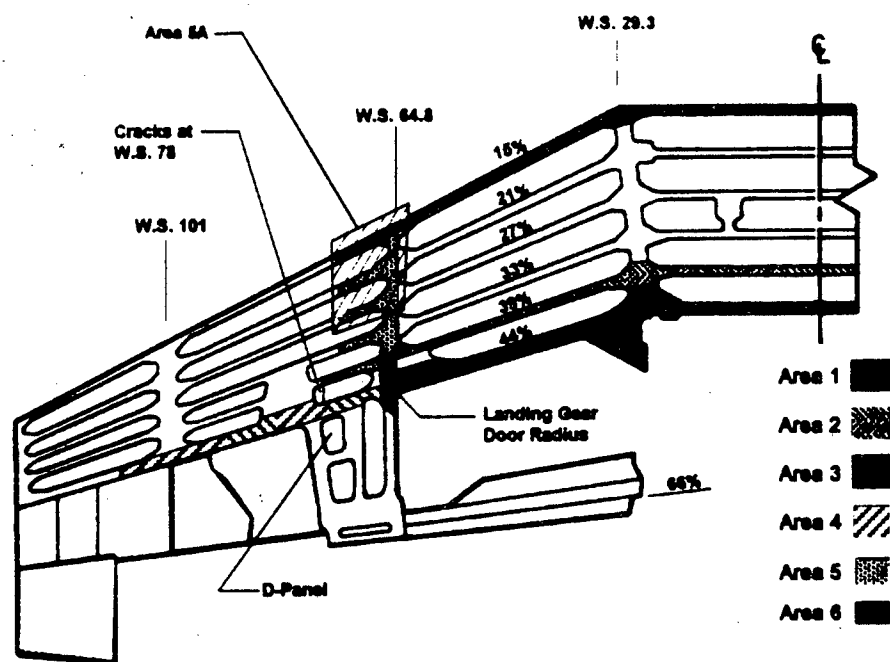
**Figure 1. T.O. 1T-38A-6 Inspection Areas**

During the conduct of the wing durability test, certain wing fastener holes were periodically inspected by rotoSCAN and eddy-current. The holes were assigned to six inspection areas, designated per T.O. 1T-38A-6, as shown in Figure 1. Table 1 lists the number of holes in each area and the initial inspection times and recurring inspection intervals. The procedure per T.O. 1T-38A-36 was to first inspect the hole by rotoSCAN, and if an indication was found, the fastener was removed and a bolt-hole eddy-current inspection was performed. If the bolt-hole eddy-current inspection confirmed the rotoSCAN finding, the fastener hole was

As shown in Table 1, Areas 1-4 and Area 6, consisting of 550 fastener holes, had only a total of five confirmed indications found during the conduct of the test. Area 5, consisting of 160 fastener holes, had a total of 52 confirmed indications. Because of the large number of confirmed indications found in Area 5 after the second inspection at 15,000 flight hours, SA-ALC and SwRI divided Area 5 into two areas (5A and 5B) for inspection purposes. Area 5A was then subsequently inspected every 500 flight hours, and Area 5B continued to be inspected at 7,000 flight hours intervals. As indicated in Figure 1, holes in Area 3 on the 15% spar outboard of WS 64.8 were reassigned to Area 5A.

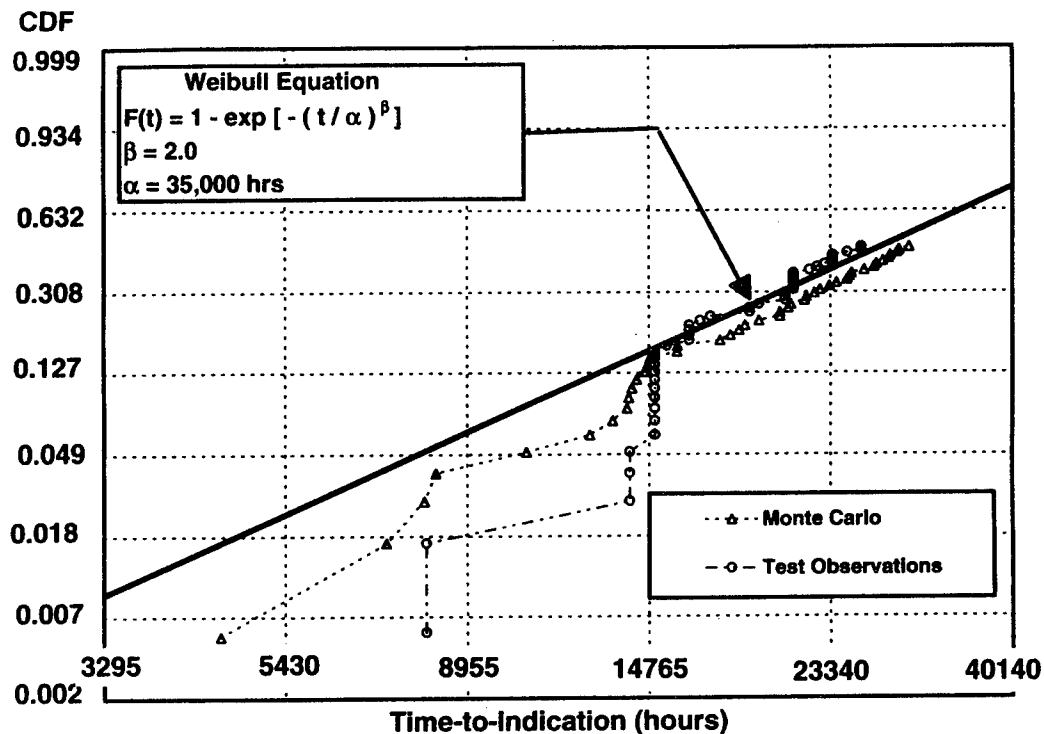
**Figure 2. Comparison of Inspection Data in Area 5A  
with 5A Monte Carlo Simulation Results**

$\beta = 2.0$  (shape parameter, slope of straight line)

$\eta = 35,000$  hours (characteristic life)

Reference 4 indicates that  $1.0 < \beta < 4.0$  implies an early wear-out and that many mechanical failure modes are in this class. The characteristic life is the life at

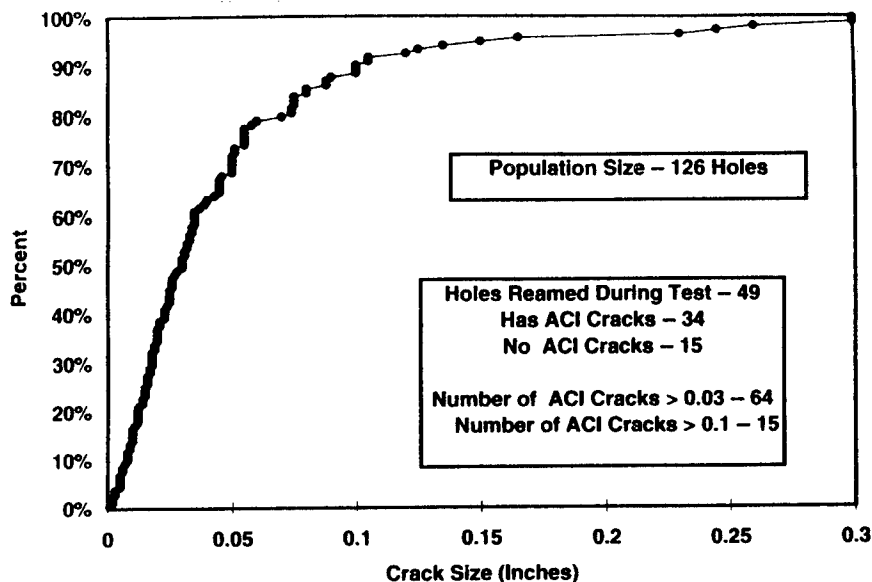
**Figure 3. ACI Crack Size Distribution — Skin Cracks  
Includes Unreamed and Reamed Holes**

To support the economic life analysis to be performed in Section 4 for the wing lower skin, an evaluation was made of the distribution of crack sizes found during the post test ACI. Figure 3 shows the distribution for 126 fastener holes in the wing lower skin. This includes 49 holes that were reamed during the test, of which 34 holes still had fatigue cracks that were found during the ACI. The crack size refers to the radial depth of the crack. If more than one crack was found at a fastener hole, the dominant crack size was taken for the analysis. Figure 3 also shows that 64 cracks had a depth greater than 0.03 inch and 15 holes had cracks greater than 0.1 inch. An analysis was also made of the crack sizes found in the 95 holes that were not reamed. The distribution is quite similar to that shown in Figure 3. Forty-six holes had cracks greater than 0.03 inch in depth, and 12 holes had cracks greater than 0.1 inch.

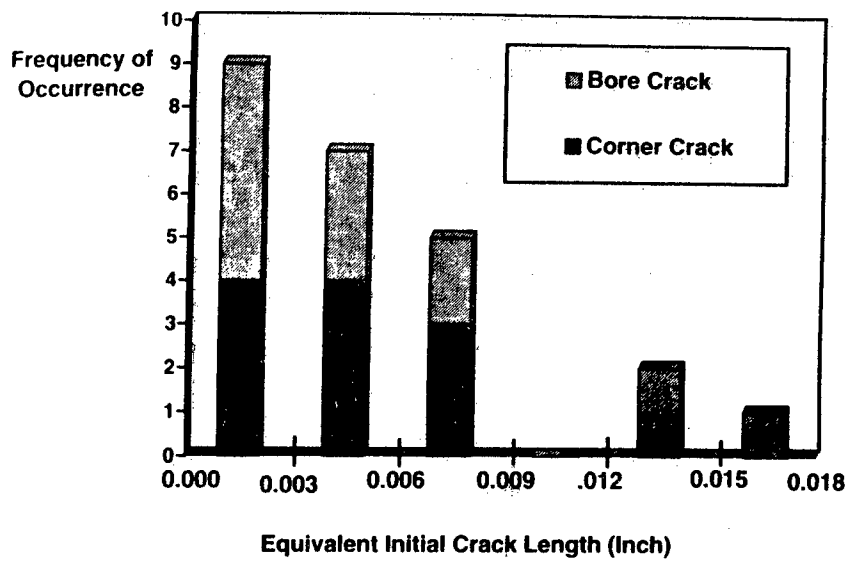
Figure 4. Histogram of Equivalent Initial Flaw Sizes

Figure 4 is a histogram for the equivalent initial flaw lengths for the 24 holes that were analyzed. It can be seen that the distribution of the initial crack sizes for corner cracks and for bore cracks are quite similar. The best distribution fit of the data was found to be Weibull with parameters  $\beta = 0.996$  and  $\eta = 0.0061$ . Since the slope,  $\beta$ , is essentially equal to unity, the distribution is exponential, a special case of the Weibull. In this case, the mean initial crack size is equal to  $\eta = 0.0061$  inch. The solid line in Figure 5 shows the EIFS data plotted using a Weibull scale.

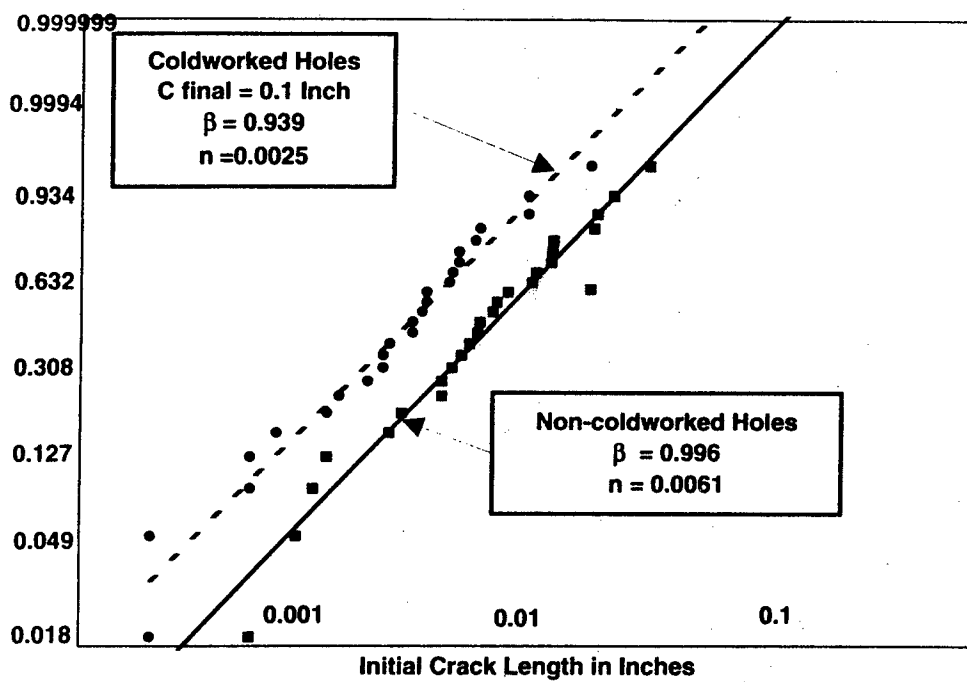
Figure 5. EIFS Weibull Distribution for Non-Coldworked and Coldworked Holes

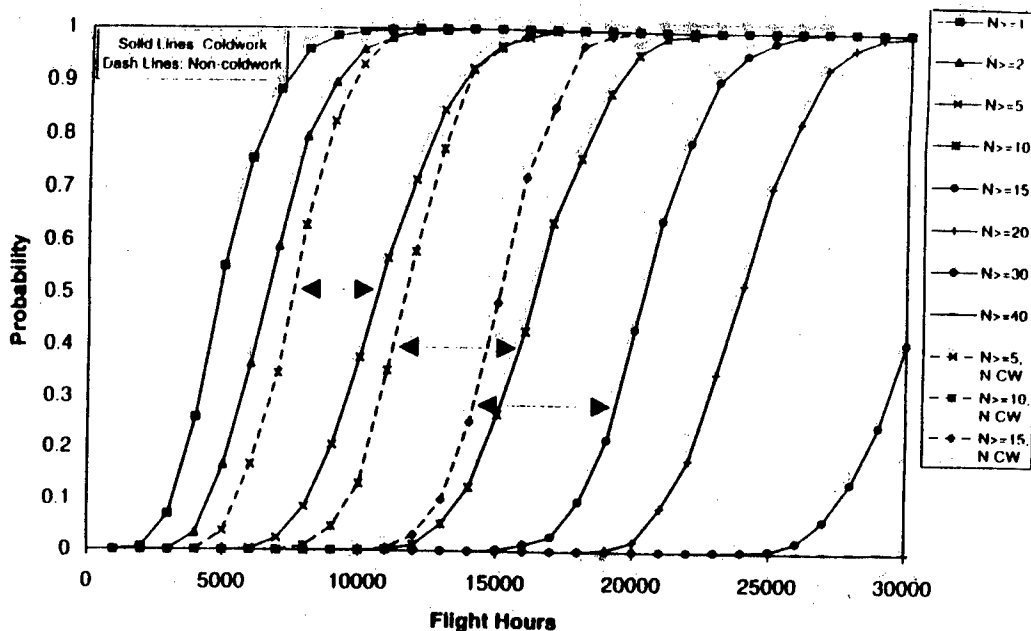
**Figure 6. Probability that N or More Holes will have a Crack Greater Than 0.1 Inch for SUPT Usage (Arrows Illustrate Difference in Non-Coldworked and Coldworked Holes)**

the criterion is established, the appropriate probability curves in Figure 6 can be multiplied by the fleet size to obtain the wing replacement rates as a function of flight hours.

After considerable discussion with SA-ALC personnel and evaluation of the wing durability test data, SwRI recommended that the economic life criteria for the wing skin fastener holes be taken as when there is a 50% probability that 15 fastener or more holes reach  $c = 0.1$  inch. Therefore, the cumulative distribution function (CDF) corresponding to the  $N \geq 15$  curve in Figure 6 was used for the economic life evaluation of the skin fastener holes without coldworking. For example at this 50% probability level ( $P_r = 0.5$ ), Figure 6 indicates that the economic life for SUPT usage is 15,000 flight hours.

Using curves similar to those in Figure 6 for  $c = 0.03$  inch, the criterion for 15 or more wing skin fastener holes reaching  $c = 0.1$  inch is approximately the same as 45 or more fastener holes reaching  $c = 0.03$  inch. From Table 4, the number of cracks exceeding 0.03 and 0.1 inch in radial depth for the unreamed and reamed holes found during the durability test ACI was 64 and 15, respectively. Although the test was concluded at 26,500 ENJJPT flight hours, if the cracking experienced during the durability test had been found on a service wing, the wing would probably have been condemned before 26,500 flight hours. Using the mission severity ratios given in Table 2, 26,500 ENJJPT flight hours would be equivalent to about 20,000 SUPT hours. Therefore, the criteria of 15 holes having cracks greater than 0.1 inch, appears to be compatible with the wing durability test results.

It is noted that the actual wing replacement schedules shown in Figure 10 were developed by using the entire probability curves in Figures 6, 8 and 9. The economic lives given in Table 5 were at the 50% probability level.

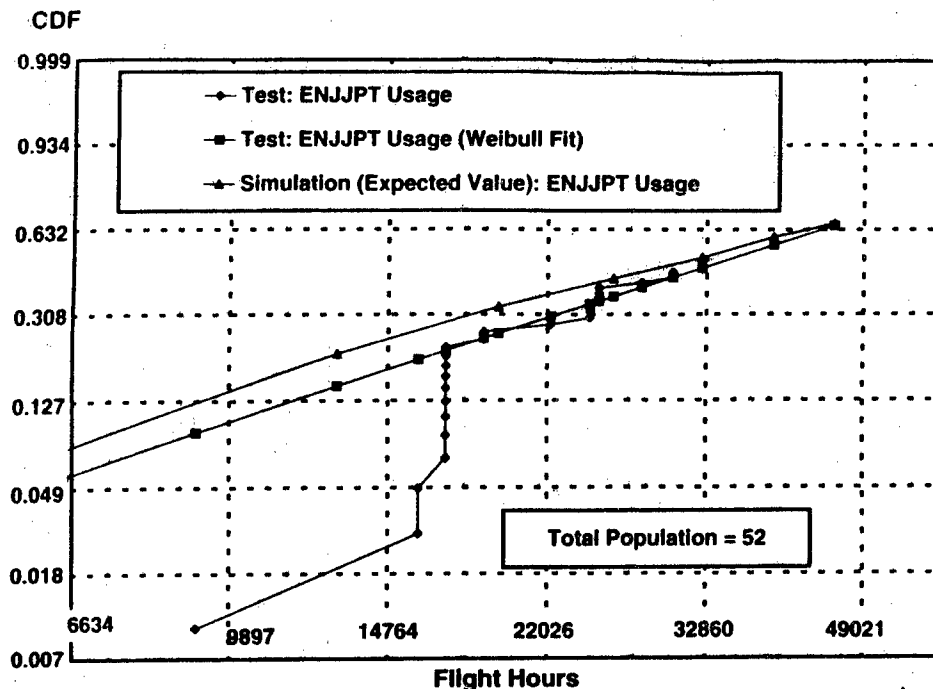
**Figure 7. Comparison of Probabilistic Simulation with Durability Test Experience**

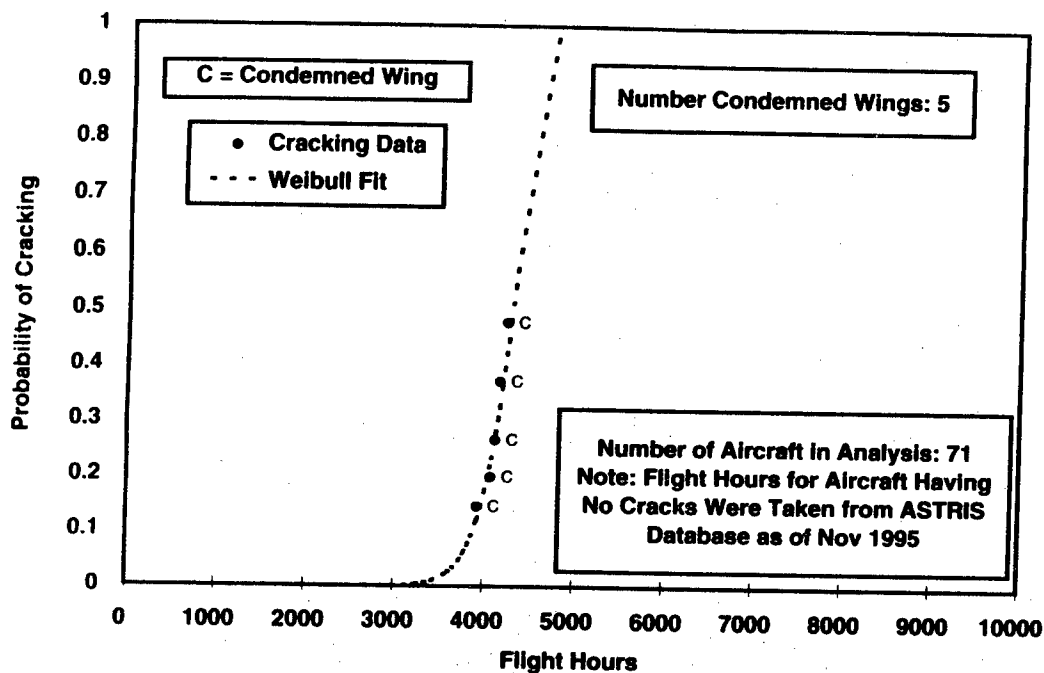
Figure 8. WS 78 — Cracking Experience  
IFF/LIF Usage

As of November 1995, five wings flying the LIF/IFF usage were condemned because of cracks found in the skin at WS 78 during field inspections. A separate Weibull analysis of cracking at WS 78 was performed for the 71 aircraft flying the LIF/IFF usage for the entire life of the wing. Figure 8 shows the probability of cracking given by the Weibull analysis. The data points for the five condemned wings fall very close to the Weibull curve. Another Weibull analysis was performed for the cracking at the WS 92.5 fastener holes. For this case the USAF had condemned eight wings, and cracks in 20 other wings has been stopped drilled and placed on a 25 hour recurring eddy-current inspection. For the economic life evaluation, all 28 wings were assumed to have reached their economic life. Figure 9 shows the Weibull fit to the cracking experienced at WS 92.5

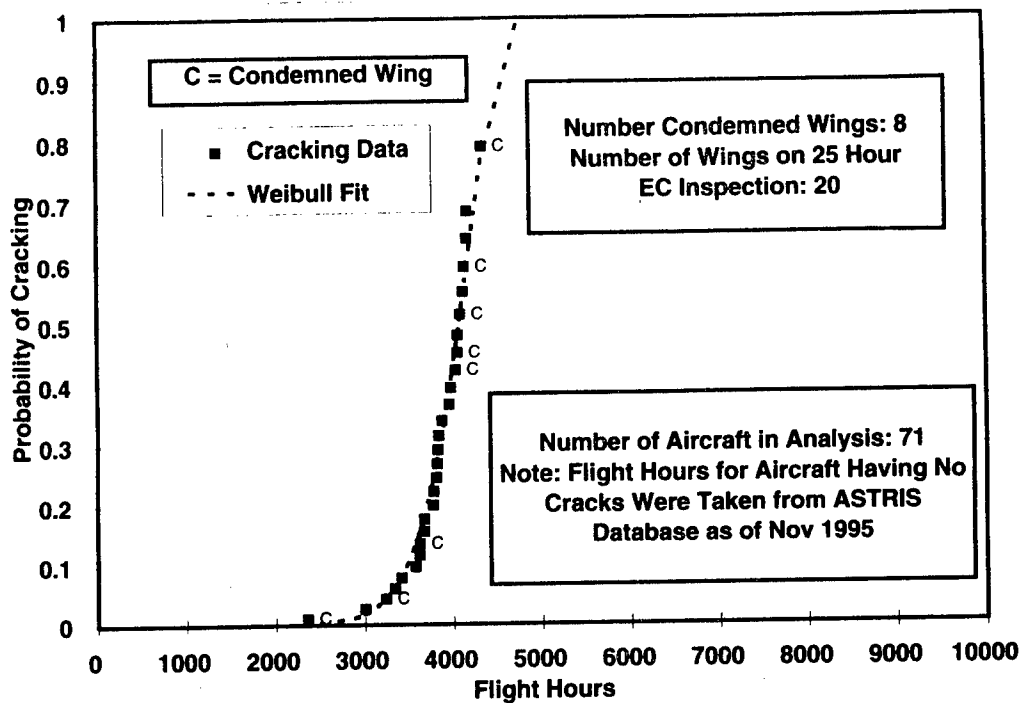
**Figure 9. WS 92.5 — Condemned and 25 Hours Eddy Current Inspected Wings - IFF/LIF Usage**

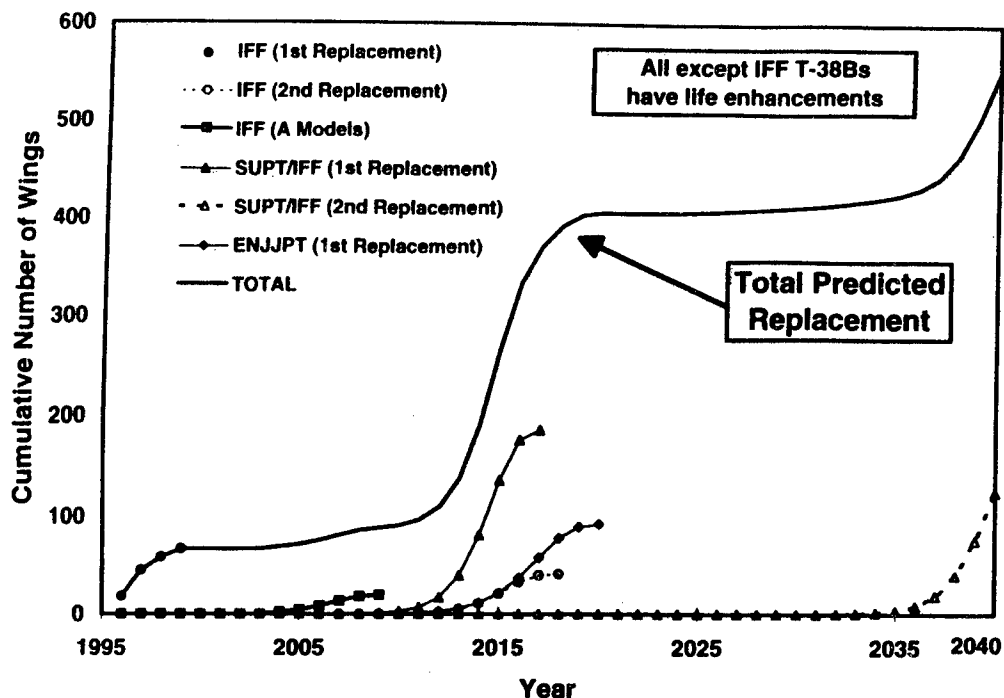
Figure 10. T-38 Projected Wing Replacement Schedule

The adjustments in equivalent flight hours from other usages to the SUPT usage were based upon the mission severity ratios given in Table 2. The number of predicted wing replacements at a given number of flight hours was obtained by multiplying the probability of wing replacement in Equation (3) by the fleet size. Results are shown in Figure 10 for the various usages. It is assumed that all aircraft, except the IFF T-38Bs, have life enhancement applied to the wing lower skin (coldworking) outboard of WS 64.8 and at the WS 92.5/15% spar fastener hole (rivetless nutplate). Figure 10 projects that two wing replacements will be required, one starting in about 2012 and a second replacement of the SUPT/IFF wings in about the year 2035.

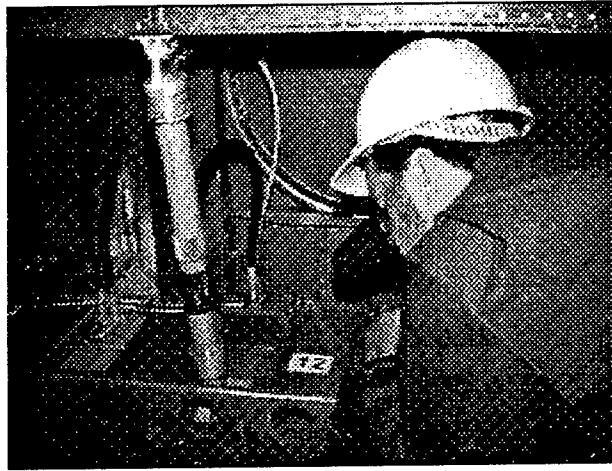
## Photographing the Repairs

In confined spaces a small digital camera is used as shown here.

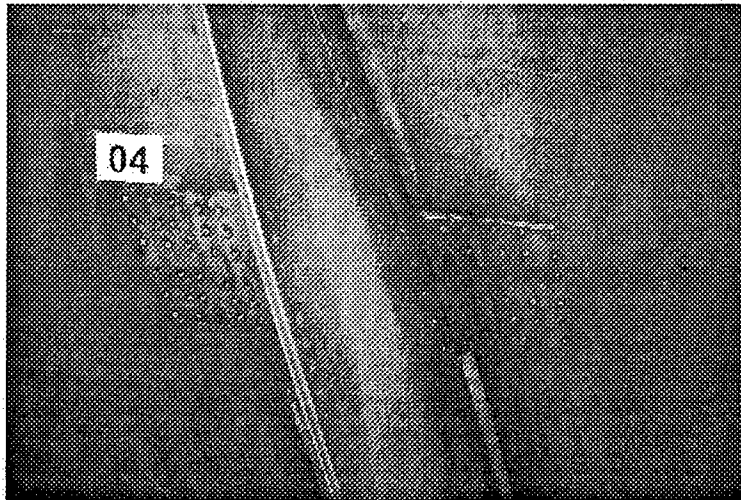
## Photo of Repair

Shown above is a typical 'E' point repair install on the no. 2 pylon left wing.

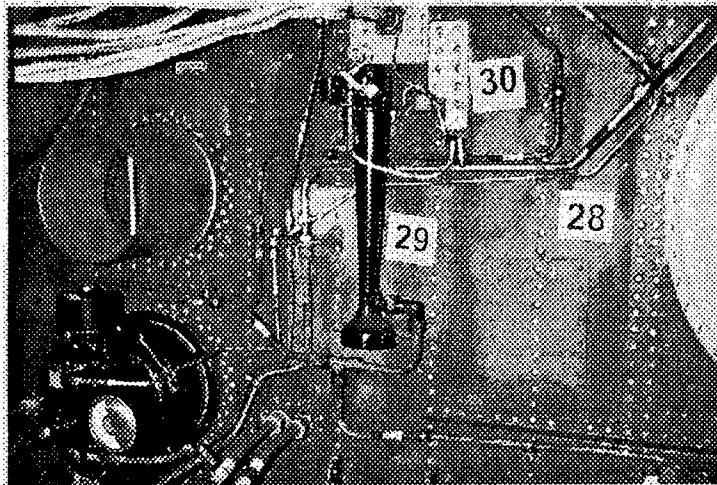
## Photo of Repair

Shown on this slide are 3 adjacent repairs located on the FS 1398 pressure bulkhead.

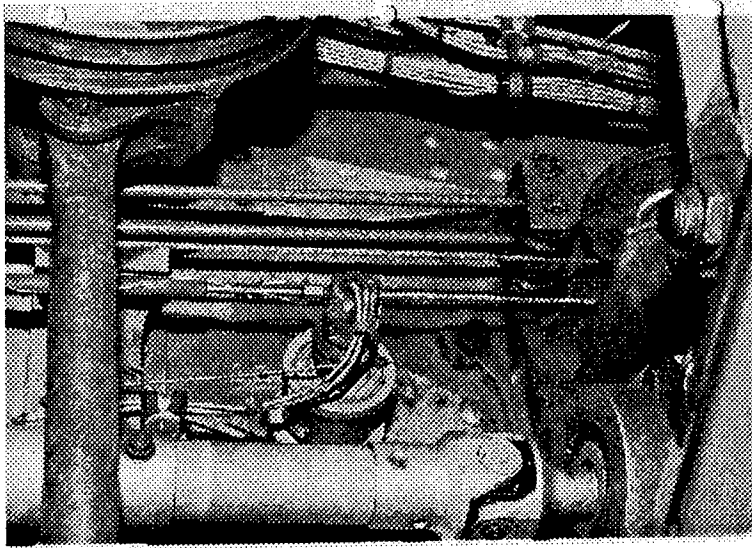
## System Check

Shown in this photograph is the fuel boost pump wiring.

<u>Area</u>	<u>Discrepancy</u>	<u>% Discrepant</u>
Fuel boost pump wiring	Worn, frayed Insulation	85 %
APU start accumulator	Corrosion	79 %
Flap tracks	Corrosion	73 %

The top three discrepant system items are shown above.

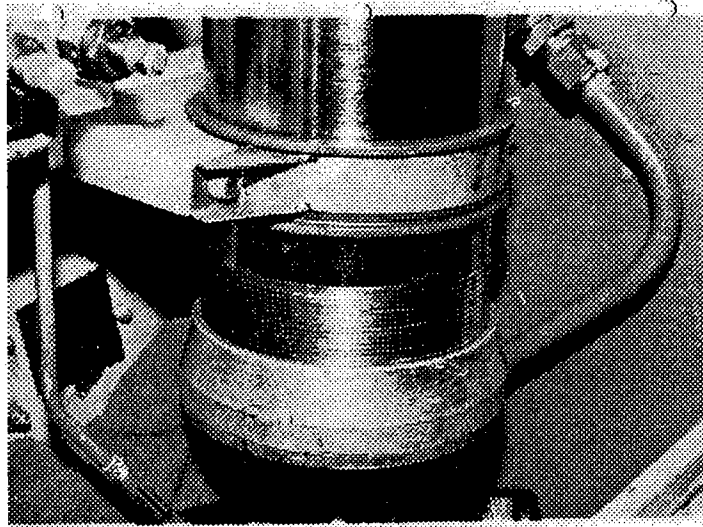
## System Discrepancy

This is the APU start accumulator, mild corrosion is on the cylinder threads.

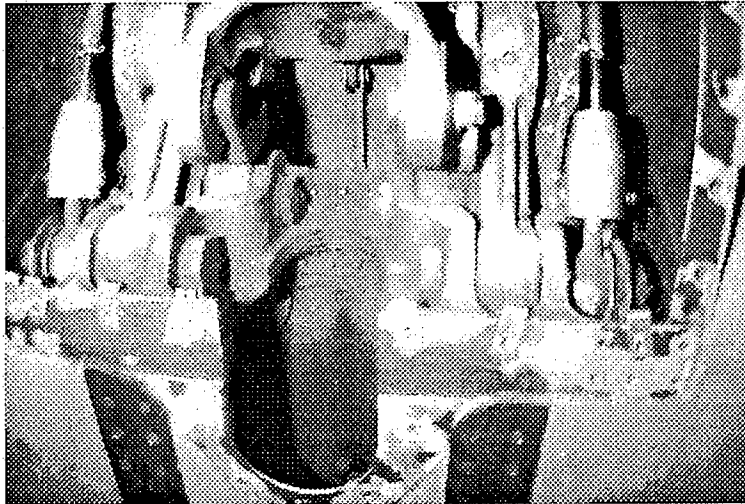
## **System Discrepancy**

This photo shows where a jackscrew has cut into a closure fitting inside the flap. This situation occurs when the flap carriage is mis-located.

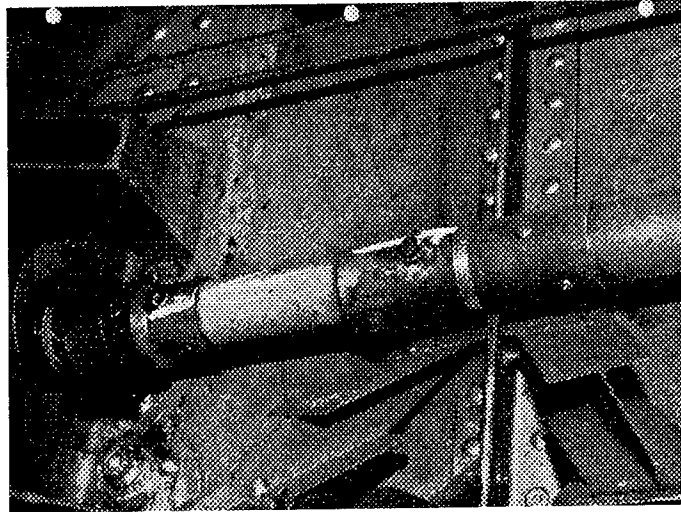
## System Discrepancy

This photograph shows the flap track drive torque tube rubbing against a stiffener on the rear beam. Notice the witness mark indicating that the torque tube rotated and rubbed against the stiffener. This was caused by the rubber bushing coming out of the gear box support, shown on the left of the photograph.

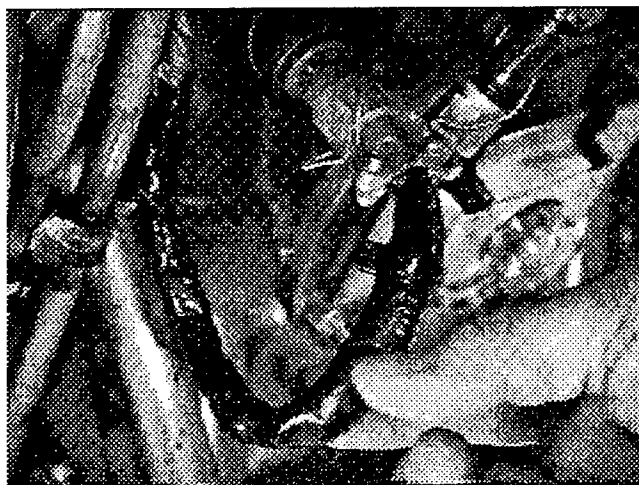
## System Problem

Black tape shown here, indicates the wrong type of electrical tape for the engine compartment.

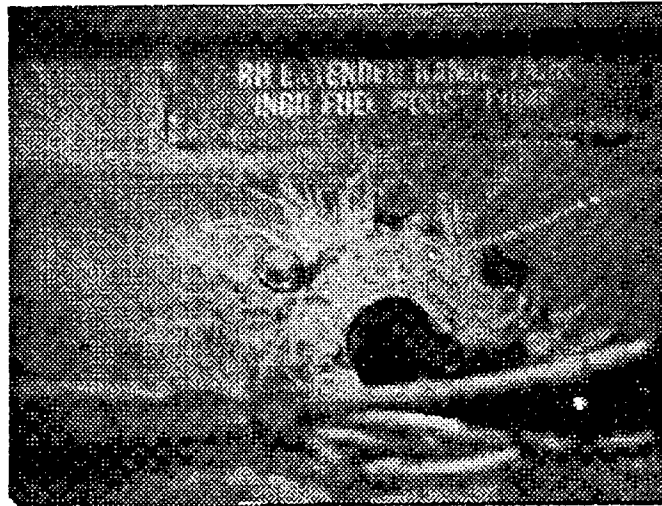
## System Check

A potentially serious area is where the wire for the fuel boost pump connector passes through the rear beam of the wing.

This photo is shot from the aft side of the wing rear beam. The connection is made within the wing box and is sealed by a housing. If the housing leaks and the hole is filled with sealant, fuel will be trapped at the connection. The hole should be clear of sealant as shown above.

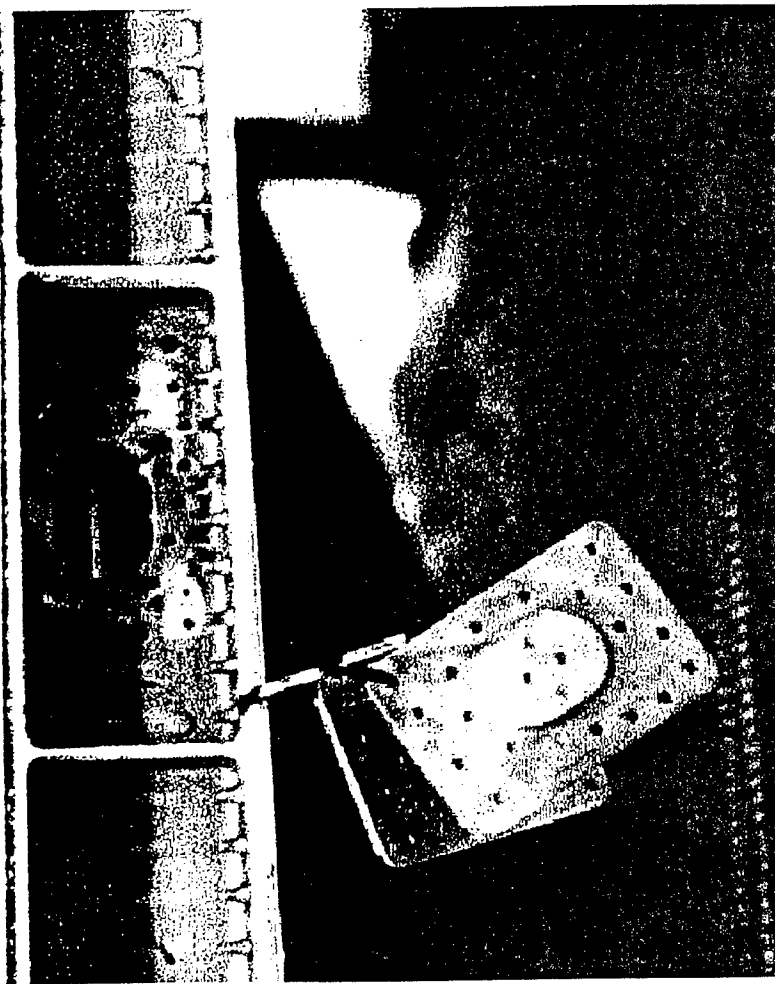
Up to 0.50 in. of material can be blended out to remove cracks.

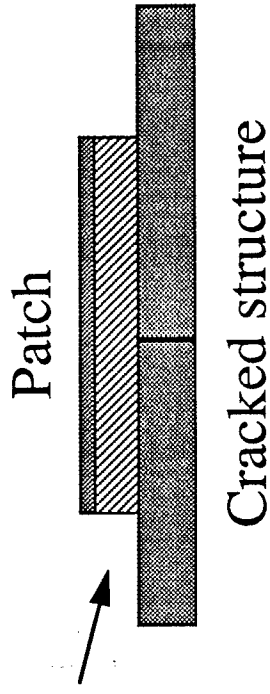
## FEM using 3-layer technique

- Modeling adhesive as continuum provides accurate analyses of:
  - Thermal effects
  - Nonlinear adhesive
  - Progressive damage

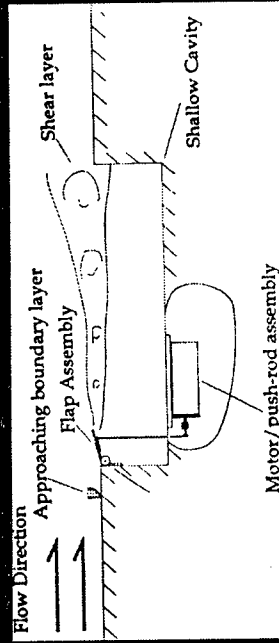
- **Evaluate Active Suppression Methods**
  - Analytical study
- **Wind Tunnel Tests - evaluate most promising**
  - Oscillating Flap (in tunnel now!)
  - Blown Air
- **Flight Test Best Concept**

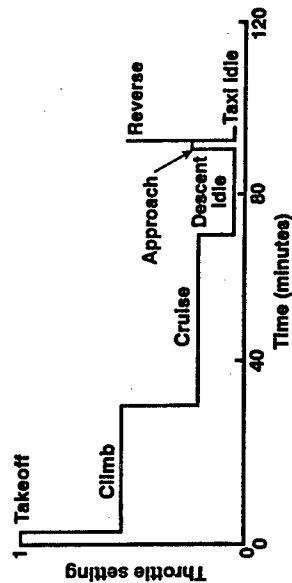
## Commercial Mission

Typical commercial mission full rated takeoff

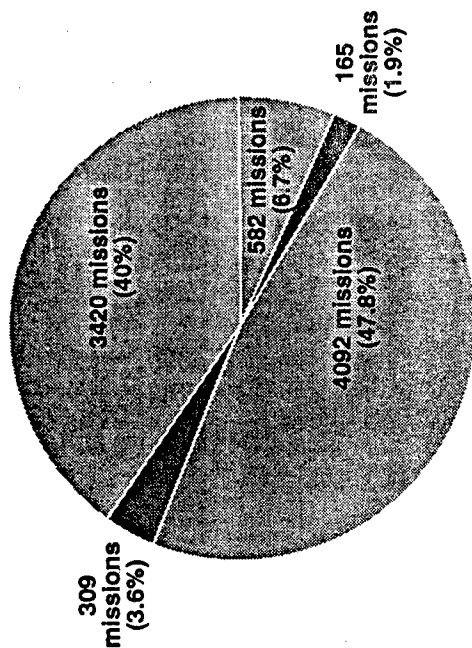
## Military Missions for ENSIP Assessment

8568 missions in 30,000 EFH

- PW2000 service experience documented for initial benchmark
- PW2000 FAA tests and reports used for ENSIP as applicable
- ENSIP assessment limited to five peace time C-17 missions defined by USAF
- Damage tolerance verification tests performed on selected components
  - HPT rotor hot cyclic spin test
  - Diffuser case hot cyclic pressure test
- X-664-13 engine telemetry test utilized to verify latest HPT thermals
- No accelerated mission engine testing performed
  - Commercial testing done for FAA certification
- Conceptual design improvement options considered
  - Detailed Design/Implementation outside the scope of this program

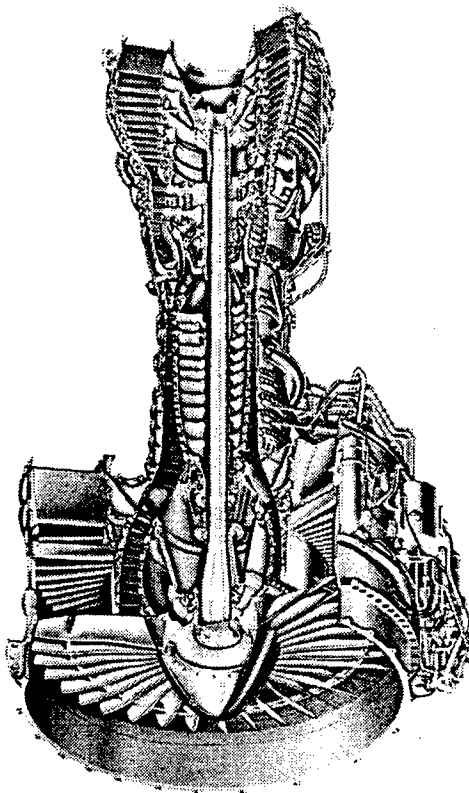
## ENHANCED INSPECTION REQUIREMENT

← Increment II →		← Increment I →	
Fan/LPC rotor		HPC rotor	
ECI	2 areas	ECI	12 areas
Re-sonic	4 areas	Re-sonic	3 areas
SWS	none	SWS	11 areas
Focused		Focused	
FPI	7 areas	FPI	17 areas
Diffuser case		HPT rotor	
Focused		ECI	10 areas
FPI	3 areas	Re-sonic	none
		Focused	
		FPI	21 areas
LPT rotor			
ECI	13 areas		
Re-sonic	1 area		
Focused			
FPI	19 areas

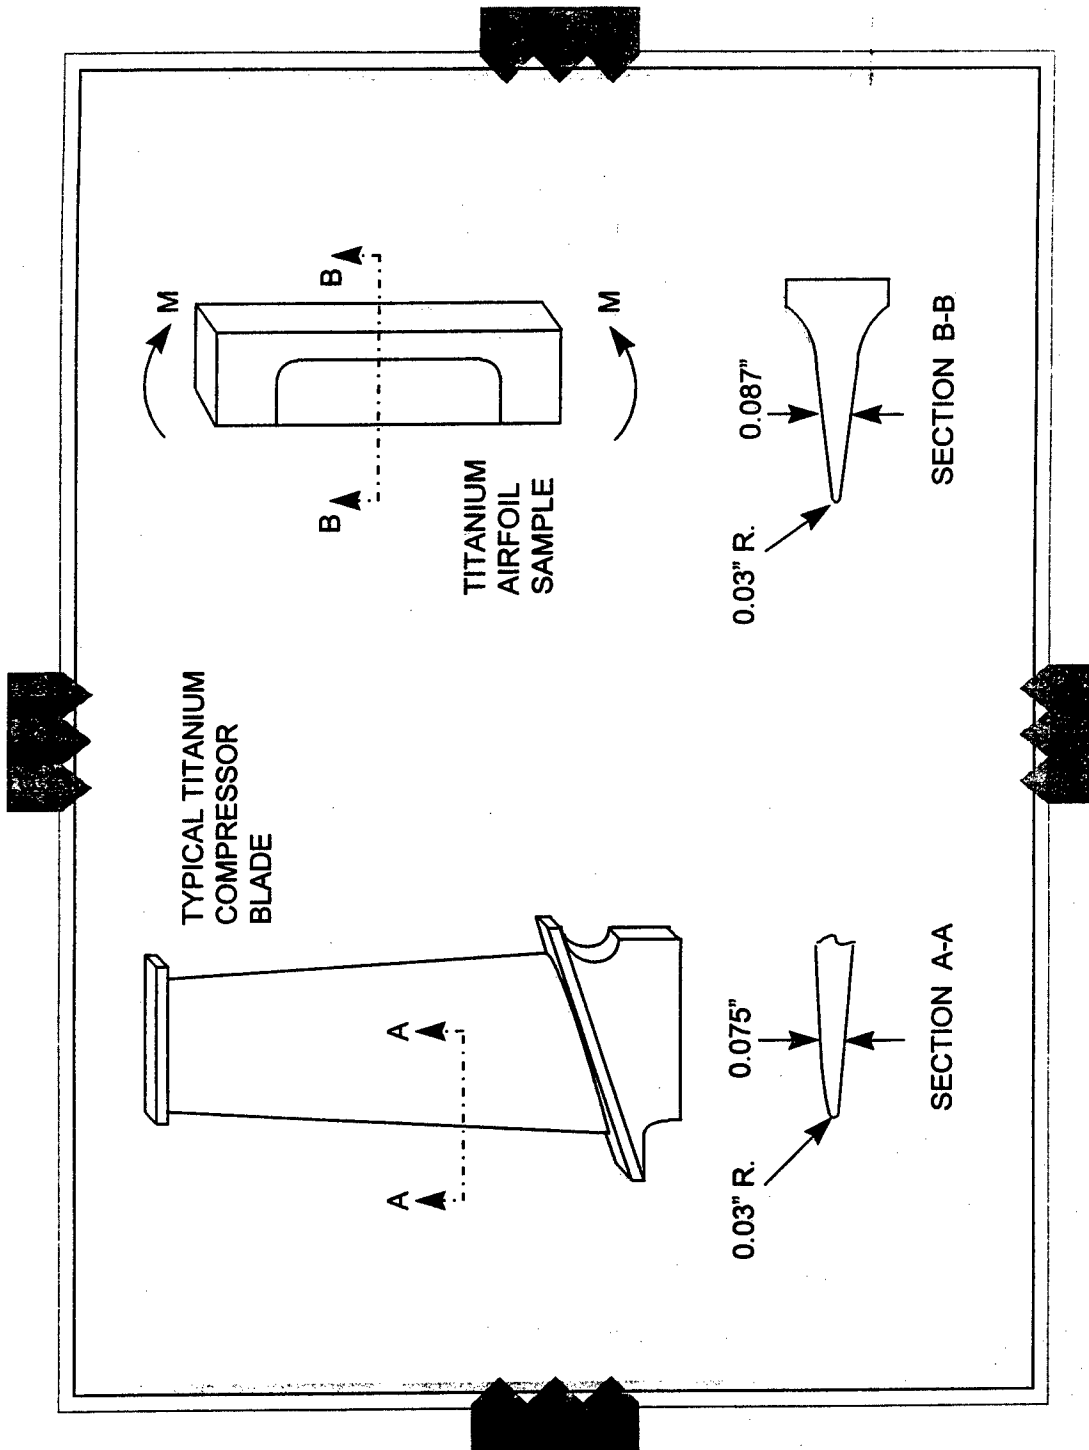
## **Test Specimen Design**

- ◆ **Designed to Simulate Fan Blade Leading-Edge**
- ◆ **3-Point Bend (able to concentrate tensile loading in particular region)**
- ◆ **Mode I Cracking Only**

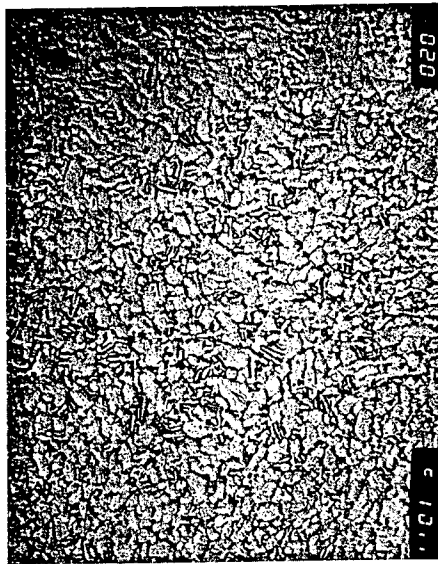
As-received (baseline)

## ◆ Microstructure of as-received and LSP

- Both microstructures consist of equiaxed grains of  $\alpha$  and transformed  $\beta$  (Widmanstätten  $\alpha$ )

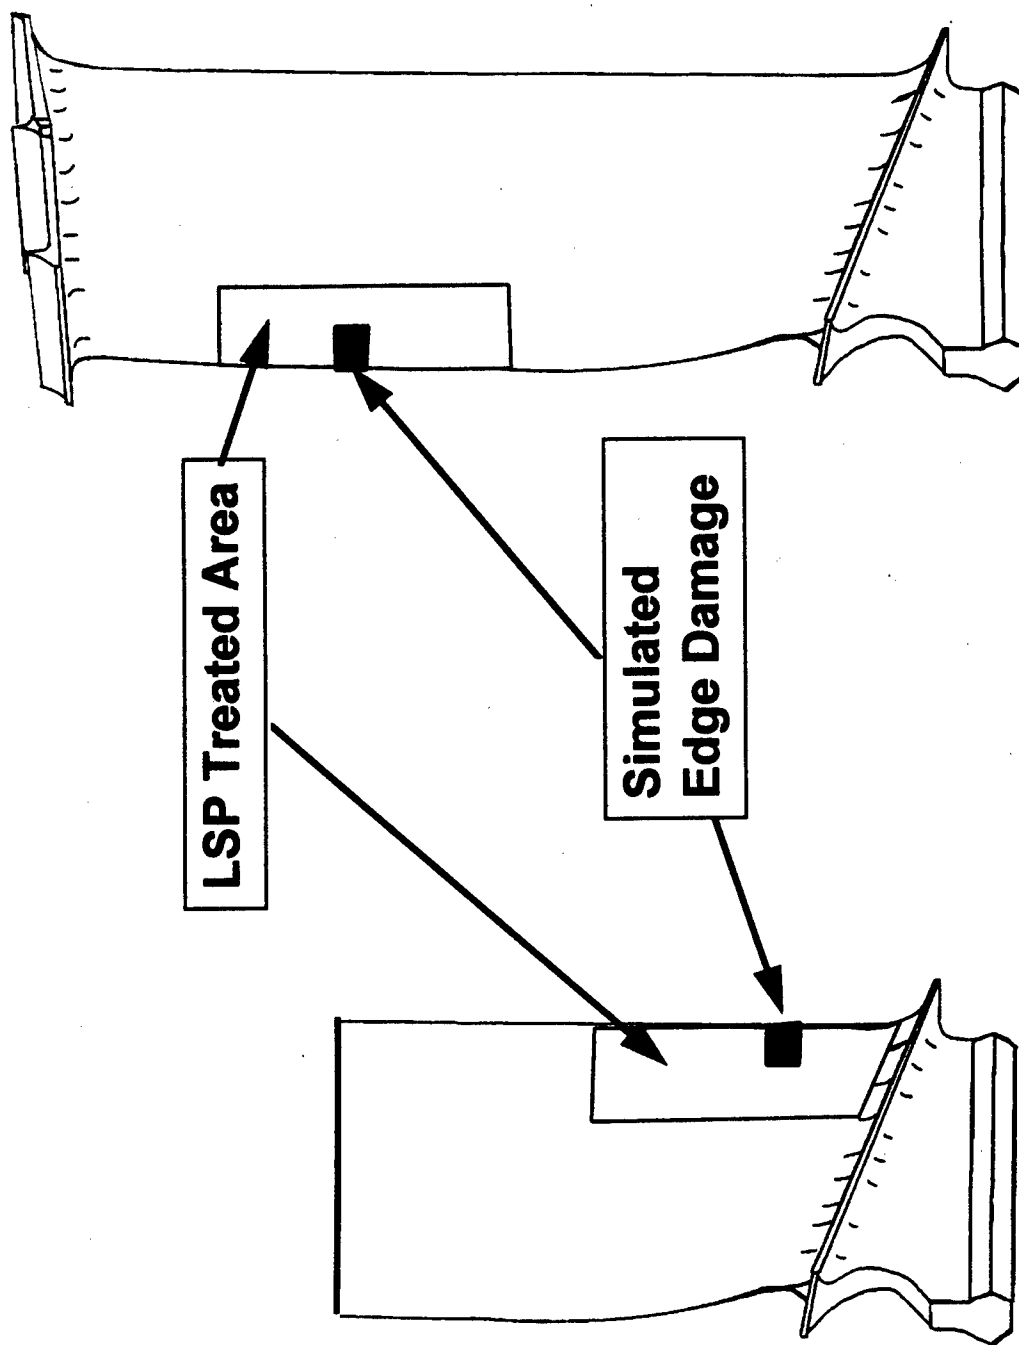
# SIREN HCF TEST FACILITY

**Flexural Blade Specimen      Torsional Blade Specimen**

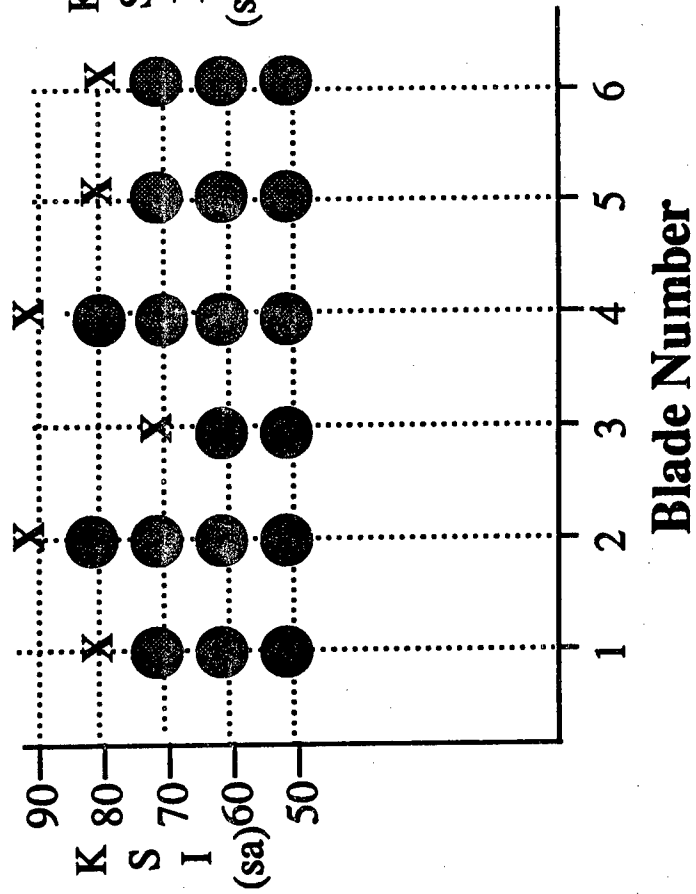
# HCF TEST METHODS

STAIR STEP

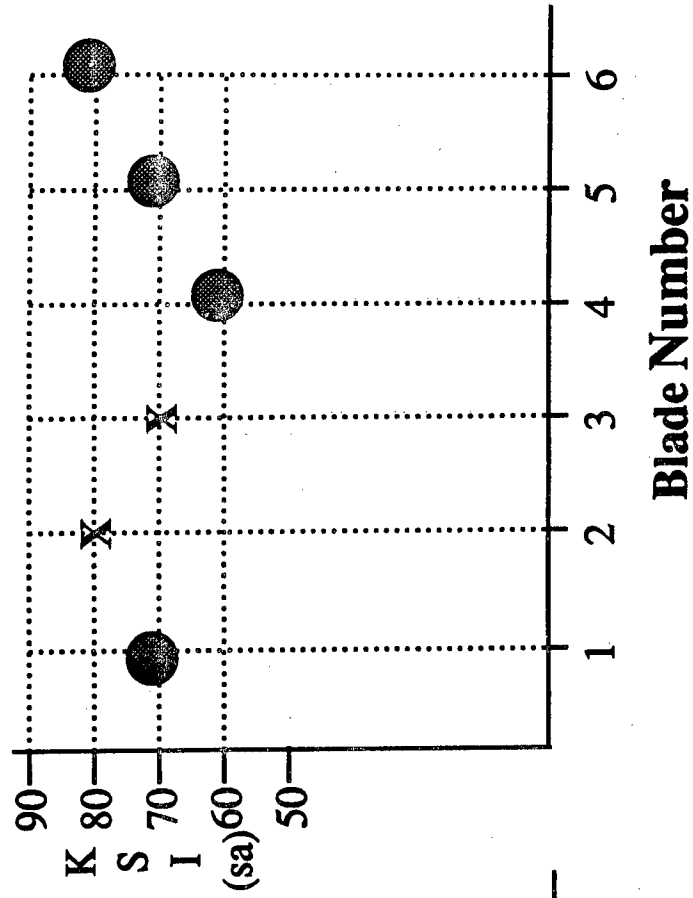
STAIR CASE

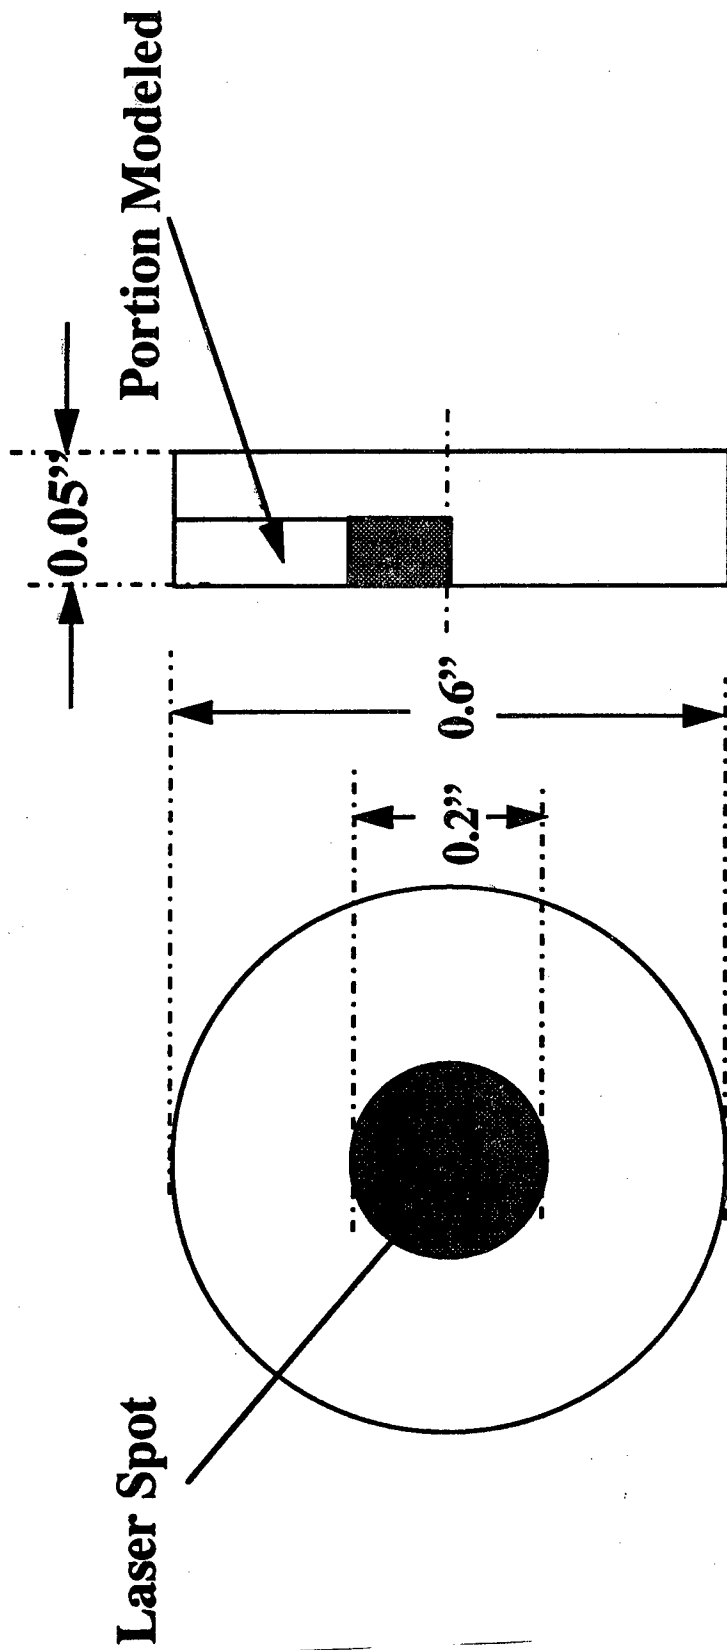
# Axisymmetric Model

- Thickness approximates an airfoil
- Analysis of one shock takes about 5.8 hours on CRAY

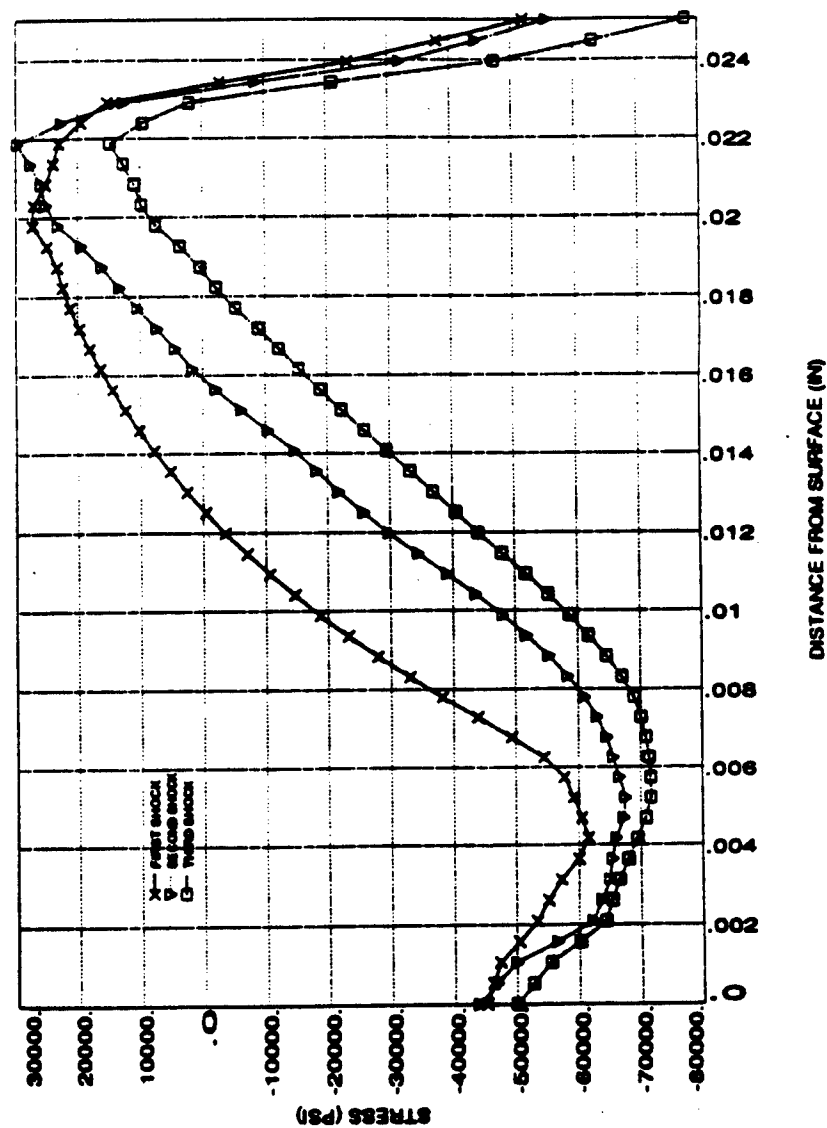
AXISYMMETRIC MODEL RESULTS  
RESIDUAL STRESS AT CENTER OF SPOT

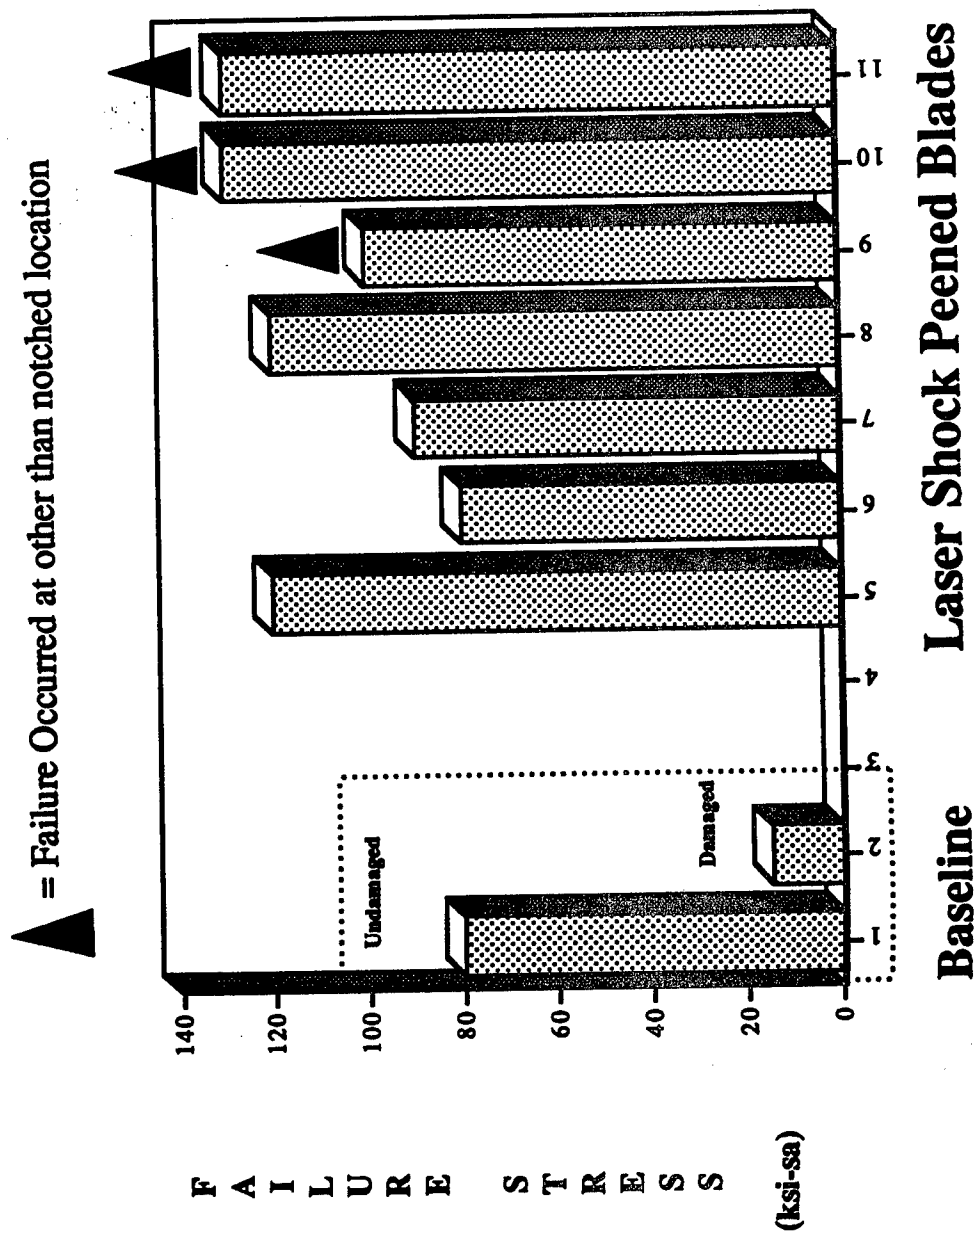
# TYPICAL LSP FAN BLADE HCF TEST RESULTS (Torsional Mode with 1/4" side shear damage)
