**WL-TR-97-4054**

**PROCEEDINGS OF THE 1996 USAF  
AIRCRAFT STRUCTURAL INTEGRITY  
PROGRAM CONFERENCE**

**USAF Aircraft Structural Integrity Program Conference  
Hyatt Regency San Antonio  
San Antonio, Texas**

**FINAL REPORT FOR PERIOD 3-5 DECEMBER 1996**

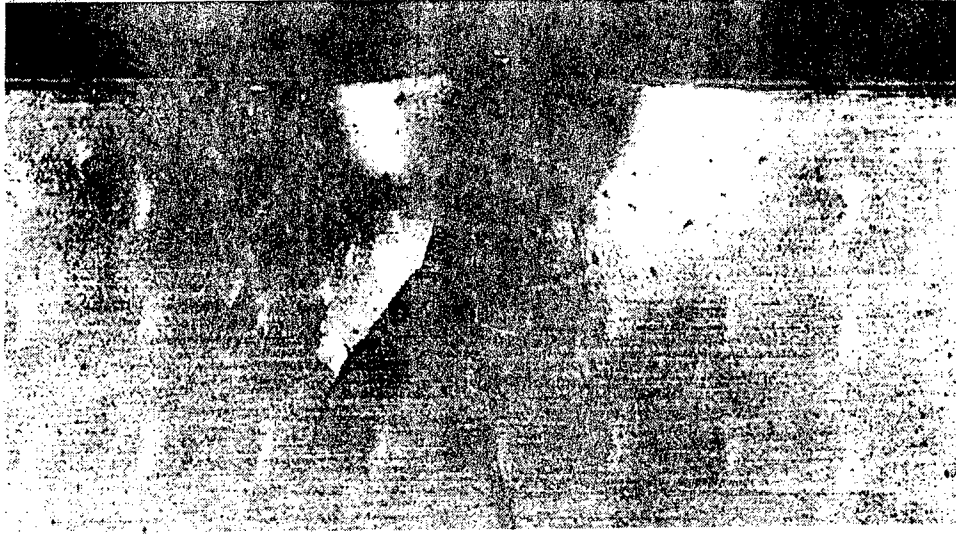
## TORSIONAL TEST OF LSP'D BLADE WITH NOTCH

Staircase test -  $10^7$  cycles

- **Baseline with Damage**

- Runout @ 20 ksida
- Failure @ 30 ksida

- **LSP With Damage**

- Runout @ 200ksida
- Crack grew to 0.44" long and stopped growing
- Total crack length is 0.69" including damage

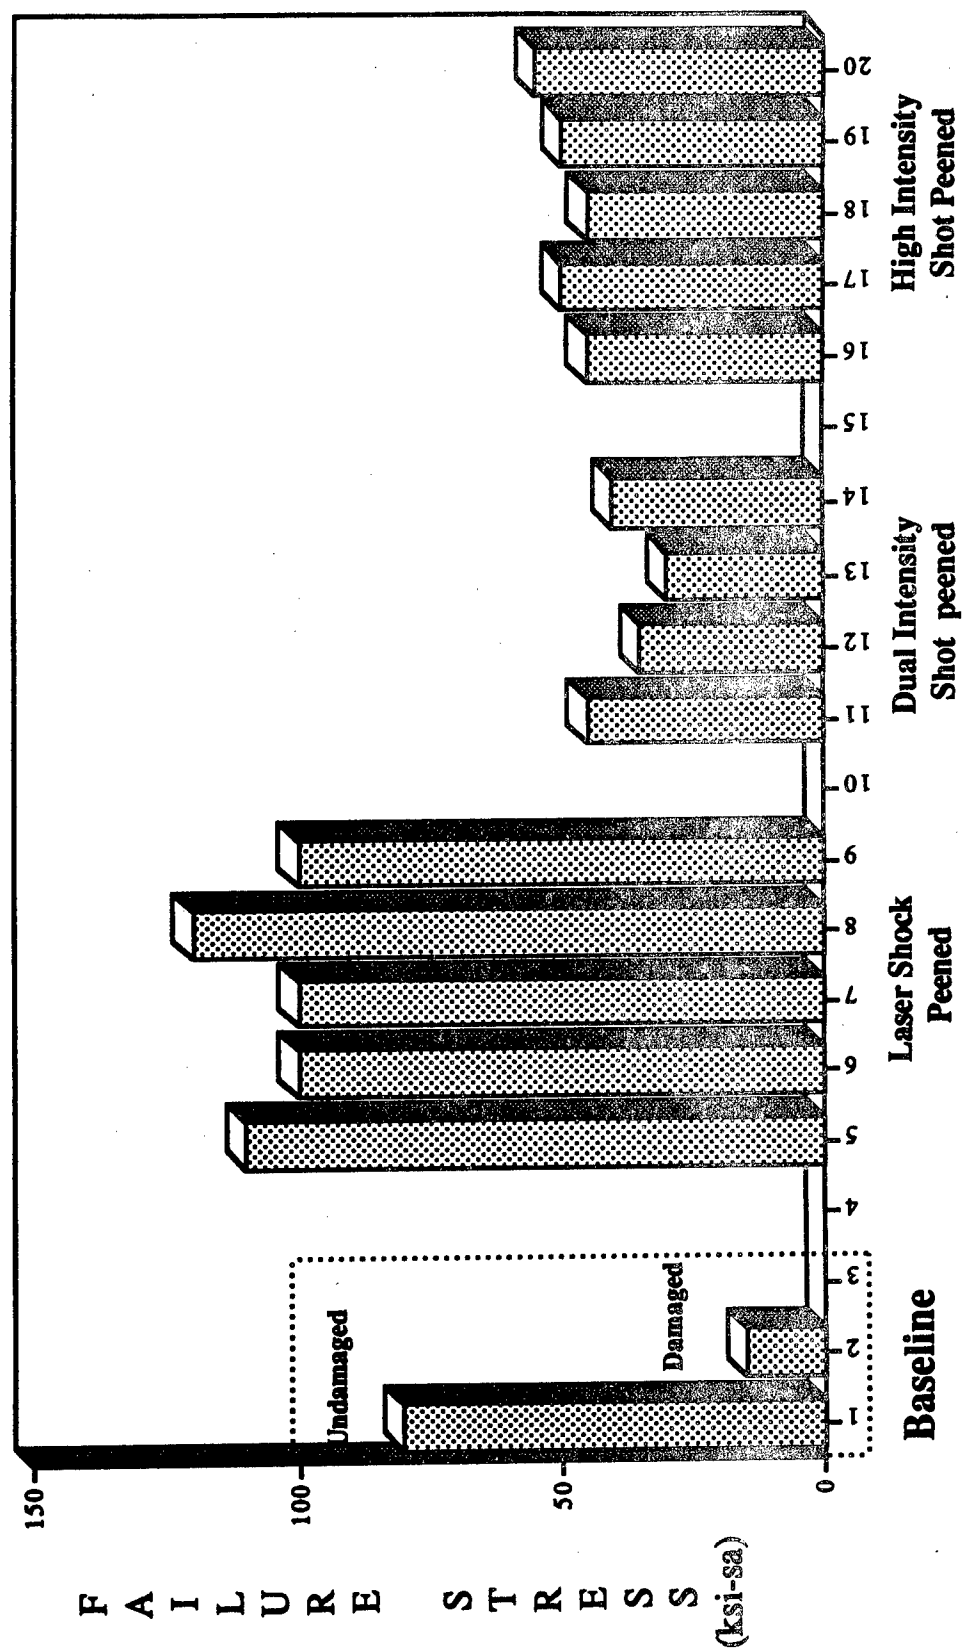
# LSP Vs. SHOT PEENING HCF TEST RESULTS (0.25" side shear damage)

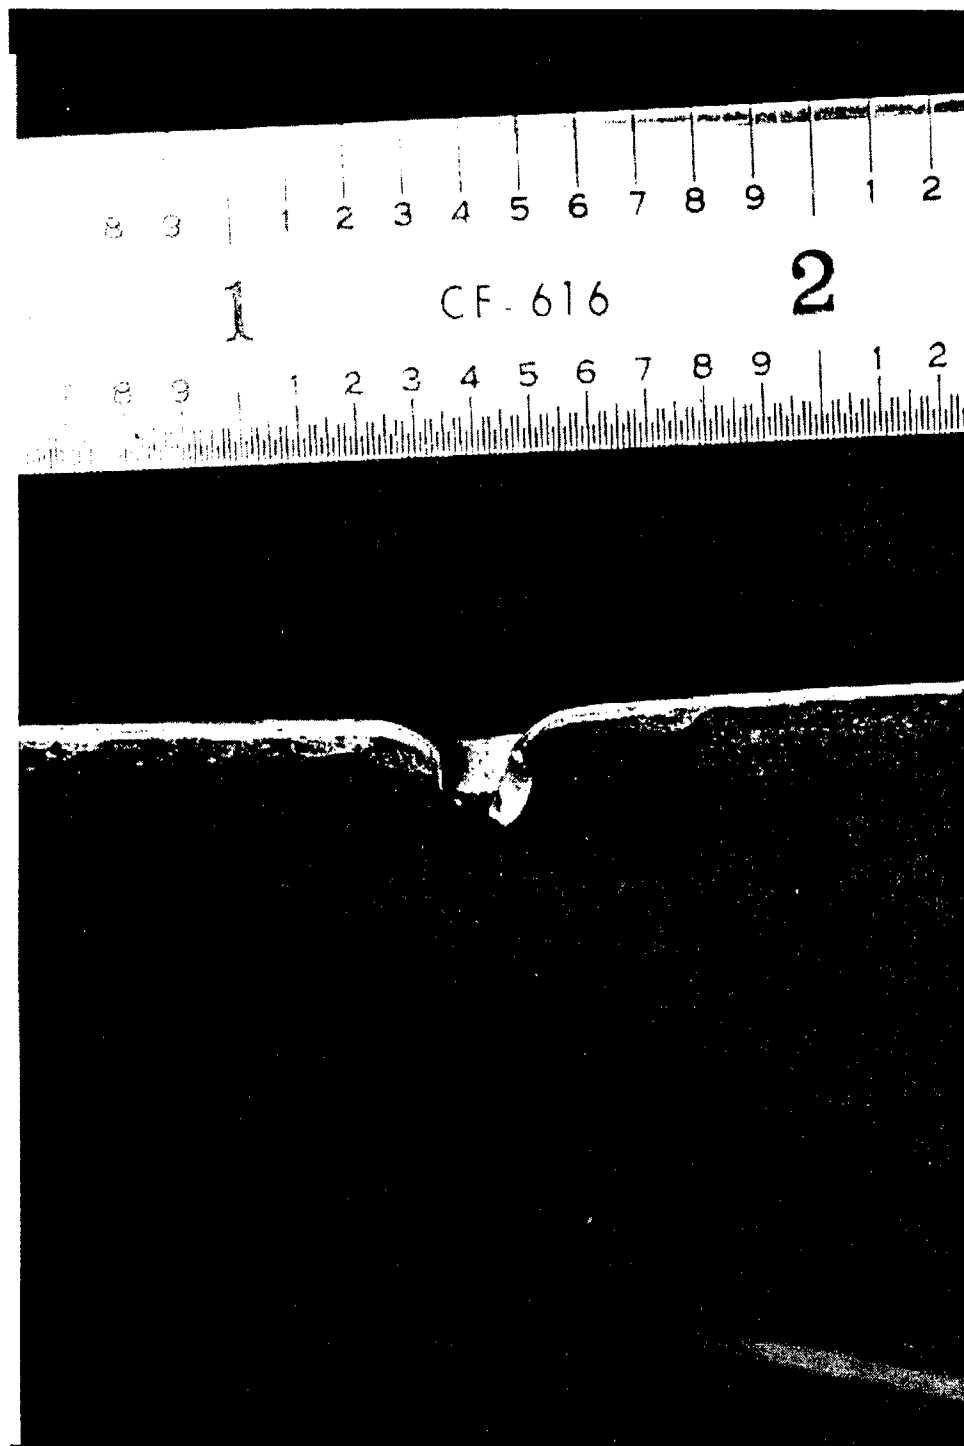
# NOTCHED BLADE FOR ENGINE TEST

- Engine test was done at Arnold Engineering Development Center in Tennessee
- Two notched blades with 0.125" deep side shear damage were installed in the engine
- Maximum Maneuver distortion screen was installed to excite critical resonance conditions
- Ten Accels and Decels prior to resonance test
- Held for 30 minutes at peak resonance near max. power
- Five Accels and Decels before the engine was shut down

**The notched blades are in pristine as originally installed. No cracks**

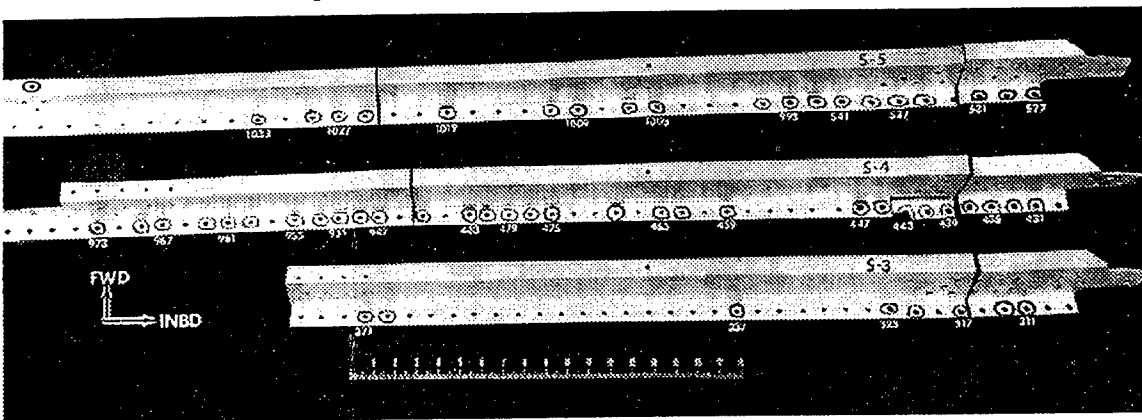
Figure 1  
Representative Stringers from KC-135 Teardown

During a recent teardown inspection of the NASA Zero 'G' Airplane Left Hand Outboard Wing Lower Surface, cracks or tears were found extending from cold expanded holes in the lower wing skin stringers [2]. Holes with tears are circled in the Figure 1.

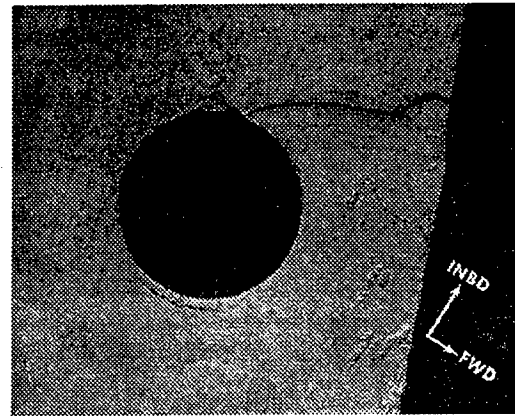
Of the 600 Cx2s holes inspected, 155 had shear tears. Some tears had actually broken through the ligament on a few of the larger (5/16 inch) short edge margin holes. All of the tears appeared to originate from a corner of the ridge left in the hole after Cx2s, i.e., the location corresponding to the split in the sleeve - see Figure 2. The tears were found only in the 7178-T6 extrusion stringers, and not in the wing skin (7178-T6 plate).

**Figure 2**  
**Typical Teardown Shear Tear**  
**in KC-135 Stringer**

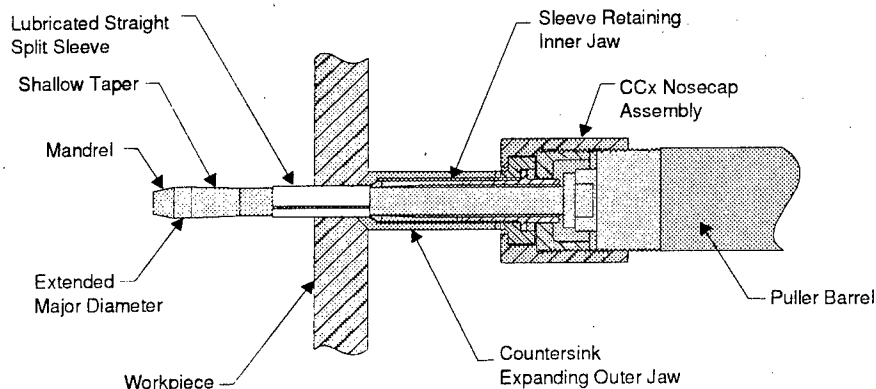
The Split Sleeve Cold Expansion to Size™ (Cx2s) process is accomplished by pulling a tapered mandrel, pre-fitted with a lubricated split sleeve through a hole, as shown in Figure 3. The function of the disposable split sleeve is to reduce mandrel pull force, ensure adequate radial expansion of the hole, preclude damage to the hole and allow one-sided processing. The process causes a radial plastic flow of material and produces an annular zone of residual compressive stress. This residual compressive stress created by cold expansion significantly increases fatigue and crack growth lives by reducing the stress concentration produced at the hole by in-service loads. The magnitude of the residual compressive stress zone is approximately equal to the compressive yield strength of the parent material. A balancing zone of tensile stress occurs adjacent to the circumferential compressive stress. This tensile stress is typically 10 to 15% of the tensile yield strength.

**Figure 3**  
**Cold Expansion to Size Tooling**

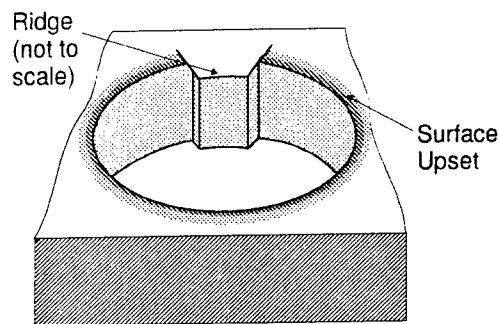
Cold expansion has been known to cause a small shear discontinuity at the surface of the hole associated with the split in the sleeve as shown in Figure 4. In some 7000 series aluminum alloys, a small tear has been evident on the surface, but generally not to the magnitude witnessed in these KC-135 stringers.

**Figure 4**  
**Schematic of Shear Discontinuity**

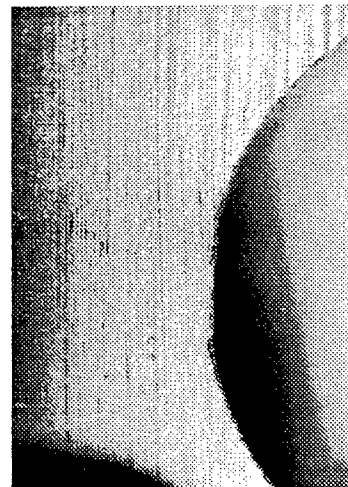
**Figure 6**  
**No Shear Tears - Sleeve**  
**Ridge 90° to Extrusion Grain**  
**Direction and Loading**

This orientation was previously thought to be the worst position when maximizing fatigue life improvement. The ECP 484 instructions specified that the sleeve split was to be placed in the longitudinal direction (0 and 180 degrees), i.e., parallel to the spanwise load direction. It turns out that this orientation and the 45 degree orientation are the worst for producing shear tears. The total absence of tears in the 90 degree orientation was a striking contrast to the others. Obviously, conventional wisdom will need to be reevaluated.

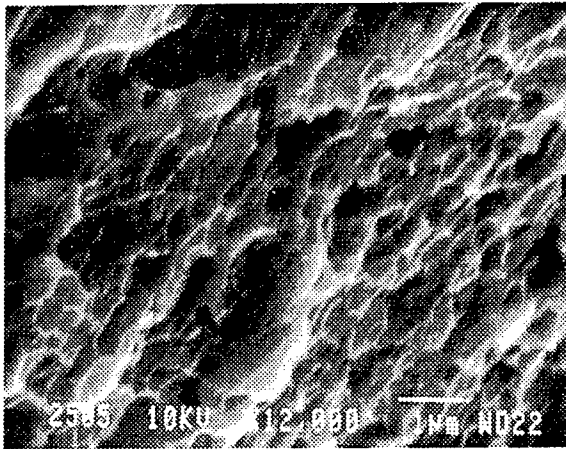
To reduce the possibility of rubbing, another specimen was cold expanded while it was held at a small tensile load. Once the tear initiated it broke through the remainder of the specimen by applying a load sufficient to pull it apart. Subsequent SEM observations revealed the presence of very fine dimples as shown in Figure 7. The actual mode of failure is quite complex, and further work is needed to determine the dominate mode, if indeed there is one.

**Figure 7**  
**SEM Photograph of Shear Tear 12,000X**

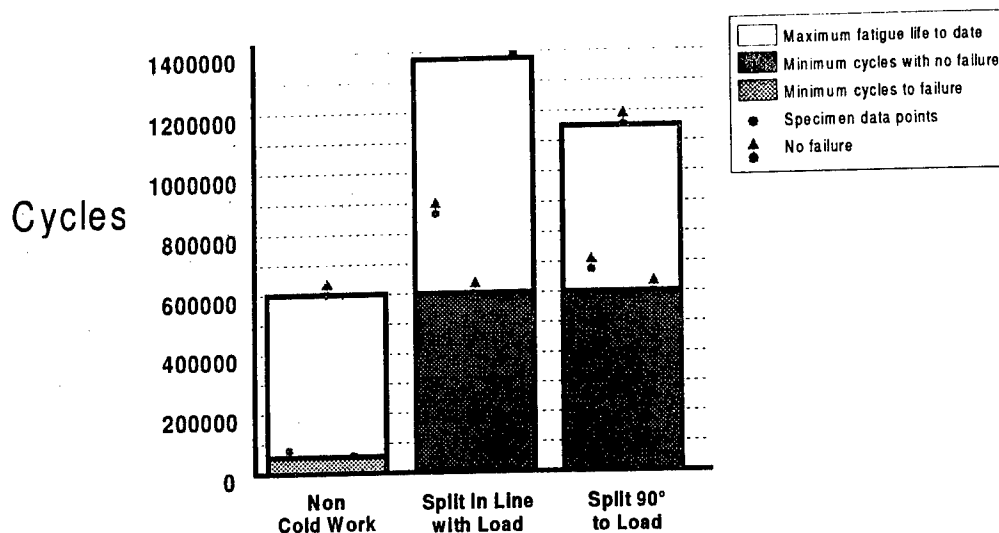
**Figure 9**  
**Fatigue Test Results**

The fatigue data are shown graphically in Figure 9. There was a considerable amount of scatter in the non-cold expanded specimens. Two specimens failed at less than 100,000 cycles, while a third specimen ran to 600,000 cycles without failure. Since one of the non-cold expanded (NCx) and several Cx2s specimens were tested without failure, it was not possible to calculate a "true" average fatigue life for any of the specimen groups. Therefore, the technique of comparing specimen minimum failure lives was used. In general, the Cx2s process improved the lives of the specimens by a factor of nine.

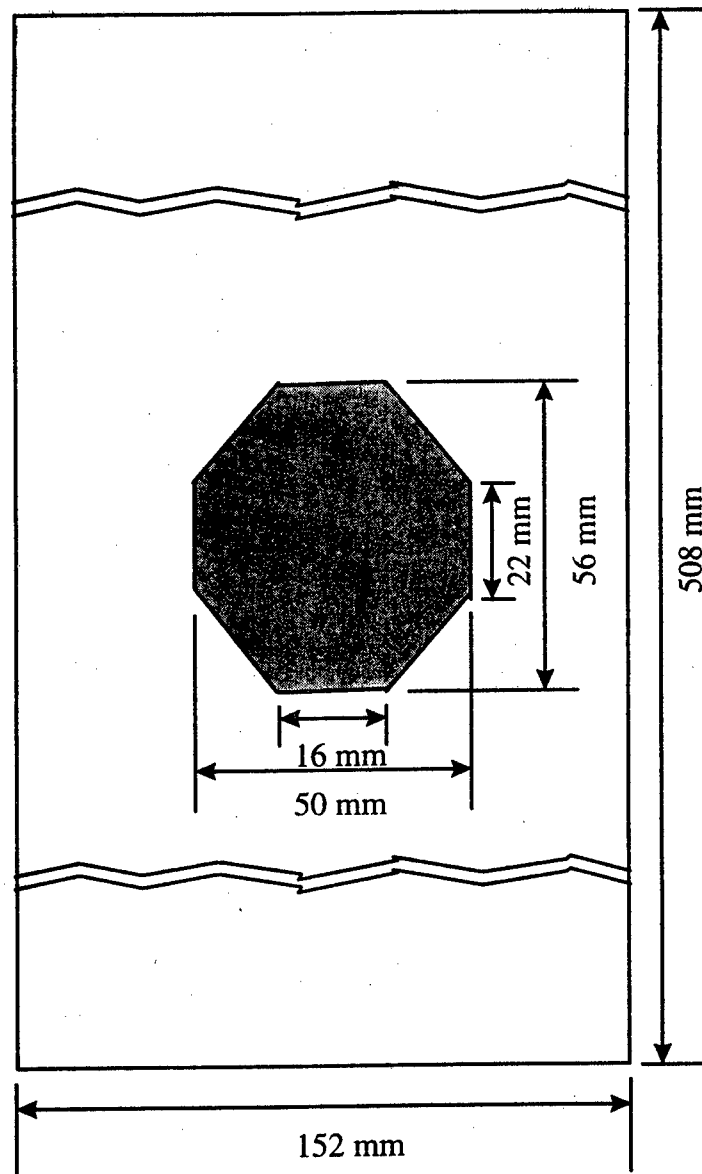
Figure 1 Geometry of the aluminum patch with the boron/epoxy patch.

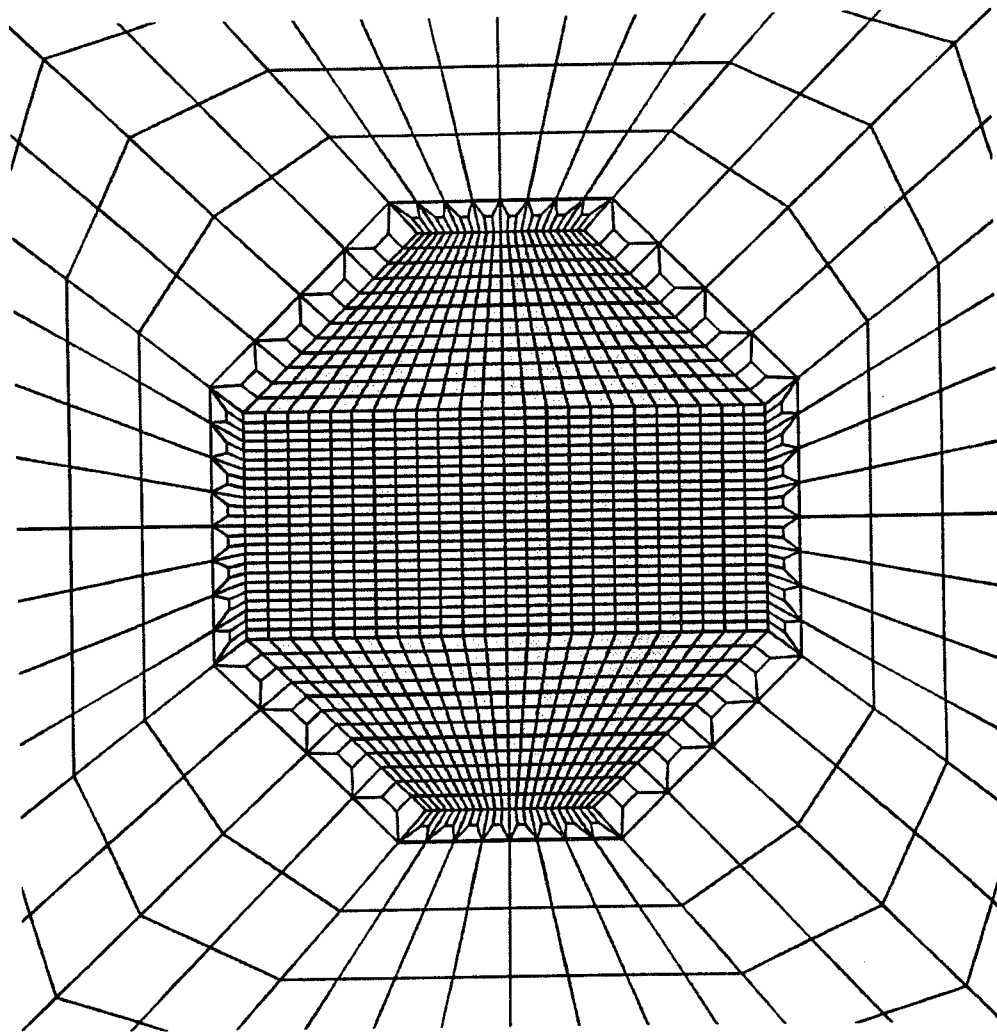
Figure 2 The finite element mesh of the composite patch on the aluminum panel.

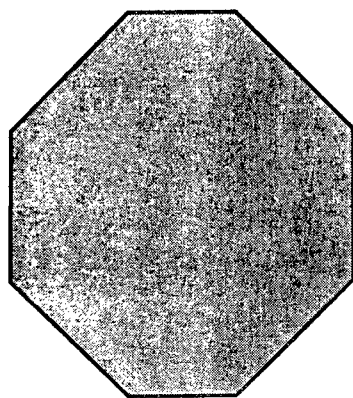
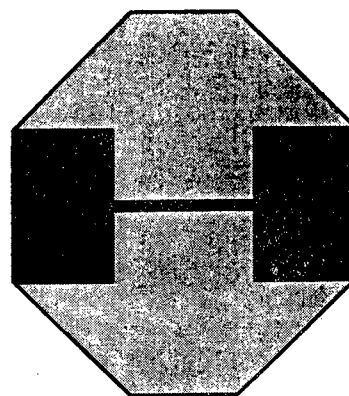
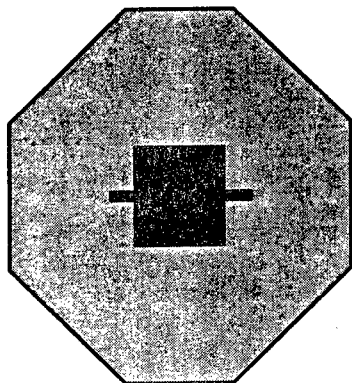
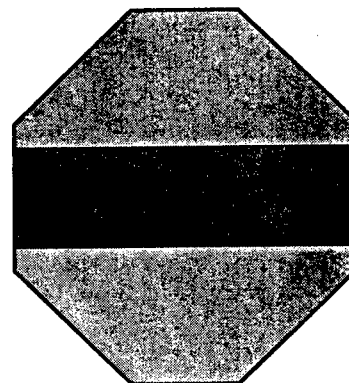
Figure 3 Disbond configuration types (i) a completely bonded patch (CBP); (ii) crack tip disbands (CTD); (iii) a center disbond (CD); and (iv) a full width disbond (FWD).

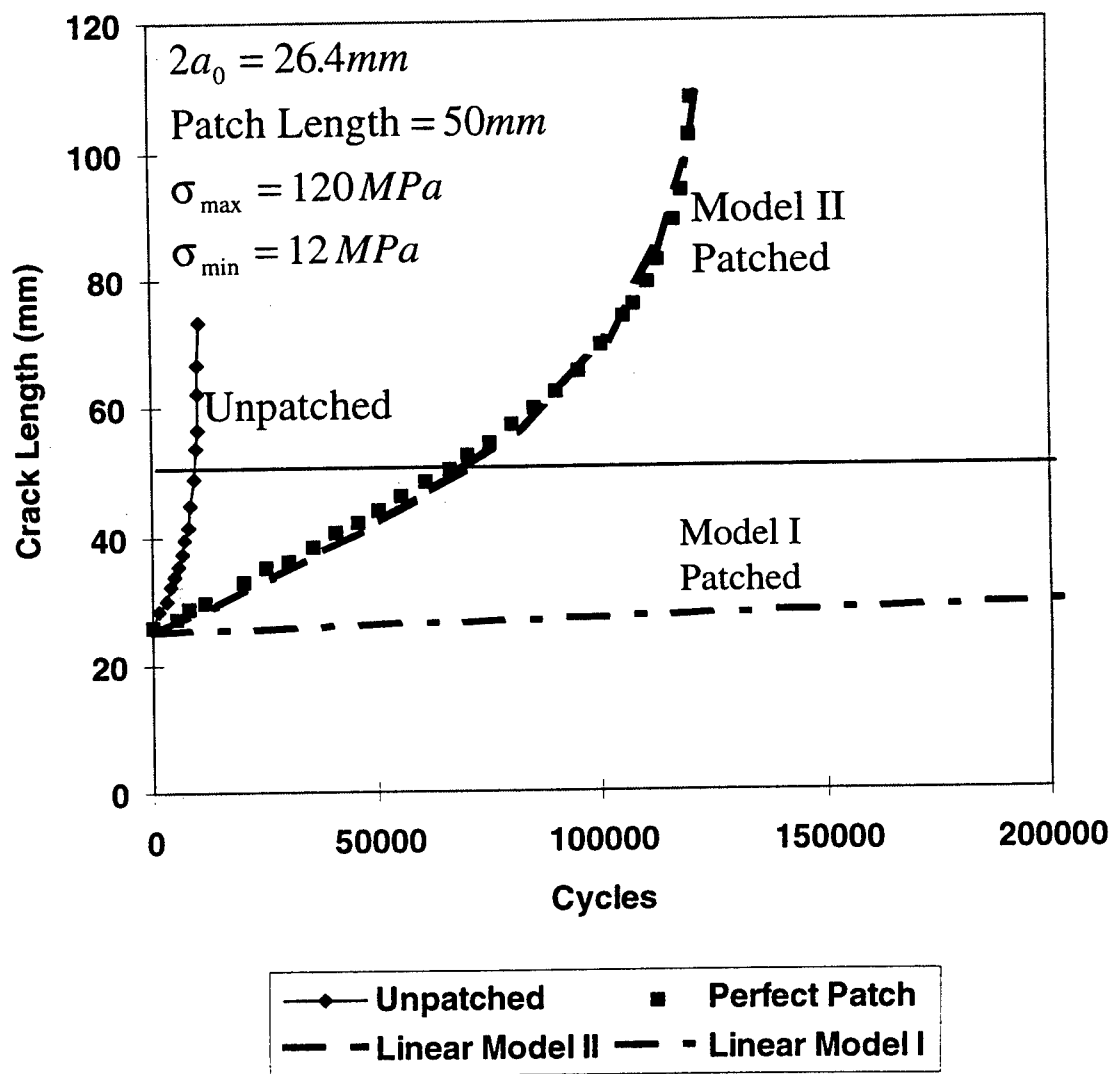
Figure 4 Comparison of results from numerical model I and II with the experimental data for completely bonded patch (CPB).

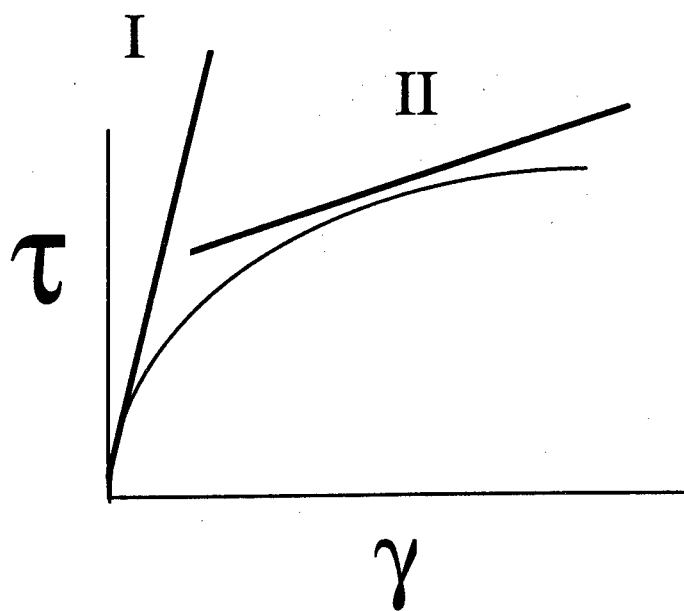
Figure 5 The nonlinear material behavior of adhesive layer where the shear modulus is strongly dependent on the shear strain.

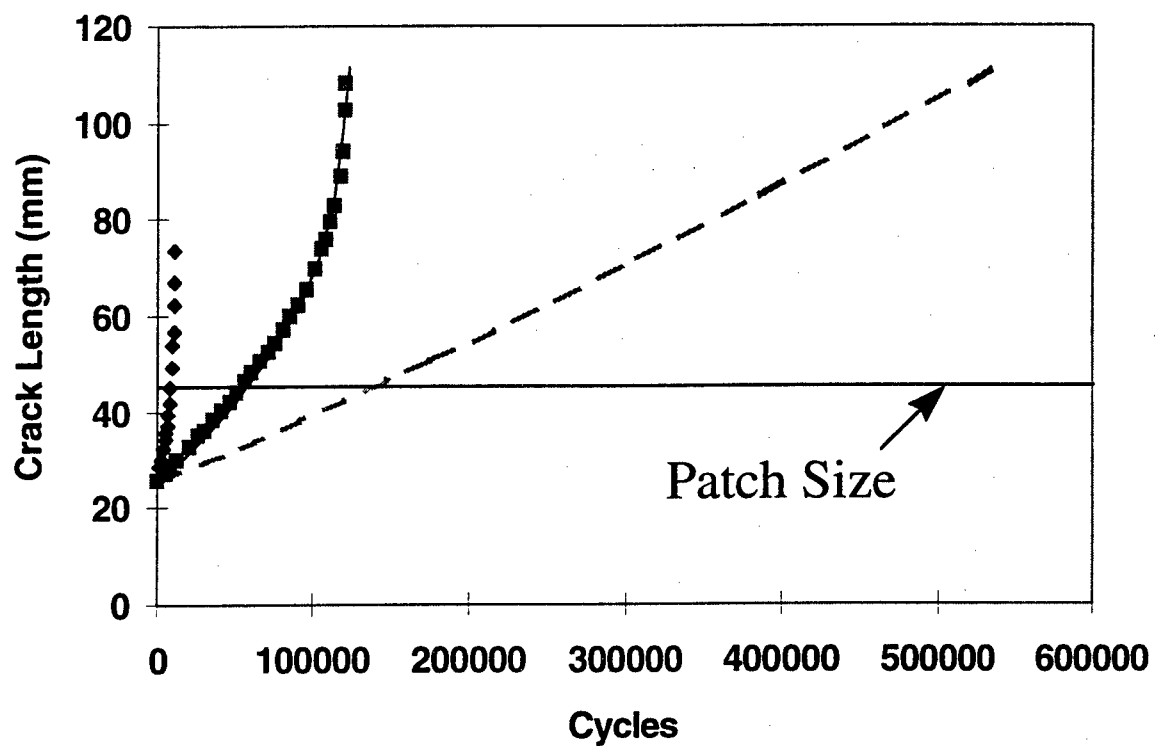
◆ Unpatched    ■ Perfect Patch    — FEAM Model    - - Rose's Model

Figure 7 Fatigue response based on FEAM and Rose's models.

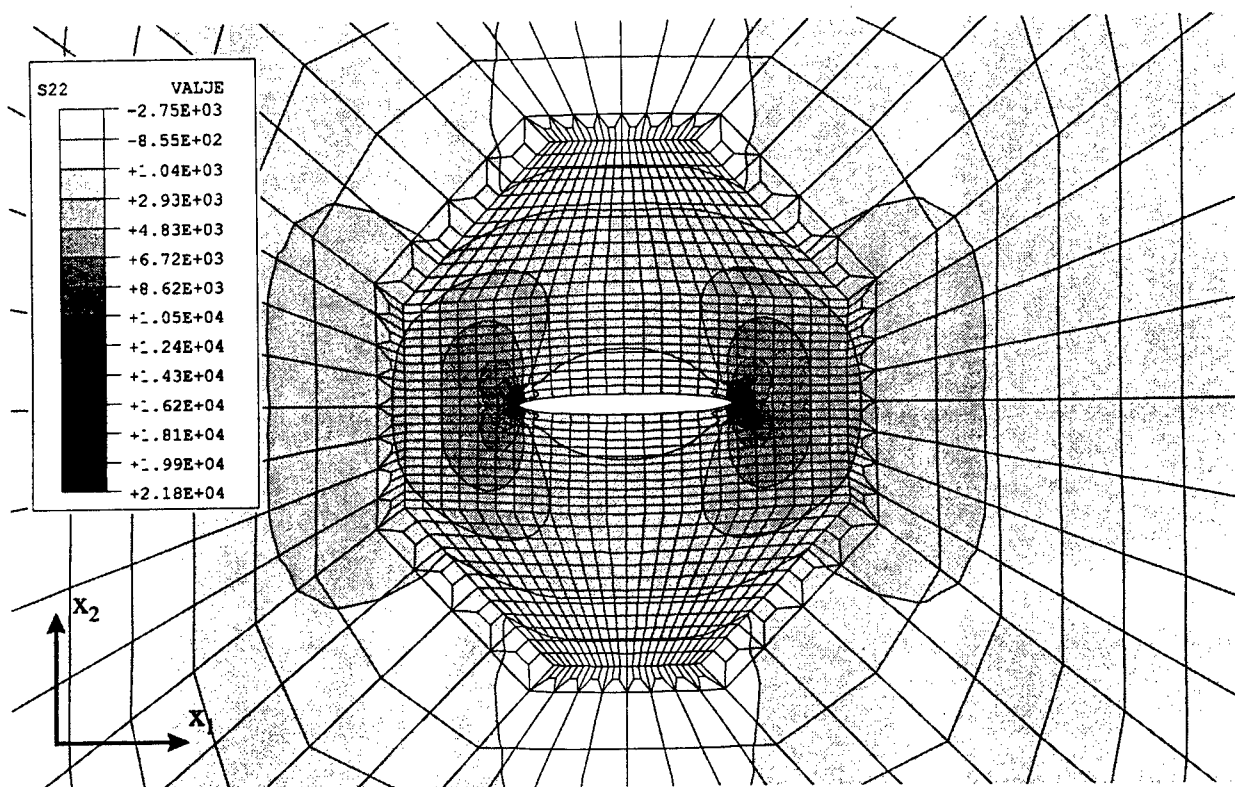
Figure 8 Contour plot of the residual stress,  $\sigma_{22}$ , due to the curing process.

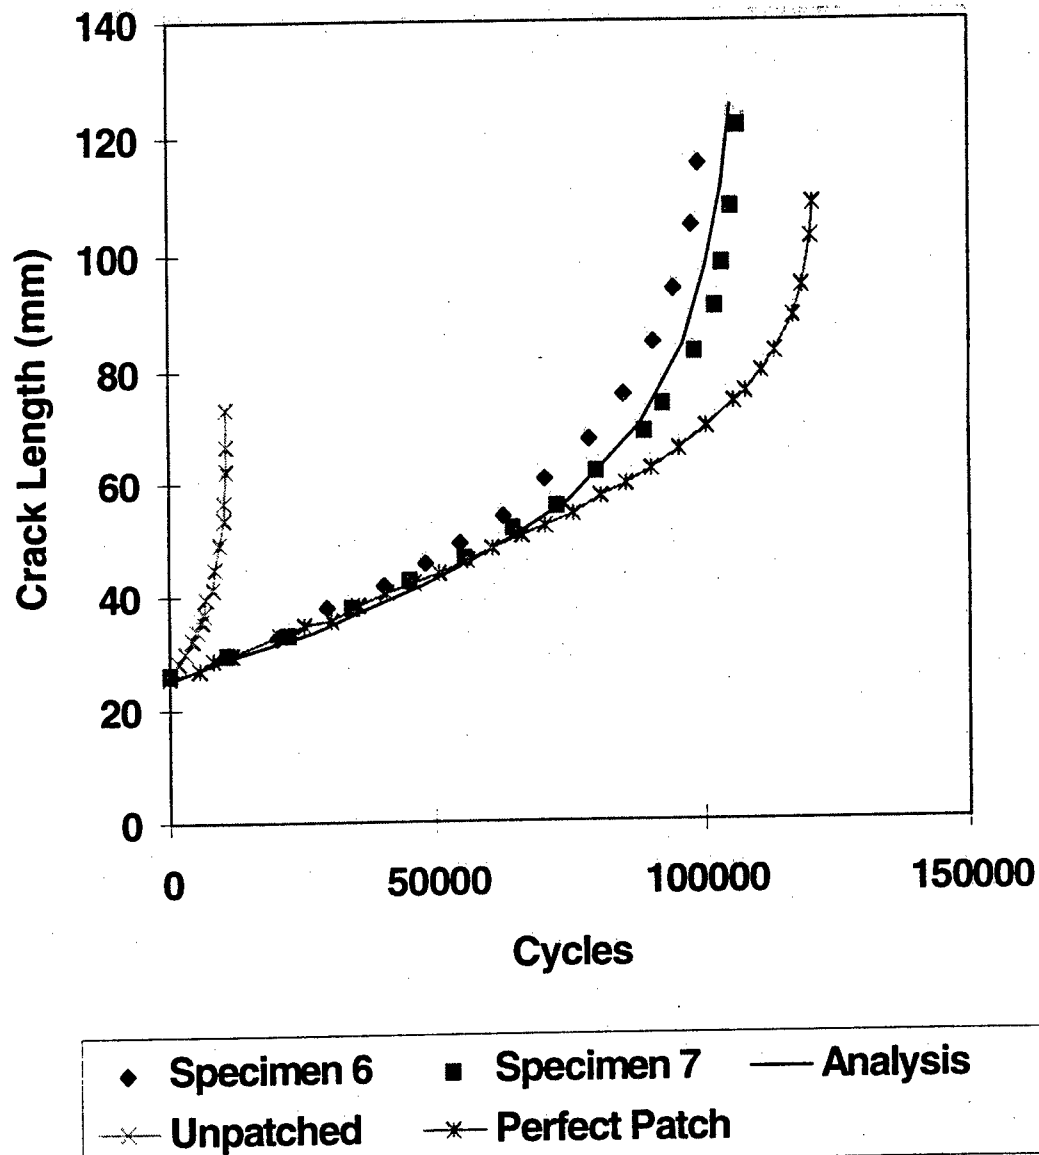
Figure 9 Comparison of numerical result with experimental data for Crack Tip Disbond (CTD)

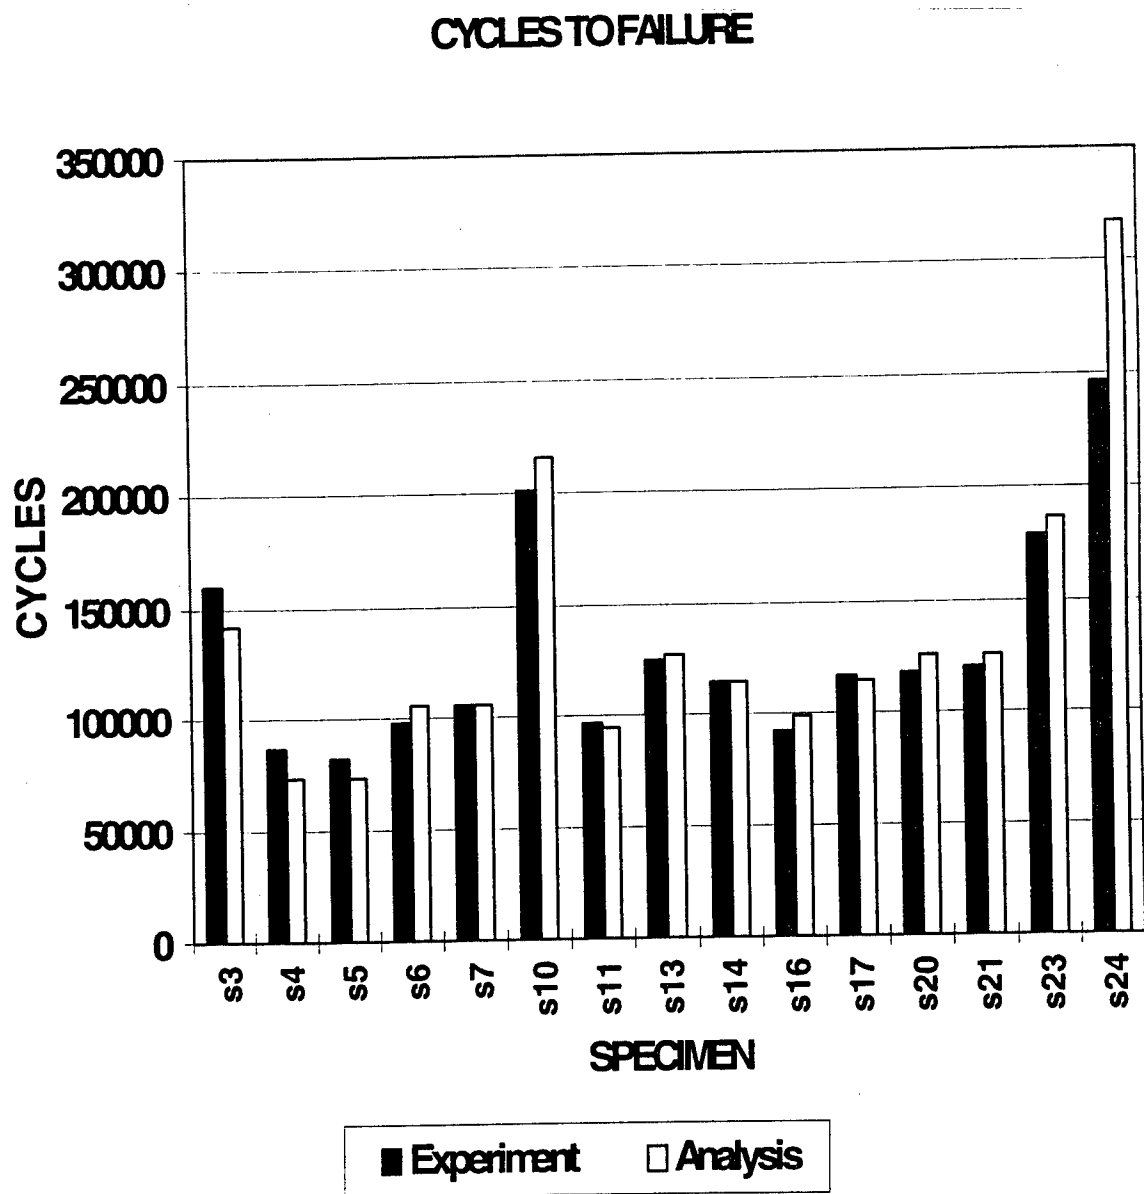
Figure 12 The predicted fatigue lifes against the experimental data.

To summarize the ability of finite element alternating method in predicting the fatigue response of partially bonded patch repair, the predicted results are displayed along with experimental data on a bar chart shown in Figure 12. The parameters that are varied in these specimens include the disbond shape, the disbond area, the initial crack length, the maximum applied stress, and the applied stress ratio. The details of each specimen are given in Table 2. Figure 12 shows that overall, FEAM can effectively predict the fatigue life of the aluminum panels with partial bonded composite patch. The overall error of prediction is found to be 7.5%.

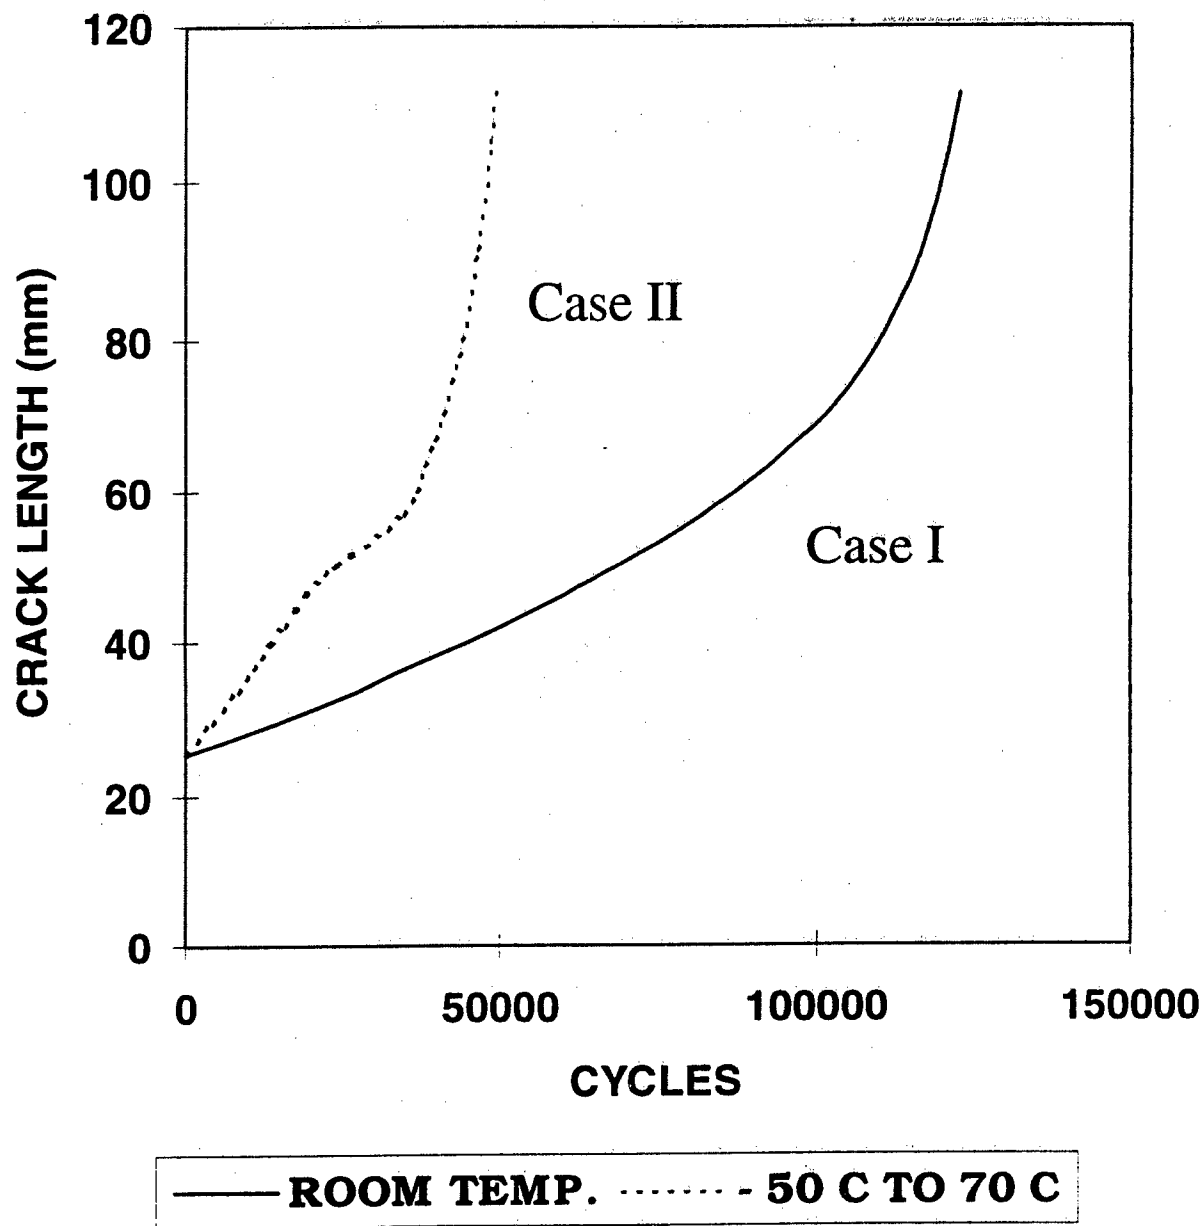
Figure 13 The fatigue response of a completely bonded patch (CBP) for Case I where the fatigue load is applied at room temperature, and Case II where the maximum load,  $\sigma_{max}$ , is applied at -50 C and the minimum load,  $\sigma_{min}$ , applied at 70 C.

In general, an aircraft would undergo a thermal cycle during each single flight. As the aircraft climbs to the cruising altitude, the air temperature can drop to less than  $-50^{\circ}\text{C}$ . However, when the aircraft is parked in a depot under a heated sun, the temperature can rise to  $70^{\circ}\text{C}$ . Since the boron/epoxy patch has a lower thermal expansion coefficient, the patch would contract much less than the aluminum panel when the air temperature drops. This induces a cyclic thermal tensile loading on the crack tip at a time when the mechanical stress is highest. In the current analysis, the sensitivity of the adhesive stiffness to the temperature is not considered, however as pointed out in the earlier section, the initial stresses due to the curing process (at  $121^{\circ}\text{C}$ ) are accounted for in this numerical model. Figure 13 shows the fatigue response of a completely bonded patch (CBP) for Case I where the fatigue load is applied at room temperature, and Case II where the maximum load,  $\sigma_{\max}$ , is applied at  $-50^{\circ}\text{C}$  and the minimum load,  $\sigma_{\min}$ , applied at  $70^{\circ}\text{C}$ . As shown in Figure 13, the fatigue life of the specimen undergoing the thermal cycles would be reduced by more than 60% when compared to the specimen loaded at room temperature. Furthermore, it was found that when crack tip disbond (CTD) is considered (where the disbond area is 20%), the fatigue life of the specimen undergoing the thermal cycles is further reduced by another 30% as shown in Figure 14. In contrast, the fatigue life of the CTD specimen loaded at room temperature is reduced by no more than 20% when compared with a perfect patched specimen. This model seems to indicate

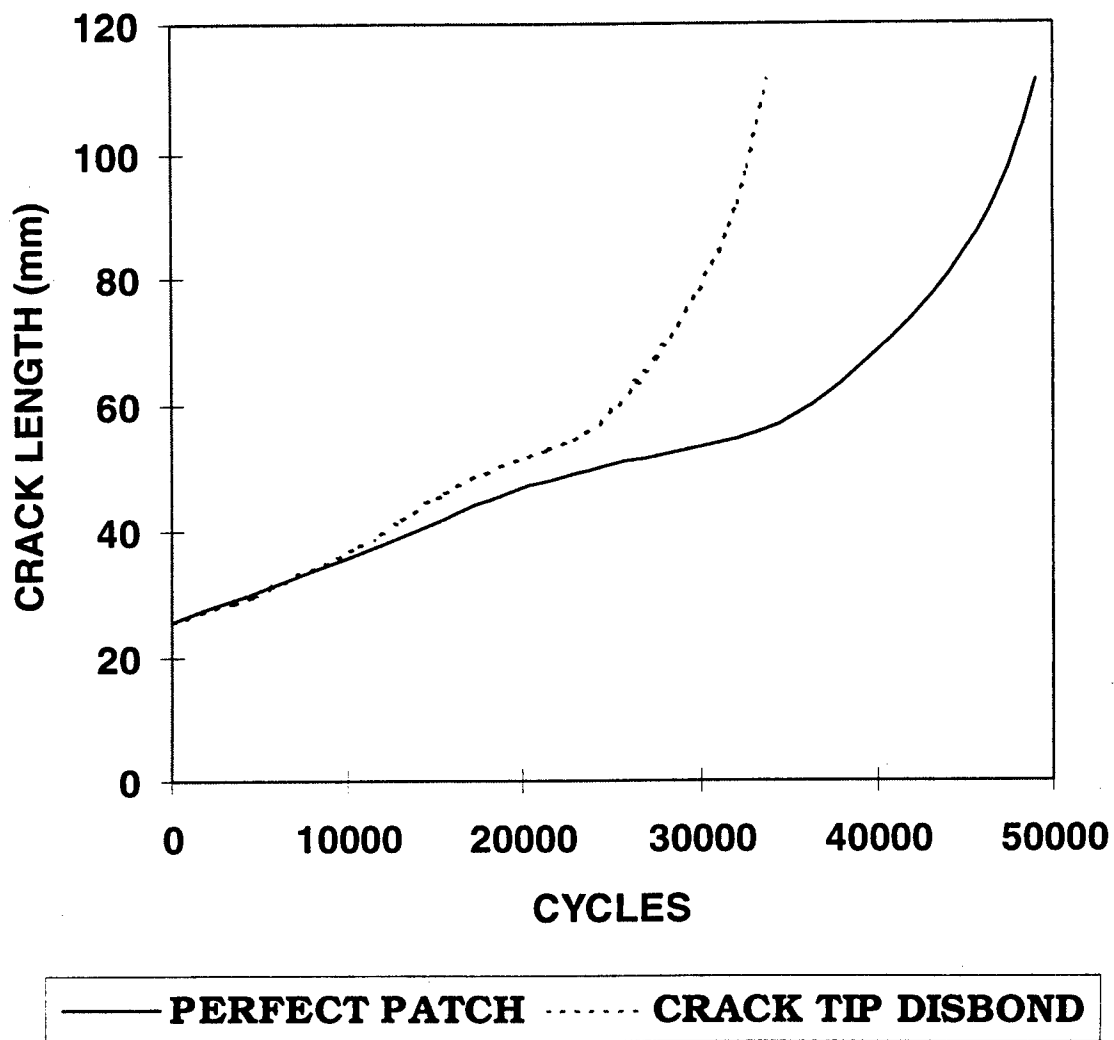
Figure 14 The fatigue life of the specimen undergoing the thermal cycles with Crack Tip Disbond (CTD).

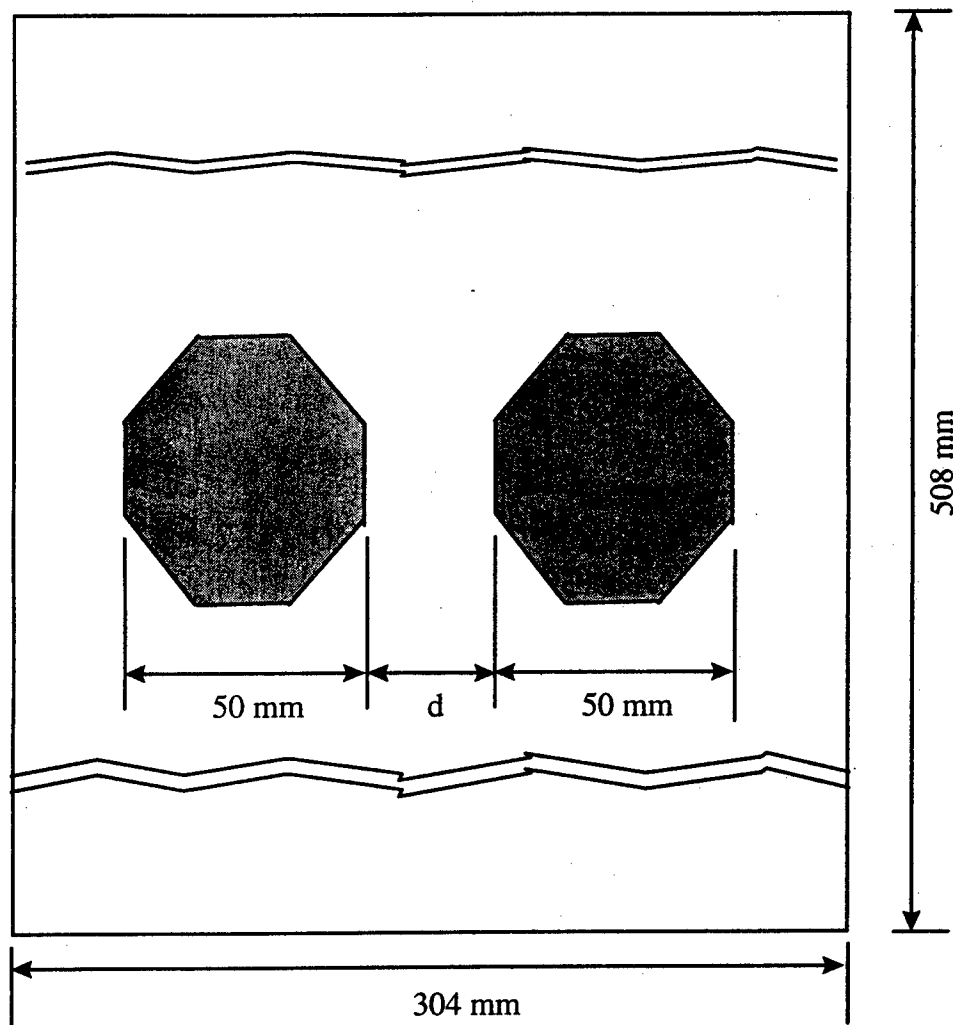
Figure 15 Geometry of the aluminum patch with two patches lying horizontally.

Given that cracks are sometimes found quite close to each other, it is important to study how two composite patches would interact with each other. In this paper, two types of patch interaction are considered. In both configurations, the two patches are considered to be perfectly patched. In the first configuration, both patches would lie on the same horizontal line as shown in Figure 15. When the patches are 100mm apart, there seems to be very little interactions between these two cracks. As shown in Figure 16, the fatigue response of the specimen with two patches is quite similar to the specimen with a single patch. When the distance between the two patches is reduced to 25mm, similar fatigue response is found in which there is very little interactions between these two cracks as shown in Figure 16.

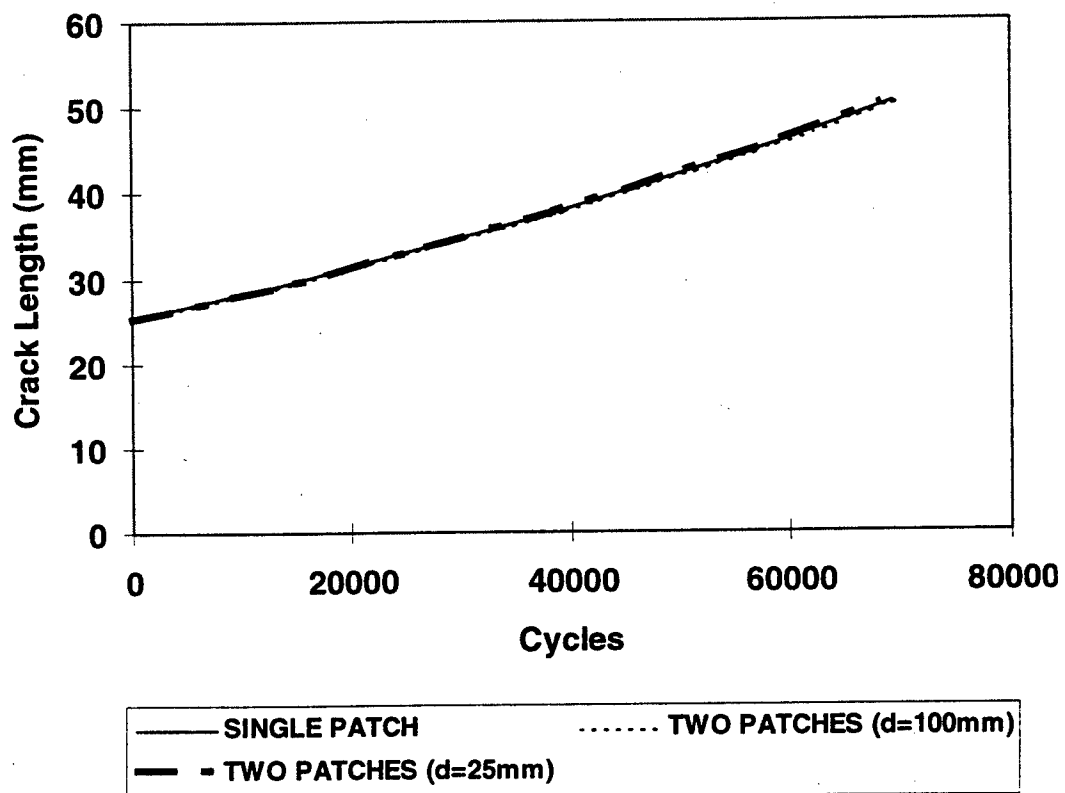
Figure 16 Interaction of two patches lying on a horizontal line.

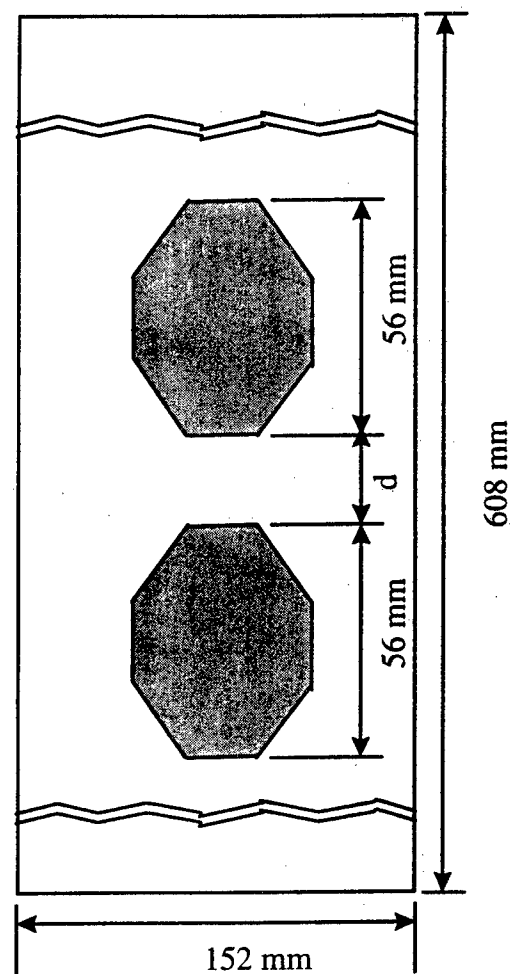
Figure 17 Geometry of the aluminum patch with two patches lying vertically.

In the second configuration, both patches would lie on the same vertical line as shown in Figure 17. When the patches are 100mm apart, there seems to be very little interactions between these two cracks as shown in Figure 18. However, when the distance between the two patches is reduced to 25mm, the fatigue crack growth is slowed by a factor of three as shown in Figure 18. Therefore, the specimen with two patches would have a longer fatigue life than the specimen with a single patch. However, it is possible that the metal in between the patches may fail in such situation; and this is not considered here.

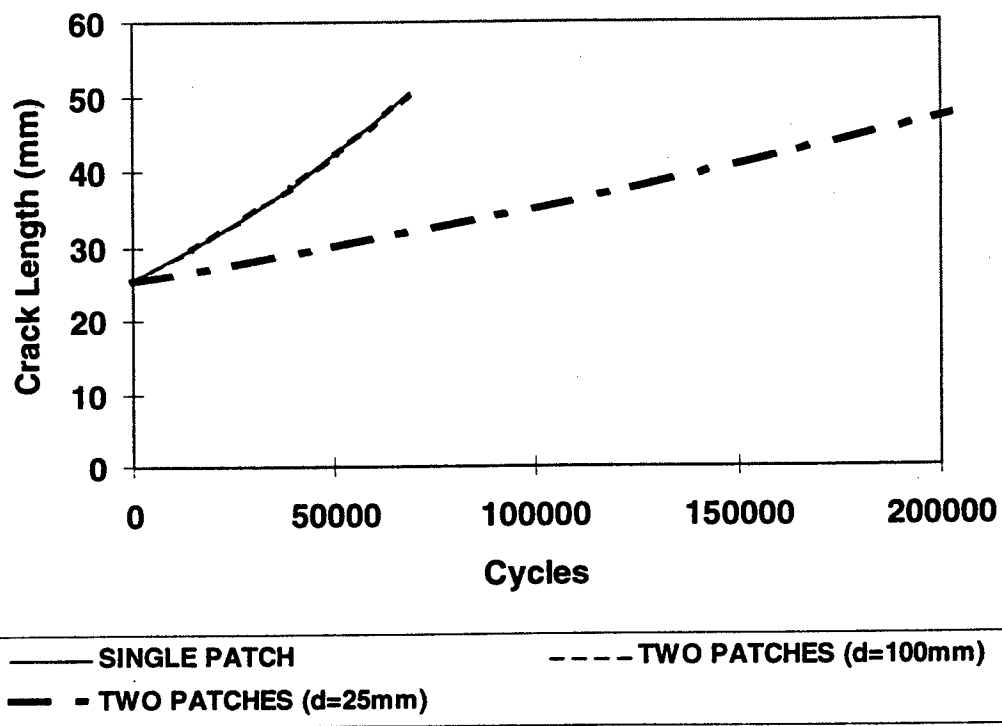
Figure 18 Interaction of two patches lying on a vertical line.
