**WL-TR-97-4054**

**PROCEEDINGS OF THE 1996 USAF  
AIRCRAFT STRUCTURAL INTEGRITY  
PROGRAM CONFERENCE**

**USAF Aircraft Structural Integrity Program Conference  
Hyatt Regency San Antonio  
San Antonio, Texas**

**FINAL REPORT FOR PERIOD 3-5 DECEMBER 1996**

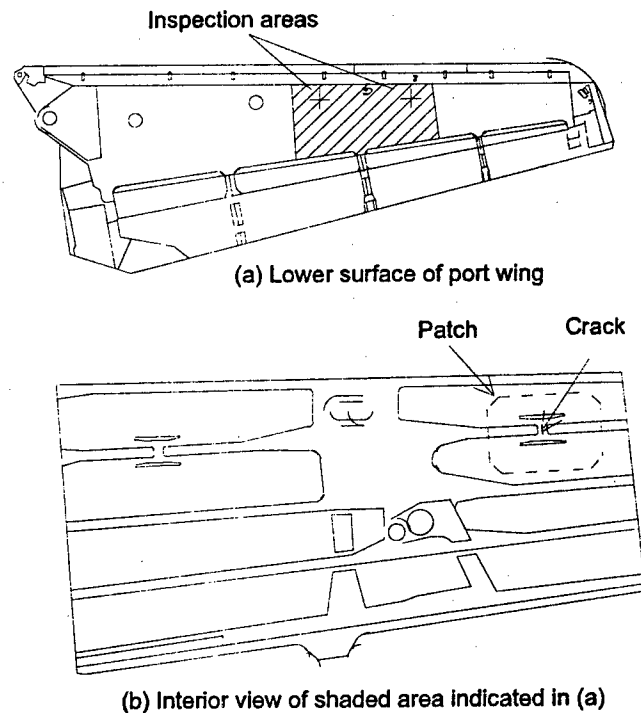
Figure 1 indicates the location of cracking on the lower wing-skin. The shaded areas indicate raised portions which serve as integral stiffeners and as attachment lands for the spars, McHenry et al. (Reference 4). The cracking occurred in an area lying below the forward auxiliary spar, at the spar station FASS 281.28, where the thickness of the integral stiffener is reduced from approximately 8 mm to the nominal skin thickness (at this location) of 3.7 mm (with the minimum acceptable thickness being 3.6 mm). The purpose of this depression in the stiffener is to allow full fuel flow and drainage between adjacent bays of the wing-box fuel tank. Two side-stiffeners are used to compensate for the loss of spanwise stiffness due to this fuel-flow passage, as indicated either side of the crack in Figure 1. The thickness variation in this region is more clearly illustrated in Figure 2. These geometrical features lead to a significant stress concentration factor and to out-of-plane secondary bending at the location of cracking, as discussed in Reference 5.

**Figure 1** Location of cracking on the F-111 lower wing-skin, at FASS 281, showing also the outline of the repair patch.

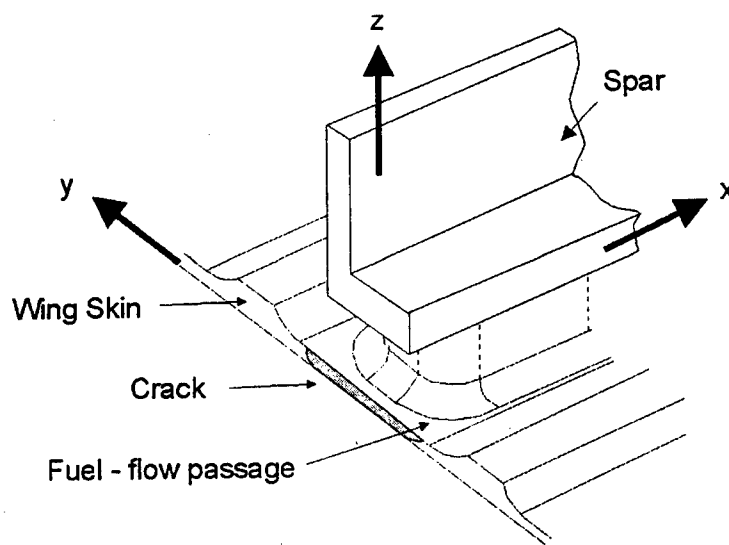
The cracking occurs in the chordwise direction, normal to the direction of the nominal principal stress at that location. The presence of secondary bending results in faster crack growth along the wing-skin's inner surface relative to its outer surface. This discrepancy between the surface traces is further accentuated by the residual compressive stress at the outer surface caused by shot peening which is done at manufacture. For the purposes of assessing the residual strength, however, it is convenient to assume a straight-fronted through-crack, as indicated by the shaded area in Figure 2. This leads to the residual strength estimate of 150 MPa cited earlier. This estimate is conservative in at least two respects. First, the effective toughness for the skin material (2024-T851 aluminium alloy, 3.6 - 3.8 mm thick, LT orientation) has been found experimentally (Reference 6) to be in the range  $57 - 62 \text{ MPa } \sqrt{\text{m}}$ , which is significantly higher than the handbook value assumed earlier. Secondly, the beneficial effect of the spar bridging the crack has been ignored in deriving this estimate.

**Figure 2:** Local cross section geometry of the wing skin in the vicinity of the fuel-flow passage, showing the location of cracking.

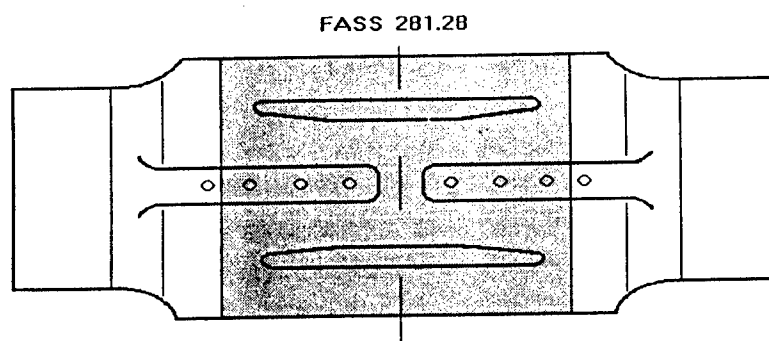
As detailed in References 8 and 9, three levels of structural testing were undertaken to substantiate the F-111 repair. The majority of the testing was performed on "panel" specimens and this paper concentrates on the panel specimen results. These specimens (working area approx. 300 mm x 190 mm) are intended to simulate the wing skin including the geometrical features shown earlier in Figure 2, *i.e.* an integral stiffener, machined out to provide a fuel-flow passage, with side stiffeners to restore the overall spanwise stiffness. The panels are wide enough that crack growth beyond the side stiffeners would not be significantly affected by edge effects, should crack growth occur after the application of patches to the (pre-cracked) specimens. Consistent with this width requirement, the panel specimens are also intended to be small enough to fit within a purpose-built environmental chamber providing a controlled temperature level. A sketch of the panel specimen is shown in Figure 3.

**Figure 3:** Panel specimen. View onto side representing upper surface of lower wing skin. Boron patch region is shown shaded.

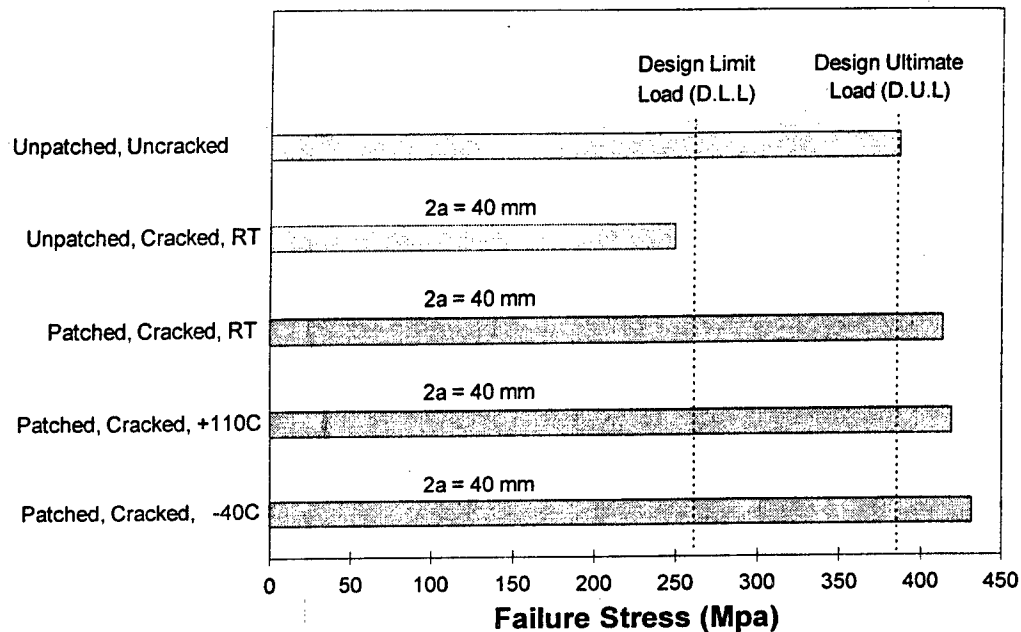
**Figure 4:** Results of static residual strength tests on panel specimens  
(RT : Room Temperature)

Figure 4 summarises the static strength results on the panel specimens. The residual strength (stress in MPa) is calculated as the failure load divided by the nominal cross sectional area ( $829 \text{ mm}^2$ , ignoring the patch and crack). Notable points are as follows:

- The residual strength in the presence of a 40 mm crack is degraded to below the Design Limit Load, confirming the fracture mechanics prediction mentioned earlier.
- The repaired panels all exceed DUL, with little effect noted between the different temperatures. The temperature gradient was such that the temperature on the specimen during the hot test (+110°C) ranged from 83.0°C to 119.4°C, and during the cold test (-40°C) from -16.3°C to -42.2°C. The maximum values were at the centre of the specimen due to heat transfer from the ends of the specimen into the grips of the testing machine. However, the hot test was repeated at a later date (August 1996) using a new environmental chamber. The specimen (FLTP-17) had already been used for fatigue loading (50,000 simulated flight hours) and the crack had grown to 69.4 mm. The

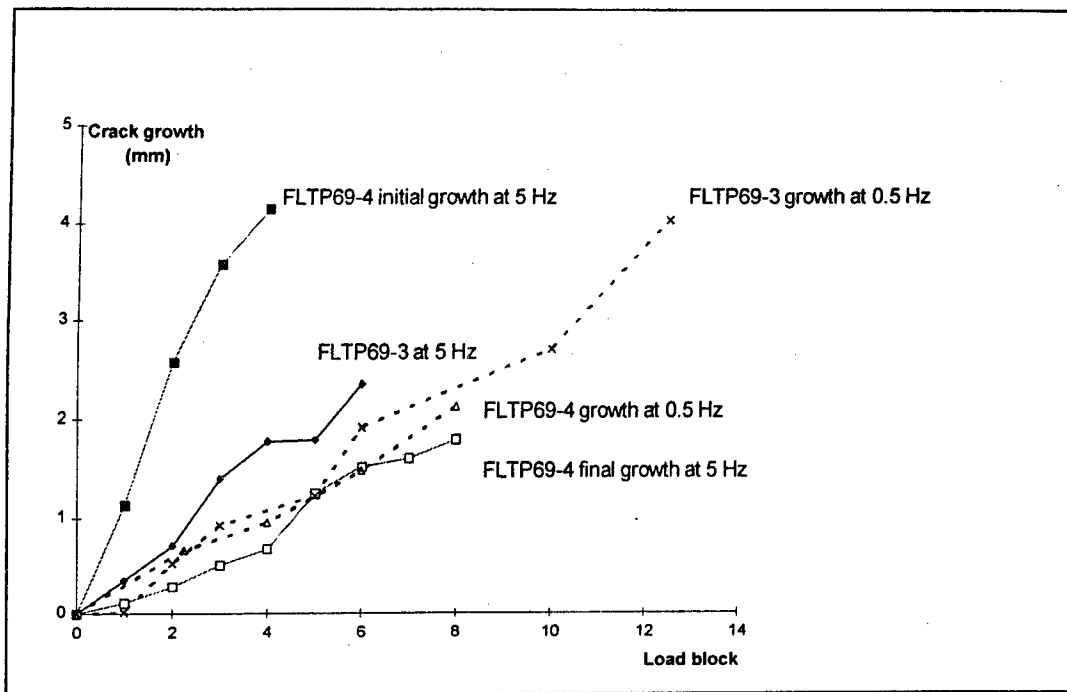
**Figure 5:** Panel Specimen crack growth comparisons at ambient temperature (end point is not necessarily the failure point)

Initial fatigue testing was performed on cracked, patched panel specimens tested at ambient conditions under a representative cycle by cycle spectrum at a frequencies of 3 and 5 Hz. Full details are given in References 8 and 9. The tests revealed an approximately constant crack growth rate of 0.7 mm per 1000 hours. Later testing investigated the effects of loading frequency and testing at a sustained, elevated temperature. Two frequencies were investigated (5 Hz and 0.5 Hz) and two temperatures (ambient and 80 °C). Crack growth results are shown in Figure 5 (ambient) and Figure 6 (80 °C). The specimens involved are numbered FLTP69-3 and FLTP 69-4. One load block represents 500 flying hours. The crack length and growth rates are always based on the total tip to tip length. The results of linear regression estimates of the growth rates from Figures 5 and 6 are summarised in Table 1.

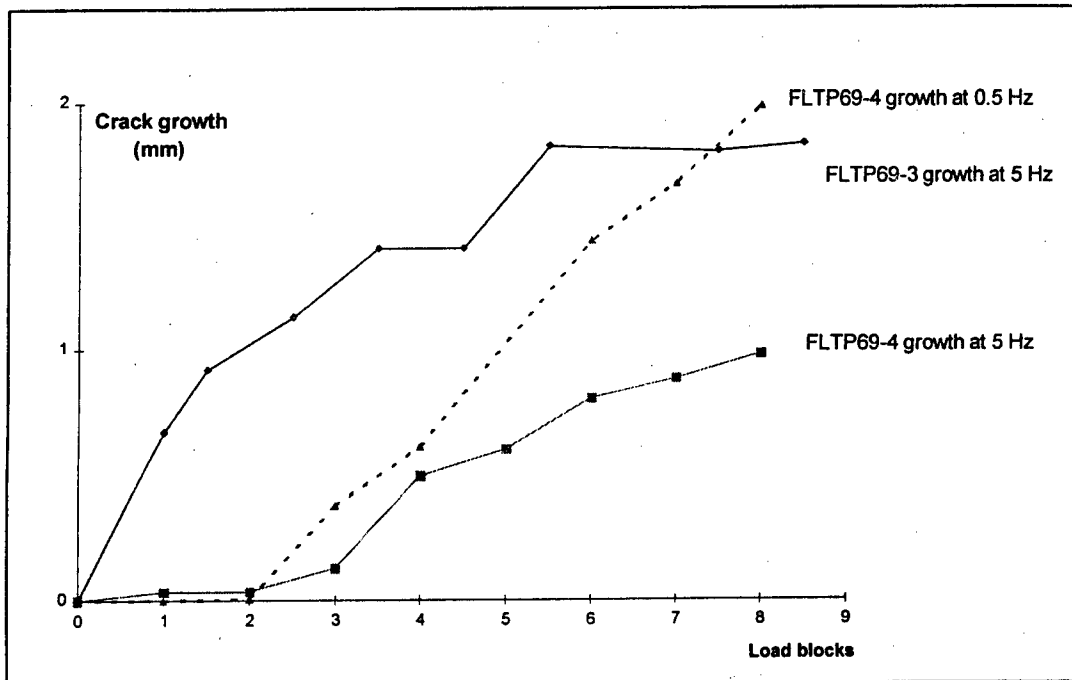
**Figure 6:** Panel specimen crack growth comparisons at 80 °C temperature (end point is not necessarily the failure point)

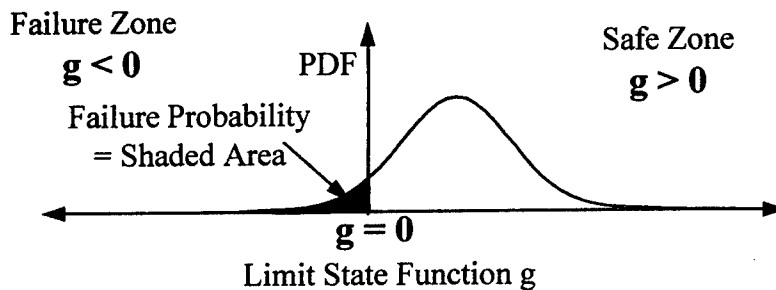
## DEFINITION OF LIMIT STATE FUNCTION (OR SAFETY MARGIN)

**LIMIT STATE FUNCTION  $g$  =**  
*RESIDUAL STRENGTH AT CURRENT TIME -*  
*CRITICAL RESIDUAL STRENGTH*

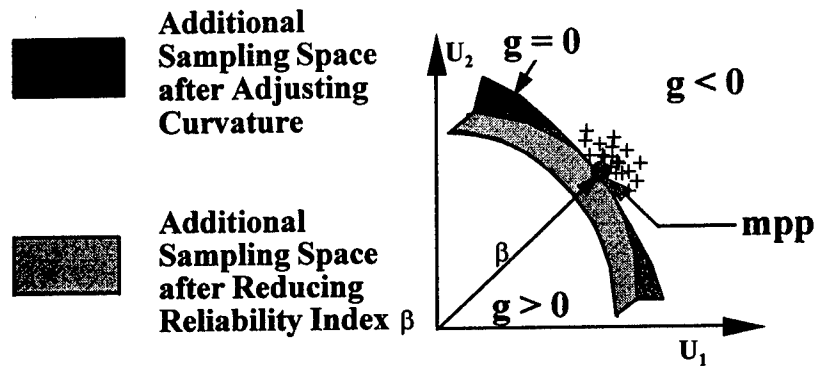
## Adaptive Importance Sampling (AIS) (mpp-based)

mpp: most probable (failure) point

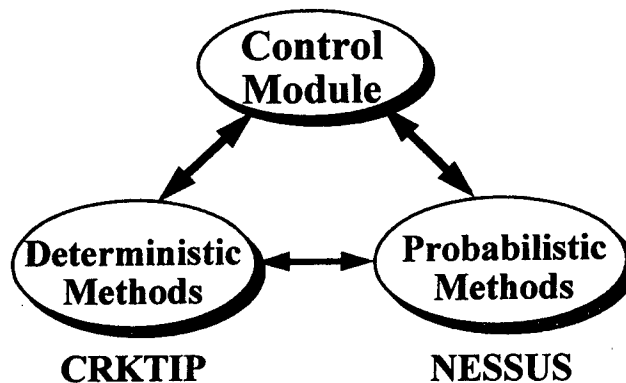
## An Integrated Computer Code for Probabilistic WFD Analysis

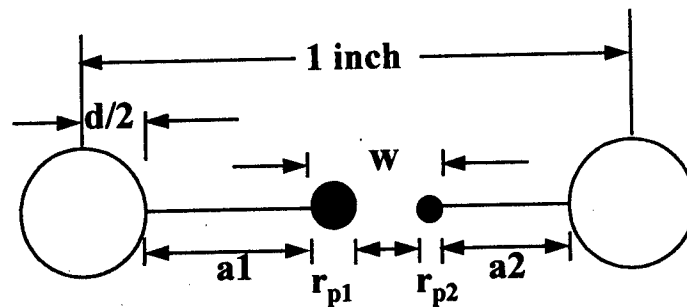
## Local Instability/Crack Linkup

$$w = 1.0 - d - a1 - a2$$

$$w = r_{p1} + r_{p2}, \text{ linkup occurs}$$

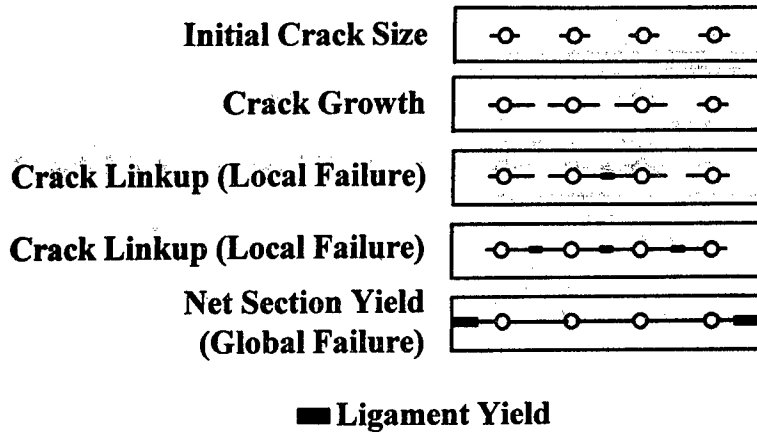
# Deterministic Analysis of A Flat Panel with WFD

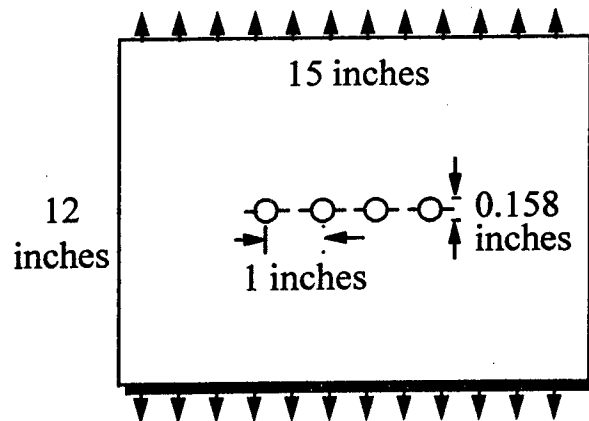
## Flat Plate with Open Holes (Case I)

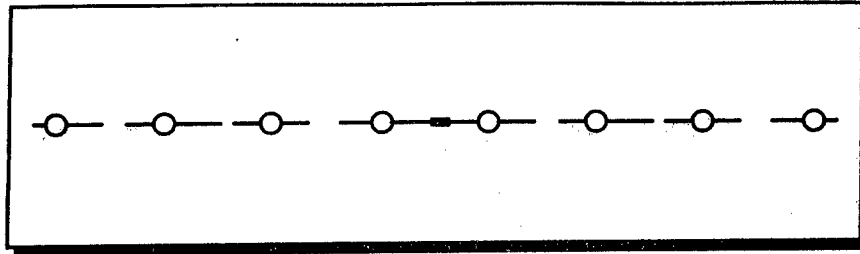
## Configuration for First Linkup (Local Failure)

■ Ligament Yield

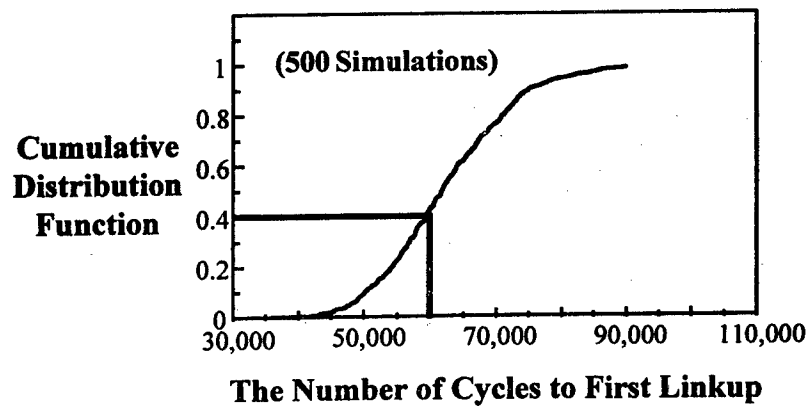
## Cumulative Distribution Function of Number of Cycles to First Linkup

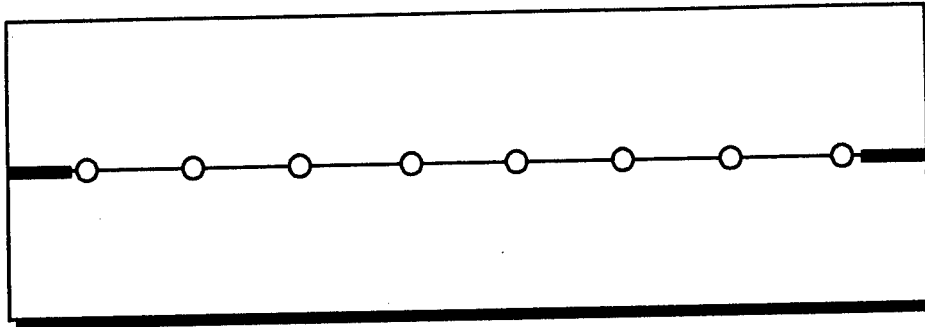
## Configuration for Net Section Yield (Global Failure)

■ Ligament Yield

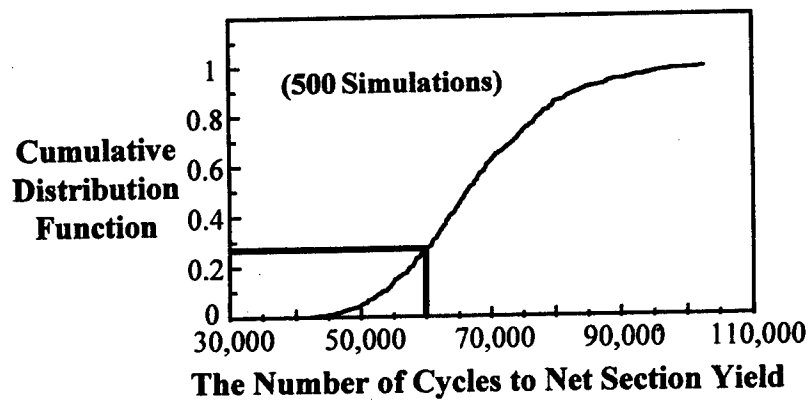
## Cumulative Distribution Function of Number of Cycles to Net Section Yield

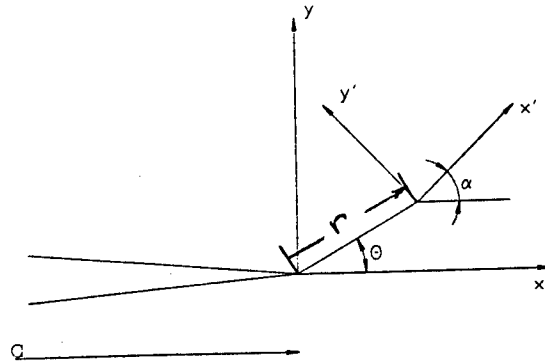
By considering the orientation of the strain gages at an arbitrary angle  $\alpha$  according to the coordinate transformation presented in figure 2, some of the terms in the strain field representation can be eliminated.

Figure 2. Coordinate system used in described crack, strain gage geometry.

The strains related to the rotated coordinate system shown in figure 2 are determined from the first invariant of strain,

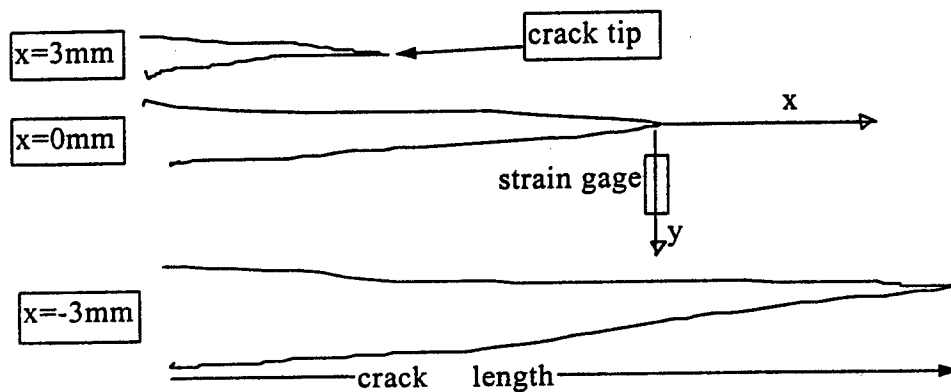
Figure 3. Strain gage location in  $y$  direction (parallel to the crack) as a function of the crack length.

The validity of the above-described analysis can be verified using the steps described in the approach. With the strain field described by equations (4) and a single strain gage, as shown in figure 3, in the vicinity of the crack tip, the strains of model and experiment can be compared. With increasing crack length, the strain results should show a similar trend.

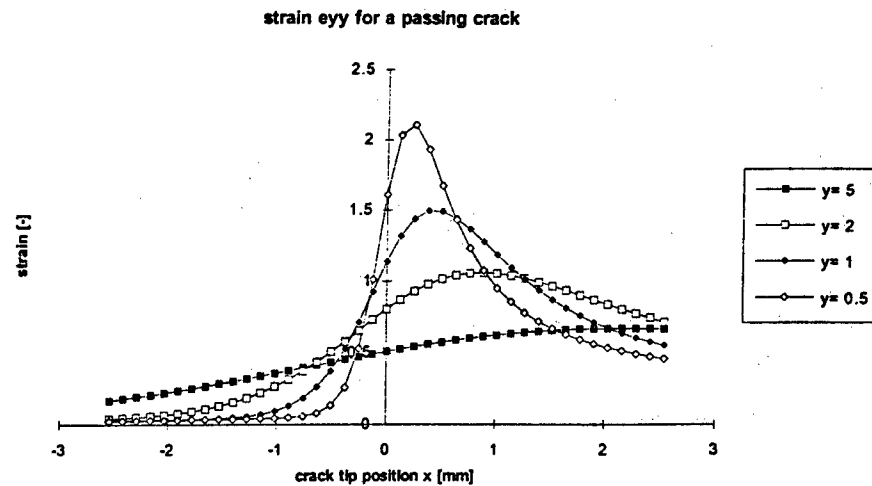
Figure 4. Strains parallel to the crack flank as function of crack length.

The analytical results for the strains at a fixed location as a function of the crack length can be determined from figure 4.

As crack length increases, the strain will increase to a maximum when the crack tip is close to the gage. However, the maximum is not achieved when the crack is just in line with the gage. The vertical displacement of the gage from the crack alters the trend, resulting in the maximum strain being displayed 2 mm before the crack tip is in line with the gage, both according to the prediction and measurement. If the same results can be obtained with strains underneath patches, the complex higher order equations remain valid to describe the stress field. A similarity approach is used: similar strains, K values, and crack opening displacements imply similar crack growth rates. Moreover, this experiment demonstrates that both the location of the crack and the onset of crack extension can be determined using strain gages.

Figure 4 demonstrated the change in theoretical strain as crack tip location changes with respect to the strain gage, while figure 5 compares experimental results with the theoretical curve for a single gage location ( $y = 4.2$  mm).

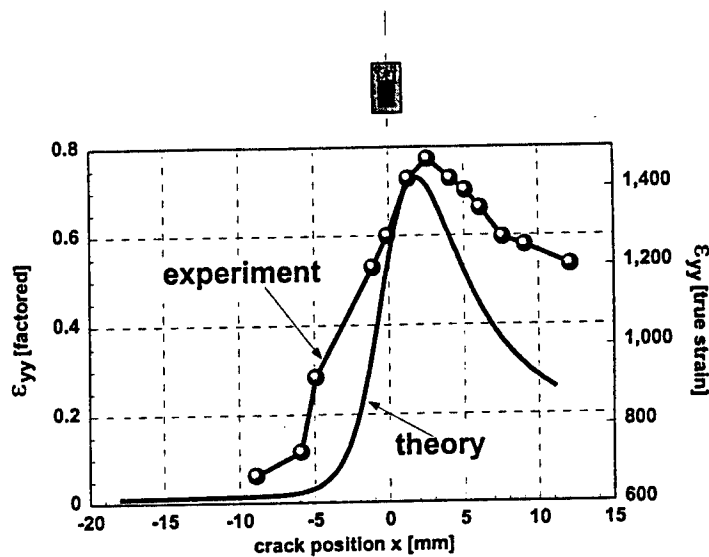
Figure 5. Strain  $\epsilon_{yy}$  in the vicinity of a crack tip as function of the crack position.

Both curves display the same order of magnitude and trend (curve shape). This approach is used to validate the use of the K-approach with strain gages underneath a patch, but this strain gage measurement also can locate the crack tip with respect to the gage: if the strain is increasing, the crack tip is approaching the gage, while if the strain is decreasing, the crack tip has already passed the gage. Considering the valid ranges for this strain approach, the closest possible location to the crack should be chosen. Gages must be located close to the crack tip for optimum results, without violating the Zone I/Zone II boundary at half the sheet thickness from the crack tip, as introduced in the theory.

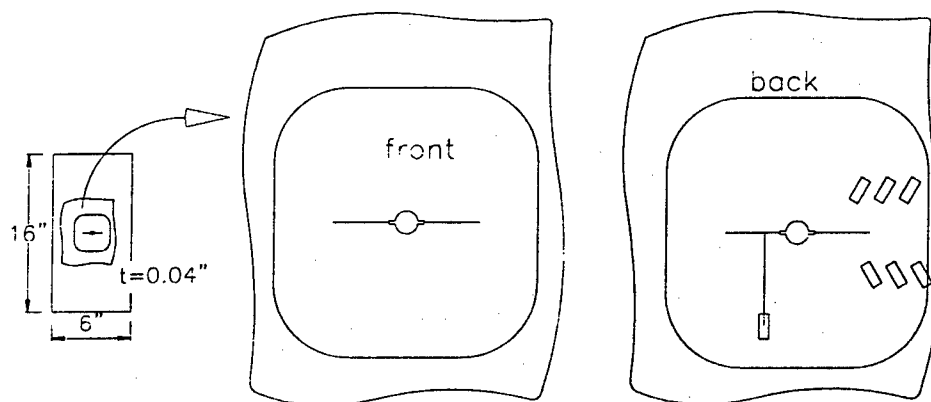
Figure 6. Schematic representation of single-sided repair and strain gages for stress intensity measurements ( $\theta = \alpha = 60$  degrees, strain field analysis gage  $\perp$  crack).

The strain gage analysis was verified using a center-cracked aluminum alloy 2024-T3 alclad sheet 1.0 mm (0.040 inches) thick with length by width dimensions 500 x 152 mm (20 x 6 inches). An equivalent stiffness, rectangular glass/epoxy/aluminum composite doubler 1.1 mm (0.044 inches) thick with length by width dimensions 92 x 77 mm (3.6 x 3.0 inches) was adhesively bonded over the crack using a rubber-toughened epoxy film cured at 120°C (250°F). Six strip gages were used and interpolation of the strains at the gages was performed. The strip gages had grid dimensions of 0.062", type EA-13-062MW-120 and were installed along the  $\theta = \alpha = 60^\circ$  line, as shown in figure 6. Static strain measurements were taken from 0 to 105 MPa uniaxial tension.

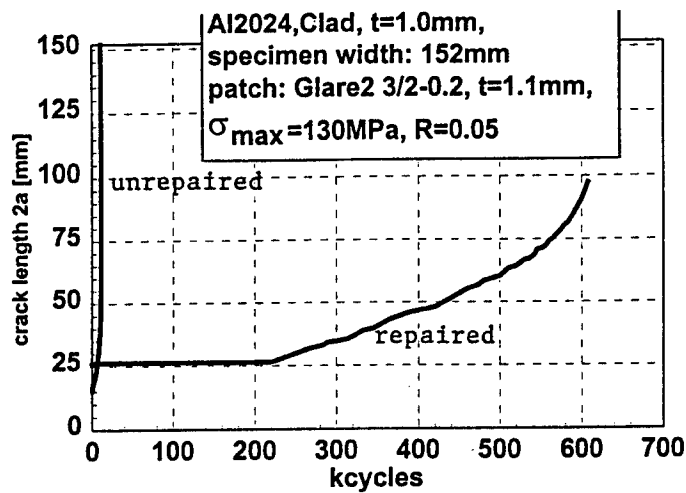
Figure 7. Repaired and unrepaired constant amplitude fatigue crack growth curves.

Properly designed bonded composite repairs can increase the life of cracked components by two or three orders of magnitude. Figure 7 shows results of two typical constant amplitude fatigue tests carried out in support of this paper. Test conditions were as follows:  $\sigma_{\max} = 130$  MPa,  $R = 0.05$ , room temperature,  $f = 10$  Hertz. In the repaired case, 200,000 fatigue cycles passed without any crack growth, followed by several hundred thousand cycles of very slow crack growth.

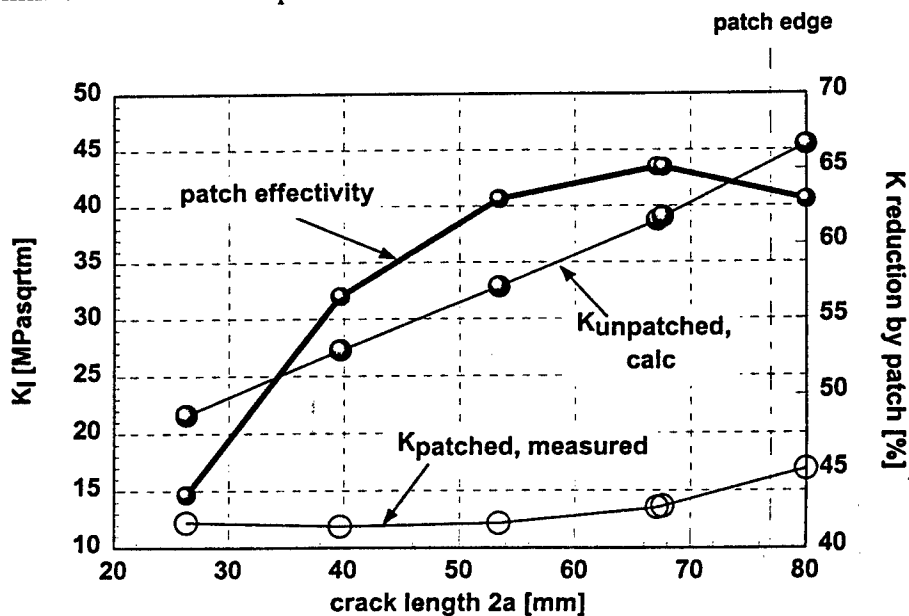
Figure 8. Reduction in stress intensity due to the application of a bonded repair.

Figure 8 shows the measured reduction in  $K_I$  achieved by applying a bonded repair to the cracked adherend. Static strain measurements were taken at six separate crack lengths from 25 to 80 mm. Strip gages containing five grids at 1.3 mm (0.050 inch) pitch were used. The gages were 1.6 mm (0.062 inches) long and the first gage was placed 5 mm from the crack tip.

Figure 8 clearly shows the significant reduction in  $K_I$  that accompanies the bonded repair. With increasing crack length,  $K$  remains constant until the crack length reaches about 80% of the patch width. (No data were taken for cracks shorter than  $2a = 25$  mm.) Although  $K_{\text{apparent}}$  (measured by the strain gages) remained constant, the absolute reduction in  $K$  increased as the crack grew longer. With increasing crack length, the patch bridges the crack more efficiently because of larger restraint on crack opening displacement. Once the crack approached the edge of the repair,  $K$  was still reduced significantly, but by a smaller percentage.

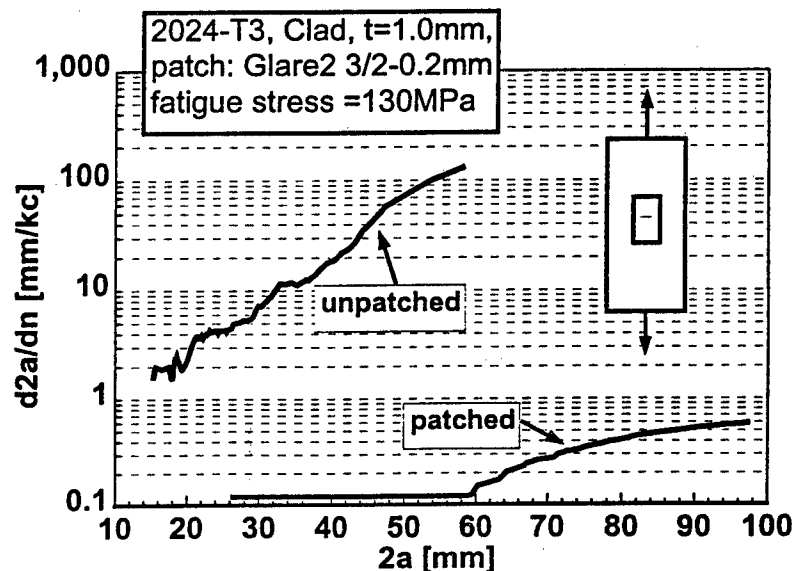
Figure 9. Plot of repaired and unrepaired crack growth rates versus crack length.

The measured crack growth rates are shown in figure 9, where  $d(2a)/dN$  is plotted as function of the crack length. A constant crack growth rate ( $d2a/dN = 1.2 \times 10^{-7}$  m/cycle) is clearly evident up to  $2a = 60$  mm. This crack growth rate corresponds to an effective  $\Delta K$  value (based on observed crack growth rate) of between 7 and 9  $\text{MPa}\sqrt{\text{m}}$  (from [12] and the authors, respectively). The apparent  $\Delta K$  values (experimentally measured with strain gages) were  $13.0 \pm 0.3 \text{ MPa}\sqrt{\text{m}}$  over the range  $25 \text{ mm} < 2a < 60 \text{ mm}$ .

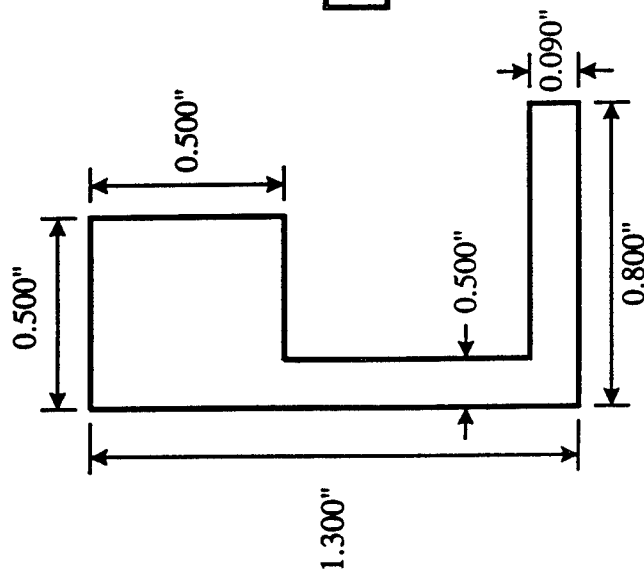
# Extruded stiffener detail before and after installation

Original extruded cross section  
(prior to finish machining)

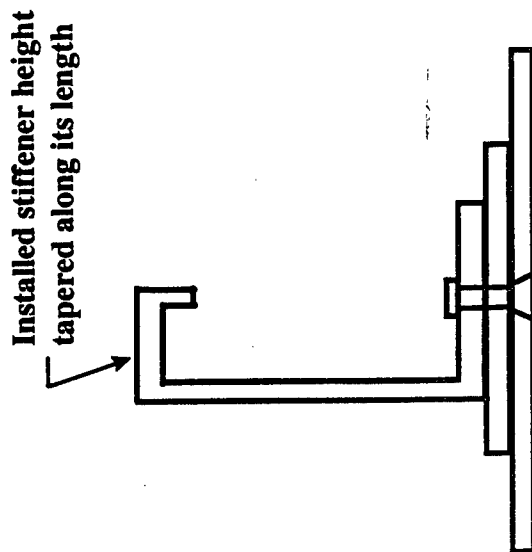
Stiffened design detail with  
machined stiffener installed

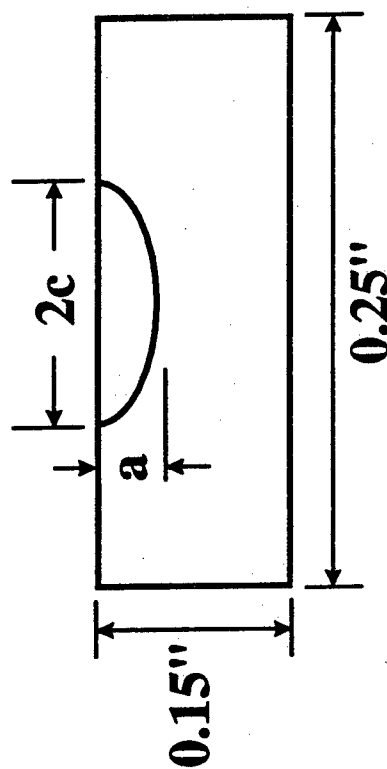
Assumed equivalent initial flaw geometry  
(equilibrium shape:  $a/2c = 0.3$ )

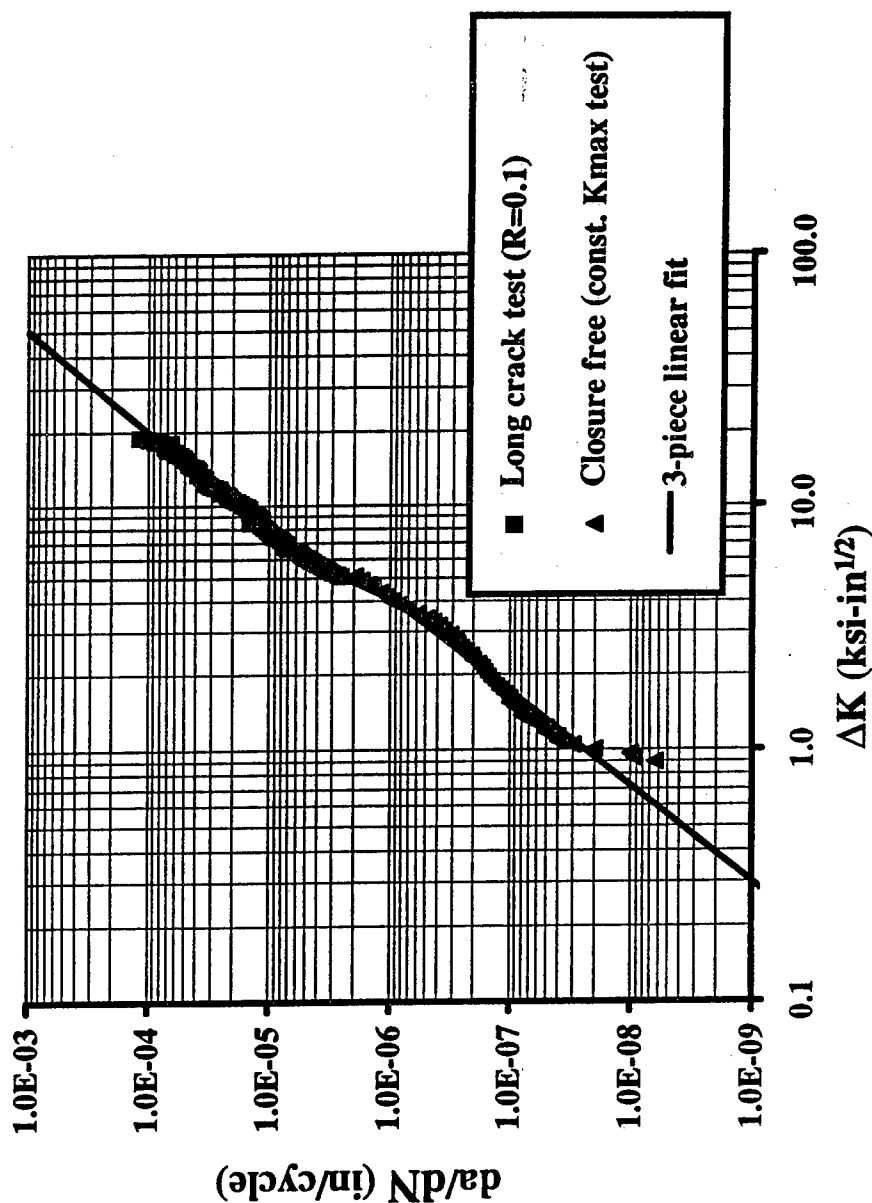
# FCGR law built from splice of closure free and conventional long crack data.

7150-T77511 Extrusion, L-T test direction

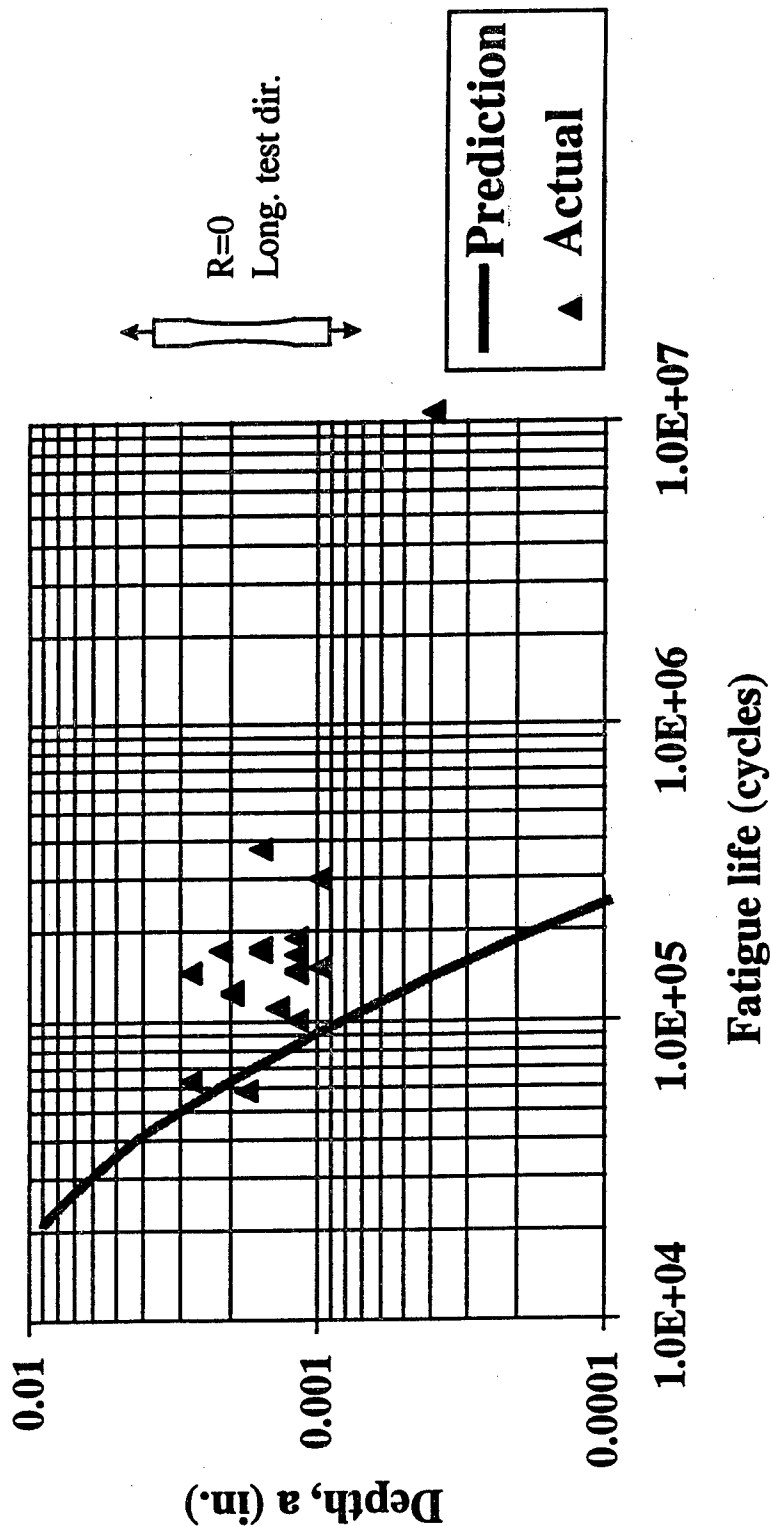
# 30 ksi: microfeature depth vs. cyclic life

7150-T77511 extrusion with surface IGC

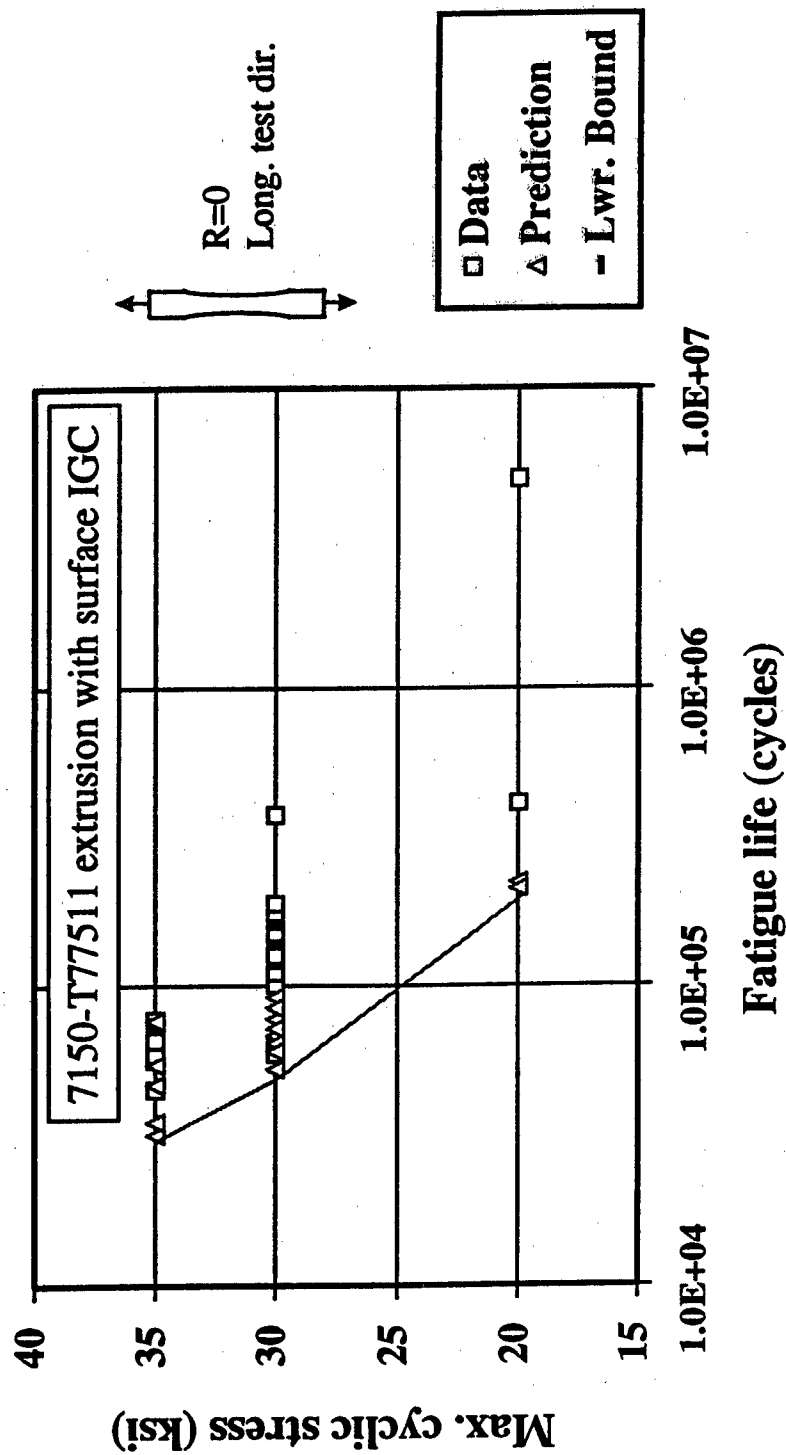
S-N test results compare favorably with the equivalent initial flaw based predictions.

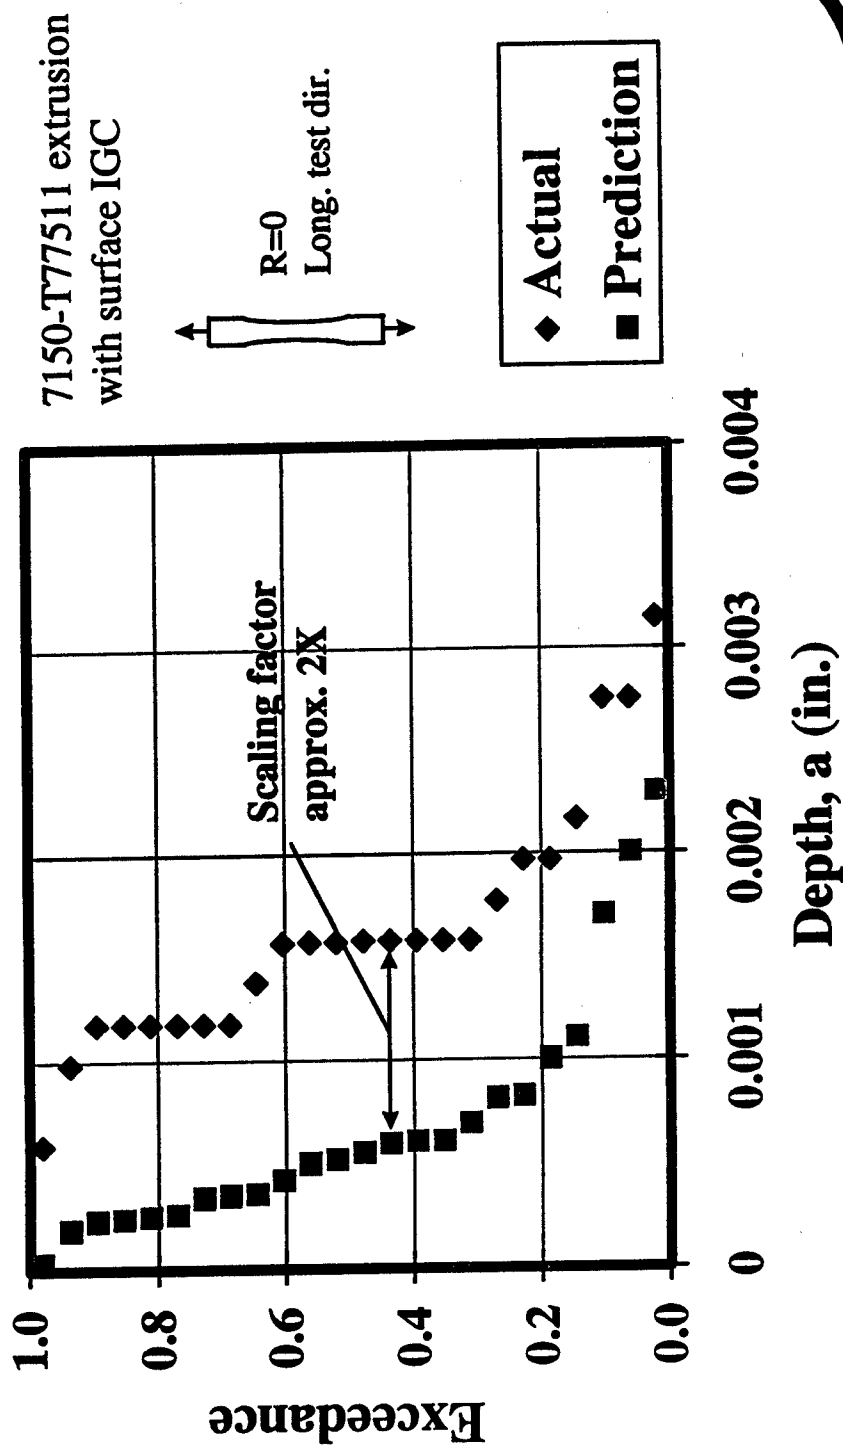
Backcalculation from coupon tests offers a means to reduce cost of generating life-limiting microfeature population data.

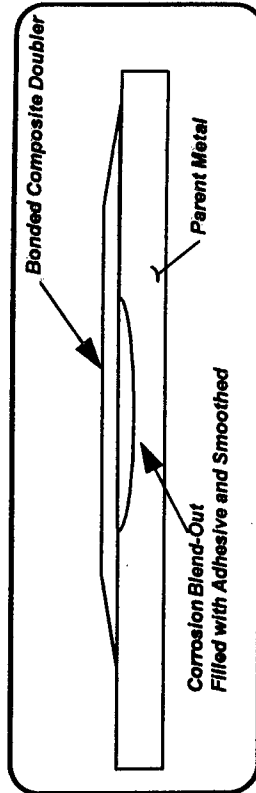
### ◇ Filled Repairs

- Comparable to Metallic Repairs but Without the Added Burden of Holes Etc.

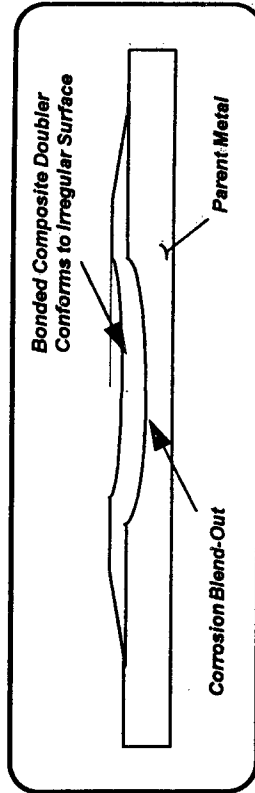
### ◇ Conformal Repairs

- No Direct Comparison With Conventional Repair Techniques
- Reinforcement Molded to Irregular Shape of Grind-out

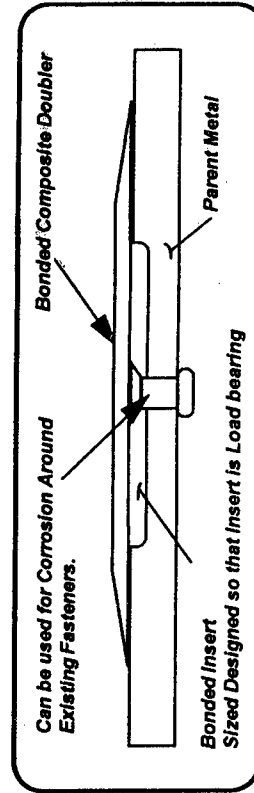
### ◇ Insert Repairs

- Structural Load Bearing Insert
- Extends the Capability of the Bonded Repair Into Thicker Sections

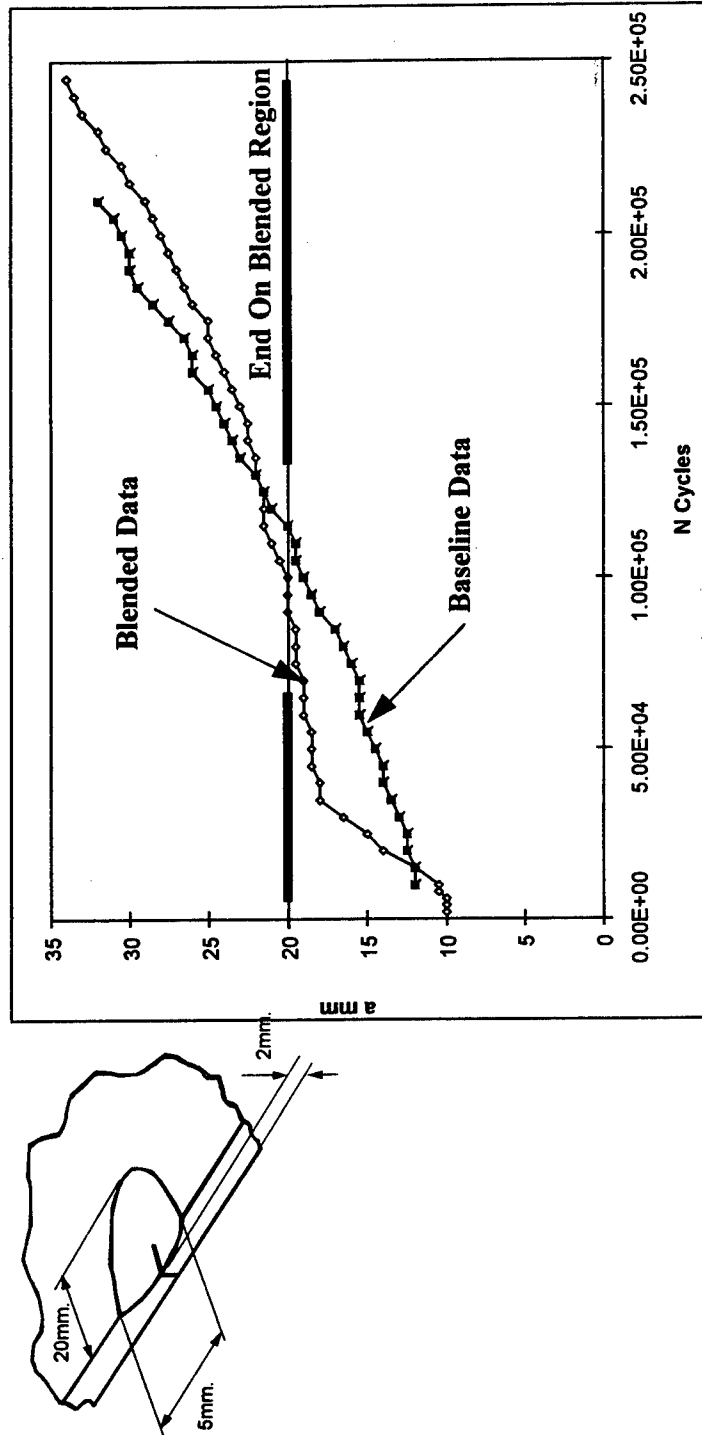
## Crack Growth Test Results

- Crack Growth Rate Effected Only in The Blend-Out Region
- Stable Predictable (Comparable) Crack Growth Outside of Blend Region

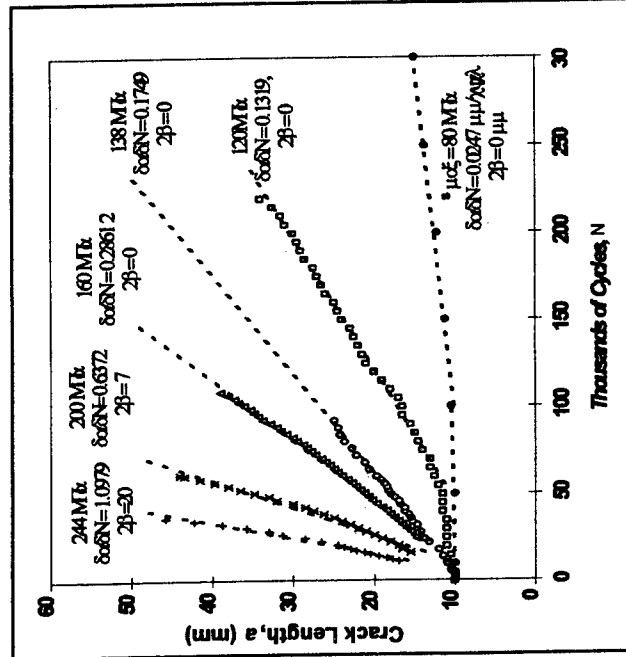
## AMRL Crack Growth Prediction Studies

- Crack Growth Independent of Crack Length

$$a = A_R \int_0^N (\Delta K_\infty)^{n_R} dN$$

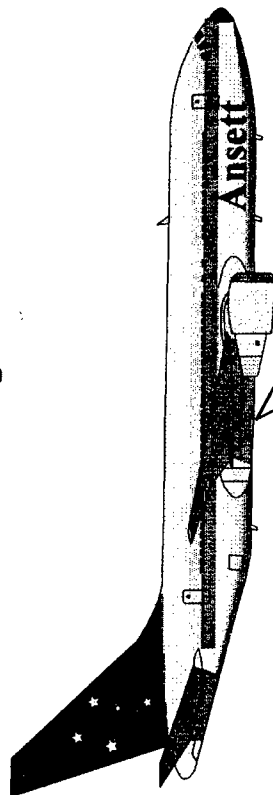
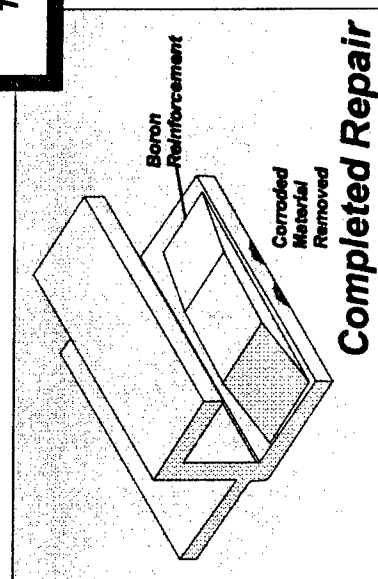
## Case Study #2 : B-767 Keel Beam

- ◆ Problem:
  - Severe Pitting Corrosion
- ◆ Solution:
  - Boron/Epoxy Reinforcement
  - Beam Replacement the Only Alternative

One Day Downtime  
Vs  
Three Weeks

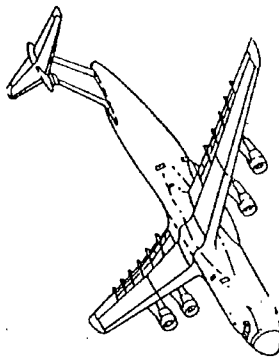
Before

Grind Out Through Skin  
@ Lift Point

0.040" Grind-out  
@ Lift Point

Surface Grind-outs  
0.030" 3 Places

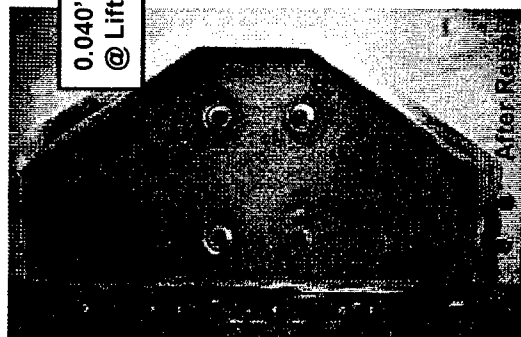
After Repair

- 5 Boron/Epoxy Bonded Repairs
- Design, and Installation in 10 Days

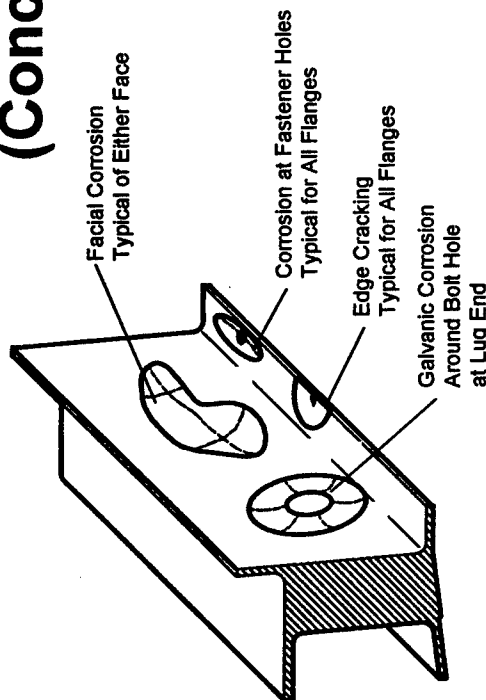
General Damage Description on Keel Beam Chord

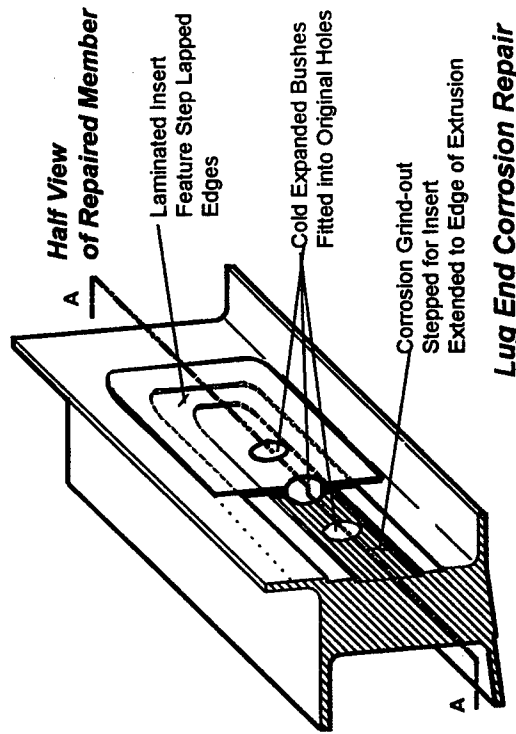
Lug End Corrosion Repair

- **Problem**
  - ◇ Corrosion Beyond Allowable Limits
- **Solution**
  - ◇ Bonded Insert Repair
  - ◇ In-Situ Application

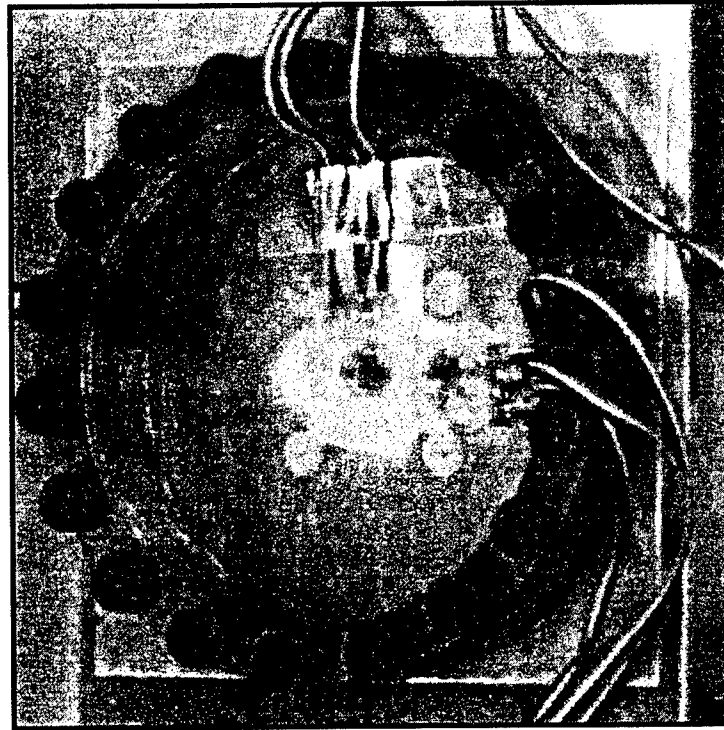
## ***Corrosion Pillowing Model Verification***

- four countersunk rivets
- 0.040" thick top skin
- hydraulically pressurized
- strain gauged
- shadow moiré
