**WL-TR-97-4054**

**PROCEEDINGS OF THE 1996 USAF  
AIRCRAFT STRUCTURAL INTEGRITY  
PROGRAM CONFERENCE**

**USAF Aircraft Structural Integrity Program Conference  
Hyatt Regency San Antonio  
San Antonio, Texas**

**FINAL REPORT FOR PERIOD 3-5 DECEMBER 1996**

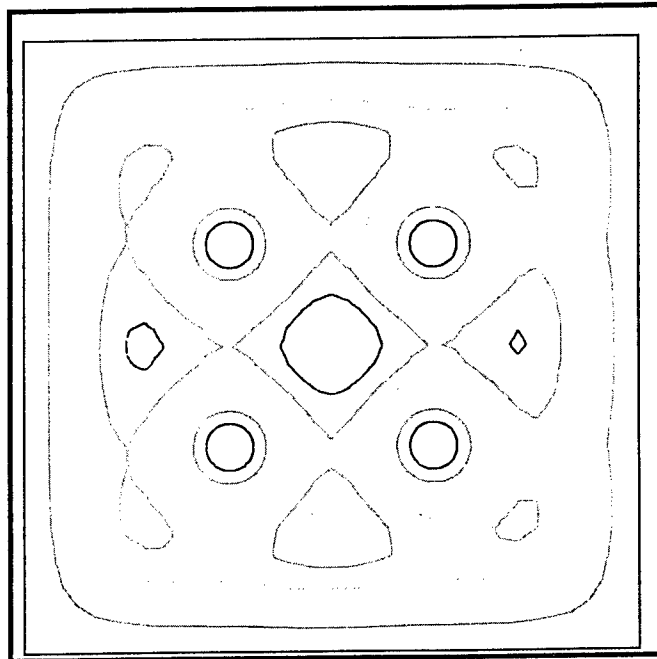
Contour plots

**Finite Element Results**

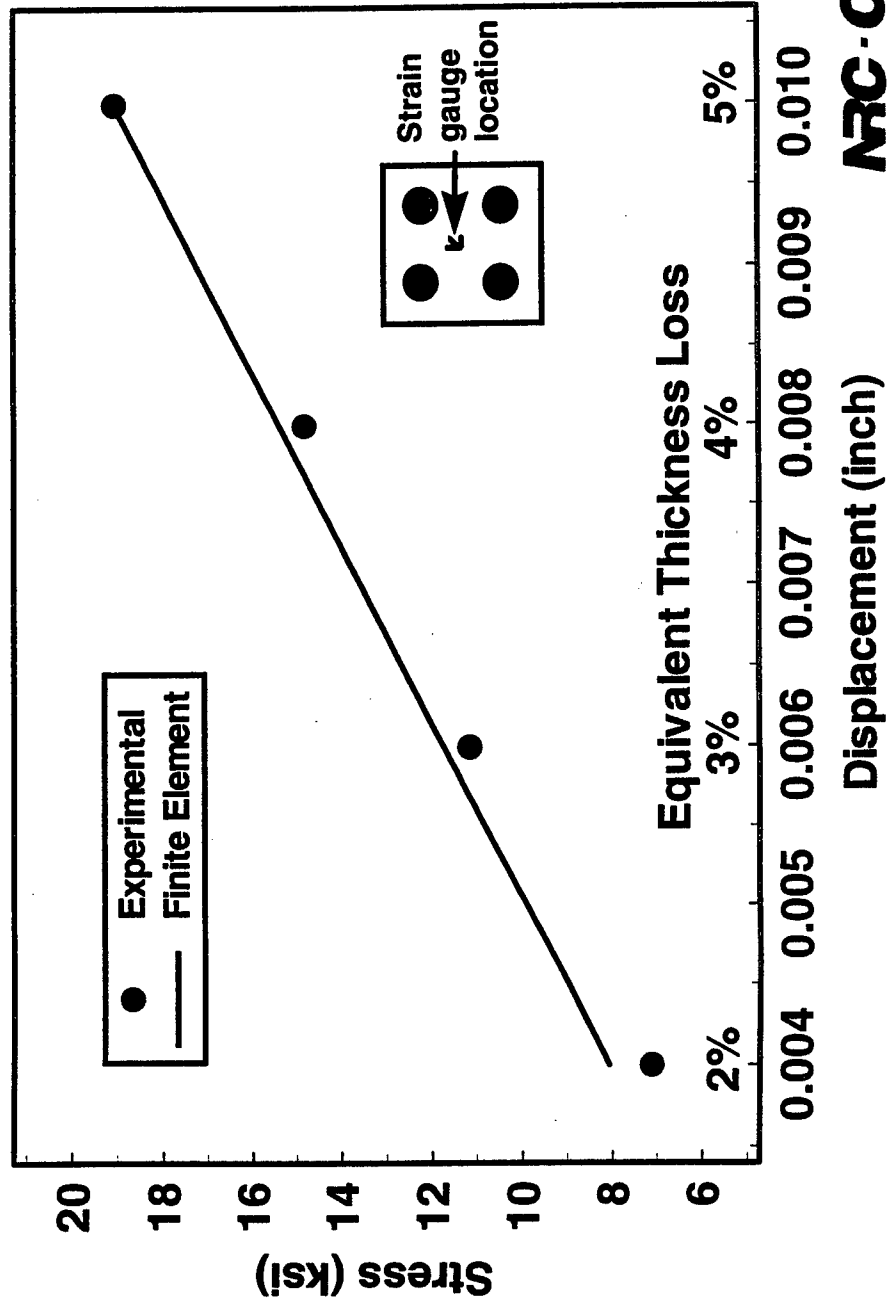
# Corrosion Pillowing Model Verification

Outer surface results at maximum pillowing deflection

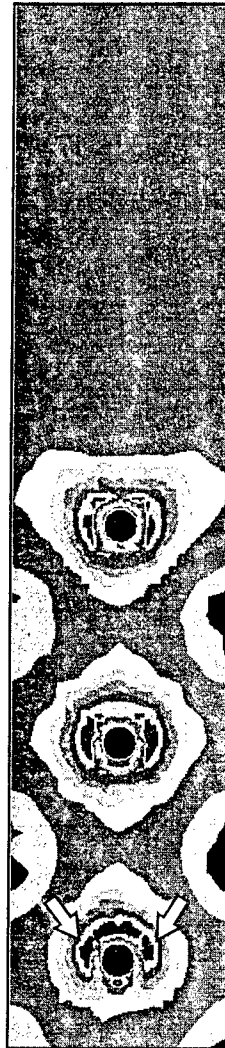
## Location of Maximum Stress

2.5% Thickness loss

6% Thickness loss

Arrows indicate location of maximum stress

- Depending on location of corrosion and severity of pilling in rivet area, maximum stress in joint may shift rivet holes or occur in other skins.

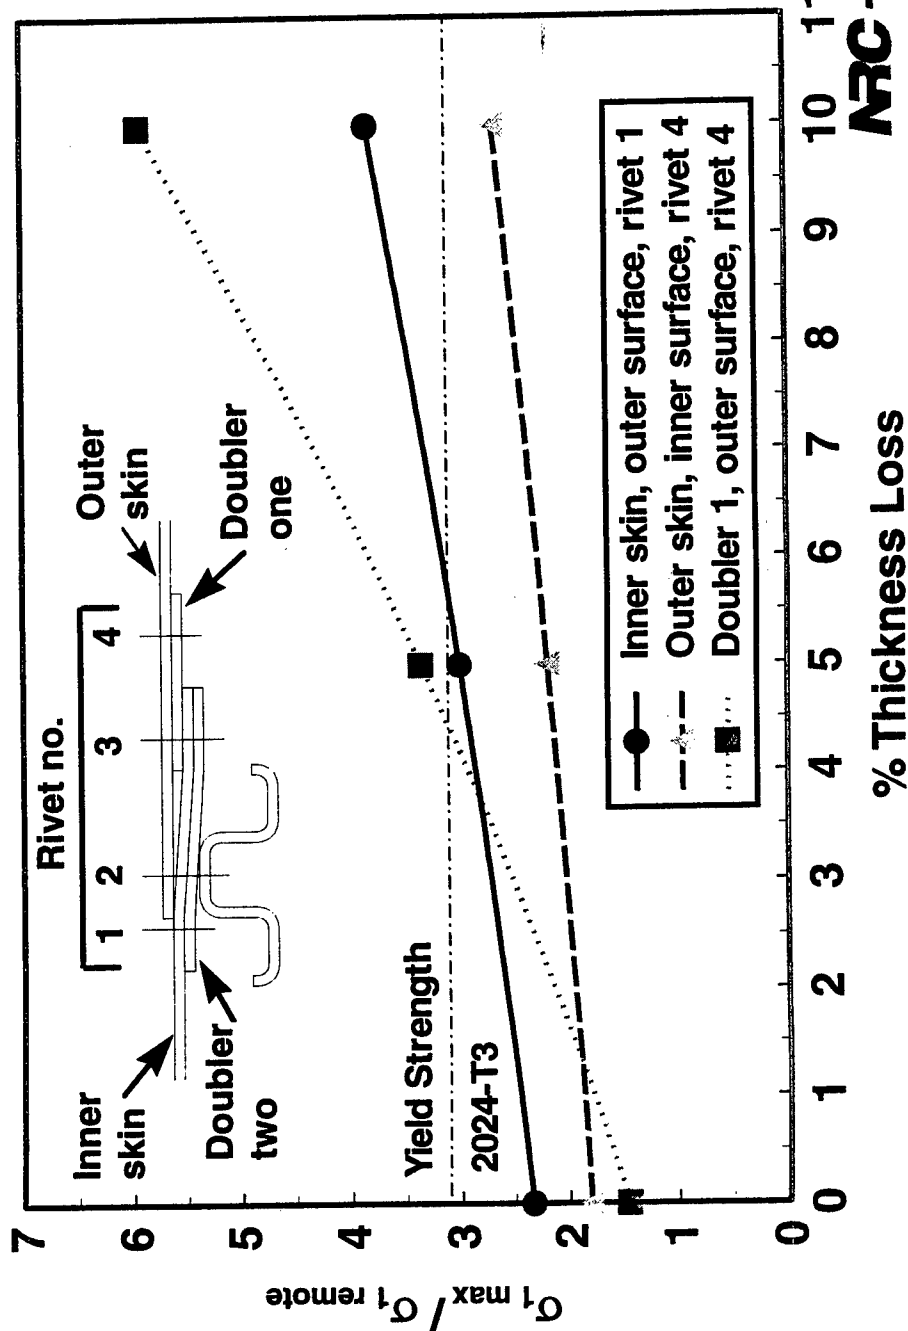
# Effect of Pillowing

Multi-layer lap joint

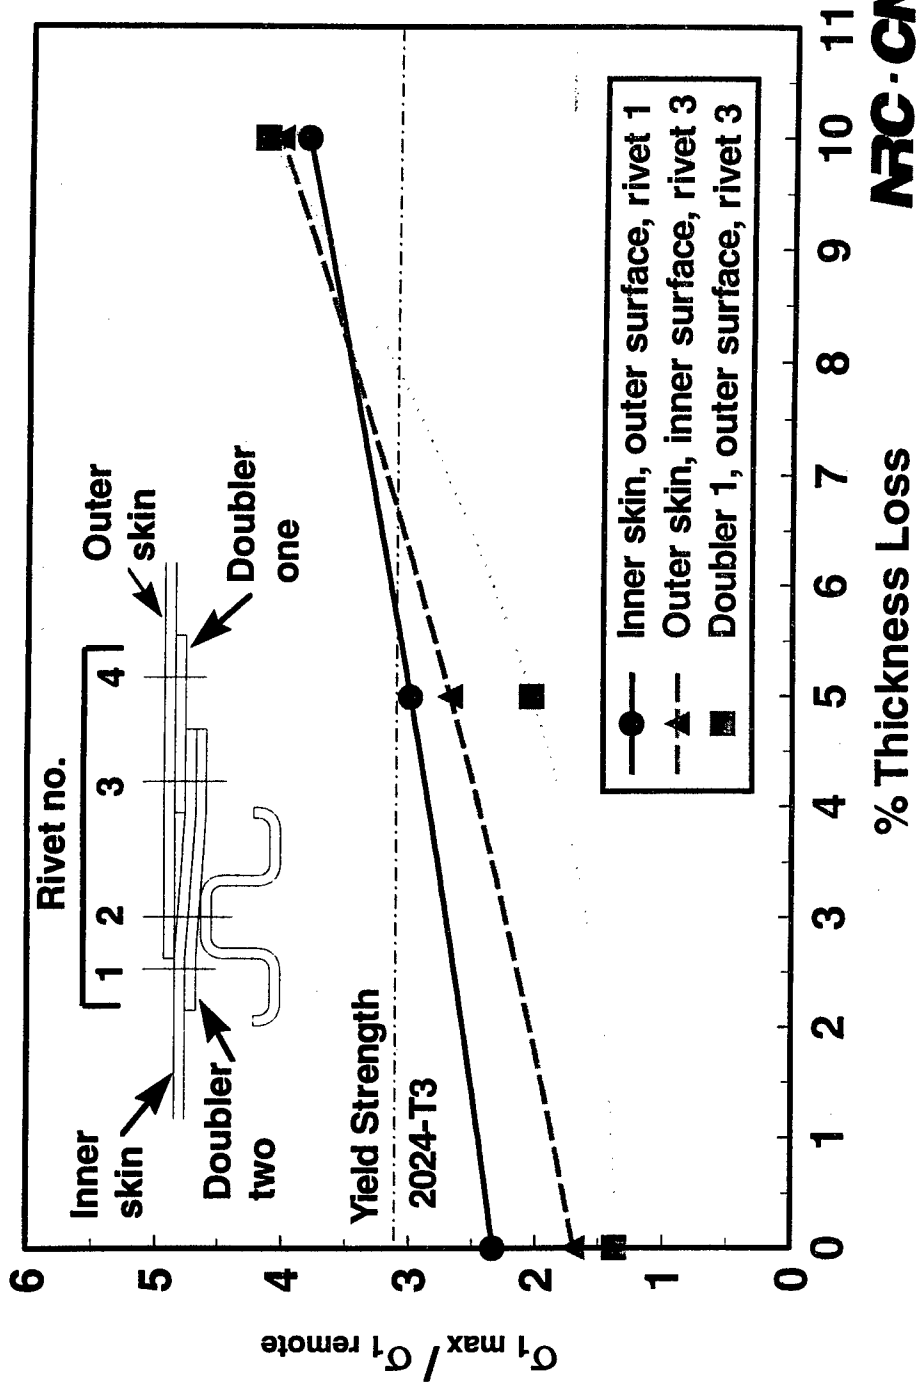
# Effect of Pillowing

Multi-layer lap joint

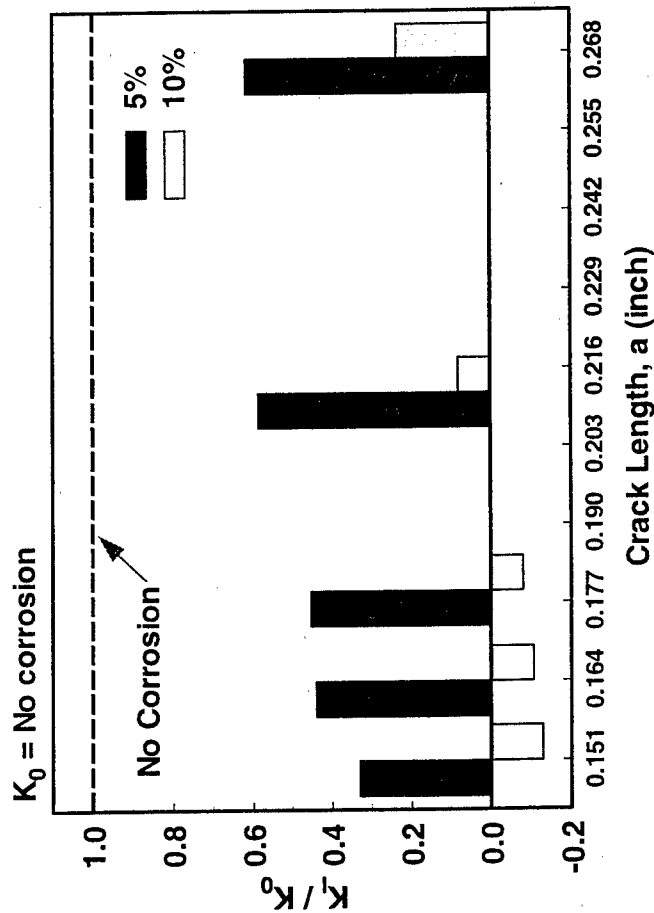
# Fracture Mechanics Analysis

Stress intensity for crack edge along outer surface

- Stress intensity for crack edge along outer surface decreases as corrosion pilling increases.
- Pilling has significant influence on crack in hole vicinity:
  - may arrest crack growth if present before corrosion.

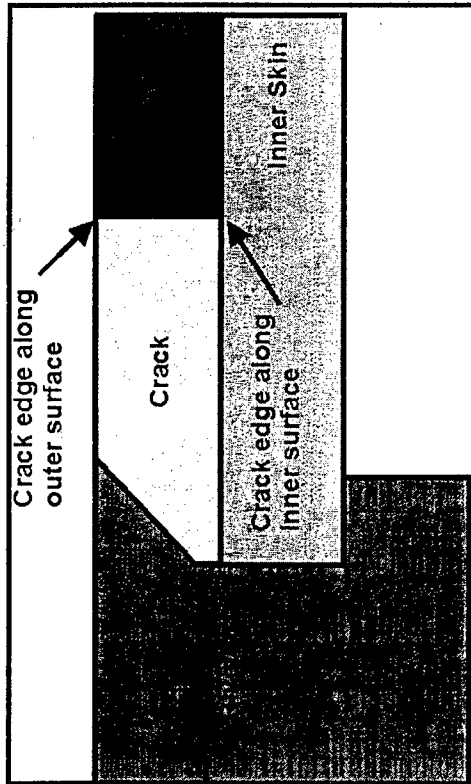
Crack shape used in model

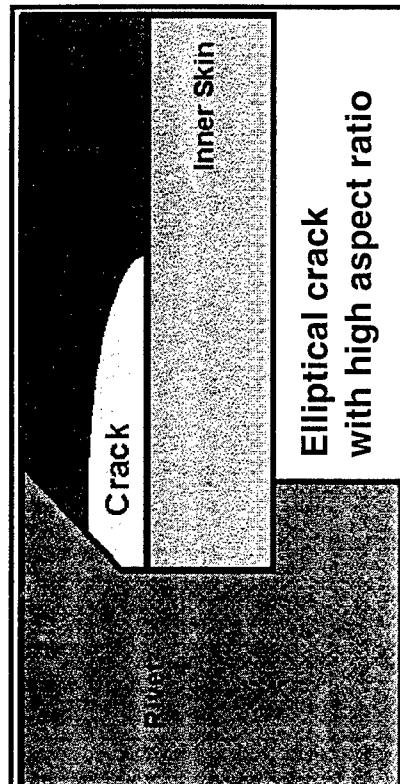
Elliptical crack  
with high aspect ratio

Predicted crack shape due to  
corrosion pitting

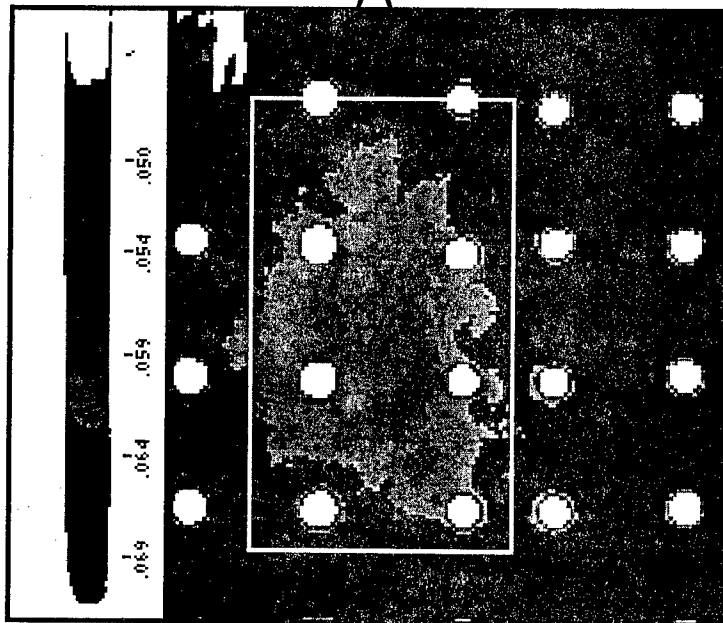
Colorized thickness  
loss map

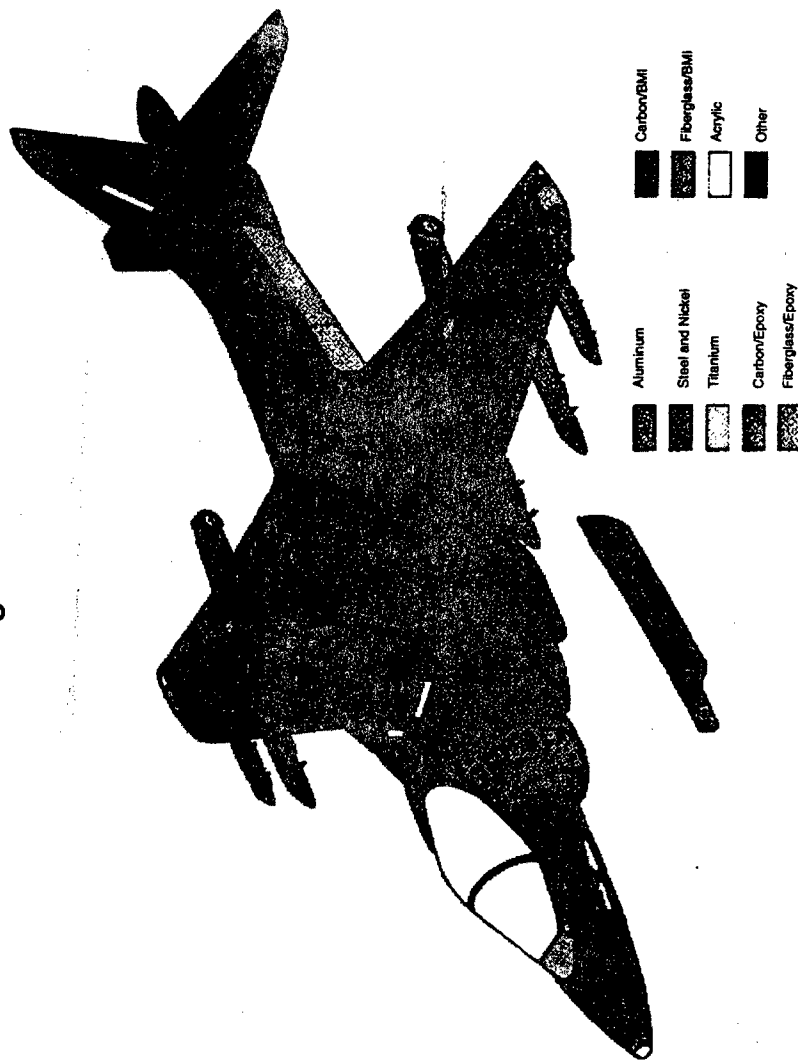
## AV-8B Material Usage

- The Structure of the Harrier Is a Combination of Carbon/Epoxy Composites and Metal.
- The AV-8B Is 26% Composite Materials.

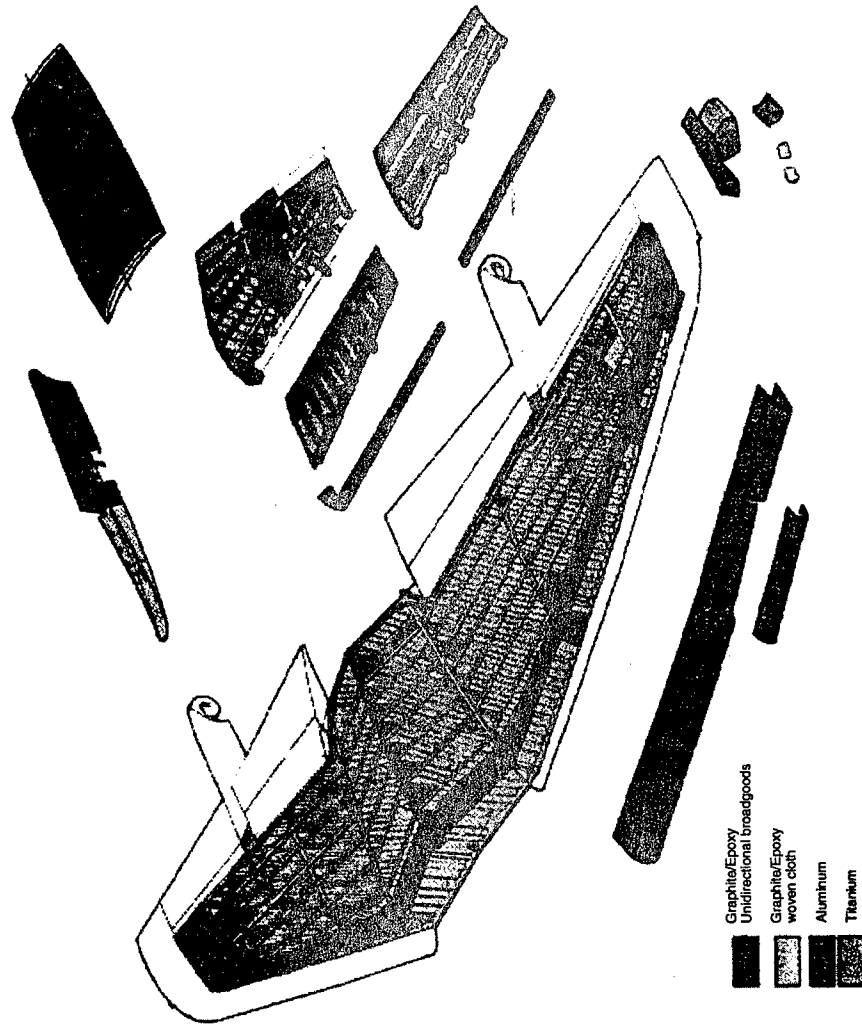
## AV-8B Harrier Overview - Wing

- The Wing Torque Box Has a Monolithic Composite Skin and Sine Wave Composite Substructure
- Only Primary Attachment Points (Wing to Fuselage, Pylons, Landing Gear) Are Metal

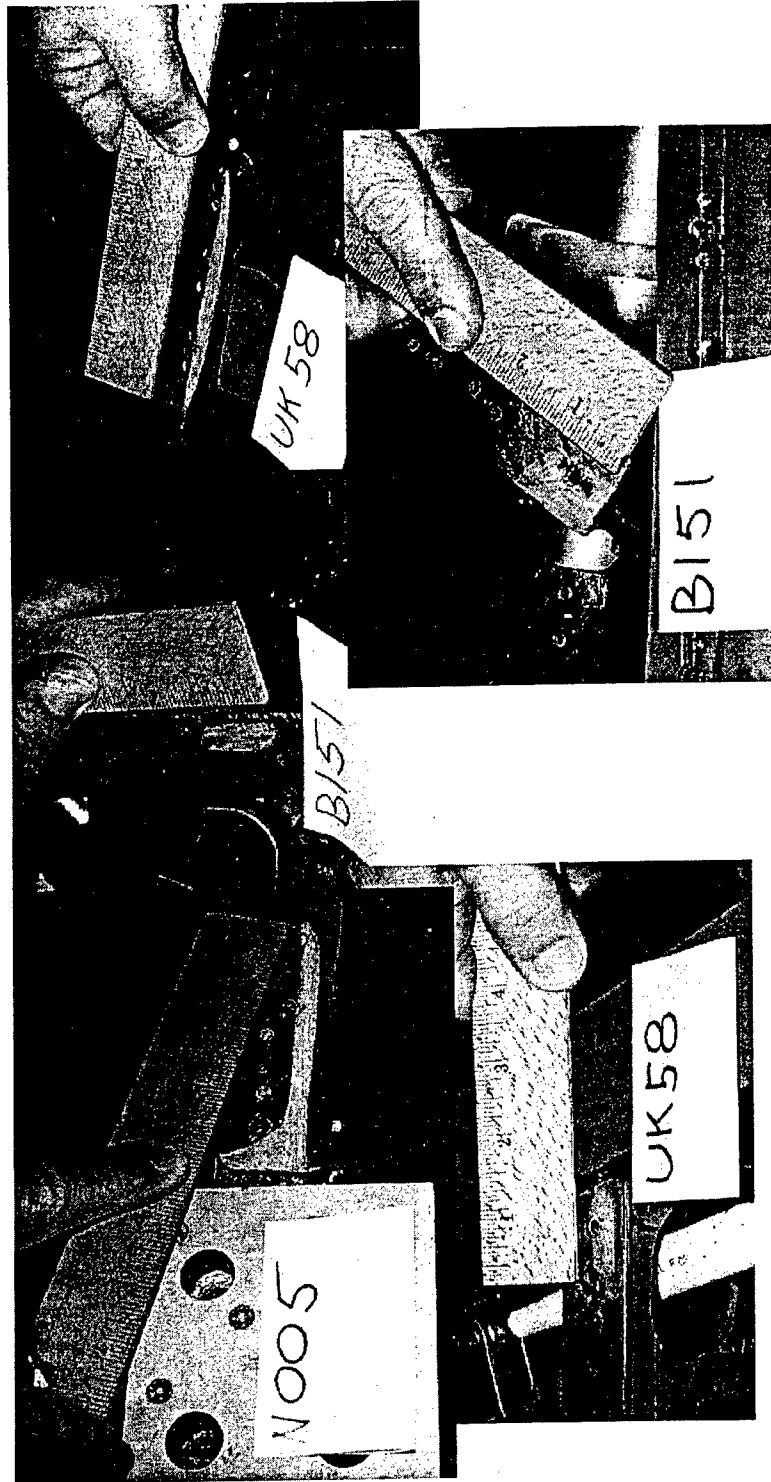
## Wing Substructure Delaminations

- Delaminations at Composite to Metal Substructure Joints

- During the Manufacture of the AV-8B Wing, the Substructure Intersections May Require Shimming.
- Failure to Shim Adequately May Result in Delaminations When Fasteners are Installed.
- McDonnell Douglas Aerospace Discovered Delaminations in Production Wings and Changed the Manufacturing Process to Alleviate Future Occurrences of Delaminations.
- Approximately 150 Wings in the AV-8B Fleet Were Suspected of Having These Substructure Delaminations.
- To Minimize Delamination Growth, Flight Loads Were Restricted to 2/3 Limit Load on All Affected Aircraft.
- A Test Program was established to Investigate the Growth of Delaminations Common to the Affected AV-8B Wings.

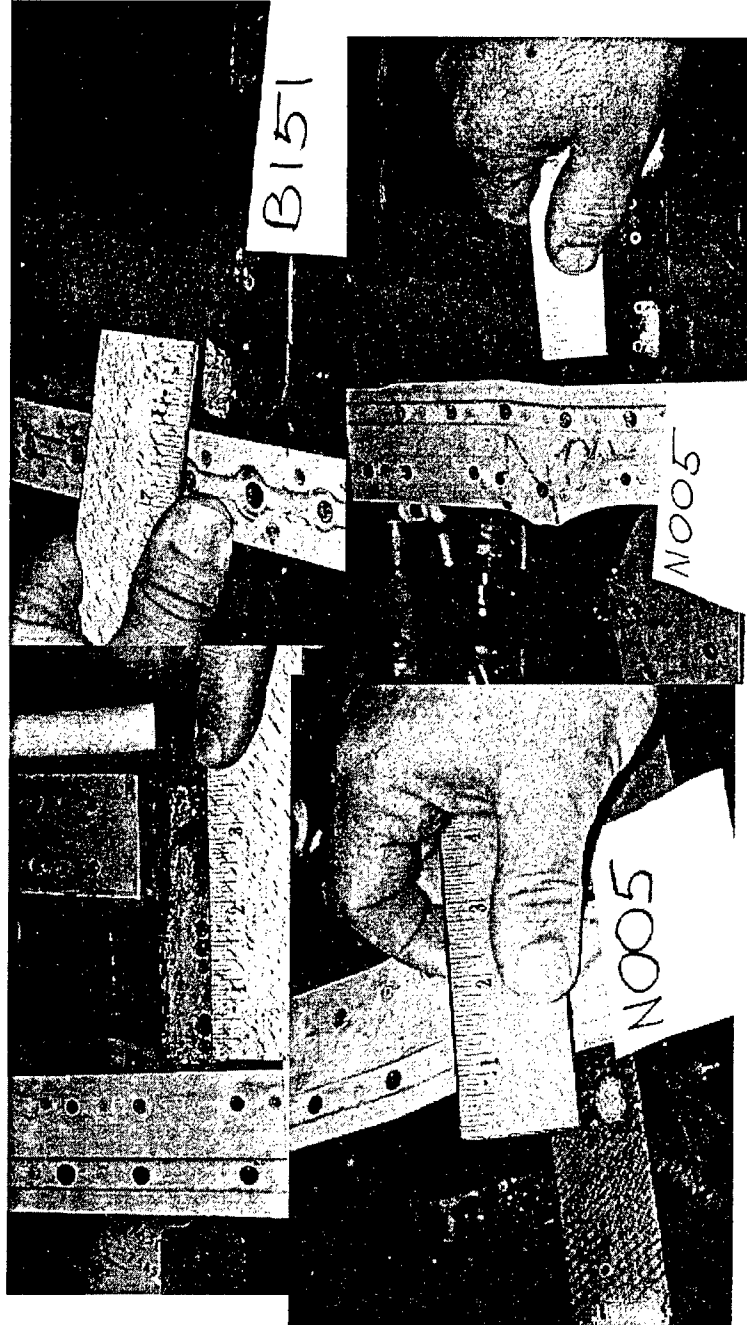
## Wing Substructure Delaminations

- More Delaminations at Composite to Metal Substructure Joints at Structure with Sealant Grooves.

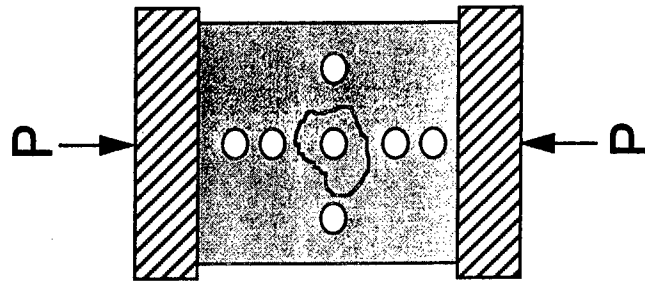
Compression Test

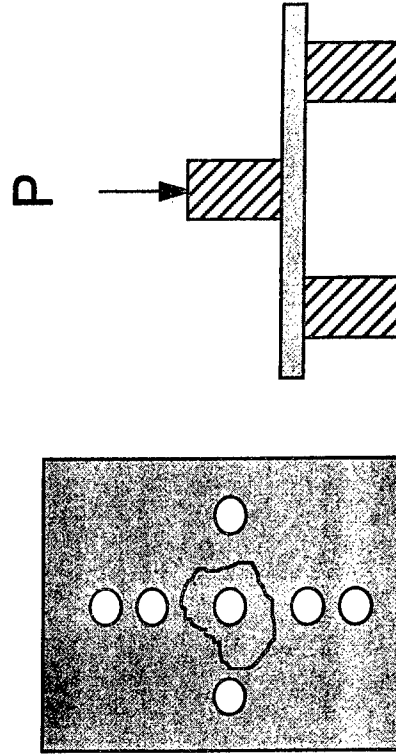
Interlaminar Shear Test

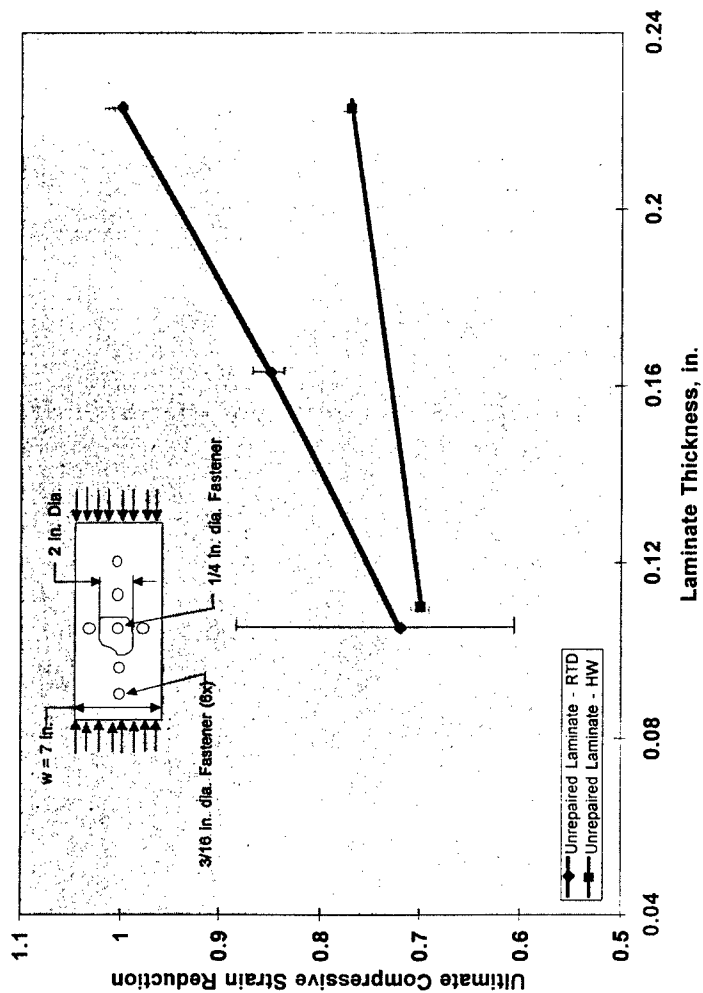
- Compression Strength Reduction Versus Laminate Thickness

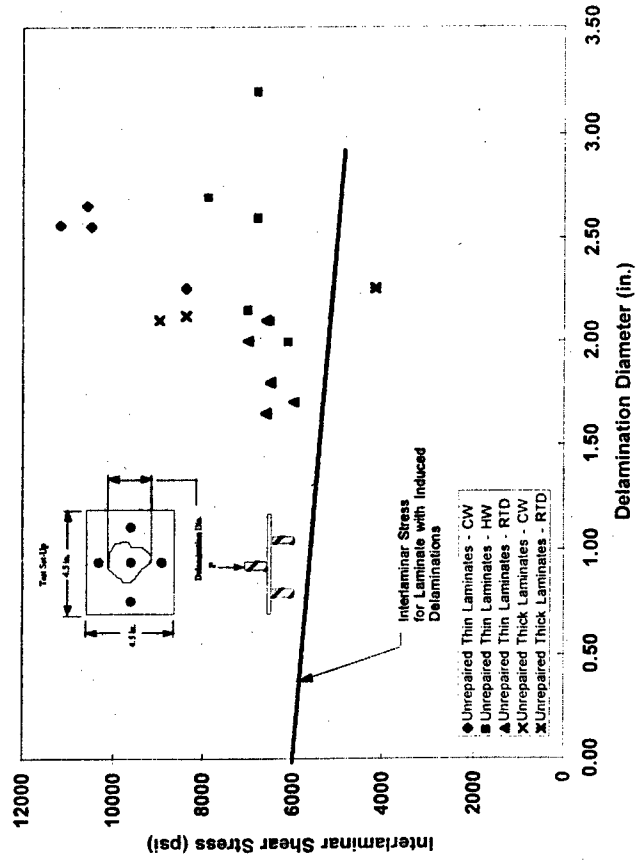
- Test Data Supporting the Reduction of Interlaminar Shear Strength in Delaminated Laminates

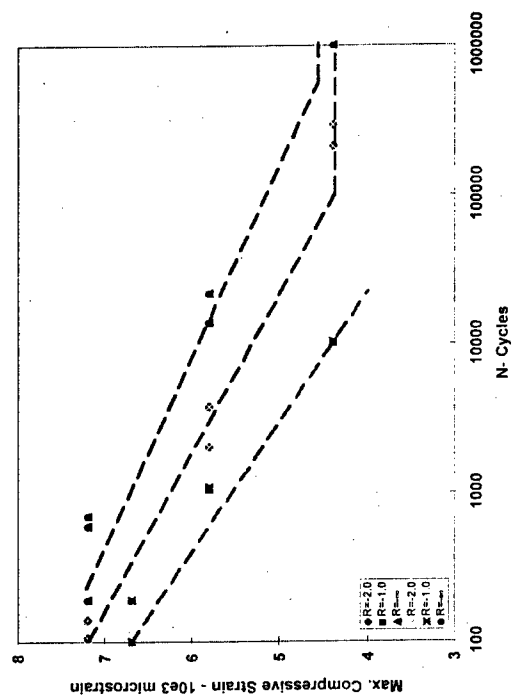
- The Effects of Composite Fatigue
  - Primarily Compression - Compression Dominated Spectrum
  - Test Data Shows That Tension Compression Can Be More Damaging to Delaminated Laminates

- Tension / Compression (T/C) Loading Has Greater Fatigue Effect Than Either Tension / Tension (T/T) or Compression / Compression (C/C) Loadings.
- The Influence of Tension Loads
  - They Do Not Directly Cause Delamination Propagation
  - They Can Cause Laminate Matrix Damage (Subcracking / Crazing)
  - Laminate Matrix Damage May Lower Compression Load Levels Needed for Delamination Propagation
- Test Program Retained All Tension Fatigue Cycles in Fatigue Spectrum

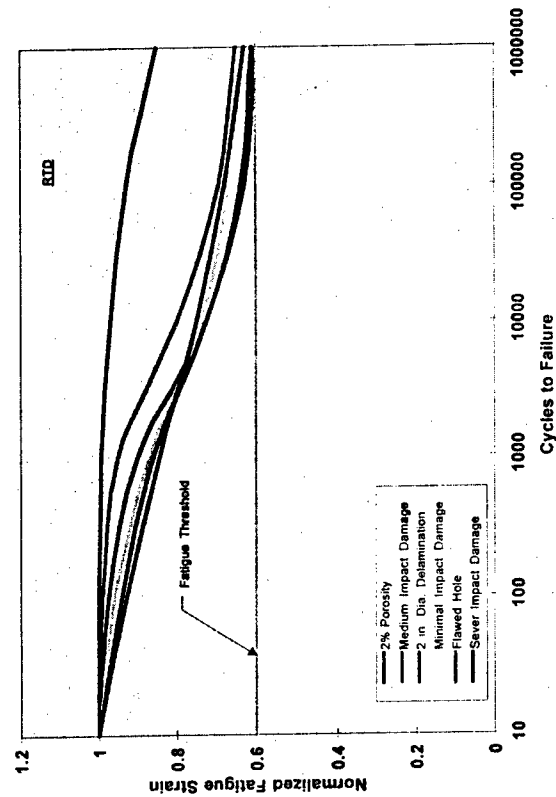
- Test Data That Shows the Influence of Delaminations on Fatigue Strength

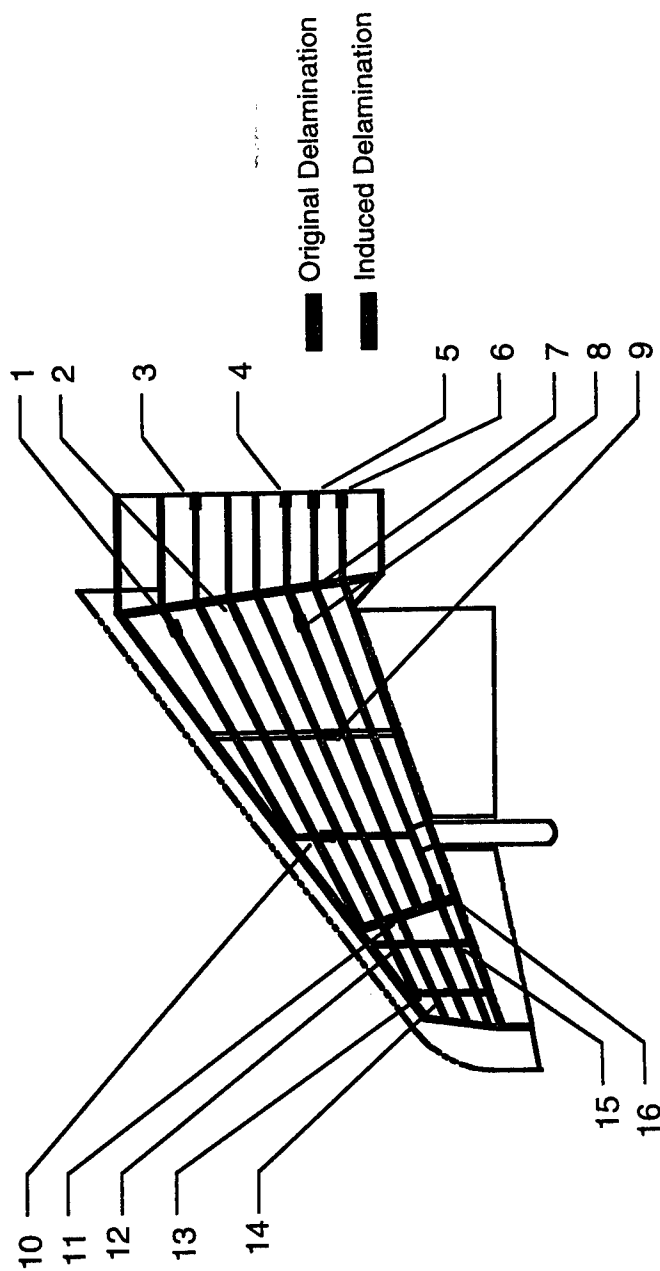
- Delaminations Induced Into UK58 Test Article
  - Six Original Delaminations Plus 10 Additional Delaminations Based on Findings From Production Wing Inspections

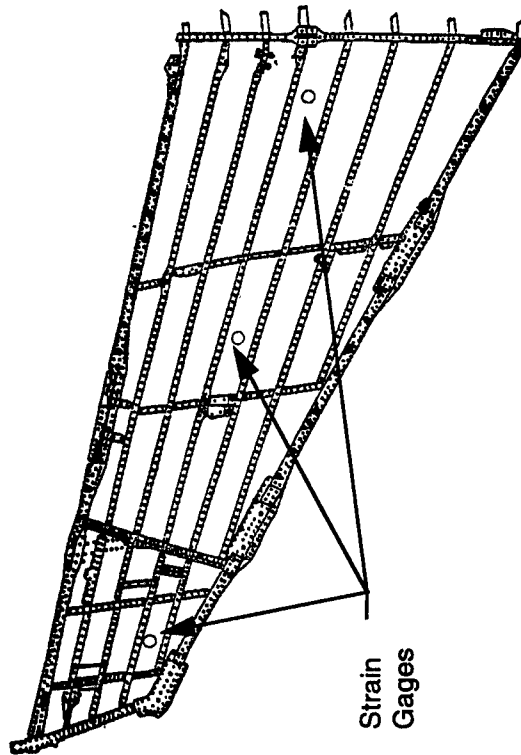
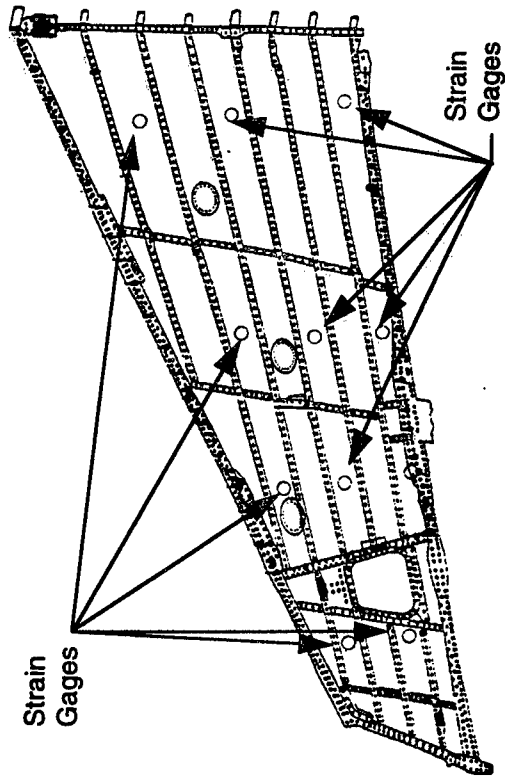
- Test Article Instrumentation - LH Side Skins
  - Linear Strain Gages and Rosettes Placed in Critical Load Paths.

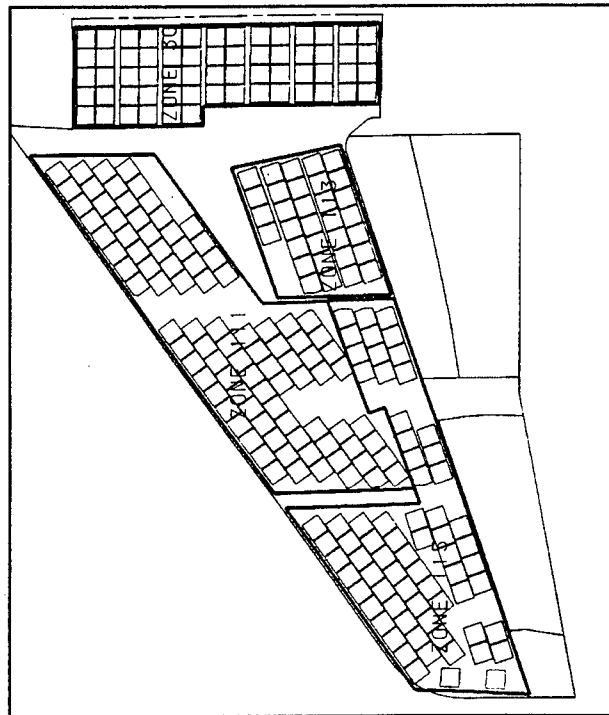
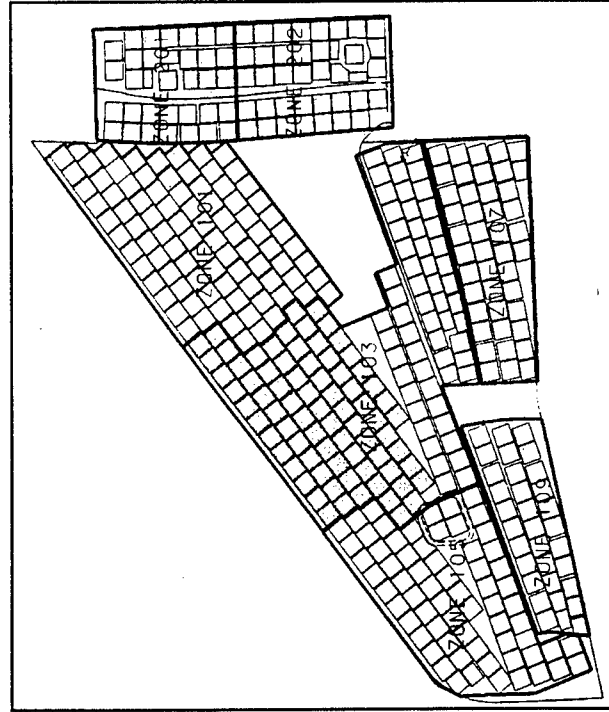
- Test Article Tension Pad Installation - Typical

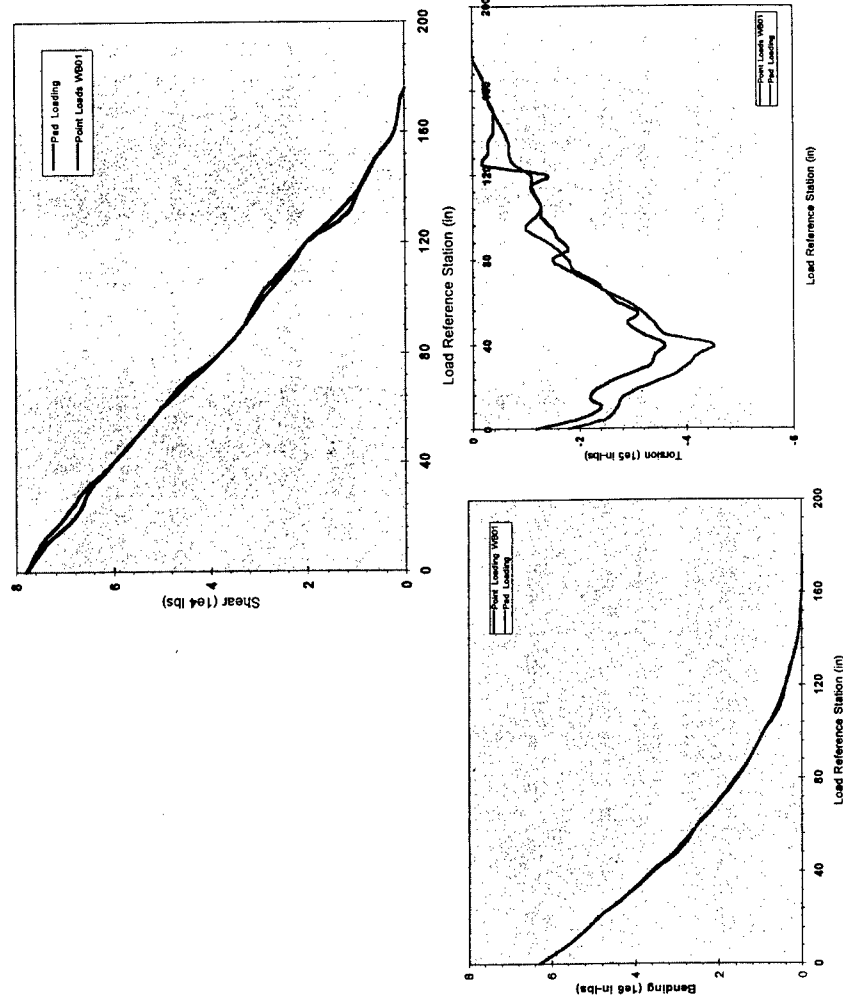
- Load Case for Ultimate Load (1.5 X Limit) for Worst Point in the Sky.
- Shear, Bending, and Torsion Graphs
- Test Loads Correlated Well With Design Loads

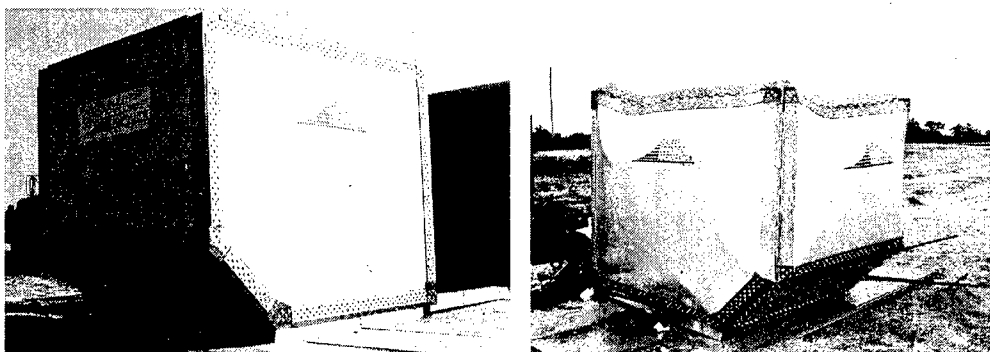
Fig. 1 GLARE® ECOS<sup>3</sup> before and after FAA-conducted explosive testing (courtesy Galaxy Scientific Co.)

The higher impact performance of GLARE® makes it an attractive material for impact prone areas like the cockpit crown, front bulkheads, leading edges, flaps, undercarriage doors and cargo floors. Its impact capabilities together with its flame resistant characteristics makes it suitable for cargo linings as well as "blast resistant" containers. Up to this moment a GLARE® container built by Galaxy Scientific Co.<sup>[4]</sup> is the only container which meets the blast and fire requirements of the FAA (Fig. 1).

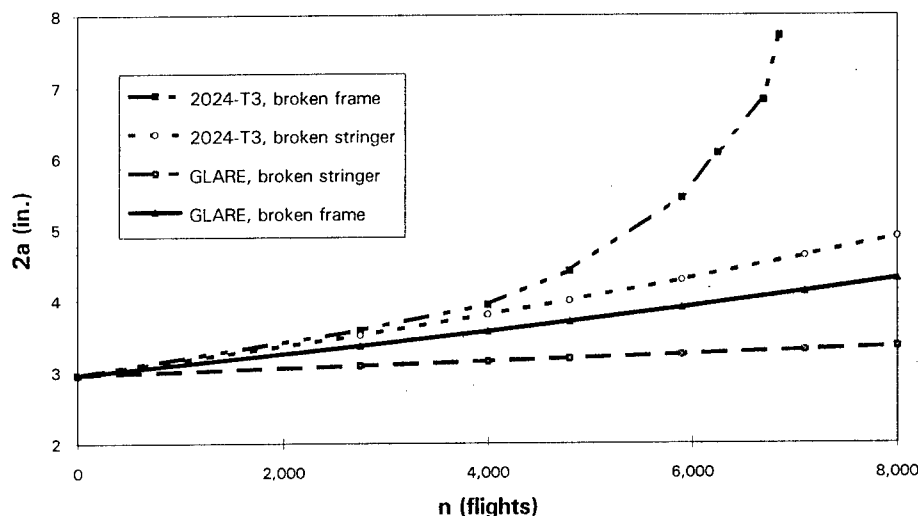
Fig. 2 Crackgrowth in the Airbus A-340 barreltest<sup>[6]</sup>

The results of the damage tolerance test on this fuselage section was extremely good. Figure 2 shows the crackgrowth behaviour of a central broken member (frame or stringer) including skin fracture with a starter crack of 75 mm ( $\sim 3.0$ " in) in an all aluminum section compared to the GLARE<sup>®</sup> section. It clearly indicates that a crack in the aluminum section over a broken frame becomes critical in about 6,500 flights,

whereas the same crack configuration in GLARE<sup>®</sup> grows slowly and turns out to become critical only after more than 40,000 flights.

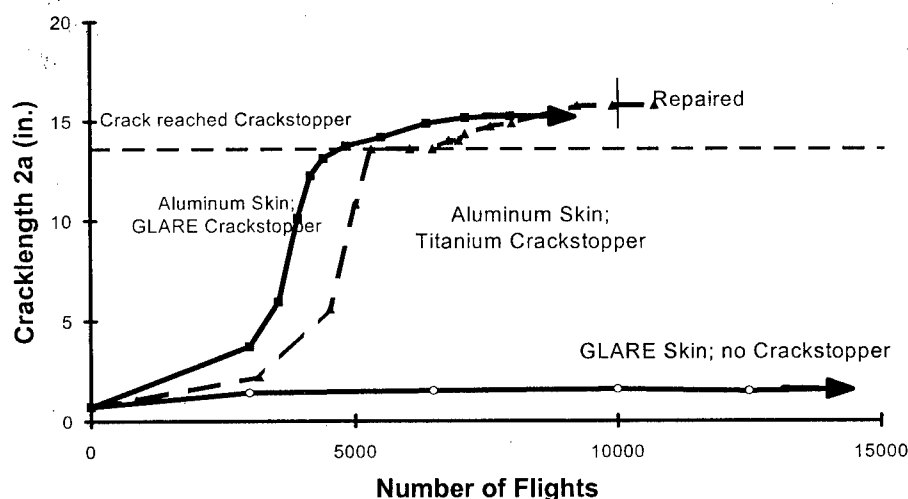
Fig. 3 Fatigue crackgrowth in the A-330 rear pressure bulkhead<sup>[7]</sup>

Compared to the standard aluminum bulkhead the GLARE<sup>®</sup> bulkhead offers more than 25% weightreduction. Furthermore the damage tolerance test shows that the GLARE<sup>®</sup> bulkhead has almost no crackgrowth at all (Fig. 3). It also clearly shows the fast crackgrowth in the aluminum part as well as the temporary crackstop capability of the Ti-strap and a GLARE<sup>®</sup> strap.

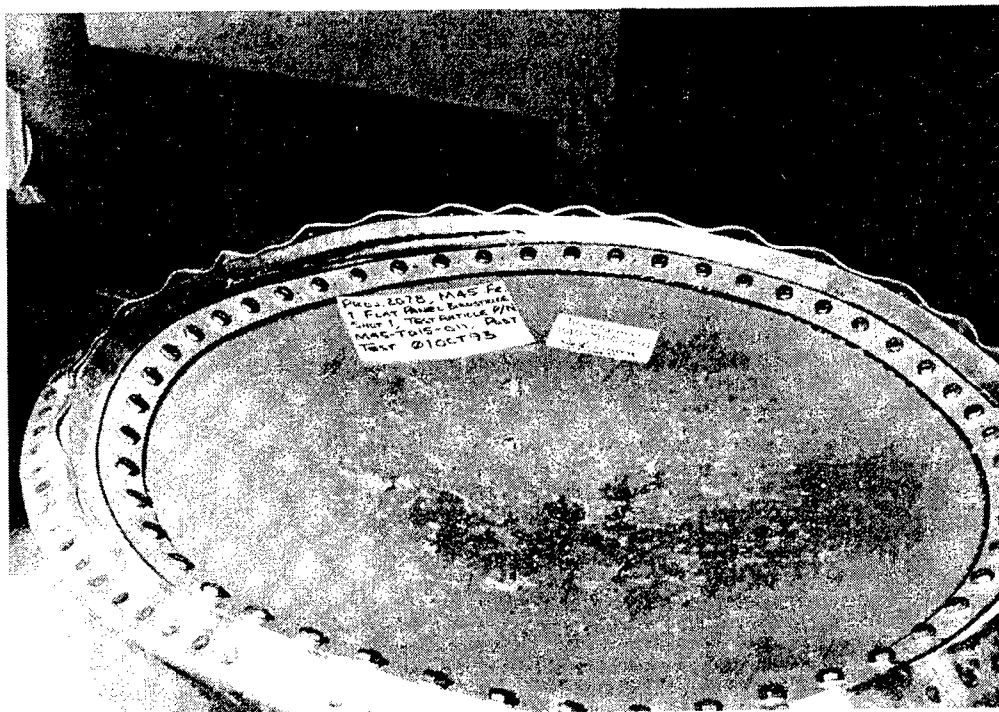
**Fig. 4 GLARE® radome front bulkhead test<sup>[8]</sup>**

Extensive testing of GLARE® justified its good impact performance. In a research program between Shorts Brothers and SLC<sup>[8]</sup> is shown that GLARE® is outperforming all other considered options, i.e. aluminum alloys and composites, glass as well as graphite. This resulted in a low weight and low cost application for the radome front bulkhead of the Lear 45. Fig. 4 shows the GLARE® component after the bird impact test.

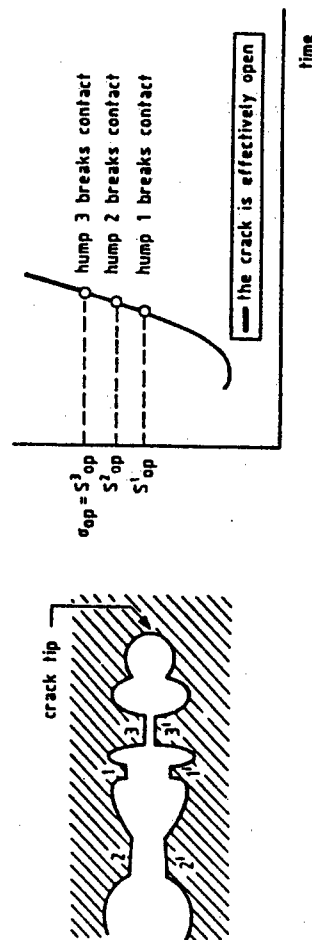
CRACK CLOSURE IS RELATED WITH THE FORMATION OF HUMPS ON THE CRACK FACES:

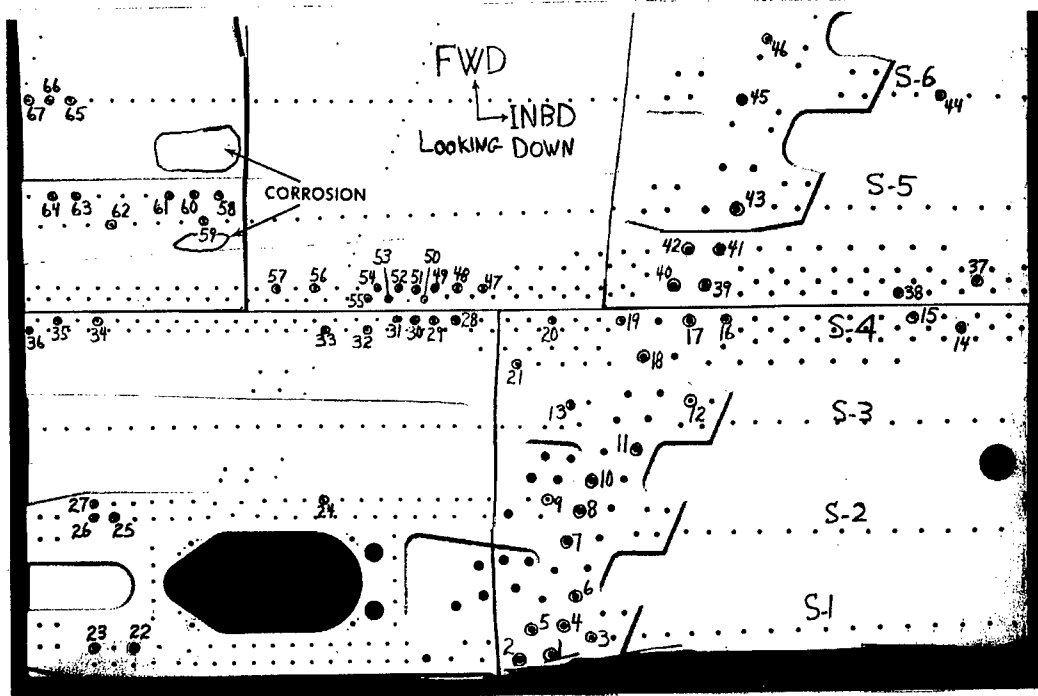
Figure 4a: Wing Skin Hole Crack Indication Locations

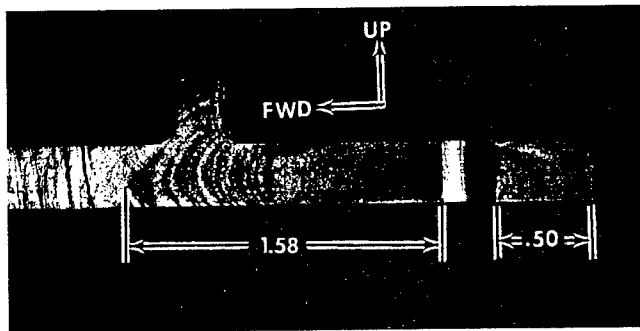
Figure 7a: CZ-180, Stiffener S8, Hole 37, Base Flange Crack

Stiffener	Crack Length (inch)	Hole ID Number	Airplane and Section ID	Photograph
8	2.38	37	CZ-180, 4/3	Figure 7a
7	1.44	65	CZ-184, 3	Figure 7b
9	0.42+, 0.84	32	CZ-180, 4/3	Figure 7c

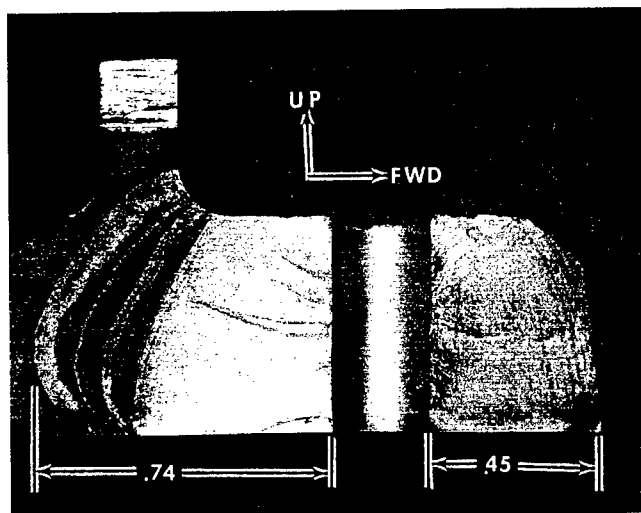
Figure 7b: CZ-184, Stiffener S7, Hole 65, Base Flange Crack

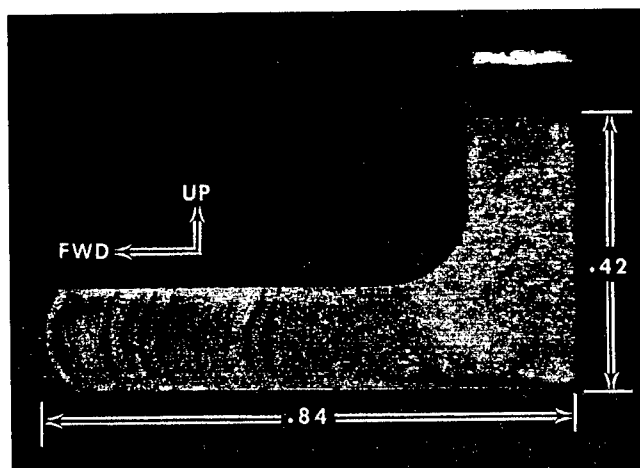
Figure 7c: CZ-180, Stiffener S9, Hole 32, Web Drain Hole Crack

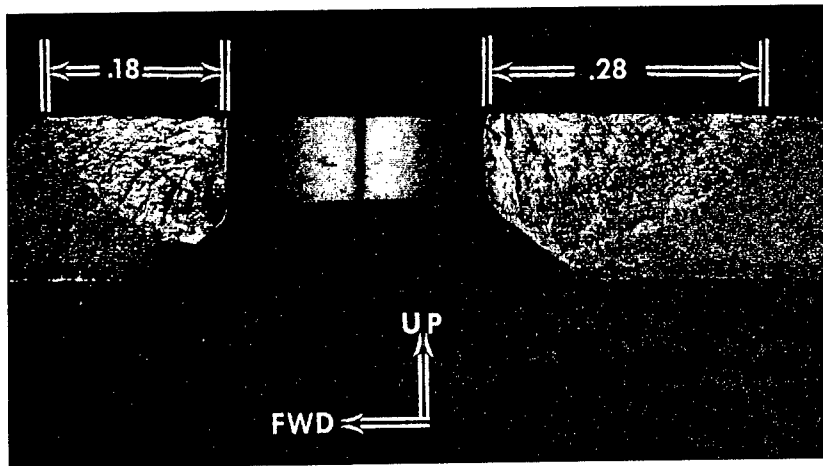
Figure 8: Largest Skin Crack, Hole 26, Section 5, CZ-184
