**WL-TR-97-4054**

**PROCEEDINGS OF THE 1996 USAF  
AIRCRAFT STRUCTURAL INTEGRITY  
PROGRAM CONFERENCE**

**USAF Aircraft Structural Integrity Program Conference  
Hyatt Regency San Antonio  
San Antonio, Texas**

**FINAL REPORT FOR PERIOD 3-5 DECEMBER 1996**

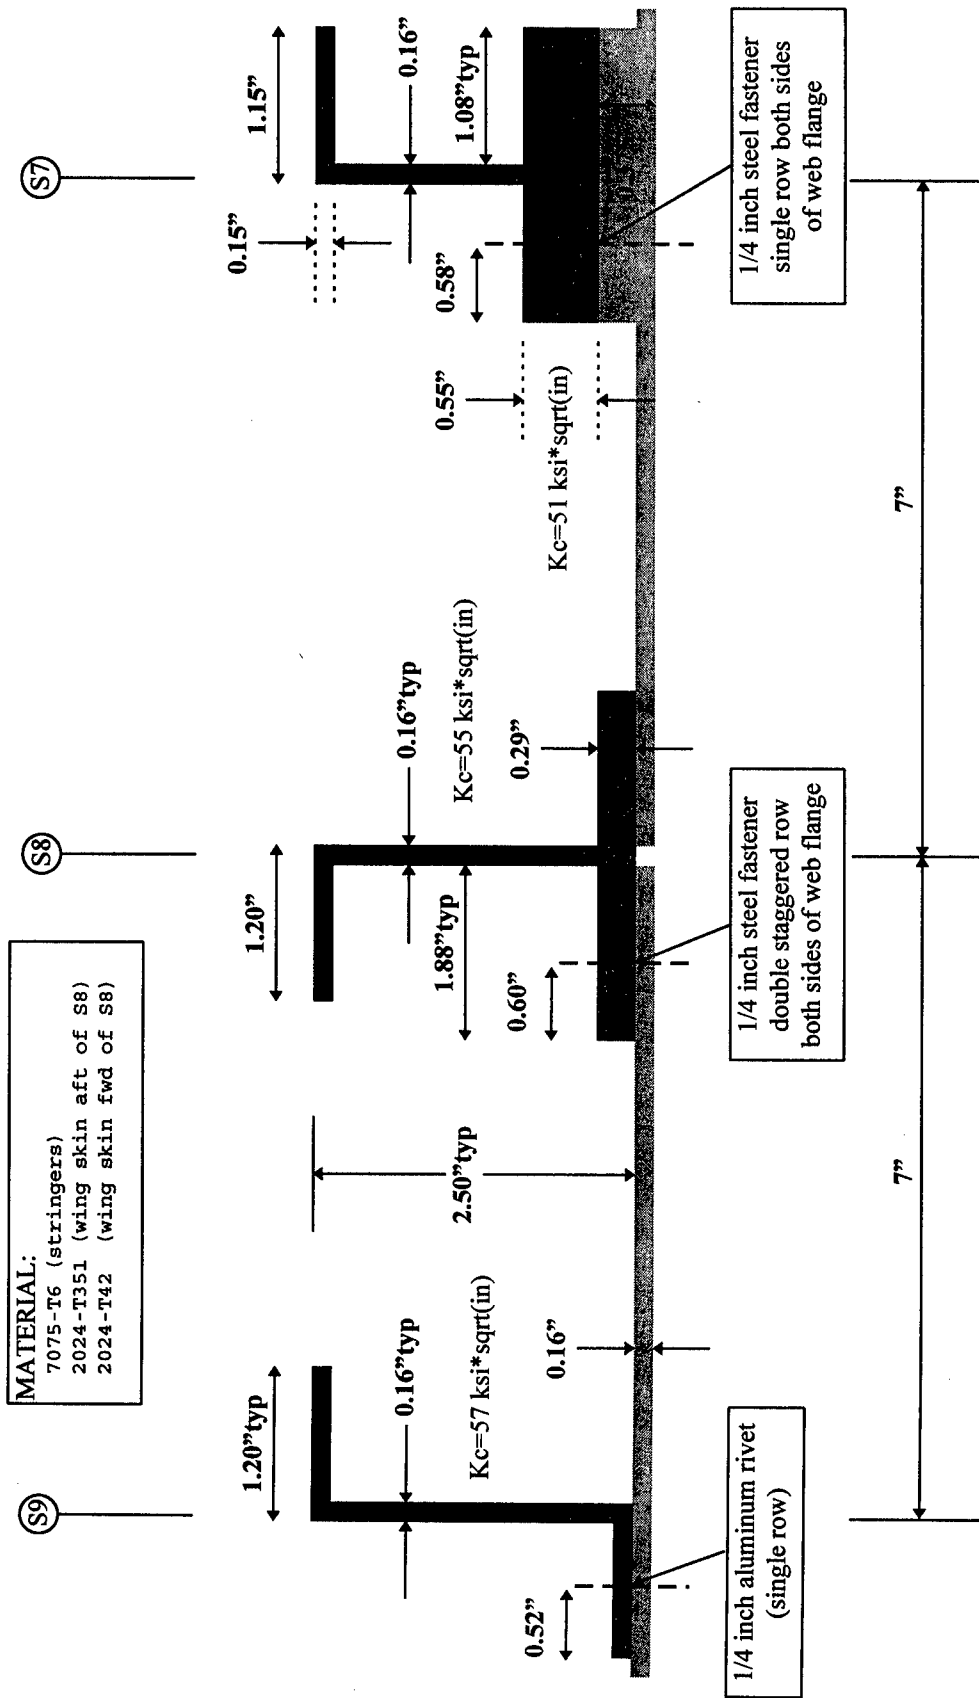
**Figure 11: Typical Stringer Lower Wing Skin Cross Section Inboard of Wing Station 360  
 (NO SCALE)**

Engineering reduction of the site specific inspection data was simplified by using typical cross section stringer/skin geometry. The analysis geometry was of stringers S7, S8, and S9, and the lower wing skin inboard of the chordwise splice joint at Wing Station 360 as shown in Figure 11. This geometry is representative of typical structure and is located in a fairly uniform ground-air-ground stress area. Skin and stringer material callouts and plane stress fracture toughness values are noted. Stringer S7 is typical of stringers S5 and S7 which are on either side of the access panel row. Stringer S8 is typical of skin splice stringers at S4, S8, S14, and S18. Stringer S9 is typical of all other stringers.

Stringer crack indication inspection data from both aircraft was reduced to equivalent single corner cracks in the analytical geometry (Figure 11) based on equivalent stress intensity factors. The inspection data was first characterized as being either single or double, corner, embedded or through thickness and a resulting stress intensity value calculated based on actual geometry. The resulting stress intensity value was then used to back-calculate the equivalent single corner crack size in the analytical geometry. A total of 1653 stringer crack indications out of 1675 reported were evaluated with this process. The difference of 22 crack indications represented unique configuration details that were not typical of the

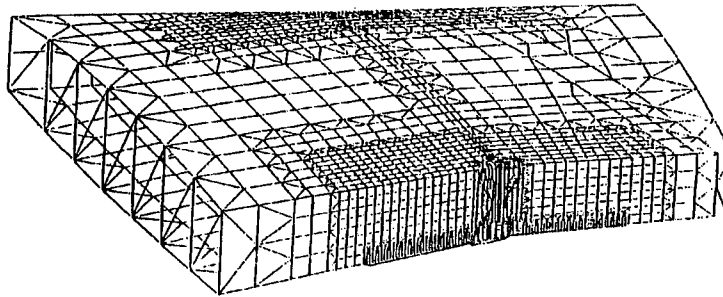
## Risk Analysis Finite Element Model

This shows the C-141 WS 405 finite element model used in one of our Risk Analyses. A model with this level of similar detail is probably required to perform risk studies. This model was originally built for analysis related to a composite repair program. It was available for our Risk studies, and we were able to modify it by constructing non-linear fastener elements.

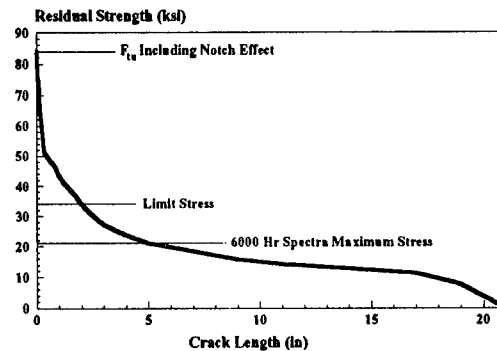
## Risk Residual Strength

The residual strength of the affected components is required for both the primary structure and the alternate load-path structure after the primary has failed. Linear fracture mechanics provides accurate predictions in crack range where the plastic radius is not more than 10% of the crack length. For the small crack range, test data or Feddersen's method have been used. This is particularly true when determining the residual strength of the alternate load-path structure after the primary failure, as it usually involves yielding and large bearing loads. Non-linear finite element models are necessary to predict the net-section stresses that can be compared to test results to determine the failing stresses of small cracks.

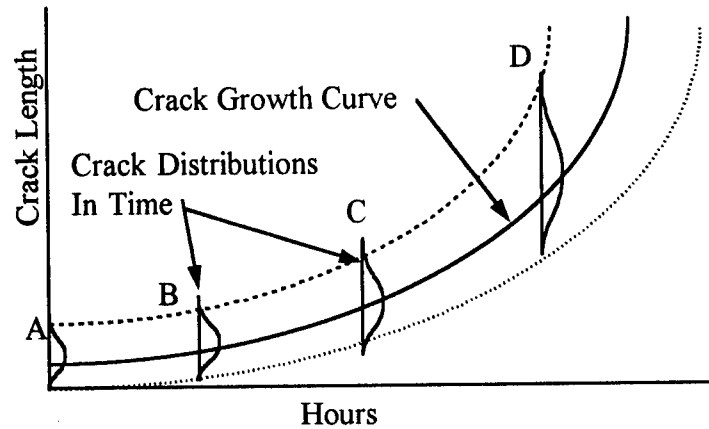
## Risk Analysis Effect of Time

This slide shows a typical crack growth curve used in the analysis. This curve is sometimes referred to as the Master Crack Growth curve. We've also included cartoons which represent the distributions of cracks at points A, B, C and D. As the curve extends out in time, the standard deviation also increases meaning that there is much more spread in the answers. Typically, for our analysis, the inspections and points of interest are close to the time that the cracking data was obtained. A rule of thumb used by other disciplines is that the standard deviation should vary as the square root of time.

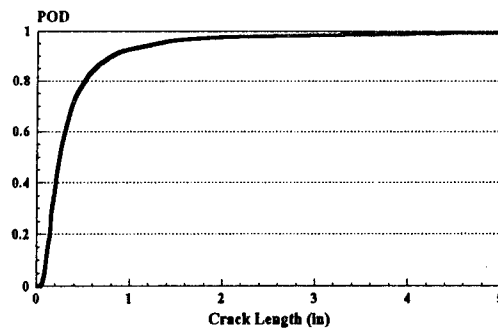
SPANWISE SPLICE OUTER TAB ECSS P

One primary objective of a risk analysis is the determination of an inspection interval which provides adequate safety as an aircraft ages. Inspection data must be in the form of a POD curve which reasonably describes the inspection performance under field conditions. "Have Cracks" data has generally been found to be acceptable for existing methods. Emerging inspection technologies need to have POD curves developed to be useful, not only for risk analysis, but for comparing NDI methods.

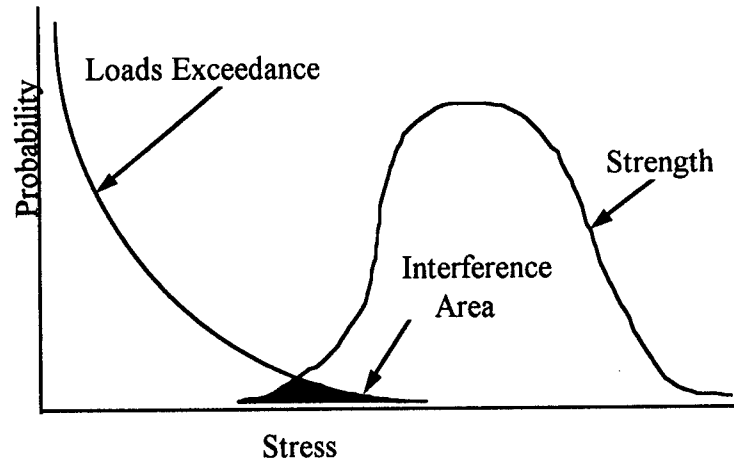
## What is the Overall Method

The above graphic portrays the method by which the Risk is calculated. However, it is over simplified in that the risk is not the area of the intersection, but rather the probability of the load exceeding the strength in this area. However, it is this calculation carried out at points in time that is used to quantify the risk. When these distributions standard, the answer can be directly calculated.

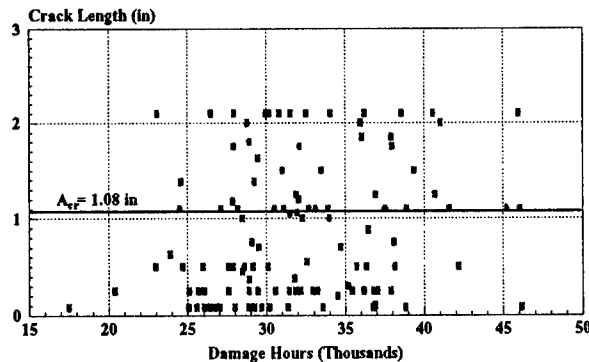
WS405 CRACK DISTRIBUTION

This slide shows the results of inspections carried out at the WS 405 Rear beam area. This inspection was precipitated by the discovery of two beam caps failed in this area on force aircraft. The risk analysis of the WS 405 inner to outer wing joint was precipitated by these discoveries.

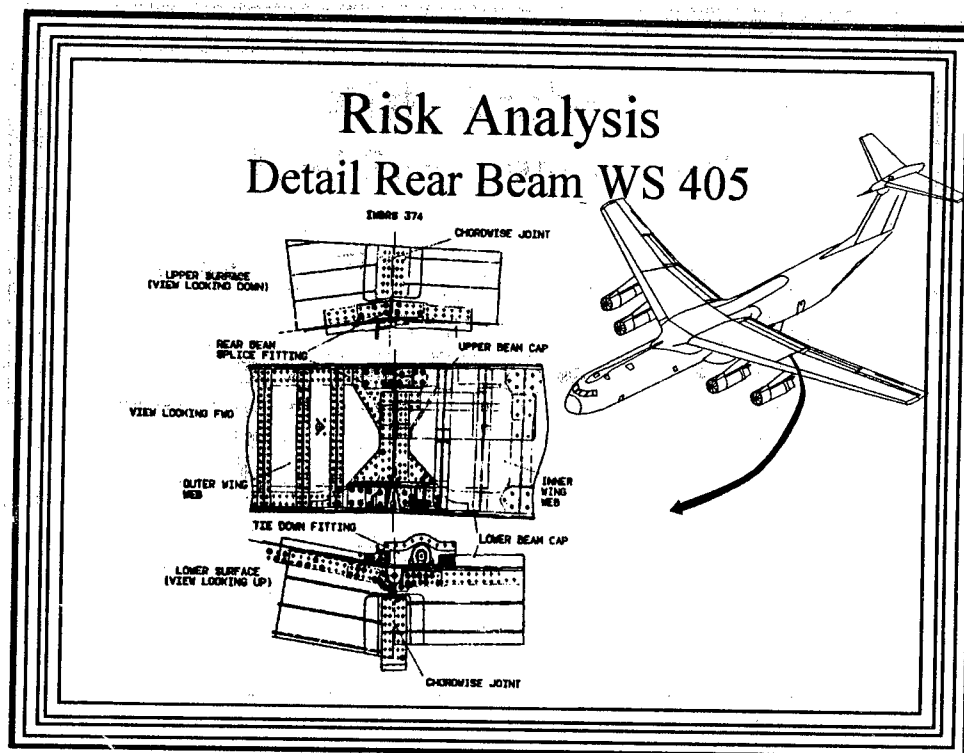
This shows the results of additional inspections carried out after the original risk analysis was concluded. These inspections verified the extent of cracking that had been hypothesized by the distributions used in the original risk analysis. The following were the major issues in this analysis.

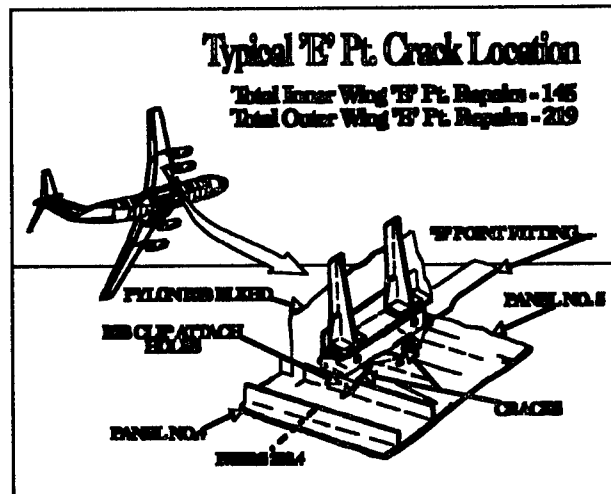
## Pylon E Point

This shows the pylon E point. This area was included because cracking of the E point area has caused complete failures of wing panels on two aircraft. Inspection of the adjacent panel revealed no damage in the spanwise splices. The real danger to the spanwise splices occurs after the first panel failure which is more likely to be precipitated by other stress risers. This was demonstrated on the Specimen A failure picture shown earlier.
