US Army Corps  
of Engineers  
Construction Engineering  
Research Laboratories

Technical Report REMR-OM-18  
June 1997

# REMR Management Systems—Navigation Structures, Condition Rating Procedures for Roller Dam Gates

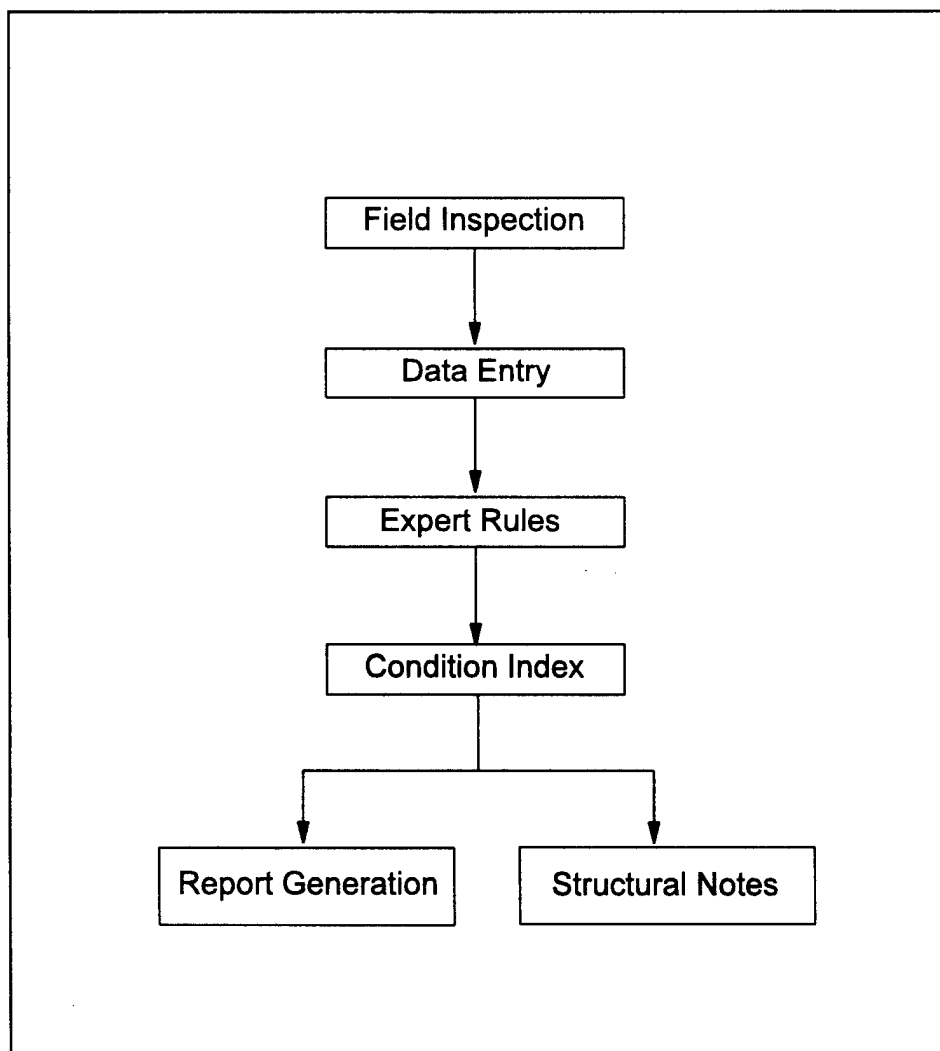
Figure 1. Inspection and rating procedure

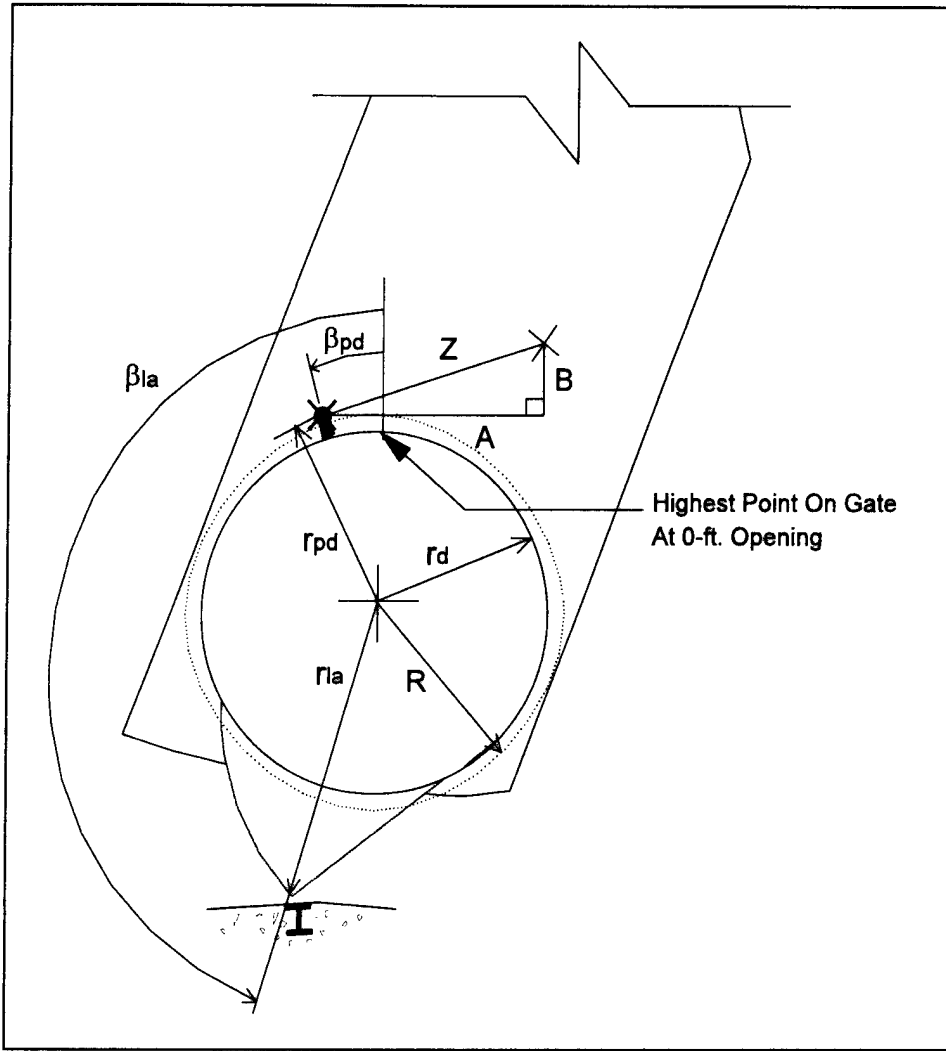
Figure A.1. Torsional misalignment geometric parameters.
