# Oak Bluffs Harbor Oak Bluffs, Massachusetts

US Army Corps  
of Engineers  
New England Division

| REPORT DOCUMENTATION PAGE | | | Form Approved<br>OMB No. 0704-0188 | |
|---|---|---|---|--|
| 4. TITLE AND SUBTITLE<br>Navigation Improvement Study, Oak Bluffs Harbor,<br>Oak Bluffs, Massachusetts, Reconnaissance Report | | | 5. FUNDING NUMBERS | |

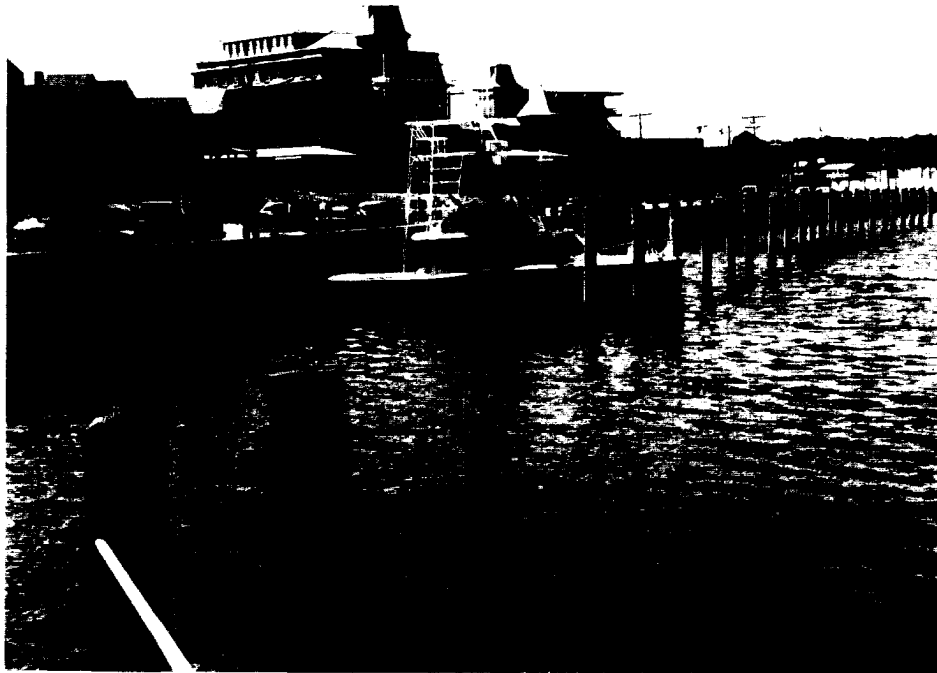
**View of steel sheet pile bulkhead along south side of the harbor.**

The present harbor configuration is characterized by numerous bulkheads defining its perimeter (see Figure 3). These bulkheads consist of steel and timber sheet piling. The south side of the harbor contains a steel sheet-pile bulkhead constructed in 1985 along Lake Avenue which is in good condition. The east side of the harbor contains a timber sheet pile bulkhead approximately 500 feet long and a steel sheet pile bulkhead (600 feet long) constructed in 1970 along Circuit Avenue. There is also a

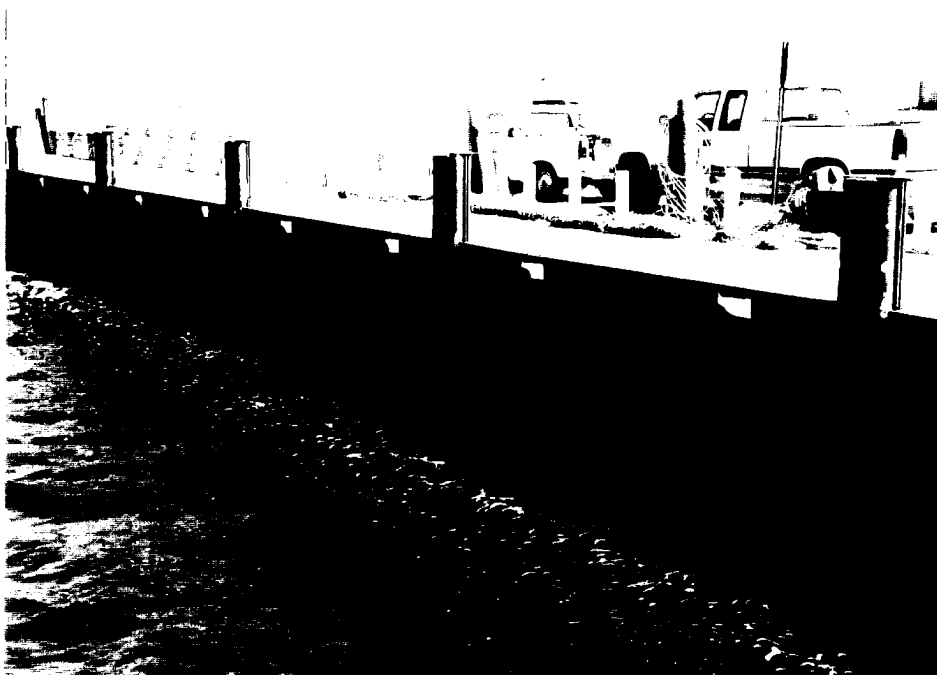
**Photographs  
Oak Bluffs Harbor  
Oak Bluffs, Massachusetts  
Figure 3**

**View of steel and timber sheet pile bulkhead along east side of the harbor.**

The timber sheet pile bulkhead along the eastern portion of the harbor is where the commercial fishing fleet and passenger ferry services dock. It is also the area least susceptible to damaging storm waves propagating into the harbor. However, town officials are concerned about the condition of this bulkhead because of the continuing loss of backfill. Abnormal high tides and accompanying wave action caused considerable damage to this portion of bulkhead in early December, 1990. The storm reportedly caused wave heights within the harbor from 3 to 4 feet. Numerous areas exhibited a loss of backfill due to localized failures of the timber bulkhead. Some of these holes were 2-3 feet deep and over 3 feet across. This condition was also noted in the 1981 CE Maguire planning study. The town routinely fills the holes created by the loss of backfill and the timber decking was recently replaced along this portion of the dock. Town officials stated the need for a replacement bulkhead and are considering replacing the existing one with used steel sheet pile.
