Technical Report CHL-98-6 February 1998

Navigation Conditions at Bonneville Locks and Dam, Columbia River

by Ronald T. Wooley

Prepared for U.S. Army Engineer District, Portland Portland, OR 97208-2946

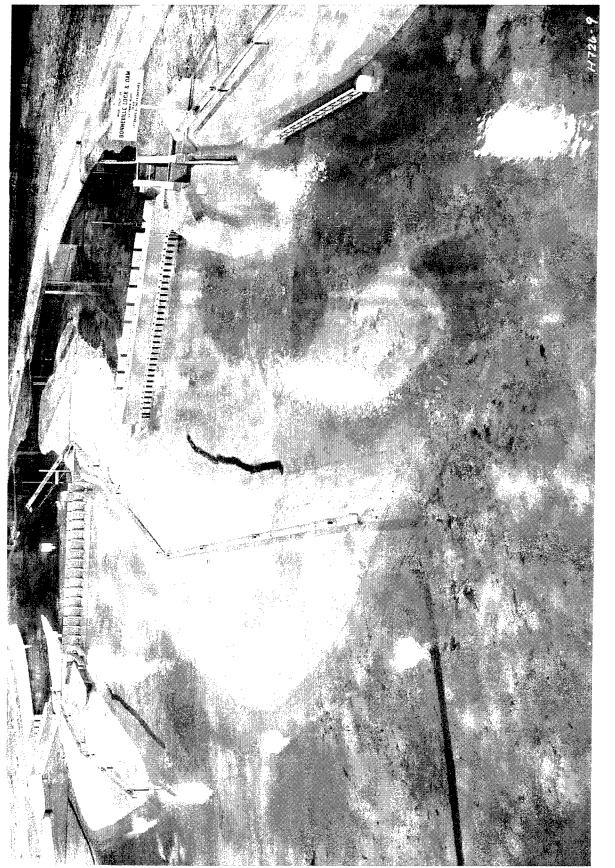
Existing structures, looking upstream from left to right, second powerhouse, spillway, first powerhouse, and existing lock Figure 3. 11

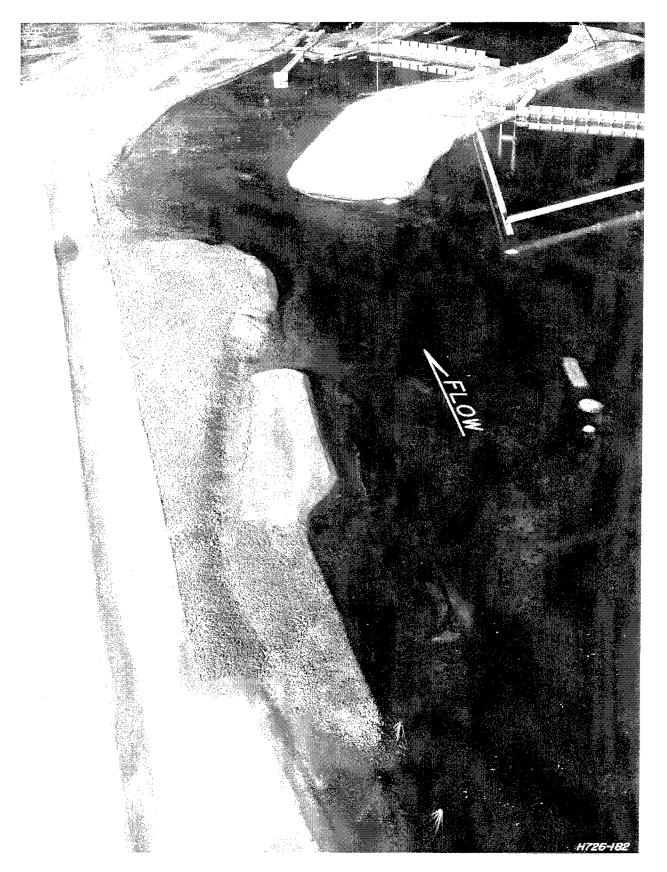
Photo 5. Plan F, looking downstream showing channel alignment

- h. A 50-ft-diam protection cell was placed along the left bank of the canal near the river channel.
- *i*. A fill with top el 81.0 was placed along the left bank upstream of Eagle Point. A berm located near the upstream end of the fill with top el 51.0 allowed tows to use the existing mooring dolphins. The fill was designated Goose Island (see Photo 5).
