DOT/FAA/AM-98/13

A Human Factors Perspective on Human External Loads

Randa L. Shehab Robert E. Schlegel The University of Oklahoma School of Industrial Engineering Norman Oklahoma 73019-0631

May 1998

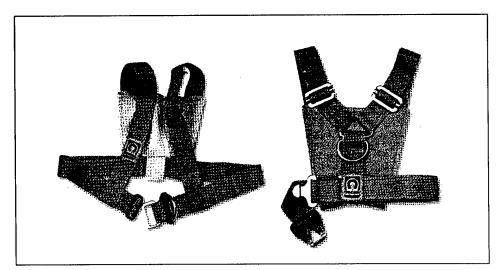
Figure 2. Safety Harnesses (Mustang Survival).

One of the more basic devices provided by HEL manufacturers is variously known as a safety harness, a rescue swimmer's harness, or a chest harness. Typically, these harnesses consist of shoulder straps attached to a waist or chest belt. The design of the straps varies. Some harnesses incorporate suspender style straps with the tether point-of-attachment at a D-ring on the front center of the chest/waist strap. Others utilize a Y-shaped design (on the front or back) for the harness, where the shoulder straps meet a strap extending vertically from the waist belt to form a threepoint intersection. This design is sometimes used at the chest, at which point a D-ring is used for tether attachment. The harnesses are either designed to be fully adjustable to accommodate a variety of users or are available sized for the individual user. The harness is constructed of nylon webbing with at least a 2 in. width. Custom padding is an optional feature offered by some manufacturers. The harness is designed to support the load (i.e., body weight) by the torso and shoulders of the user. Figure 2 presents two versions of safety harnesses manufactured by Mustang Survival (1)¹. These types of harnesses are utilized to transport or suspend people from helicopters for short durations.

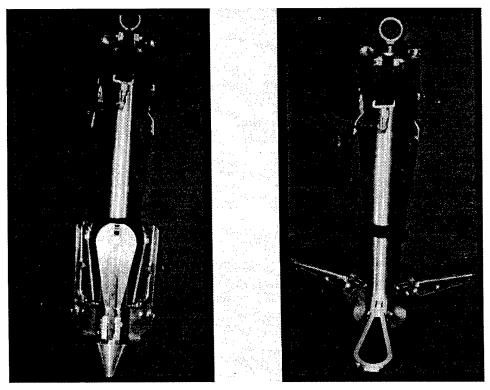
Figure 7. Forest Penetrator Rescue Seat (Life Support International, Inc.).

A different HEL device, the rescue seat, is patterned after the military jungle penetrator. The rescue seat is a vertical metal bar with seats that extend from the bottom end and retention straps that are attached at the top. In the stowed position, the rescue seat is about 3 ft. long and 9 in. in diameter. The model, marketed by Life Support International, Inc. (6), and shown in Figure 7, includes 3 easily extended seats positioned at equal intervals around the center bar. Although it is intended for 1 user, 3 people can be hoisted in emergency situations. This device could be utilized for passive, short-haul operations, but this would require securing the individual's legs as well. The rescue seat marketed by Lifesaving Systems Corporation is very similar, with the exception of the seat design. This device provides only 2 folding seats positioned on opposite sides; both seats are equipped with safety straps. The primary use for these devices is short-haul transport operations. Rescue seats are not suitable as work platforms.

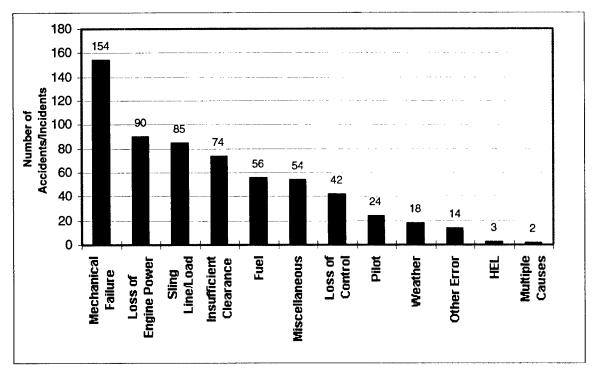
Figure 11. Number of Rotorcraft Accidents/Incidents by Cause (N=616).

A histogram detailing the number of external load rotorcraft accidents/incidents by cause is presented in Figure 11. Figure 12 presents the categorization as a percentage of total accidents/incidents. As shown in both figures, mechanical failure was involved in the largest number of accidents. One hundred fifty-four (25%) helicopter accidents resulted from some form of mechanical failure; mechanical failure implied failure of the airframe, a component, or system due to material fatigue. Loss of engine power was the second most common cause, contributing to 90 events, or 15% of all rotorcraft accidents. Engine power was lost either totally or partially and was typically due to specific mechanical failures and malfunctions of the engine.

A similar number of accidents was associated with improper use of the sling line/load. Eighty-five accidents (14%) occurred from tangled sling lines, insufficient load clearance, excessive load weight, etc. Obviously, these accidents occurred during external load operations. Seventy-four accidents (12%) resulted from a lack of sufficient clearance for the rotors or the skid. In these situations, it is felt that the pilot may have been focusing on external factors (such as external loads) and neglected to assure sufficient clearance for the rotorcraft. The remaining 214 events were distributed among 8 categories, including (in descending order of frequency) fuel exhaustion or contamination, miscellaneous factors (all accidents that did not fall within the defined categories), loss of

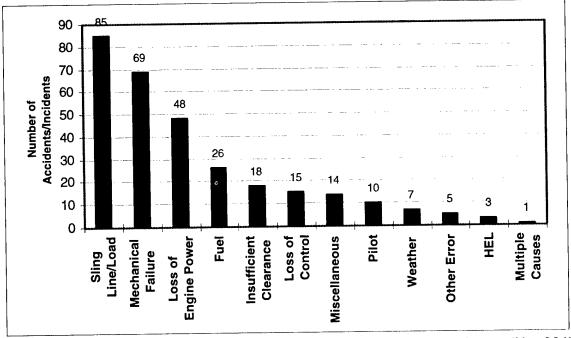
Figure 13. Accidents/Incidents During External Load Operations by Cause (N = 301).

Figures 13 and 14 display the categorized data for the number and frequency, respectively, of accidents/incidents occurring during external load operations. The charts show that the predominant cause of external load accidents (85 accidents or 28%) was problems with the sling line/load. Specifically, 28 accidents were attributed to failure to maintain sufficient clearance for the sling line or load. The typical scenario in these accidents was that the load, cargo hook, or cargo basket was dragged along the ground and became snagged on an environmental obstruction. In most cases, these were initiating events that led to the accident's direct causes, including the line rebounding into the rotor, the load falling and hitting a member of the ground crew, failed load release, or losing control of the helicopter. Twenty-four accidents involved the sling line becoming tangled in the tail or main rotor. Often, these accidents were due to turbulent winds, shifting loads, unweighted lines, inappropriate line tension, incorrect line length, failed emergency release, or other inappropriate operations. These accidents were the most critical, as evidenced by the highest frequency and severity of injuries. In 16 events, the weight of the load exceeded the maximum rated capacity of the helicopter. The remaining 17 events involving the sling line or load were distributed among excessive load swing, broken sling line, and sling line caught on the skid.

The second most common condition contributing to accidents/incidents was mechanical failure. Sixtynine events (23%) were attributed to some form of mechanical failure of the airframe, components, or system, that occurred either during or immediately after an external load operation. This number represents almost half (45%) of all mechanical rotorcraft failures. It was anticipated that, although the external load was not the direct cause of the accident, the continual excess loading of the helicopter under external load operations would be an important factor leading to an increased occurrence of mechanical failure. This was not realized in the data as the proportion of mechanical failures during external load operations (23%) was actually less than the overall rate of mechanical failures (25%).
