Interim Runway Visual Range (RVR)/ Automated Surface Observing System (ASOS) Interface Regression Operational Test and Evaluation (OT&E) Report

August 1998

DOT/FAA/CT-TN98/14

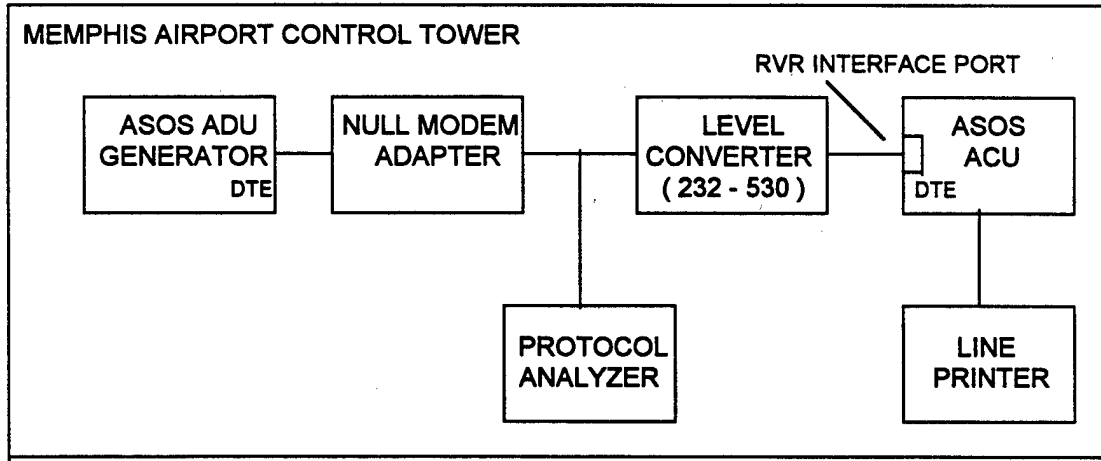
The ASOS ADU generator was connected to ASOS as shown in figure 4.5.1.2-1. ASOS was initialized with its operational software during test setup.

FIGURE 4.5.1.2-1. SIMULATED RVR TO ASOS TEST SETUP

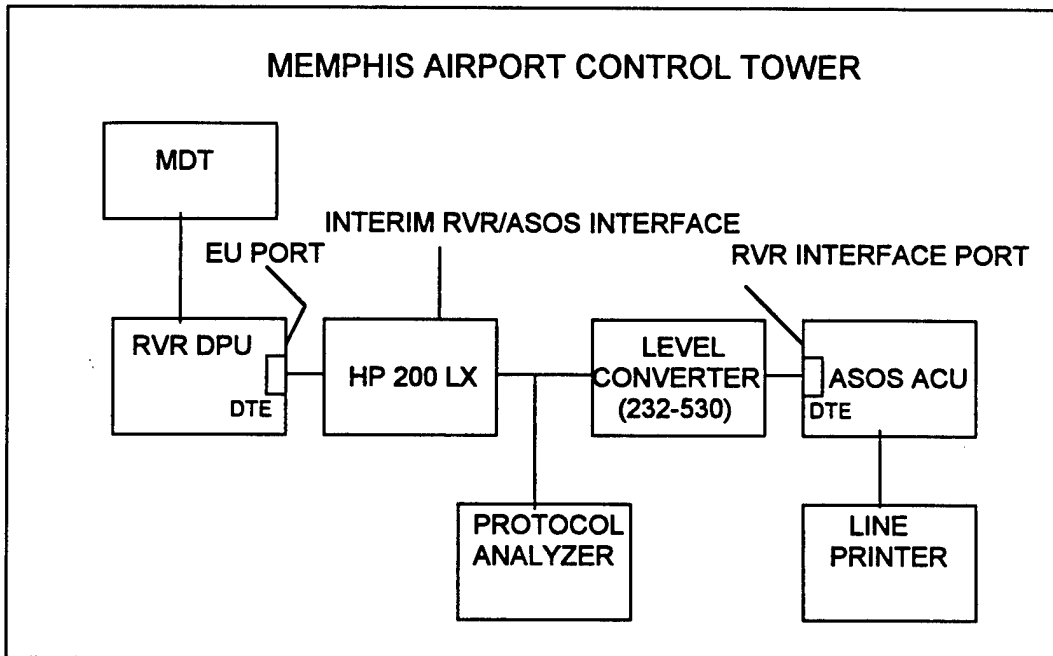
Data collection devices, test equipment, and the RVR/ASOS interface were connected as shown in figure 4.5.2.2.1-1.

FIGURE 4.5.2.2.1-1. OPERATIONAL PROCEDURE TEST SETUP

Test setup for Operational Procedure Test Part 2 remained as shown in figure 4.5.2.2.1-1.
